## Technical Memorandum

**Re:** Gene Coulon Park Shoreline Habitat Monitoring – Baseline Survey

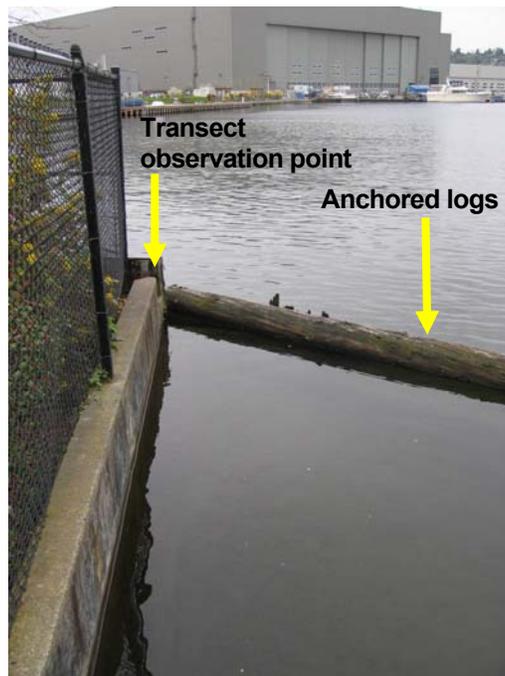
Transect 1 was different from the other transects in that it was not possible to set a true transect from the start location. Rather, the general area was characterized by recording visual and depth observations from a single observation point at the corner of the anchored logs and the seawall, because water depth was too great to wade waterward of the seawall (Photo 1). It is notable that the bridge crossing from the mainland to the bridge at Bird Island is armored with several anchored logs spanning the length of the bridge and extending from the seawall to the northwest bridge footing. Water depth as measured inside the anchored log at the southwest corner of the seawall/bridge was 7.2 feet with a fine (sand) substrate; outside the anchored logs, depth was 2.1 feet and the substrate was fines (sand) and gravel. Because the seawall and anchored logs adequately protect the shore from erosion in the area from the mainland to Bird Island, any erosion issues that may occur in this area in the future could potentially be expressed as evidence of coarser substrate and/or an undermining of the seawall (i.e., one would expect a greater water depth at the locations measured in this survey).

**Photo 1**  
**Deep water at observation point at**  
**Transect 1, looking southwest**

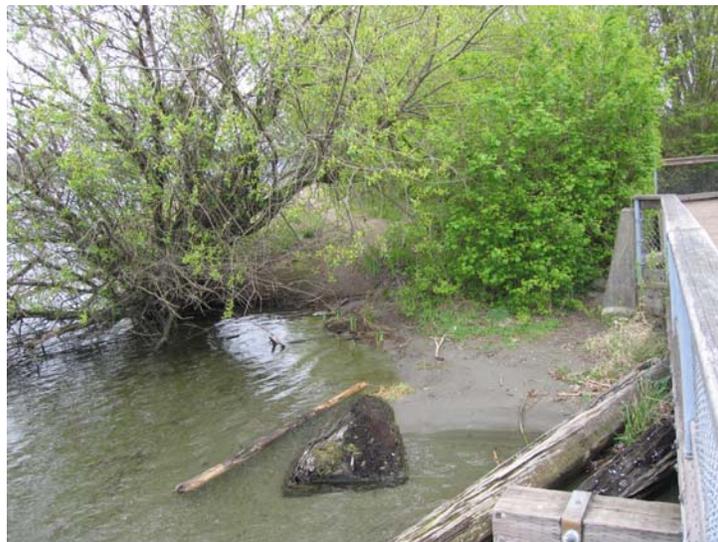
Transect 2 extended from the muddy area at the northwest Bird Island bridge footing out into the littoral zone toward the Southport development (Photo 2). This area has a small, protected cove near the bridge footing. Water depths ranged from 0 feet at the start of the transect to 4.1 feet at the end of the 42-foot-long transect. Substrate ranged from fines (sand) at the start of the transect to pebbles in the middle, transitioning to fines (muck) at the deepest end of the transect (Attachment A). Future erosion issues in this area could potentially be expressed as the disappearance of the muck and sand and/or replacement by a coarser substrate.

**Photo 2**  
**Shallow-water area at northwest Bird Island bridge footing, looking northeast**

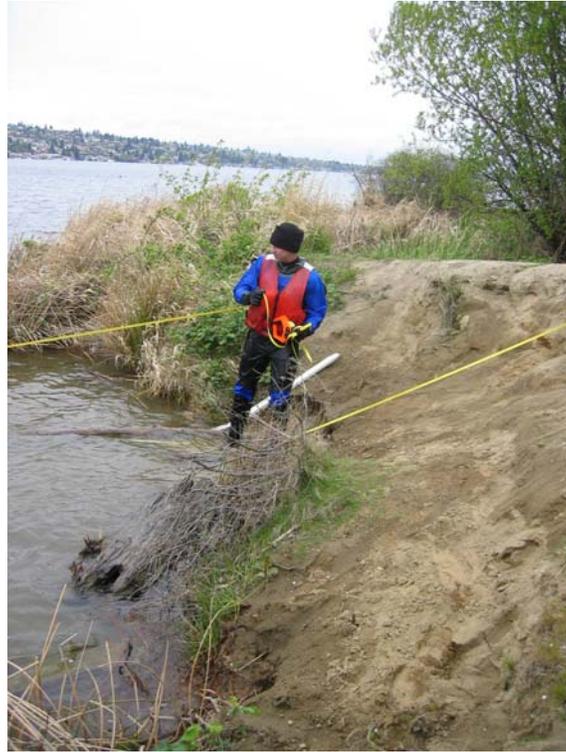
Transect 3 extended waterward from a short, highly eroding escarpment bluff on the southwest side of Bird Island (Photo 3). The short bluff is already approximately 5 feet in height from the waterline to the top of the bank, and is actively eroding in large chunks (Photo 4). The area evidently receives heavy amounts of foot traffic, as it contains several informal bootpaths and displays compacted vegetation and soil. Water depths ranged from 0 feet to 5.4 feet at the end of the 90 foot long transect, and substrate ranged from fines (muck) at the end of the transect to gravel and pebble in the middle, to sand at the shoreline. In this area, future erosion could potentially be expressed as increased subsidence of the bluff, deepening of the offshore shelf waterward of this bluff, and/or more coarse offshore substrates.

**Photo 3**  
**Short bluffs at shore of southwest Bird Island, looking west**

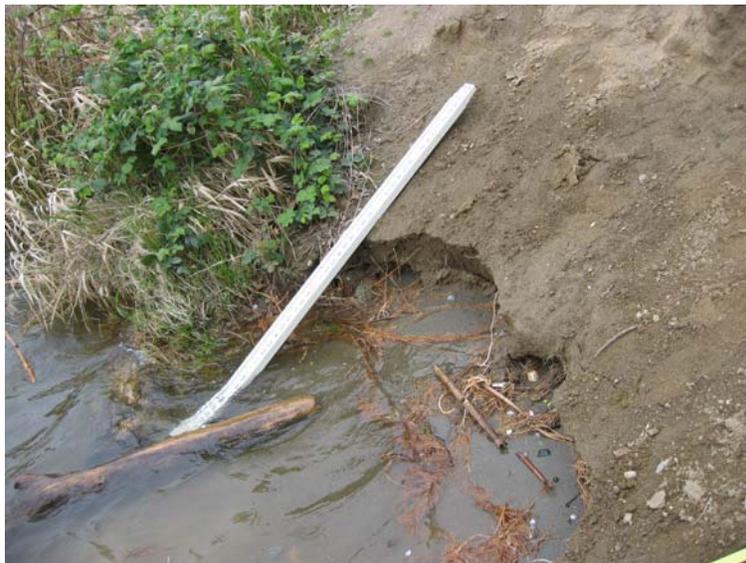
**Photo 4**  
**Active erosion at shore of southwest Bird Island (with 4-foot-long stadia rod for scale)**

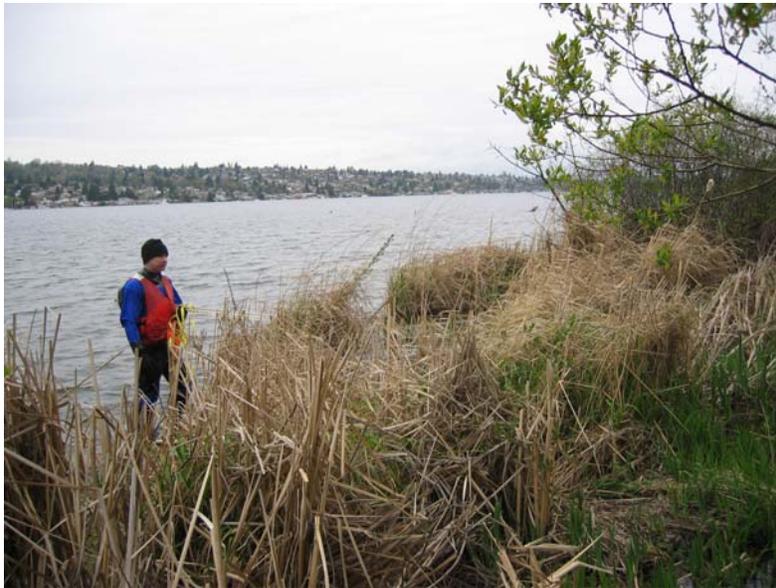
Transect 4 extended waterward from a freshwater marsh (rushes, cattail, and reed canary grass) into the lake (Photo 5). Water depths ranged from 0 to 3.2 feet at the end of this 150 foot long transect, and substrate was mostly fines (sand) throughout the transect, with some occurrences of cobble and gravel. There was a small low/backwater area behind (east of) the marsh that likely floods at higher lake levels; this had standing water of several inches at the time of the site visit. Shoreline erosion in this area could potentially be expressed as disappearance of the existing fine substrates, shoreline retreat, and/or die-off of marsh vegetation as wave energy increases.

**Photo 5**  
**Freshwater marsh at northwest side of Bird Island,**  
**looking west**

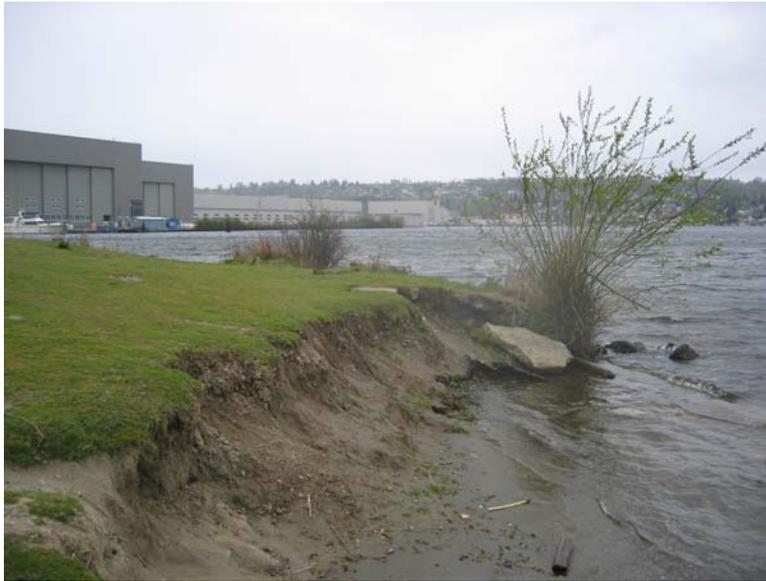
Transect 5 extended waterward from the northwest shore of Bird Island into the lake. Water depths ranged from 0 feet to 3.5 feet at the end of this 100-foot-long transect. The substrate was characterized by fines (sand/silt) at the deep end of the transect; to cobble, pebble, and concrete rubble near the shore. This area has an extended area of active erosion at the northern point of Bird Island (Photo 6), which exhibits scattered concrete rubble and angular rock (riprap) armoring that increases toward the east. Rounding the tip of Bird Island to the east, erosive banks have increasing height, from several inches at the west side, to more than 2 feet on the

**Photo 6**  
**Active erosion on northwest tip of Bird Island, looking southwest**

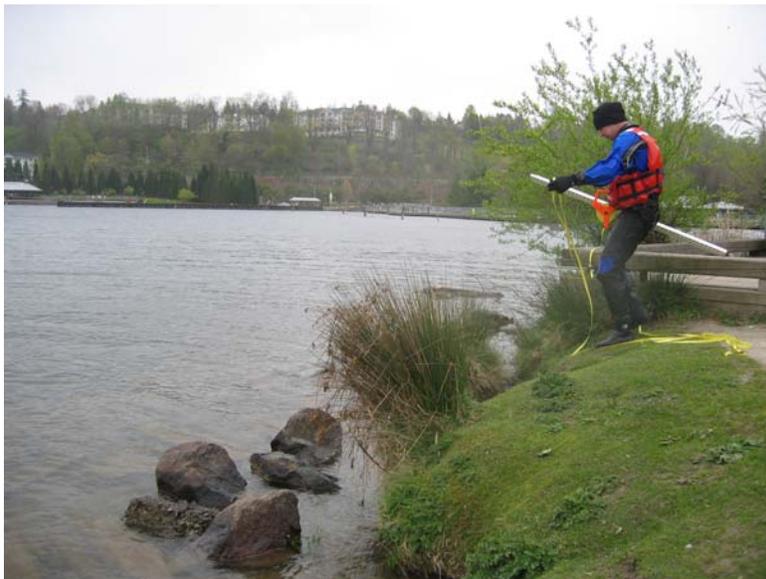
eastern tip of the island, and are slightly undercut in several places (Photo 7). Shoreline erosion in this area could potentially be expressed as a marked increase in retreat of the shoreline above existing conditions.

**Photo 7**  
**Concrete rubble, angular rock, and undercut banks at north east tip of Bird Island, looking northeast**

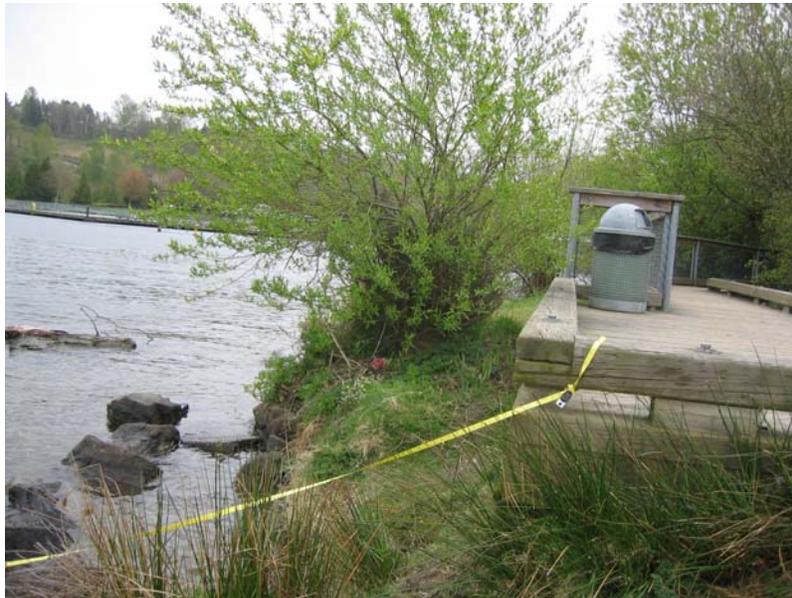
Transect 6 extended waterward from the northeast tip of the boardwalk footing, eastward into the lake. Water depths ranged from 0 feet to 3.9 feet at the end of this 50-foot-long transect. The substrate was characterized by fines (muck) at the deep end of the transect, to cobble, pebble and armoring rubble at the shore. The shore in this area does not appear to be eroding as actively as the rest of the park, as it receives some protection with angular rock, concrete rubble armoring, and the roots of shoreline vegetation (Photo 8). Future erosion issues in this area could be potentially expressed as a retreat of the vegetation, shoreline retreat, and an increase in the existing undercut banks.

**Photo 8**  
**Concrete rubble, angular rock, and undercut banks at northeast tip of Bird Island, looking northeast**
