Reconnaissance study of landslides related to the January 2009 storm in the Acme Watershed

January 2010

By
Jack Powell, LEG, LHG
Leslie Lingley, LEG
Garth Anderson, LEG

Washington State Department of
Natural Resources
Forest Practices Division
Olympia, Washington

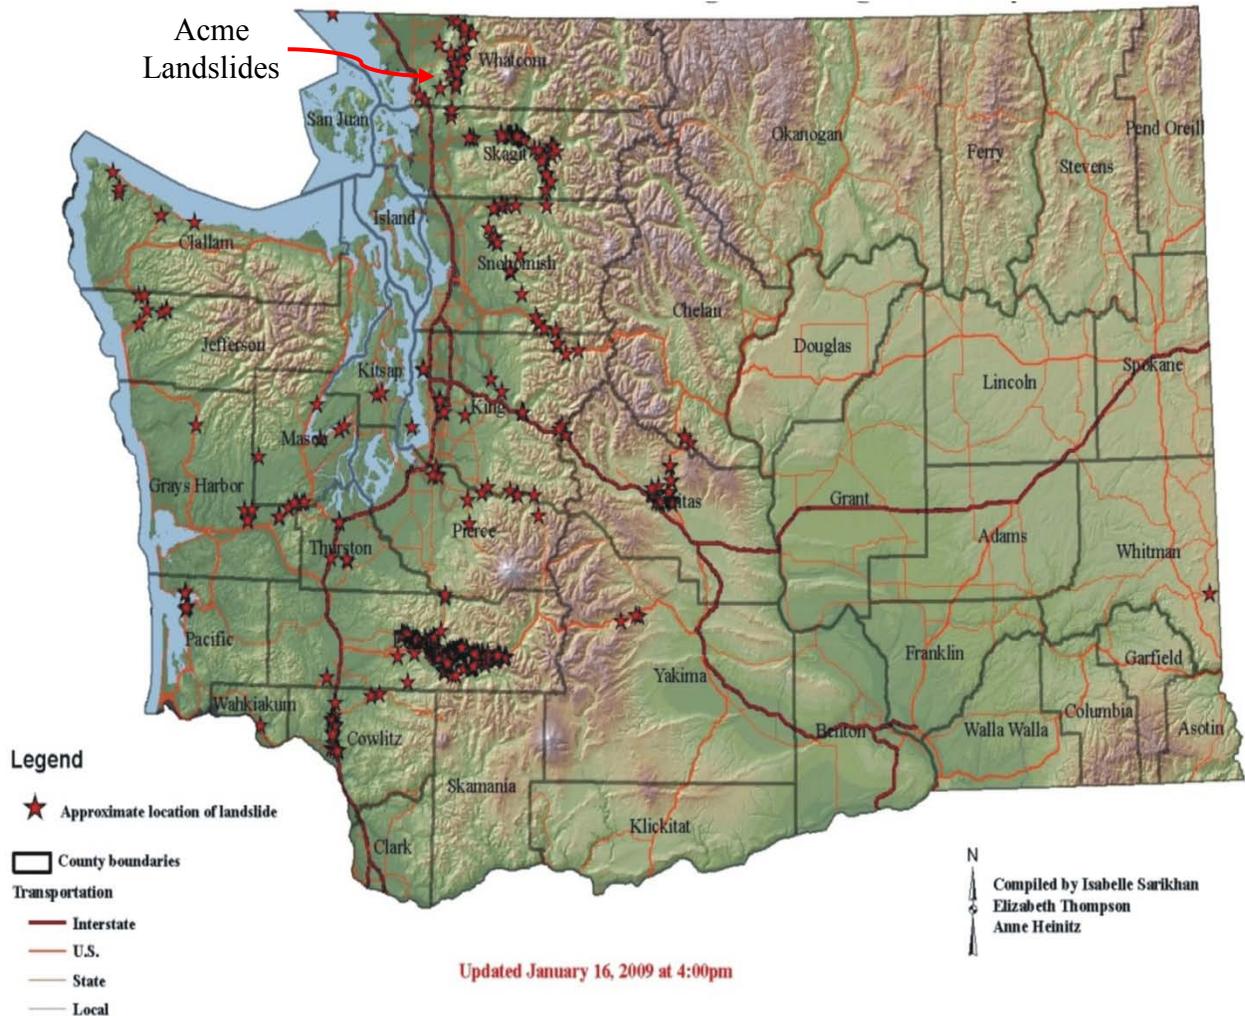
An analysis of the January 2009 storm is presented in Grizzel and others (2009) who report that about 5.0 inches of rain fell in 24 hours and about 7.3 inches of rain fell during a 48 hour period. In addition, they note that 12 to 18 inches of snow was present at lower elevations prior to the storm, but most of this accumulation melted below 1,000 feet elevation during the storm. Their conclusion is that the rainfall return interval for the storm is on the order of 50 to 100 years (note that these values are probabilities, and as a consequence, fewer or more storms of this magnitude may actually occur during any given 50 to 100 year time period). Statewide, the 2009 storm event produced several clusters of landslides (Fig. 2).

Figure 2. Landslide locations from the January 2009 storm event (modified from Sarikhan, 2009). Also see http://www.dnr.wa.gov/ResearchScience/Topics/GeologicHazardsMapping/Pages/ger_quickreport.aspx.

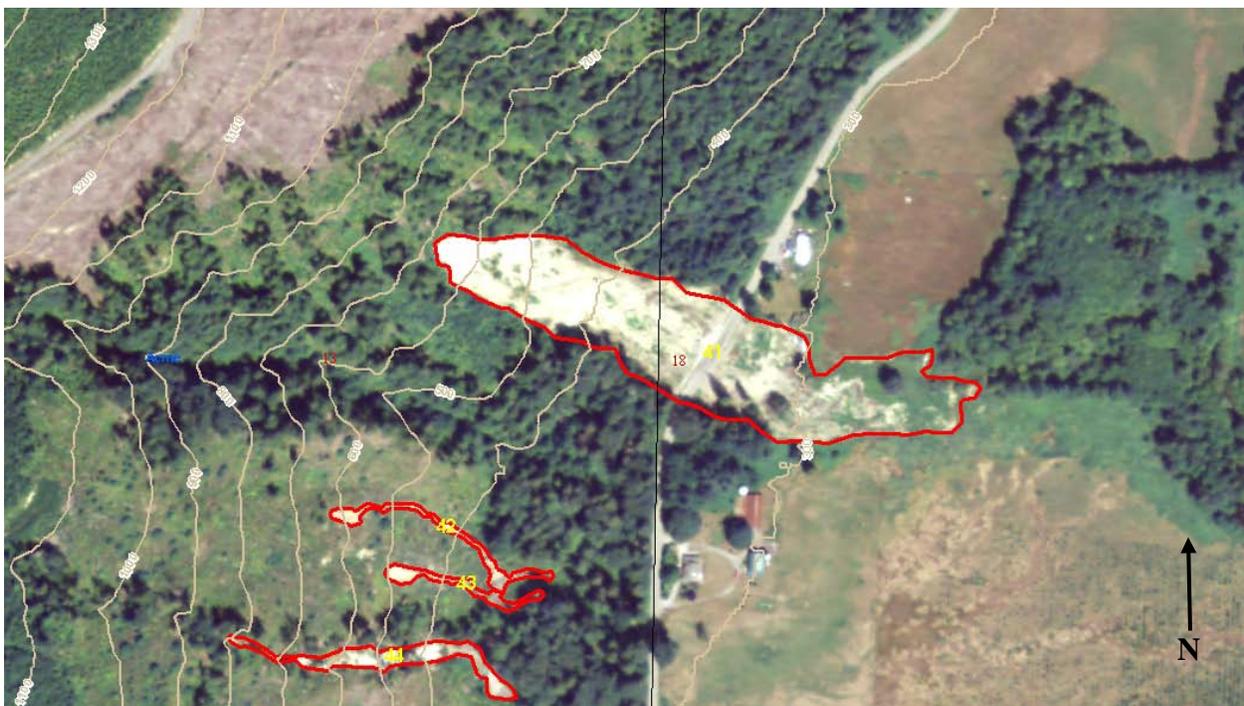
Figure 4 shows a typical debris avalanche in the Acme watershed.

Figure 4. Air photo of a debris avalanche north of Sygitowicz Creek. The landslide area is approximately six acres.

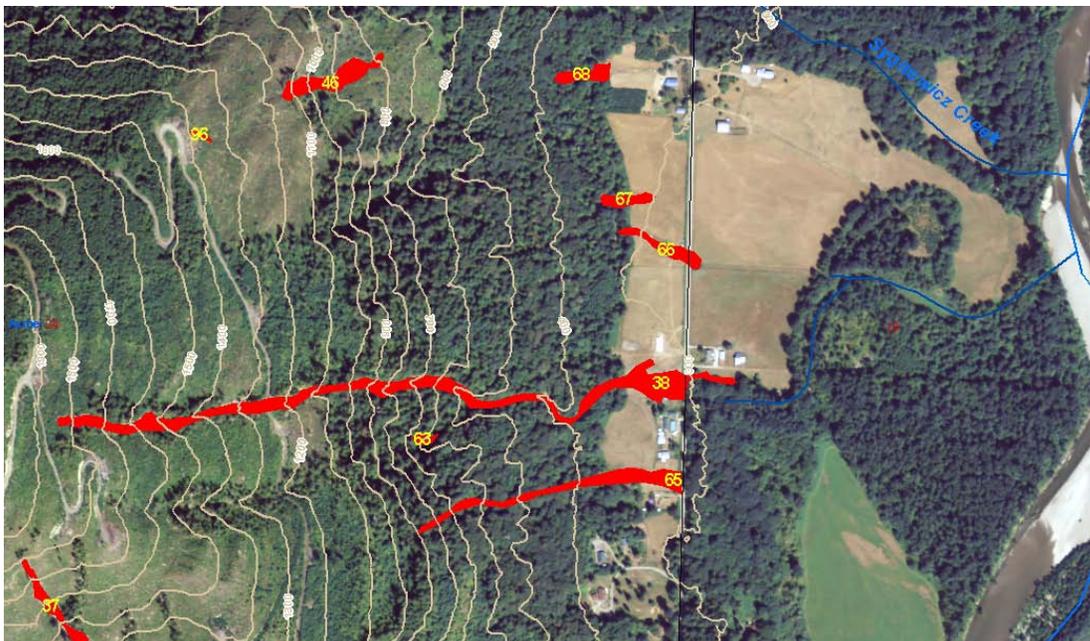
Some landslides deposited sediment and debris on the South Fork Nooksack River Valley; several of which impacted private property or public infrastructure. For example, Figure 11 shows impacts of debris flows delivering to the valley bottom of the South Fork Nooksack Valley south of Sygitowicz Creek.

Figure 11. NAIP orthophoto image flown in August 2009 showing several debris flows (red) south of Sygitowicz Creek. Numbers refer to landslide Inventory numbers in Appendix A

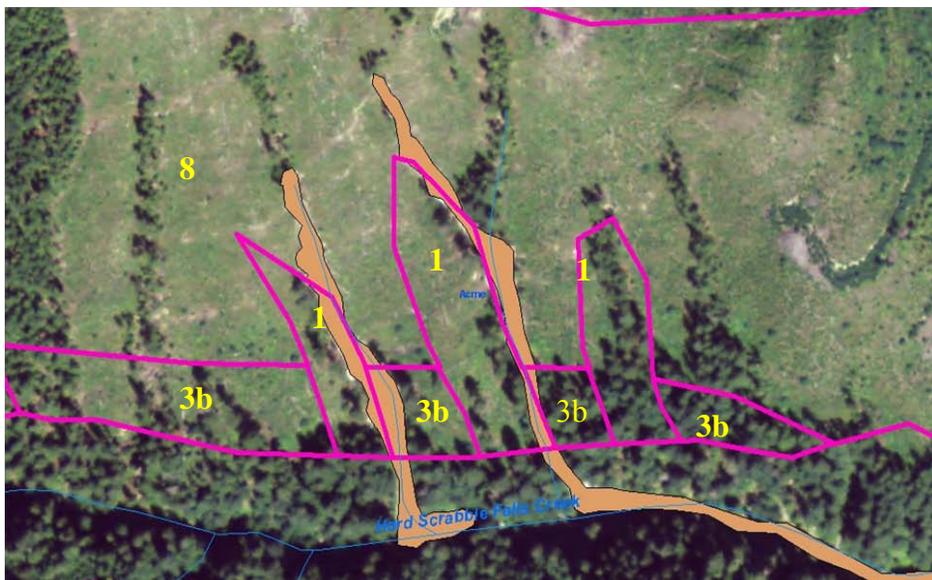
Figure 16. Acme Watershed MWMUs (magenta polygons with yellow labels) overlain on 2009 NAIP orthophoto imagery. Two debris flows that probably occurred in 2009 are shown in orange.

Some MWMU boundaries do not correspond with current digital information, orthophotography, and/or lidar imagery. Some MWMUs defined by Benda and Coho can be mapped with greater accuracy using this current technology (Fig. 16). For example, the buffered area for MWMU #1, shown by strips of timber in obvious bedrock hollows meets the goal of the MWMU #1 prescriptions, but does not correspond to the MWMU boundary as taken from the DNR database. The initiation areas of these landslides would have been tallied in MWMU #8, which suggests that land sliding should be rare or non-existent. However, we determined these two landslides are actually MWMU #1. Apparently in the example above, the layout of harvest units left on the
