INACTIVE AND ABANDONED MINE LANDS— Van Stone mine, Northport Mining District, Stevens County, Washington

by Fritz E. Wolff,
Donald T. McKay, Jr.,
and David K. Norman

WASHINGTON
DIVISION OF GEOLOGY
AND EARTH RESOURCES
Information Circular 100
December 2005

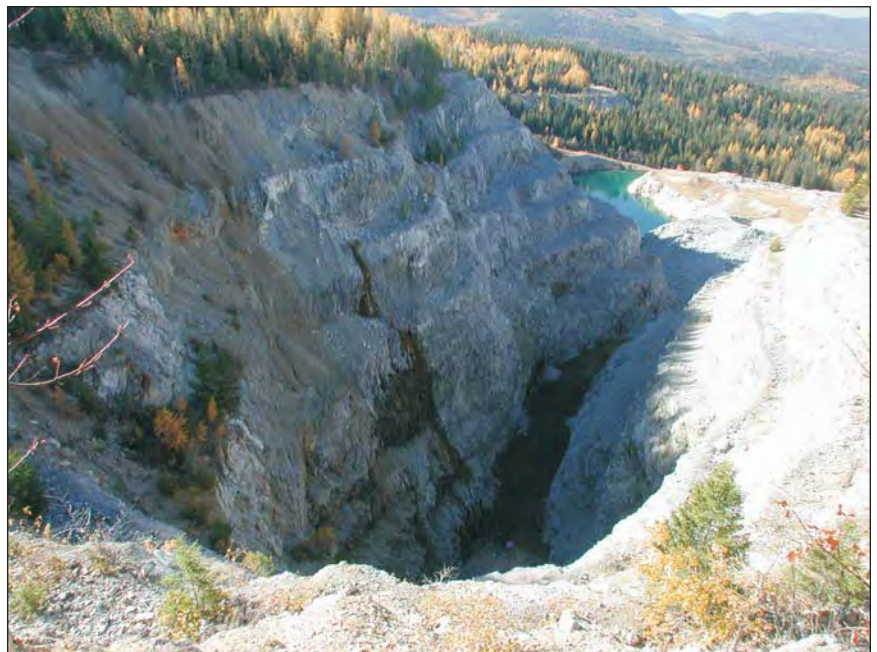
Figure 3. Overview of the North pit (foreground) and West End pit (background) with pit lake. View to the west.

The North pit (Figs. 3–5) is a composite of two different operations separated in time, but contiguous geographically. We refer to the area mined initially by Asarco as the North pit high-wall and the area mined by Equinox as the West End pit. The North pit highwall excavation is 400 feet wide rim-to-rim and approximately 1000 feet long. Its longitudinal axis strikes N80E. The floor is littered with boulders and scree. The pit walls show significant structural cracks and signs of failure. The difference between the highest rim elevation and the pit floor is approximately 430 feet. The area is inaccessible except by helicopter or boat because the benches transition into cliff bands and the West End pit lake prohibits land access at the pit floor.

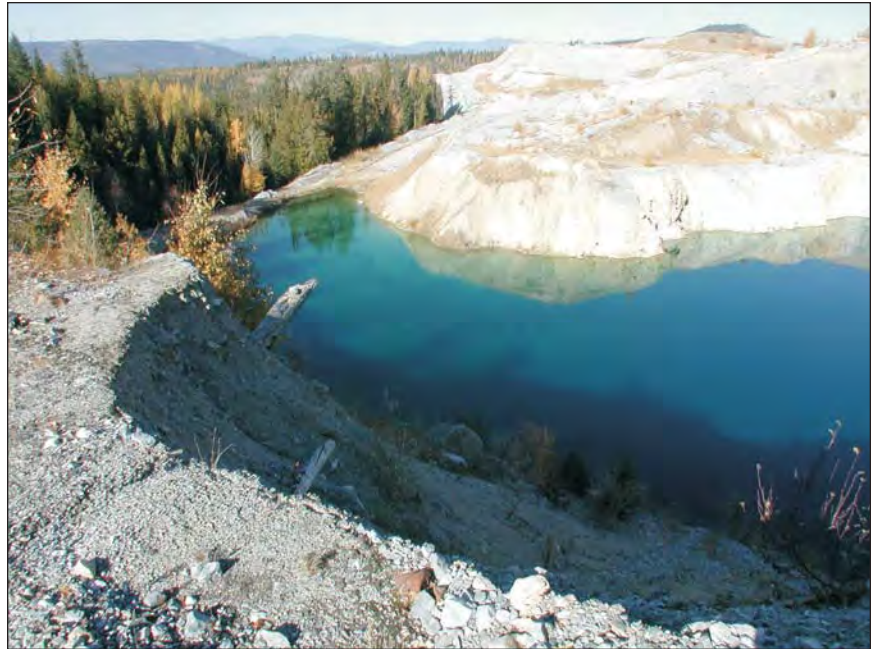
Figure 4. West End pit lake. Note glacial alluvium slope in foreground. View to the northwest.

The West End pit is 700 feet long and 700 feet wide, including pit walls. With the exception of an unexcavated blast at a bench on the north side of the lake, all the mining done by Equinox was below the current water level at elevation 3510 down to elevation 3400 (Randy Miller, caretaker, written commun., 2003). The south bank of the lake is a steep and badly eroding exposure of glacial alluvium.

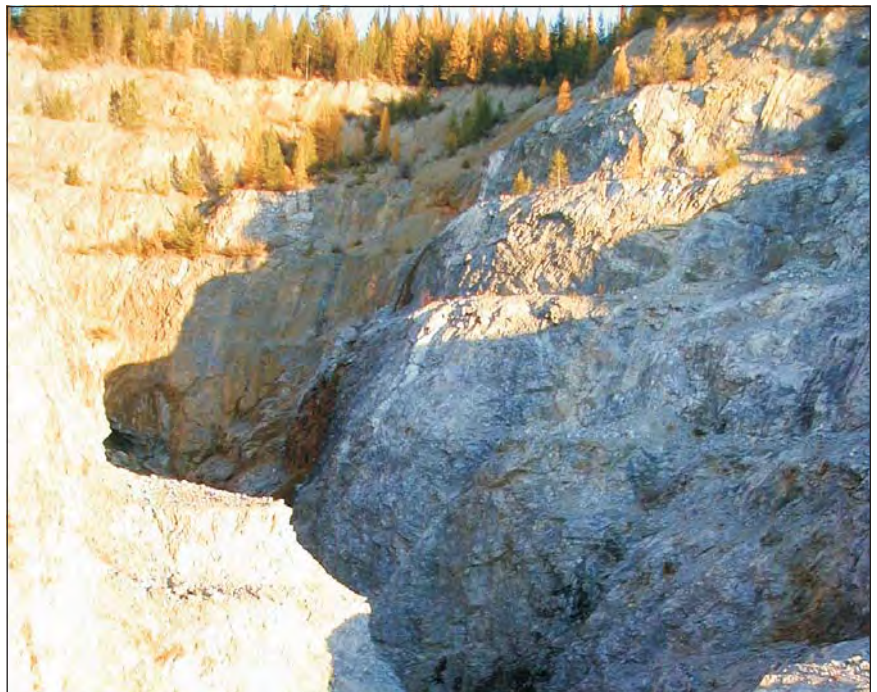
Figure 5. North pit. View to the east.

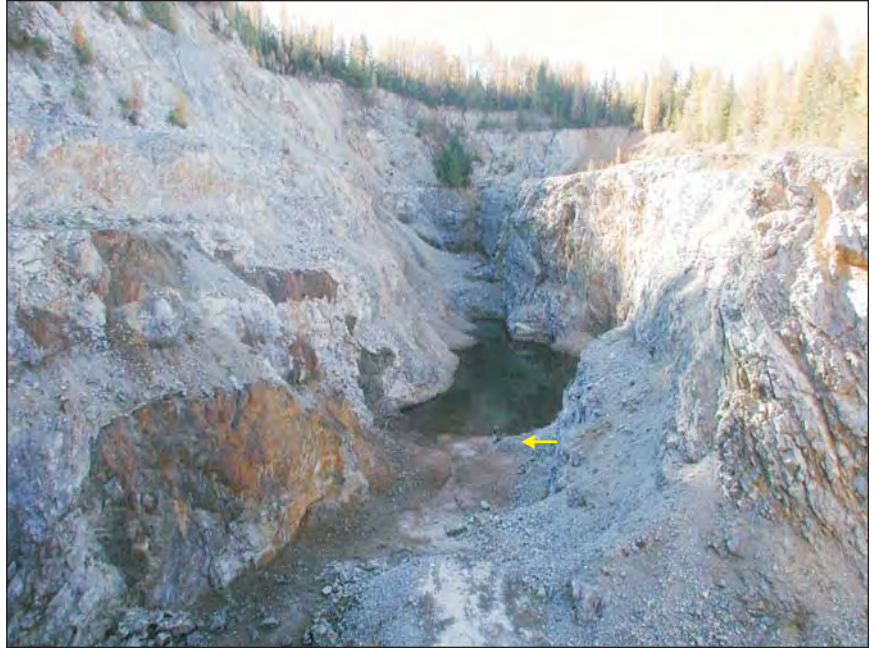
The South pit (Fig. 6) is smaller and structurally in better condition than either end of the North pit. It lies 130 feet above

Figure 6. South pit. Geologist for scale (arrow). View to the south.

the West End outlet dam and approximately 1000 feet south. It resembles a box canyon in that the entry and exit points are through a narrow cut in the northwest corner. Maximum elevation difference from rim to floor is 180 feet. Snowmelt and precipitation have created a lake 2 to 3 feet deep in the center.

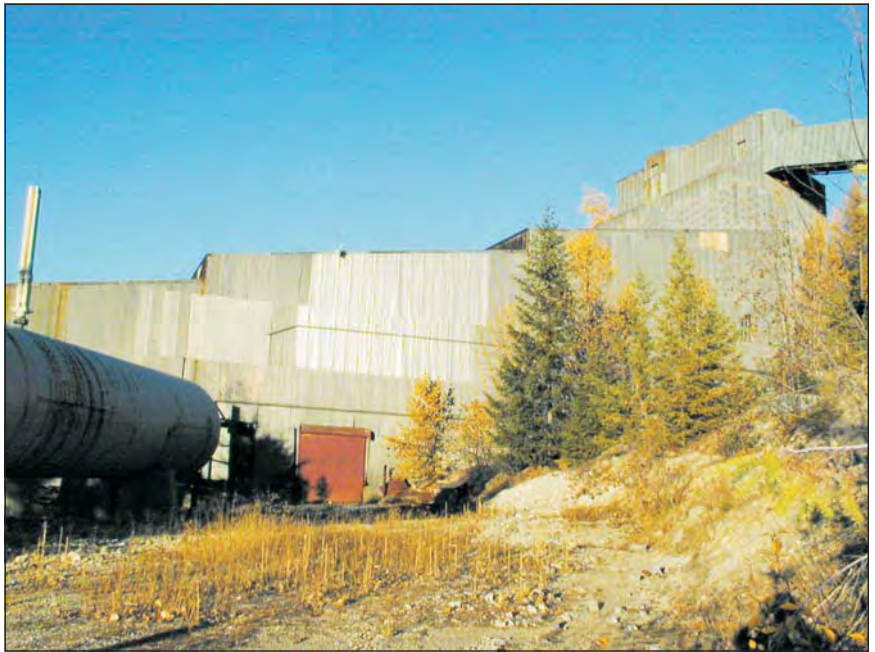
Figure 7. Mill buildings. View to the north.

The mill building and crusher plant are the largest structures on the property (Figs. 7 and 8). Both were in excellent condition in October 2002. A machine shop, warehouse, and receiving shed are located near the north side of the mill. A core-storage shack, assay office, mine office, and scale house are closely spaced along the entry road. A two-ton flatbed truck with hydraulic

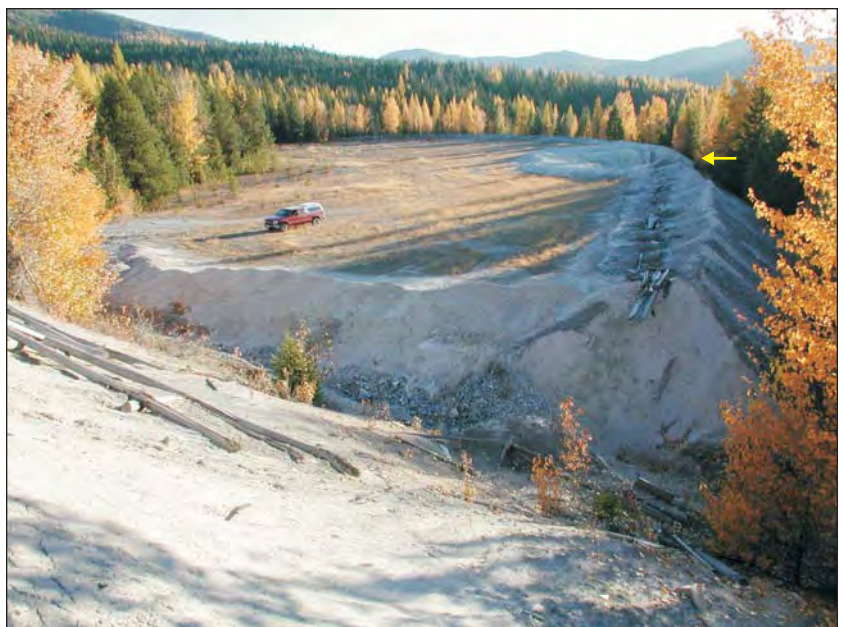
Figure 22. (middle) Upper tailings pond, point of 1961 berm failure in west basin. View to the northwest.

In April 1961, the dam at the western extreme end of the west basin failed (Fig. 22), sending a wall of water down Onion Creek. The flood widened Onion Creek by 20 to 30 feet and created a debris dam that plugged a culvert at the county road and eventually failed. Oddly, we found little evidence of erosion or rilling downslope from the breach. The channel supports a vigorous stand of pine and fir. It appears Asarco abandoned this disposal area soon after the accidental discharge in favor of an 80-acre site in secs. 29 and 30, approximately 2 miles to the northwest. Some revegetation has taken place on the west basin. Equinox installed an 8-inch ABS tailings discharge line to the Upper site in case of failure at the Lower repository. This line, which was never used (Miller, written commun., 2002), can be seen emerging from the forest near the south end of the berm separating the two basins.

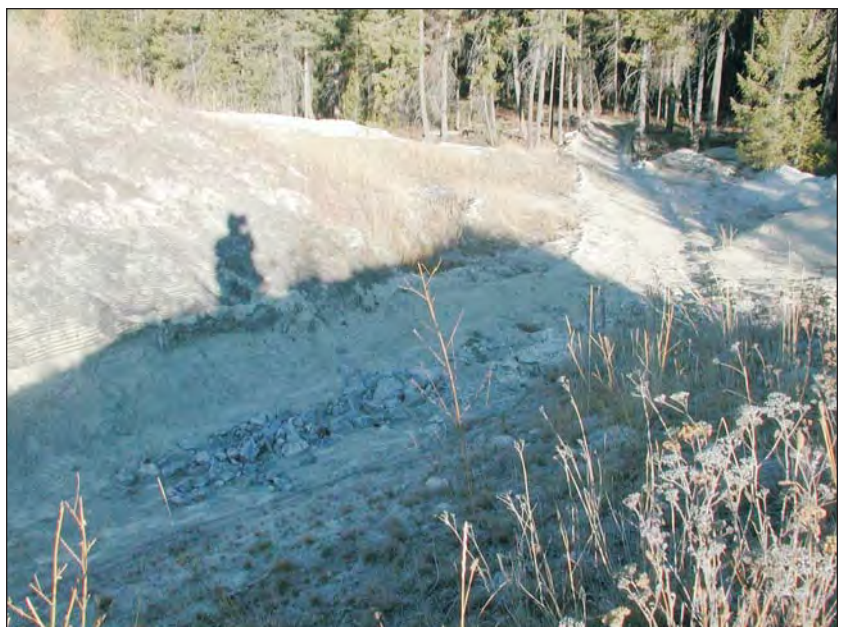
Figure 26. (bottom) Rilling and erosion at the north-west corner of the Lower tailings pond. View to the southwest taken October 2002.

rushes and grass covering about 10 percent of the total surface (Fig. 24). Eight-inch cement-asbestos pipe and wood-stave pipe from the Asarco era lie on the surface in various places. Stacks of black ABS flexible tailings line and 6-inch steel water-return line from the Equinox era are also located at numerous points. According to caretaker Randy Miller (written commun., 2003) all of the tailings produced by Equinox were discharged at the lower site. The height of the impoundment dam varies from 30 feet at the northeast corner to 90 and 100 feet respectively on the south and west extremities. Two lifts are present, separated by a 30-foot-wide bench (Fig. 25). The edges of the berm are rilled with holes, cracks, gullies, and it is piping in places. A chain link fence is intact on parts of the perimeter, but collapsed at other points where the berm has slumped (Fig. 26).

2. *Inspect pond drainage channel before re-cutting. Place Fabric+Rock where needed if existing channel shows signs of erosion. It is very important that this channel be developed and reinforced so a failure similar to the failed west channel will not occur in the future.*

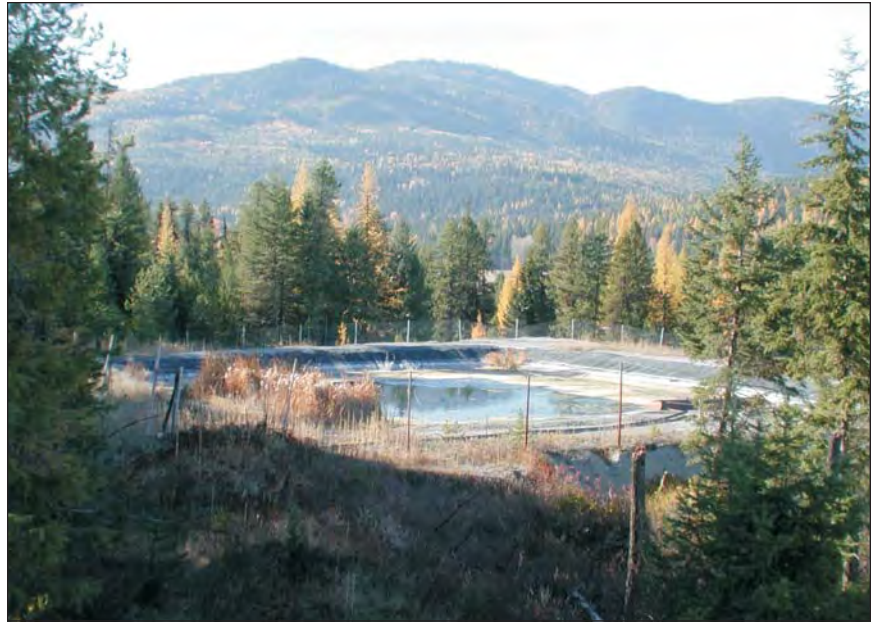
Figure 27. Waste-water retention facility near the Lower tailings pond. View to the southwest.
