**CAPITOL CAMPUS GREENHOUSE SOIL STABILITY INVESTIGATION
STATUS REPORT**

January 19, 1995

Stephen P. Palmer and Wendy J. Gerstel
Washington Department of Natural Resources
Geology and Earth Resources Division
P.O. Box 47007
Olympia, WA 98504-7007
(360) 902-1450

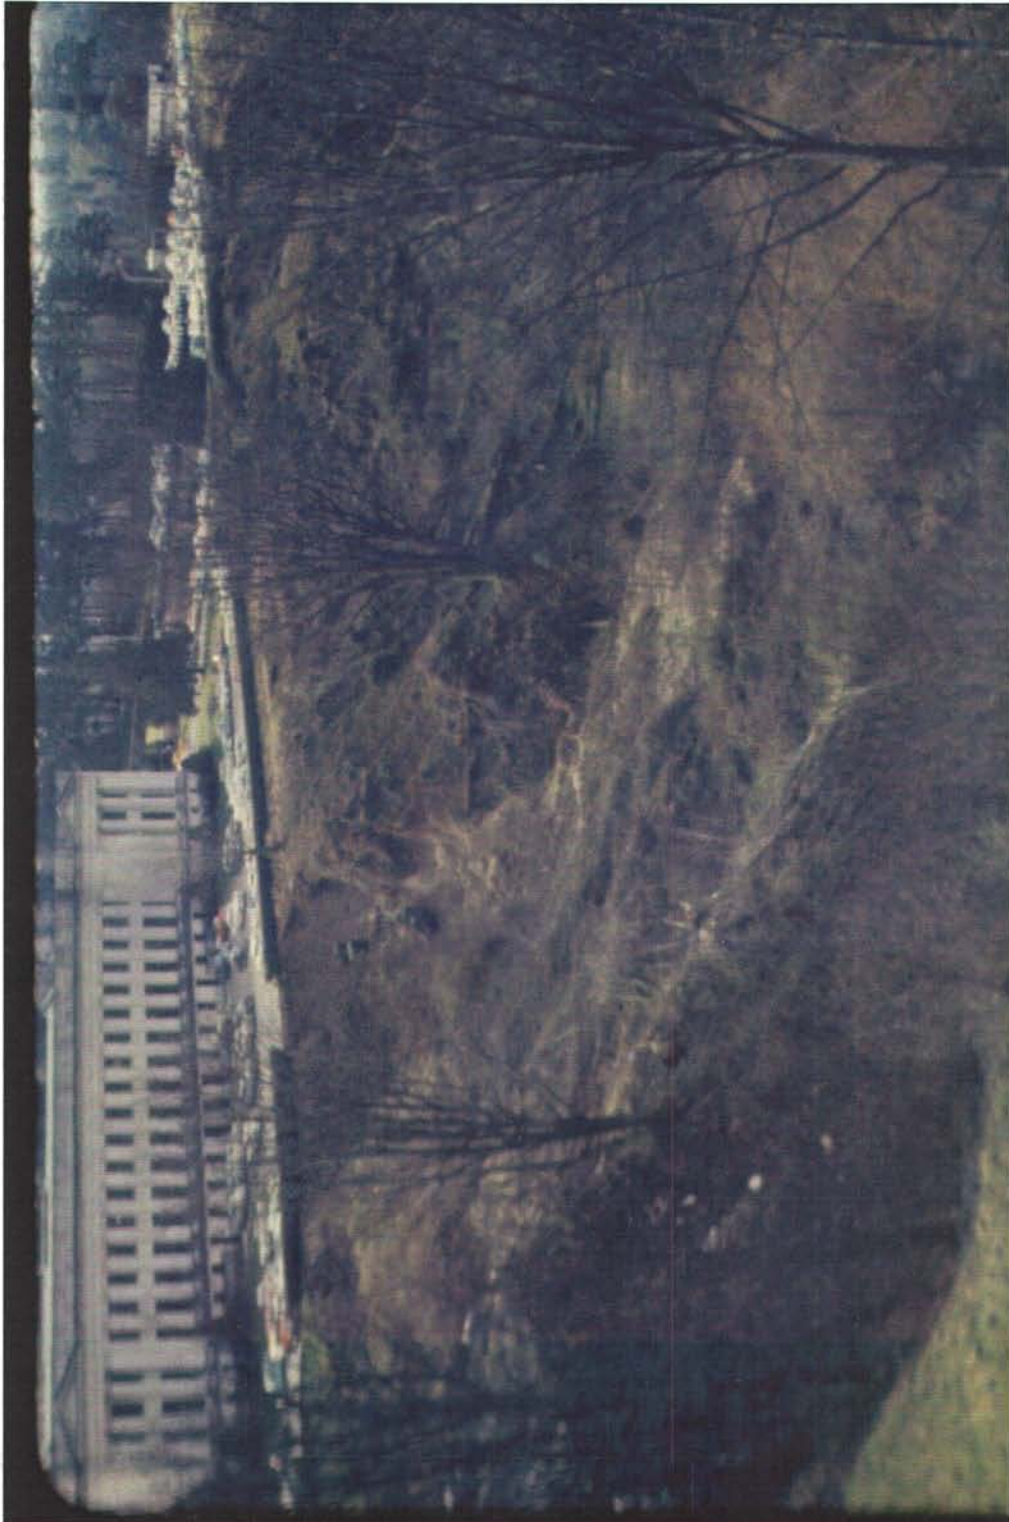
Figure 4 is a picture of a landslide failure on the slope north of the Temple of Justice that occurred during the winter of 1958/59, and Figure 5 is a picture taken recently from approximately the same vantage point. Ritchie and Cashman (1959) report that this particular failure was caused by overflow of surface runoff from the Temple of Justice parking lot onto the slope, which resulted in saturation of the soils and consequent strength loss. They recommended removal of the slide material, and

construction of a rock-filled trench cut down to the underlying consolidated sandy silts. No rock-filled trench was observed during our inspection of this slope.

Figure 4 Landslide failure on the slope north of the Temple of Justice that occurred during the winter of 1958/59. View from north near the Conservatory.

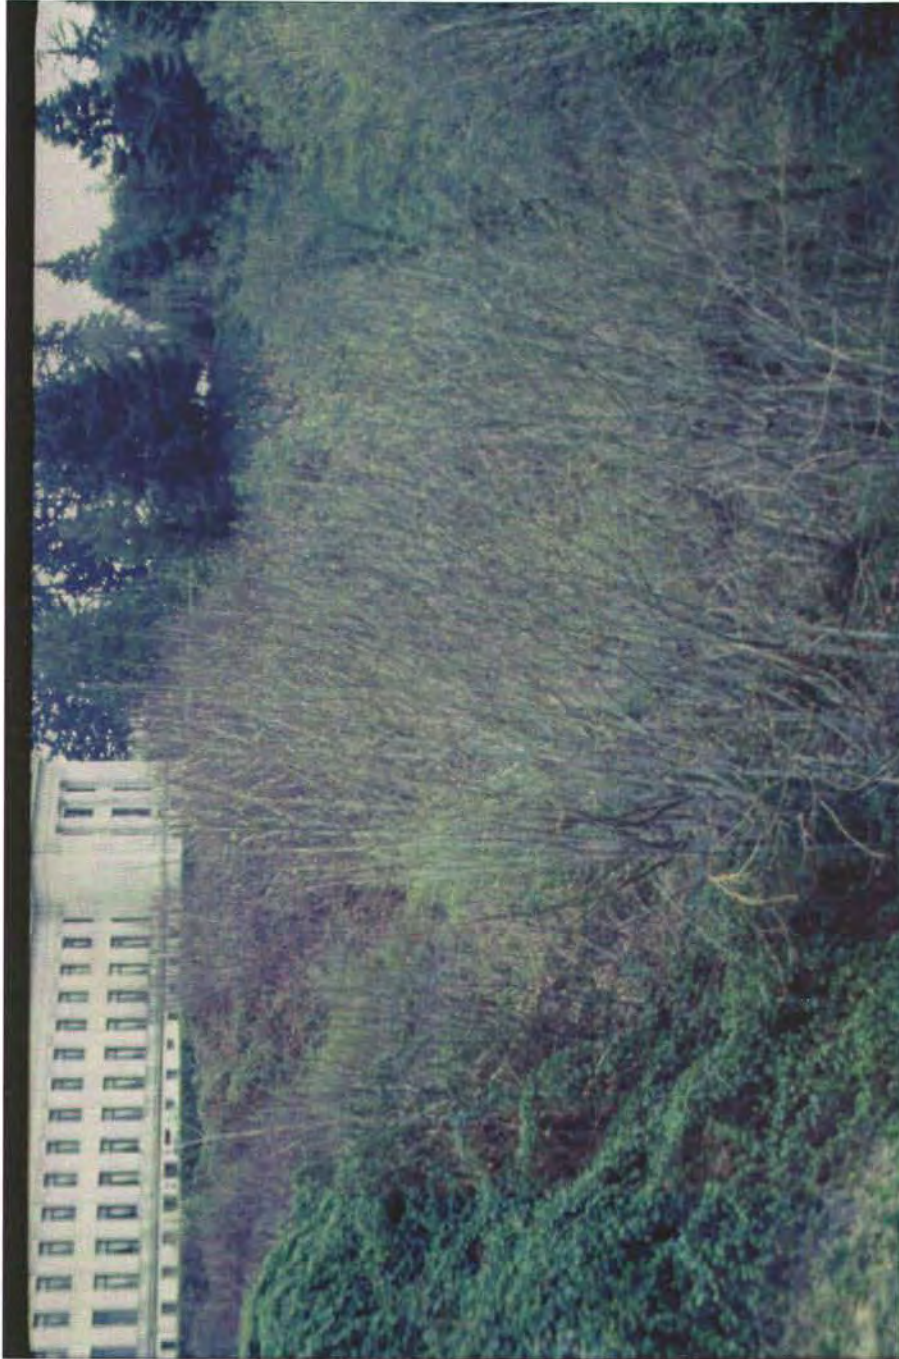
Figure 5 Photograph of the existing slope north of the Temple of Justice from approximately the same vantage point as Figure 4. Note the dense growth of alder and blackberries covering the old landslide scar.

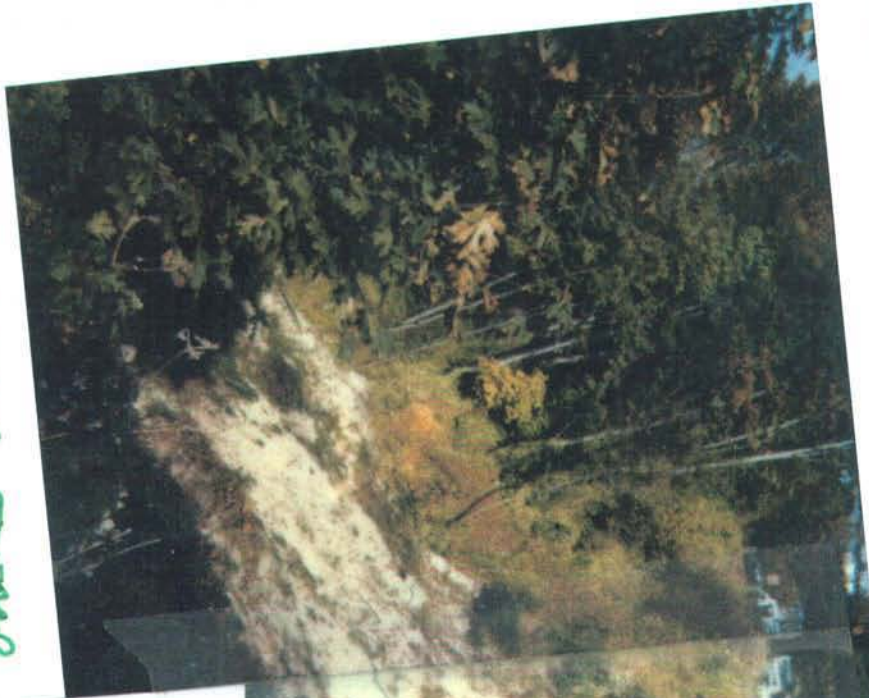
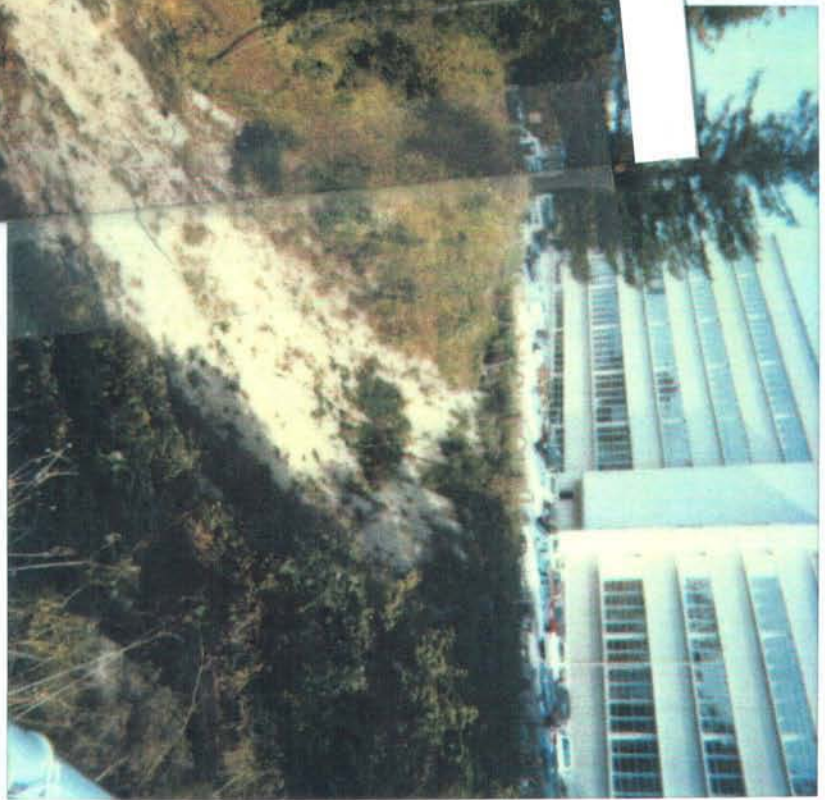
Figure 6 is a picture of the landslide that occurred in the fall of 1987 west of the GA building. To stabilize this failure, a retaining wall was constructed along the north edge of the fill and west of the GA parking lot. Comparison of Figures 4 and 6 shows that these landslides had a similar failure mechanism. They are both the result of rotational failures that occur on oversteepened slopes in either the fill material or the native soils. These landslides are progressive, in that an initial large landslide had previously created an oversteepened slope in the area of the head scarp. This oversteepened slope is then prone to smaller failures similar to those shown in Figures 4 and 6. These smaller landslides will continue to occur as long as the oversteepened conditions are preserved, and will result in the rapid retreat of the top of the bluff.

Figure 6 Photograph of the landslide that occurred in the fall of 1987 on the slope west of the GA building. Failure of this slope was resolved by construction of a high retaining wall west of the GA building and north of the Conservatory.

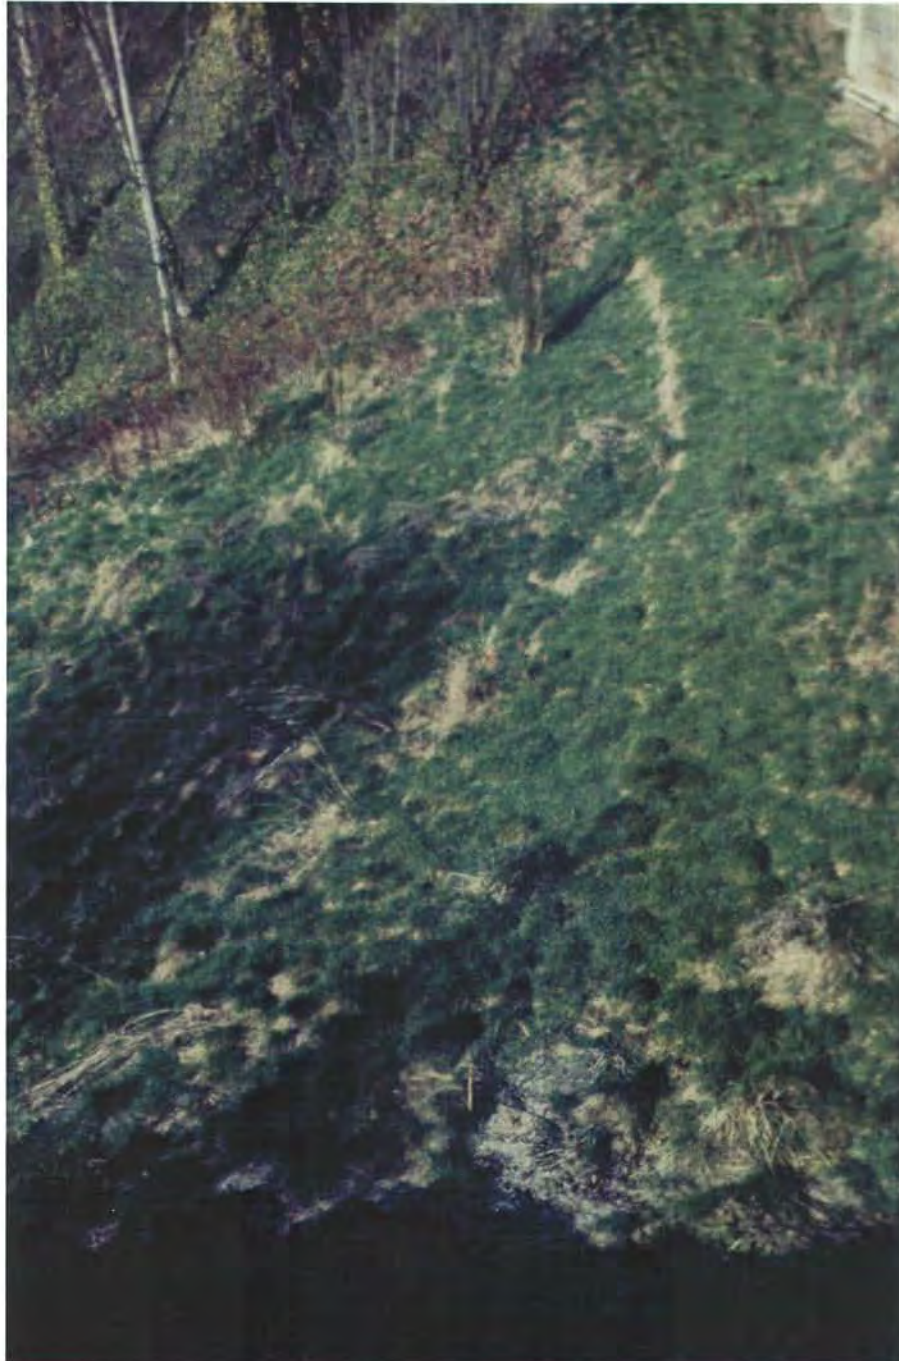
During the reconnaissance a significant landslide was observed on the slope below the retaining wall. The slope is extremely hummocky, and a 2 foot high scarp was observed at the head of the slide (see Figure 7). The pipe draining the gravel backfill of the retaining wall was separated at the headscarp by the downslope movement. The pipe separation indicated that the soil mass slipped 3 feet, and that this slippage was parallel to the existing slope. Drain water leaking out of the severed pipe caused deep erosion of the soils beneath the separation. At that time, we recommended that the pipe be repaired, and the void beneath the pipe filled with suitable soil. This recommended work was quickly performed by the Capitol Grounds staff. We estimate that this failure probably occurred sometime between the fall of 1992 and the spring of 1993.

Figure 7 Photograph of the headscarp of a landslide failure that occurred on the slope below the retaining wall west of the GA building. This failure occurred sometime between the fall of 1992 and the spring of 1993.

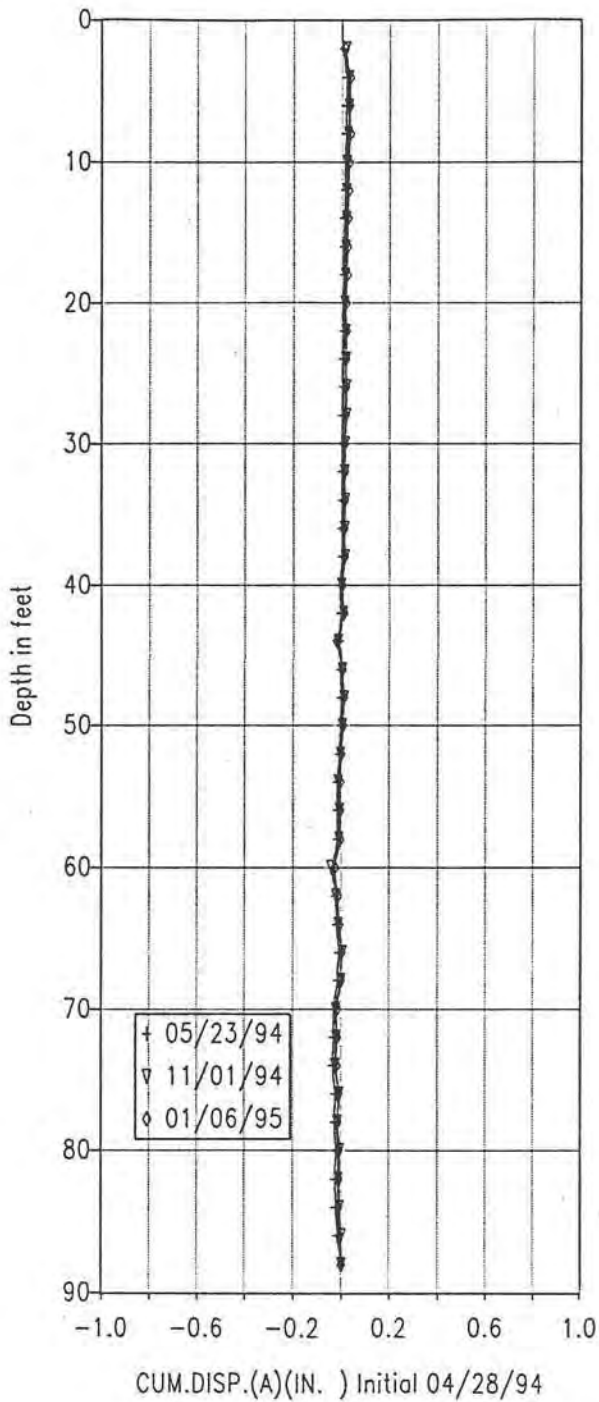
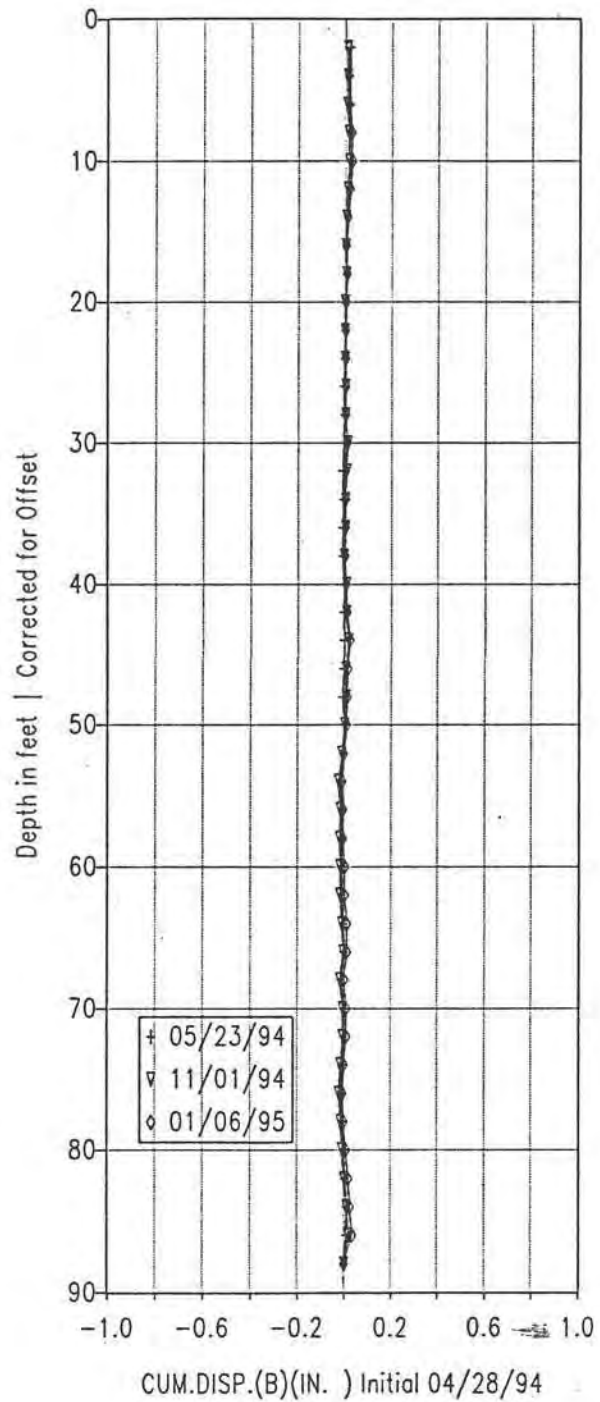
Figure 9 presents the inclinometer monitoring results of boring DH-2 from April 28 to January 6, 1995. These measurements indicate that there was no lateral movement of the soil mass surrounding the inclinometer casing. This monitoring period included a very dry summer in Olympia, and

Figure 9 Display of inclinometer survey results in boring DH-2. No indication of slope movement is indicated between April 28 and January 6, 1995.

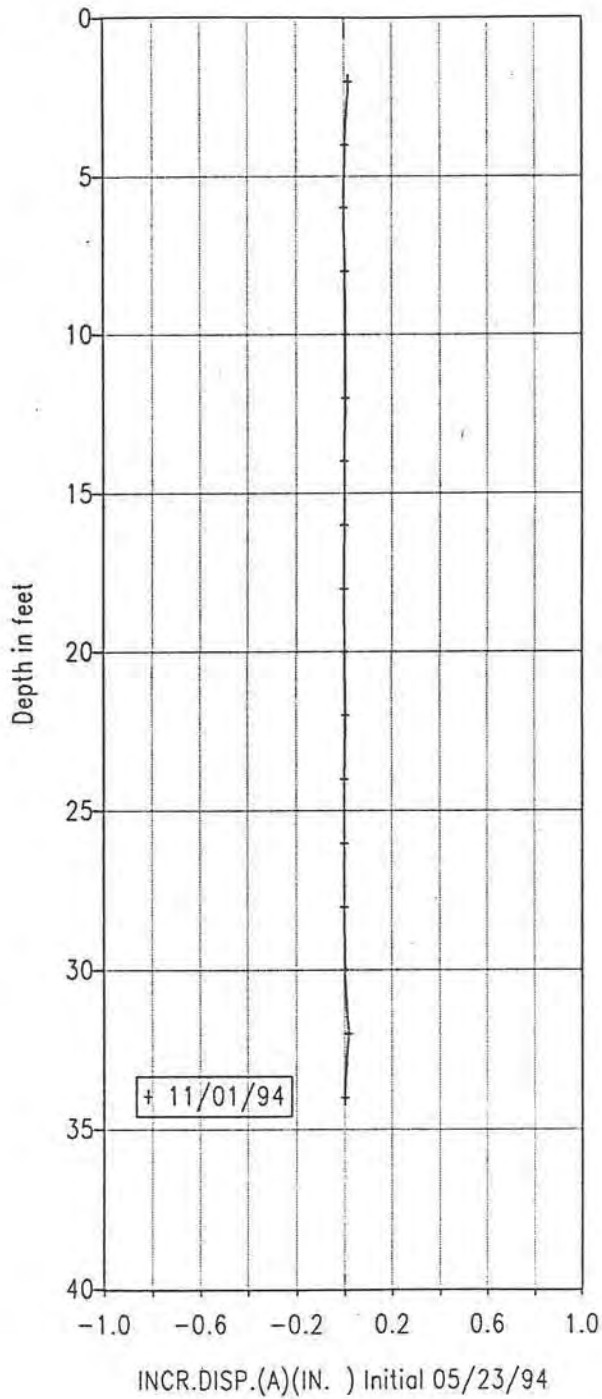
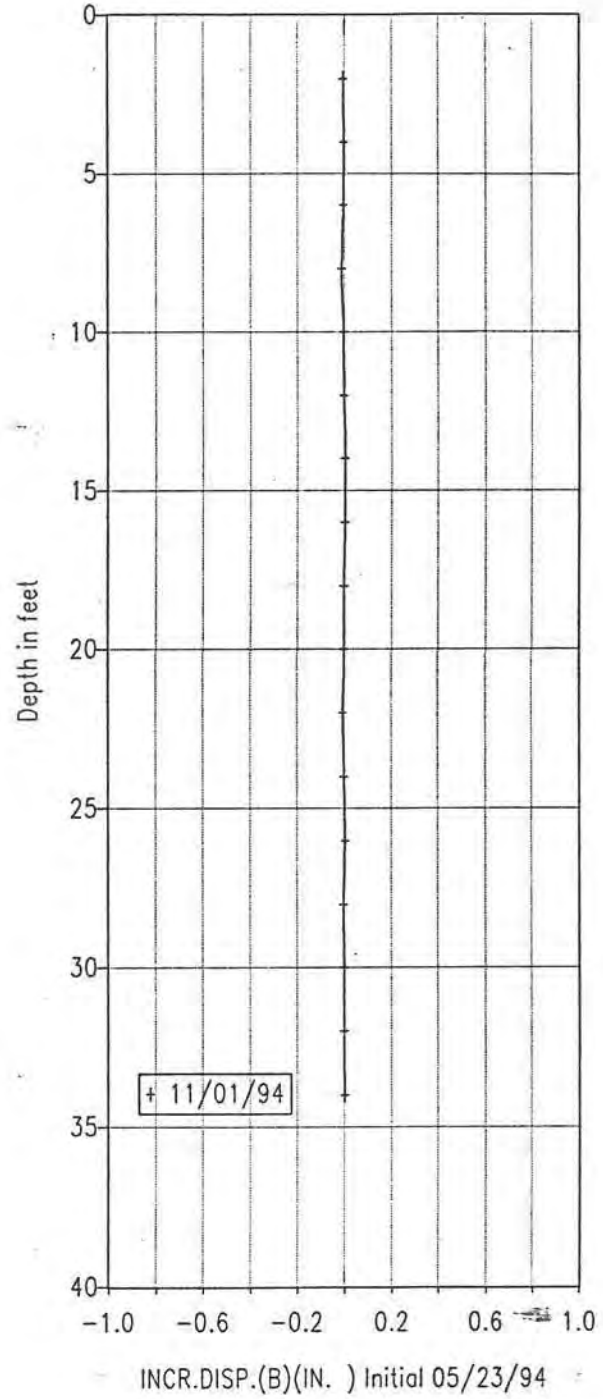
The inclinometer installed in J-1 was re-initialized on May 23, 1994. The first reading was made on November 1, 1994; a survey performed in July did not satisfy data quality standards. Figure 10 displays the results of the November 10 inclinometer survey. The incremental displacement curves indicate that there has been no movement between May 23 and November 1, 1994.

Figure 10 Display of inclinometer survey results in boring J-1. No indication of slope movement is indicated between May 23 and November 1, 1994.

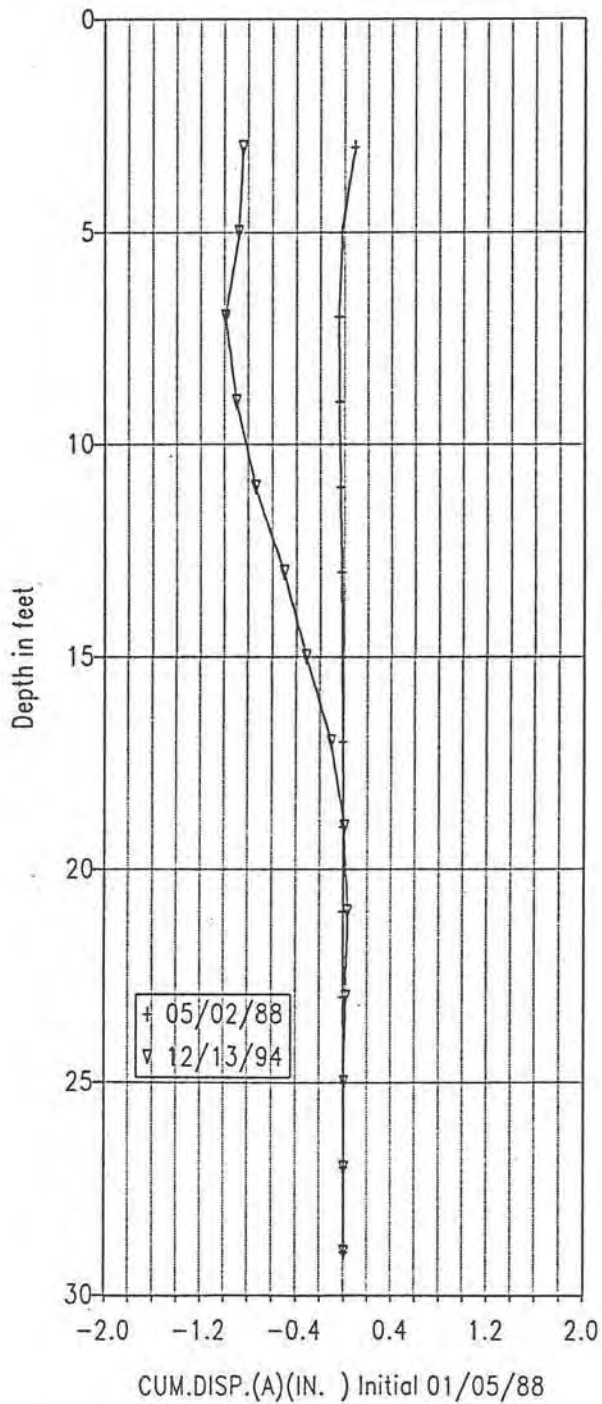
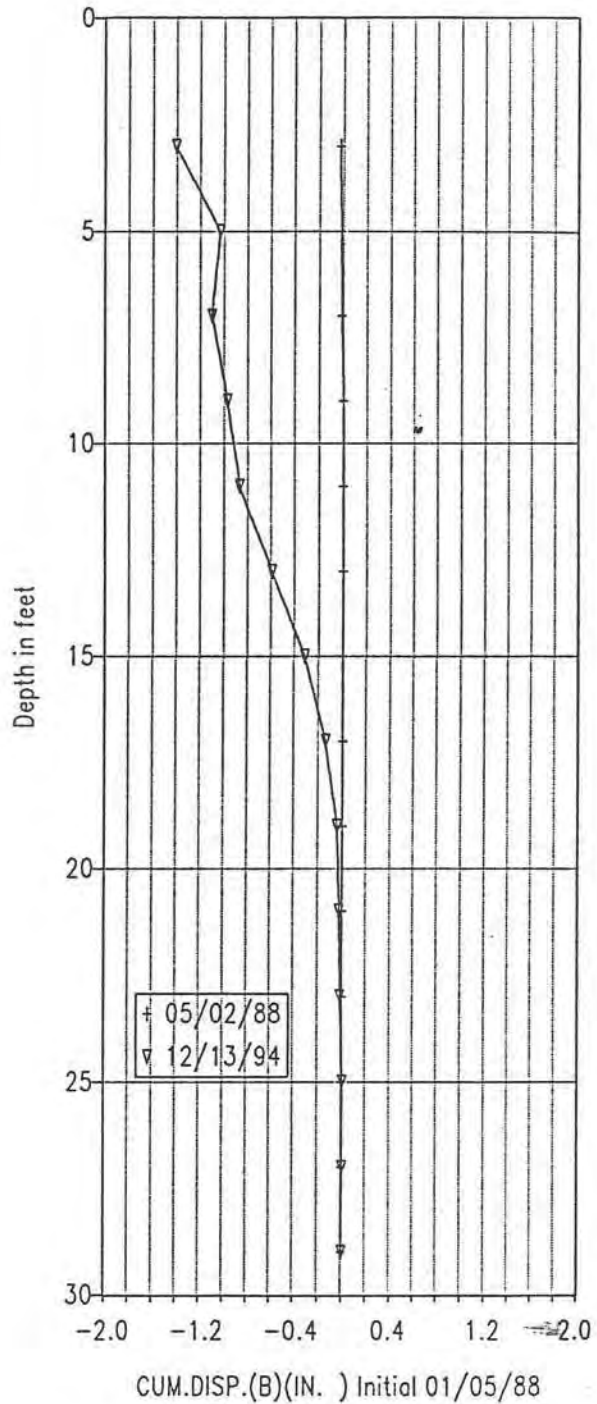
Figure 11 presents an inclinometer survey performed on December 12, 1994, and referred to an initial reading made on May 2, 1988. The figure shows that the soil mass adjacent to J-1 has moved downslope during this 6 year period, causing approximately 2 inches of downslope deflection of the inclinometer casing. Two observations can be made about this movement: (1) the movement is occurring only in the soft soil unit, and, (2) the movement is not along a sharp failure plane but is distributed throughout the lower half of the soft soil unit. We interpret the inclinometer displacement as being the result of slow creep of the lower portion of the soft soil unit, and not indicative of the soil mass slipping along a discrete failure plane. However, the inclinometer data and the landslide that occurred upslope of J-1 during 1992 or 1993 demonstrate active downslope movement.

Figure 11 Display of inclinometer results for J-1 from 1987 to 1994. Cumulative displacements in both the A and B directions are about 1 in, with a resultant downslope movement of approximately 1.5 in during this seven year period.

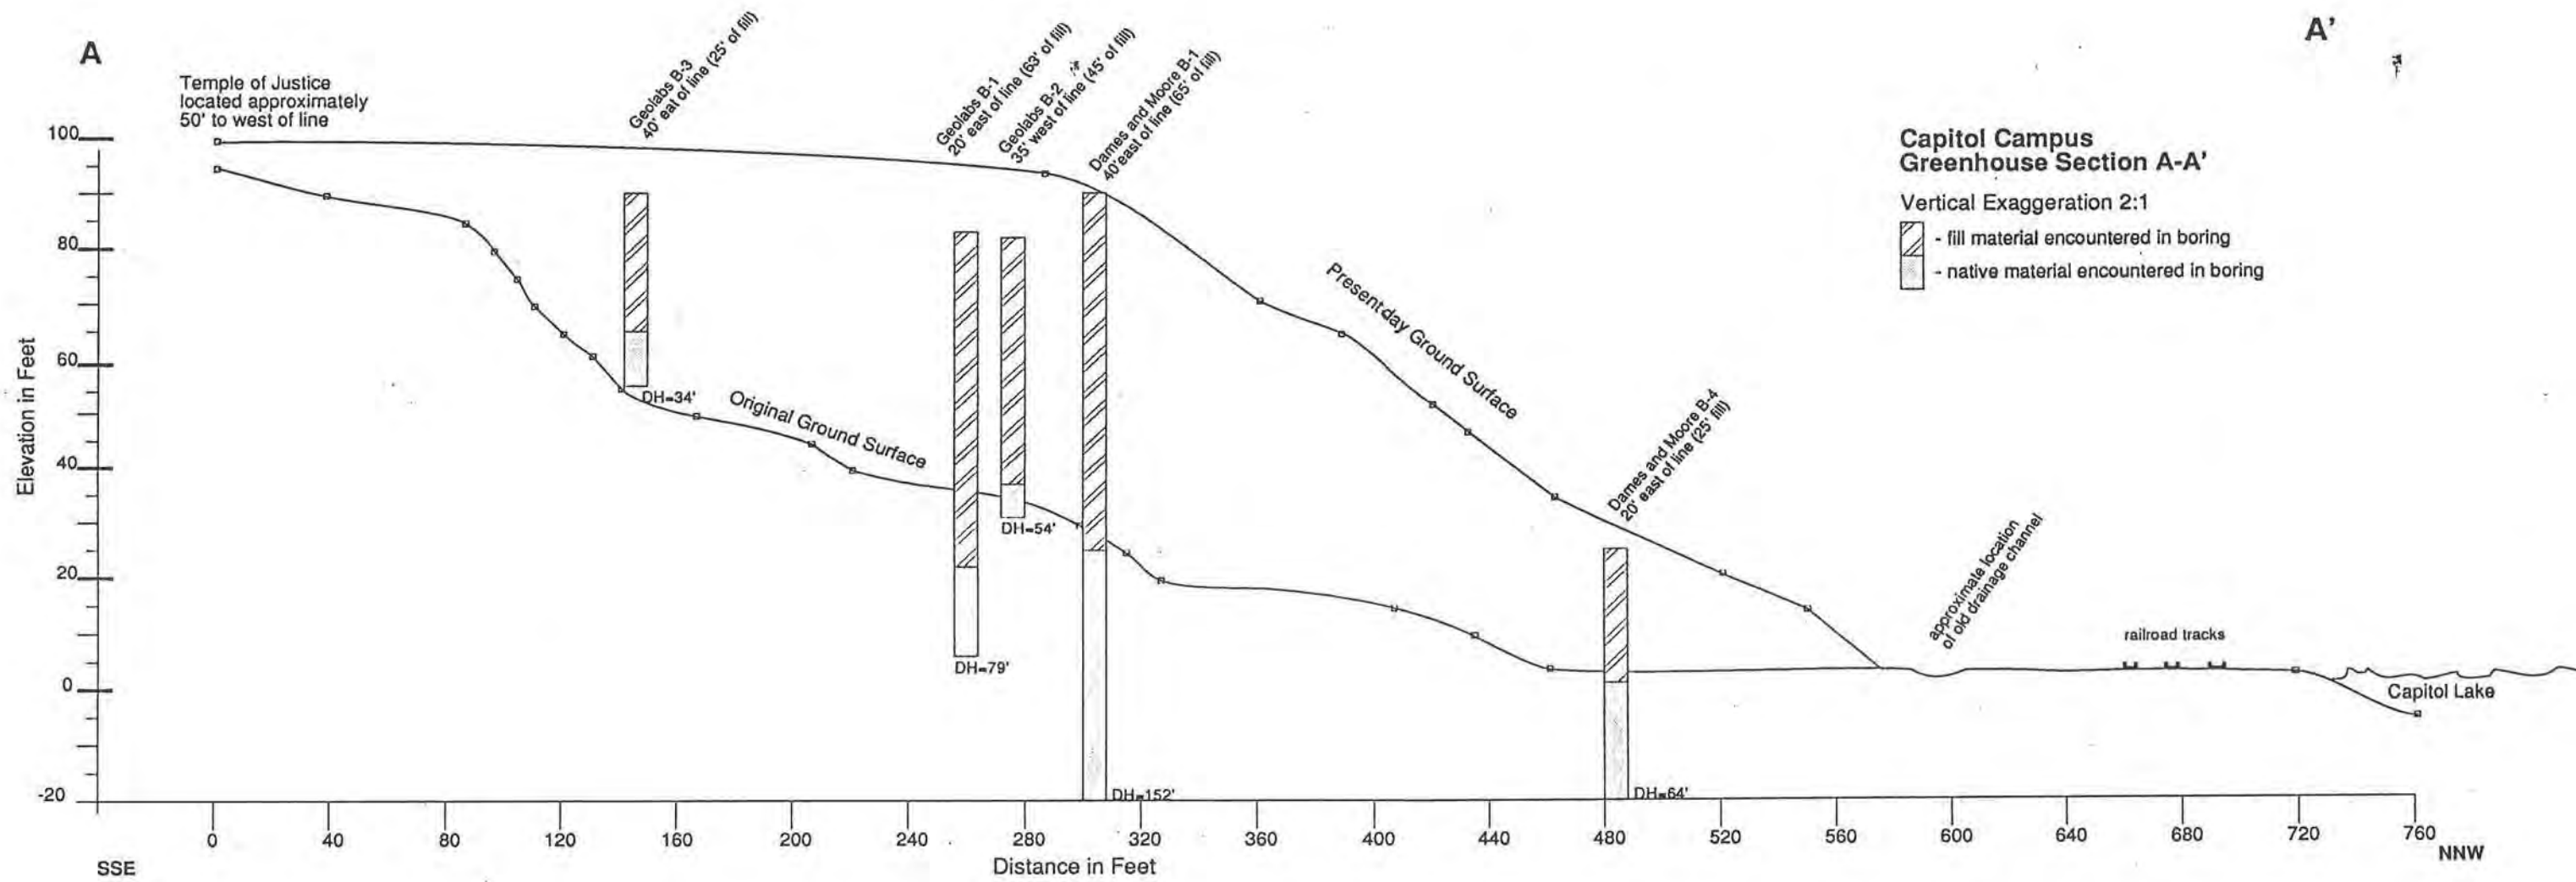
Figure 12 Cross-section A-A'; approximate location shown on Figure 1.

The elevation of the contact between fill and native soil shown in Section A-A' (Figure 12) was

obtained from the circa 1919 topographic map. This contact correlates well to the fill/native soil contact interpreted from five borings located along the profile line. The cross section shows the maximum fill thickness is about 65 feet, and is located just west of the Greenhouse building.

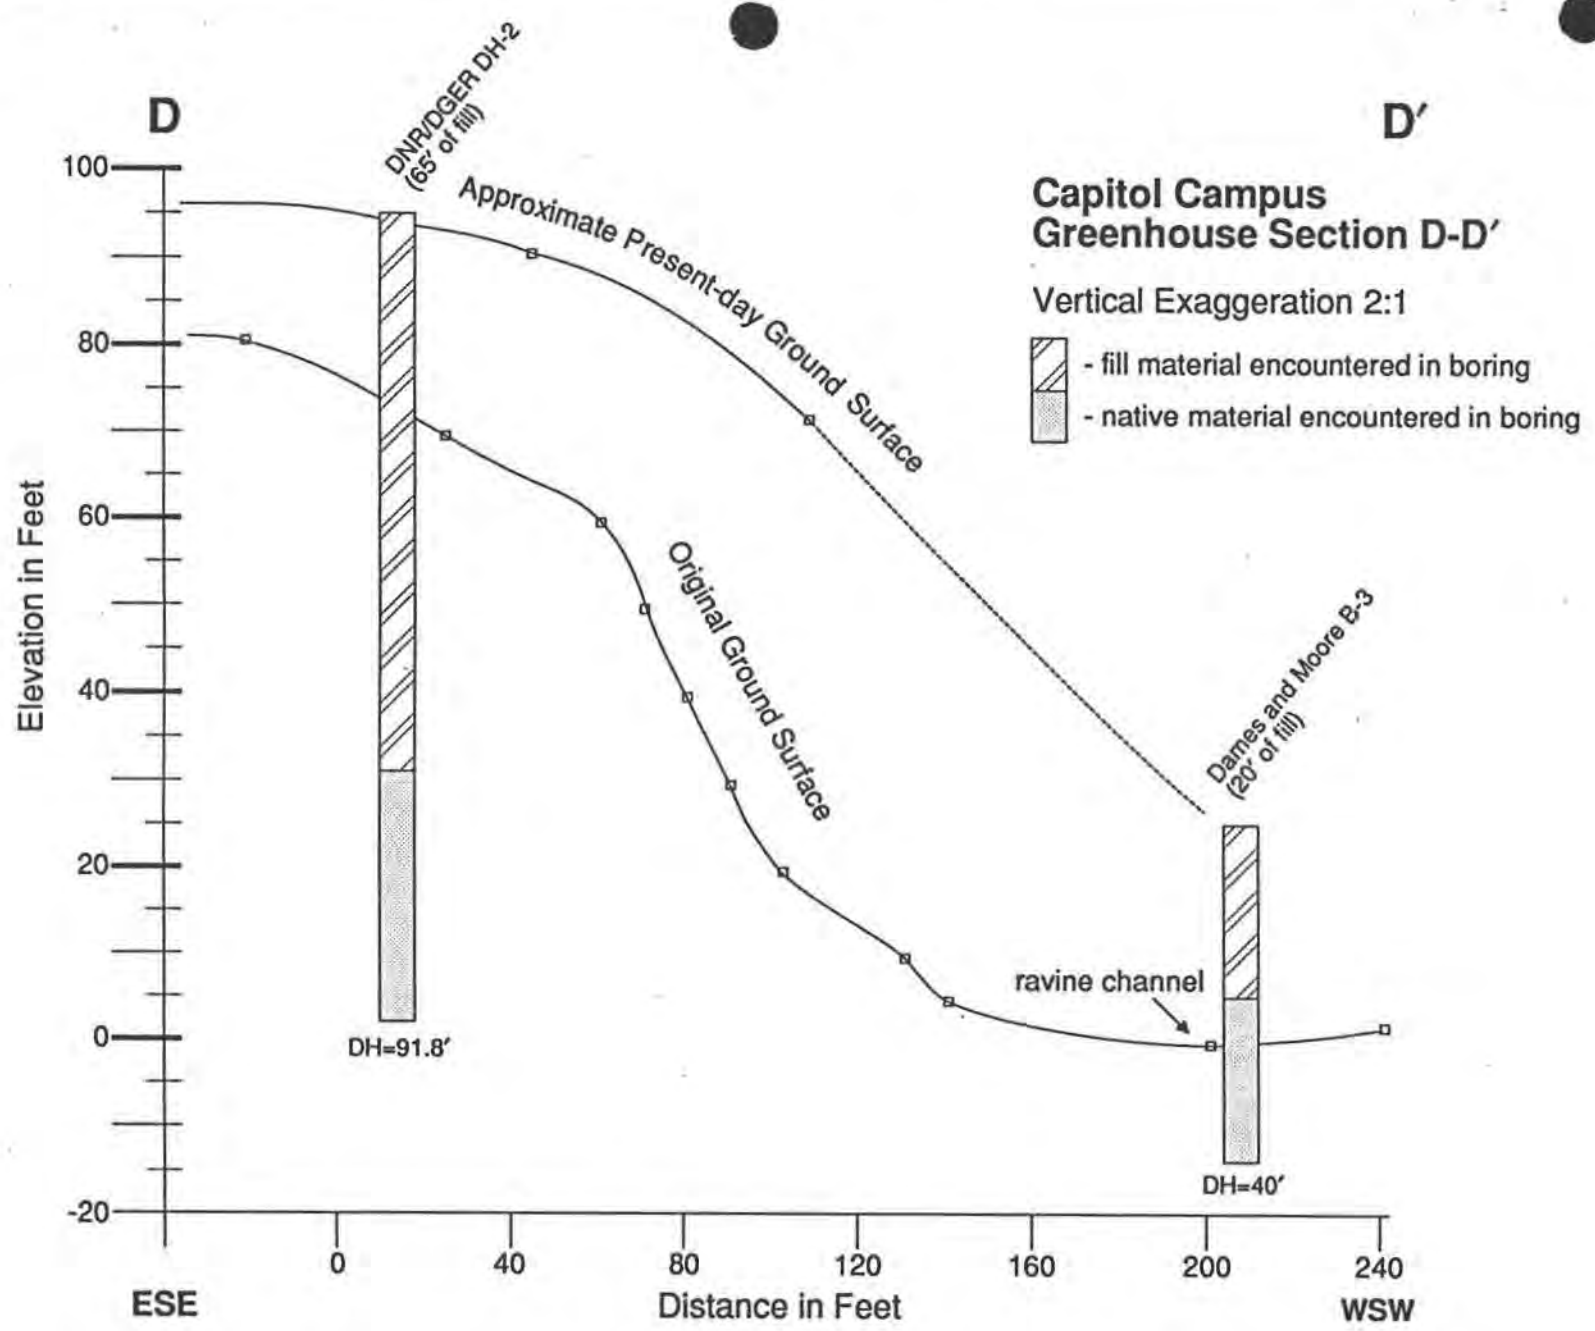
Figure 13 Cross-section D-D'; approximate location shown on Figure 1.

The present-day ground surface reconstructed for Section D-D' is approximated from three survey points combined with qualitative field observations, and is consequently poorly constrained. The original ground surface on Section D-D' is again reconstructed using the circa 1919 topographic map. Boring DH-2, drilled for this study, shows the thickness of fill to be about 65 feet, whereas the reconstructed ground surface requires a fill thickness of only about 25 feet. This discrepancy may result from fill placed in this area prior to 1919, possibly associated with early Campus construction activities including the initial excavation of the Capitol Building foundation and the construction of the Temple of Justice. Thus, the topography shown on the circa 1919 map may not reflect the true original ground surface, which might lie at a greater depth.
