MEMORANDUM

To: Marshall T. Huntting, Supervisor
From: Gerald W. Thorsen
Subject: Landslide of January 1967 which diverted the North Fork of the Stillaguamish River near Hazel
Date visited: November 28, 1969

Hazel Slide

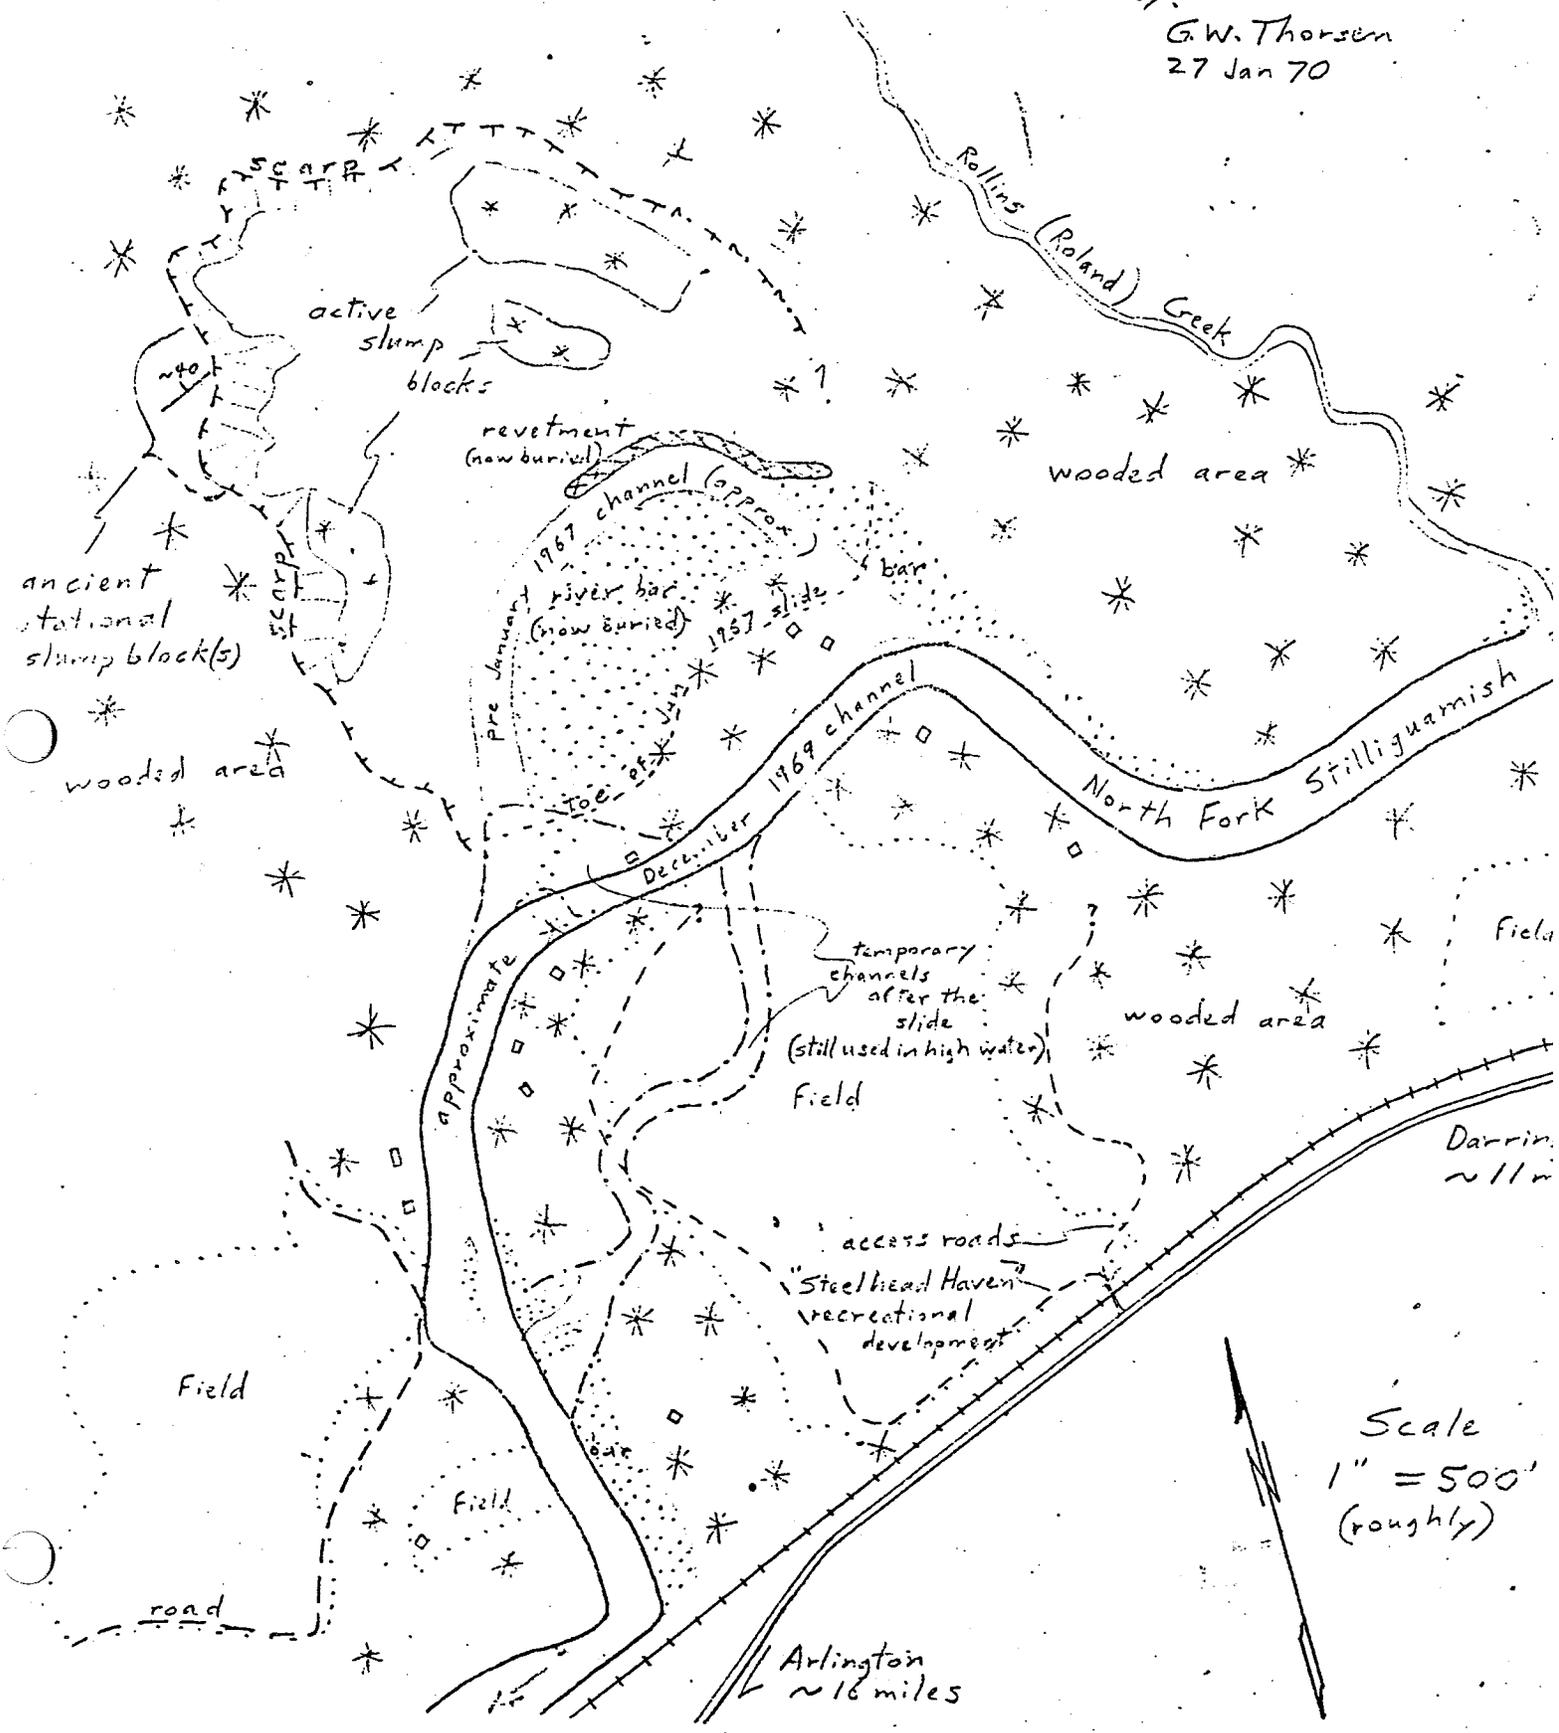
After the 1967 slide the river established a channel not in contact with the clay bank or slide debris (see Plate 1). As the time of my visit a 150-foot section of scarp had recently caved and a mudflow several hundred feet long resulted. Travel across the slide surface is extremely treacherous because of hidden "pockets" of saturated material that will not support a man's weight.

From January 1967
vertical airphoto 5671-2-2
uncorrected

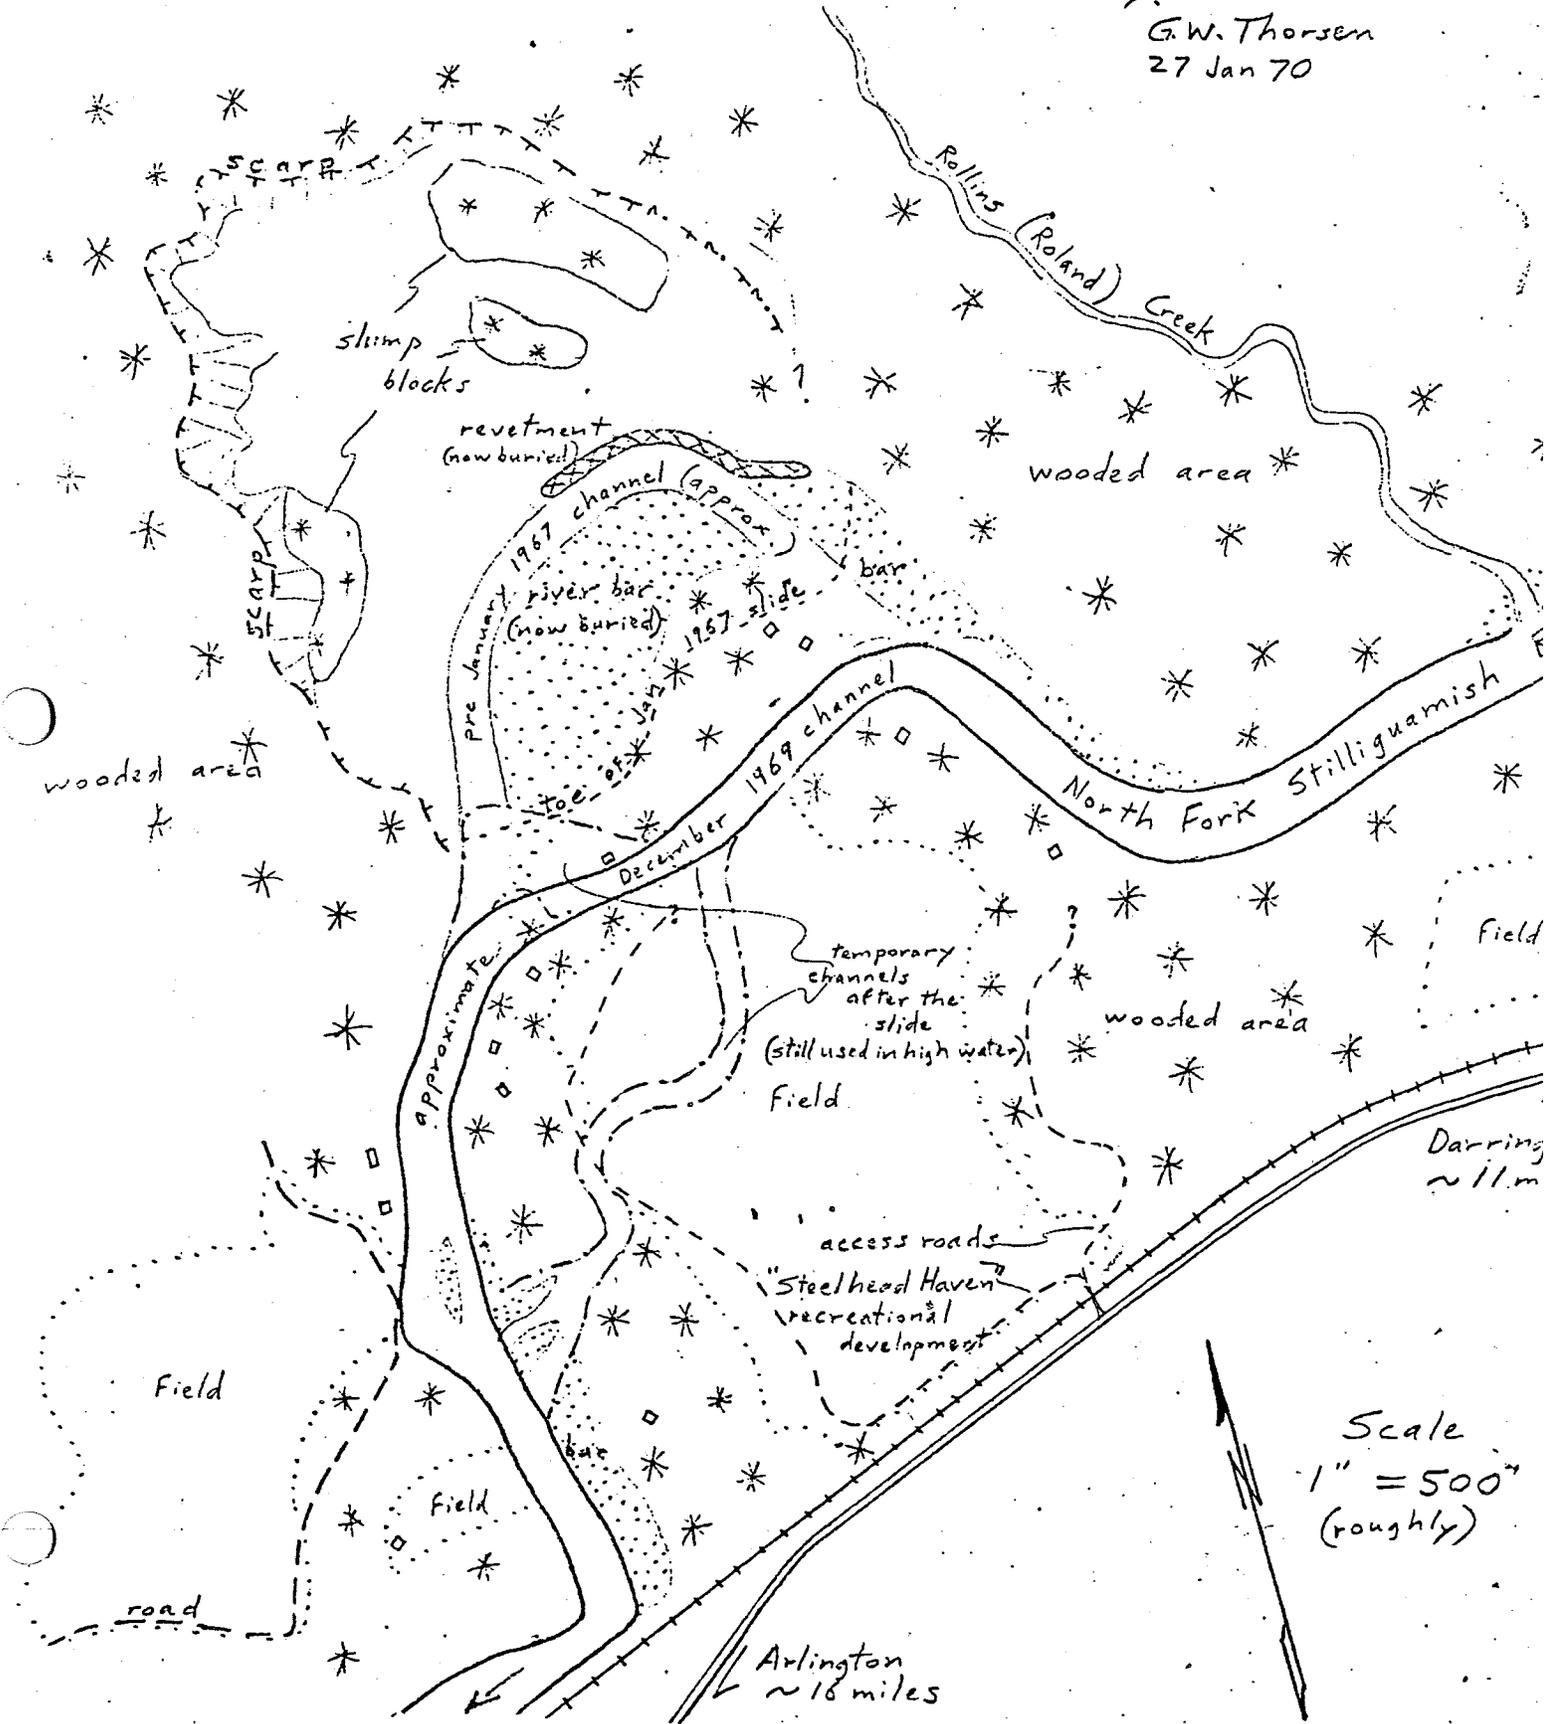
From January 1967
vertical airphoto S671-2-2
uncorrected

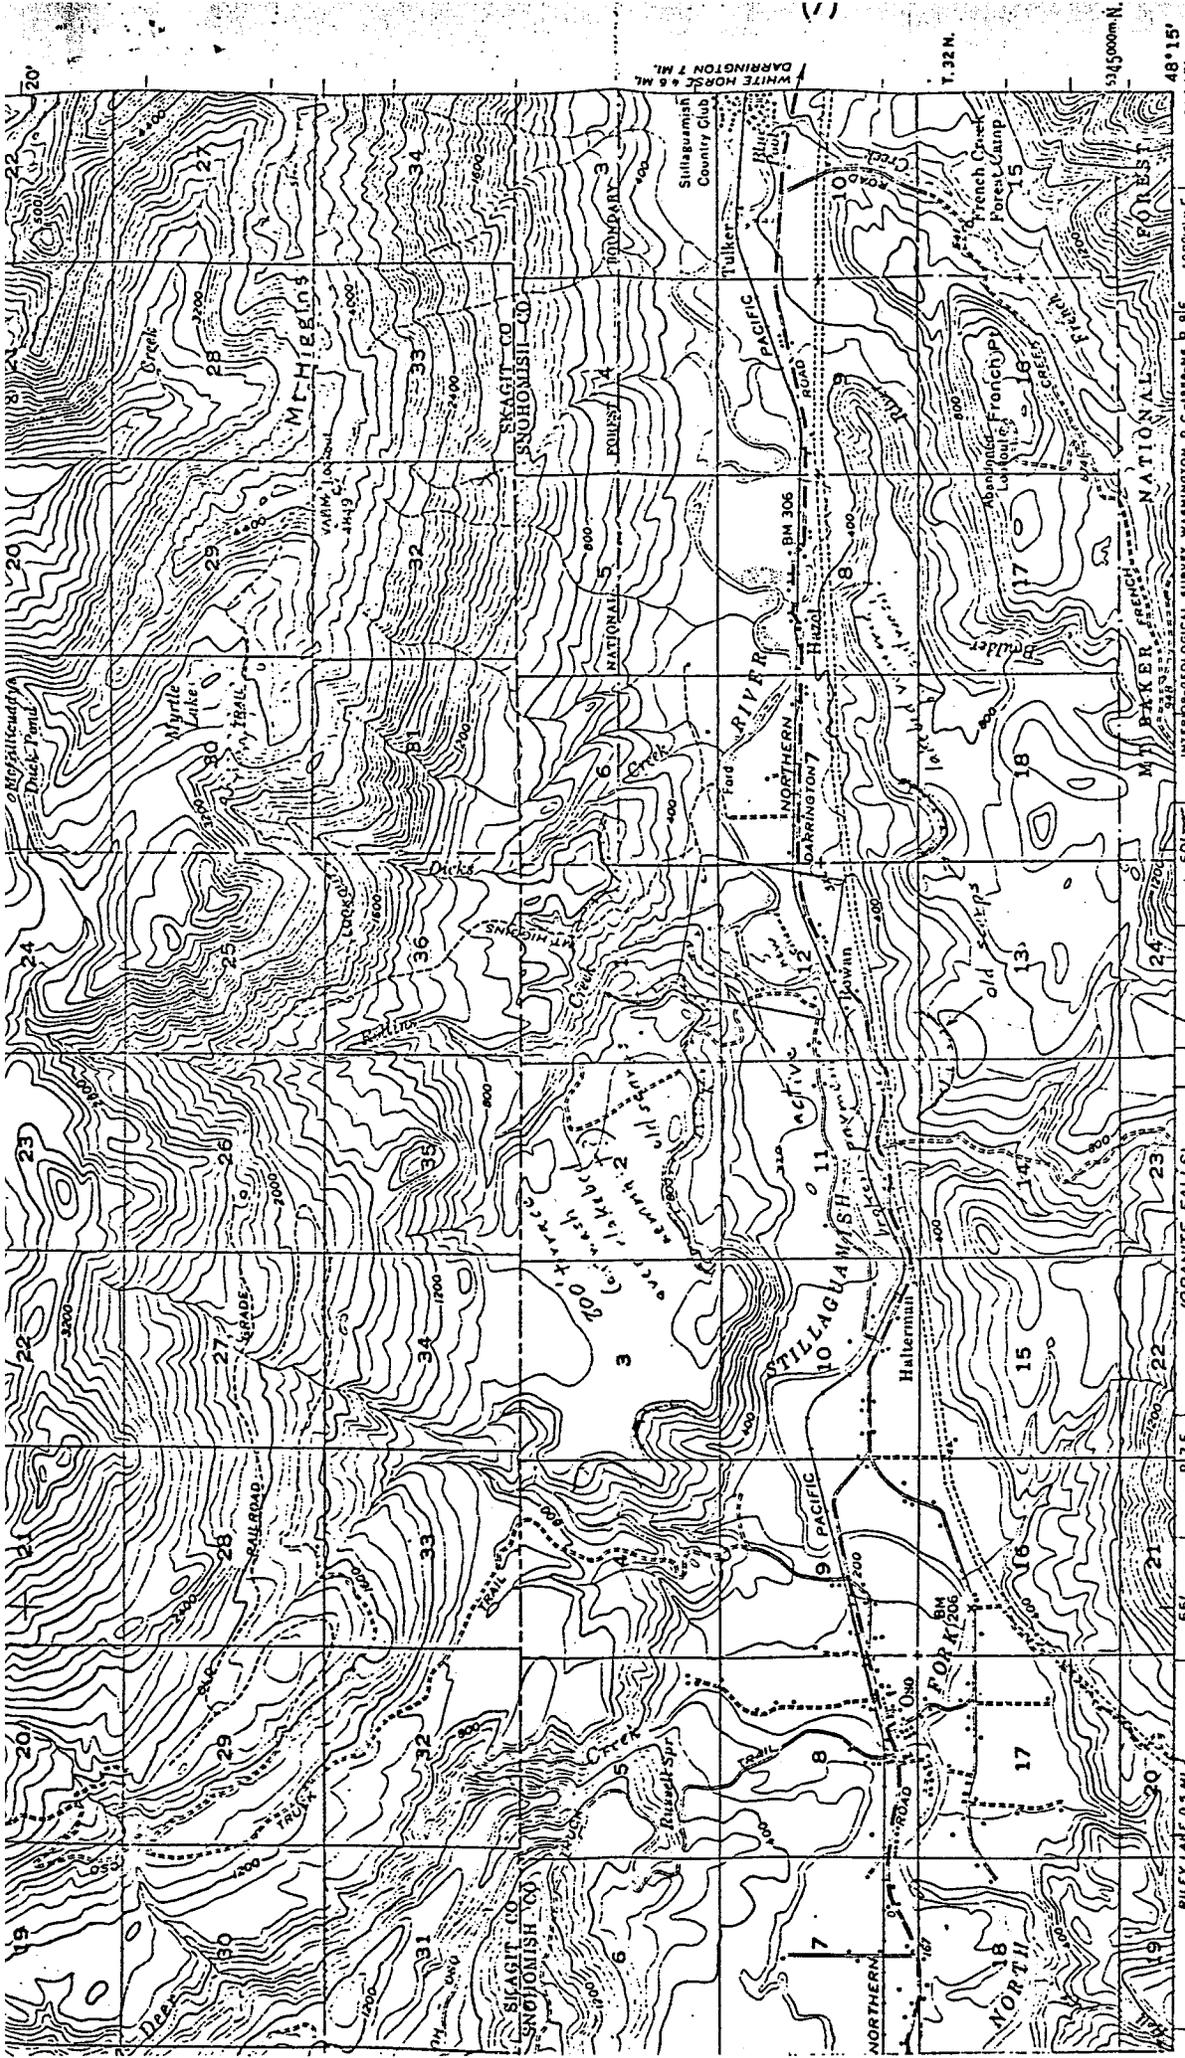
Careful examination of topographic maps (see Plate II) and air photos of the area between Hazel and Oso show that this present active slide area is probably just part of one of a series of ancient slides. The scars of these ancient slide scarps still show as semicircular bites out of the 800-foot elevation terrace remnants left on both sides of the river valley. The debris lobes from these slides have been greatly modified or, in place, almost completely removed by stream erosion.

Air photos indicate no activity among these ancient slides other than the partial reactivation of the one, the subject of this report. Nevertheless, this slide has shown that major construction below any of these old scarps (Plate II) should be done with extreme caution.
