THUNDER CREEK BASIN
Skagit County
Report of DNR Study Team

by
Jerry Thorsen, Geologist

To
DNR-NW Regional Office
Georgia Pacific Corp.
Crown Pacific

1989

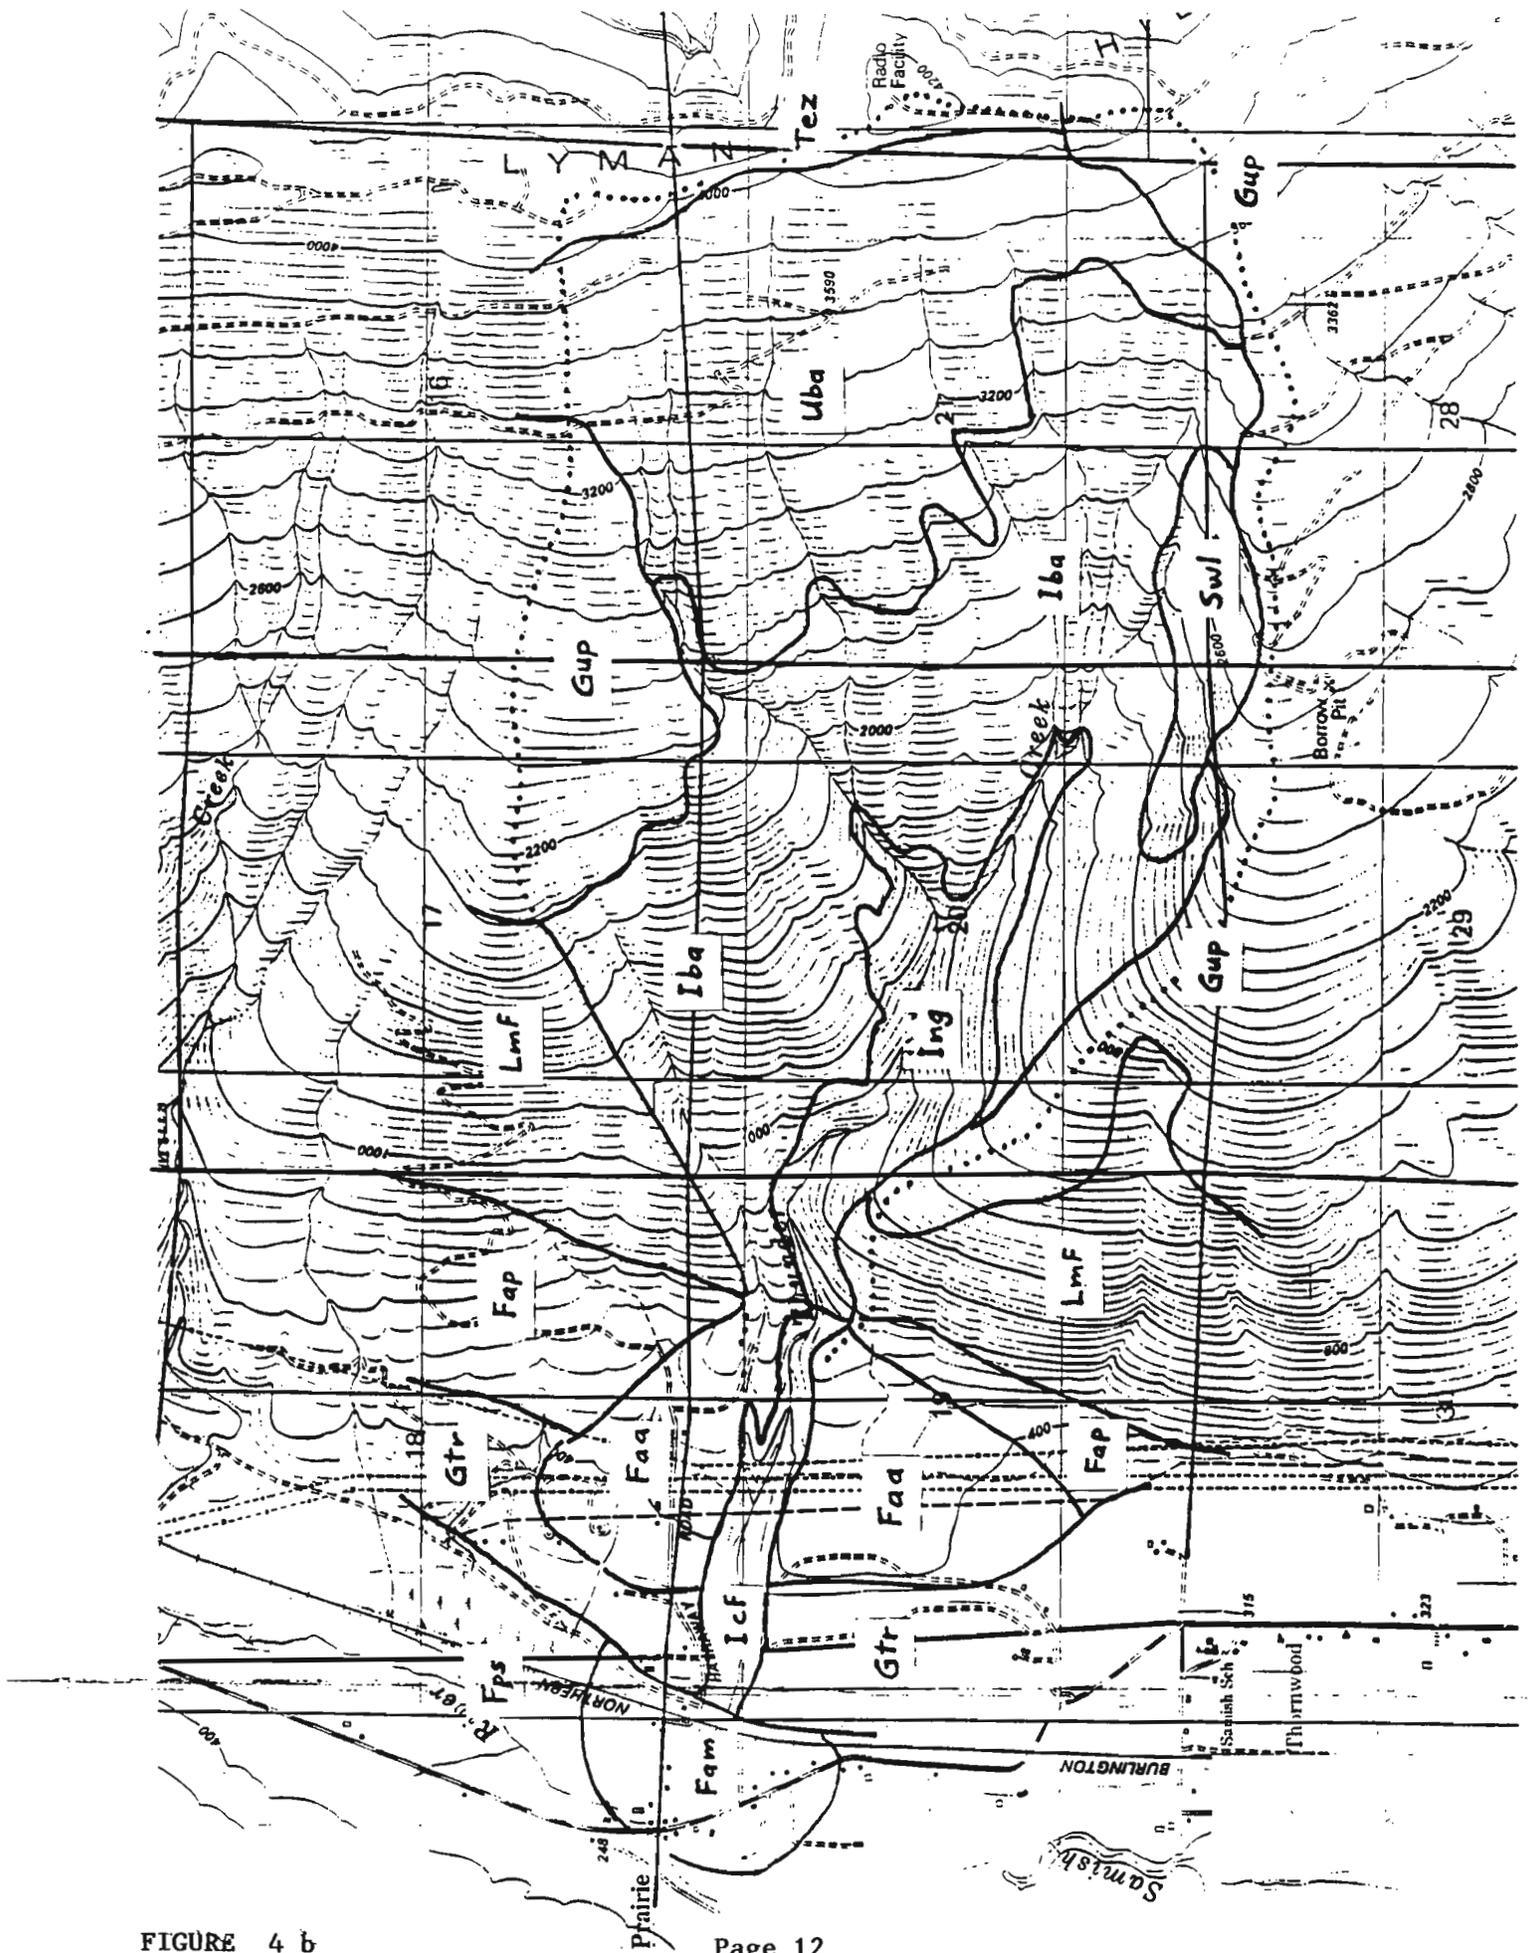
FIGURE 4 b

Subtle flank scarps are visible in places along the north edge and within the Thunder Creek basin. Such scarps commonly occur where one slide "block" has moved further than an adjacent one. Steep, angular rock faces can be seen in the central and southern upper basin. The inner basin contains abundant hummocky terrain, with small discontinuous benches and steep-nosed ridges, all indicative of landslide deposits. (The large deeply dissected fossil fan at the mouth of the ancestral Thunder Creek (Fig. 4b) developed as the stream flushed slide material out onto the glacial outwash.) Although the basin undoubtedly existed in some form prior to glaciation, these features and those along the ridge crest are too delicate to have survived glaciation, thus, they must be post glacial. The abundance of till as a soil parent-material in the upper basin suggests, however, that there was relatively little churning as a result of all this slide activity.

The processes just described are now essentially dormant; however, the present basin landscape is still evolving as a result of the combined processes of stream erosion, slumps and earthflows, and debris avalanches. Most of this current activity is concentrated along the banks of the deeply incised mainstem and major tributaries of Thunder Creek. Stream incision has been particularly deep and apparently rapid between 600 ft and about 2000 ft elevations because it was largely cutting through

the easily erodible ancient landslide deposits. Another area of activity is along the oversteepened ancient landslide scarps forming the south wall of the basin. An understanding of the origin of such landforms can be helpful in explaining the processes still active today; processes important to basin management.

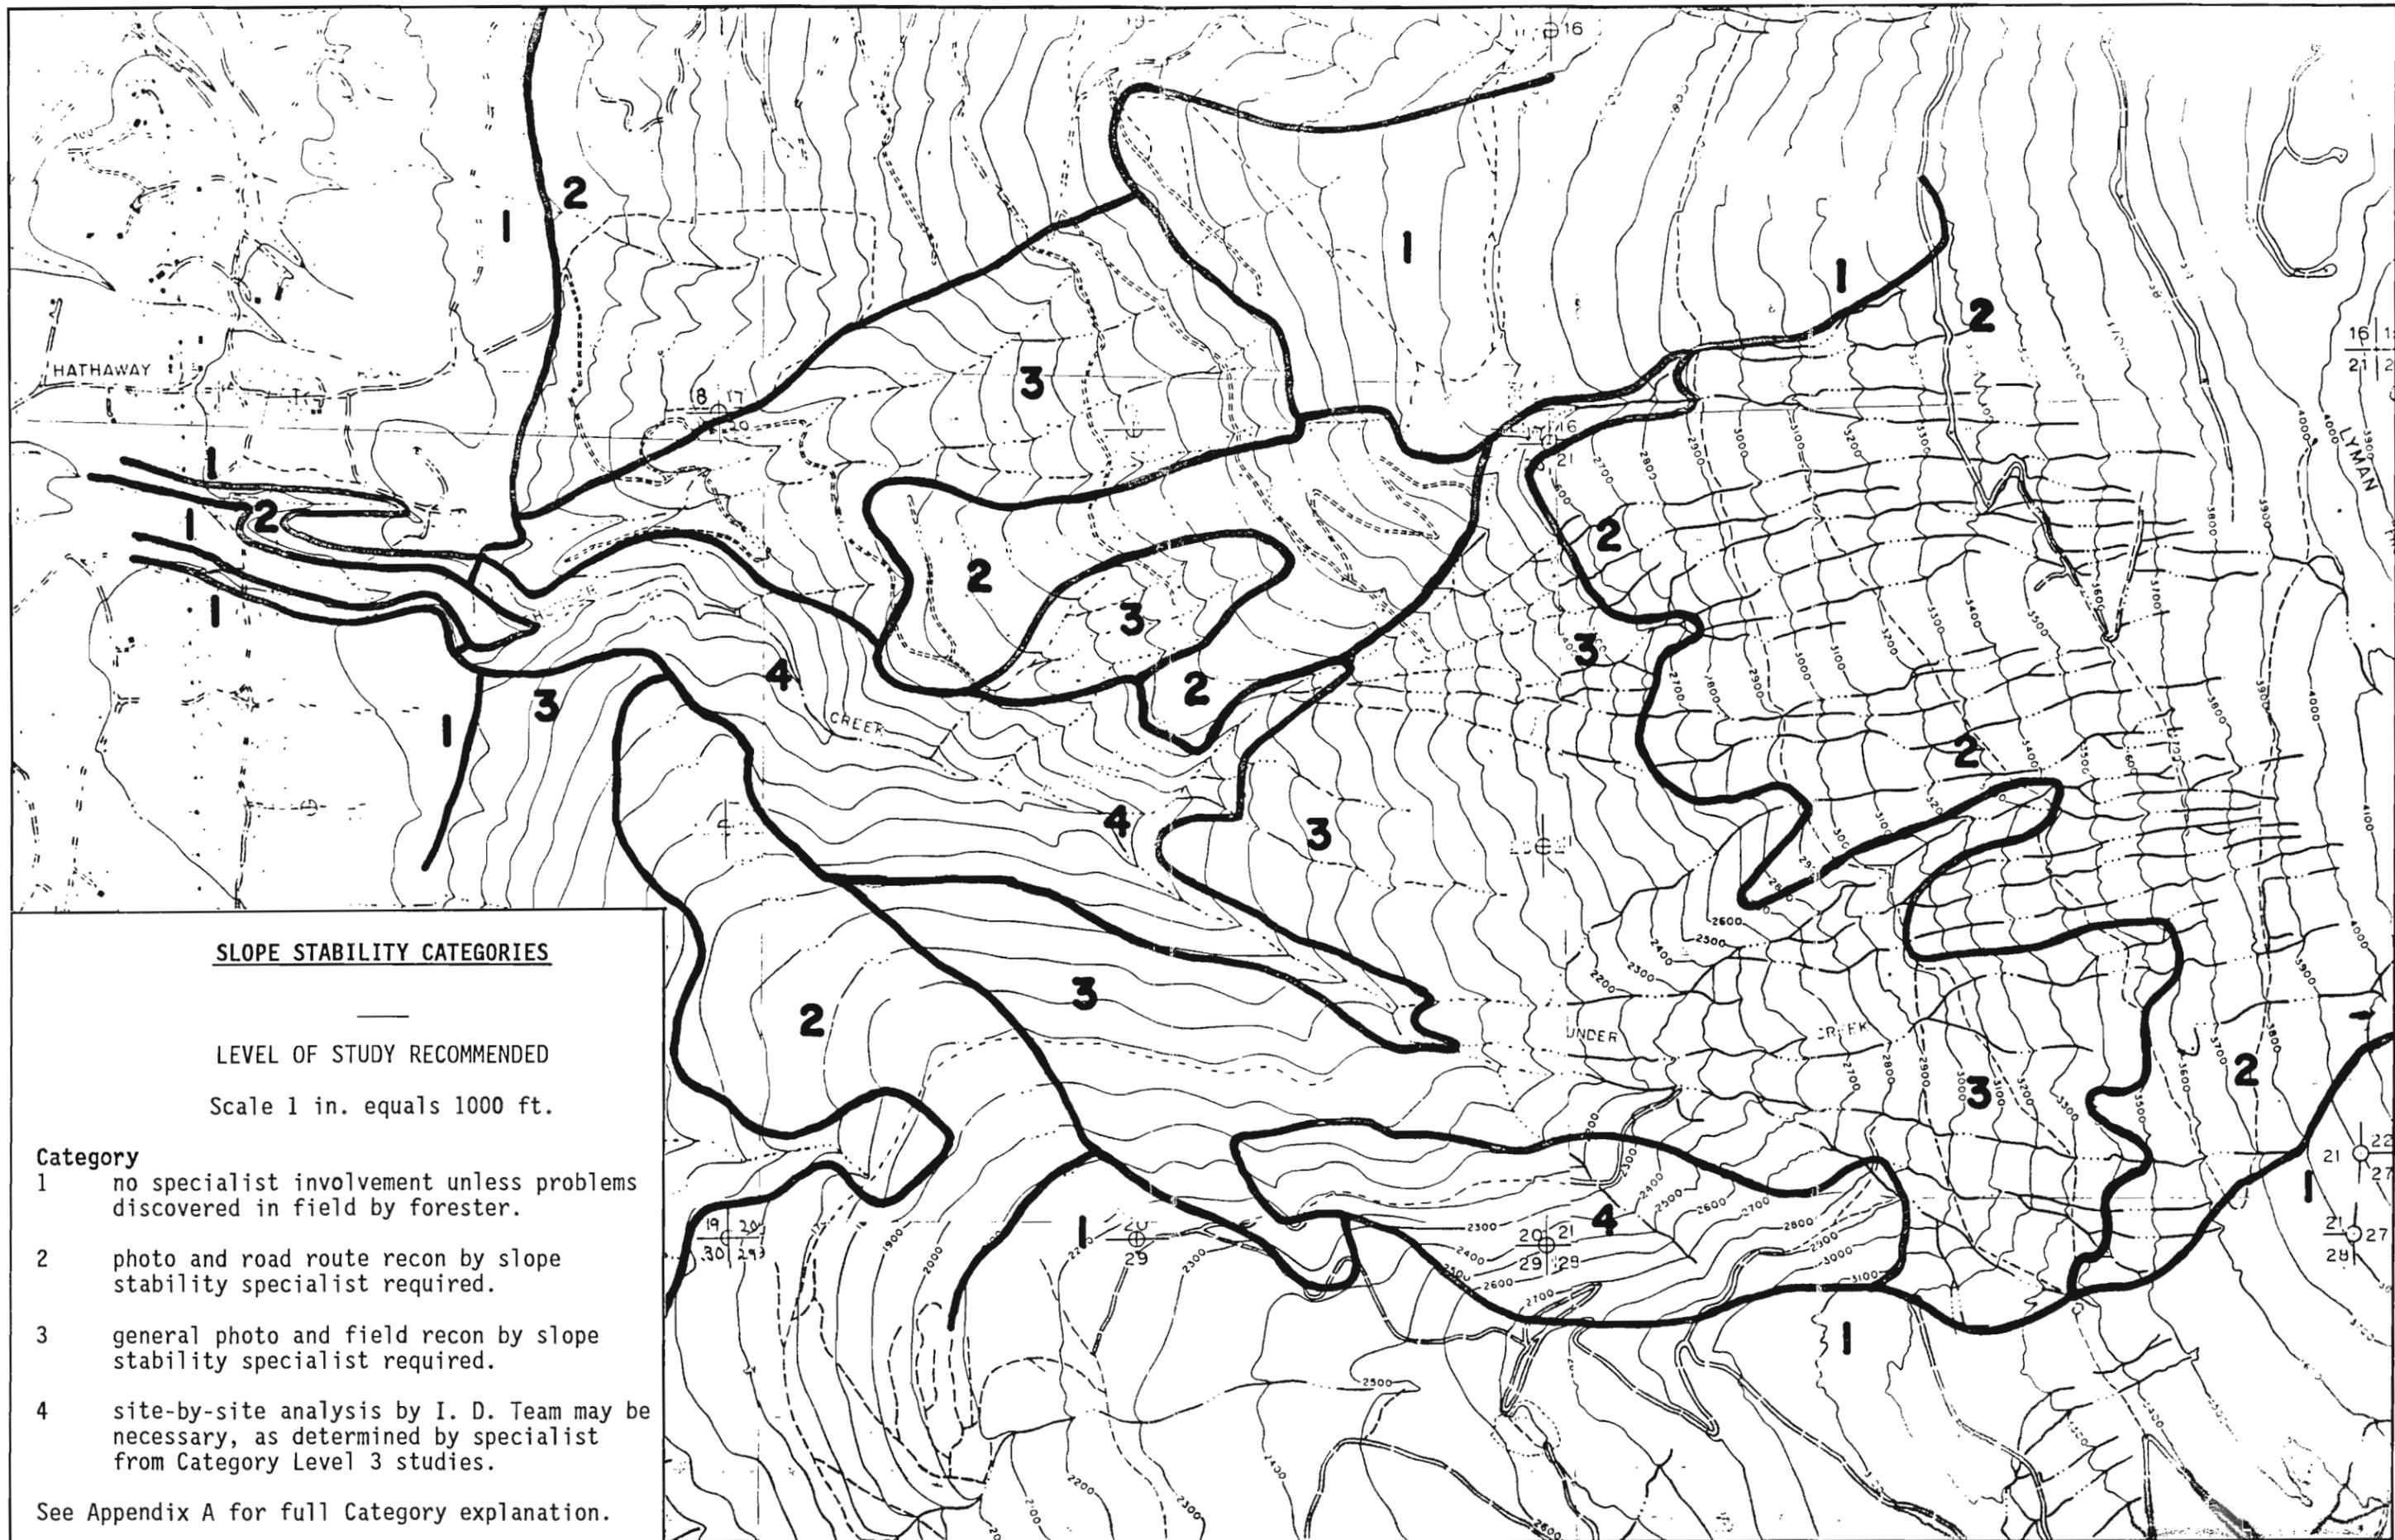
FIGURE 5

The slope stability map (Fig. 5) represents an attempt to incorporate in a generalized form, factors of geologic history and current terrain shaping processes, soils, slope, and hydrology. Obviously, the mapped stability category boundaries based on such factors are no more accurate than the known distribution of the factors themselves. Thus, the map is of variable "accuracy". Some category boundaries can be established within the limits of map scale. Other boundaries may include unidentified areas of a different slope stability category. Nevertheless, the stability categories in such a map can provide the forester/engineer as well as the land manager with information useful in their particular roles.

Areas designated as slope stability Category 4 are areas that photo recon and limited field checking have identified as probable "worst case" examples, for a variety of reasons. Such areas range from the walls of the "inner gorge" to the south wall of the "upper basin" (Fig. 4), with slopes commonly averaging 60 percent, but some exceeding 100 percent in old bedrock slide scarp areas. Both are sites of ancient deep-seated as well as shallow recent landslides. The January 1983 debris avalanche from the scarp forming the south wall (SE $\frac{1}{4}$ SE $\frac{1}{4}$ Section 20) stopped on a bench formed by the head of an ancient slide. Otherwise, it almost certainly would have entered the then flood-swollen Thunder Creek at a point where stream gradients average 27 percent. In short, Category 4 slopes are known stability problem areas. The principle unknown is their exact boundaries.

Category 3 slopes are a mixed bag, no doubt including some Category 4 slopes, but also some that may be relatively stable. It is for this reason that a general field and photo recon by a slope stability specialist is deemed necessary (Appendix A). Photo interpretation should include those taken as early as possible after previous harvest of a particular site, in order to take advantage of the lack of ground cover. Category 3 terrain in the Thunder Creek basin is generally the inner basin, made up largely of slide deposits, and the steeper and more broken areas of the upper basin. The latter areas and the south wall are where the inner basin slide deposits came from. There are probably remnants of these ancient landslides still remaining in places on these slopes.

The areas mapped as slope stability Category 2 are considered, in general, to be stable. Some of this terrain may have moved as much as 50 to a 100 feet when the mountain "settled" in early post-glacial times (see "Geology"). Such "rafts" may be thousands of feet across and still more-or-less intact. They do not appear to be sensitive to the hydrologic impacts of clearcutting. However, the closely spaced incised drainages in much of this terrain tend to collect concentrations of debris from yarding. Another management-related concern in Category 2 areas relates to roads, particularly drainage. Cutbanks in these generally wet soils are commonly unstable, and the cuts may produce surface water that needs to be controlled (see "Climate/Hydrology"). Stream crossings are of concern, not only because of the sheer number, but because they are essentially all incised. Thus, small but numerous fills are needed in an area of generally unsuitable fill material.

Category 1 areas are considered to be the most stable. They are, in general, glacially smoothed upland areas with relatively gentle slopes and small or nonexistent surface drainage. Because of the rather complex geologic history of the Thunder Creek basin, Category 1 areas may include large "rafts" of displaced material and low, generally discontinuous scarps such as found in Category 2 terrain. The rocky scarps are steep and, in places shattered, but should present few surprises for the careful road builder. Slopes in this terrain may be wet but because most of it is high in the basin the size of streams and their depth of slope incision is relatively small. Additional implications for management of the various areas in various slope stability categories can be found in Appendix A.

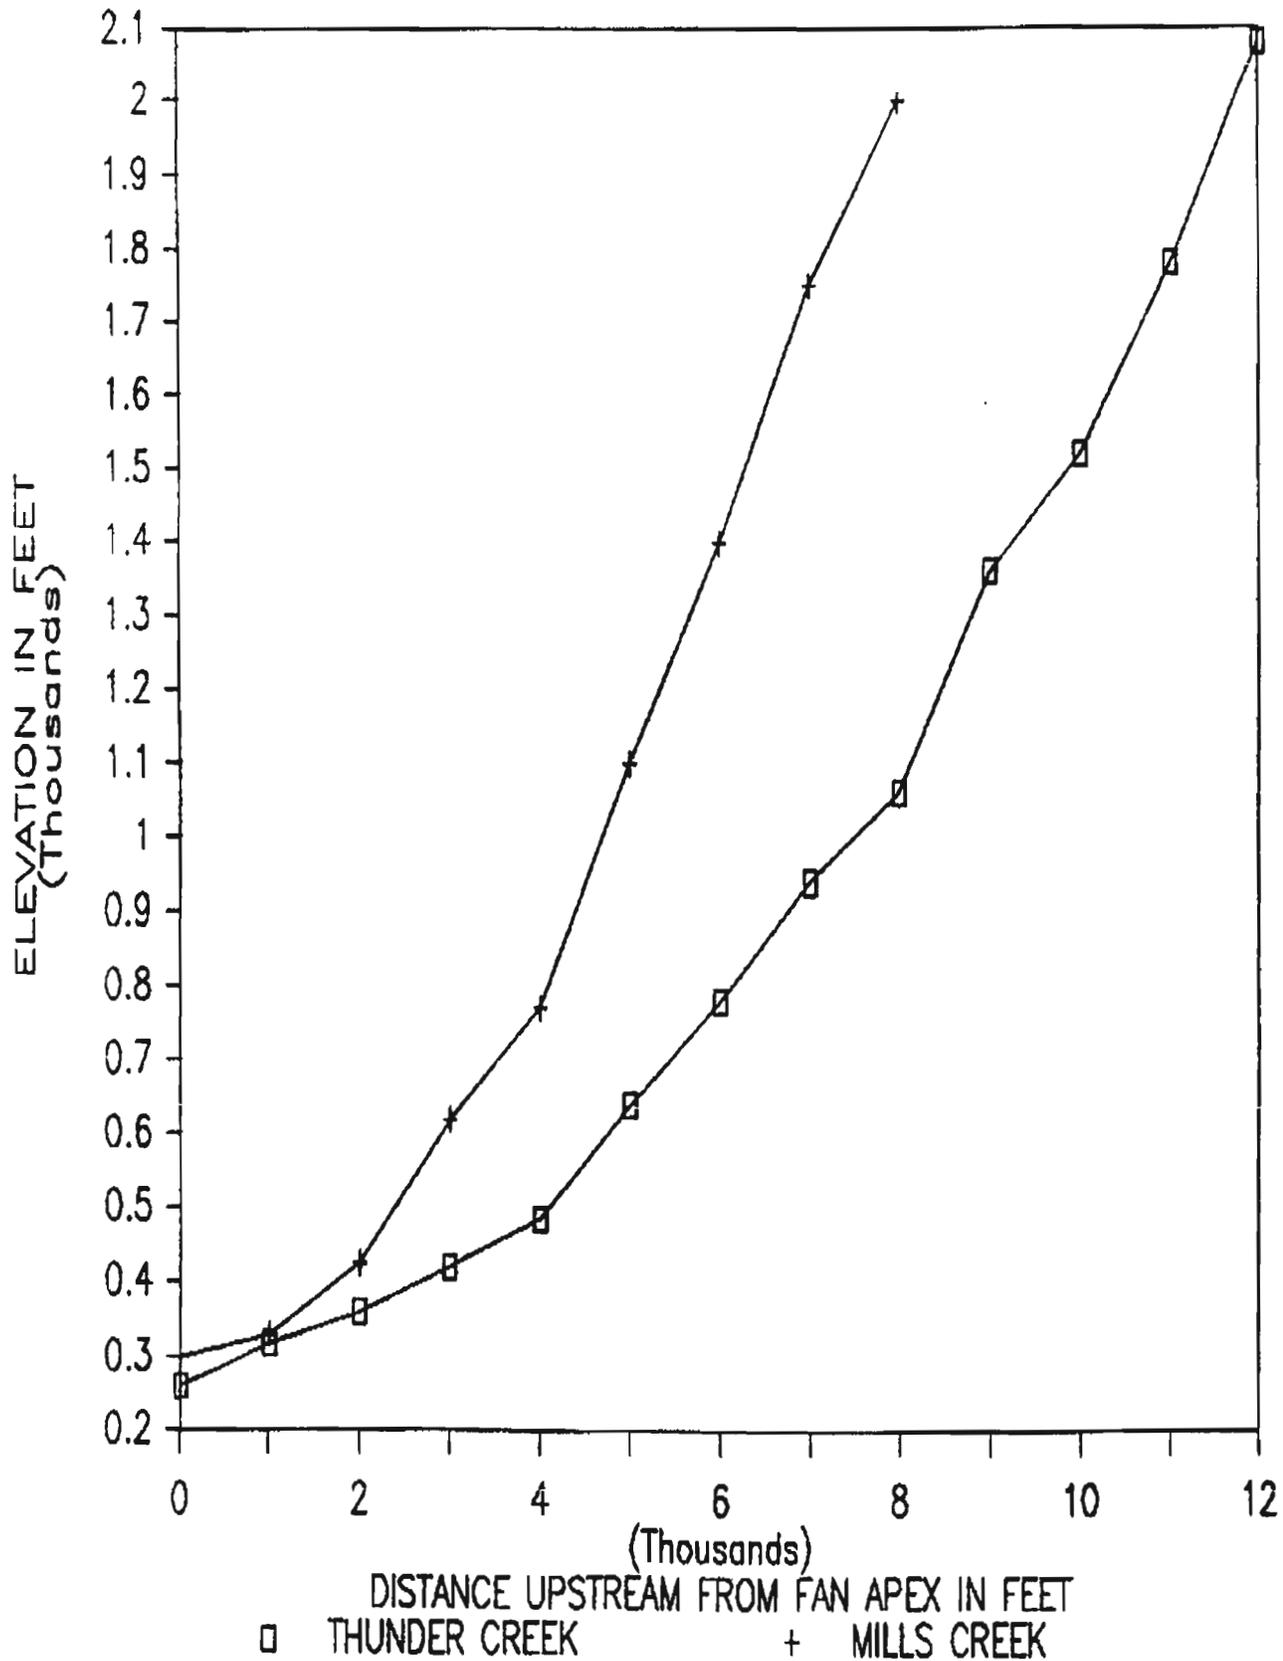
FIGURE 6

Also, the Thunder Creek basin is substantially larger than that of Mills Creek. Its theoretical discharge rate is nearly twice as great. Thus, a debris torrent of a given size would become more diluted as it progressed

down Thunder Creek compared to a comparable one in Mills Creek. Everything else equal, the resulting lower slurry density for the Thunder Creek event would mean less ability to transport material, especially bedload. Thus, Mills Creek, with its steeper more confined channels, could sustain a fast-moving debris torrent to lower elevations than could Thunder Creek.

Although Thunder Creek is much less likely to sustain a debris torrent into currently developed areas than Mills Creek, it is more capable of transporting torrent-generated debris by flooding. Much of the damage from the 1983 storm in Whatcom County was from floods laden with floating debris initially mobilized by debris torrents. Such damage was not confined to fan apex areas, but commonly occurred along the distal edges of the fan, in areas of low gradient, and not necessarily bordering present stream channels.. As residential development progresses upstream along the banks of Thunder Creek the odds for such damage will increase, with or without forest management activities.

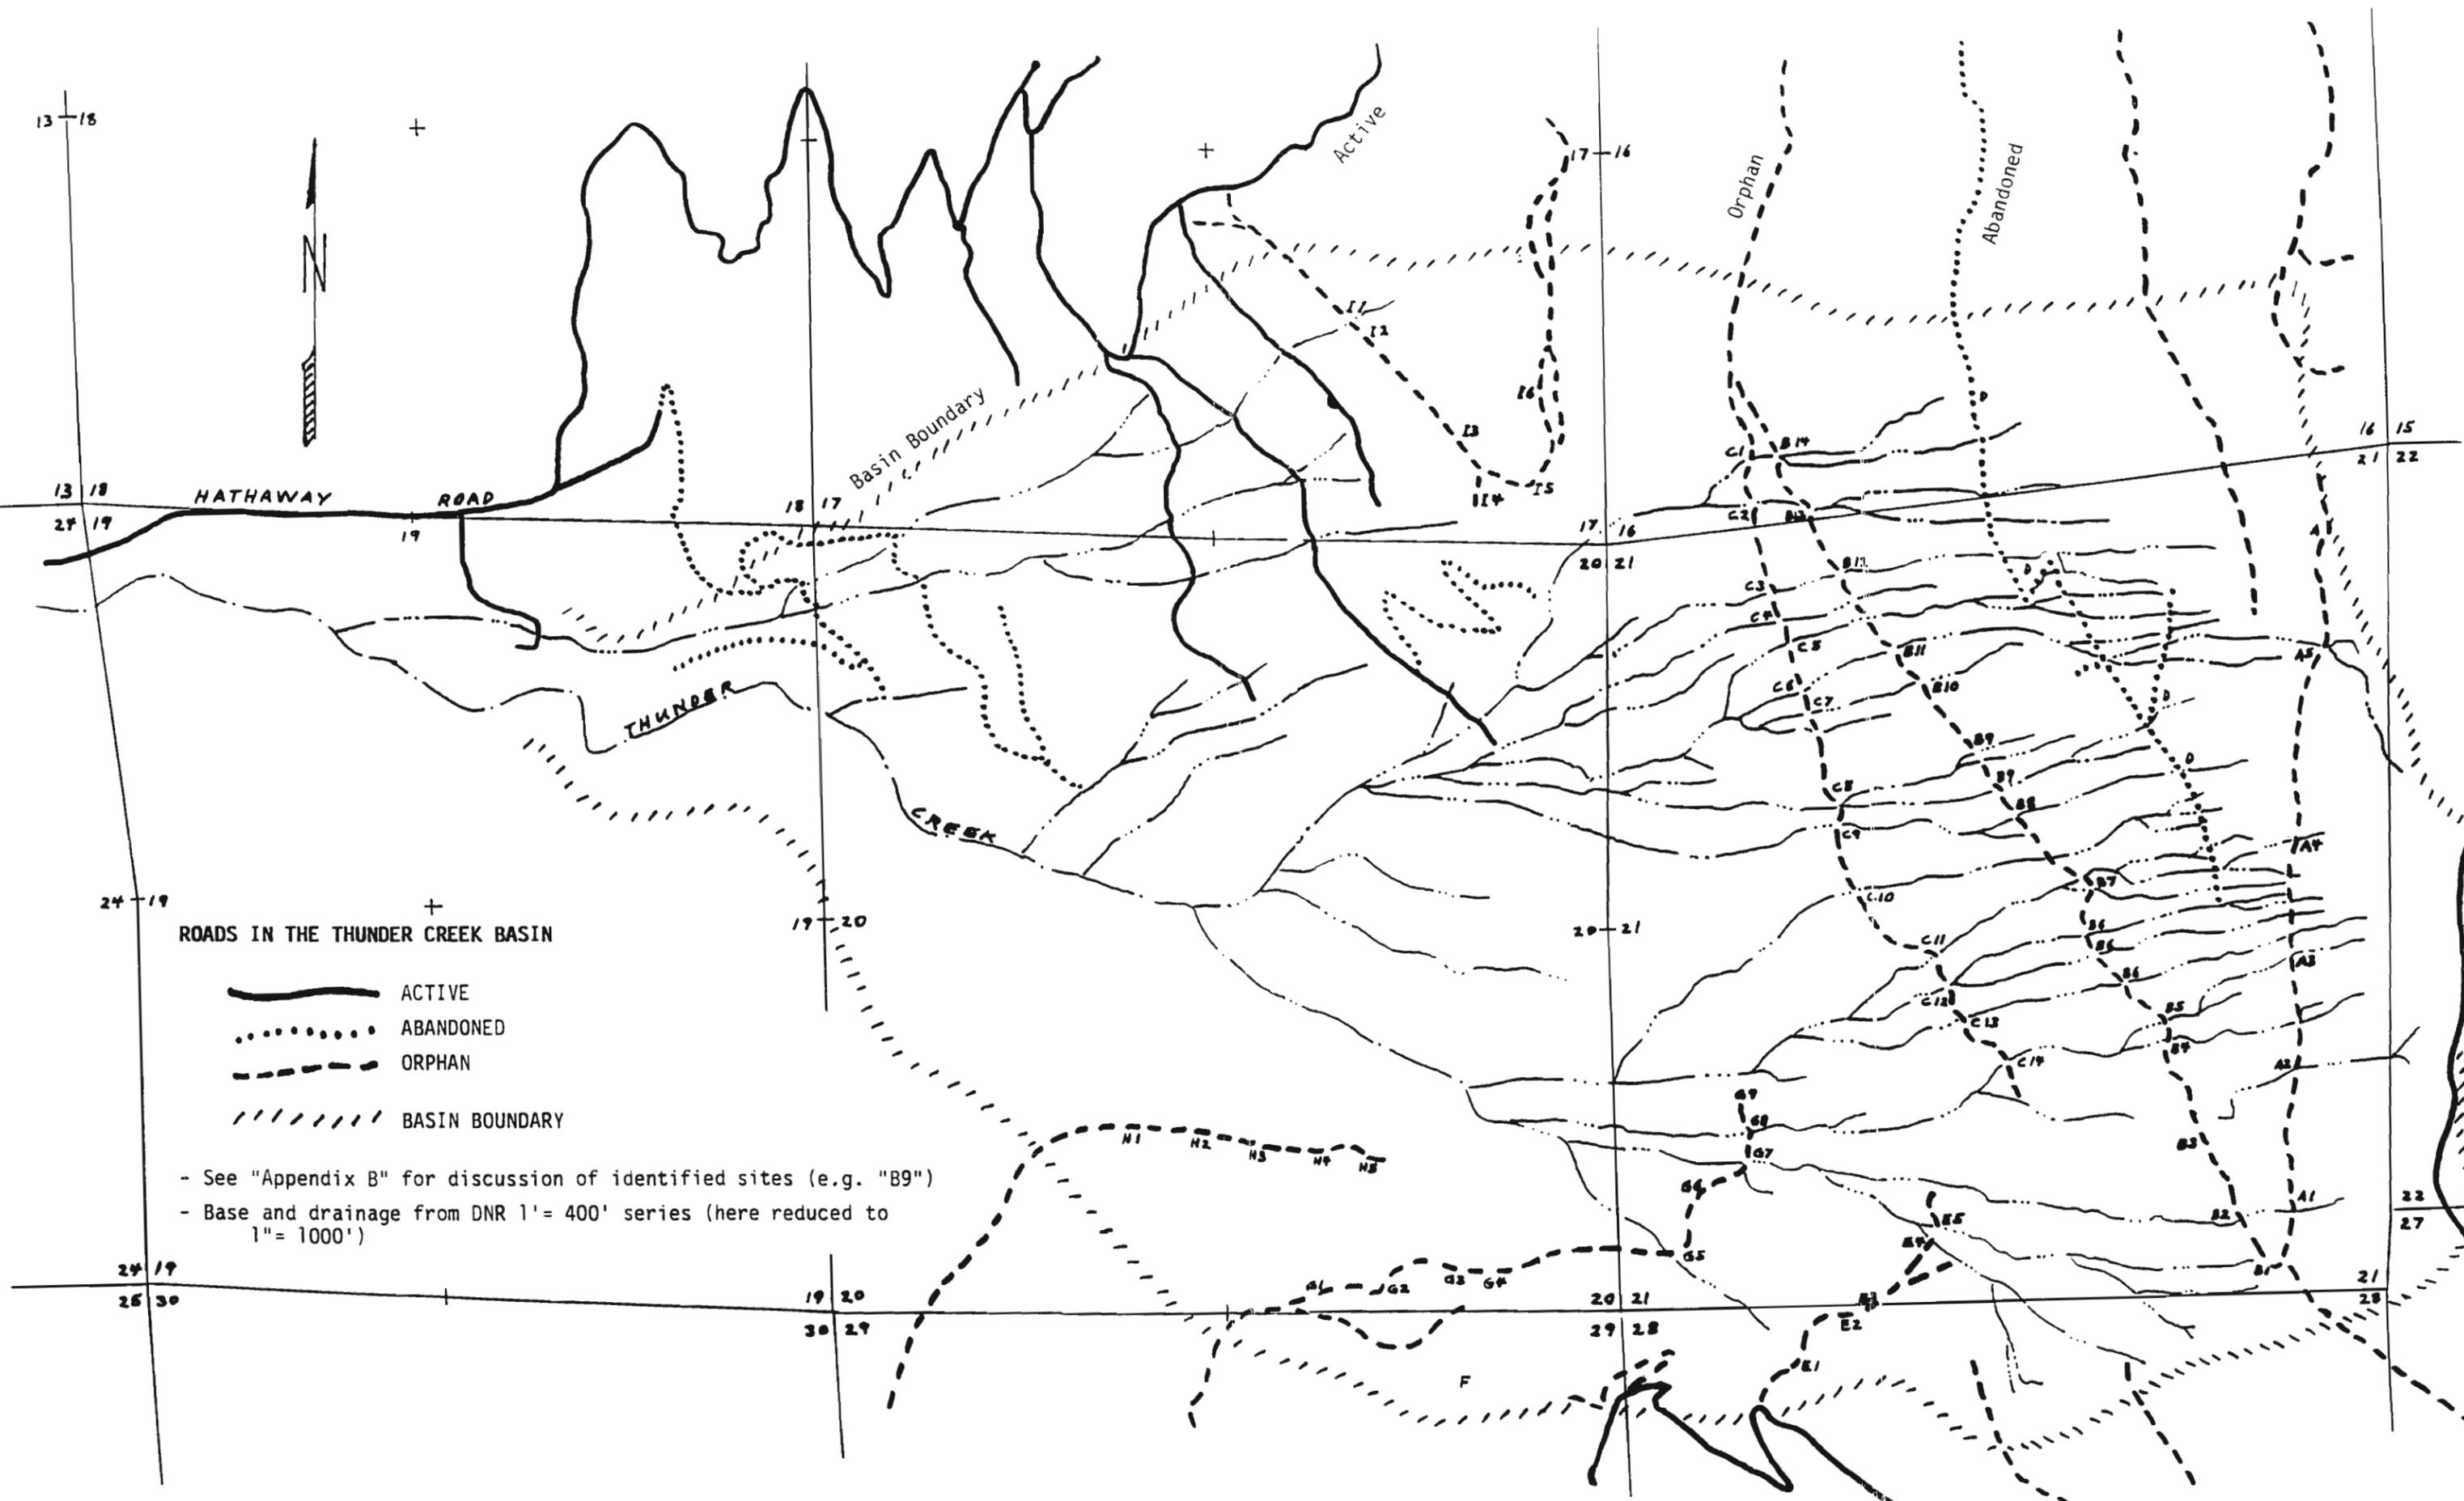
ROADS IN THE THUNDER CREEK BASIN

The present general condition of the approximately 8 miles of orphaned roads in the Thunder Creek basin is not easily characterized. Their condition reflects their age, method of construction, original intended use (railroad, truck, cat trail), and terrain (slope gradient, stability, presence of stream channels) involved - some of which vary markedly over short distances. Probably the main reason these roads have created as few problems as they have is because most were constructed with very low grades.

Road Segment B Summary: This road segment is about 1.4 miles long. Small streams cross this road at close intervals. Road was constructed with wood culverts most of which have failed or are in the process of failing. Steep slopes and steep channels below the road are common. Some specific crossing structures have potential to be involved in significant debris torrents. Most practical access to this road segment is from the south through Scott Paper Company. The road is brushy and has many alder trees as large as 6+ inches DBH. Methods of removing or reducing the stream crossing fills/structures should be considered.

Road Segment "C" Summary: This road segment is just over 1 mile long. Trees growing in the road are commonly 10 to 12 inches at DBH and some are 16 inches. Many stream crossing structures are washed out and the remaining ones are failing. Road gradient is relatively flat and there is little standing water on the road. Considerable harvest-related large woody material remains in most of the channels. Machinery access is not practical due to washed out crossings and large trees. There is not much that can be done on this road segment - biggest potential problem seems to be the amount of large wood in the channels.

Road Segment E Summary: This road segment is about 2,000 feet in length and crosses the very steep scarp of a large ancient slope failure. Equipment access would require reconstruction of a part of the road and is not practical. Other means of controlling road drainage could probably help stability through the steeper/wetter sections of road.

Road Segment G Summary: This road segment is about 0.8 mile in length and crosses the very steep scarp of a large ancient slope failure. Portions of the road have experienced debris avalanche-type failures along the steepest sideslopes and the road is gone. Settling sidecast is common and much of the road surface is wet due to seepage from the cutslopes and/or the steep basin upslope. Equipment access to most of the road is impractical but better control of surface water could help stability on portions of the remaining road.

Recommendations: An overall orphaned road treatment plan should be developed before further abandonment work. Various treatment options and combinations (including heavy equipment, handwork, helicopter support, and explosives) should be evaluated.
