# Slope Stability Analysis of the Bluffs along the Washington State Capitol Campus, Olympia, Washington

by Wendy J. Gerstel

WASHINGTON  
DIVISION OF GEOLOGY  
AND EARTH RESOURCES

Open File Report 96-3  
April 1996

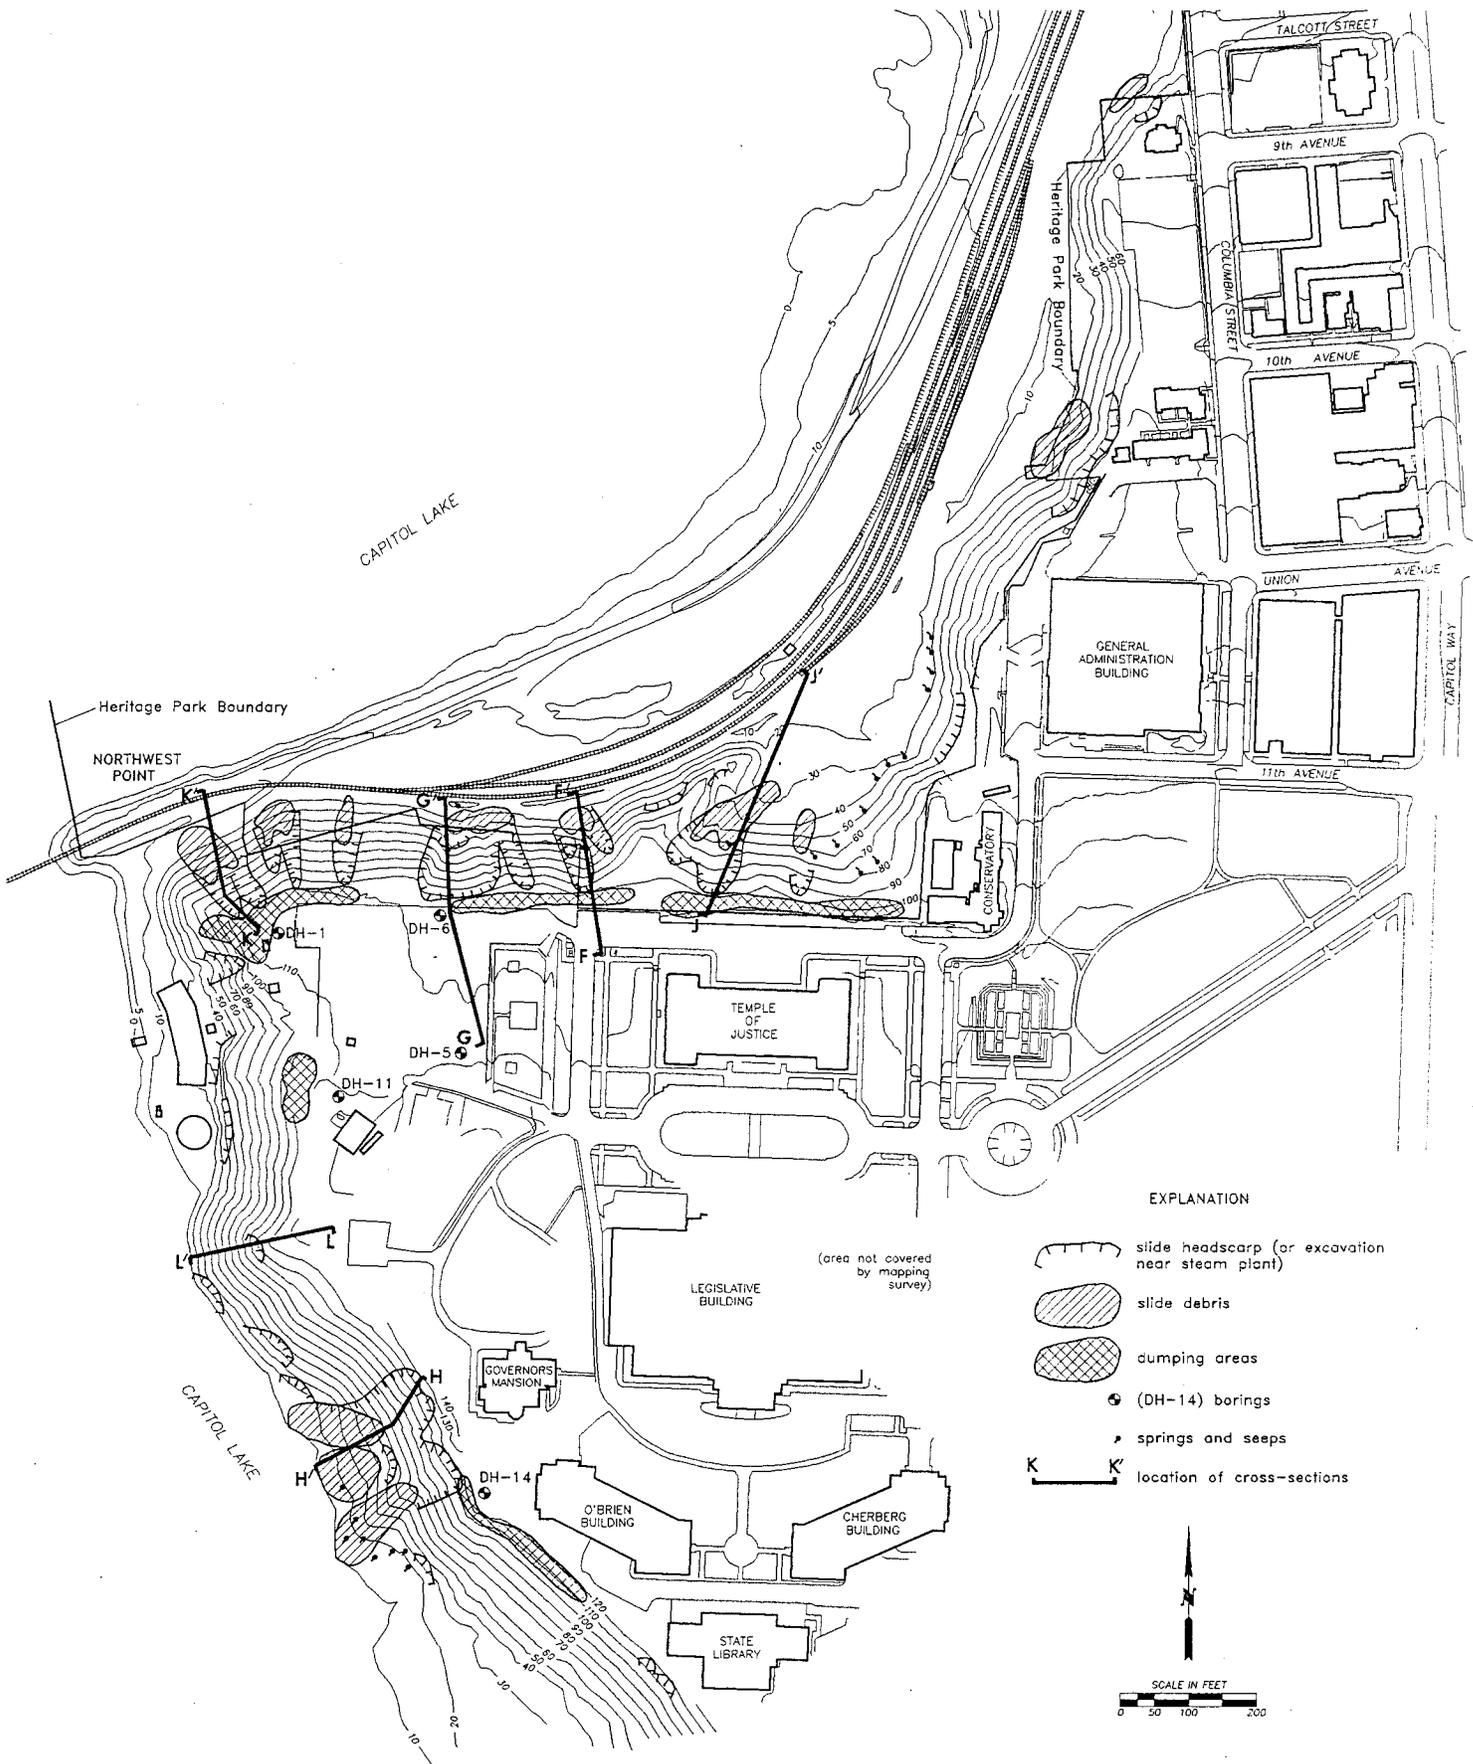
The airphoto analysis, along with field observations, interviews with long-time Capitol Campus employees, and a search of historical records, have identified slope failures in several places along the bluffs (Plate 1 and Fig. 2). The two largest occurred just north of the Temple of Justice and west of the GA building, respectively. Both involved the failure of native

two large slump-earthflows with steep headwalls and hummocky slide debris at the base. These failures formed debris fans that extend out into Capitol Lake approximately 20 ft beyond the rest of the shoreline (Plate 1 and Fig. 2). Springs and seeps are visible in the headwall areas as well as at the base of the slope in the slide debris. Slope movement in this area has probably been sporadic with different portions moving at different times, making it difficult to estimate the age of movement.

PLATE 1: Landslide and location map of the north- and west-facing bluffs of the Washington State Capitol Campus.

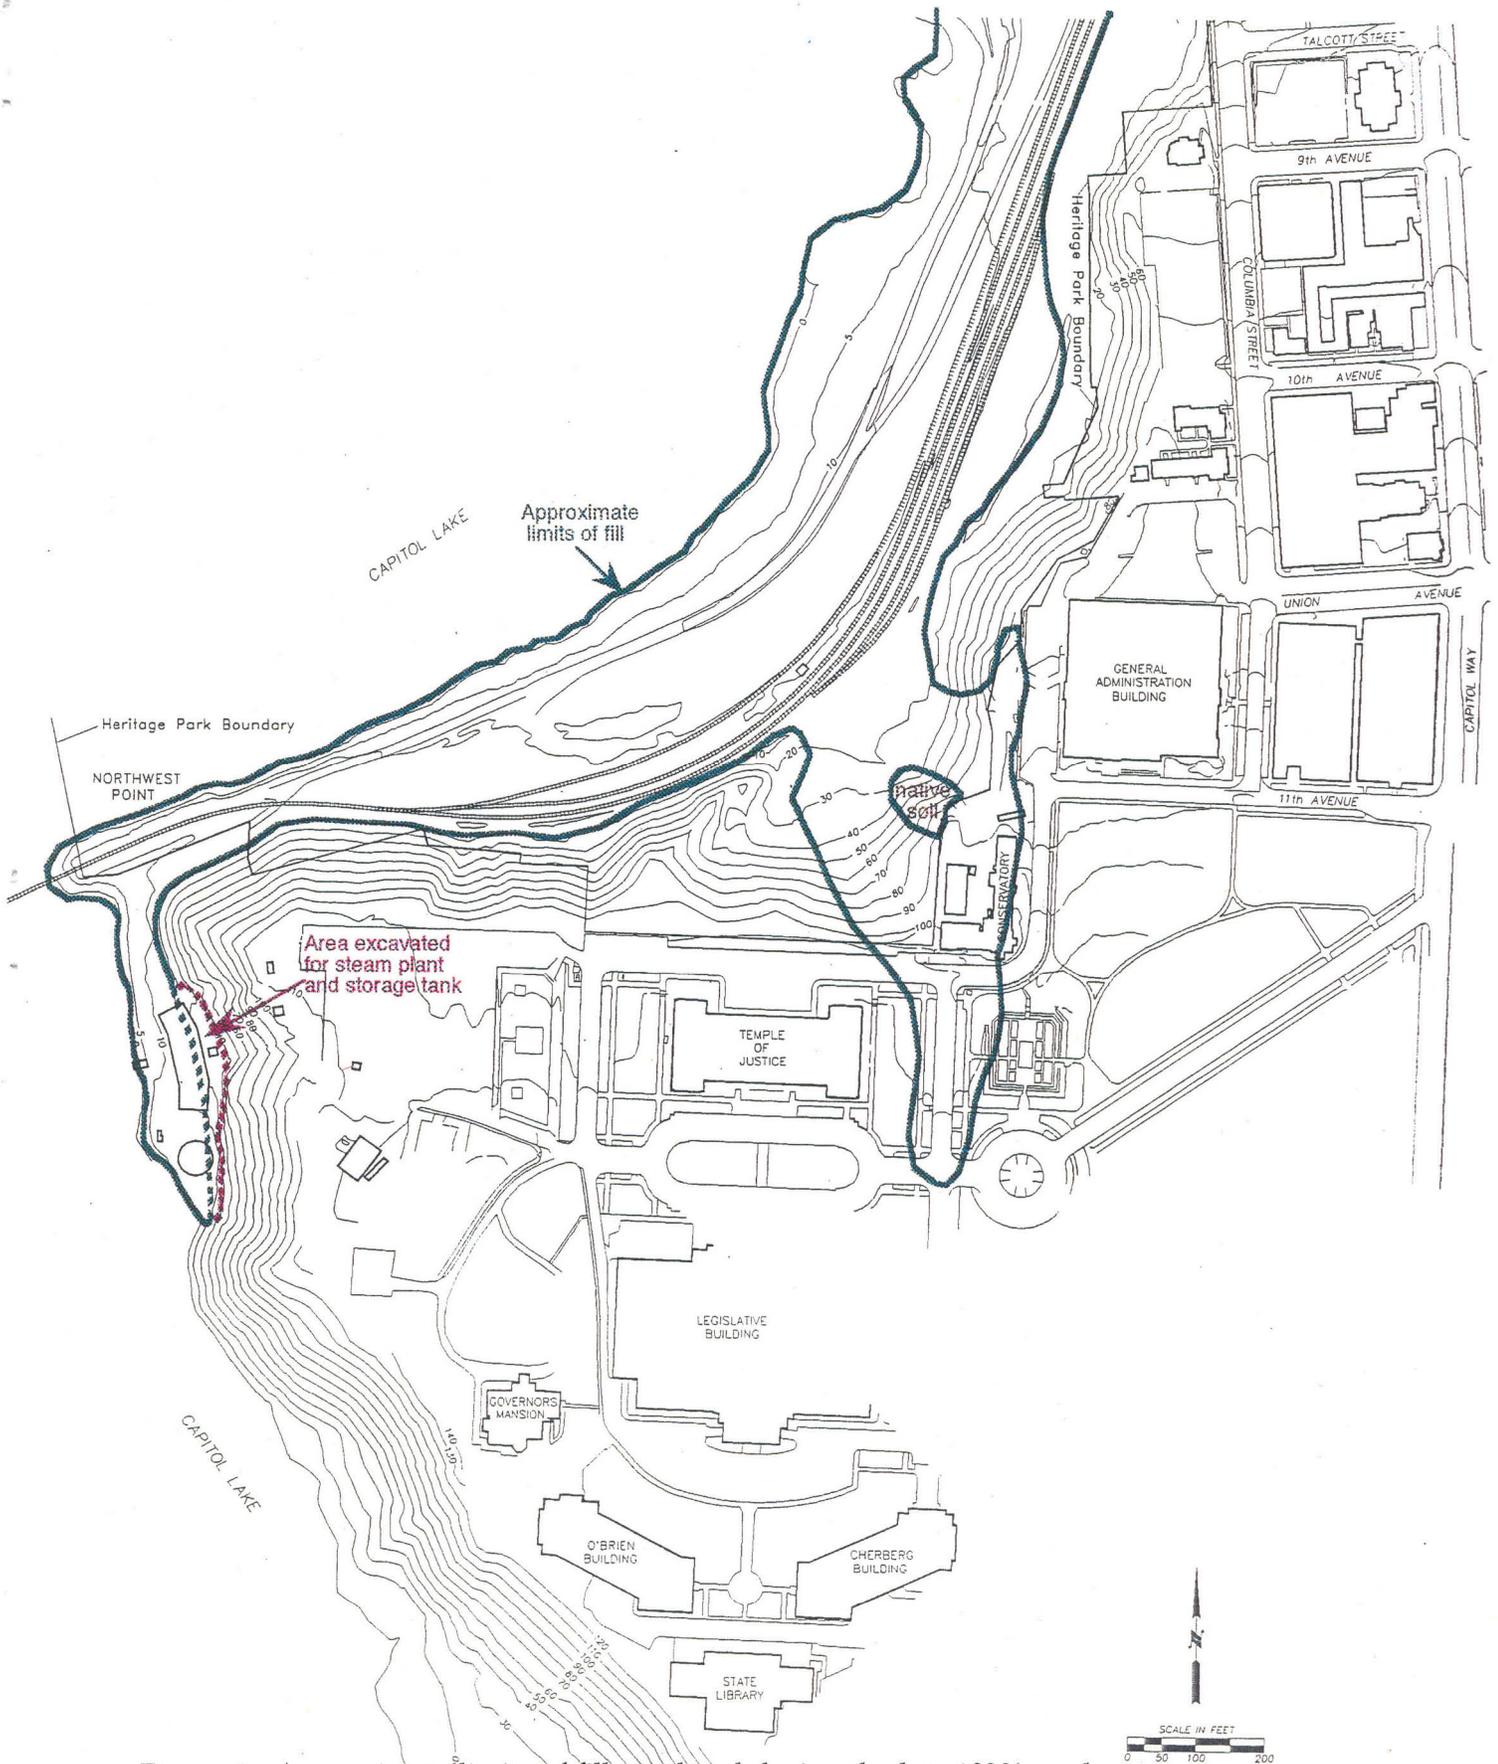
Figure 1. Approximate limits of fill emplaced during the late 1800's and early 1900's. Fill material generally consists of dredge spoils and/or construction waste. Material excavated from the bluffs for the construction of the steam plant in the early 1920's provided fill material for the plant foundation. Additional material was excavated in the 1970's for the larger replacement of the original storage tank.

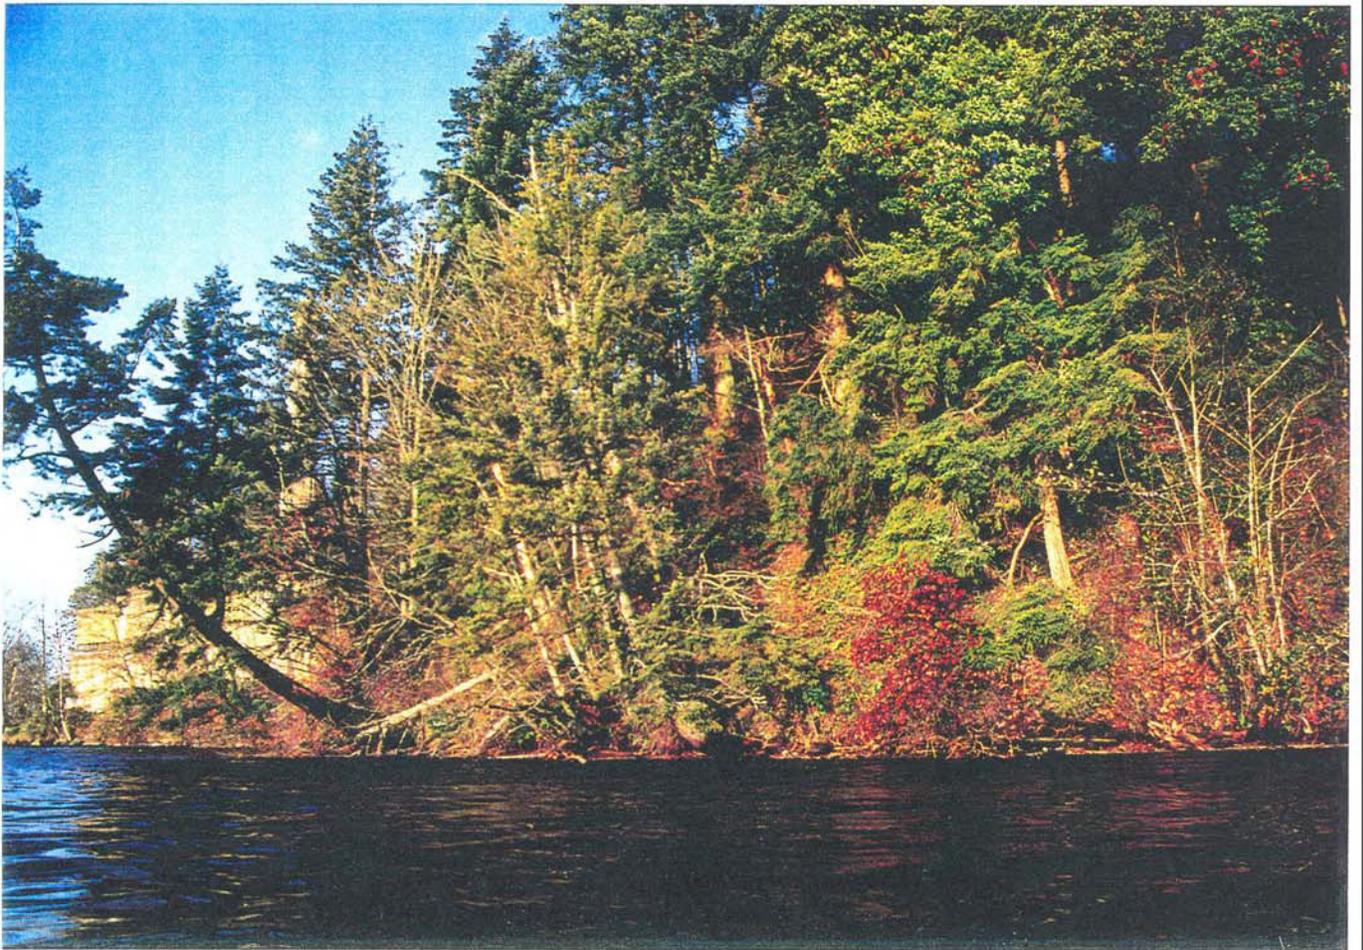
From the steam plant southward for approximately 120 ft along the west-facing bluffs, there is little evidence of debris slides. There has, however, been persistent soil creep and small-scale slumping, especially along the lower part of the slope within about 15 to 25 ft of the lake (Fig. 3). Airphotos show stressed vegetation and toppled trees in the area of active slope movement, particularly since 1985. The upper part of the slope shows evidence of at least one small rotational slump. South of that, just west of the Governor's mansion, is an area of larger rotational failures and debris slumps and slides (Fig. 2). Both ground observations and airphoto review suggest that these failures have been active in the past 30 years.

Figure 3. View looking northeast from Capitol Lake to convex slope south of the steam plant. Approximate location of Section LL'. Note leaning trees along lower portion of slope.

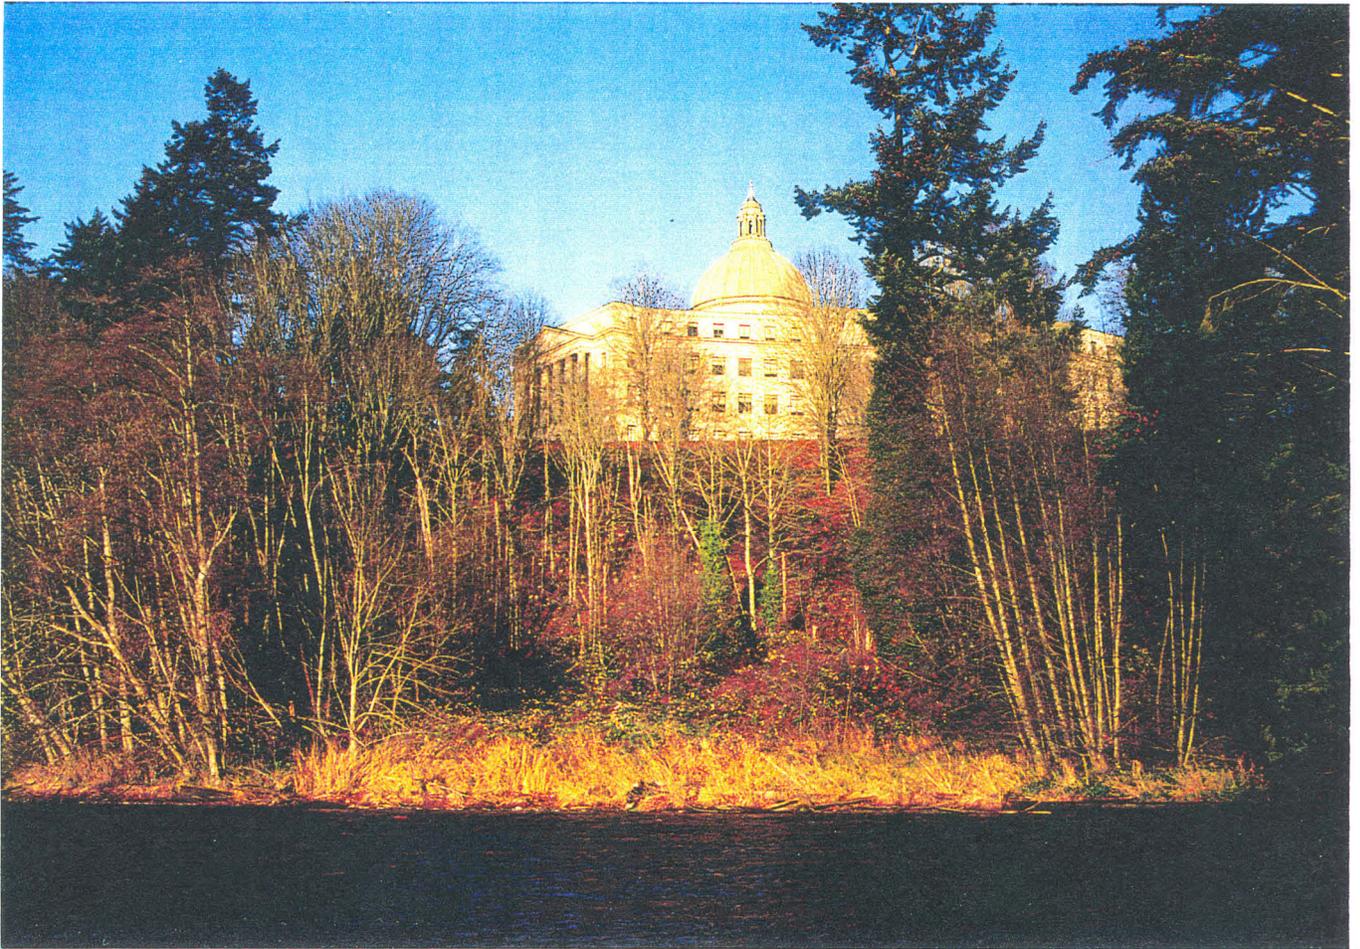
Figure 4. View looking east-northeast from Capitol Lake to slope south and west of the O'Brien Building. Capitol dome is in the background. Note uniformity of slope and sparse vegetation. Left foreground with alder is underlain by debris slide material from slopes west of Governor's mansion. Boring DH-14 is located at top of slope to left of O'Brien Building.

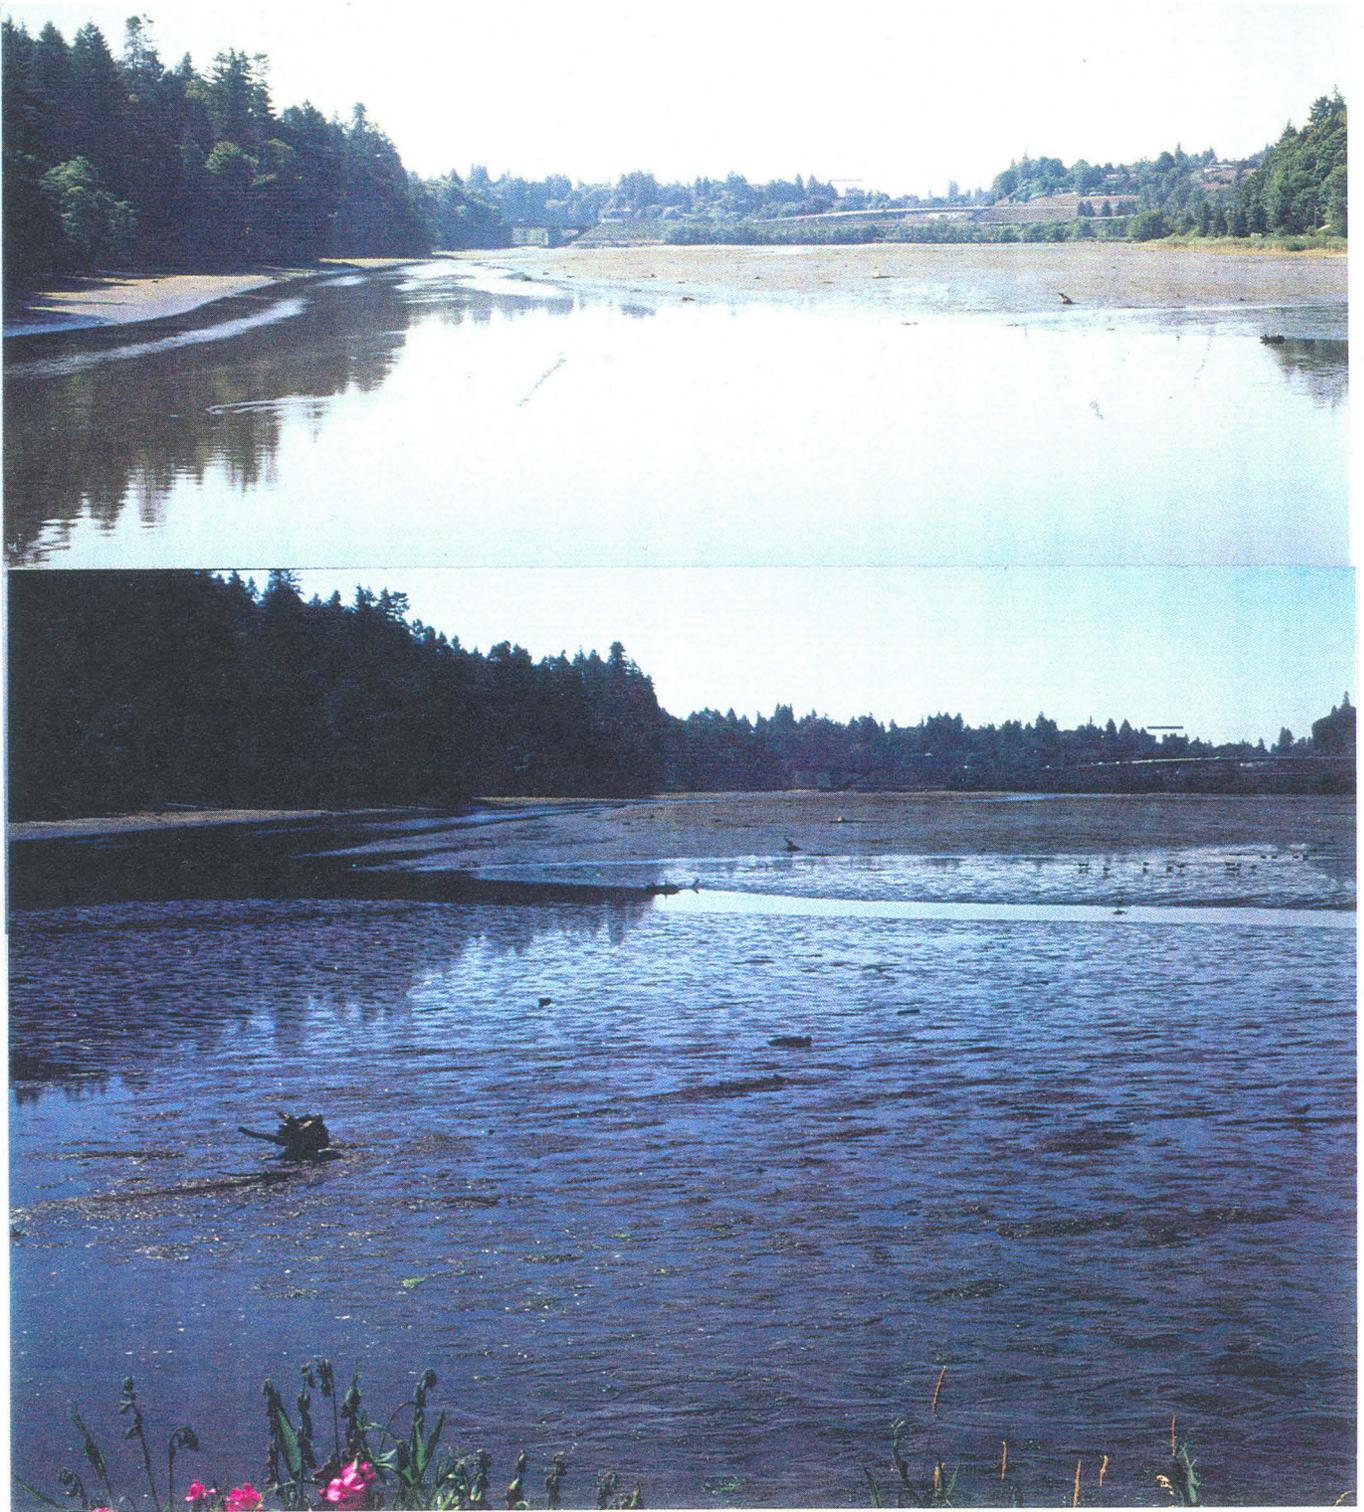
Figure 6. Views looking south of Deschutes River channel at base of west-facing Capitol Campus bluff slopes. Photos taken during drawdown of Capitol Lake in the summer of 1994. Percival Creek channel is visible entering from west in lower photo.

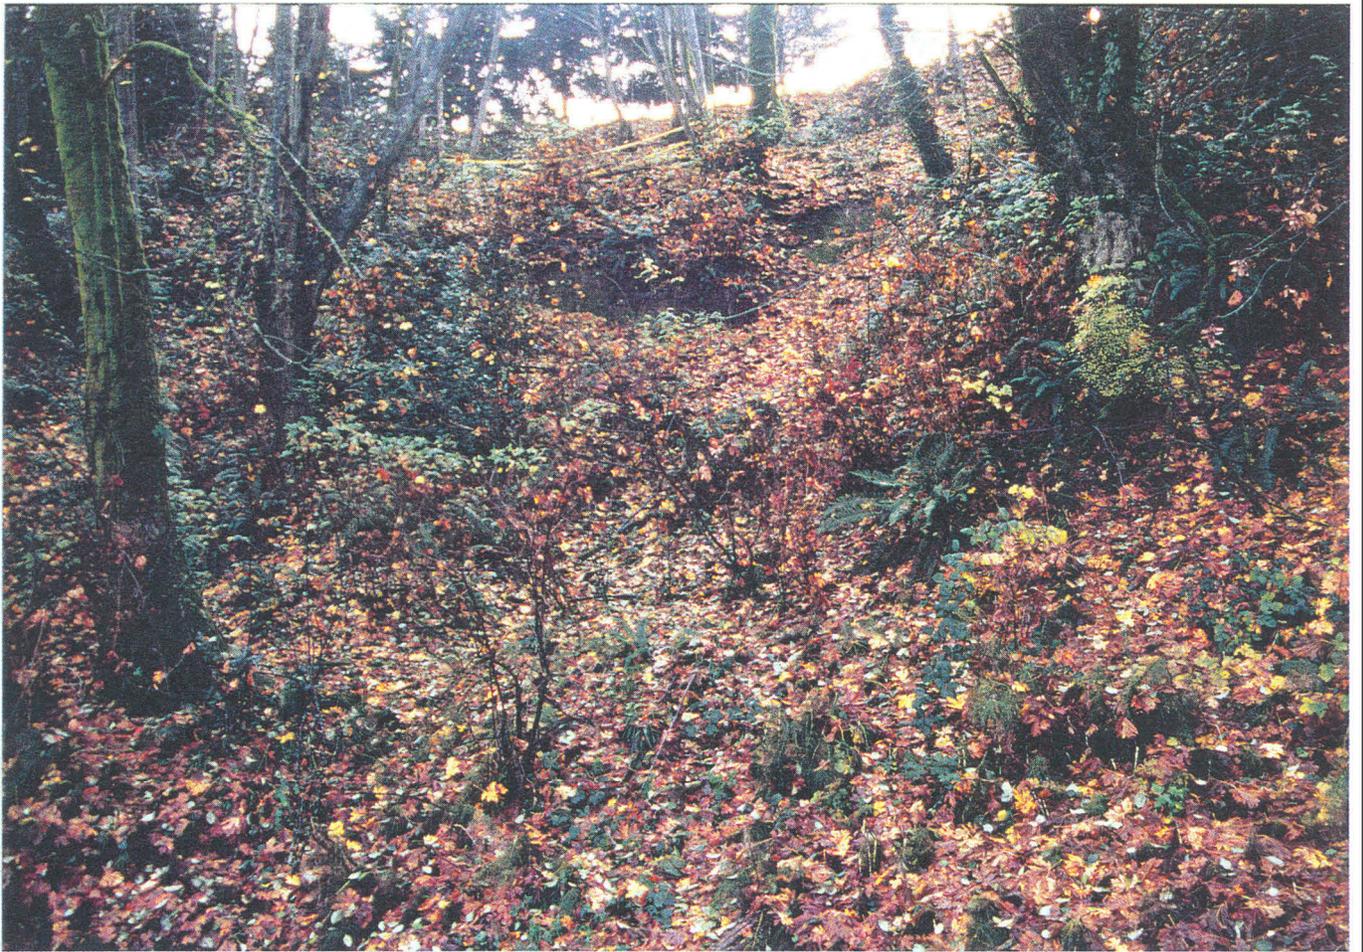
Figure 7a. View looking up slope along Section GG'. Note silts exposed midslope.

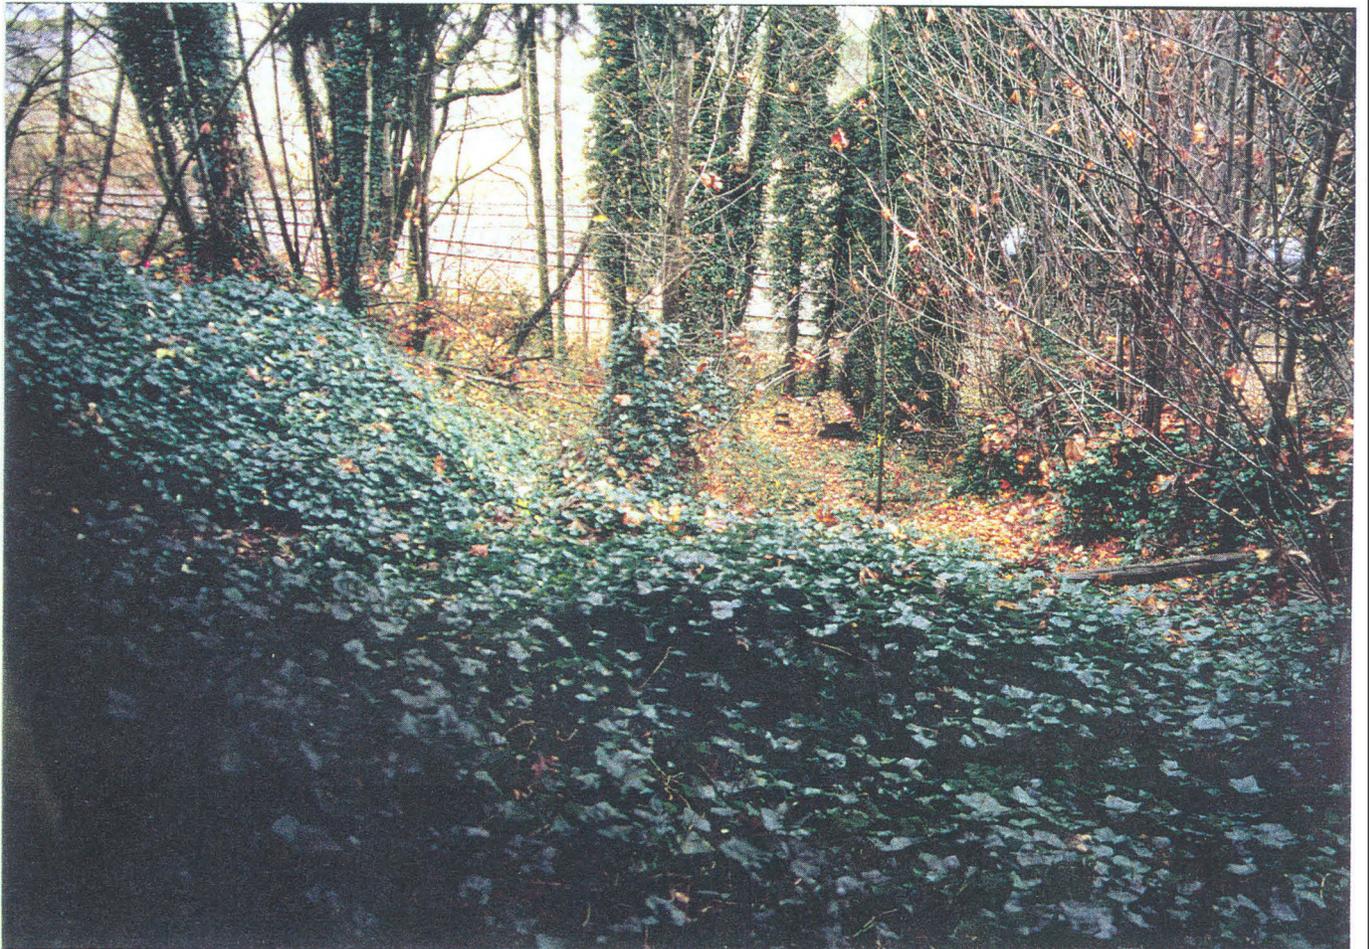
Figure 7b. View looking down slope along Section FF'.

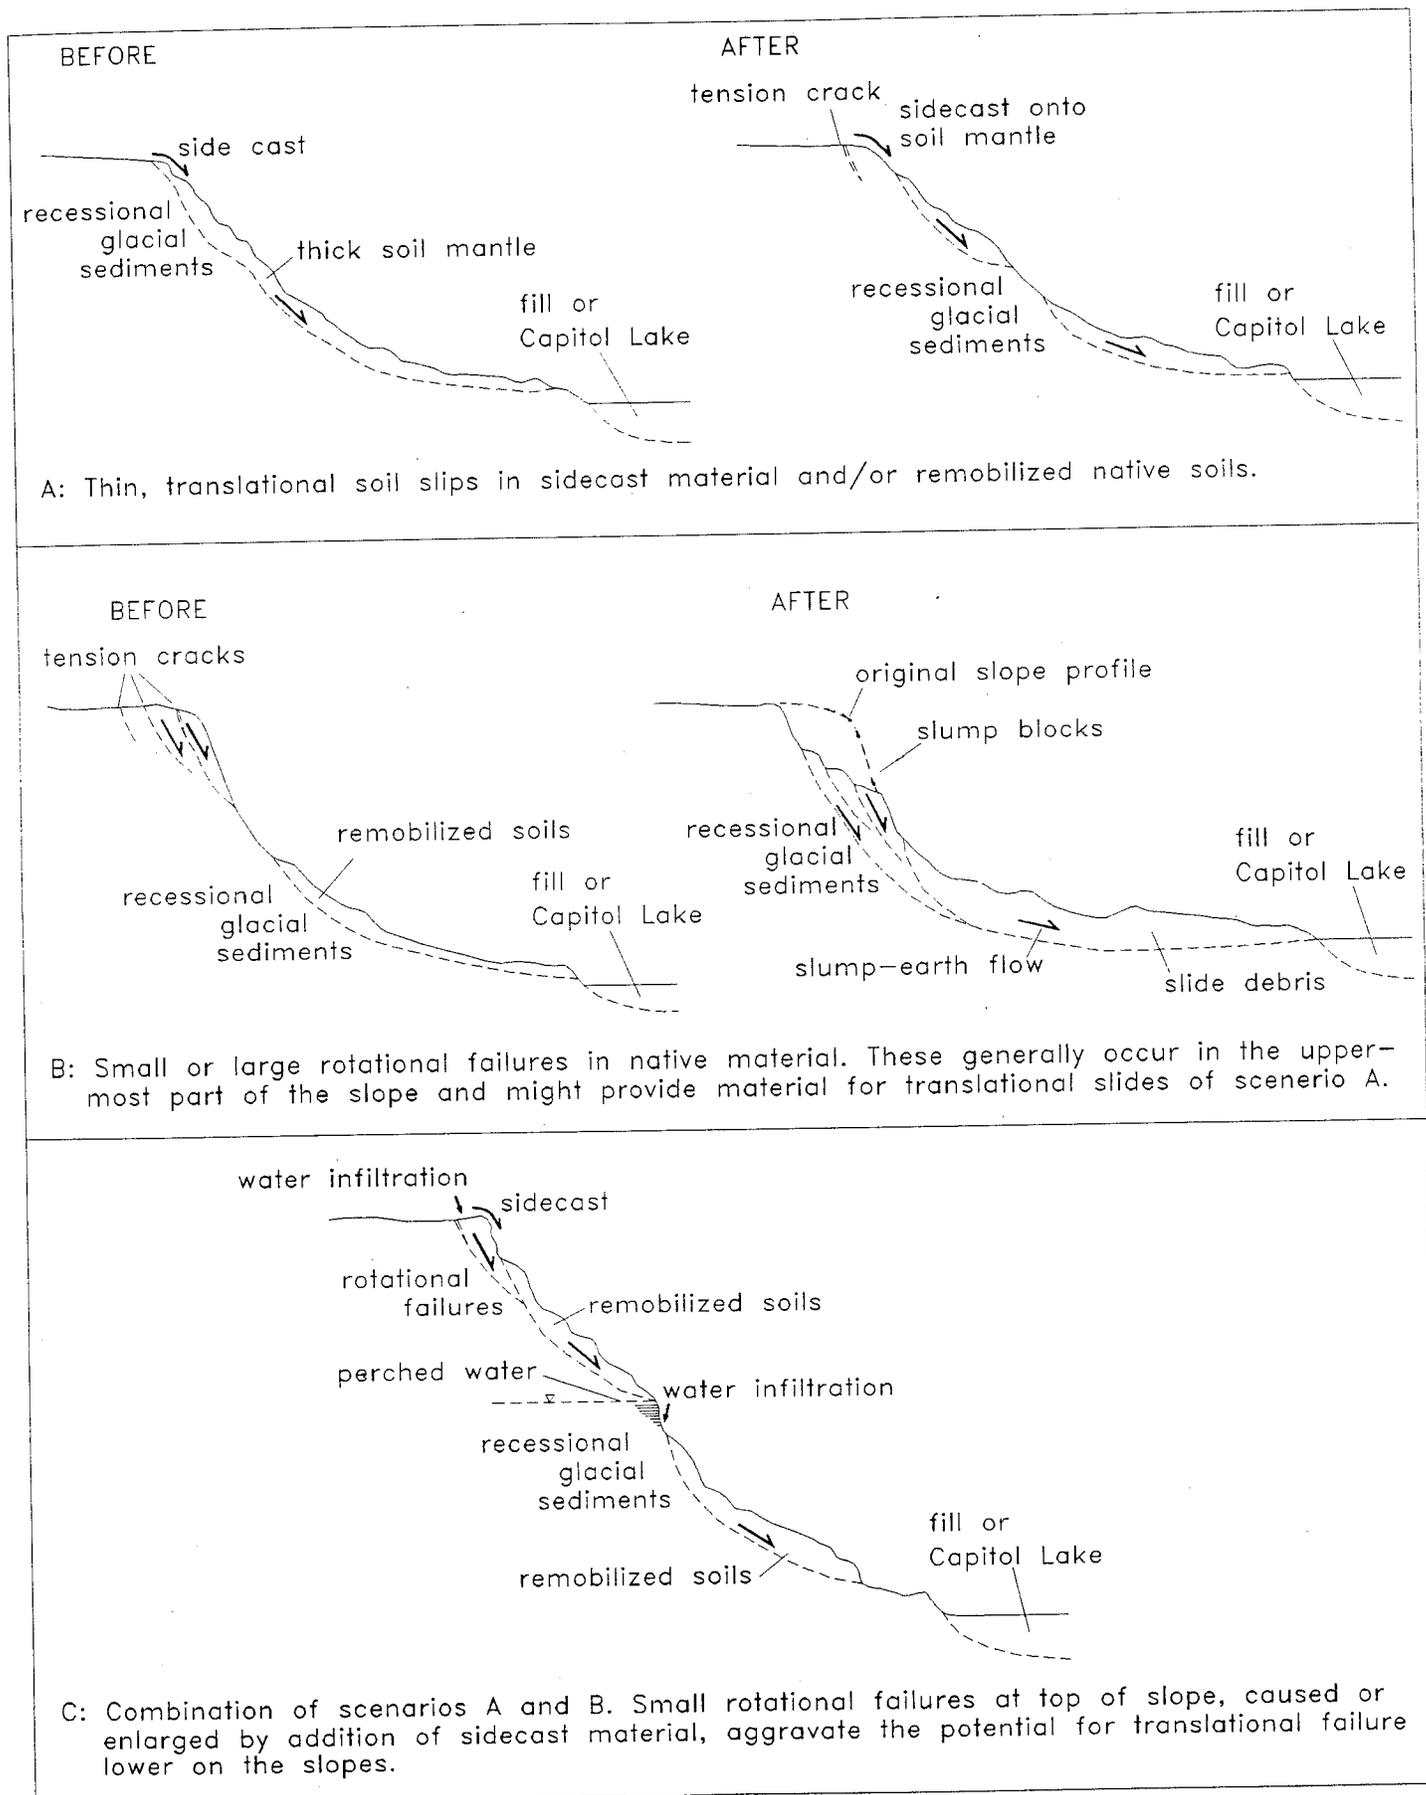
Field observations combined with borehole data suggest three likely mechanisms for slope failure along the bluffs of the Capitol Campus (Fig. 8). Figure 8A illustrates a simple, thin translational failure of an approximately 3- to 6-ft-thick mantle of sidecast material and/or remobilized native soil or colluvium. Figure 8B illustrates a small rotational slump in native soils, common on the upper slopes west of the Governor's mansion and the mechanism of the 1986 failure near the GA building. Locally these slumps transform into slump-earthflows as the soils attain residual strengths and develop excess porewater pressures. Such features are visible at the base of the slope west of the Governor's mansion. Figure 8C illustrates a combination of the processes depicted in 8A and 8B, in which failures are caused or enlarged by both the addition of sidecast material and the mobilization of native material by small rotational failures. This is the most likely mechanism causing the instability of the north-facing slopes along the Campus bluffs.

Slope stability modeling suggests that the bluffs are most likely to continue failing by the processes depicted in diagram A or C of Figure 8. With residual shear strengths for Soil Unit 1 of  $\phi = 20^\circ\text{--}23^\circ$  or less and low cohesion values, the random-search XSTABL runs show that failures will occur most frequently at the soil mantle/native soil contact (Example 1 in Appendix F). These failures are particularly likely to occur during or shortly following periods of heavy rainfall and runoff with the resulting high water table in the soil mantle

Figure 8: Likely mechanisms of bluff failure on the Washington State Capitol Campus

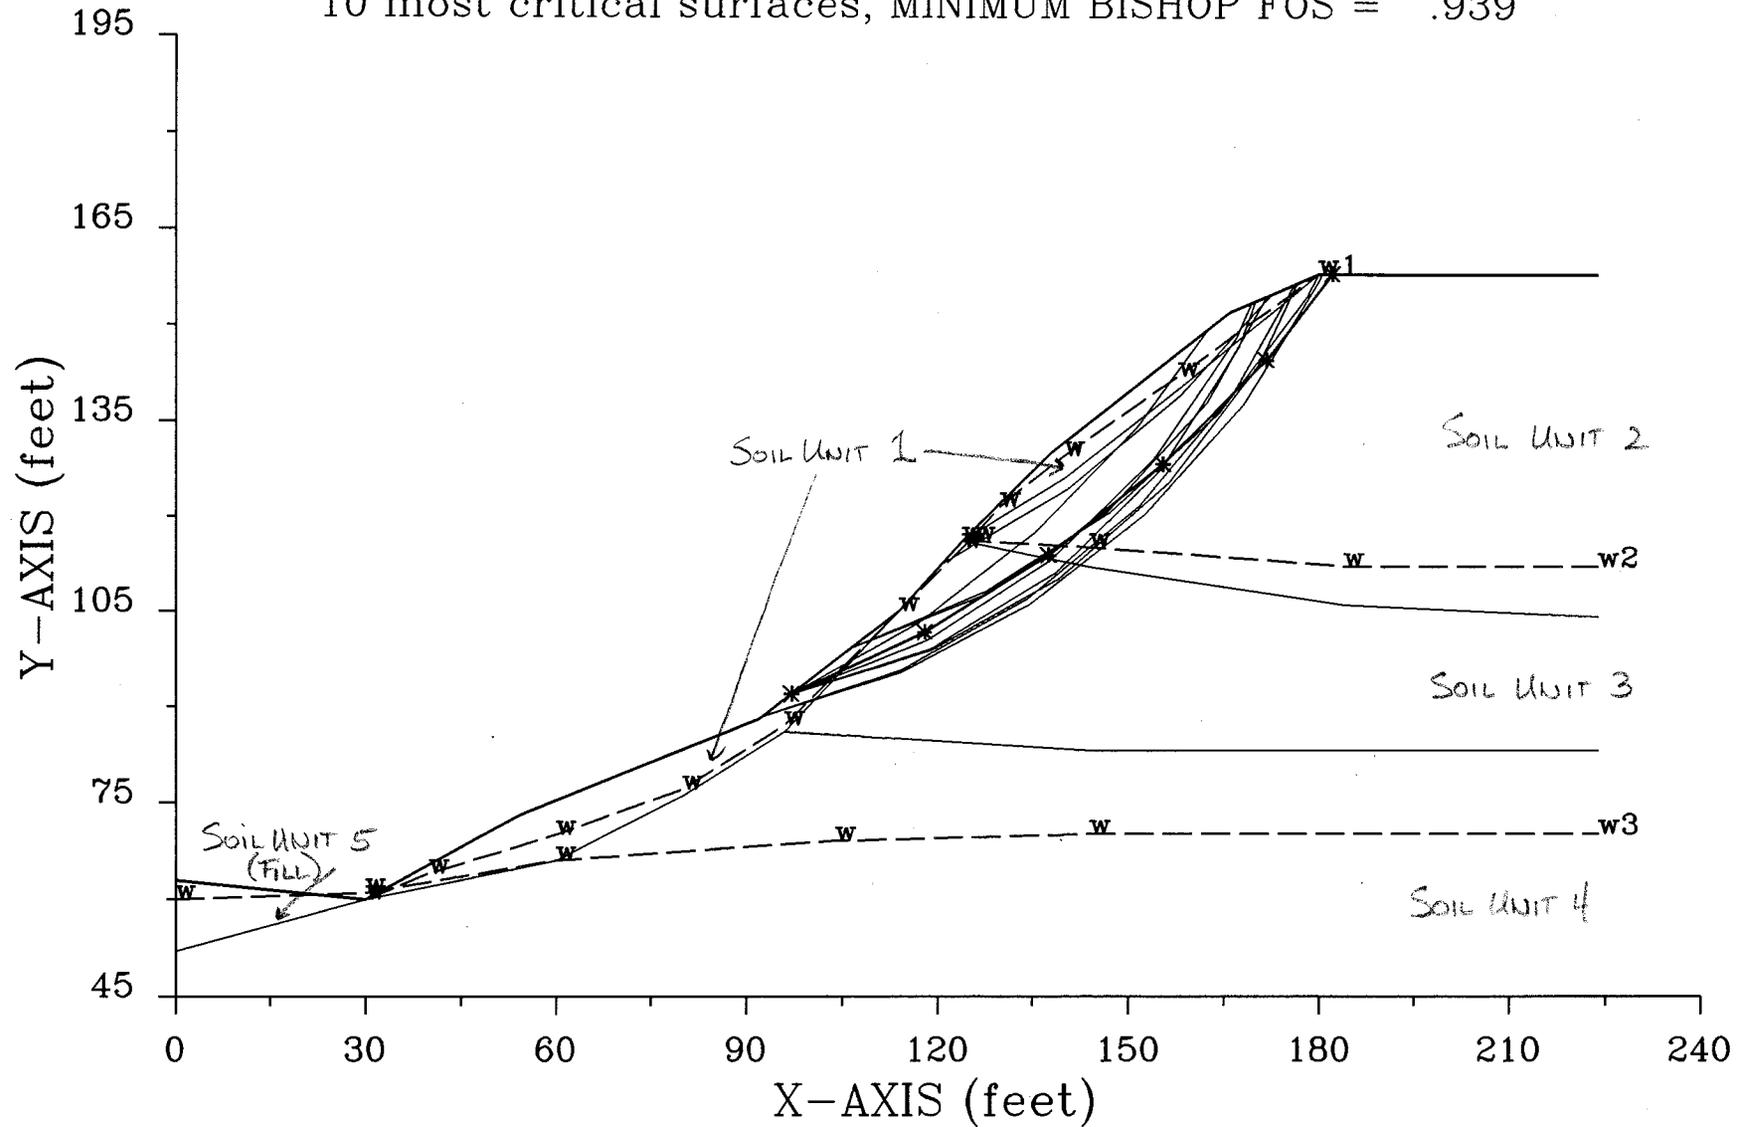
# BLUFF STABILITY ANALYSIS (SEC. G-G')

10 most critical surfaces, MINIMUM BISHOP FOS = .939

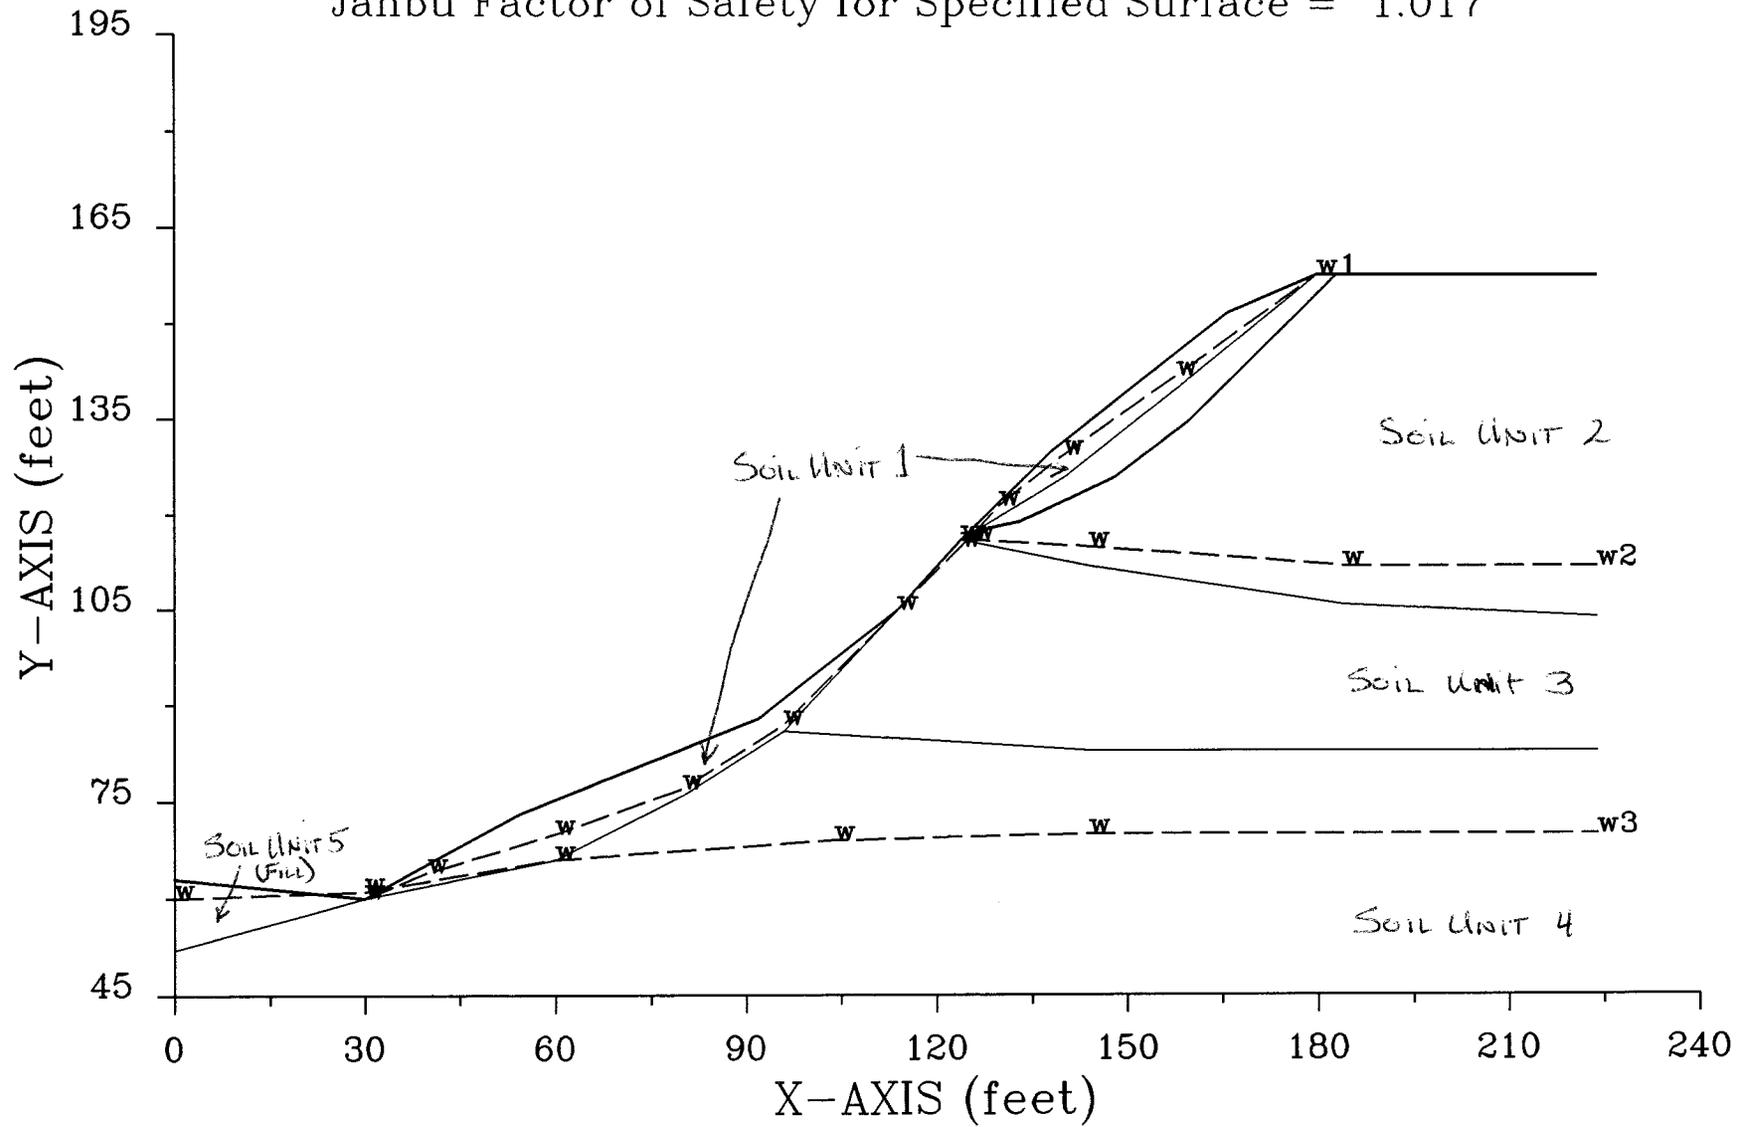
# BLUFF STABILITY ANALYSIS (SEC. G-G')

Examples 3–5 illustrate conditions of low to moderate stability, with calculated factors of safety of 1.02. Example 6 shows an unstable situation, with a calculated factor of safety of less than 1.0.

Janbu Factor of Safety for Specified Surface = 1.017

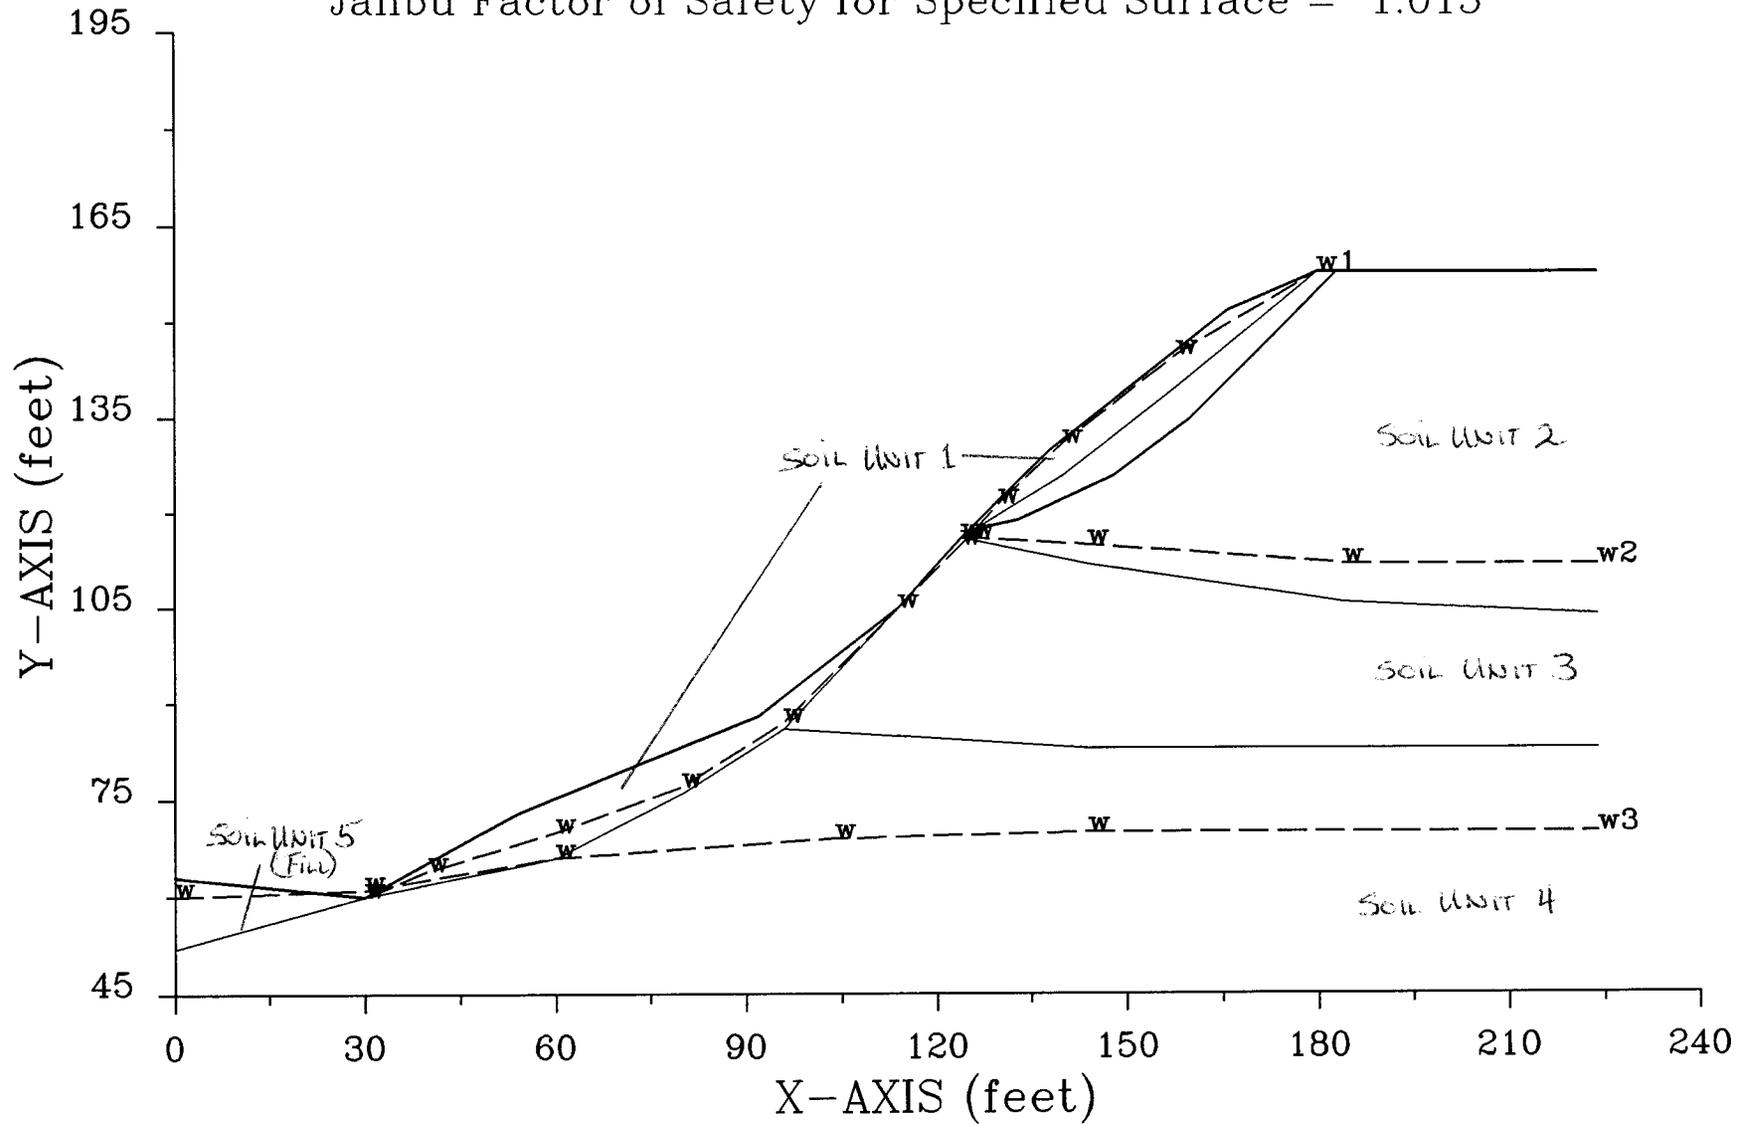
# BLUFF STABILITY ANALYSIS (SEC. G-G')

Janbu Factor of Safety for Specified Surface = 1.015
