# Slope Stability Analysis of the Bluffs along the Washington State Capitol Campus, Olympia, Washington

by Wendy J. Gerstel

WASHINGTON  
DIVISION OF GEOLOGY  
AND EARTH RESOURCES

Open File Report 96-3  
April 1996

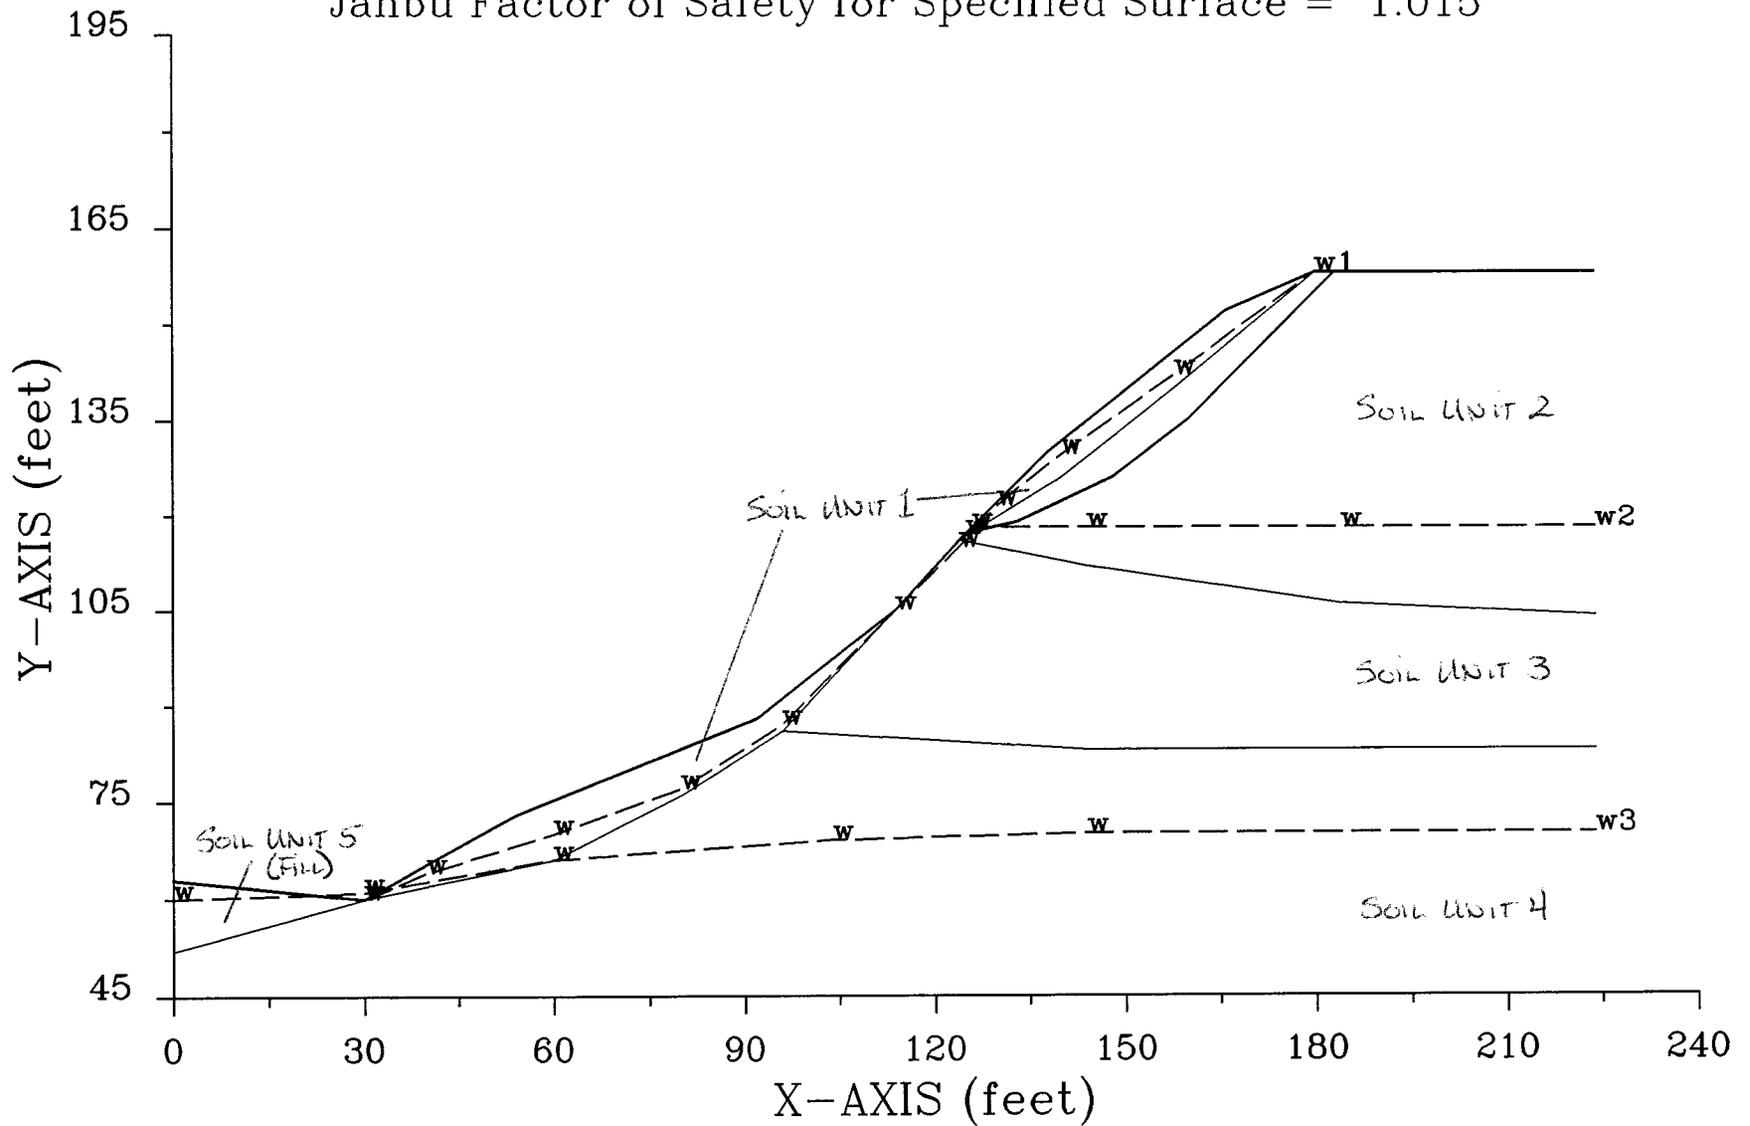
# BLUFF STABILITY ANALYSIS (SEC. G-G')

Examples 3–5 illustrate conditions of low to moderate stability, with calculated factors of safety of 1.02. Example 6 shows an unstable situation, with a calculated factor of safety of less than 1.0.

Janbu Factor of Safety for Specified Surface = 1.015

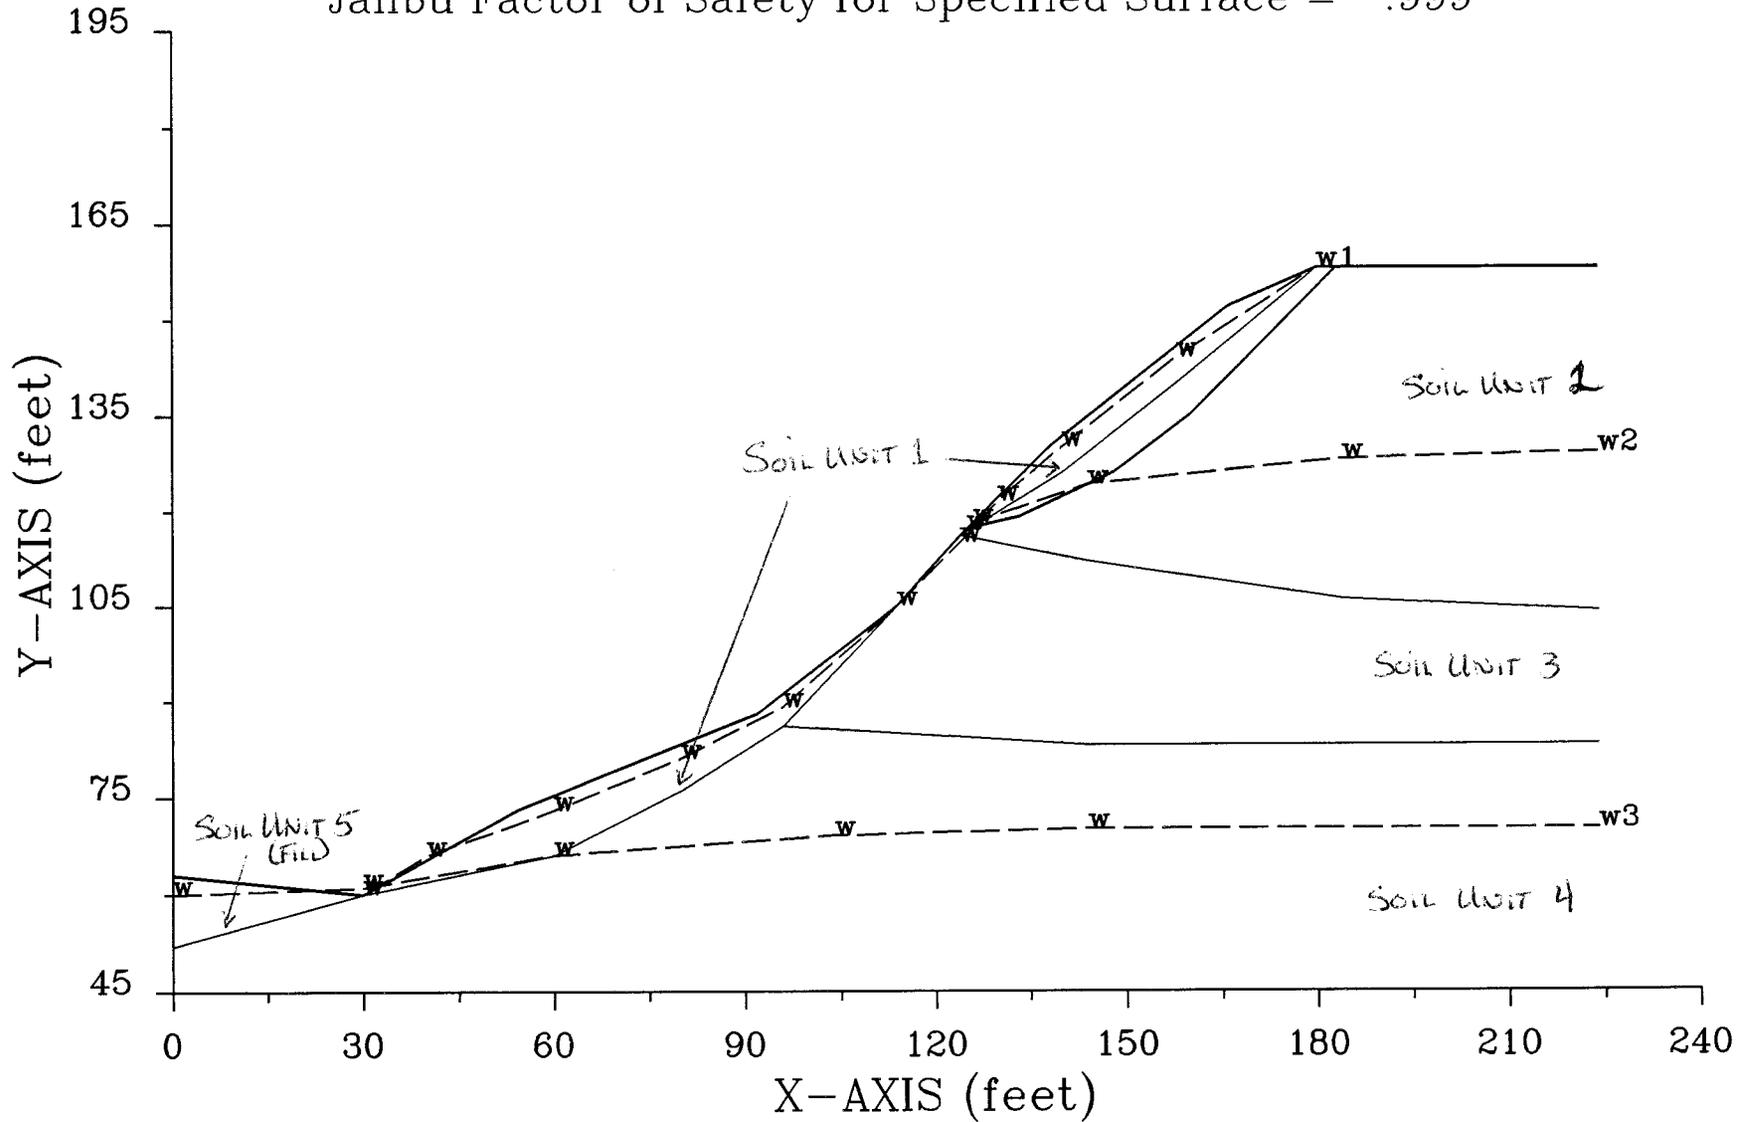
# BLUFF STABILITY ANALYSIS (SEC. G-G')

Janbu Factor of Safety for Specified Surface = .999

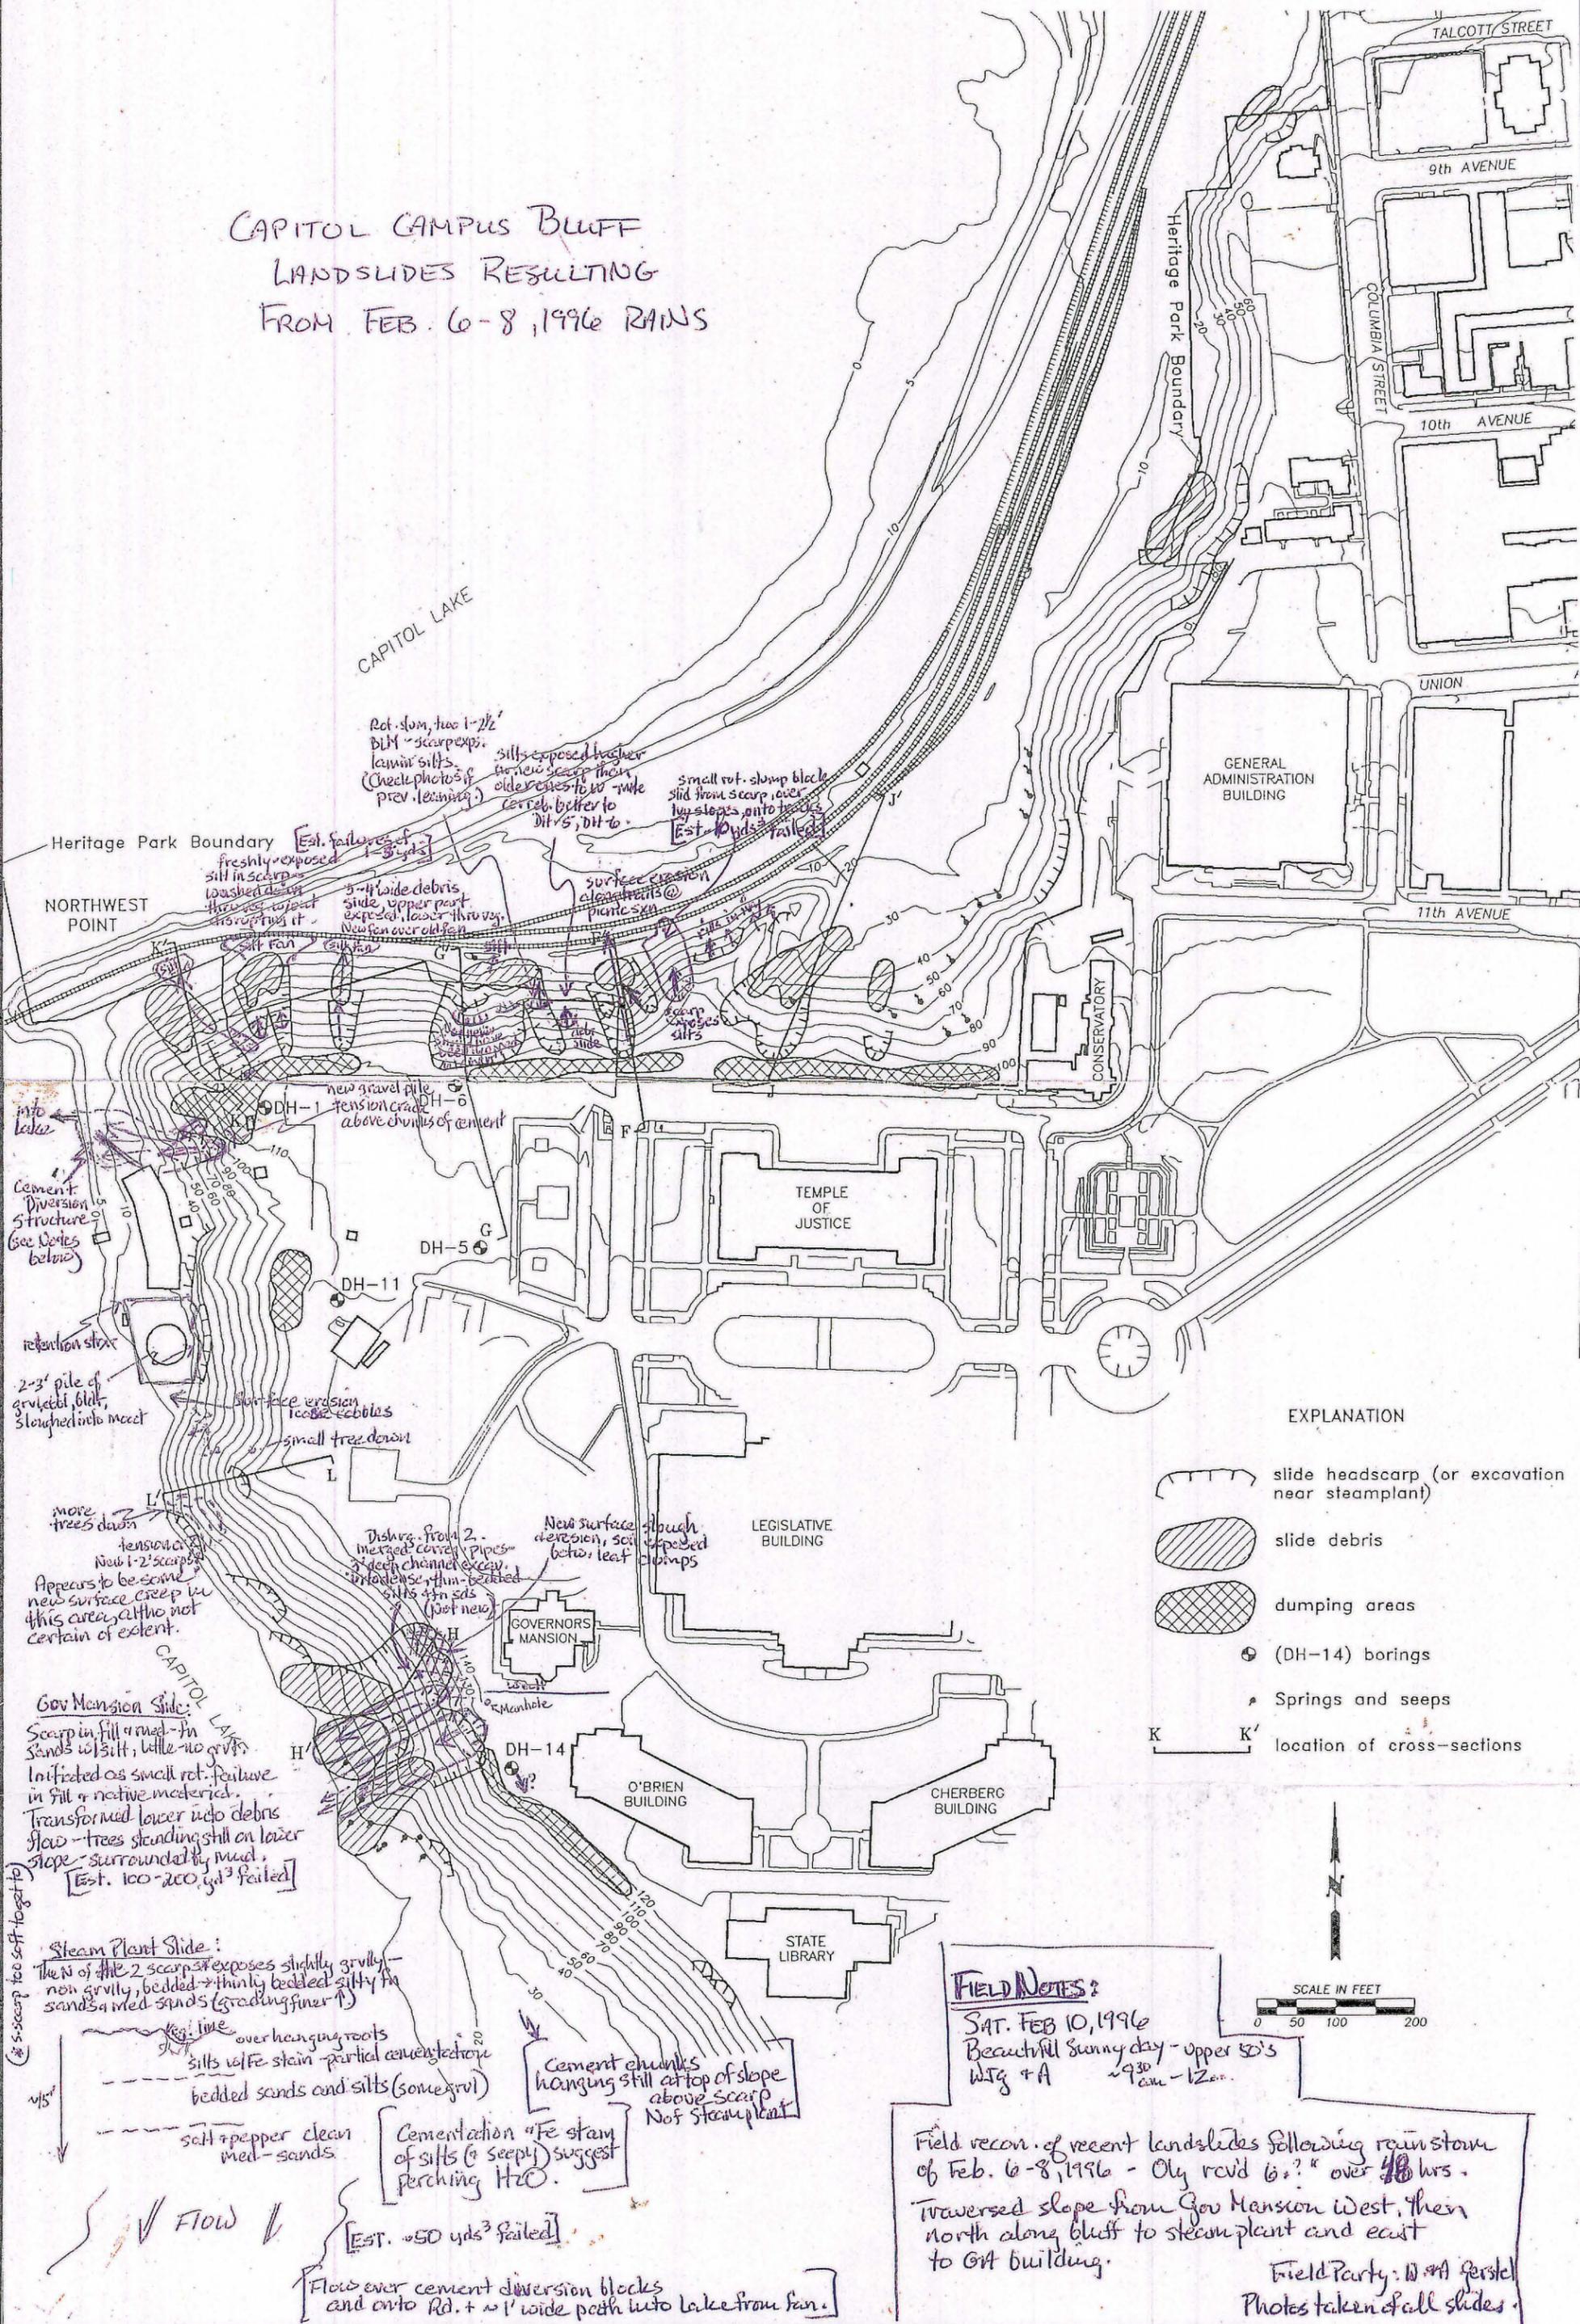
# CAPITOL CAMPUS BLUFF LANDSLIDES RESULTING FROM FEB. 6-8, 1996 RAINS

**Gov Mansion Slide:**  
Scarp in fill + med. fin sands w/ silt, little no grav. Initiated as small rot. failure in fill + native material. Transformed lower into debris flow - trees standing still on lower slope - surrounded by mud. [Est. 100-200 yds<sup>3</sup> failed]

Rot. slm, has 1-2 1/2' BIM - scarp exp. silt exposed higher than new scarp, older scarp to 10' wide corr. better to DH-5, DH-6

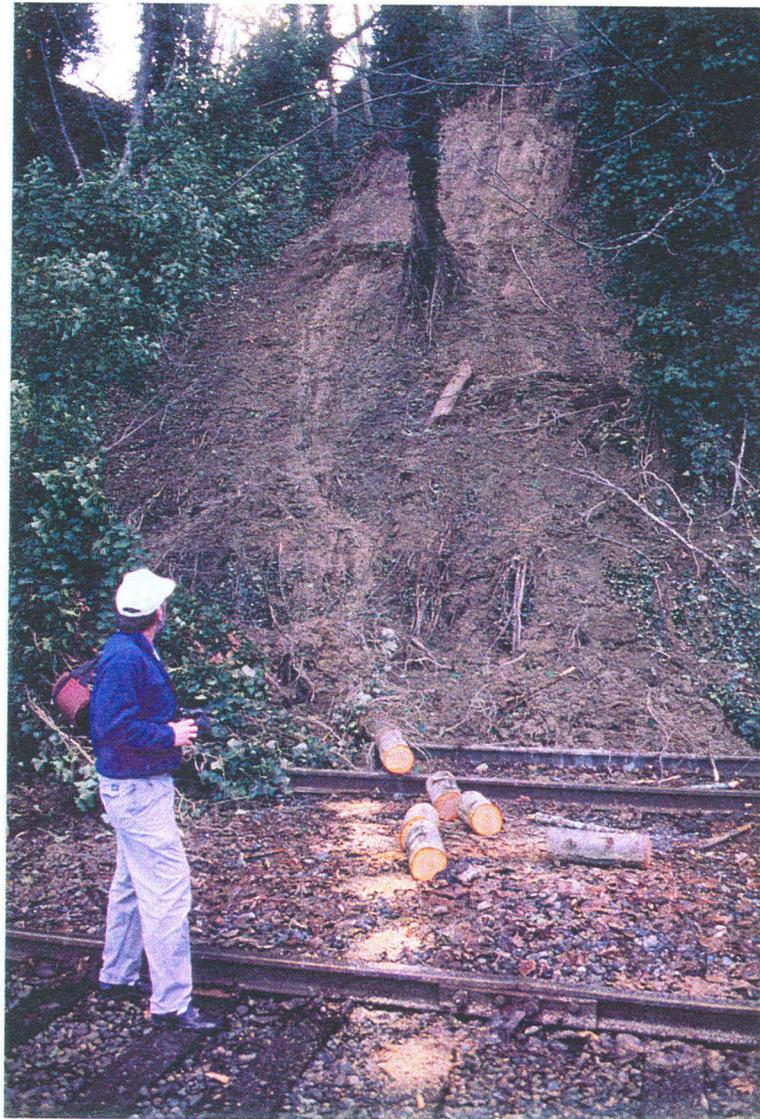
Figure 1. This debris slide is located on the slope north of the west end of the Temple of Justice building. It is the eastern-most slide occurring on the Capitol Campus bluffs as a result of the February, 1996 storm. The slide initiated in the loose sandy material overlying the dense laminated silt unit. It incorporated approximately 10-12 yds<sup>3</sup> of material from the upper portions of the slope, including a 1' diameter tree, which then overrode the vegetation on the lower portions of the slope, and was deposited onto two lines of railroad tracks.

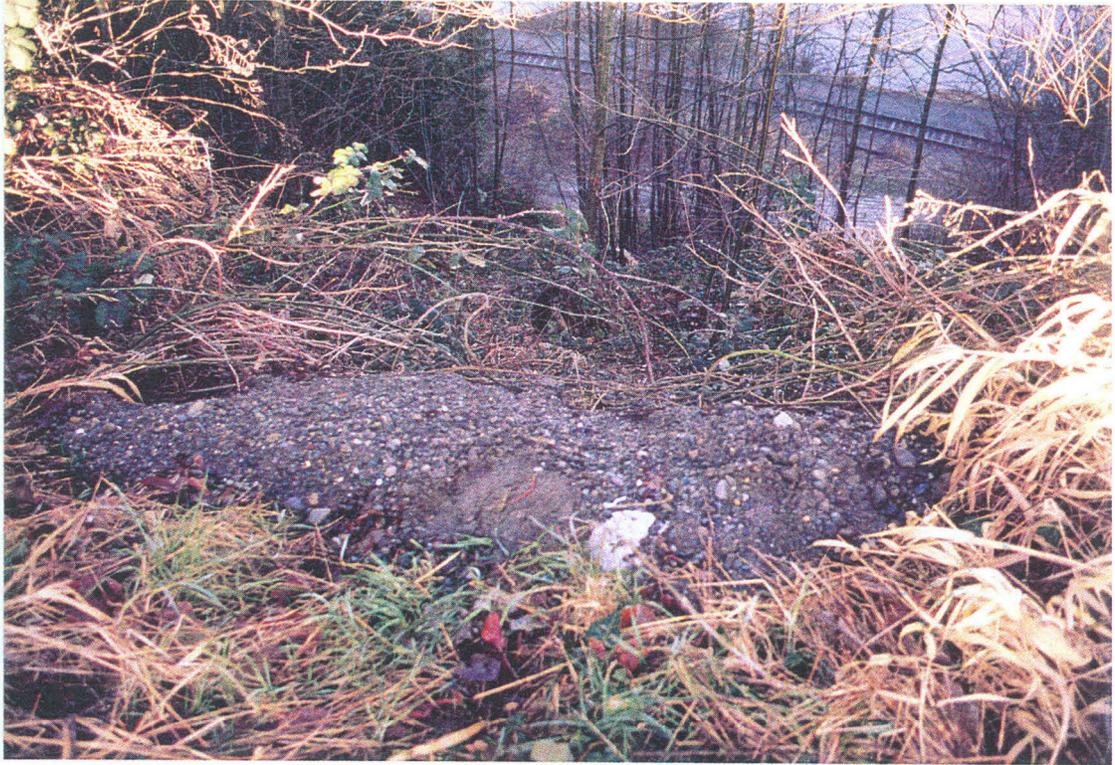
Figure 2. This debris slide is located on the north-facing slope of the northwest point of the Capitol Campus. The extreme precipitation associated with the February, 1996 storm, combined with sidecast construction waste, **above**, created the conditions of instability. The slide initiated at or just above the dense laminated silt unit and incorporated approximately 5 yds<sup>3</sup> of material. The jersey barrier at the base of the slope, **right**, served to contain the larger vegetation debris and coarse slope material. A fan of fine sediment flowed through the gap between sections of the cement barrier and onto the powerplant access road.

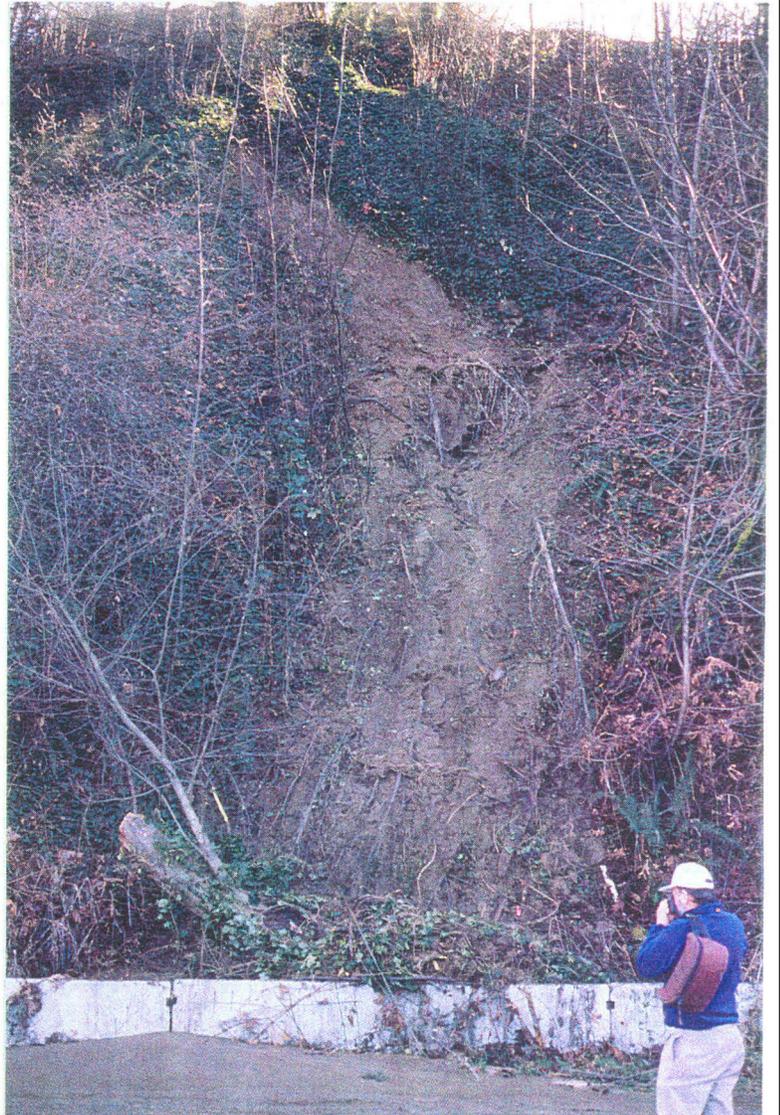
Figure 3. This debris slide is located at the north end of the steam plant and occurred as a result of the extreme precipitation associated with the Feb., 1996 storm, combined with loading of the slope with side-cast cement construction debris (**visible in Figure 4**). The slide incorporated approximately 50 yds<sup>3</sup> of material. It initiated from two separate headwall areas (top center of photo and to left of center, behind trees) (**also visible in Figure 4**) in interbedded sands and silts (some laminated). Slide debris was deposited on the steam plant access road, and fine sediment from the slide run-out reached Capitol Lake.

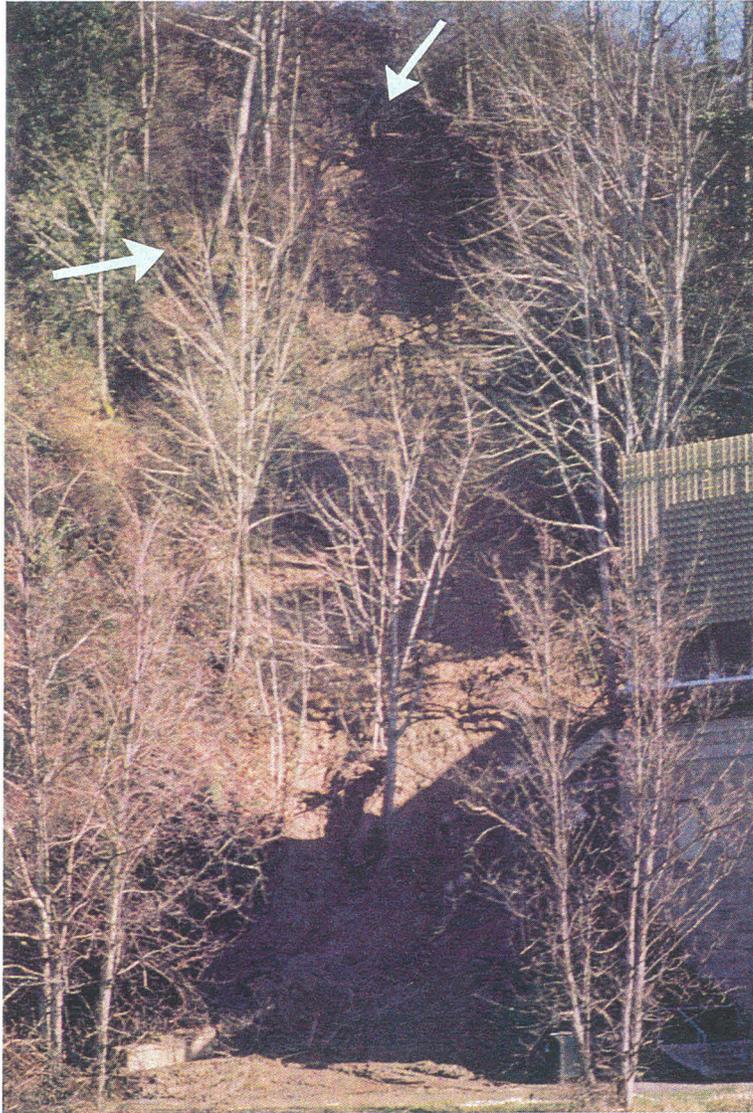
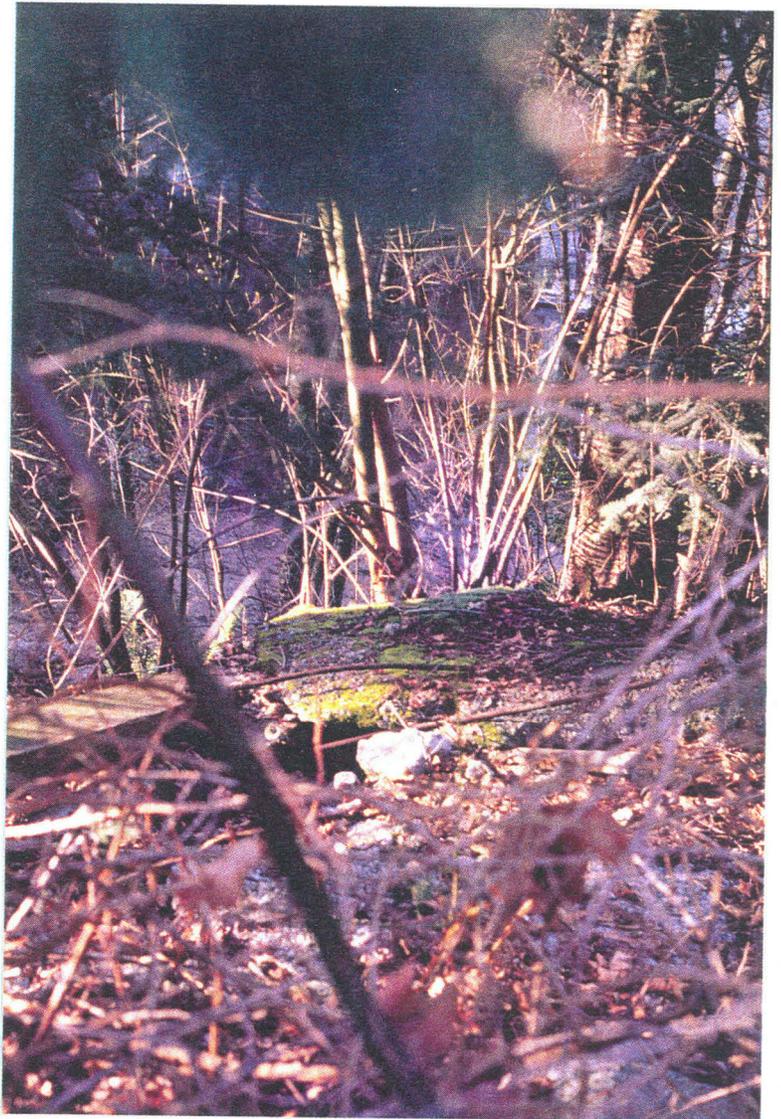
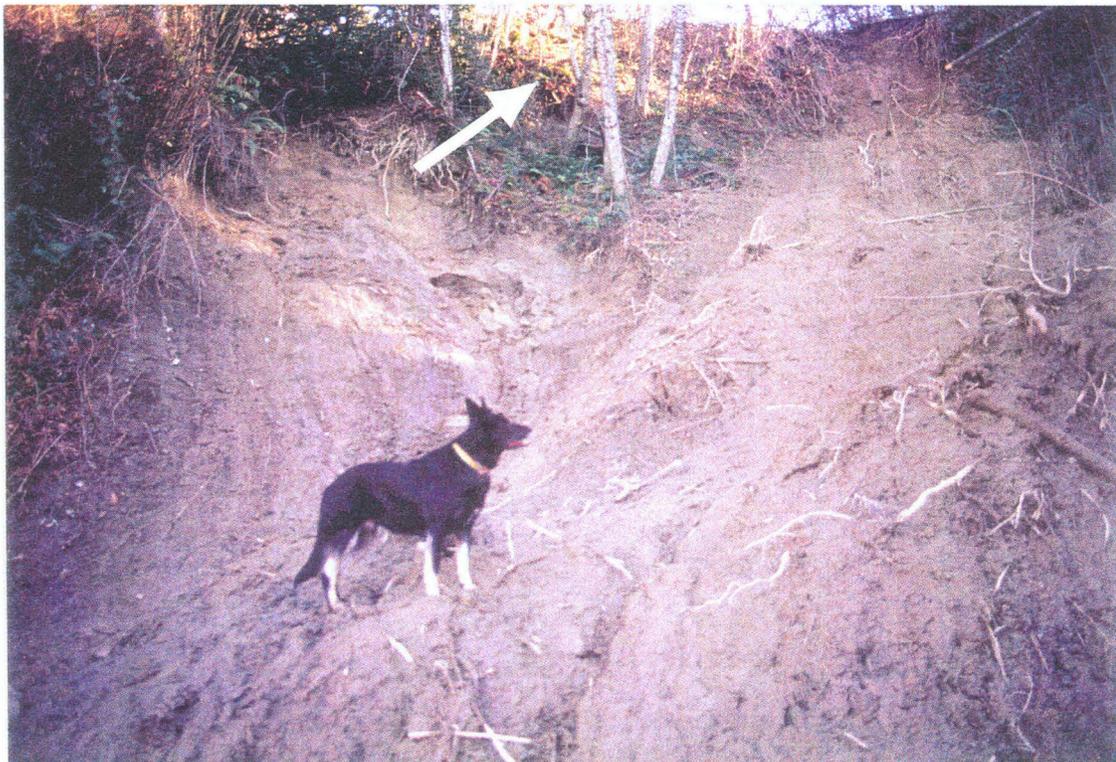
Figure 4. These are views of the upper portions of the debris slide that occurred at the north end of the steam plant during the Feb., 1996 storm (also see Figure 3). Two areas of initiation are visible (below). Chunks of cement construction waste are still perched at the top of the scarp (right, view is looking down on the slide area with Capitol Lake behind the trees in the background). A tension crack exists in the lower right corner of the photo. The arrow in the lower photo points to the location of the cement construction waste.

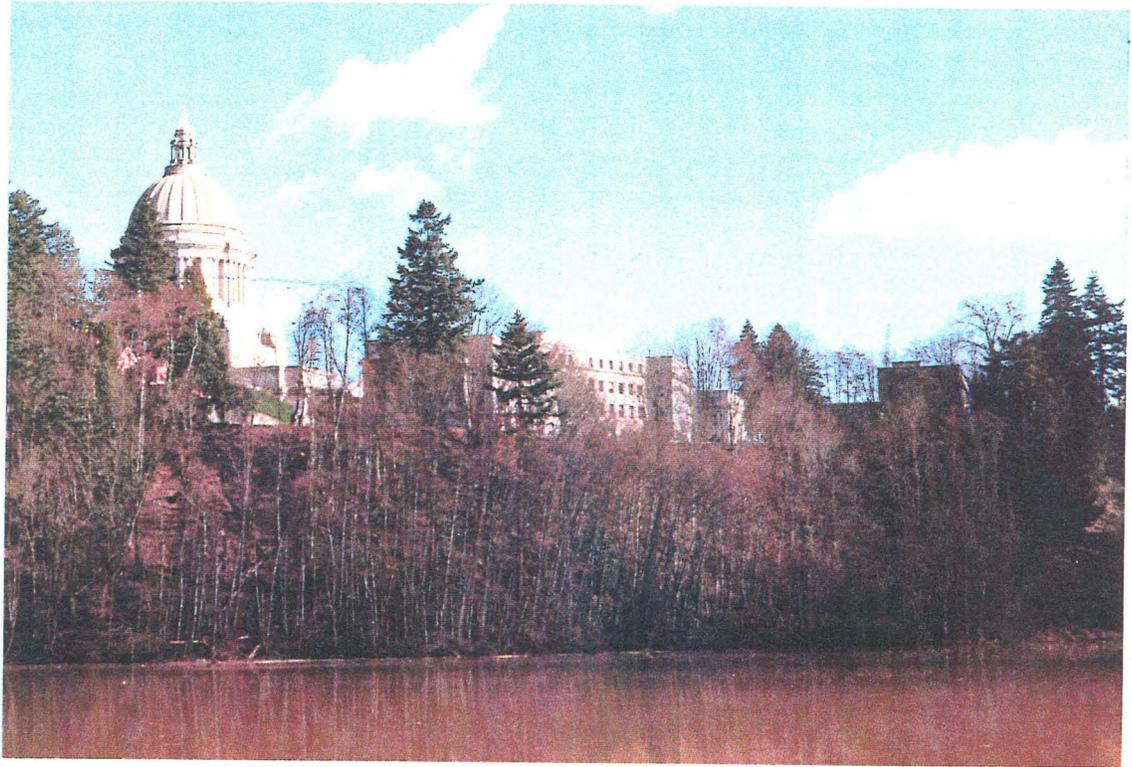
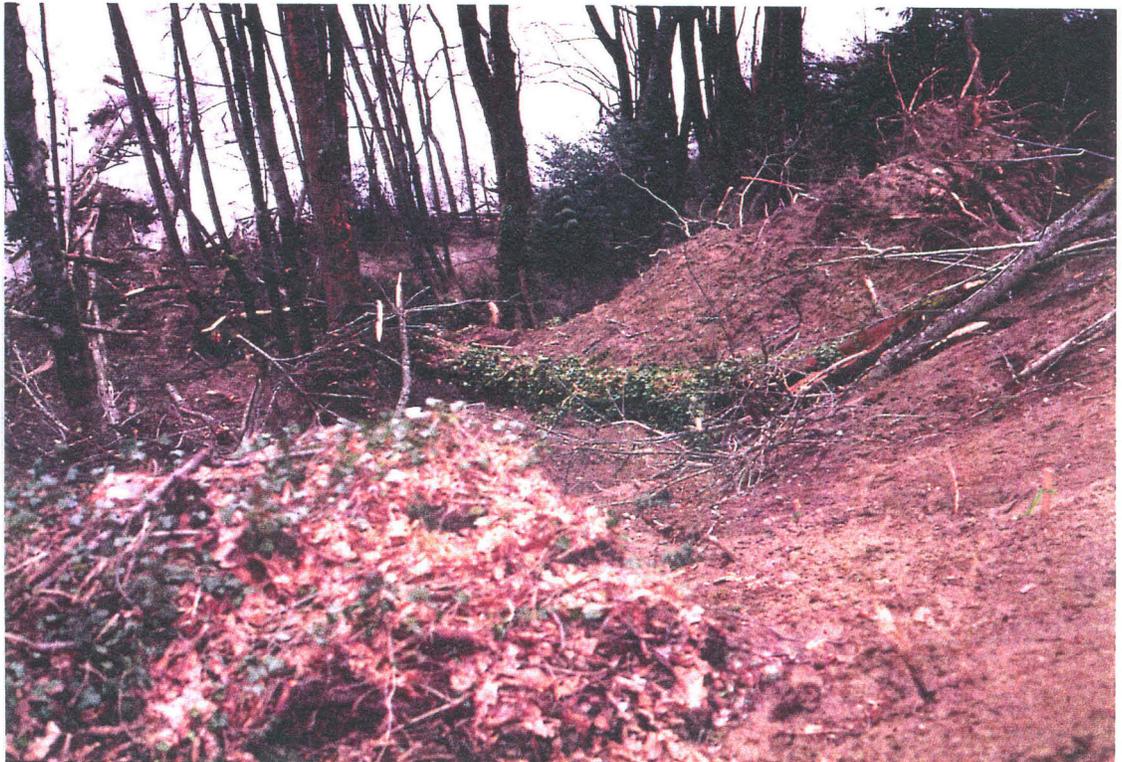
The largest slide occurred just to the southwest of the Governor's mansion. This one actually consisted of two debris flows separated by about 20 ft of undisturbed slope. Of the two flows, the larger, southernmost one is approx. 50 ft across and initiated at the top of the slope. The smaller one is approx. 30 ft across and initiated approx. 10-15 ft below the top of the bluff. Both slides reached Capitol Lake and deposited sediment and large organic debris into the water. The cause of these two slides is not yet certain, although they may be related to an abandoned sewer line located in the area.

Figure 5. **Above**, view across Capitol Lake to debris slides located south of the Governor's Mansion, behind the O'Brien Building. **Below**, view is looking down larger slide path from just south of the retaining wall behind the Governor's Mansion. The headscarp of the smaller slide lies just to the north, out of view of the photo; however, the deposition area of the smaller slide is visible in the center of the photo. Note slide material in Capitol Lake. These two slides initiated in the unconsolidated sandy material overlying the dense laminated silts.
