STATE OF WASHINGTON
DEPARTMENT OF NATURAL RESOURCES
DIVISION OF MINES AND GEOLOGY

HOLDEN TAILINGS

GERALD W. THORSEN

March 3, 1970

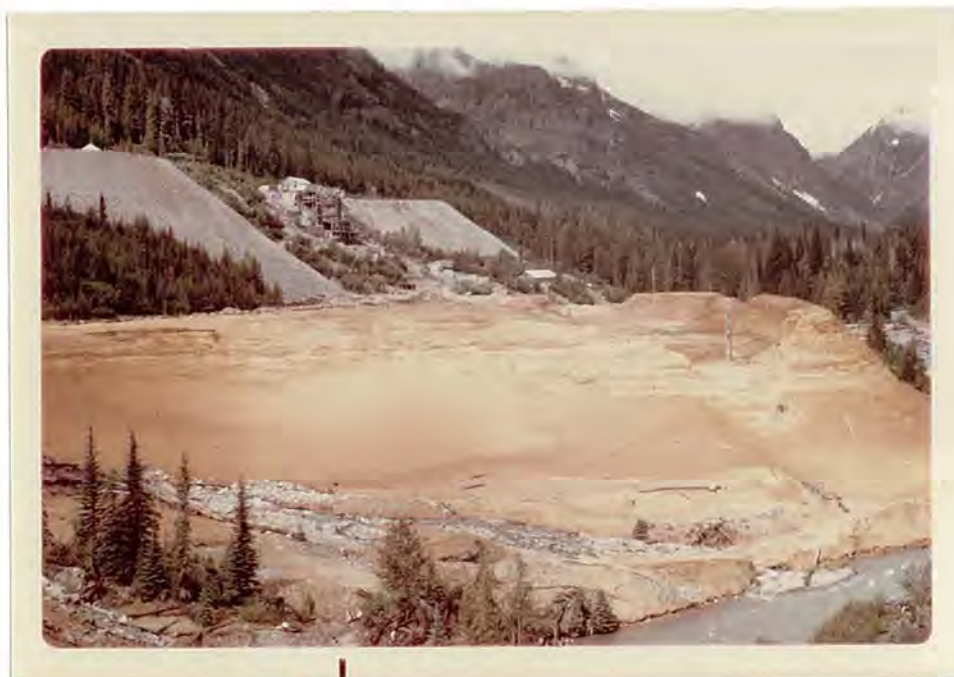
Photo No. 1. — Mill tailings pile number 1 with mine dumps in background, looking west, up valley of Railroad Creek. This pile was partially hydrauliced (1947), remilled, and pumped underground as sand fill. This operation was apparently responsible for presence of tailings in the creek bank as no such condition exists along the other tailings piles.

Oxidation of iron sulfide minerals has cemented the particles at the surface of the tailings piles to a depth of at least 10 inches and stained them an orangish-brown color (see photo No. 1). While this cemented material is quite erosion resistant, accumulation of windblown material has built up over the years on the lee sides of the piles (see photos 1, 2, and 4).

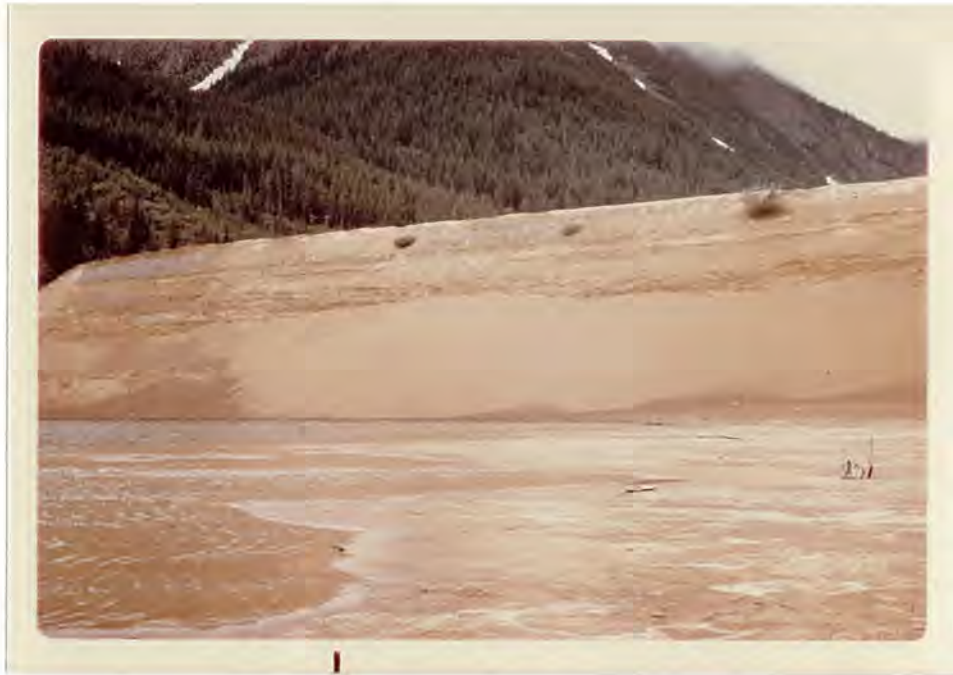
Photo No. 2. — East face of tailings pile number 2 viewed from surface of pile number 3. Bank is about 75 feet high. Note wind deposited material at angle of repose on this lee slope. Note also the willows and unidentified brush rooted in talus material used as diking near upper level of the dike. Thimble berry and a few conifers are present at this same level on the other side of the pile.

During the later stages of use of tailings pile number 2 a dike of bouldery soil (apparently about 10 feet high) was used (see Photo 2). Above this level tailings were again used, but this latter dike appears to have been built by dozing the tailings into a peripheral ridge rather than by the conventional construction previously described.

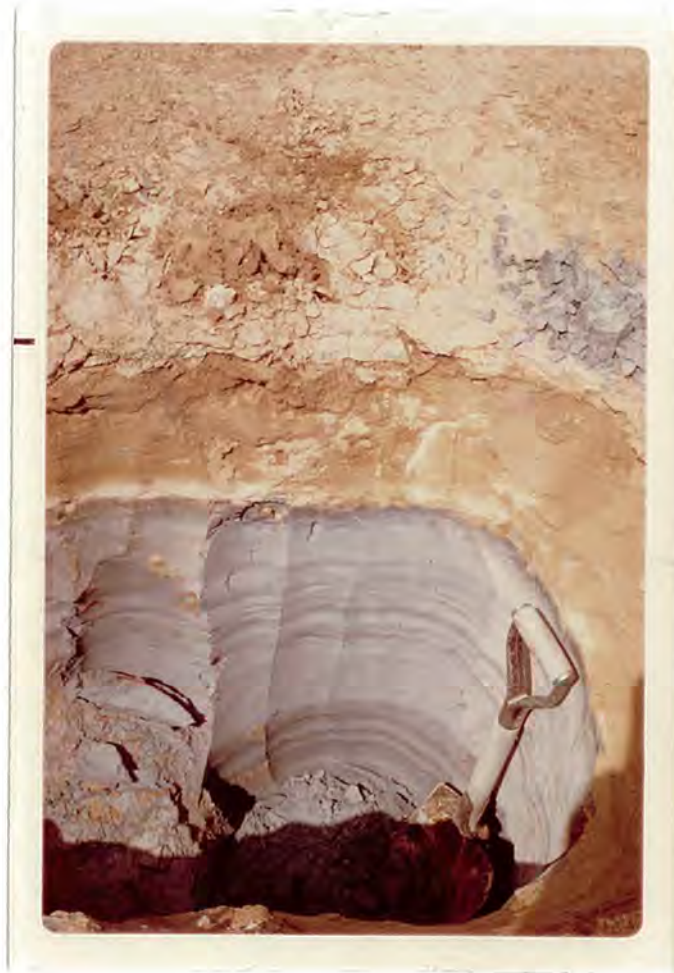
Photo No. 3. — Test pit dug 4 feet into tailings pile number 2 approximately 20 feet from a small central pond. The finer grained dark layers showed the glisten of surface moisture characteristic of "fat" clays but no water accumulated in the hole after 18 hours. The oxidized layer is about 10 inches thick. Note that there are no loose fines on the tailings surface but a "desert pavement" of iron oxide cemented chips.

A test hole dug near the center of tailings pile number 2, about 20 feet west of a pond, was started in oxidized material but encountered unoxidized tailings within 10 inches of the surface (Photo 1). The damp unoxidized material in this hole stood up well in a 4-foot vertical face. Despite the nearness of the pond, there was no seepage into the test pit after 18 hours. This may have been due to partial sealing of the pond by wind-blown fines rather than being a true indication of lateral permeability. The tailings in the lower foot or so of the pit were noticeably darker, and the gray-black clay-size layers at this level showed a distinctly wet surface when disturbed; as though they were saturated. Both bulk and undisturbed samples taken from the unoxidized portion of the pit were tested by the Materials Laboratory of the Washington Department of Highways. The following data are representative of the samples, with the moisture content and moisture-dependent properties based on an undisturbed sample taken at the 42 to 46 inch depth interval:

Moisture content	37.6 percent
Liquid limit	25.6
Angle of internal friction	20°
Dry density	78 lb/ft ³

The material as a whole was found to be nonplastic although there are muddy partings, generally less than $\frac{1}{4}$ inch thick, that, by themselves, are plastic. It should be kept in mind that material from this test hole is not representative of the dikes (see Construction of the Tailings Piles); the dikes being practically unstratified and considerably coarser grained.

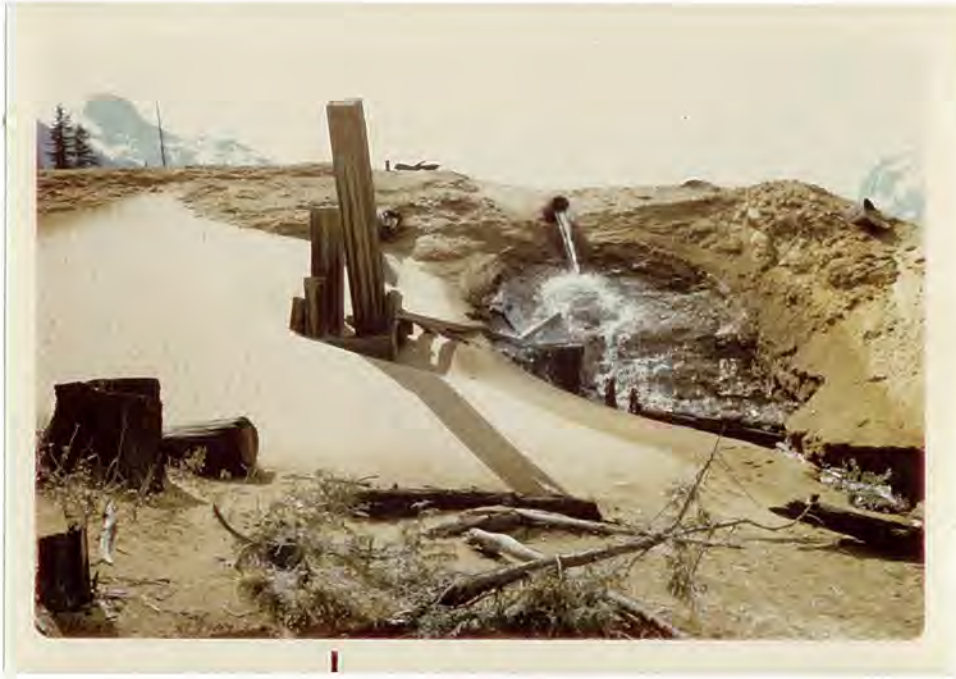
Photo No. 4. — East edge of tailings pile number 1 (photo is "off-color"). This picture shows the relative resistance to erosion of undisturbed oxidized tailings compared to wind deposited tailings. Culvert discharging stream of about 3 square inches in cross section falling 4 feet onto sloping surface of stratified tailings. Note the relatively minor erosion considering that this stream has apparently flowed, at least intermittently, for at least 20 years. No turbidity noticeable in the runoff.
