# GEORESOURCES

Revised Geotechnical Report  
Discovery Bay Pit Reclamation Plan  
Jefferson County, Washington  
PN: 902133005  
Doc ID: DiscoveryMaterials.Hwy101.RG02

**GEOTECHNICAL ENGINEERING  
INVESTIGATION REPORT  
PROPOSED M & E TRUCKING PIT EXPANSION  
JEFFERSON COUNTY, WASHINGTON**

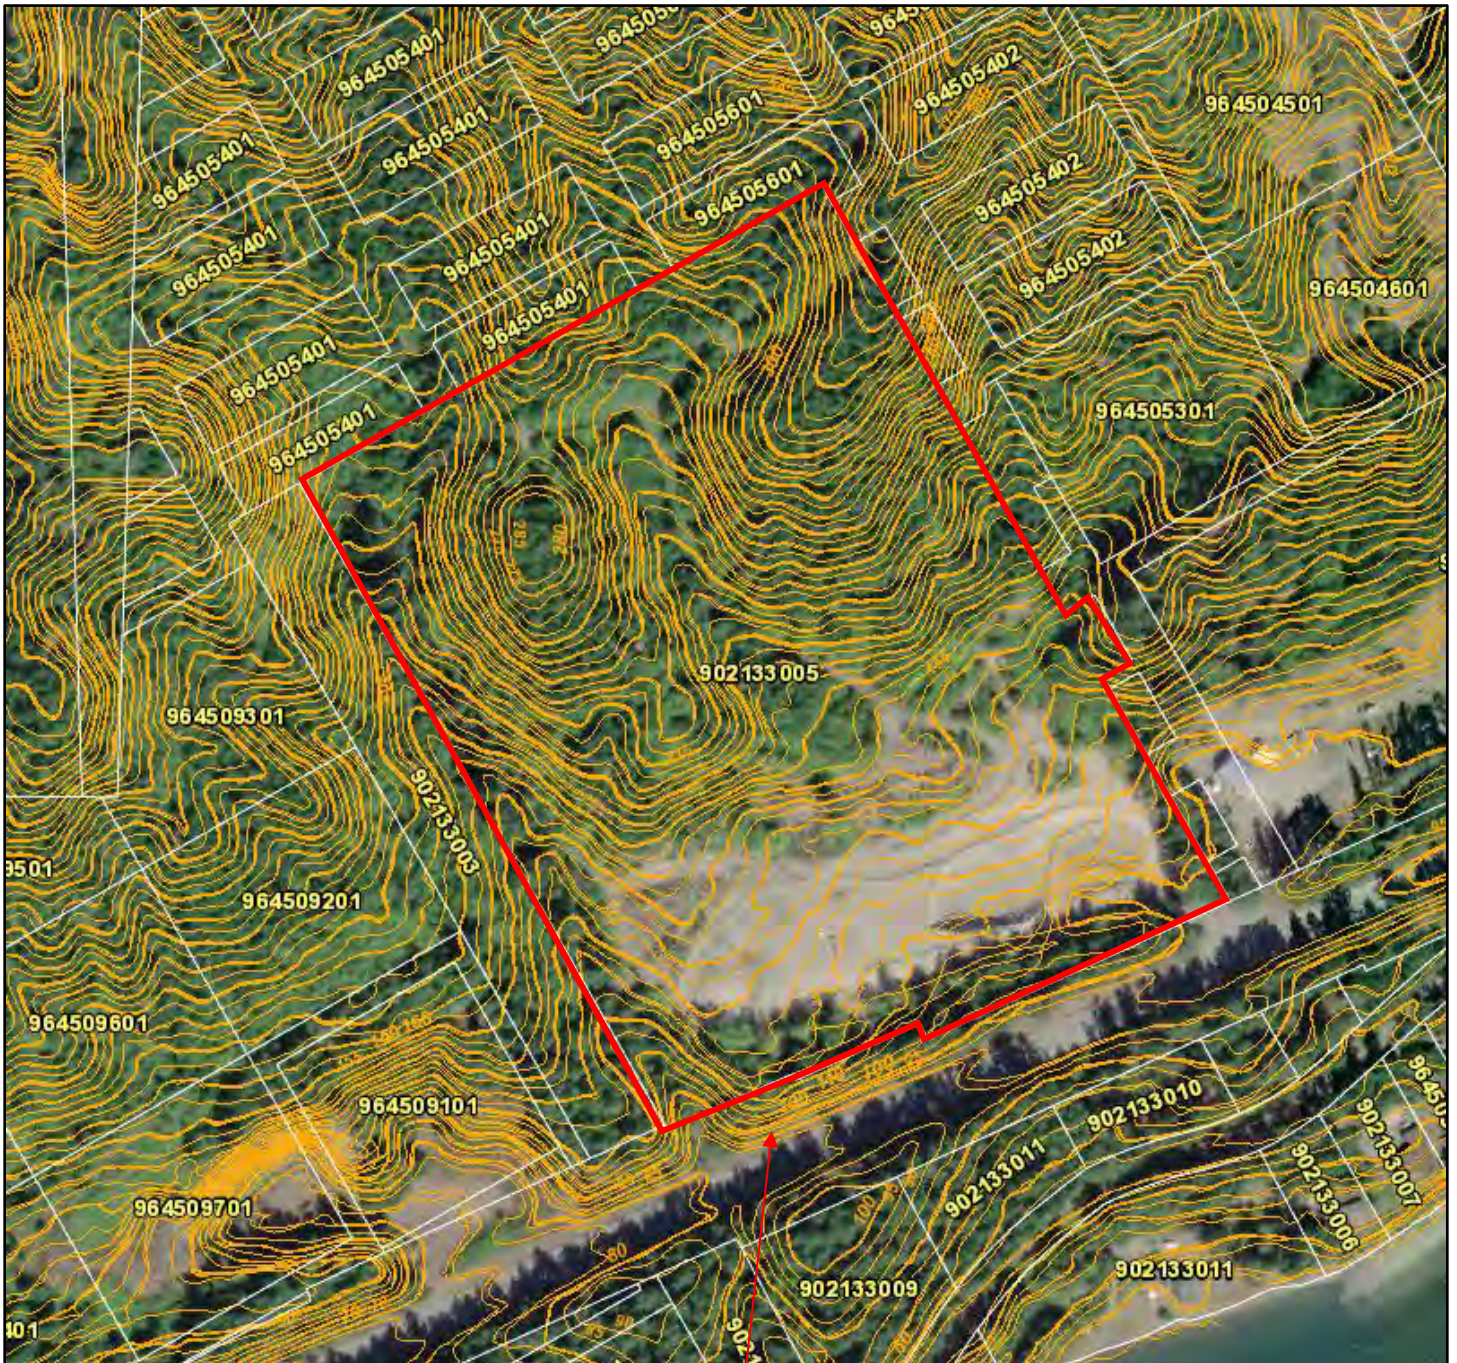
**Site Vicinity Map**  
 Discovery Pit Reclamation  
 Jefferson County, Washington  
 PN: 90133005

**Approximate Site Location**

Vegetation has largely been removed from the active operation area, while the remaining northern portion of the site is well vegetated with mature to sub mature forest of species typical for the area. The existing site conditions and topography are shown on the attached Site Vicinity Map, Figure 2. Proposed reclamation grading is shown on Figure 3.

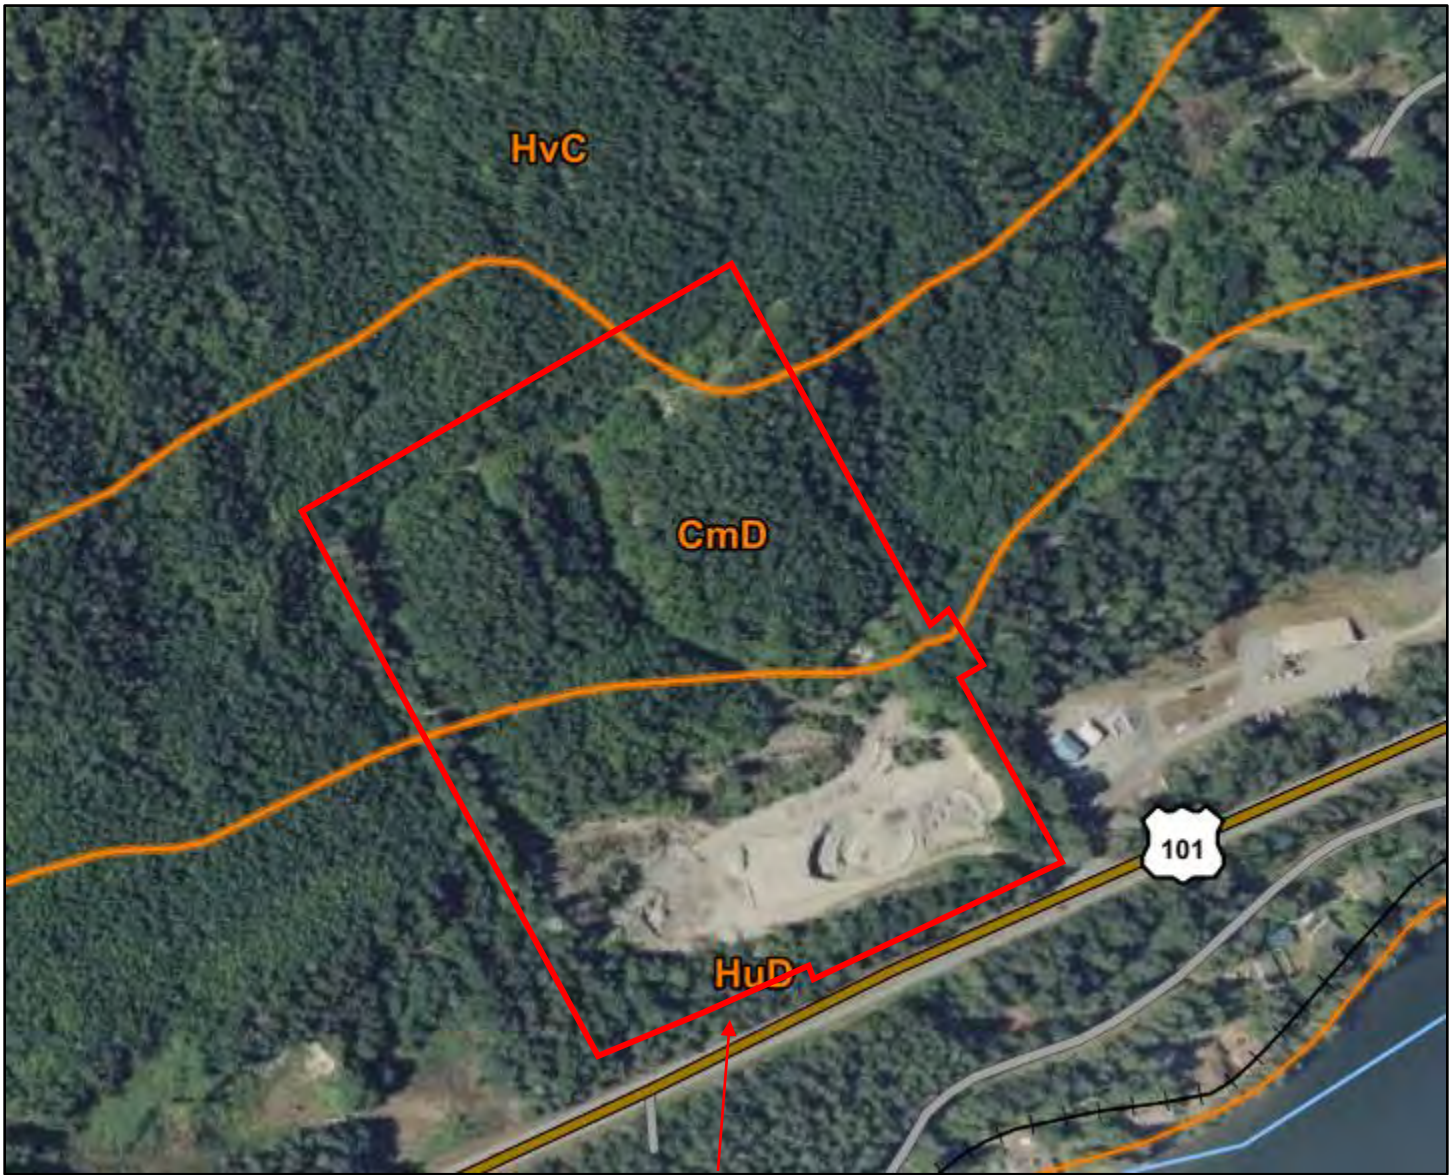
Figure 4

**Approximate Site Location**

Map created from Web Soil Survey (<http://websoilsurvey.sc.egov.usda.gov/App/WebSoilSurvey.aspx>)

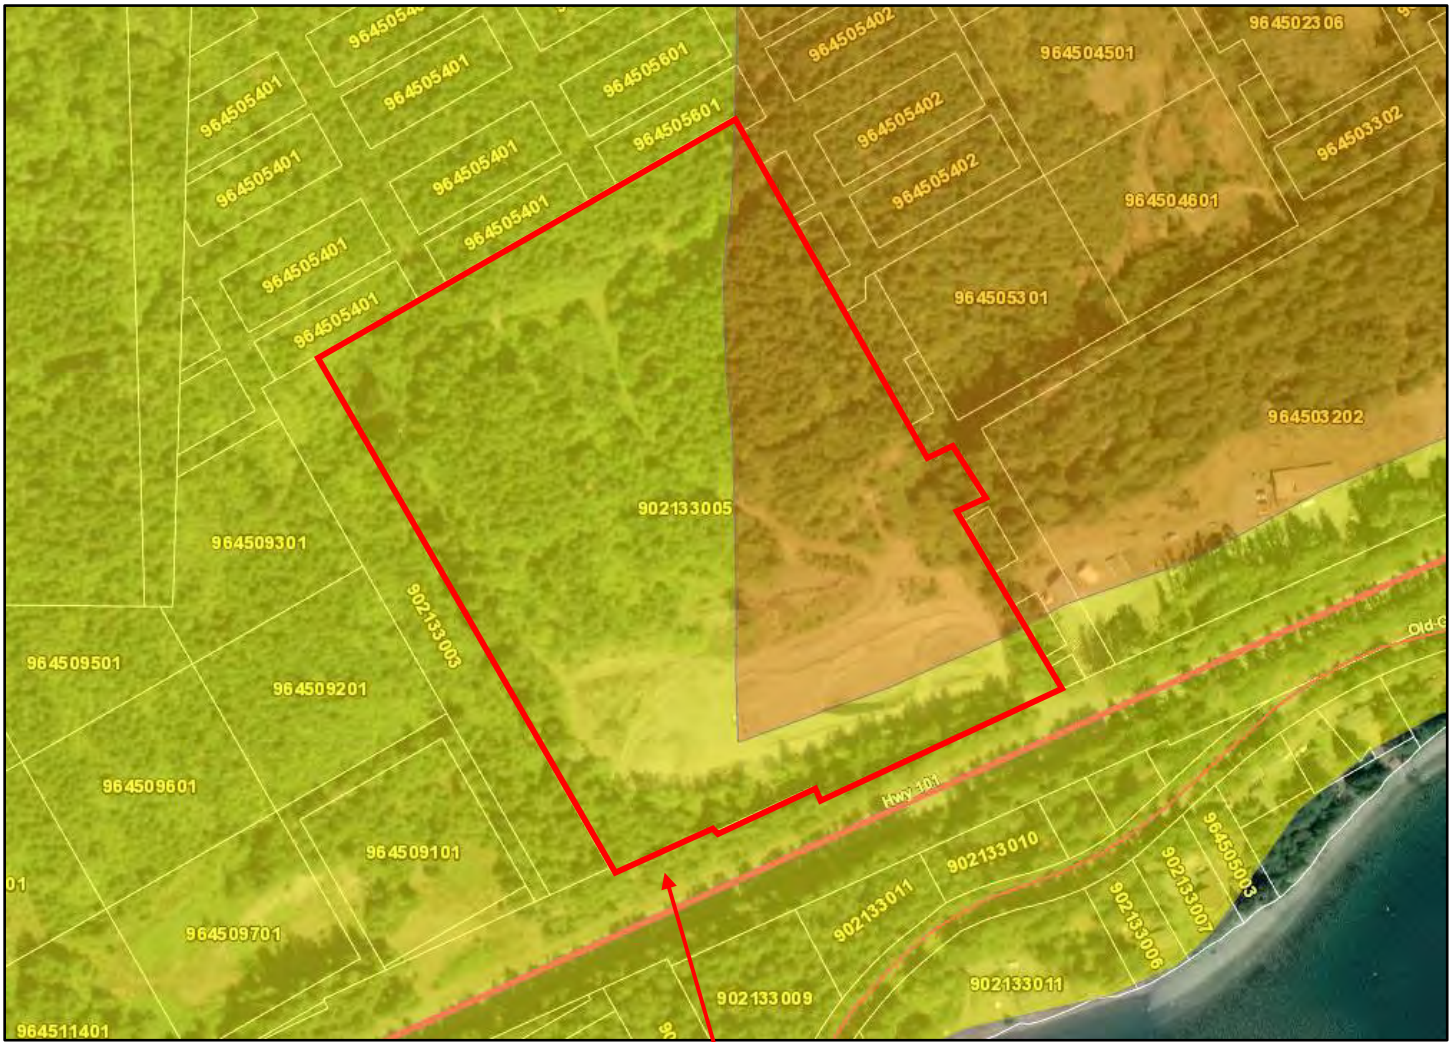
**Jefferson County Landslide Hazard Map**

**Approximate Site Location**

According to the Jefferson County Landslide Hazard Map, the majority of the site is mapped as a “slight” landslide hazard with the eastern portion of the site being mapped as a “moderate” landslide hazard. An excerpt of the County Landslide Hazard Map for the site area is included as Figure 6.

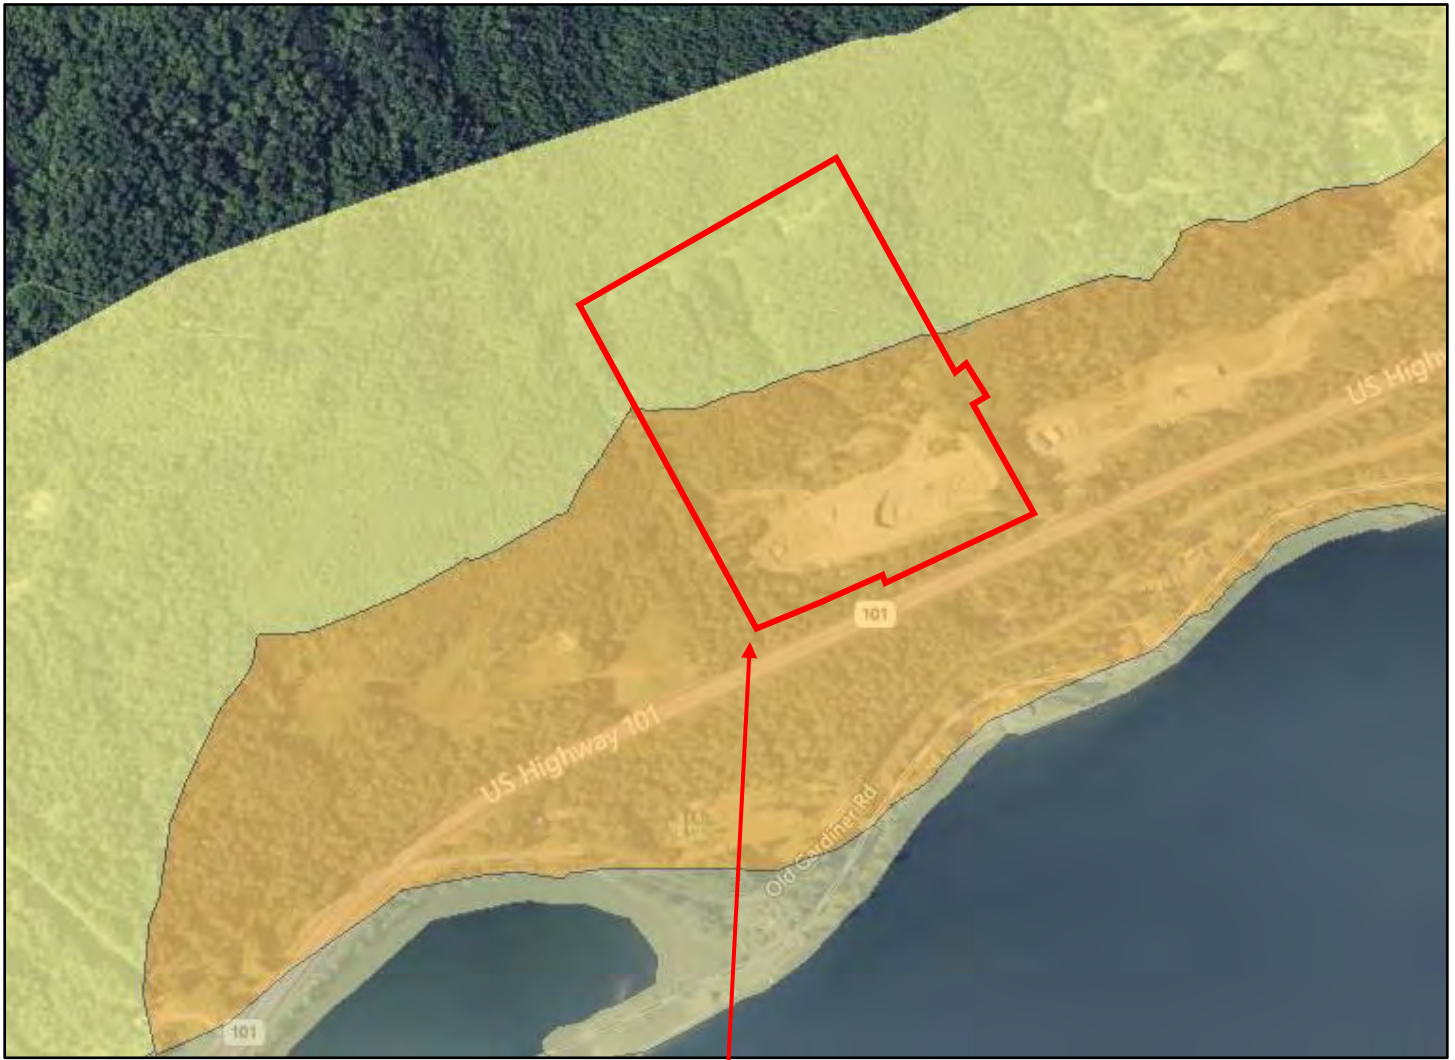
**DOE Coastal Atlas – Slope Stability**

Map created from the Washington State Coastal Atlas Map (<https://fortress.wa.gov/ecy/coastalatlus/tools/Map.aspx>)

- Stable
- Intermediate
- Modified
- Unstable
- Unstable (old slide)
- Unstable (recent slide)

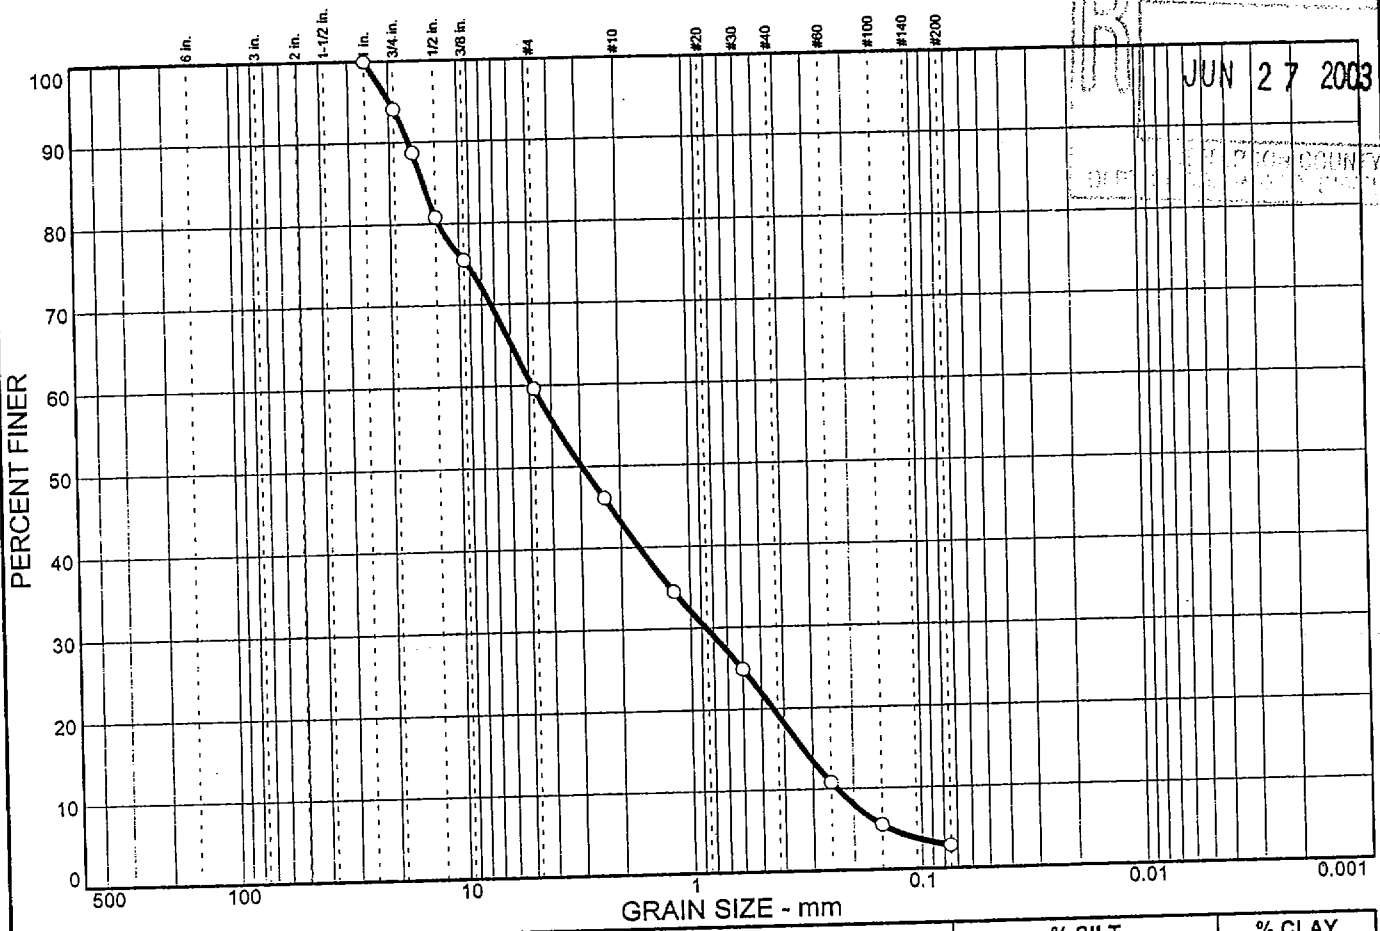
% COBBLES	% GRAVEL	% SAND	% SILT	% CLAY
0.0	40.4	56.8	2.8	2.8

SIEVE SIZE	PERCENT FINER	SPEC.* PERCENT	PASS? (X=NO)
1.0 in.	100.0		
0.75 in.	94.1		
0.625 in.	88.7		
0.5 in.	80.8		
0.375 in.	75.5		
#4	59.6		
#8	46.1		
#16	34.5		
#30	24.9		
#60	10.8		
#100	5.5		
#200	2.8

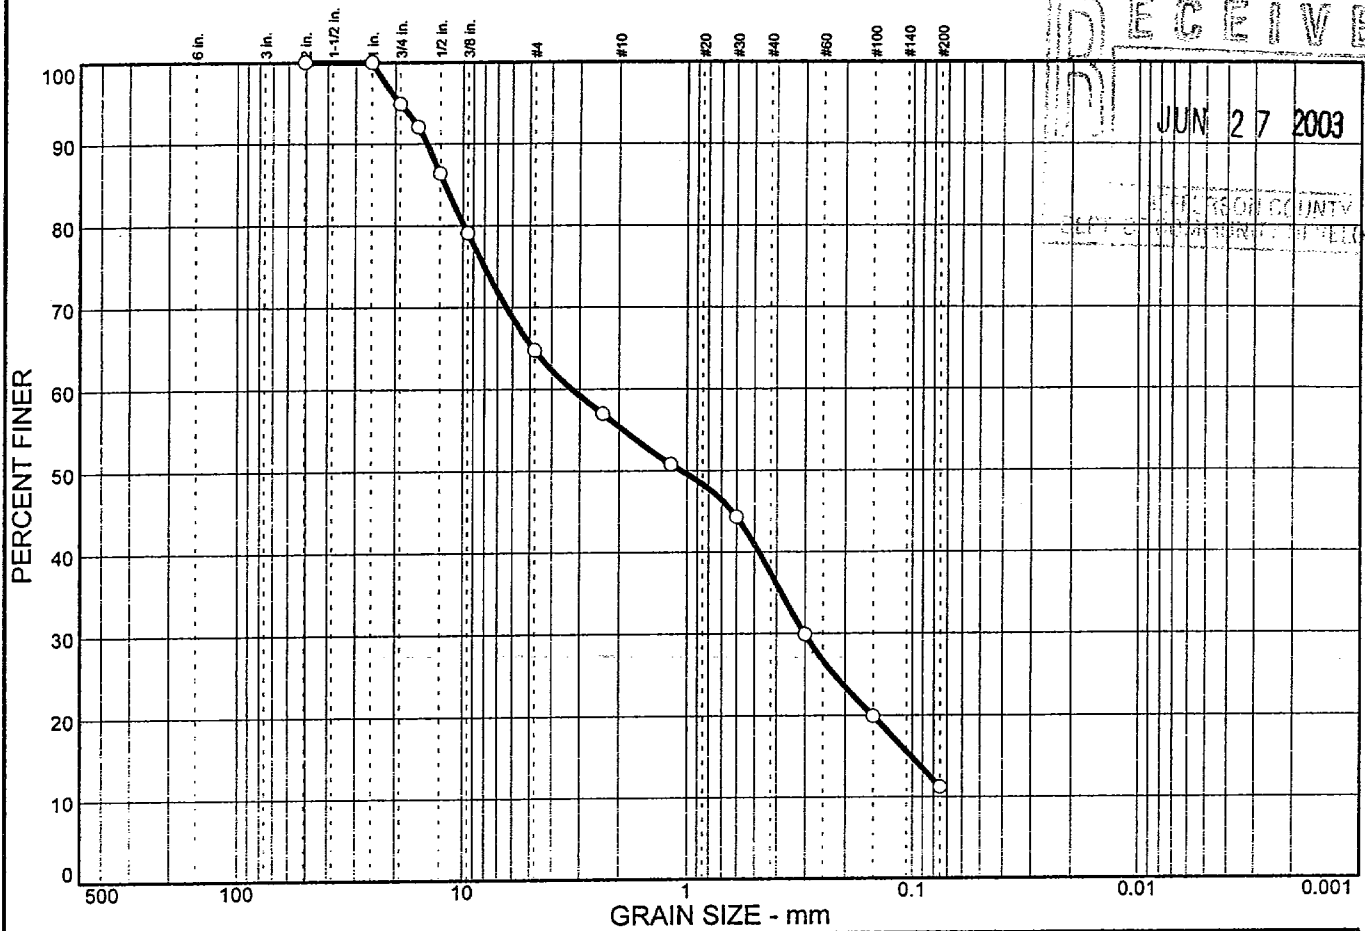
% COBBLES	% GRAVEL	% SAND	% SILT	% CLAY
0.0	35.3	53.5	11.2	11.2

SIEVE SIZE	PERCENT FINER	SPEC.* PERCENT	PASS? (X=NO)
2.0 in.	100.0		
1.0 in.	100.0		
0.75 in.	94.9		
0.625 in.	92.1		
0.5 in.	86.4		
0.375 in.	79.1		
#4	64.7		
#8	57.0		
#16	50.8		
#30	44.3		
#50	29.9		
#100	19.9		
#200	11.2
