## MEMORANDUM

**To:** Todd Black, City of Renton  
**From:** Ali Wick, Anchor QEA, LLC.  
**Re:** Bird Island Habitat Survey, Gene Coulon Memorial Park, February 26, 2010  
**Date:** April 27, 2010  
**Project:** 100355-01

**Figure 1**  
 Gene Coulon Park Shoreline Habitat Monitoring  
 City of Renton

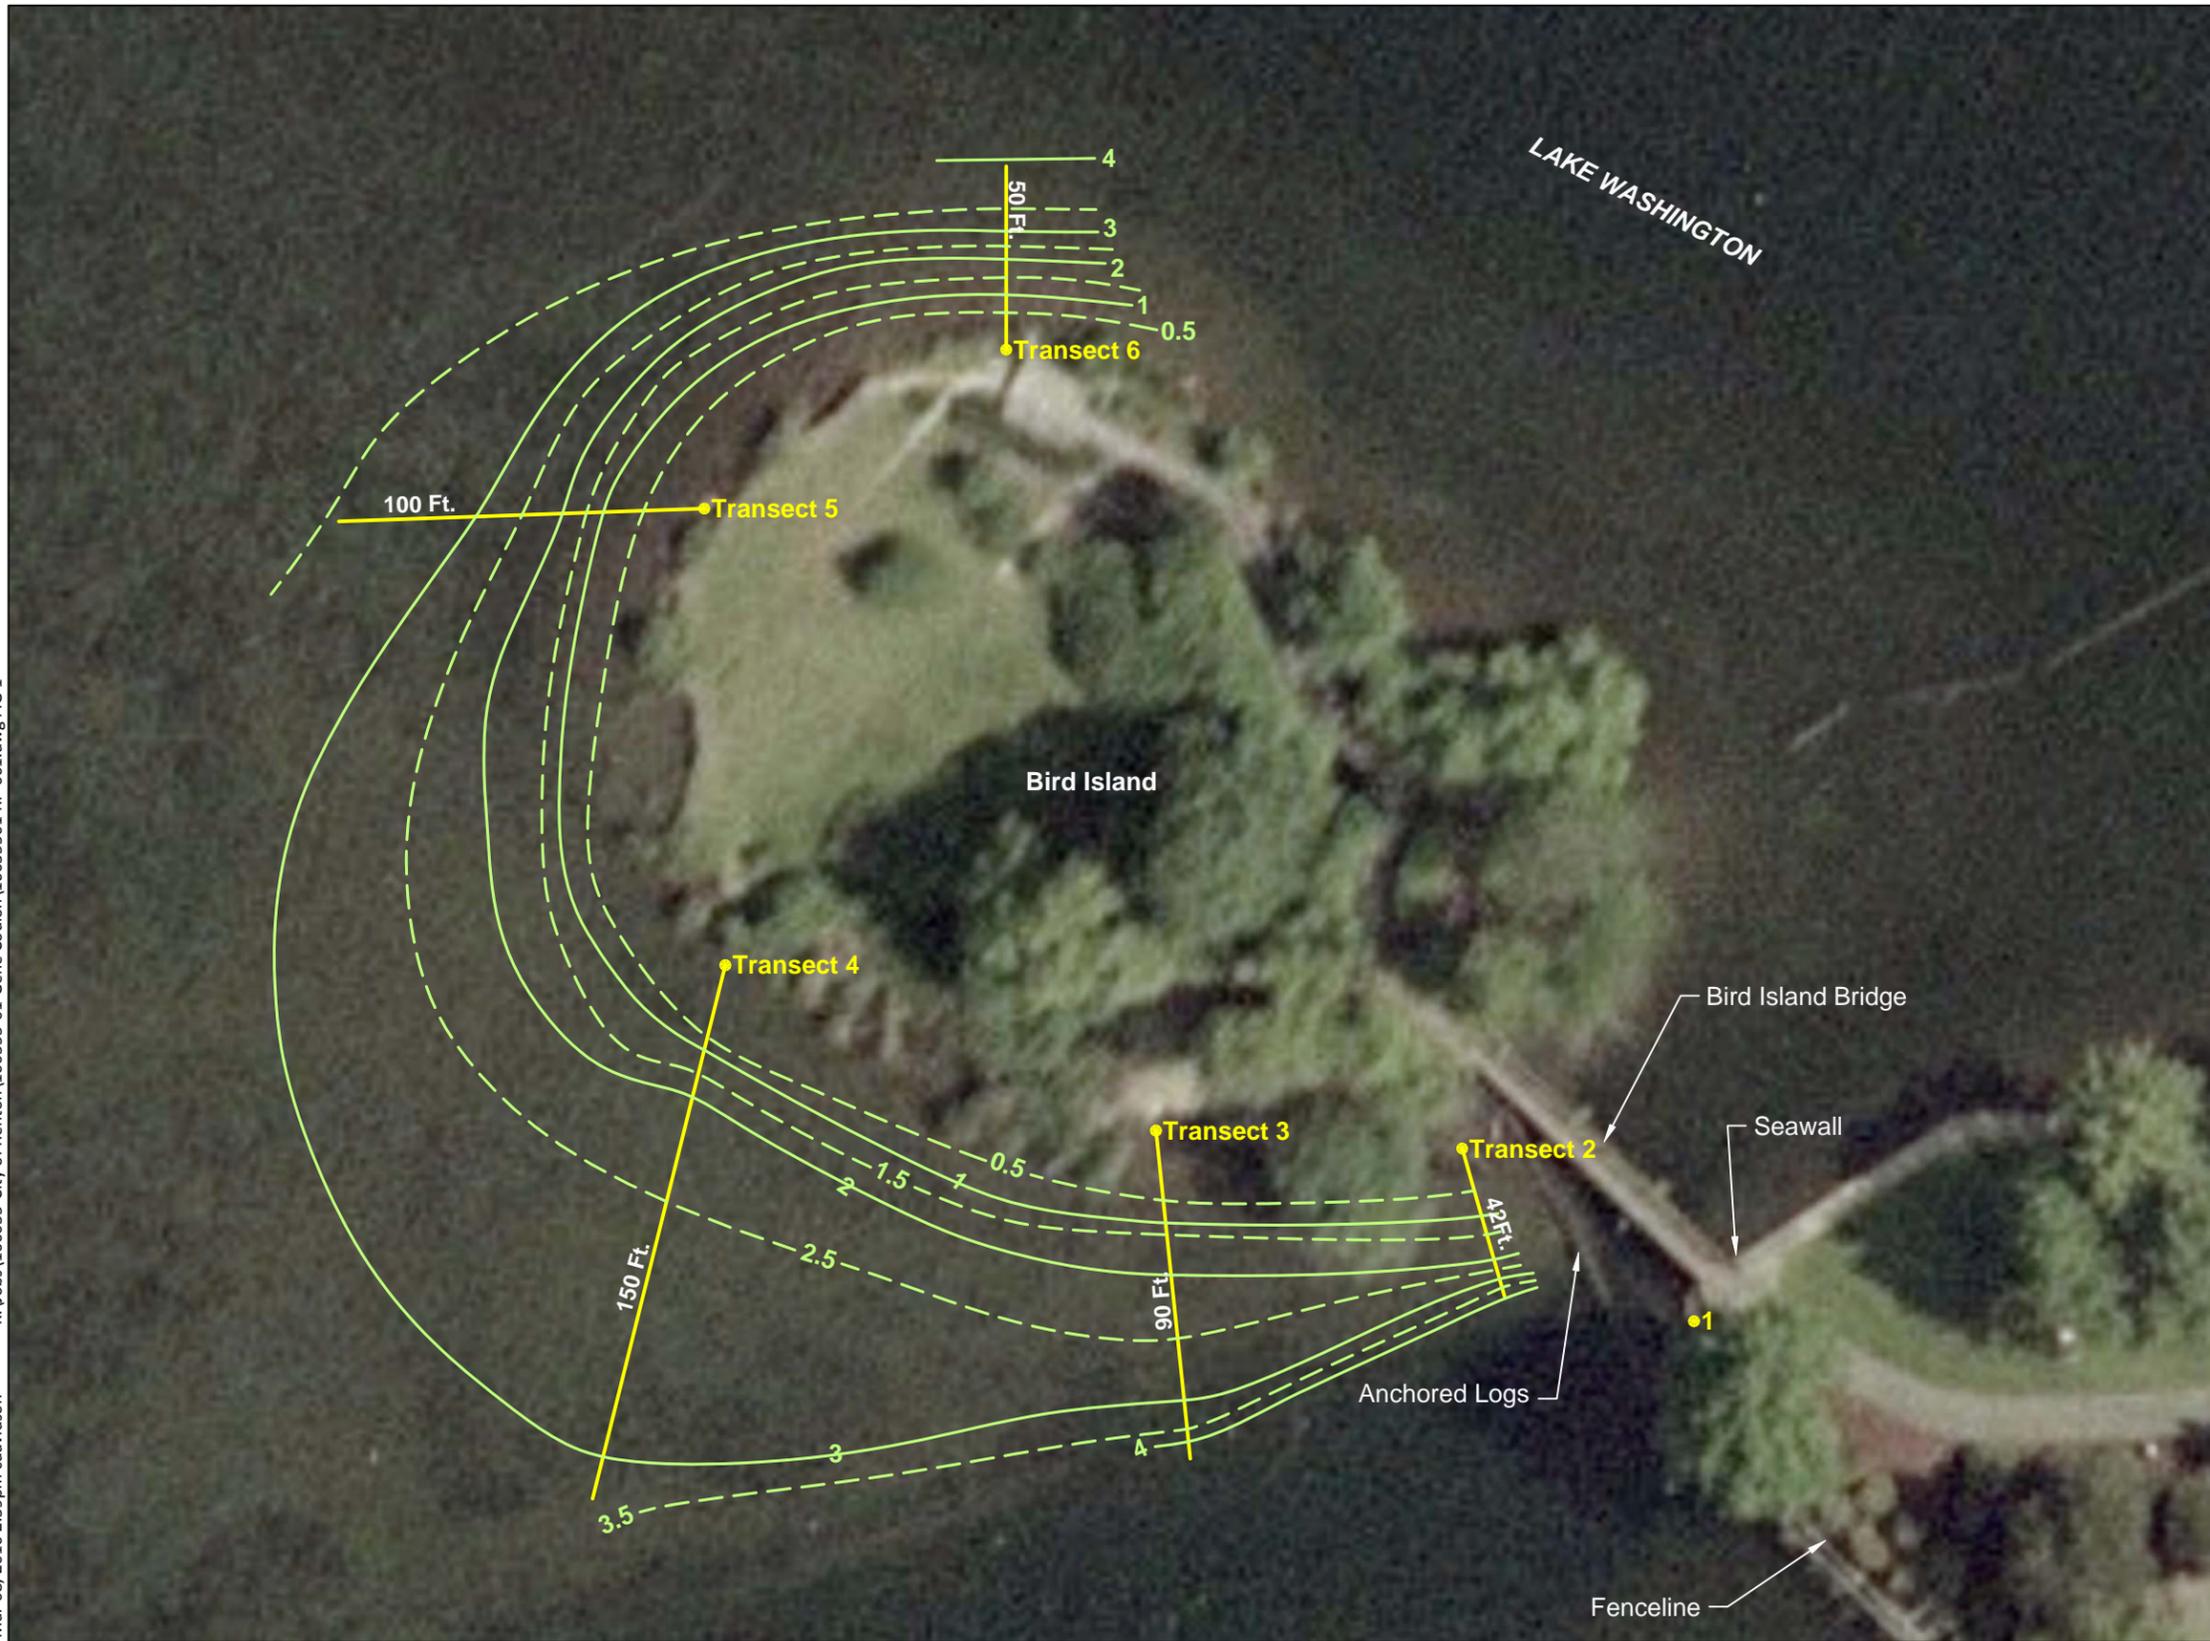
The survey transects in 2010 were again located at the Nature Island Bird Sanctuary Feeding Area (Bird Island) at the southwest end of the park. Information for the six transects is shown in Table 1 and on Figures 1 and 2. Methods in 2010 were the same as in 2006; these methods are repeated here from the 2006 memorandum, for clarity:

The landmark and global positioning system (GPS) location of each transect start point from 2006 were re-located and the transect point was re-occupied. Table 1, below, repeats the transect location information from 2006.

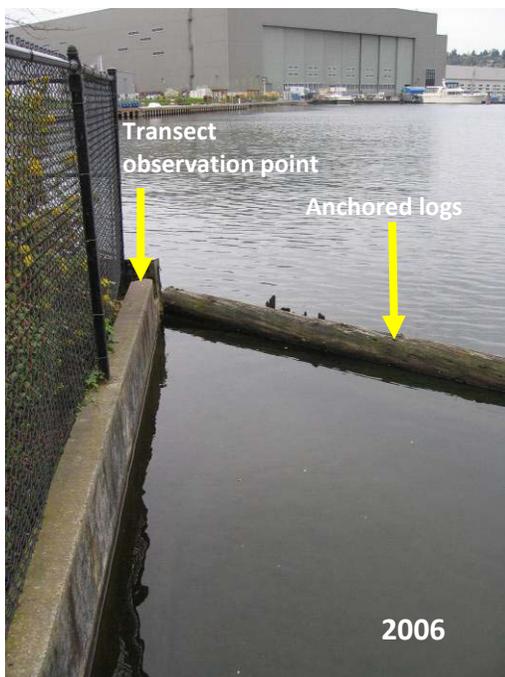
**Photo 1a**  
2006 photo of deep water at observation point at Transect 1, looking southwest

As noted in 2006, Transect 1 was different from the other transects in that it was not possible to set a true transect because water depth was too great to wade waterward of the seawall, and so the general area was characterized by recording visual and depth observations from a single observation point at the corner of the anchored logs and the seawall (Photos 1a and 1b). Water depth as measured inside the anchored log at the southwest corner of the seawall/bridge was 6.2 feet with a fine (sand) substrate; outside the anchored logs, water depth was 1.1 feet and the substrate was fines (sand) and gravel. These water depths were approximately 1 foot less than in 2006, consistent with the lake level difference as described above, and observations indicate no change in substrate level or type. Upland vegetation was the same, consisting of landscaped plants.

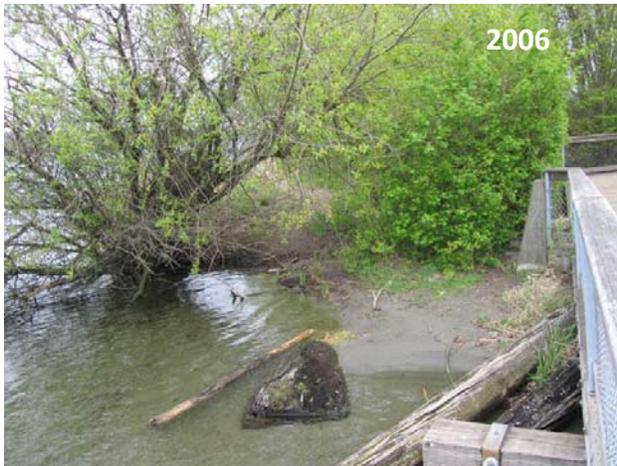
**Photo 2a**  
**2006 photo: shallow-water area at northwest Bird Island bridge footing, looking northeast**

As in 2006, Transect 2 extended from the muddy area at the northwest Bird Island bridge footing out into the littoral zone toward the Southport development (Photos 2a and 2b). Water depths in 2010 ranged from 0 feet at the start of the transect to 3.1 feet at the end of the 42-foot-long transect. Substrate ranged from fines (sand) at the start of the transect to pebbles in the middle, transitioning to fines (muck) at the deepest end of the transect. These depths and substrates are again consistent with the lake level variation from 2006, and observations indicate no change in substrate level or type. The vegetation in 2010 was still the same as in 2006 (reed canary grass and overhanging shrubs), although there was less growth evident in 2010 because the 2010 site visit was slightly earlier in the growing season than the 2006 site visit was (February 2010 versus April 2006). The slope in the transect remained at 6 percent.

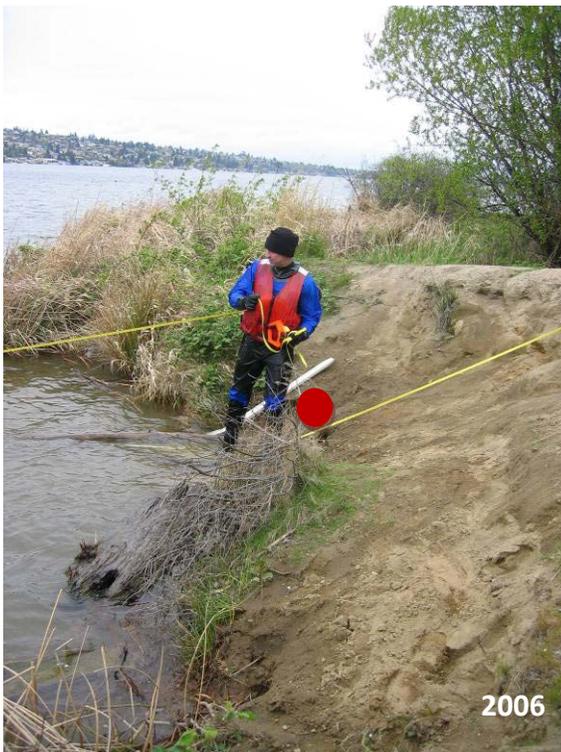
**Photo 3a**  
2006 photo: short bluffs at shore of southwest Bird Island, looking west; red dot indicates same location in all four photos (Note: water level is lower in 2010)

As in 2006, Transect 3 extended waterward from a short, highly eroding escarpment bluff on the southwest side of Bird Island (Photo 3a). The short bluff was approximately 5 feet in height from the waterline to the top of the bank, which is the same height as it was in 2006

(Photos 3b and 3c). Water depths in 2010 ranged from 0 feet to 4.3 feet at the end of the 90-foot-long transect, and substrate again ranged from fines (muck) at the end of the transect to gravel, pebble, and cobble in the middle, to sand at the shoreline. These depths are again consistent with the lake level variation from 2006, and no differences were observed in substrate and vegetation conditions between 2006 and 2010. Vegetation in 2010 was still the same as it was in 2006 (Photos 3a and 3d). The slope in the transect remained at 7 percent.

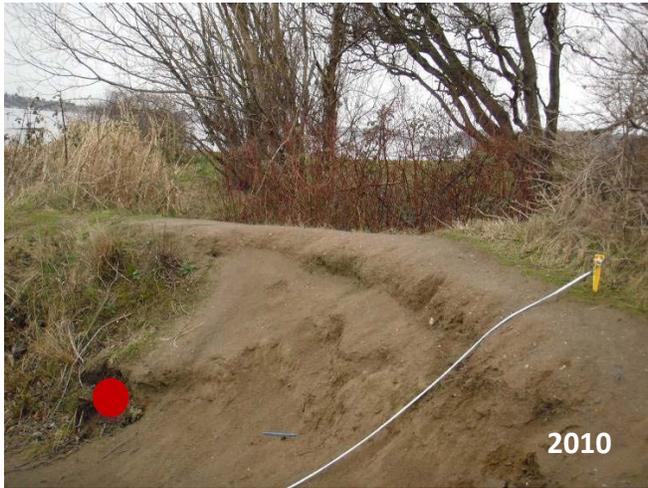
**Photo 3c**

**2010 photo: short bluffs at shore of southwest Bird Island, looking west; red dot indicates same location in all four photos**

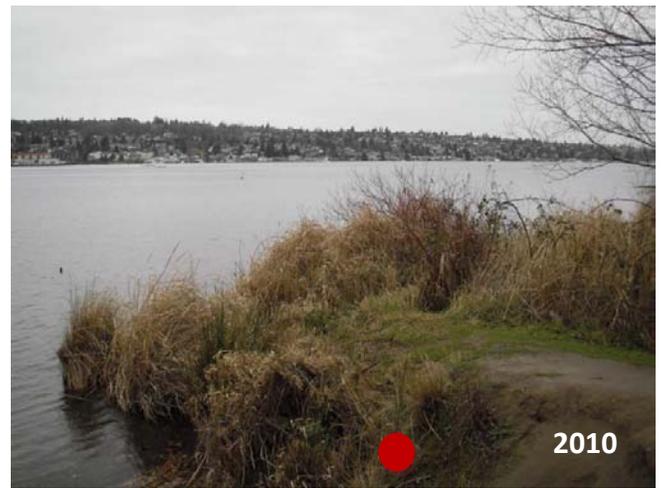
**Photo 3d**

**2010 photo: short bluffs at shore of southwest Bird Island, looking west; red dot indicates same location in all four photos**

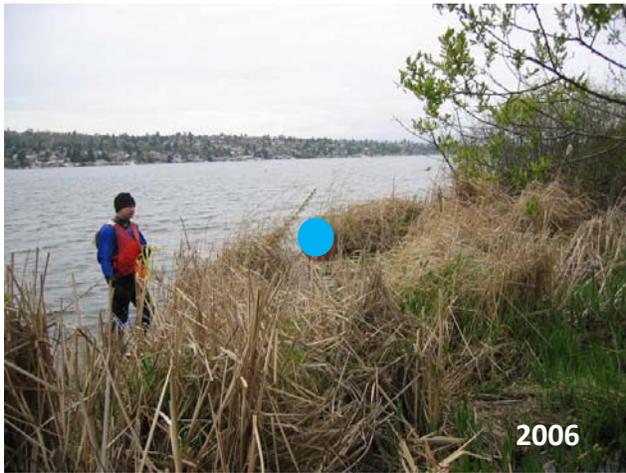
**Photo 4a**  
**2006 photo: freshwater marsh at northwest side of Bird Island, looking west; blue dot indicates same location in both photos**

As in 2006, Transect 4 extended waterward from a freshwater marsh into the lake (Photos 4a and 4b). Water depths in 2010 ranged from 0 to 2.3 feet at the end of this 150-foot-long transect, and substrate was mostly fines (muck) throughout the transect, with pebble near the shore. These depths are again consistent with the lake level variation from 2006, and no differences were observed between substrate and vegetation conditions in 2006 and 2010. The slope in the transect remained at 1 percent.

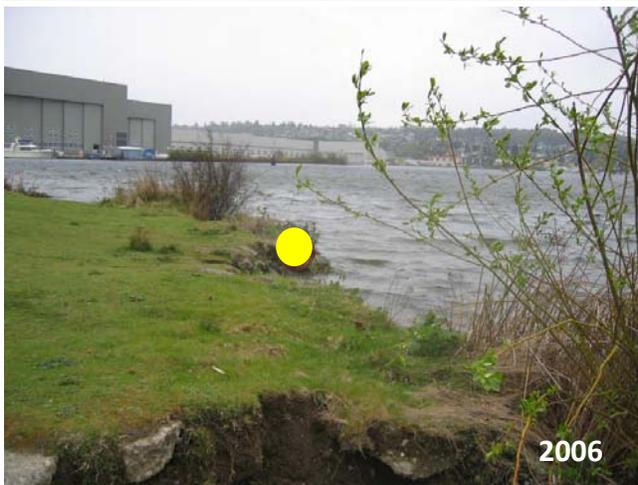
**Photo 5a**  
**2006 photo: northwest tip of Bird Island, looking southwest; yellow dot indicates same location in both photos (Note: water level was higher in 2006, and thus more of eroded area is visible in 2010 photo; also, photo angles are slightly different in the two photos)**

As in 2006, Transect 5 extended waterward from the northwest shore of Bird Island into the lake. Water depths in 2010 ranged from 0 feet to 2.3 feet at the end of this 100-foot-long transect. As in 2006, the substrate was characterized by fines (sand/silt) at the deep end of the transect, ranging to cobble, pebble, and concrete rubble near the shore. In 2010 as in 2006, the entire north shore of Bird Island was actively eroding and had scattered concrete rubble and angular rock (riprap) armoring that increased toward the east (Photos 5a and 5b). Vegetation is essentially absent aside from lawn grass and two shrubs. Based on observations, photos, and measurements of small bluffs present, conditions in these areas in 2010 were not significantly altered from conditions in 2006. The slope in the transect remained at 4 percent.

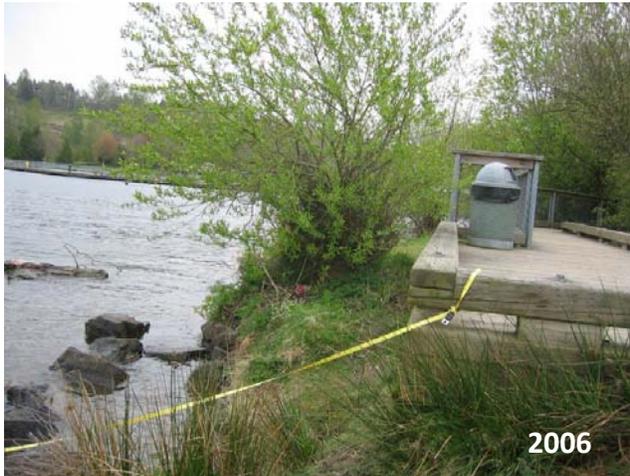
**Photo 6a**  
**2006 photo: Concrete rubble, angular rock, and undercut banks at northeast tip of Bird Island, looking northeast**

As in 2006, Transect 6 extended waterward from the northeast tip of the boardwalk footing, eastward into the lake (Figures 6a and 6b). Water depths in 2010 ranged from 0 feet to 4 feet at the end of this 50-foot-long transect. As in 2006, the substrate was characterized by fines (muck) at the deep end of the transect, ranging to cobble, pebble, and armoring rubble at the shore. The slope in the transect remained at 5 percent. The water depth was slightly less in 2010 at the end of the transect than in 2006 (approximately 1 foot), but based on on-site observations, this apparent difference can be attributed to a slight difference in observer stance in the mud substrate than to a real difference in water level.
