# December 3<sup>rd</sup> Landslide Reconnaissance

WASHINGTON STATE DEPARTMENT OF  
**Natural Resources**

**Washington Geological Survey**

**February 13 2008**

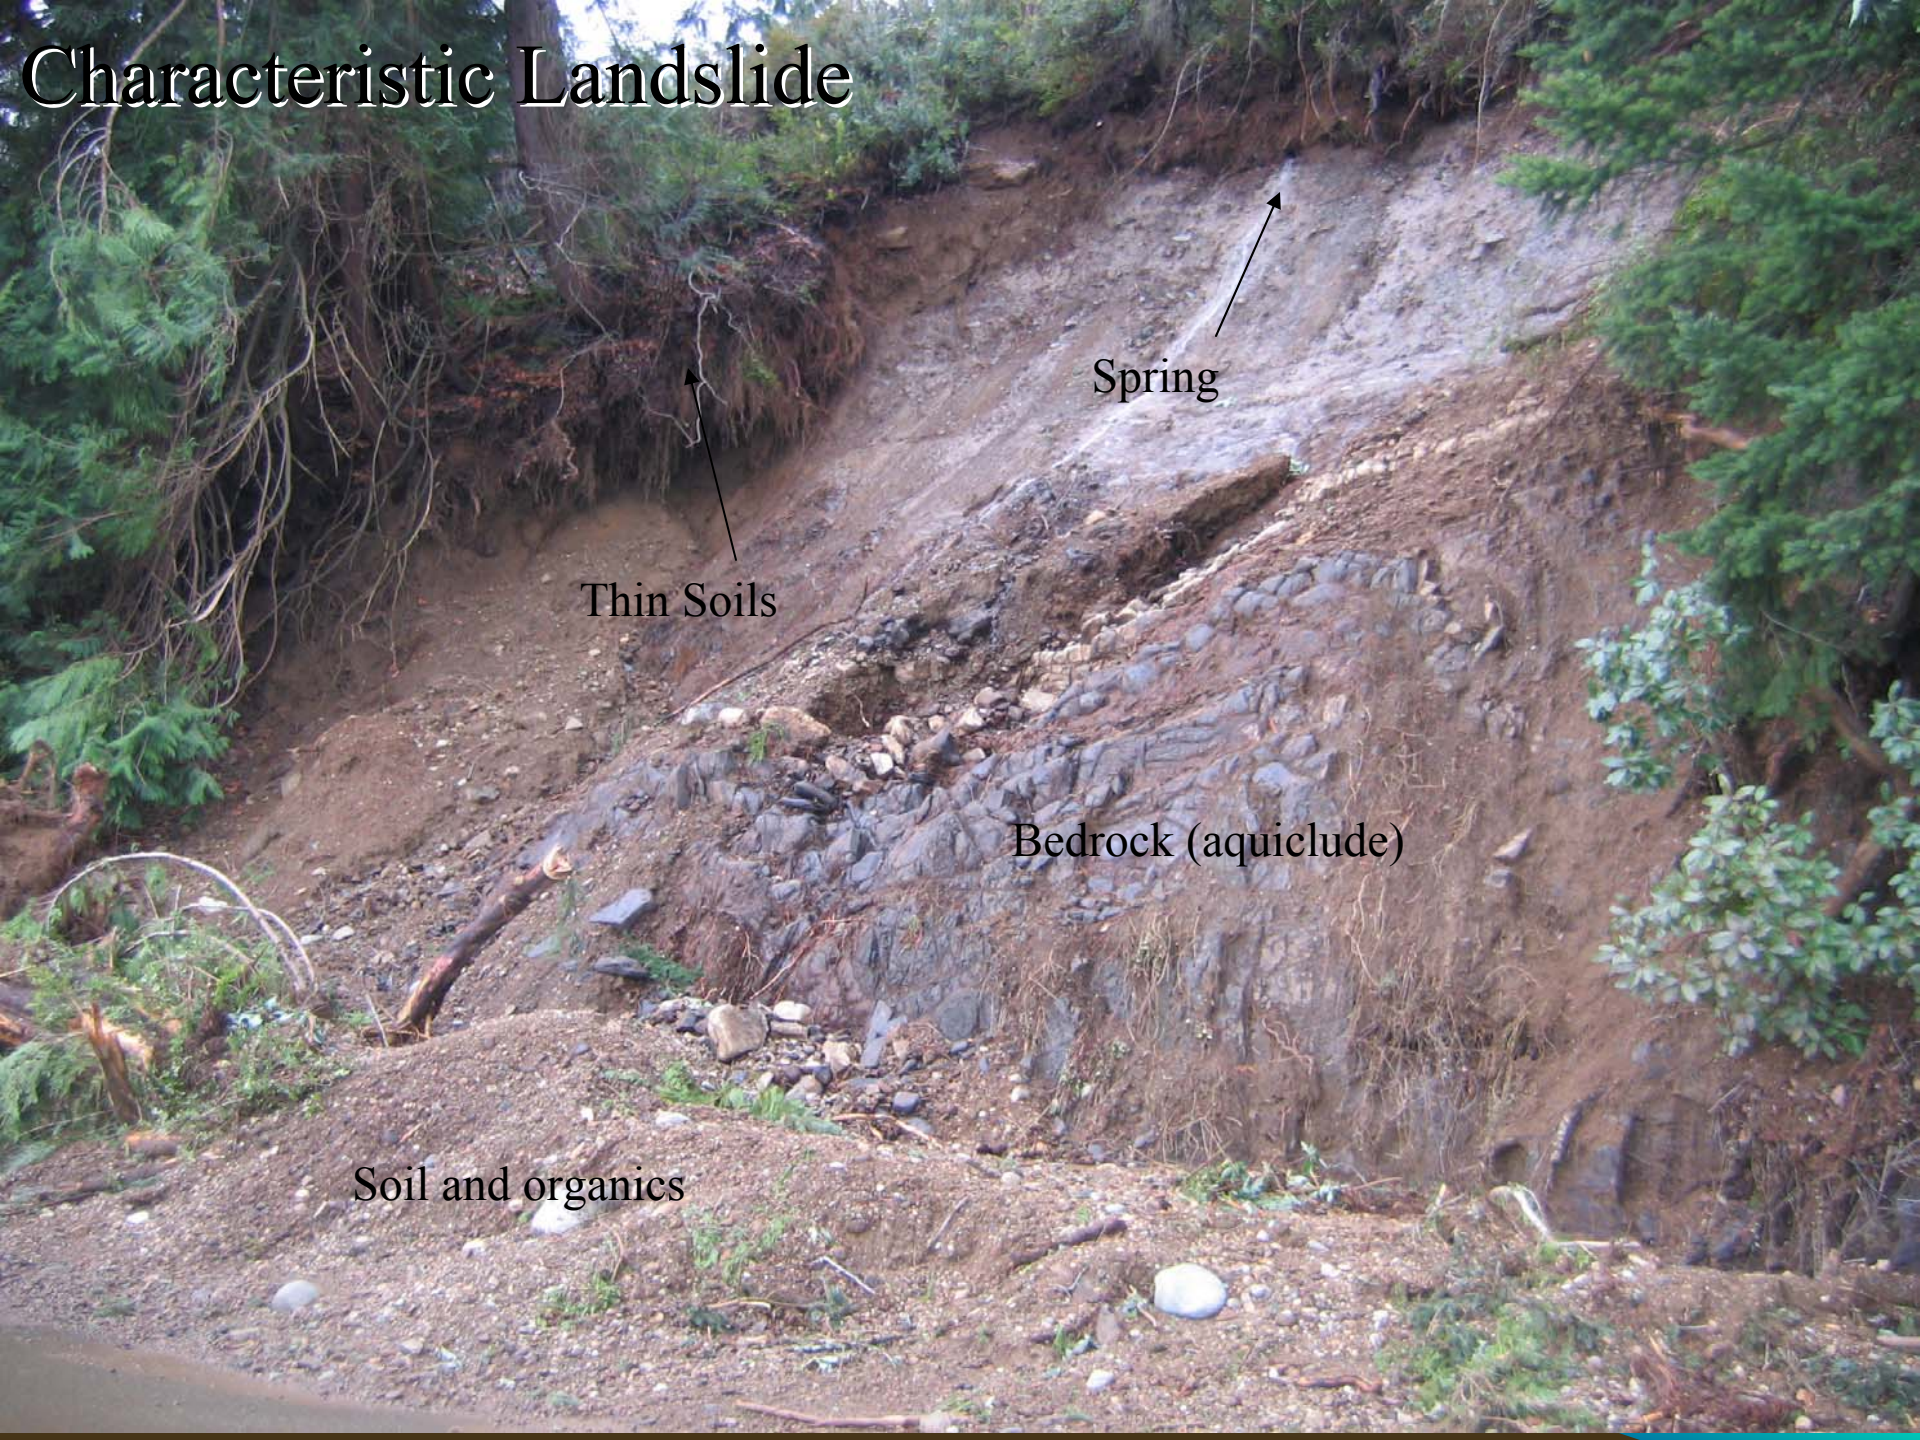
# Characteristic Landslide

Spring

Thin Soils

Bedrock (aquiclude)

Soil and organics

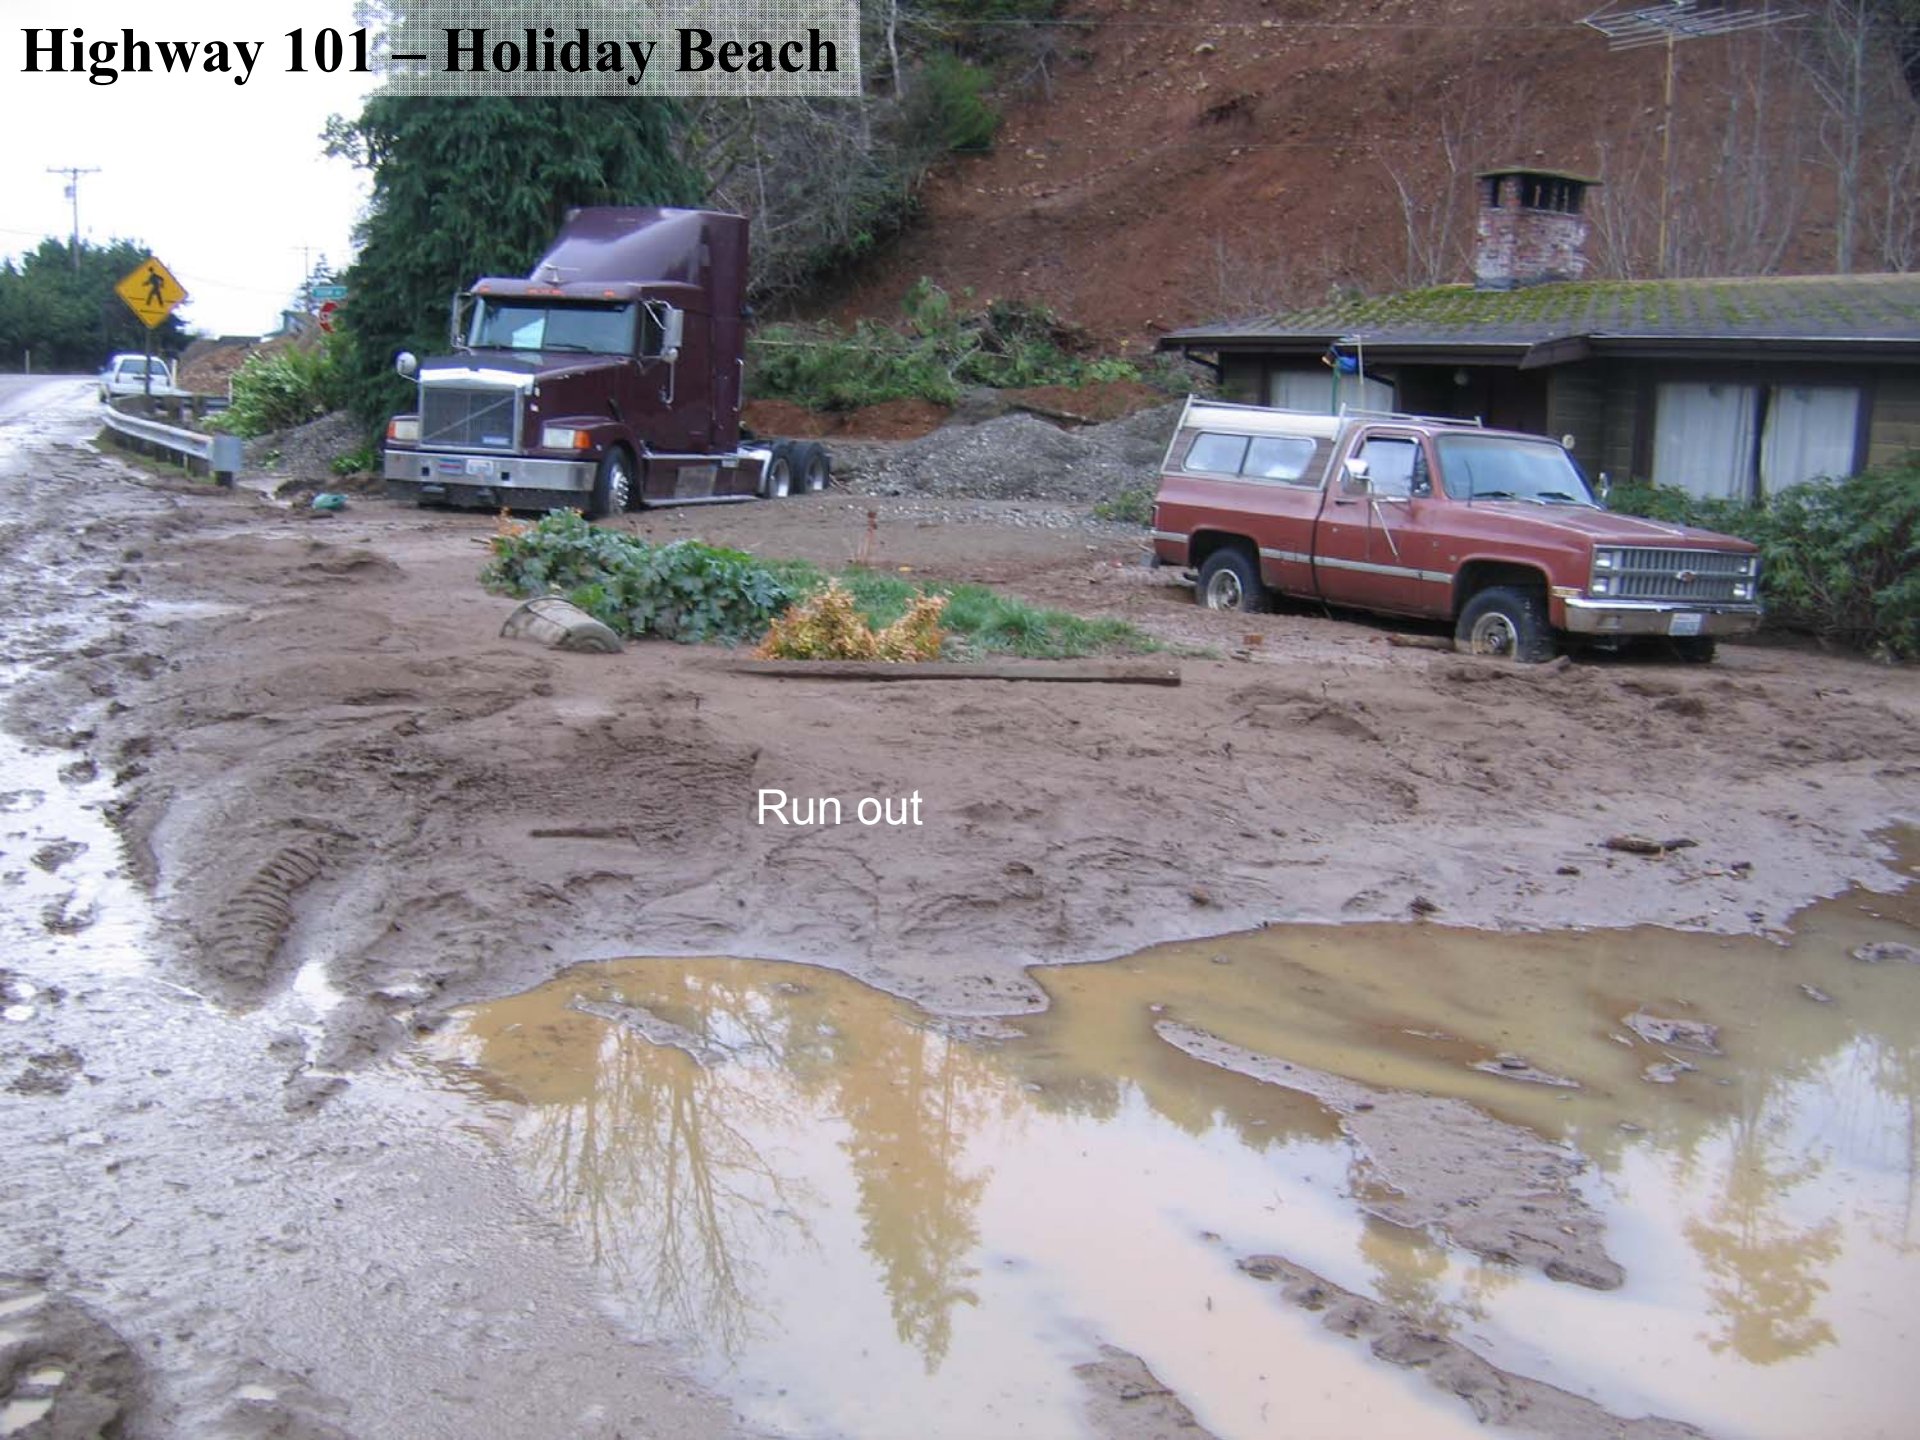
# Highway 101 – Holiday Beach

Run out

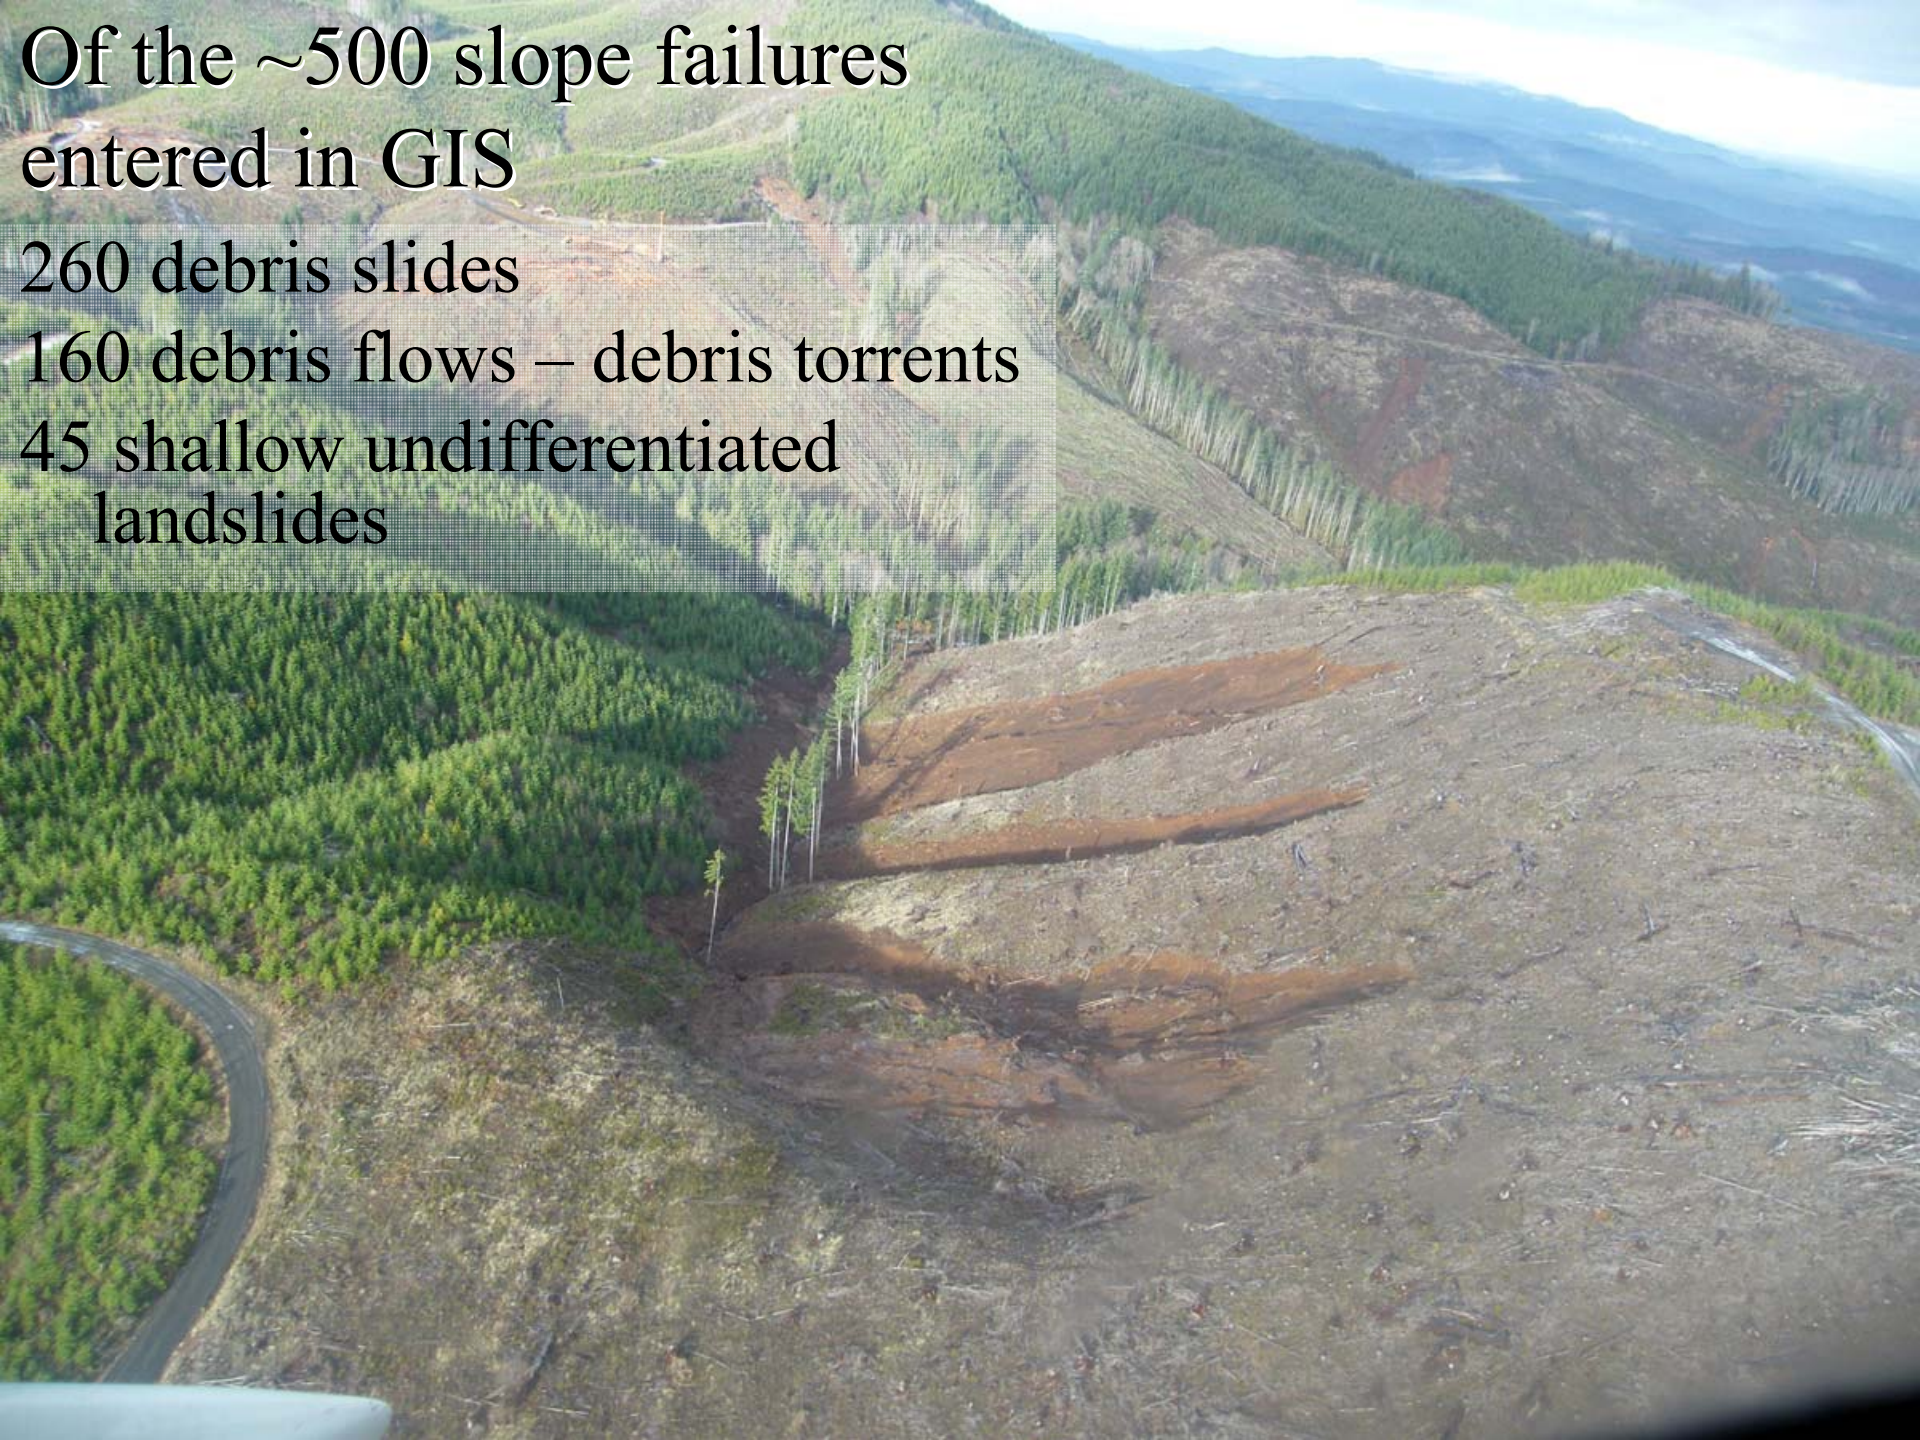
Usually the debris slides  
transformed into debris flows.

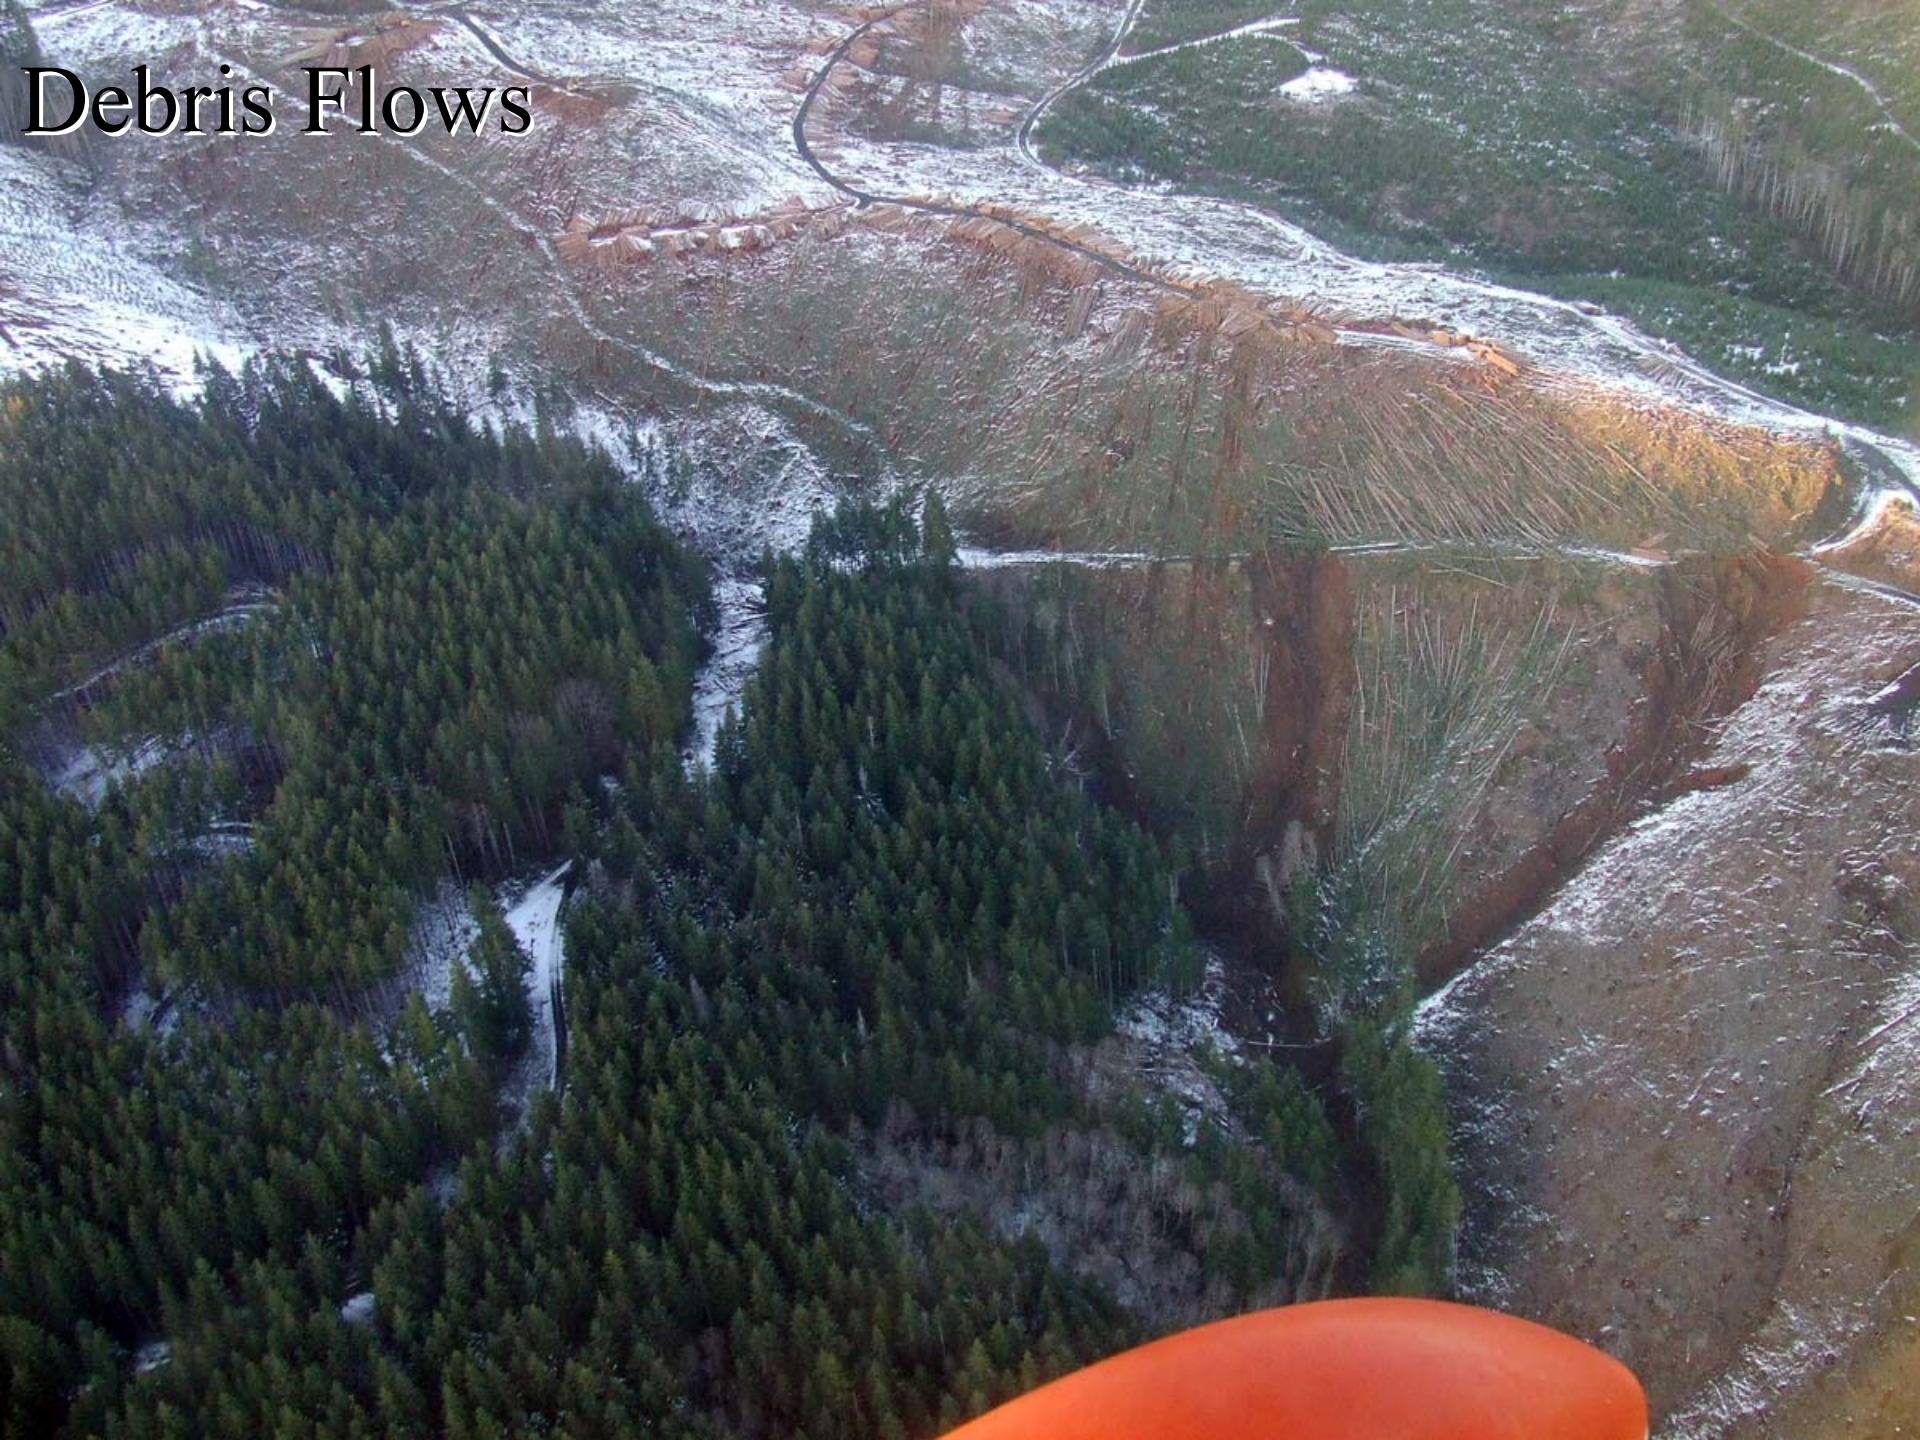
# Debris Flows

Of the first 177 landslides inventoried:

62 either initiated in clear cuts or initiated at a road in a clear cut 0 to 5 years old

15 initiated in timber aged 5 to 15 years or at roads in timber 5 to 15 years old

96 initiated in timber 15 to 50 years old or at roads in timber 15 to 50 years old

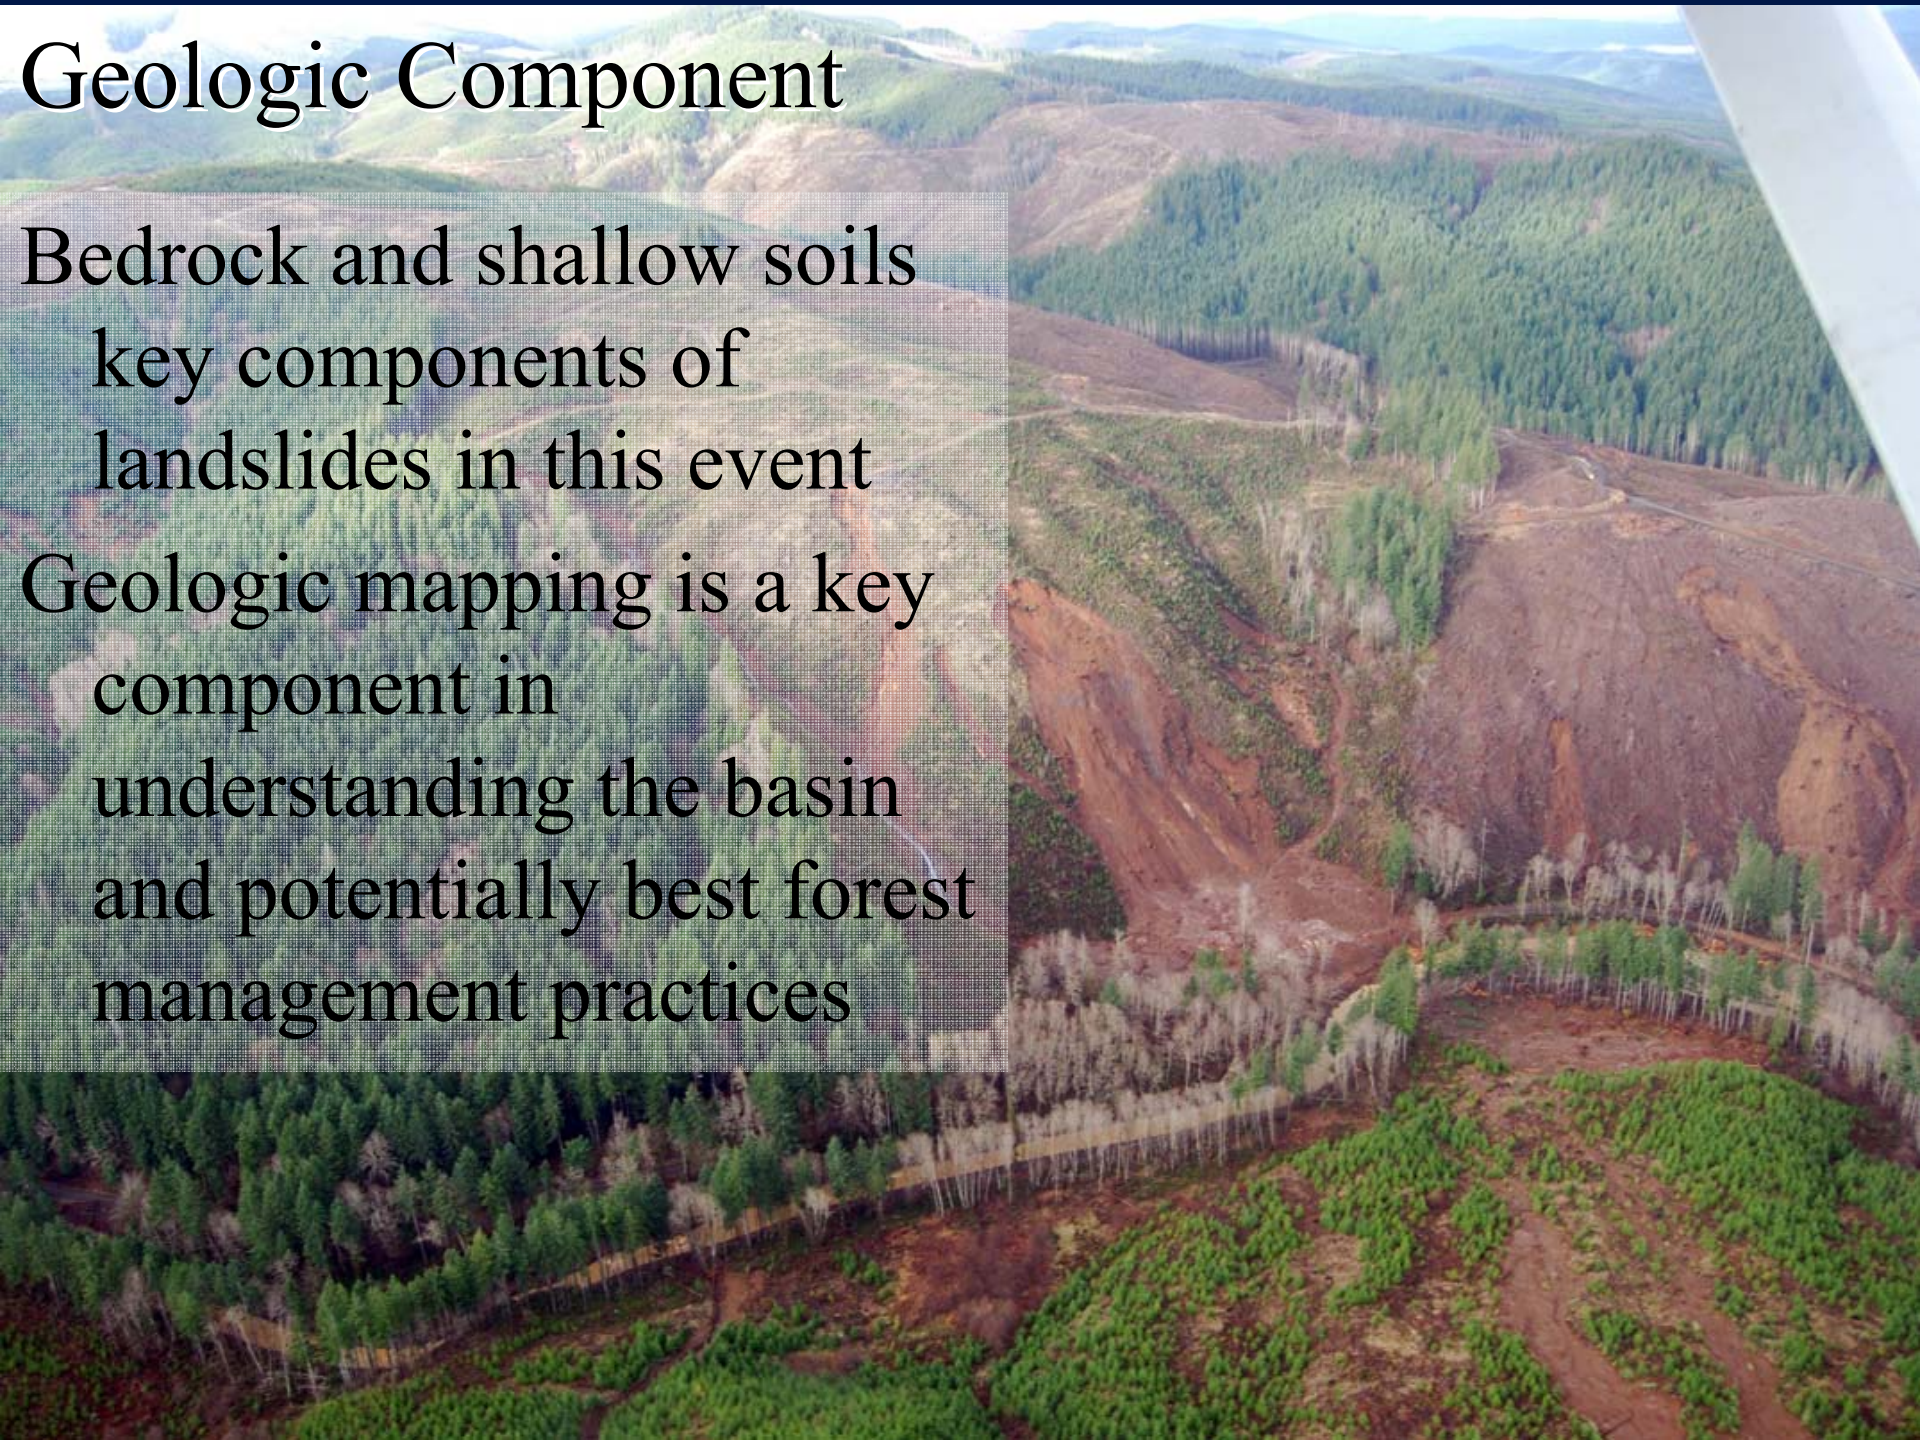
# Geologic Component

Bedrock and shallow soils  
key components of  
landslides in this event

Geologic mapping is a key  
component in  
understanding the basin  
and potentially best forest  
management practices
