## ***SR530 Landslide near Oso, Washington***

Jonathan Godt PhD  
Research Physical Scientist  
Geologic Hazards Science Center  
Golden, CO

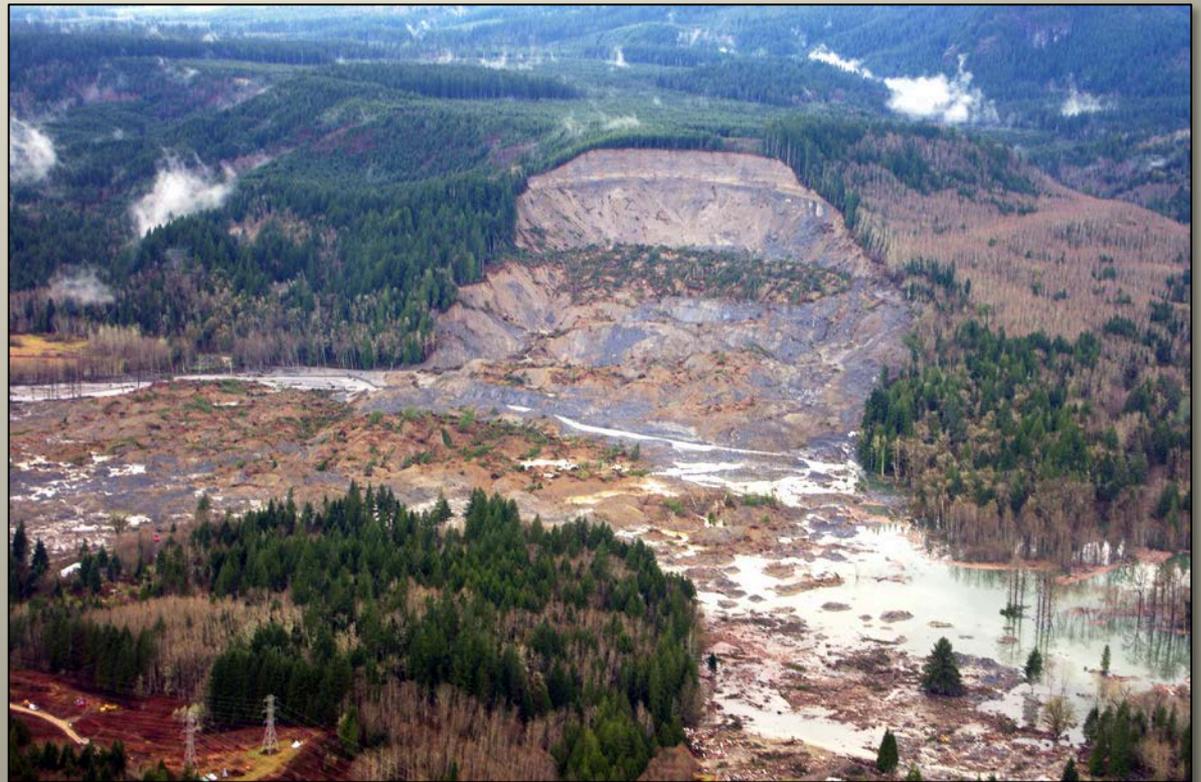
**Buried about 40 homes and 0.8 mile of SR530**

**Slide volume about 10 million cubic yards**

**Occurred on a 600 ft high glacial plateau**

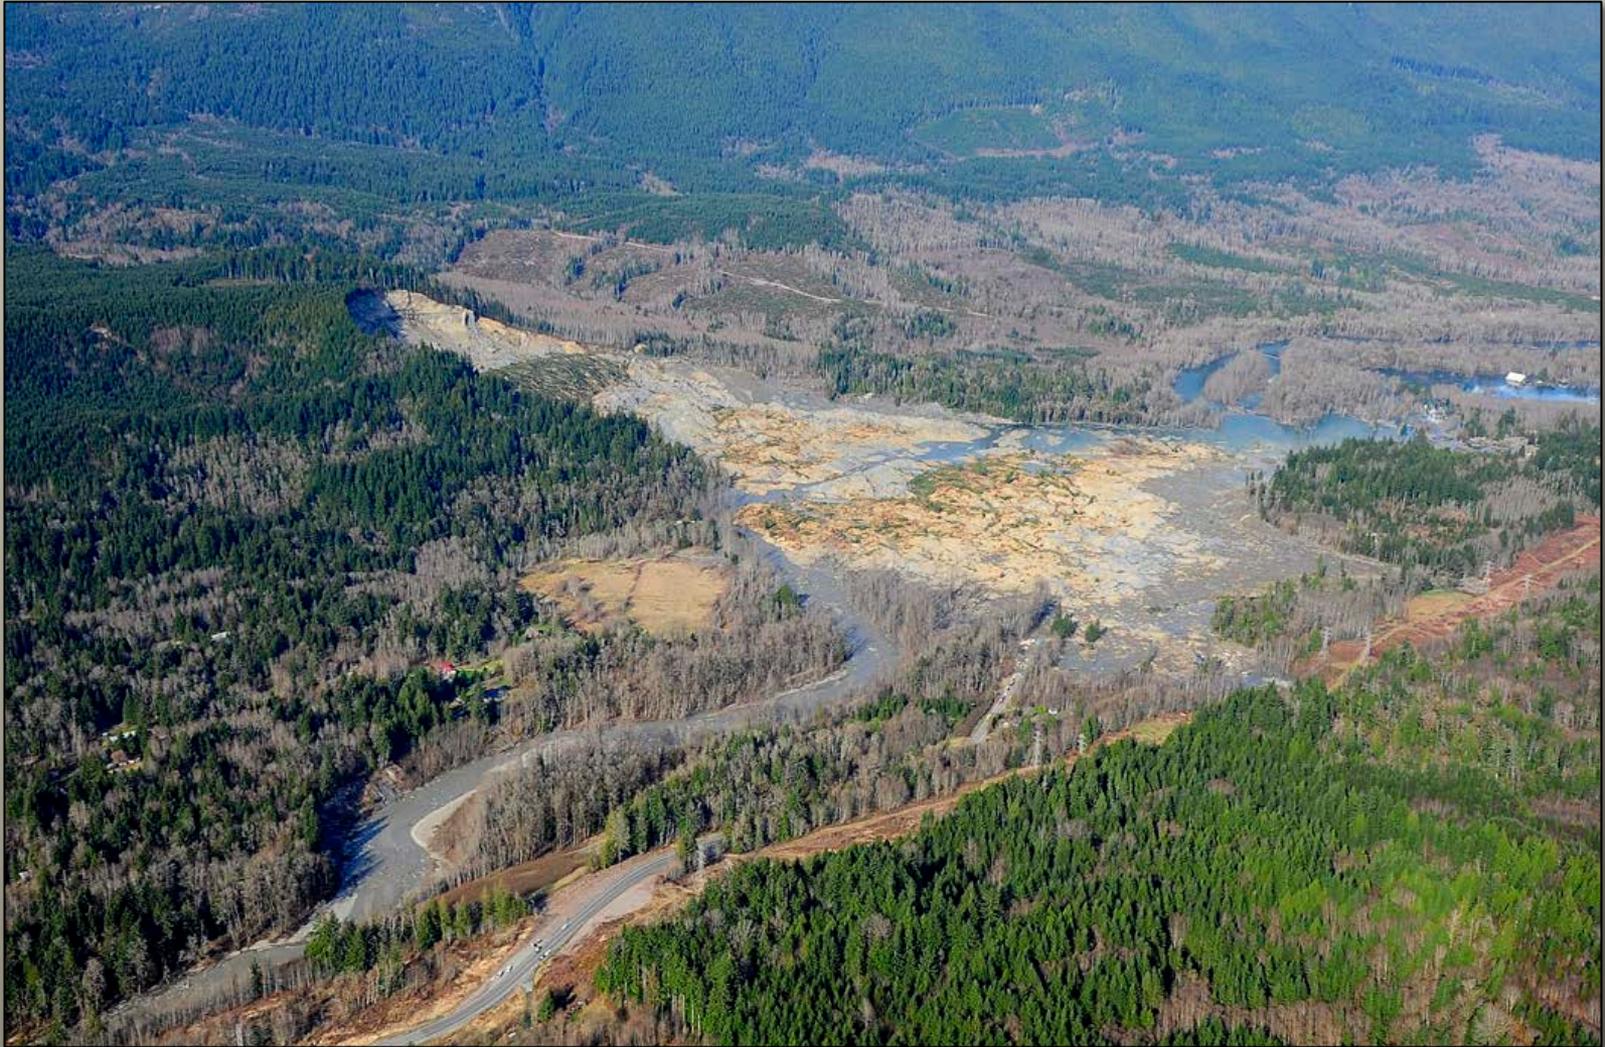
**Travelled more than 0.7 miles from the toe of the slope**

## *SR50 landslide travelled a remarkably long distance*

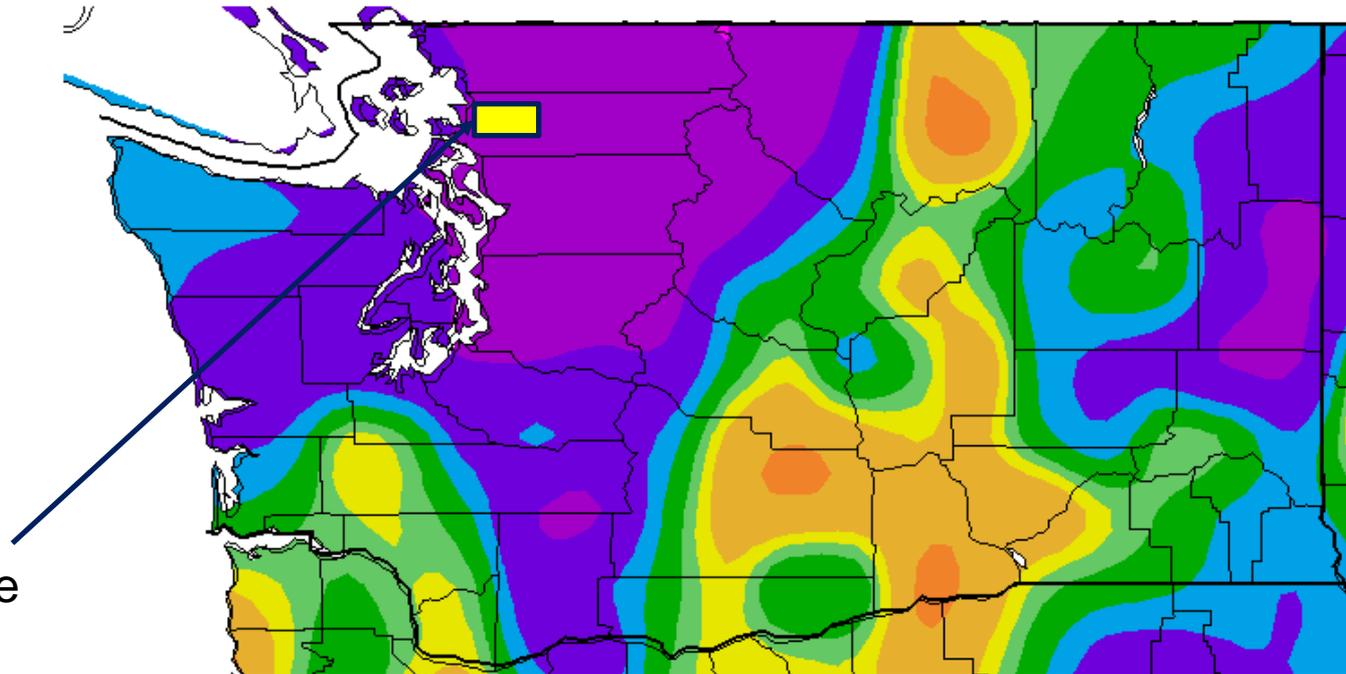
Percent of Average Precipitation (%)  
2/21/2014 – 3/22/2014

## Following a wet period in late February and March

SR530 slide

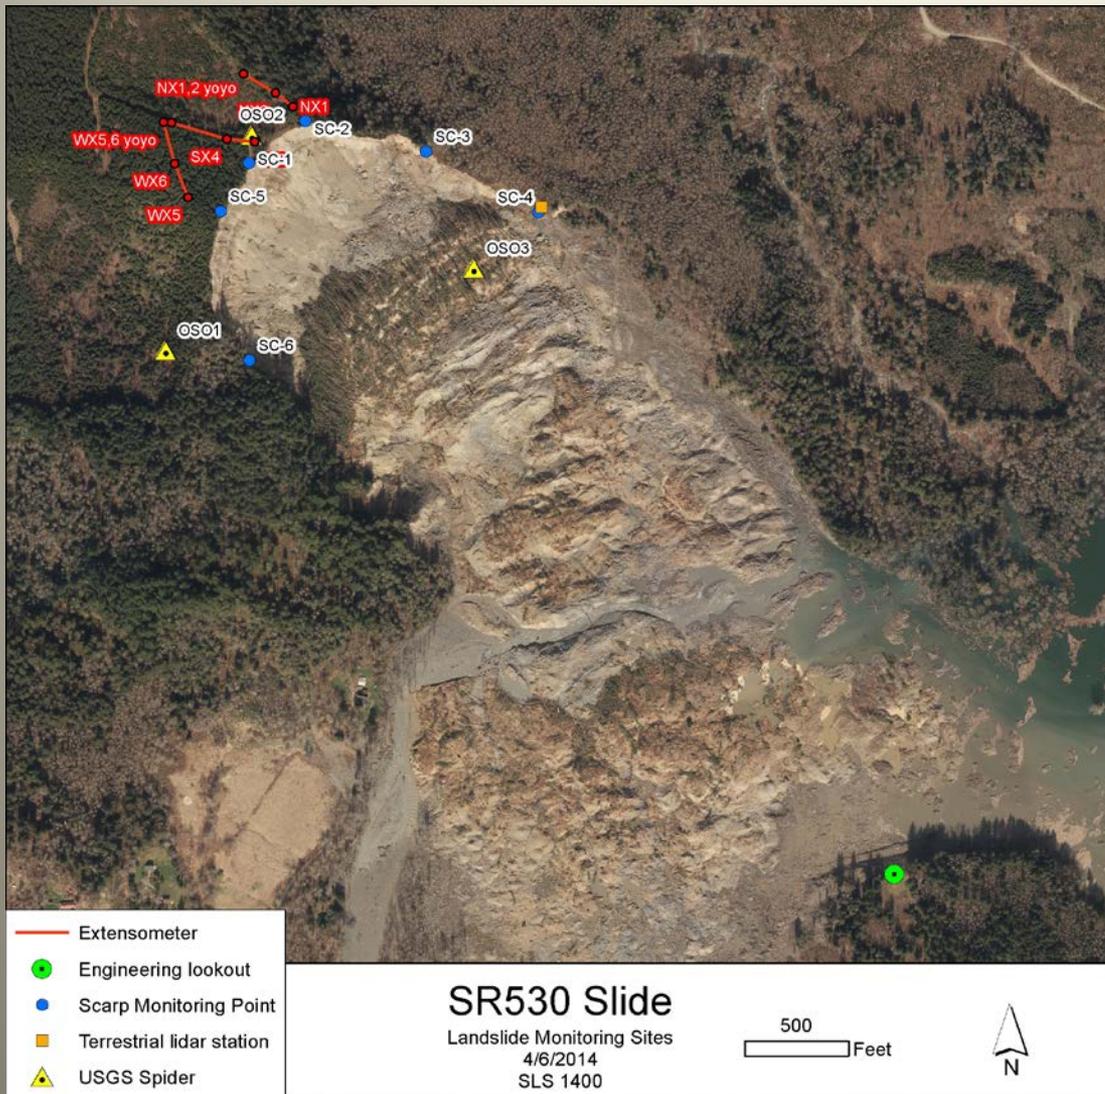
# ***Snohomish County, WA State, and USGS monitoring network***

Threat from additional movement

County survey lines and points

WashDOT extensometers

WashDOT TLS scans

USGS Spider Units

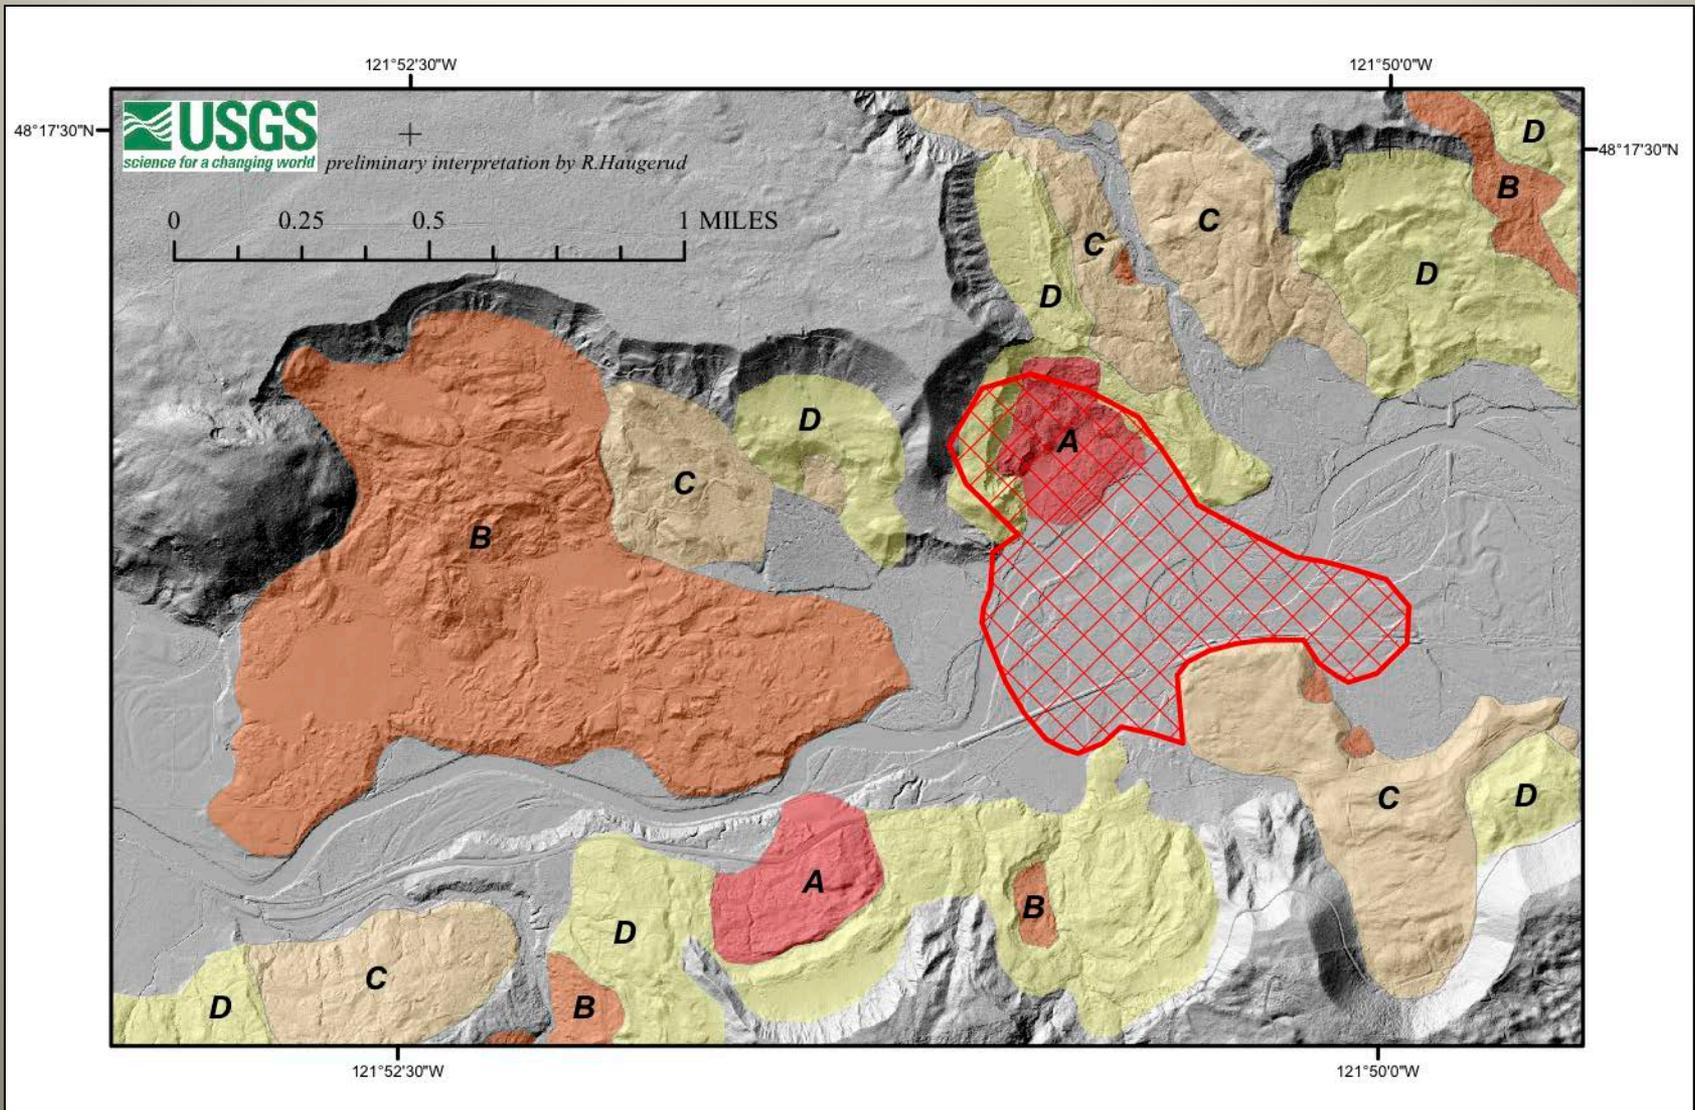
# Slides in the area may have run out similarly in the past

Haugerud (2014)
