Seattle Freeway Construction, Interstate Highway 5, 1960-1966

KENNETH A. JOHNSON

Washington State Department of Highways, Retired

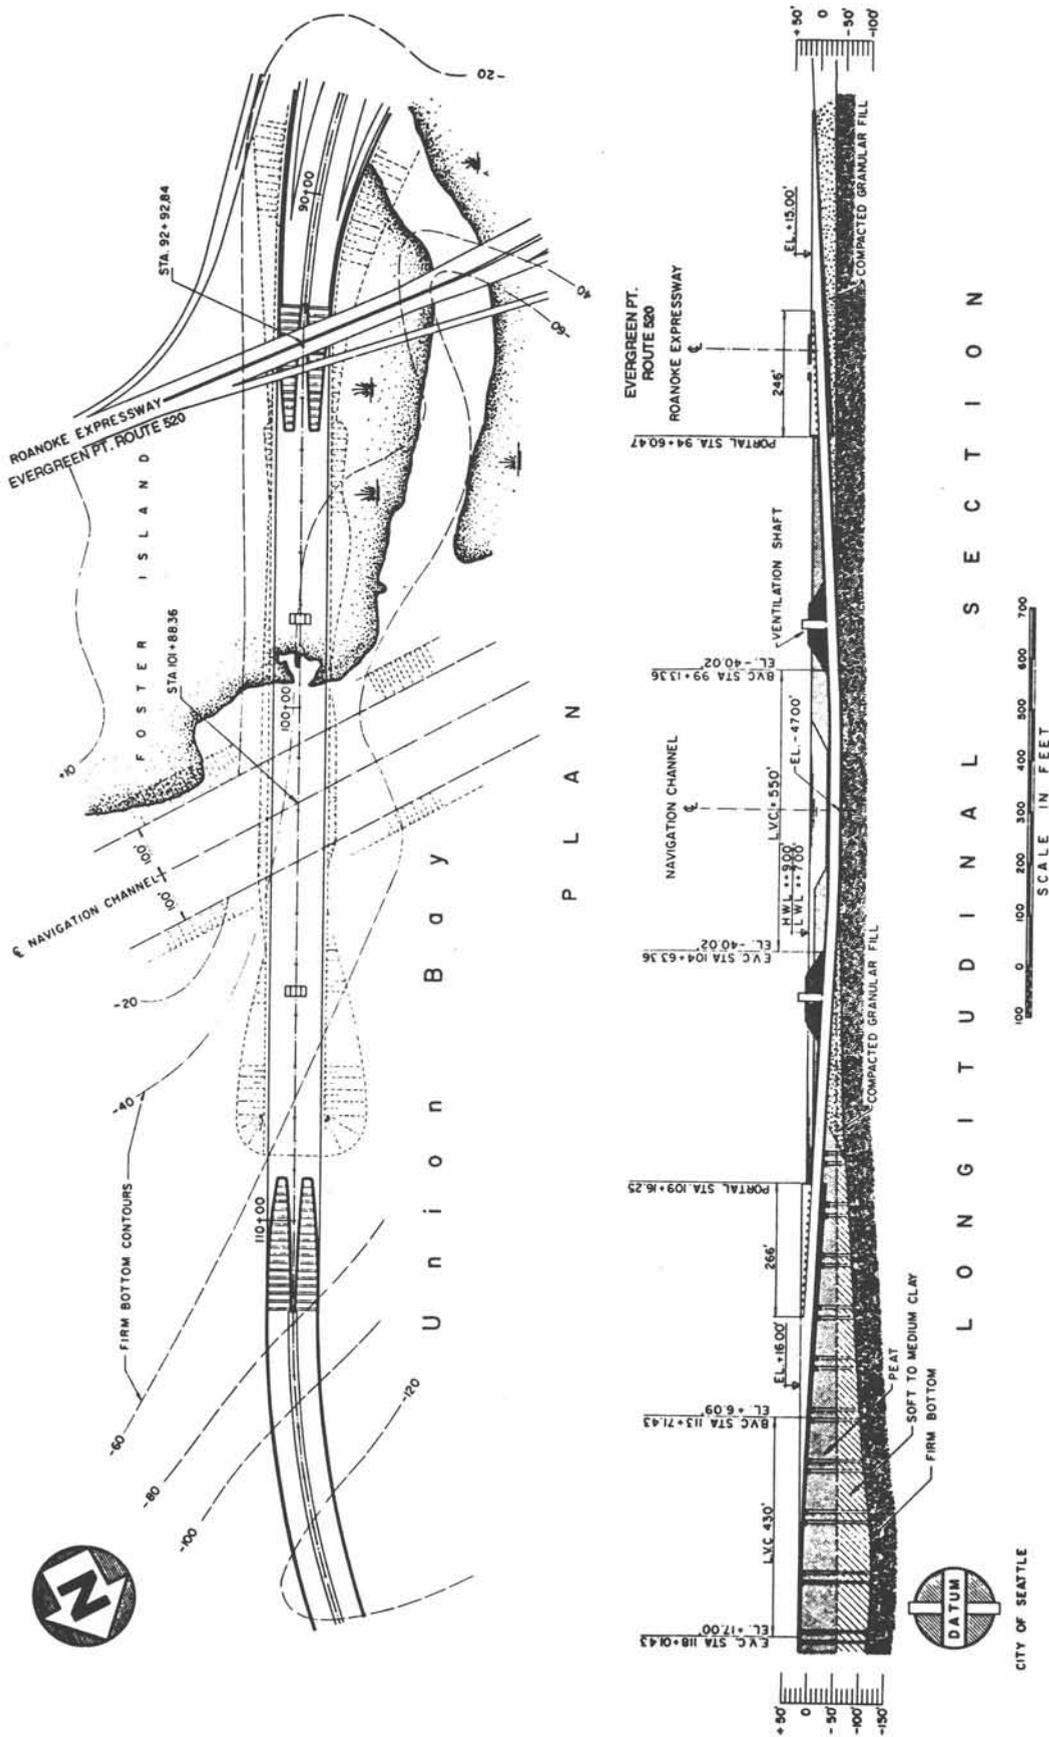
Figure 2. Plan and longitudinal section of a sunken tube tunnel for the conceptualized R. H. Thompson Expressway across the Union Bay Ship Canal. Note the thick sequence of soft soils at the north end of the alignment.

cient to allow ships with considerable draft to pass. Soil borings indicated a thick sequence of soft organic soils which would have to be removed and replaced along major portions of the aesthetically preferred tunnel (Figure 2). The presence of this soft compressible soil would also complicate construction and increase foundation costs for any bridge.

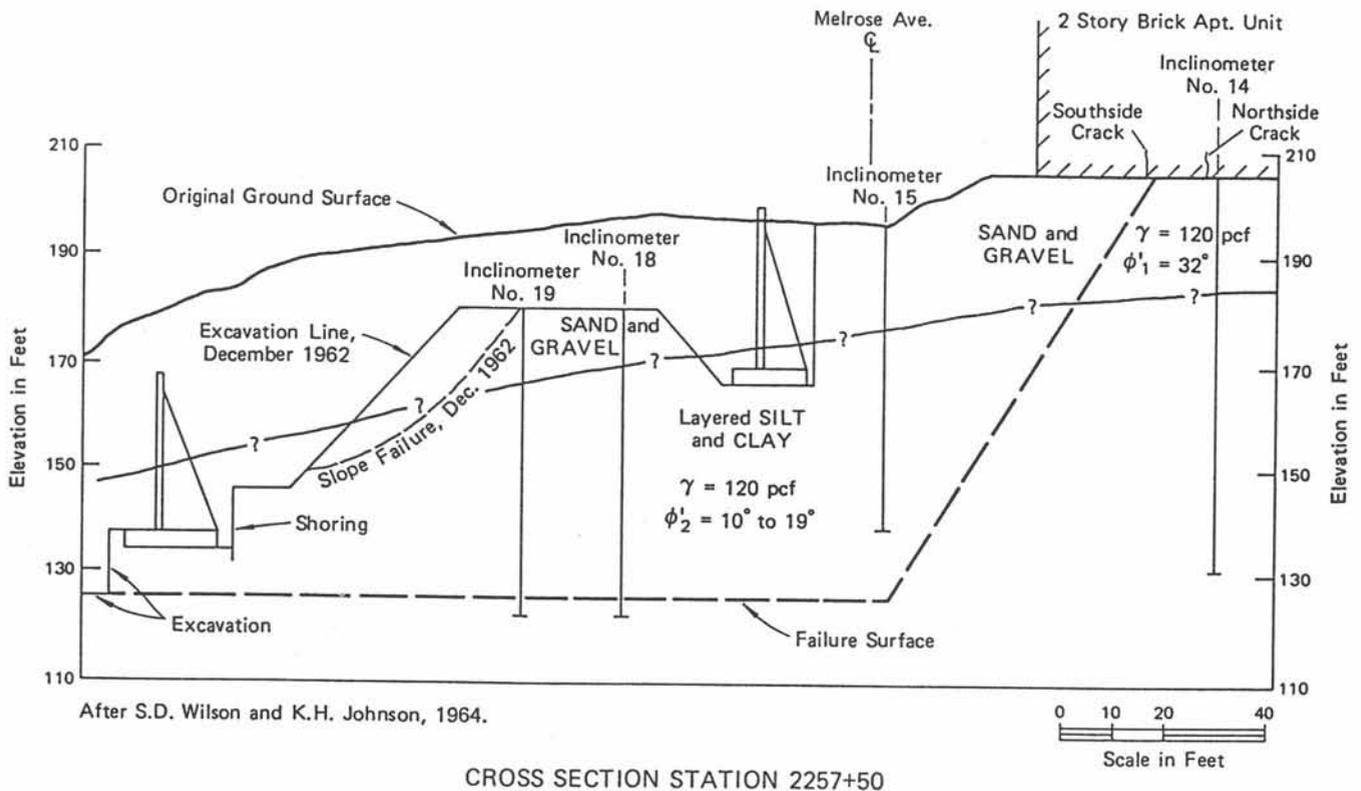
Figure 3. First deep-seated slide near Republican Street and Melrose Avenue. Note inclinometers used to determine the location of the slide plane for back-analysis of soil properties.

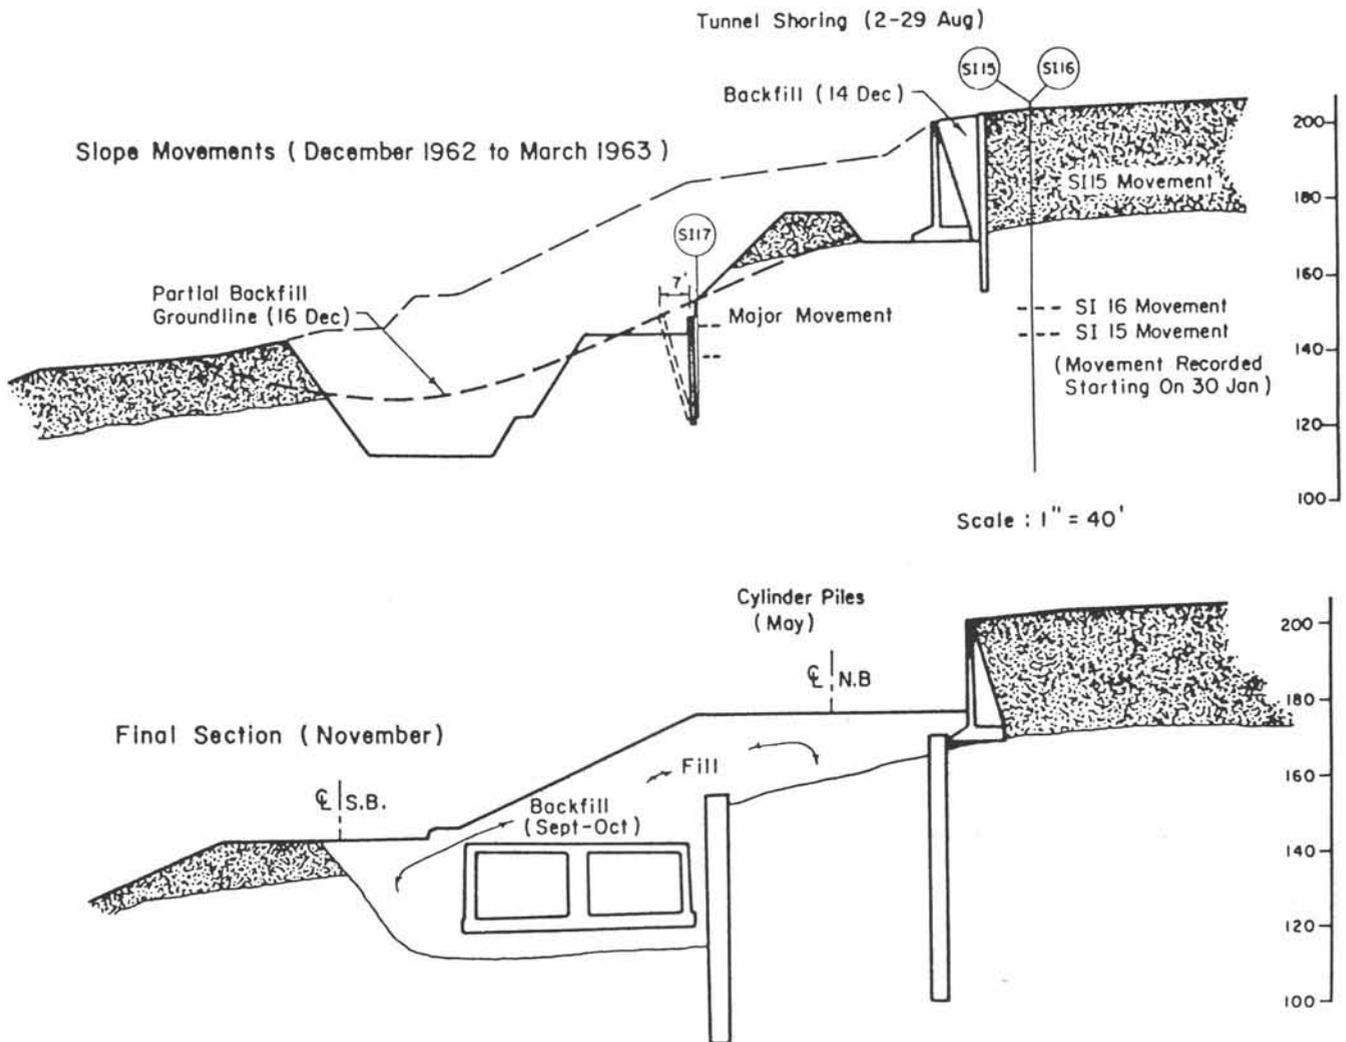
Figure 4. Original construction excavation and retaining wall design (upper drawing) near Olive Way and the revised as-built design (lower drawing) employing cylinder pile walls installed to support the upper retaining wall and lower cut-and-cover tunnel excavation.

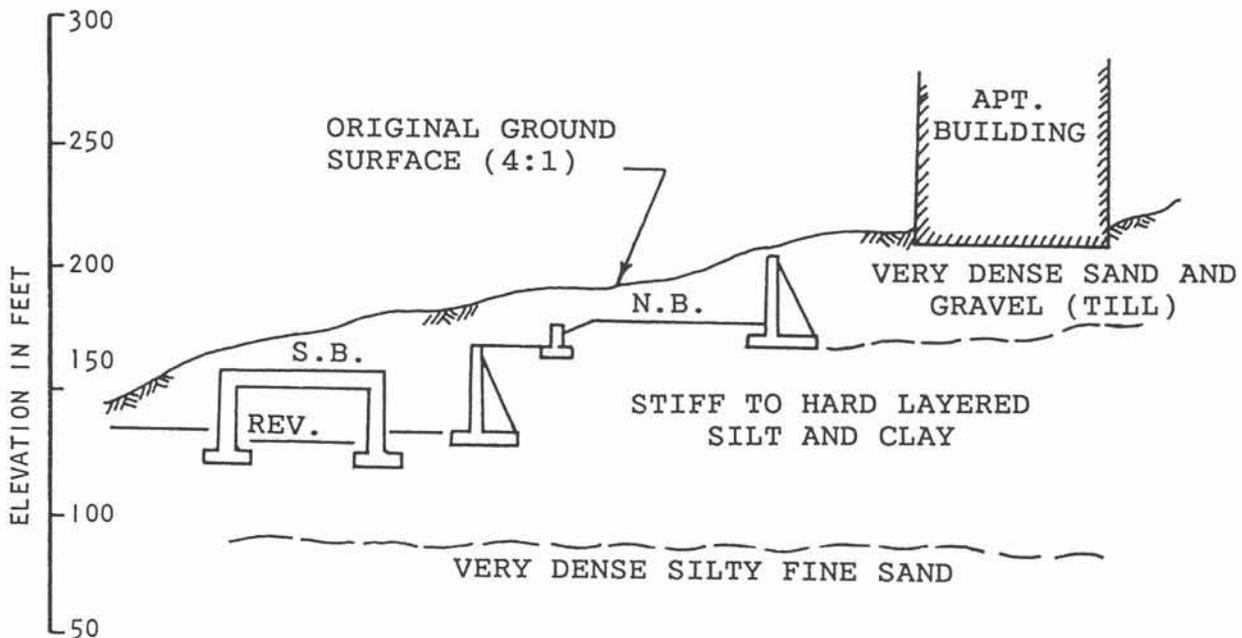
Figure 1. Cross-section A-A' (generalized) showing the proposed construction of the Seattle freeway and the geologic profile. N.B., northbound lane; S.B., southbound lane; Rev., reversible lane.

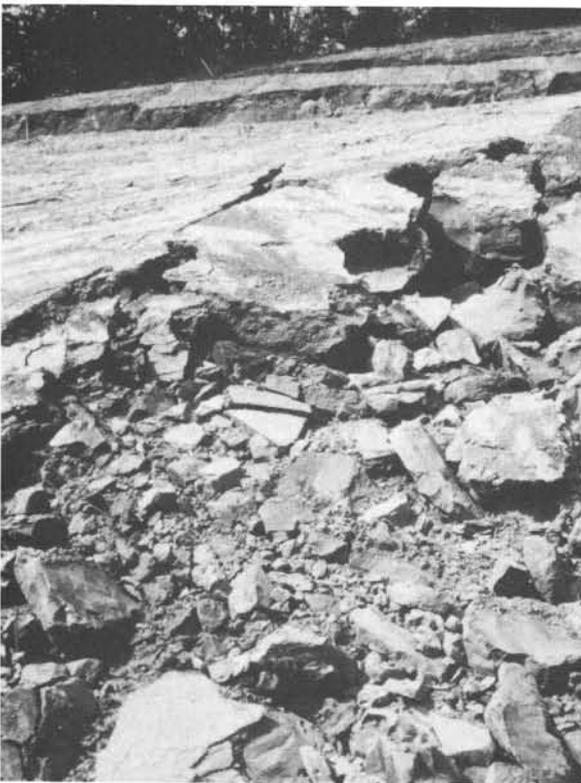
Figure 2. Hard blocks and chunks of clay in a landslide mass. Largest chunk in the upper middle part of the photograph is about 5 ft across.

The lacustrine deposits consist principally of unweathered silt, silty clay (CH, Unified Soil Classification System), and clay (CH), with representative Atterberg limits as tabulated below. The deposits are either massive or layered and in some places varved. The consistency of the material varies from very stiff to hard, and in the undisturbed state it exhibits a remarkably high strength. The *in-situ* properties of the material, however, are influenced by the existence of structural features consisting of joints and fissures and, generally, horizontal bedding planes. When disturbed, such as by ground movements, the fissured nature of the material creates a broken mass composed of hard blocks and chunks (Figure 2).

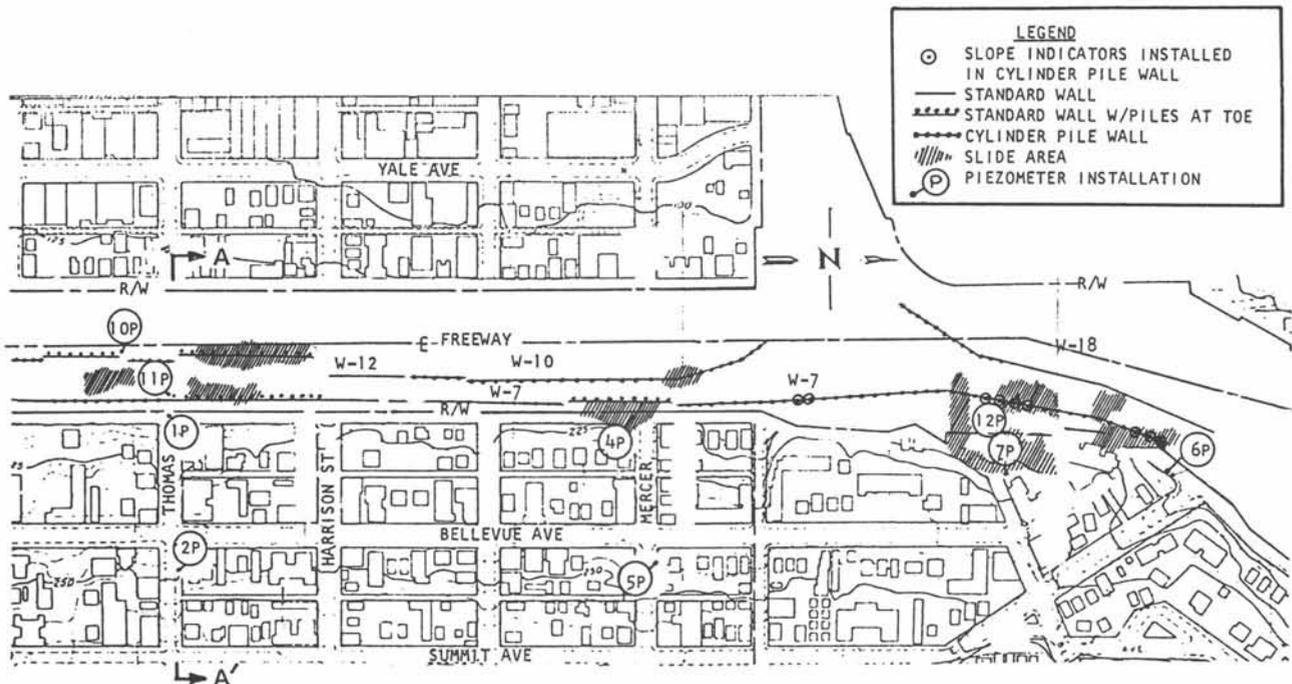
Figure 3. Site plan of the north portion of the first contract (1962).

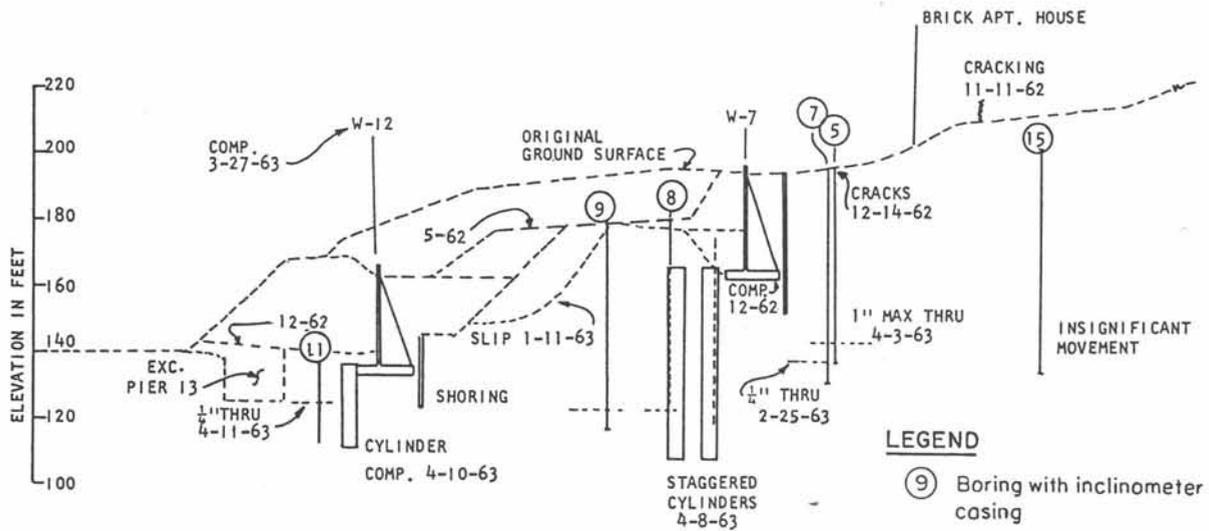
Figure 4. Cross-section A-A' showing the sequence of events associated with slope failure. See Figure 3 for location of section. Horizontal scale same as vertical.

The sequence of events associated with a typical section, cross section A-A', is shown on Figure 4. At this section a shallow cut was made in May 1962, followed by excavation during September and October for the upper retaining wall, W-7. The wall was completed at the end of December 1962. In late fall of 1962, a major excavation was being made in the lower part of the slope, not only for wall W-12, but also probably for pier 13 of the southbound structure. On November 11 cracks

appeared in the buildings across the street at the head of the slope. A slip in the back slope of the excavation for wall W-12 was noted at about elevation 150 ft. Inclinator I-5, established at the top of the hill, indicated significant movements at about the same level (elevation 145 ft) between December 15 and 27, 1962. Inclinator I-9, established in early 1963 near mid-height of the slope, indicated shallow movements in January and February 1963 and also movement during February at about elevation 125 ft, approximately the same elevation as the base of the footings excavated for the southbound structure. When, in April 1963, cylinder-pile excavations were made in front of wall W-12, further evidence of movement at this level was noted.

This section clearly demonstrated the deep-seated nature of some of the landsliding movements. The movements in inclinometer I-5 near elevation 145 ft in December and in inclinometer I-9 near elevation 125 ft through February could have been caused only by the excavations associated with wall W-12 and the piers for the southbound roadway structure.

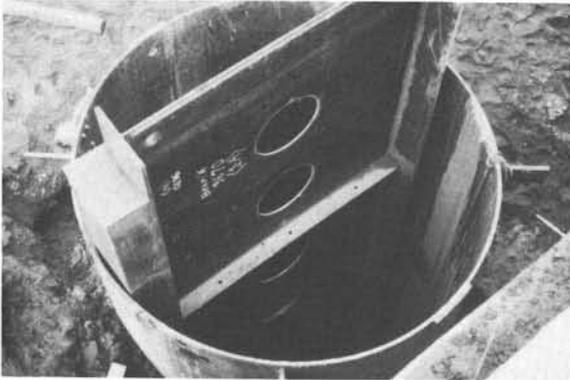
Figure 5. Cylinder pile (diameter 4 ft 9 in.) at the toe of an existing conventional wall. Steel beam is in place and ready for concrete pour.

the lowest failure plane required cylinders as long as 81 ft. The design loading was too great to permit the use of reinforcing steel, and therefore welded steel beams were employed as shown on Figure 5.

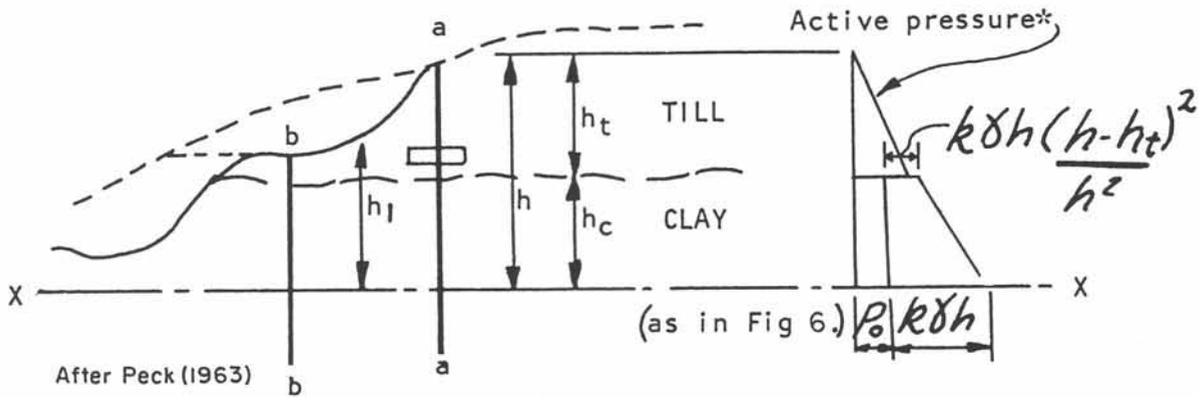
Figure 7. Design criteria for cylinder walls where cuts are in till over layered clay. *Active pressure includes effect of surcharge, if present, to depth h_t only. If the site is adequately drained, omit water pressure; if not, include hydrostatic pressure.

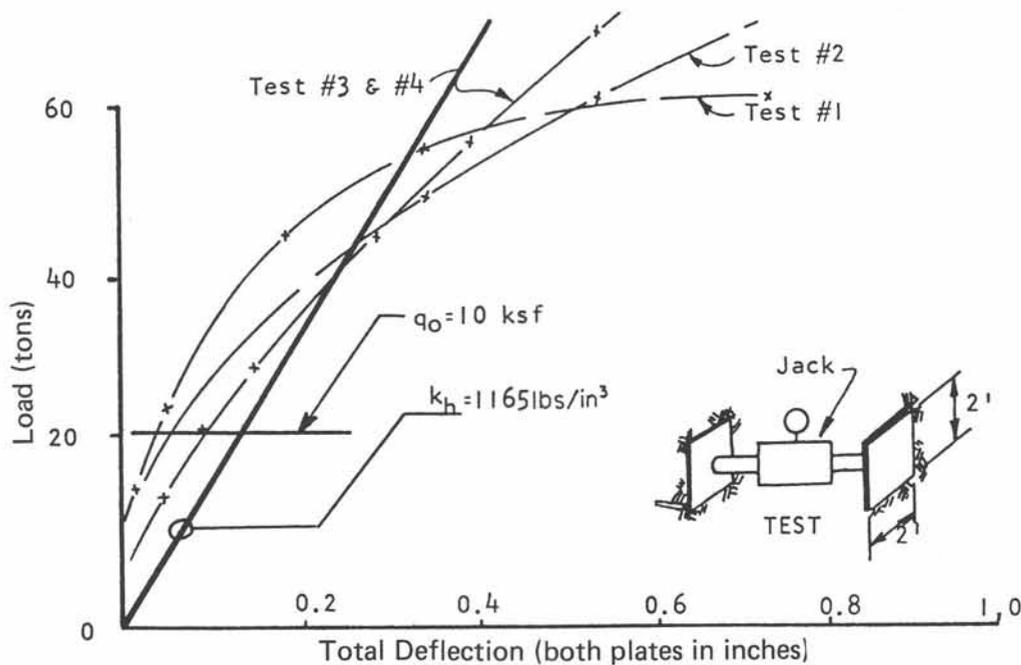
Figure 9. Load versus deflection curves for k_h test.

where D' = depth of wall moving into the soil (refer to Eq. 3), which yields a value of k_h equal to 200 pci. This value was evaluated and, later, recommended for the design of subsequent cylinder pile wall sections along the freeway. (See Table 2.)

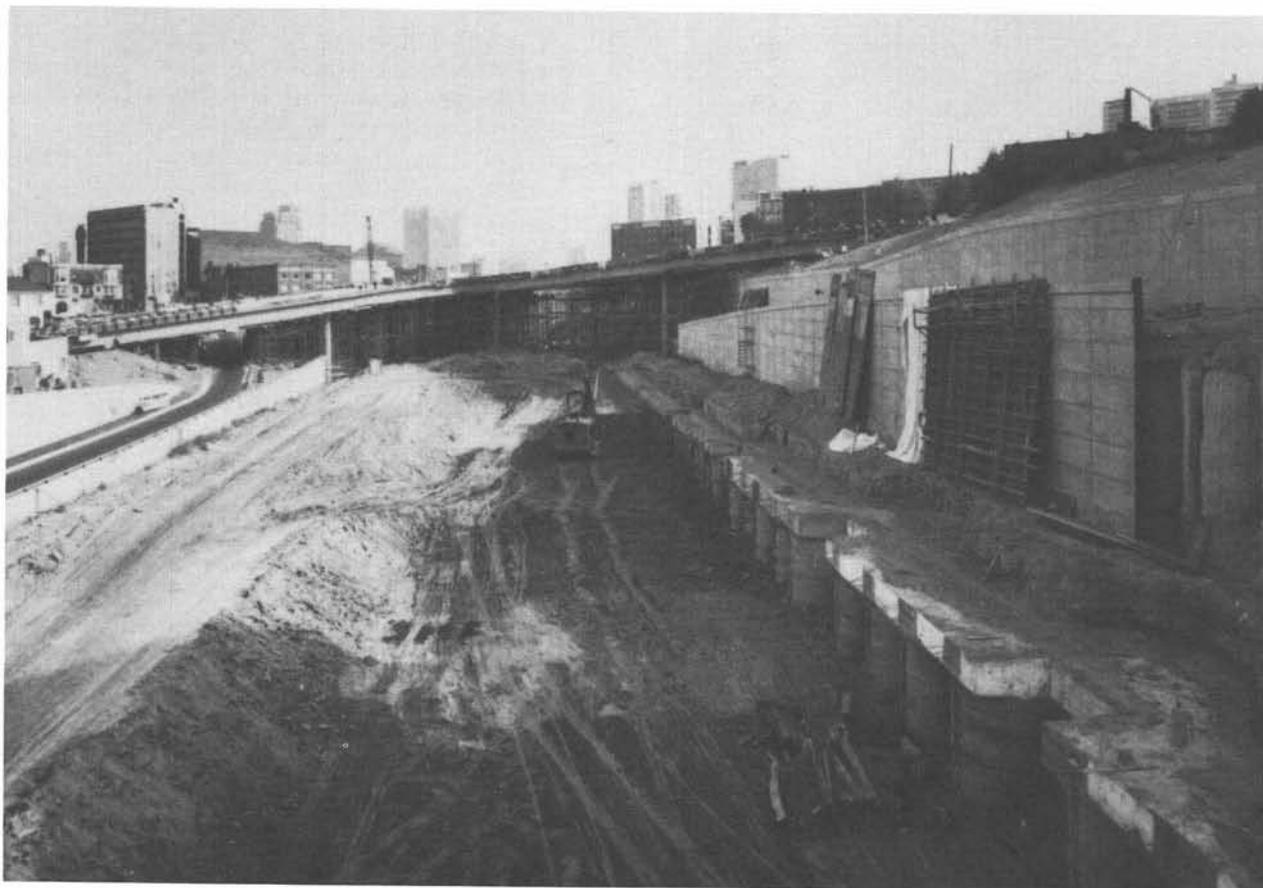
Figure 10. View north along the southbound lanes at the intersection of Boren Street and Pine Street. Two cylinder pile walls (10-ft diameter) were designed to accommodate the reversible lane under the southbound lane.

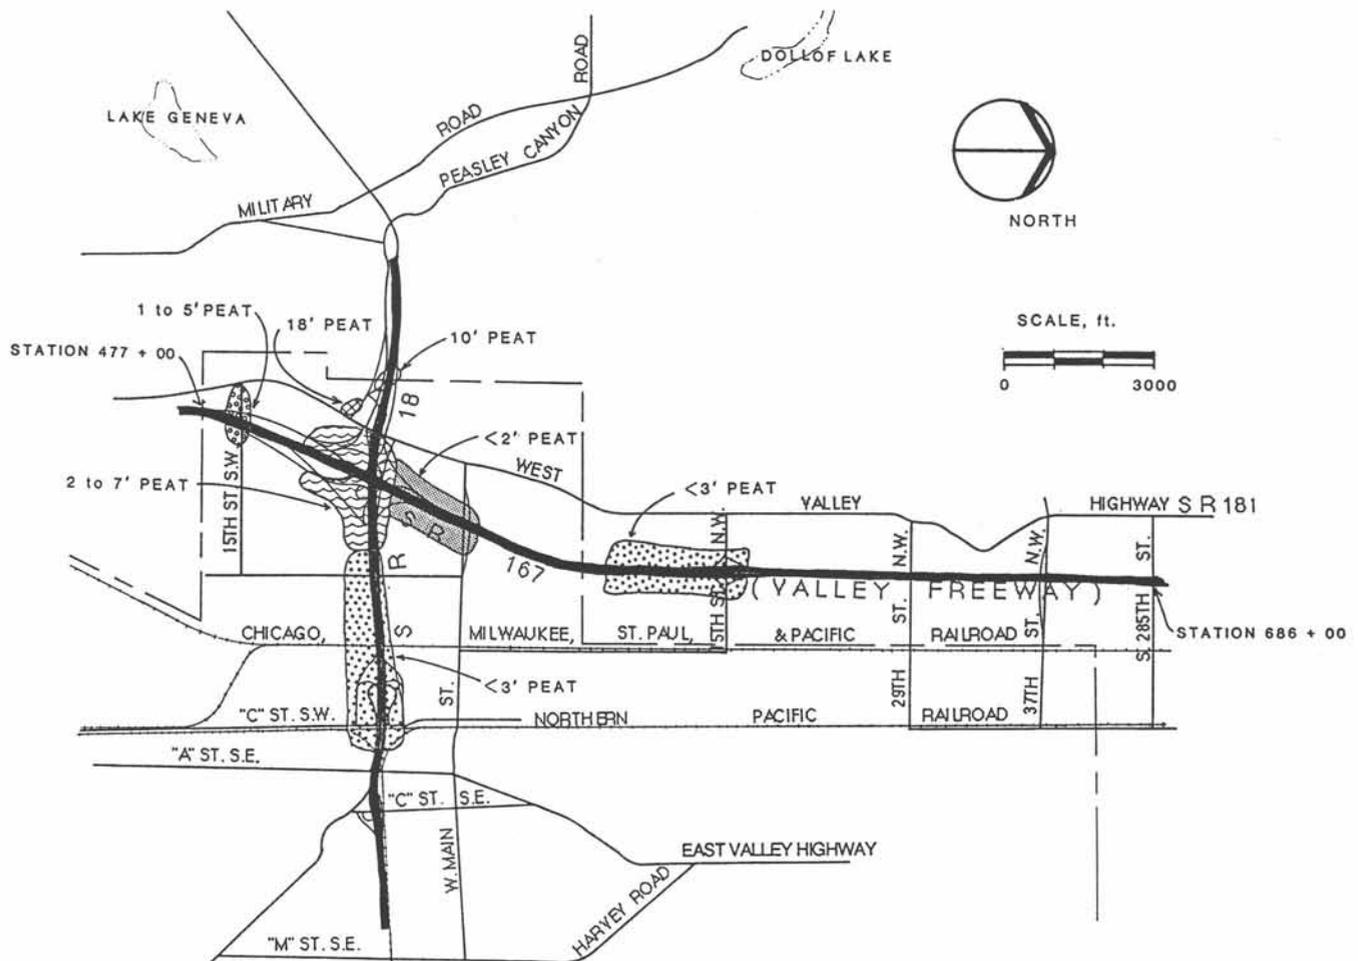
Figure 2. Depth and extent of soft organic soils near the West Auburn Interchange, Station 555+00 to 686+00, Valley Freeway.

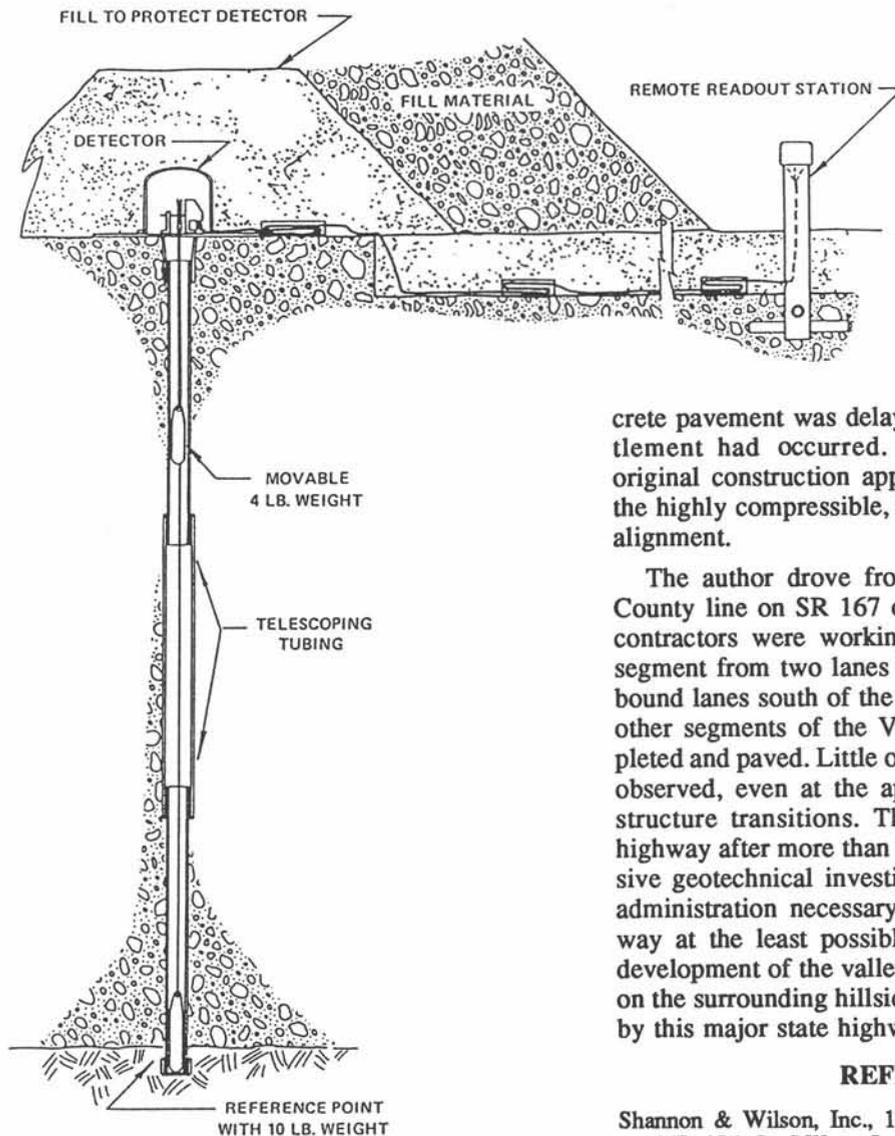
Figure 3. Electrical settlement monitoring instrumentation designed for the Valley Freeway (SR 167) project and installed in bridge approach embankments.

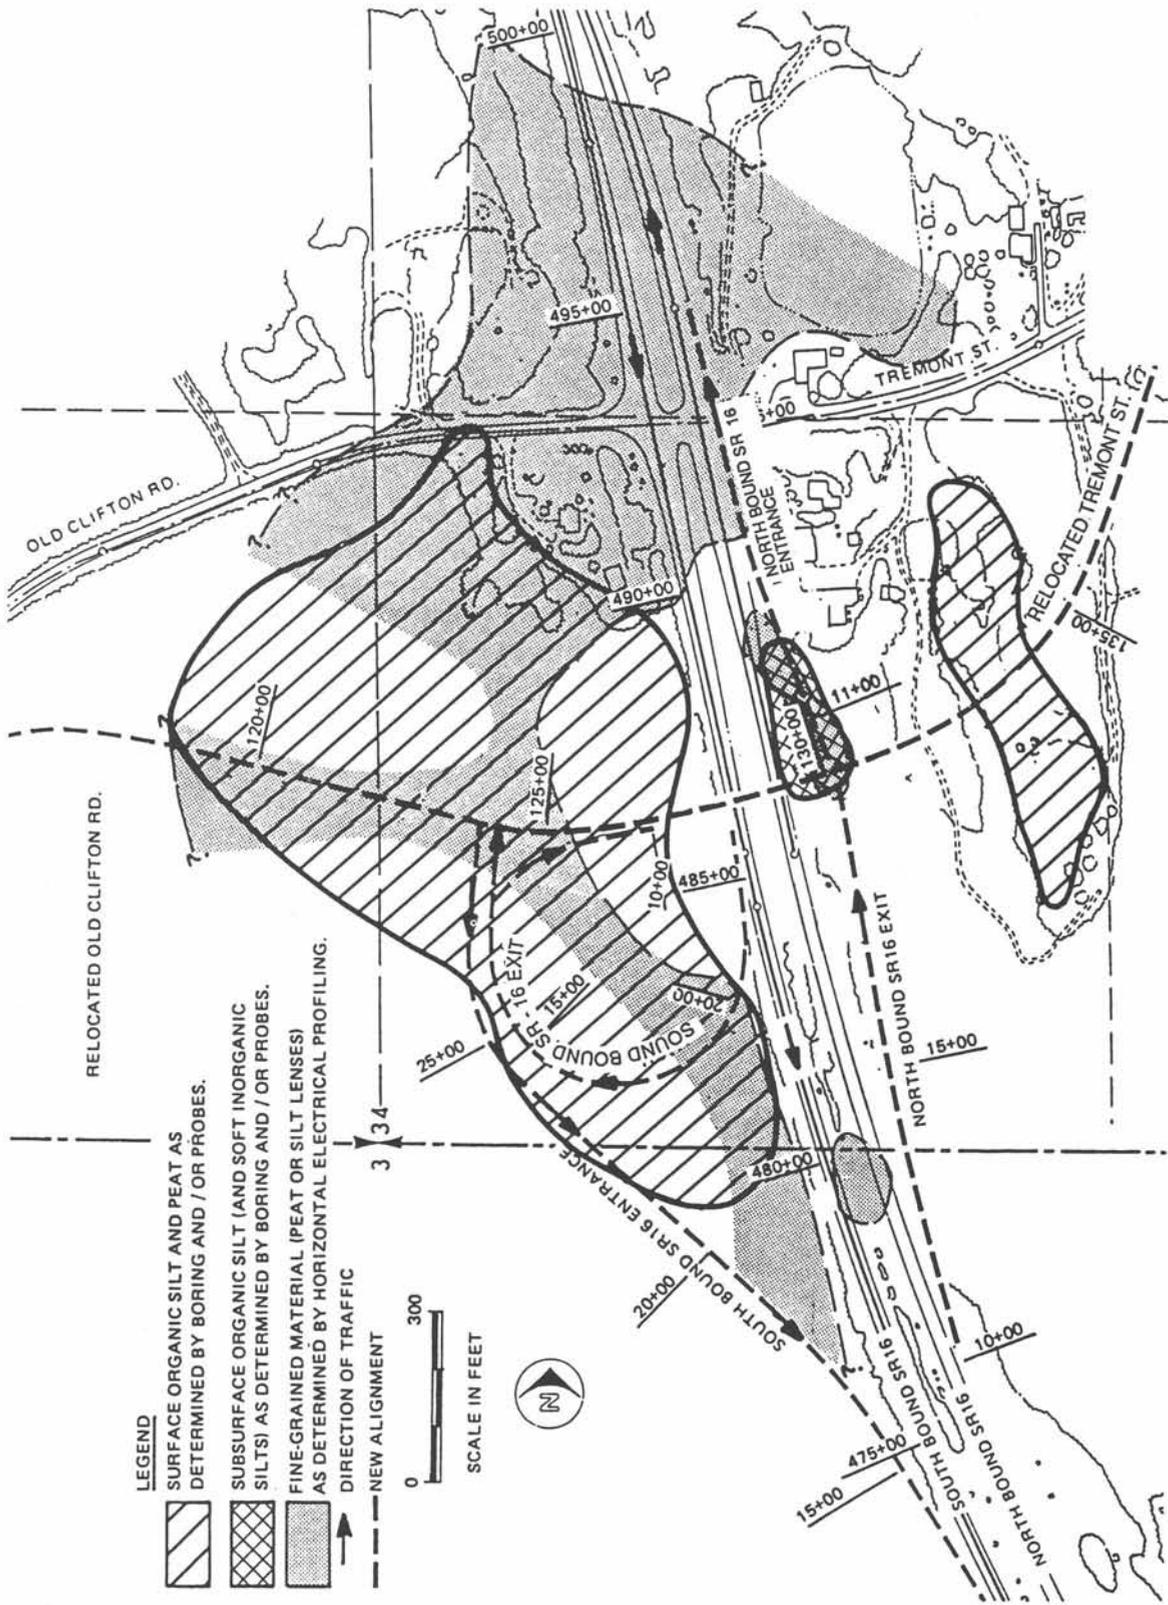
Figure 3. Surface and subsurface peat and silt deposits at interchange.

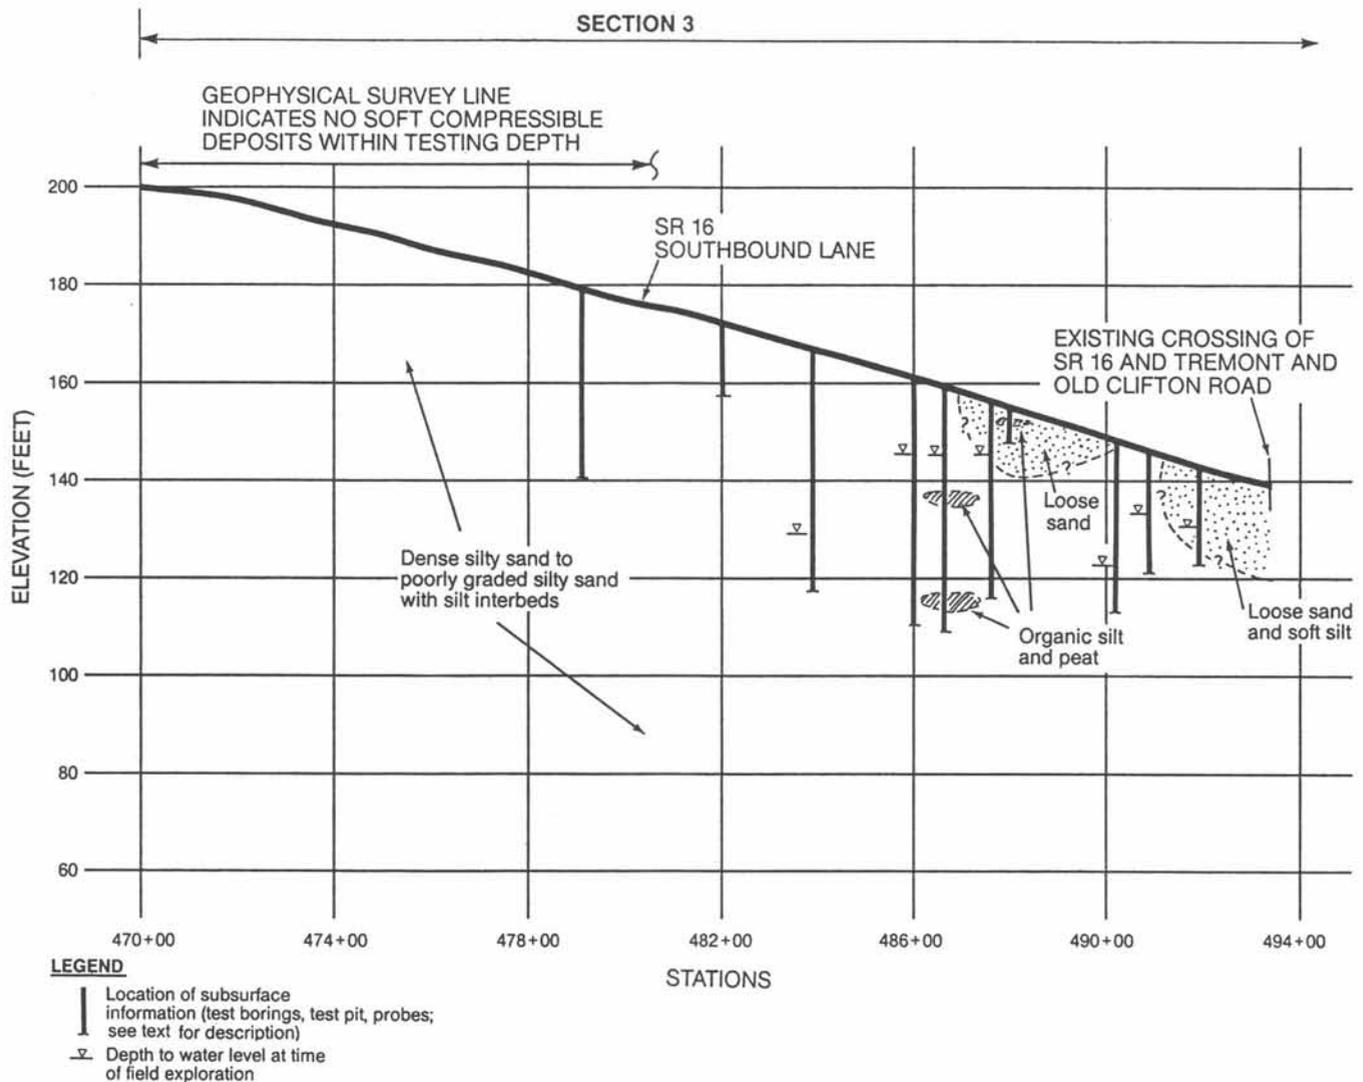
Figure 4B. Subsurface profile along State Route 16, southbound lane.

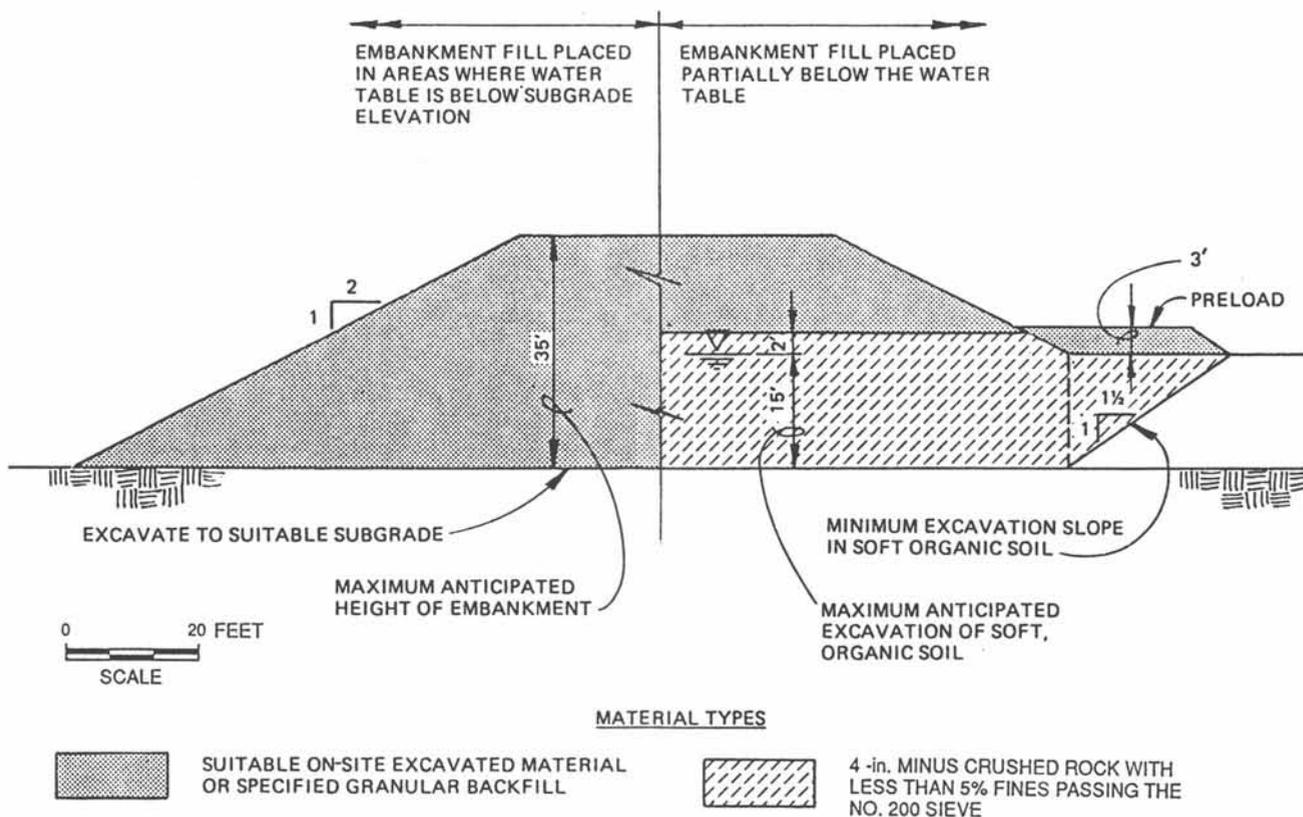
Figure 5. Embankment cross section, Tremont interchange.

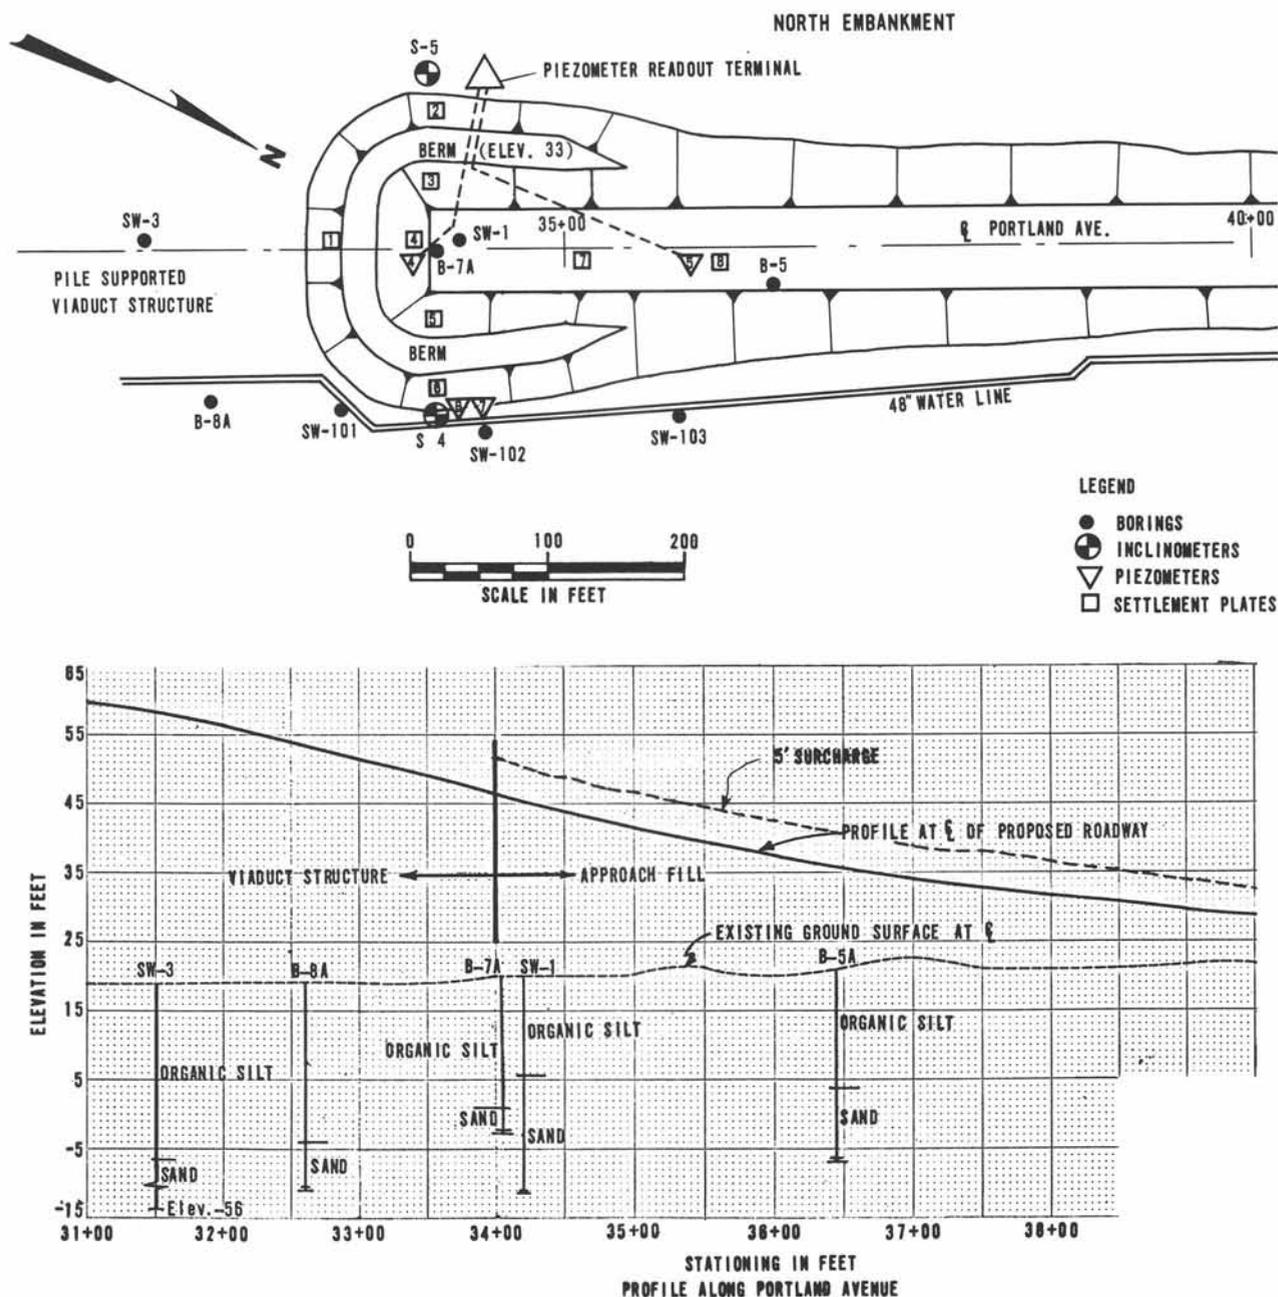
Figure 2. North embankment, plan and profile.

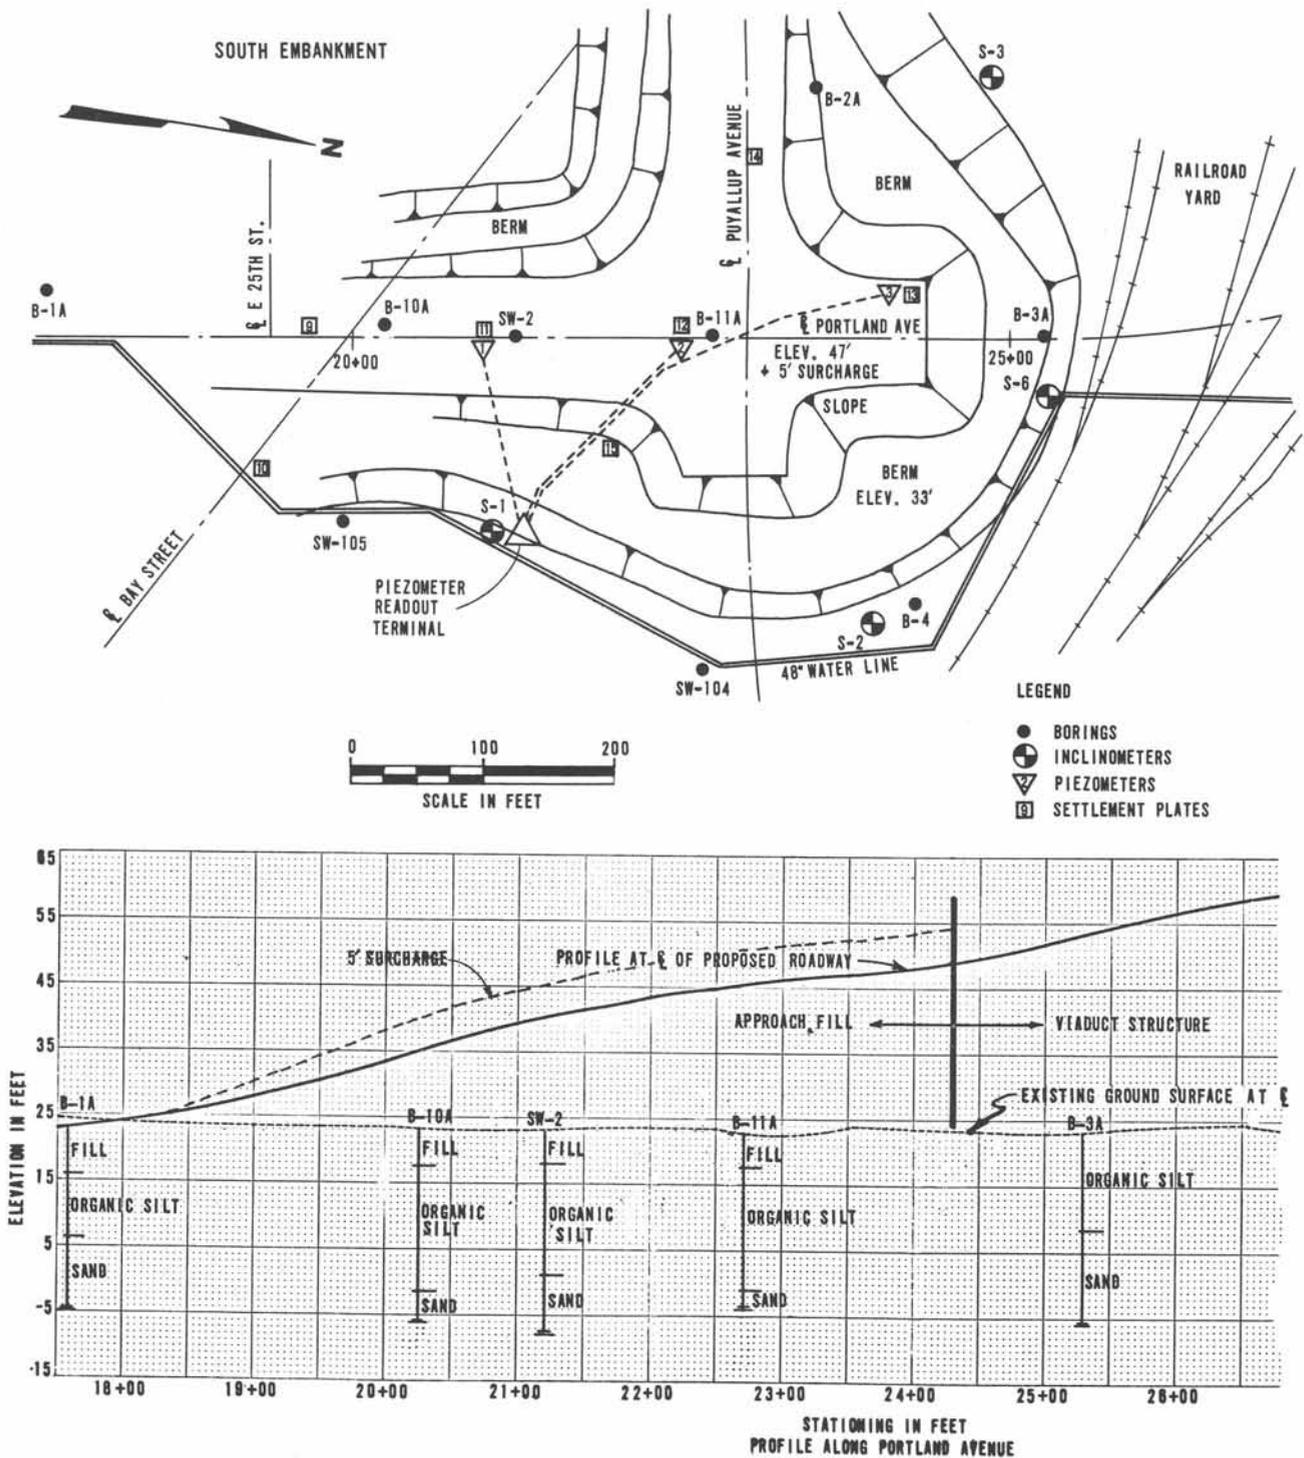
Figure 3. South embankment, plan and profile.

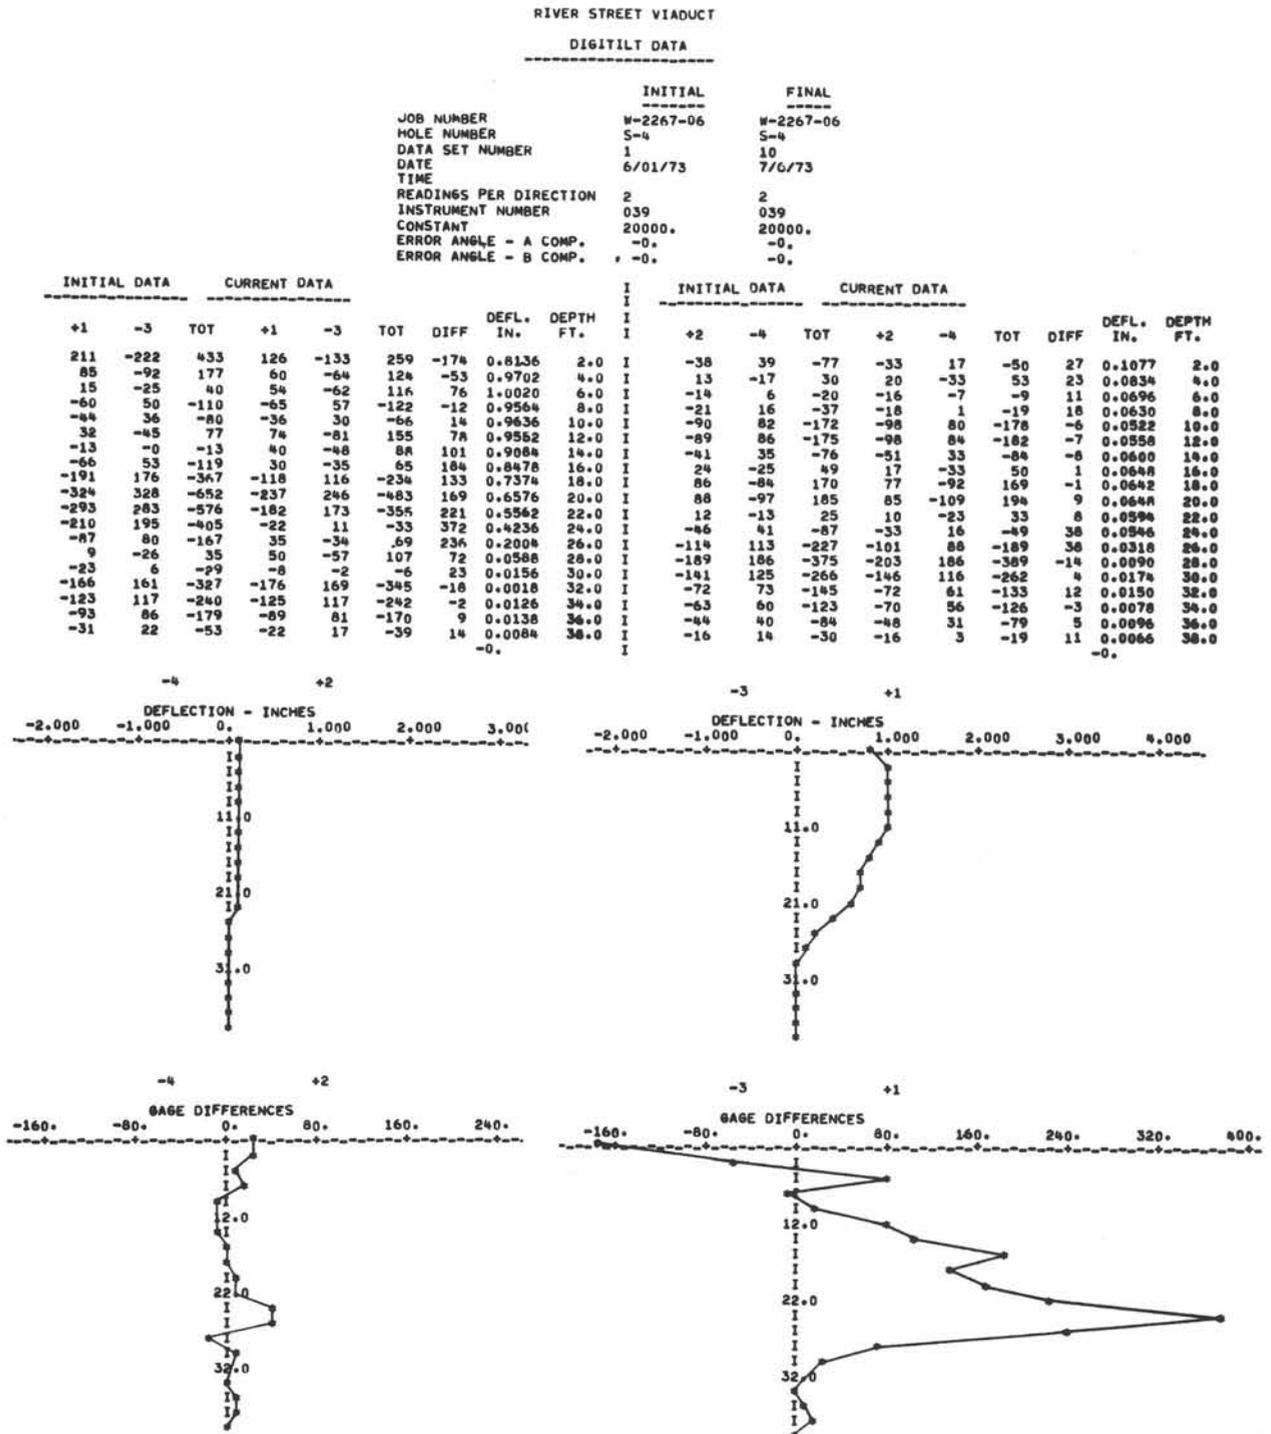
Figure 8. Sample of inclinometer data computer output.
