Seattle Freeway Construction, Interstate Highway 5, 1960-1966

KENNETH A. JOHNSON

Washington State Department of Highways, Retired

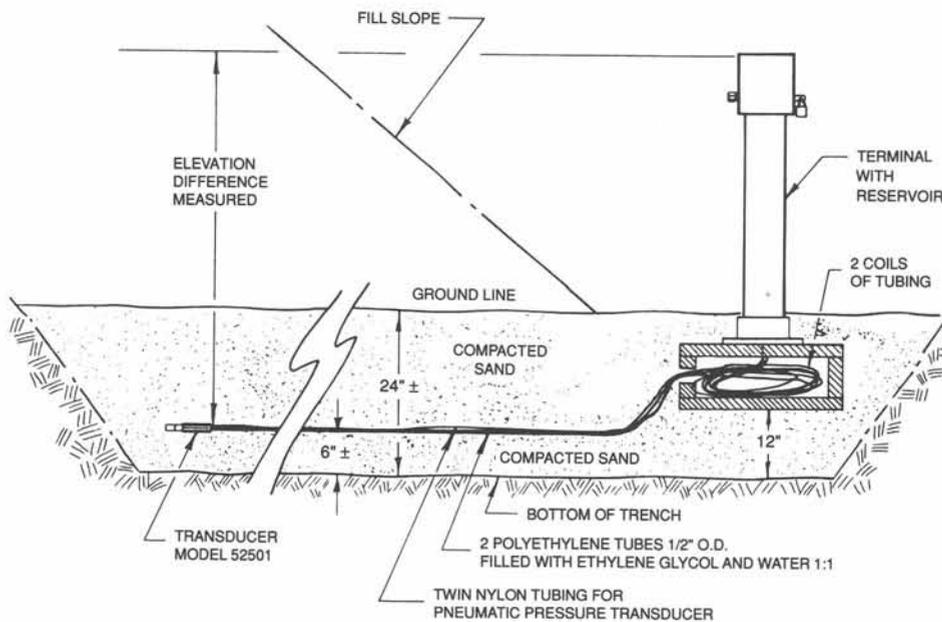
Figure 11. Liquid settlement system with pneumatic sensor.

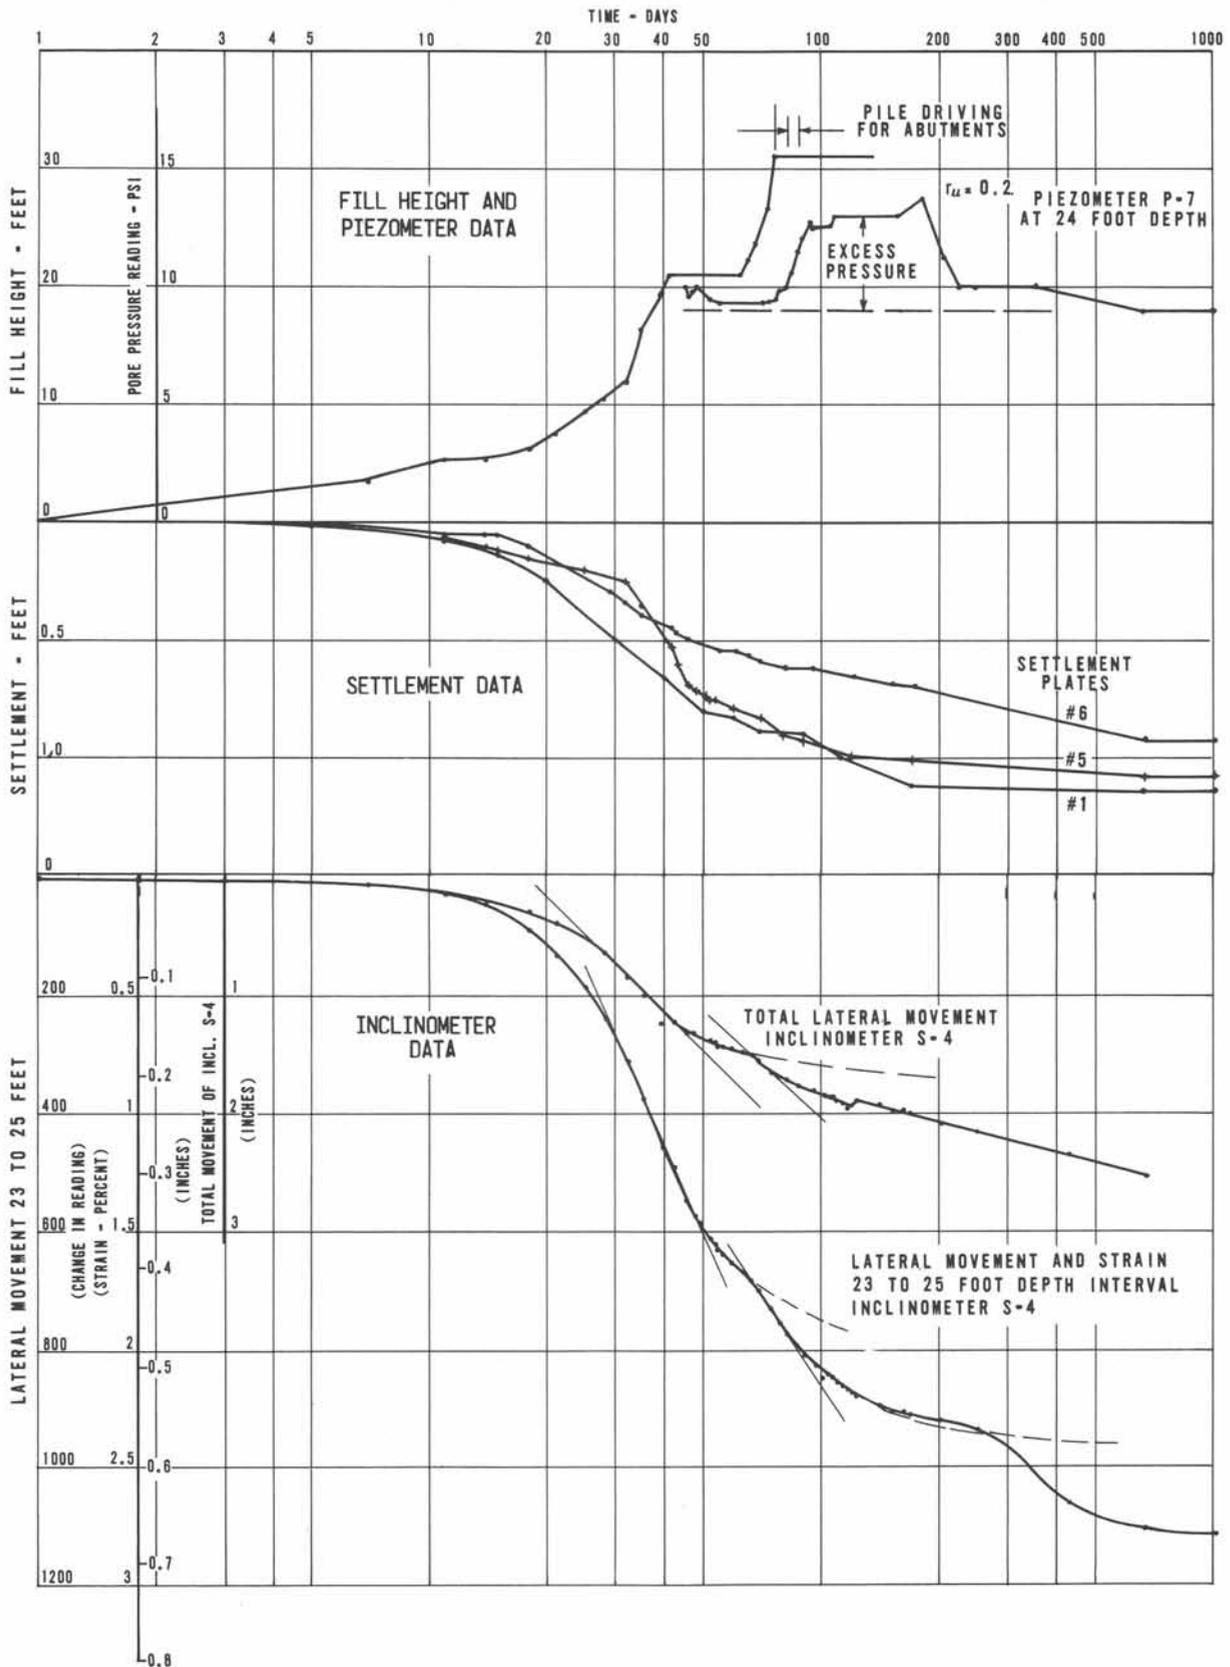
Figure 12. Instrument data, north embankment.

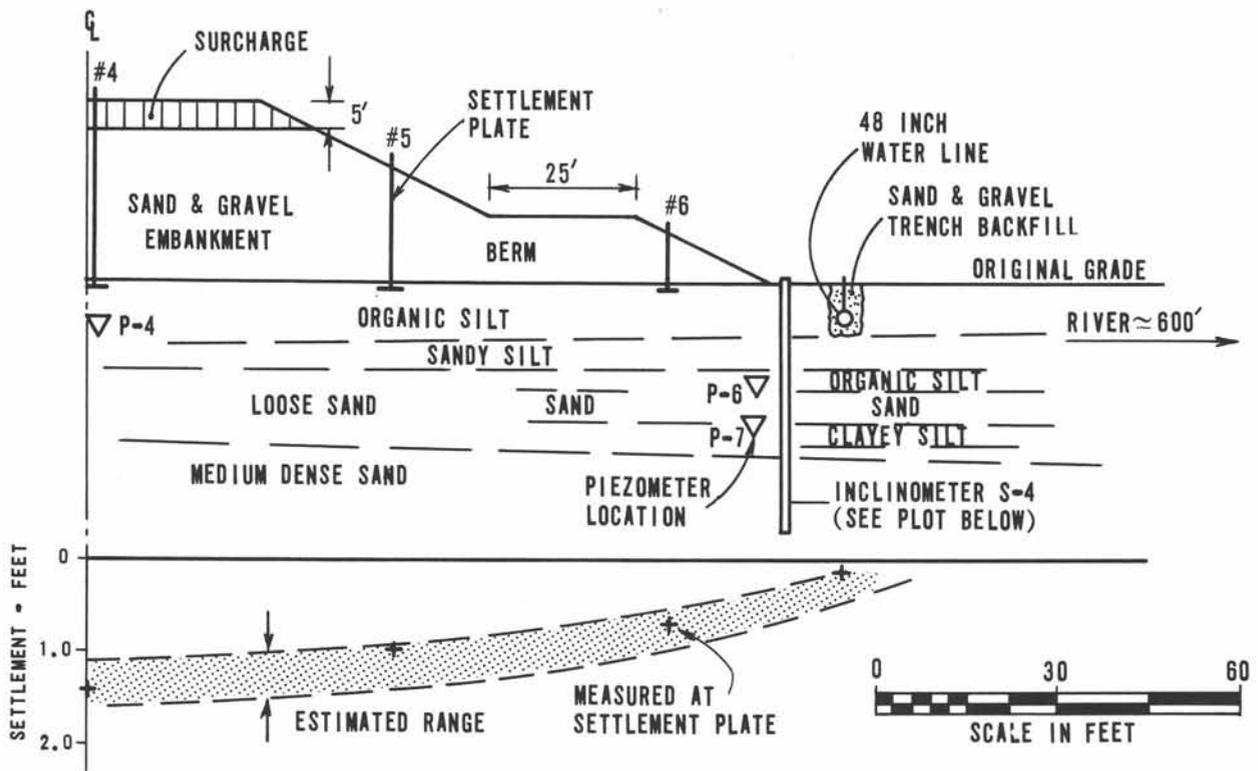
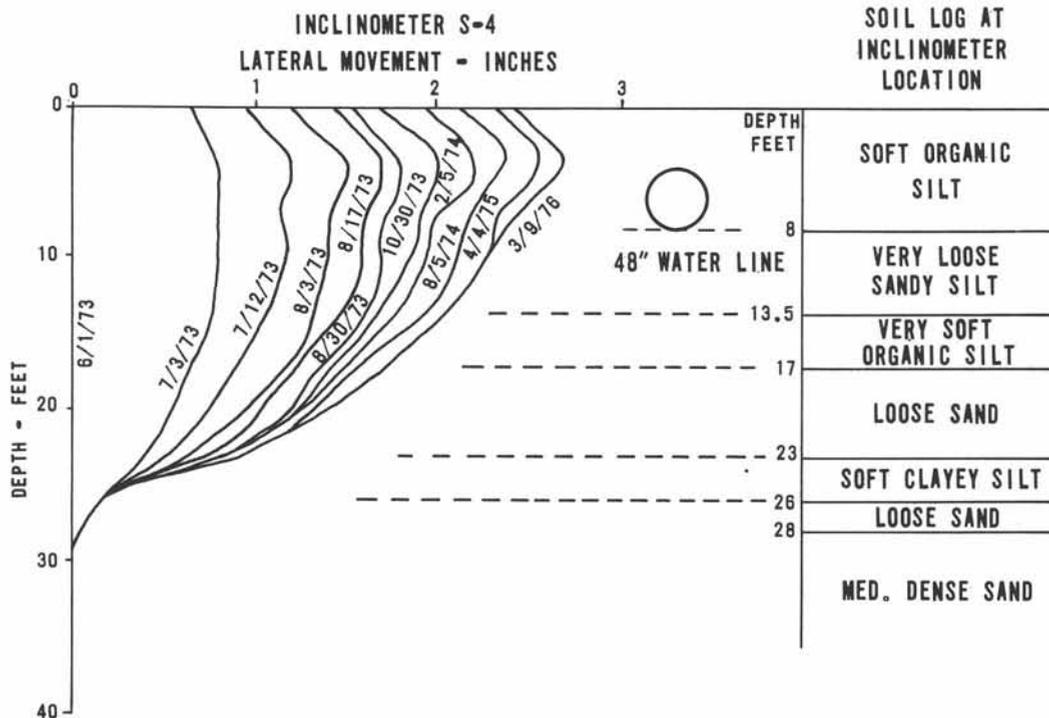
Figure 13. Inclinometer displacement and settlement plate data for the north embankment.

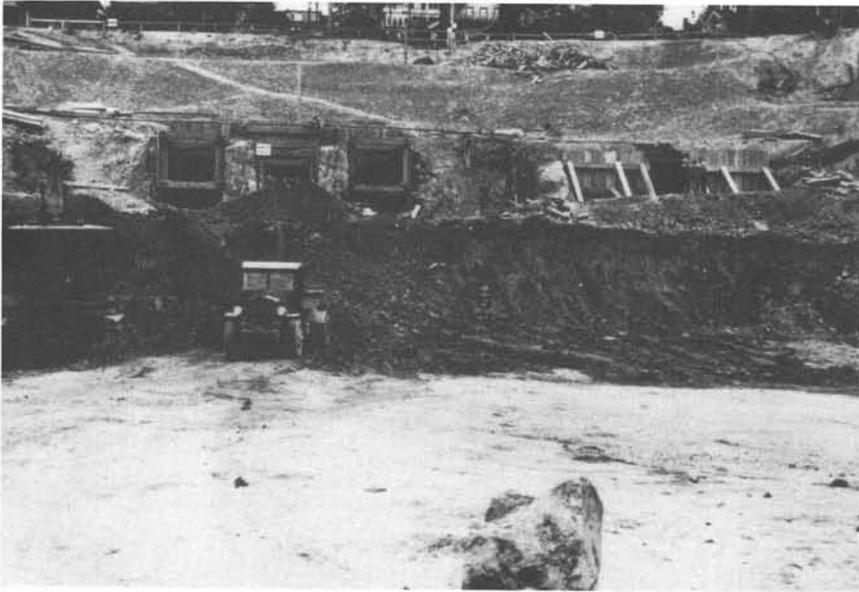
West portal drift excavations for tunnels through Mt. Baker Ridge, Seattle. These two double-lane tunnels were driven by the stacked drift method through glacially overridden hard clay. Note the large glacier-transported boulder in the foreground. 1939 photograph courtesy of Shannon & Wilson, Inc.

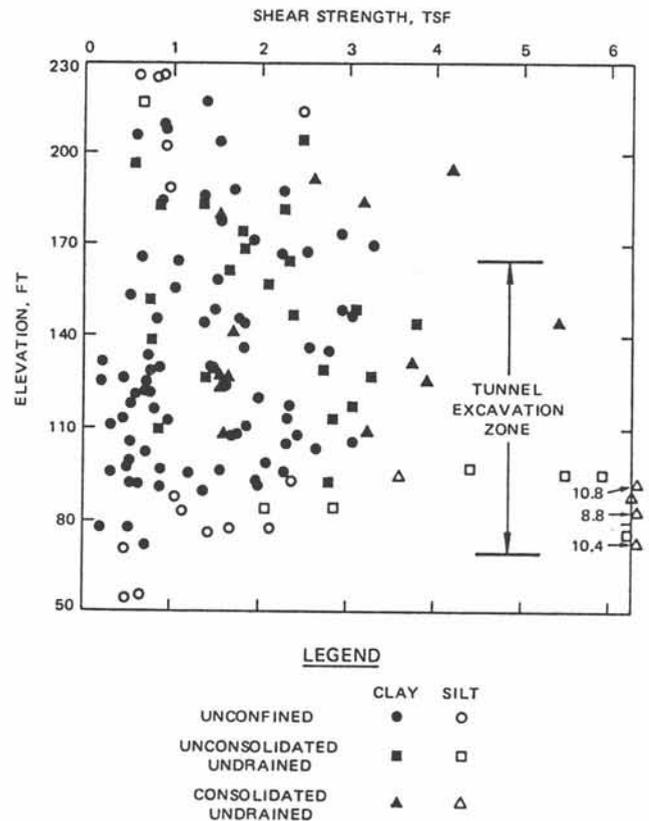
Figure 4. Soil peak shear strength versus elevation in Mt. Baker Ridge.

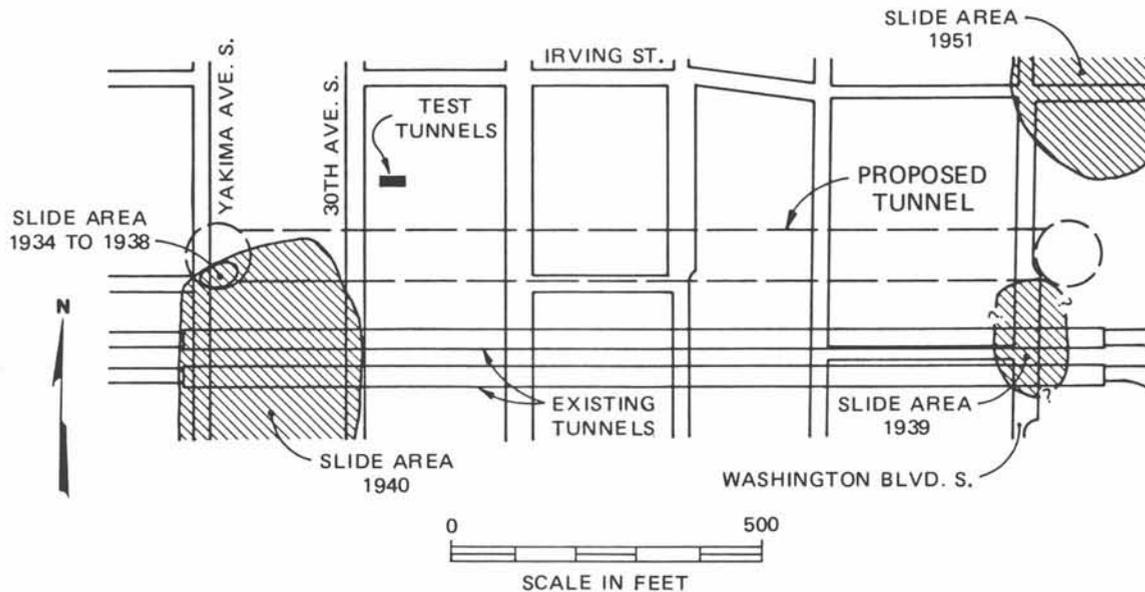
Figure 5. Historic landslide activity in the area of Mt. Baker Ridge Tunnel.

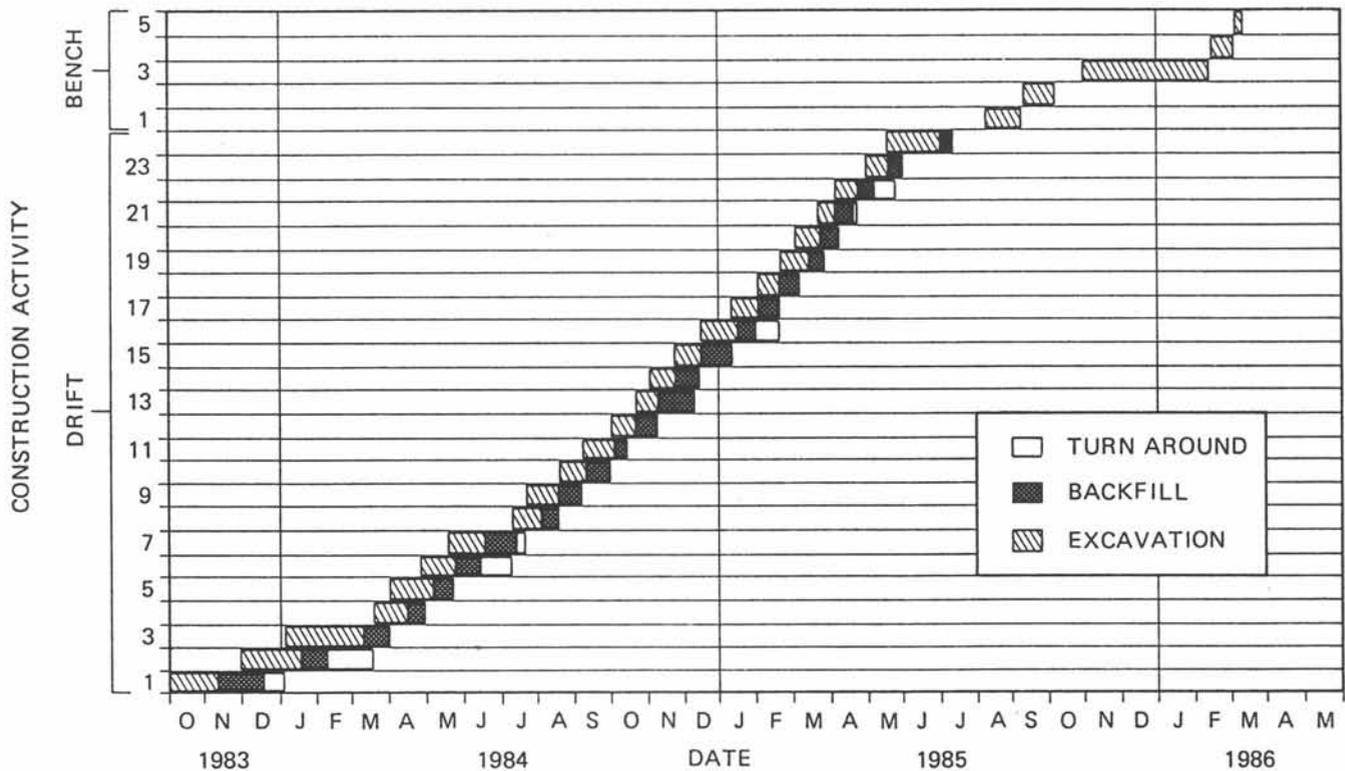
Figure 7. Mt. Baker Ridge Tunnel construction progress.

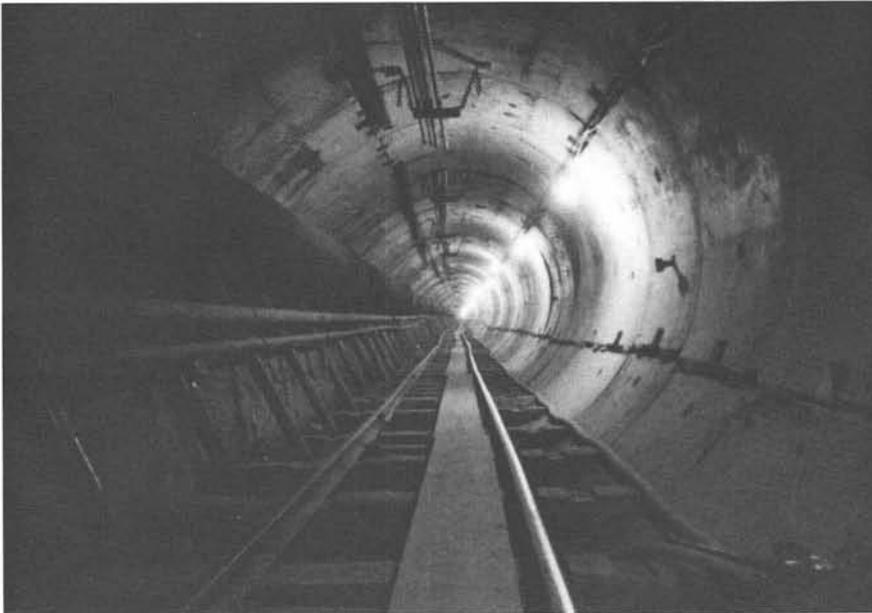
Figure 11. Temporary 5-in.-thick concrete segment lining for drift #3 with exterior of prior drift #1 on the left, wood wedges for liner expansion on the right, and grout lines in the crown.

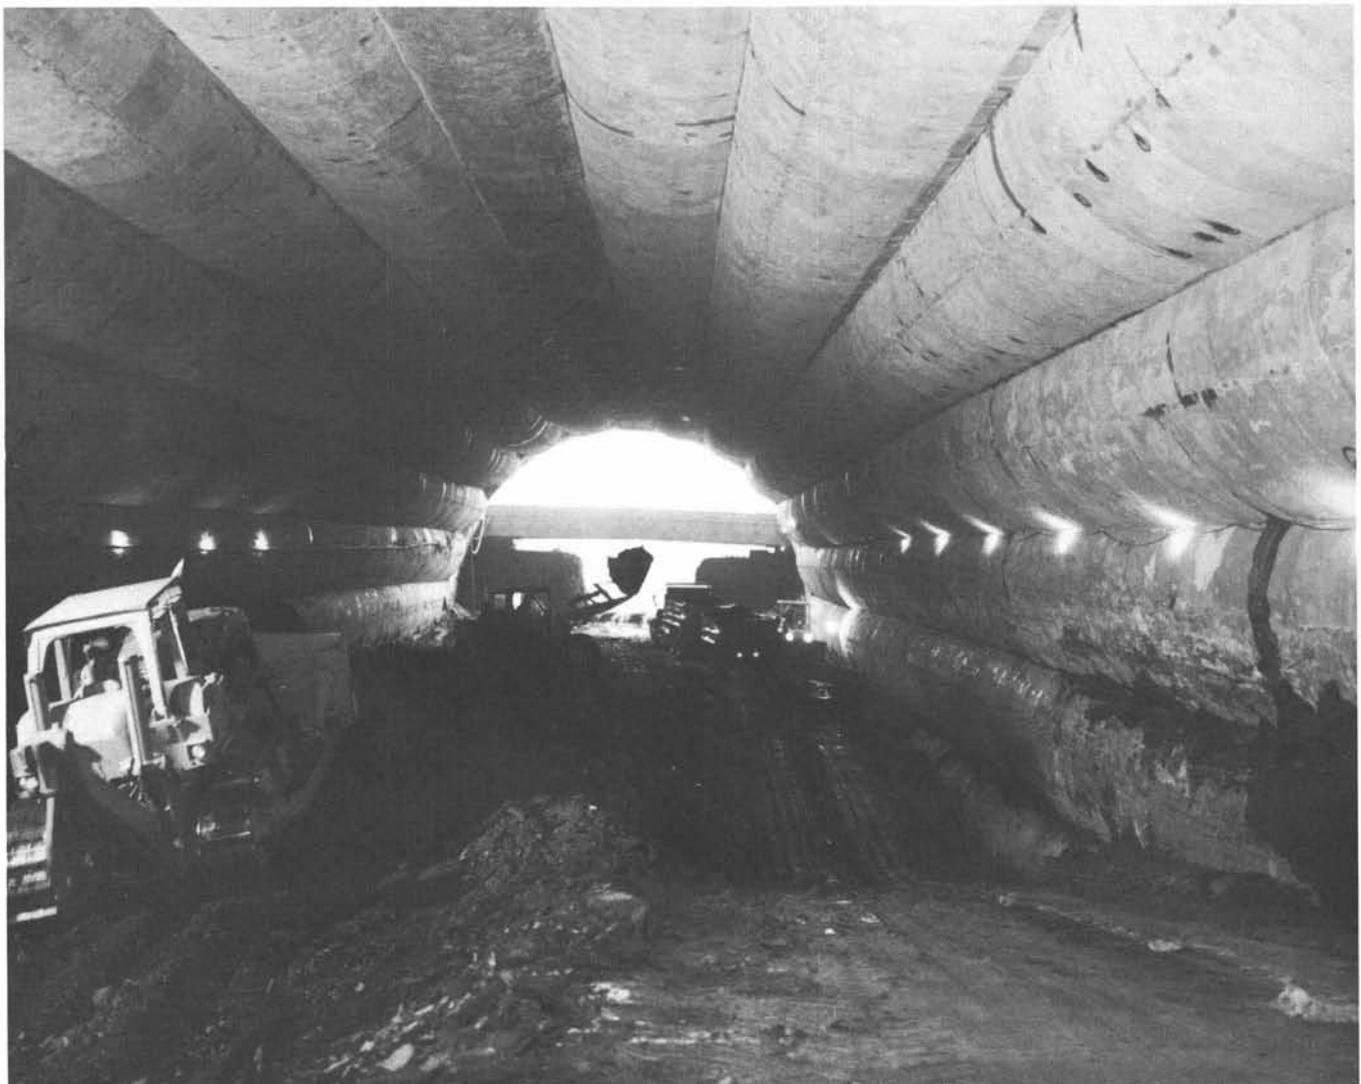
Figure 12. Excavation of bench #3 showing drift exterior and east access pit with upper level bracing.

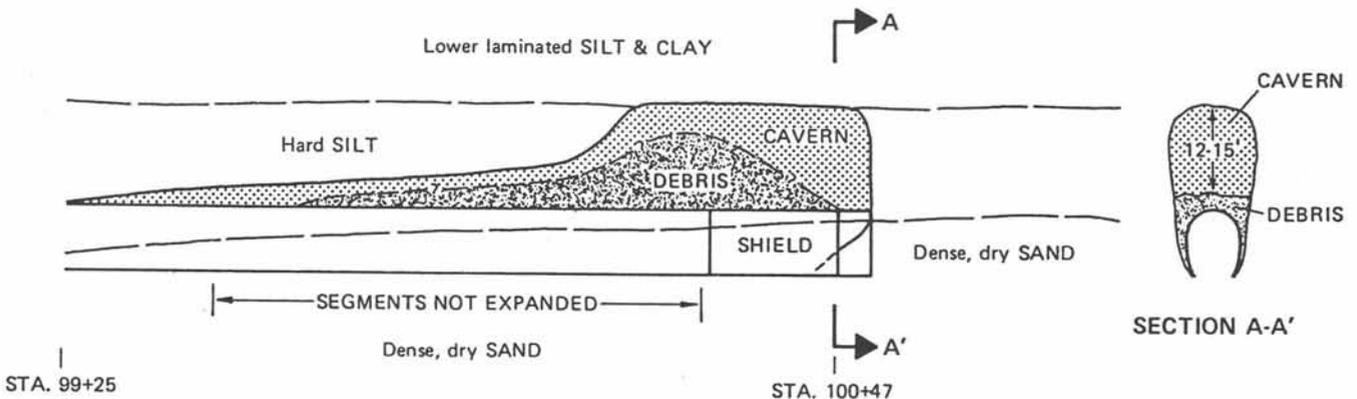
Figure 13. Large overbreak cavern in drift #1 that became progressively larger from Station 99+25 to Station 100+47, where the shield was halted.

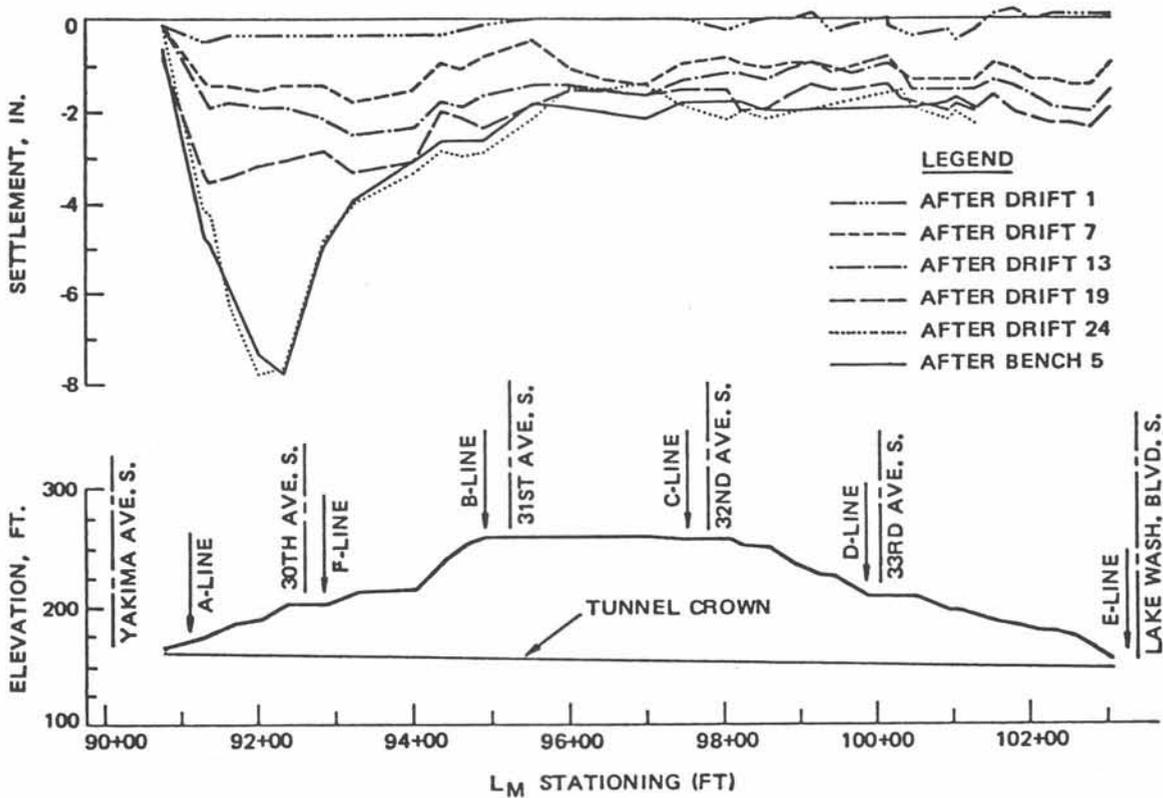
Figure 14. Plot of longitudinal surface settlements along the Mt. Baker Ridge Tunnel centerline.

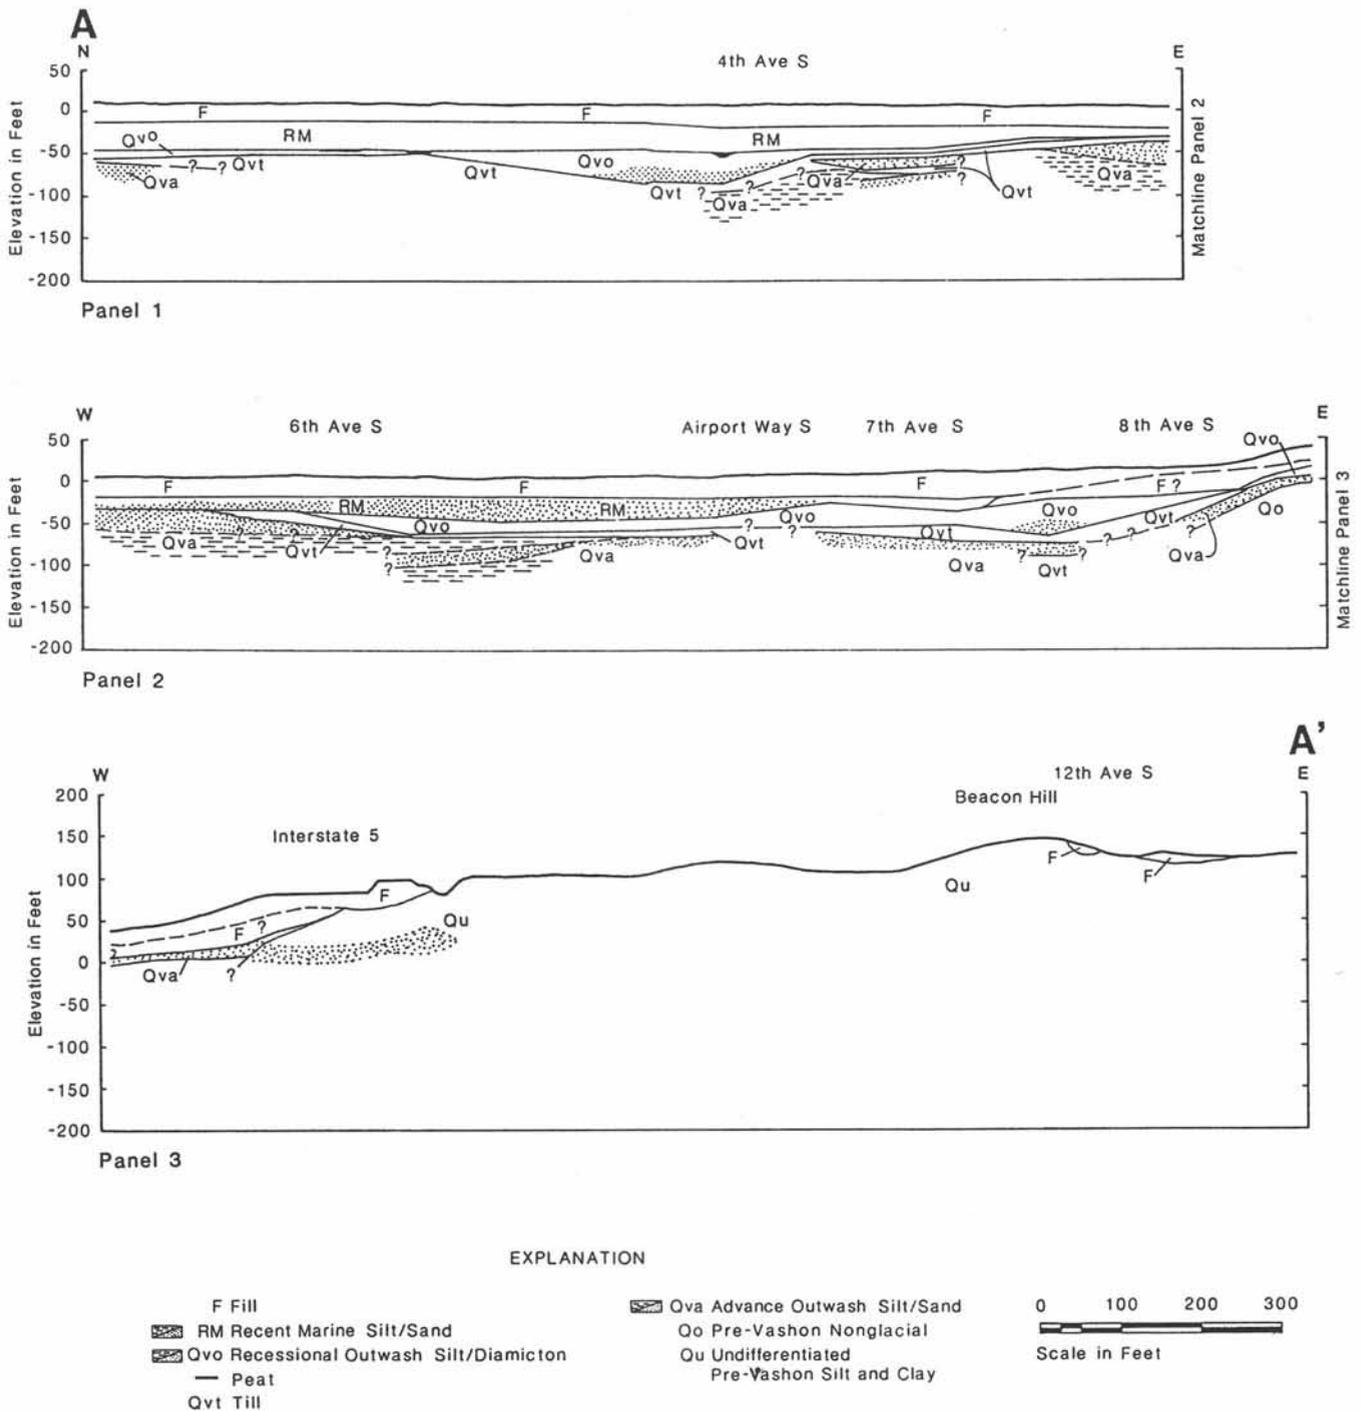
Figure 5. Geologic cross-section along the Seattle Access portion of Interstate Highway 90.

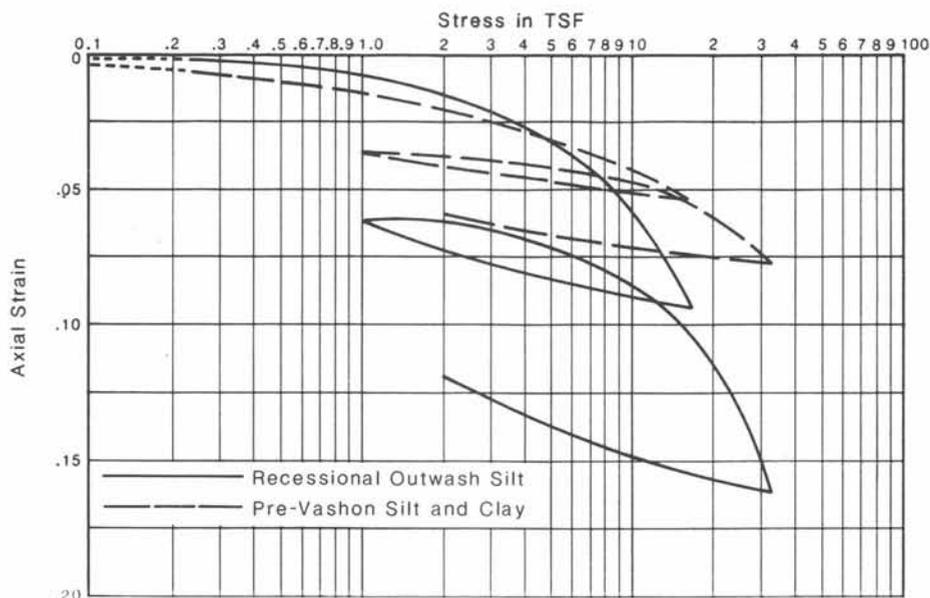
Figure 6. Comparison of consolidation test results for the recessional silt and pre-Vashon silt and clay.

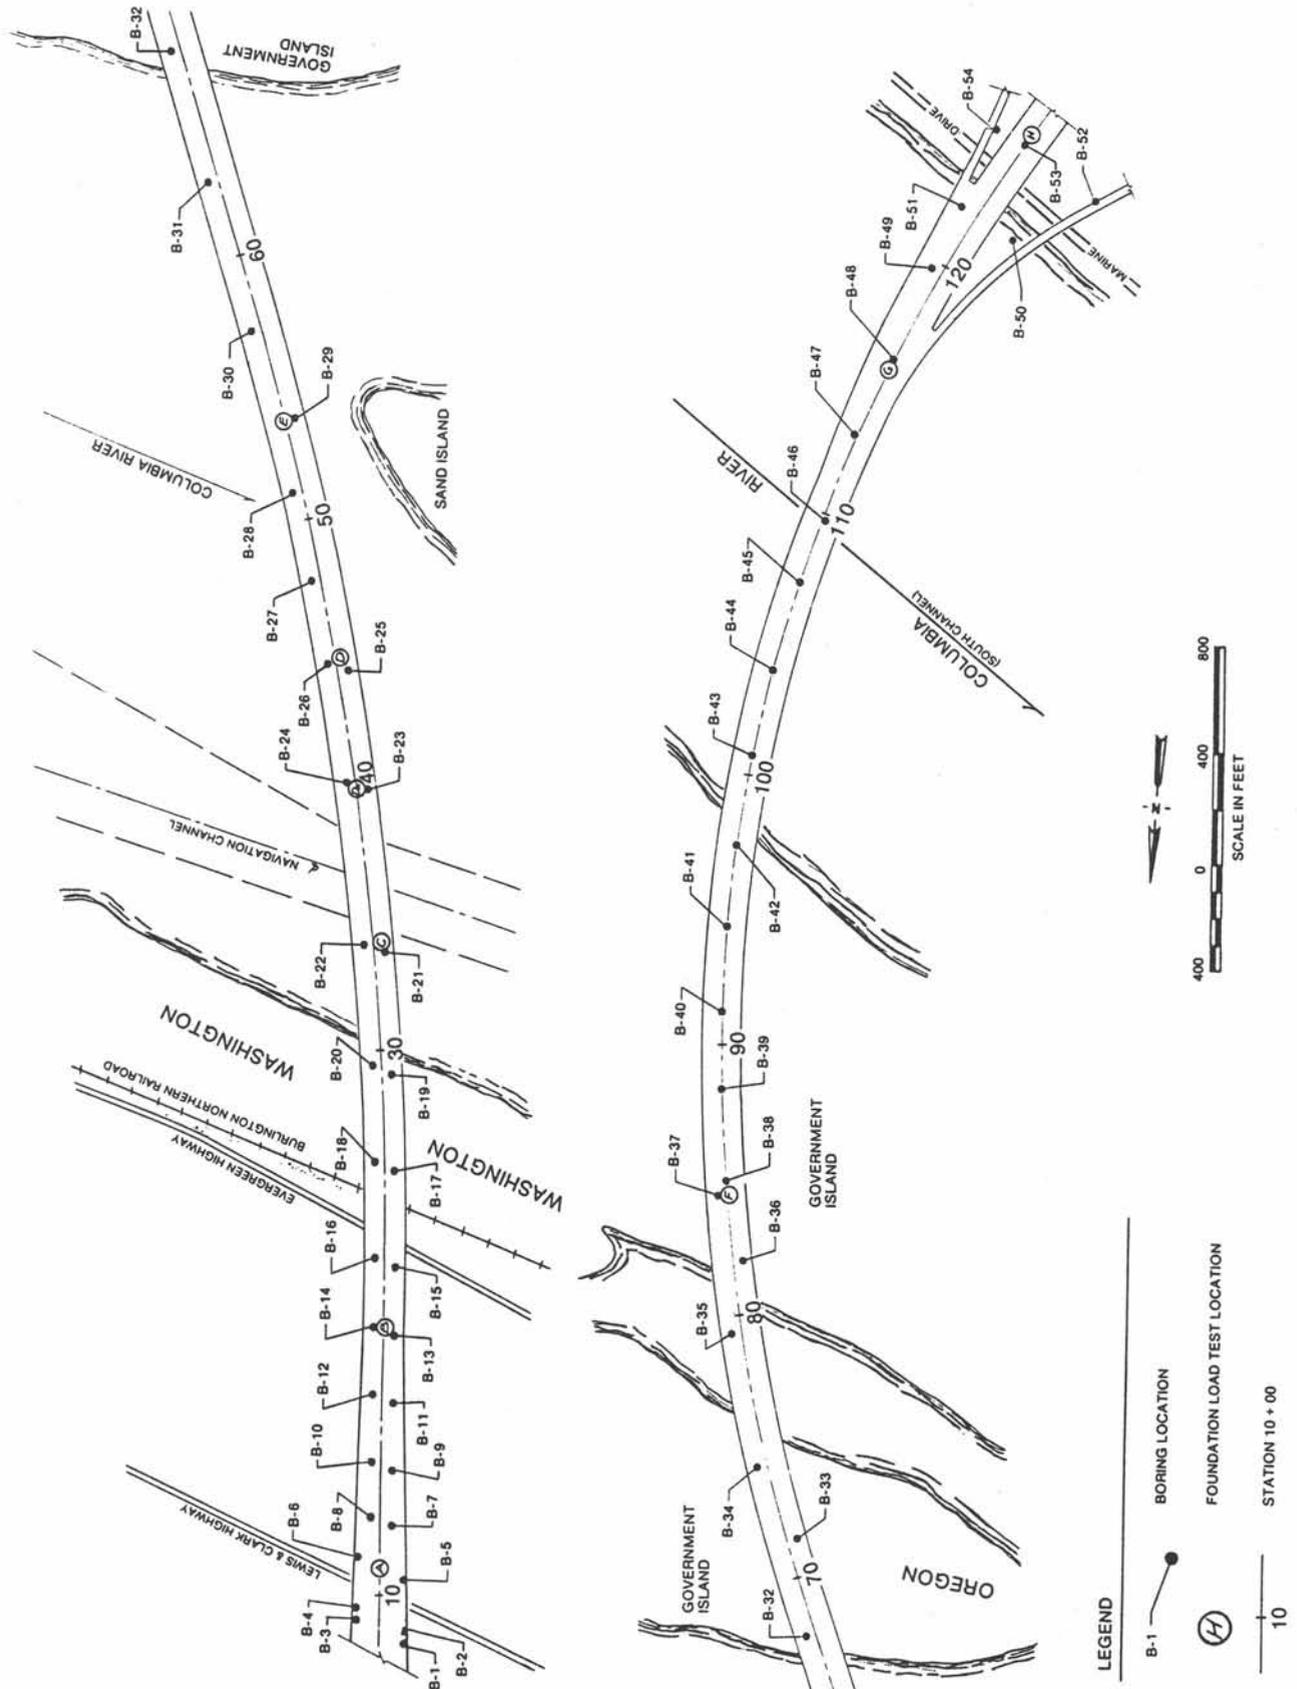
Figure 3. Site plan and boring and load test locations, Glenn Jackson Bridge.

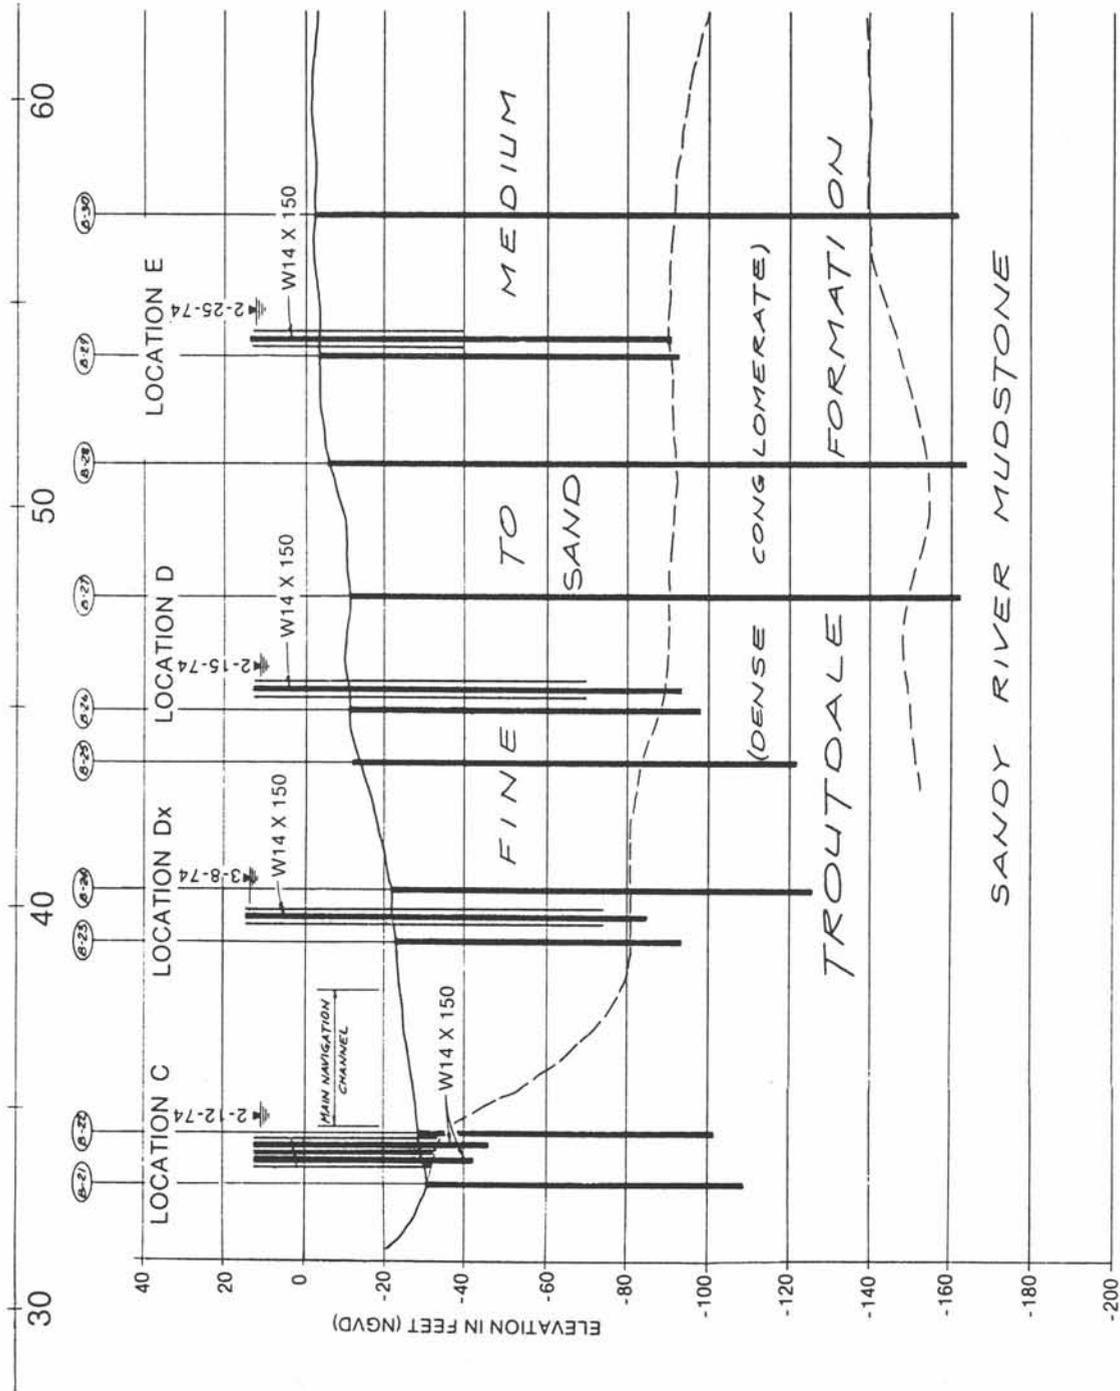
Figure 4. (continued) Subsurface profile, main Columbia River channel. See Figure 3 for station locations and the first page of this figure for explanation of symbols.

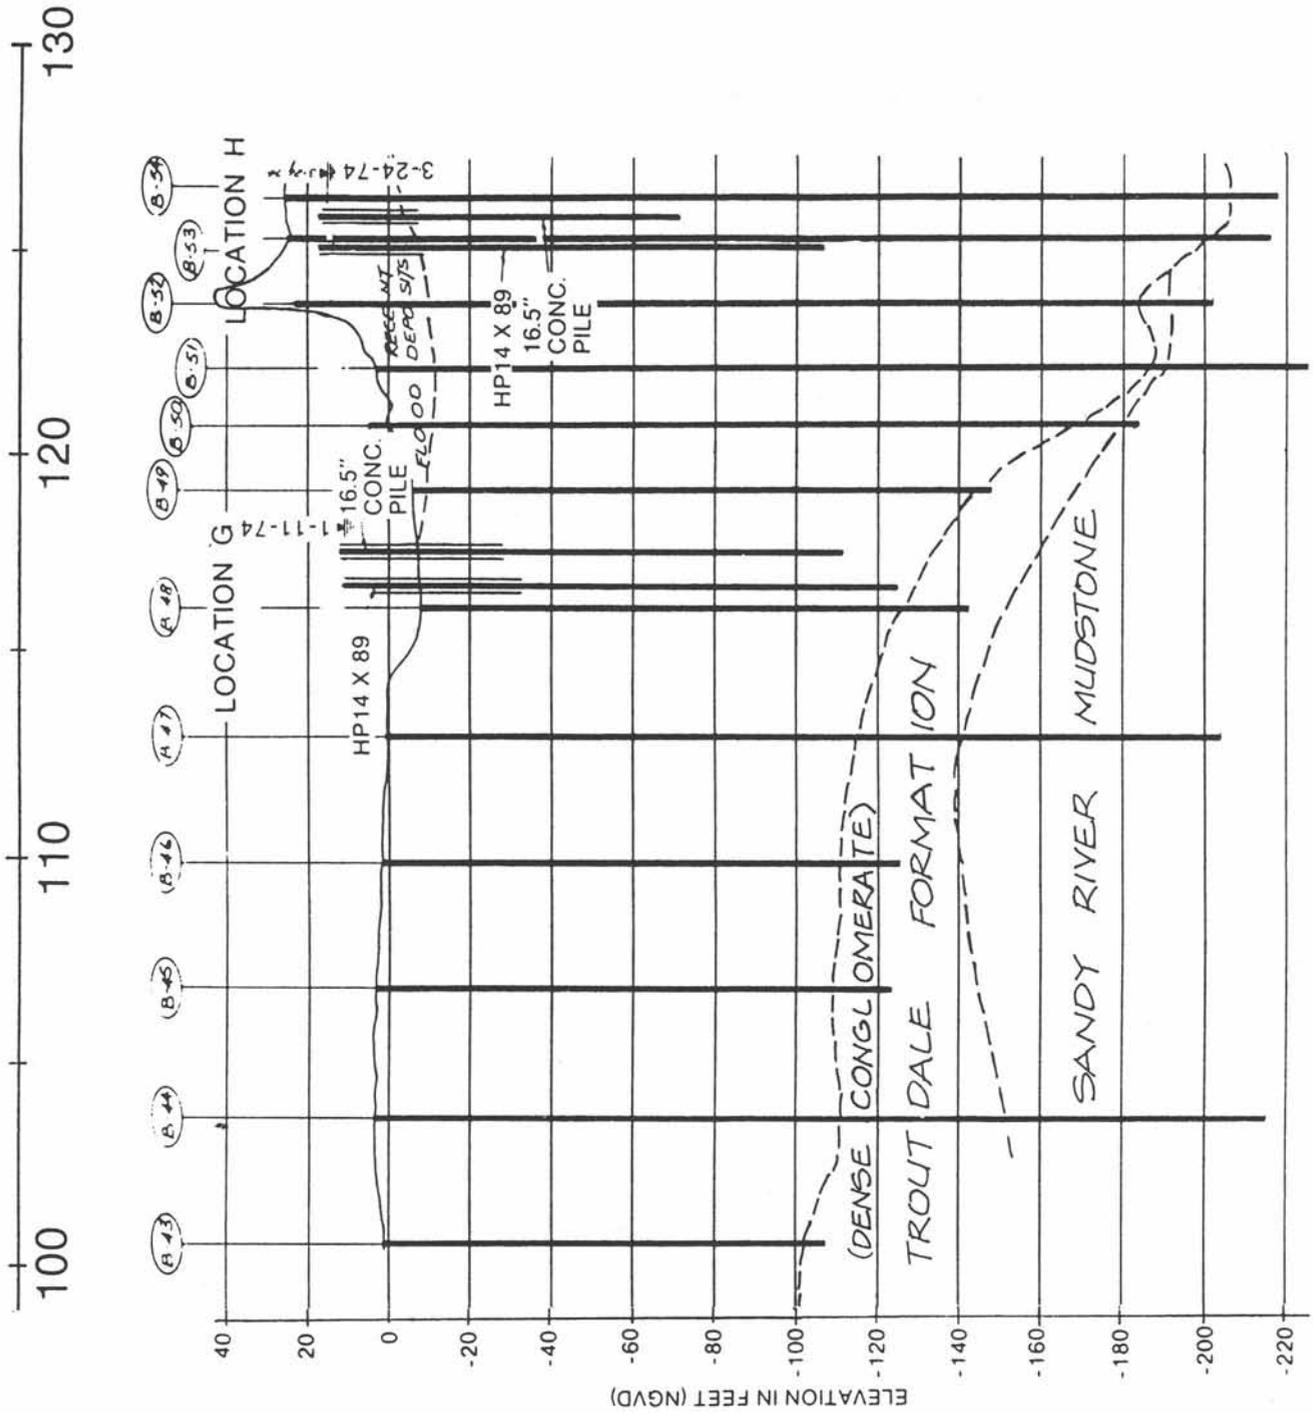
Figure 4. (continued) Subsurface profile, Government Island and South Channel. See Figure 3 for station locations and the first page of this figure for explanation of symbols.

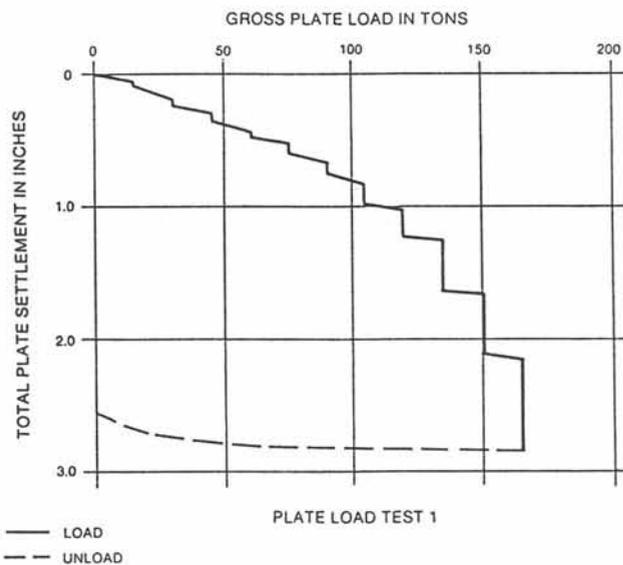
Figure 5. Pile load test at location A on Figure 4, north end of the Glenn Jackson Bridge.

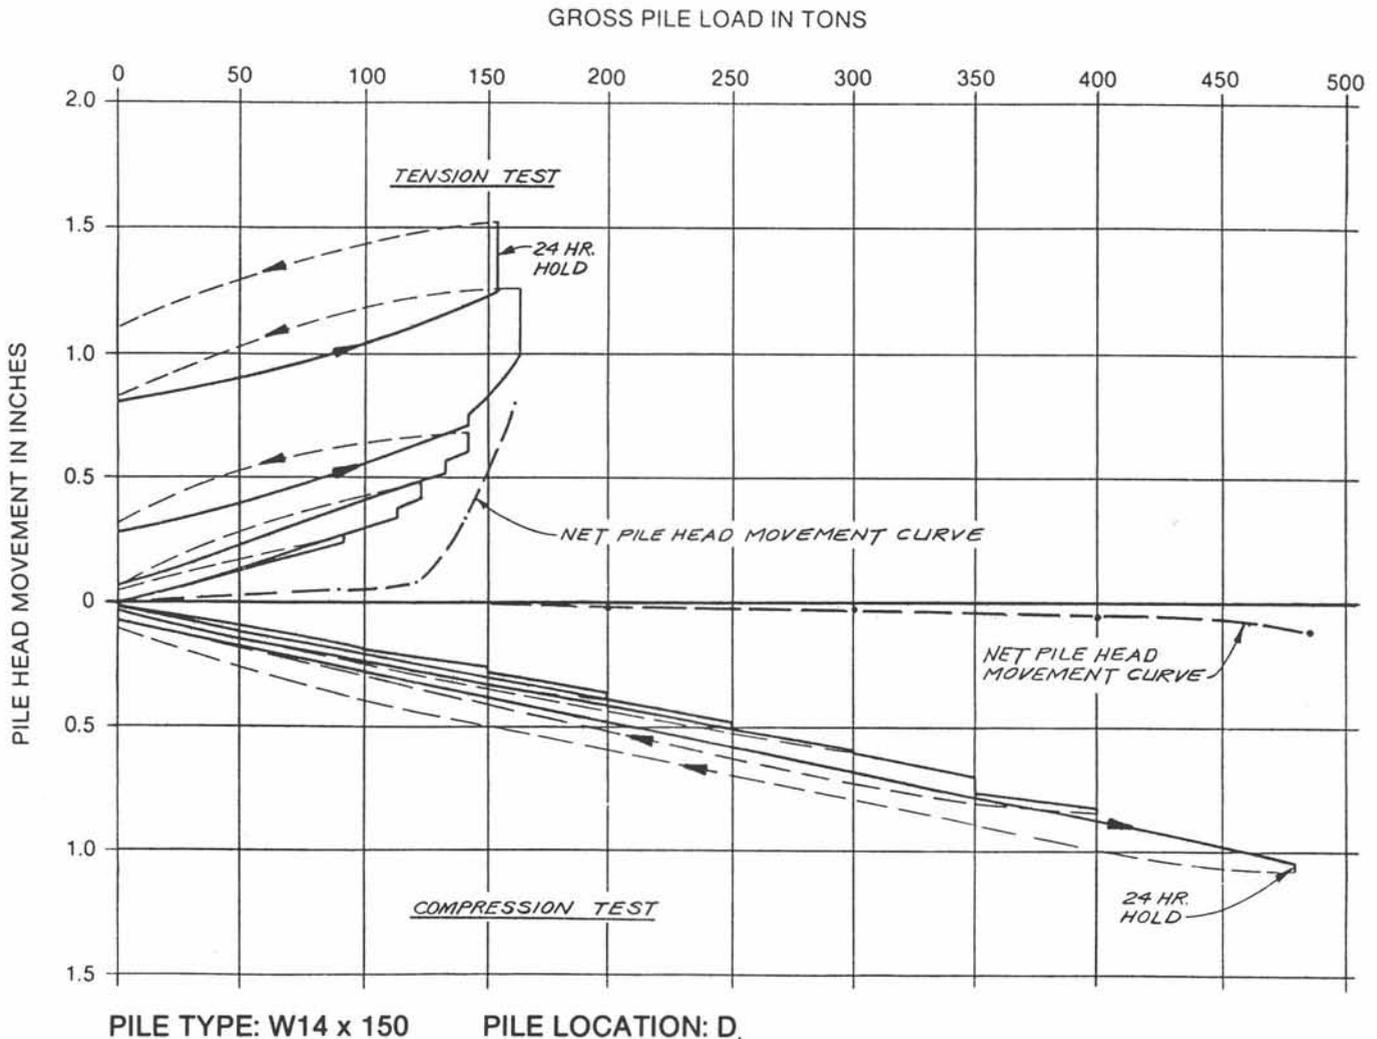
Figure 6. Pile head movement versus load at location D, south of the main navigation channel, Columbia River. (See Figure 4 for location.)

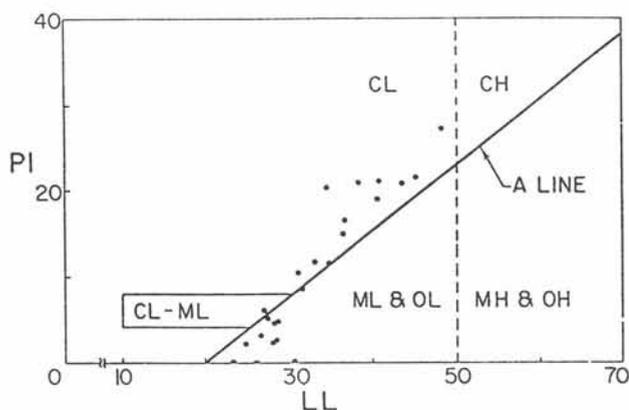
Figure 11. Plot of plastic index (PI) vs. liquid limit (LL) for southeastern Washington loess.

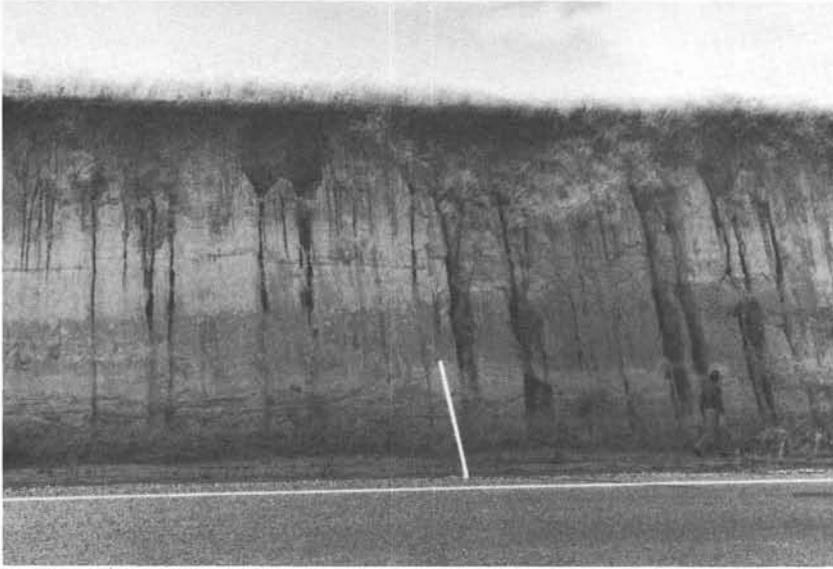
Figure 14. Erosion pipes developing into gullies on a 30-ft-high cut along U.S. Highway 12 near Walla Walla.

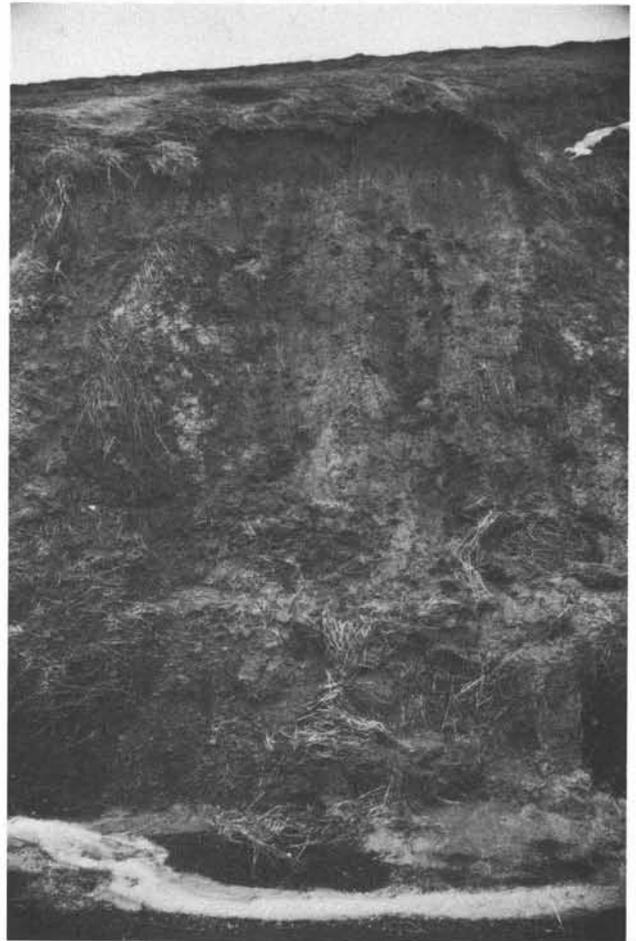
Figure 16. Small flow of soil and vegetation in a 15-ft-high cut slope along U.S. Highway 195 near Pullman.

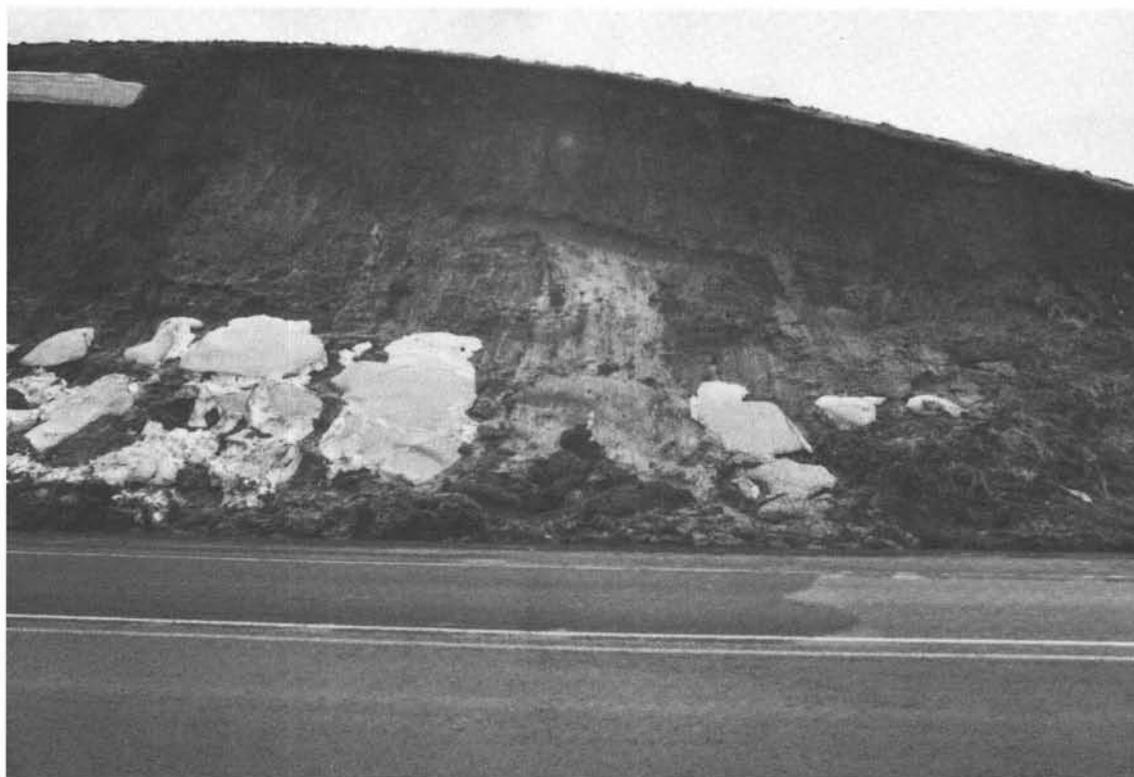
Figure 17. Failure of cut slope in clayey loess near Pullman. White areas are snow. Cut is about 30 ft high.
