Seattle Freeway Construction, Interstate Highway 5, 1960-1966

KENNETH A. JOHNSON

Washington State Department of Highways, Retired

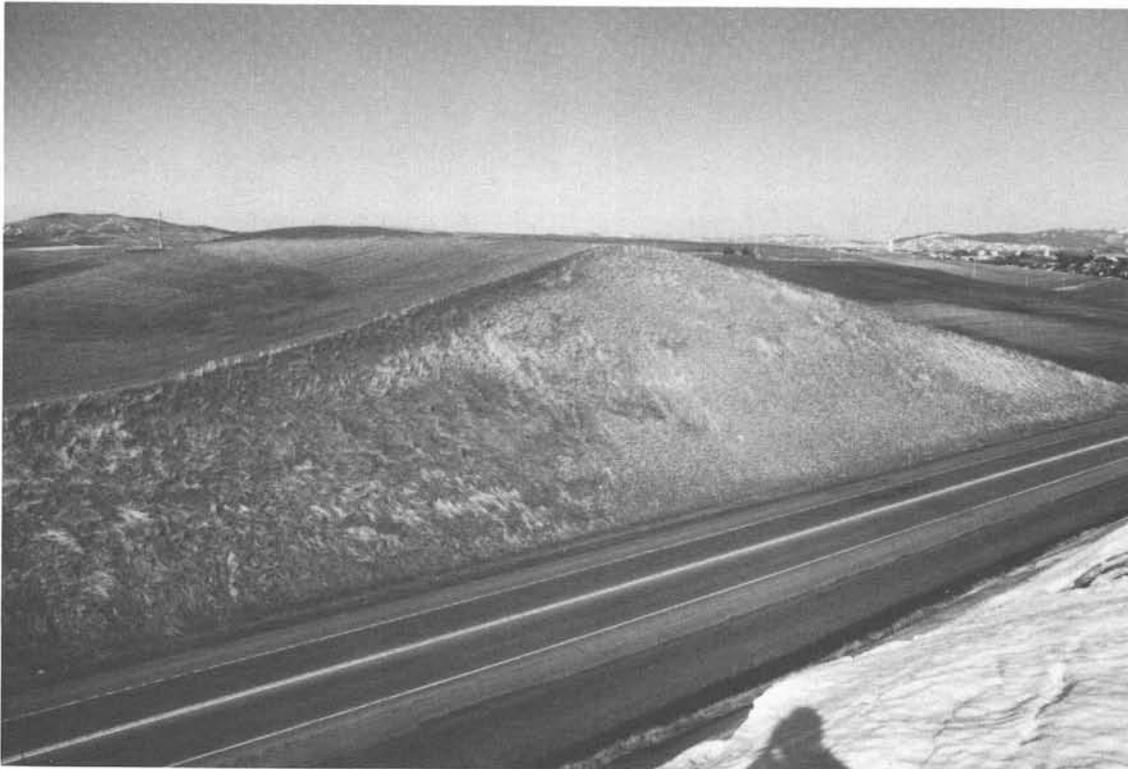
Figure 18. South-facing slope near Pullman shows little degradation. Cut is about 60 ft high.

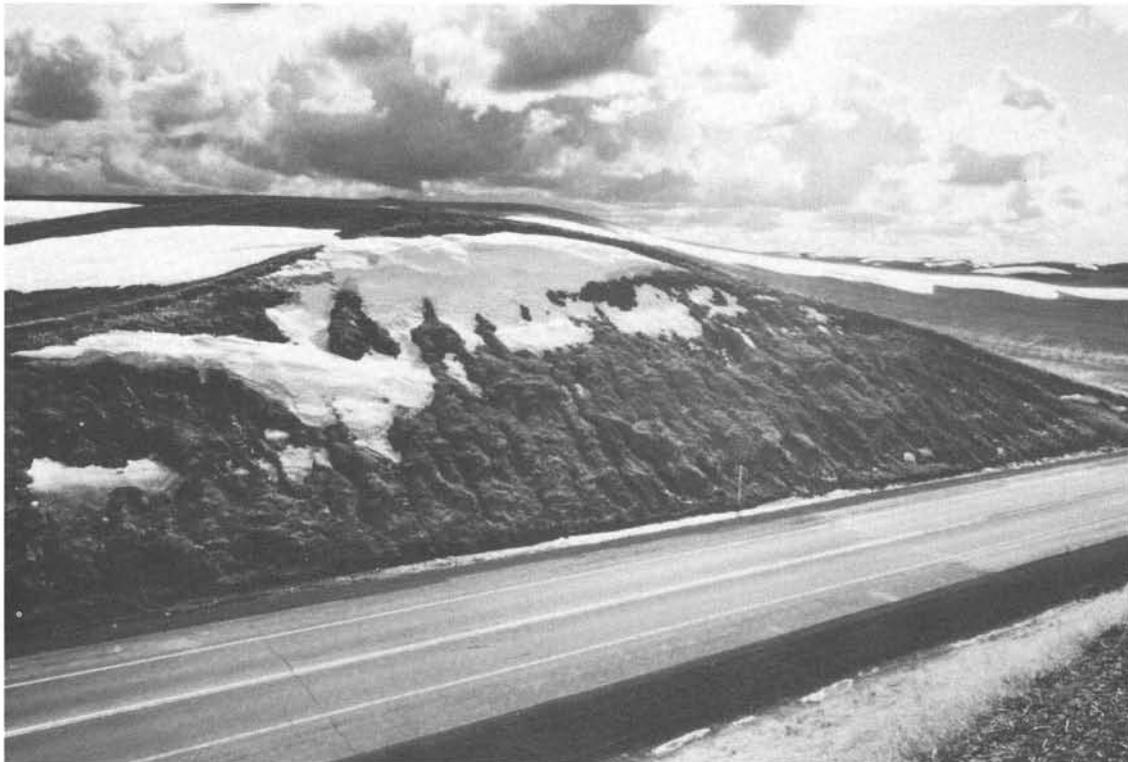
Figure 19. North-facing slope (counterpart of slope in Figure 18) exhibits slide scar and severe gully erosion.

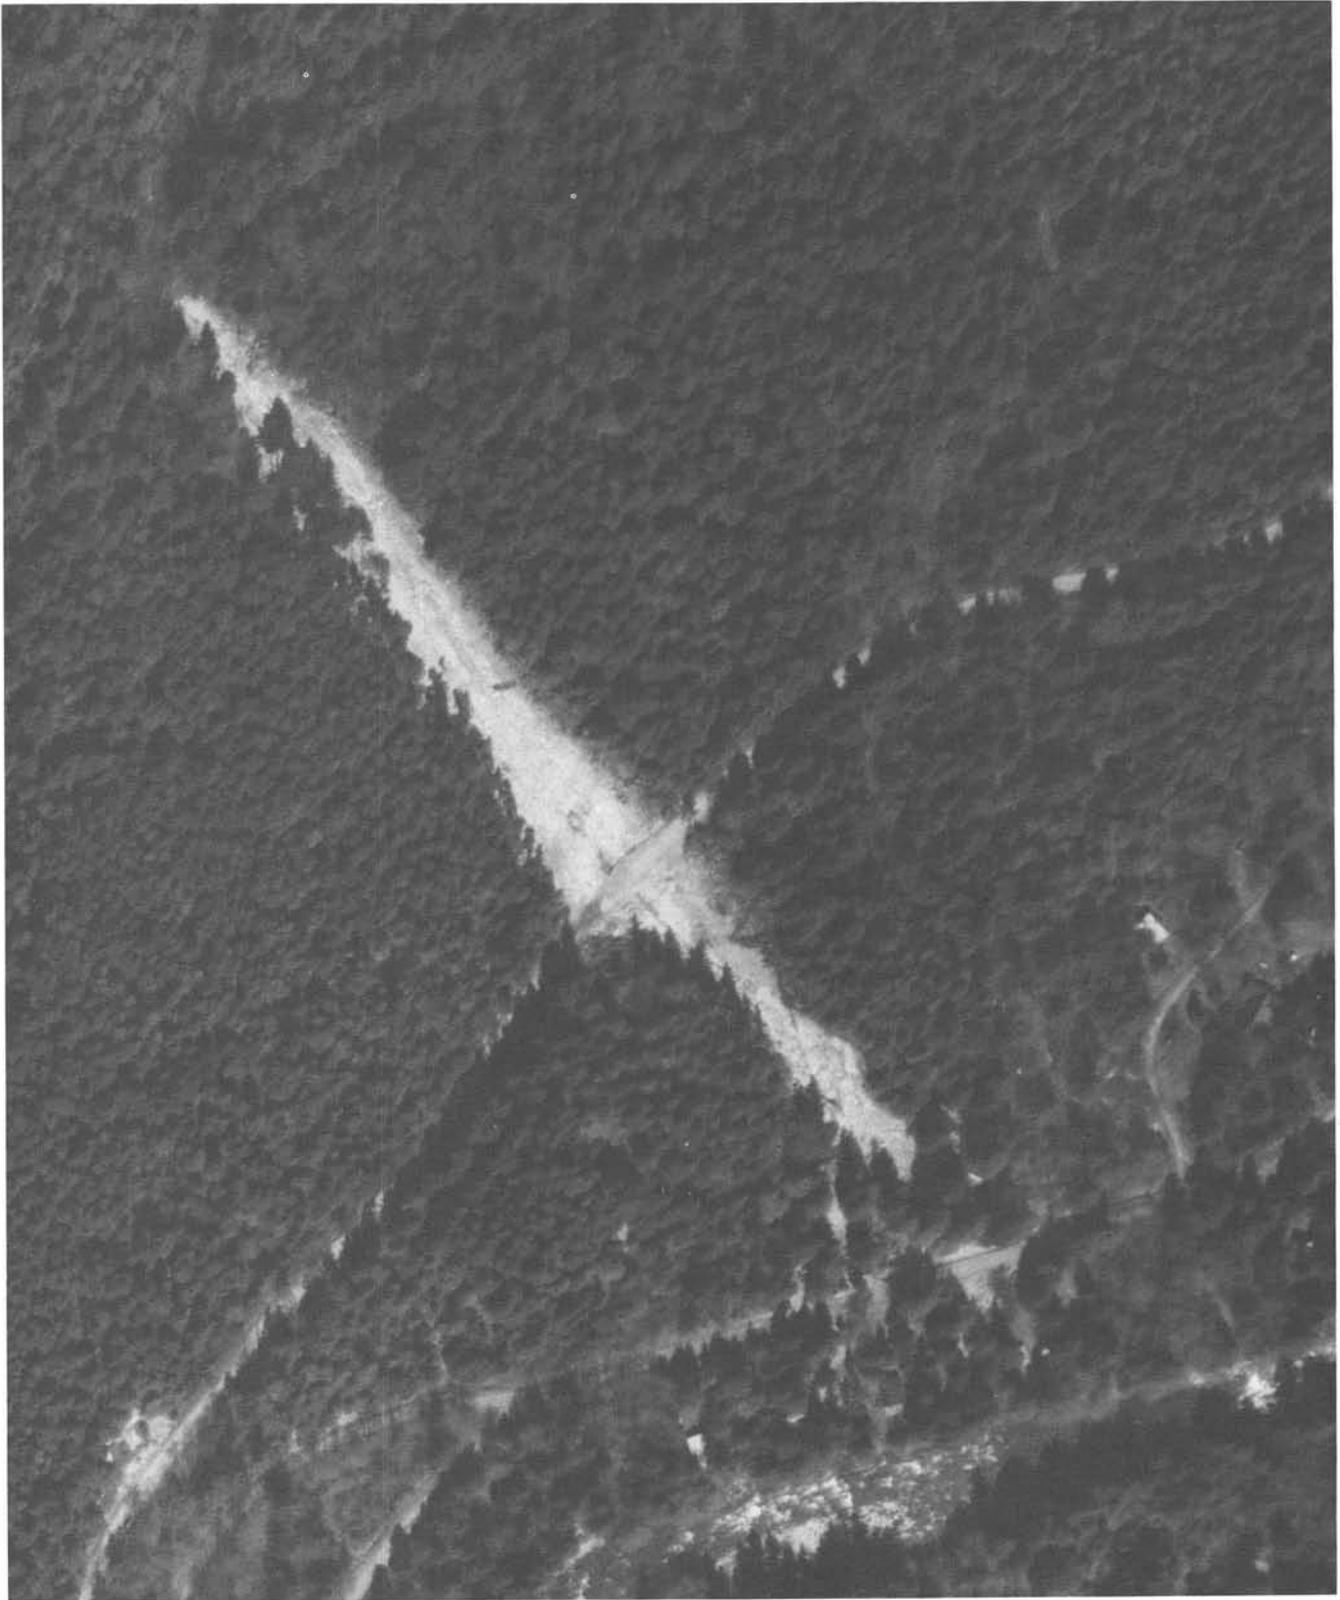
Figure 2. Scar caused by landslide. The Cascade River is located in the lower right corner of the photograph, the switchback in the upper center, and the county road just to the right of center, about one-third of the way up the scar. Photograph was taken after the roads were cleared of slide debris. Photographs by Walker and Associates for DNR.

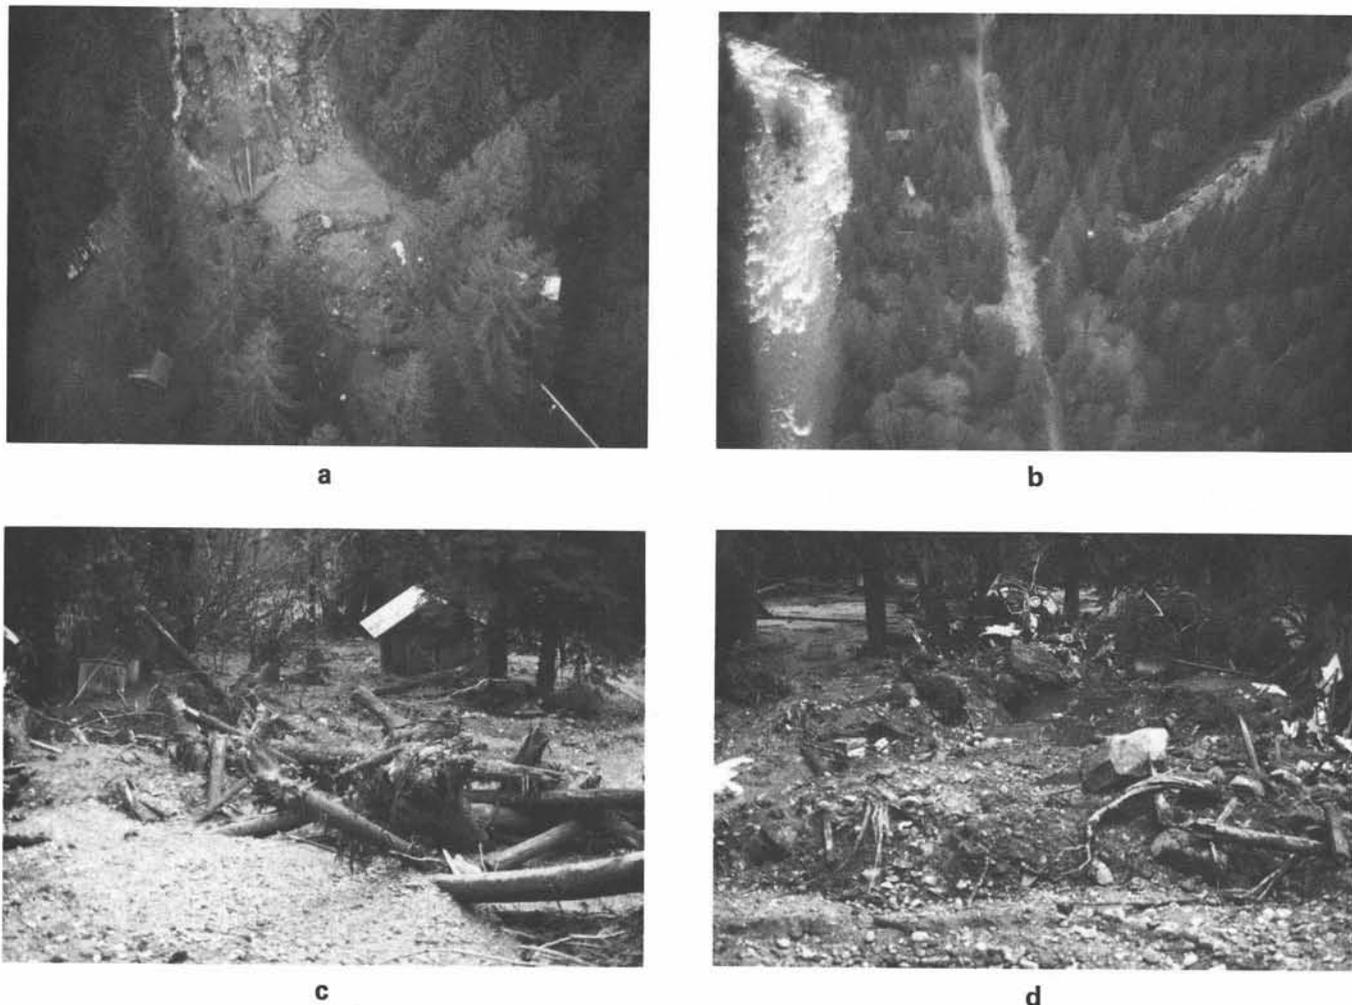
Figure 3. Aerial photographs of (a) the Cascade River development and damage caused by the slide and (b) transition and runout areas in the Cascade River development where the landslide crosses the access road below the county road; view to the west. Views (c and d) of landslide deposits and damage within the development. Photographs by G. W. Thorsen, 1985.

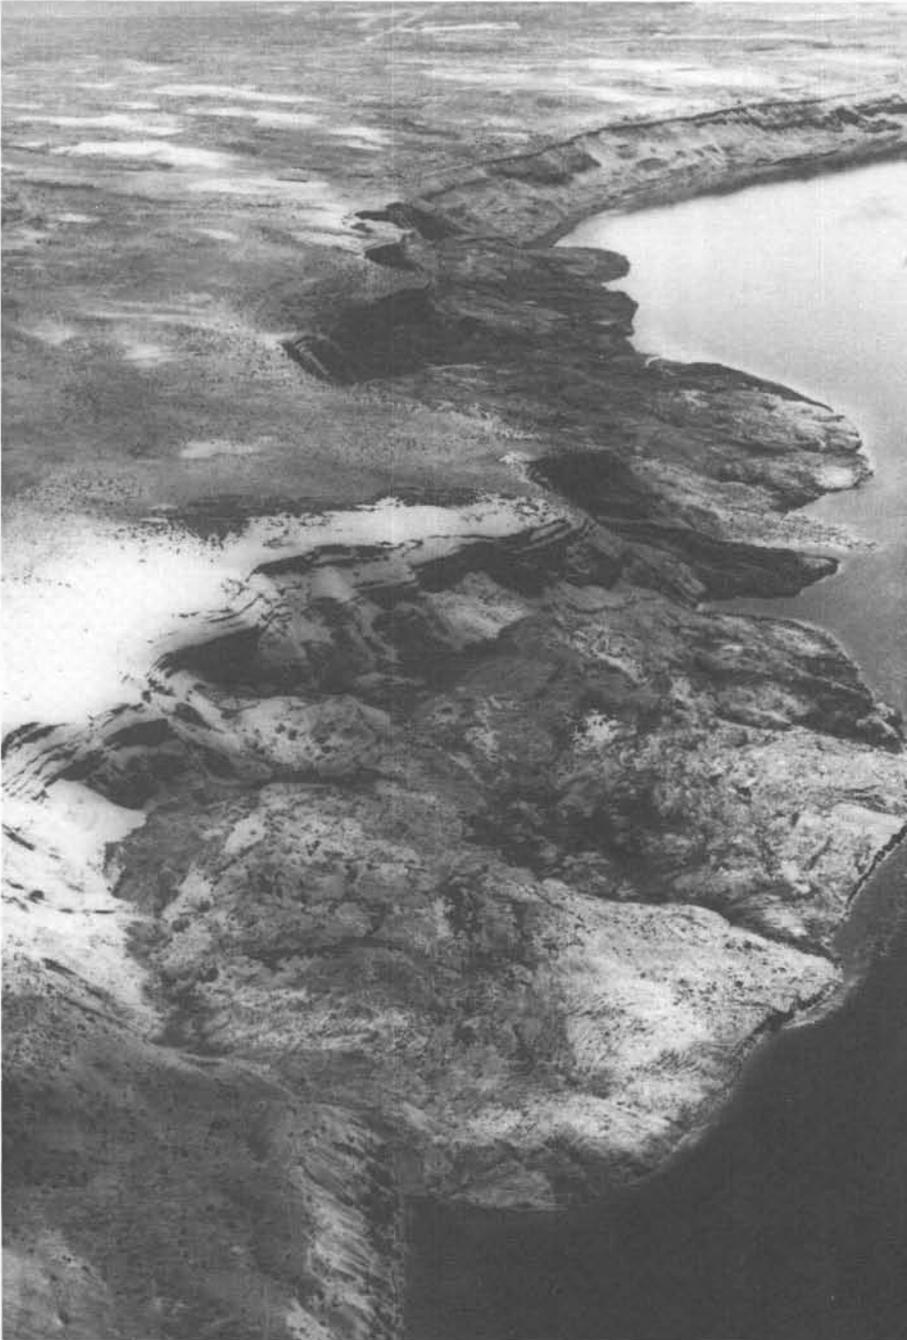
Figure 2. Locke Island landslides and northeast channel of Columbia River; view downstream. See Figure 3 for scale. Photograph by H. S. Holmes, U.S. Bureau of Reclamation, April 1985.

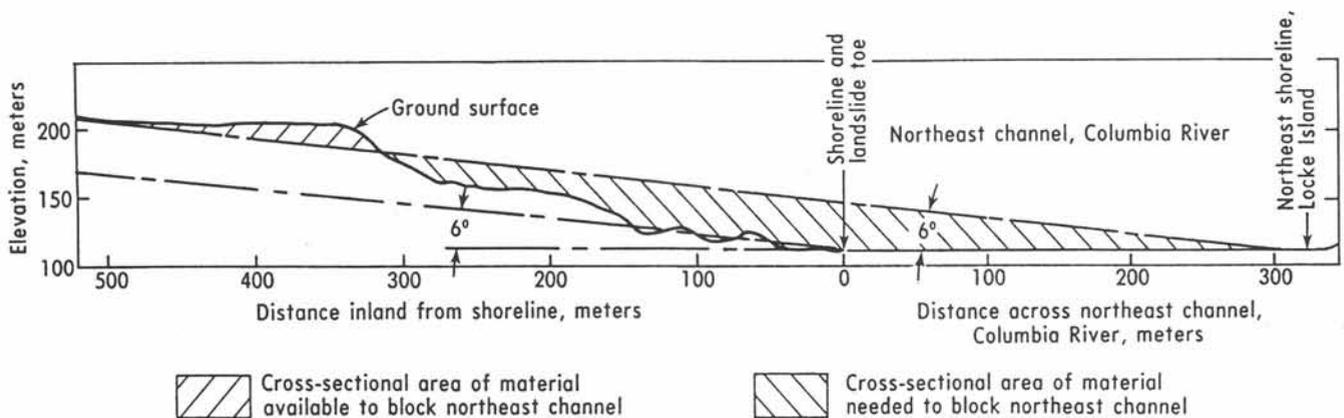
Figure 6. Balance-of-materials approach to illustrating that, for a "worst-case" example, there is no possibility that a landslide in the Locke Island area (along section A-A' of Figure 3) can dam the northeast channel of the Columbia River. The 6° slope chosen for the hypothetical worst-case landslide that would just reach the near shore of Locke Island is based on measured flattest slopes of the toes of existing earth flows shown in Figures 2, 3, and 4. Events that might produce depositional slopes flatter than 6° are very unlikely.

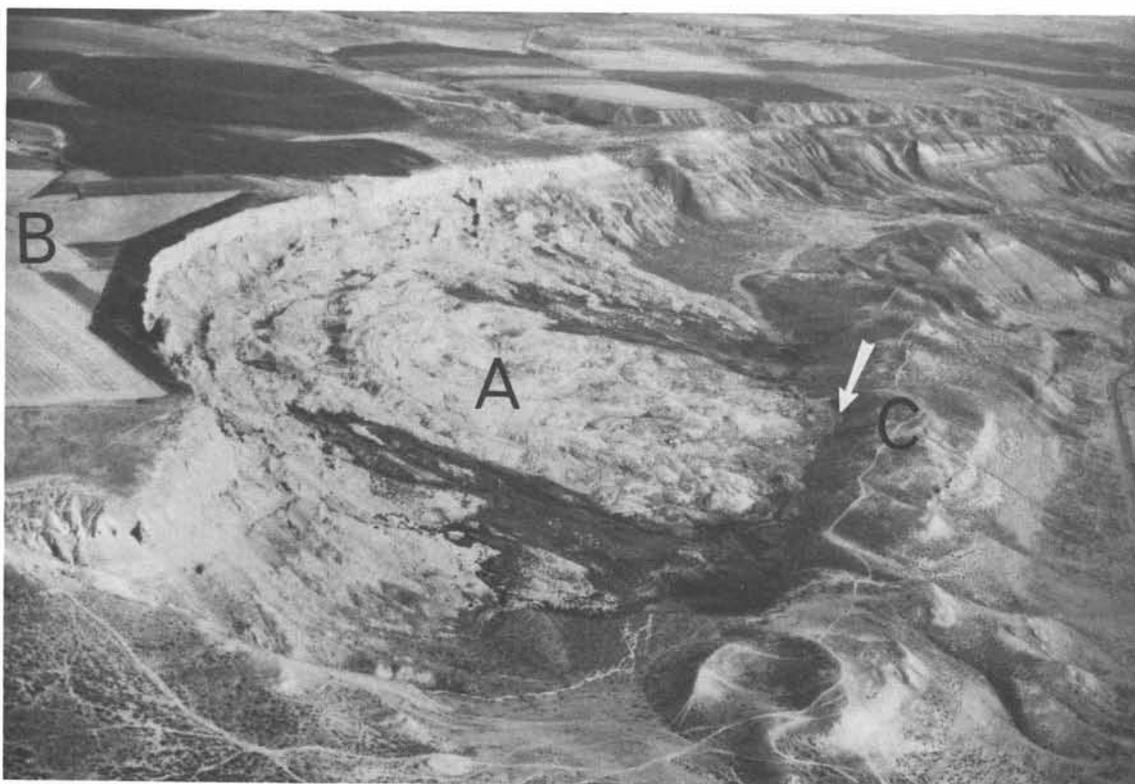
Figure 7. Aerial view (south) of the Savage Island landslide area, September 1982. A, center of active landslide; B, irrigated cropland immediately east of landslide; C, ridge of Ringold Formation that is blocking additional movement of the landslide. In the spring of 1982, the toe of the landslide (indicated by white arrow) moved 15 m (measured vertically) up the east side of the ridge at C. See Figure 8 for scale.

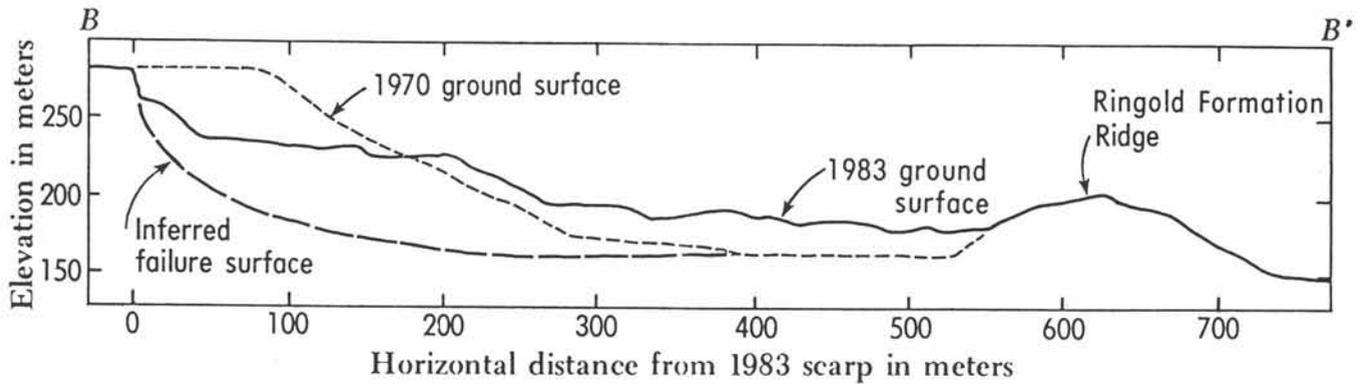
Figure 10. Cross section B-B' (Figure 8) through the active Savage Island landslide. The position of failure surface has been inferred from field evidence. Note "runup" of toe of landslide onto outlying Ringold Formation ridge.

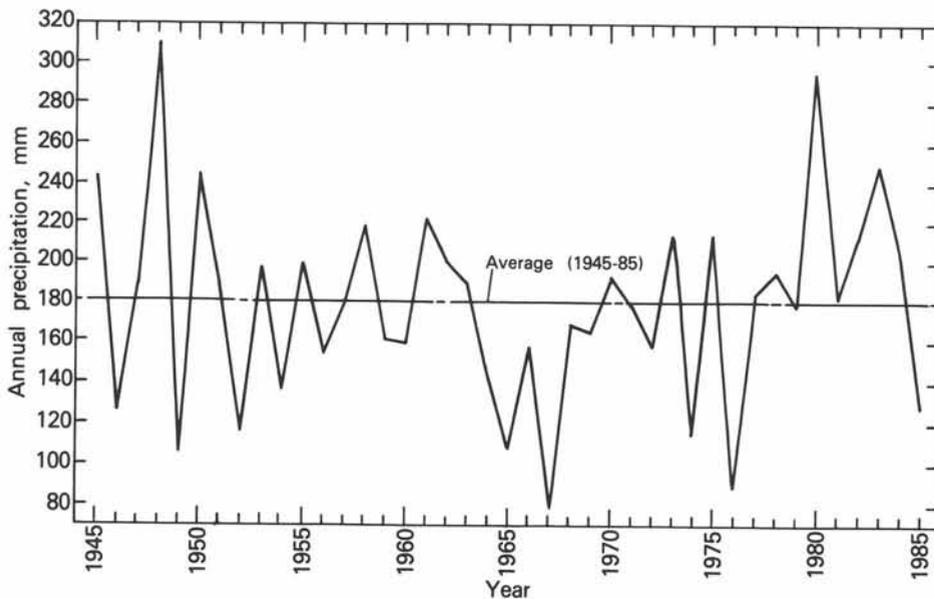
Figure 11. Annual precipitation from 1945 to 1985 at Richland on the west bank of the Columbia River approximately 10 km south of the south end of the White Bluffs landslide area.

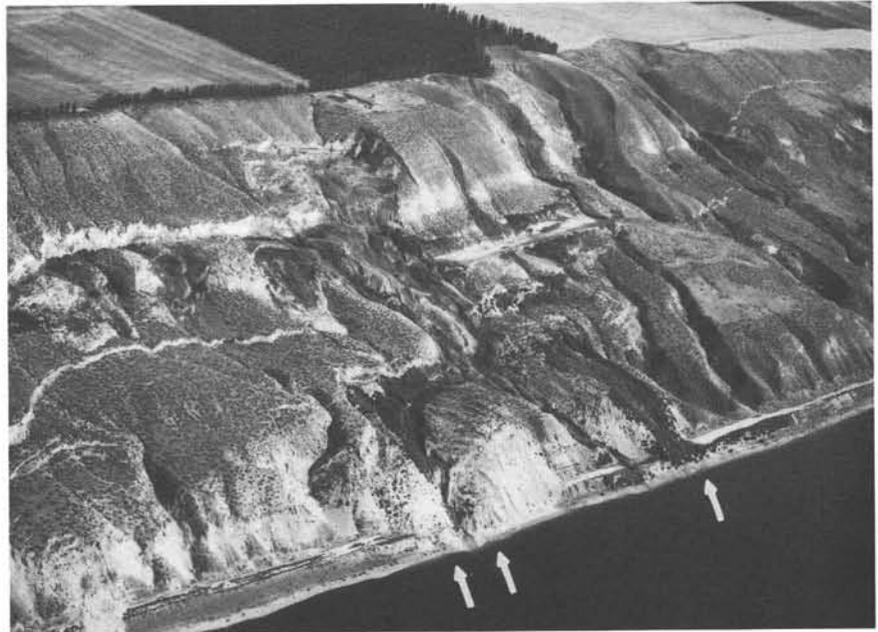
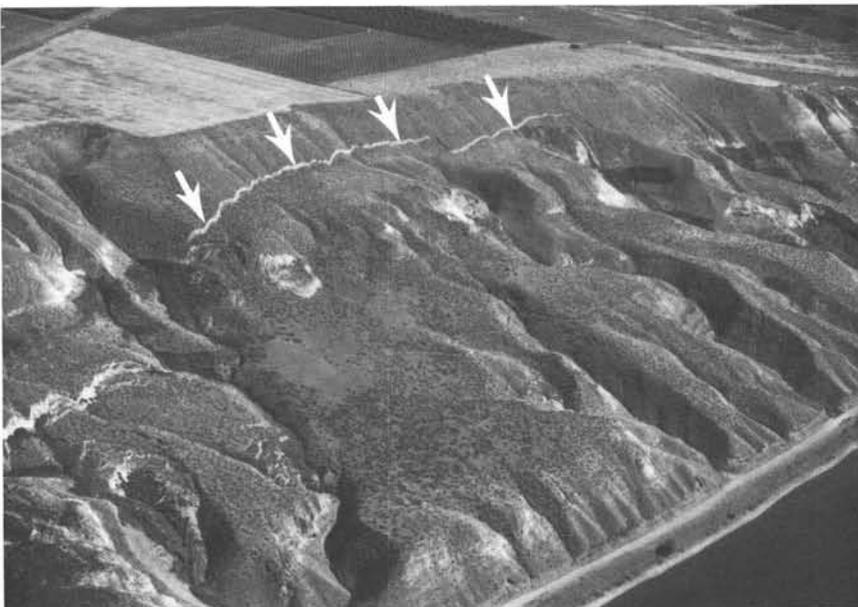
Figure 14. South end of the Johnson Island landslide area, showing the 0.5-km-long shear crack (white arrows) that formed along the upper face of the bluffs in 1981.
