Hydrogeologic Characterization of a Rural Landfill for Compliance Operation and Closure Design

JAMES S. BAILEY and PETER J. ROWLAND
Sweet-Edwards/EMCON, Inc.

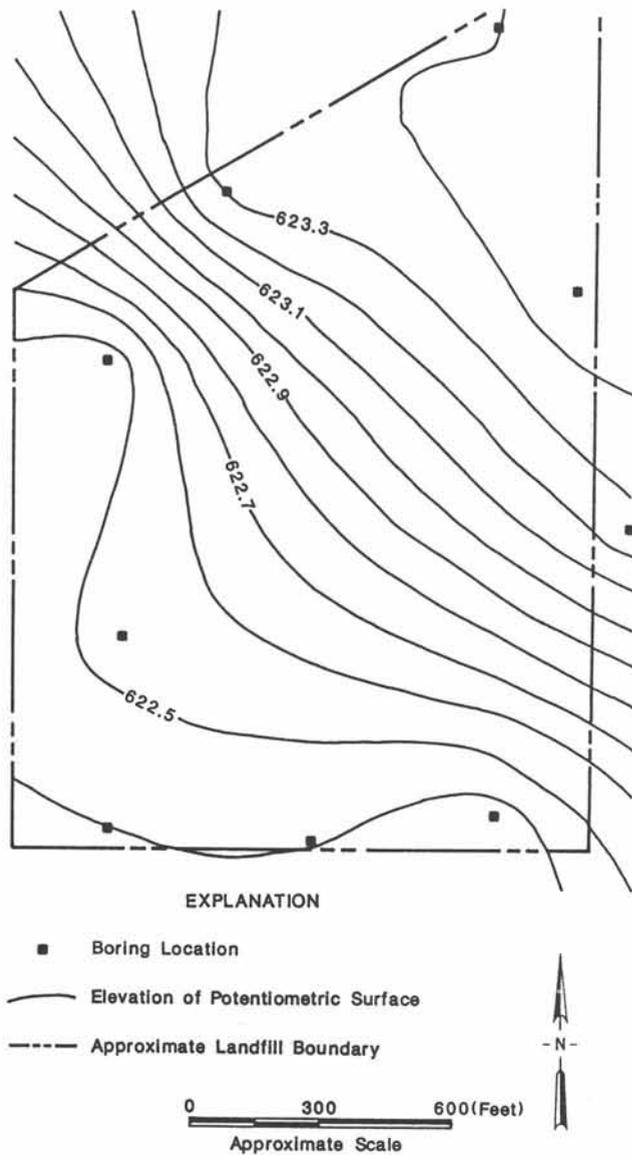
Figure 6. Potentiometric map of shallow aquifer October 1985, Hobart landfill.

Potentiometric maps indicate that flow in the shallow aquifer is generally to the southwest. Seasonal fluctua-

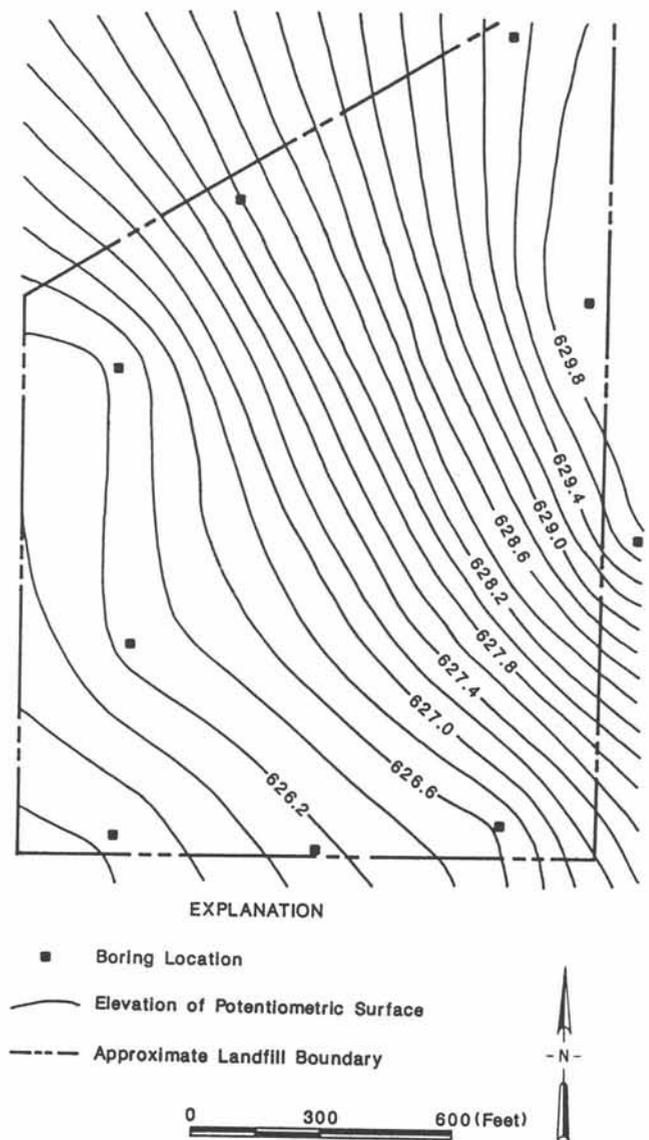
Figure 7. Potentiometric map of shallow aquifer January 1986, Hobart landfill.

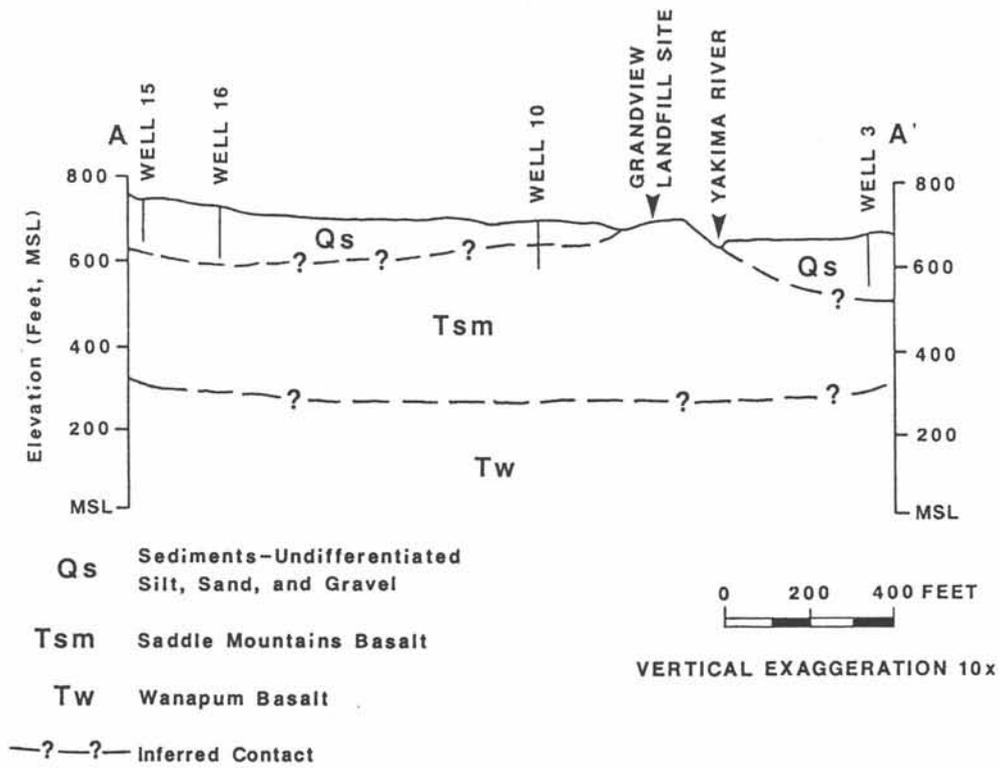
Figure 4. Geologic cross-section A-A' for Grandview landfill; see Figure 3 for cross-section location.

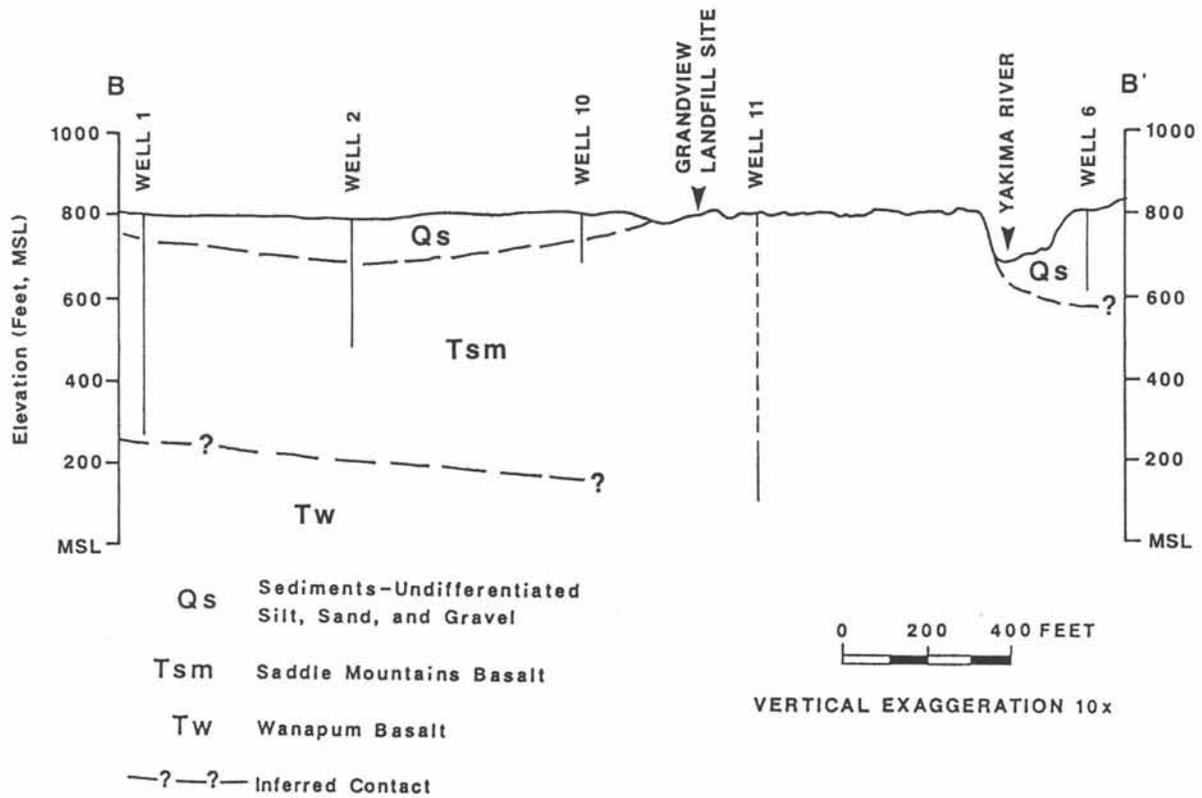
Figure 5. Geologic cross-section B-B' for Grandview landfill; see Figure 3 for cross-section location.

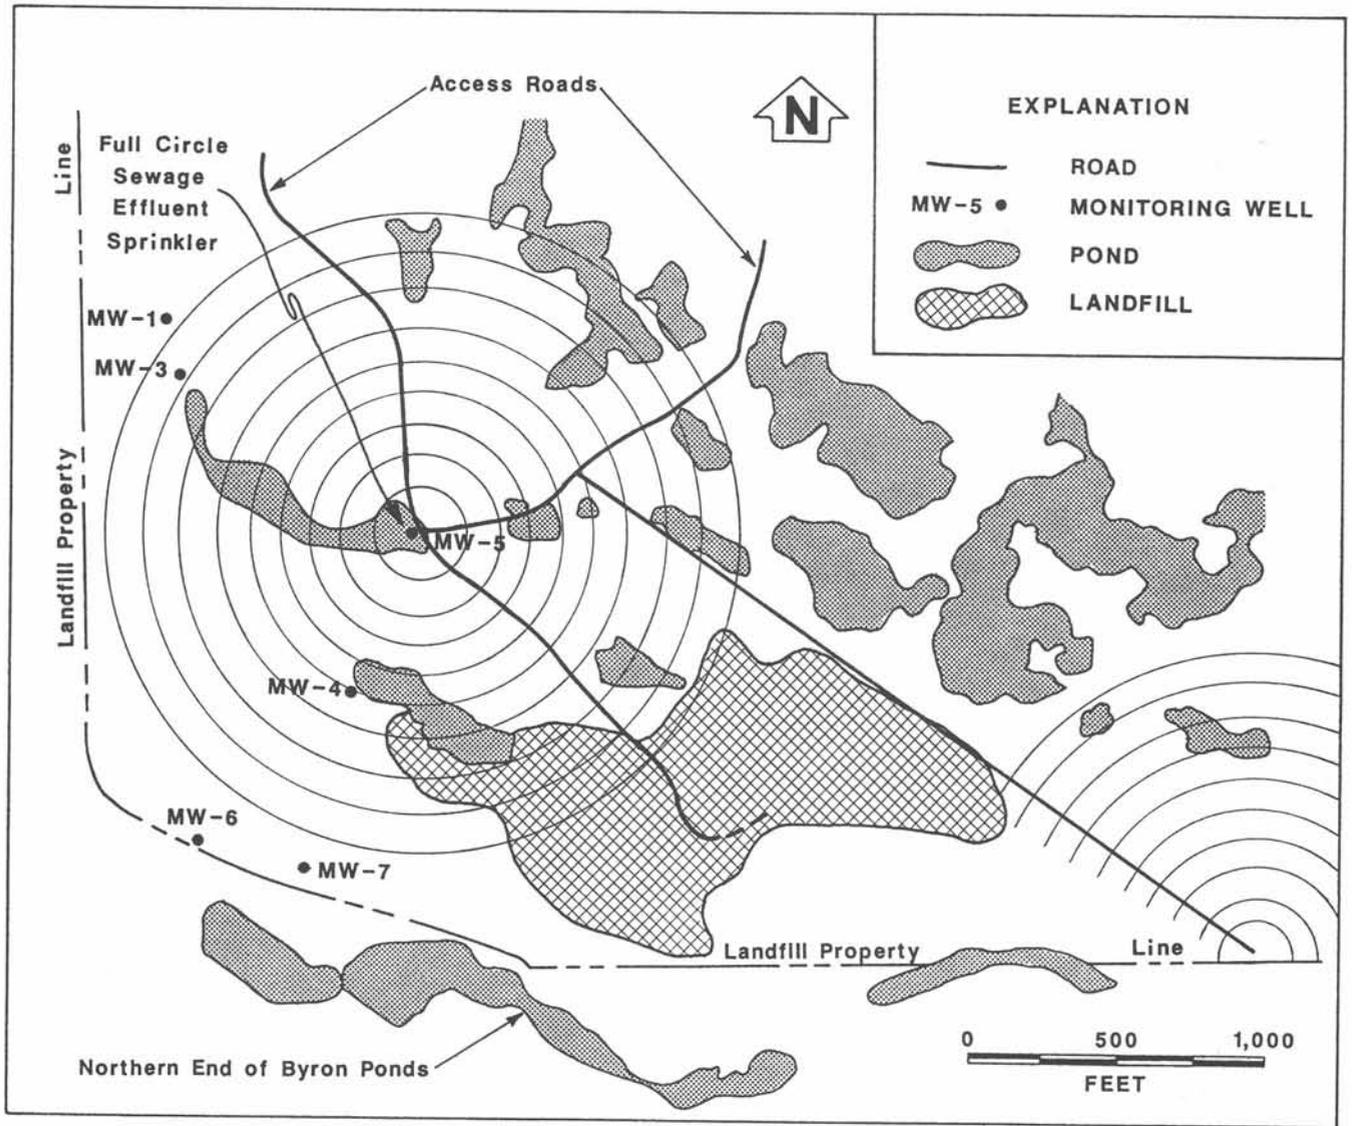
Figure 6. Site map of the Grandview landfill.

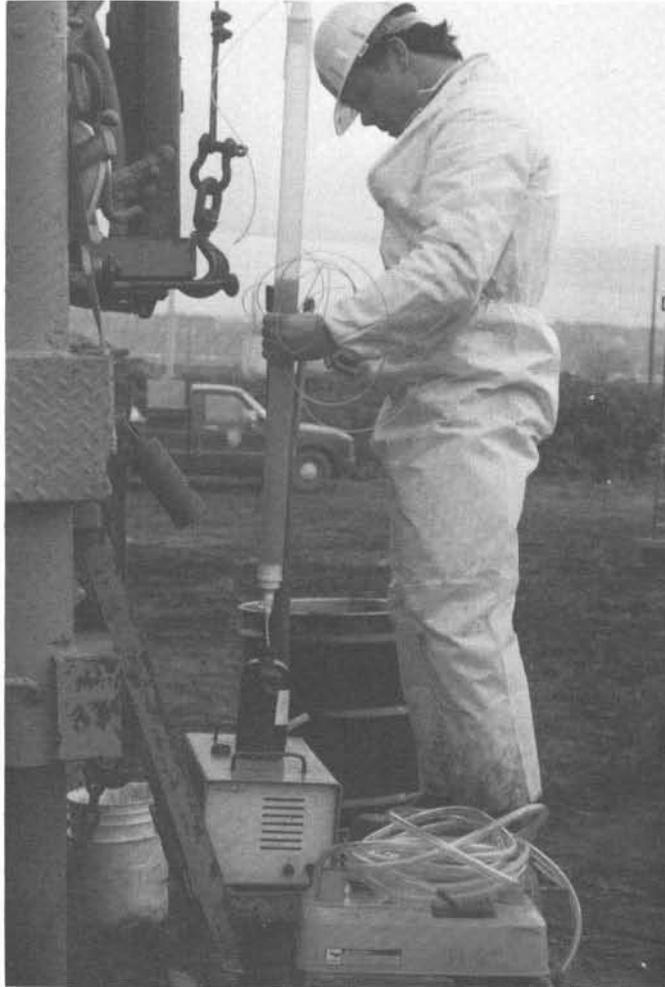
Ground-water sample collection for a temporary drive point well screen, King County. Photograph by Denise E. Mills.

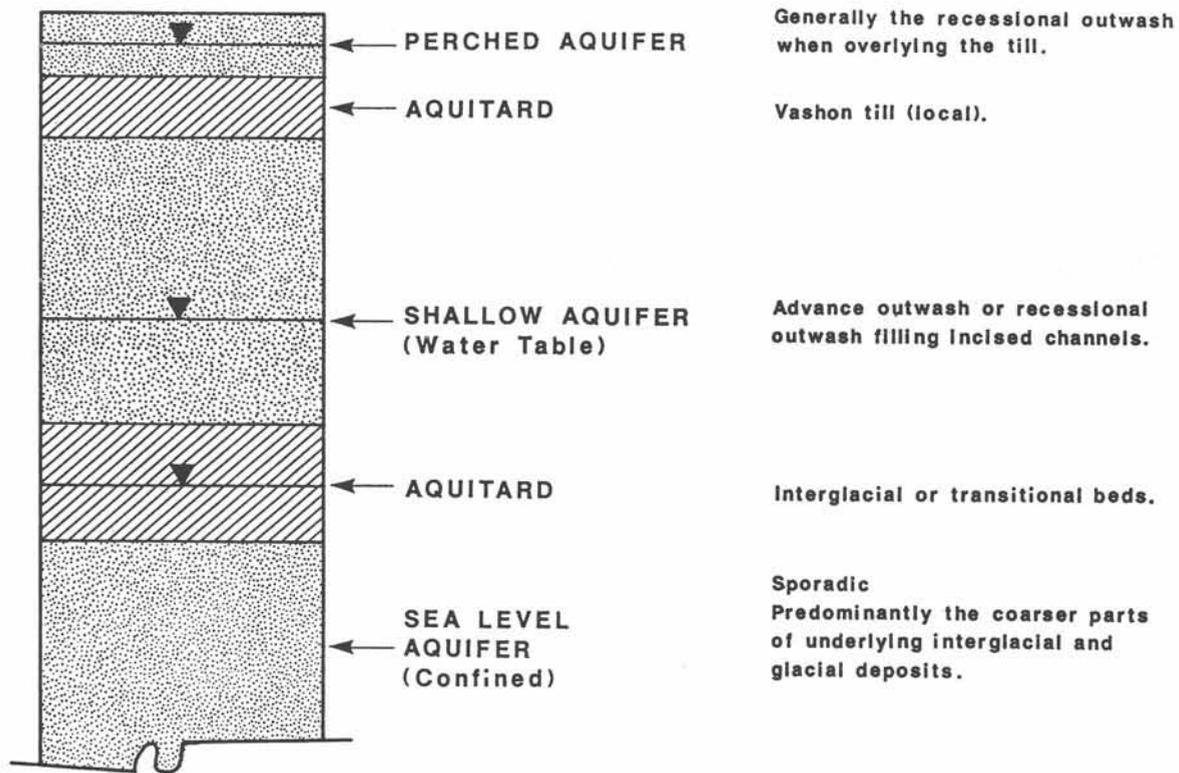
Figure 3. Hydrostratigraphic relations in Island County.

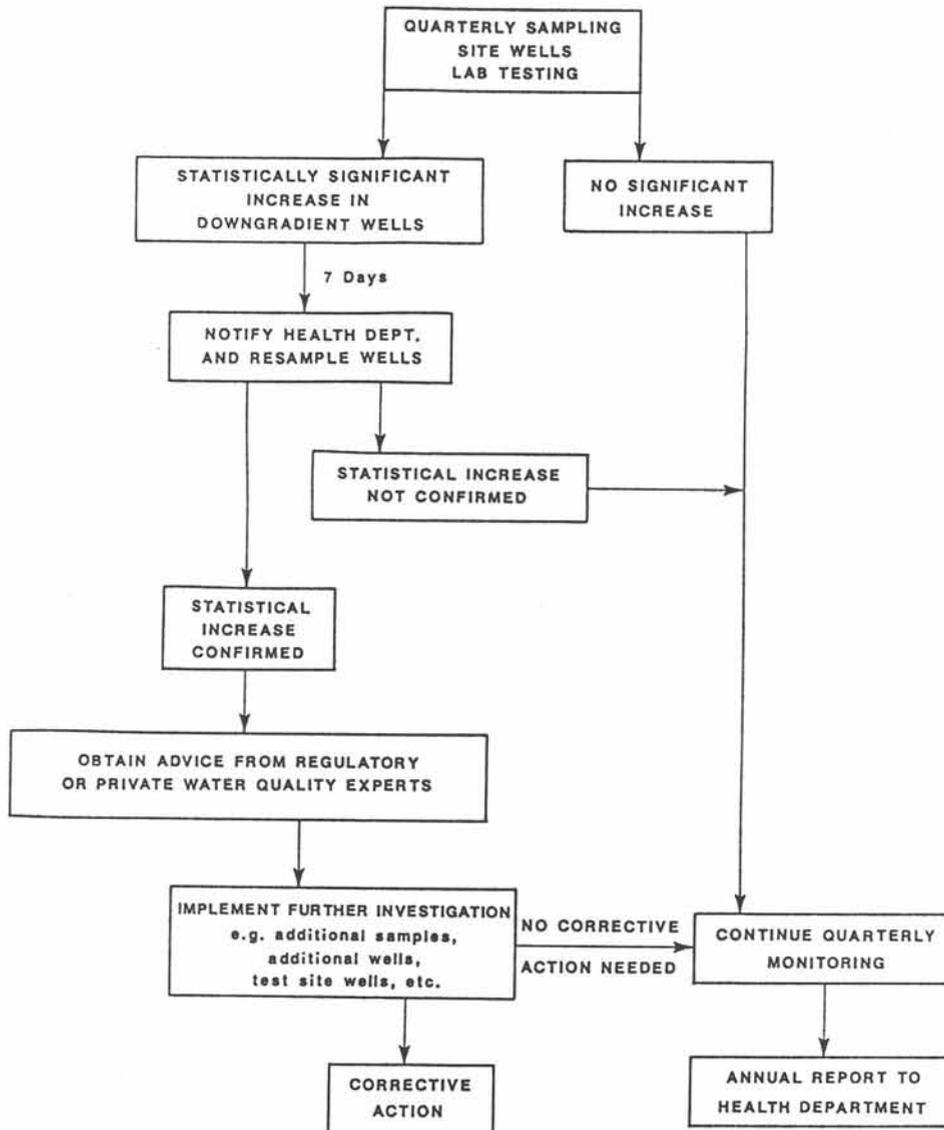
Figure 4. Solid waste site ground-water monitoring flow chart.

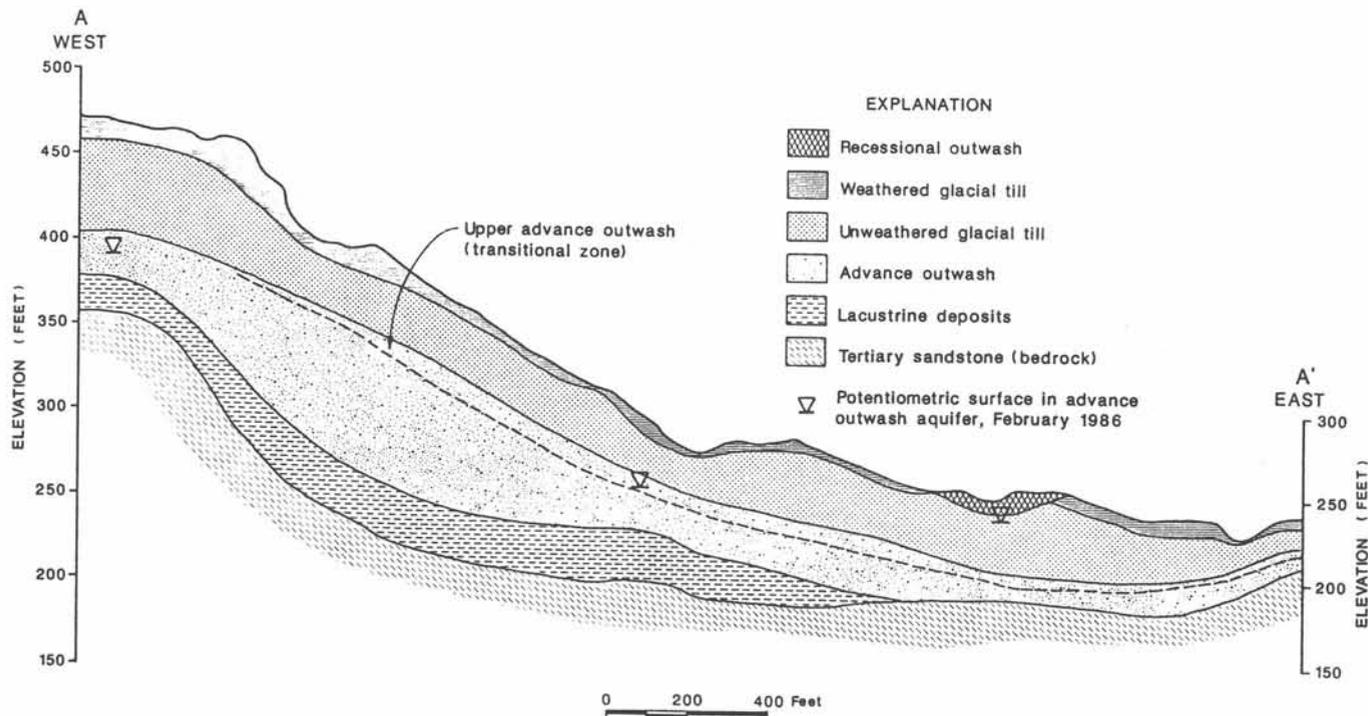
Figure 3. Geologic cross-section A-A' at the Snohomish landfill; see Figure 2 for location of section.

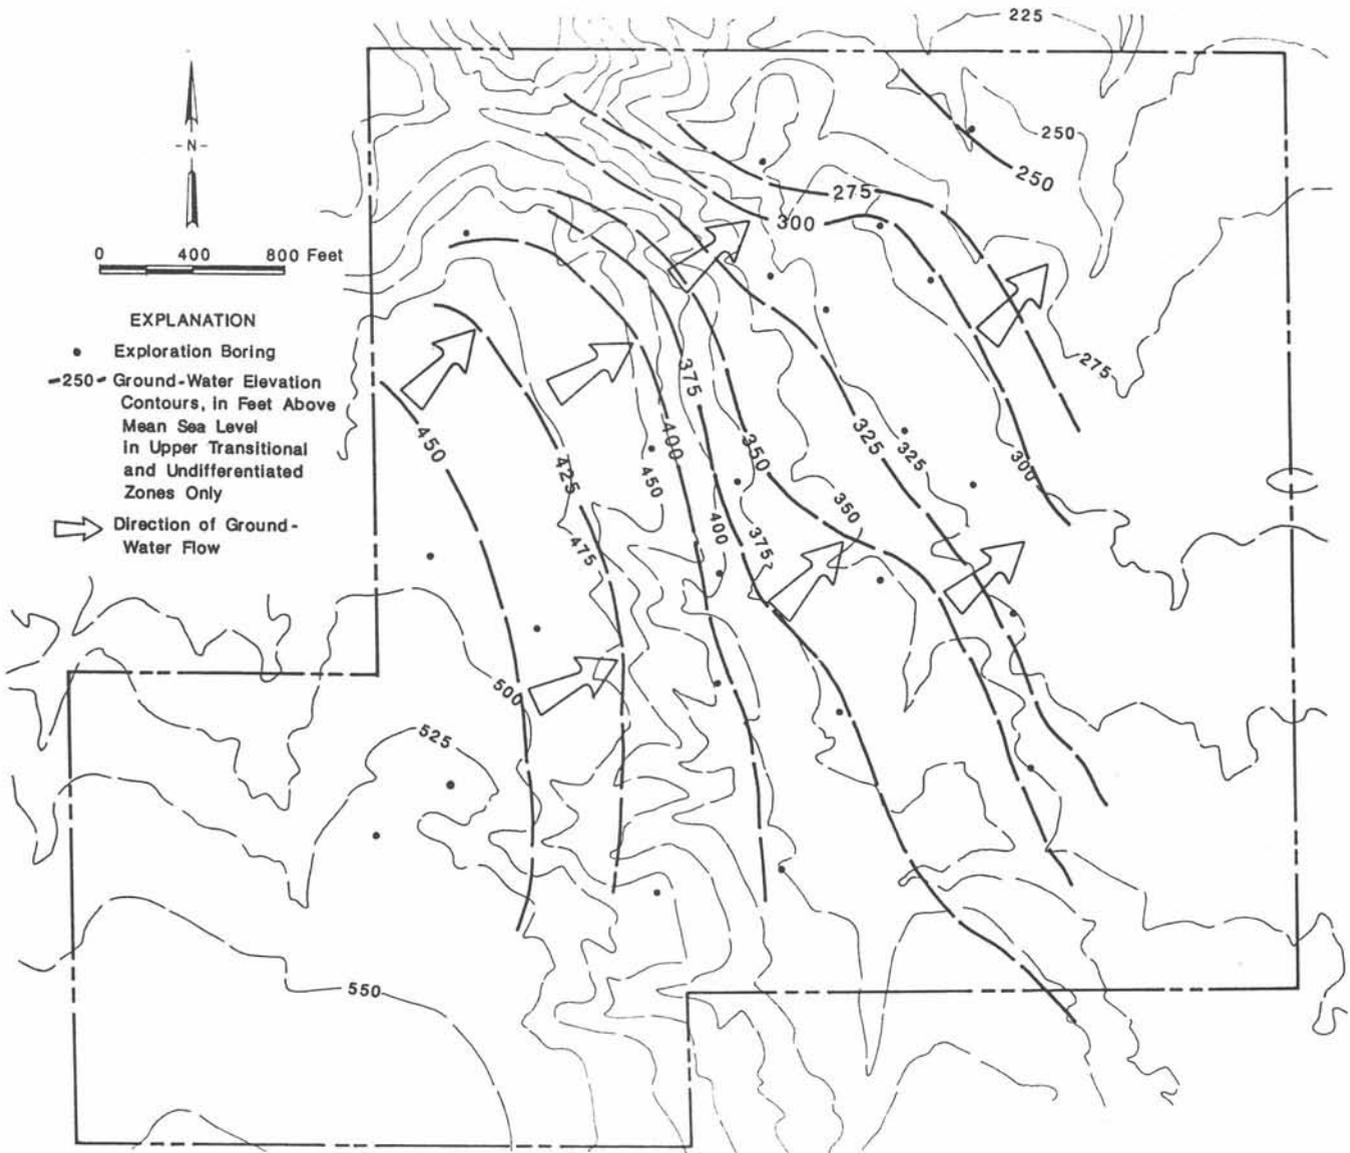
Figure 4. Potentiometric surface of the advance outwash aquifer, Snohomish County Regional Landfill.

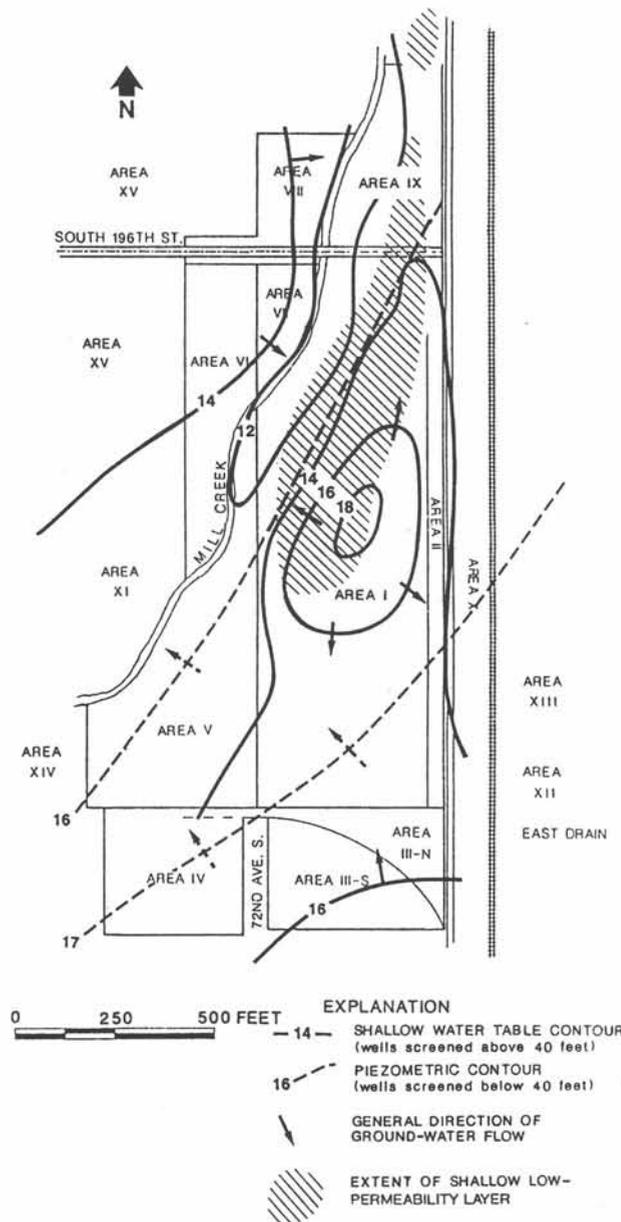
Figure 4. Site layout showing shallow water table and deeper piezometric contours. Also shown is the general direction of ground-water flow and lateral extent of shallow low-permeability layer.

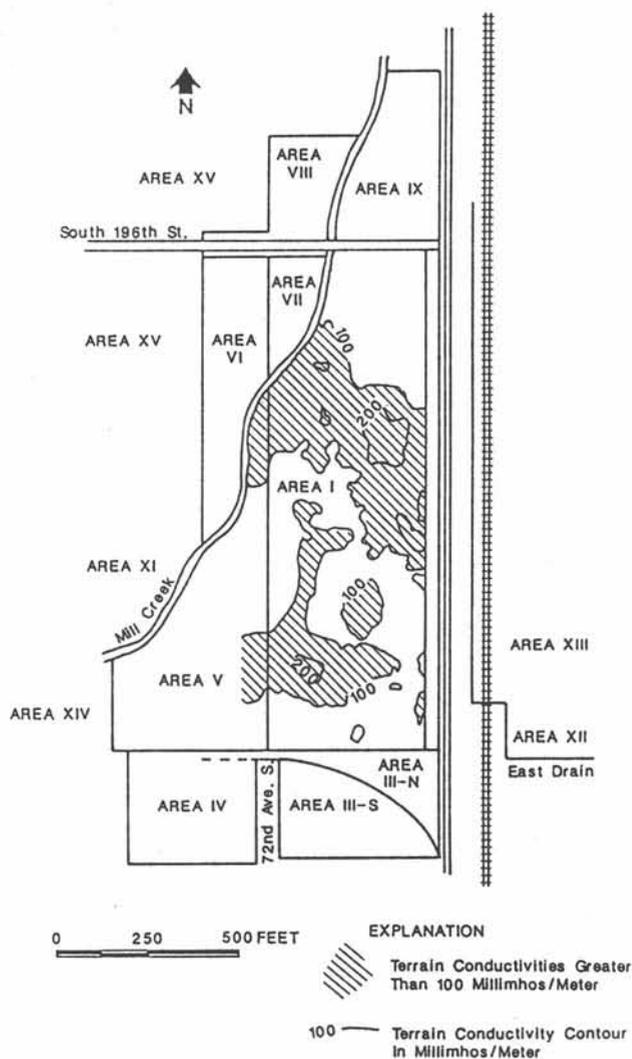
Figure 5. Terrain conductivity map showing areas of anomalously high terrain conductivities which may represent ground-water contamination and/or areas of high metal concentrations in the underlying soil.

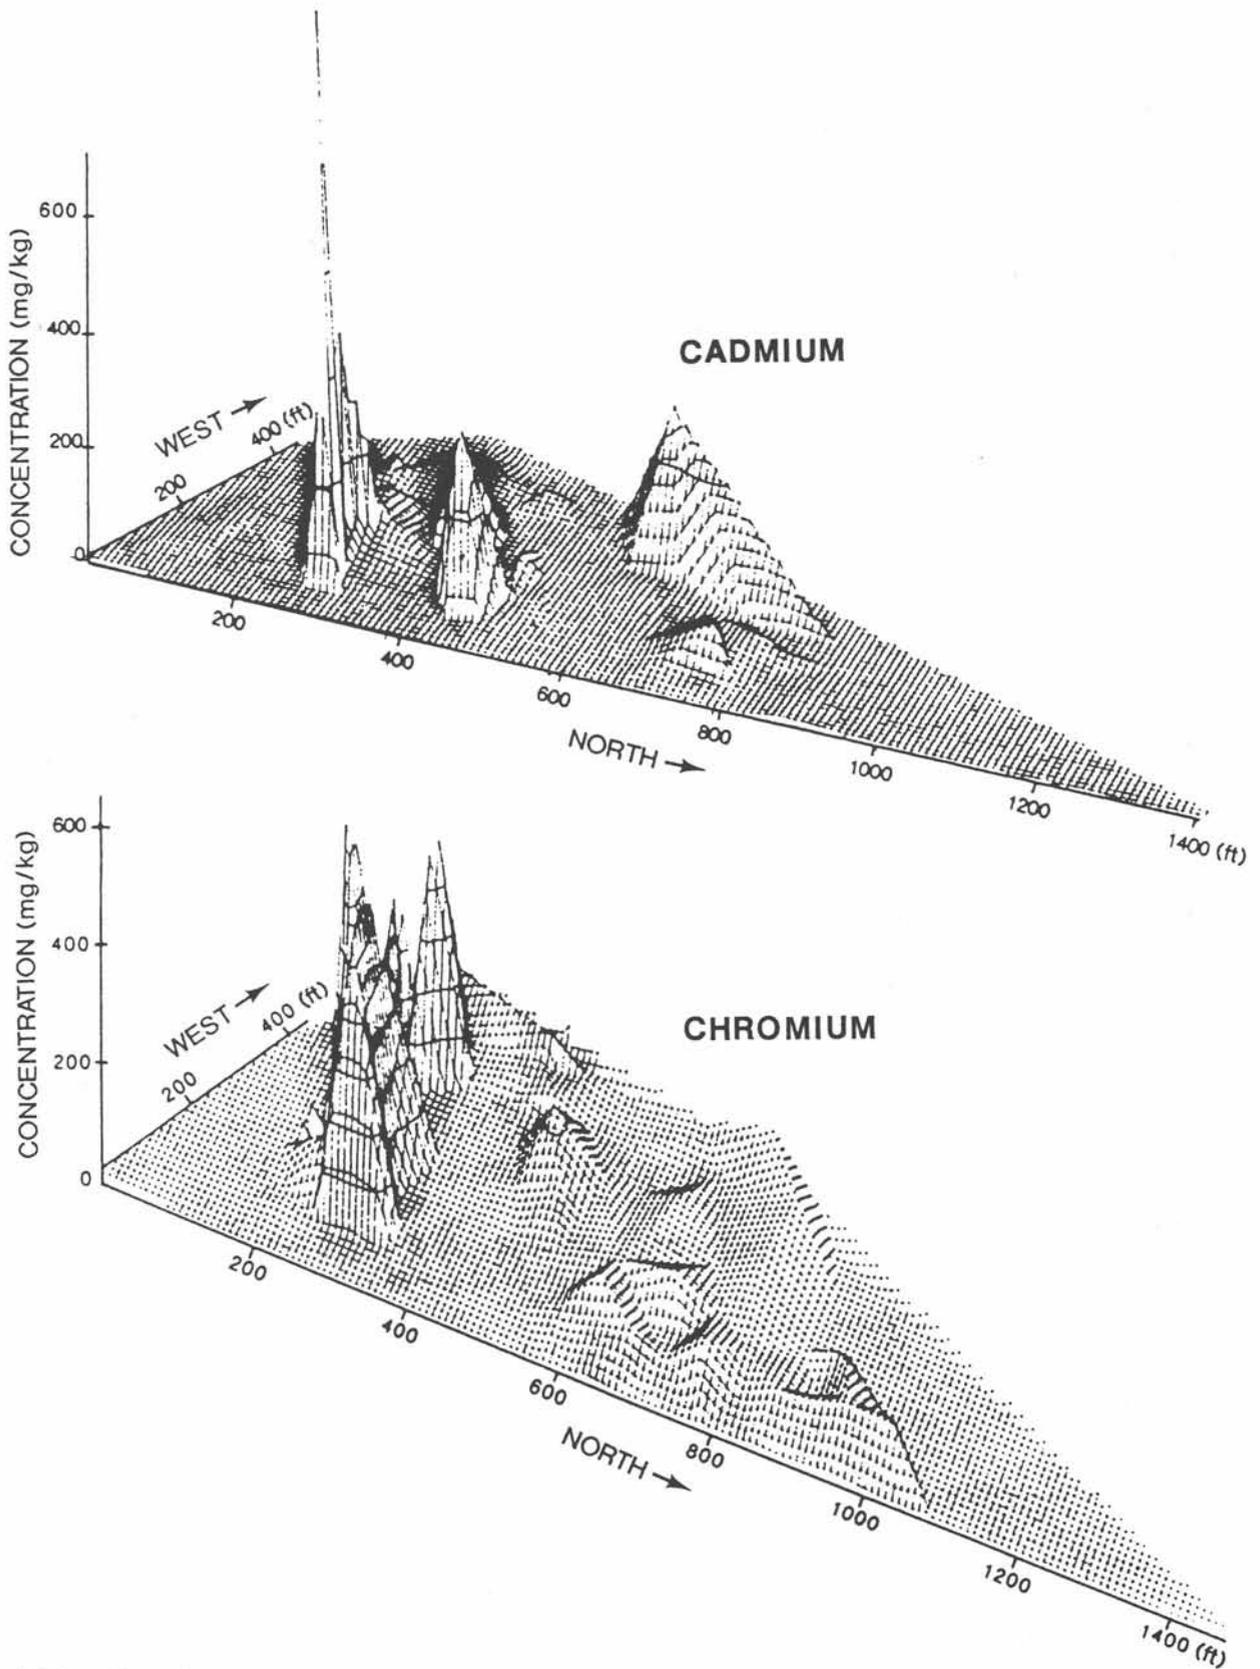
Figure 9. Three-dimensional plots for cadmium and chromium concentrations for surficial soils across the entire Western Processing site.

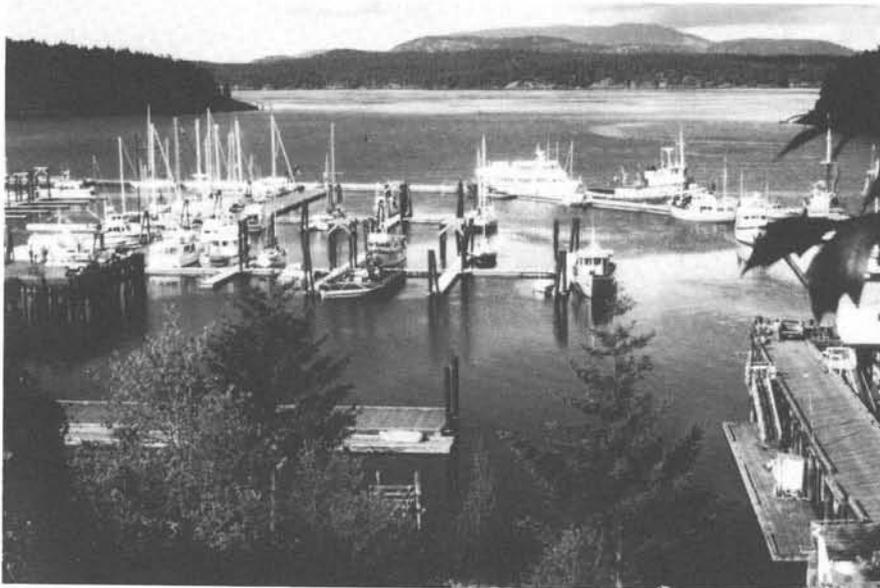
Floating breakwater protecting the former boat basin at Friday Harbor, San Juan Island. The marina has subsequently been enlarged, and a new concrete floating breakwater has been constructed. Photograph by R. W. Galster, May 1984.

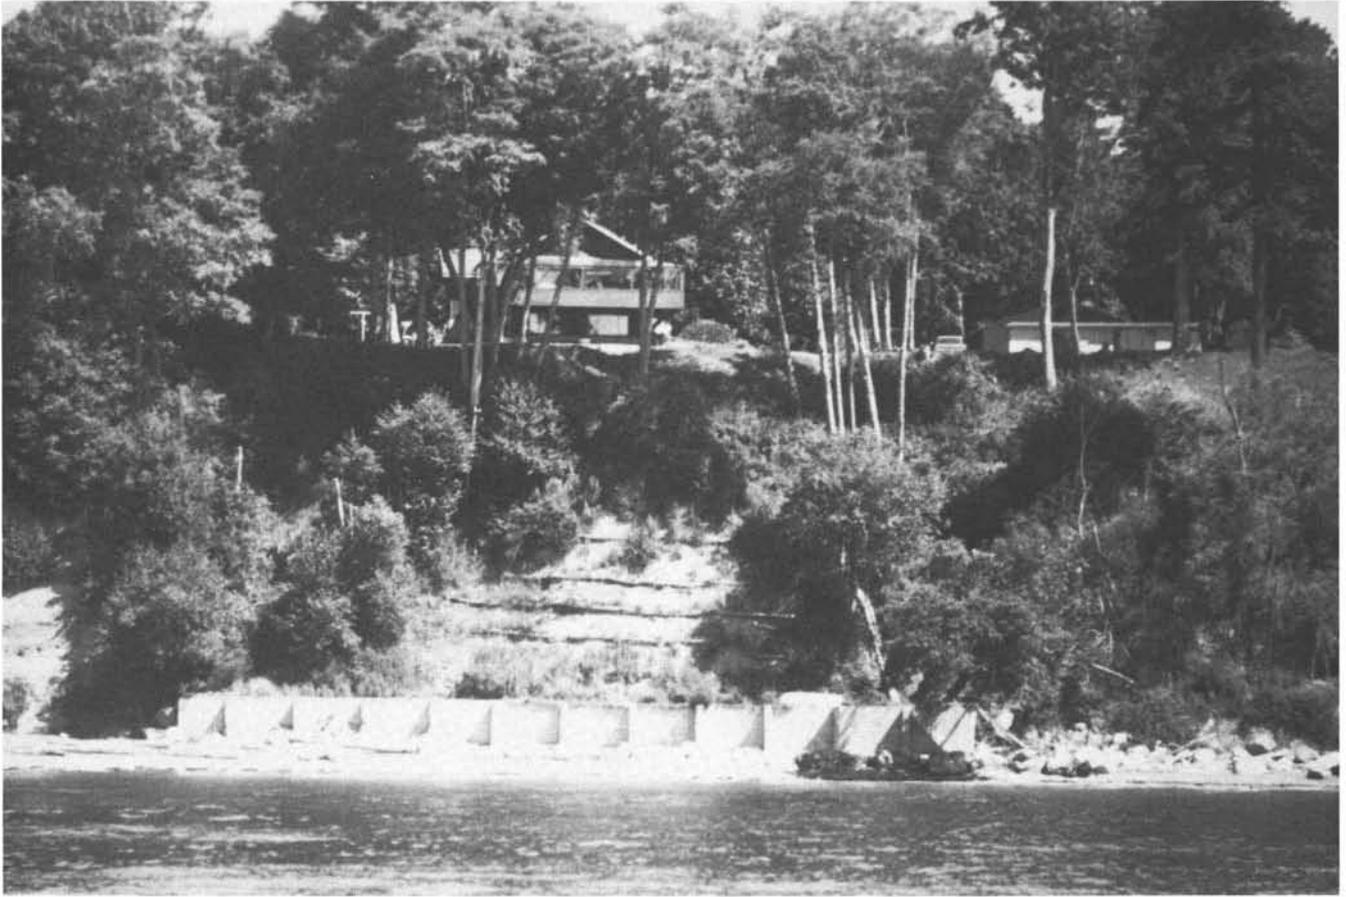
Figure 1. Typical high shorebluff with erosion protection.

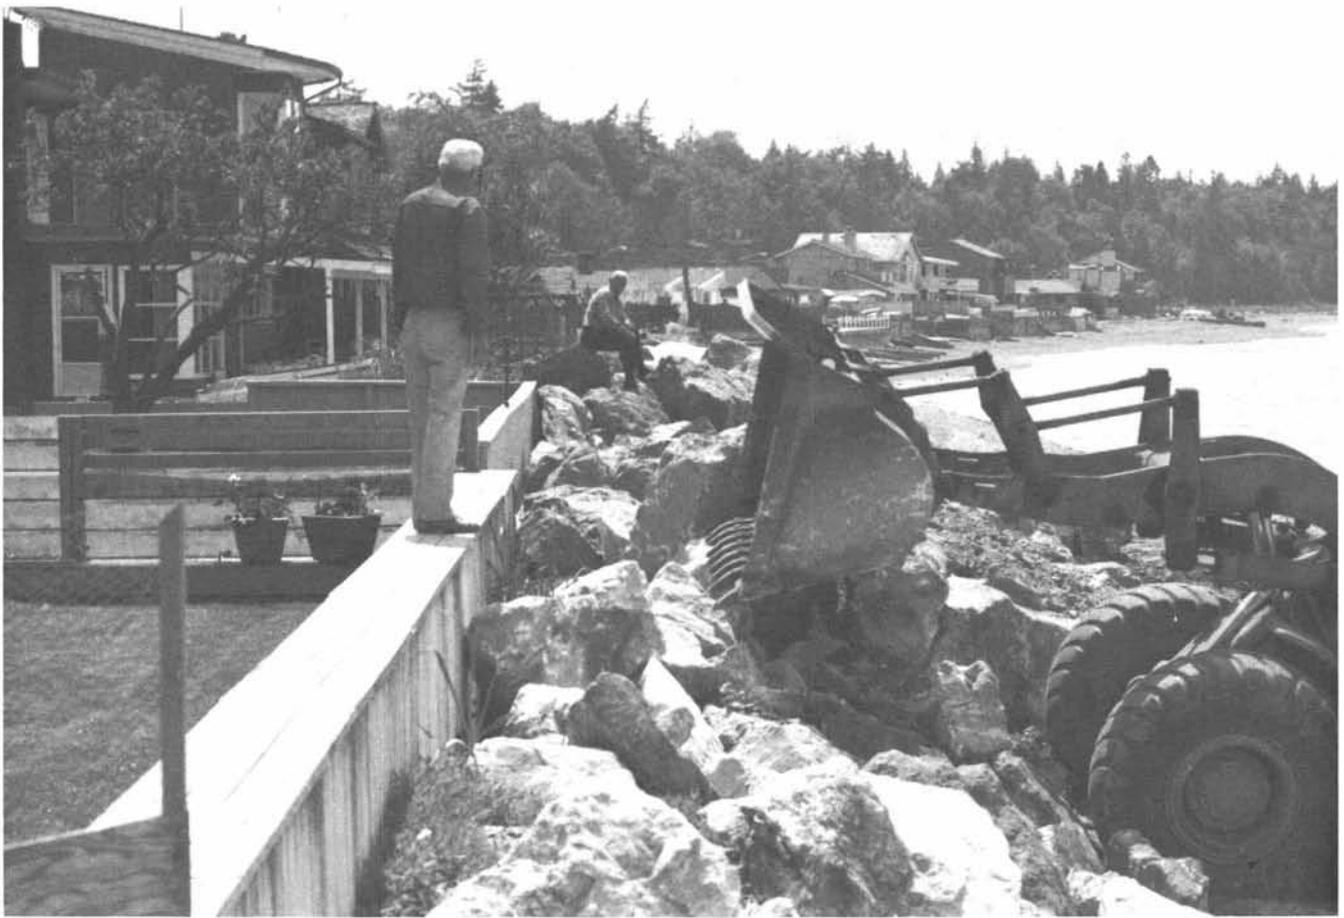
Figure 2. Seawalls and riprap protection at homes on a low depositional beach.

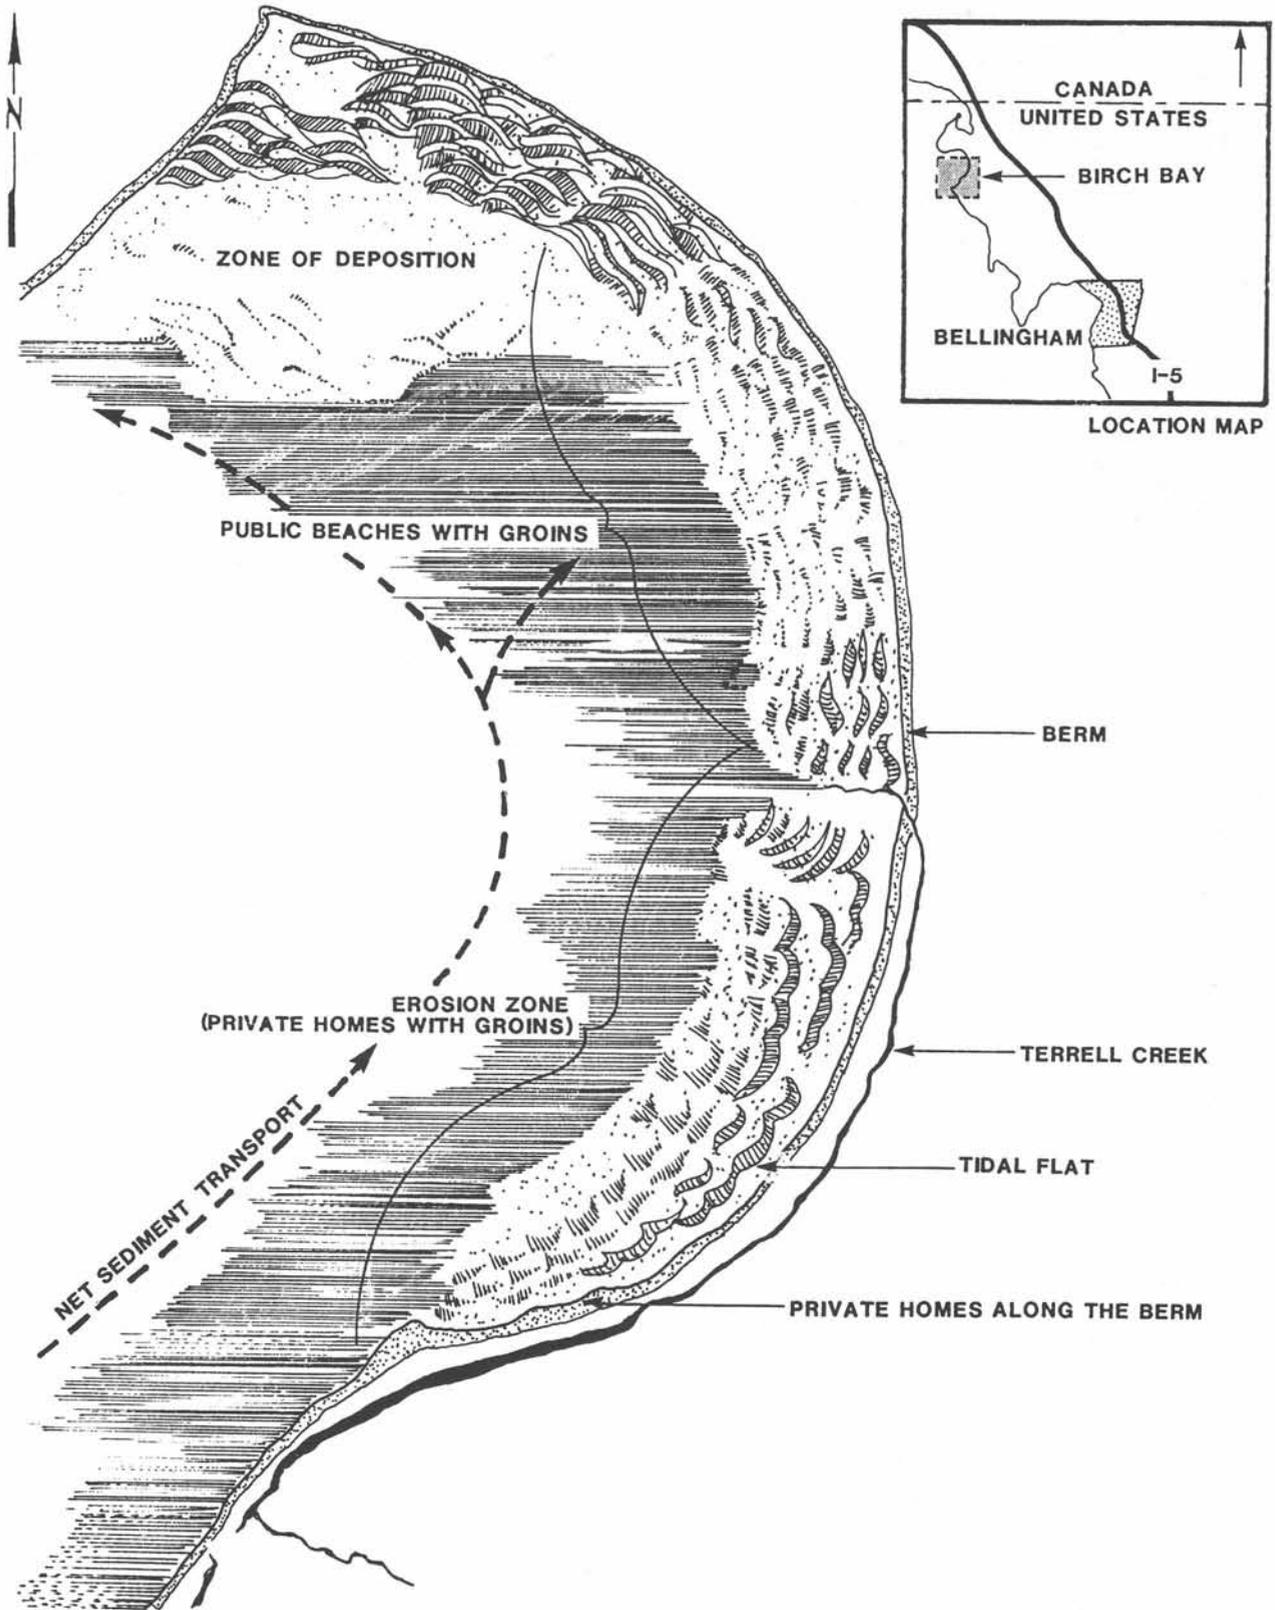
Figure 3. Birch Bay in Whatcom County. Net sediment transport flows from south (bottom) to north (top) in a counterclockwise motion. Homes built on the upper berm along the southeastern part of the shore have "starved" the public beaches to the north of beach sediment.

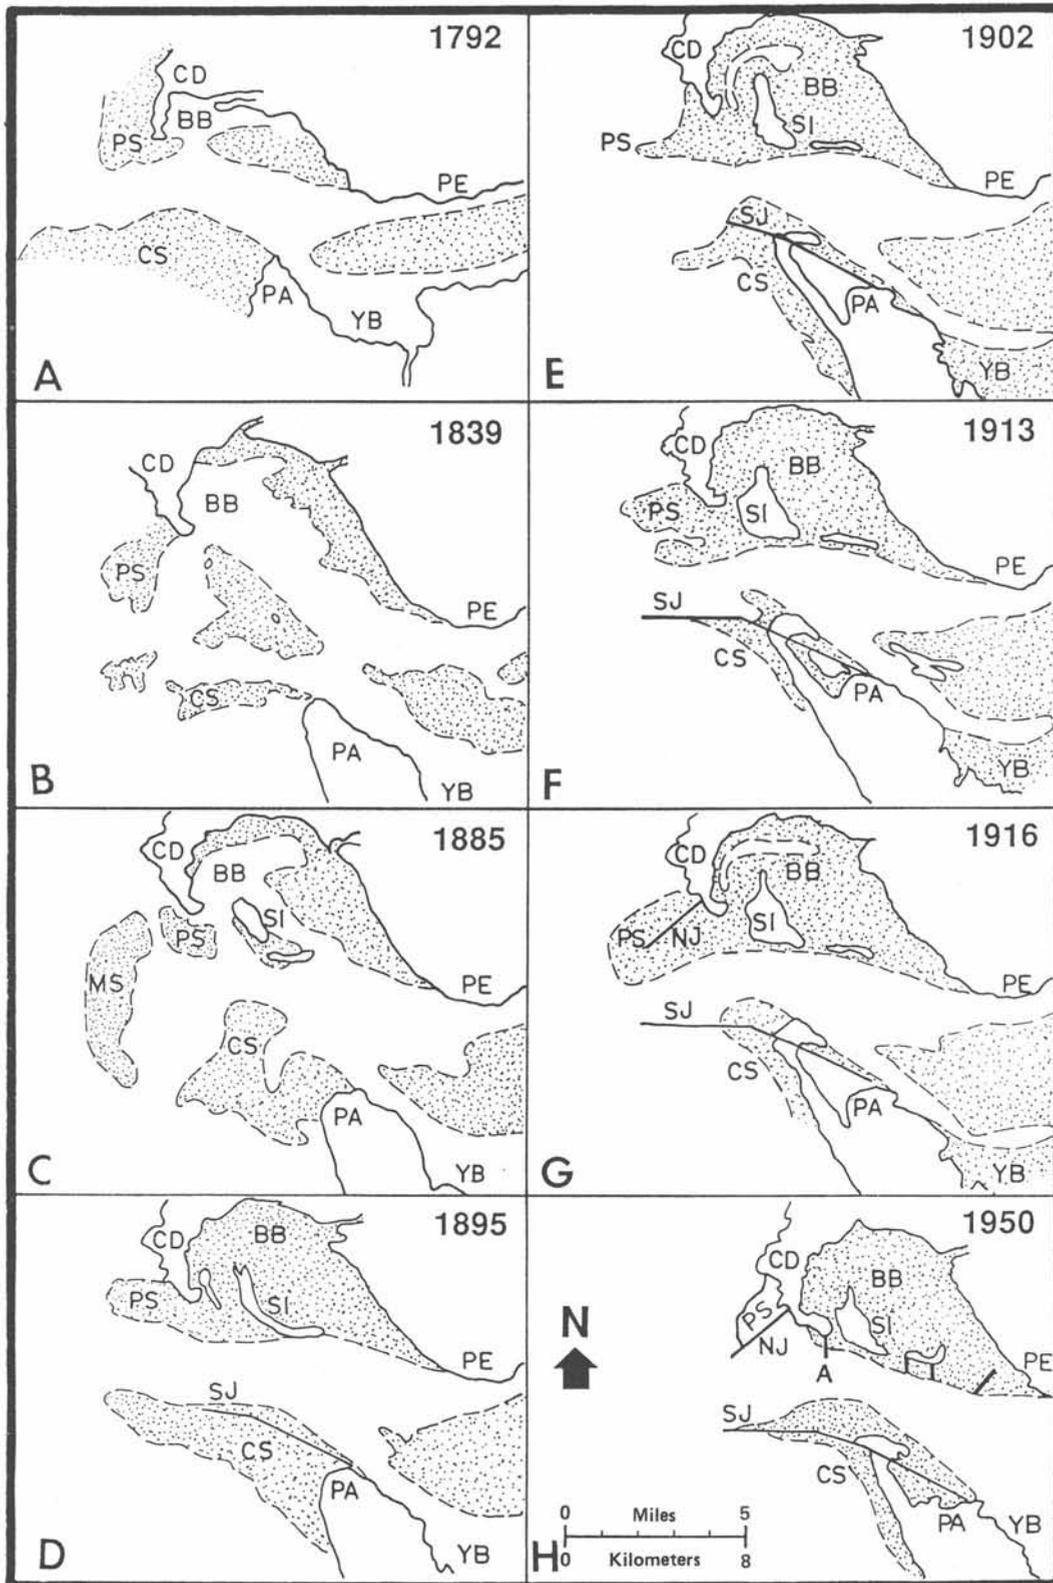
Figure 1. Columbia River entrance changes, 1792-1950. Configuration for 1792 based on a survey by Vancouver; for 1839 based on a survey by Belcher; the others based on U.S. Army Corps of Engineers surveys (after Hickson and Rodolf, 1950). A, Jetty A; BB, Baker Bay; CD, Cape Disappointment; CS, Clatsop Spit; MS, Middle Sands; NJ, North Jetty; PA, Point Adams; PE, Point Ellice; PS, Peacock Spit; SI, Sand Island; SJ, South Jetty; YB, Youngs Bay. Dashed lines represent shoals, solid lines the approximate position of mean high water.

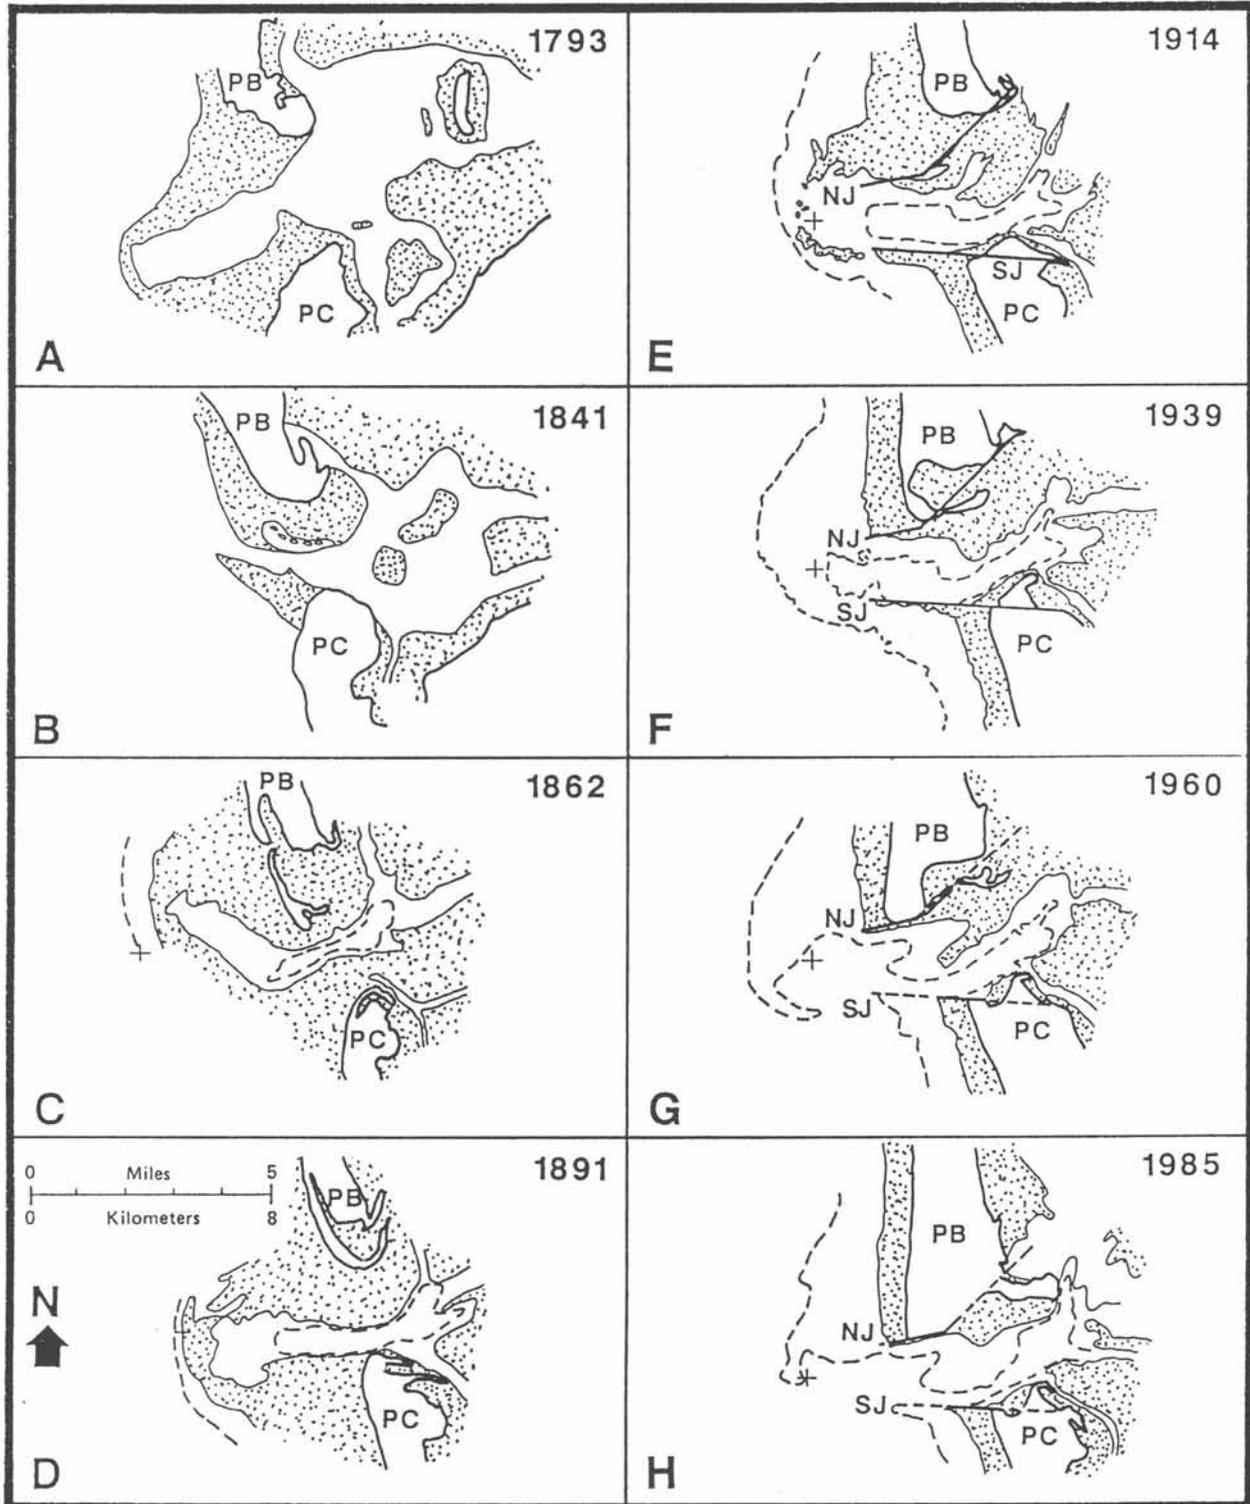
Figure 2. Grays Harbor entrance changes, 1793-1985. Configurations for 1793 are based on the Vancouver survey; for 1841 based on U.S. Exploring Expedition (Wilkes) survey; those for 1862 and 1891 are based on U.S. Coast and Geodetic Survey data. Those for 1914, 1939, and 1960 are based on U.S. Army Corps of Engineers surveys; for 1985 based on a National Oceanic and Atmospheric Administration survey. Stippled area represents area between mean high water and -18 ft. Dashed line represents the approximate position of -36 ft contour. PB, Point Brown; PC, Point Chehalis; NJ, North Jetty; SJ, South Jetty.
