Hydrogeologic Characterization of a Rural Landfill for Compliance Operation and Closure Design

JAMES S. BAILEY and PETER J. ROWLAND
Sweet-Edwards/EMCON, Inc.

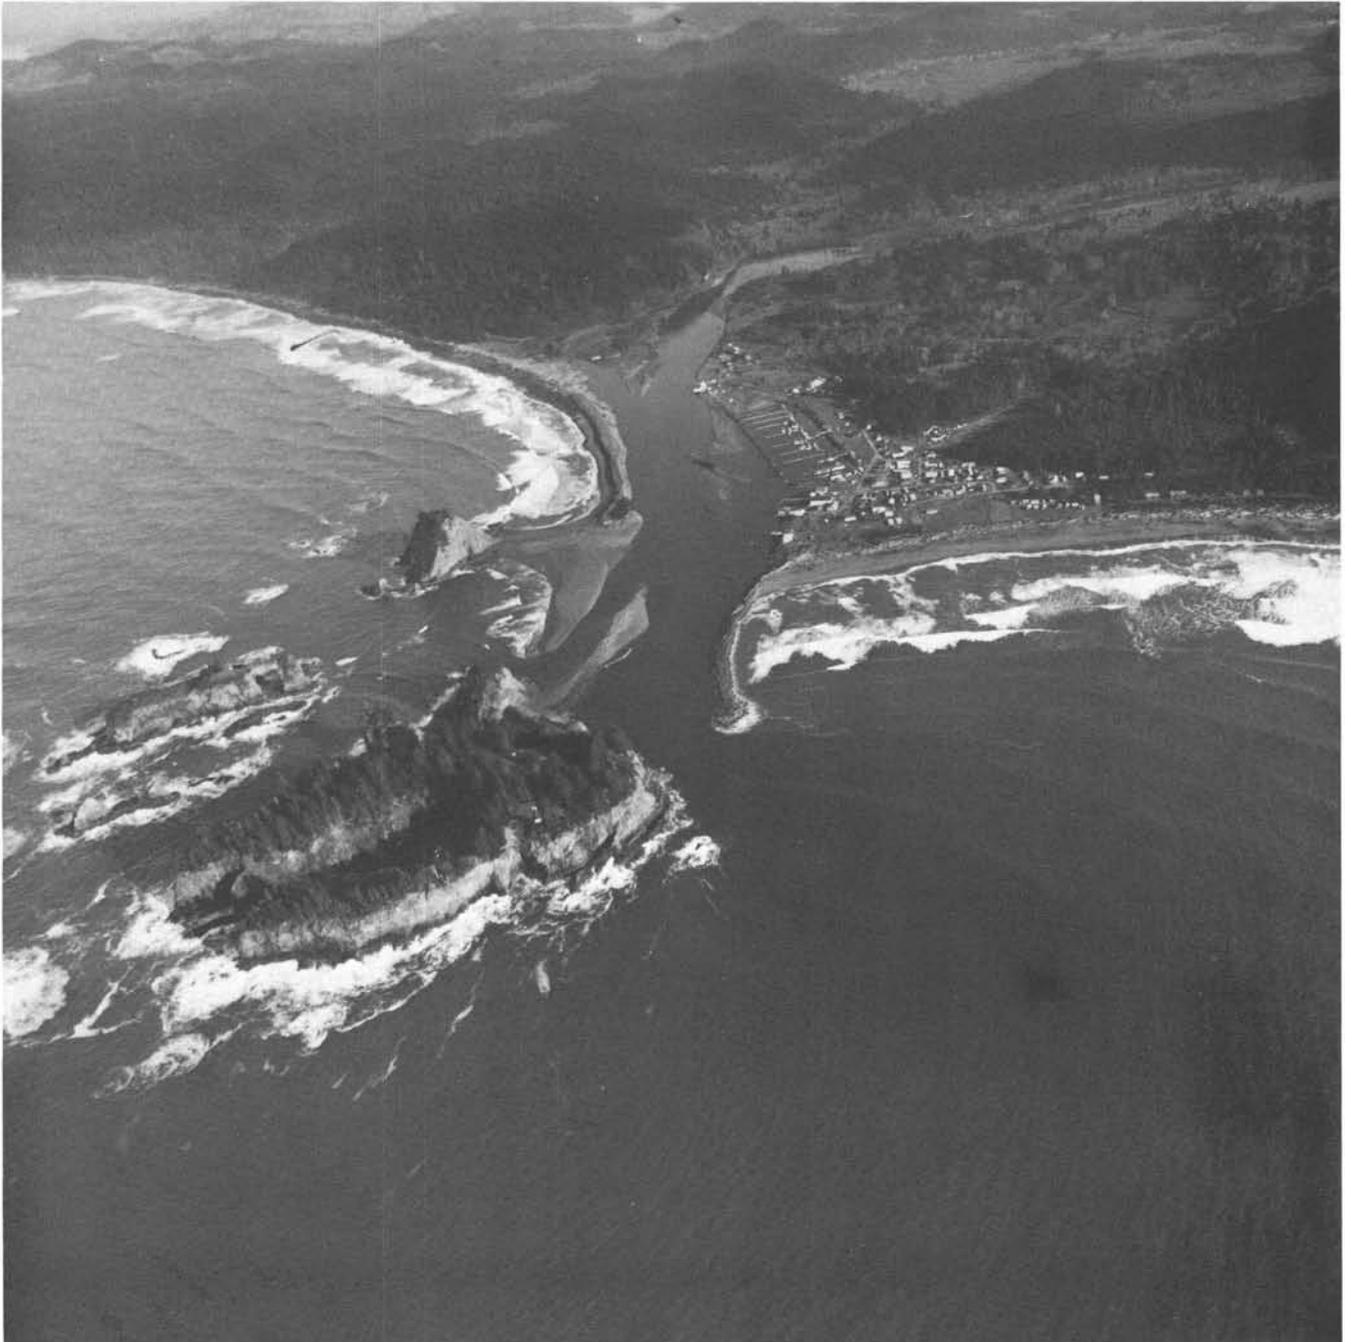
Figure 3. Mouth of Quillayute River and La Push. View to the northeast on January 22, 1980. Quillayute Spit on the left connects Rialto Beach with James Island (foreground) and Rock Island (left center). Revetment on the spit inhibits breaching of the spit and damage to the boat basin on the opposite side of the estuary at La Push. The distal end of the lower spit is breached in this view. The jetty protrudes from the northwest end of First Beach (right). Photo by U.S. Army Corps of Engineers.

ample, are diverted northward in response to the dominant littoral drift direction, the Quillayute is diverted to the south, partly protected from southwest wave action by a group of near-shore stacks, including James and Rock islands (Figure 3). A narrow cobble-

gravel-sand spit, Quillayute Spit, has formed on the right bank (ocean side) of the estuary, ephemerally connecting the right bank headland, in which it is rooted, with James and Rock islands. While the spit appears to owe its origin to wave action from the west and northwest, the material forming the feature originates from limited northward littoral drift and flood detritus from the Quillayute River itself. During some large river floods, the spit has been breached, sometimes near its root at Rialto Beach, and it was probably periodically breached by westerly ocean storms although it is protected from southwest winds. An adequate supply of littoral material permitted rapid healing to its normal form. The last historic record of breaching by the river was in 1876, when a log jam at the river mouth resulted in a breaching near the root. Gradual southerly migration of the outlet occurred, and the outlet reached its present position in 1911.

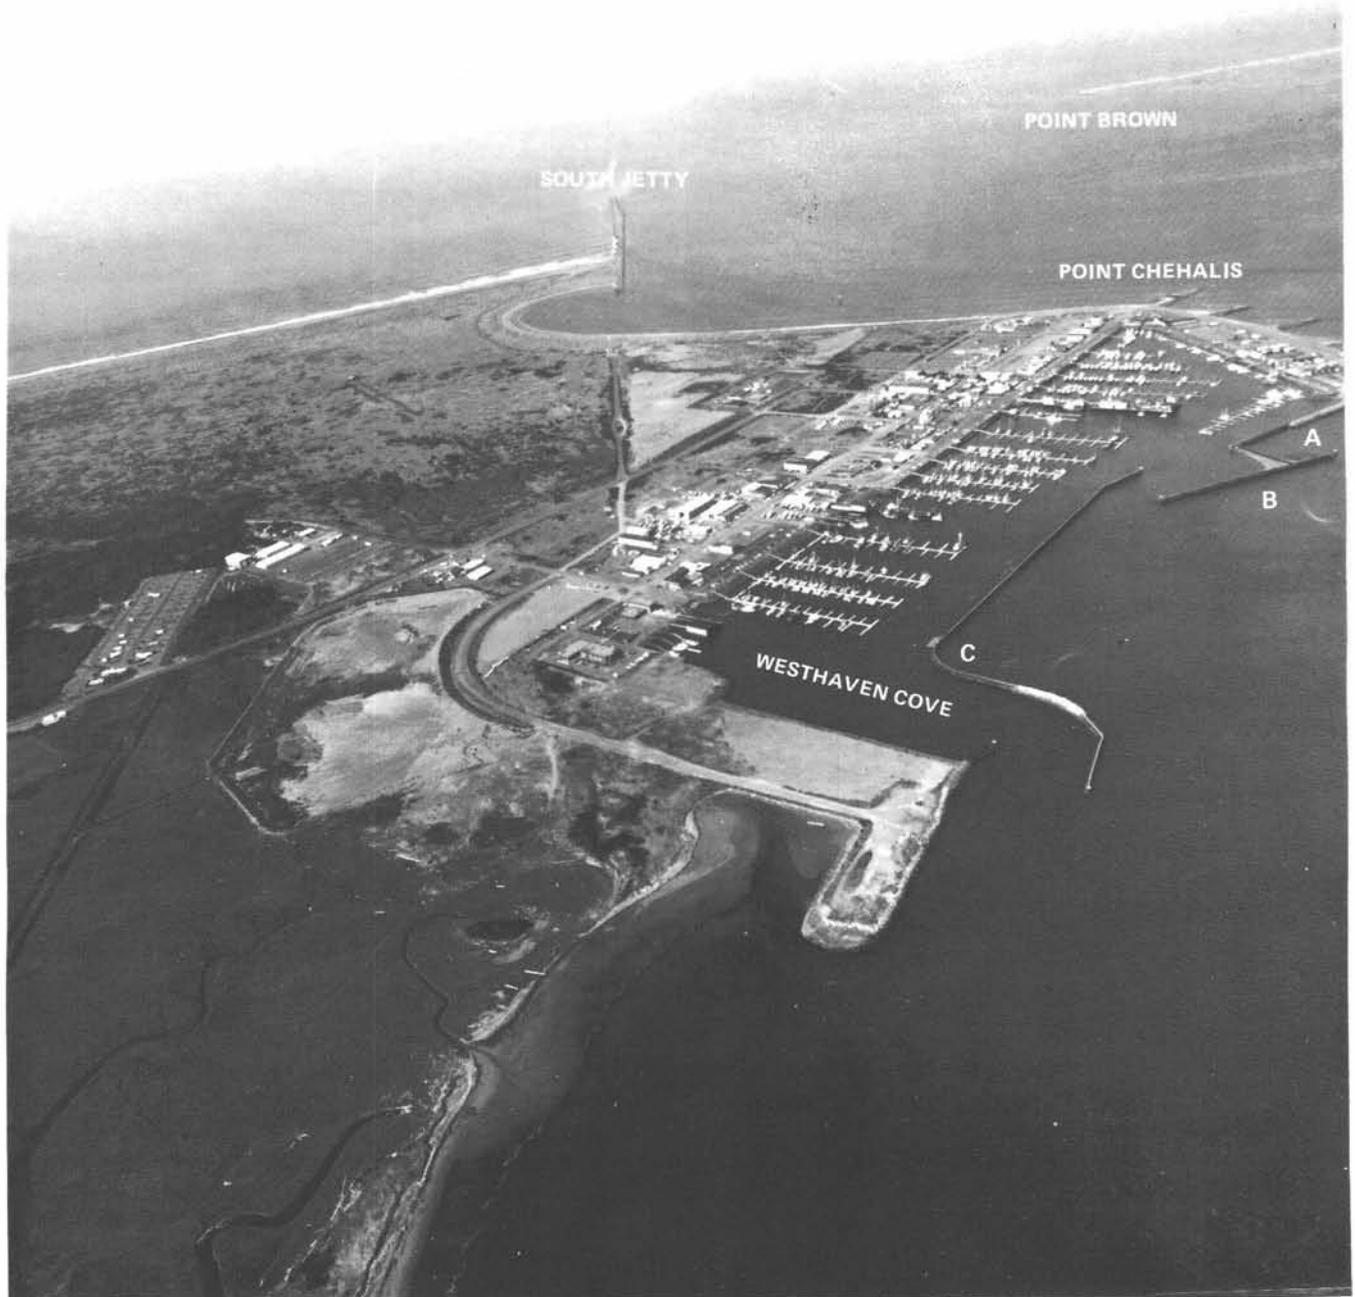
Figure 4. Point Chehalis, Westhaven Cove, and mouth of Grays Harbor, September 15, 1981. View west along the axis of South Jetty showing both former and present positions of the jetty and the accreted lands to the north and south. Groins protecting Point Chehalis are at the far right-center. Point Brown is at the upper right corner. Breakwaters A and B are at far right; breakwater C is the long structure at right center. Photo by U.S. Army Corps of Engineers.

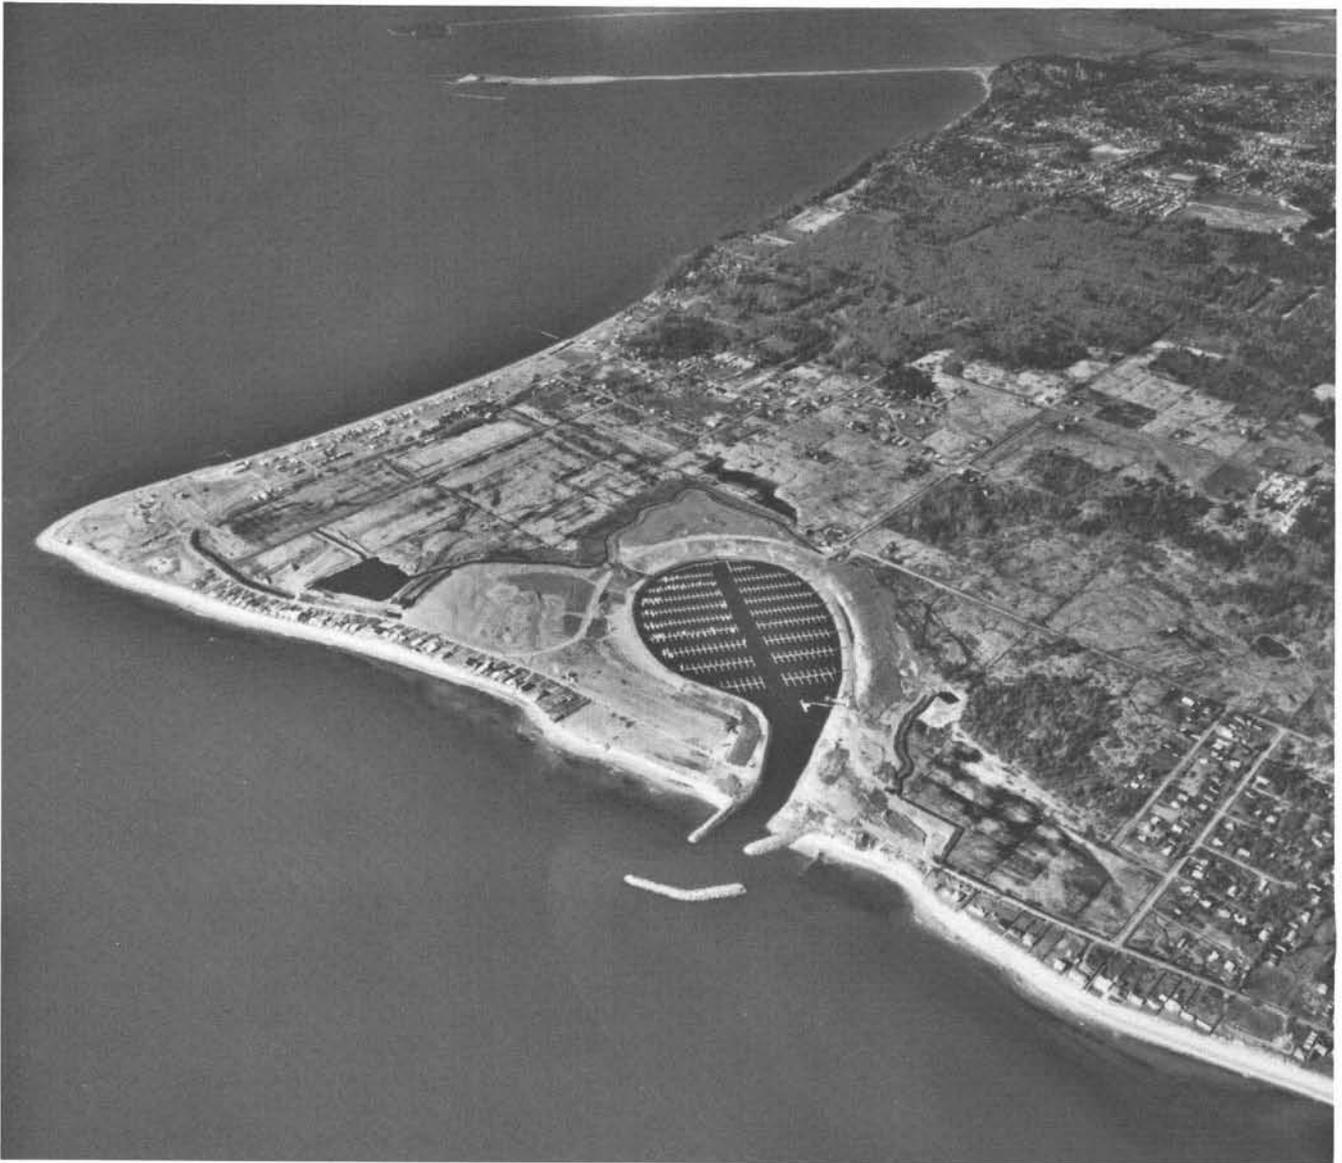
Figure 5. Point Roberts breakwater and boat basin, March 2, 1978. View to the northwest, Lighthouse Point on the left. Causeways at Tsawwassen, B.C., are in the background. Photo courtesy of J. A. Layton, Layton and Sell.

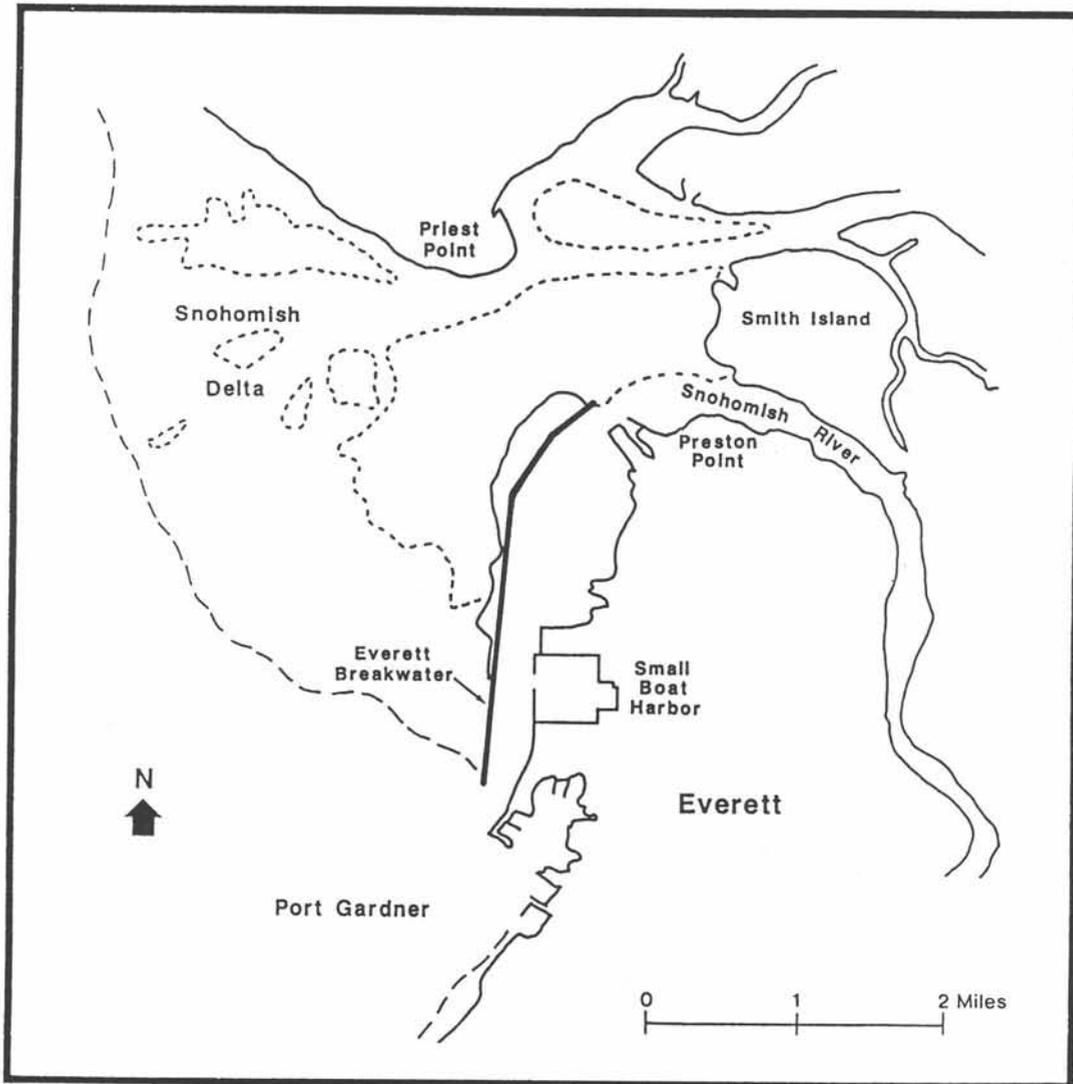
Figure 6. Everett breakwater and the mouth of the Snohomish River. Dashed line shows the landform at -9 ft. Dotted line represents MLLW. The area of proposed U.S. Navy facilities lies south of the small boat harbor and fronts directly on Port Gardner. Taken from National Oceanic and Atmospheric Administration chart 18444.

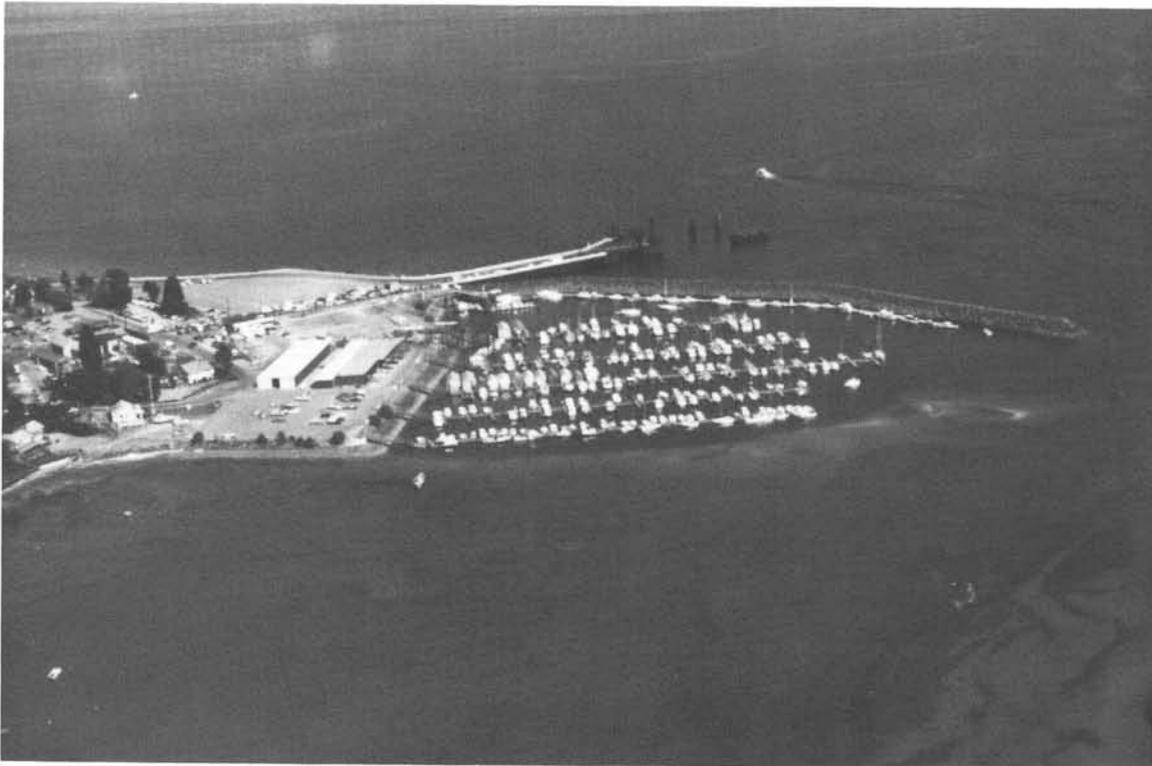
Figure 8. Kingston boat basin and breakwater at Apple Tree Cove. Note shallow water in foreground, outside dredged basin. State ferry dock lies beyond the breakwater at the center.

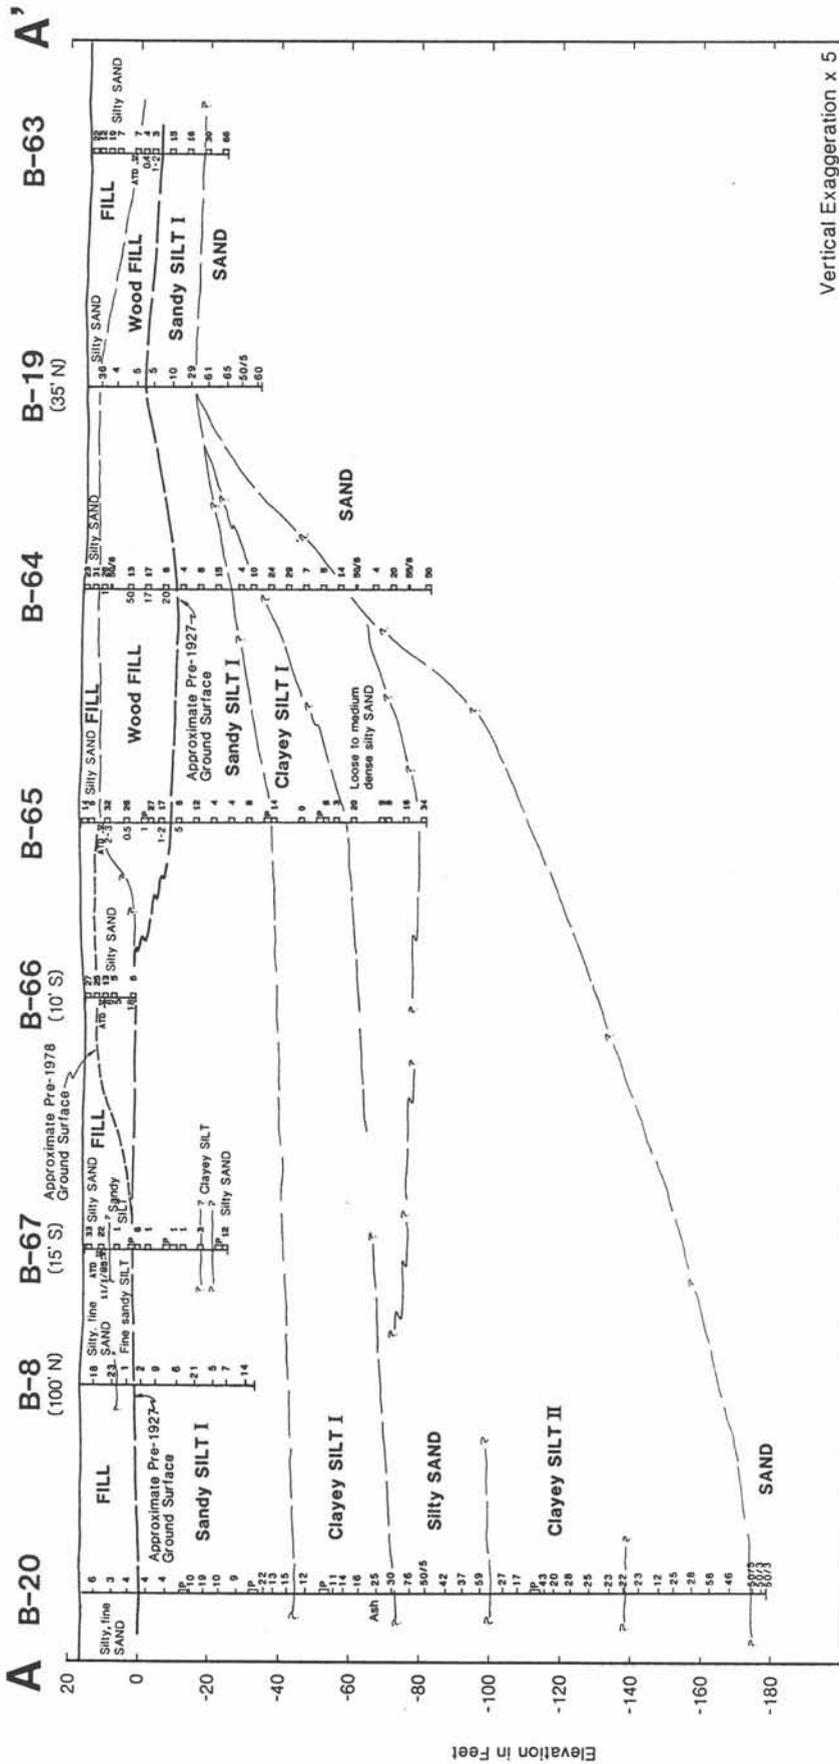
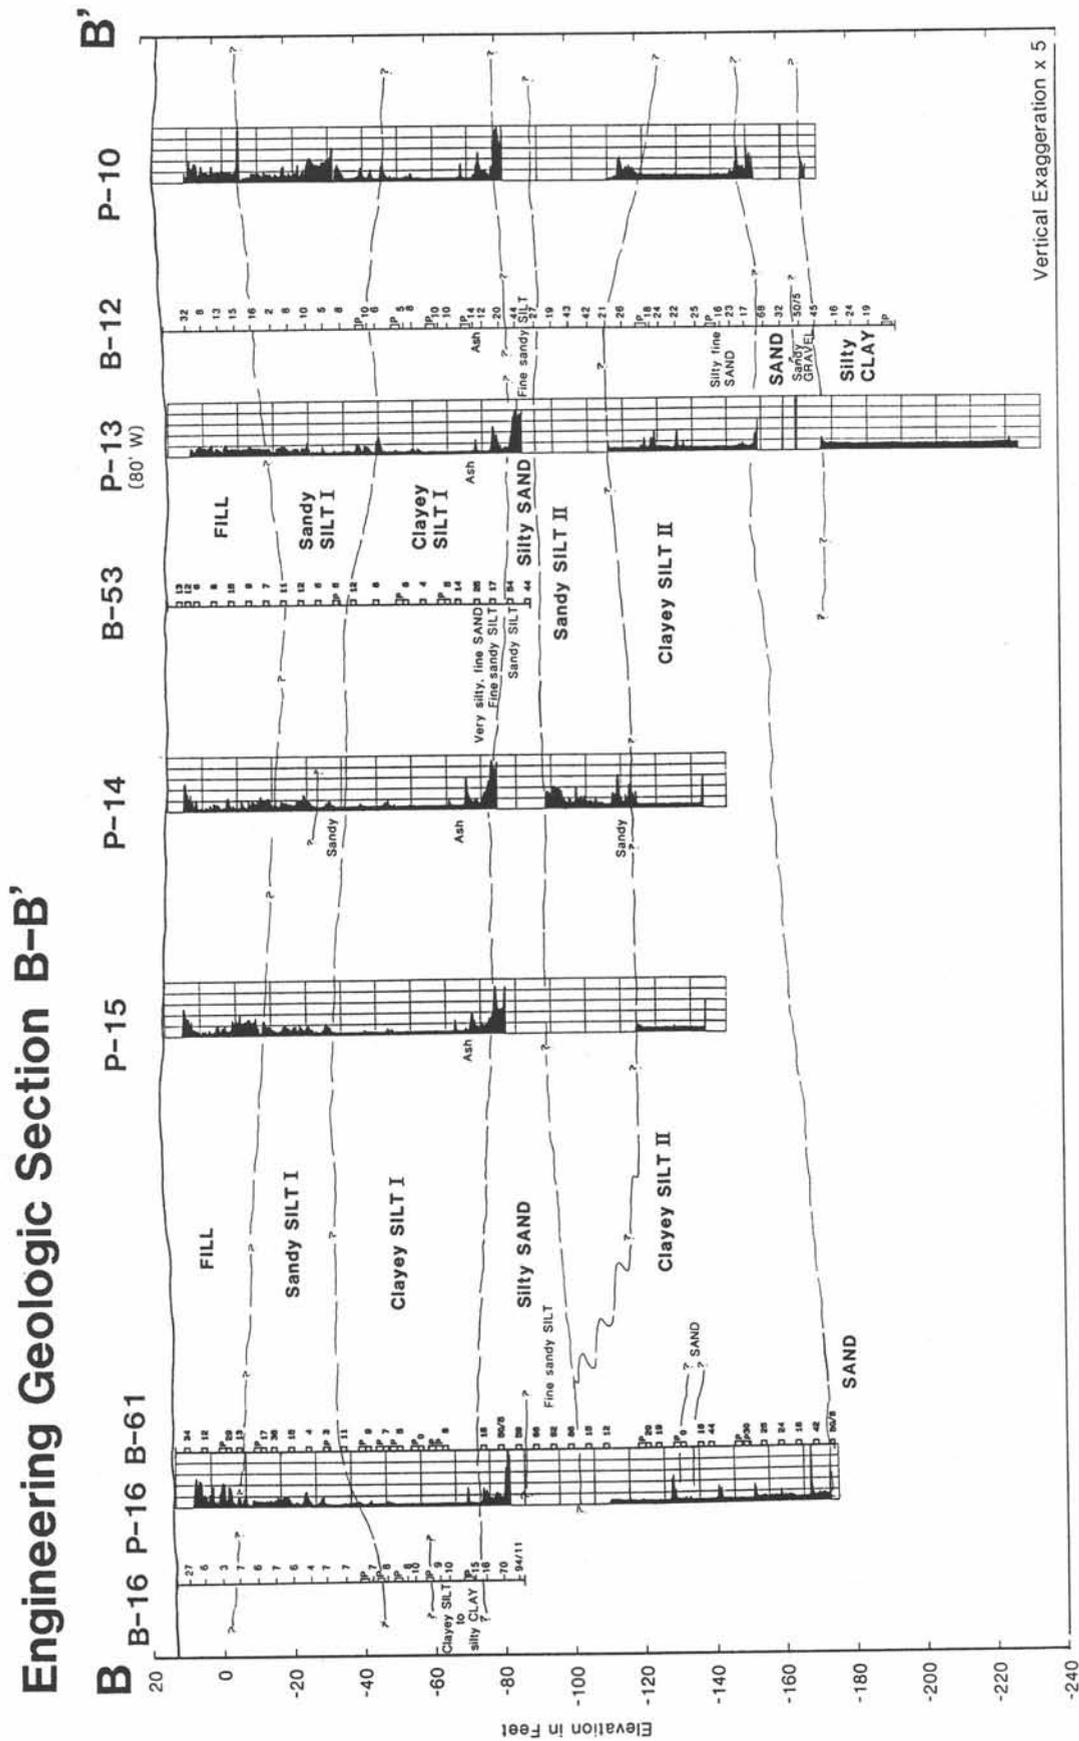
Figure 3. Generalized engineering geologic sections representative of deltaic stratigraphy near Port Gardner. Section A-A' shows offshore to onshore conditions. Section B-B' is a north-south section about 100 ft offshore.

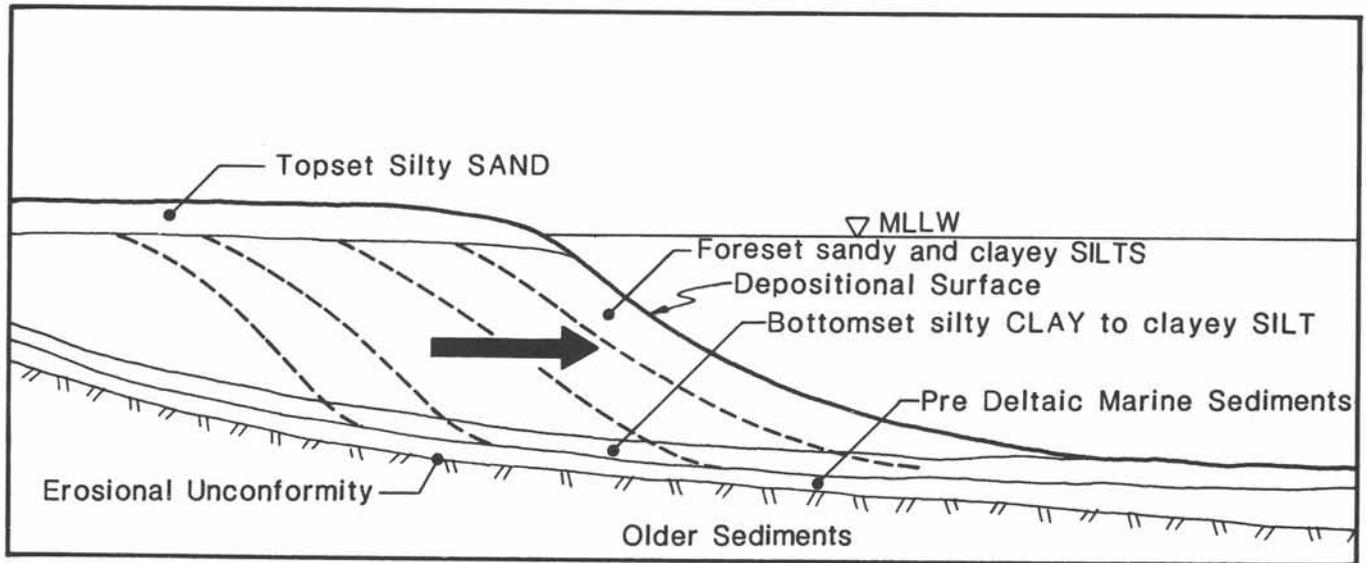
Figure 4. Diagrammatic representation of the internal structure of a prograding delta.

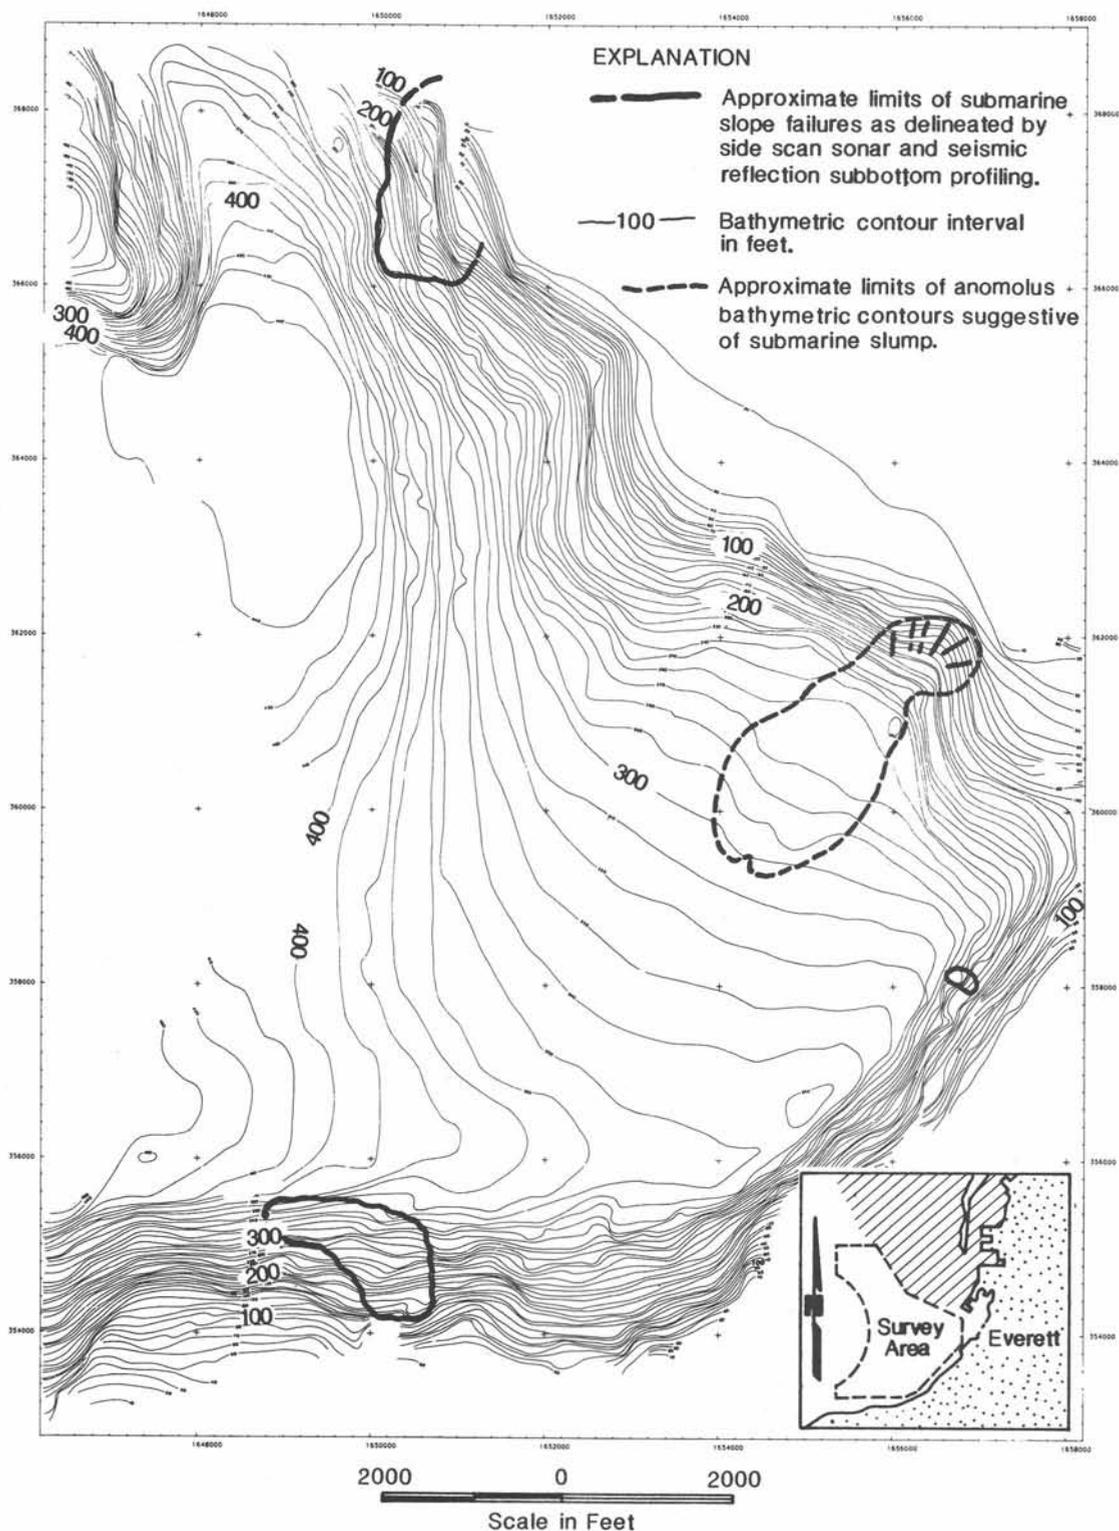
Figure 6. Bathymetric contour map prepared from high resolution subbottom profiling for a portion of the Snohomish river-mouth delta (NORTEC, 1985). Identification of slope failures from seismic reflection data by NORTEC. Geomorphic interpretation of submarine failure is by the authors.

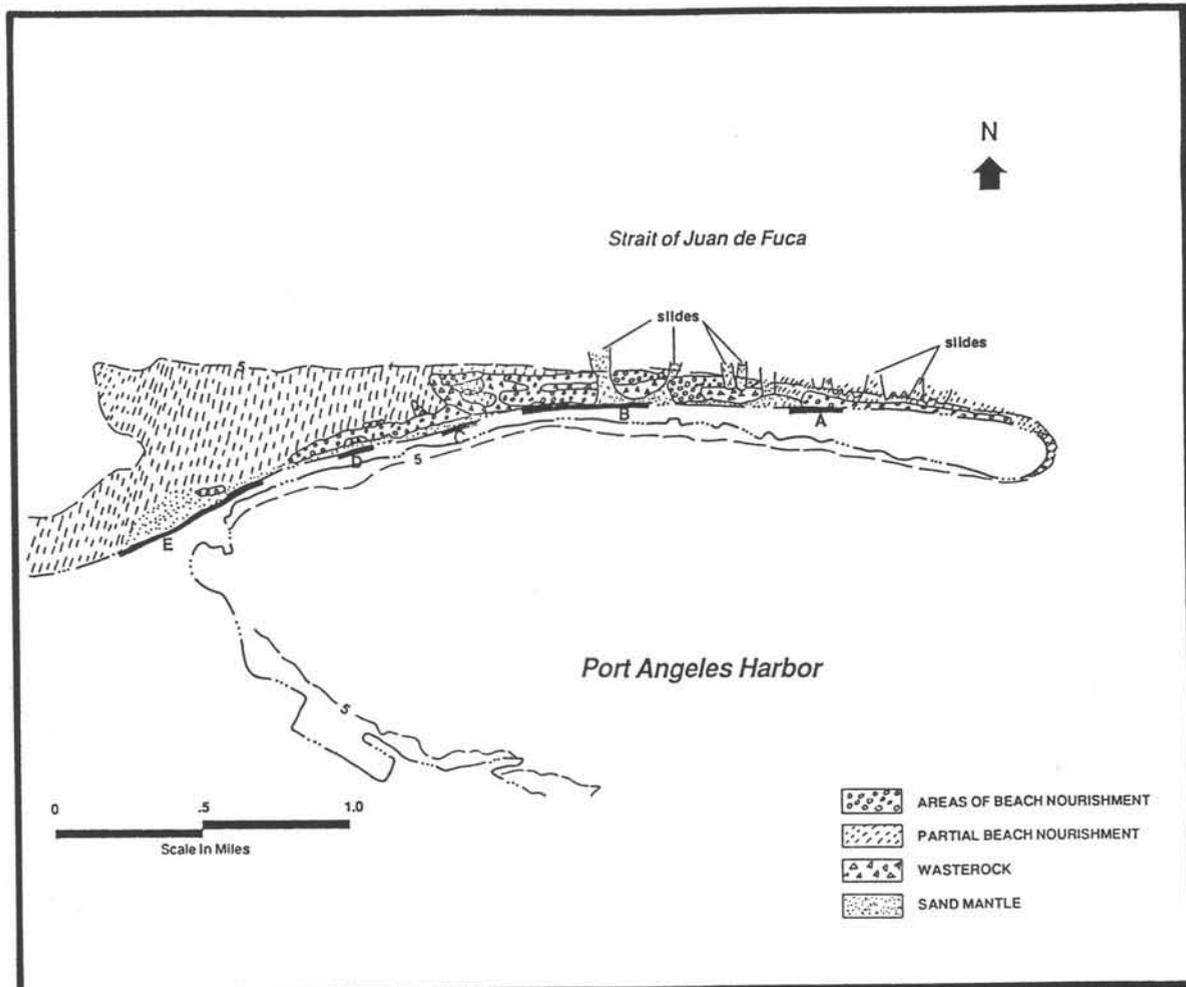
Figure 5. Ediz Hook. Project condition in October 1983 from interpretation of side-scan sonar and grab sample data to approximately the 5-fathom contour.

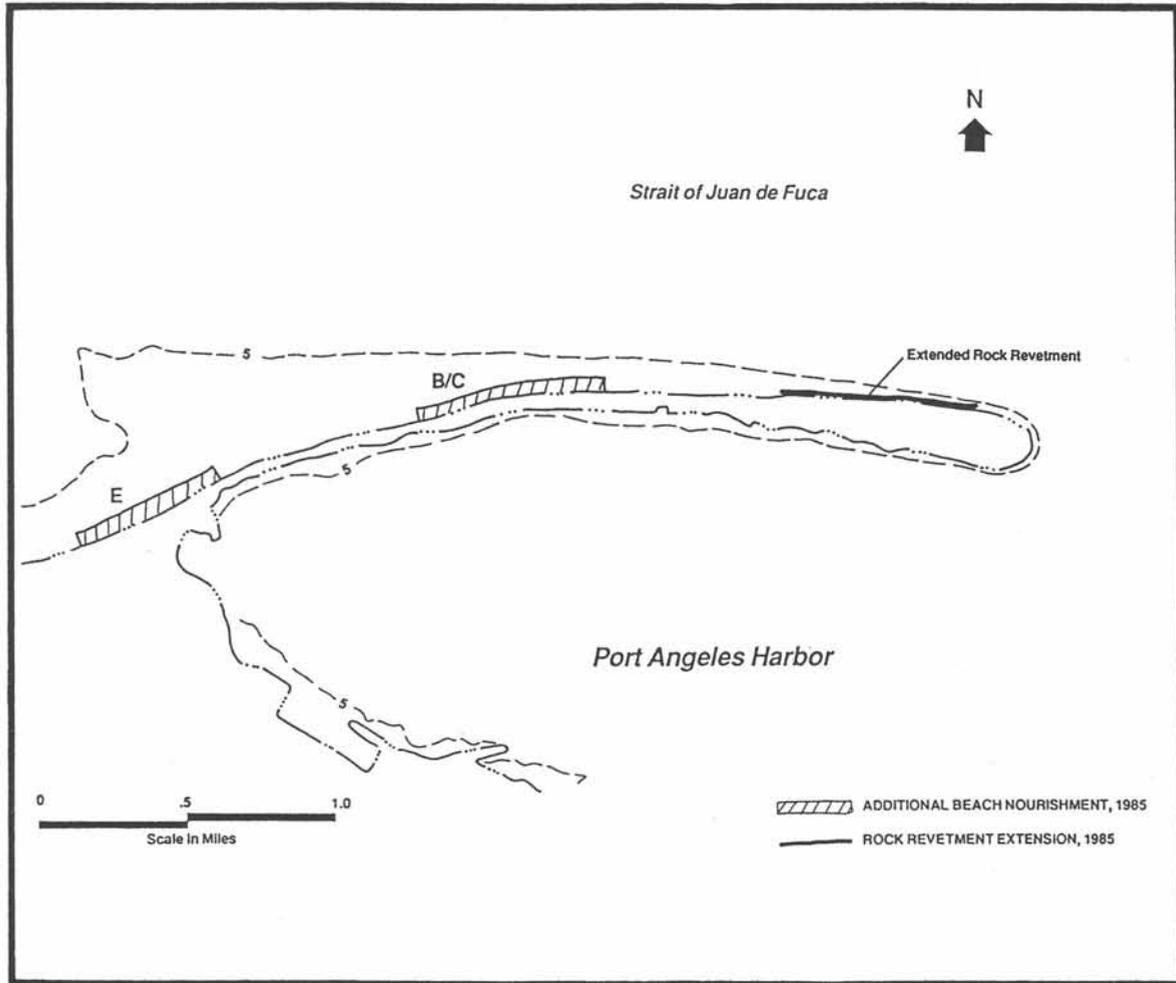
Figure 6. Ediz Hook. Project rehabilitation in 1985 (5-fathom contour shown).

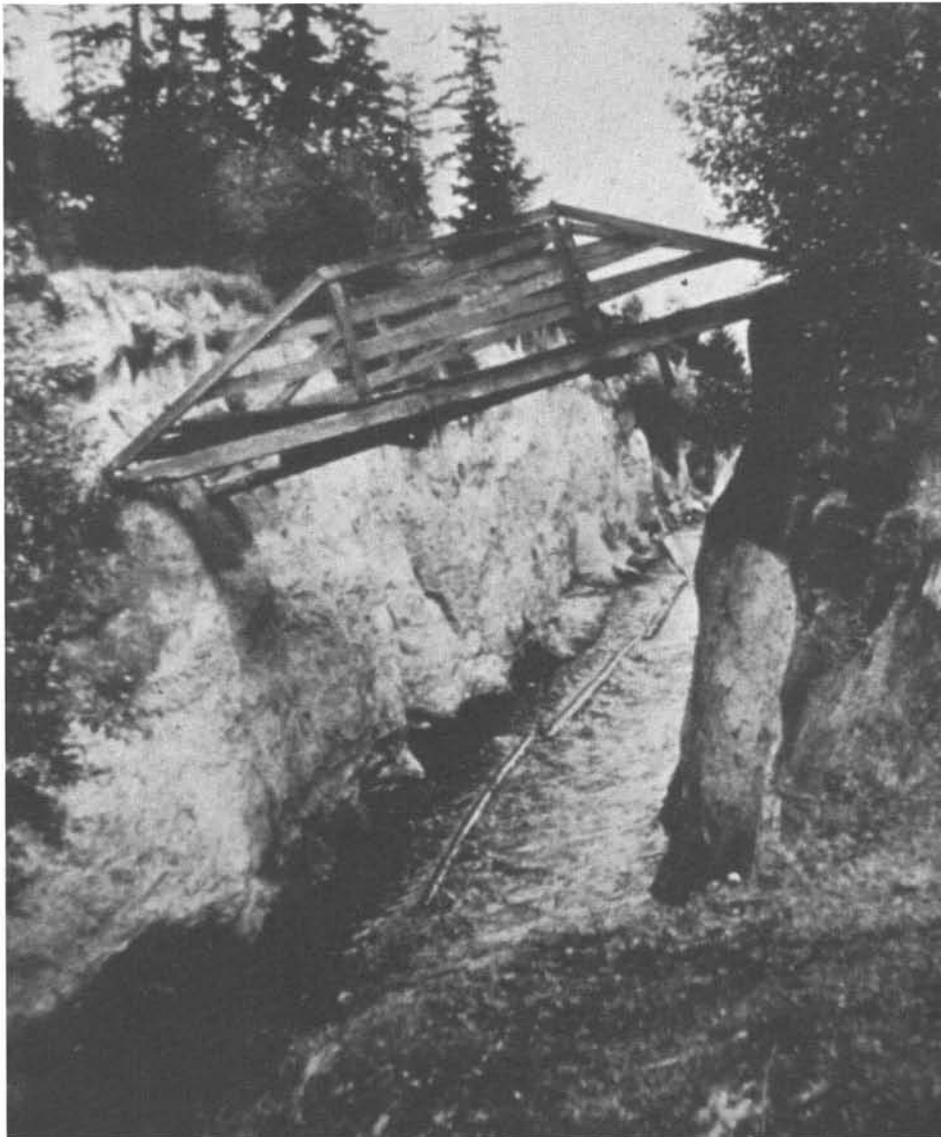
Figure 3. Lake Washington Ship Canal. Portage log canal in about 1911; view to the west showing steep cut in Vashon till and an early edition of the Montlake Bridge. Photo from U.S. Army Corps of Engineers collection.

reached an elevation of about 80 ft. The construction of a log chute through the isthmus in the mid-1880s and the wooden control structure at the Union Bay outlet resulted in a narrow, near-vertical cut through the till which withstood serious erosion for a quarter of a century (Figures 3 and 4). The log chute was cut a short distance south of the present Montlake cut and exited into Union Bay southeast of the present Seattle Yacht Club; it was backfilled following completion of the cut. Borings drilled in 1911 showed that the till surface beneath the Portage Bay section of the canal varied from MLLW to -10 ft; a local rise to elevation 18 ft exists on the south side near the present University Bridge. On the Union Bay (Lake Washington) side, the till surface dropped off sharply to well below MLLW, and the channel into Lake Washington was largely dredged in mud and soft clay, an ooze which was later found to extend to considerable depths. The single exception to this was just north of Foster Island, where a narrow rib of till rose to elevation 25 ft, a mere 5 ft below the nominal level of the lake.

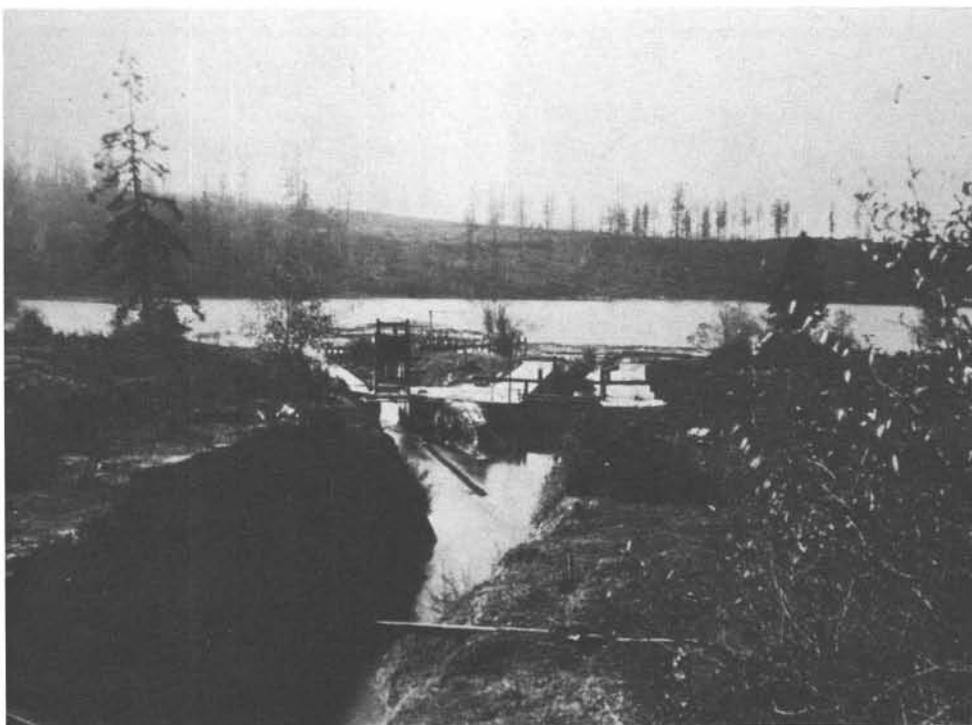
Figure 4. Lake Washington Ship Canal. Wooden control works at Union Bay (east) end of Portage log canal, 1911. In addition to the log chute head gate, the structure included a wooden lock (right) for transit of small craft between Lake Union and Lake Washington. View to the northeast across Union Bay to what is now the Laurelhurst district. Photo from U.S. Army Corps of Engineers collection.

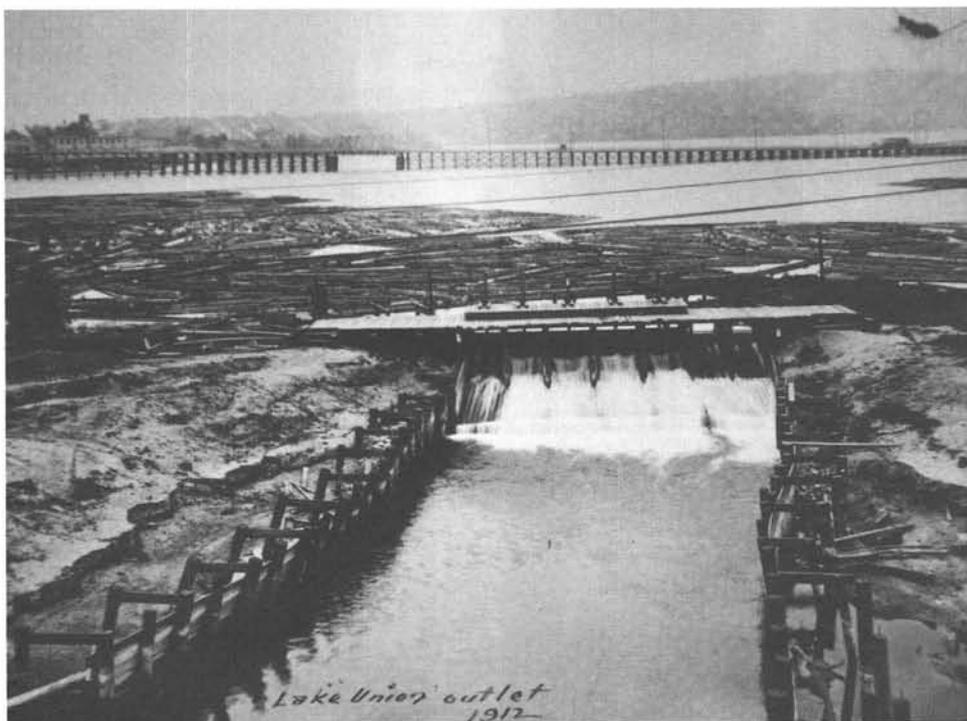
Figure 5. Lake Washington Ship Canal. Original wooden control structure at Lake Union outlet just east of the present Fremont Bridge as seen from the west. The structure failed in March 1914 and was replaced by a second wooden structure pending project completion. Photo from U.S. Army Corps of Engineers collection.

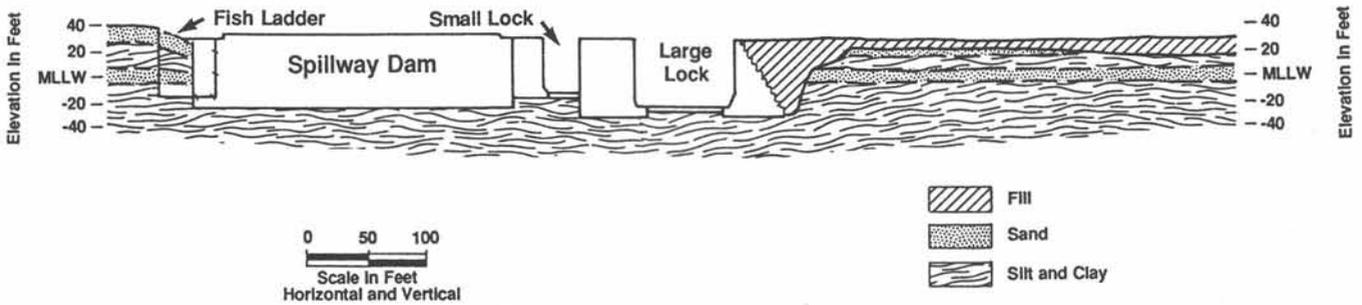
Figure 7. Geologic section through Chittenden Dam and Locks on the Lake Washington Ship Canal. View northwest (downstream) toward Shilshole Bay.

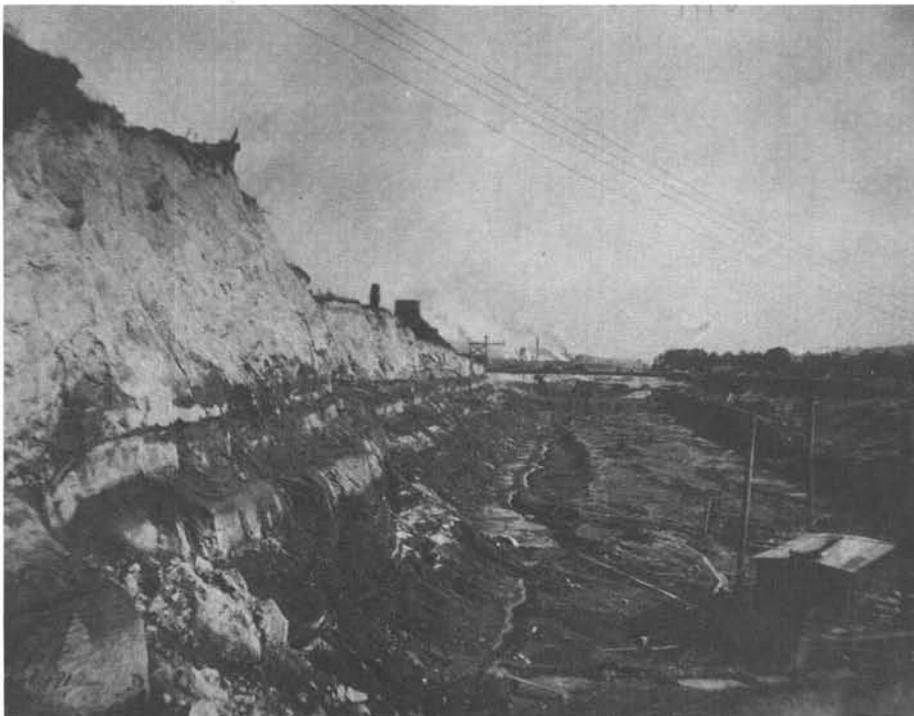
Figure 8. Excavation for large lock chamber at Chittenden Dam and Locks, Lake Washington Ship Canal. View SSE toward Salmon Bay. Here, the Lawton Clay and the overlying sand and silt are well exposed in the north wall of excavation. Photo by U.S. Army Corps of Engineers, October 1912.

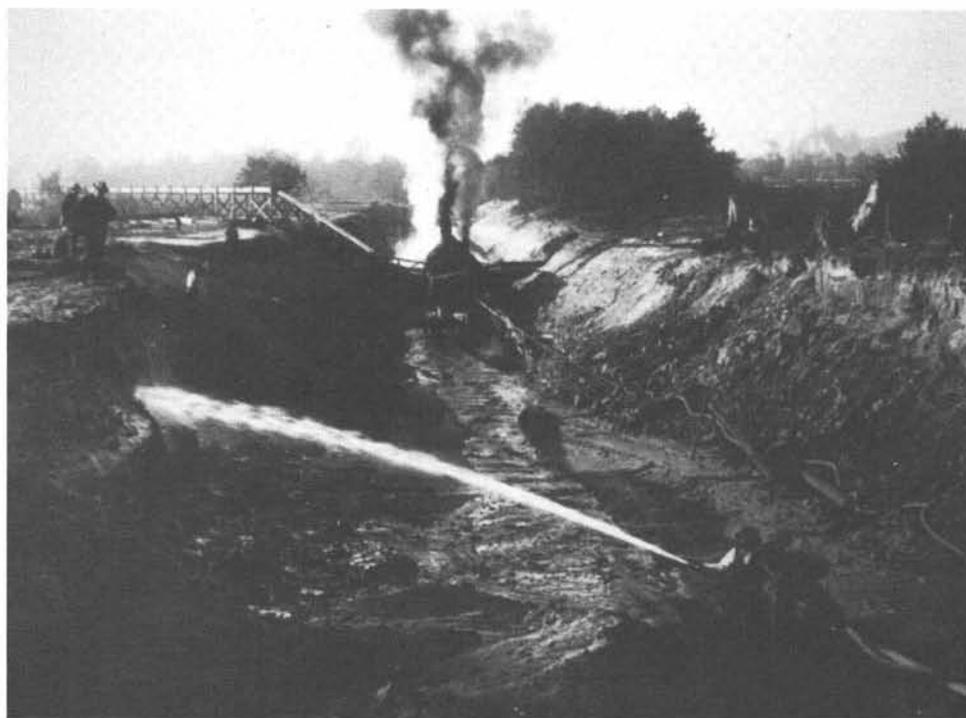
Figure 9. Excavation of Fremont cut, Lake Washington Ship Canal, in 1912. View to the northwest showing sluicing and pumped slurry activities for excavation and material transport. Photo from U.S. Army Corps of Engineers collection.

Construction of the ship canal through this area was done during 1911 and 1912 largely by hydraulic sluicing and steam shovel (Figure 9). Much of the material was disposed of on adjacent lands as a pumped slurry. The predominantly soft material in the cut was found to be highly susceptible to erosion, requiring a temporary pile and timber revetment for control. This was replaced several years later by the present concrete revetment, which extends several feet below canal water level and rests on piling backed by brush mats (fascines). Although several minor failures have occurred through the fascine and pile section over the years (largely as a result of excavation for placement of buried utilities), the basically unlined channel has served well.

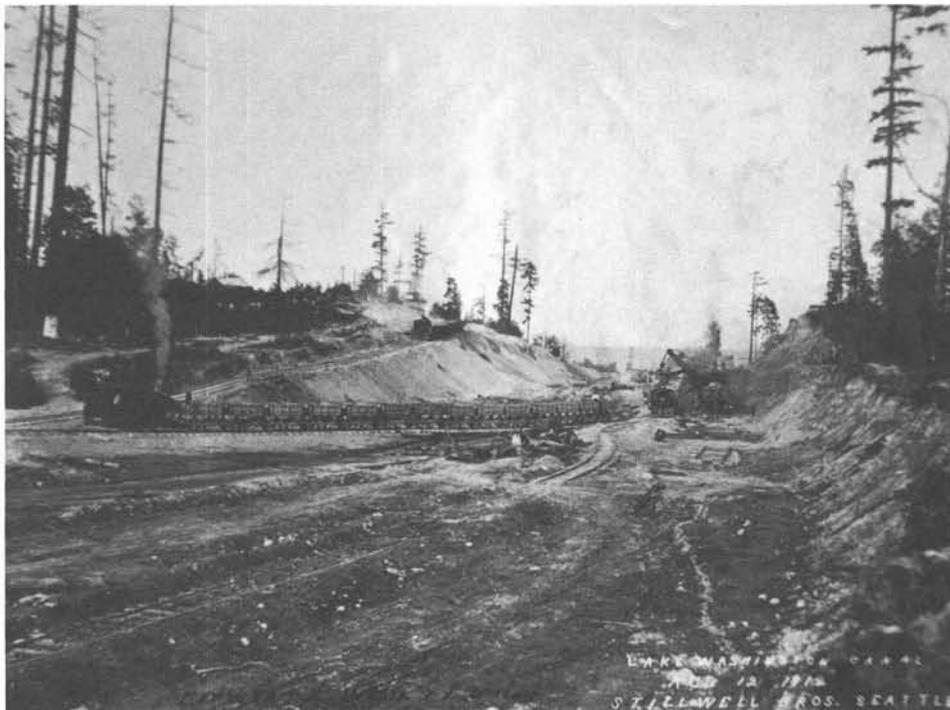
Figure 10. Excavation of Portage (Montlake) cut. View to the east on August 12, 1912. Photo from U.S. Army Corps of Engineers collection.

Construction of the Montlake cut took place between 1912 and 1914. Excavation was mainly by steam shovel, and material was removed by muck cars on rails (Figure 10). Concern for bank erosion resulted in construction of concrete walls on both banks. The south bank concrete wall, completed in 1914, was founded at eleva-
