Hydrogeologic Characterization of a Rural Landfill for Compliance Operation and Closure Design

JAMES S. BAILEY and PETER J. ROWLAND
Sweet-Edwards/EMCON, Inc.

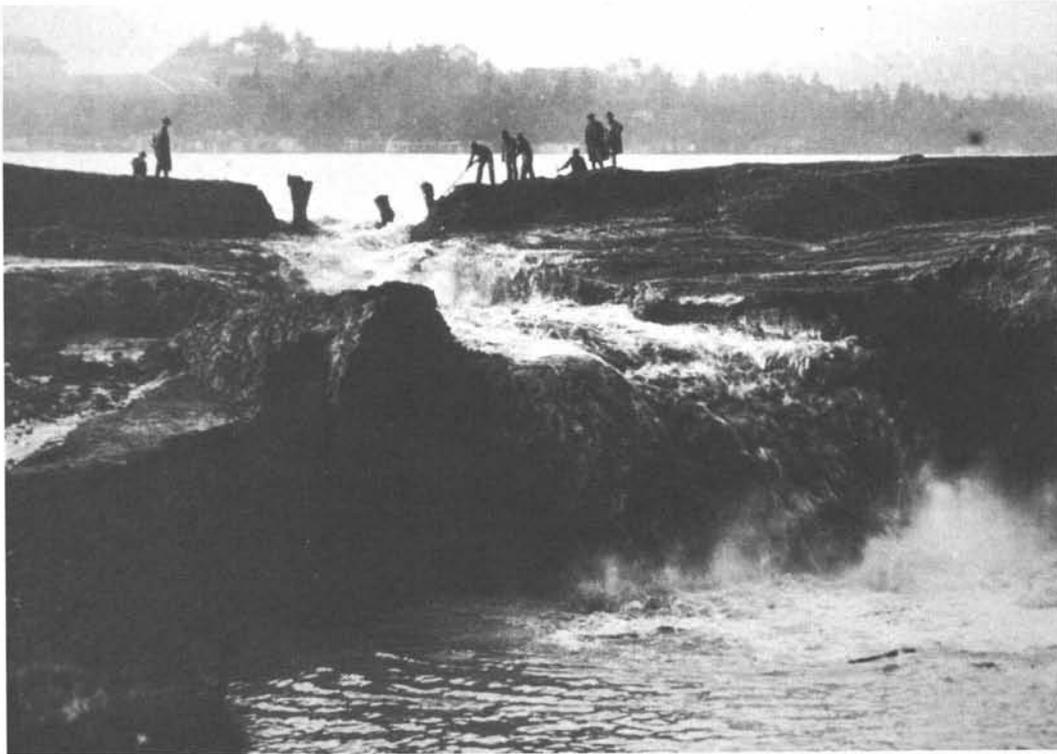
Figure 11. Breaching of cofferdam at west end of Portage (Montlake) cut, Lake Washington Ship Canal, August 25, 1916. View southwest across Portage Bay to Capitol Hill. Photo from U.S. Army Corps of Engineers collection.

The final cut to change the outlet of Lake Washington from the Black River to Montlake was made in August 1916, permanently rerouting the drainage of the Cedar and Sammamish basins through the Lake Washington Ship Canal. At 2:00 p.m. on August 25, the cofferdam on the Portage Bay (west) end of the cut was breached (Figure 11), and the water from Lake Union filled the cut in about an hour (*Seattle Times*, August 26, 1916). Three days later, gates at the temporary wooden control works on the Union Bay (east) end were opened. The level of Lake Washington gradually dropped in 4 to 5 weeks, exposing a wave cut terrace around much of its periphery. On the Seattle

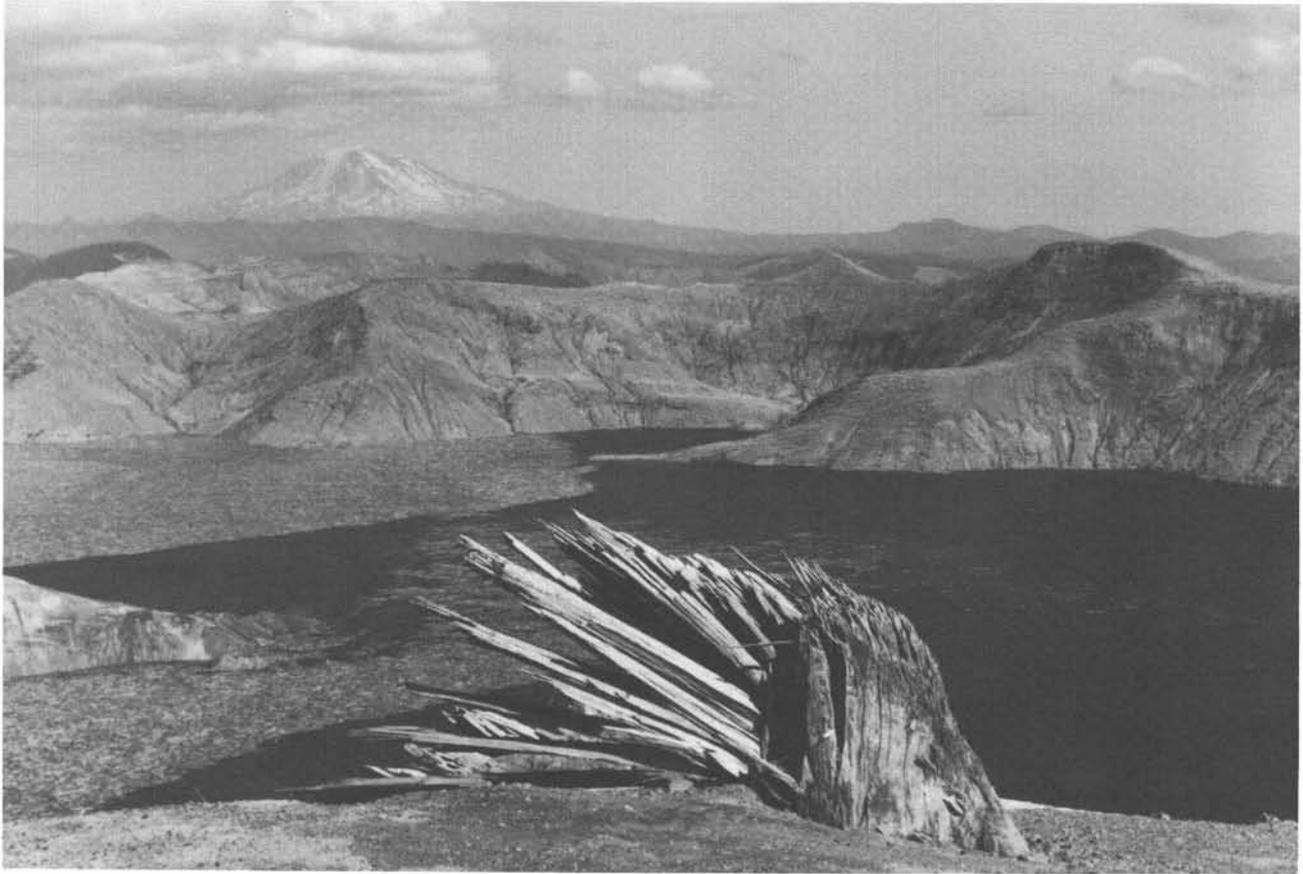
Figure 6. Stump (about 1 1/2 m high) of fir tree located 8 km north of the volcano. Large trees were wrenched from their stumps during the passage of the dense, high-velocity blast cloud. Note that the lateral blast has stripped nearly all vegetation from the slopes surrounding Spirit Lake. Volcano in background is Mount Adams. Photograph by Lyn Topinka, U.S. Geological Survey.

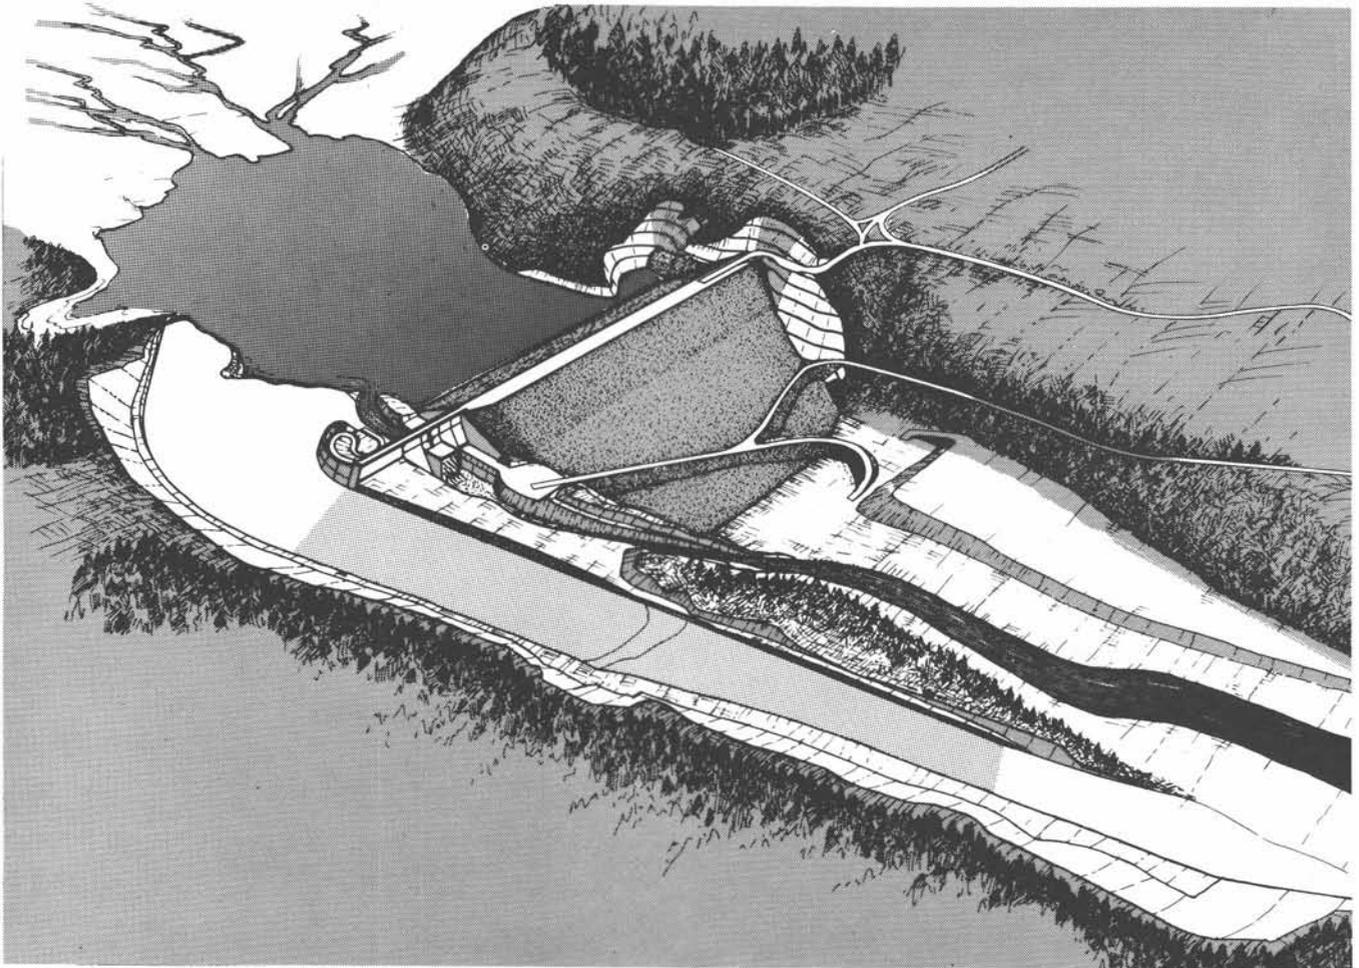
Figure 7. Diagram of sediment-retention structure currently under construction on the North Fork Toutle River. Courtesy of U.S. Army Corps of Engineers, Portland District.

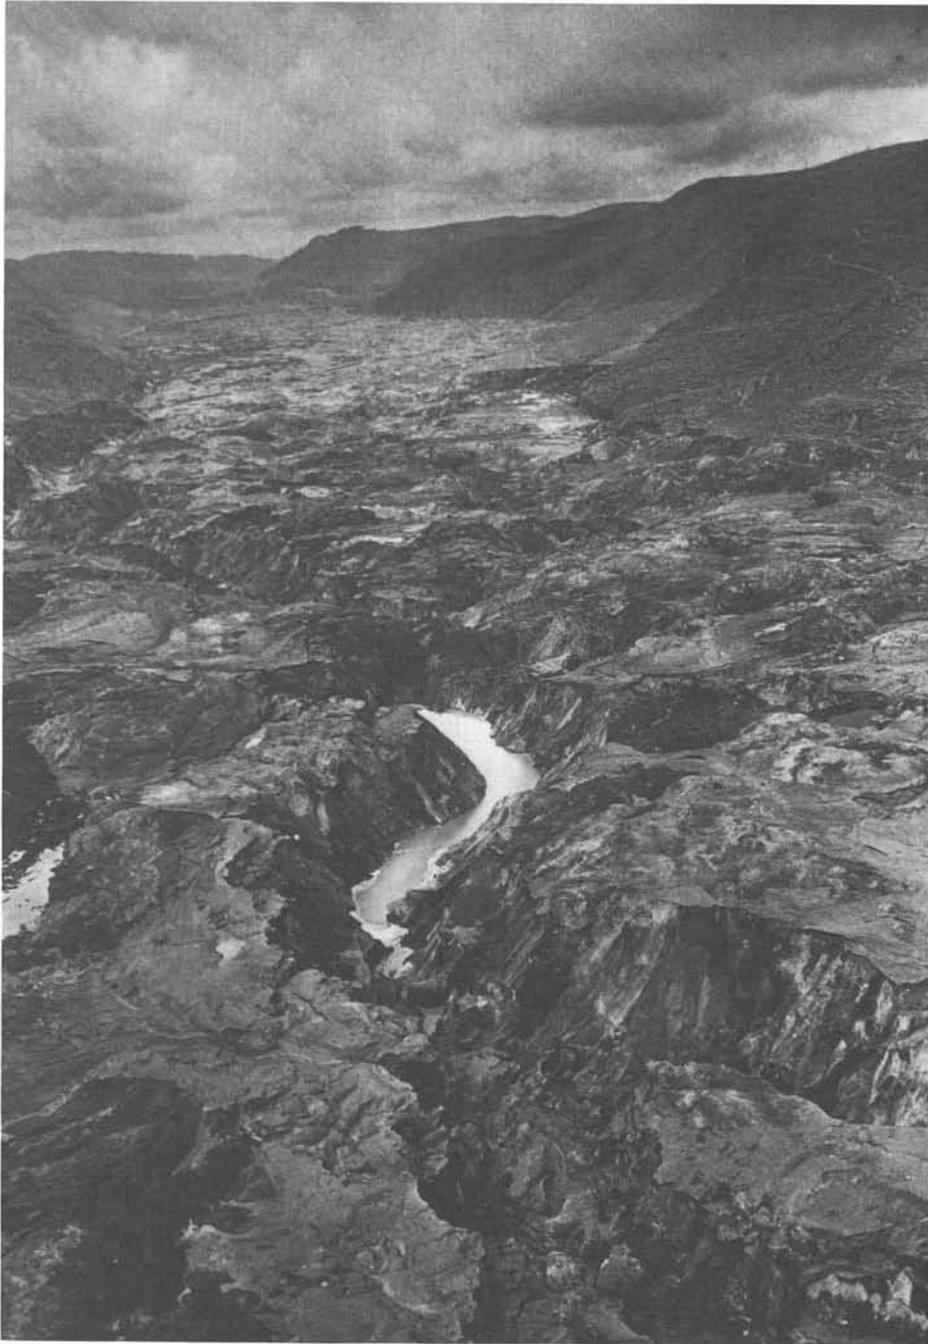
Figure 9. Elk Rock Lake (middle foreground) as it appeared in the summer of 1980 shortly before breaching its natural dam and draining. View is to the west down the Mount St. Helens debris avalanche. Copyrighted photograph by Jan Fardell, The Daily News, Longview, WA, published with permission.

Elk Rock Lake (Figure 9), the smallest of the four, filled first. By August 1980, it was 9 m deep and had a volume of 300,000 cu m (Jennings et al., 1981). The new lake was recognized as a flood hazard. On August 27, the landslide dam failed after a rainstorm, discharging a peak flow of 450 cu m/sec. The ensuing minor flood resulted in damage to equipment used for channel maintenance, but it caused no injuries or deaths. However, in a small way this failure provided a warning of what might happen if the much larger Spirit, Coldwater, or Castle lakes should be allowed to breach their respective landslide dams. Thus, monitoring and control measures were established on each of these three dams and their impoundments.

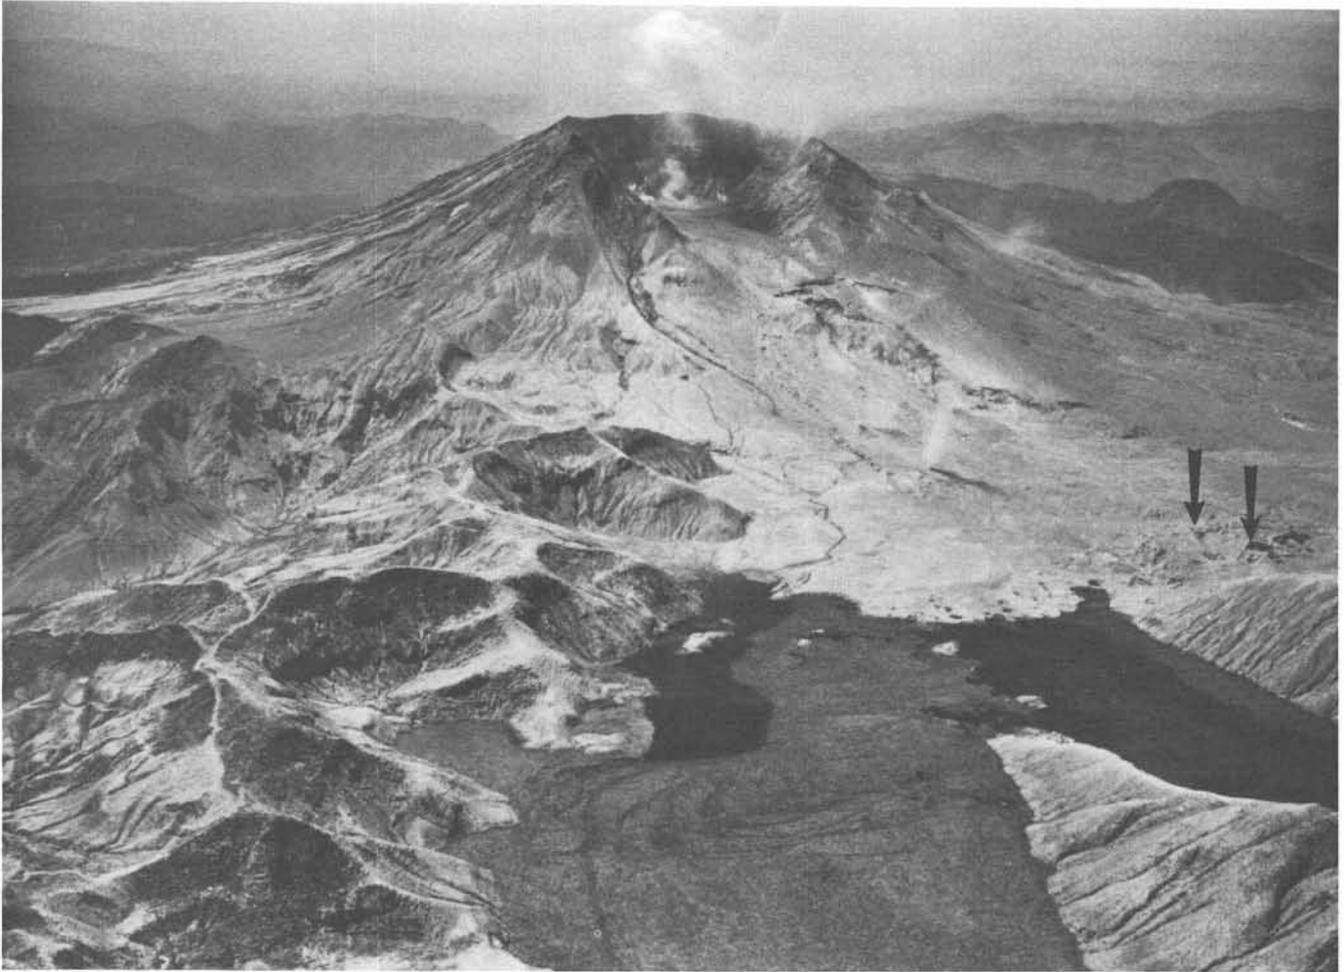
Figure 10. View from the north of the truncated cone of Mount St. Helens a few days after the May 18 eruption. Spirit Lake (middle and right foreground) is largely covered by floating logs that were stripped from the surrounding slopes by the lateral blast. The approximate crest of the debris-avalanche dam impounding Spirit Lake is shown by the arrows at the right edge of the photograph. Photograph by R. M. Krimmel, U.S. Geological Survey.

Spirit Lake (Figure 10) is the largest of three remaining impoundments. Soon after the May 18 eruption, Youd et al. (1981) recognized that eventual overtopping

of the blockage by the rising lake could cause erosion that would lead to breaching. By August 1982, about 330 million cu m of water had been impounded by the debris-avalanche dam. Lake level at that time was at an elevation of 1,055 m. At about the same time, a government task force concluded that the dam could not im-

pound water above elevation 1,060 m without danger of breaching (Sager and Chambers, 1986). Using a mathematical dam-break model, Swift and Kresch (1983) arrived at a hypothetical flood/mudflow of 75,000 cu m/sec if the Spirit Lake blockage were to breach. This catastrophic flooding would inundate

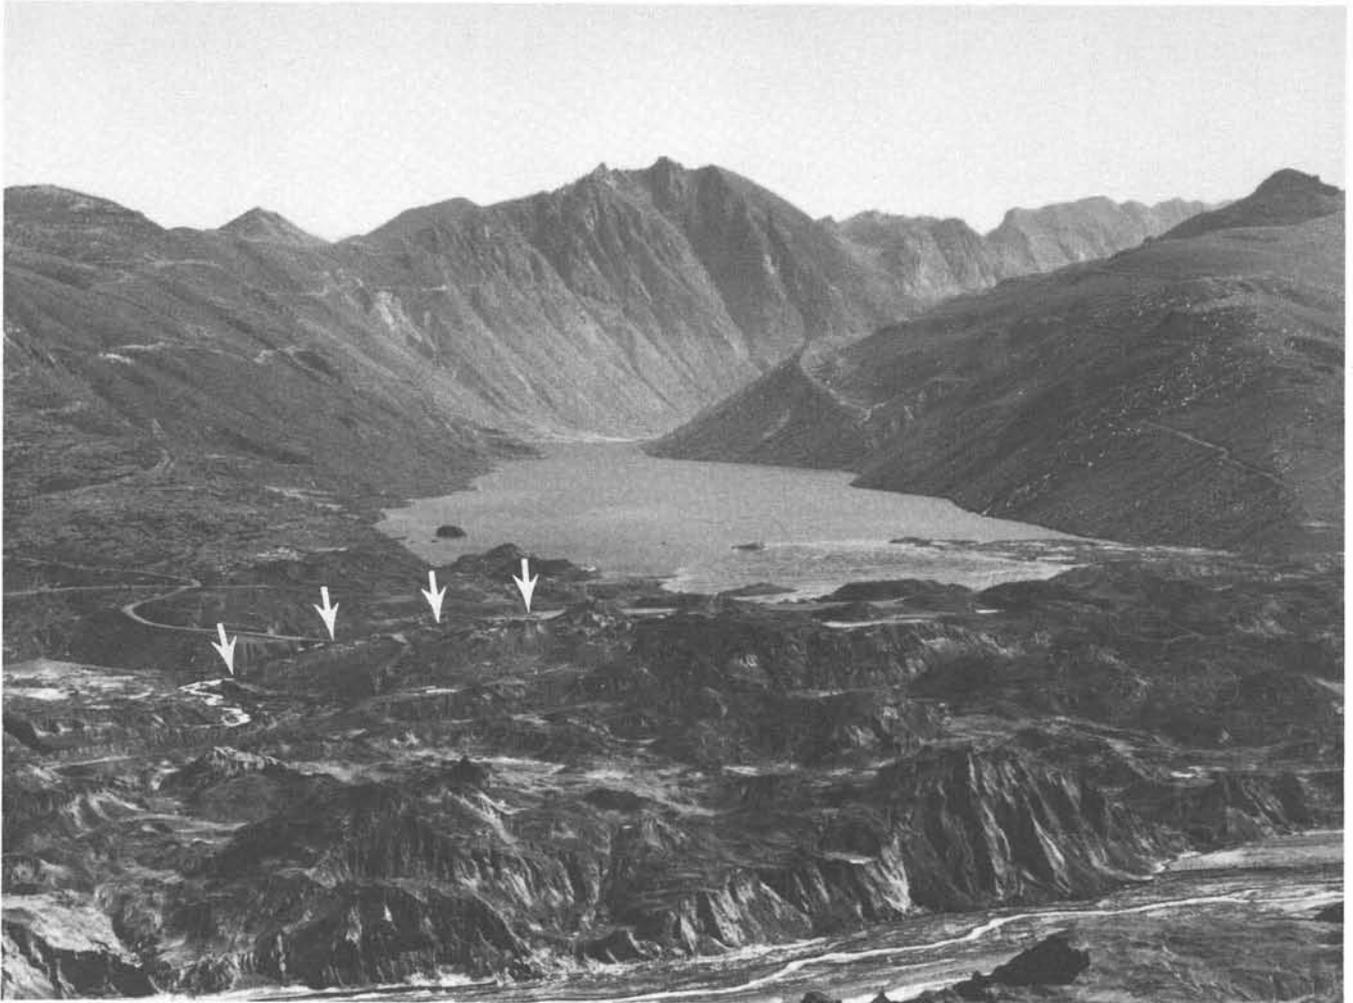
Figure 11. Coldwater Lake and its debris-avalanche dam, June 1983. Note spillway (white arrows) excavated through the bedrock right abutment, and incised North Fork Toutle River (foreground) which flows from right to left through the debris avalanche.

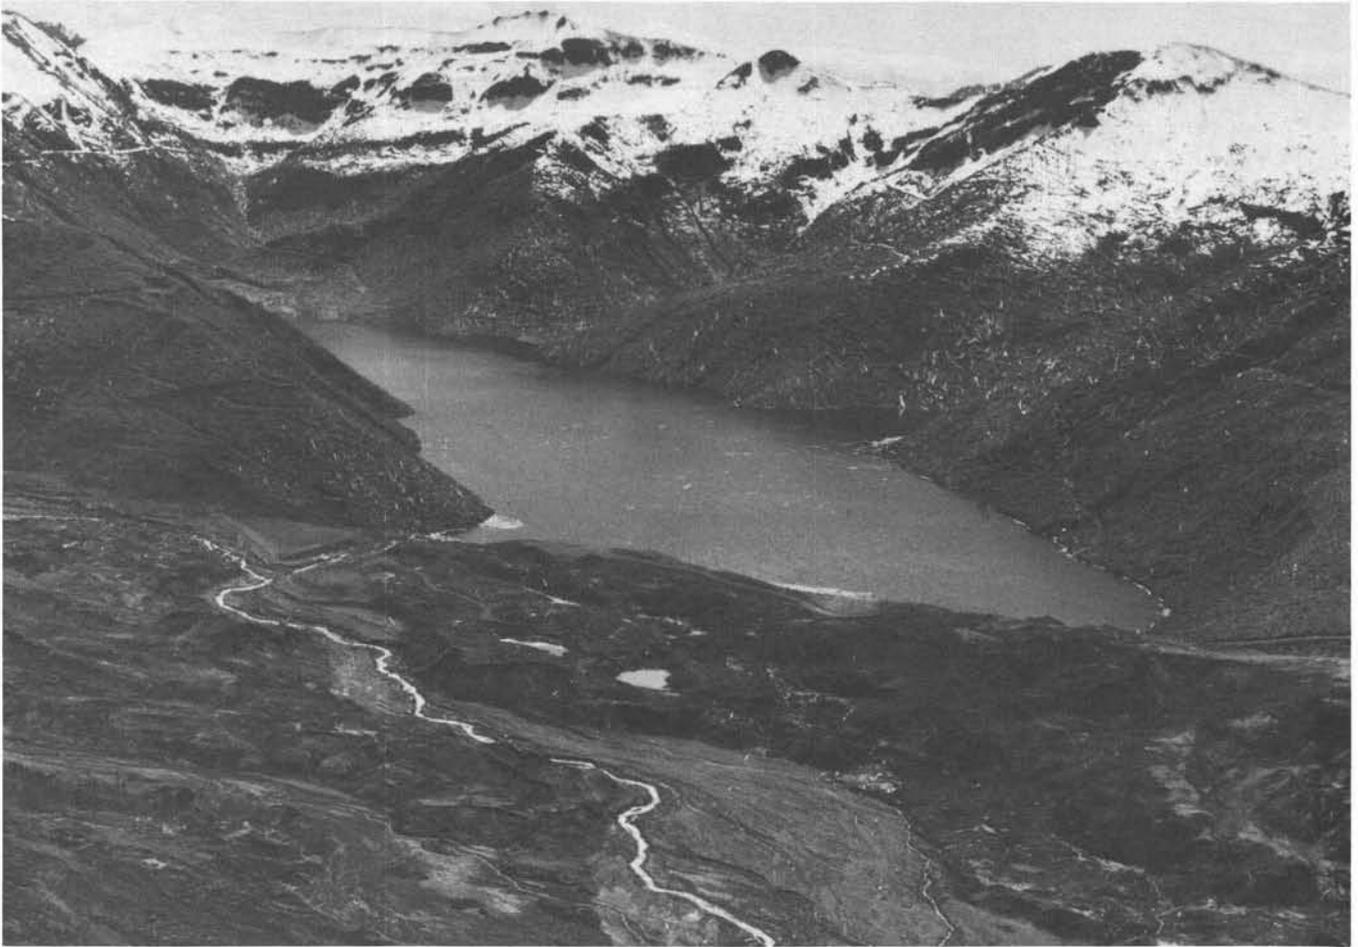
Figure 12. Castle Lake and its debris-avalanche dam (1983 photograph). Water exits the lake through spillway at left end of dam. The debris avalanche descended the valley of the North Fork Toutle River from left to right (east to west).

Similarly, the volume of Castle Lake (Figure 12) has been maintained at about 24 million cu m by a spillway excavated through its natural dam. Thus, there is little possibility of Castle Lake failing by overtopping. However, significant seepage occurs through the Castle Lake blockage at current lake levels, and analytical studies have suggested that the Castle Lake blockage may be only marginally stable in regard to the possibility of piping (Meyer et al., 1986). Using a dam-break computer model, Laenen and Orzol (1987) have estimated that failure of this natural dam would cause a flood with a peak magnitude of 42,500 cu m/sec immediately downstream. According to this scenario, the peak flood would attenuate to 27,000 cu m/sec at Toutle (on the Toutle River 50 km downstream), 9,000 cu m/sec at Castle Rock (on the Cowlitz River 80 km downstream), and 3,000 cu m/sec at Longview, where the Cowlitz River enters the Columbia River (Figure 3); the communities of Toutle, Castle Rock, Kelso, and Longview would experience extreme to moderate flood-

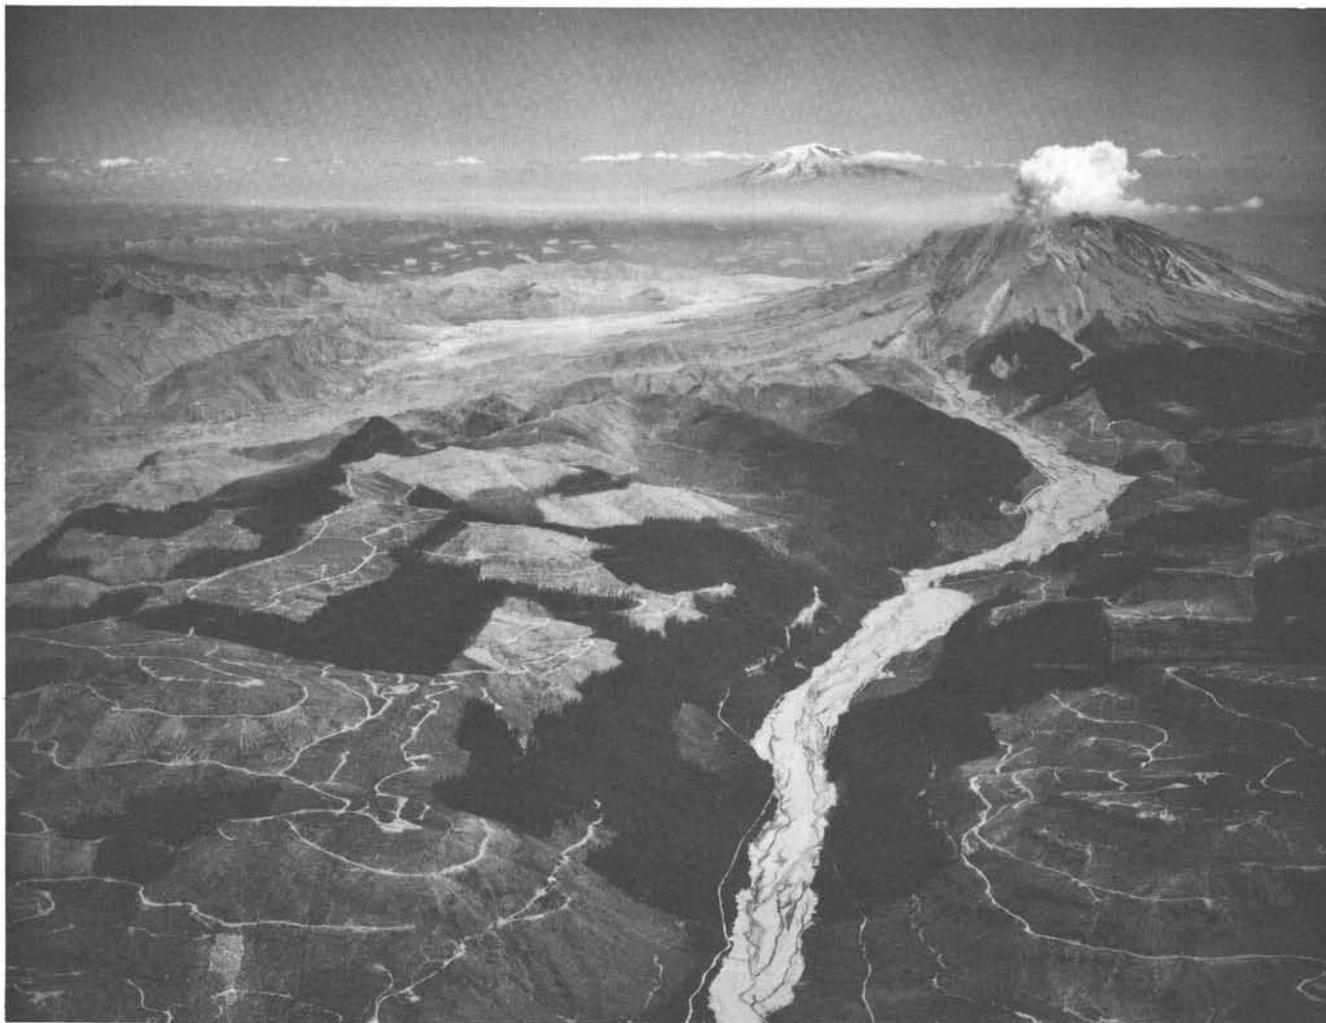
Figure 13. Mudflow on the valley floor of the South Fork Toutle River; view to the east toward steaming Mount St. Helens. The debris-avalanche-covered valley of the North Fork Toutle River is in the left middle background. Mount Adams is in the far background. Photograph by Austin Post, U.S. Geological Survey.

versely, the mudflow in the valley of the South Fork Toutle River (Figure 13) originated on the slopes of Mount St. Helens and impacted the entire length of the valley.

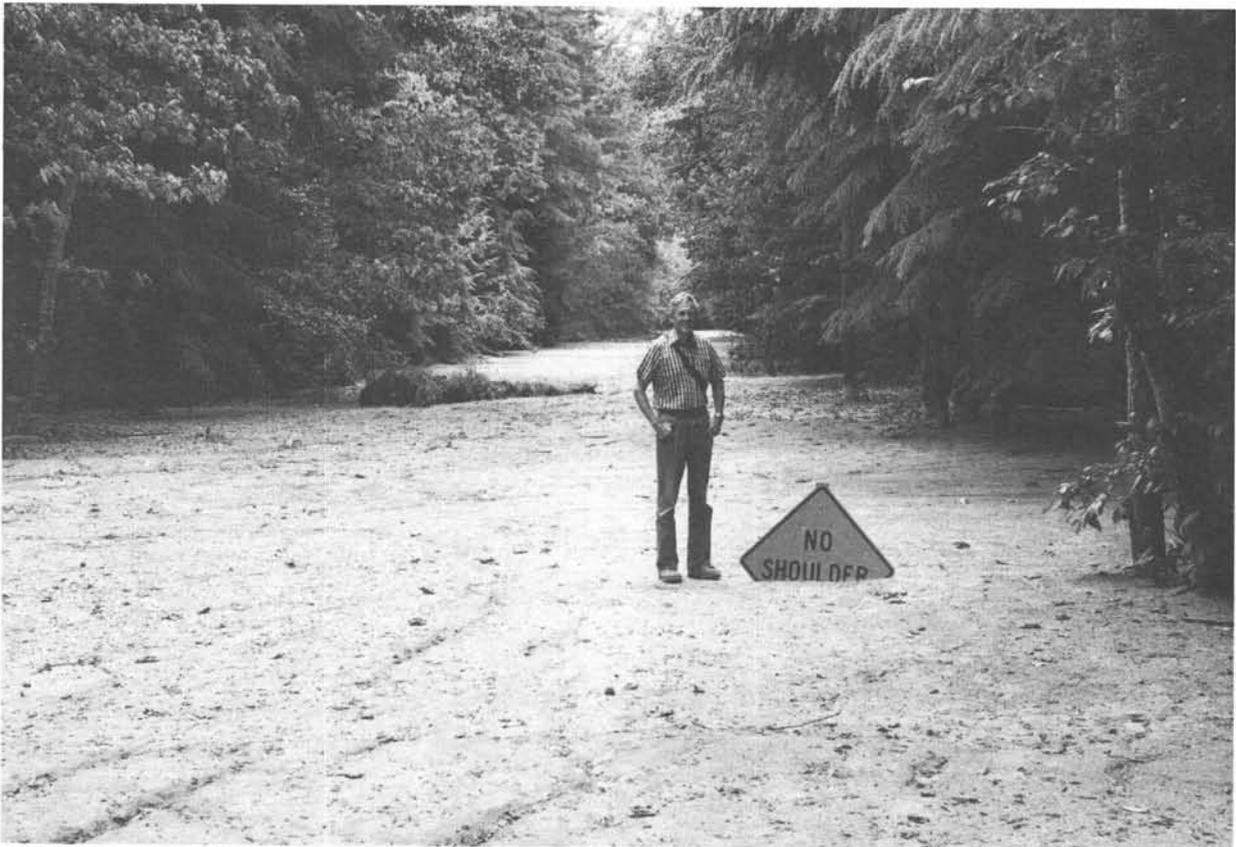
Figure 14. Mudflow deposit covering State Highway 504 to a depth of 2 m near the town of Toutle. Geologist is D. R. Crandell, U.S. Geological Survey).

- (1) Buried under as much as 2 m of sediment about one-half of the 28 km of Washington State Highway 504 in the valley of the North Fork Toutle River immediately downstream from the terminus of the debris avalanche (Figure 14). Mudflows also buried many kilometers of private logging roads and Cowlitz County roads. In addition, 17 km of private logging railway were destroyed. Most of the buried stretches of highways and roads were restored merely by removing the sediment. The railroad was abandoned, however.

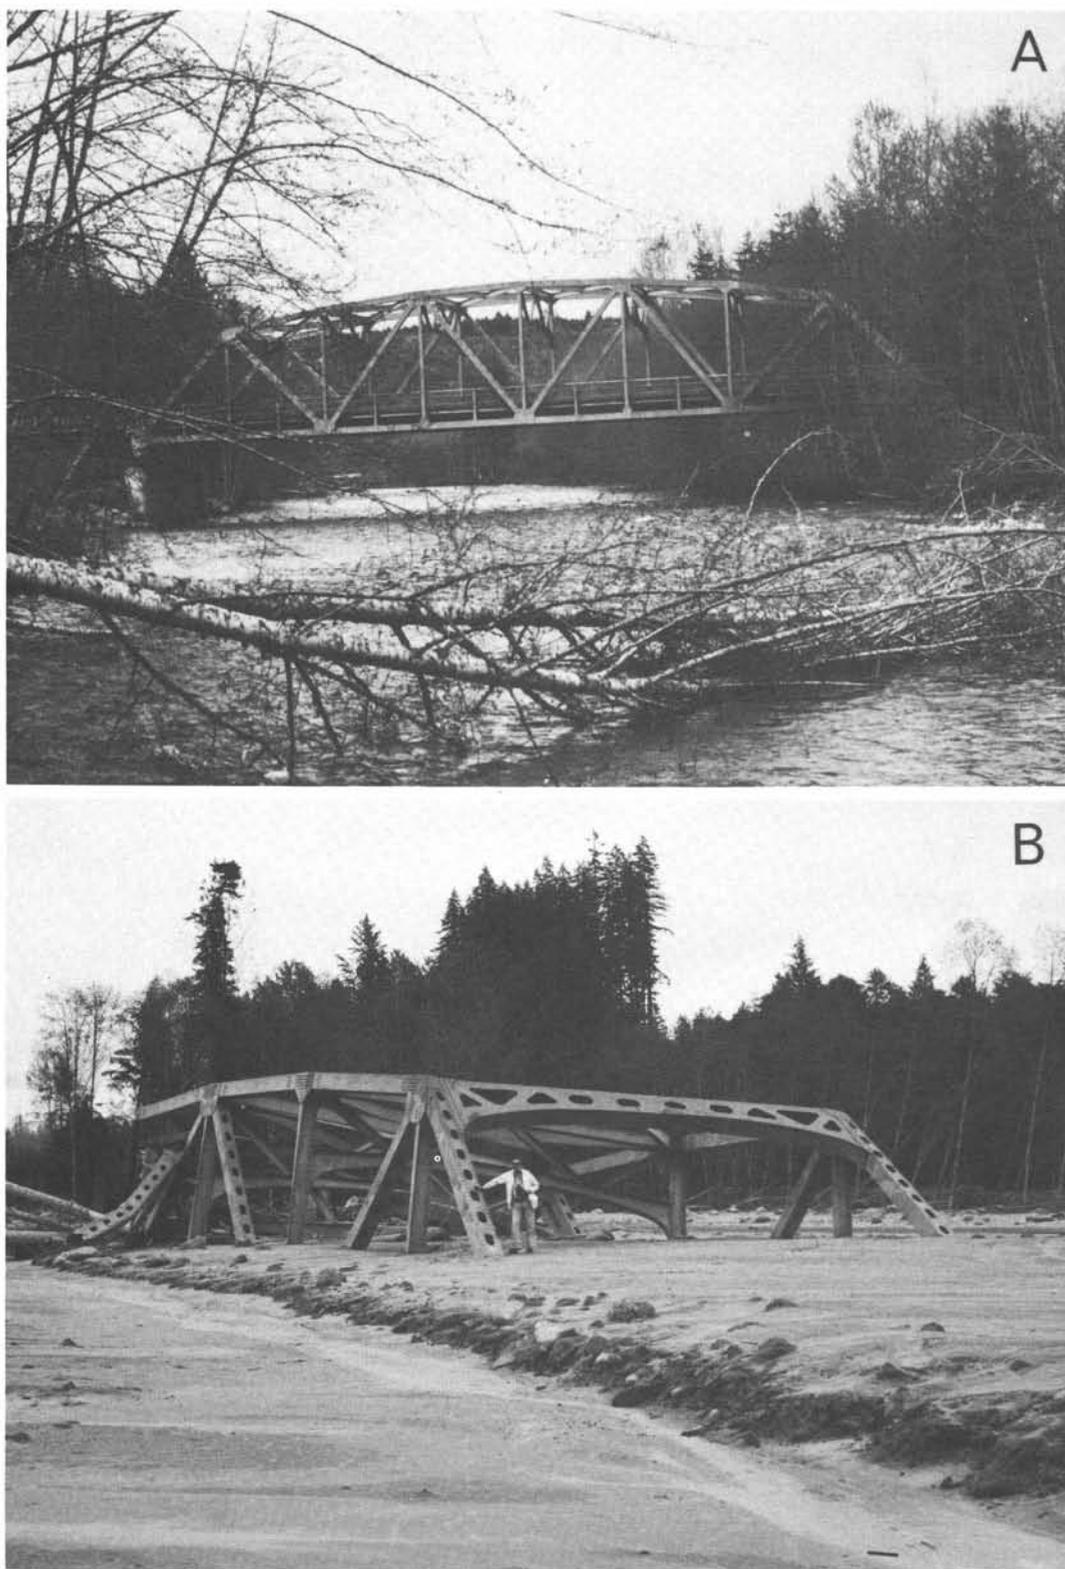
Figure 15. The 75-m-long St. Helens bridge on State Highway 504. A, before the May 18 eruption, with North Fork Toutle River in the foreground; photograph by D. R. Crandell, U.S. Geological Survey. B, after May 18 when it was washed out by the mudflow on the North Fork Toutle River. This steel structure was carried about 1/2 km downstream and was partially buried by the mudflow.

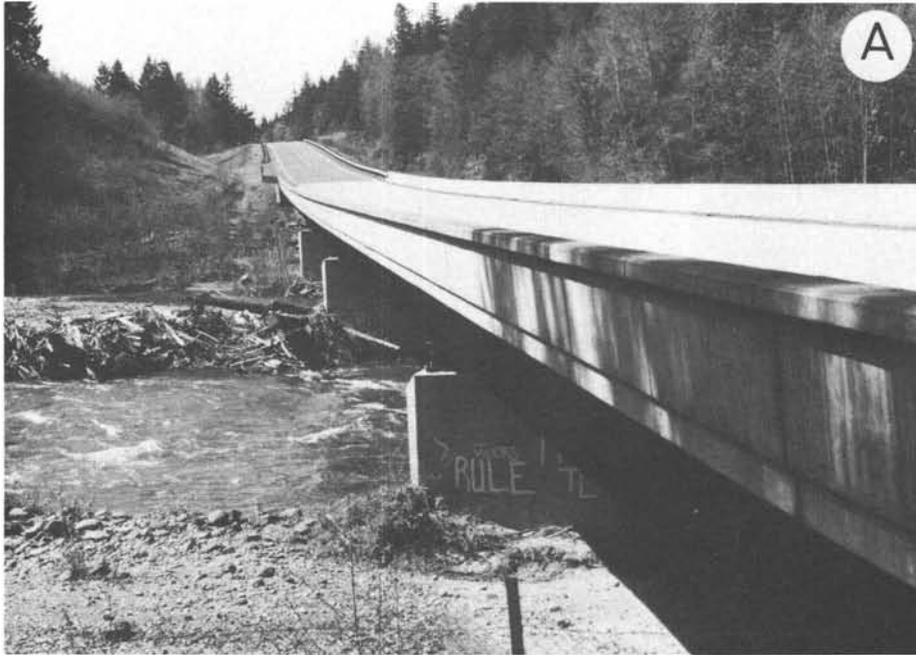
Figure 16. The 160-m steel-girder Coal Creek bridge spanning the Toutle River near the town of Toutle. A, ground-level view before May 18; B, aerial view after the bridge had been destroyed by the May 18 mudflow. Photographs by D. R. Crandell, U.S. Geological Survey.

- (2) Destroyed or badly damaged 27 bridges (22 highway and 5 railway) in the Toutle River valley (example, Figure 15). Most of these were modern concrete and/or steel structures, the longest being a 160-m steel-girder bridge spanning the Toutle River on Washington State Highway 504 near the town of Toutle (Figure 16).
- (3) Partially submerged and heavily damaged three large logging camps (two on the North Fork Toutle River and one on the South Fork). Much equipment was also badly damaged (Figures 17 and 18).
- (4) Destroyed or badly damaged water-supply and sewage-disposal systems along the Toutle River that were owned by local governments, companies, and private residents.

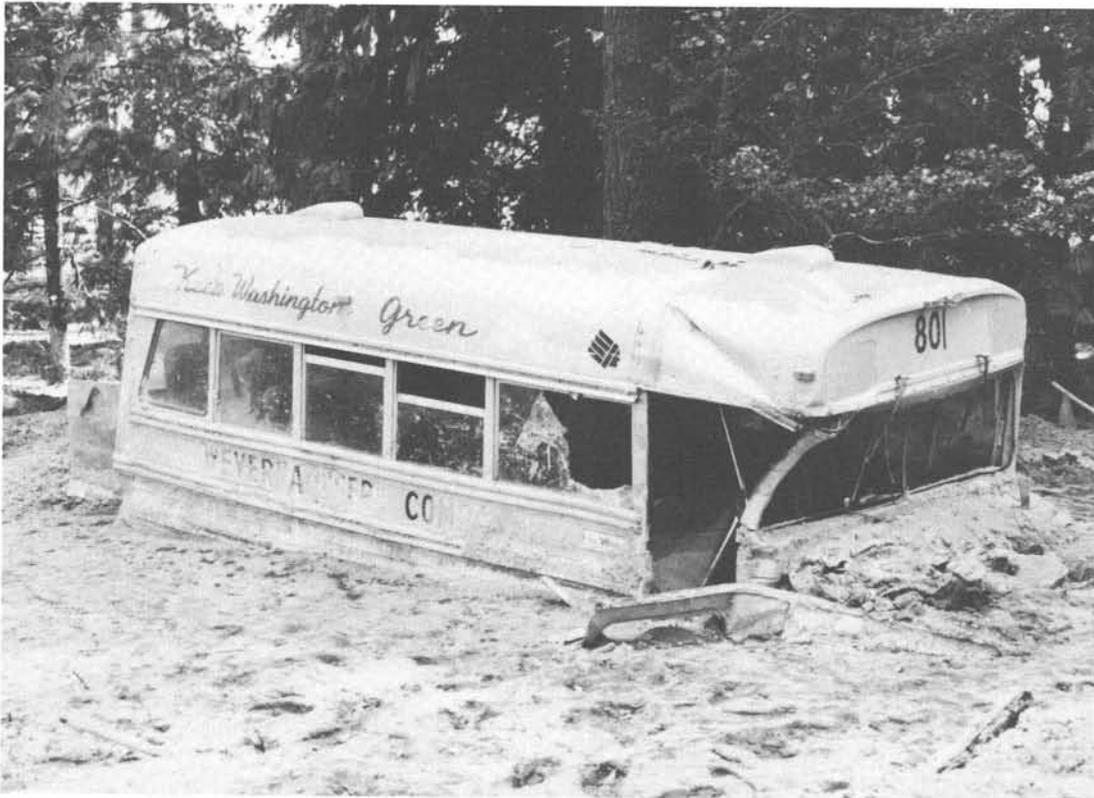
Figure 17. Weyerhaeuser Company employee bus heavily damaged and partially buried near Camp Baker by the May 18 mudflow on the North Fork Toutle River. Bus was unoccupied when hit by the mudflow.

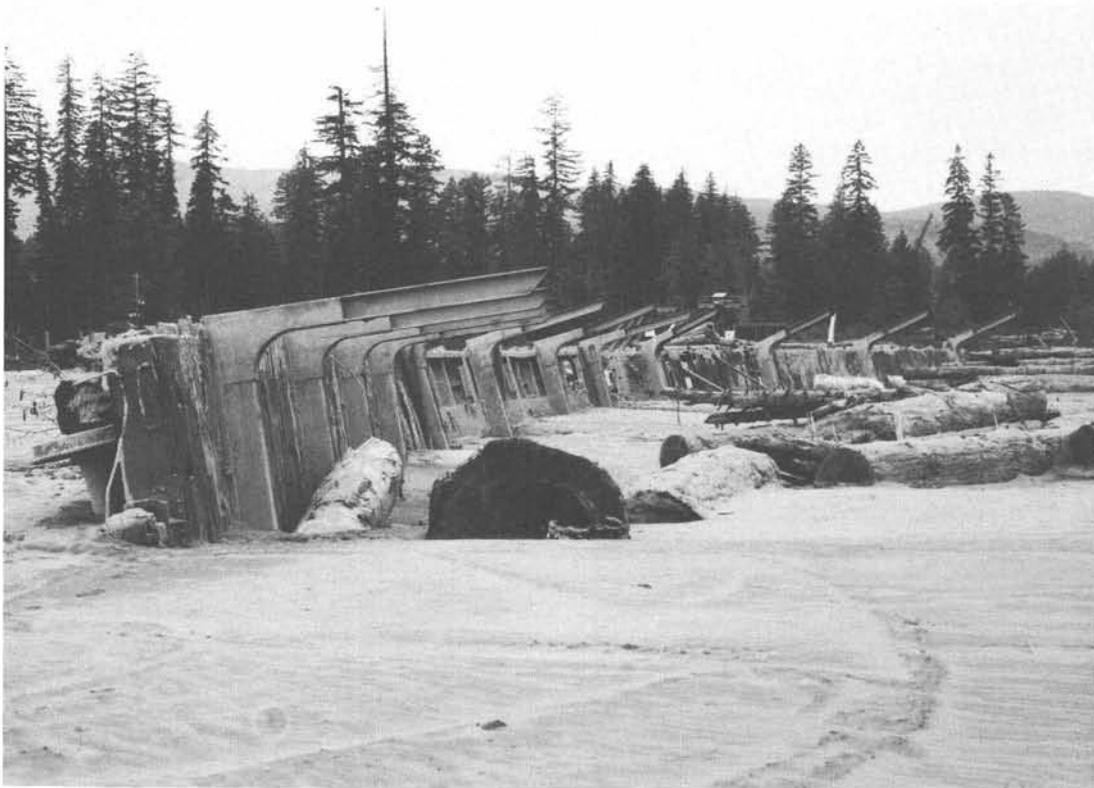
Figure 18. Railway cars and logs overturned by the May 18 mudflow on the Toutle River.

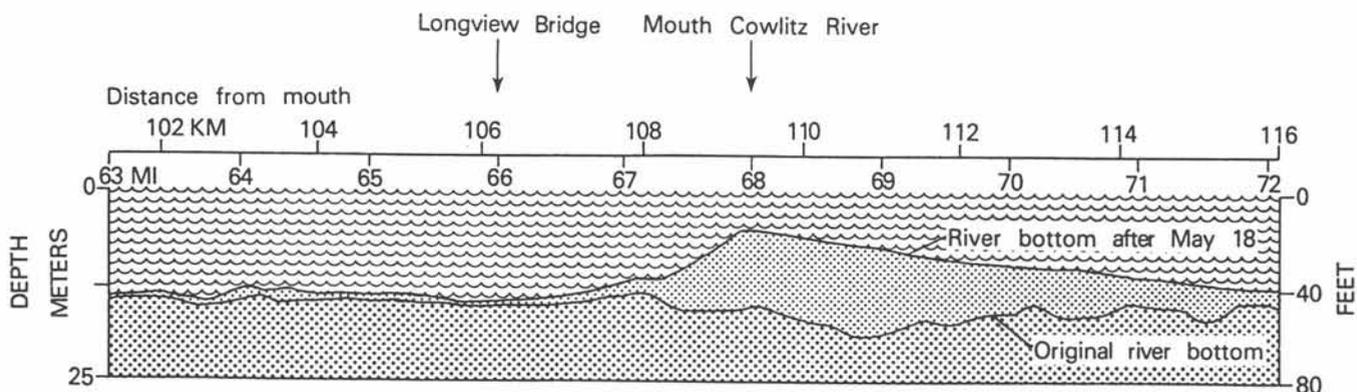
Figure 20. Longitudinal profile of the bottom of the Columbia River where sediment resulting from the May 18 mudflows entered from the Cowlitz River. Note that most of the sediment was deflected upstream. Modified from Bechly (1980).

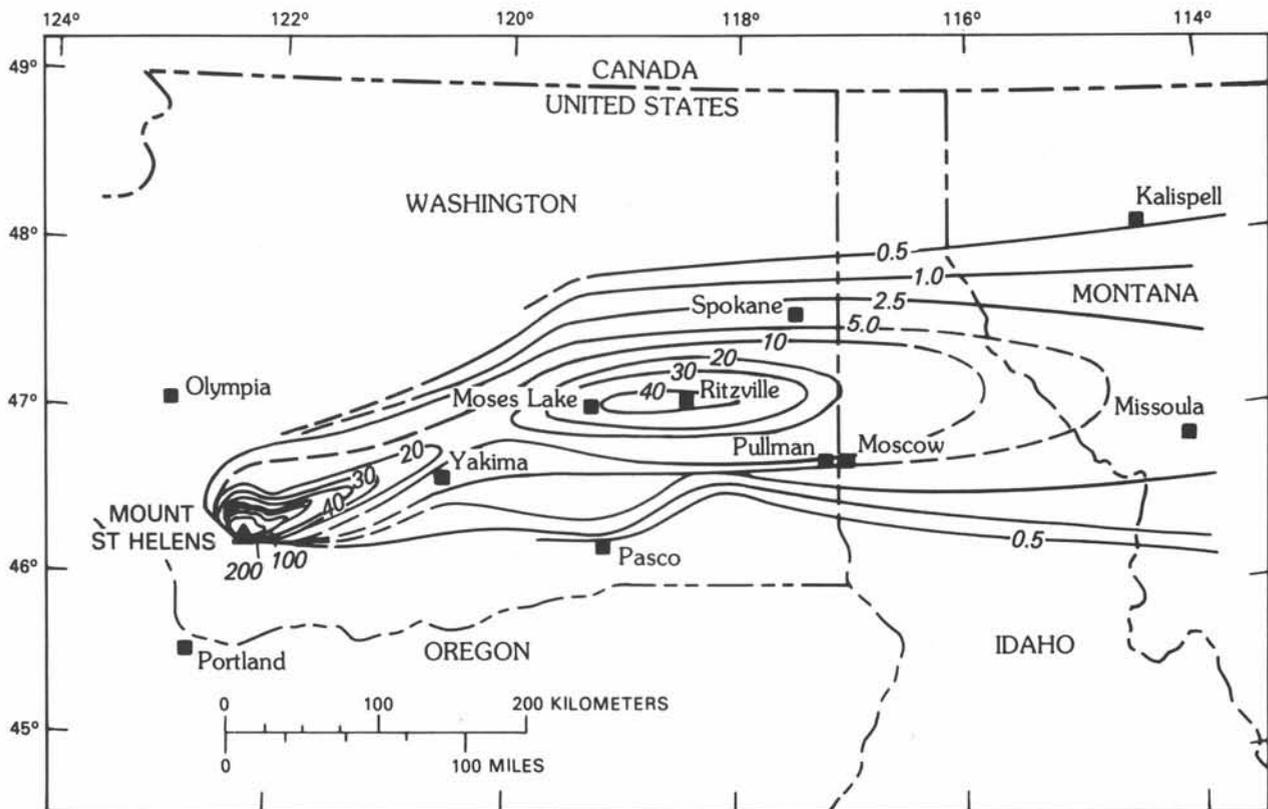
Figure 21. Isopach map of ash erupted from Mount St. Helens on May 18. Lines represent accumulated thicknesses in millimeters. Depths shown are generally a little less than those reported by local officials and noted in the text of this report. The difference probably is due to natural compaction that occurred before the measurements used in this figure were made. After Sarna-Wojcicki et al. (1981).

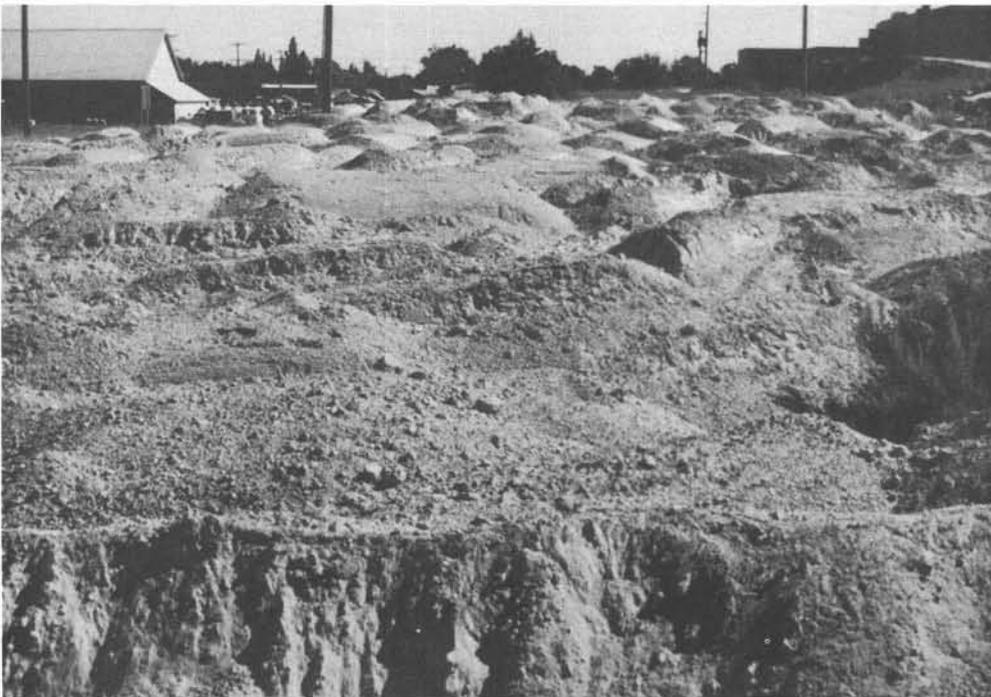
Figure 22. Temporary spoil pile at Ritzville containing 10,000 cu m of ash from the May 18 eruption. Photograph by G. B. McLucas, Washington Division of Geology and Earth Resources.

Municipalities in eastern Washington experienced some of the most serious ash-removal problems. For example, at Moses Lake where the average ash depth was about 6 cm, approximately 230,000 cu m was placed in disposal piles (McLanahan, 1980). Ritzville (population 2,000), the county seat of Adams County, was covered by about 8 to 10 cm of ash; 115,000 cu m of ash from the town and nearby county roads was permanently disposed of in an old quarry outside town (Figure 22) (Miller, G., 1980). Farther east, Pullman (population 22,000), Washington, and Moscow (population 16,000), Idaho, each received about 1 cm of ash; each city removed about 15,000 cu m of ash from its street system.

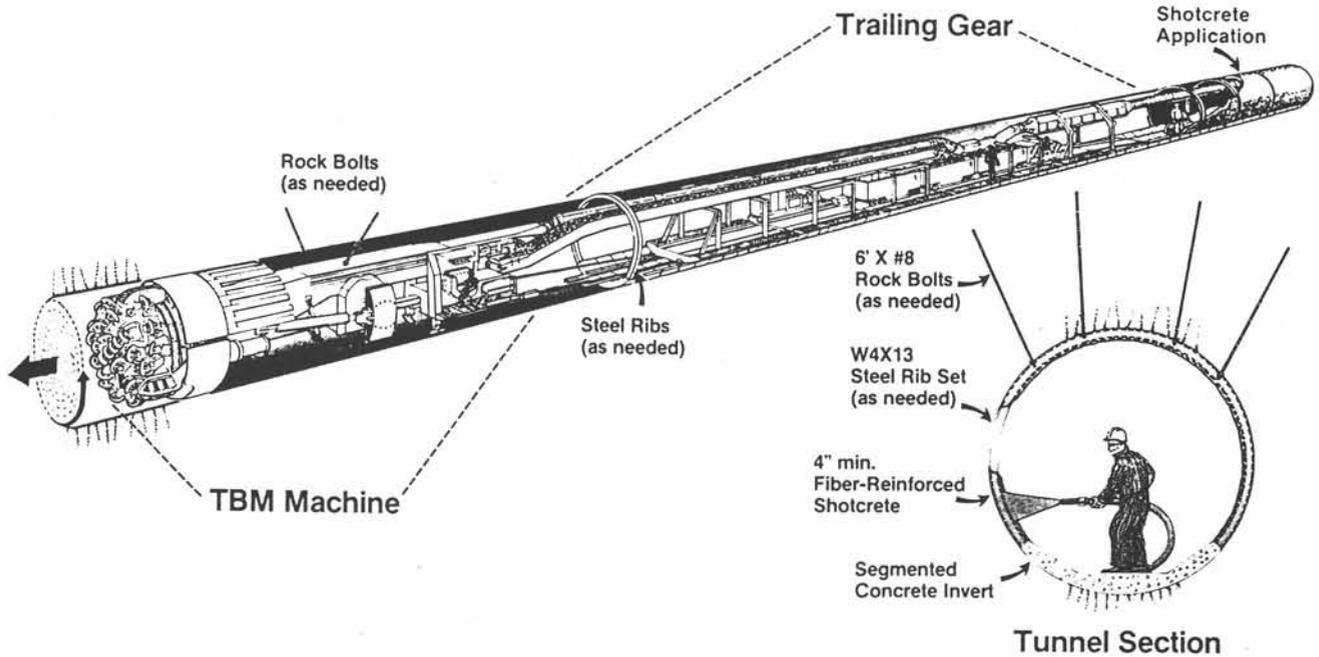
Figure 4. Sketch of the tunnel boring machine (TBM) used at the Spirit Lake tunnel. Courtesy of U.S. Army Corps of Engineers, Portland District.
