INACTIVE AND ABANDONED MINE LANDS— Cleveland Mine, Springdale Mining District, Stevens County, Washington

by Fritz E. Wolff,
Donald T. McKay, Jr.,
and David K. Norman

WASHINGTON
DIVISION OF GEOLOGY
AND EARTH RESOURCES
Information Circular 101
January 2006

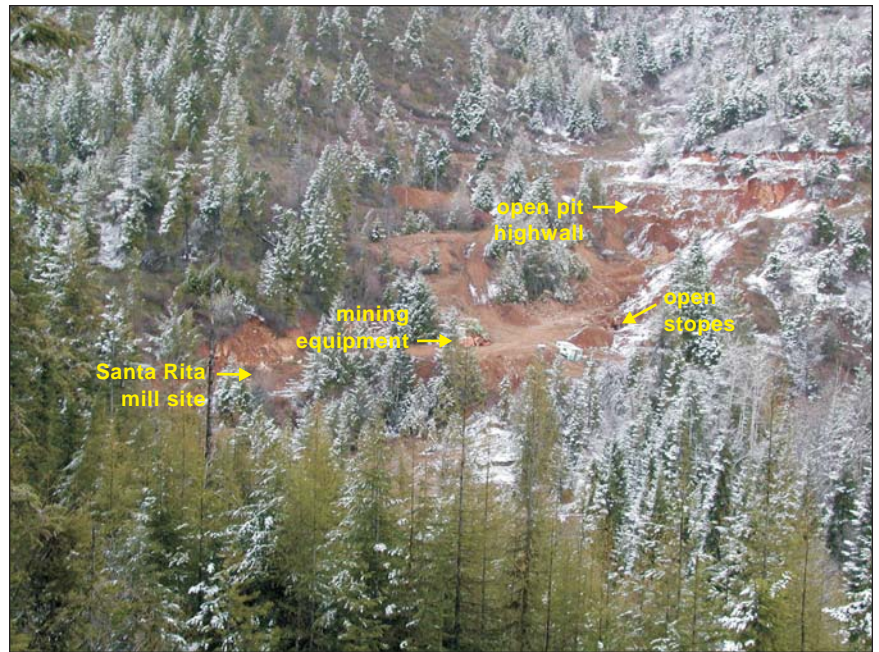
Figure 2. Partial overview of the Cleveland mine site. The Lower Level portal, tailings, and access road are off the photo at the far left center. View to the northwest.

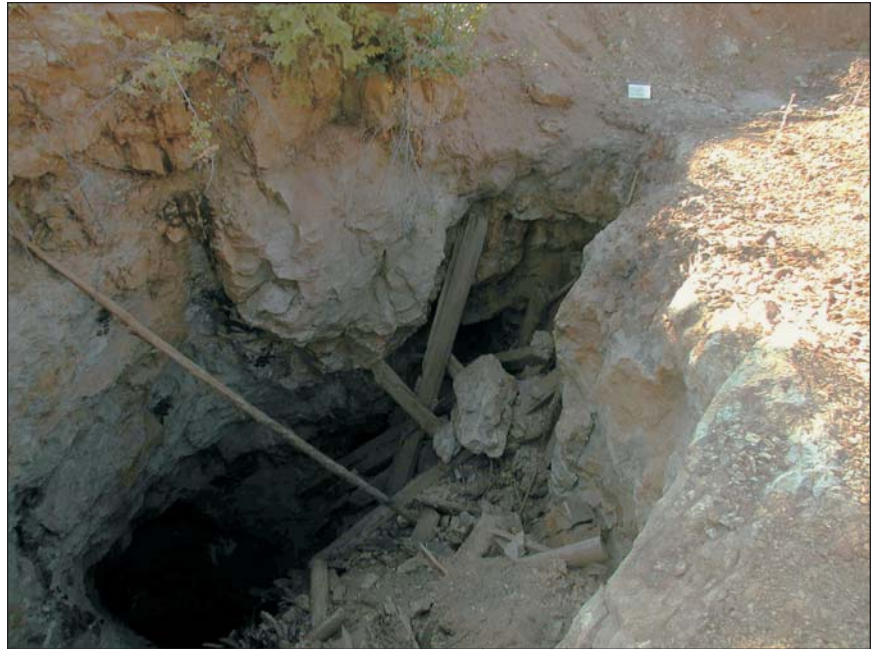
Figure 4. Underground opening excavated by surface mining. View to the southeast.

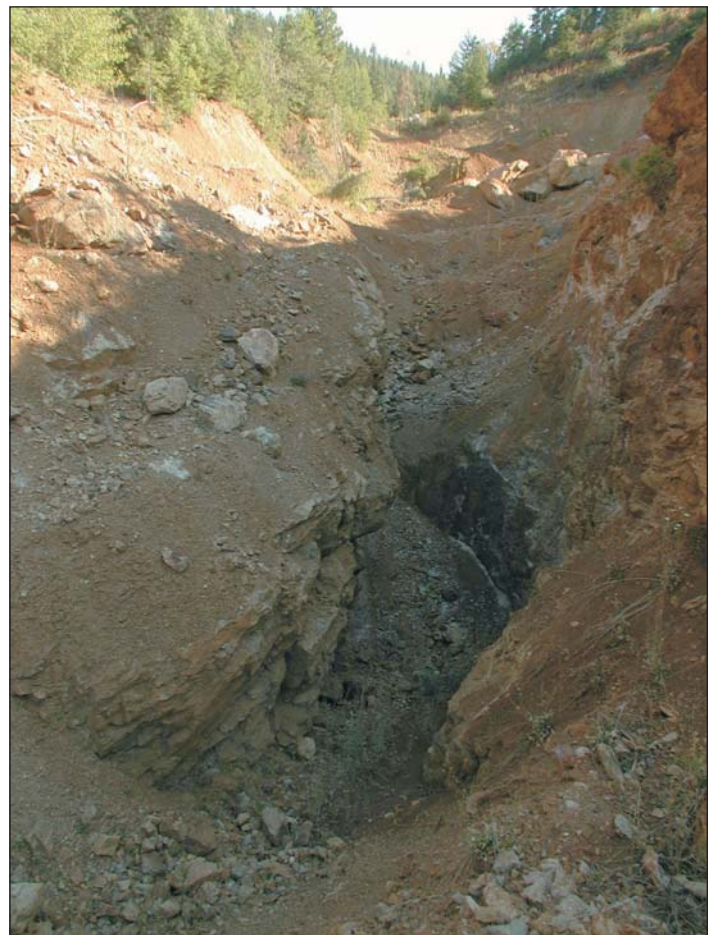
Figure 5. Caved stope. Open-pit excavation in the background. View to the north.

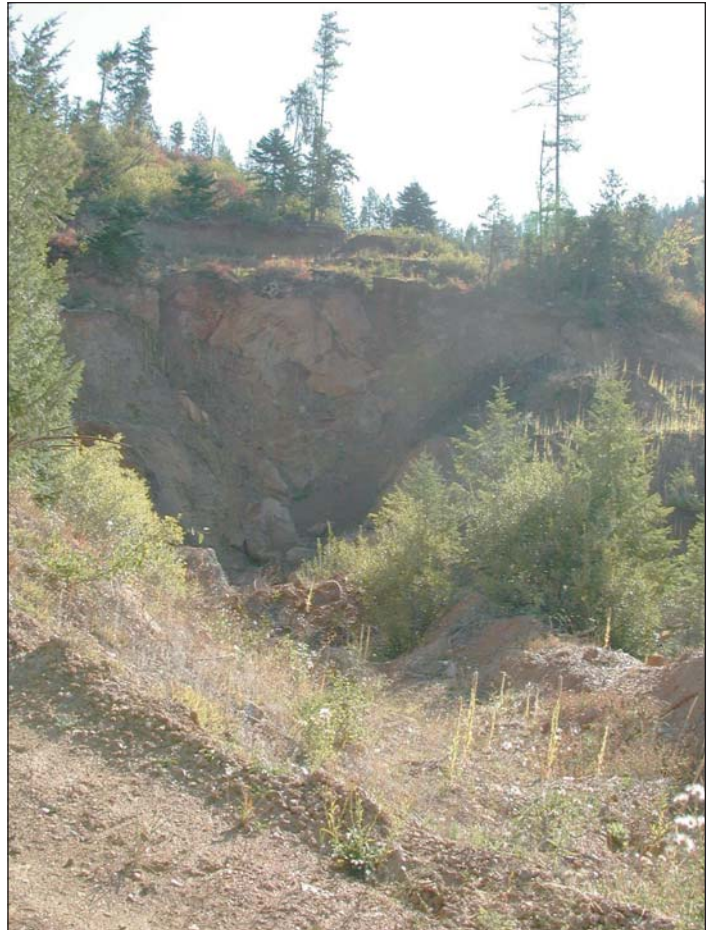
Figure 6. North pit highwall. View to the north.

| Description | Condition | Fenced (yes/no) | Length (feet) | Width (feet) | Height/depth (feet) | True bearing | Elev. (feet) | Decimal latitude | Decimal longitude |
|---|---|---|---|---|---|---|---|---|---|
| open pit highwall | vertical, sloughing | no | N/A | ~100 | ~75 | N/A | N/A | 48.1171 | 118.0241 |

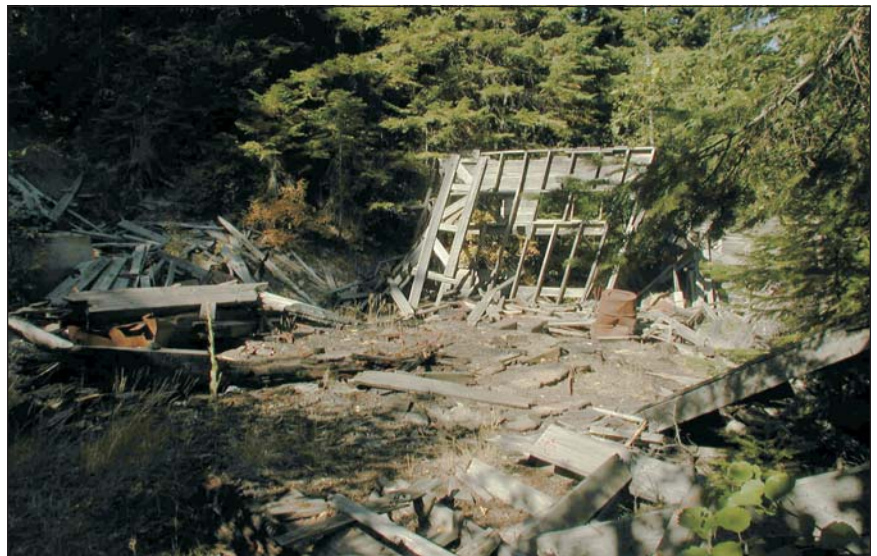
Figure 7. Remains of the 1939 mill on the west bank of the tributary.

The foundation of the flotation mill built by Santa Rita in the 1920s can still be observed near the entry to the north open pit. One wall of the 20-tpd mill built in 1939 was found in the tributary drainage (Fig. 7). Two recreational buildings are located on the Olympia claim across the gulch to the south of the mine. A track-mounted Ingersoll-Rand pneumatic drill, compressor, and Euclid bulldozer were parked on the floor of the open pit near a locked storage container (Fig. 8). The equipment appeared to be in operable condition.

A second mill of 20-tpd capacity (Fig. 7) was built in 1939 on the tributary just below the Lower level portal. The remains of both mills were burned by a private owner in fall of 1994.

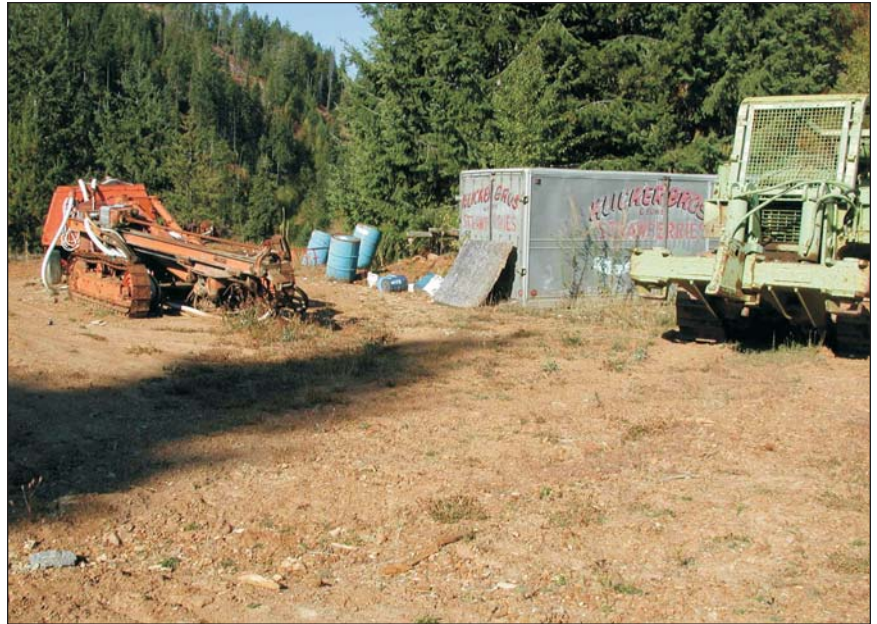
Figure 8. Heavy equipment and storage container. View to the west.

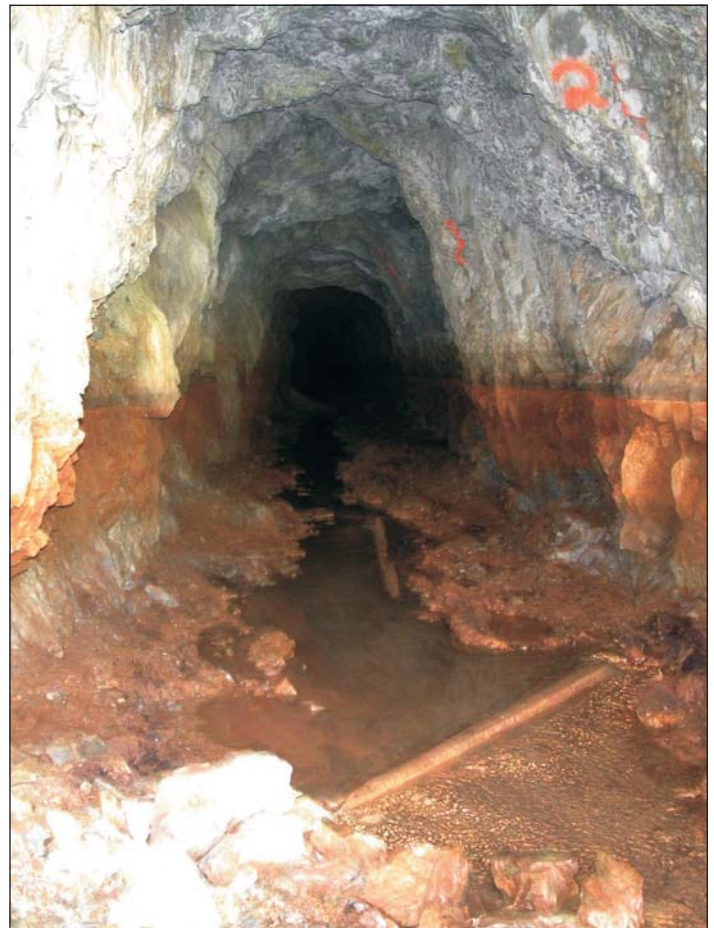
Figure 9. Water discharge at the Lower level adit. Note the iron staining on the wall to a height of about 36 inches.

Iron staining on the walls of the Lower level portal indicates that a water column was impounded behind the portal at some time in the past (Fig. 9). Miners using a backhoe to remove the portal blockage released a calculated 125,000 gallons of water (Jake Jakobosky, BLM, written commun., 2005). Such a release helps explain why the road below the portal is undercut to a depth of 3 feet. The present discharge flows approximately 250 feet downgradient across the road and spreads out on a marshy area where tailings are impounded behind a log-crib dam (Fig. 10). At this point the adit discharge flows into the tributary.

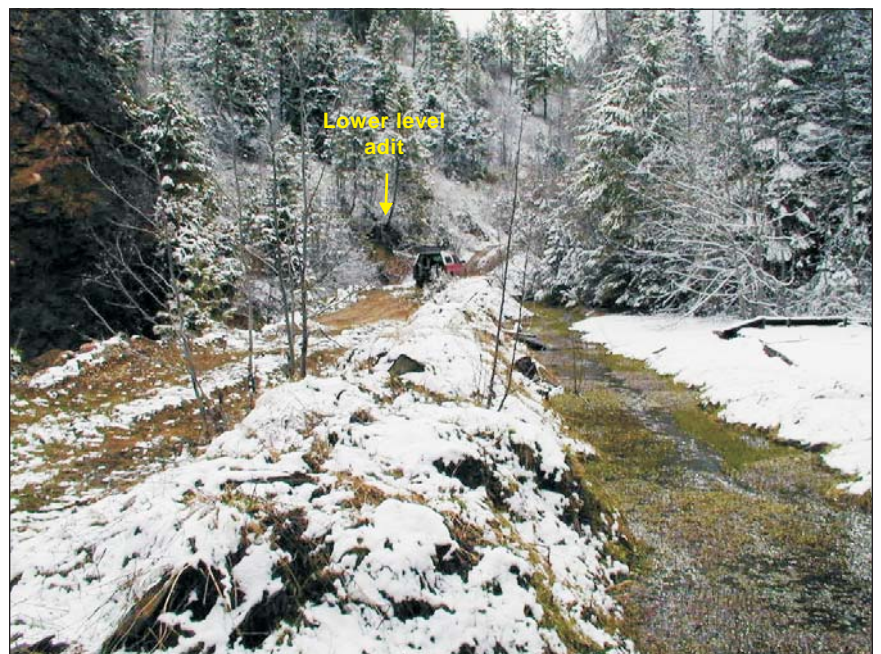
In 1994, private owners diverted the main stem of the unnamed tributary into a channel that skirts the Lower level's waste rock dump (Jakobosky, written commun., 2005)(Fig. 11).

Figure 11. Diversion channel carrying tributary. Flow downgradient from center to far bottom right. Access road at left. Pickup for scale. View to the southeast.

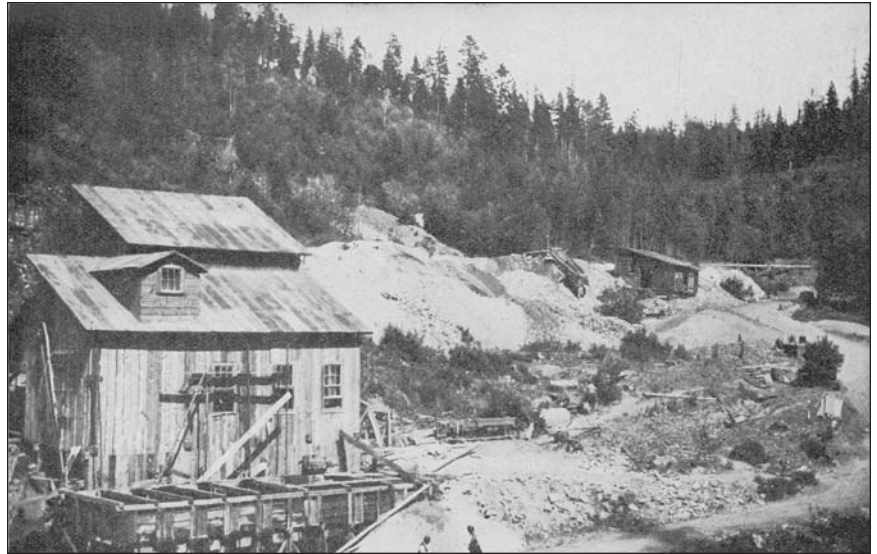
Figure 12. (top) Overview of Cleveland mine circa 1920 (Weaver, 1920). Santa Rita Mining Co. mill at left. Tributary to Hunters Creek (hidden in foreground) flows downgradient right to left. View to the north.

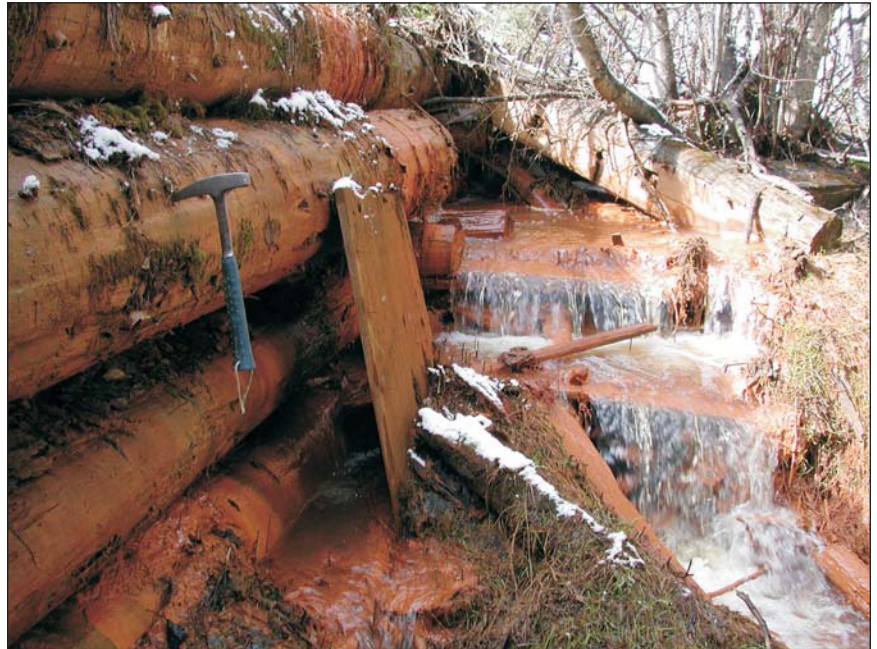
Figure 13. (middle) Log-crib dam at tailings repository 1. Tailings are about 3 feet thick. View to the west.

Repository 1 is located in the tributary just below the Lower adit on the Ona claim. It is impounded behind a log-crib dam (Fig. 13), and partially buried by the adit's waste rock dump (Fig. 10). Repository 2 is located on the same claim on the north side of and adjacent to the mine access road (Fig. 14). It is not directly in the tributary and has been used as a log landing.

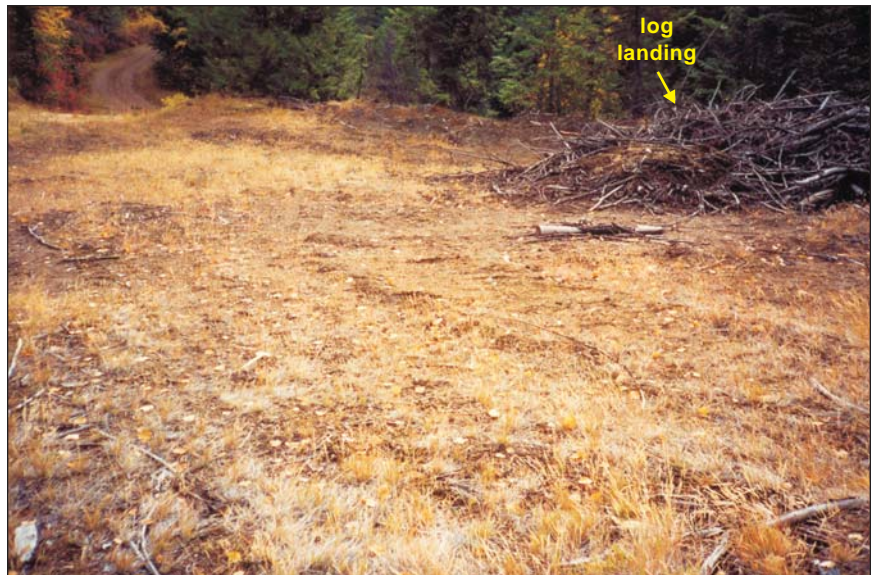
Figure 14. (bottom) Tailings repository 2 and log landing. Mine access road in upper lefthand corner. View to the southeast. BLM photo taken October 2001.

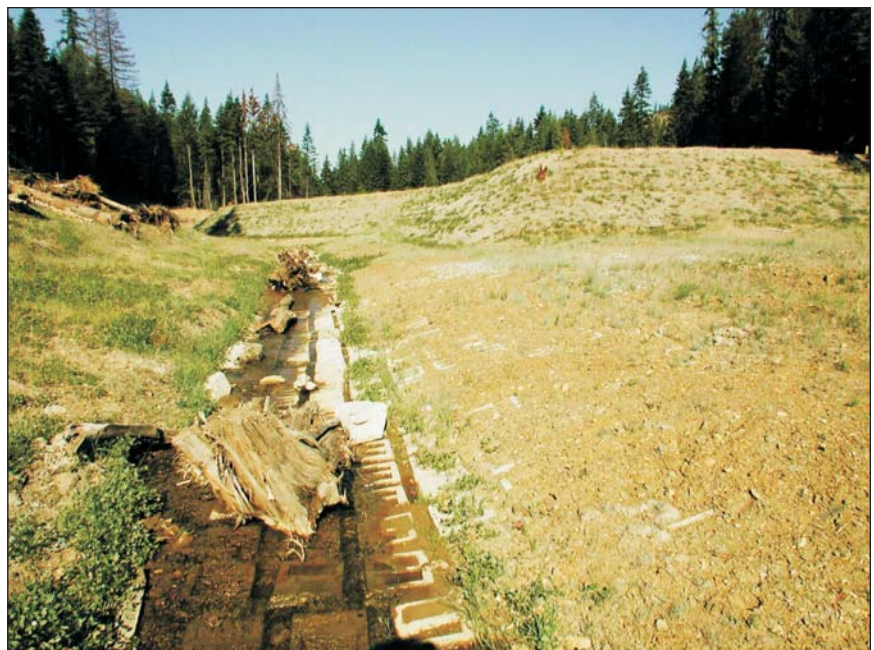
Figure 18. (bottom) Woody debris and concrete block armoring in place, post reclamation, on tailings repository 4. View downgradient to the northwest.

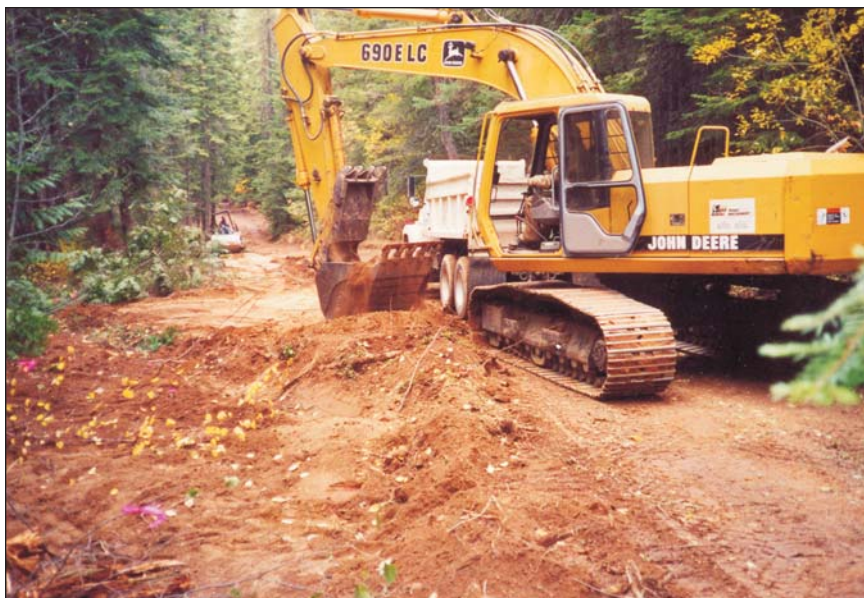
Figure 19. Excavation of tailings from mine access road on public land. View to the west. BLM photo taken October 2001.

The reclamation work accomplished the following key elements (Jakabosky, written commun., 2005): Repository 3 was consolidated and moved to the north bank so that the stream bypassed the tailings. Repository 4 was consolidated and isolated from contact with the stream by construction of a bypass channel. A geotextile capillary break was installed on top of both tailings repositories to prevent infiltration of surface water. Topsoil spread on top of the break was seeded with grass (Fig. 17). Tailings in the streambed between the two sites were removed in 2001, and the stream channel was armored with cabled concrete blocks to prevent further erosion and undercutting (Fig. 18). Tailings that had inundated the mine access road were removed in 2001 and placed on the north side of repository 4. Figures 19 and 20 show principal elements of this work.

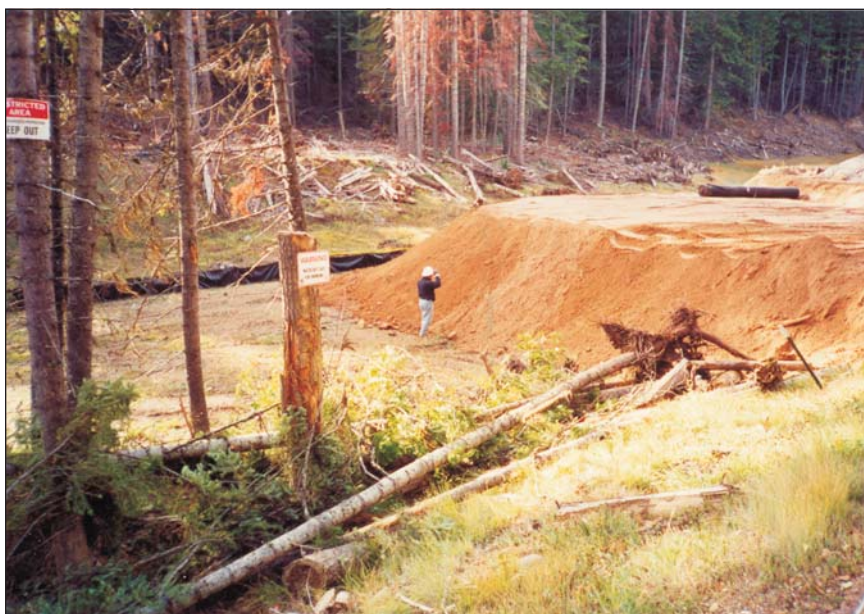
Figure 20. Roadside tailings placed in new cell adjacent to tailings repository 4. View to the southwest. BLM photo taken October 2001.
