INACTIVE AND ABANDONED MINE LANDS— First Thought Mine, Orient Mining District, Stevens County, Washington

by Fritz E. Wolff,
Donald T. McKay, Jr.,
and David K. Norman

WASHINGTON
DIVISION OF GEOLOGY
AND EARTH RESOURCES
Information Circular 103
October 2006

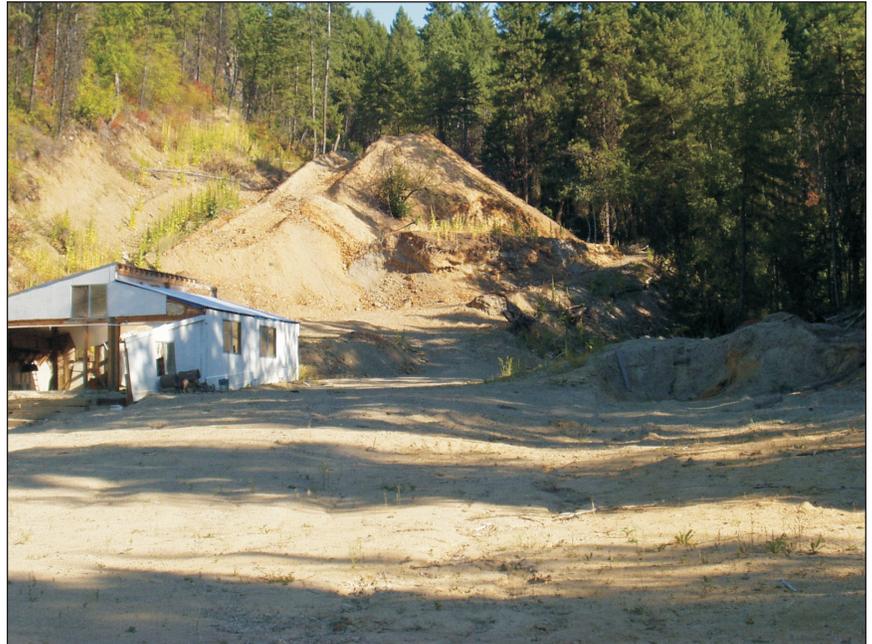
Figure 4. Gold recovery processing shed sitting on tailings from original mill. Bulldozed waste rock dump left center. View to the north.

Some time in 2004/2005, operators erected a shed on the tailings that appears to house a rudimentary batch cyanide process aimed at recovering gold from the waste rock bulldozed into a headwall (Fig. 4). The effort has been abandoned.

The wood-frame building erected in 2004/2005 to recover gold from the waste rock dumps is empty and in a state of disrepair (Fig. 4).

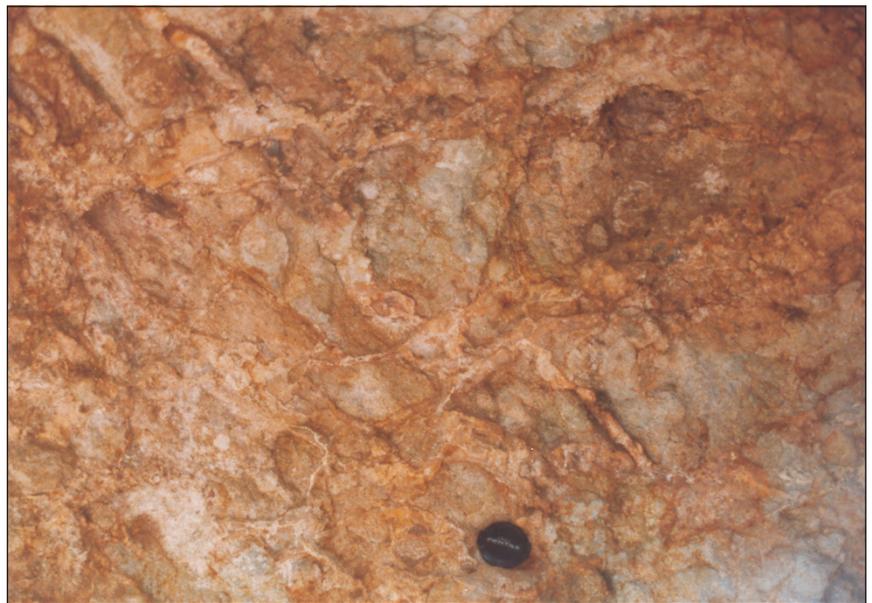
Figure 5. Typical exposure of stockwork veining in the open stope. Lens cap for scale. (Reprinted from Goetz, 1990.)

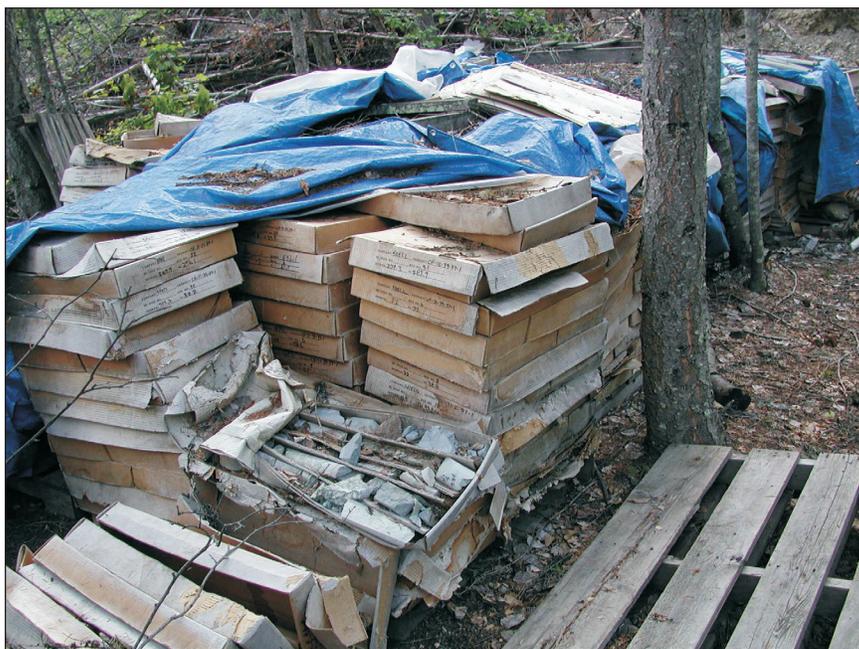
Figure 9. Circa-1980s drill core storage.

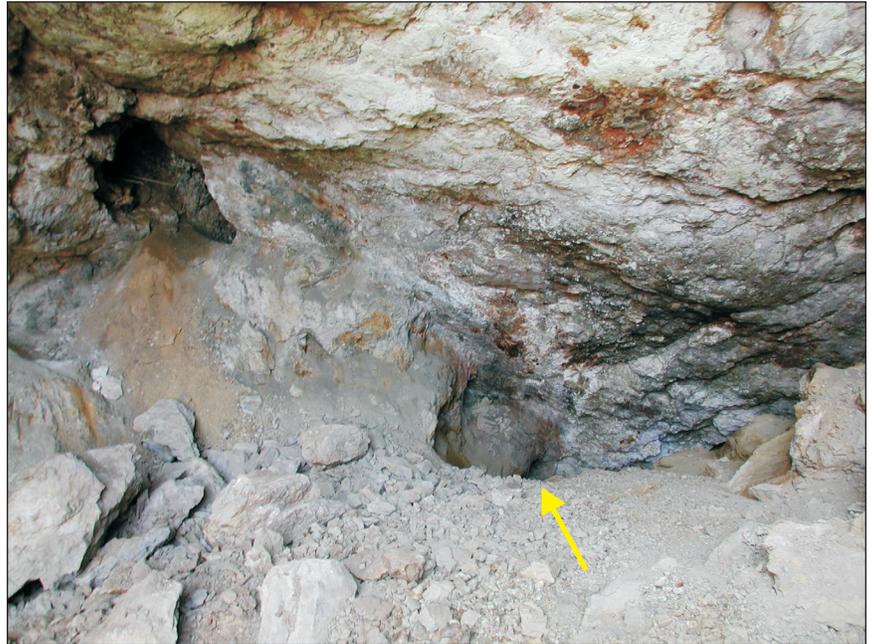
the northeast-facing mine ridge. Bancroft's (1914) photo shows the "65" stope daylighting into the cliff. Subsequent mining continued through the overlying ore body to the surface, thus forming the open stope (Fig. 10). The unfenced winze found at the bottom of this stope shown in Figure 12 descends to the No. 3 level (Bancroft and Lindgren, 1914). Wall angles around the perimeter range from vertical to past-vertical overhangs of 90 feet or more. The rockfall potential is extreme.

Figure 12. (top) Winze (yellow arrow) at the bottom of the open stope. It declines at -65 degrees west.

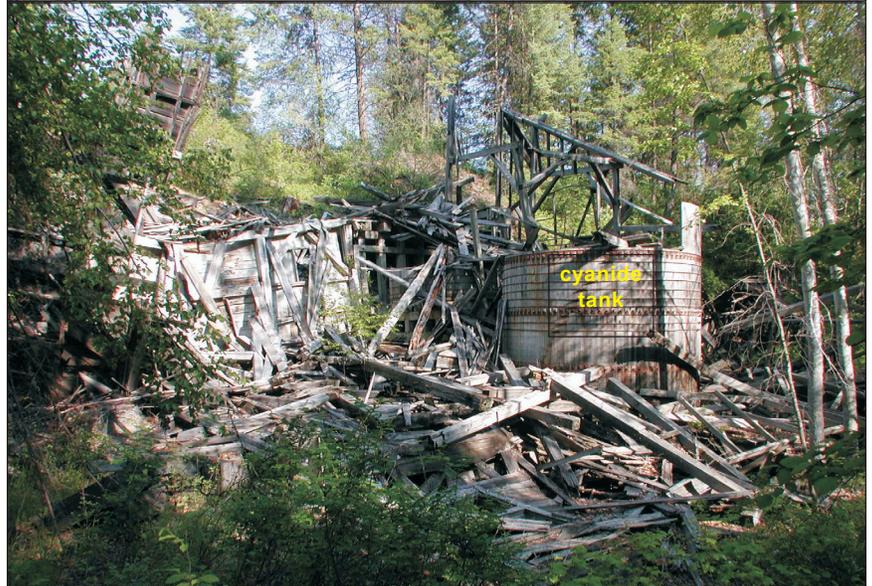
The circa-1937 mill building has collapsed (Fig. 13). The crusher, ball mill, classifier, thickener, and precipitation tanks have been salvaged. The cyanide tank is recognizable but inaccessible because of debris. The original bunkhouse, office, blacksmith shop, power plant, and accessory buildings are gone. The 200-bucket tramline used prior to 1910 has been salvaged. A private residence is situated on the Rosie Lee claim 800 feet northeast of the mine dump.

Figure 13. (middle) Mill site. Note the cyanide tank, which was unreachable because of debris. View to the southeast.

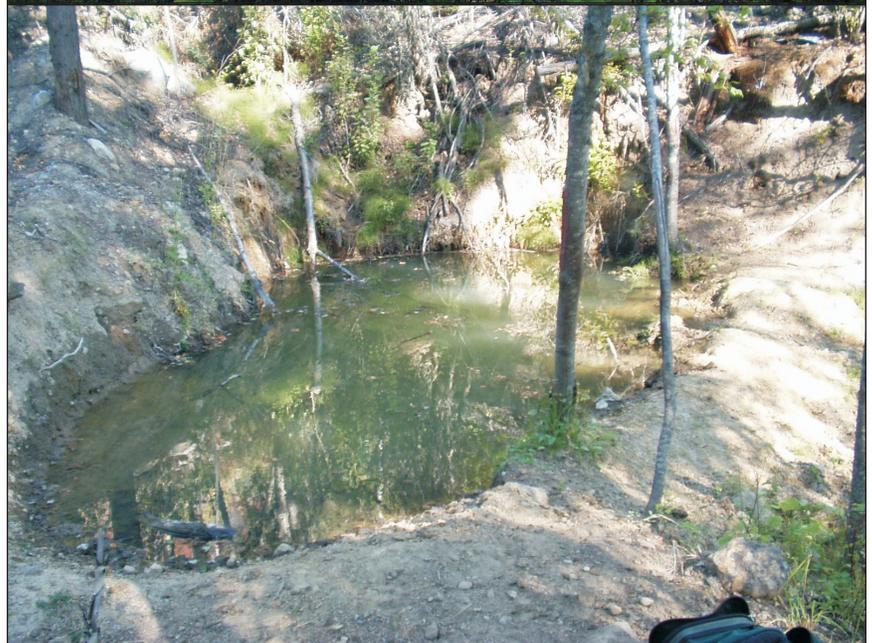
FTMC's stock prospectus (1945) states that the mine made "water sufficient to run the mill." However, the site was dry in June 2002 and August 2006, with the exception of a small seep at the toe of the waste dump. The less than 1 gallon/minute discharge collects in a 10-foot-diameter pond (Fig. 14) used by open-range cattle. Analysis of the water sample taken here is shown in Table 8. Notes on Shell's 1982 underground sample map (Landress, 1982) indicate that the mine was flooded below the No. 5 level at elevation 2850 feet.

Figure 14. (bottom) Seep and pond below waste rock dump. Pack for scale.
