INACTIVE AND ABANDONED MINE LANDS— Bodie Mine, Wauconda Mining District, Okanogan County, Washington

WASHINGTON
DIVISION OF GEOLOGY
AND EARTH RESOURCES
Information Circular 106
November 2007

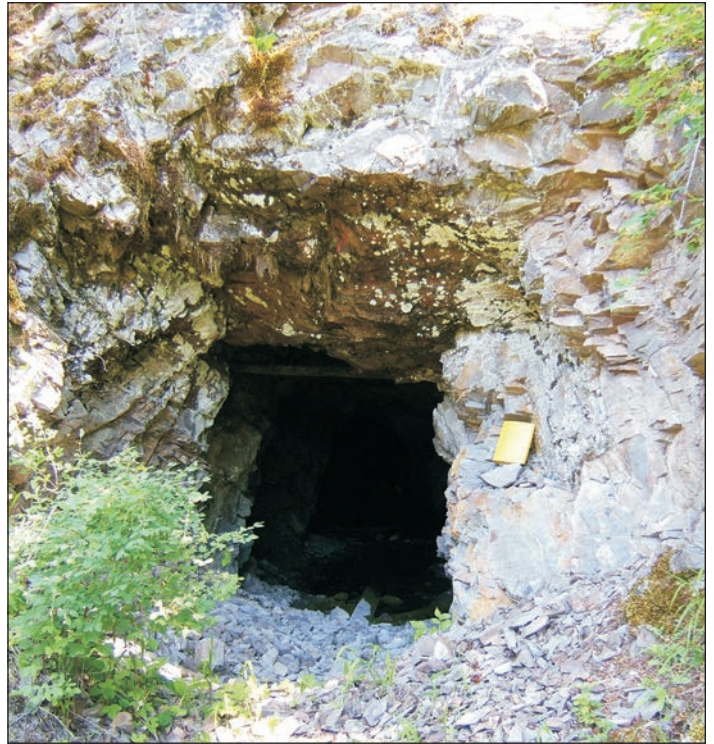
Figure 2. Massive andesite exposure at the 700-level portal. Platy fragments are spalling around opening. View is to the east.

Gold mineralization at the Bodie mine is remarkably similar to and of the same age as epithermal (50–200°C) hot-springs type gold deposits found at the First Thought mine in Stevens County and the Republic Mining District in Ferry County. Two host rocks, both in the upper Eocene Klondike Mountain Formation, surround the Bodie vein: a dense microcrystalline andesite flow grading to dacite in places, and one or more units of brecciated volcanic rock containing minor pyroclastic sediments. The andesite ranges in color from light green to dark purple and commonly displays a platy flow structure that dips into the hillside at moderate angles (Fig. 2).

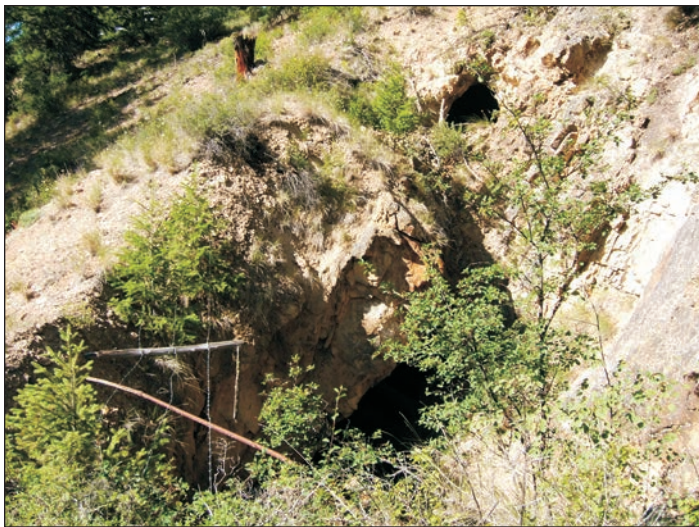
All of the mine workings, underground and on the surface, are hazardous and should not be entered (Figs. 7 and 8). Most of the crosscutting adits are caved or partly caved. Cool air exhausting from the 200-, 300-, and 400-level portals indicates that they are open to some extent (see Table 2). We observed no air exhausting from the 700-level portal.

Figure 7. Open stopes along mine ridge. View is to the northeast.

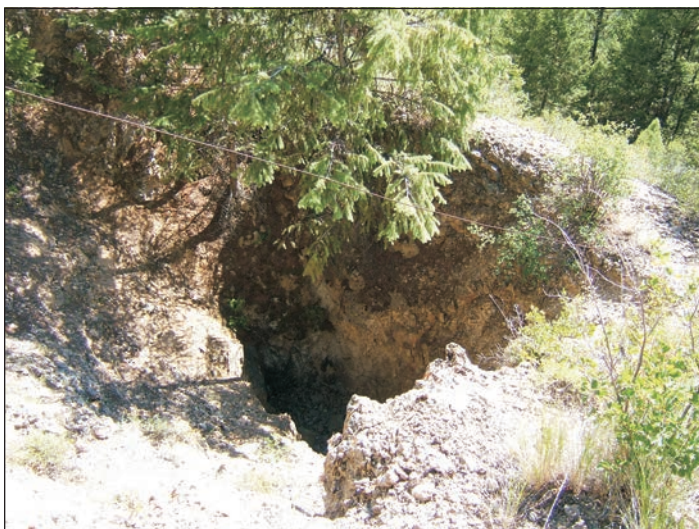
Figure 9. Glory hole, ~50 feet in diameter by 40 feet deep. The Bodie vein is 250 feet to the east. View is to the south.

A feature that resembles a glory hole is approximately 40 feet deep with vertical sidewalls (Fig. 9). It does not appear to be a subsidence feature. It is located 250 feet west of the northernmost open stopes. As such, it either represents a branching of the vein or a pocket of economic gold mineralization in the breccia.

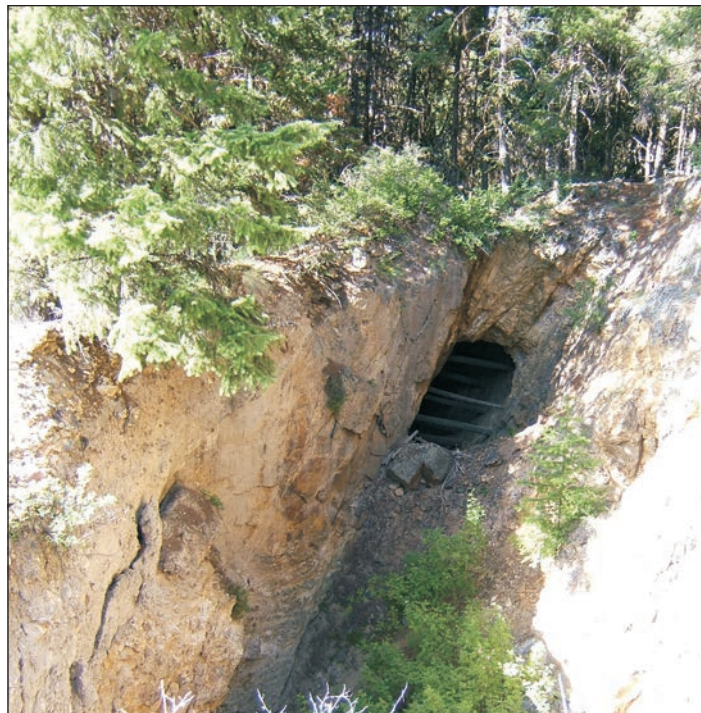
Figure 8. Open stopes along mine ridge. View is to the northeast.

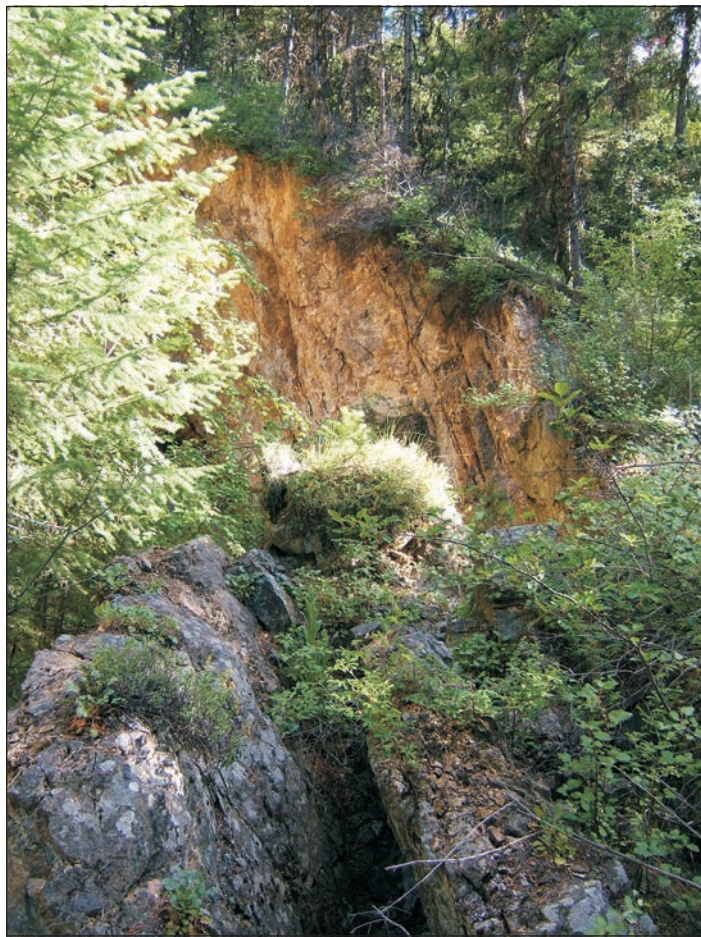
The headwall in an open pit located on strike ~250 feet southeast of the 300-level portal is about 100 feet in height with several adits and at least one raise entering the sidewalls (Fig. 10). The area could not be safely entered. The vein's hanging wall at the pit location is separating and falling into the opening, and caved beneath it during DGER site characterization (Fig. 11).

Figure 11. Ten-foot-deep cracks in the open pit hanging wall. Material is collapsing into the pit. View is to the south.

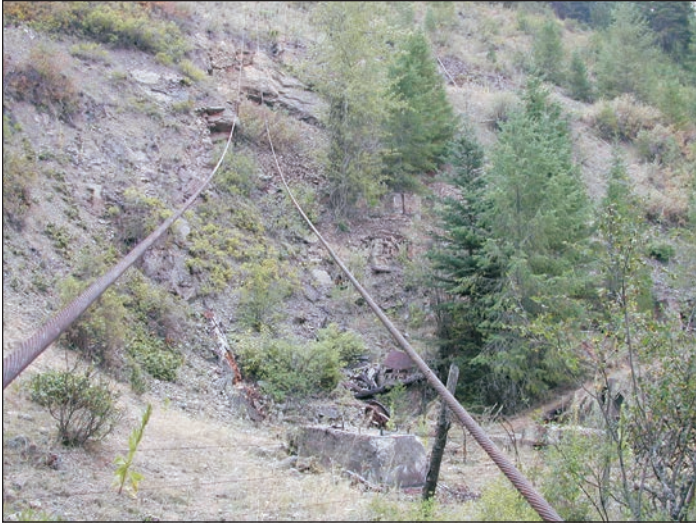
The mill site is marked by the presence of crusher and ball mill foundations, but the mill burned in 1962 (Fig. 13). A photo taken in 1936 by Chamberlain shows the Northern Gold mill site, tramway, and ore bin (Appendix F, Fig. F3). The original ore mined in the 1890s was sufficiently high-grade to be direct shipped to a smelter. In 1902, Bodie Mining Co. installed a ten-stamp 20 tpd mill using mercury amalgamation and cyanidation. Precious metal recovery was poor considering the relatively high assays of the run-of-mine ore, resulting in the property changing hands several times until operations stopped altogether in 1916 (DGER mine file).

Figure 13. Mill site footing and tram cable to the 400-level adit. View is to the east.

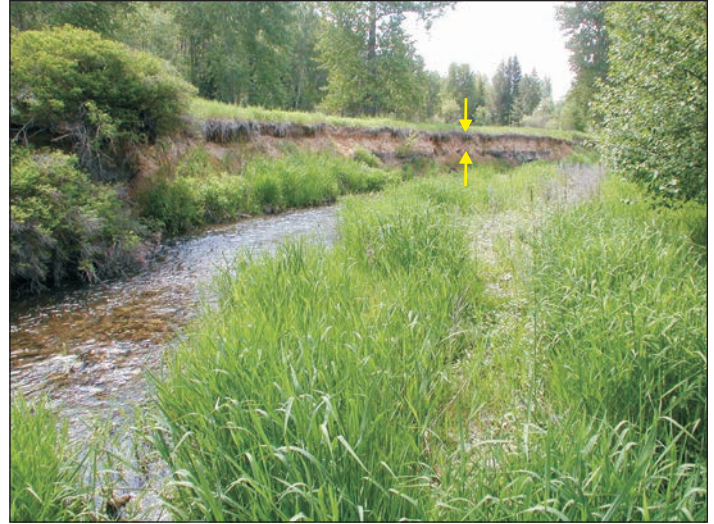
The tailings are exposed for 1500 feet along a cut bank on the east margin of Toroda Creek. They cover an area of 6.5 acres, 4 feet thick on the margins and about 8 feet thick closer to the mill site. Cottonwood trees up to 20 inches in diameter and a thick stand of grass have established on the surface (Fig. 14). The total volume is in the range of 30,000 to 40,000 cubic yards at a density of 1.65 tons per cubic yard.

Figure 14. Cut bank on Toroda Creek. Light brown tailings (between arrows) overlie the original land surface. Flow is right to left. View is to the south.
