INACTIVE AND ABANDONED MINE LANDS—GERMANIA MINE, CEDAR CANYON MINING DISTRICT, STEVENS COUNTY, WASHINGTON

WASHINGTON
DIVISION OF GEOLOGY
AND EARTH RESOURCES

Information Circular 117
February 2014

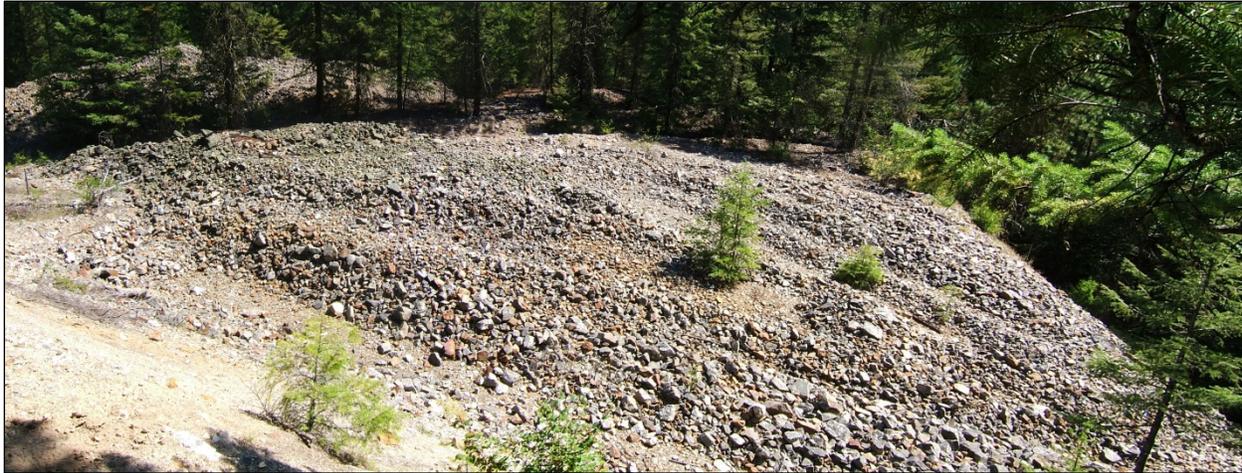
Figure 2. Stockpiles of cobble-sized vein talus at the mill level. The tailings repository in Sand Creek draw is hidden by forest at the top of the photo. View is to the east.

The only available information we have on the grade of the stockpiled vein talus shown in Figure 2 is from the 11,528 tons run through the mill between April and October 1940, which yielded 1 pound per ton of WO_3 or 0.05 percent (Page, 1941). We estimate that the stockpile contains a minimum of 100,000 tons.

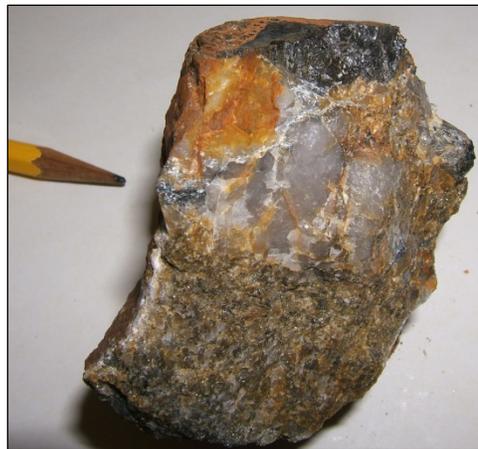
Figure 3. Euhedral wolframite crystal in glassy vein quartz and granitic host rock.

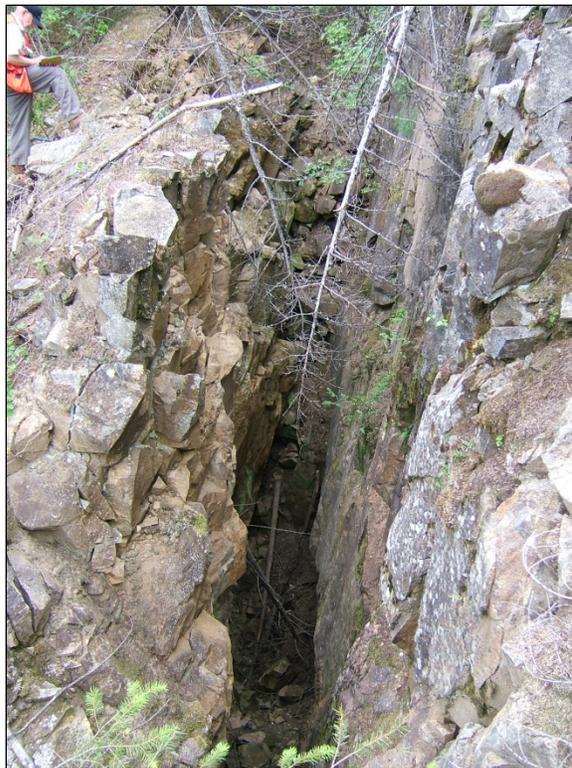
Figure 4. Typical surface expression of the stopped-out Exodus vein. The walls are 6 to 8 feet apart. View is S25W.

DGER’s site characterization (2013) confirms the geomorphology shown on Anderson and Puffett’s 1954 map, in that the linear near-vertical stope is open to the surface from the top of the ridge at elevation 3,957 feet to the mill site, with vertical openings of 400 feet to 40 feet, depending on location along the ridgeline. Figures 4 and 5 are typical of the surface expression. It appears that the 100 and 200 levels no longer exist *per se*; that is, no feature resembling an adit can be seen. The location of the 200 level was probably as shown in Figure 5 because of the size of the excavation, mine rail, and an overgrown road leading into the site.

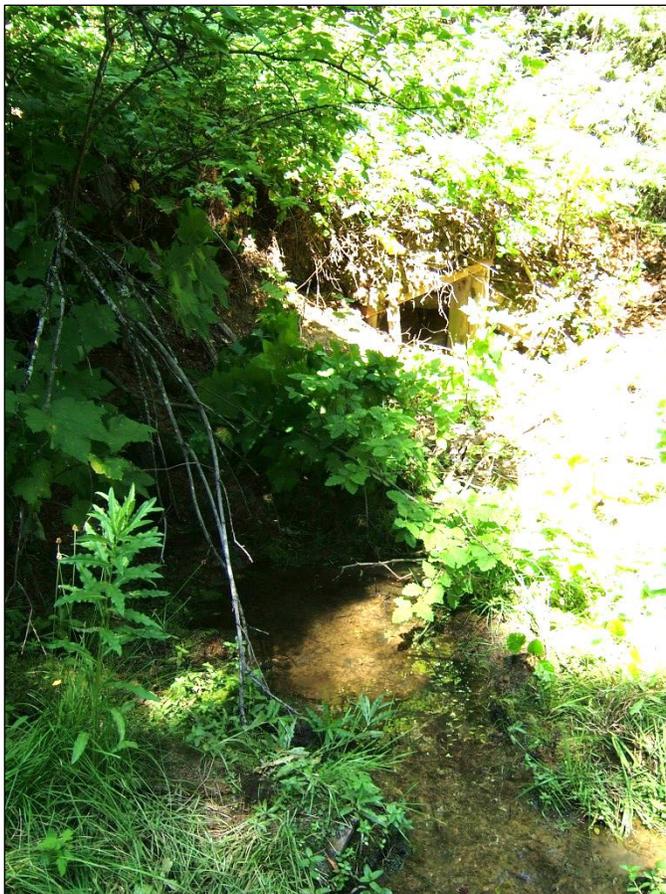
Figure 6. Caved 400 level portal at upper right showing water discharge. View is to the northwest.

Two water samples were taken during site characterization: (1) The 400-level adit discharged about 2 gallons per minute (gpm). The pH was neutral to slightly basic (7.4) and electrical conductivity (EC) was 570 $\mu\text{S}/\text{cm}$. The discharge was clear and the bed appeared natural (Fig. 6). The flow crossed the access road above the mill and infiltrated the top of the tailings pile in a spring-fed ravine of a Sand Creek tributary. (2) Water emerged from the base of the tailings 100 feet in elevation below the 400-level adit at a rate of ~ 5 gpm, forming a year-round stream. The pH was 7.0 and the EC measured 380 $\mu\text{S}/\text{cm}$. The water was clear, and the bed was stained light orange-brown. Chemical analyses for metals at both locations met the applicable standards shown in Table 7 for Ground Water (WAC 246-290) and Surface Water (WAC 173-201A). Contrary to expectation, hardness level and metal concentrations decreased (with the exception of a slight increase in copper), after the water flowed through the tailings.

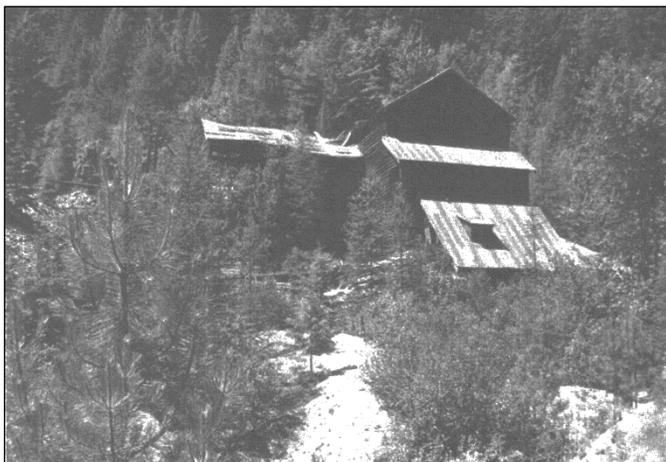
Figure 7. Germania mill circa 1985 (from Bunning, 1985). View is to the north.

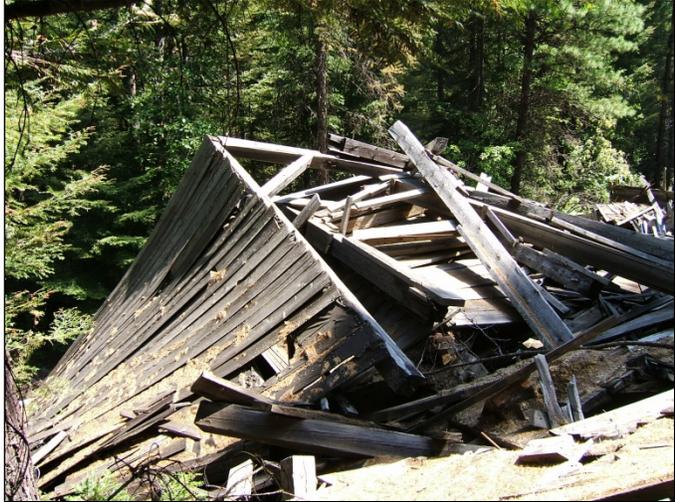
Figure 8. Mill ruins circa 2013. View is to the east.

In August 1914, the original mill of 40-tpd capacity was reported destroyed by arson and the 200-level portal blasted shut (*Northwest Mining*, July 1936). The second mill of 100-tpd capacity shown in Figure 7 is the structure most commonly associated with the Germania Mine. It was built by Tungsten Producers, Inc., in 1931 and expanded to 200-tpd capacity by General Electric in 1938. Power for the mill was supplied by 440-volt 75-Kw diesel or gasoline generators. The mill building has collapsed (Fig. 8).

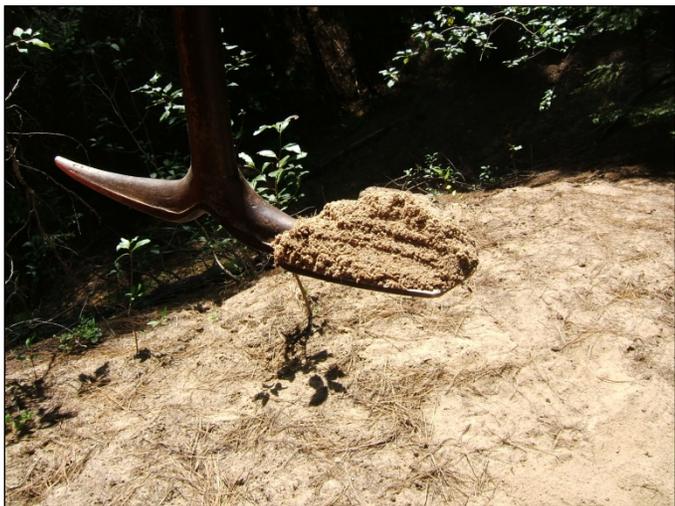
Figure 10. Typical tailings exposure.

The tailings are deposited in chaotic piles filling about 700 lineal feet in the Sand Creek tributary ravine located east of and adjacent to the mill. Based on the documented mill output, we estimate 90,000 to 100,000 tons of minus ¾-inch material remain (Fig. 10). Analyses for metals from a grab sample taken at one location are shown in Table 3. Levels of arsenic and selenium in this sample exceed soil standards shown in Table 4.

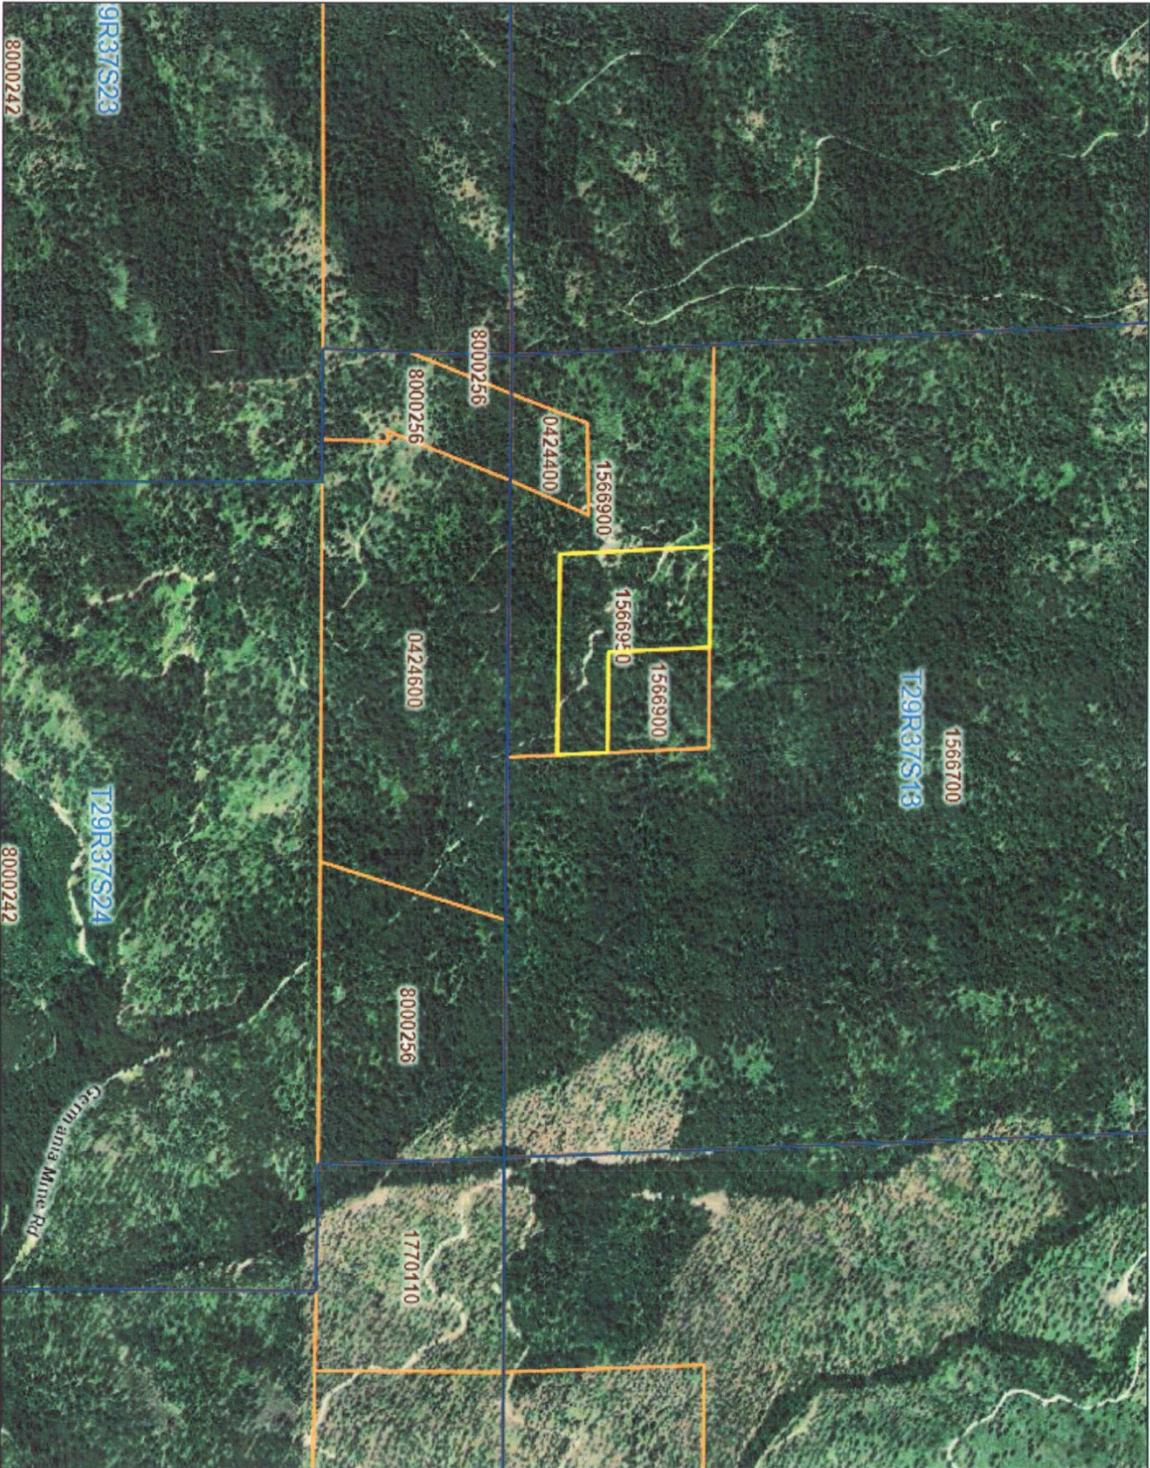
Figure C2. Land status. Former claims are marked by orange boundary lines with black claim numbers inside. The yellow 10-acre parcel is privately held. All other lands above the Spokane Indian Reservation boundary (lowest horizontal orange line), including the Exodus claim (angular parcel), are held by the Bureau of Land Management (Stevens County Assessor). Dark blue lines and blue numbers indicate township and range.
