# LANDSLIDES IN SEATTLE

By  
DONALD W. TUBBS

DEPARTMENT OF NATURAL RESOURCES  
DIVISION OF GEOLOGY AND EARTH RESOURCES  
INFORMATION CIRCULAR NO. 52

INFORMATION CIRCULAR 52

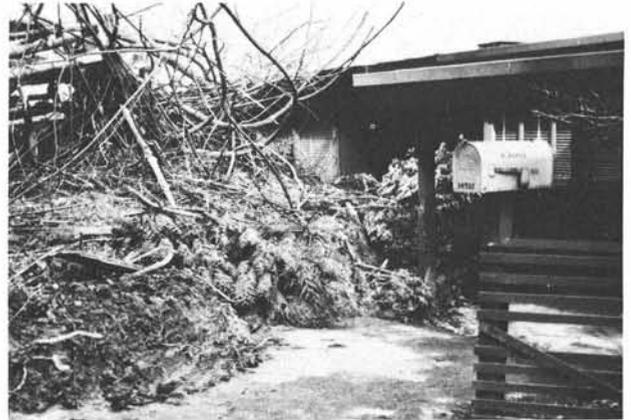
FIGURE 2.—Landslide along Edgewater Lane N.E.

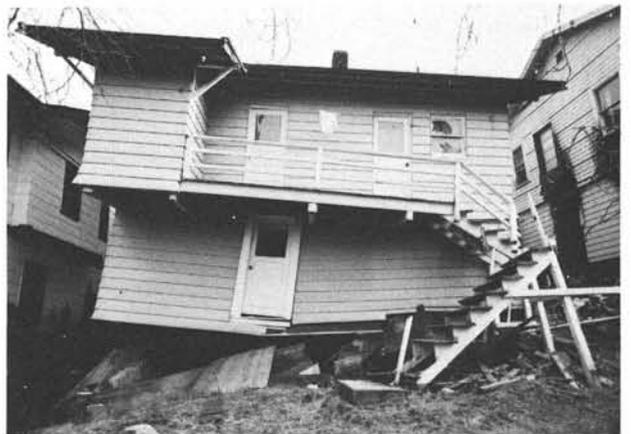
FIGURE 3.—Landslide effects in the Madrona District.

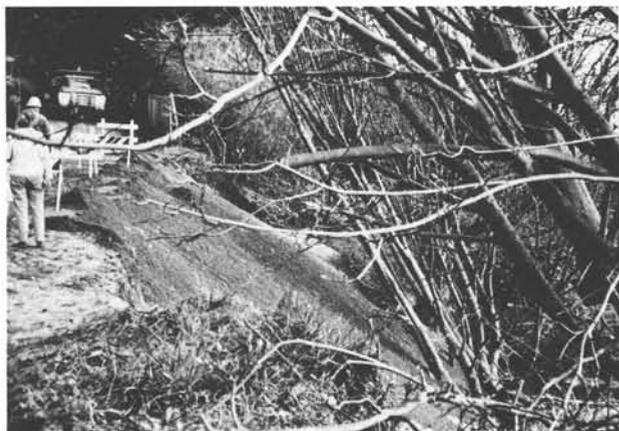
FIGURE 4.—Landslide along Perkins Lane W.

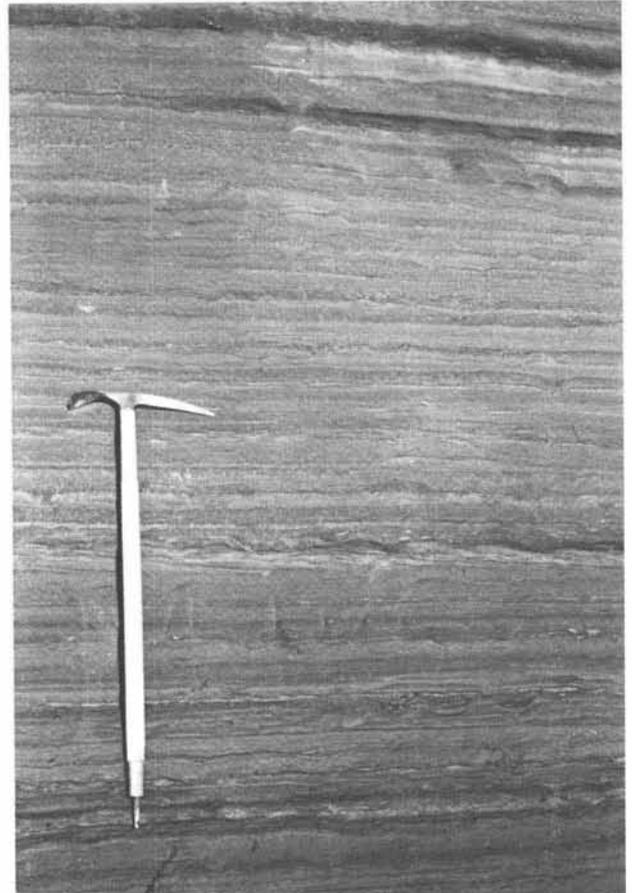
FIGURE 8.—Olympia Interglacial sediments.

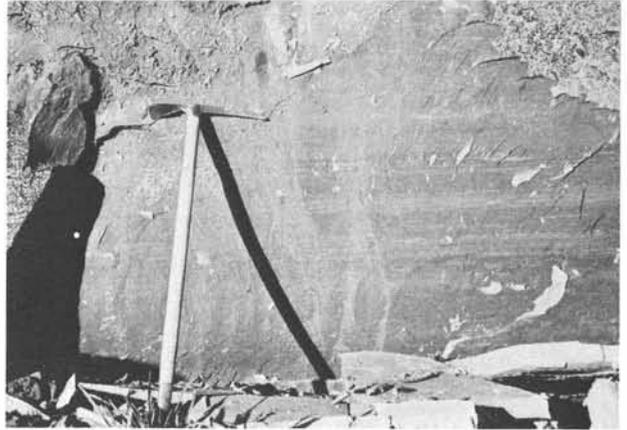
FIGURE 9.—Lawton Clay.

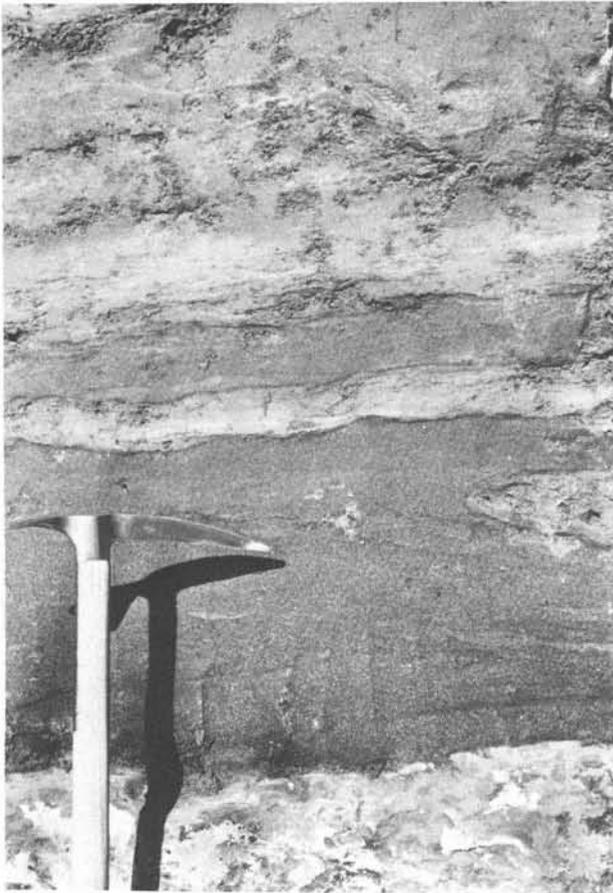
Where well exposed, the transition between the Lawton Clay and the Esperance Sand is not always a simple, abrupt change from clay and silt below to sand above. Rather, there often exists a layer, up to several tens of feet in thickness, in which alternating beds of sand and clay occur (fig. 11). In the formal stratigraphic literature this interval has been arbitrarily assigned to the lower

FIGURE 11.—Sand-clay interbeds in Esperance Sand-Lawton Clay contact zone.

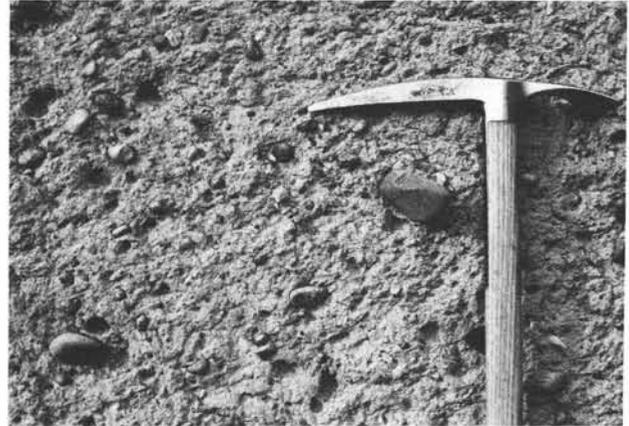
Some of the material that the glacier eroded was redeposited farther south as advance outwash. Much of it, however, was incorporated into the Vashon till—a nonsorted, nonstratified sediment deposited directly by the glacial ice (fig. 13). Most of the Vashon till is very compact, because it was "plastered" onto the ground surface under the weight of several thousand feet of ice. However, as the glacier finally began to melt away, a less compact

FIGURE 13.—Vashon till.

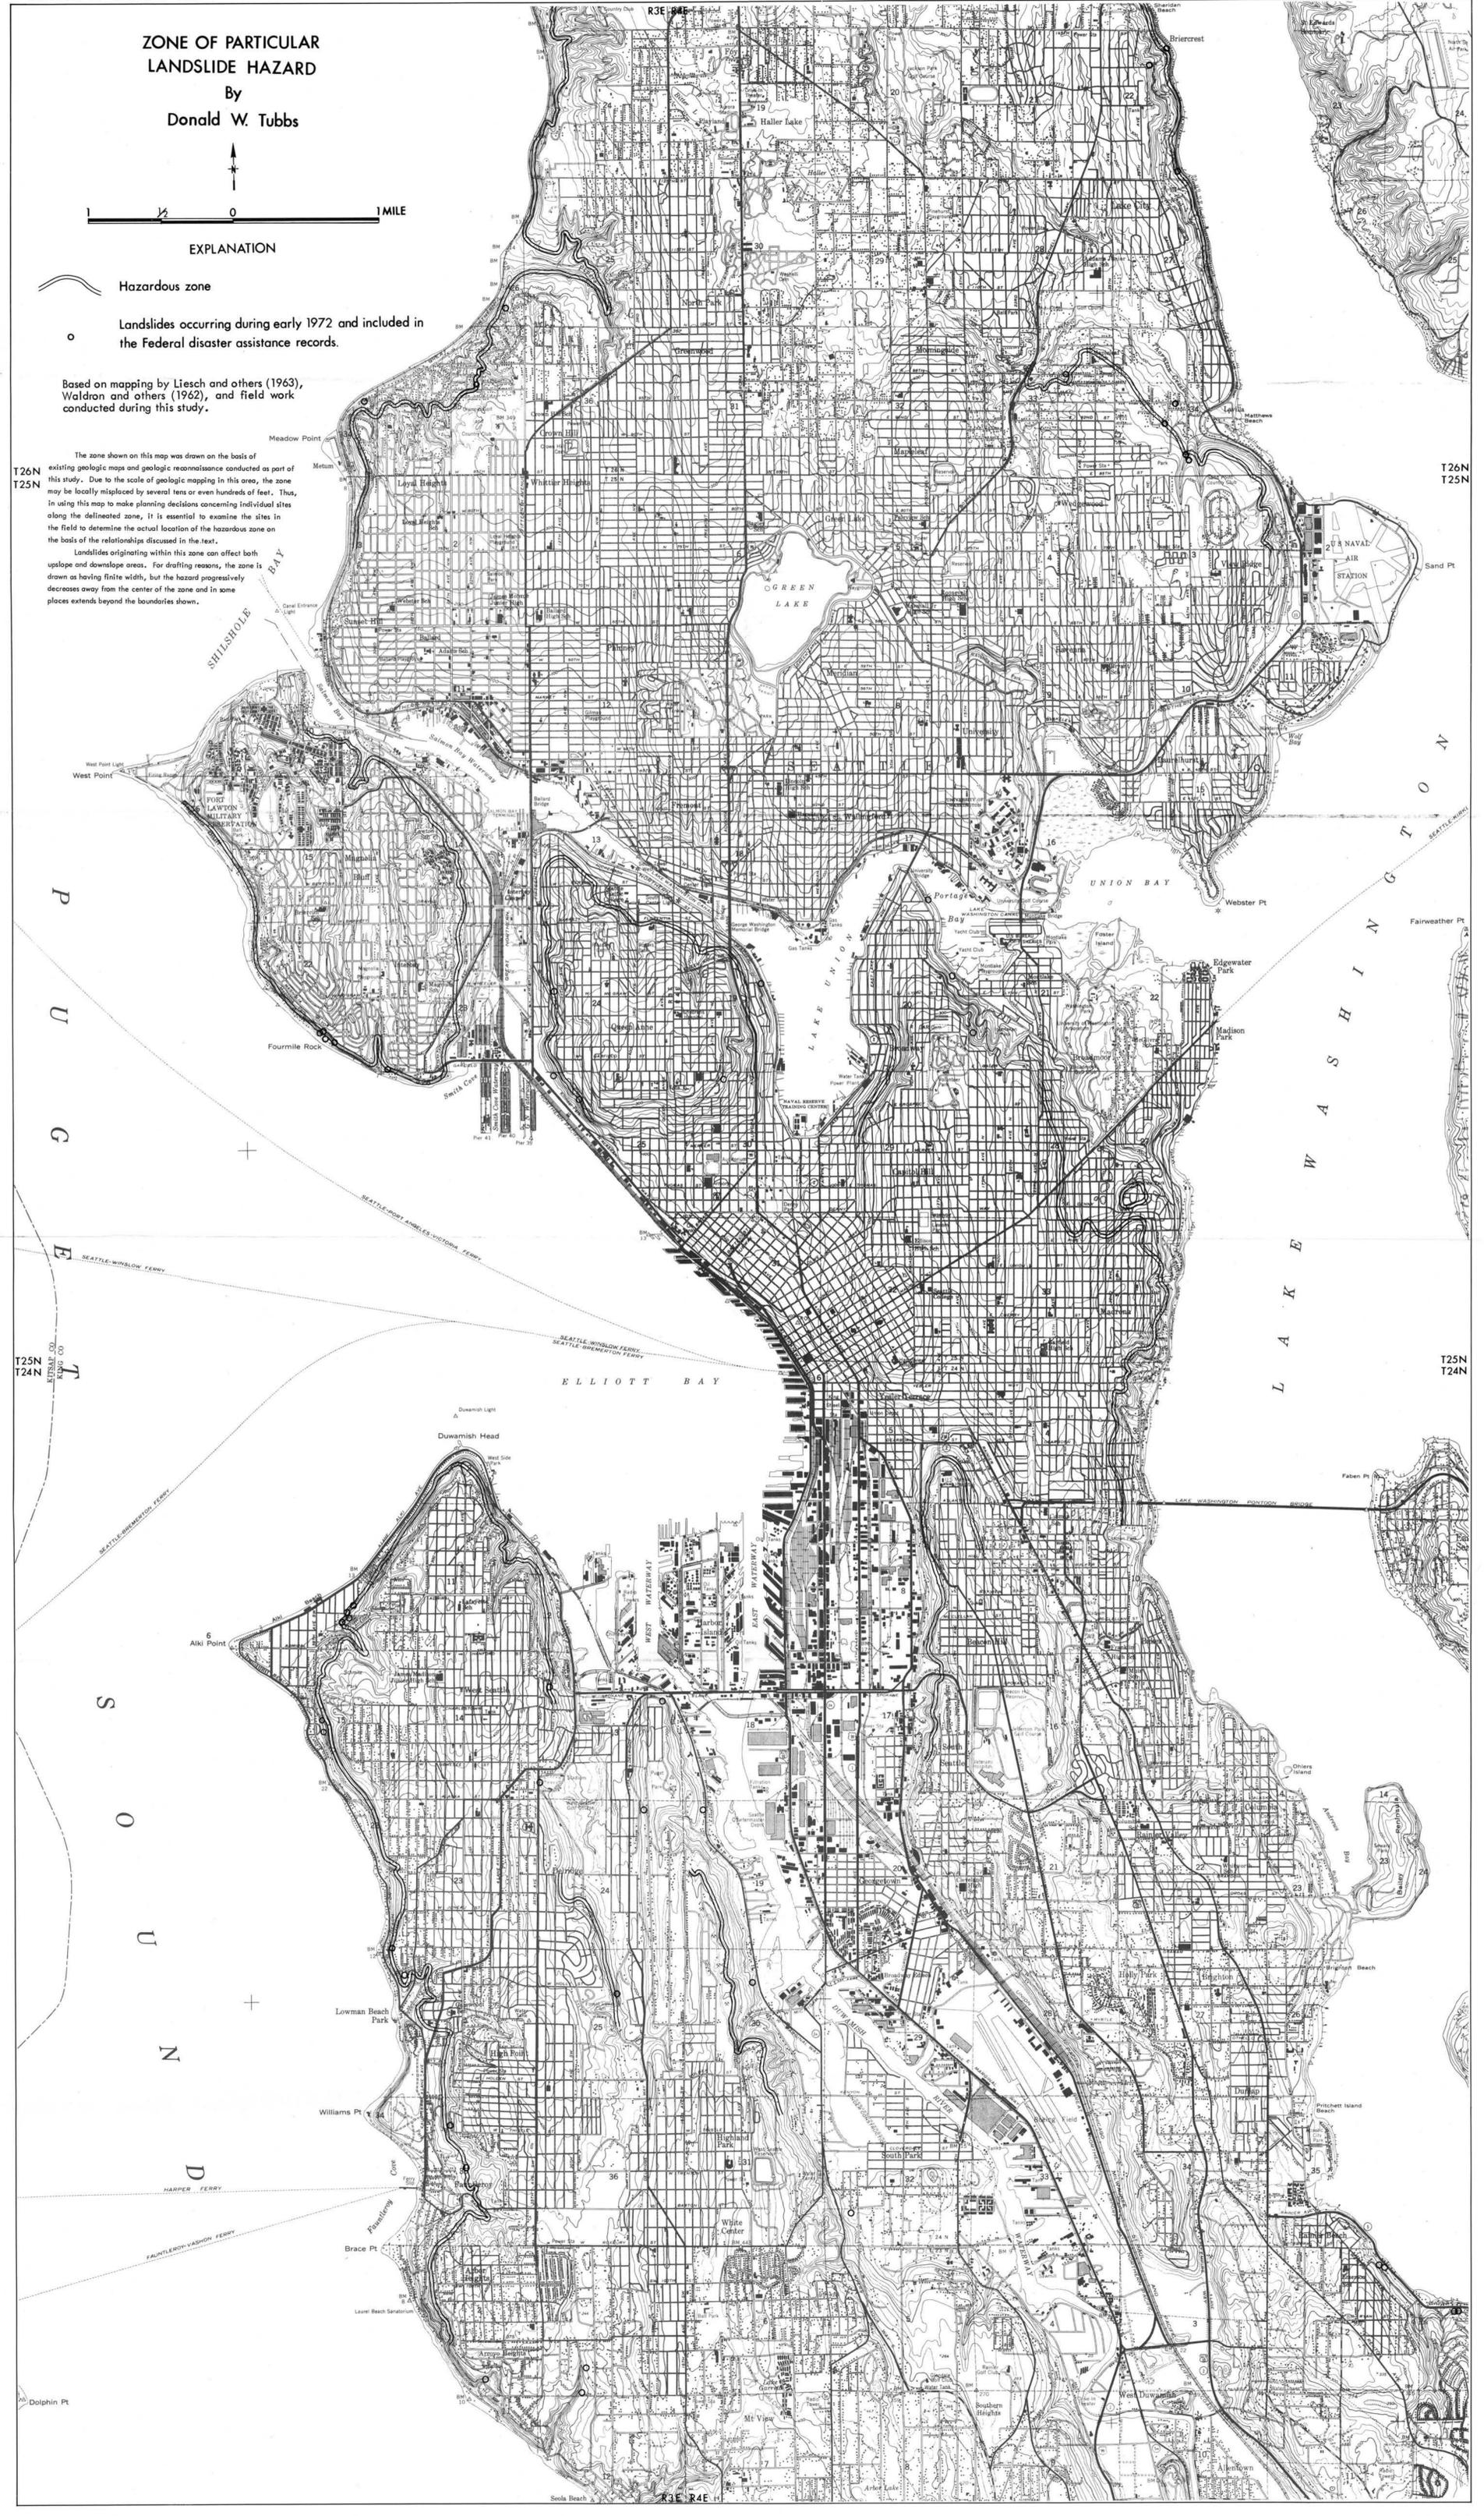
### ZONE OF PARTICULAR LANDSLIDE HAZARD

contact in localizing landslide activity, it is possible to delineate a relatively narrow zone of particular landslide hazard near the base of the Esperance Sand. This zone, shown on plate 1, was drawn on the basis of existing geologic maps and geologic reconnaissance conducted as part of this study. Landslides originating along the trace of the relevant contacts can affect areas both upslope and downslope from the line of origin. For drafting reasons, the hazardous zone is shown on plate 1 as having finite width, but the hazard progressively decreases to either side of the trace and in some places extends beyond the boundaries shown. Because of the scale of geologic mapping in this area, the contacts shown on the maps (and thus the zone depicted in plate 1) may locally be misplaced by several tens or even hundreds of feet. Thus, in using plate 1 to make planning decisions concerning individual sites along the delineated zone, it is essential to field-check the sites to determine the actual location of the hazardous zone on the basis of the relationships previously discussed.

The zone shown on this map was drawn on the basis of existing geologic maps and geologic reconnaissance conducted as part of this study. Due to the scale of geologic mapping in this area, the zone may be locally misplaced by several tens or even hundreds of feet. Thus, in using this map to make planning decisions concerning individual sites along the delineated zone, it is essential to examine the sites in the field to determine the actual location of the hazardous zone on the basis of the relationships discussed in the text.

Landslides originating within this zone can affect both upslope and downslope areas. For drafting reasons, the zone is drawn as having finite width, but the hazard progressively decreases away from the center of the zone and in some places extends beyond the boundaries shown.

with this zone of particular landslide hazard, which is delineated on plate 1. This zone is expected to be the location of much future landsliding, and its existence should be considered in land use zoning.
