# LANDSLIDES IN SEATTLE

By  
DONALD W. TUBBS

DEPARTMENT OF NATURAL RESOURCES  
DIVISION OF GEOLOGY AND EARTH RESOURCES  
INFORMATION CIRCULAR NO. 52

Prepared in cooperation with  
UNITED STATES GEOLOGICAL SURVEY  
1974

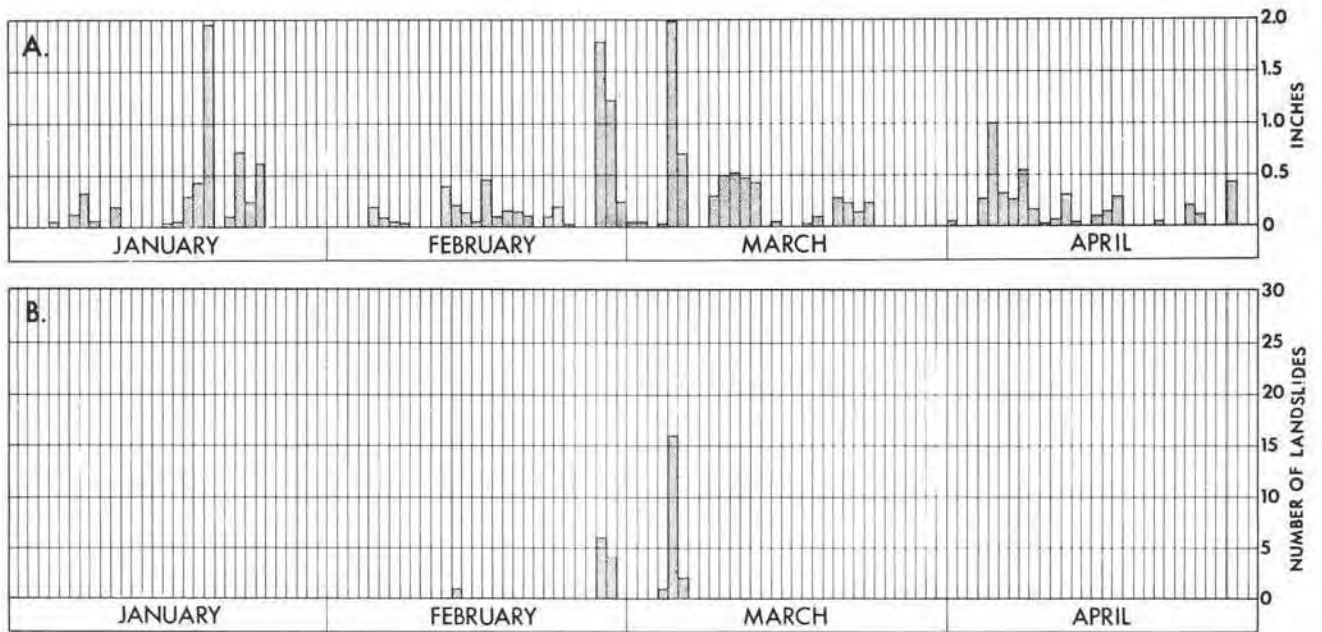
Daily precipitation is illustrated in figure 6, along with a plot of the frequency of landslides. The exact date of occurrence is known for only 30 of the 50 landslides examined during this study. As shown, over 70 percent of those slides occurred on one of the two days in late February and early March during which more than 1.75 inches of rain fell in a 24-hour period. Nearly 90 percent of the slides occurred on one of the three days in the same period that received more than an inch of rain.

FIGURE 6.—Daily precipitation and landsliding. A. Daily precipitation. B. Frequency of landslides.

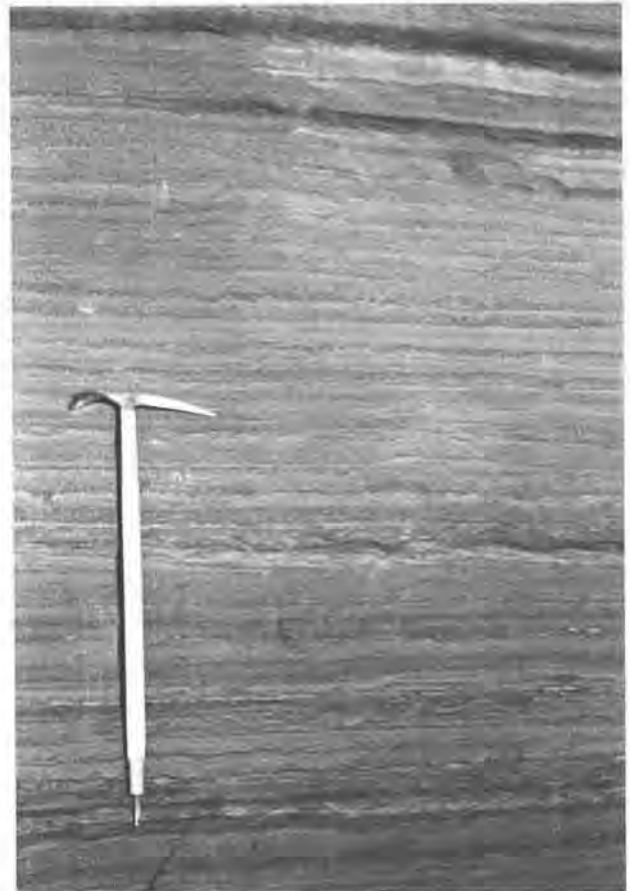
FIGURE 8.—Olympia Interglacial sediments.

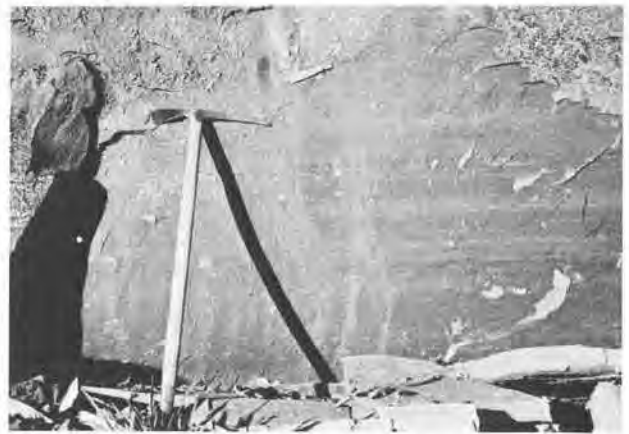
FIGURE 9.—Lawton Clay.

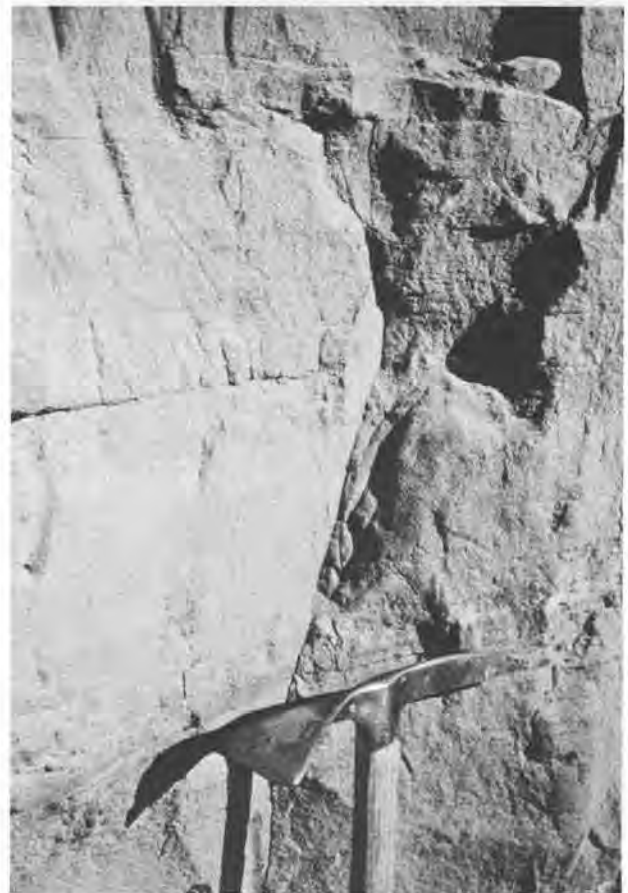
FIGURE 10.—Esperance Sand.

thick layer of sand was deposited. This geologic unit, called the Esperance Sand Member of the Vashon Drift (fig. 10), spread over not only the Lawton Clay but also the hills of older drift that were protruding through the Lawton Clay.

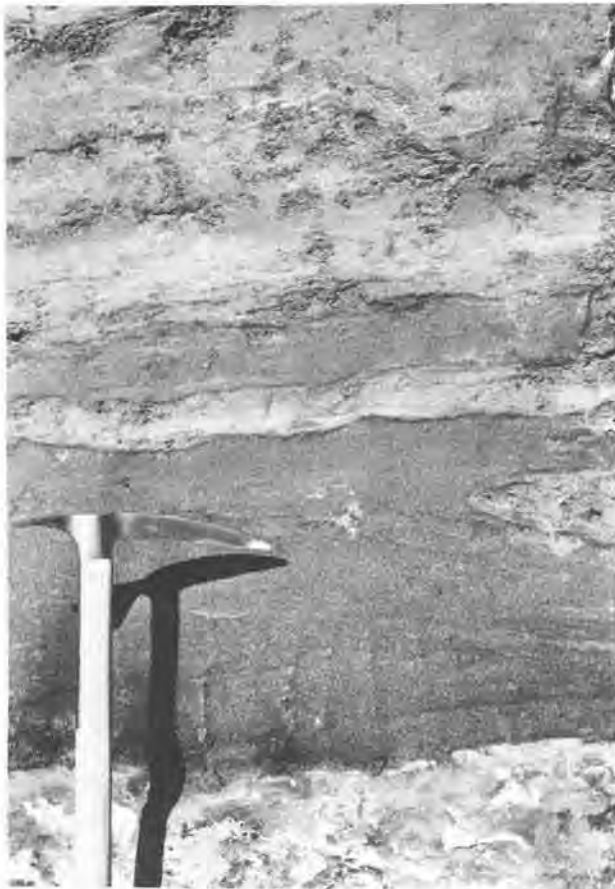
Where well exposed, the transition between the Lawton Clay and the Esperance Sand is not always a simple, abrupt change from clay and silt below to sand above. Rather, there often exists a layer, up to several tens of feet in thickness, in which alternating beds of sand and clay occur (fig. 11). In the formal stratigraphic literature this interval has been arbitrarily assigned to the lower

FIGURE 11.—Sand-clay interbeds in Esperance Sand-Lawton Clay contact zone.

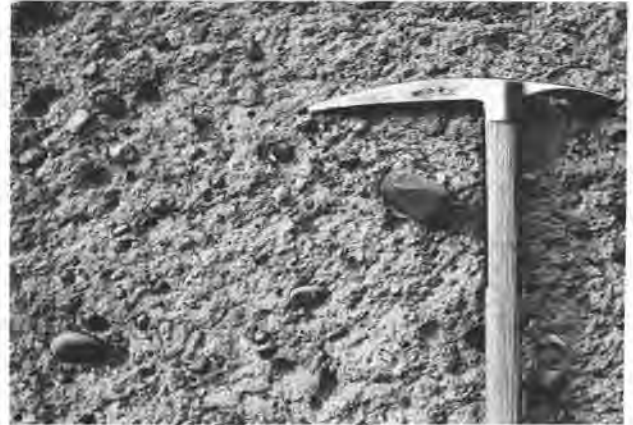
Some of the material that the glacier eroded was redeposited farther south as advance outwash. Much of it, however, was incorporated into the Vashon till—a nonsorted, nonstratified sediment deposited directly by the glacial ice (fig. 13). Most of the Vashon till is very compact, because it was "plastered" onto the ground surface under the weight of several thousand feet of ice. However, as the glacier finally began to melt away, a less compact

FIGURE 13.—Vashon till.

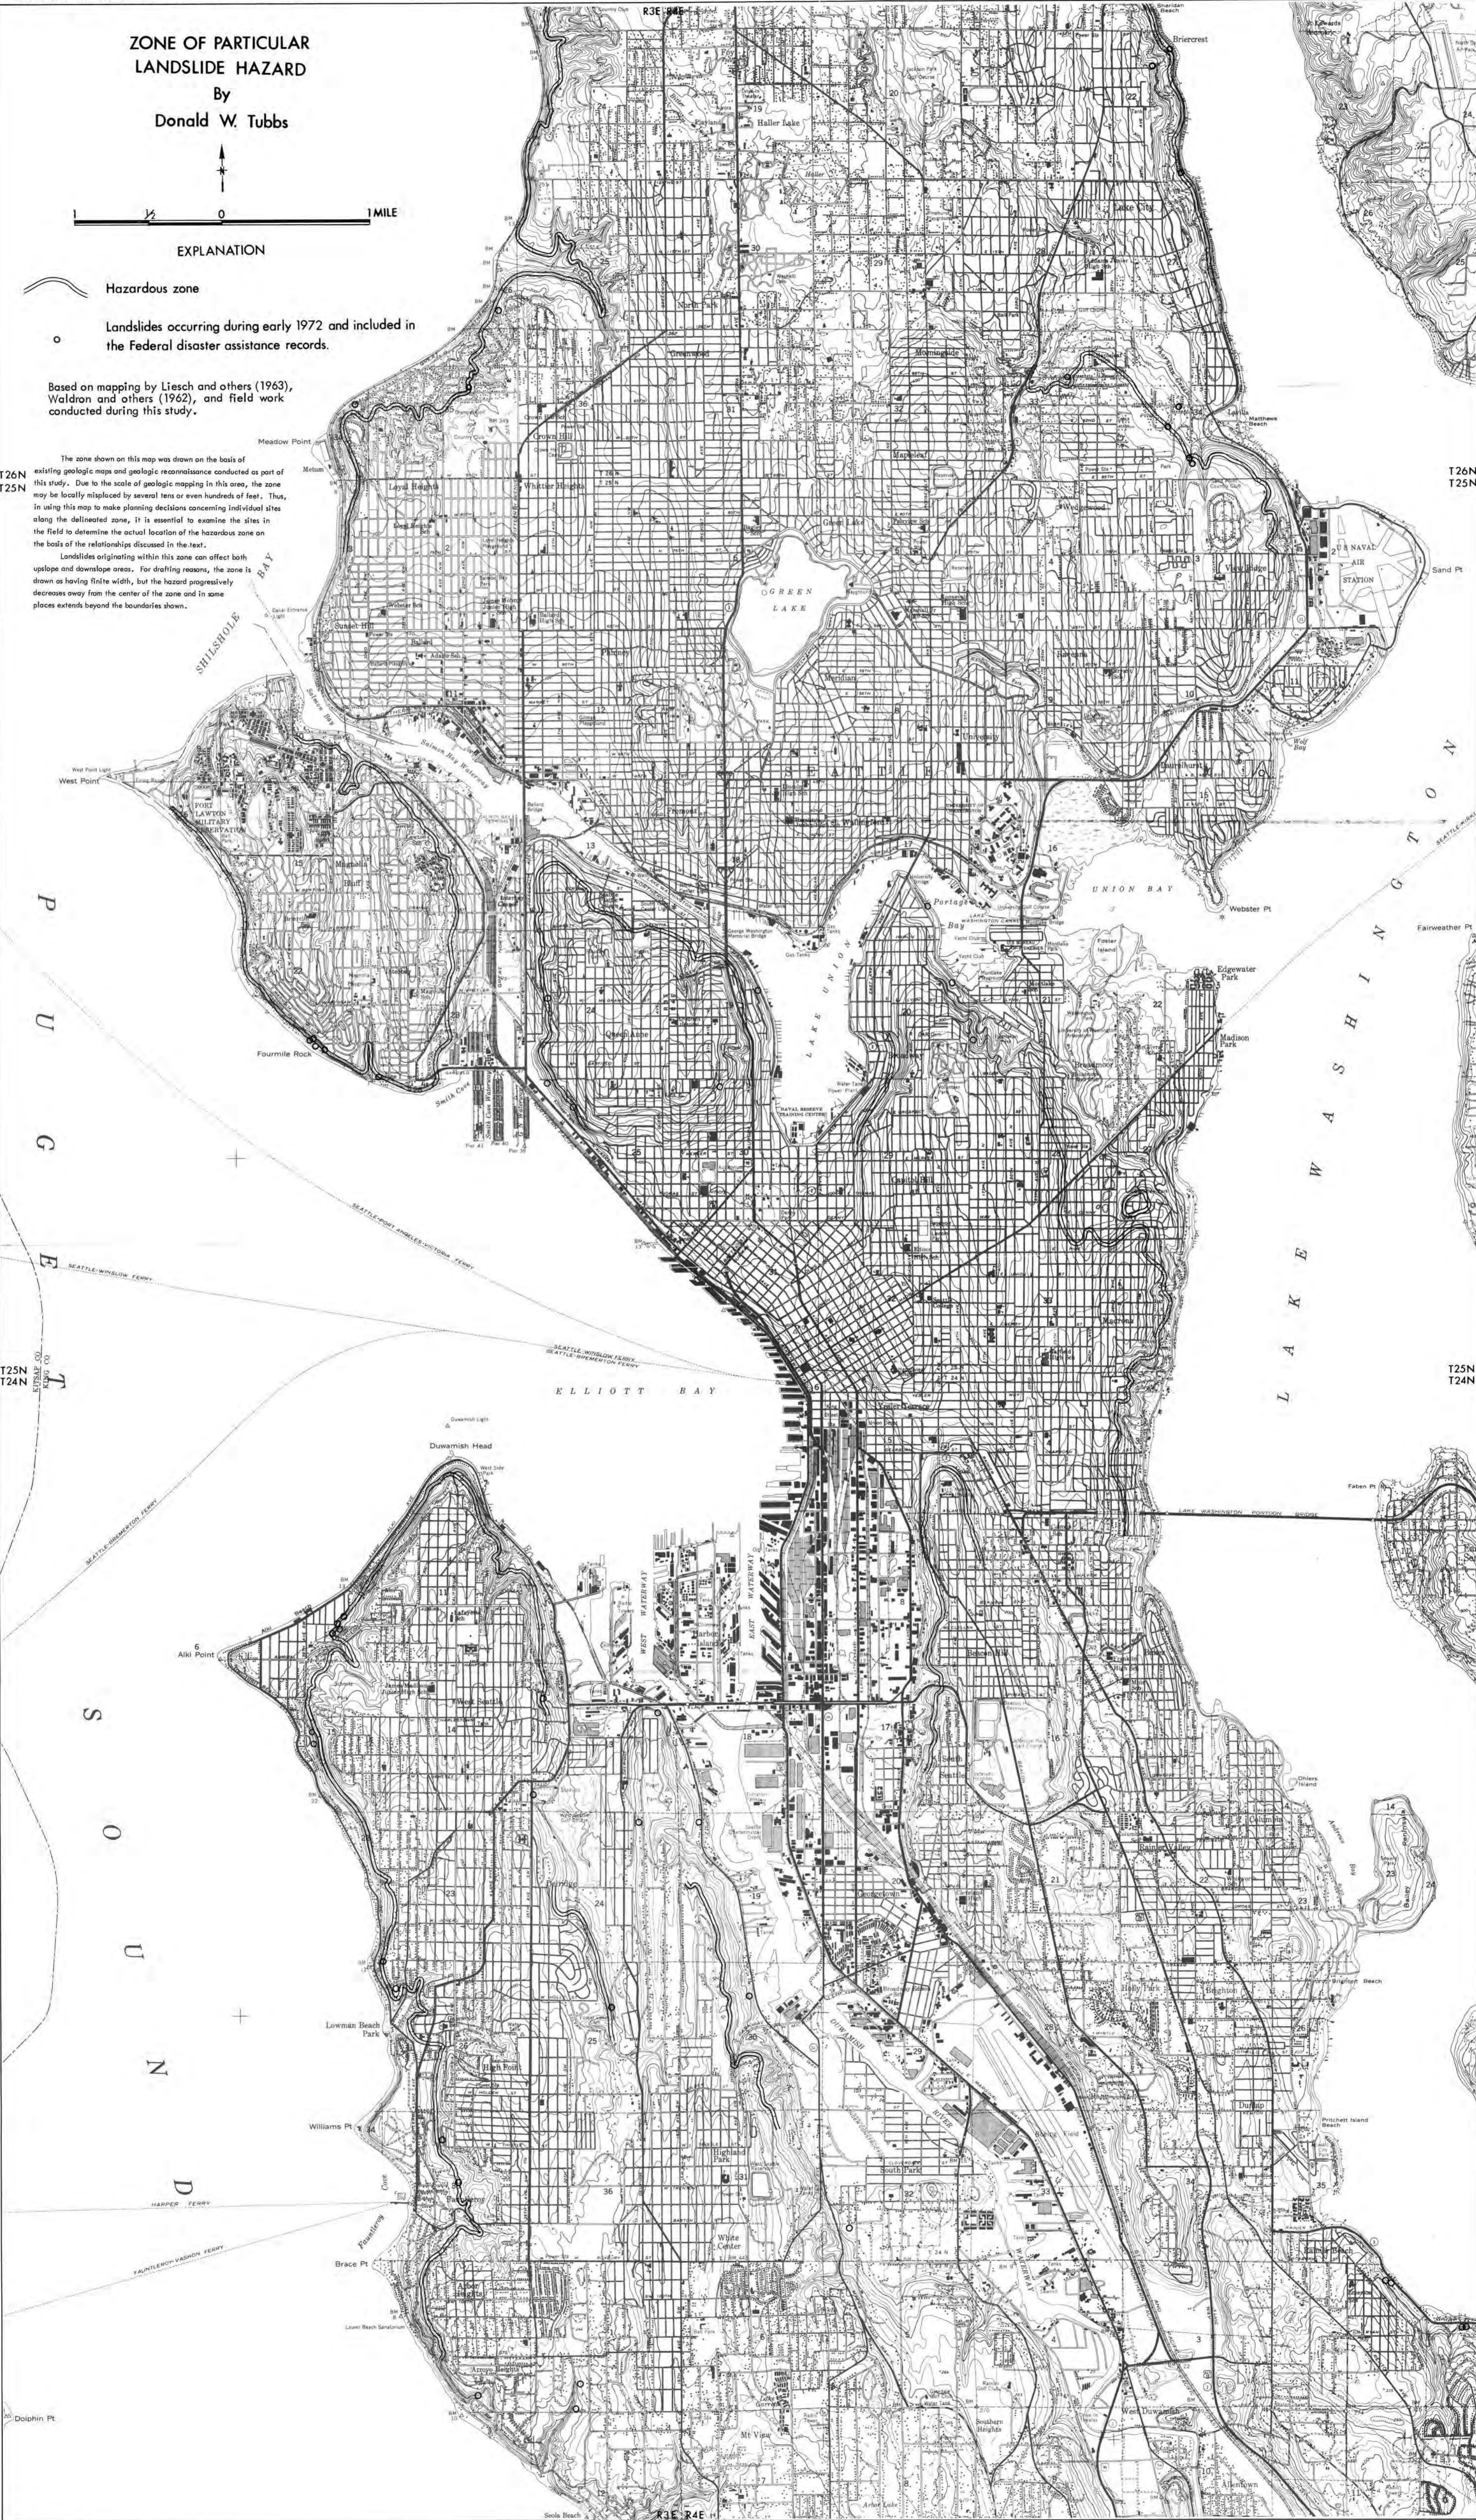
### ZONE OF PARTICULAR LANDSLIDE HAZARD

The zone shown on this map was drawn on the basis of existing geologic maps and geologic reconnaissance conducted as part of this study. Due to the scale of geologic mapping in this area, the zone may be locally misplaced by several tens or even hundreds of feet. Thus, in using this map to make planning decisions concerning individual sites along the delineated zone, it is essential to examine the sites in the field to determine the actual location of the hazardous zone on the basis of the relationships discussed in the text.

Landslides originating within this zone can affect both upslope and downslope areas. For drafting reasons, the zone is drawn as having finite width, but the hazard progressively decreases away from the center of the zone and in some places extends beyond the boundaries shown.

contact in localizing landslide activity, it is possible to delineate a relatively narrow zone of particular landslide hazard near the base of the Esperance Sand. This zone, shown on plate 1, was drawn on the basis of existing geologic maps and geologic reconnaissance conducted as part of this study. Landslides originating along the trace of the relevant contacts can affect areas both upslope and downslope from the line of origin. For drafting reasons, the hazardous zone is shown on plate 1 as having finite width, but the hazard progressively decreases to either side of the trace and in some places extends beyond the boundaries shown. Because of the scale of geologic mapping in this area, the contacts shown on the maps (and thus the zone depicted in plate 1) may locally be misplaced by several tens or even hundreds of feet. Thus, in using plate 1 to make planning decisions concerning individual sites along the delineated zone, it is essential to field-check the sites to determine the actual location of the hazardous zone on the basis of the relationships previously discussed.

with this zone of particular landslide hazard, which is delineated on plate 1. This zone is expected to be the location of much future landsliding, and its existence should be considered in land use zoning.
