INACTIVE AND ABANDONED MINE LANDS— Boundary Red Mountain Mine, Mt. Baker Mining District, Whatcom County, Washington

WASHINGTON
DIVISION OF GEOLOGY
AND EARTH RESOURCES
Information Circular 99
April 2005
Revised January 2008

Inactive and Abandoned Mine Lands— Boundary Red Mountain Mine, Mt. Baker Mining District, Whatcom County, Washington

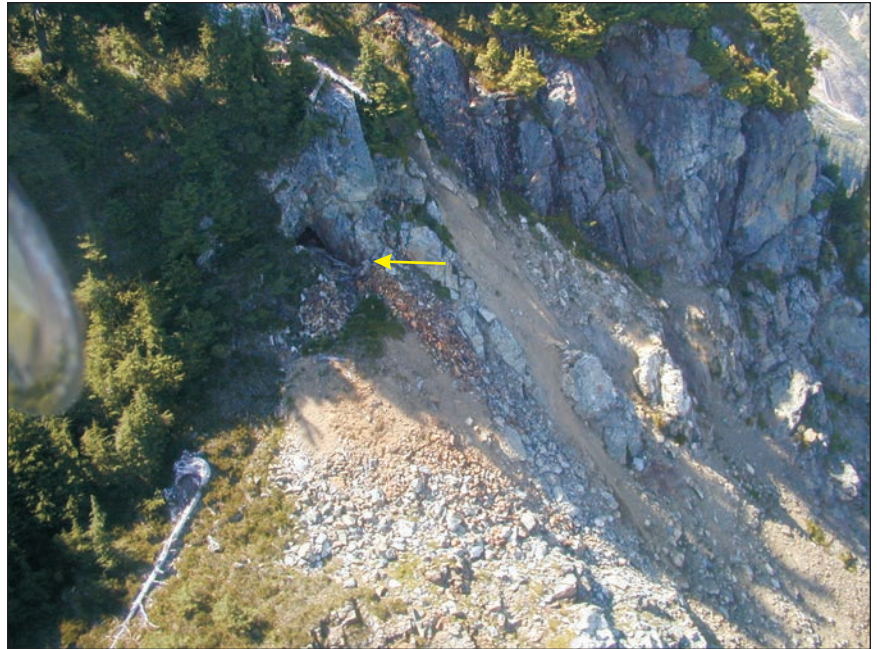
Figure 3. Outcrop and adit (arrow) of the Mountain Boy vein. View to the west.

The relationship of the veins to each other and to various levels is shown in Figure 2. The quartz fissure vein cropping out on the southeast skyline above the 500 Level portal is probably the Mountain Boy vein (Fig. 3) described by Krom (1937). It is at the approximate location of his point EE1 on plate 3 (DGER mine file). A short drift was driven on this outcrop and a 3-foot deep by 200-foot long trench extends to the east before disappearing in a cliff.

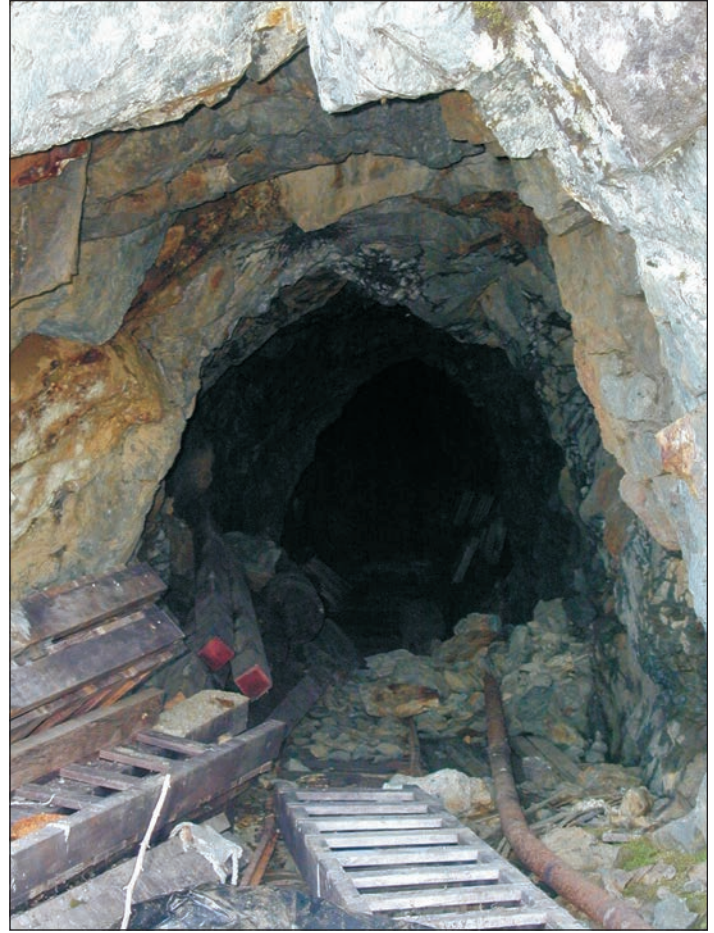
Figure 4. 500 Level portal with circa-1989 ladders and timbers.

The 500 Level portal is located on a relatively level bench. The aerial tramway used for lowering ore to the mill began at this point. The tram terminal foundation and a crushed tram bucket are still in place. The entrance is open, but shows sloughing a short distance inside. The overall condition is unknown as of September 2003; however, according to Grant, it was in good condition and open to the face 1987. A few replacement ladders and dimensional timbers are stored at the entrance (Fig. 4). A sparse trail proceeds uphill from this area to the 200 and 100 Level adits (Fig. 5).

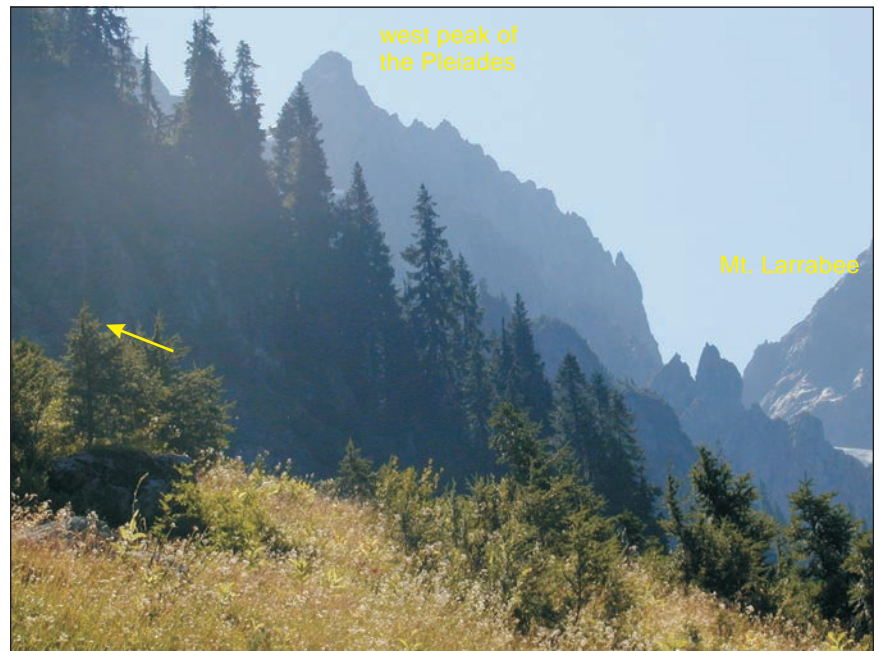
Figure 5. View to the southwest from the 500 Level landing. Arrow points to a trail leading to 100 and 200 Level portals.

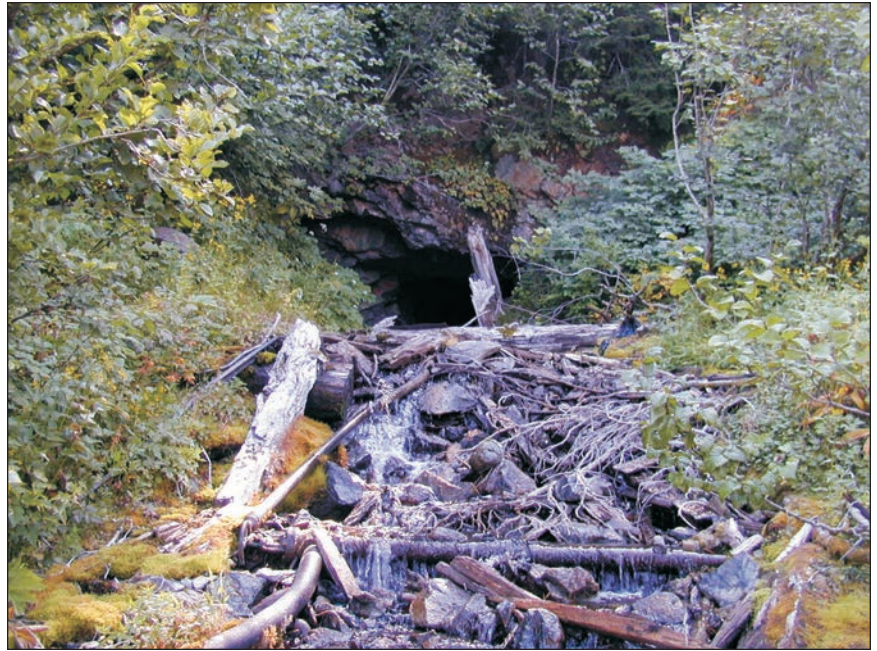
The floor of the 1200 Level is essentially a streambed 6 to 8 inches deep. The portal is open, but the overall internal condition is unknown (Fig. 6). Grant reported it open to the face in 1987. The vertical extent of the mined area from stopes in the 100 Level to the 1200 Level haulage tunnel is approximately 950 feet (Moen, 1969).

Water discharged from the 1200 Level portal in September of 2002 at 500 gallons/minute. The pH measured 8.5 and conductivity reading was 90 μ S/cm. Analyses for arsenic and copper were below the Washington State requirements shown in Table 5 for domestic consumption (WAC 246-290). At a measured hardness of 43 mg/L, the copper content exceeds the calculated standard for chronic effects on aquatic life specified in Table 5 (WAC 173-201A). The water was clear; the bed natural color. Water temperature was 39°F.

Figure 6. Water discharging from 1200 Level portal. Miscellaneous piping and mill equipment in foreground. View to the south.

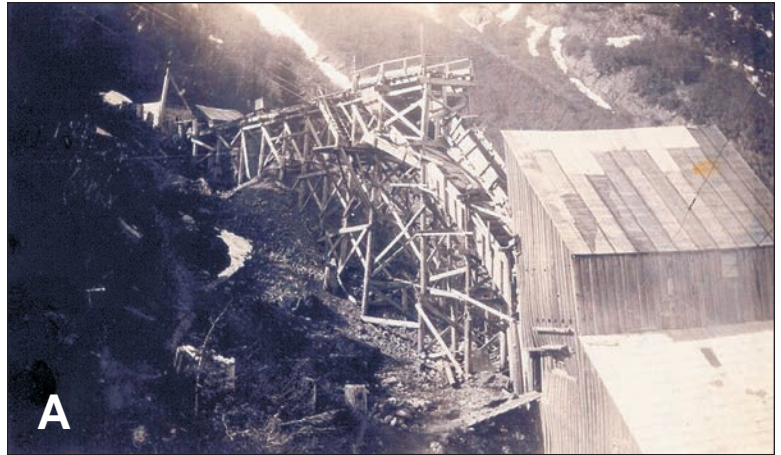
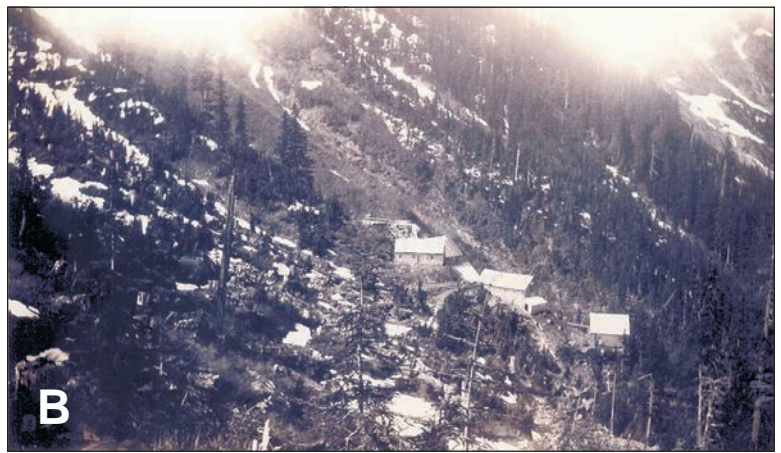
Figure 7. A. The Boundary Red Mountain camp site and mill. View is to the west. B. The mill itself opposite the 1200 Level portal. View is to the south. Both photos taken circa-1930. Courtesy of Mike Impero, Bellingham, Wash.

Errata: The photo (Fig. 7) shown in the earlier edition of this IC as the Boundary Red Mountain mine mill was actually of the Lone Jack stamp mill shortly after it was built in 1900. The photo was mislabeled in the collection from which it was taken. New photos of the Boundary Red Mountain mine mill have been added to this edition. The correction is based on photos that appeared in an article in *The Olympian* on Dec. 2, 1979: "Searching the Lone Jack for Gold and Ghosts," by Mary Ellen Benson. Verification of the photo location was based on a site investigation by a DGER geologist in 2003.
