# INACTIVE AND ABANDONED MINE LANDS— Alder Mine, Twisp Mining District, Okanogan County, Washington

by Fritz E. Wolff,  
Donald T. McKay, Jr.,  
and David K. Norman

WASHINGTON  
DIVISION OF GEOLOGY  
AND EARTH RESOURCES  
Open File Report 2004-16  
July 2004

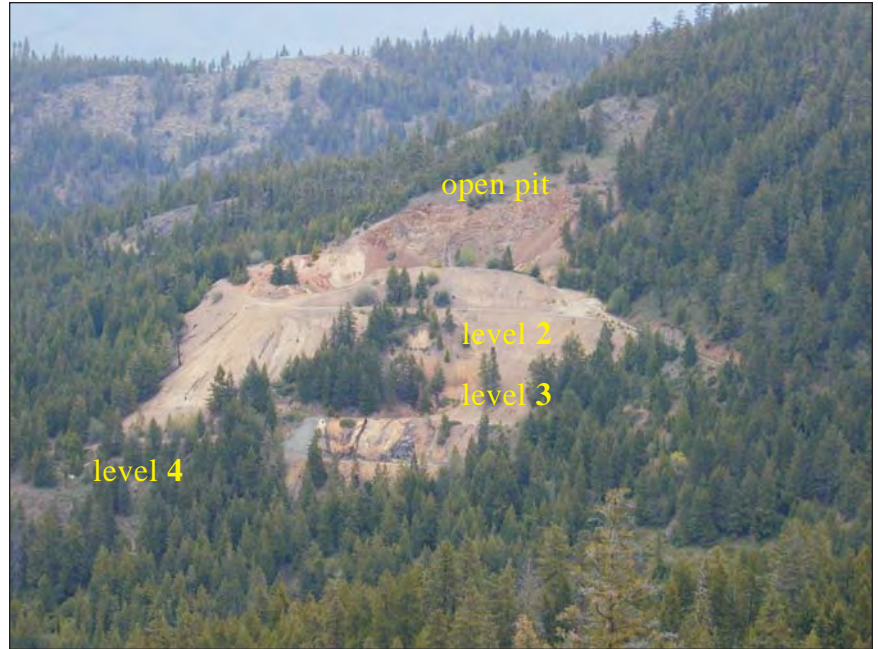
**Figure 2.** Overview of the Alder mine site. Disturbed area totals about 13 acres. View to the northeast.

A veneer of waste rock covers almost the entire mine site west of the open pit hanging wall (Fig. 2) and continues around the north end for some distance. This material covers the original location of the level 2 portal and is so pervasive that we consider any attempt to reconstruct the undisturbed geologic units in this area as problematic. The open pit floor and walls are littered with talus accumulated since the last activity in 1953.

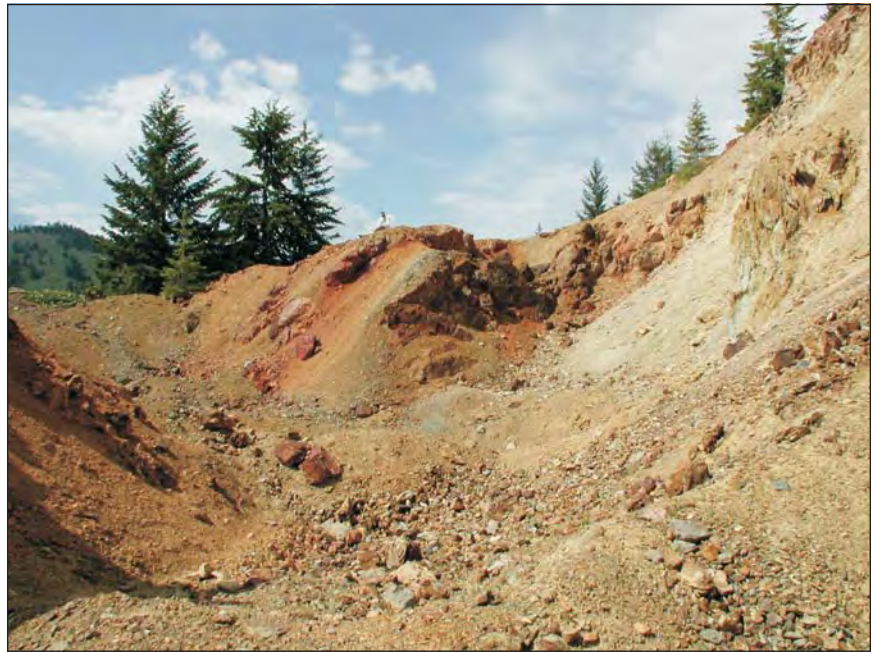
**Figure 3.** Inside the Alder open pit. View to the north. Geologist atop iron-stained outcrop on the rim for scale.

The northern limit of the open pit terminates in a heavily iron-stained zone extending approximately 50 feet west of the footwall (Fig. 3). Mining during the post-1939 operations would obviously have sampled this area extensively, leading to the supposition that the exposure was uneconomic. A surface geology map drawn by Kirkemo in 1951 (DGER mine map file) while employed by Alder Gold indicates that the footwall contact continues to the northwest from the iron-stained zone, but is obscured by dump material and overburden.

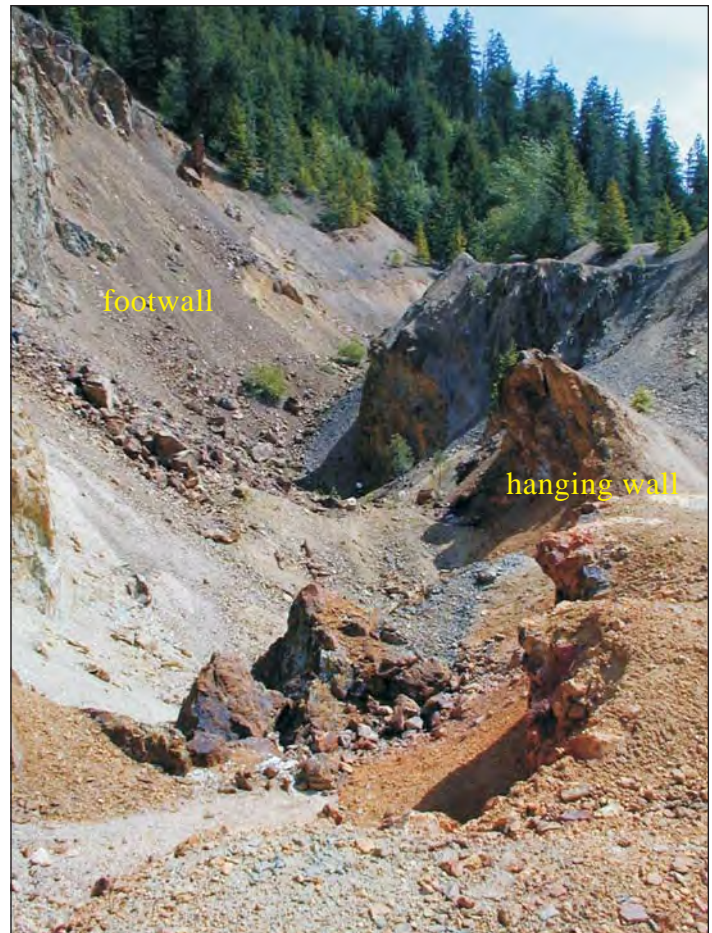
**Figure 4.** Inside Alder open pit. Note footwall of Alder Creek stock and hanging wall of metavolcanics. View to the south.

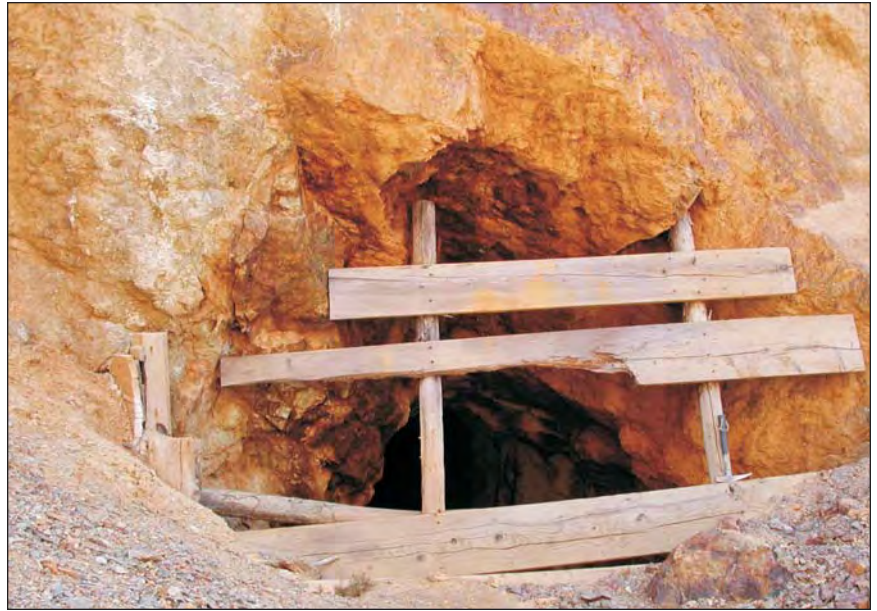
**Figure 5.** Intersection of level 2 raise with pit floor. View vertical (looking straight down).

Underground workings at the Alder mine exceed 3500 feet, including four adits, an open pit, and a sublevel between levels 2 and 3. Kirkemo's 1951 map (DGER mine map file) indicates that the open pit incorporates levels 1 and 2, intercepting a vertical raise and timbers in the "H.W. Drift" 40 feet above level 3 (Figs. 5 and 6).

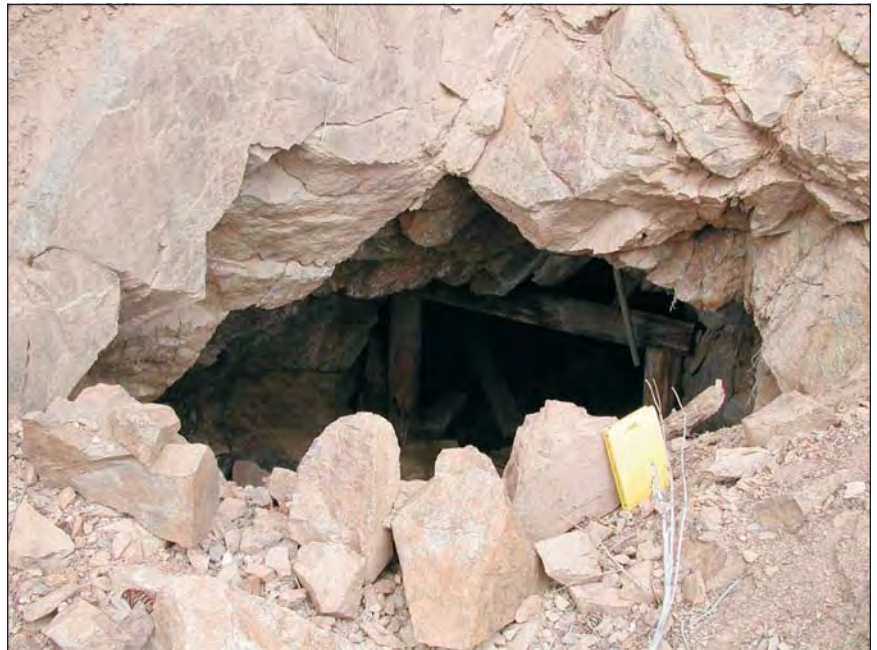
**Figure 6.** Sublevel drift that holes out into the open pit 40 feet above level 3 (Methow level). View to the west.

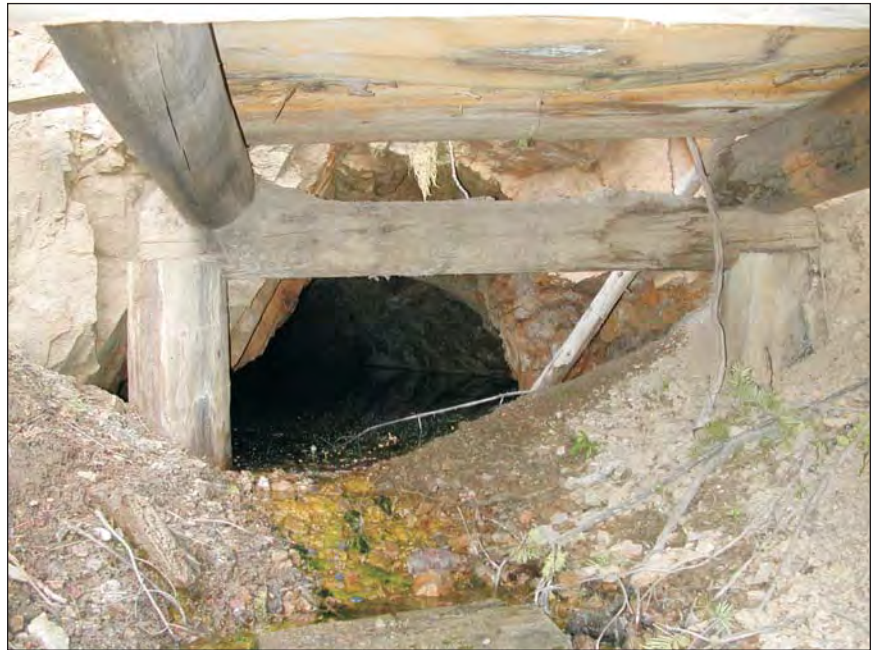
Water discharged at a rate of 4 gpm from level 4 (Fargo) about 600 feet north and 100 feet below level 3 (Methow). We observed a 12-inch-deep impoundment of mine water behind surface slough at the portal, migrating by sheet flow to a pond 12 inches deep, 25 feet long, and 15 feet wide about 50 feet west of the portal. The area between the portal and the pond is covered with a thick mat of dark green algae. The water is clear, but the sediment bed is stained bright orange (Figs. 12 and 13). The electrical conductivity meter pegged at 2000 mhos/cm maximum scale, and pH measured 3.0. Wildlife and cattle use the pond. Peplow's (1999) data regarding Alder Mine impact on Alder Creek indicates water from this pond reaches Alder Creek at a point directly below the pond, probably during periods of heavy rainfall or spring runoff. In addition to direct water-laden transport, Peplow estimated, "Over 90% of the more than 11,000 kg of metals discharged annually from the mine tunnels are retained by the forest soils between the mine and creek making soil the principal reservoir for the deposition of elements delivered to the environment."

**Figure 8.** Entrance to level 4 (Fargo level). View to the east. Water impounded behind colluvium slough is discharging in foreground.

plored...." The tunnel has a wye at a point 175 feet from the portal. The left hand entrance was "caved tight" at the time of Leggat's investigation. From there it wanders southwest approximately 900 feet, passing directly underneath the upper levels and encountering only pyritized quartz, diorite, and black andesite. We detected noticeable amounts of hydrogen sulfide in the air exiting the portal, which is open but badly deteriorated. Crawford (1928) reported "The air in this tunnel was so bad... that only a very hurried inspection was possible." This level, which discharges a small amount of toxic water as described below, should be considered an extreme hazard to human health. The portal is caved almost to the drift caps (Figs. 8 and 9).

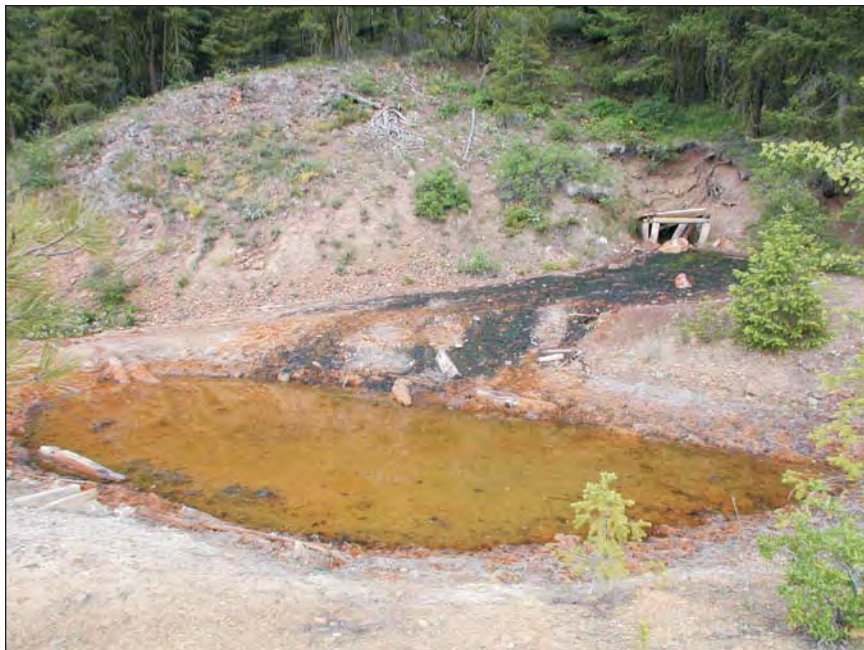
**Figure 9.** Overview of level 4 adit, water discharge, and pond (pH 3.0).

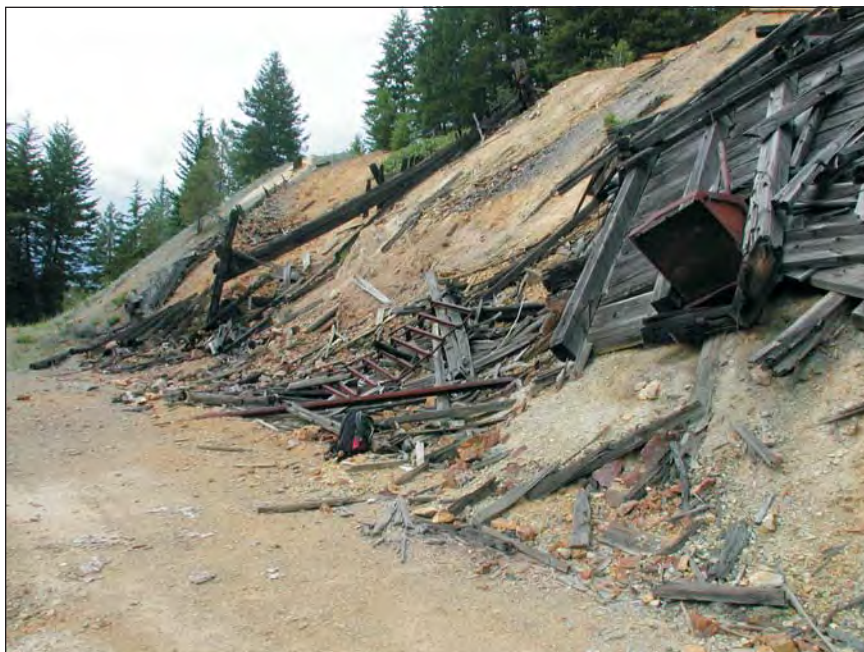
**Figure 10.** Remains of the ore-loading bunker. View to the north.

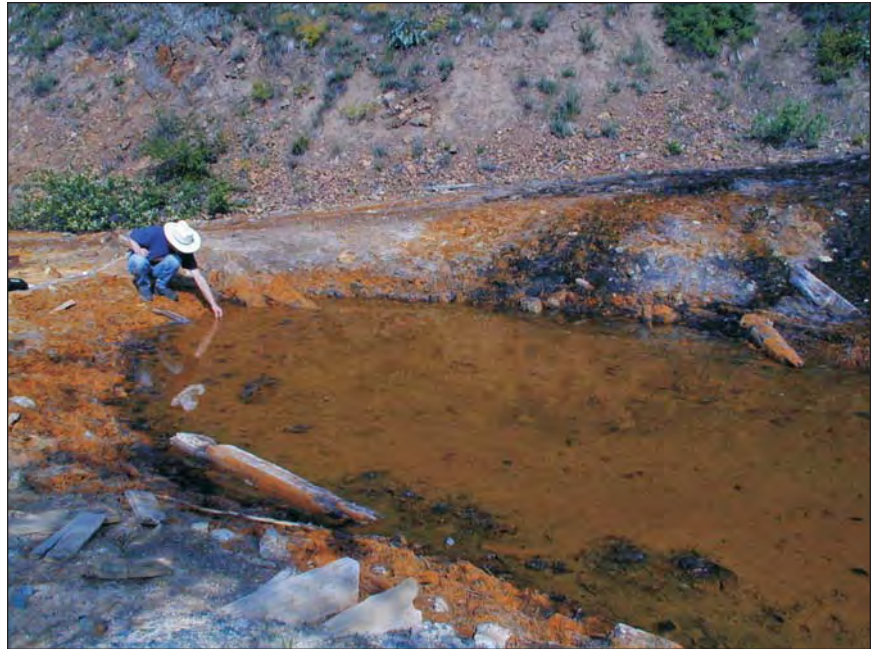
**Figure 12.** Site of water sample at level 4 (Fargo level) adit (pH 3.0). View to the east.
