INACTIVE AND ABANDONED MINE LANDS— Iroquois Mine, Leadpoint Mining District, Stevens County, Washington

WASHINGTON
DIVISION OF GEOLOGY
AND EARTH RESOURCES
Open File Report 2004-17
November 2004

Inactive and Abandoned Mine Lands— Iroquois Mine, Leadpoint Mining District, Stevens County, Washington

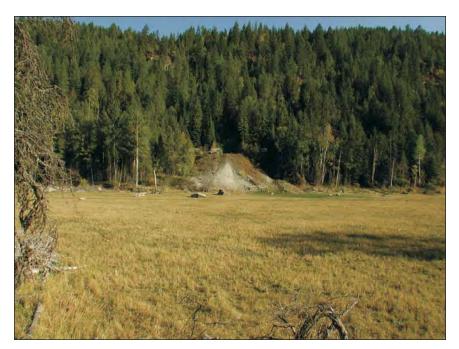
Figure 2. Iroquois mine site. View to the southwest.

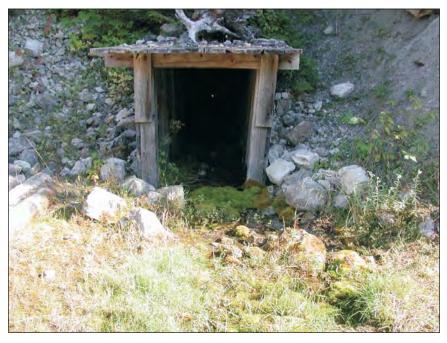
The principal physical feature is a caved adit 780 feet long bearing S45E (Figs. 4 and 5). In addition, 880 feet of drifts and 1350 feet of crosscuts were driven, plus a 350-foot raise to the surface. Very little stoping was done. The adit discharges 50 to 200 gallons/minute, depending on the season, onto a grassy marsh below the waste rock dump (Fig. 6). This discharge is clear, has a pH of 8.2, and meets the Washington State ground water standards (WAC 246-290) for lead and zinc. The zinc content exceeds the chronic standard (WAC 173-201) for surface fresh water supporting aquatic life. Water standards are shown in Table 5 and Appendix B. DGER personnel collected field data on site during September 2001 and June 2004.

Figure 4. Main haulage adit.

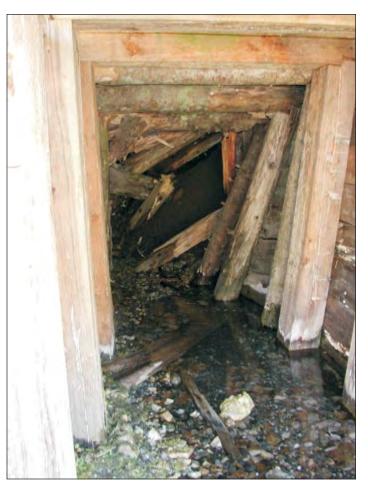
Drift timbers supporting the main adit have collapsed about 20 feet inside the portal. The condition of the adit after this point is unknown.

Figure 5. (top) Condition of adit inside portal.

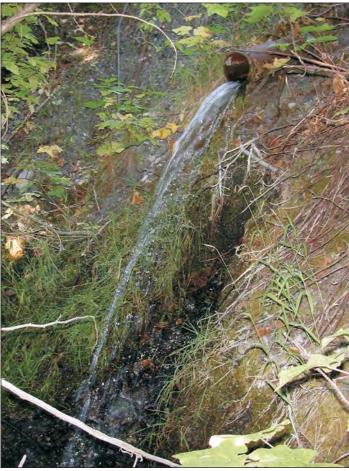
A 6-inch pipe running from the adit to the edge of the waste rock dump discharges approximately 200 gallons/minute during the spring runoff and 50 gallons/minute in the fall. The water has a pH of 8.2. Lead and zinc analyses of a sample taken from the pipe met the Washington State ground water standards for domestic consumption (WAC 246-290). The zinc content exceeded the hardness-based standard (WAC 173-201) for aquatic life in surface fresh water, chronic level. (See Table 5 and Appendix B.) The flow is clear and the bed sediment unstained.

The discharge flows down a gully in the waste rock dump onto a marshy field approximately 1250 feet long by 250 feet wide. Color aerial photos taken in August 2000 (Flight NE-C-2000) show this field inundated with water a foot or two deep. The inundation may be intermittent since the field was relatively dry at the time of DGER site visits in 2001 and 2004.

Figure 6. (bottom) Adit discharge at margin of waste rock dump.

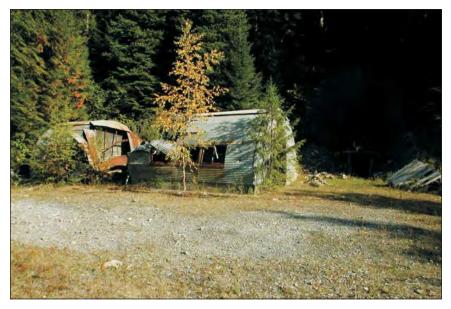
Two buildings occupy the landing next to the main adit portal. One, a Quonset-type that originally housed the machine shop, dry house, and air compressor is partly collapsed (Fig. 7). A sheet metal/frame building, presumably the mine operations office, is still intact (Fig. 8).

Figure 7. Machine shop, dry house, and compressor building.

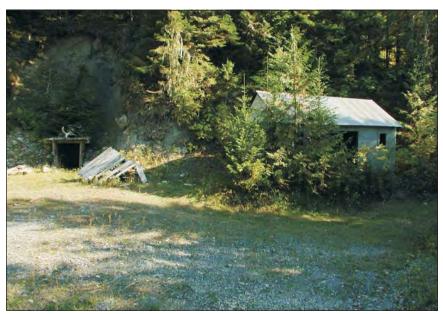
Figure 8. Mine office with main haulage adit to the left of center.
