INACTIVE AND ABANDONED MINE LANDS— Talisman Mine, Orient Mining District, Ferry County, Washington

by Fritz E. Wolff,
Donald T. McKay, Jr.,
and David K. Norman

WASHINGTON
DIVISION OF GEOLOGY
AND EARTH RESOURCES
Open File Report 2004-18
September 2004

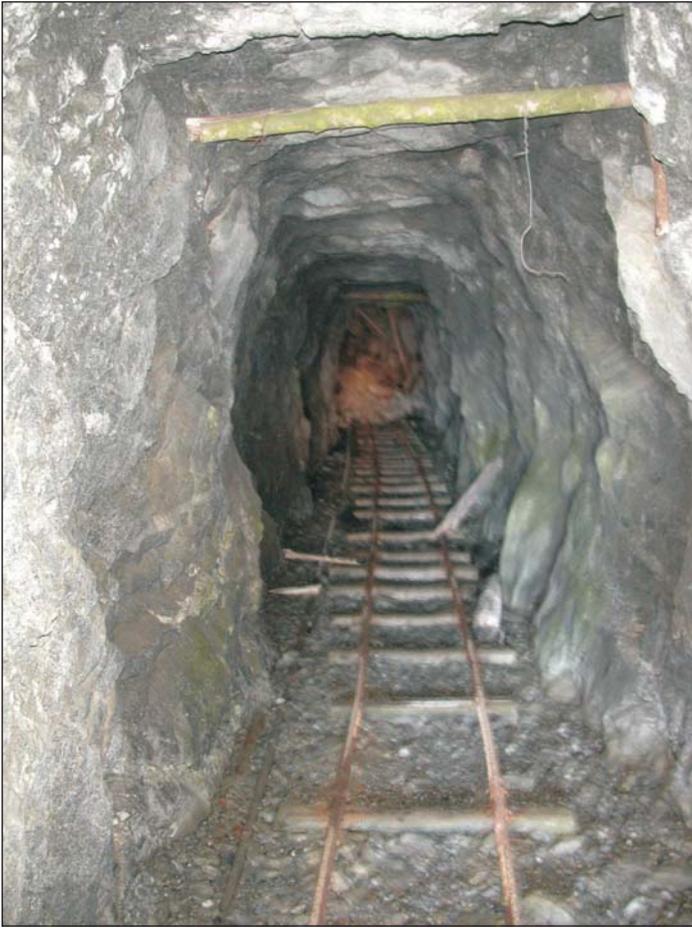
Figure 4. Interior of adit 1, the main haulage tunnel. View to the southwest. Note caved portion.

The principal opening is a horizontal adit entering the cliff crest at elevation 3575 feet. It bears S52W to a point 220 feet from the portal and then extends due west 100 feet. It is open and unfenced, but appears to be partially caved about 90 feet from the entrance. Two stopes lie approximately 25 feet above the adit. The vertical shaft shown on Magill's 1950 maps has caved about 10 feet from the surface (Fig. 3). An open stope at elevation 3630 feet dips 55 degrees to the west and extends downward an estimated 100 feet. It is partly caved but accessible. Although the main haulage adit appears sound up to a point 90 feet from the entrance, the flat-lying stopes and openings to the surface are extremely hazardous.

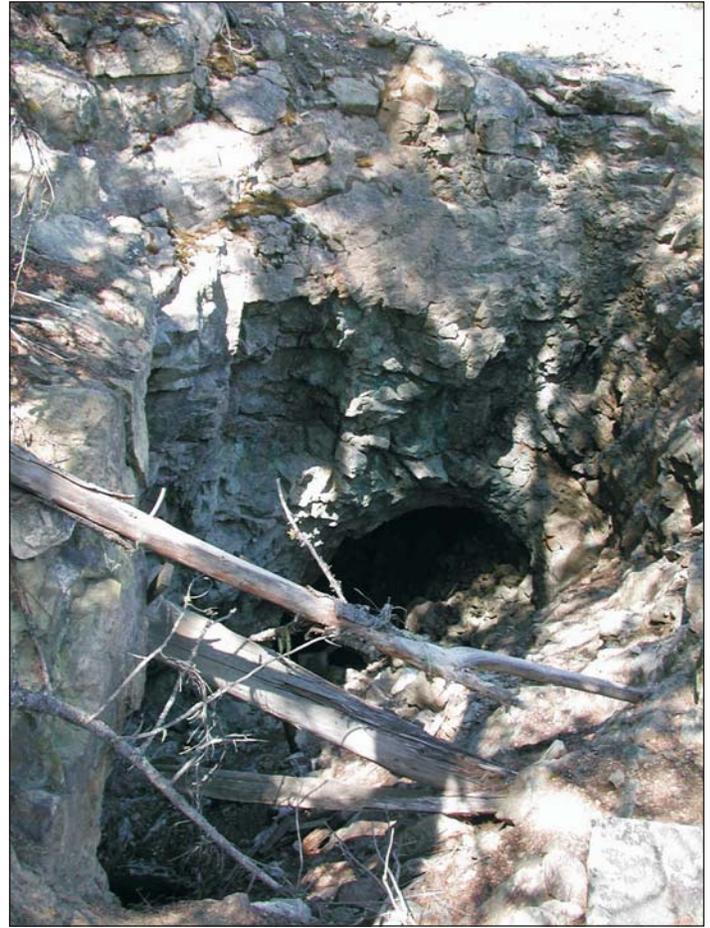
Figure 5. Surface expression of open stope with a -55 degree dip to the southwest.

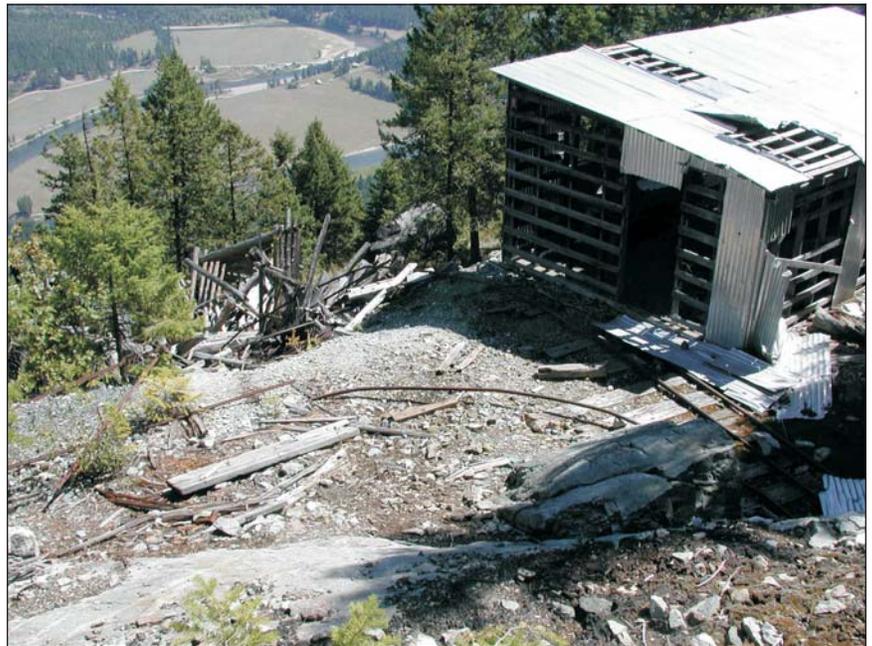
Figure 6. Blacksmith shop/change house at portal. View to the east.

A building identified as a change house and blacksmith shop lies on a bench adjacent to the adit. The roof is still covered with corrugated sheet metal, but the sides have been stripped. Two ore bunkers that served as headworks for the aerial tramway have collapsed. The aerial tramway cable can be observed draping discontinuously over the cliff face.

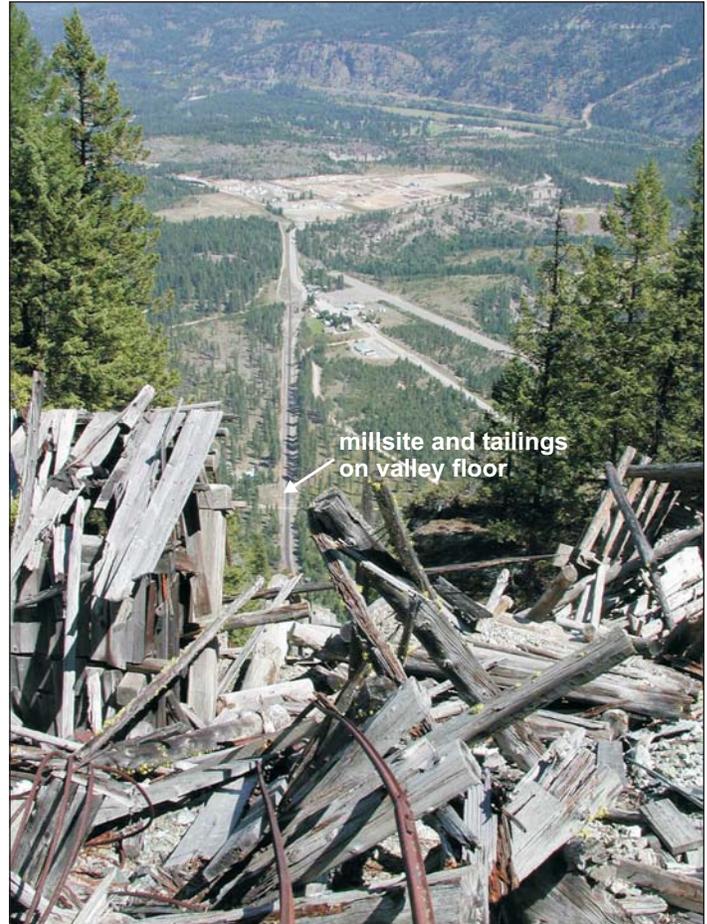
Figure 7. Upper tramway terminus and ore storage bunkers. View to the northwest.

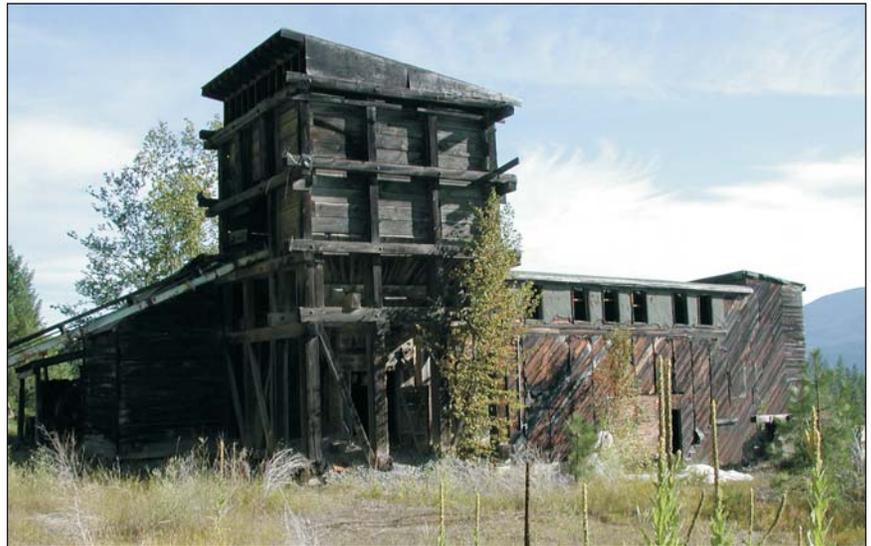
Figure 8. Talisman mill. View to the north. Burlington Northern tracks out of the picture on the far right.

The Talisman mill, which first operated in 1948, is intact but open to the weather and deteriorating. It served as the lower terminus of an aerial tramway spanning a 3200-foot slope distance (Fig. 7). It is located on private property no longer connected with the mine. It contains a resin extraction pilot plant possibly related to reprocessing the mill tailings. A variety of circa-2000 reagent containers were found in the mill—hydrochloric and sulfuric acid, sodium hypochlorite, solvent, resins, ferric chloride, and hydrogen peroxide. A tailings impoundment 150 feet long by 60 feet wide lies 100 feet north of the mill. It contains an estimated 1000 to 1500 cubic yards of material, most of which has been partially re-deposited in conical heaps next to the railway tracks (Fig. 11). Chemical analysis of a grab sample indicates that the tailings exceed state standards for land use shown in Table 3 for copper, lead, and zinc. (Standards for tungsten, silver, and gold have not been determined.)

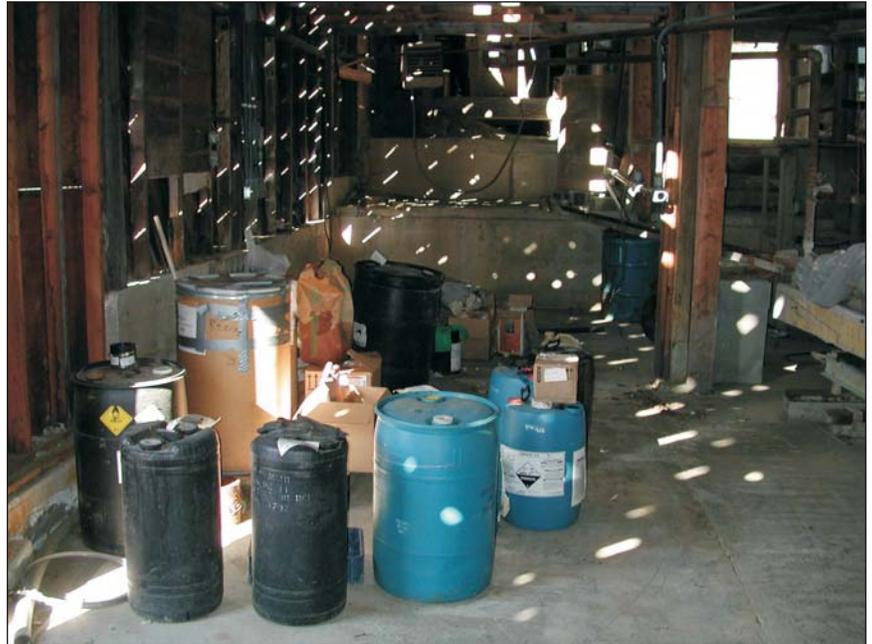
gen peroxide and sulfuric and hydrochloric acid (Figs. 9 and 10). The mill is on private property no longer connected with the mine operation *per se*. The mine can only be reached by a 3.6-mile mine-to-market road that is now little more than a trail.

Figure 9. Reagent containers in mill.

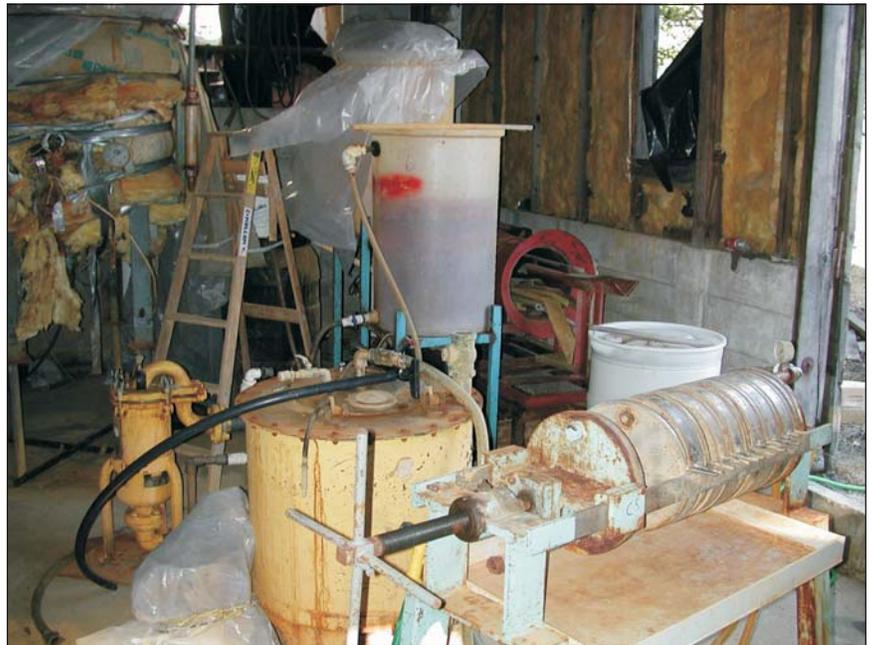
Figure 10. Resin extraction pilot plant.

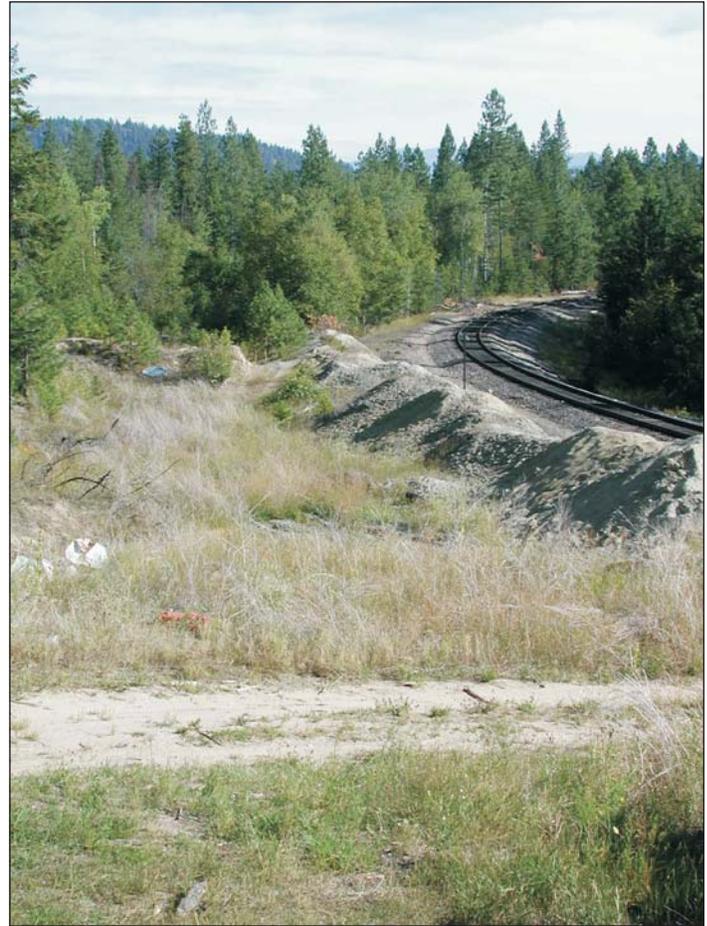
Figure 11. Tailings impoundment.

Sample location	Arsenic ^{III}	Cadmium	Copper	Tungsten	Lead	Mercury	Zinc	Silver	Gold
tailings impoundment	---	---	650	381	472	---	2680	5	≤5.4
