WASHINGTON STATE SCHOOL SEISMIC SAFETY PILOT PROJECT— Providing Safe Schools for Our Students

written by Timothy J. Walsh and John D. Schelling
for the Washington State Seismic Safety Committee

WASHINGTON
DIVISION OF GEOLOGY
AND EARTH RESOURCES
Open File Report 2011-7
July 2011

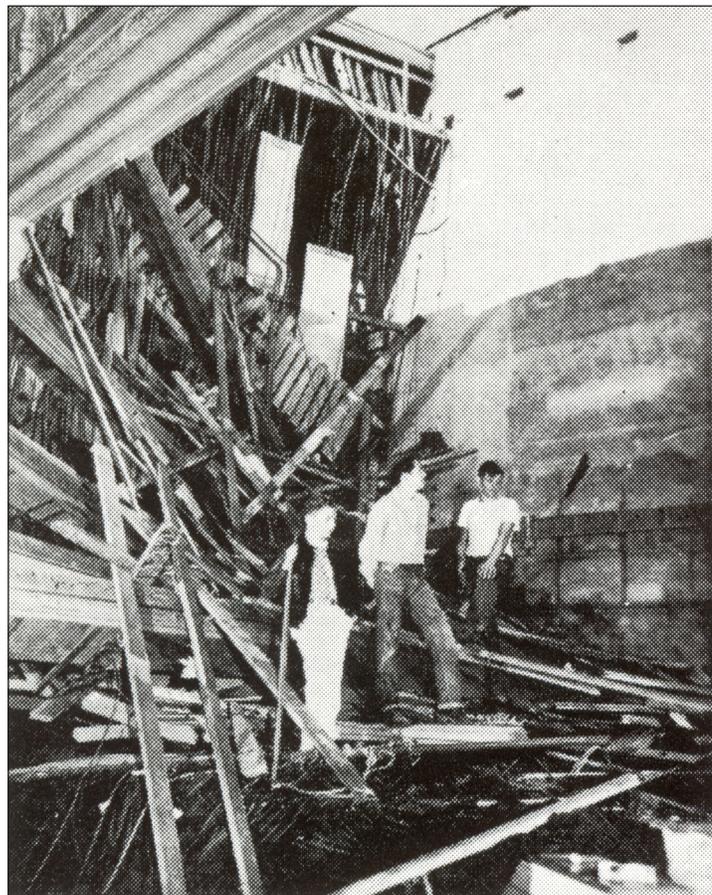
Figure 1. Open air theatre—Three members of the stage crew at Puyallup High School survey the wreckage of the stage, which was caved in by the earthquake just as they were leaving for lunch. Under the debris are a ping-pong table and a grand piano. *Seattle Times* staff photo by Larry Dion (from Ulrich, 1949).

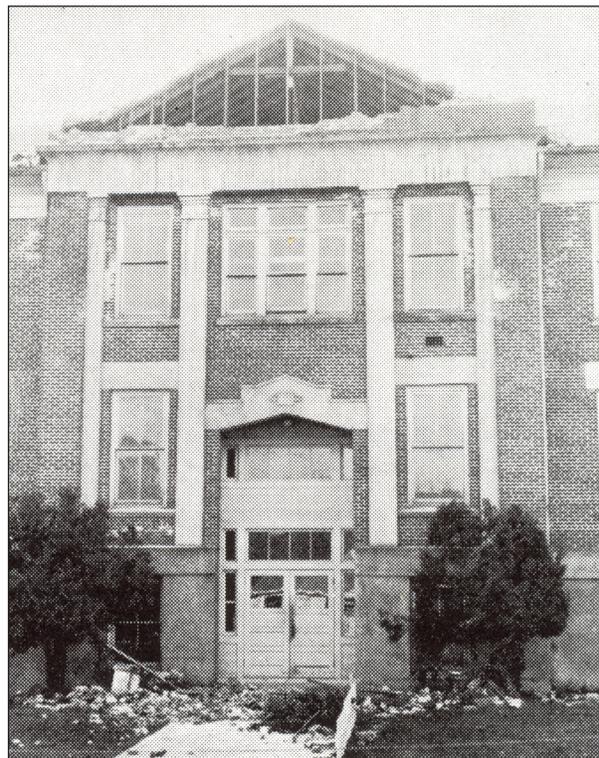
Figure 2. At Castle Rock, a high school student was killed as unanchored gable masonry cascaded to the walk outside the entrance. There could have been more casualties. (From Edwards, 1951.)

been greater. At Castle Rock High School, however, falling masonry killed the student body president as he tried to escape from the building (Fig. 2). Another student was killed by falling bricks at Lowell Grammar School in Tacoma (*Seattle Post-Intelligencer*, April 14, 1949). In all, thirty schools were damaged in this earthquake (Washington State Seismic Safety Council, 1986). This earthquake eventually led to enactment of RCW 70.86 in 1955, which established “Earthquake Standards for Construction” and required that all schools and other high-occupancy buildings be “designed and constructed to withstand probable earthquake intensities at the location thereof”. This standard was strengthened in 1974 when the Washington State Legislature passed RCW 19.27, the State Building Code Act, which incorporated the more stringent standards of the Uniform Building Code. In 1993, the Scott’s Mills earthquake in Oregon severely damaged Molalla High School, requiring it to be torn down and rebuilt (Wang and Clark, 1999). This led to a number of actions in the state of Oregon. Of particular interest here is Oregon Senate Bill 2, which requires that all schools be evaluated for seismic risk and that all high-risk schools be retrofitted.

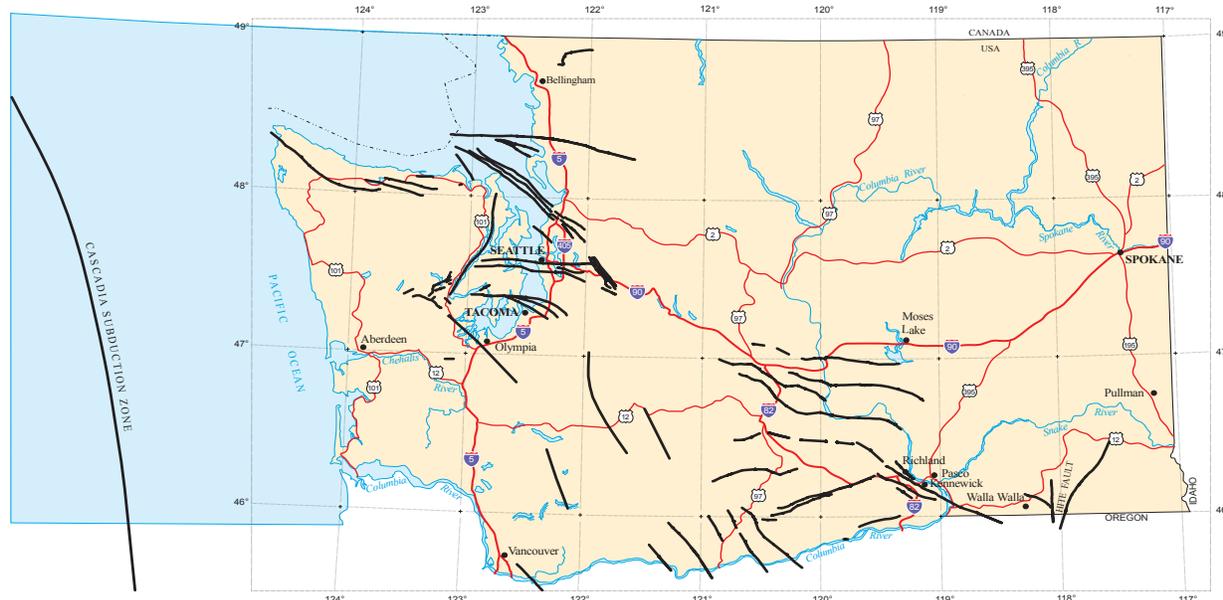
Figure 3. Simplified map of known and suspected active faults (heavy black lines) affecting earthquake hazard in Washington. It includes faults that have been demonstrated to have caused earthquakes since the last ice age but also faults that are under investigation.

In subsequent years, we hope to be able to secure dedicated funding to extend this analysis statewide or at least to school districts prioritized on the basis of the analysis in Figure 3. Alternatively, school districts could be prioritized in order of the amount by which ground shaking hazard has increased in the current building code since enactment of the State Building Code Act of 1974. Based upon the results of this pilot project, it is estimated that completing a statewide assessment program using the previously described approach would cost roughly 10 to 13 million dollars that could be phased over an 8- to 10-year period. This equates to approximately \$3,500 to \$4,500 per public school throughout the state, and such an approach could be supported by a combination of federal, state, and local resources.

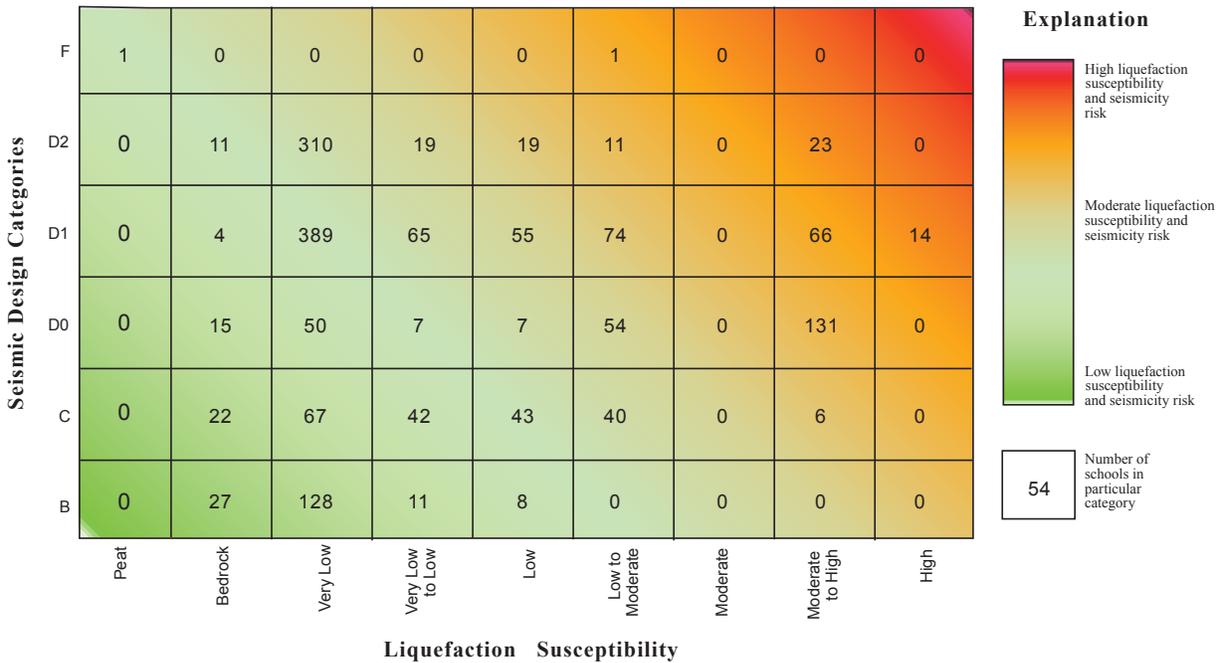
Figure 4. Number of schools in Washington in each category of the combined liquefaction susceptibility and seismic design category grid. We matrix-plotted seismic design category (a measure of the expected strength of ground shaking; Cakir and Walsh, 2007) against liquefaction susceptibility (Palmer and others, 2004). The number in each cell is the number of public schools, grades K-12.

- 1) Our initial screening was to consider school districts that had high earthquake hazard. We mapped schools on a combination of the seismic design category map (Cakir and Walsh, 2007) and liquefaction susceptibility maps (Palmer and others, 2007). The seismic design category combines an estimate of the strength of ground shaking at any individual site with the amplification caused by the local geology. This will be discussed more fully in the next section.
- 2) We then considered school districts in both eastern and western Washington that scored high in criterion 1 and mapped them onto Figure 4.
- 3) We matched the number of schools per district, both to equalize each district and to select a number of school buildings that could be evaluated with the available resources.

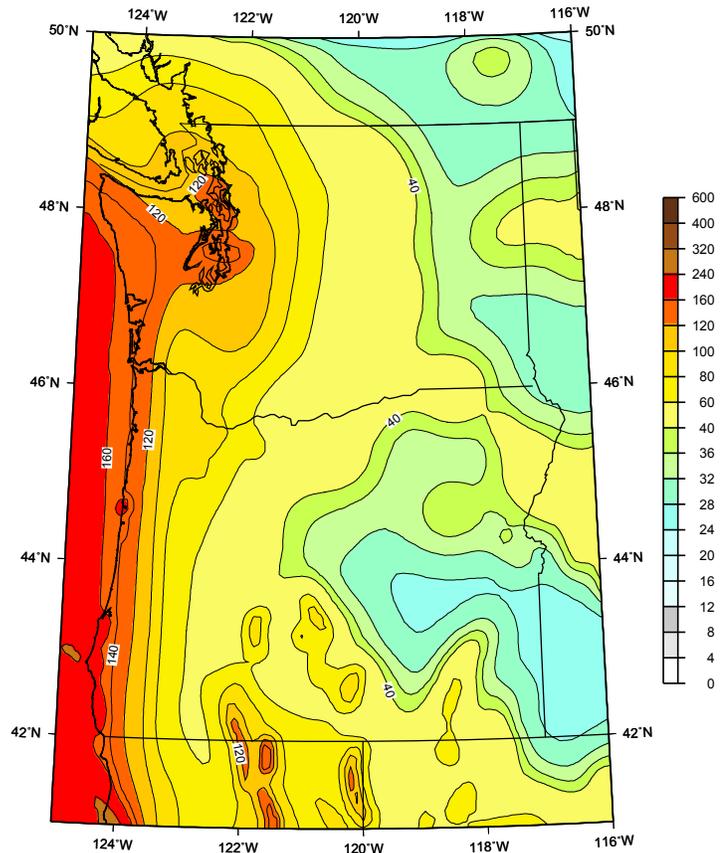
Figure 5. Probabilistic map of ground shaking that has a 2% probability of being exceeded in a 50-year period, calculated for shaking that has a frequency of 5 cycles/second. This is the map used in the 2009 International Building Code to determine the level of ground shaking for building design.

We estimated the strength of ground shaking at school locations from the National Seismic Hazard Map by the U.S. Geological Survey (Frankel and others, 2002). This map is probabilistic, that is, it assesses the strength of ground shaking at a frequency of 5 cycles/second from all earthquake sources (Fig. 5).

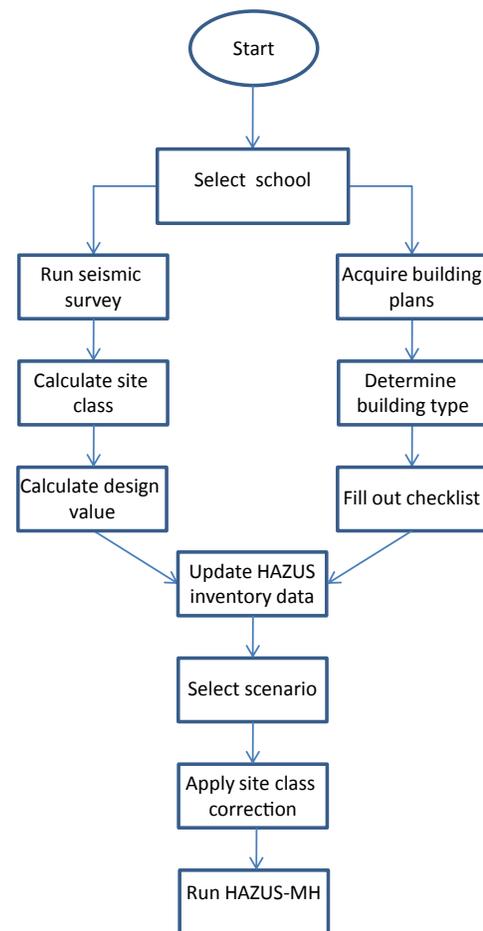
Figure 6. Flowchart of data collection and analysis for HAZUS-MH. Data collection for geologic conditions is on the left and data collection for buildings is on the right.

Given the level of support available from the pilot school districts in the form of access to buildings and original design documents, as well as volunteer support from the Structural Engineering Association of Washington, we chose to use a more detailed methodology called *ASCE 31-03 Seismic Evaluation of Existing Buildings*. ASCE 31-03 is intended to be completed by a structural engineer with access to the building and original design documents whenever possible. It provides a three-tiered process for the evaluation of existing buildings for either Life Safety Performance or Immediate Occupancy Performance. The three tiers defined include Tier 1 – Screening Phase, Tier 2 – Evaluation Phase, and Tier 3 – Detailed Evaluation Phase. The project team and school districts agreed that we should use the ASCE 31-03 Tier 1 process and a Life Safety Performance Objective. The process of building assessment is as follows (see Fig. 6):

We then combined these inputs into HAZUS-MH, FEMA's loss estimation model (Fig. 6), to estimate the potential damage to school buildings from two different levels of earthquake ground shaking—the level of ground shaking specified in the current building code and for a likely scenario earthquake deemed appropriate for the site (Schelling and others, in prep.). HAZUS-MH applies empirically derived fragility curves, which are estimates of the probability of damage to a structure from a specified strength of ground shaking, to each building type

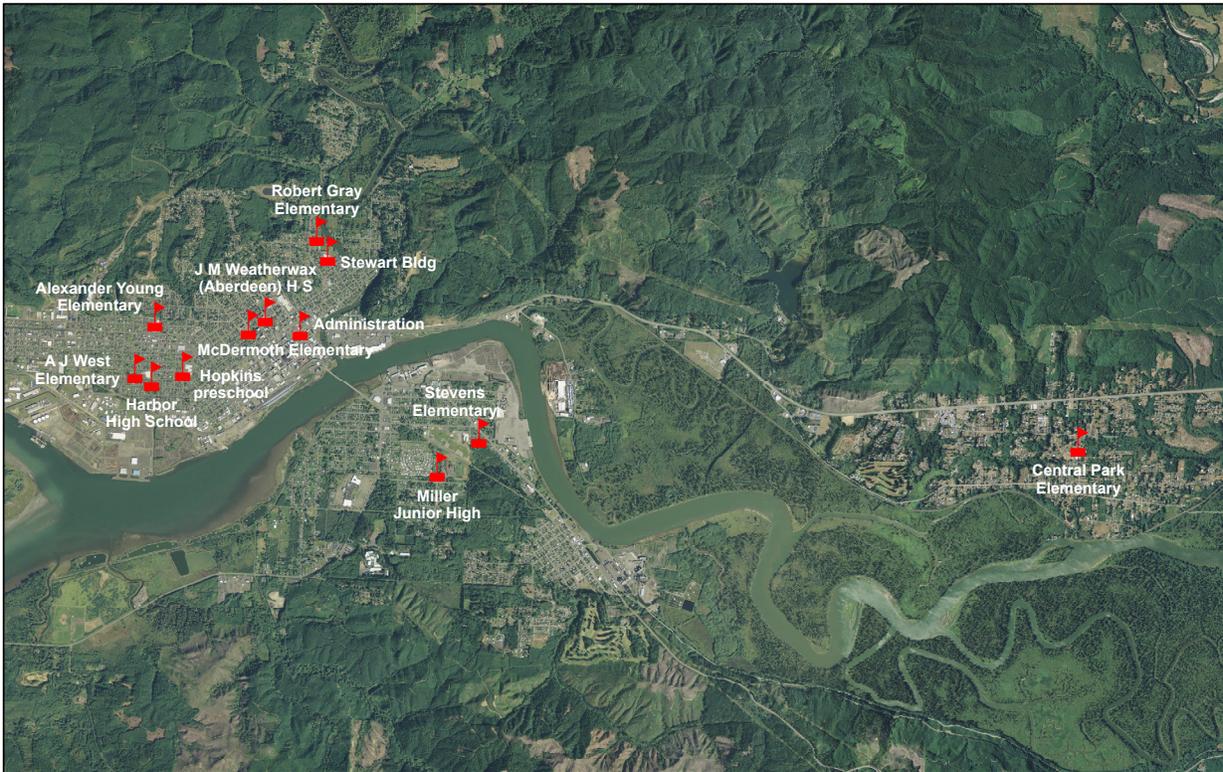
Figure 8. Orthophoto map of the Aberdeen School District showing the location of buildings analyzed in this study.

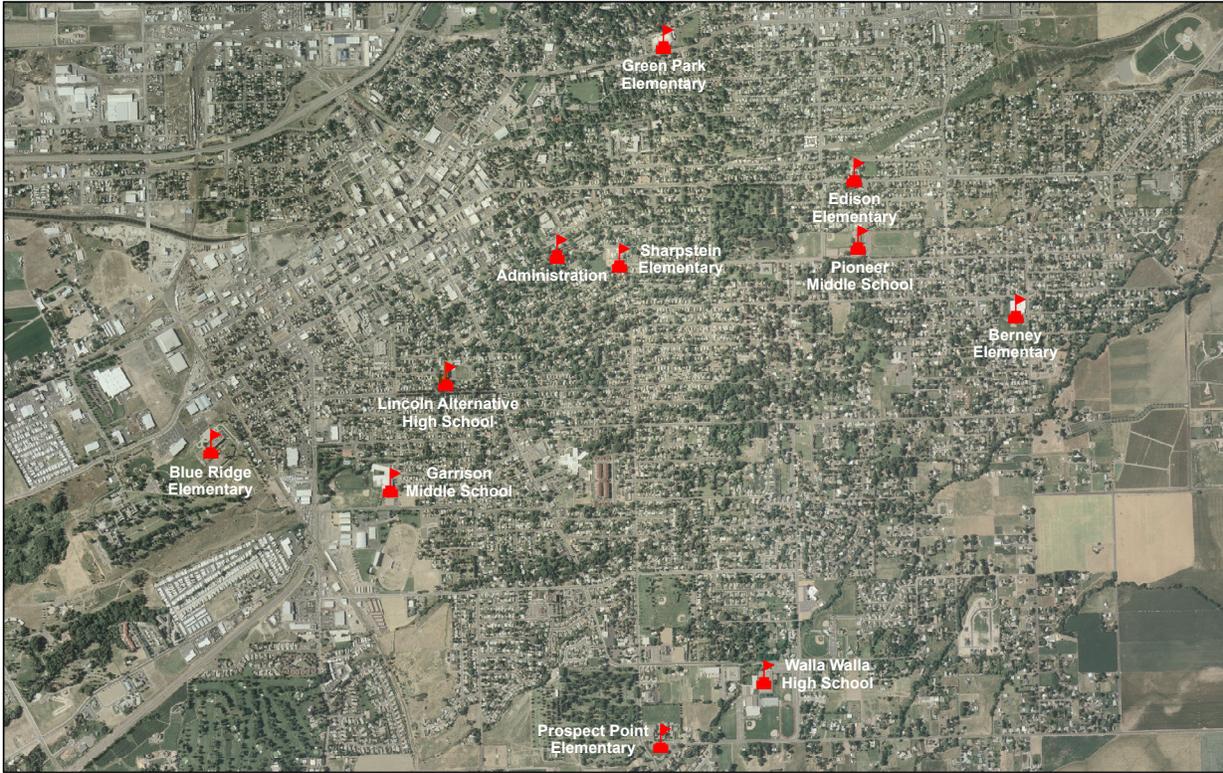
Figure 9. Orthophoto map of the Walla Walla School District, showing the location of buildings analyzed in this study.

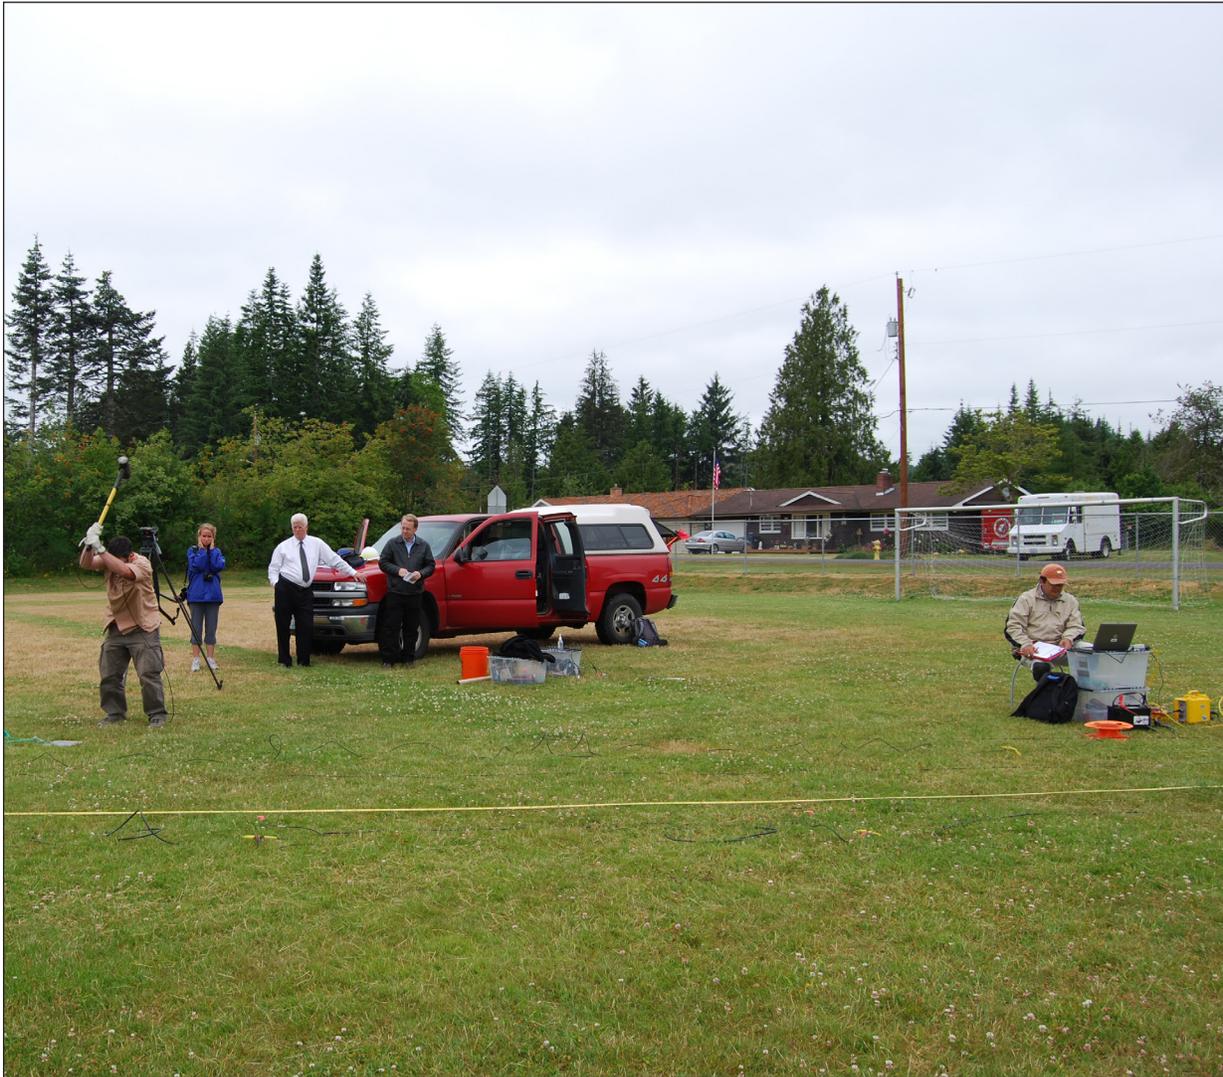
Recep Cakir and Christopher Maffucci (with hammer) collect seismic data at Central Park Elementary School in the Aberdeen School District as Deirdre Clarke of the Department of Natural Resources, Chuck Wallace of Grays Harbor Emergency Management, and Glen Farley of KING-TV watch.
