OPEN FILE REPORT OF 77-1

COASTAL PROCESSES OF
THE WHATCOM COUNTY MAINLAND

Thomas A. Terich
Dept. of Geography & Regional Planning
Western Washington State College

January 1977

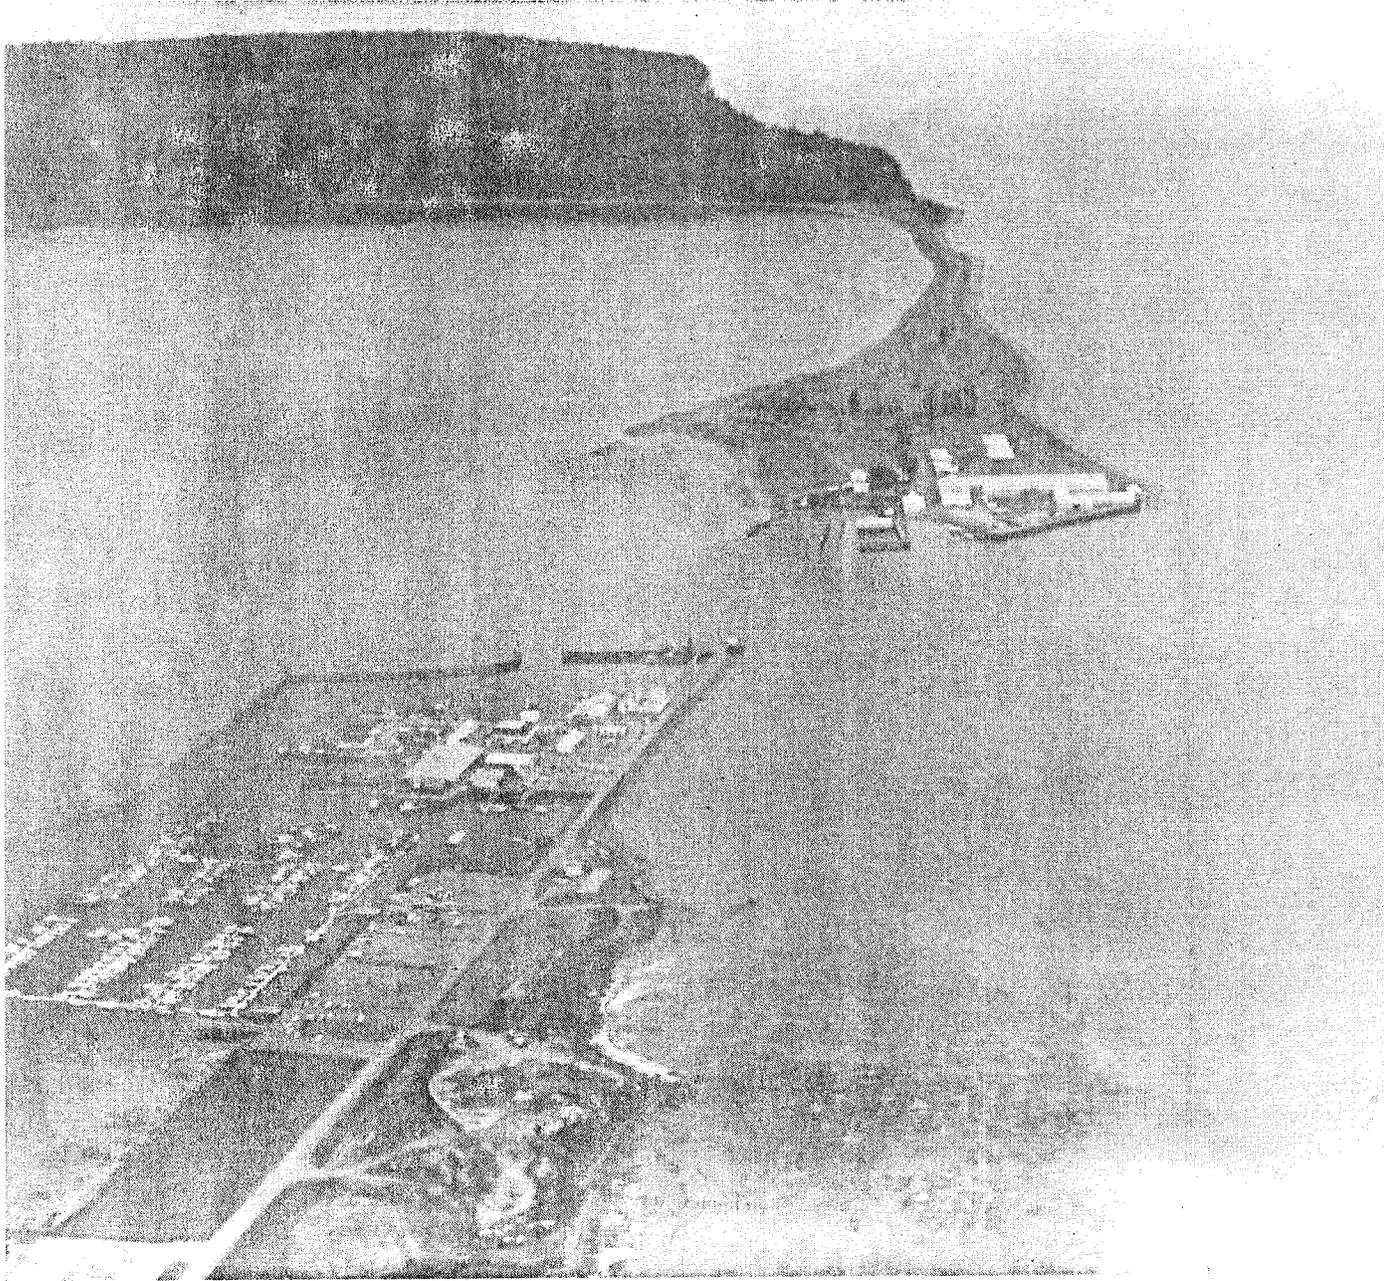
Figure 2

At the northern most reach of Whatcom County's shoreline is a spit approximately 2000 meters long trending northeasterly from the north side of Birch Point (fig.2). The spit separates Drayton Harbor from Semiahmoo Bay and provides some protection for small boats and shoreline developments within the bay.

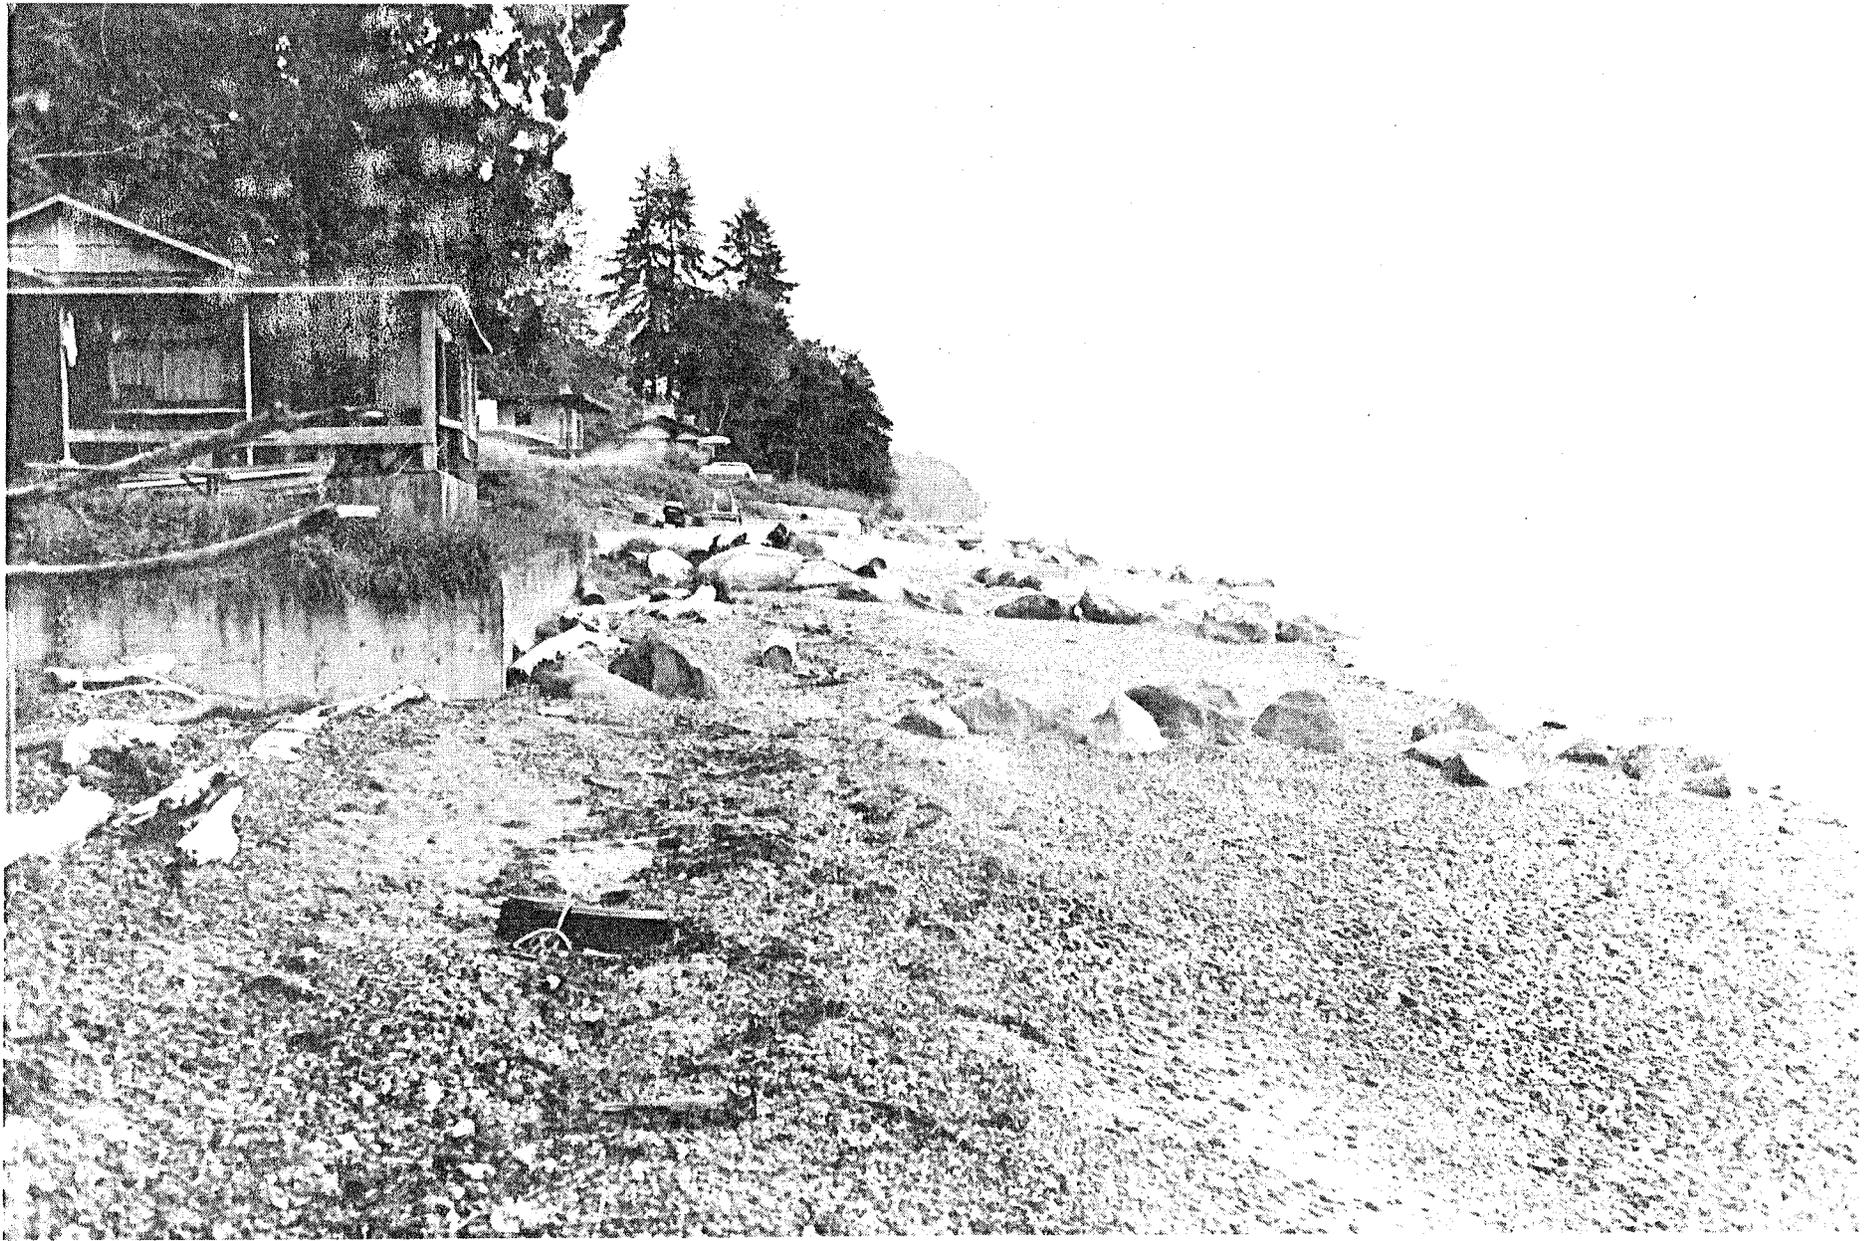
Figure 3

A few homes have been constructed on the backshore, at the base of the sea cliffs north of Birch Point. In most cases, the beach fronting the structures is only 10 meters wide, requiring seawalls or bulkheads for protection from wave attack. A few residents have constructed small concrete groins, or laid boulders transverse to the beach in an effort to trap the northward moving sediment and build up the beach fronting their property (Fig. 3).

Here is a clear case where homes have been constructed too close to the shoreline. Home owners have been forced to install erosion defense structures. While protecting their own properties, they may be aggravating the erosion of nearby or distant properties. Bulkheads and seawalls armor the backshore reducing the amount of sediment available to the beach. Groins and similar structures installed transverse to the beach restrict the prevailing northward movement of beach sediment which ultimately feeds Semiahmoo Spit.

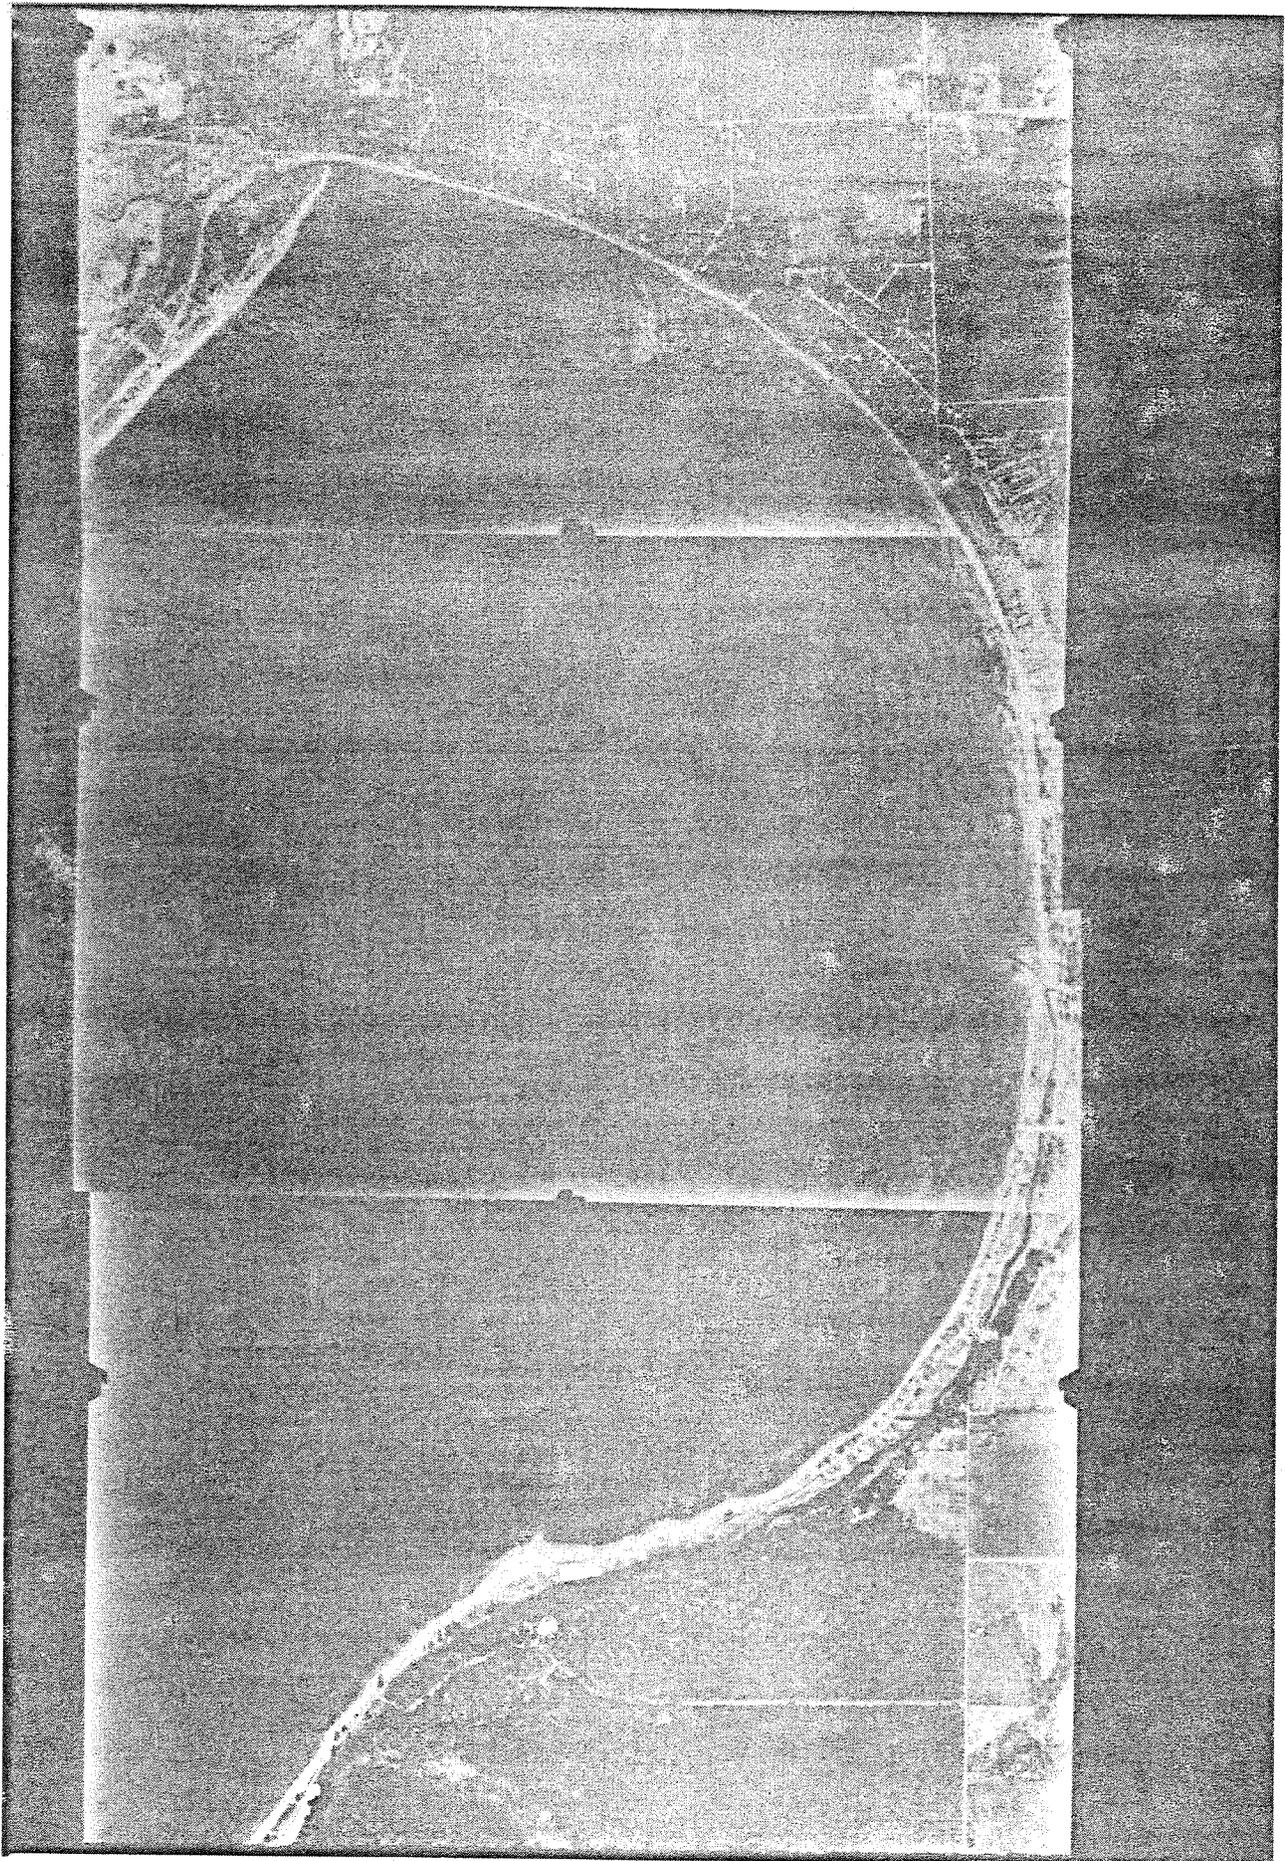
Figure 4

Birch Bay is a very interesting place of study for both the coastal geomorphologist and anthropologist. Larsen (1971) studied the relationship between former stands of sea level and early Indian settlements around Birch Bay. The curvilinear shape of Birch Bay's shoreline resembles similar shorelines around the world that are shaped by the refraction or bending of waves to the lee of a nearby headland (Fig. 4).

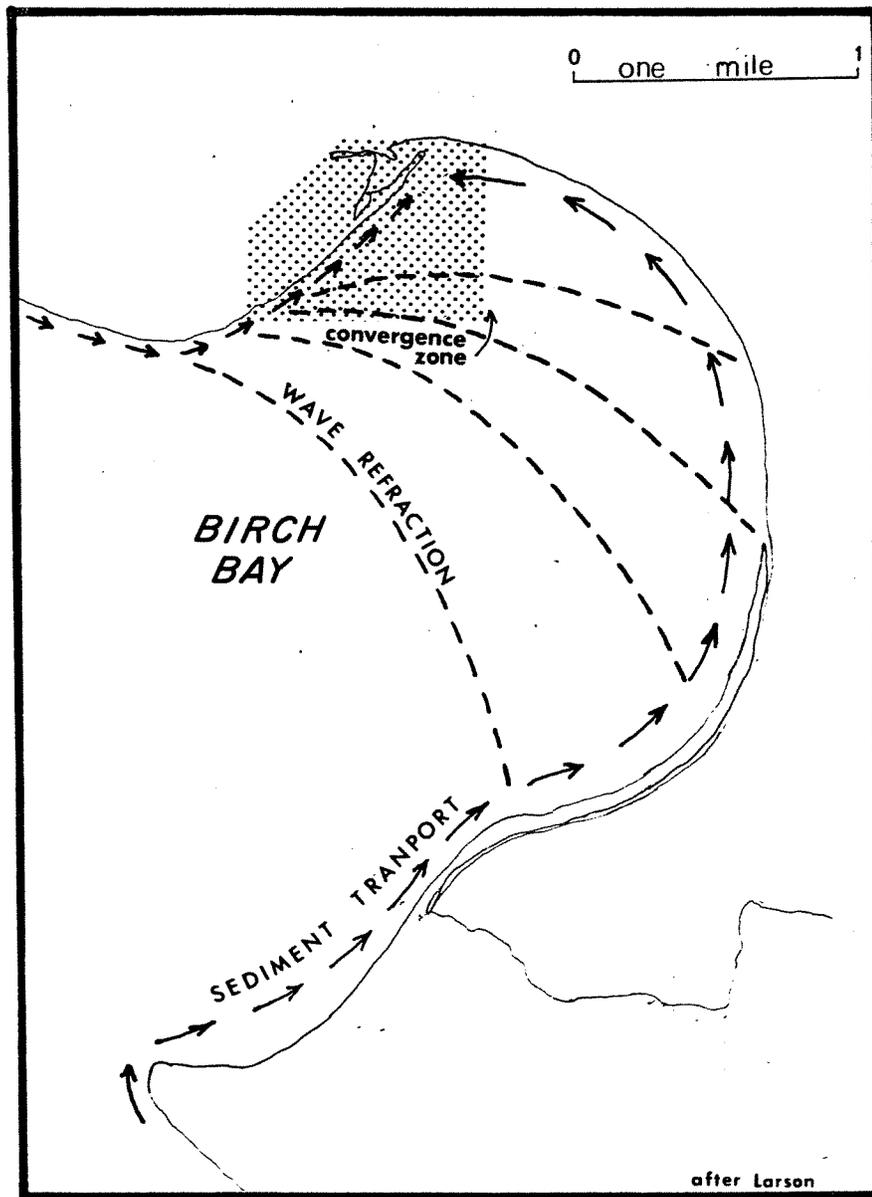
Northwesterly waves travel down Georgia Strait and are refracted around Birch Point into Birch Bay (Fig. 5). Waves sweep counter-clockwise around Birch Bay transporting beach sediment in the same direction. Evidence of this sediment movement is shown by Terrell Creek which approaches within 100 meters of flowing into the south end of Birch Bay but is offset nearly 3 km to the north before emptying into the bay. Moreover, many property owners on the bay's southwestern shoreline have constructed small groins in an effort to retard the longshore sediment transport and build up the beach fronting their properties. In all cases, sediment build-up occurs on the south side of the groins, indicating a south to north (counter clockwise) direction of wave energy transmission and resultant longshore sediment transport.

Figure 5. Wave refraction and sediment transport at Birch Bay.

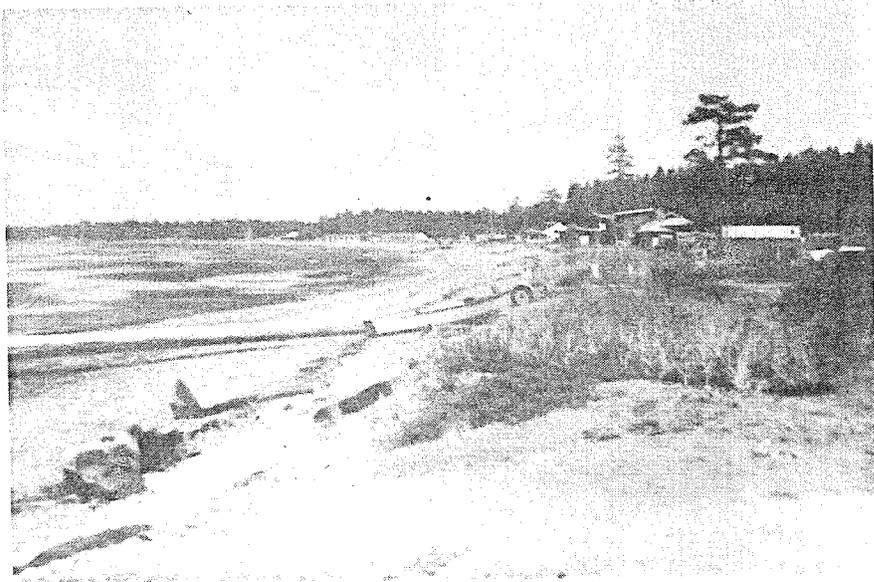
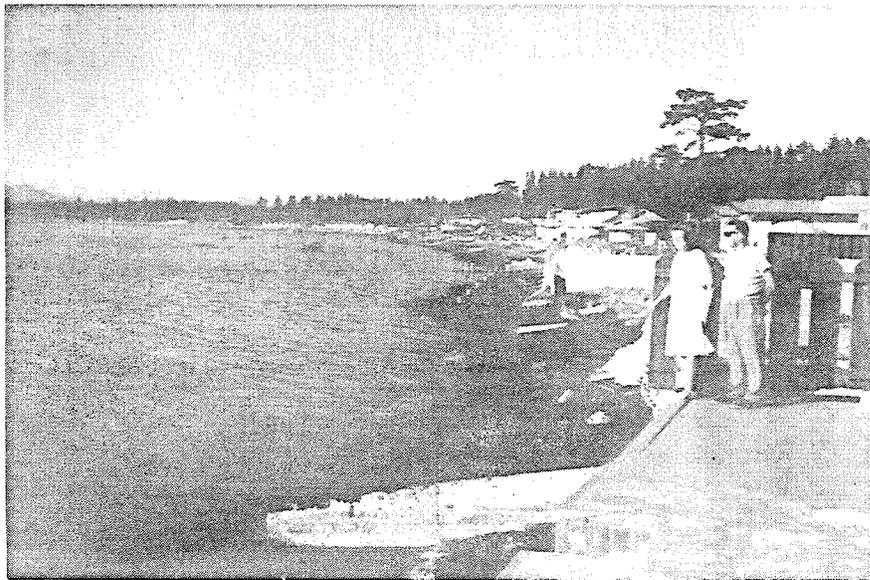
Birch Bay is a very popular recreational site in Whatcom County. Thousands of visitors may be found enjoying the bay during summer holidays. The recreational attraction of Birch Bay has led to the construction of many bayfront homes over the past twenty-five to thirty years. Bayfront property and homes sell for premium prices, and such homes line the eastern shore. Many of the homes have been constructed very close to the shoreline to take full advantage of the bayfront location. The short construction setback has limited the amount of beach "buffer" each home has from high waves and natural beach erosion. This has forced most of the residents to build bulkheads and groins to protect their properties. The proliferation of bulkheads and groins on the shoreline is shown by the contrasting photos taken of the same beach in 1957 and 1964 (Fig. 6).

Birch Bay shore in 1957 (note tree in upper right)

Figure 6. Birch Bay shore in 1957 (above) and 1964 (below). Note tree in upper right of both photos.

Property owners downdrift of groins experience rapid loss of their beach and have been forced to also construct groins lest the waves threaten

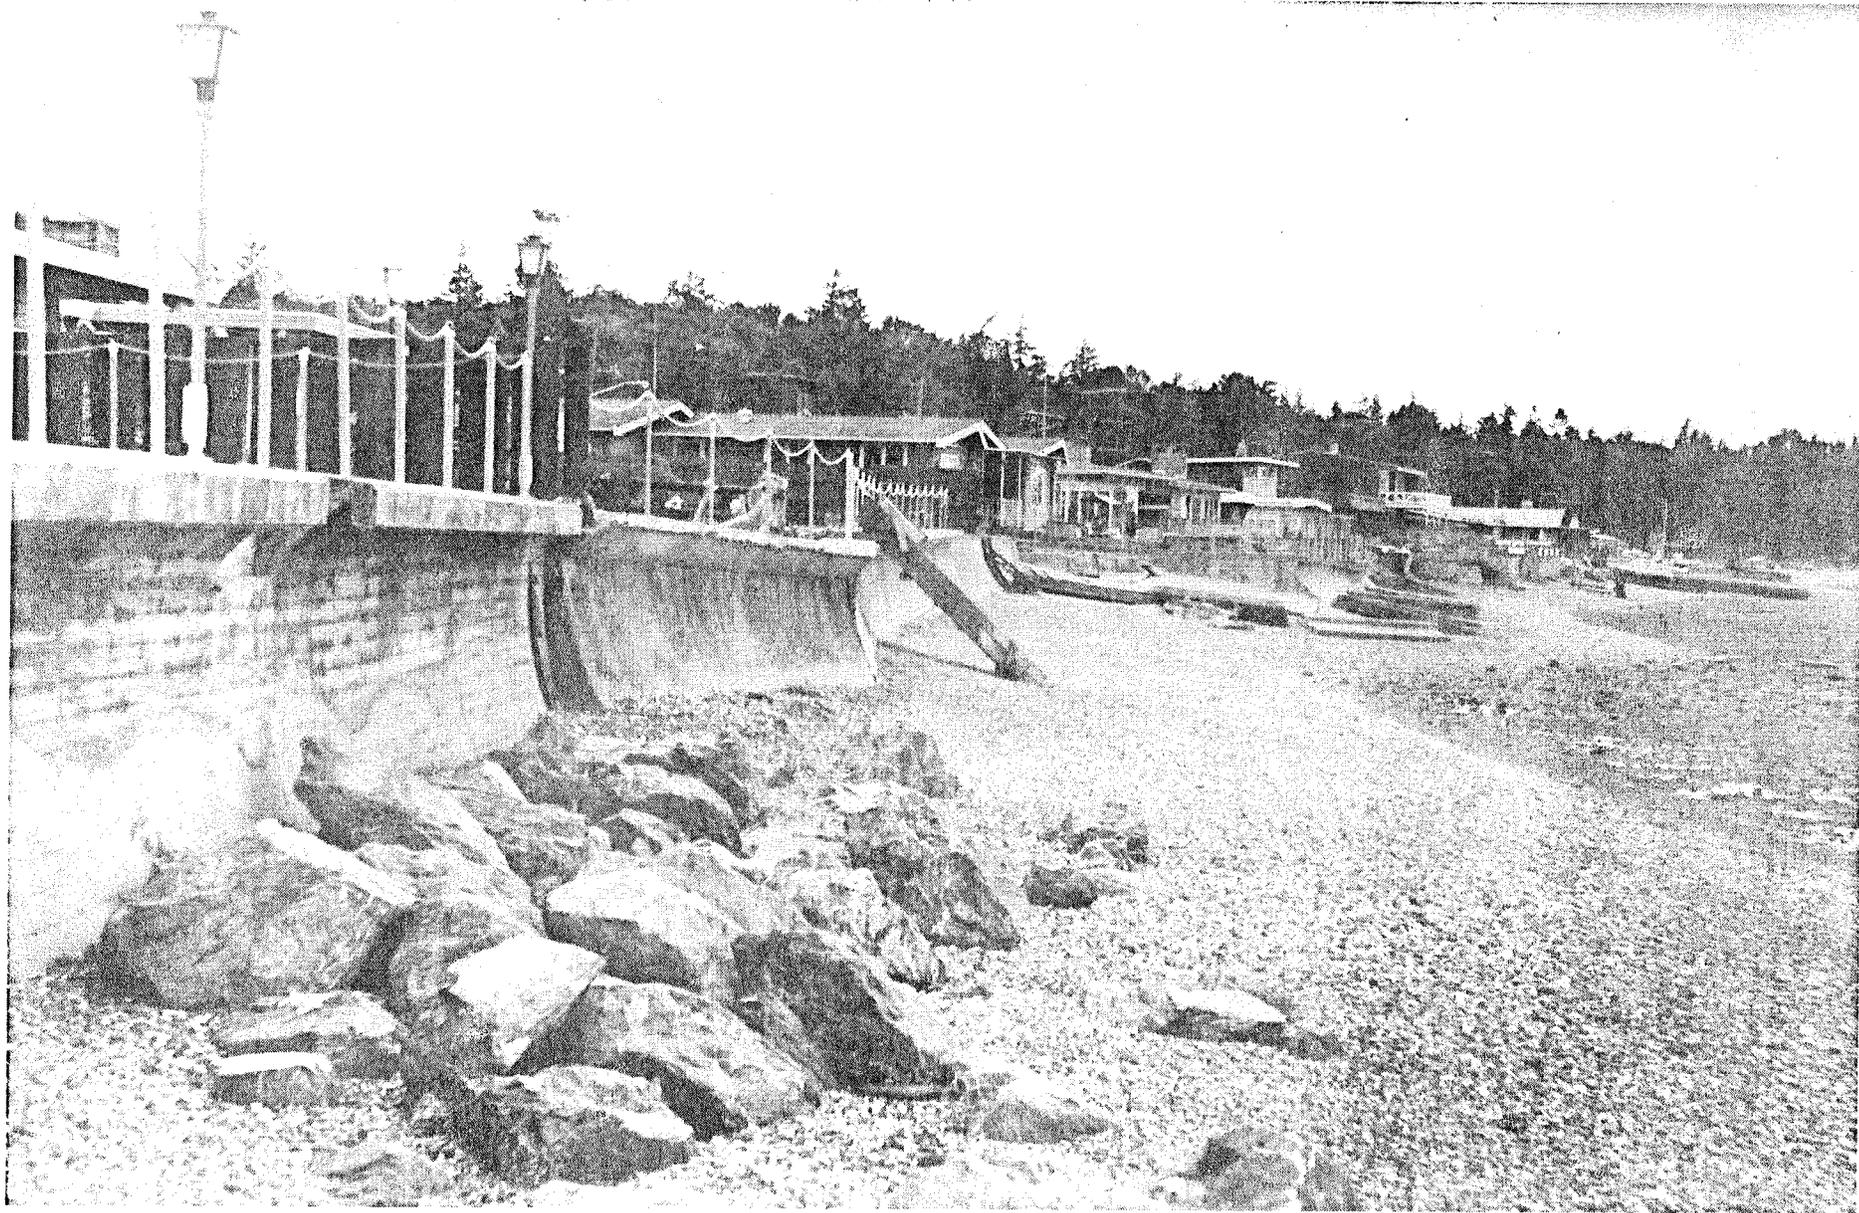
Figure 7

their homes. Thus, the beachfront property owners around Birch Bay's eastern shore are in competition for beach sediment. This competition has led to ill feelings and legal action for property damage claims by few of the homeowners against their neighbors (Fig. 7).

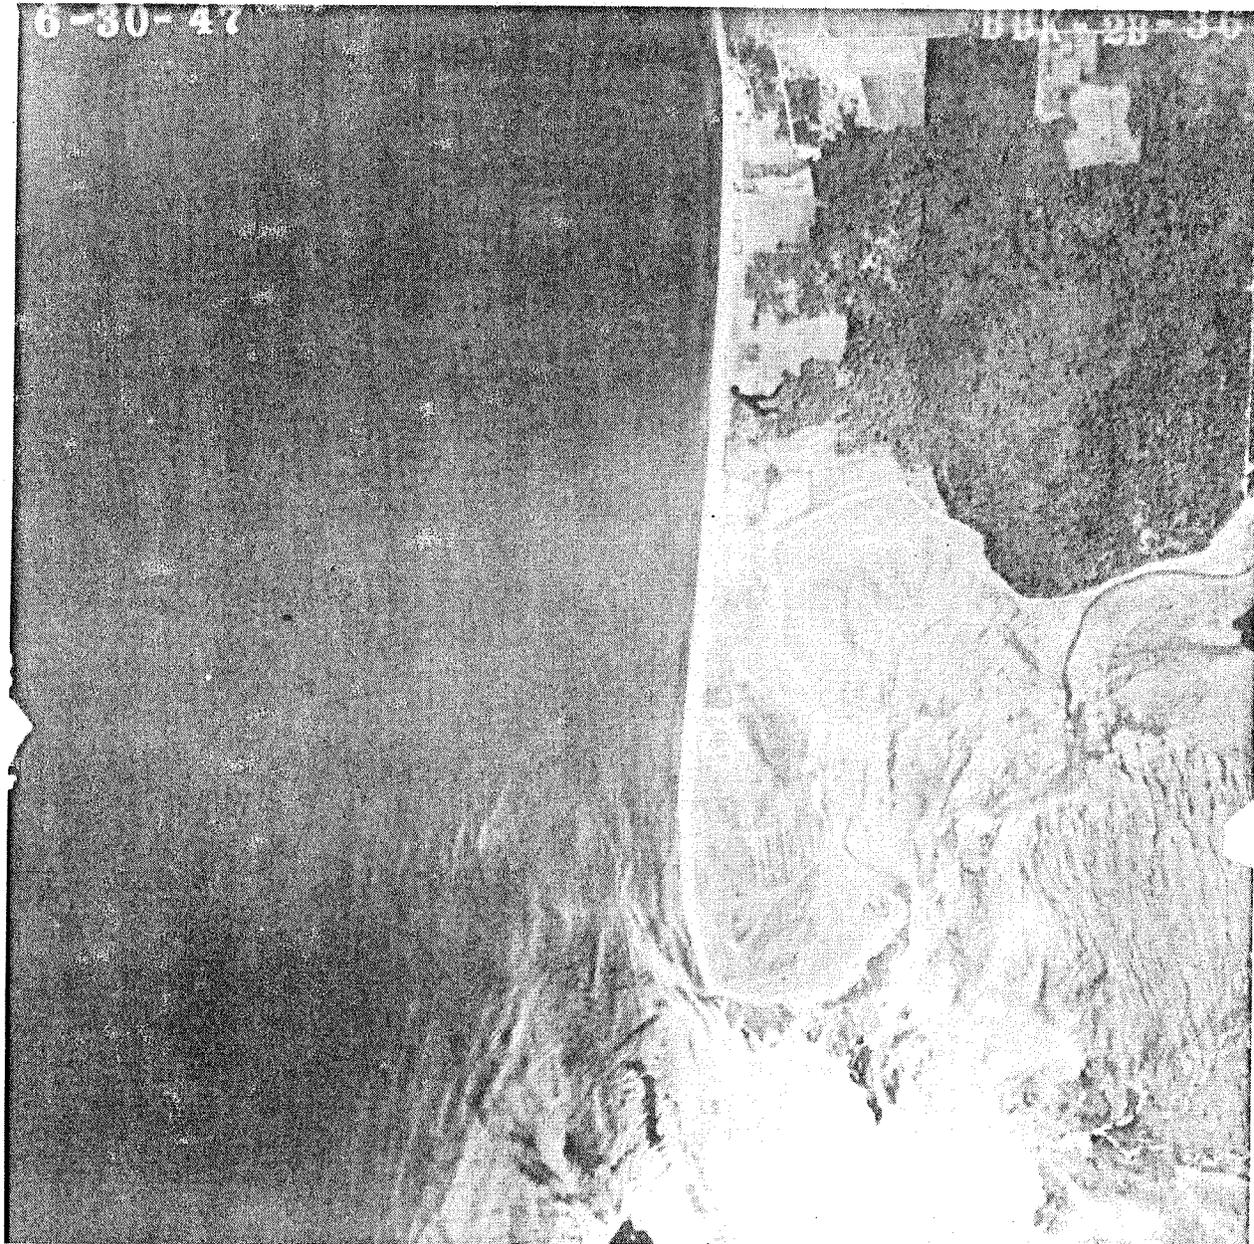
Figure 8

Sandy Point is about three to four meters above mean sea level. Its low undulating sandy surface has been significantly modified by channel dredging and home construction. A 1947 aerial photo shows that prior to development, it was devoid of trees and used for agriculture and grazing (Fig. 8). Over the last twenty years, Sandy Point has become a popular housing development. Many homes have been constructed along its western

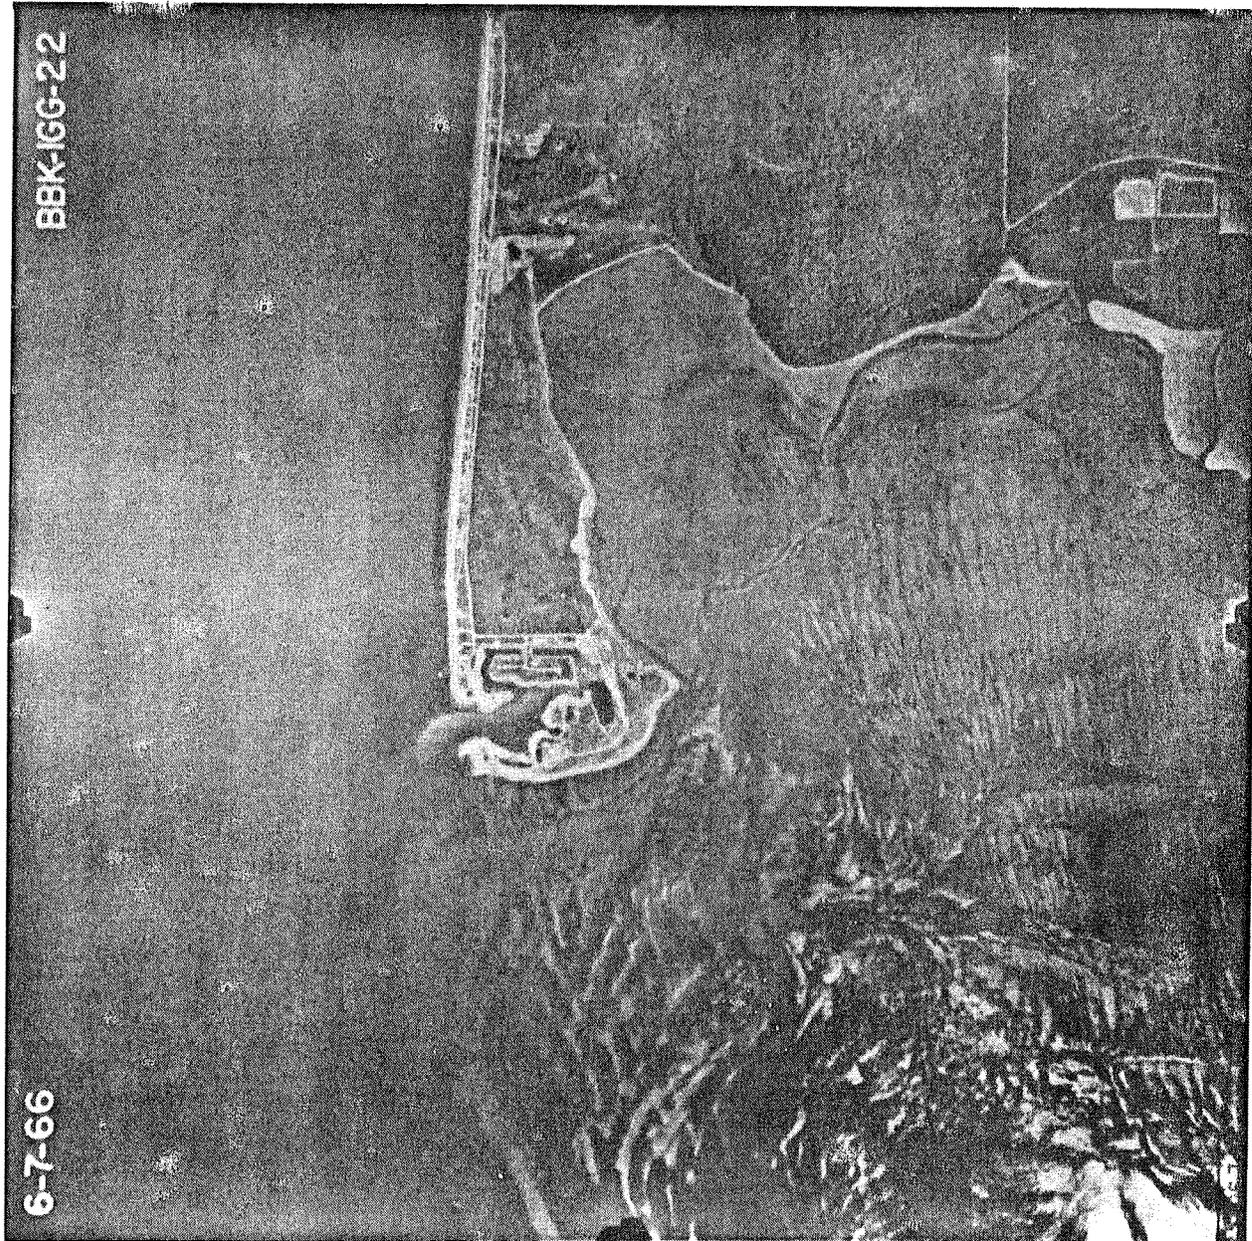
Figure 9

shoreline. Lately, additional homes have been built in the interior, adjacent to channels that have been dredged to provide additional waterfront properties (Fig. 9). Unfortunately, the channel dredging is creating sediment erosion and deposition problems. The channel entrance has interrupted the longshore sediment transport along the southwestern shore. Much of the southward moving sediment is driven into the channel by wave and tidal action resulting in two immediate problems. First, the sediment supply to the distal end of the spit has been significantly reduced causing erosion of the beach. The owners of two large homes there have been forced to install concrete bulkheads and groins to help preserve the remaining beach (Fig.10). Secondly, the inflow of sediment into the channel is causing shoaling within the mouth. Dredging of the sediment is necessary to keep the channel open to navigation.

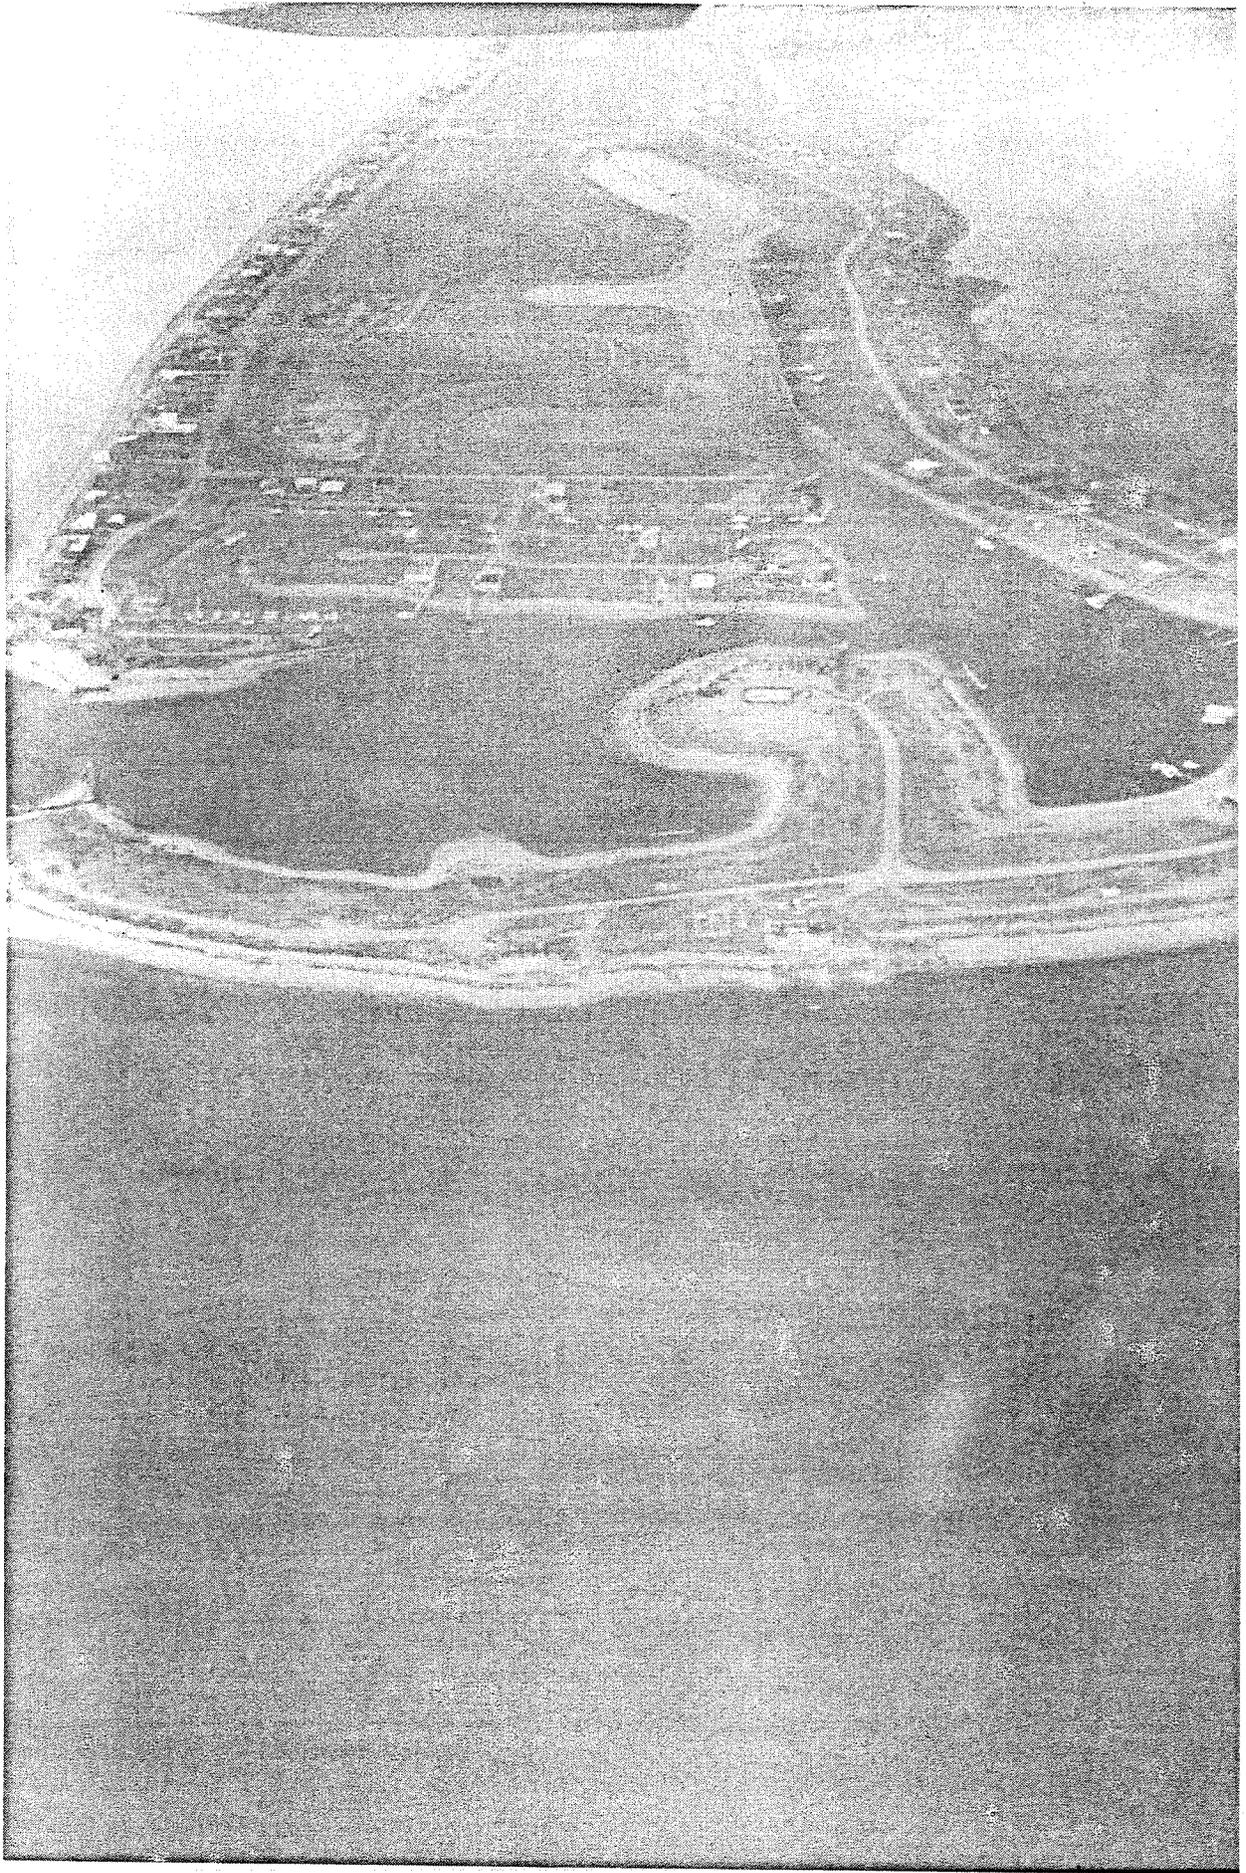
Figure 10

One very large active erosion site is located about 200 meters north of the Mobil pier (Fig. 10). Large uprooted trees and debris indicate

very rapid erosion is occurring. The headwall of the site is semicircular in plan and shows no sign of having been cut by water flowing down the face of the cliff. The indications are that erosion is the result of groundwater action similar to those slope failures along the sea cliffs north of Cherry Point and at Birch Point.

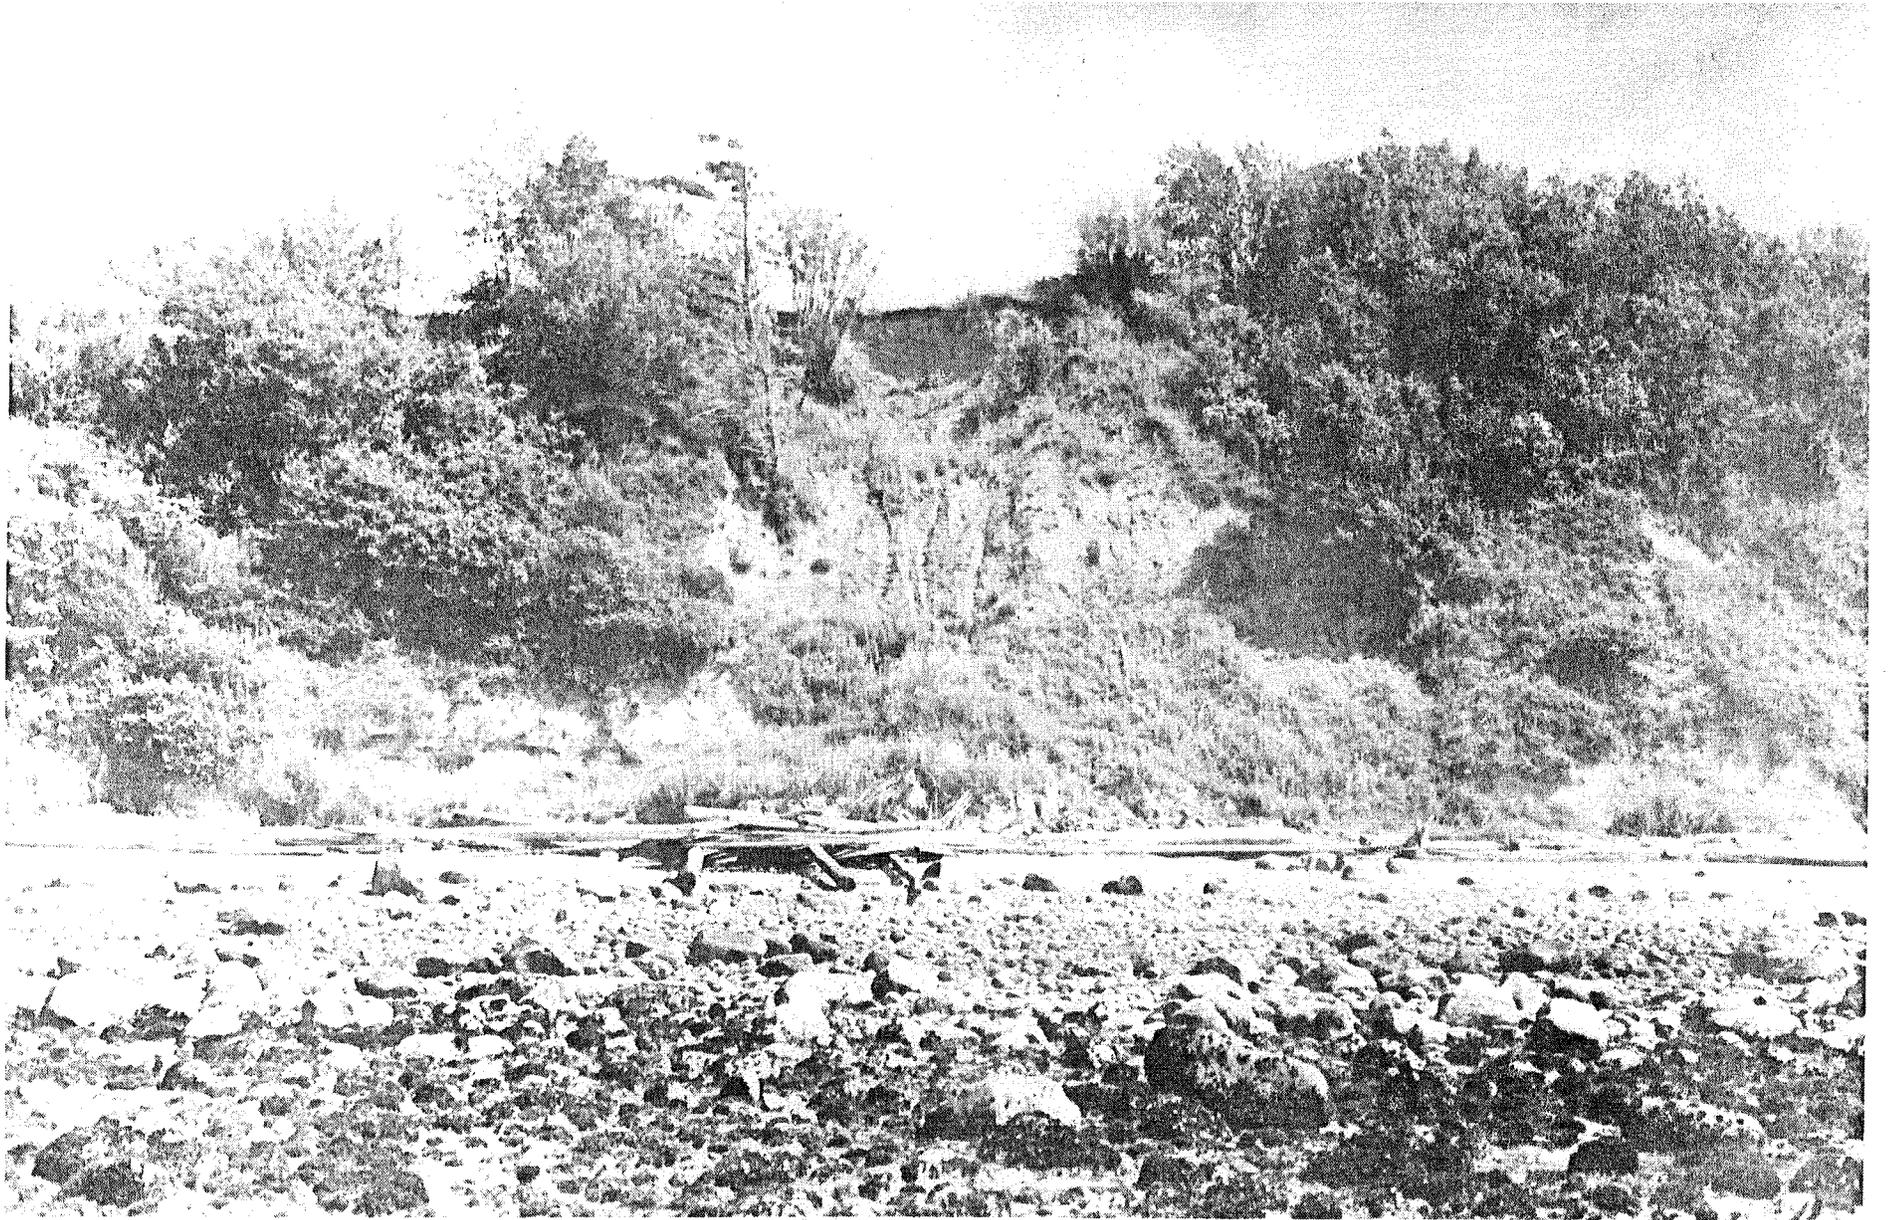
Figure 11

Point. These are caused when saturated glaciomarine drift dislodges and slumps down the face of the underlying impermeable till onto the beach below (Fig. 11). Small gullies are also carved into the face of the sea cliffs by small intermittently flowing streams draining the cultivated fields on the top of the bluffs. During the long wet winter season, these streams are very active sites of localized sea cliff erosion.

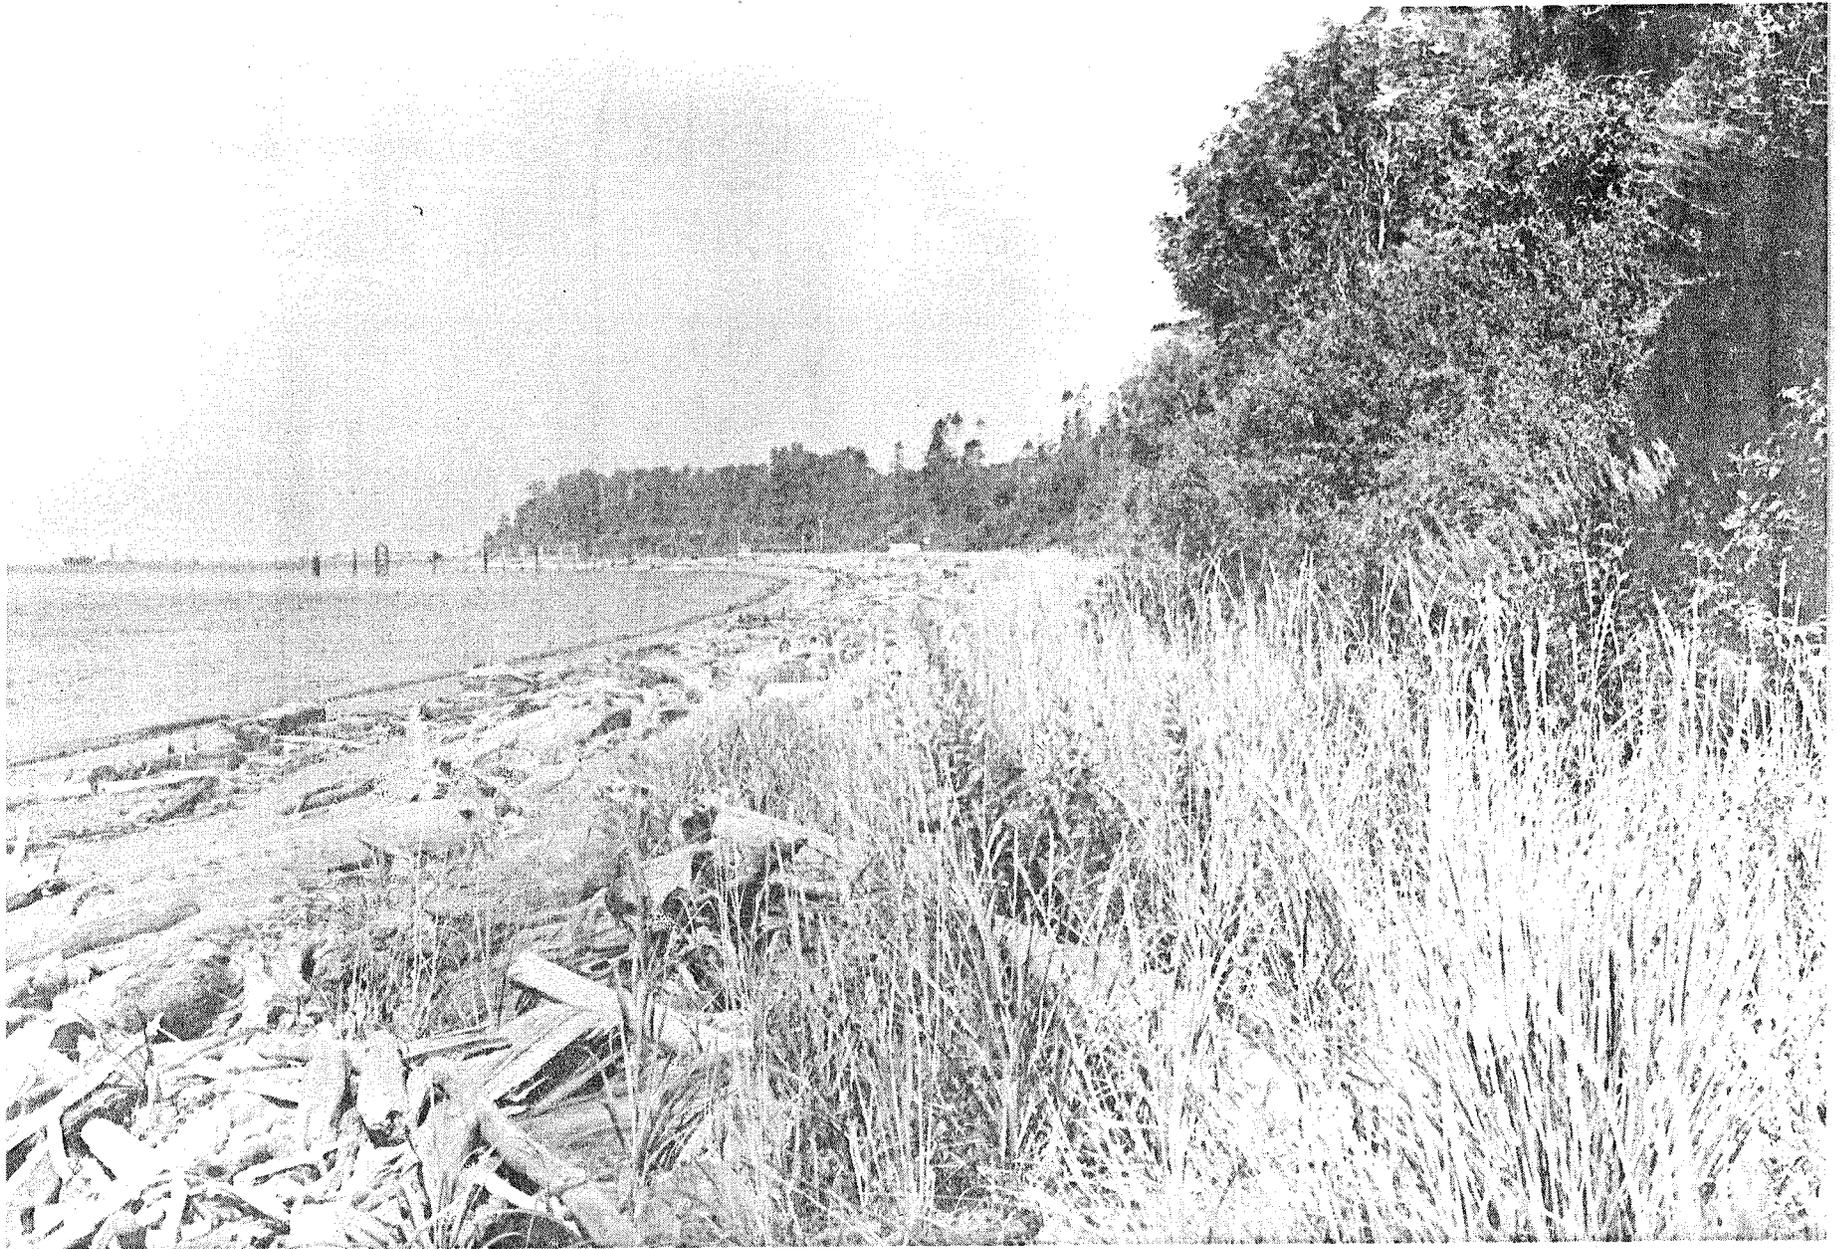
Figure 13

The beach to the south of Cherry Point has a greater abundance of sands and gravels that may reflect the receipt of lower wave energy as fetch is limited. Furthermore, the berm at the base of the sea cliffs has intermittent growths of coastal dune grass (*Elymus Mollis* Complex). The dune grass is evidence of stability indicating waves seldom erode the berm or sea cliffs (Fig. 13).
