OPEN FILE REPORT OF 77-1

COASTAL PROCESSES OF
THE WHATCOM COUNTY MAINLAND

Thomas A. Terich
Dept. of Geography & Regional Planning
Western Washington State College

January 1977

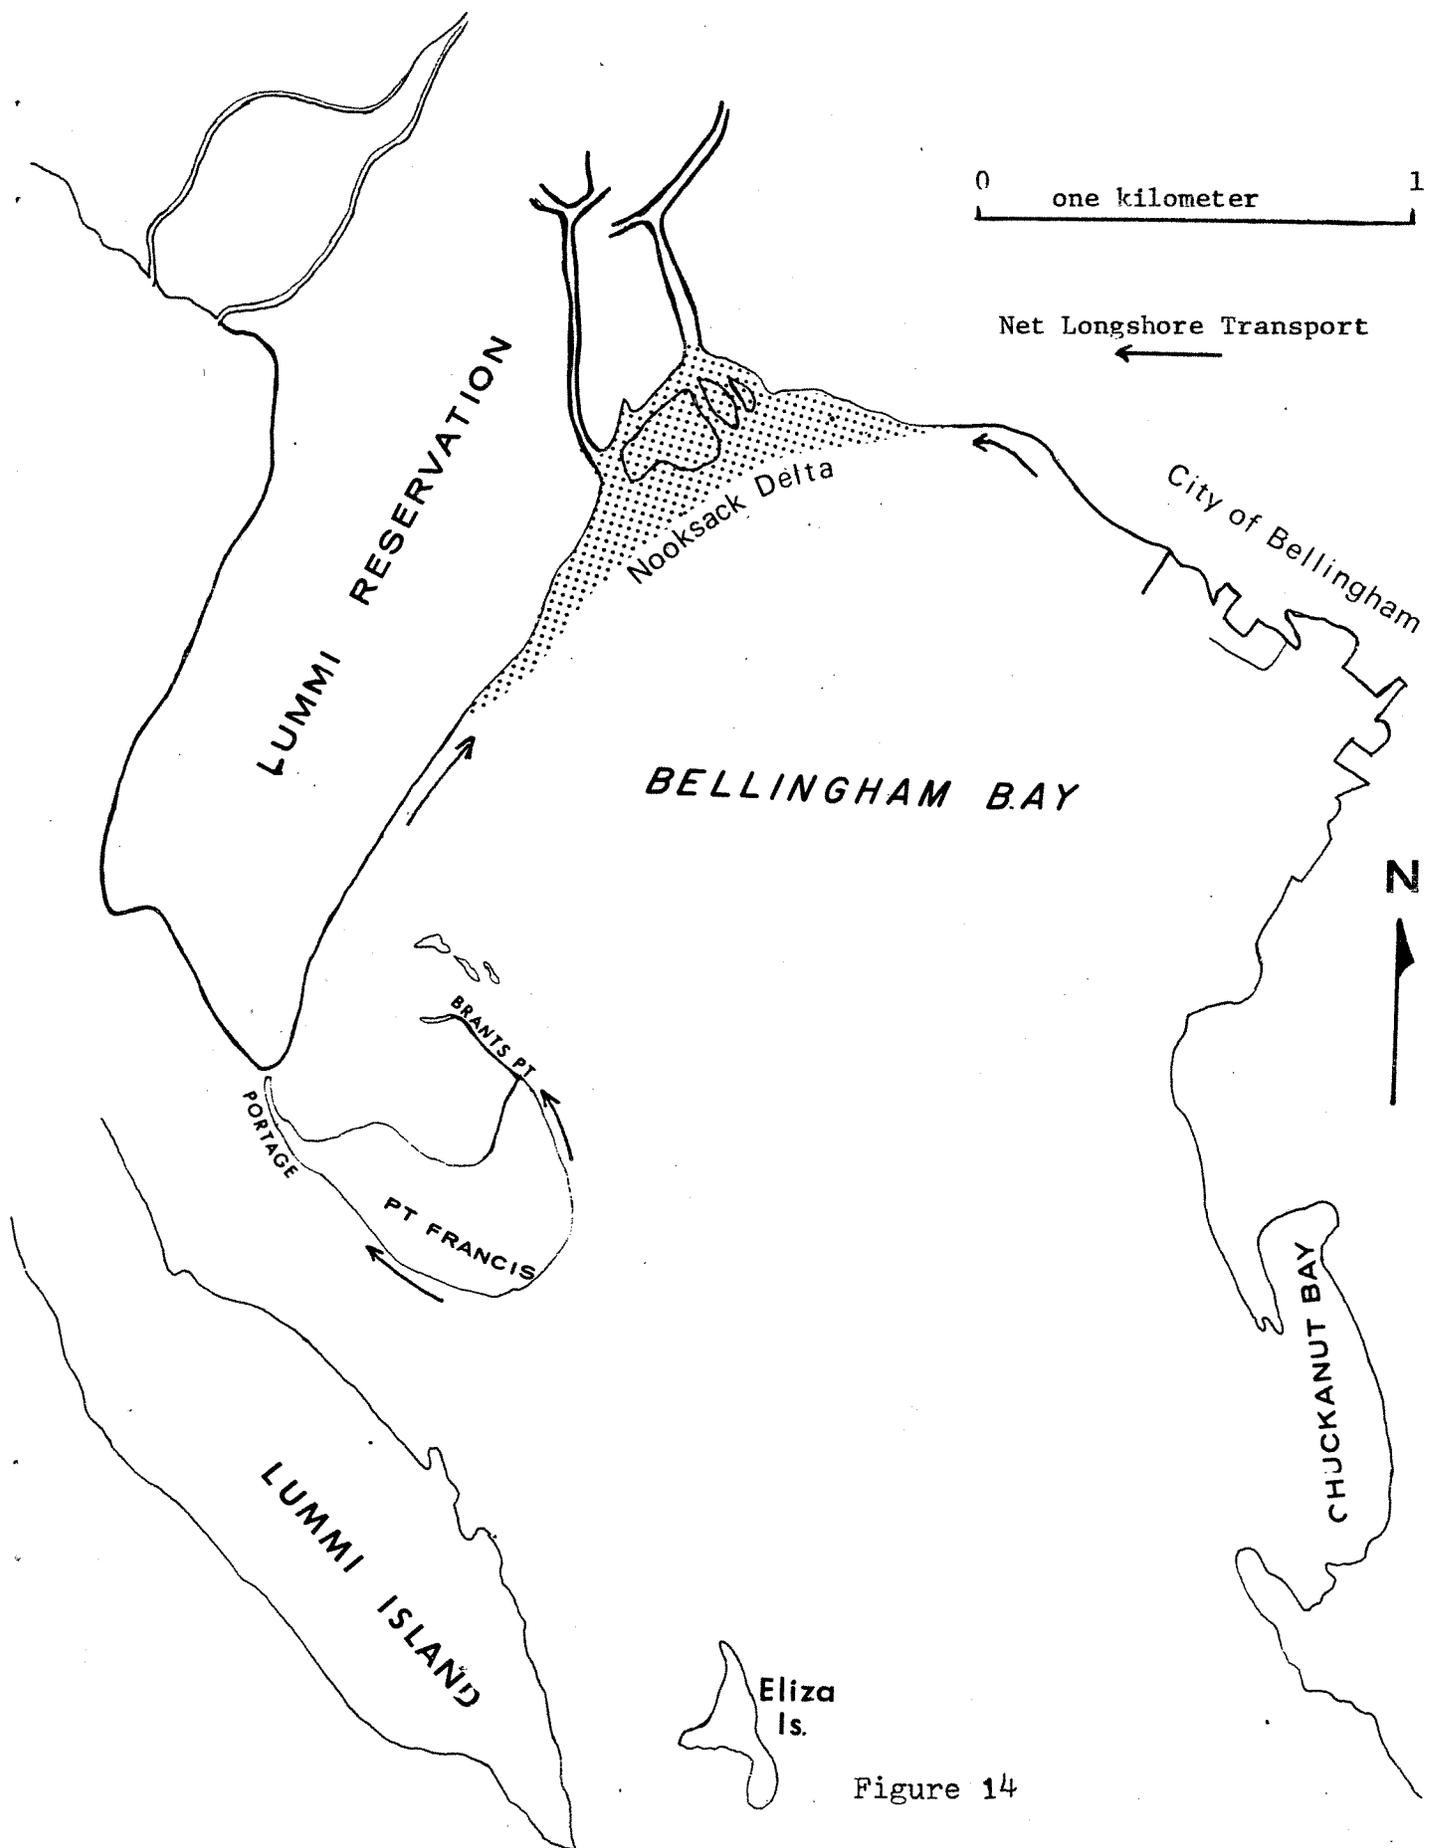
Figure 14

mately 20 km. of shoreline (Fig. 14). The Nooksack River enters the bay from the north dividing the bay's shoreline into two distinctive east and west sections. The shoreline to the east of the delta has been significantly modified over the past decades by landfills, piers, and breakwaters for numerous port oriented industrial and commercial establishments associated with the port and City of Bellingham. Furthermore, the shoreline southeasterly from the port is comprised of the Chuckanut Formation, a massive sandstone, which creates a different interface between land and water from that found elsewhere along the county's shoreline. The shoreline to the west of Nooksack delta has narrow beaches rimmed with low bluffs composed of glacial material. A similar shoreline is found on the small island off the tip of the reservation known as Point Francis or Portage Island. The shoreline and tidelands of the reservation and the tidelands of the island are under the jurisdiction of the Lummi Indian Tribe and remain largely undeveloped.

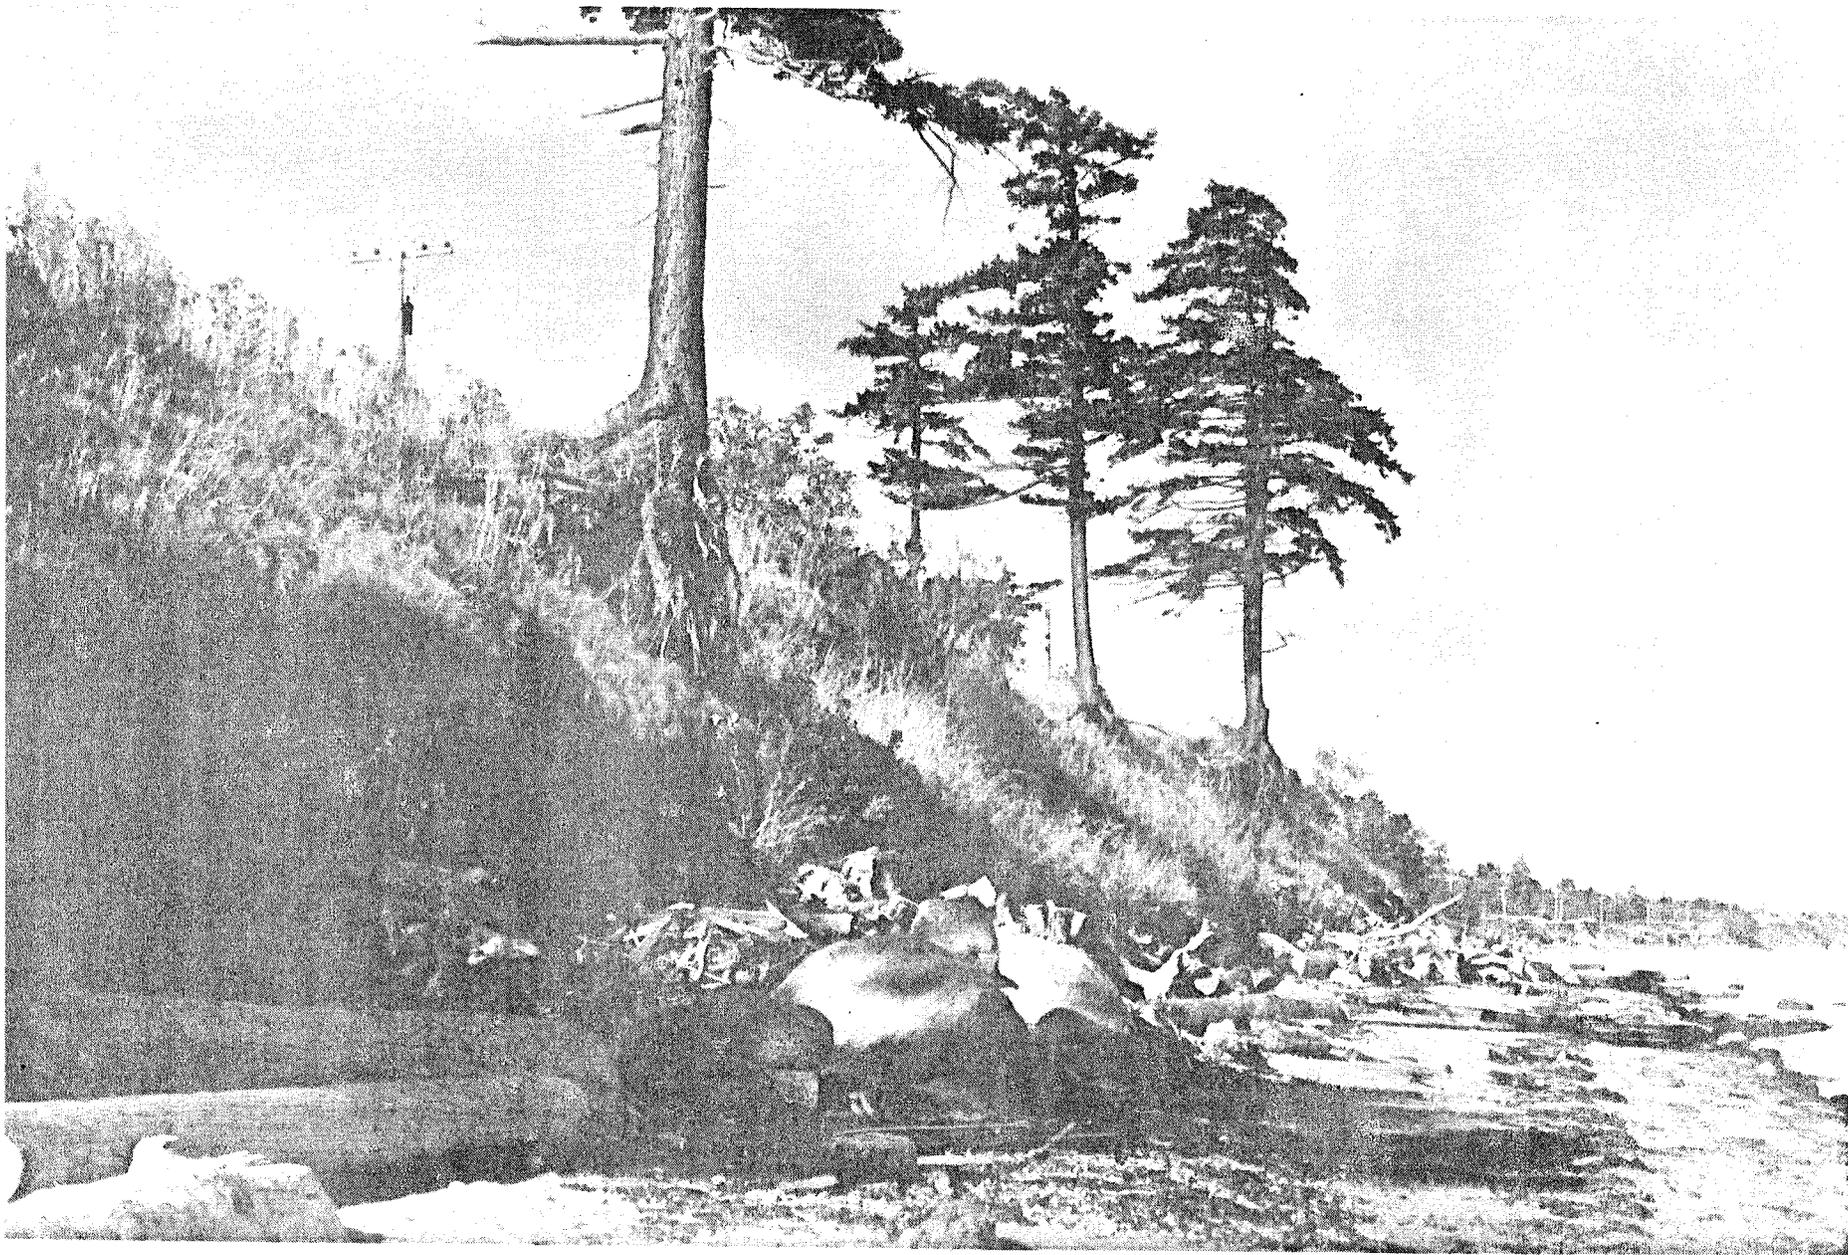
Figure 15

North and northeasterly of Point Francis are the shore bluffs of the Lummi Reservation. These bluffs are exposed to southerly wave attack as are those on the south shore of Point Francis. Waves, armed with drift debris from the Nooksack River actively erode and oversteepen the bluffs (Fig. 15). Recently fallen trees on the beach and trees soon to fall from the bluff, as it retreats undermining roots, are positive indicators of the rapid and continual erosion.

Closer inspection of the bluffs reveal that wave attack is not the only cause of bluff erosion. Many slumps and debris falls along the 6 km. long shore bluffs have a dense growth of Equisetum. This plant, more commonly known as horsetail, thrives on highly saturated soils. They indicate that the bluffs are saturated during the wet season, which is another factor leading to instability and slope failure. During the summer dry season, the plant dies due to a reduction of soil moisture. Large desiccation cracks form as the bluff face dries and the soil contracts.

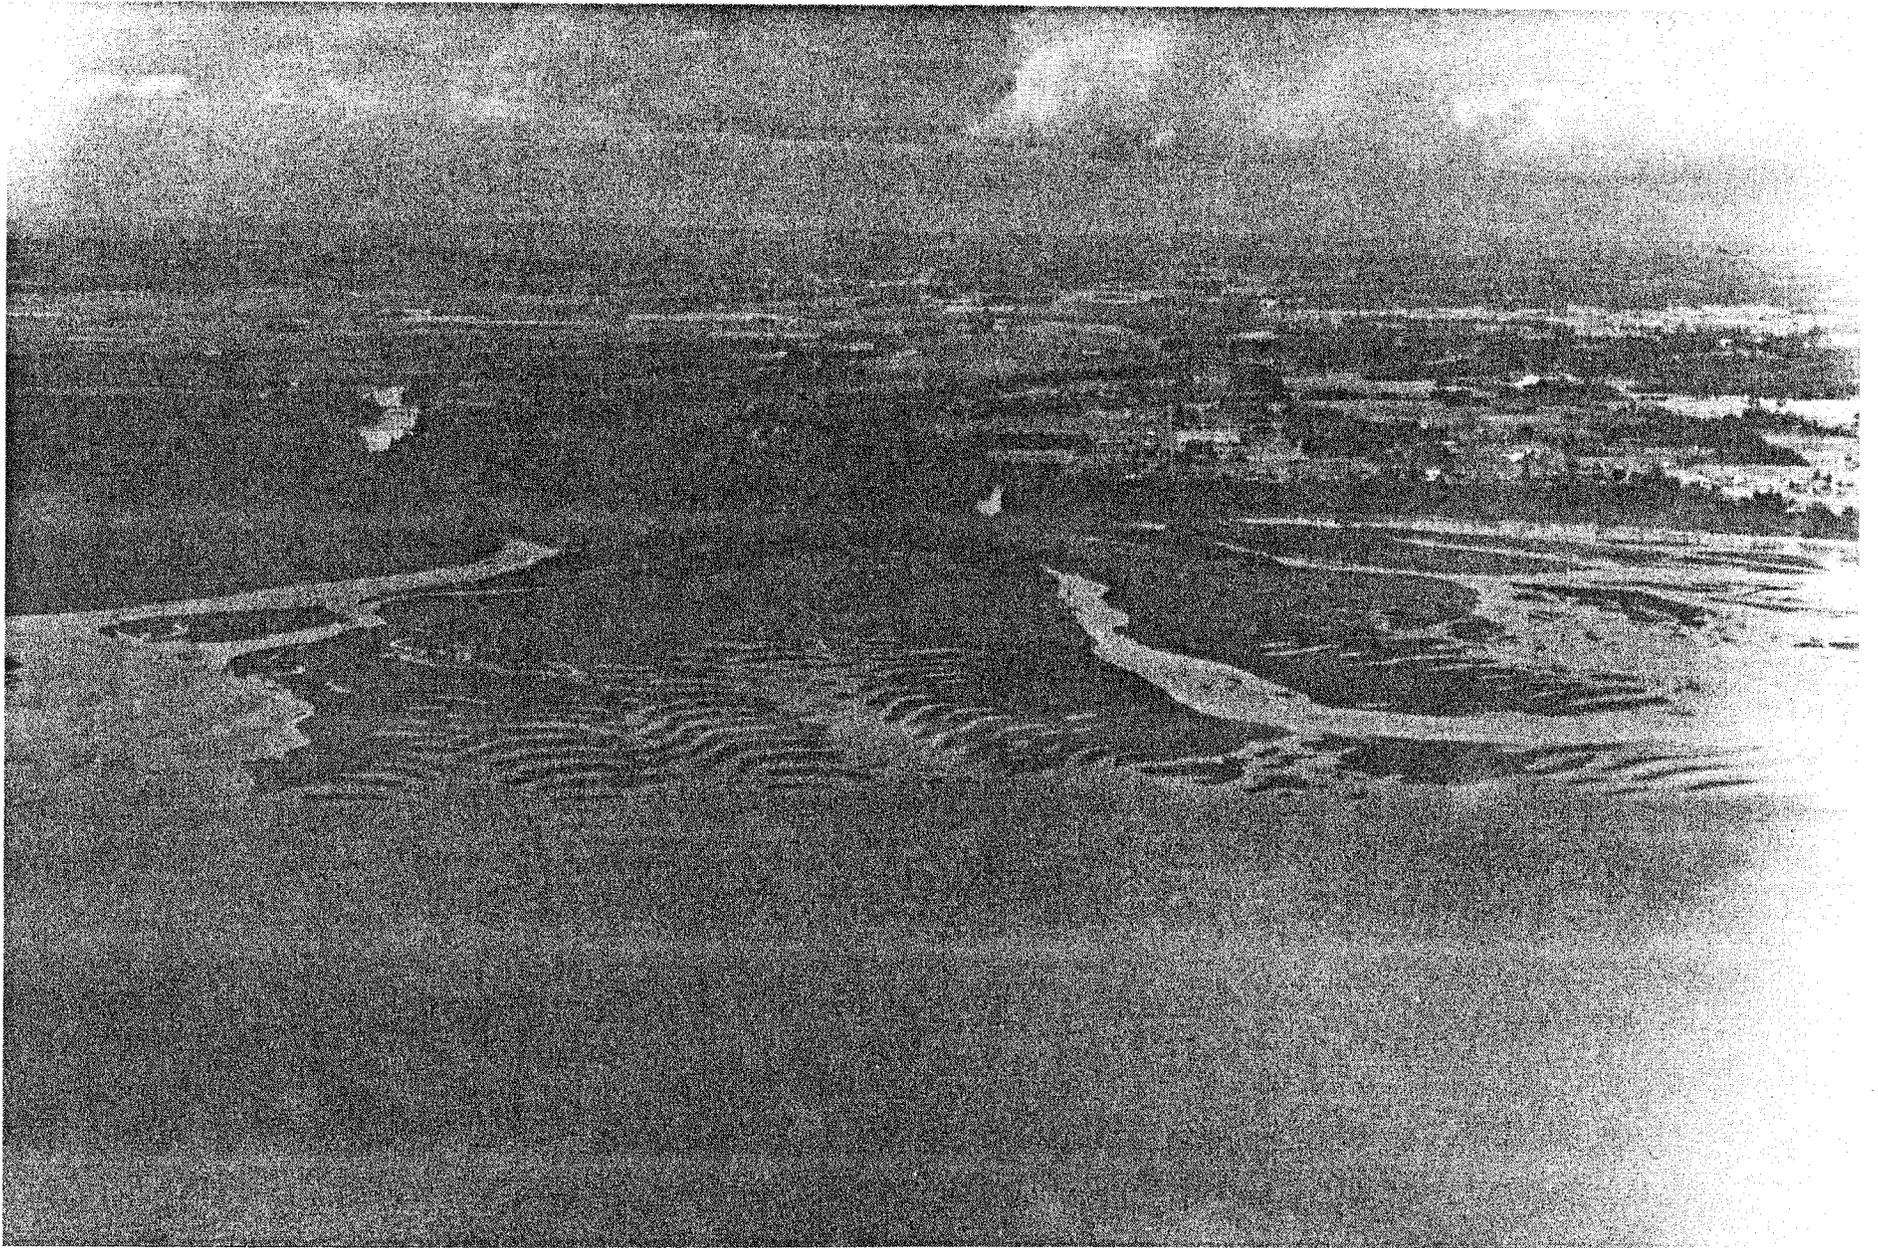
Figure 16

The Nooksack River has flowed between Lummi Bay, north of the Lummi Peninsula, and Bellingham Bay in the recent past (Easterbrook, 1973). At the turn of the century, the course of the river changed so that the main flow went into Bellingham Bay where it remains today. ^(fig 16) Sternberg (1967) has estimated the river to deposit 690,000 cubic meters of sediment into Bellingham Bay annually. Prevailing southerly waves have stunted the forward growth of the delta into the bay forcing the sediment to be deposited laterally along the eastern and northwestern margins of the bay. The lateral movement of the sediment is causing much shoaling and the development of large tidal flats near the delta. The shoaling on the east side of the bay is a problem for port expansion and shipping.

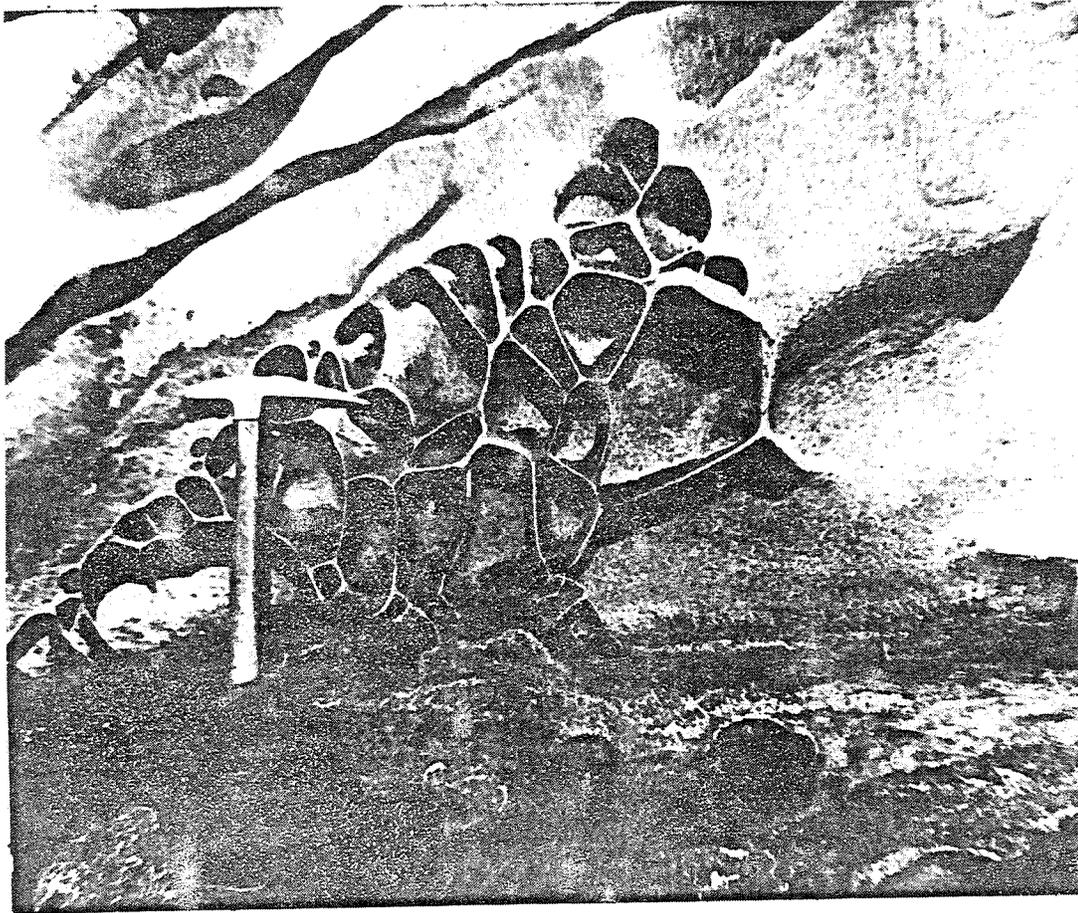
studied the shoreline weathering characteristics of the Chuckanut Formation in order to explain some of the curious patterns that resemble cavities (Fig. 18). Mustoe refers to these features as aveoli and attributes their formation to biochemical weathering of the rock surfaces. Additional beauty is shown by the drapery-like blankets of rock that overhang more actively eroding parts of the sandstone.

Figure 18 Alveoli weathering on Chuckanut Formation
(Mustoe 1971)
