Liquefaction Features from a Subduction Zone Earthquake: Preserved Examples from the 1964 Alaska Earthquake

by Timothy J. Walsh,
Rodney A. Combellick,
and Gerald L. Black

Report of Investigations 32
December 1995

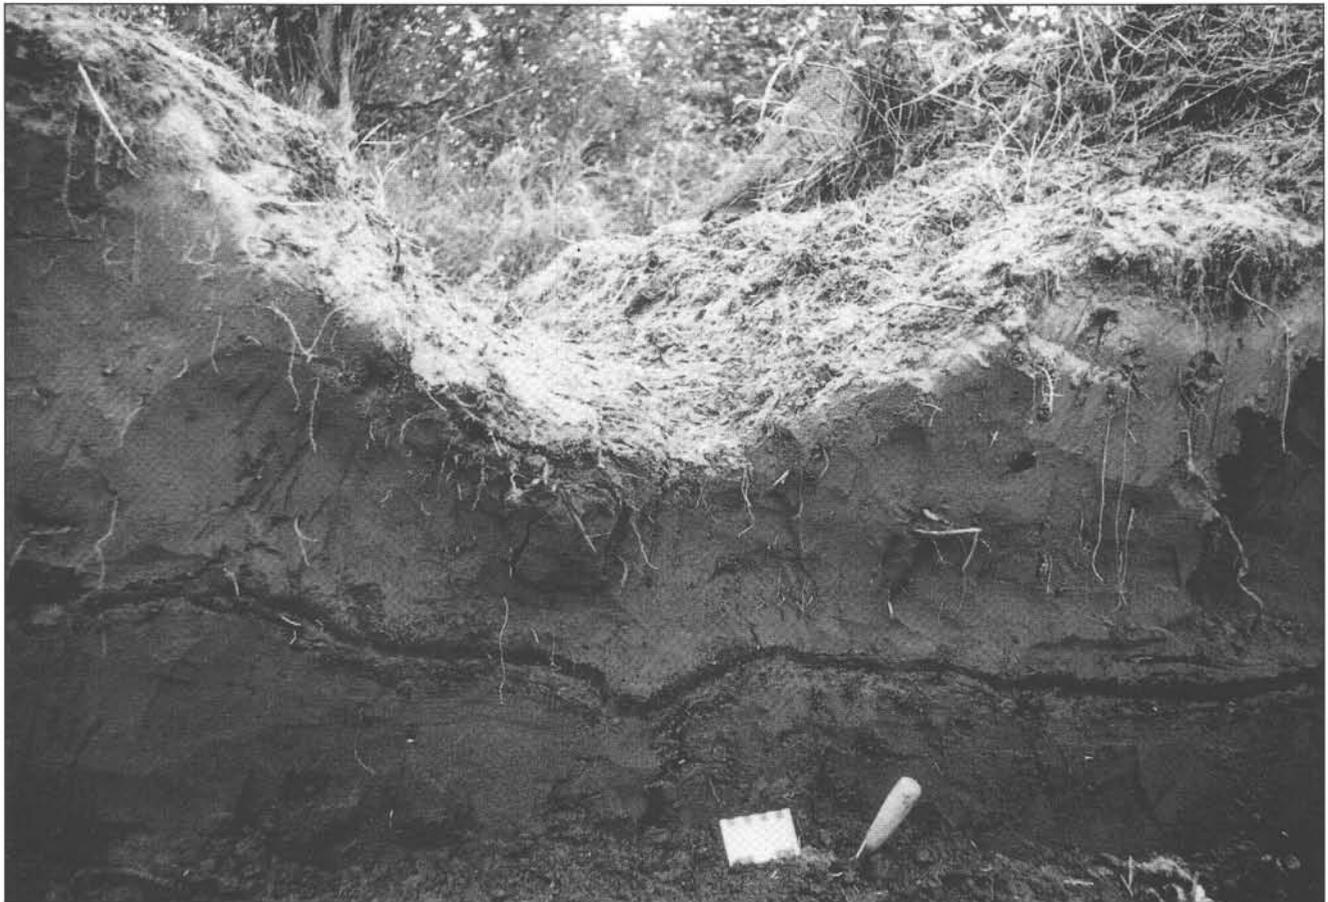
Figure 5. Photo and drawing of excavation of ground crack at site 6 along the Knik River. We found no evidence of extruded sand although the peaty soil 30 cm below the bottom of the ground crack shows evidence of having been pulled apart and then compressed. The scale bar here and in the rest of the figures is marked in inches and centimeters.

In the Knik and Matanuska Rivers area, we investigated several dozen interconnected ground cracks inferred to have been caused by the 1964 earthquake. Many cracks are open to as much as 1.3 m depth and 3.7 m width. The cracks are U-shaped and appear to have been extensively modified by running water. Our excavations did not expose any clear-cut evidence of sand extrusion, although there was evidence of contorted bedding and extension (Figs. 5, 6). We infer that ground

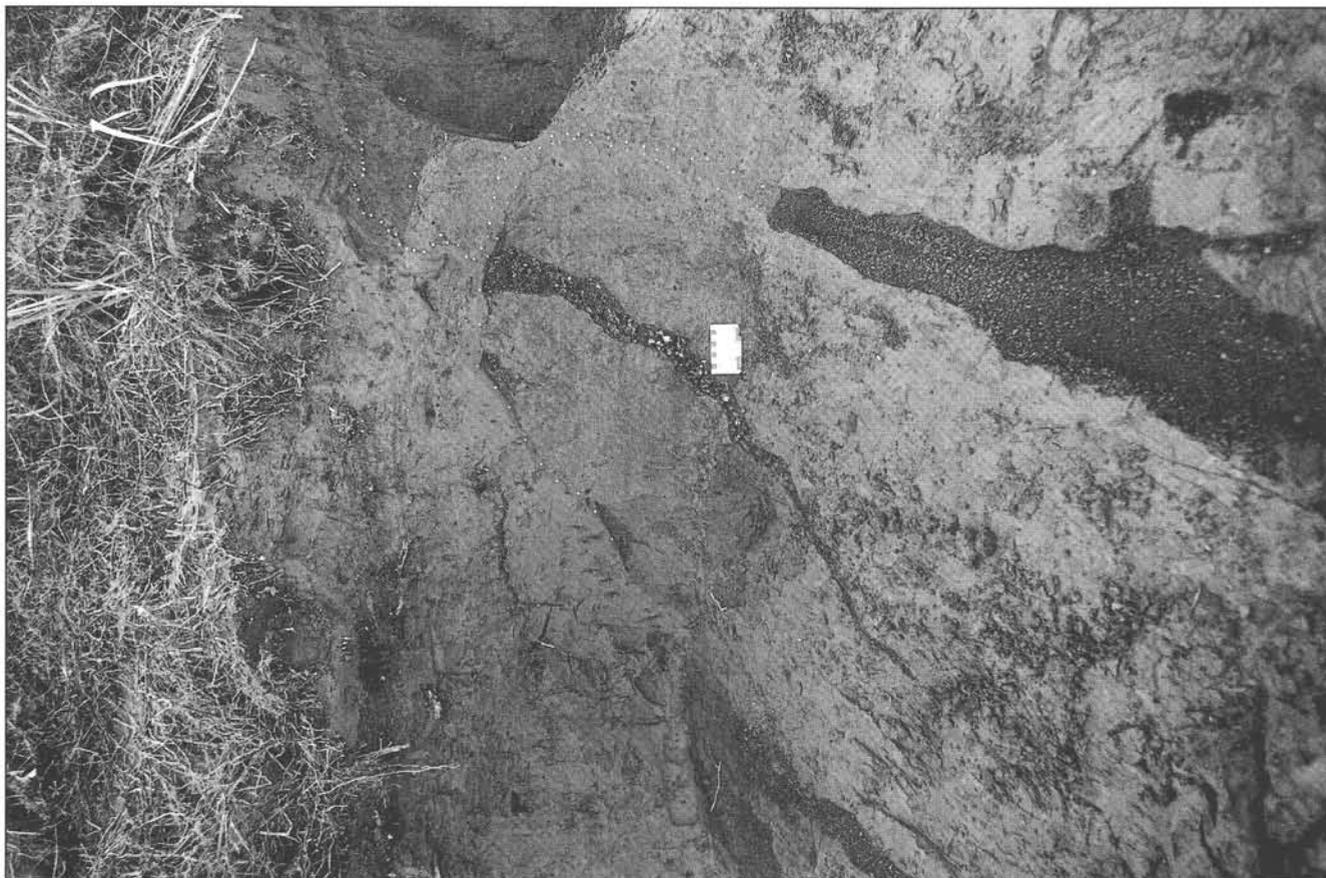
Figure 12. Photo and drawing of dikes at site 14 on Twentymile River. Three dikes of medium sand to sandy pebble gravel merge upward to connect at a single 33-cm-wide break in the pre-1964 peat layer. The upper parts of the dikes have been truncated and replaced by silt infilling from above, probably as a result of reworking by tidal flooding after the earthquake. Silt replacement extends to a maximum of 83 cm below the top of the pre-1964 surface.

In at least 50 cases, dikes terminated at depths as much as 92 cm below cracks in the 1964 soil surface, and the cracks were filled with unoxidized, massive silt up to the 1964 surface (Figs. 12, 13, 15, 16, 18, 21, 33, 34, 55). In at least 17 cases, the margins of the ground crack above these silt-filled dike throats are mantled with extruded sand, suggesting that these dikes erupted to the surface. We infer that the loosely packed, noncohesive sand and gravel of the dikes were sluiced out of the narrow channels of the ground cracks by currents from spring tides, which inundated this area after approximately 2 m of coseismic subsidence. On several occasions, we witnessed incoming tides sluicing out dikes we had excavated (note, for instance, Fig. 17, site 20). On one occasion, we left a trenching tool, folded into an 'L' position, standing with handle up at one of our excavations when the tidal bore in Turnagain Arm reached the site. When we retrieved the trenching tool the next day, 5 cm of silt had been deposited on the blade. A similar process probably eroded many dikes during the rising tide from the spring tides about two weeks after the earthquake, then deposited cohesive, less erodible silt during still-stand, thus protecting the dikes from further erosion. Eventually, the cracks were filled by the more cohesive Placer River Silt deposited by the glacial-flour-rich Placer and Twentymile Rivers, Portage Creek, and Turnagain Arm (Bartsch-Winkler and others, 1983). This contact is well defined by the color contrast between the pale blue-gray post-1964 silt and the buff-to-pale yellowish-orange pre-1964 silt.

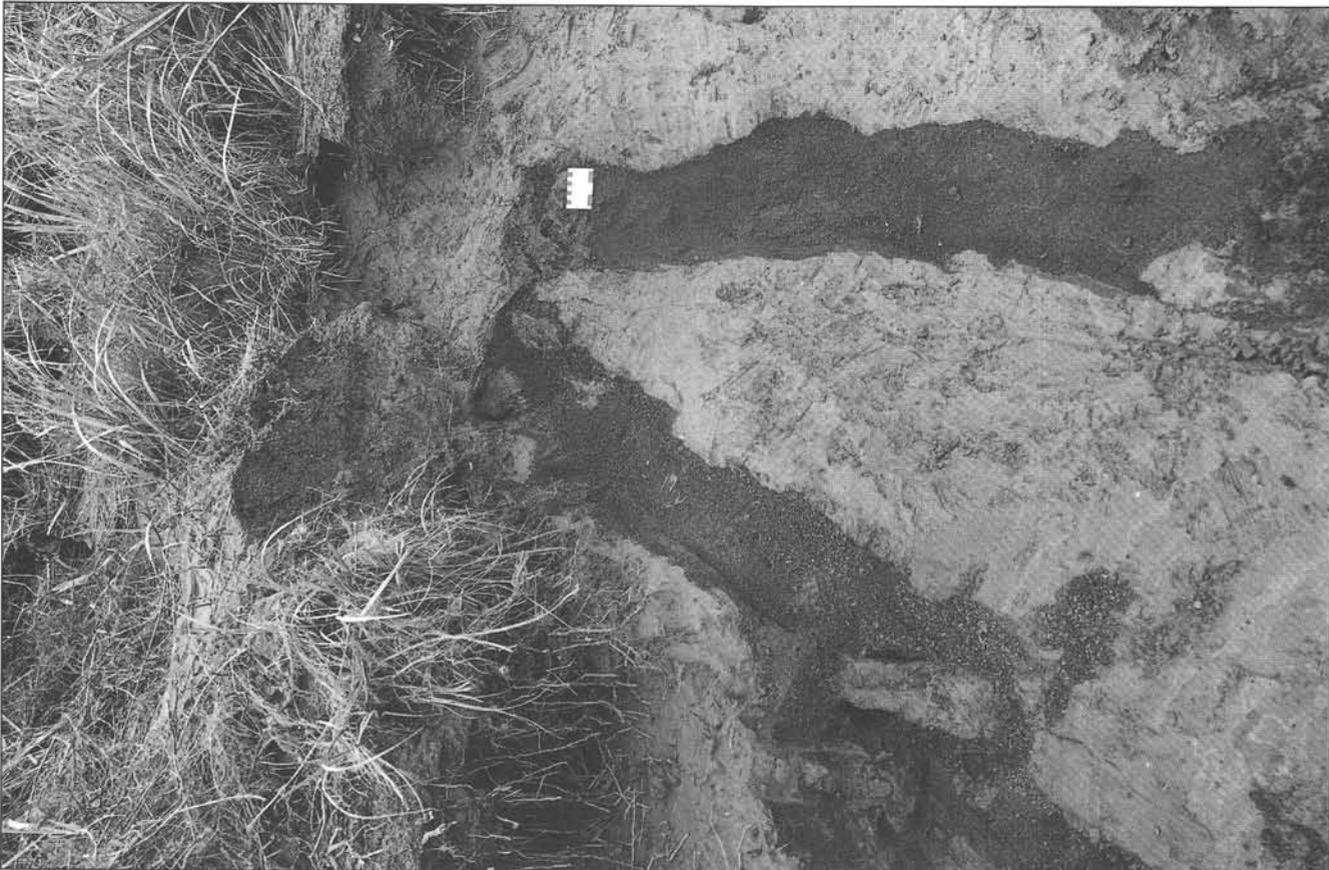
Figure 13. Photo and drawing of dikes at site 16 on Twentymile River. Two dikes of medium to coarse sand merge upward to connect at a single 42-cm-wide break in the pre-1964 peat layer. Dikes are locally gravelly, with pebbles ranging in size to as much as 2 cm diameter. Dike margins have oxidized crusts up to 3 cm thick. The upper parts of both dikes are reworked and replaced with silt from above.

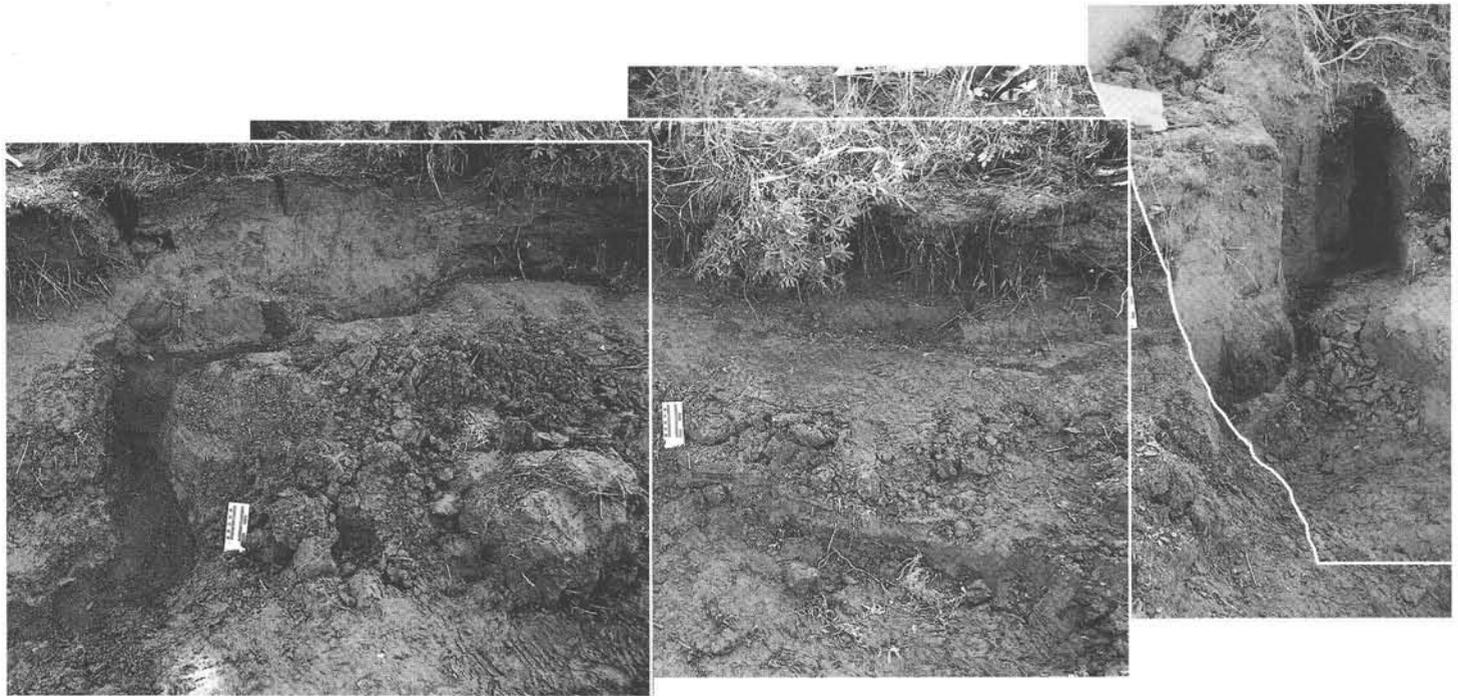
Figure 14. Photo and drawing of complex dike at **site 17** on Twentymile River. This dike extends parallel to shore for 17.5 m and has three branches that are normal to shore, apparently bounding two landslide blocks caused by lateral spreading.

Figure 14. (continued) Photo and drawing of complex dike at site 17.

Some dikes we observed were tabular, but many dikes were very irregular, changing appearance significantly as we excavated. Figure 14, for instance, shows a shore-parallel dike that bifurcates into shore-normal dikes, probably defining the margins of lateral-spread blocks. Parts of this dike system are tabular, but areas of the dike near these bifurcations are highly irregular. Because sediment-laden water forming a clastic dike follows a pressure gradient, these orthogonal corners where the gradient drops off in several directions at once and where stresses are omnidirectional (McCulloch and Bonilla, 1970) are places where complex dikes form. Also, because they follow pressure gradients, dikes can be injected downward as well as laterally or upward. The dike at site 80e (Fig. 57) apparently filled a relatively large (6 cm) crack upward and

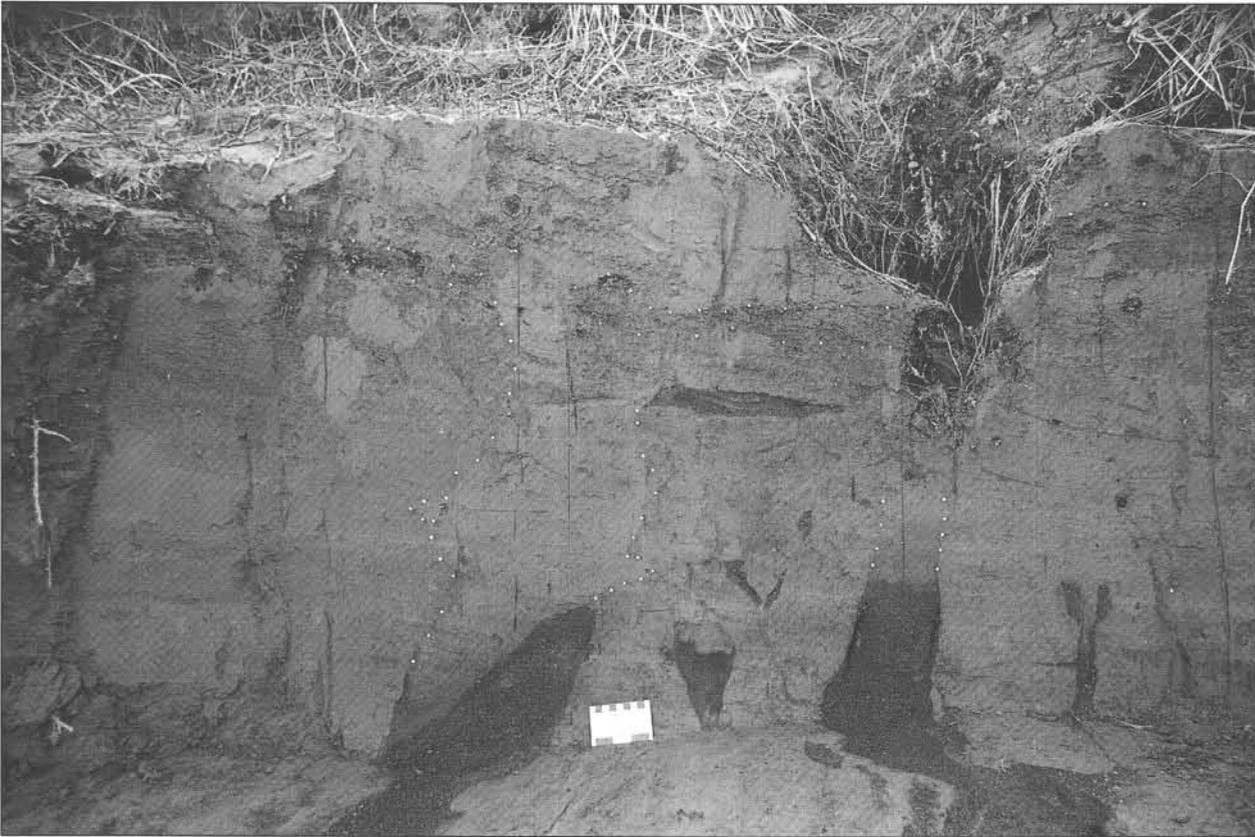
Figure 15. (above) Photo of two large sand dikes at **site 18** on Twentymile River. Dikes consist of dark gray medium sand and terminate 40–45 cm below the top of the pre-1964 peat layer. The peat layer is delimited by two horizontal rows of white pins. The upper parts of the dikes are replaced with silt from above, probably as a result of tidal reworking after the earthquake. Both dikes show cross-bedding in silt near the sand–silt contacts, indicating reworking of the sand into the lower portion of the silt. Replacement silt in the dike on the left truncates a sand sill that was likely injected from the dike. A thin layer of medium sand overlying the peat layer near the left dike is probably a remnant of a sand boil associated with the dikes.

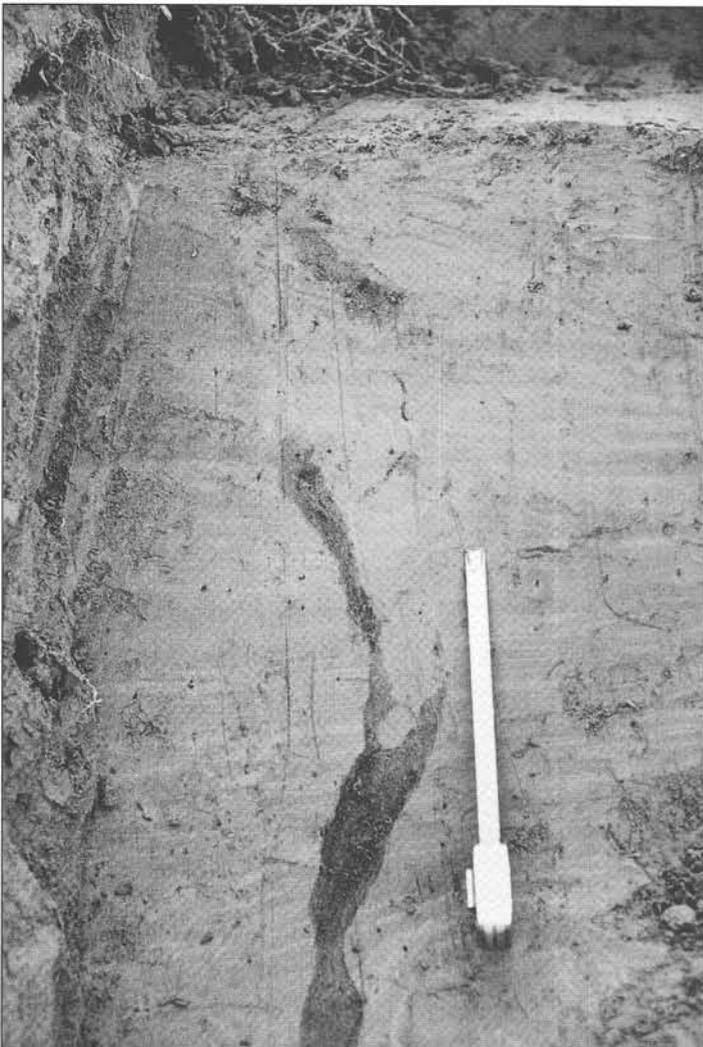
Figure 16. (left) Photo of thin (3–5 cm) dike at **site 19** on Twentymile River that bifurcates 70 cm below 1964 peat (not shown in photograph). Dike is composed predominantly of medium lithic sand with minor granule-bearing sand. Thin (1–2 mm) sand stringers define the right margin of the dike above where it bifurcates. The area between the limbs is filled with very fine, light-gray sand that is coarser than the silt intruded or the overlying Placer River Silt.

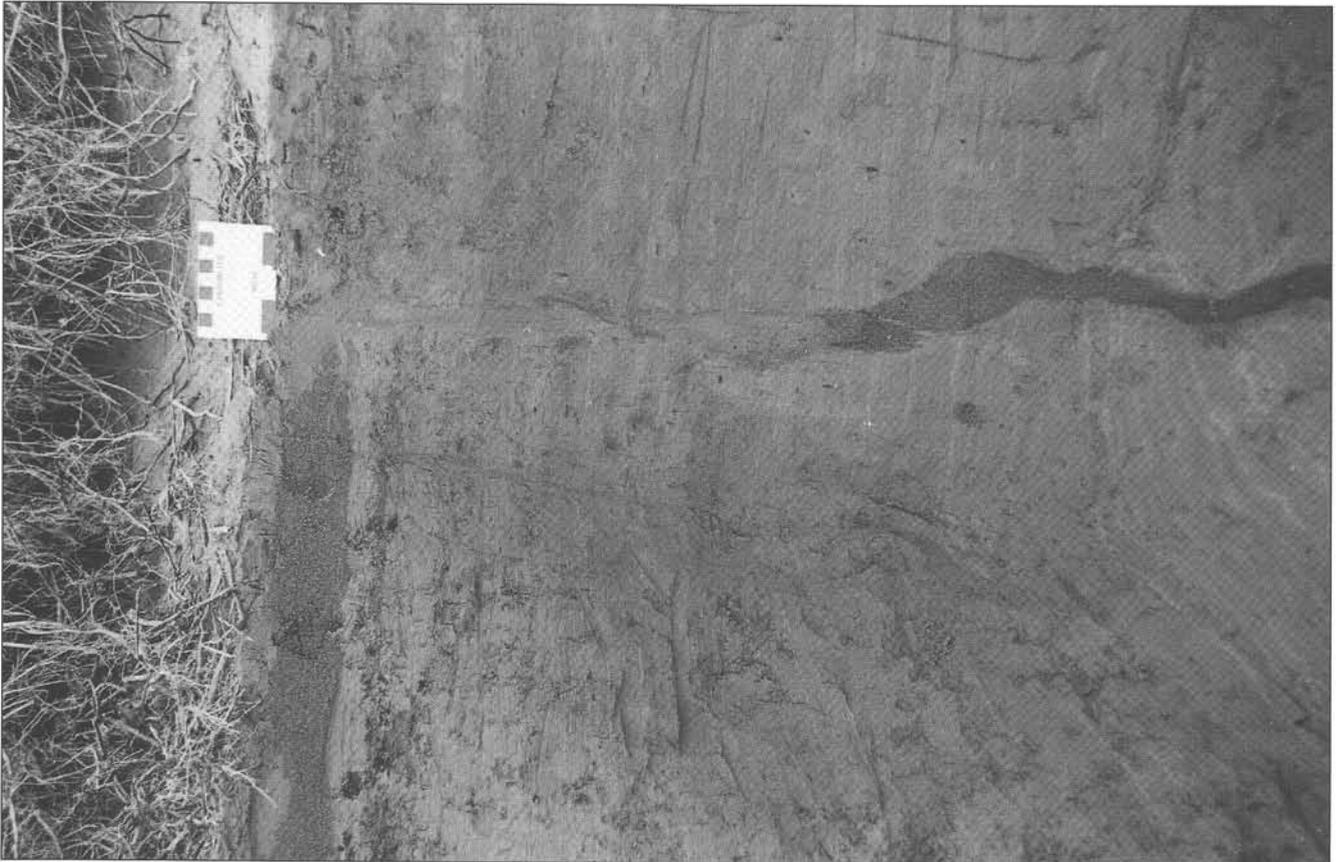
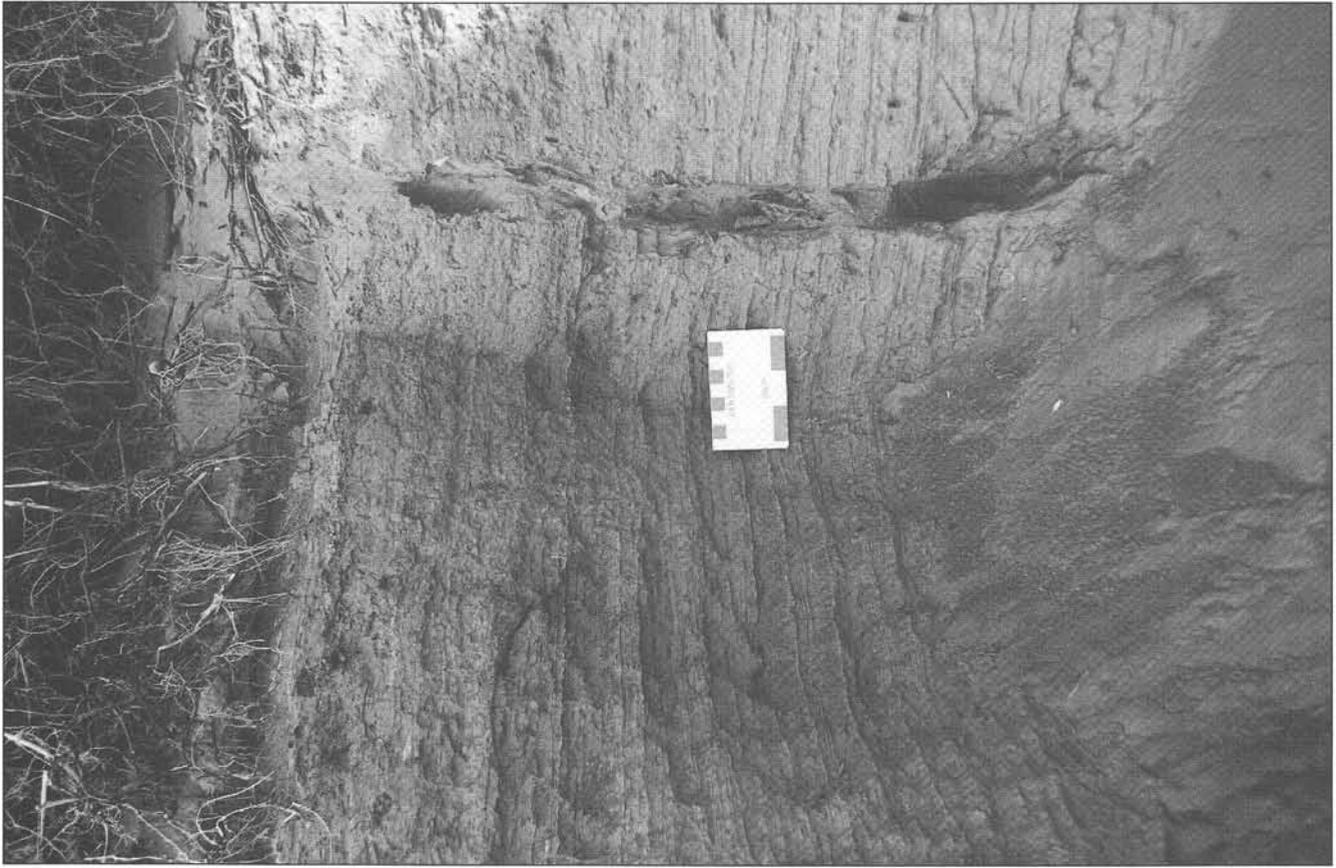
Figure 17. Photos of sand dike and boil at **site 20** on Twentymile River before and after etching by high tide. The left photo shows the remainder of a partially eroded sand boil, 5 cm thick, extending to the left of the dike. This sand boil overlies 2 cm of silt, which in turn overlies a thin (1 cm) peat that marks the pre-1964 surface. The upper part of dike is replaced with silt to 36 cm below the pre-1964 surface. The right photo shows that the sand erodes much more rapidly than silt during tidal flooding.

We found sand boils at 26 sites. Extruded sand is generally limited to 1- to 2-grain thickness but reached a maximum of 6 cm. Sand boils rest on 1 to 2 cm of silt containing vertically oriented rootlets overlying the peat (Figs. 17, 21, 29, 50, 55). This silt is probably analogous to the layer of windblown silt trapped at the base of the plants on the modern marsh surface.

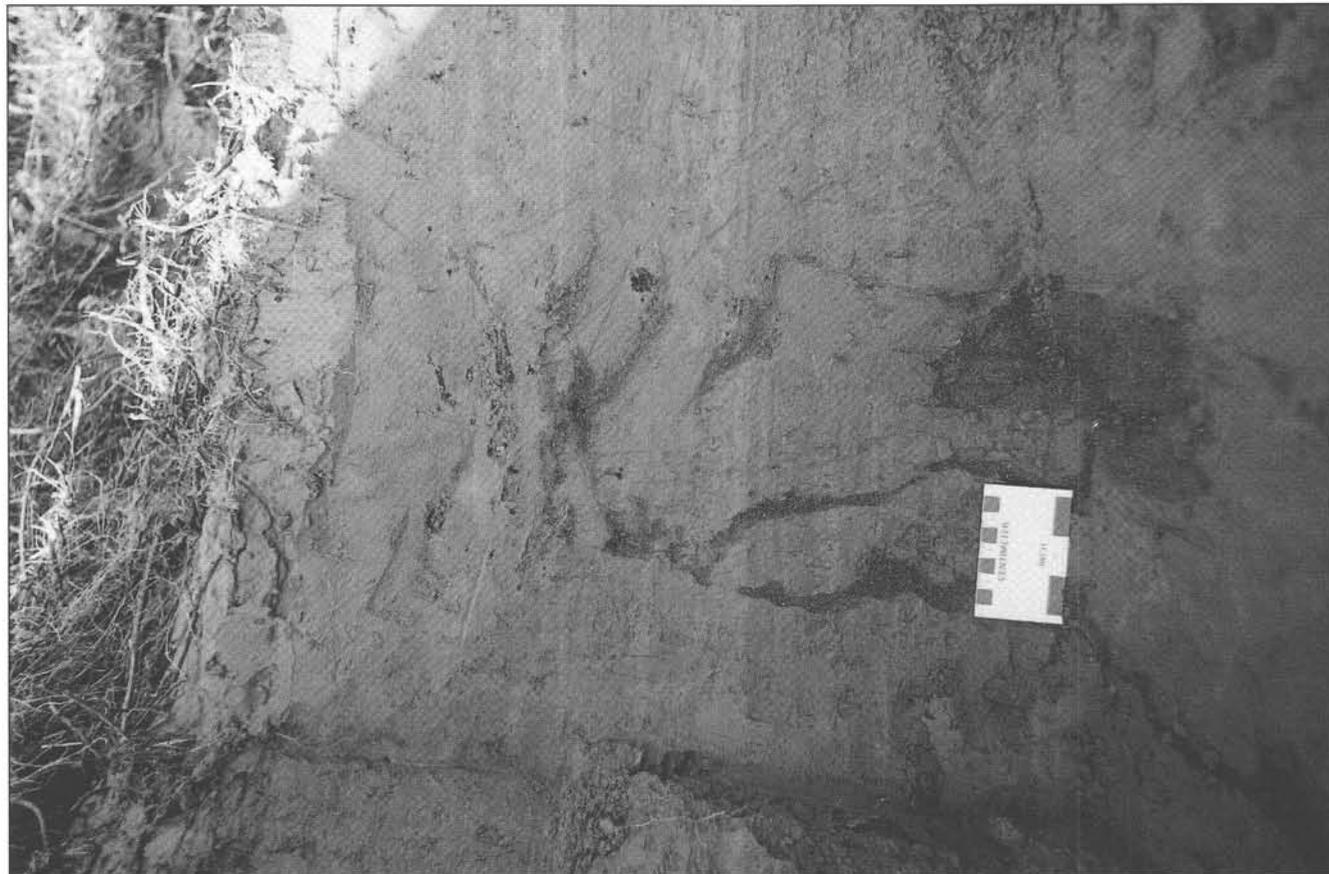
Figure 18. Photo and drawing of discontinuous, anastomosing dikes at site 21 on Twentymile River. Silt replaces the upper 40 cm of the thicker dike on the right and truncates the thinner dike on the left. Reworked peat and dike sand appear in the replacement silt, which was probably emplaced during tidal flooding after the earthquake. Host silt is laminated. The break in the pre-1964 surface (top of peat layer) is 35 cm wide.

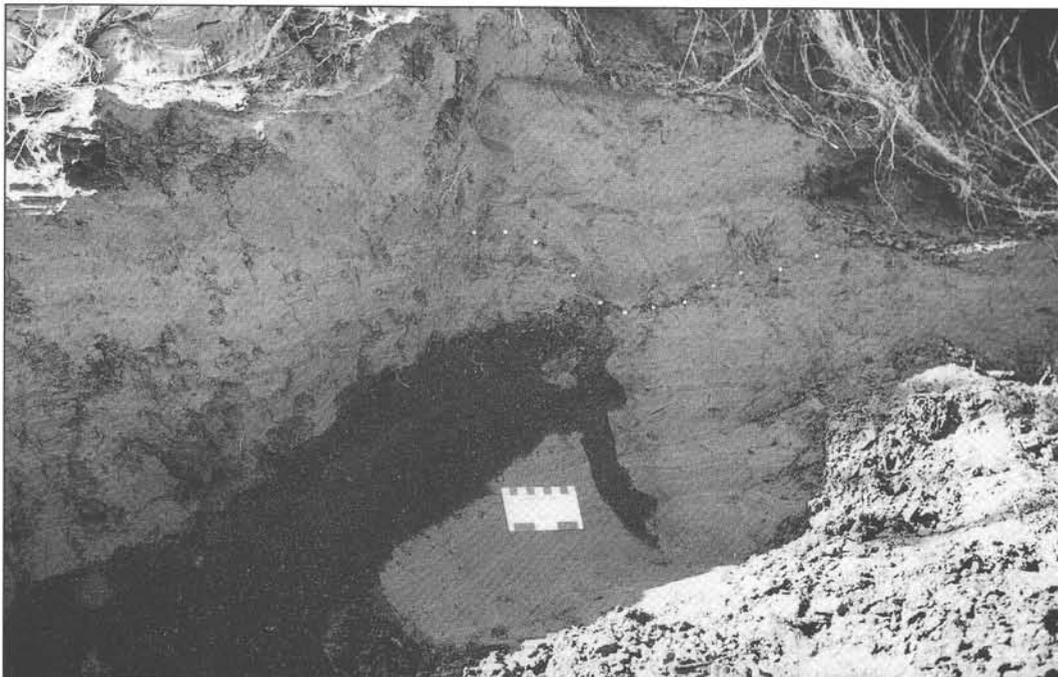
Figure 19. Photo of dike/sill 20 cm thick at site 22 on Twenty-mile River. It is composed of pebbly medium to coarse lithic sand. Largest clast is 3 x 2 x 0.4 cm. Pins mark the position of poorly expressed 1964 peat surface. A thin sand stringer over the peat surface may be extruded sand. The source is shown at base of the photo. The vertical distance from the source to the peat is approximately 42 cm.

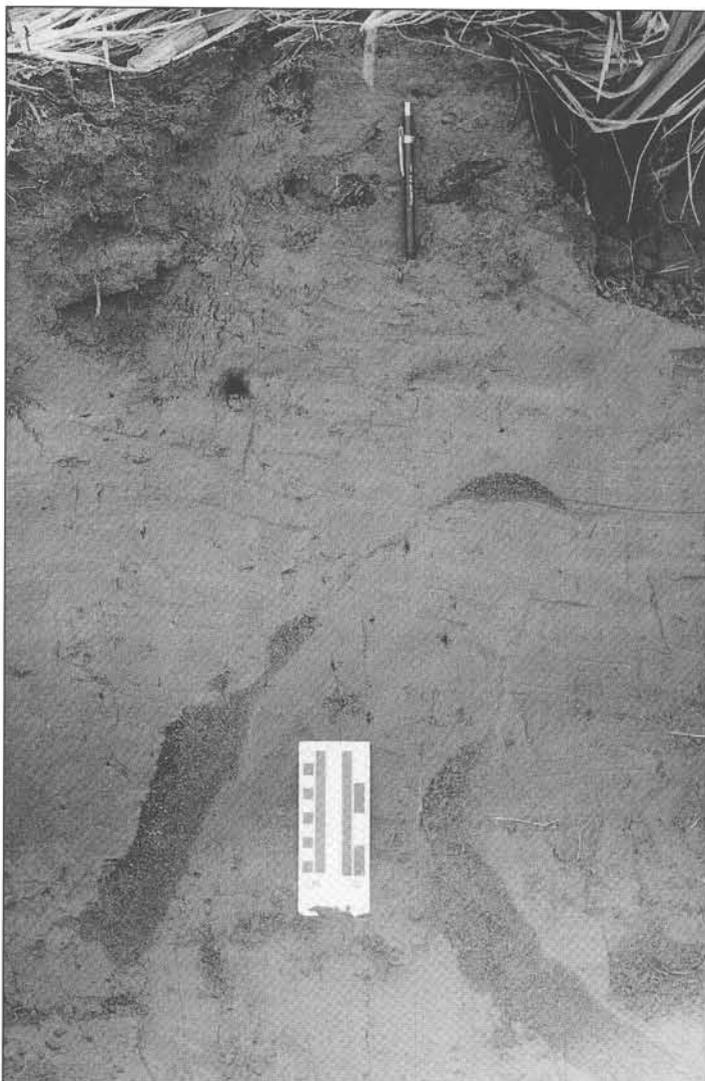
Figure 20. Two dikes at site 24 that coalesce 32 cm below base of the 1964 peat. The top of the pencil marks the base of the 1964 surface. Dikes are 5 cm (left) and 6 cm (right) wide and pinch out approximately 50 cm below the 1964 surface. Both dikes are composed of medium to coarse sand. The upper 20 cm of the dike has been replaced by Placer River Silt. There is 20 cm of open fracture between the top of the dike and the 1964 surface. There is no evidence of erupted sand.

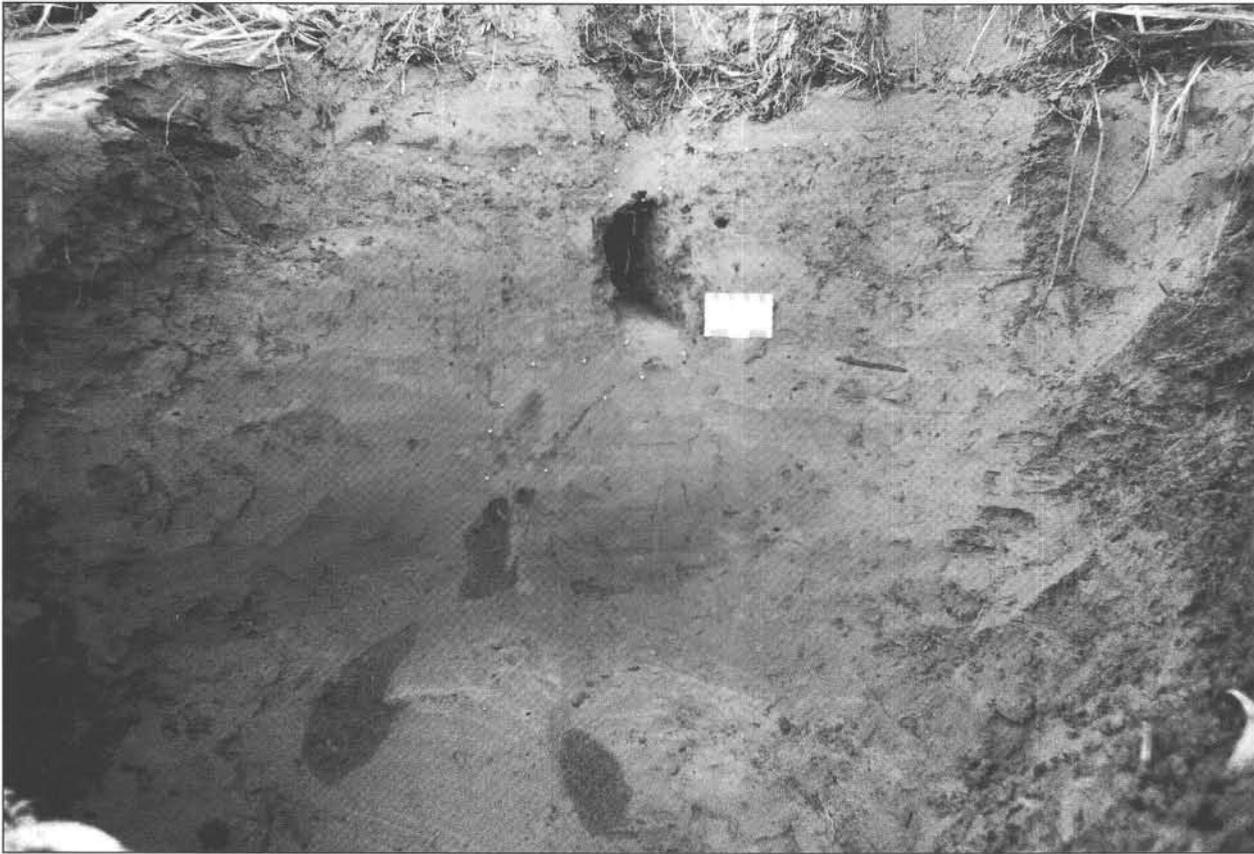
Figure 21. Photo and drawing of discontinuous, coalescing dikes at site 25 on Twentymile River. White pins mark the boundaries of the dike above the junction and the pre-1964 surface above the peat layer. Silt from above replaces the dike sand down to the junction at a depth of about 40 cm below the pre-1964 surface. Small sand pods above the pre-1964 surface left of the dike are probably remnants of a sand boil that emanated from this dike. The large void in the upper part of the dike is from recent tidal erosion.

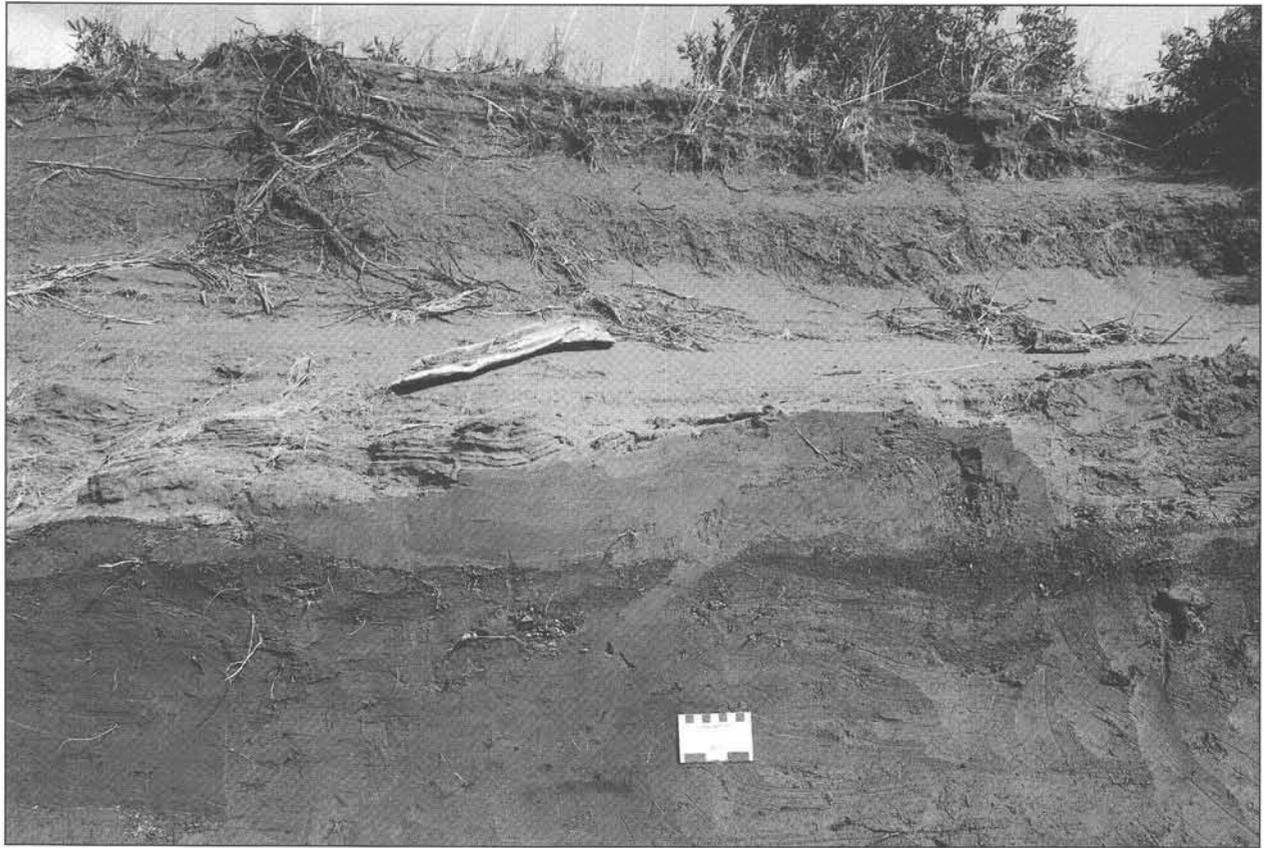
Figure 22. Photo and drawing of silt or very fine sand dike and boil at site 28 on Twentymile River. The dike originates from a thin source bed 80 cm below the pre-1964 surface. Near the base of each dike, the source bed thins to 1.0–1.5 cm for a lateral distance of 20–25 cm. A boil of very fine sand as much as 4 cm thick extends over the pre-1964 surface laterally about 70 cm. In a paleoseismic setting, similar dikes and boils with little textural contrast to surrounding material would be difficult to recognize without a corresponding break in the pre-earthquake surface peat layer.

In the Portage area (Figs. 22, 25 (bottom), 26, 54), the submerged surface and its vegetation (1964 peat) were buried by as much as 2 m of intertidal deposits (Placer River Silt) within a decade of the earthquake (Ovenshine and others, 1976). Lateral migration of stream channels has exposed many breaks in the 1964 peat (Figs. 49, 54, 56, 58) that we infer to be associated with the ground cracks mapped by McCulloch and Bonilla (1970) shortly after the earthquake. In contrast to the Knik and Matanuska Rivers area, ground cracks are sharp-walled and typically narrow (mostly 2 to 7 cm, ranging up to 42 cm), and nearly every ground crack investigated could be traced downward to a clastic dike.

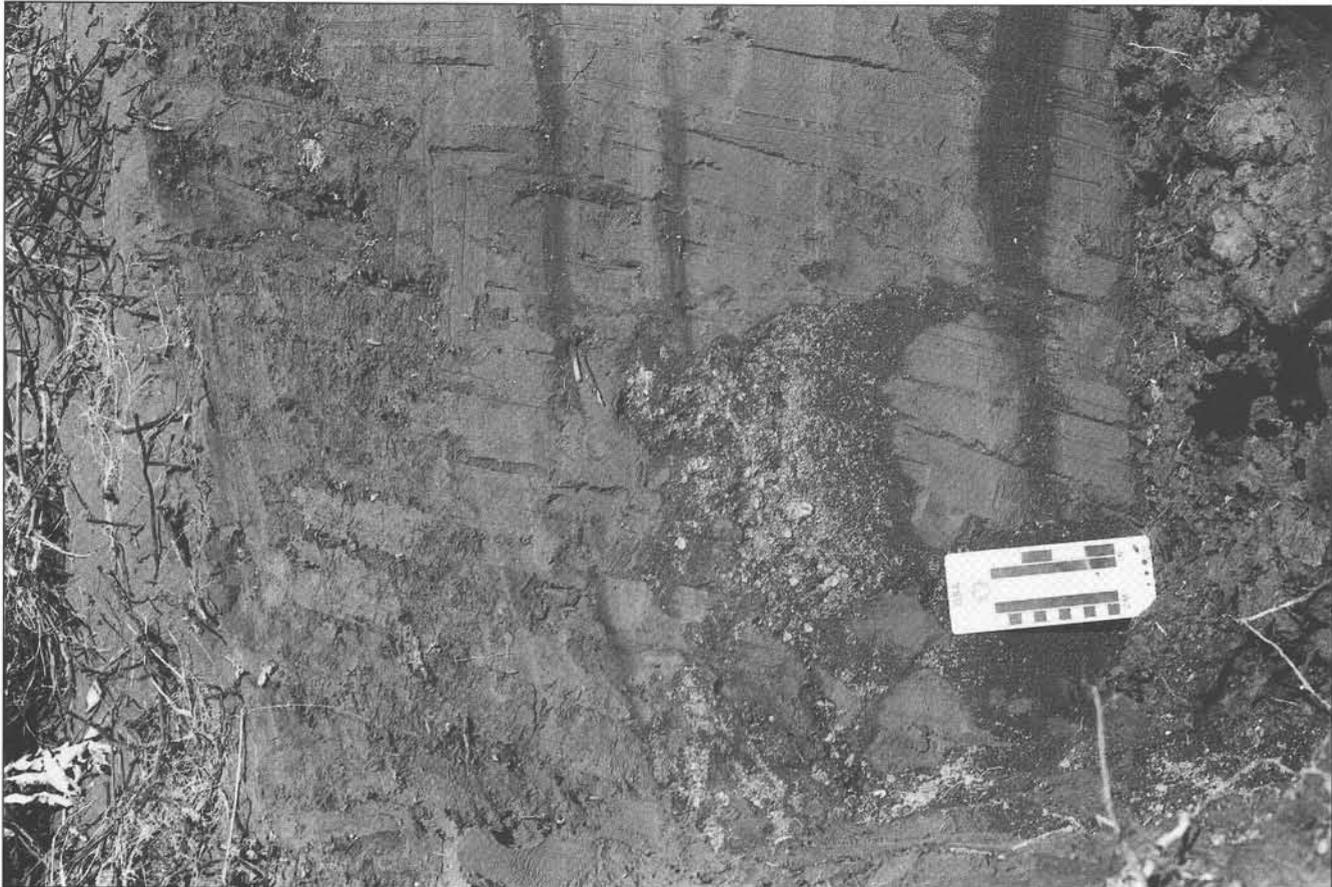
Figure 23. Photo and drawing of dike and silt complex at site 30 on Twentymile River. This intrusion ranges from fine sand to pebbly coarse sand; it was briefly examined earlier as the tide was rising and appeared to be dominantly gravel. An apophysis of this dike penetrates the 1964 surface, but there is no evidence of a sand blow. The analysis of the indicated sample is given in Appendix figure A5.

The dikes and sills contain predominantly dark gray to black medium to coarse sand and gravel as large as coarse pebble size; 27 contain appreciable pebble-size gravel and three are dominantly gravel (that is, median diameter 2.0 mm). Gravel in some of the coarsest dikes is clast supported (Figs. 23, 44), suggesting either that the gravel liquefied or that the matrix was winnowed out. In other dikes, gravel is matrix supported in sand, indicating passive upward movement of gravel in a rapidly moving slurry of liquefied sand. Dikes of gravel or gravelly coarse sand are moderately sorted, typically fine upward, and contain generally less than 5 percent silt.

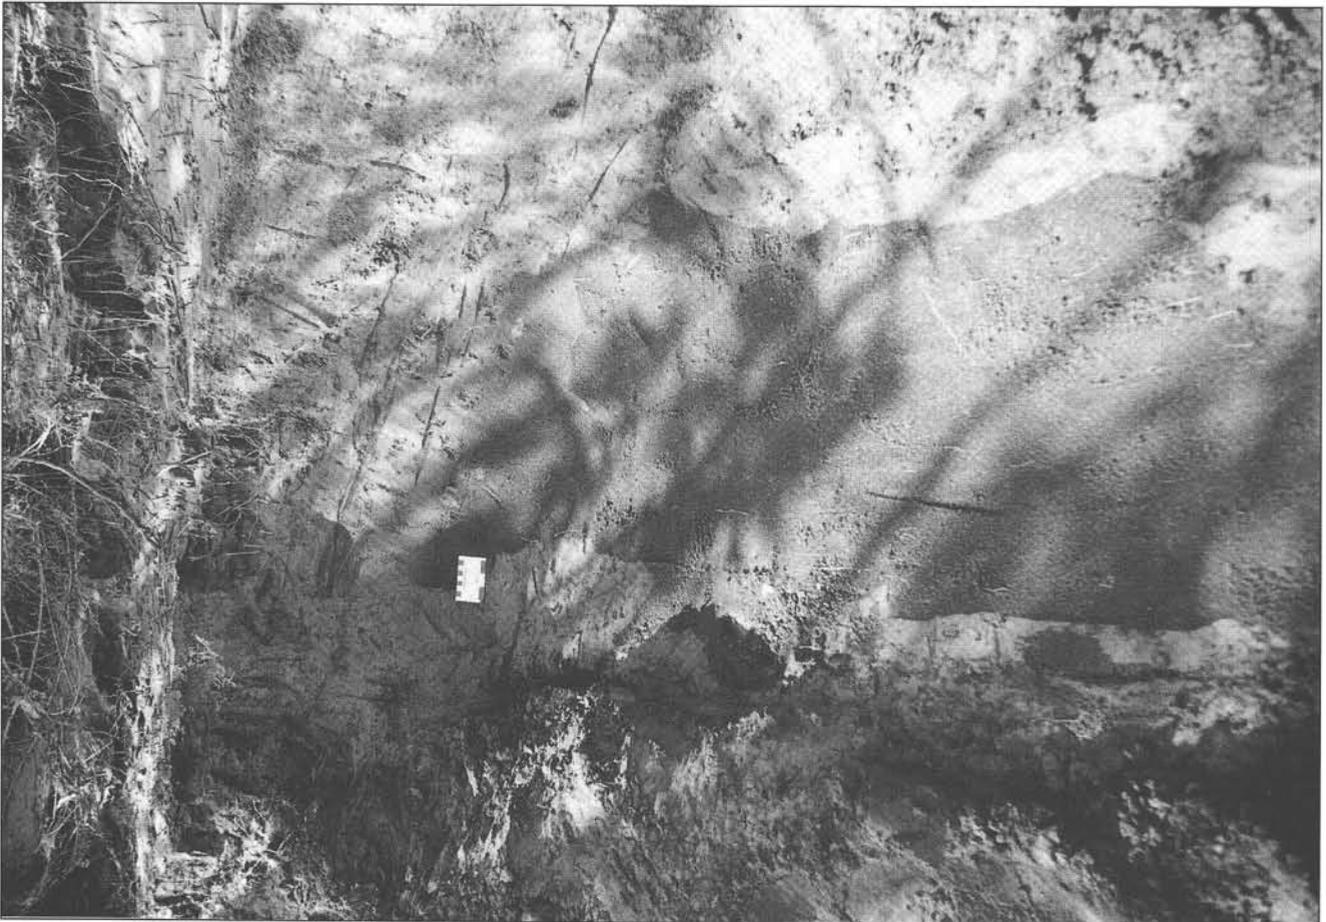
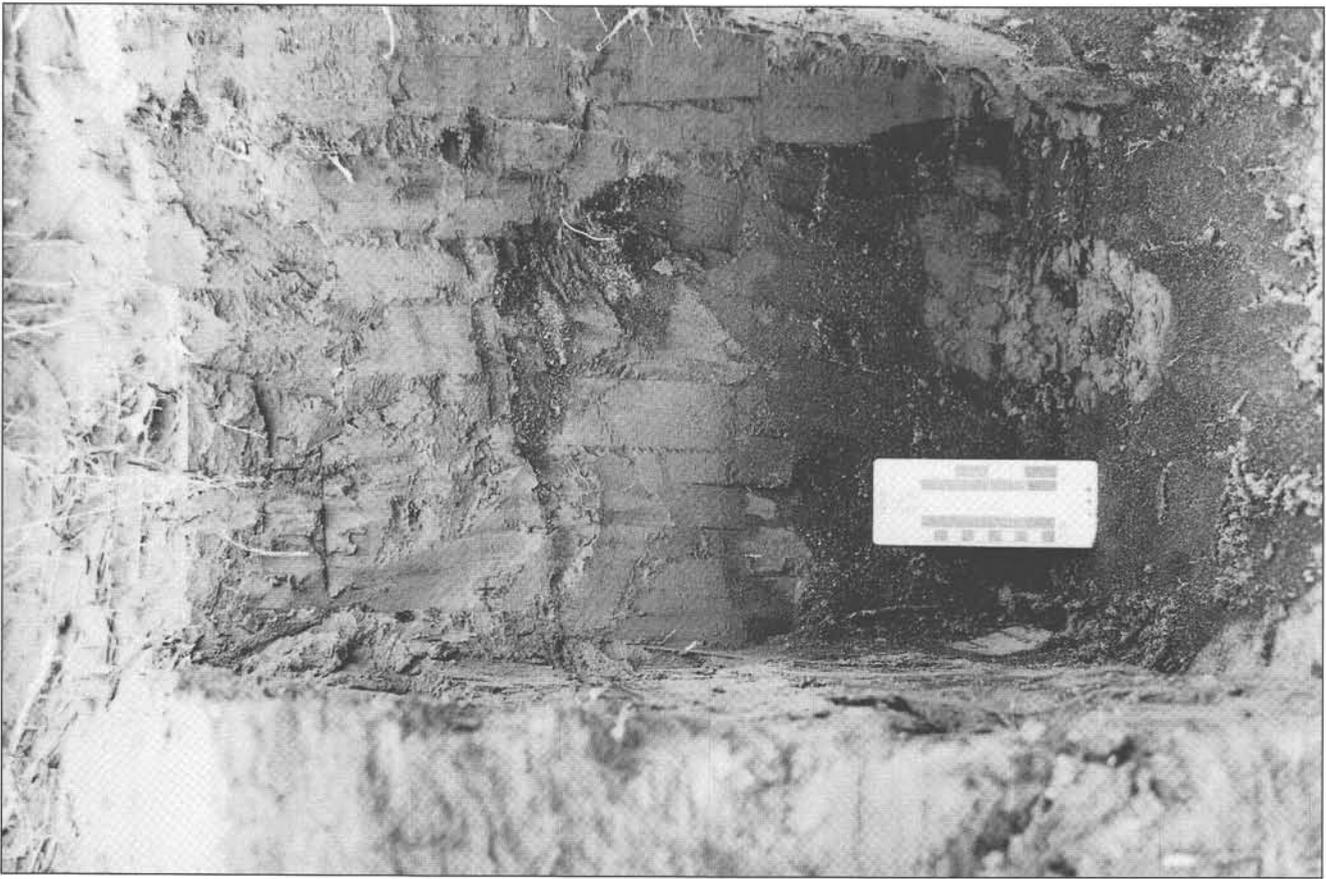
Figure 24. Photos of a large sand dike at site 31 on Twentymile River. The dike (left) is composed of dark-gray, medium to coarse sand with minor pebbles to 1.5 x 2 x 3.5 cm. A relatively resistant pre-1964 peat layer forms a bench near the top of both photos and has a 34-cm-wide break above the dike. Sand similar to the dike sand appears on the pre-1964 surface nearby but cannot be traced to the dike. Sand in the upper portion of the dike is replaced with cross-bedded silt and sand to a depth of 41 cm below the pre-1964 surface. Detail photo (right) shows a silt inclusion suspended in the upper part of the sand dike, probably dislodged from the dike wall.

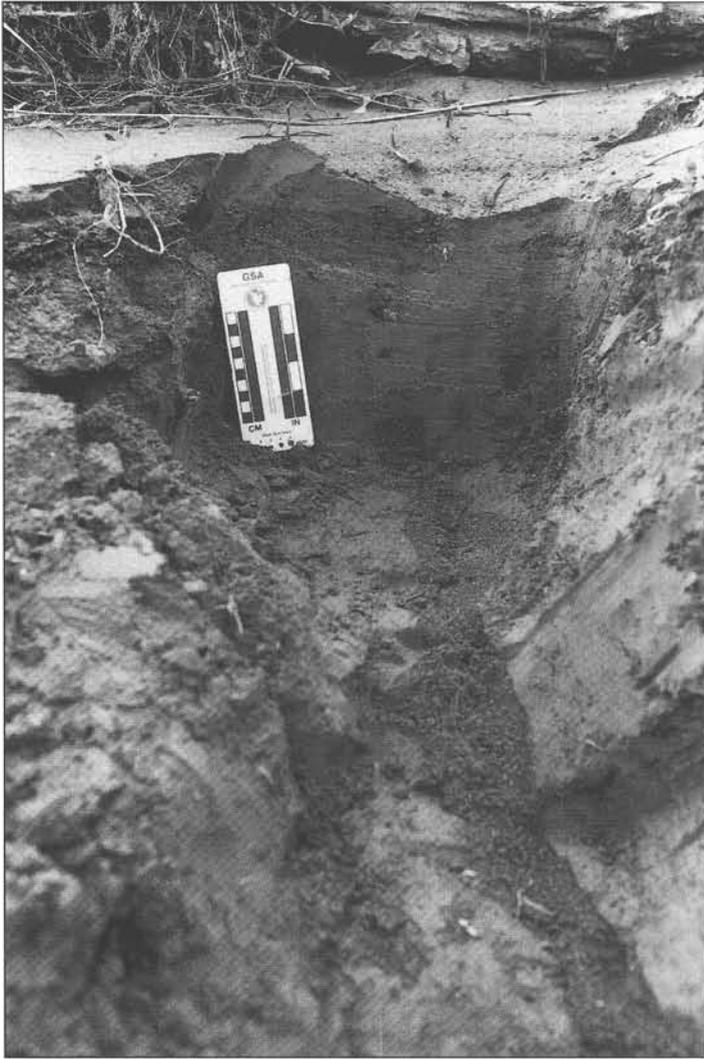
Figure 25. Photo (*left*) of a clastic dike at site 32 on Twentymile River. This dike is truncated and filled with silt to 19 cm below the 1964 surface. No sand extrusion is visible directly above this dike, but there is a sheet of sand 2 m across preserved atop the 1964 surface about a meter to the west of this dike. A large slump obscured the pre-1964 exposure.
