Liquefaction Features from a Subduction Zone Earthquake: Preserved Examples from the 1964 Alaska Earthquake

by Timothy J. Walsh,
Rodney A. Combellick,
and Gerald L. Black

Report of Investigations 32
December 1995

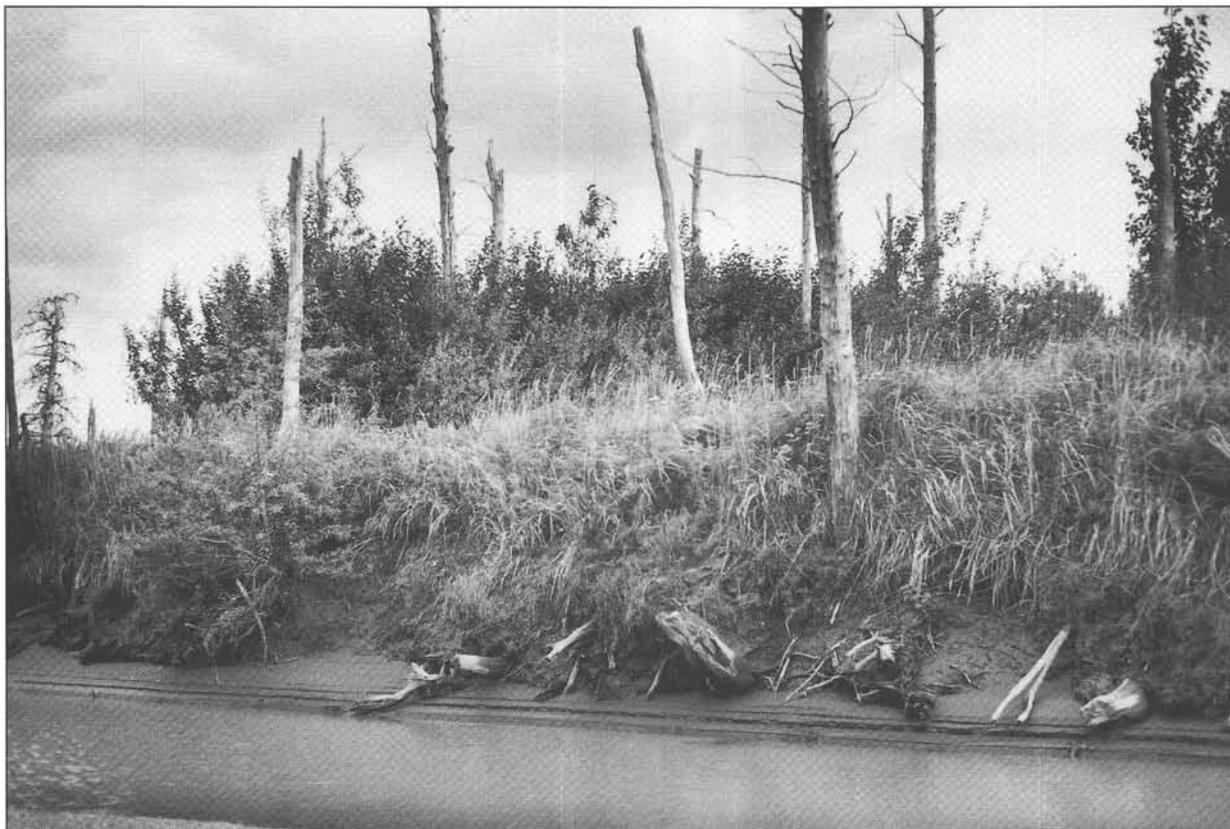
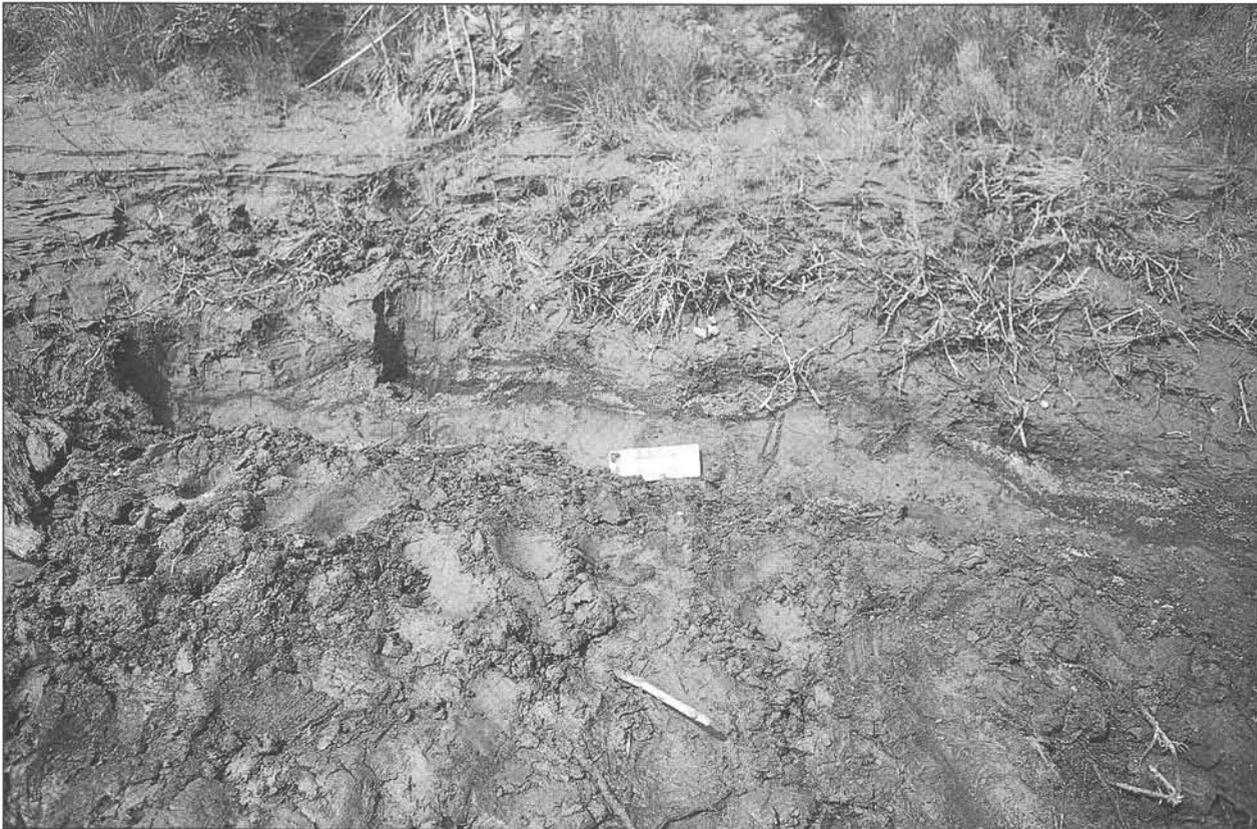
A

Figure 26. Photos of a 6.8-m-long sill of medium to coarse sand at site 33 on Portage Creek. The west end of this sill dipped to beneath water level; black sand from beneath the 1964 surface was actively eroding from the bank for another 28 m and may have been a continuation of this sill.

In the Portage area (Figs. 22, 25 (bottom), 26, 54), the submerged surface and its vegetation (1964 peat) were buried by as much as 2 m of intertidal deposits (Placer River Silt) within a decade of the earthquake (Ovenshine and others, 1976). Lateral migration of stream channels has exposed many breaks in the 1964 peat (Figs. 49, 54, 56, 58) that we infer to be associated with the ground cracks mapped by McCulloch and Bonilla (1970) shortly after the earthquake. In contrast to the Knik and Matanuska Rivers area, ground cracks are sharp-walled and typically narrow (mostly 2 to 7 cm, ranging up to 42 cm), and nearly every ground crack investigated could be traced downward to a clastic dike.

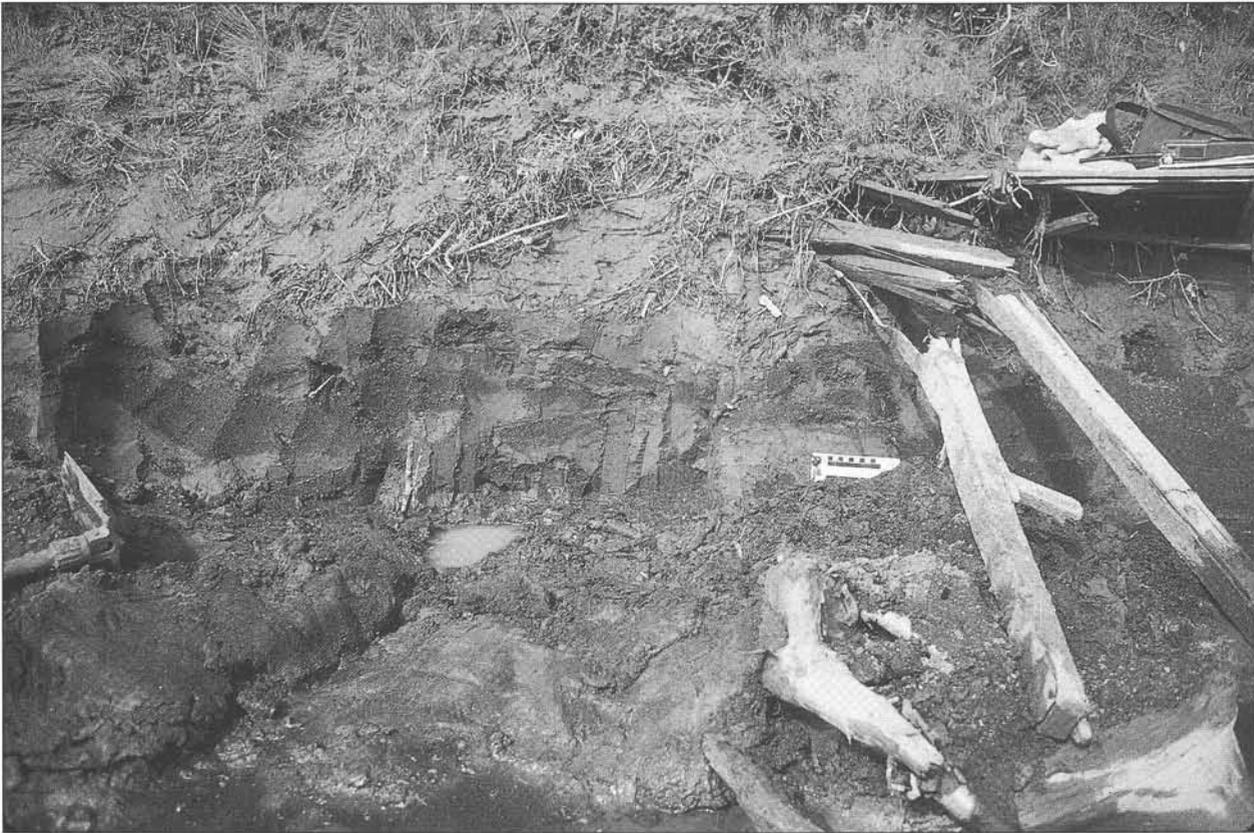
C

Figure 26. (continued) Photos of a 6.8-m-long sill of medium to coarse sand at site 33 on Portage Creek. The 1964 surface is marked by the pallet and hewn wood and other debris. Near the eastern end of this exposure (shown in the lower photo) the sill is underlain by a 25-cm-wide dike that can only be traced down to water level.

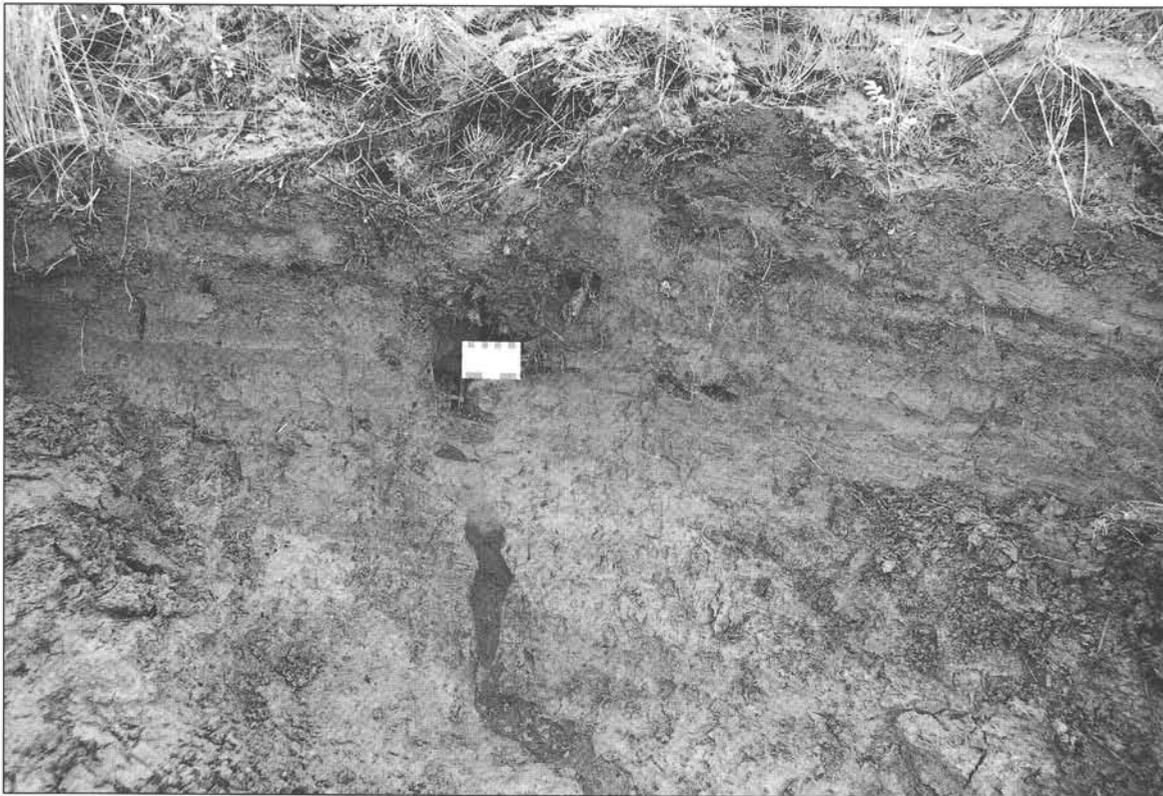
Figure 27. Photo of a dike at **site 34** on Portage Creek. It is filled with medium sand and terminates in a sand blow 128 cm in diameter and 1.5–2.5 cm thick. The upper 10 cm of the dike is an open fracture (partially obscured by scale). Beneath the scale is 12 cm of wavy- to lenticular-bedded sand and silt resting on 11 cm of silt. Between the 1964 surface and the extruded sand is a 2–3-cm layer of silt containing vertically oriented rootlets.

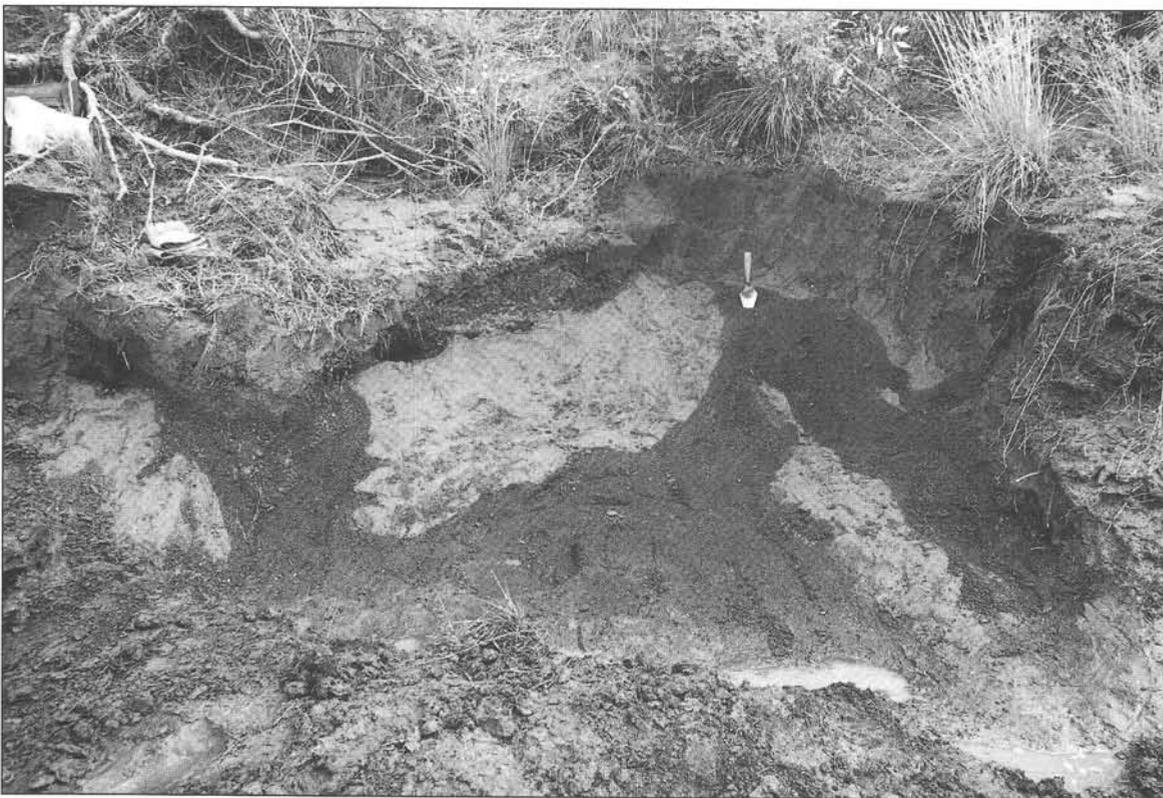
Figure 28. Photo of complex sand intrusion at **site 351** on Portage Creek. The dikes widen downward to as much as 1.5 m, probably near the source bed. The source bed appears to be slightly below low-tide level, about 1.5 m below the pre-1964 surface. The intrusion consists of medium to coarse sand with minor pebbles to 1.7 x 2.3 x 3.0 cm. A 1-cm-wide dike intruded the pre-1964 peat layer and erupted minor sand on the pre-1964 surface. Two wider dikes are associated with breaks in the pre-1964 peat but are replaced with silt to depths of 22 and 46 cm below the pre-1964 surface.

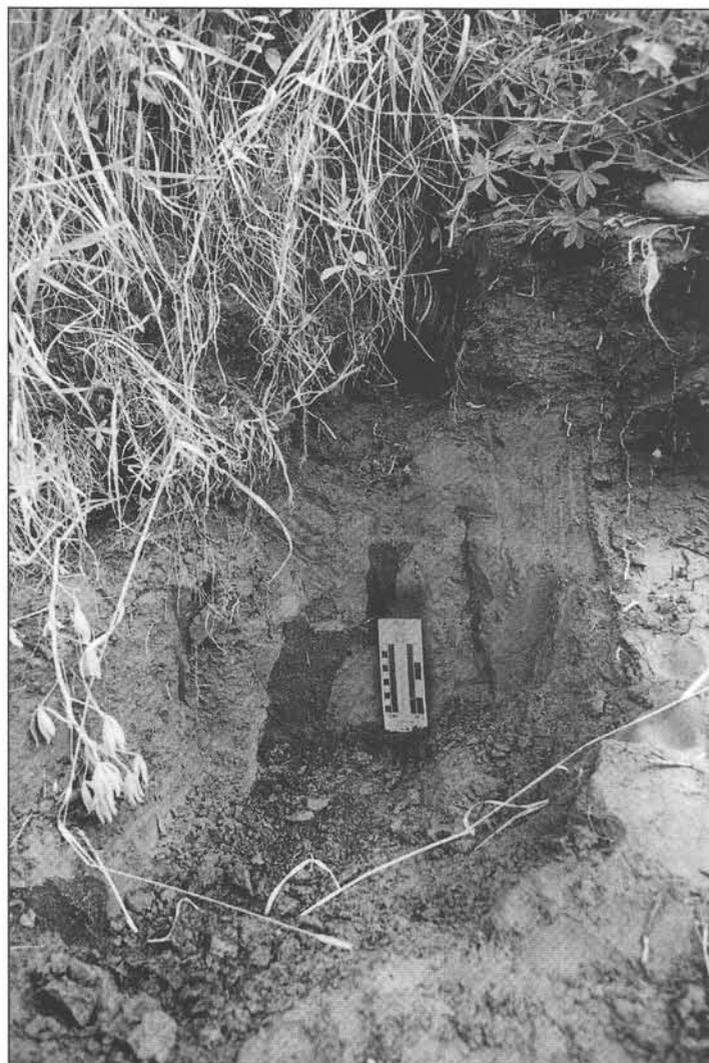
Figure 29. (above) Photo of a sand dike and boil at site 35w/36 on Portage Creek. The dike is continuous through a 7-cm break in the pre-1964 peat layer, which appears here as two dark, thin seams below the sand boil. The peat layer is offset about 2 cm by the dike. Dike margins are locally oxidized to bright reddish brown. Both the dike and sand boil are composed of clean, fine to medium sand. The sand boil, maximum 4 cm thick, overlies 2–3 cm of silt lying on top of the pre-1964 peat layer and extends 33 cm to the left. To the right, the sand boil merges with another sand boil emanating from a dike 50 cm away.

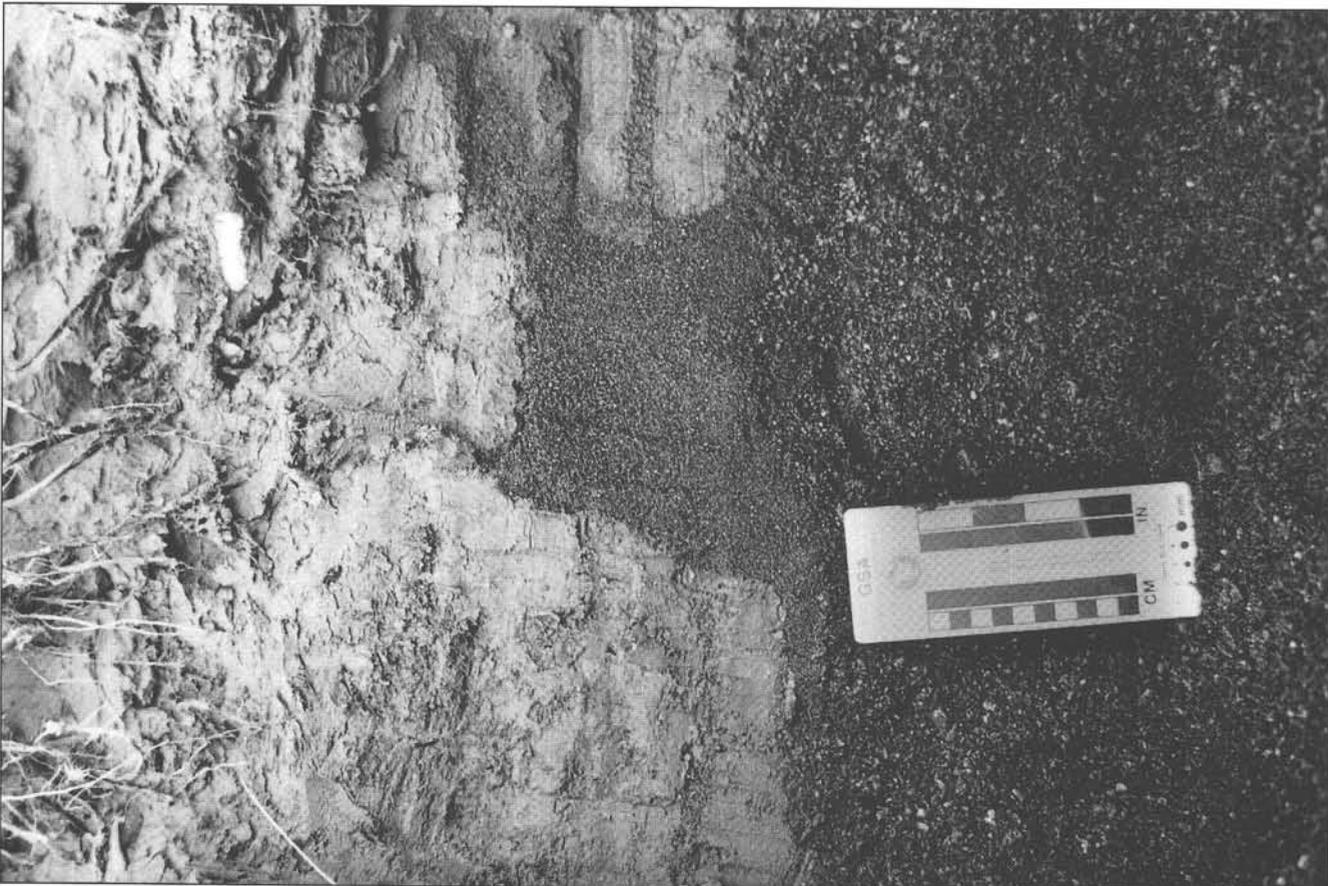
Figure 31. Photo and drawing of a clastic dike at site 37a on Placer River. The top of the source bed is only 42 cm below the 1964 surface. Note the sill of medium sand immediately above the scale and the abundance of centimeter-size gravel.

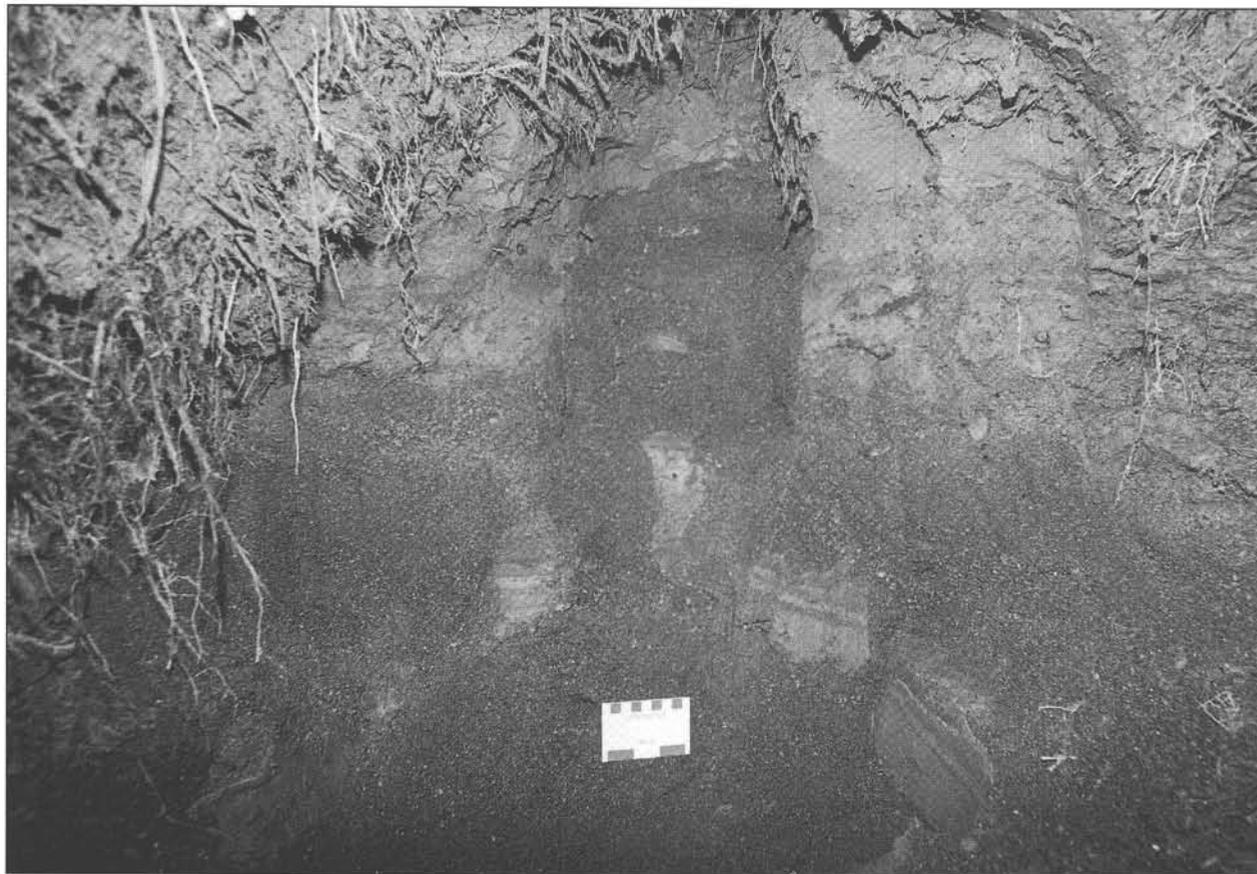
Figure 32. Photo and drawing of a clastic dike with inclusions of silt at site 37b on Placer River. The laminated silt in the lower right and lower left corners are in place. The ripped-up blocks of silt in the center indicate relative displacements that are larger in the center of the dike than on its margins, suggesting that during emplacement, the dike had enough shear strength to undergo frictional resistance at the margins. Also note that the blocks are not rotated, which suggests laminar flow. Analysis of the indicated sample is given in Appendix figure A6.

A few dikes contain inclusions. Figure 32 shows a dike at site 37b with inclusions of the silt that is interbedded with the top of the source bed. This dike carried blocks of laminated silt that capped the liquefied layer upward into the crack in the 1964 soil. Laminae in the silt, which can be correlated from one block to another, remained horizontal, showing that there was no rotation about axes in the horizontal plane and suggesting that this dike intruded the soil by laminar flow. Figure 33 shows a dike of predominantly medium to coarse sand at site 39 that carried an isolated metamorphic rock pebble (3.8 cm x 4.8 cm x 5.9 cm) at least 50 cm above its source bed.

Spring tides in this area presently reach the 1964 surface. Because this area subsided about 2 m, many of these source beds must have been significantly above tidewater at the time of the earthquake. Sites 37a and 37b (Figs. 31, 32), in particular, are located on the bank of a small low-relief island in the inactive flood plain of Placer River; the top of the source bed for liquefaction is 42 cm below the 1964 surface and initially must have been above the water table.

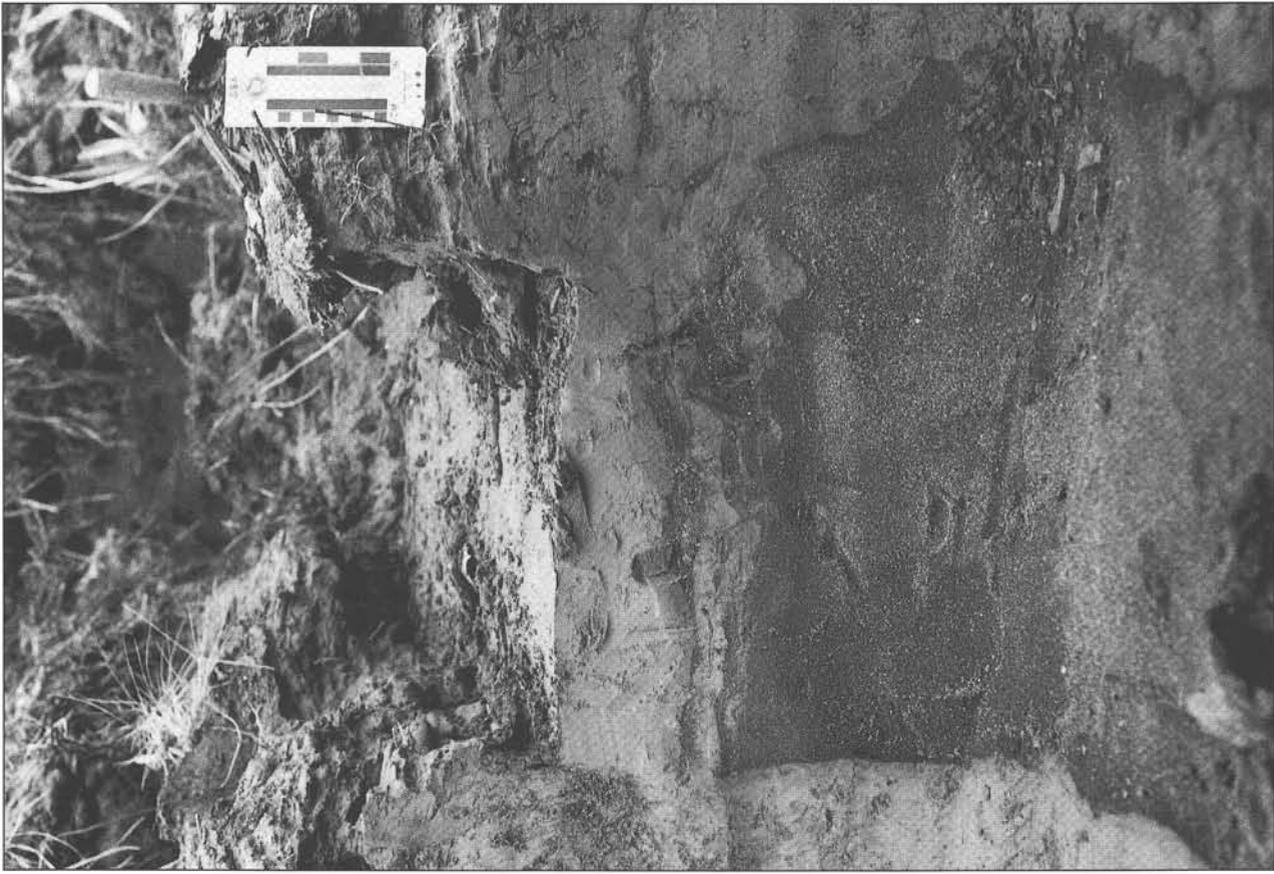
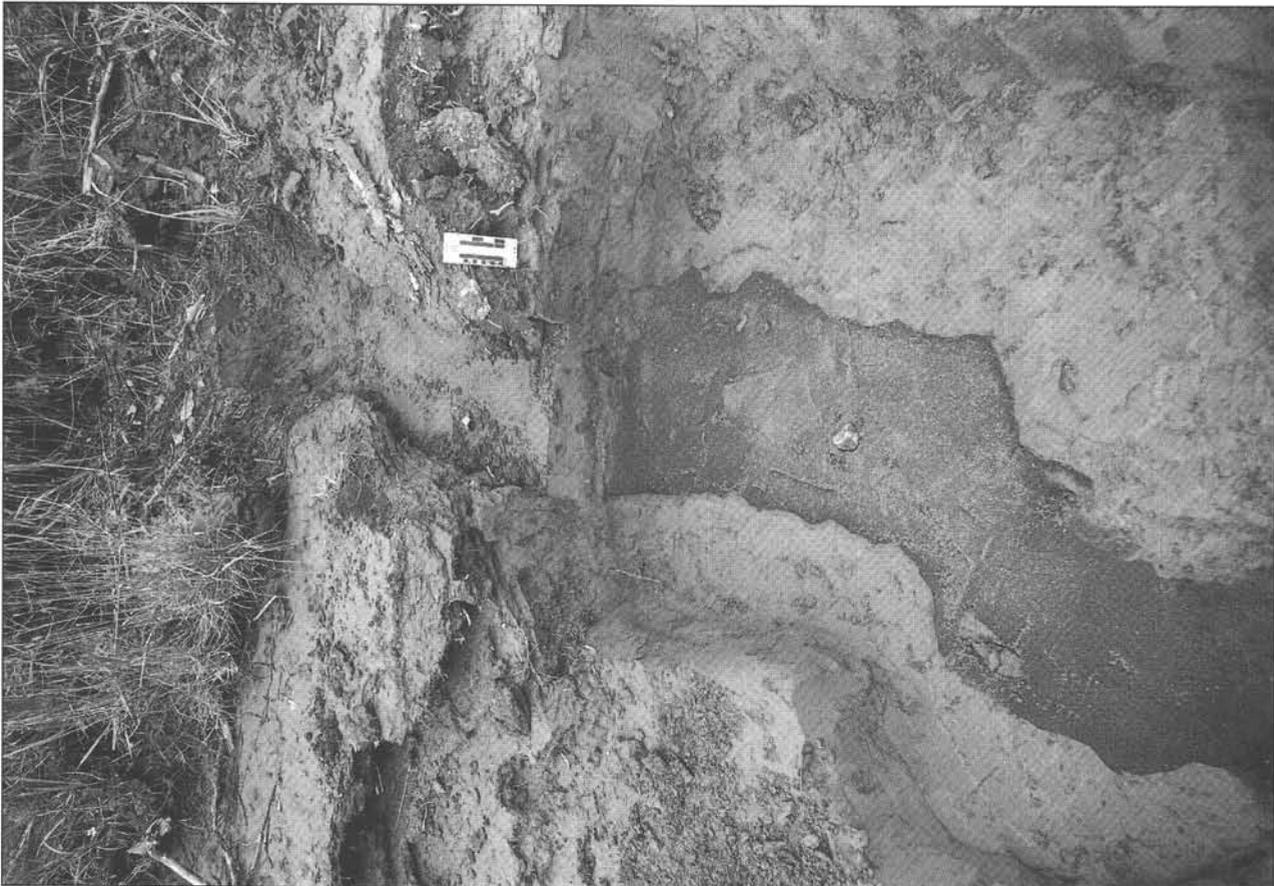
Figure 33. Photos of a large dike of medium to coarse sand at site 39. Maximum width is 52 cm. The host material is mottled gray silt. The pre-1964 peat layer forms a resistant bench and has a 40-cm-wide break in line with the dike. A single subrounded pebble, 3.8 x 4.8 x 5.9 cm, is suspended in the sand near the center of the dike, about 50 cm below the pre-1964 surface. Near the left margin of the dike (lower left center) is a silt inclusion suspended in the sand dike, probably dislodged from the dike wall. The sand-source layer is 90 cm below the 1964 surface and is 6-11 cm thick. The upper portion of the dike is replaced with silt and reworked sand to a depth of 38 cm below the pre-1964 surface. The detail photo (right) shows reworked and crudely bedded sand and silt in this upper portion, where replacement silt has been partially removed by erosion in the break in peat. No erupted sand remains on the pre-1964 surface at this location.

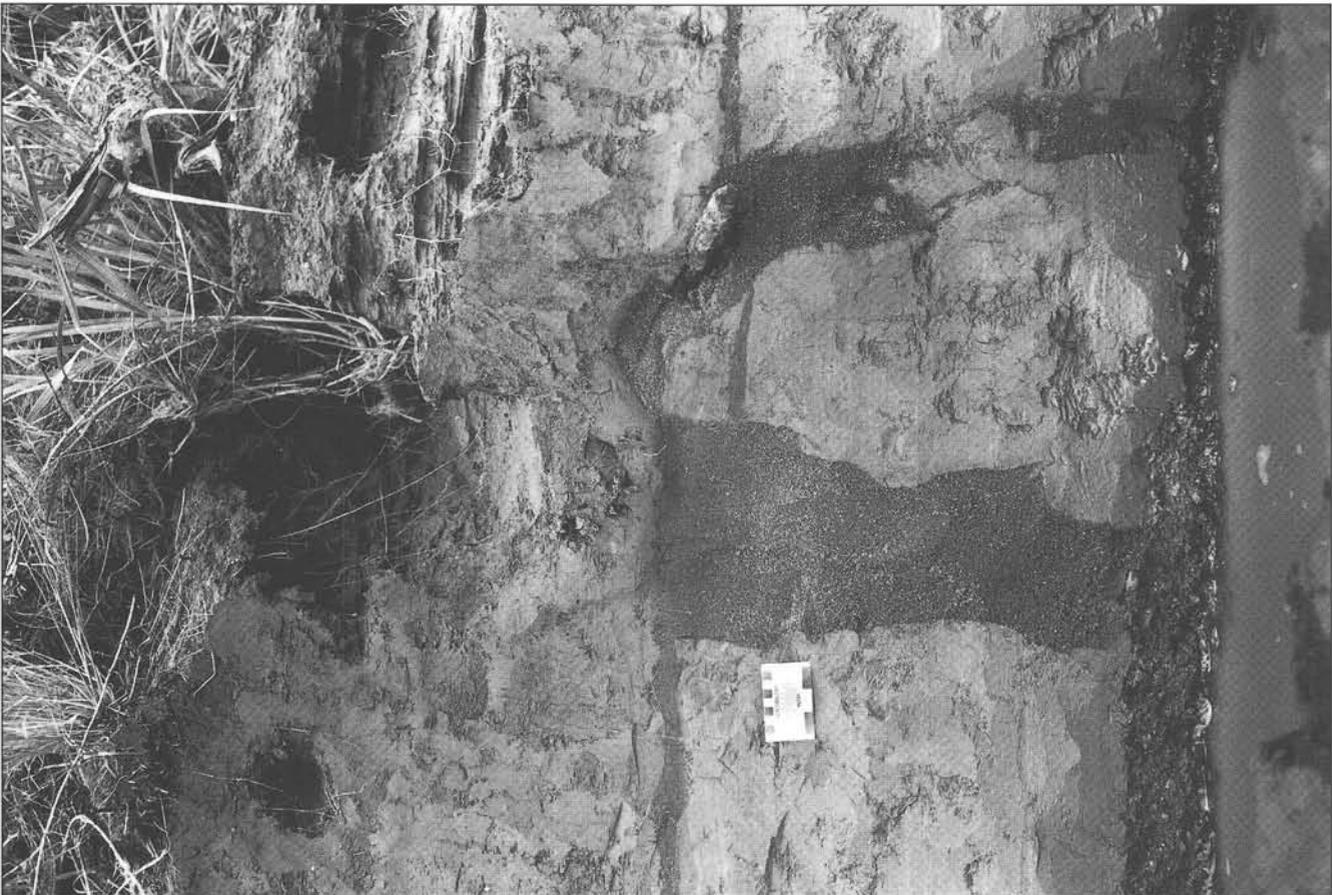
Figure 34. Photo and drawing of clastic dike at site 40 on Twentymile River. It shows a truncated top infilled with silt and some of the complex branching that was common in the larger dikes. Compare grain-size analyses in Appendix figure A8.

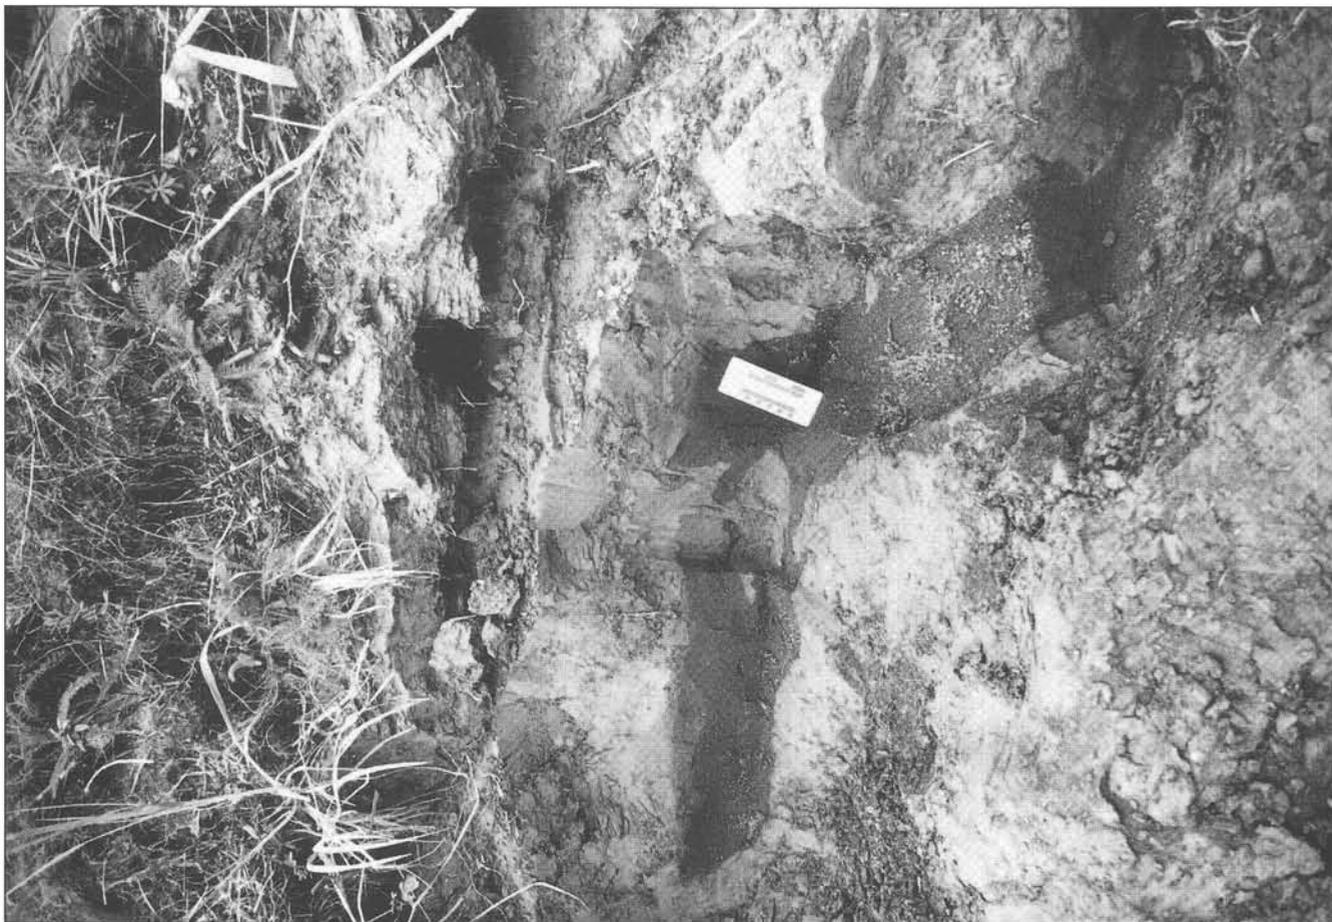
Figure 36. Photo of a complex dike at site 43 on Twentymile River. This dike has two different textures separated by a sharp (but faint in this photo) contact. This suggests either two dikes, one intruding the other, or infiltration of silt into the margins of the dike during the waning stages of emplacement.

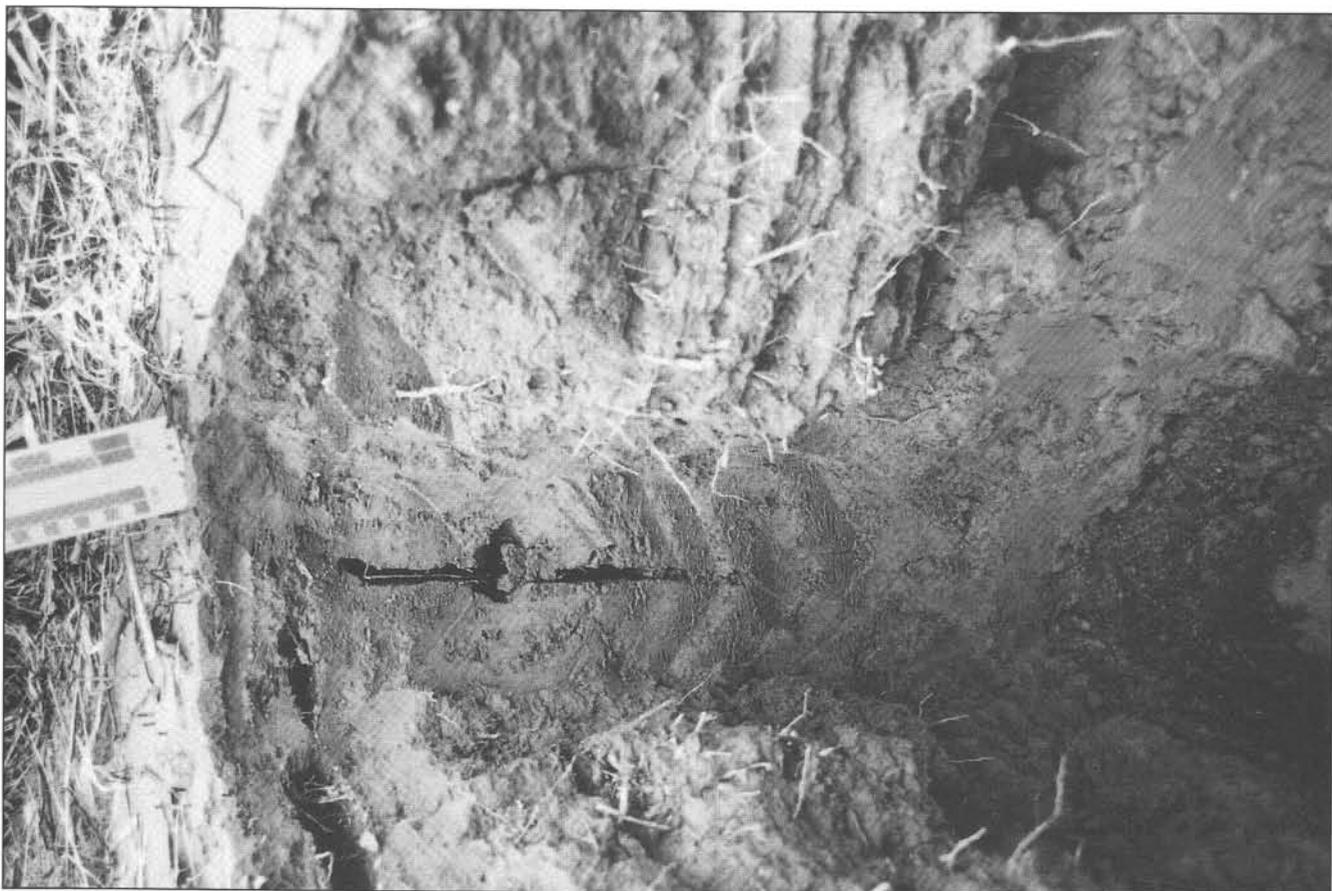
Figure 35. Photo of a narrow (1 cm) dike at site 41 on Twentymile River. This dike appears to have left a sand blow, but the dike could not be traced all the way to the sand resting on the 1964 surface.

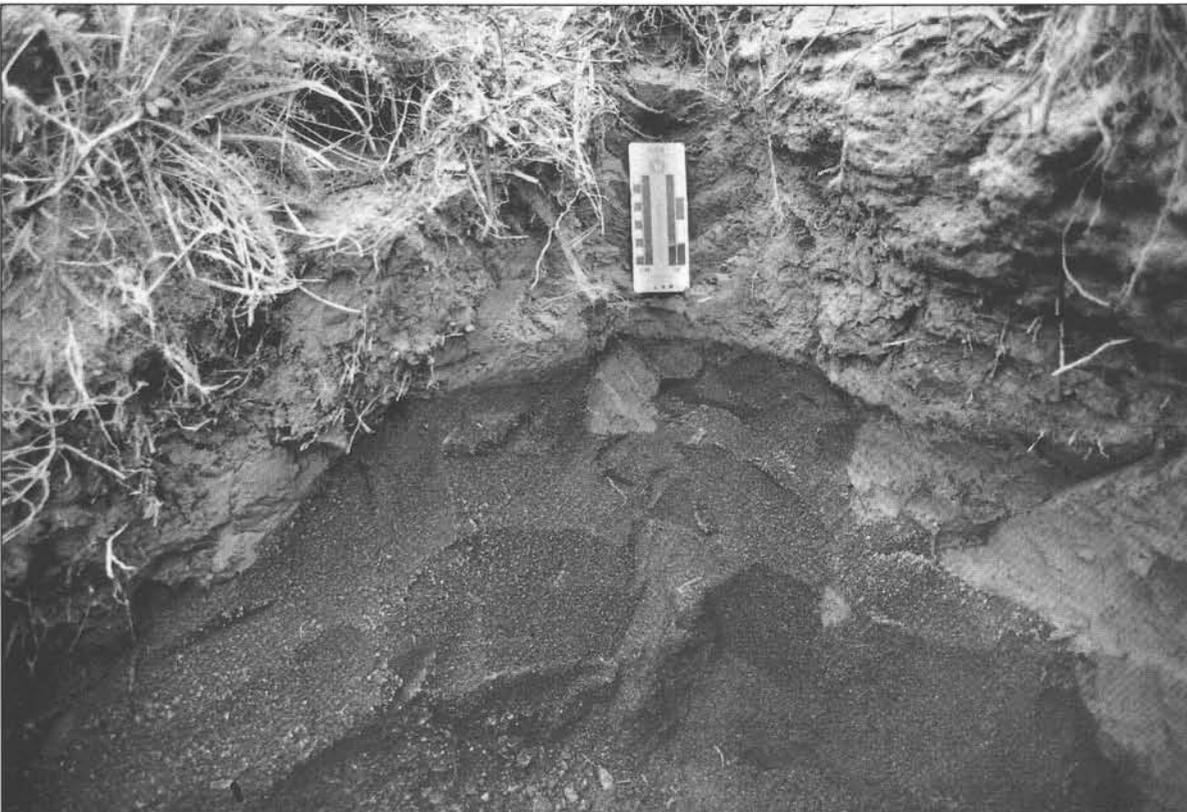
Figure 37. (left) Photo of a clastic dike at site 42 along Twentymile River. The dike at the bottom of this photo is 1.5 m wide.

(below) A closeup of the top of the dike, which has narrowed to 52 cm.

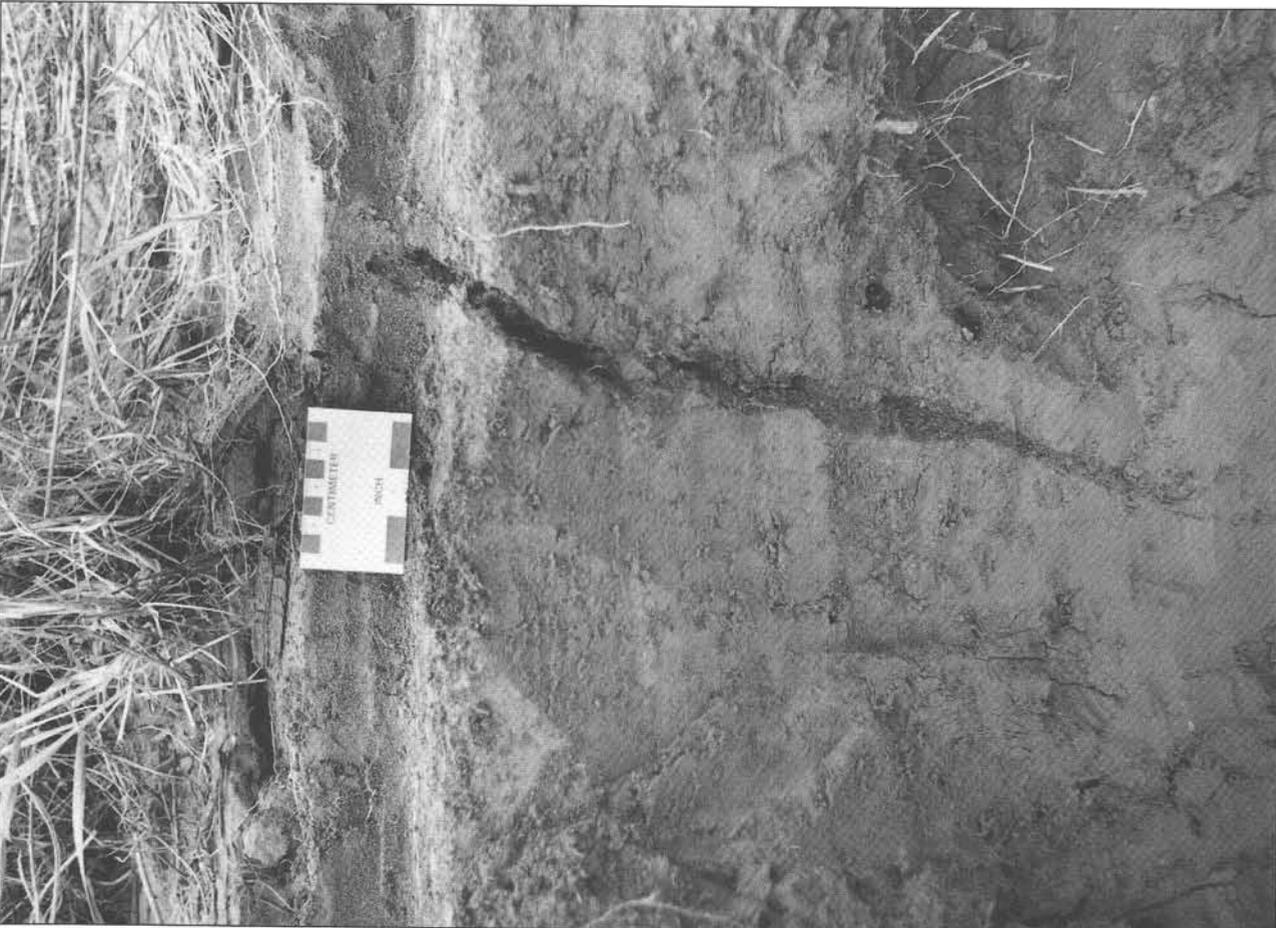
Figure 38. Photo of a thin (maximum 2 cm) sand dike at site 45 on Twentymile River. The scale rests on the pre-1964 surface, which is at the top of a thin, indistinct peaty silt layer. The dike tapers downward and disappears 48 cm below the 1964 surface. This dike may be either a tapering apophysis of a larger dike behind the bank or a surface crack that was filled from above. A 5-cm-thick sand layer overlying the pre-1964 peat (behind the scale) may be the source of the dike fill. The host material is bedded silt with abundant roots.

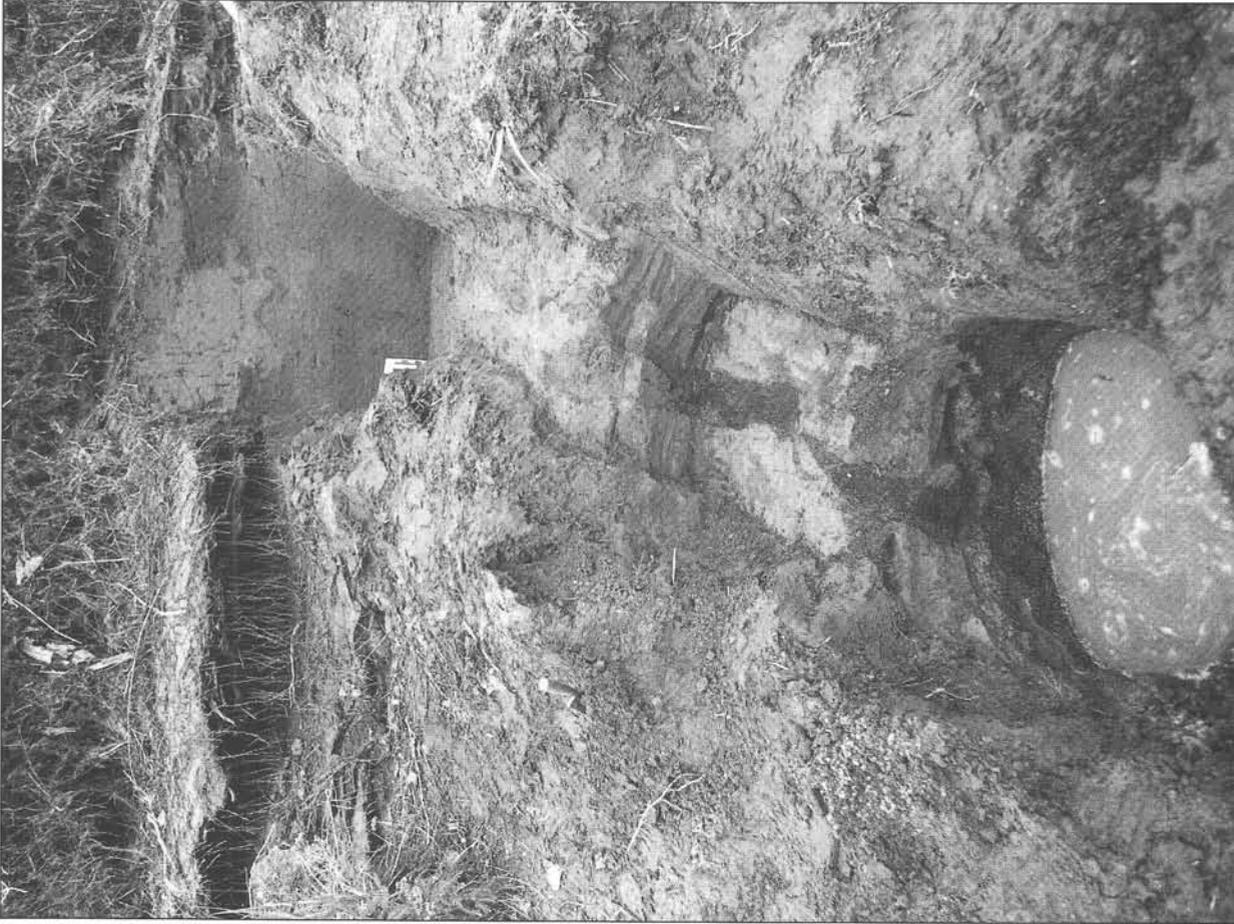
Figure 39. Photo of a large complex dike at site 46 on Placer River. The vertical distance from source bed to the break in the 1964 peat surface is 1.8 m. Maximum dike thickness is 23 cm; the break in well-developed 1964 peat surface is 39 cm wide. The base of peat surface is offset 20 cm across dike (down to the left of the photo). Three distinct phases of injection are represented—very fine sand, medium sand, and granule-bearing coarse sand. The upper part of the source bed is visible just above the pool of water at the base of the photograph. It consists of pebbly to granule-bearing coarse sand. The upper 10–20 cm of the dike has been replaced by Placer River Silt.

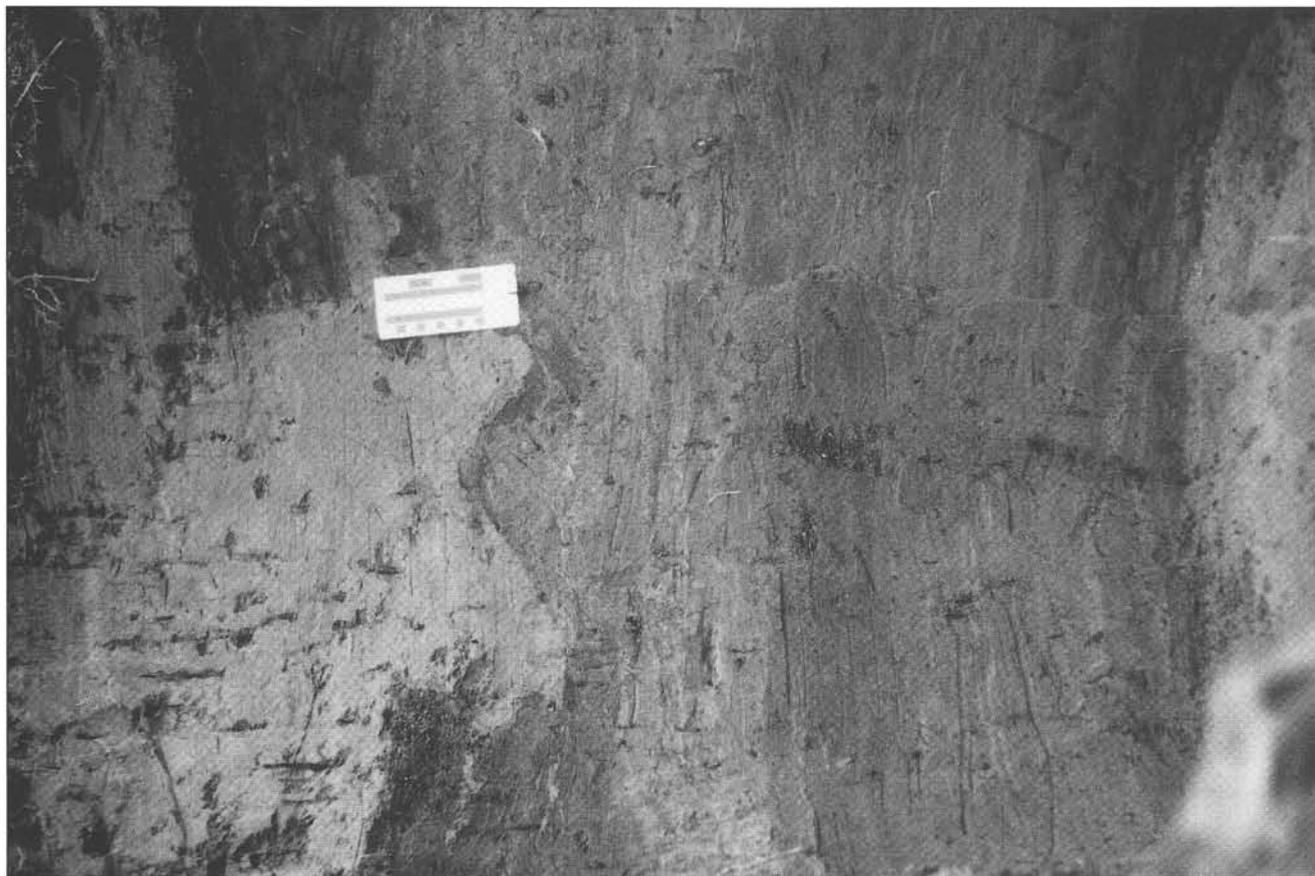
Figure 40. Photo and drawing showing details of the top of the dike at site 46 on Placer River. The 1964 peat surface (represented by the dark upper 4 cm of the layer above the scale) is well developed. The remainder of the dark layer is *in-situ* fine sand. The break in 1964 surface is 39 cm wide; the 1964 surface is offset 20 cm (down to the left of photograph). A dike on the left is composed of thin discontinuous stringers of coarse sand (see line drawing, right). The upper 10–20 cm of dike is replaced by Placer River Silt. There is a 25–30 cm zone of reworked material (interbedded fine sand and silt) below the replacement Placer River Silt.

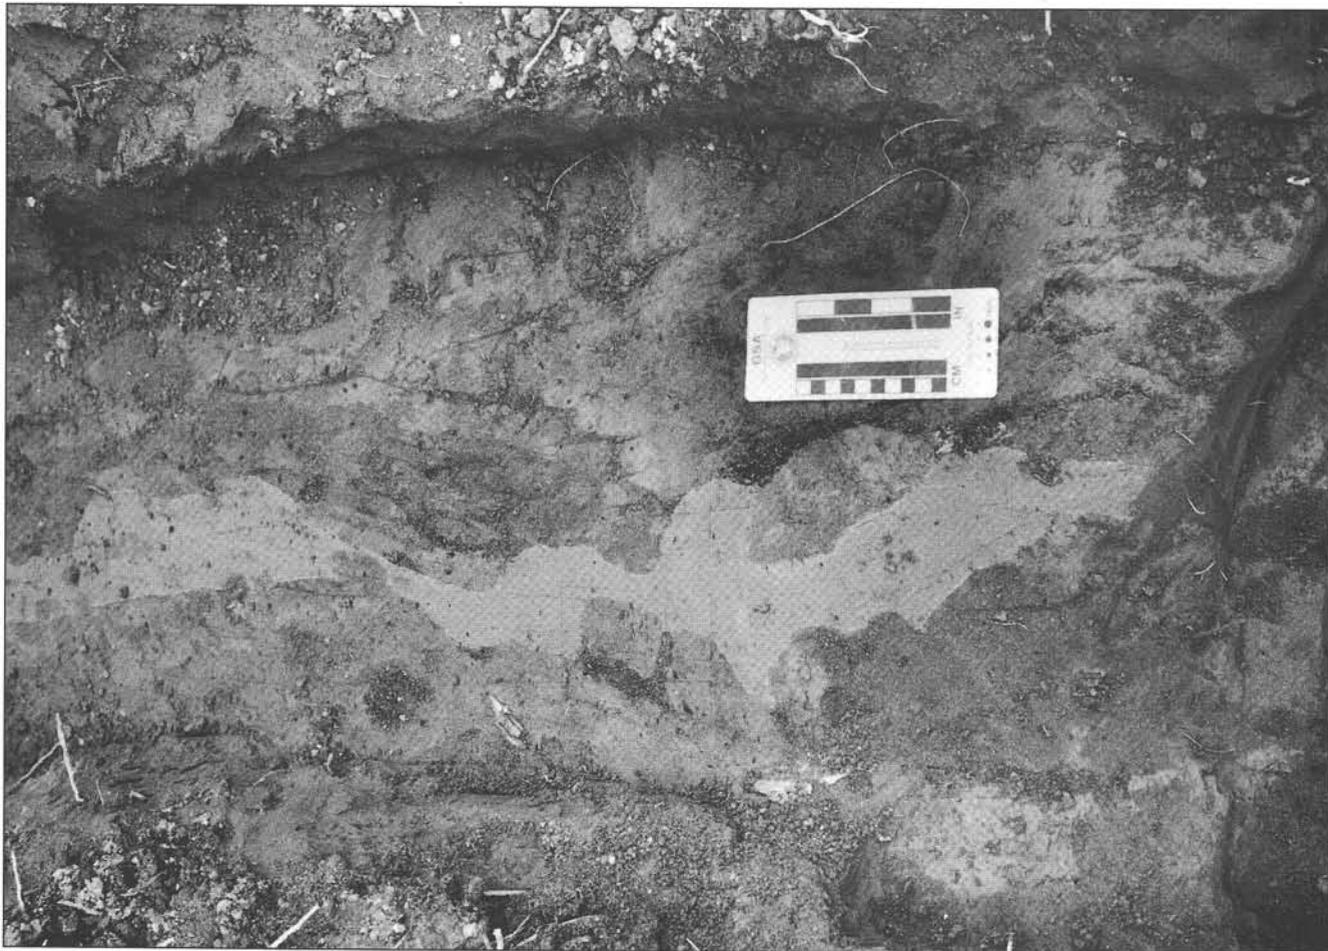
Figure 41. Photo and drawing showing details of three phases of injection at the approximate midpoint of site 46. The first phase is represented by stringers of granule-bearing to coarse sand at the dike margins. Second phase is represented by medium sand. The final phase of injection, represented by very fine sand, cuts across all other contacts. A thin (1 mm) silt selvage, common in many dikes in this area, is also present at the margins of this final phase.
