Liquefaction Features from a Subduction Zone Earthquake: Preserved Examples from the 1964 Alaska Earthquake

by Timothy J. Walsh,
Rodney A. Combellick,
and Gerald L. Black

Report of Investigations 32
December 1995

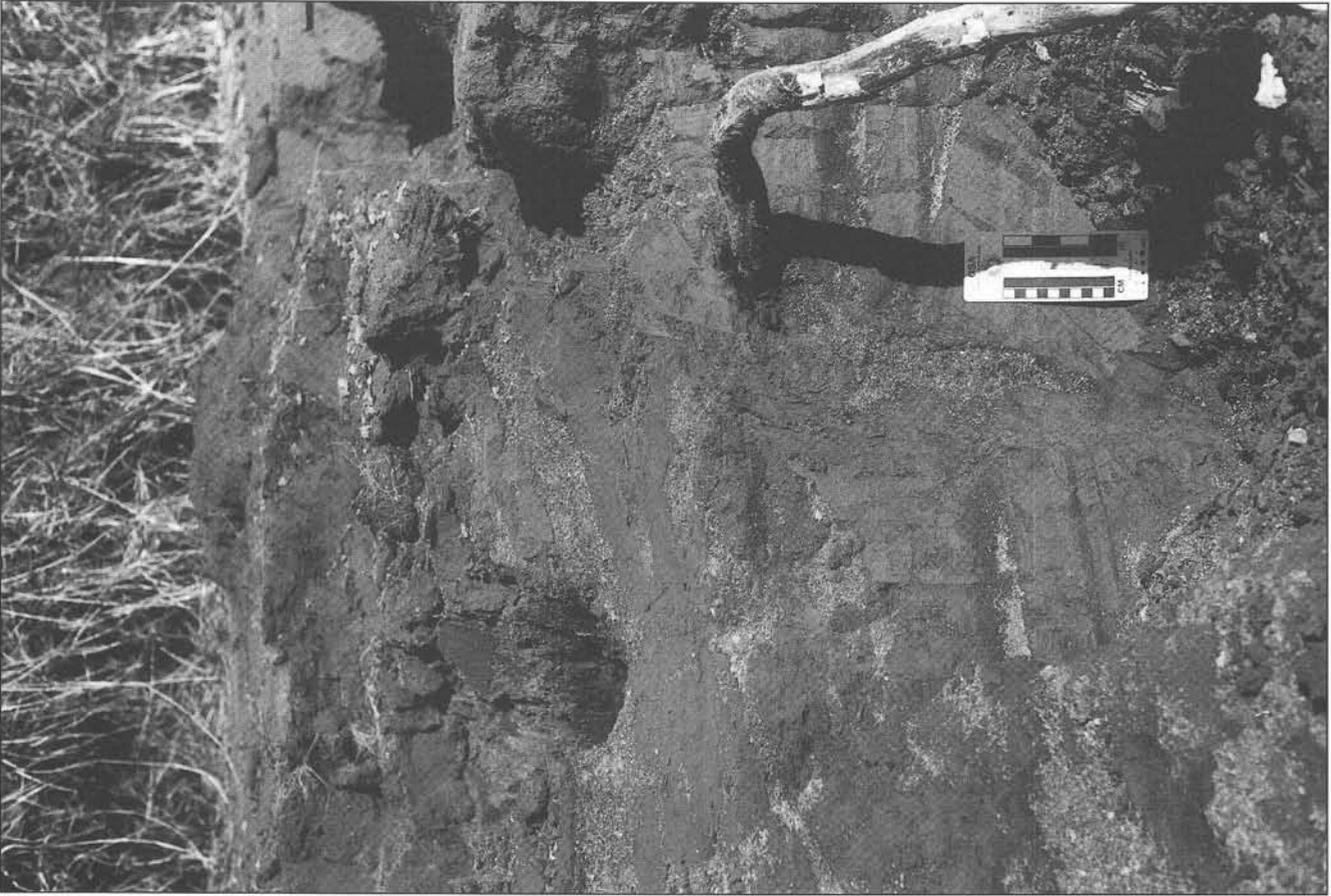
Figure 43. Photo of a medium to coarse sand dike at site 55 on Portage Creek. The dike ranges in thickness from 7 to 13 cm.

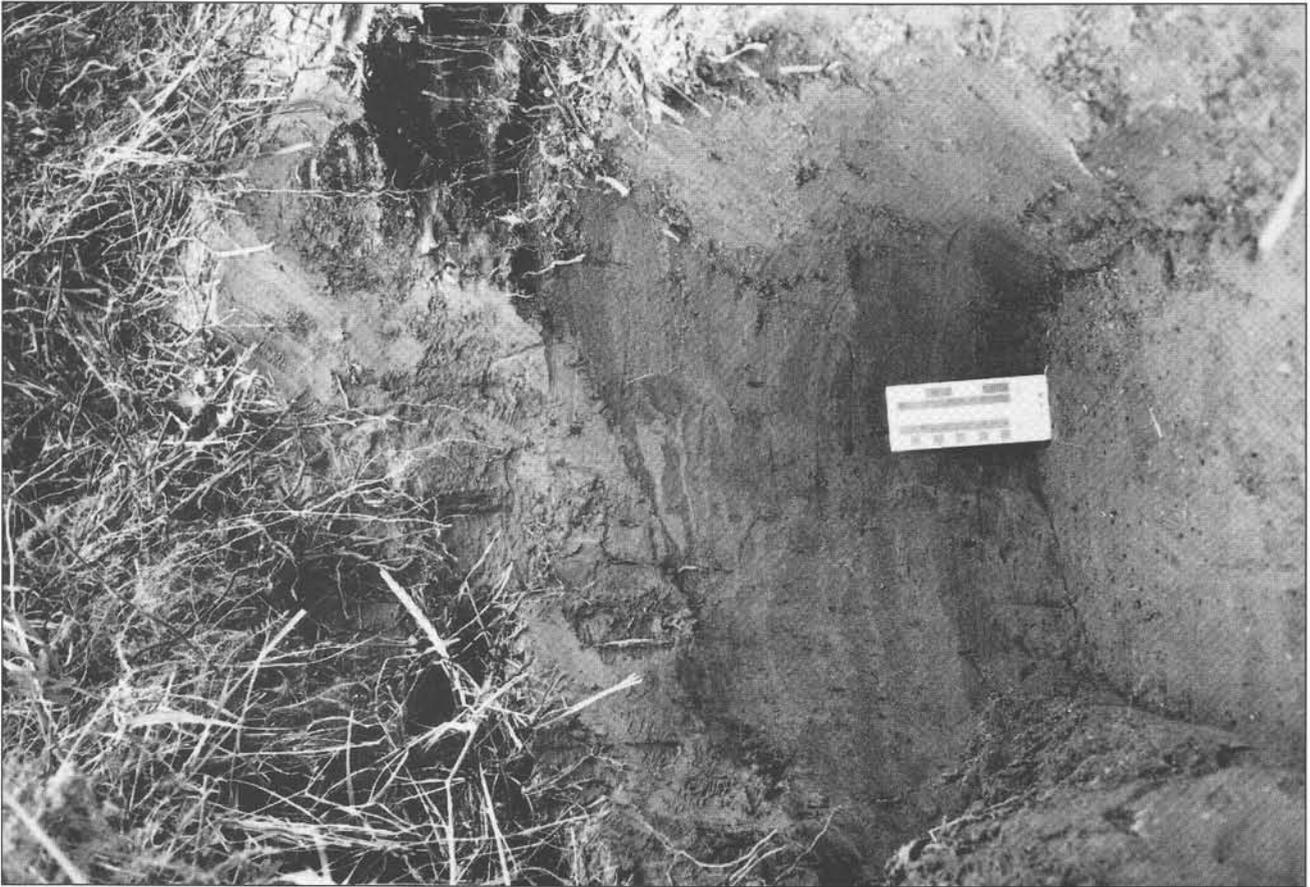
Figure 45. Photo showing detail of the top of the dike at site 49. The dike fines upward over a vertical distance of 22 cm from granule-bearing sand (base of branch in Figure 44), through medium sand, fine sand, and very fine sand. At the top of the dike is a cusp-shaped reworked zone consisting of 50 cm of interbedded fine sand and silt. There is a break in the 1964 peat surface, but there is no obvious extruded sand.

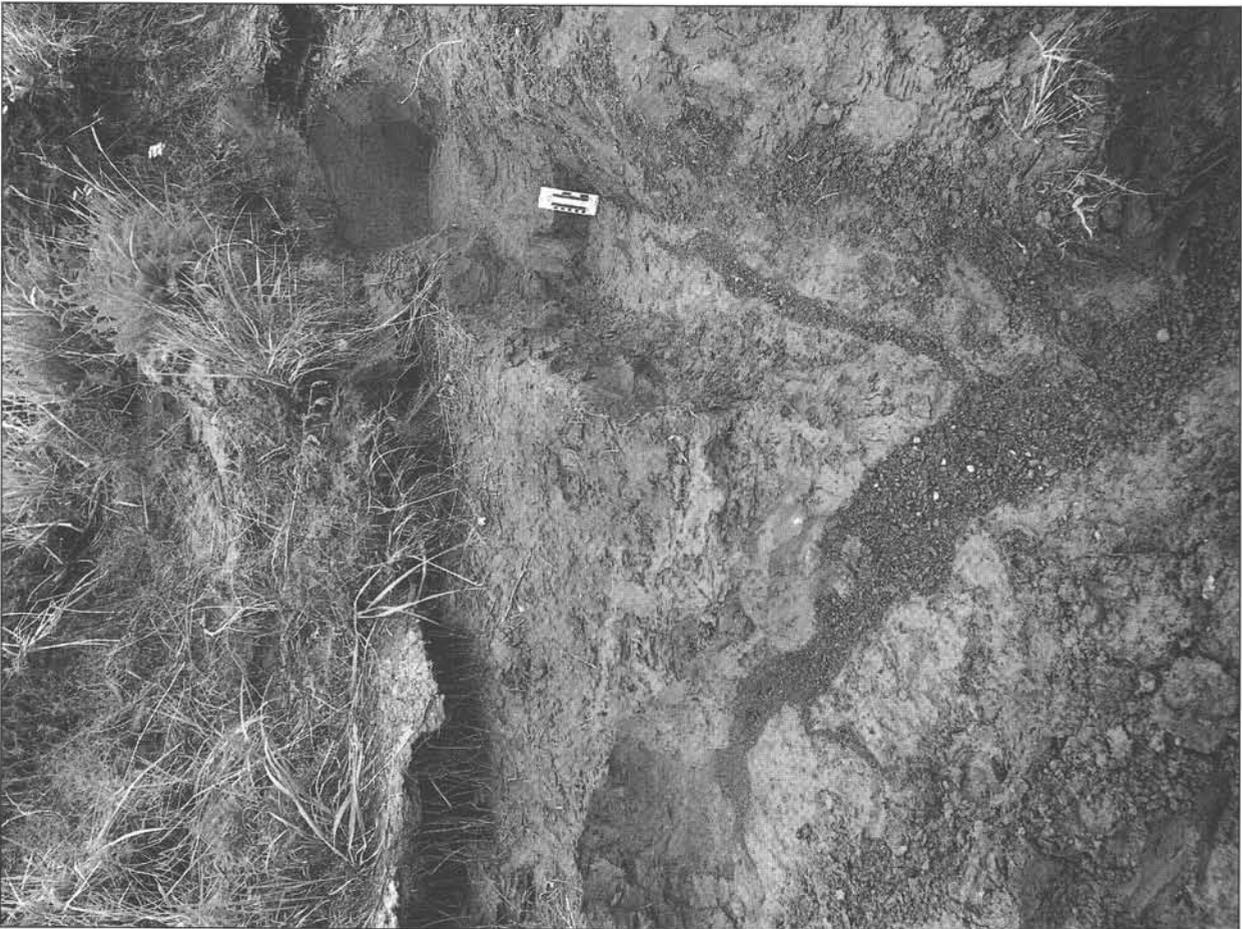
Figure 44. Photo of the lower part of a dike at site 49 on Placer River. The dike is composed of pebbly granule-bearing sand. Maximum clast size 3.5 x 2.3 x 1.8 cm; maximum width 21 cm. A sample (the coarsest of all our samples; Table 3) was taken immediately left of the bifurcation. The branch trending toward the scale is 3 cm wide and fines upward from pebbly sand to granule-bearing sand at the apex. A second upward fining en echelon dike starts just below the scale. The two dikes probably connect laterally. The area above the scale is shown in Figure 45.

The dikes and sills contain predominantly dark gray to black medium to coarse sand and gravel as large as coarse pebble size; 27 contain appreciable pebble-size gravel and three are dominantly gravel (that is, median diameter 2.0 mm). Gravel in some of the coarsest dikes is clast supported (Figs. 23, 44), suggesting either that the gravel liquefied or that the matrix was winnowed out. In other dikes, gravel is matrix supported in sand, indicating passive upward movement of gravel in a rapidly moving slurry of liquefied sand. Dikes of gravel or gravelly coarse sand are moderately sorted, typically fine upward, and contain generally less than 5 percent silt.

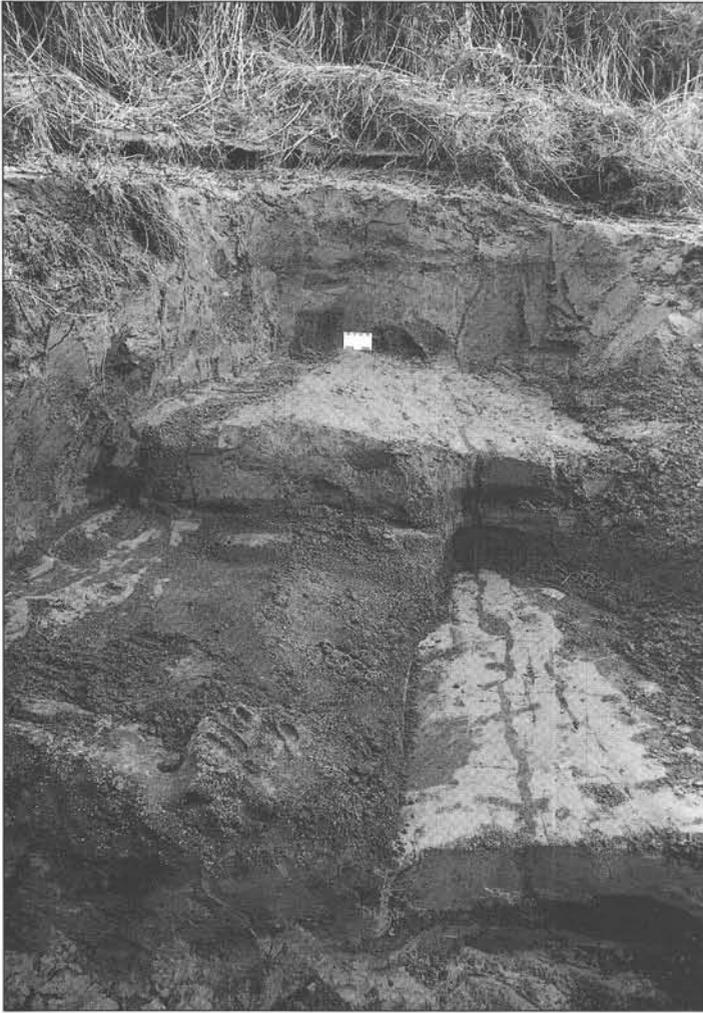
Figure 46. (left) Photo of a dike pair at site 52 on Portage Creek. Both are composed primarily of granule-bearing to coarse sand. The left dike is 14 cm wide and contains a few scattered entrained pebbles 35–40 cm below 1964 peat surface (maximum clast size 1.0 x 0.6 x 0.2 cm). Right dike is 2 cm wide. The top of this dike is shown in more detail in Figure 47.

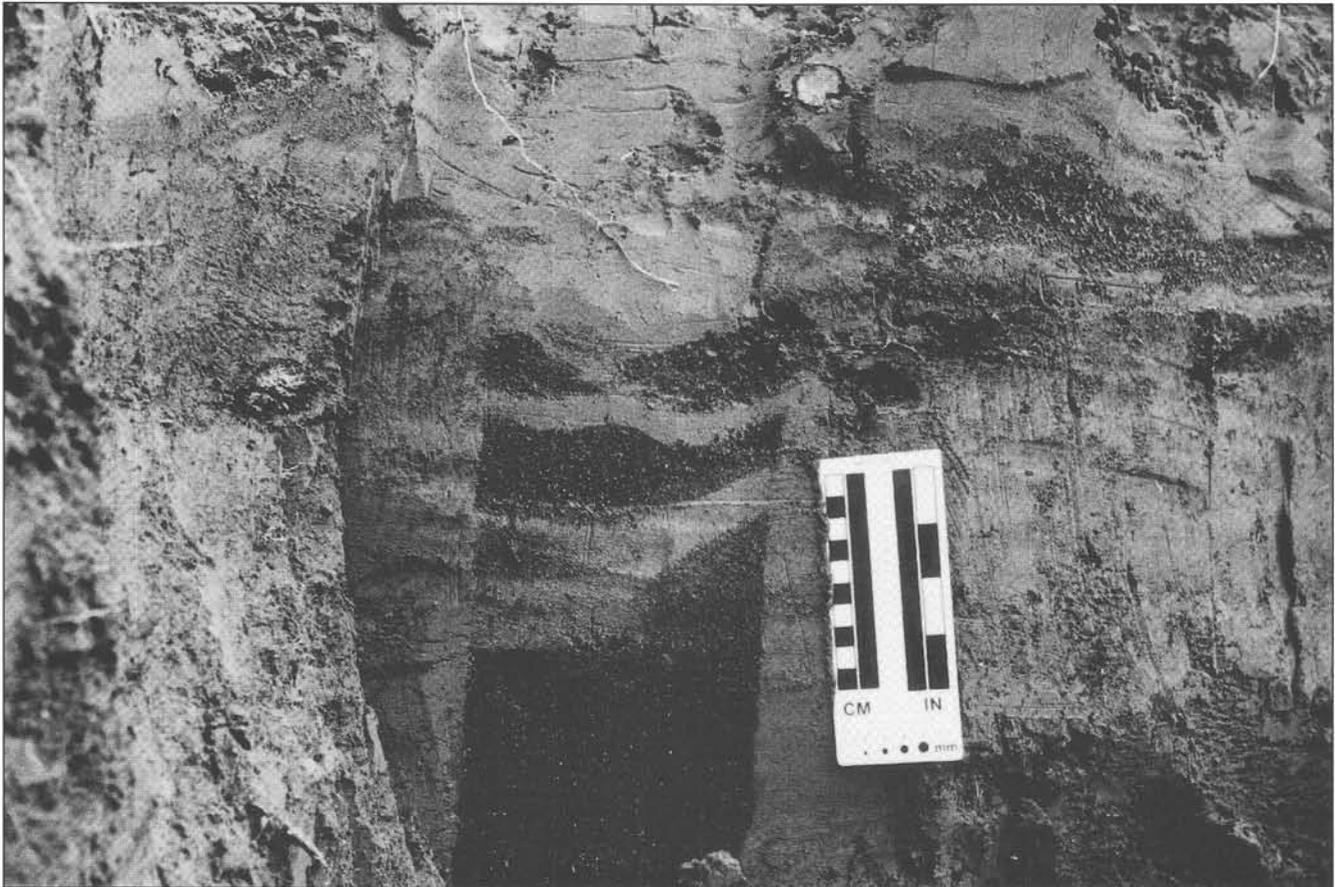
Figure 47. (below) Photo of the termination of the larger dike at site 52 shown in Figure 46. The reworked zone left of the scale is interbedded sand and silt. The 1964 peat surface is the diffuse dark band just above the scale. Above the 1964 surface is a 1–2 cm silt layer containing vertically oriented rootlets. Above the silt layer is a 4-cm layer of extruded sand.

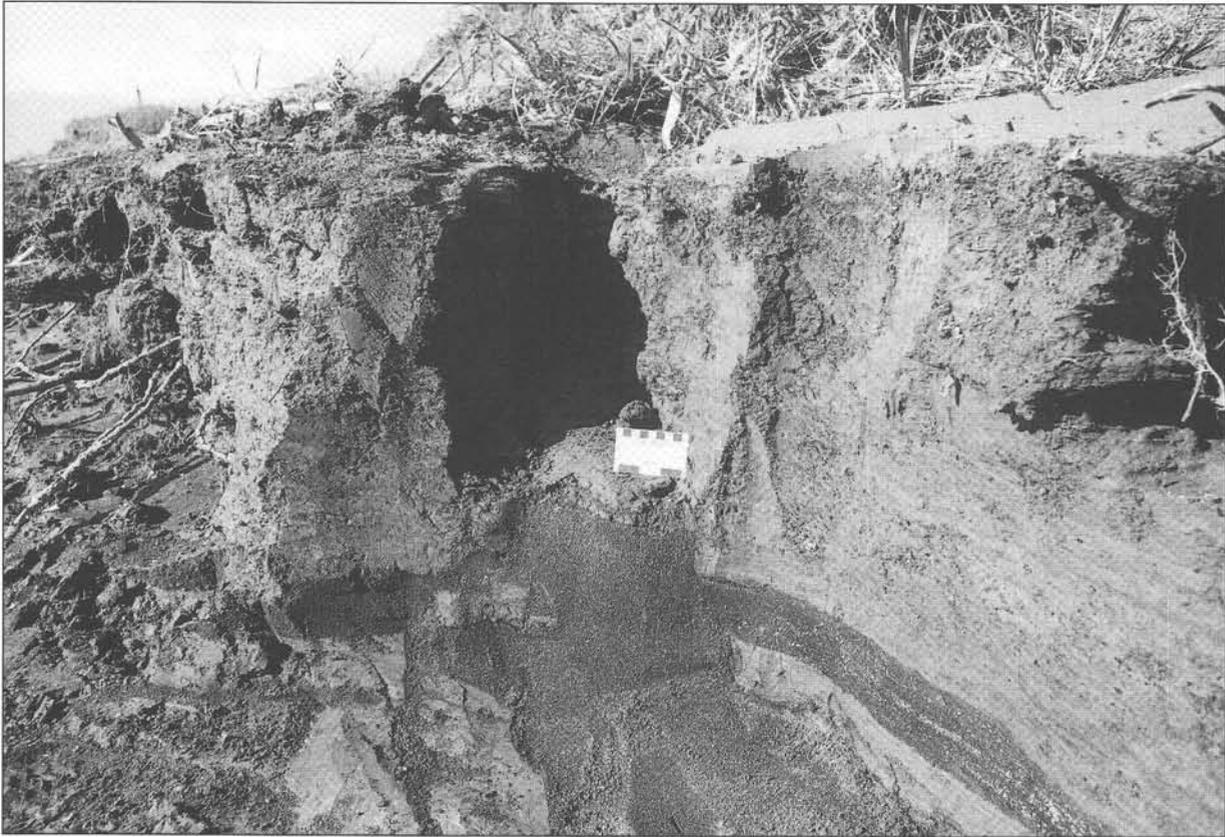
Figure 48. Photo of a shore-parallel sand dike and layer at **site 57** on Portage Creek. This dike has a maximum width of 20 cm and a corresponding break in the pre-1964 peat layer and surface, which form the upper bench in this photo. The dike feeds subsidiary dikes at sites 56–59 and cuts across a 7-cm-thick sand layer in section about 40 cm below the pre-1964 surface. The upper portion of the dike has been replaced with silt to about 30 cm below the pre-1964 surface, but this silt has been largely removed by modern tidal erosion. Host material is layered silt.

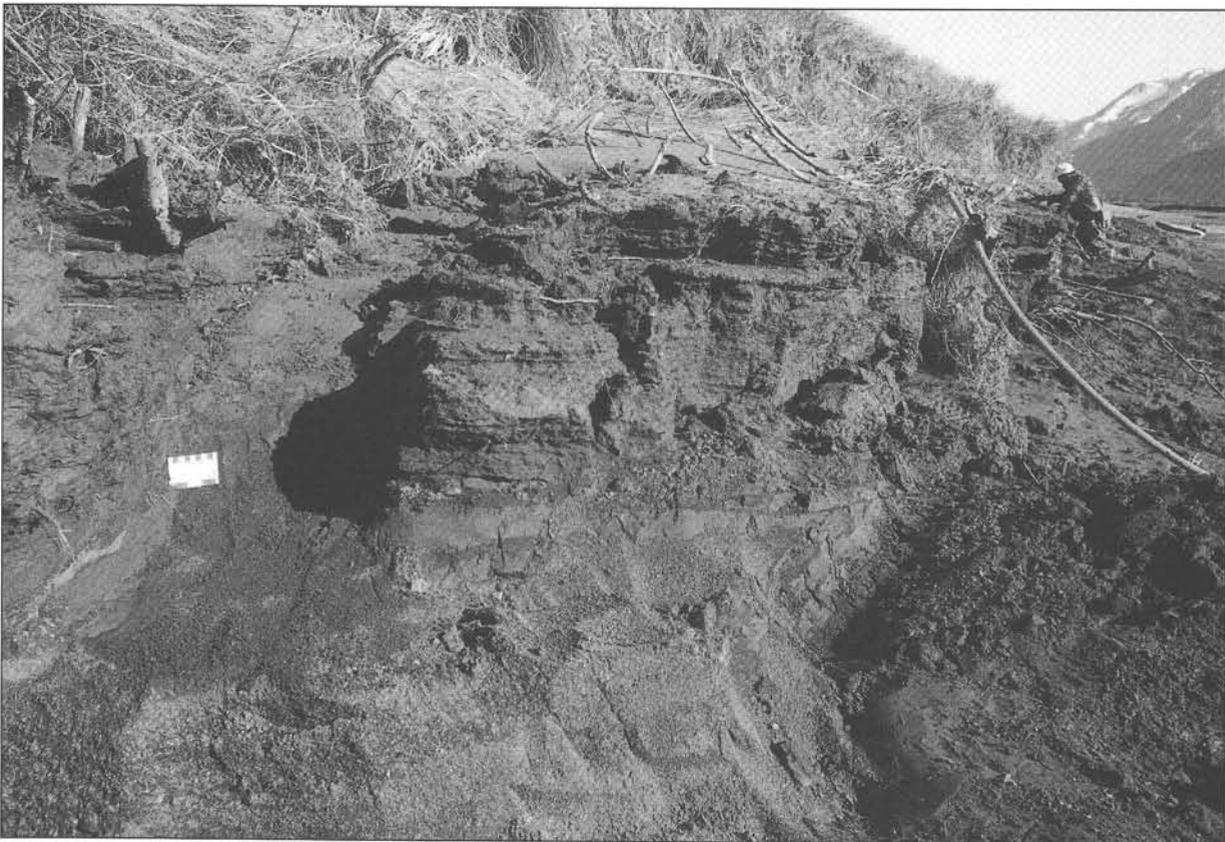
Figure 49. View east along the north bank of Portage Creek (north channel), showing a shore-parallel dike emerging from the bank at left at **site 58**. This is the same dike as shown in Figure 48 at site 57. Maximum dike width here is 29 cm.

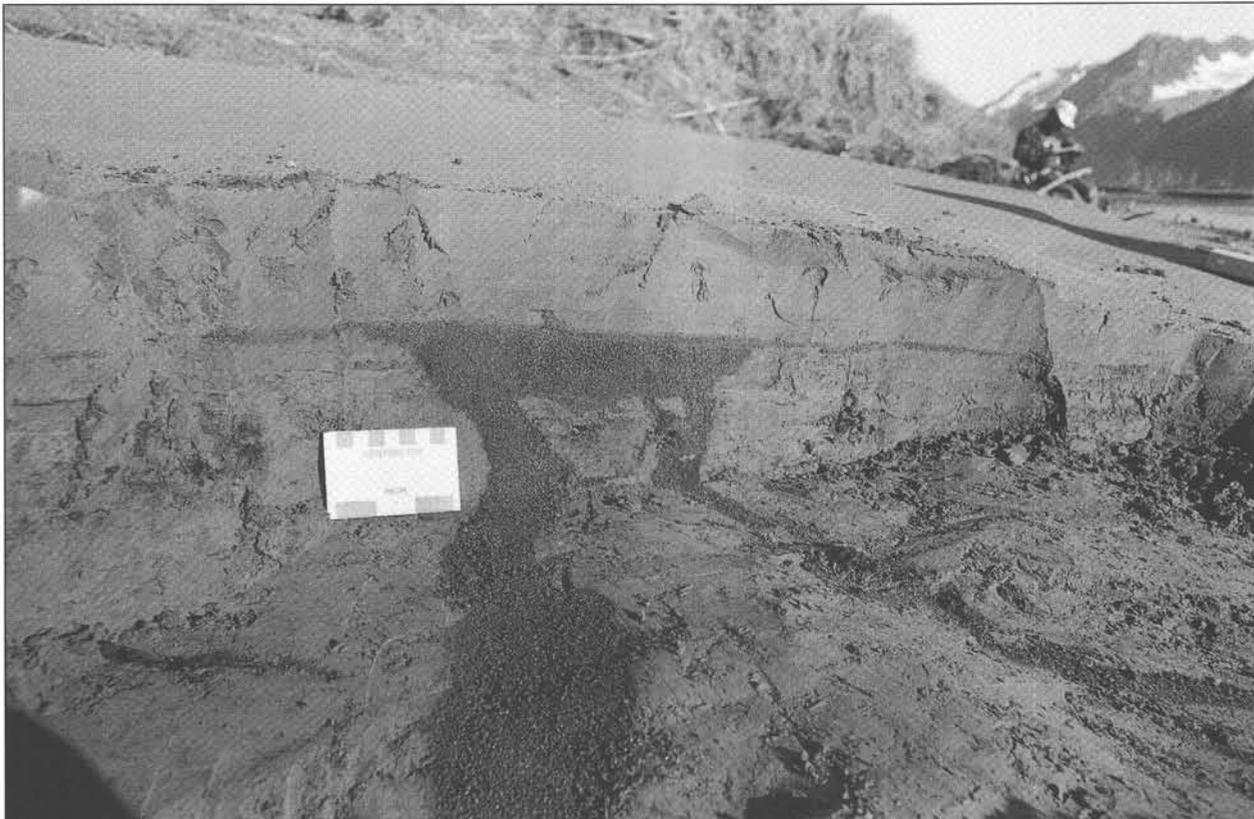
Figure 51. Photo of two dikes of medium to coarse sand at **site 60** on Portage Creek. The dikes feed a sand-filled depression that may have been part of a sand boil before it was truncated by erosion. The pre-1964 surface and peat layer are not visible here and were probably removed by erosion.

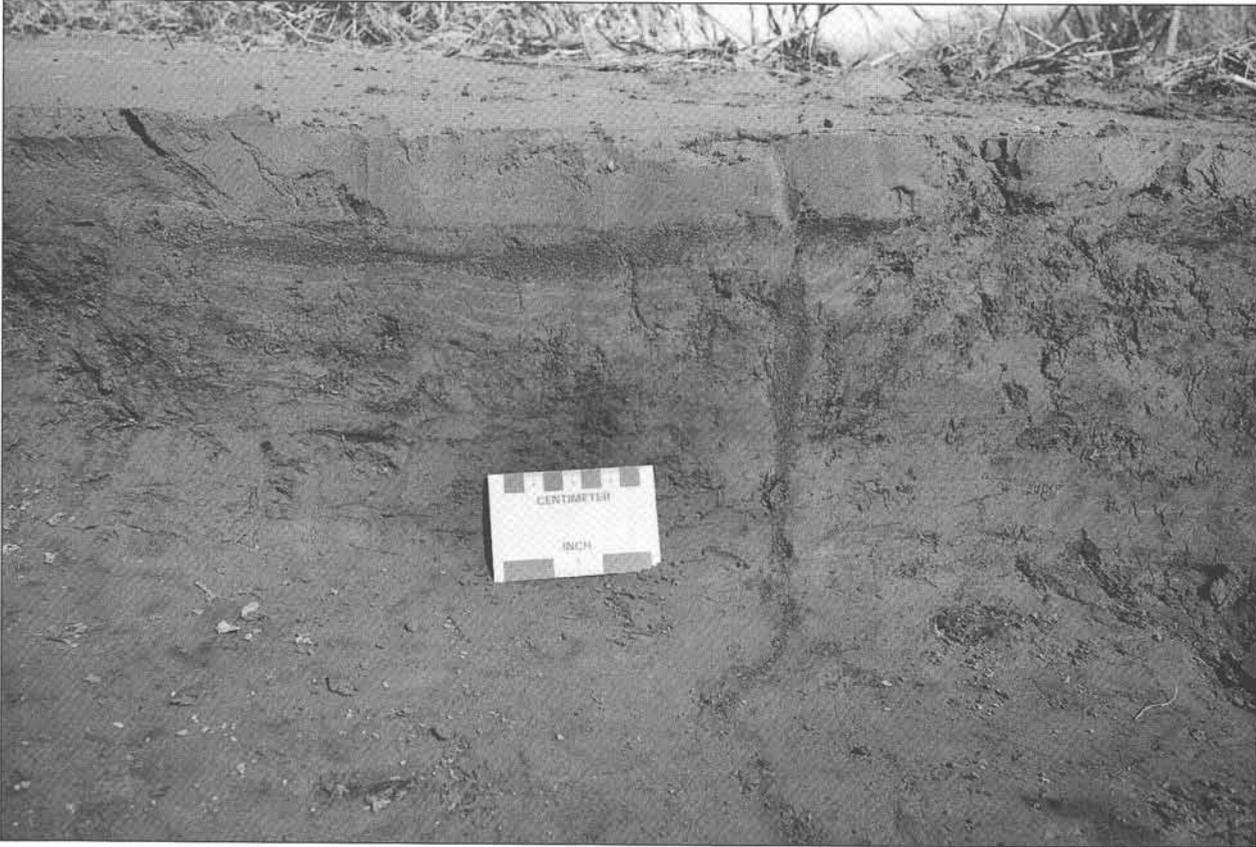
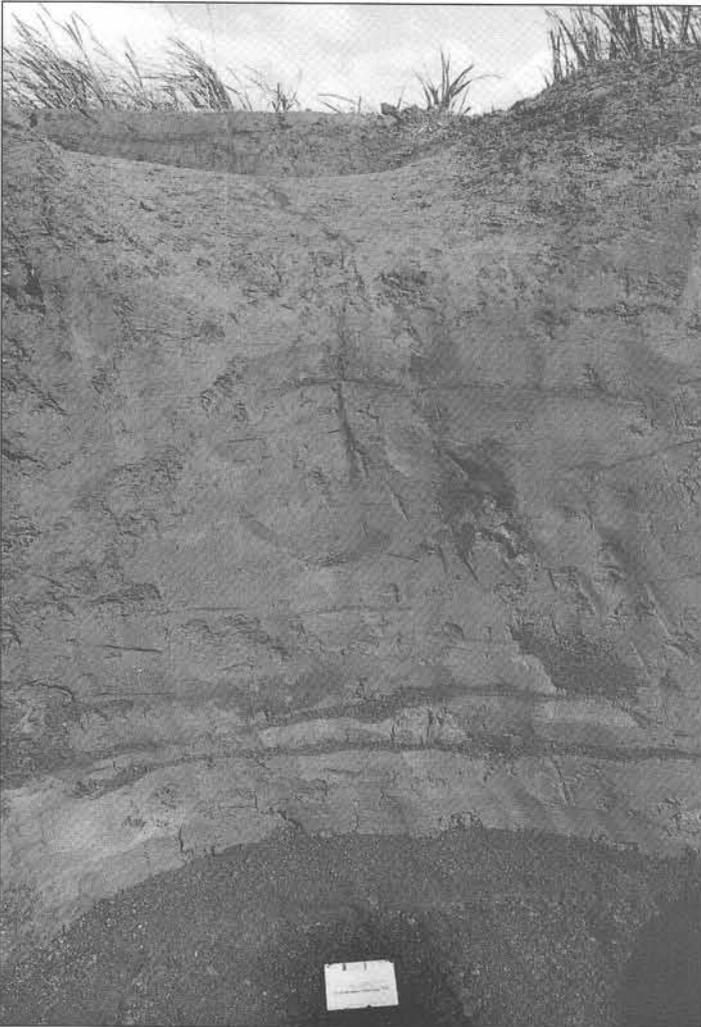
Figure 52. Photos of a thin (maximum 2.5 cm) sand dike at **site 61** on Portage Creek. At the unconformity between older laminated silt and modern massive silt, a sand layer as much as 2.5 cm thick extends laterally about 40 cm to the left. This sand layer may be either a remnant of a sand boil or dike sand that has been reworked during tidal erosion. The sand dike tapers downward and disappears 30 cm below the unconformity. (*left*) This photo including the lower part of the section shows a possible source layer, but no visible connection to the dike.

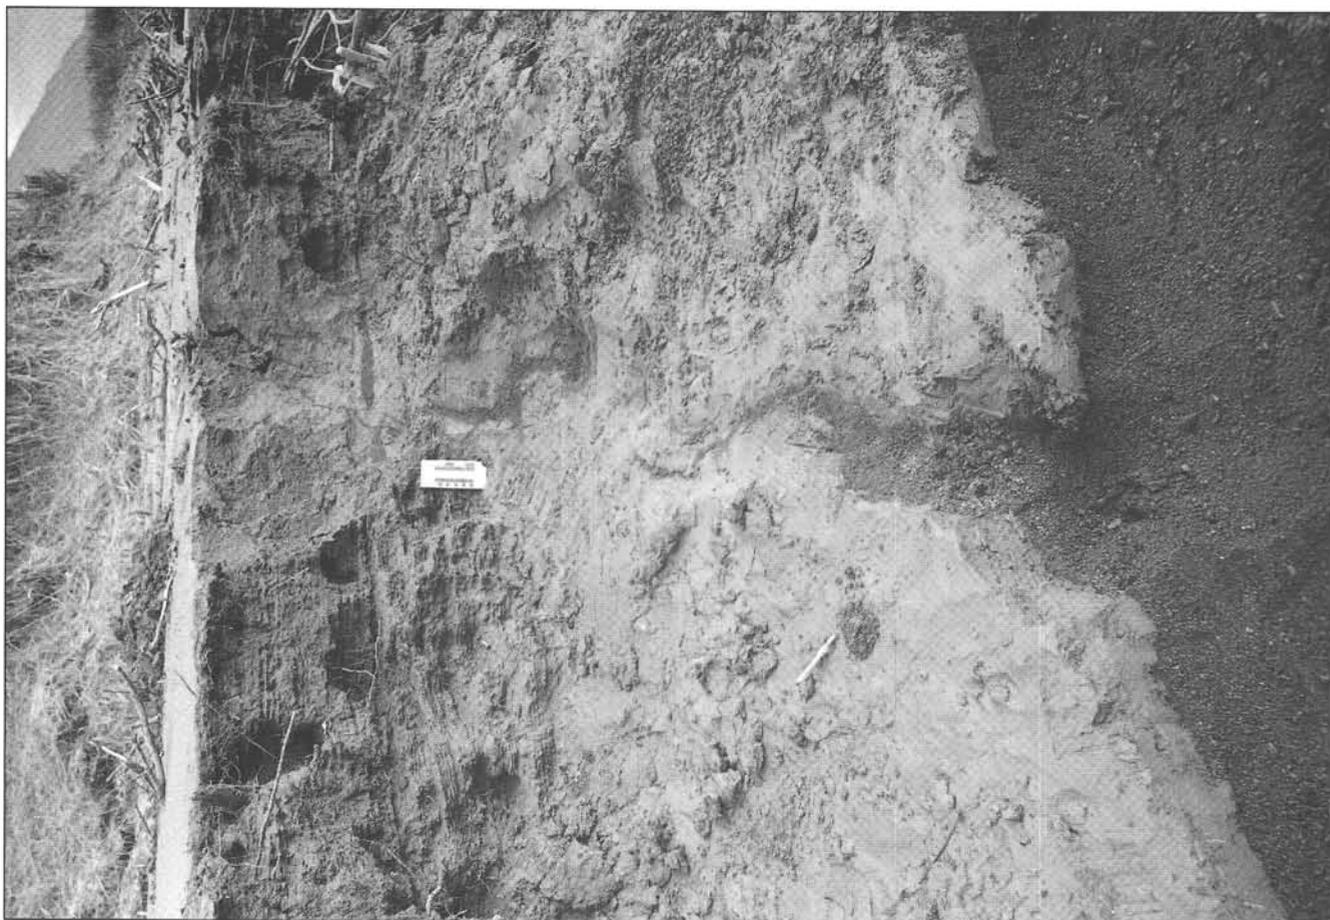
Figure 53. Photo of dike at site 62 on Portage Creek at its confluence with Placer River. The source of this dike is 95 cm below the top of the 1964 surface. Its maximum width is 10 cm.

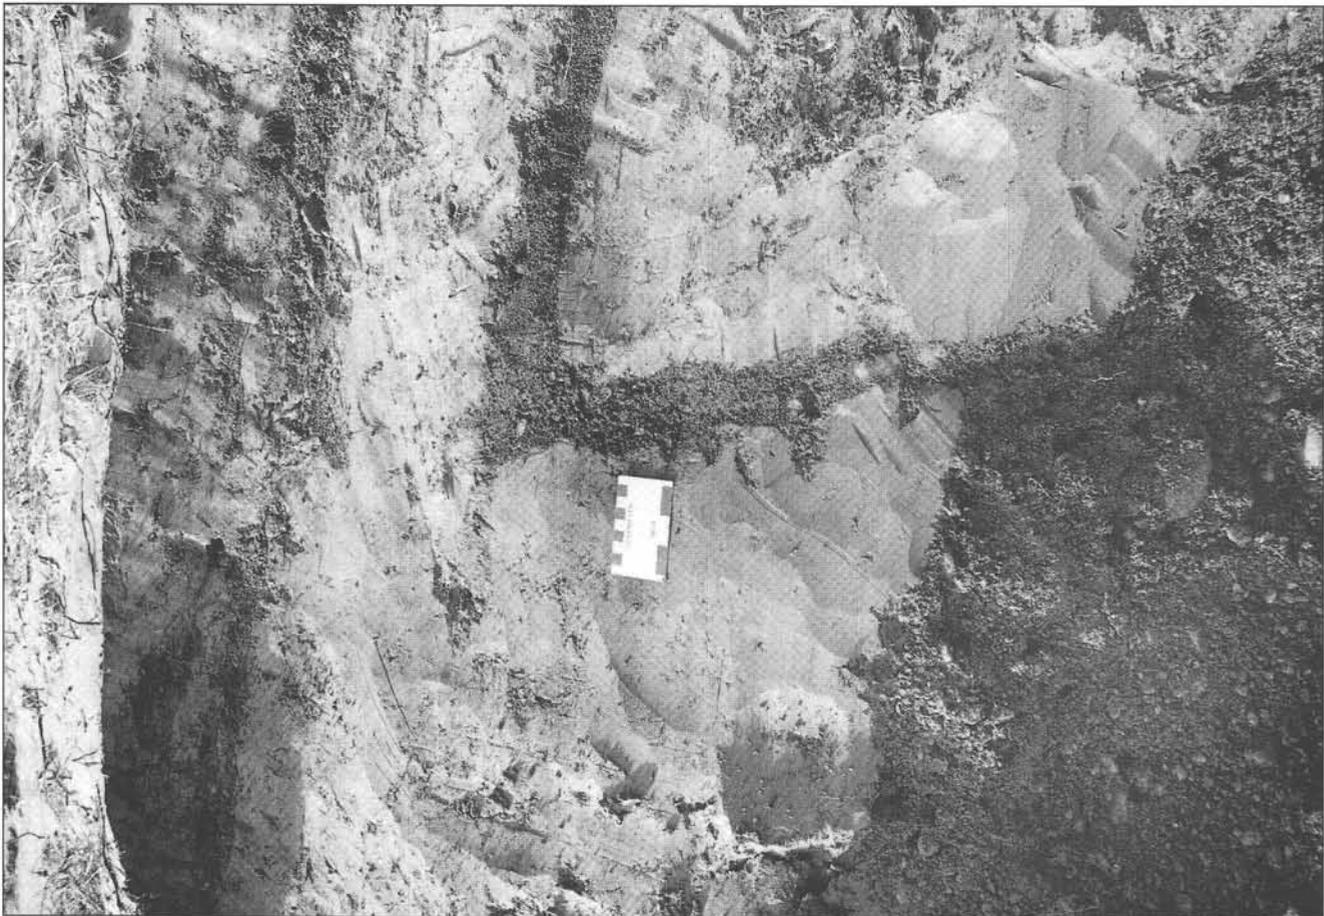
Figure 55. Photo and drawing of a gravelly medium to coarse sand dike and silt at site 74 on Portage Creek. The portion of this dike above the silt has been replaced with silt from above, probably as a result of tidal reworking following the 1964 earthquake. The replacement silt fills a break in a gravelly sand layer near the top of the section and in a discontinuous layer of peat above this layer. A lens of sand above the discontinuous peat layer may be a remnant of a sand boil emanating from the dike. The silt filling at the top of this dike is barely distinguishable from the surrounding faintly laminated silt. A thick bed of gravelly coarse sand (bottom) is the apparent source for this dike. The top of this bed is about 60 cm below the pre-1964 surface.

In at least 50 cases, dikes terminated at depths as much as 92 cm below cracks in the 1964 soil surface, and the cracks were filled with unoxidized, massive silt up to the 1964 surface (Figs. 12, 13, 15, 16, 18, 21, 33, 34, 55). In at least 17 cases, the margins of the ground crack above these silt-filled dike throats are mantled with extruded sand, suggesting that these dikes erupted to the surface. We infer that the loosely packed, noncohesive sand and gravel of the dikes were sluiced out of the narrow channels of the ground cracks by currents from spring tides, which inundated this area after approximately 2 m of coseismic subsidence. On several occasions, we witnessed incoming tides sluicing out dikes we had excavated (note, for instance, Fig. 17, site 20). On one occasion, we left a trenching tool, folded into an 'L' position, standing with handle up at one of our excavations when the tidal bore in Turnagain Arm reached the site. When we retrieved the trenching tool the next day, 5 cm of silt had been deposited on the blade. A similar process probably eroded many dikes during the rising tide from the spring tides about two weeks after the earthquake, then deposited cohesive, less erodible silt during still-stand, thus protecting the dikes from further erosion. Eventually, the cracks were filled by the more cohesive Placer River Silt deposited by the glacial-flour-rich Placer and Twentymile Rivers, Portage Creek, and Turnagain Arm (Bartsch-Winkler and others, 1983). This contact is well defined by the color contrast between the pale blue-gray post-1964 silt and the buff-to-pale yellowish-orange pre-1964 silt.

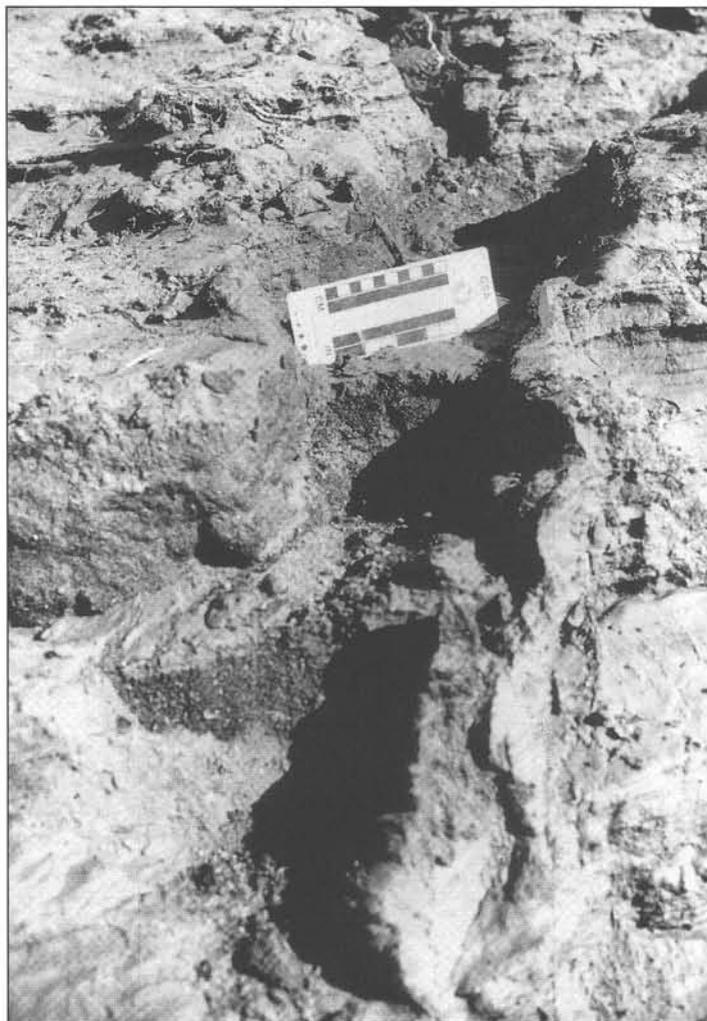
Figure 56. Wide-angle photo (*above*) and closeup (*left*) of a natural exposure of a clastic dike with oxidized rims at **site 80a** on Portage Creek. The source bed, which is 65 cm below the 1964 surface, is composed of pebbly coarse sand. The dike fines upward from granule gravel at the base to medium sand at the surface. The dike is 13 cm wide at its base, bifurcating 20 cm upward into 12- and 6-cm-wide dikes.

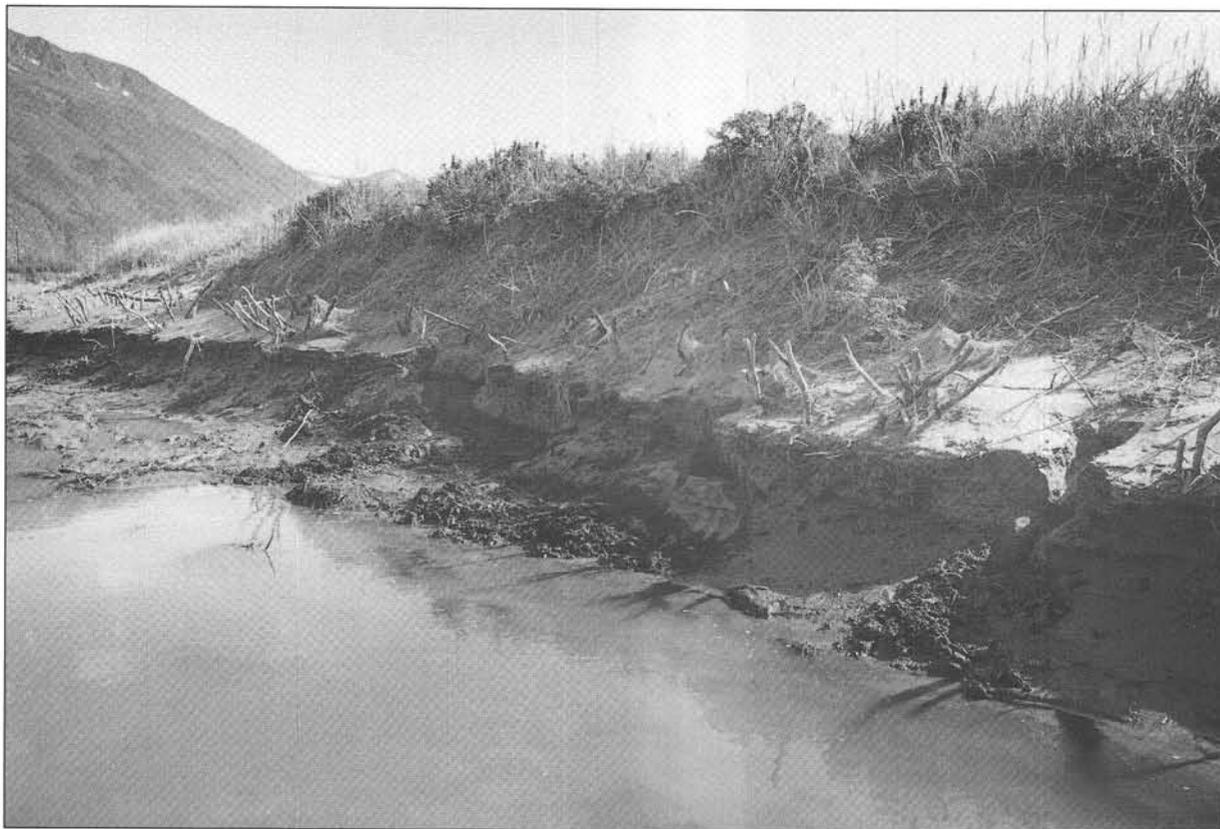
Figure 58. View southeast along the south bank of Portage Creek (north channel), showing sand dikes intersecting the bank at sites 79g-h. A large dike at the center is nearly shore-parallel and has a maximum measured thickness of 74 cm. All the dikes are associated with breaks in the pre-1964 surface and peat layer, within which the upper part of the dike has been replaced with silt. Minor thin sand above the pre-1964 surface may be remnants of sand boils erupted from these dikes. Exhumed bushes at the break in slope are rooted in the peat layer that was buried as a result of submergence during the 1964 earthquake. The overlying Placer River Silt is about 2 m thick.

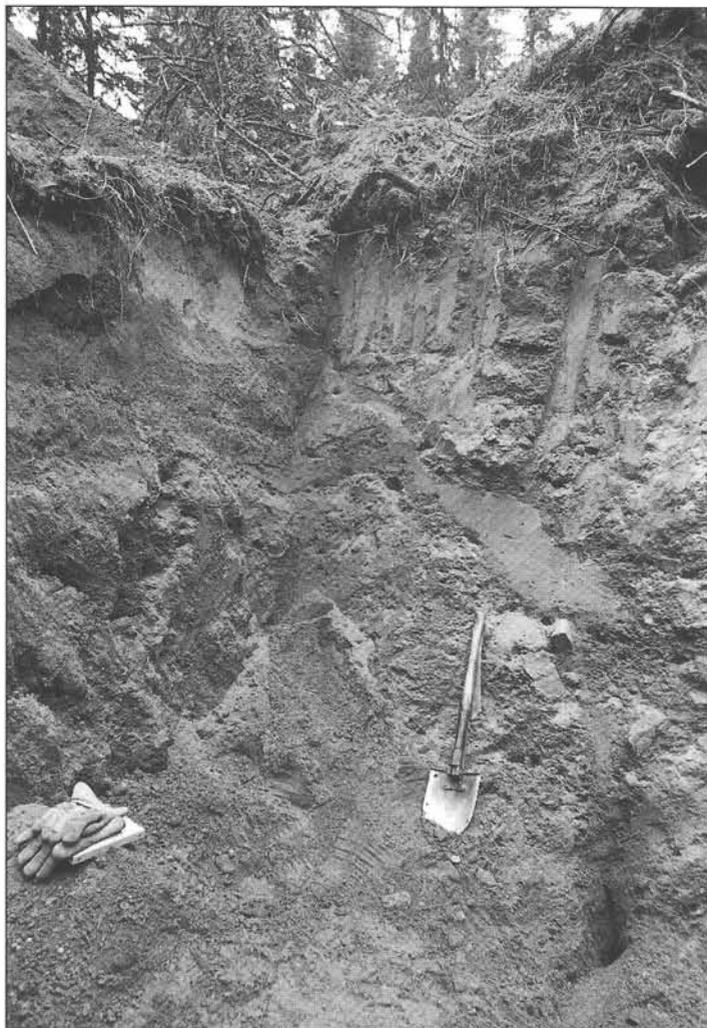
Figure 63. (left) Detail of the left side of the previous photo. Beneath the vegetative cover at top left of this photograph is a light-colored extruded sand. This sand can be traced downward via a sloping, pinching and swelling dike to the pod of light-colored sand above the shovel handle. A vertical dike can be traced downward from this pod to the floor of the pit. The hole to the right of and below the shovel represents a portion of the dike that was propped open by a clast from the boulder till after the extrusion process was complete.

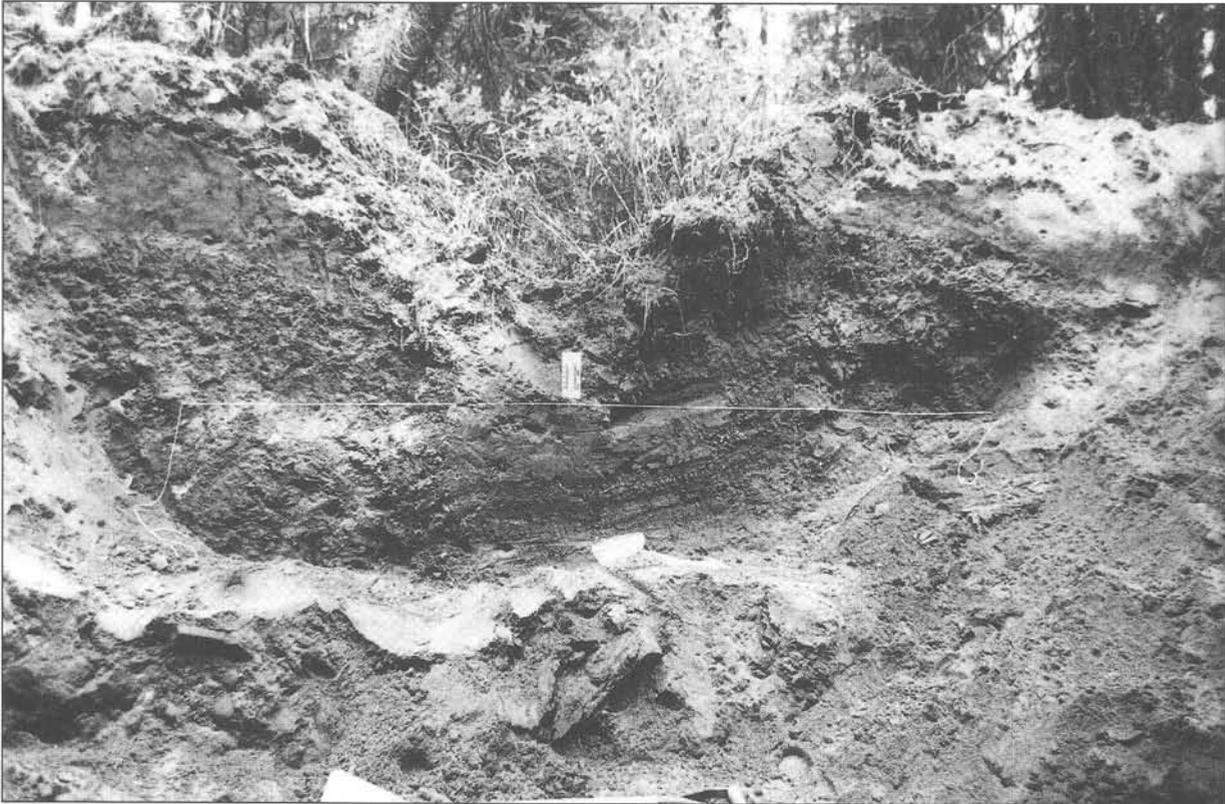
Figure 64. Photo of the east side of the pit at the Foster and Karlstrom site. Above the scale is the open ground crack, ~1 m deep and 1.5 m wide. After sand extrusion, the soil column collapsed into the crack. The vertical distance from the base of the peat on the south (right) side of the fracture and the base of the peat in the crack is 82 cm. The base of the 1964 peat surface is the dark layer at the top of the scale. Extruded sand mantles the north (left) slope of the crack to a depth of 10–14 cm and is 15 cm thick in the axis of the crack. Extruded sand is absent from the south slope of the crack. Figure 65 shows the area immediately to the left of the scale.

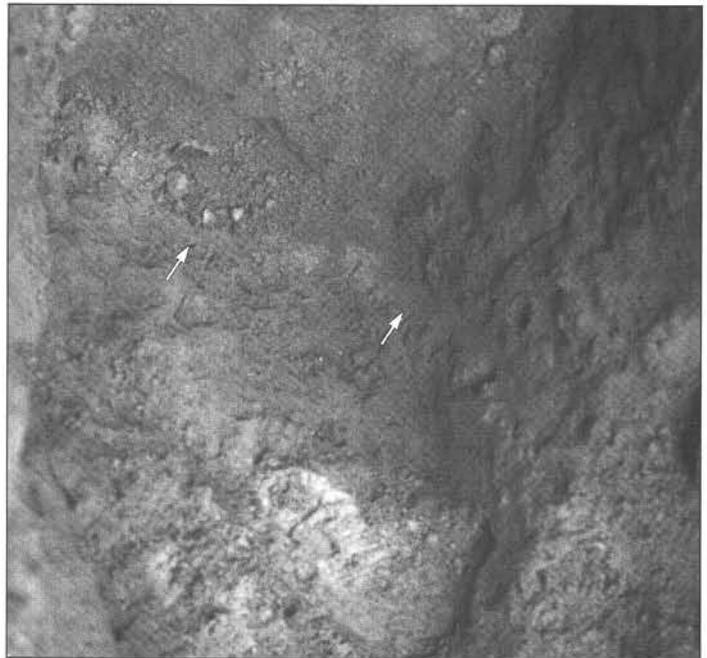
Figure 66. (above) Photo of the bottom of the pit at the Foster and Karlstrom site showing the faint trace of the feeder dike crossing the pit.
