Summary Report: Landslides, State Trust Lands, and the January 2009 Storm in Whatcom County

Land Management Division
Earth Sciences Program

October 2009

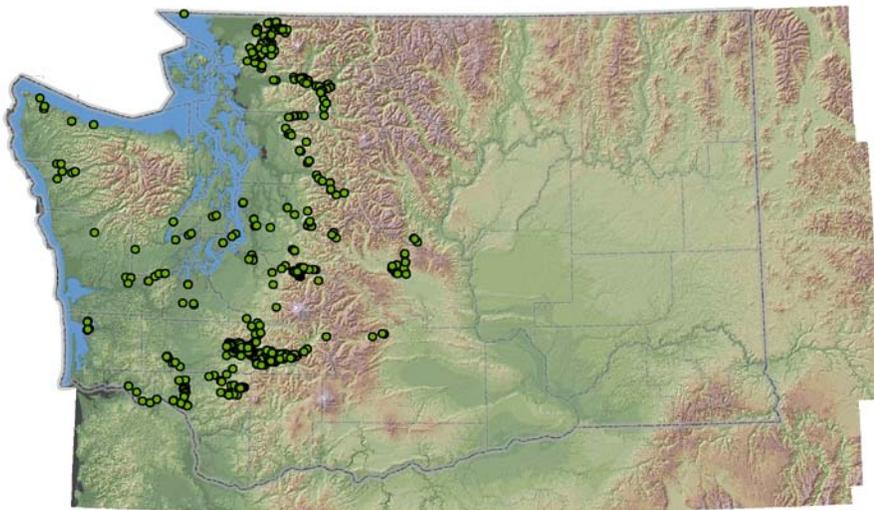
Figure 1. Map of Washington showing the distribution of the more than 1400 landslides that resulted from the January 2009 storm (data courtesy of DNR Division of Geology and Earth Resources).

On January 7th and 8th, 2009 heavy rainfall and melting snow from a strong Pacific storm triggered more than 1400 landslides across western Washington (Figure 1). One of the highest concentrations of landslides was in Whatcom County. Many of these landslides originated in steep forested terrain and traveled hundreds or even thousands of feet before depositing at the base of mountain slopes. Most began on private, State, and Federal forestland including lands managed by the Washington State Department of Natural Resources (DNR; hereafter referred to as State Trust Lands). Several of the landslides that began on State Trust Lands impacted downslope private properties. These landslides deposited mud, boulders, trees and woody debris on many of the properties and in some cases also damaged homes or other structures.

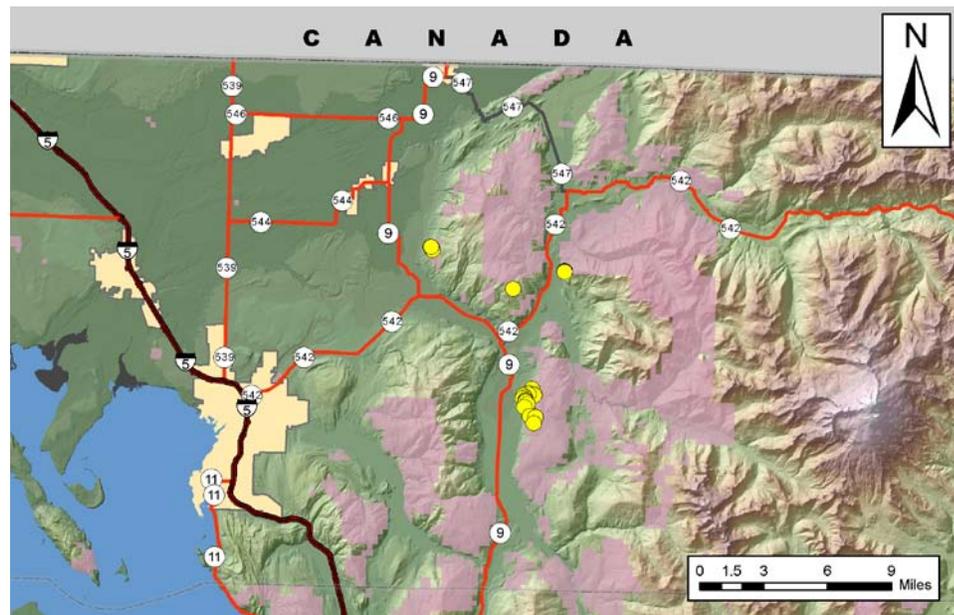
Figure 2. Map of Whatcom County showing the initiation points of landslides (yellow circles) on State Trust Lands that impacted private properties. State Trust Lands are shown in pink.

The distribution of the landslides investigated is illustrated in Figure 2. The landslides are located along a north-south trending line in western Whatcom County that extends from the southwestern part of Sumas Mountain to the northwestern flank of Van Zandt Dike. The landslides initiated at elevations ranging from 700 to 2100 feet above sea level although most occurred between 1000 and 1500 feet. The affected private properties are located along Goodwin Road, Siper Road, Mount Baker Highway, Marshall Hill Road, North Fork Road, Clipper Road, and Nelson Road.

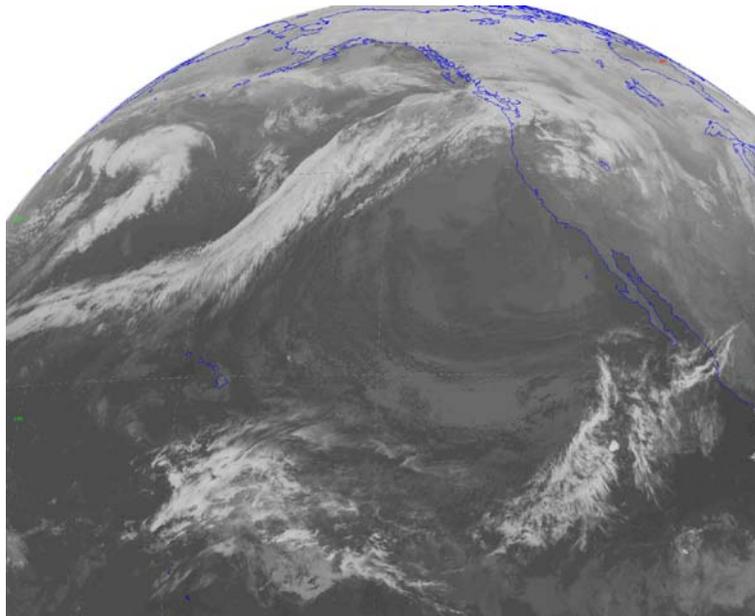
Figure 3. Infrared satellite image taken January 7th, 2009 showing the “pineapple express” moisture plume extending from the south Pacific into Washington and southern British Columbia.

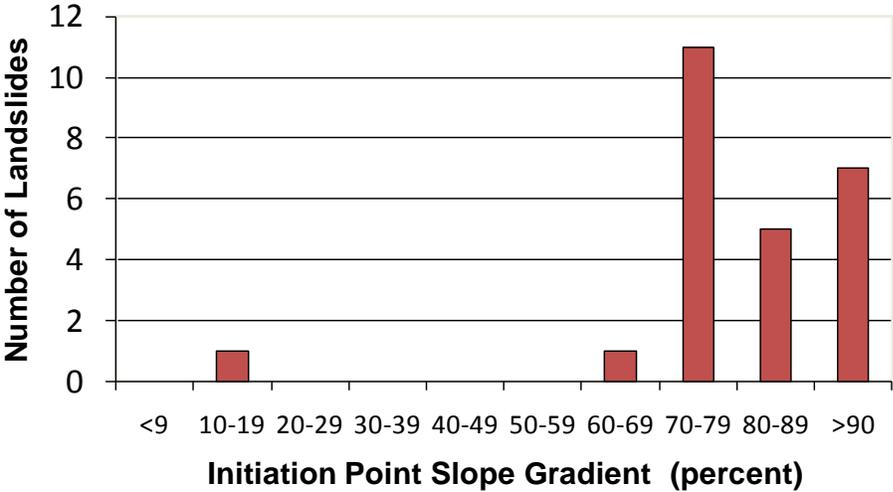
Figure 4. Bar chart of landslide initiation points by slope gradient class for the 25 landslides that began on State Trust Lands and impacted private properties during the January 2009 storm in Whatcom County.

A total of 25 landslides that initiated on State Trust Lands and impacted downslope private properties were reviewed. Except for two, all of the landslides began on slopes that exceeded 70 percent gradient (Figure 4). The one landslide that initiated on relatively gentle slopes began in a low-gradient stream channel when an orphaned road collapsed and produced a dam-break flood.

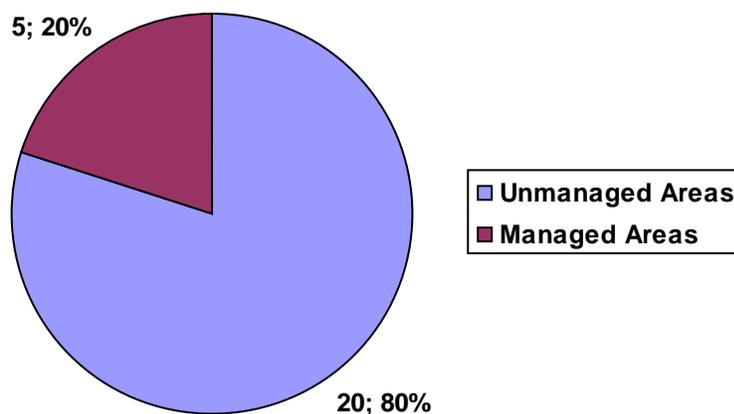
Figure 5. Distribution of 25 landslides that originated on State Trust Lands during the January 2009 storm based on the land use status (managed or unmanaged) of the landslide initiation site.

A total of 25 landslides that initiated on State Trust Lands and impacted downslope private properties were reviewed. Twenty of the landslide initiation points are located in unmanaged areas while five are located at sites where some type of forest management activity has occurred in the past (Figure 5). **Unmanaged areas** include sites where the landslide initiation point is surrounded by mature forest cover and no direct influence from forest roads or timber harvesting was identified (for purposes of this report, we define “mature forest” as stands where the overstory vegetation is at least 50 years of age). This includes fully intact mature forest and buffers or “leave areas” of mature forest within or along the margins of recently harvested areas. **Managed areas** include sites where roads or recent timber harvesting are immediately adjacent, or in close proximity, to the landslide initiation point (for purposes of this report, we define “recent” as being within the past 20 years).

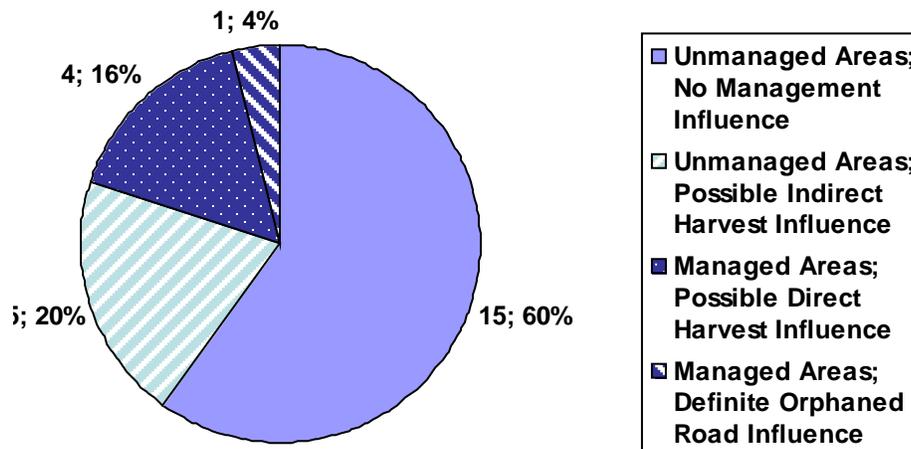
Figure 6. Distribution of 25 landslides that originated on State Trust Lands during the January 2009 storm based on land use status (managed or unmanaged) and likely degree of management influence (none, possible, or definite).

We have further subdivided the “unmanaged” and “managed” categories based on the likelihood that management activities contributed to landslide initiation (Figure 6). Of the 20 landslides that initiated in unmanaged areas, 15 occurred without any contribution or influence from forest management activities on State Trust Lands. This represents 60 percent of all landslides investigated (Figure 6). These landslides began in fully intact mature forest stands, some of which were between 100 and 200 years of age. In all cases, no forest roads were present immediately upslope from the initiation point and no previous timber harvesting had occurred upslope. The landslide that affected the van den Heuvel property located at 3800 Nelson Road is an example of a landslide that occurred in the absence of any upslope management activities (Figure 7).

Without knowing the characteristics and patterns of rainfall, snowmelt, and slope hydrology that existed at each of the five landslide sites during the early January storm, it is difficult to confidently say if, and to what extent, upslope harvesting contributed to landslide initiation in the leave areas. As a result, we have classified these five landslides as having a “possible indirect harvest influence” even though they began in unmanaged areas (Figure 6).

In addition to the 20 landslides that originated from unmanaged areas, there were five landslides that began in managed areas (Figure 6). Four of these landslides initiated on slopes that had been harvested. This represents 15 percent of all landslides investigated. Three of the four harvested landslide initiation points are located in an area that was clearcut about 16 years ago (Figure 9). This area is referred to as the “TAT” harvest in the corresponding investigation report (Appendix A). The other harvested landslide initiation point is located in an area that was clearcut about 21 years ago. This area is referred to as the “Strand Extension” harvest in the corresponding investigation report (Appendix G). It is important to note that at the time the TAT and Strand Extension harvests occurred, neither parcel was under DNR management. Both parcels were privately owned and DNR acquired the parcels in 1993, after the logging was completed. Additionally, the Forest Practices Rules in place at the time of the harvesting did not specifically address logging on potentially unstable slopes. Since that time, the Acme watershed administrative unit (in which these sites are located) has undergone watershed analysis and approved management prescriptions are in place that restrict harvesting in landslide-prone areas such as these four sites.

Of the 25 landslides investigated, one is directly attributable to past management activities on State Trust Lands – specifically, an orphaned road grade (Figure 6). The landslide occurred when the orphaned road collapsed, triggering a dam-break flood that traveled more than 1.5 miles to the base of Sumas Mountain where it destroyed one residence and damaged several others as well as Mount Baker Highway and Marshall Hill Road. The orphaned road collapsed when water became impounded on the upslope side of the road to a depth of approximately eight feet, saturating the base of the road prism. The road is located on nearly flat terrain at the outlet of a wetland approximately 1.5 acres in size.

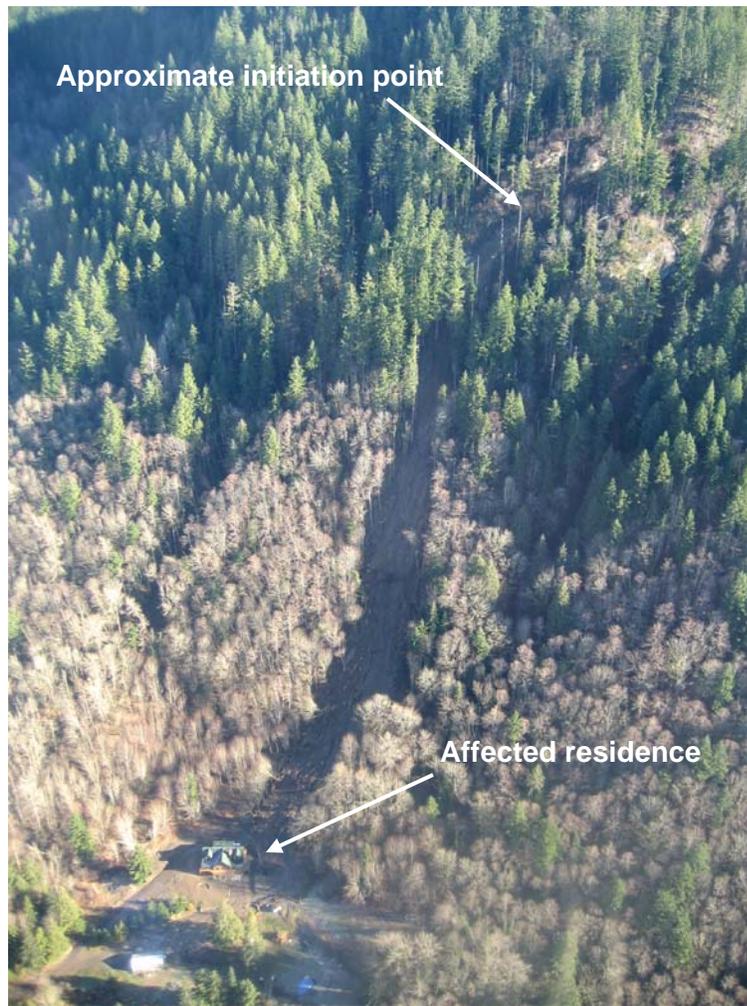
Figure 7. Oblique aerial photograph taken January 20th, 2009 showing the landslide that affected the van den Heuvel property at 3800 Nelson Road. Photo credit: D. Hooks.

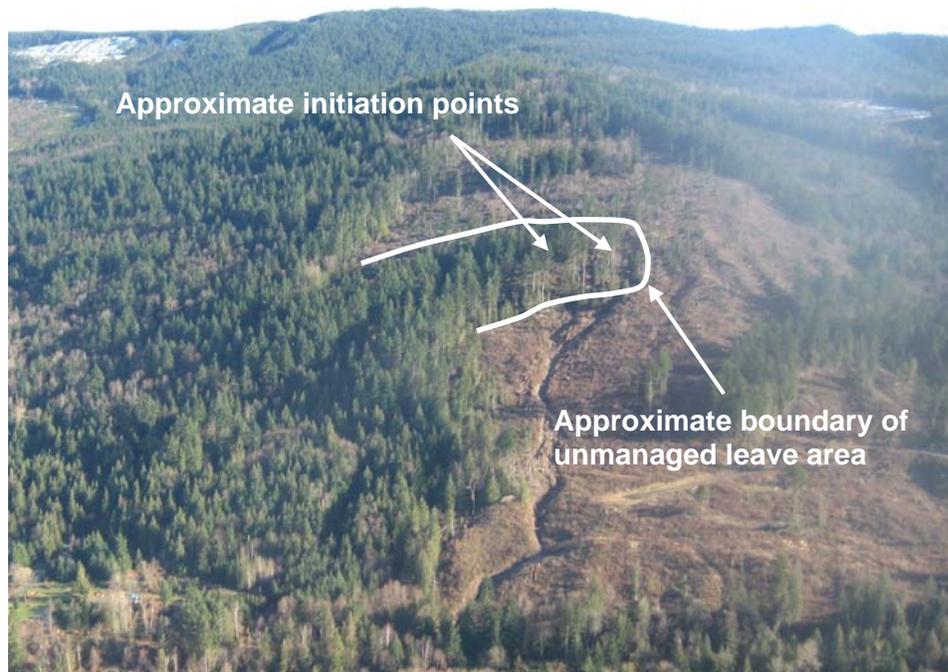
Figure 8. Oblique aerial photograph taken January 20th, 2009 of the two landslide initiation points that originated in an unmanaged leave area within the DNR “Gasping Goodwin” timber sale. The resulting debris flow track is visible below the initiation points in the harvest unit. Affected properties along Goodwin and Siper Roads are not visible. Photo credit: D. Hooks.

The five remaining “unmanaged area” landslides originated within buffers or leave areas of mature forest within or along the margins of two recently harvested DNR timber sales. Three of these landslides originated in leave areas adjacent to the “Jack Straw Aerial” timber sale along the west side of Van Zandt Dike; the other two landslides originated in a leave area embedded within the “Gasping Goodwin” timber sale on the southwest side of Sumas Mountain (Figure 8). Based on a review of the timber sale files and communication with staff familiar with these sales, the sites where these five landslides initiated were identified as potentially unstable during the pre-sales review process; as a result, DNR staff decided to exclude them from the proposed harvest units in an effort to mitigate landslide hazard.

While the sites where these five landslides occurred were excluded from the timber sales due to slope stability concerns, areas directly upslope from the initiation points and associated leave areas were harvested. Given this, a question arises as to if the upslope harvesting could have contributed to landslide initiation in the leave areas. The short answer is “it’s possible, but there’s no way to be sure”. The mechanism by which timber removal can contribute to landslide initiation at sites downslope from harvested areas is through alterations in slope hydrology. During rain-on-snow events such as the early January storm, removal of the forest canopy can reduce snow interception and allow more snow to accumulate on the ground. Canopy removal also can allow a higher rate of heat transfer from warm rain and wind to the snowpack, potentially causing more rapid snowmelt. A higher rate of snowmelt combined with more snow available for melt can mean more water entering the soil. As described earlier, high rates of water input to the soil elevates local water table levels, sometimes reducing soil shear strength to the point of failure.

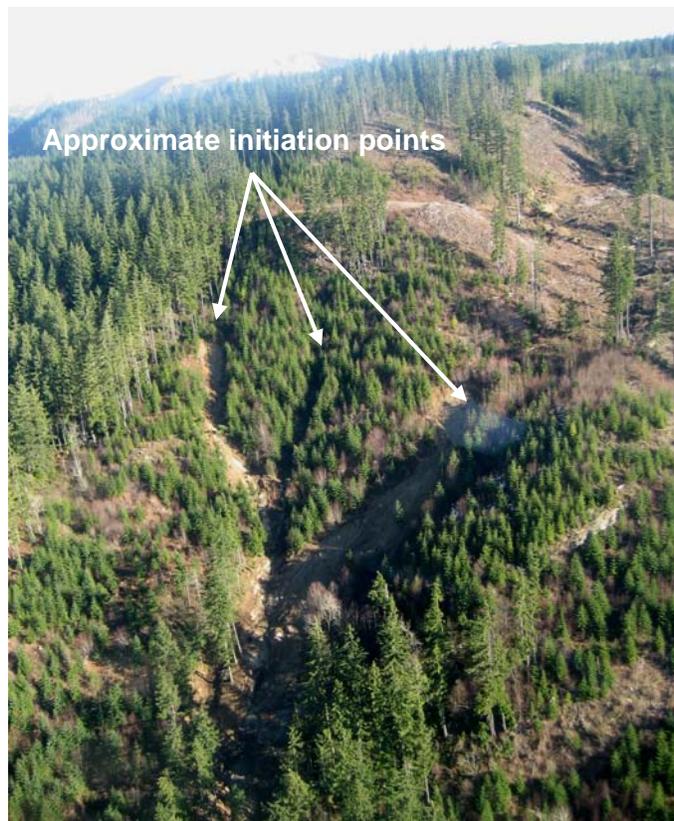
Figure 9. Oblique aerial photograph taken January 20th, 2009 showing the three landslides that initiated in the “TAT” timber sale that was harvested circa 1992. These landslides coalesced into a debris flow that impacted properties along Nelson Road. Part of the DNR “Jack Straw Aerial” timber sale is visible in the upper right portion of the photo. Photo credit: D. Hooks.

Because the trees surrounding the four landslide initiation points described above were cut, it is possible the harvesting contributed to landslide initiation. Tree removal at the landslide sites probably led to reductions in root strength. Tree roots provide lateral reinforcement and vertical anchoring of shallow soils and root decay can reduce soil shear strength and resistance to failure. Once trees are removed, root strength associated with the harvested trees begins declining while the regenerating forest is adding root strength. The net effect is a reduction in overall root strength for several years following harvest, with root reinforcement reaching a minimum about seven years after trees are cut (Figure 10). The timing of the TAT and Strand Extension harvests 16 and 21 years ago, respectively, suggests that root strength, while increasing, was probably not fully recovered at either site at the time the landslides occurred.

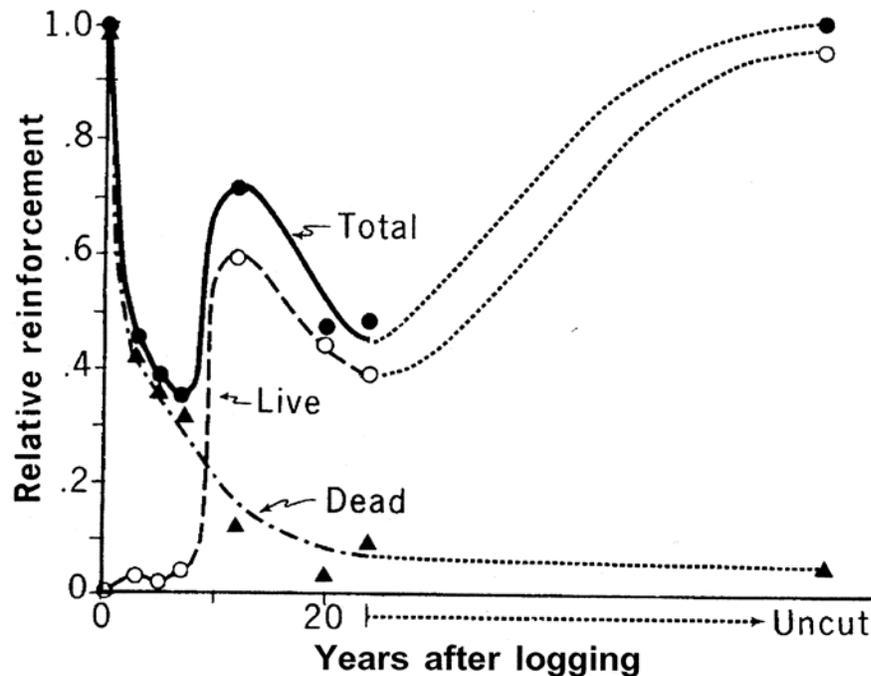
Figure 10. Relative soil reinforcement by tree roots from a study in northwestern California. Soil reinforcement by live roots generally increases while that of dead roots rapidly decreases with increasing time after timber harvesting. The total reinforcement by live and dead roots drops to a low point about seven years after harvesting (from Ziemer 1981).
