WASHINGTON STATE EARTHQUAKE HAZARDS

by
LINDA LAWRENCE NOSON, ANTHONY QAMAR,
AND GERALD W. THORSEN

WASHINGTON DIVISION OF GEOLOGY AND EARTH RESOURCES
INFORMATION CIRCULAR 85

1988

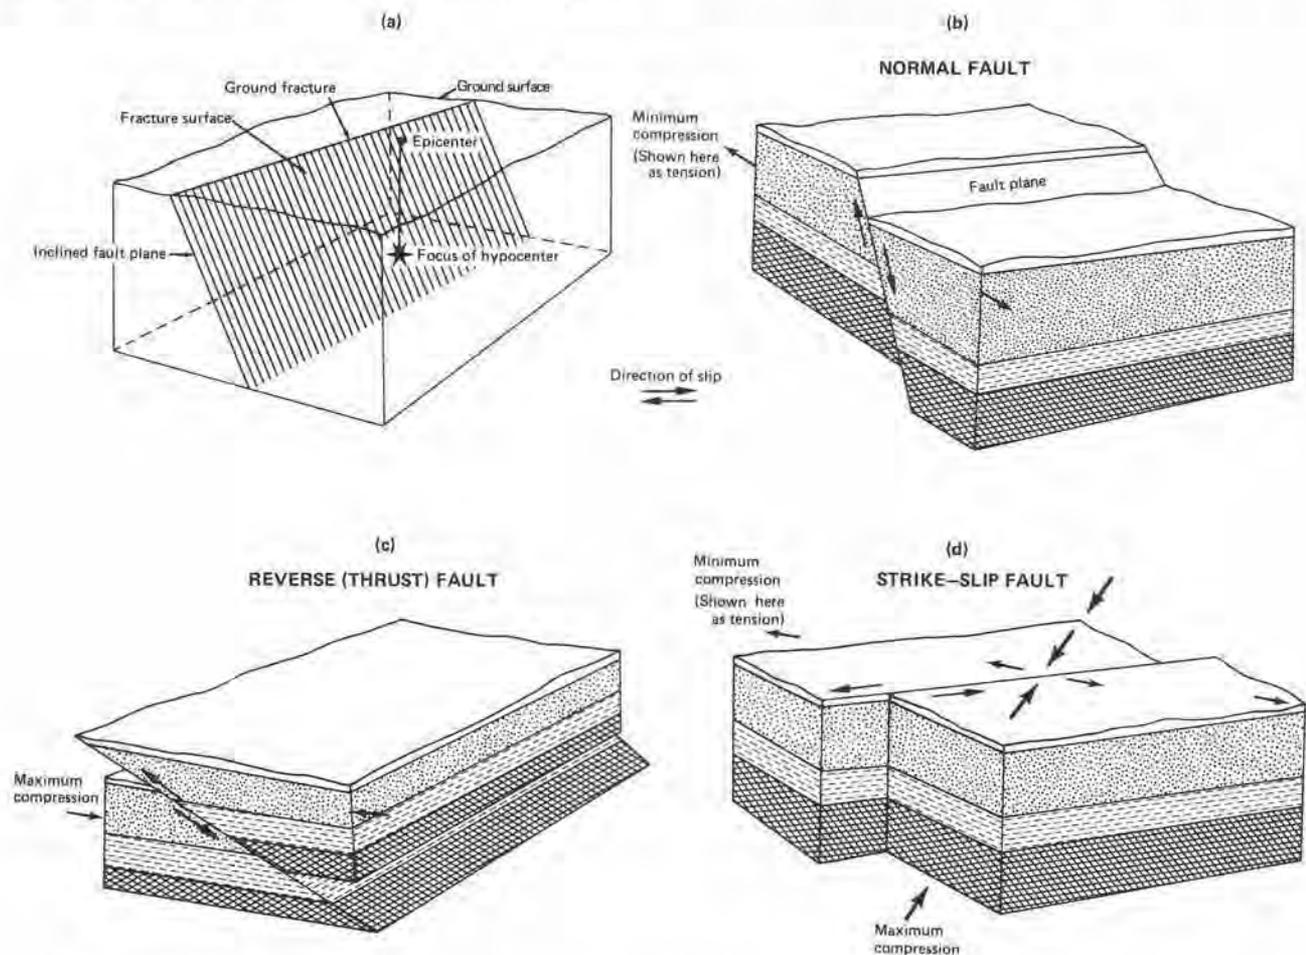
Figure 1. Block diagrams of fault types. (a) An earthquake is caused by the sudden fracturing of rock along part of a fault surface, shown here as a plane. If the fault reaches the surface, a visible ground fracture is created. The **focus** or **hypocenter** is the point on the fault plane where fracturing begins. The **epicenter** is the point on the ground surface directly over the focus. If the fault plane is inclined, the position of the epicenter will not coincide with the ground fracture. Simple fault motions are shown in (b), (c), and (d); directions of compressive stress are indicated. In a normal fault, (b), adjacent blocks of rock behave as if they were being pulled apart; the upper block slides downward along the fault relative to the other. In a thrust fault, (c), the blocks behave as if they were being pushed together; the upper block rides up the fault plane. In a strike-slip fault (d), one block moves horizontally past the other. Oblique motion of the blocks (not illustrated) combines thrust or normal fault motion with strike-slip motion. From an analysis of the seismic waves generated by an earthquake, called a **fault-plane solution**, scientists can determine the type of fault motion that occurred.

An **earthquake** is the shaking of the ground caused by an abrupt shift of rock along a fracture in the Earth, called a **fault** (Fig. 1). Within seconds, an earthquake

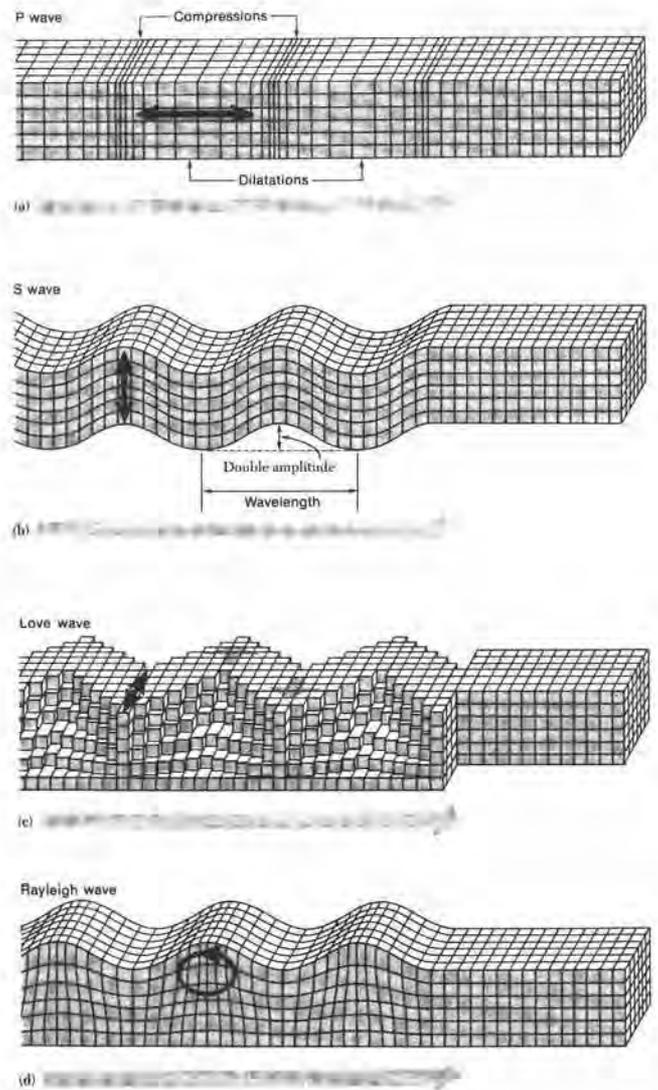
Figure 2. Diagrams of near-surface ground motions produced by seismic waves. The P and S waves, (a) and (b) respectively, travel through the earth in all directions from the focus of the earthquake; the first wave to reach an observer during an earthquake is the P wave. Two types of surface waves shown in (c) and (d), travel along the ground surface, somewhat like water waves, and arrive after the S waves. The direction the wave travels is indicated by the arrow below each diagram; the direction of ground movement caused by each wave is indicated by the solid arrows on the diagrams. P and S waves cause the ground to vibrate in mutually perpendicular directions. (Modified from "Earthquakes" by Bruce A. Bolt. Copyright ©1978, 1988 W.H. Freeman Company. Reprinted with permission)

Earthquakes generate several kinds of seismic waves that vibrate the ground (Fig. 2). These seismic waves travel through the Earth at speeds of several kilometers per second, and they cause ground motions that can be detected by **seismographs** (or by **accelerographs**) far from the **epicenter** of the earthquake. In 1987, the University of Washington was operating more than 100 seismograph stations in Washington and northern Oregon (Fig. 3). Several thousand seismographs are operated throughout the world by other groups of seismologists.

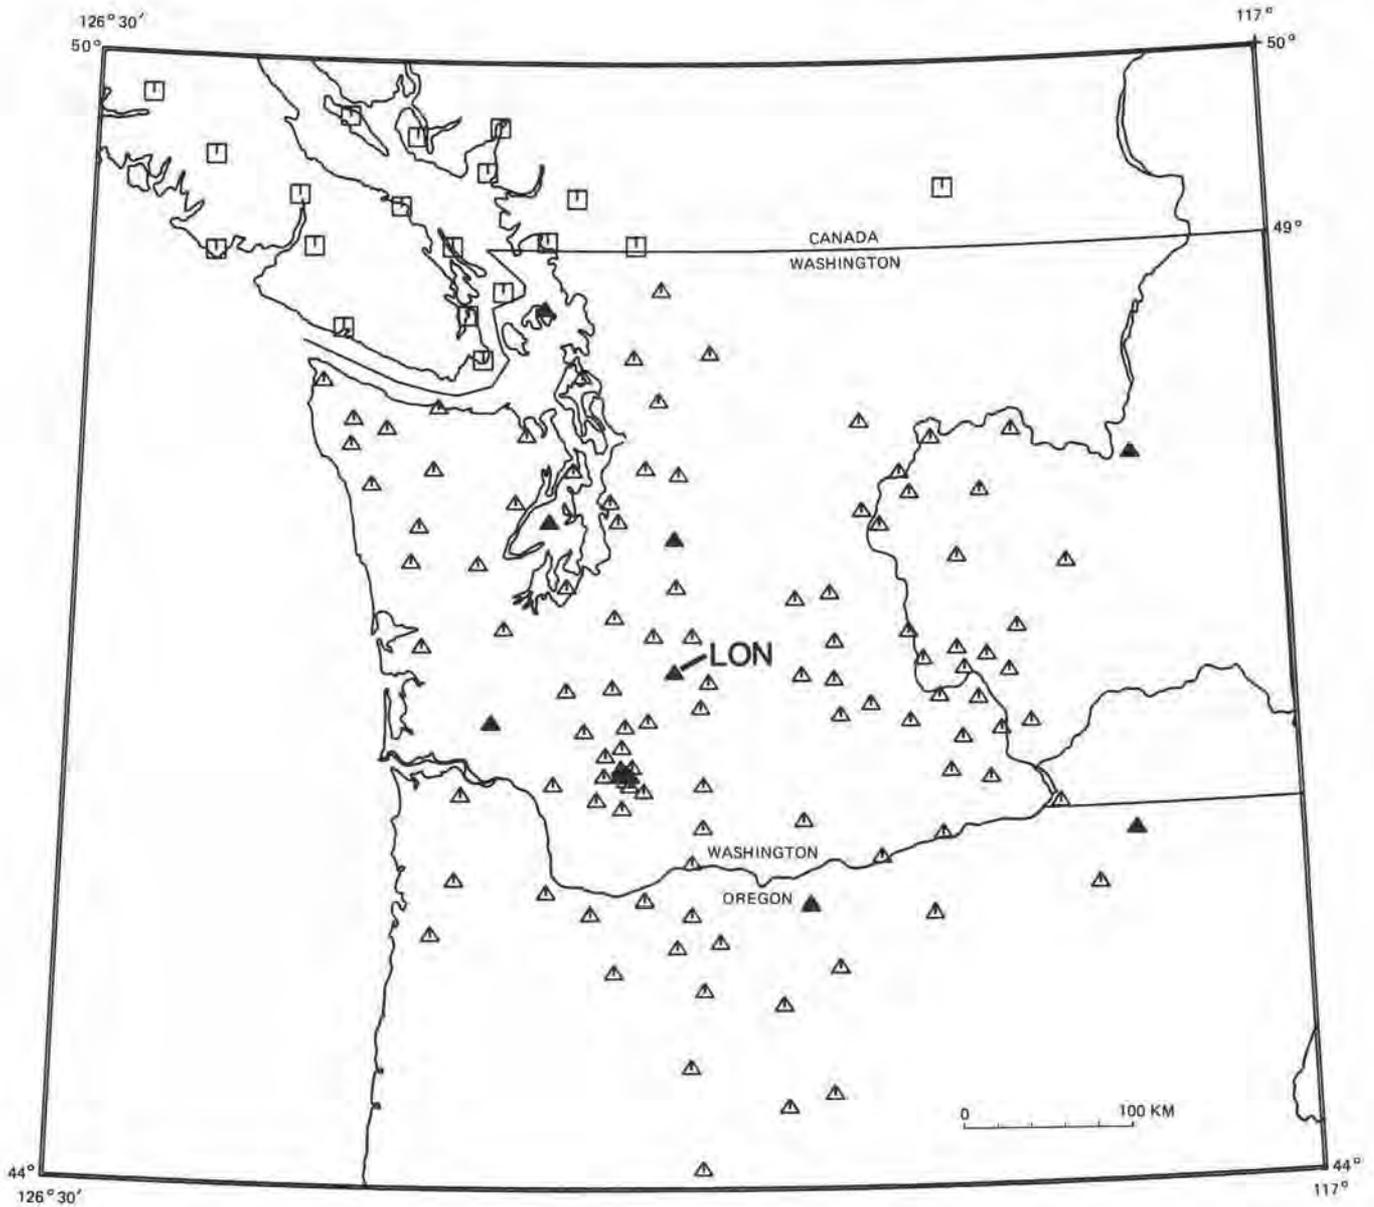
Figure 3. Active seismograph stations in the Pacific Northwest in 1987. Stations operated by the University of Washington are shown as triangles, Canadian stations as squares. Seismic signals from the University's stations are received in Seattle. Signals from stations shown as solid triangles are also transmitted to the National Earthquake Information Service in Golden, Colorado. Station LON, at Mount Rainier, is part of an international recording system known as the World Wide Standard Seismograph Station Network (WWSSN). At LON six seismometers measure the various kinds of seismic waves shown in Figure 2.

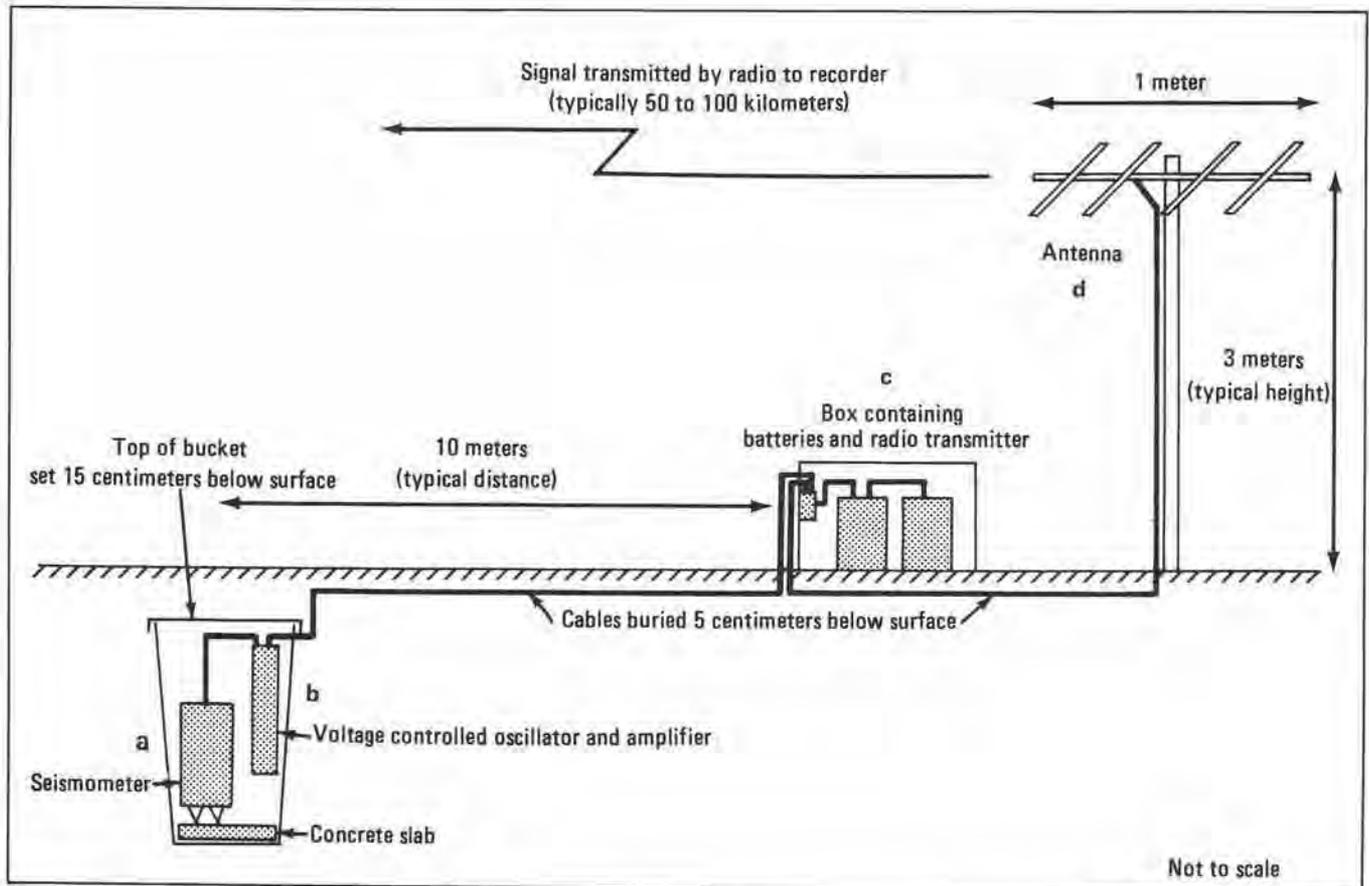
Figure 4. Components and dimensions of a typical remote seismograph station, similar to stations located on Figure 3. The seismometer (a) converts small ground motions into an electric signal that has varying voltage. An amplifier and a voltage-controlled oscillator amplify this signal and convert it to a frequency-modulated (FM) tone. The radio transmitter (c) and the antenna (d) transmit the tone signal to the recording site.

Typical components of a modern seismograph station are shown in Figure 4. The signals produced by the seismographs in response to ground vibrations from an earthquake are commonly recorded on paper and magnetic tape. The display of ground motion versus time on a paper record is called a **seismogram** (Fig. 5). Seismographs can detect ground motions caused by sources other than earthquakes, such as explosions, volcanic eruptions, sonic booms, helicopters, and cars. Each of these sources can generally be identified from their characteristic signals recorded on seismograms.

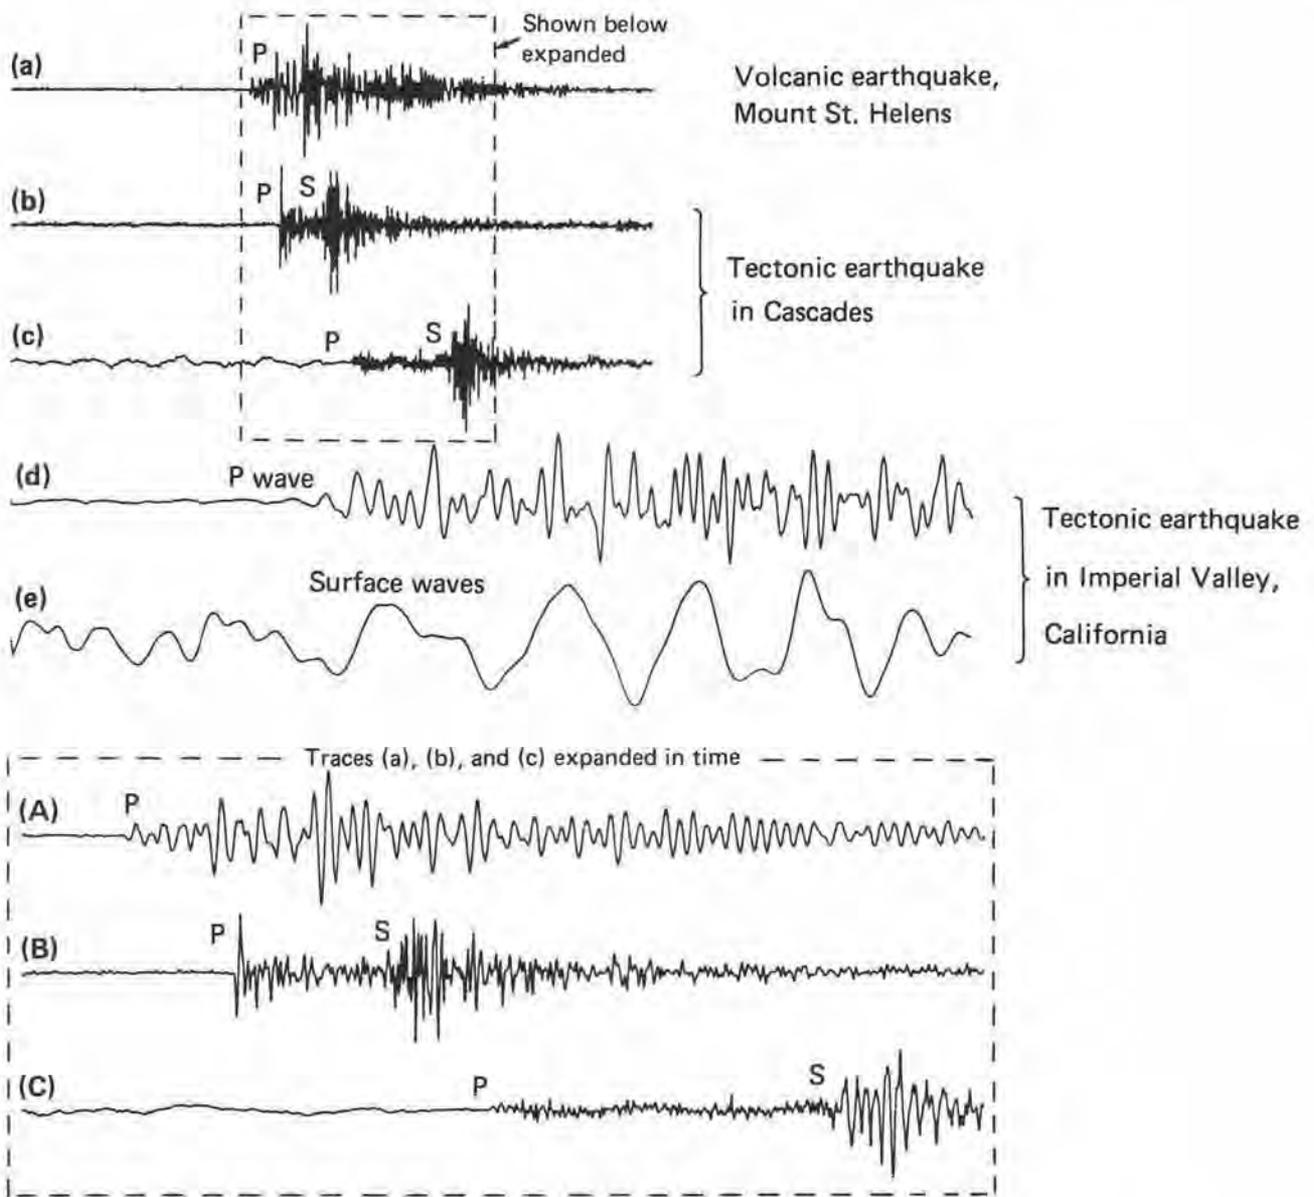
Figure 5. Seismograms (a) through (e) were recorded by stations in Washington and Oregon and illustrate the range of ground motion frequencies commonly recorded. The seismometers that recorded these motions are similar, and all had natural periods of 1.0 second. The seismograms for (a), (b), and (c) are expanded as (A), (B), and (C) in the lower part of the figure. P and S waves are marked on all seismograms. (a) Seismogram of a small (magnitude 1.2) volcanic earthquake at Mount St. Helens on November 23, 1987. The focus was less than 1 km below the surface, and the epicenter was less than 1 km from the station. (b) and (c) Seismograms of a magnitude 0.9 earthquake in the Cascade Range on November 18, 1987. The focus was at a depth of 17 km, and the epicenter was 13 km from the station that recorded (b) and 47 km from the station that recorded (c). (d) and (e) Seismograms from a magnitude 6.3 earthquake in the Imperial Valley of California on November 24, 1987 (d) shows the P wave as recorded at a station in northern Oregon, 1427 km from the epicenter. (e) shows the surface waves, which have lower frequencies, recorded at the same station. The surface waves arrived about 5-1/2 minutes after the P waves.

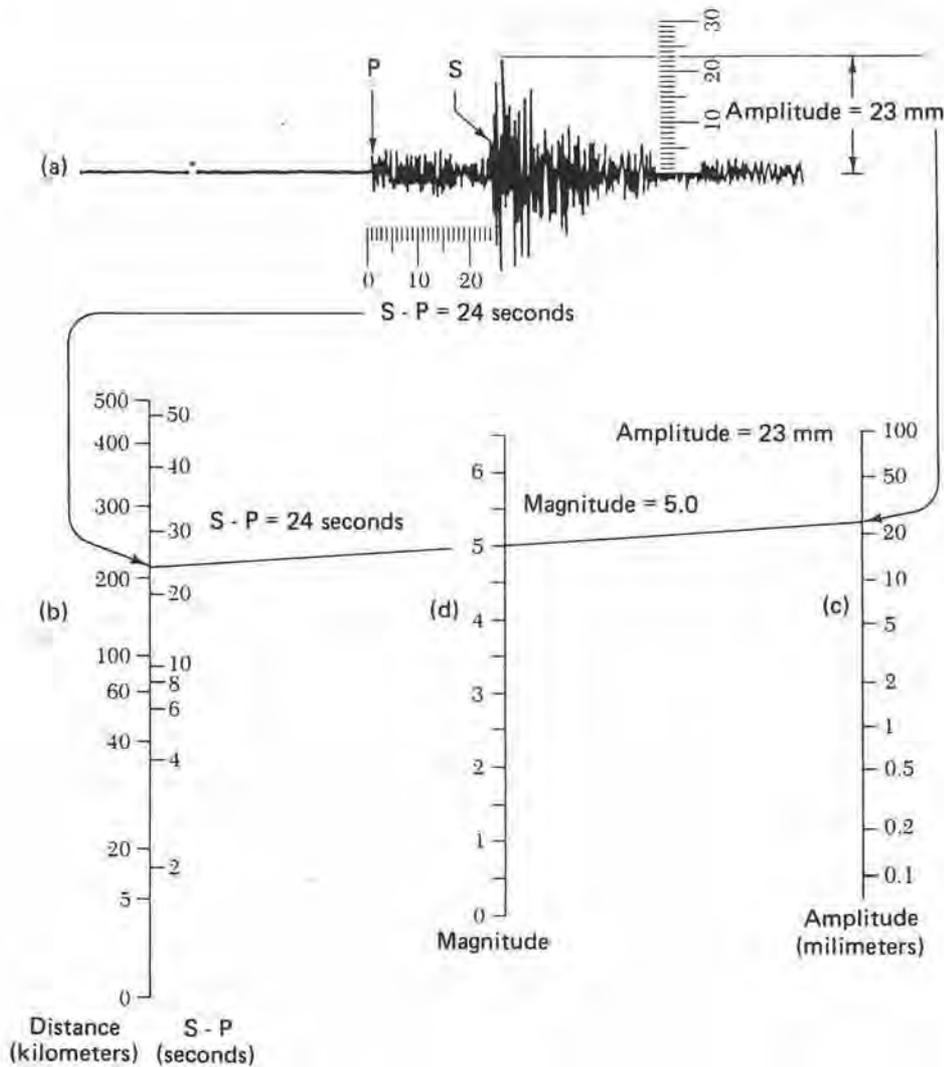
Figure 6. A method for calculating the epicentral distance and magnitude of a local earthquake (M_L) from the wave amplitude recorded on a seismogram. The seismograph that recorded this seismogram is a standard Wood-Anderson seismograph. In this example, the ruler below the seismogram in (a) indicates the time in seconds between the arrivals of the P and S waves; here, $S - P = 24$ seconds. This difference between arrival times can be used to calculate the distance between the epicenter and the recording station. The arrival-time difference is shown on the vertical scale (b) and corresponds to an epicentral distance of about 214 km. The amplitude of the seismic waves, 23 mm, is measured on the vertical scale in (a); this measurement is noted on the vertical scale (c, on the right). The magnitude is determined by drawing a line that connects the points on vertical scales (b) and (c). This line passes through 5 on vertical scale (d), corresponding to a magnitude of 5.0 (Modified from "Earthquakes" by Bruce A. Bolt. Copyright ©1978, 1988 W. H. Freeman and Company; reprinted with permission)

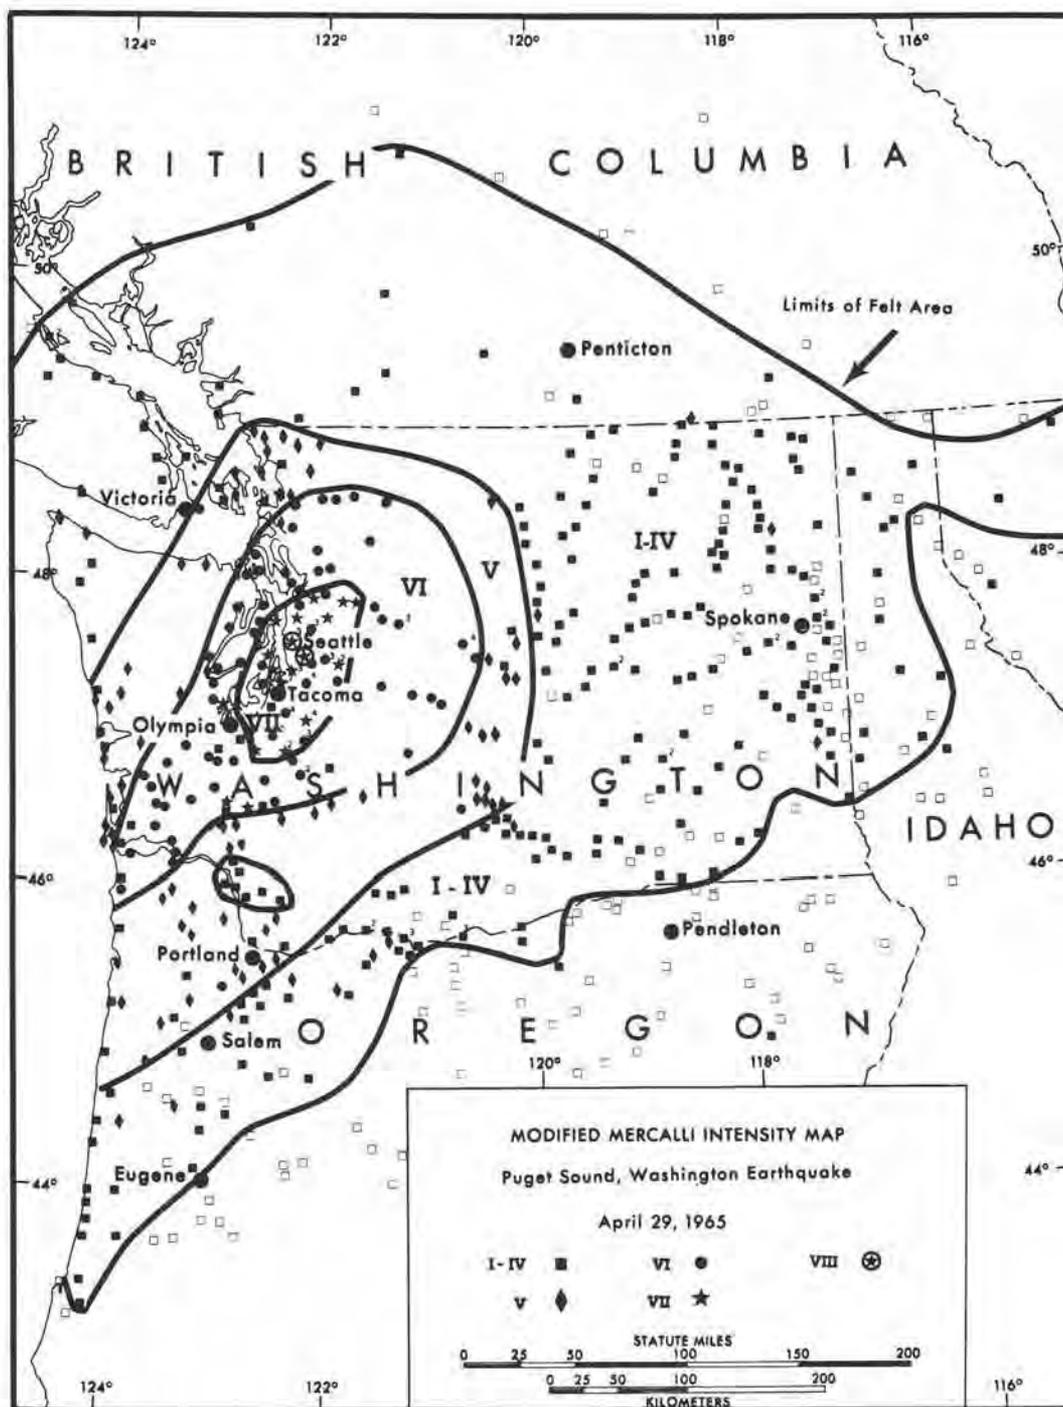
Figure 7. Isoseismal map for the Seattle-Tacoma earthquake of April 29, 1965. The lines enclose areas of equal intensity as designated on the Modified Mercalli Intensity Scale (Table 1). (From Algermissen and Harding, 1965)

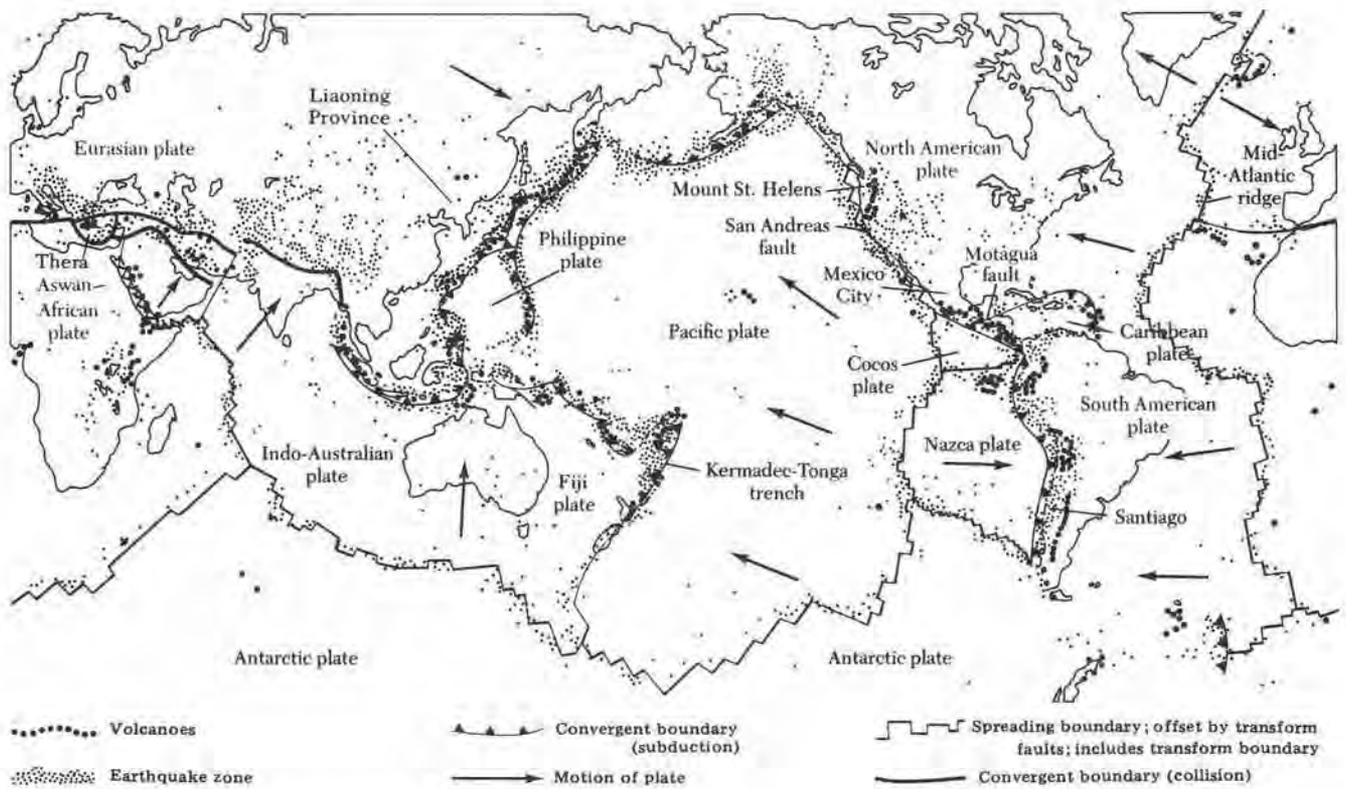
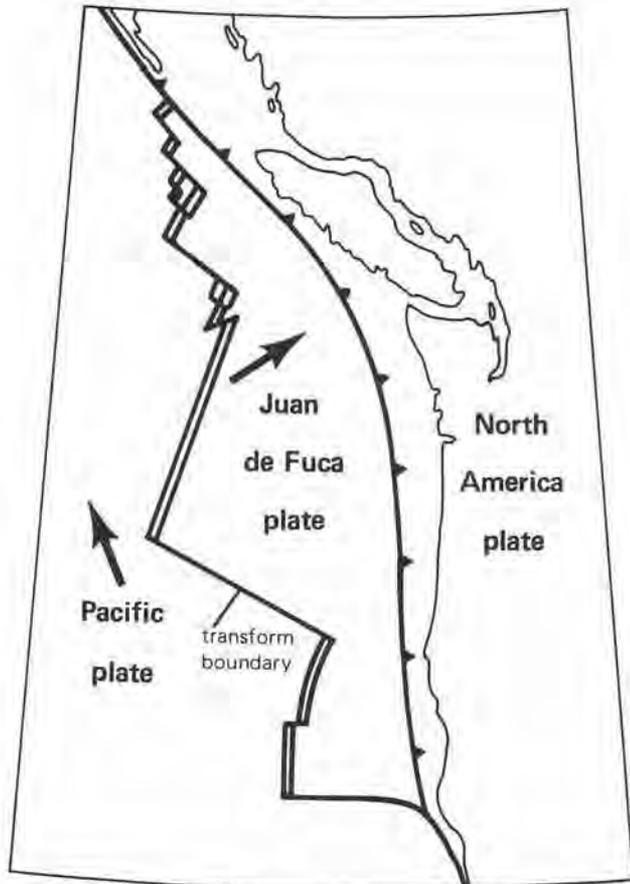
Figure 8. Relation between major tectonic plates and earthquakes. The Earth's surface is made up of 10 major plates and several smaller plates. Most earthquakes occur along plate margins. Small dots represent earthquake epicenters; large dots indicate locations of volcanoes. An enlargement (left) shows tectonic plates along the Pacific coast of North America. Arrows show motions of the Pacific and Juan de Fuca plates relative to North America. (World plate map from "Earthquakes" by Bruce A. Bolt. Copyright ©1978, 1988 W. H. Freeman and Company. Reprinted with permission; the explanation has been modified)

The **plate tectonics** theory is a starting point for understanding the forces within the Earth that cause earthquakes. **Plates** are thick slabs of rock that make up the outermost 100 kilometers or so of the Earth (Fig. 8). Geologists use the term tectonics to describe deformation of the Earth's crust, the forces producing such deformation, and the geologic and structural features that result.

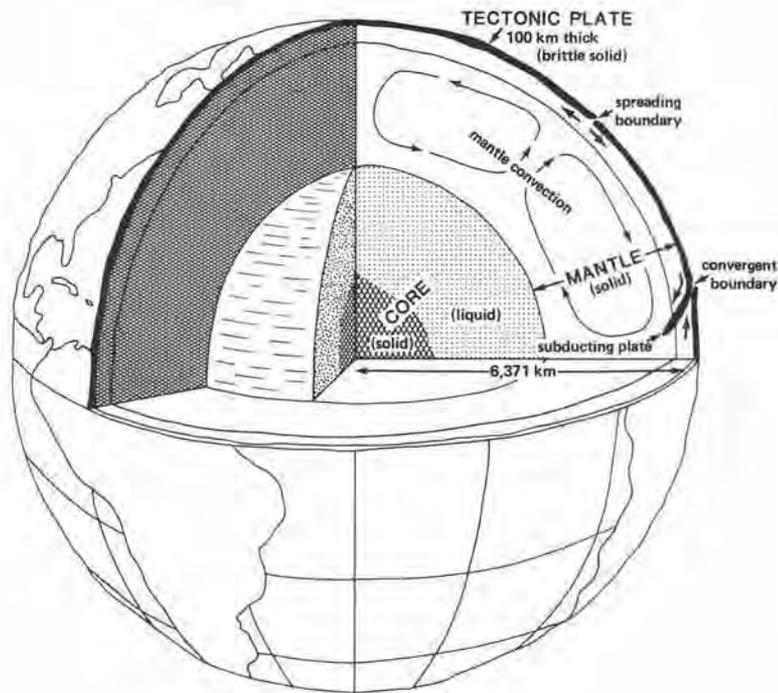
Figure 9. Cutaway view of the Earth showing the rocky mantle and iron core. The outermost layer consists of tectonic plates that are commonly about 100 km thick. Earthquakes occur within or at the boundaries of these plates. Although the mantle is solid, the rocks that comprise it act like a very viscous liquid and may move a few centimeters a year in great convection cells driven by temperature differences in the Earth. The plates move slowly with these currents. Spreading plate boundaries are thought to lie above areas of upwelling currents, and converging plate boundaries above areas where the currents move towards the center of the Earth. (See also Figure 10.)

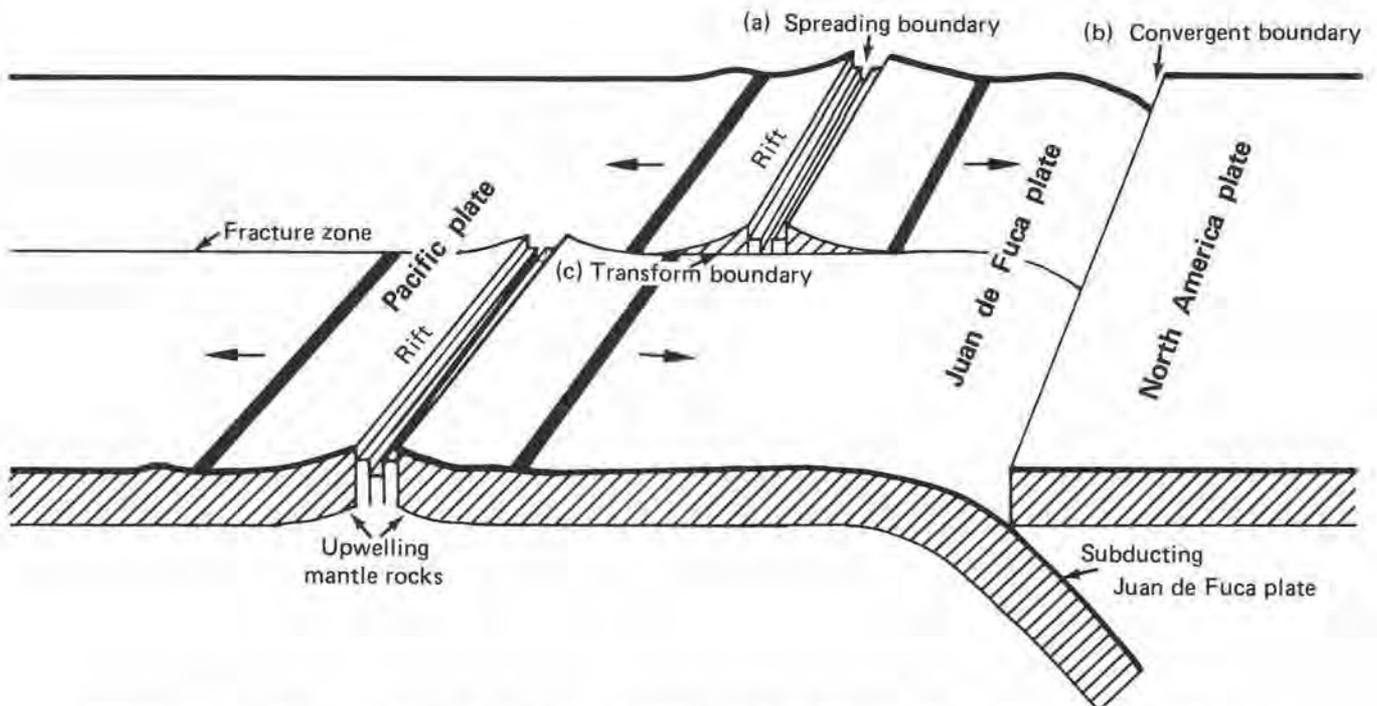
Figure 10. Three types of plate boundaries. A spreading boundary (a) marks the divergence of two plates. Material welling up from the mantle creates a rise or ridge bordering the rift between separating plates. A convergent boundary (b) occurs where one plate moves towards another. If one of these plates slides beneath the other, the motion is called subduction. A transform boundary (c) occurs where relative plate motion is neither divergent or convergent, but is parallel to the plate edges. The geometry of plates off the coast of Washington is schematically shown in this figure; plate locations are shown in Figure 8.

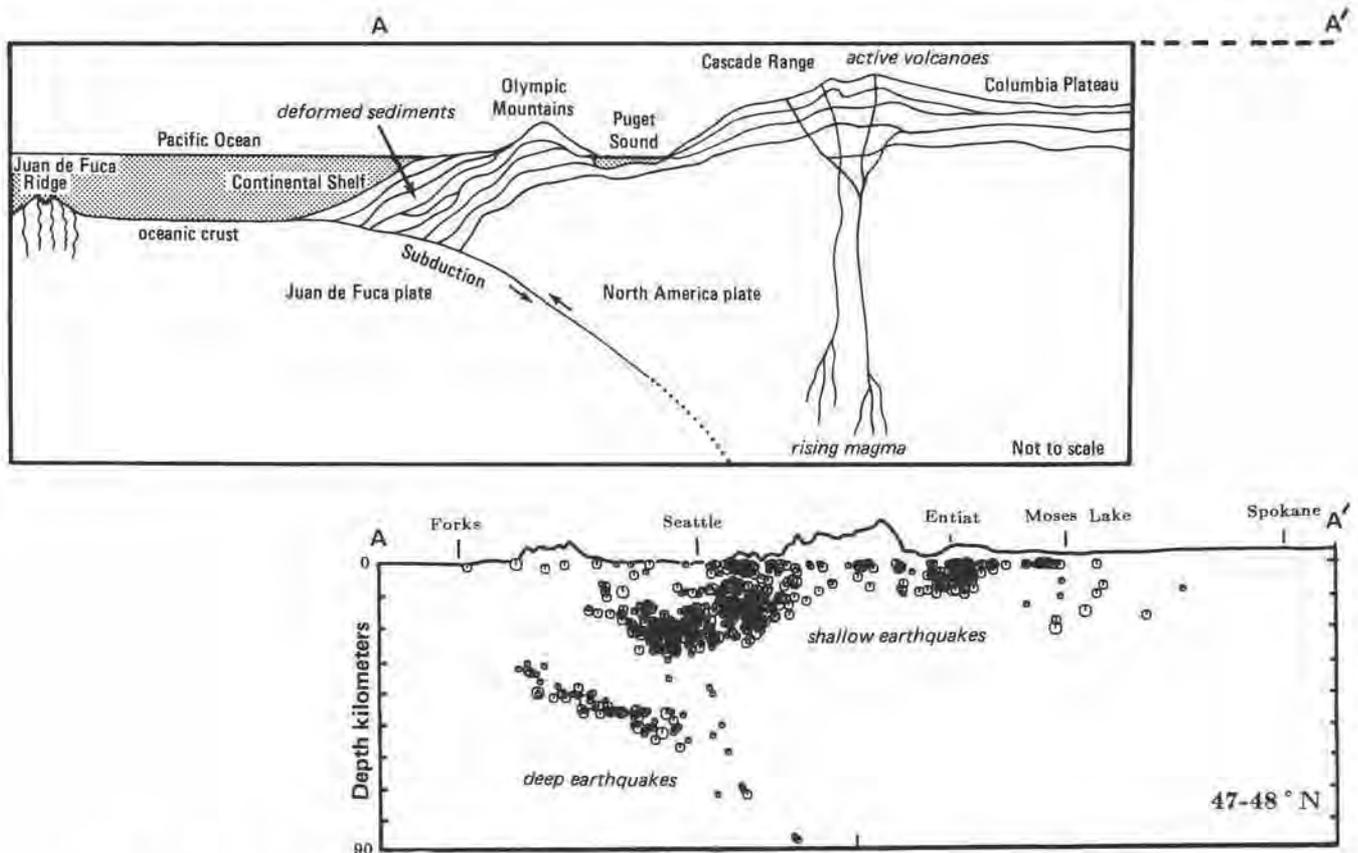
Figure 11. Cross sections of Washington showing plate convergence (top figure) and earthquake hypocenter locations. Some major topographic features and underlying geologic structures of Washington are shown diagrammatically in the upper figure. In the lower figure, selected hypocenters of earthquakes that occurred in 1982 through 1986 between latitudes 47° and 48° N are projected onto a vertical plane that generally corresponds to the diagram in the upper figure. Because of the great number of shallow earthquakes that occurred between 1982 and 1986, only hypocenters of those having magnitudes equal to or greater than 1.8 are shown in the lower figure. Below 30 km, hypocenters of all earthquakes having magnitudes of 1.0 or greater that occurred during this period are shown. The distribution of deep earthquakes indicates the slope of the zone of subduction. In the lower figure there is a vertical exaggeration of 2 to 1 below sea level; this creates the illusion that the subducting Juan de Fuca plate dips more steeply than it actually does. Topography indicated on the lower figure has a vertical exaggeration of 12 to 1.

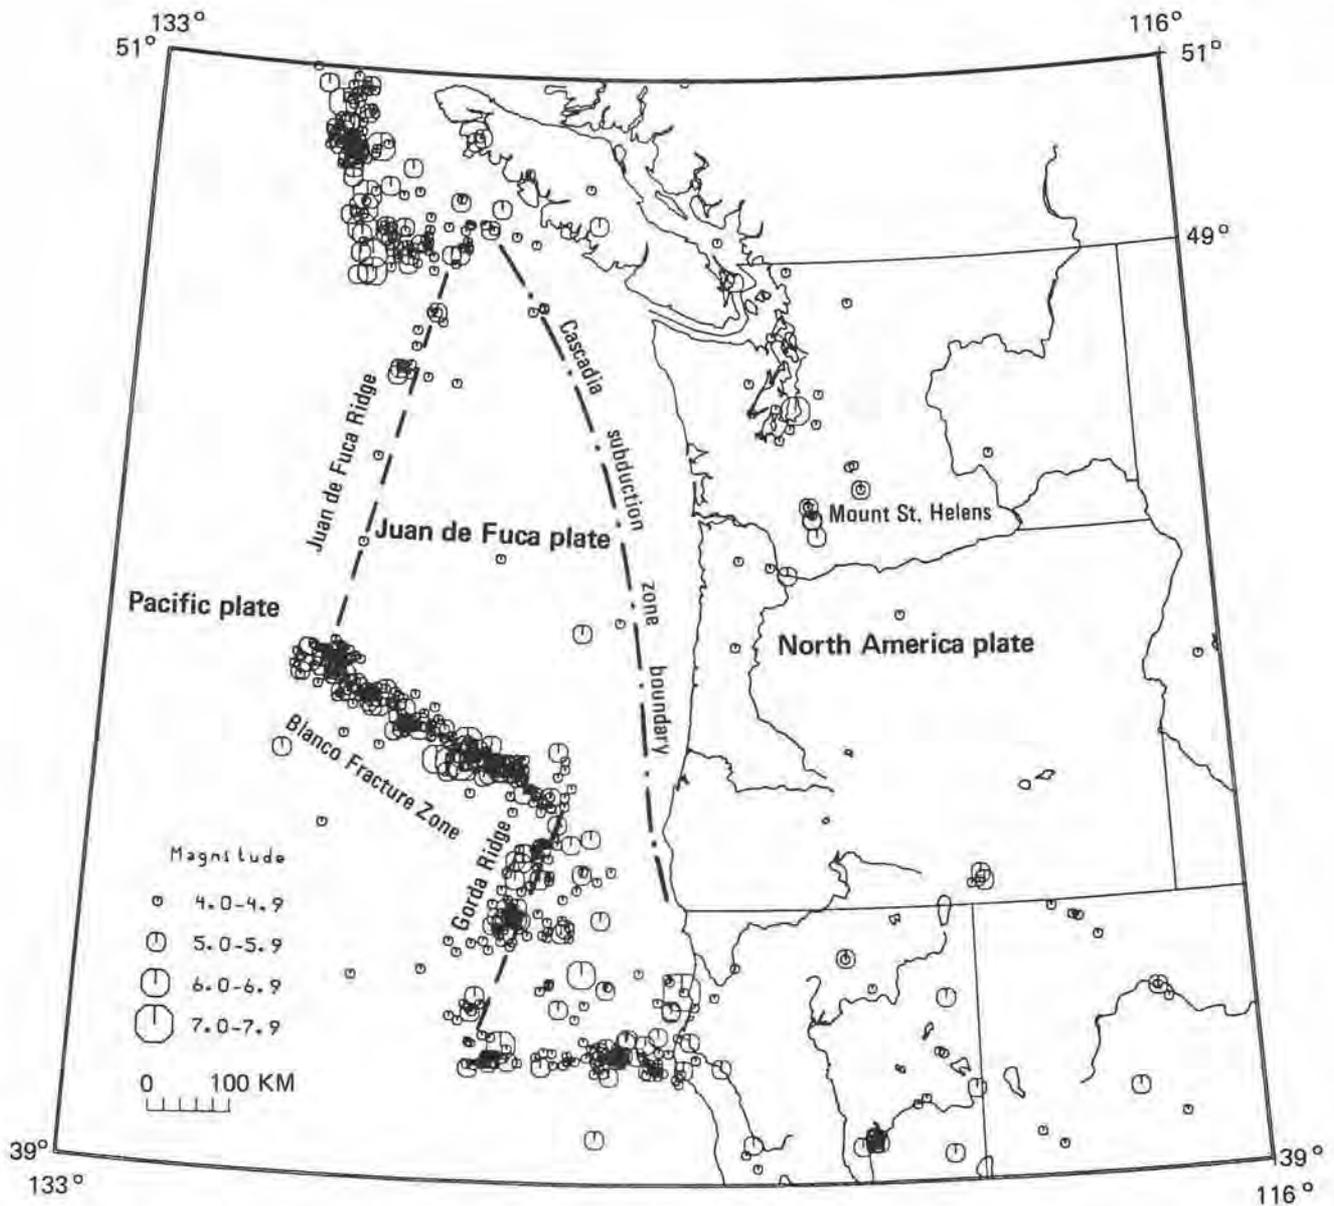
Figure 12. Epicenters of earthquakes in the Pacific Northwest since 1960. Only the largest earthquakes near Mount St. Helens are indicated. Note the position of the Cascadia subduction zone relative to Washington's coast and that epicentral locations mark plate boundaries shown in Figure 8. (Data from the National Oceanic and Atmospheric Administration and the University of Washington.)

The major plate boundaries in the Pacific Northwest are graphically delineated by the locations of recent earthquakes (Fig. 12). Narrow zones of shallow offshore earthquakes result from the movement of the Juan de Fuca plate relative to the Pacific plate, particularly along transform boundaries such as the Blanco Fracture Zone off the coast of Oregon. As expected, a few shallow offshore earthquakes occur along the Juan de Fuca Ridge, a **spreading boundary** between the Juan de Fuca and Pacific plates. Scattered earthquakes occur to the east in Washington, Oregon, and northern California, both in the subducting Juan de Fuca plate and in the overlying North America plate.

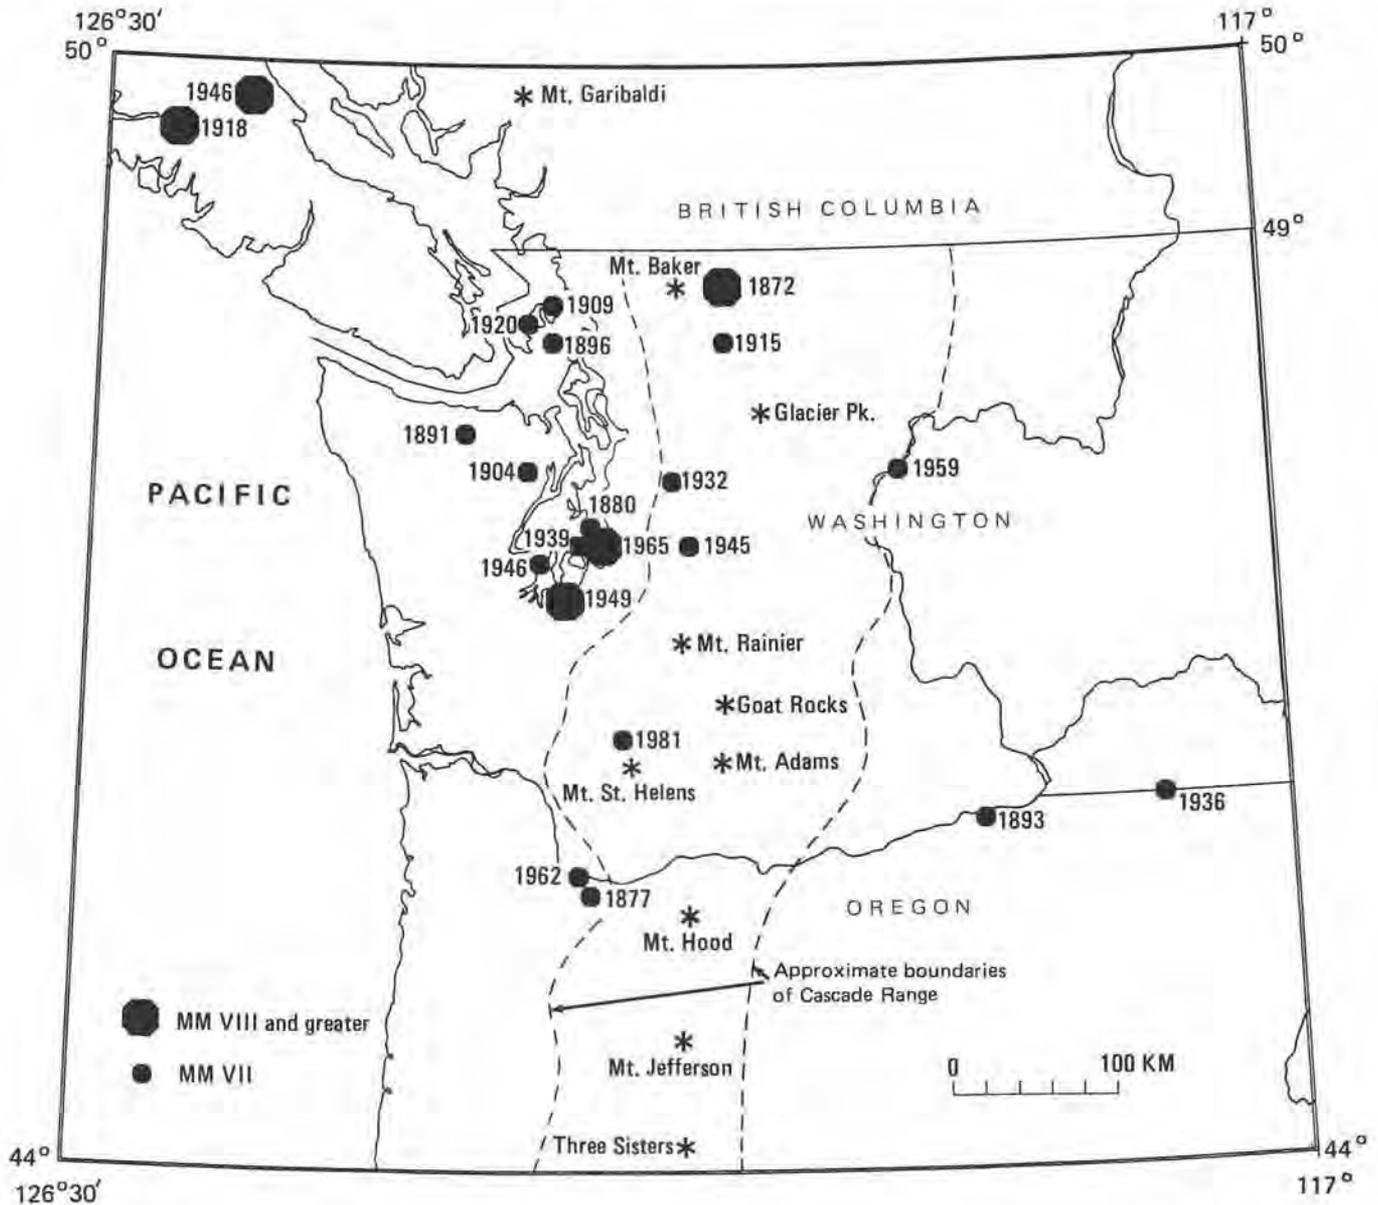
Figure 13. Epicenters and dates of the largest Pacific Northwest earthquakes that occurred between 1872 and 1987. The large symbols are epicenters of earthquakes whose maximum intensities were reported as VIII or greater on the Modified Mercalli Intensity Scale (MM) (Table 1); smaller symbols are MM intensities of VII. The locations of principal volcanoes in the region are also shown.

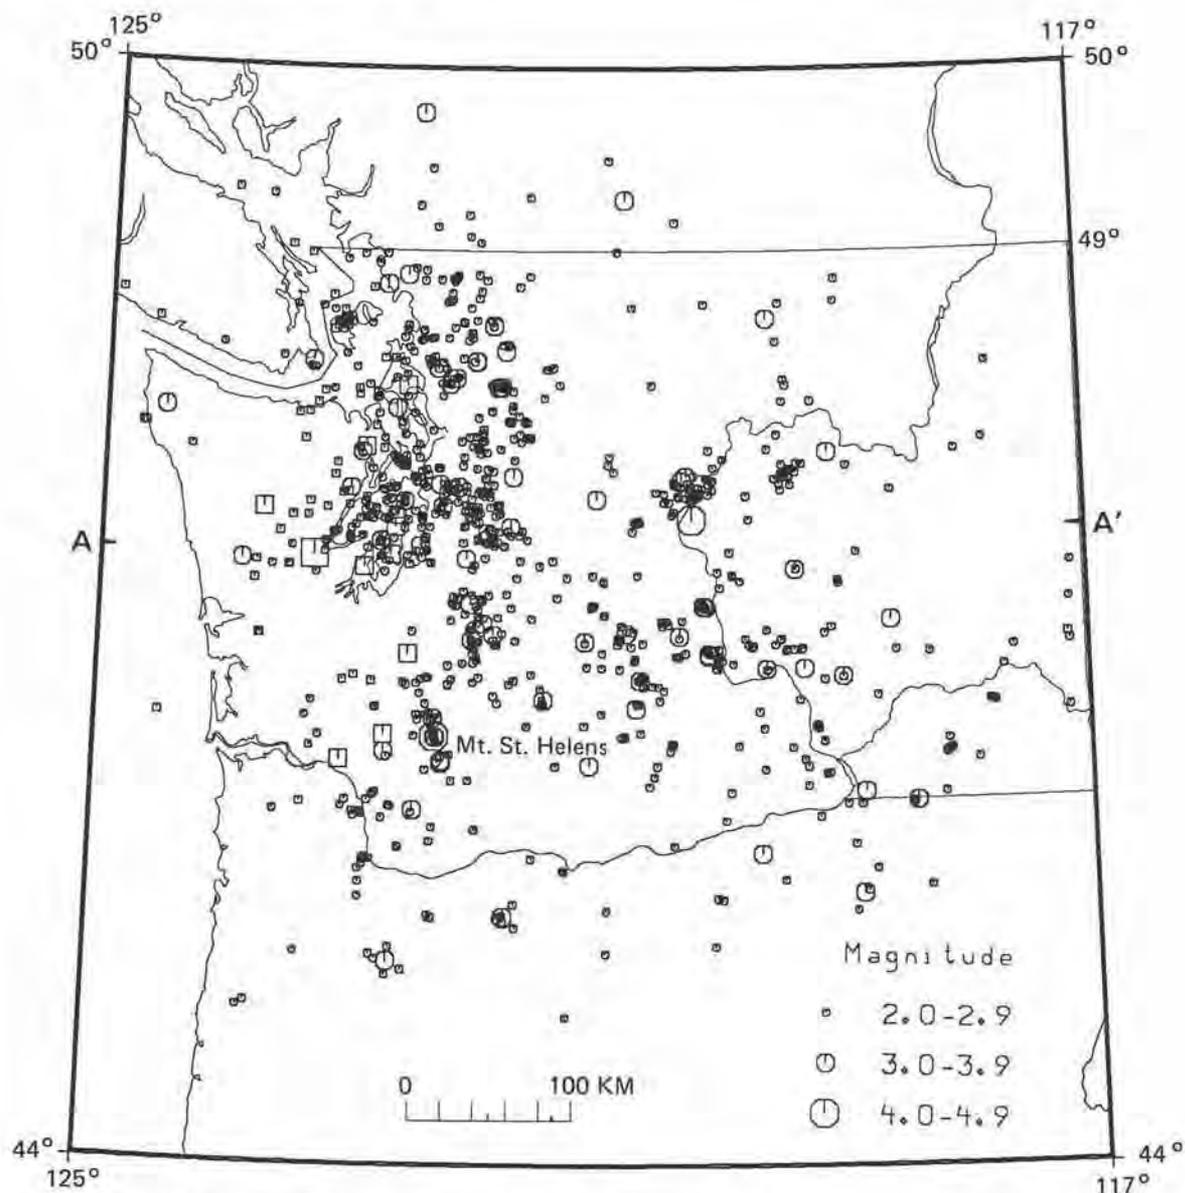
Figure 14. Washington earthquakes recorded from 1982 to 1987. Epicenters are shown for earthquakes having magnitude $M_c \geq 2.0$. Earthquakes deeper than 30 km are shown as squares. Only the largest earthquakes in the Mount St. Helens region are shown for clarity. Points A and A' are the endpoints of the vertical cross section shown in Figure 11b.
