WASHINGTON STATE EARTHQUAKE HAZARDS

by
LINDA LAWRENCE NOSON, ANTHONY QAMAR,
AND GERALD W. THORSEN

WASHINGTON DIVISION OF GEOLOGY AND EARTH RESOURCES
INFORMATION CIRCULAR 85

1988

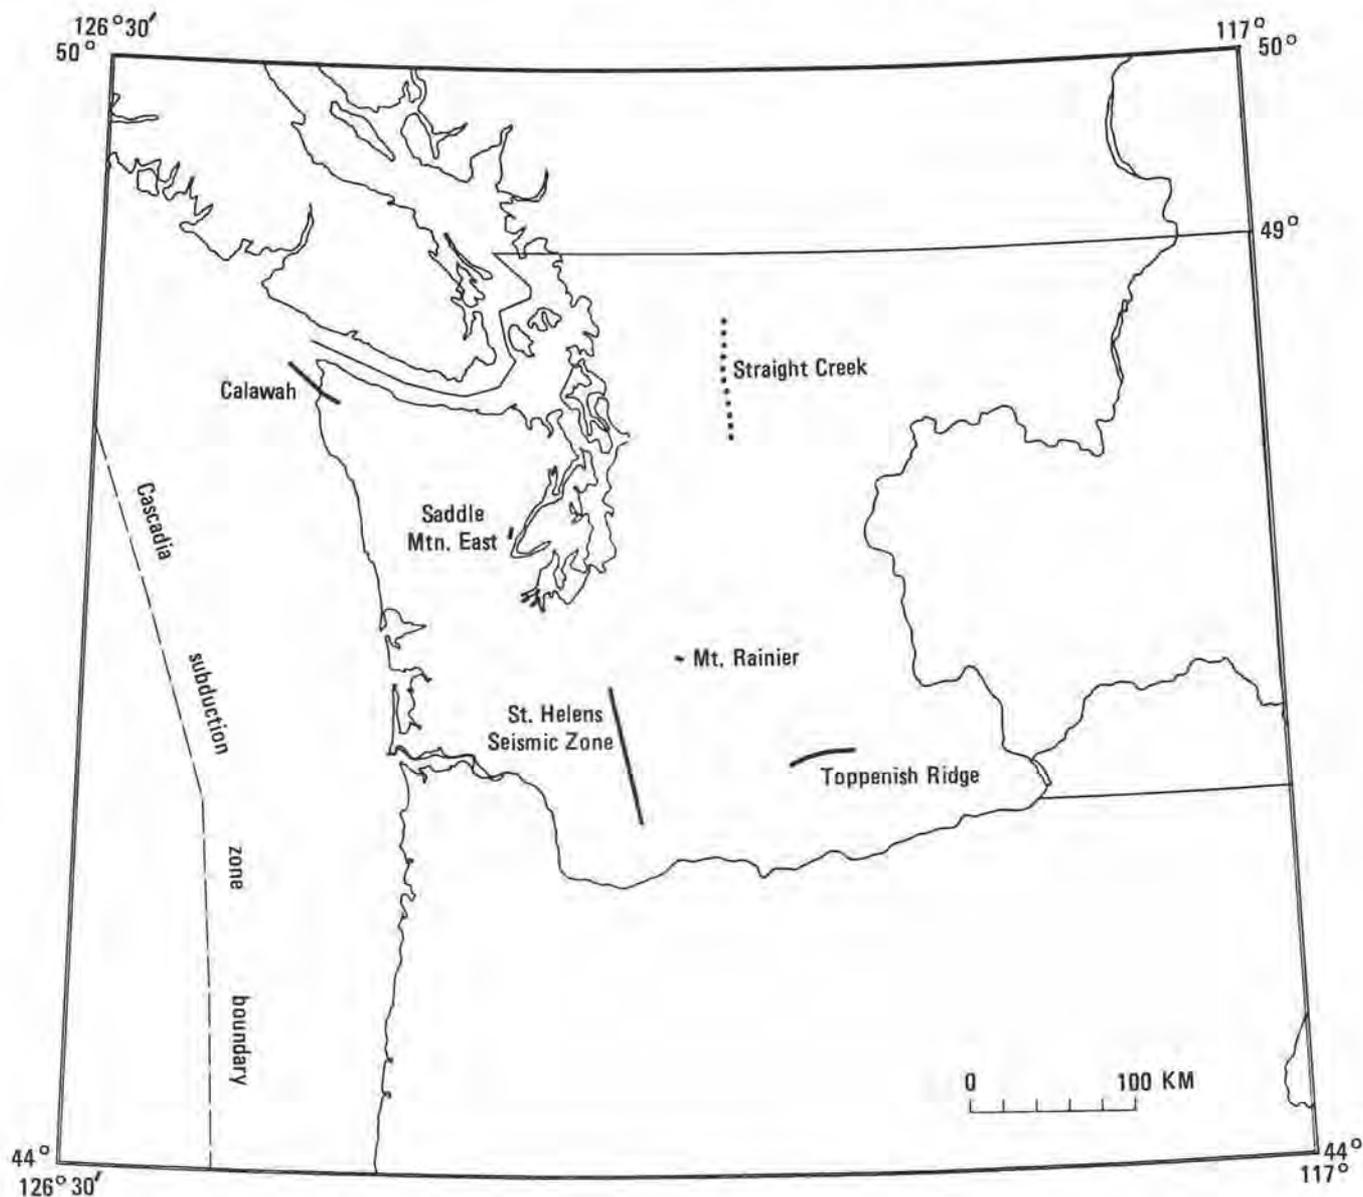
Figure 15. Faults in Washington that are known to be active or thought to have been active in the last 10,000 years. Solid lines indicate faults well documented by geologic or seismic data; dotted lines show faults of uncertain age thought to have been active in recent geologic time; dashed line shows the surface trace of the Cascadia subduction zone. Sources of information about the faults are tabulated below:

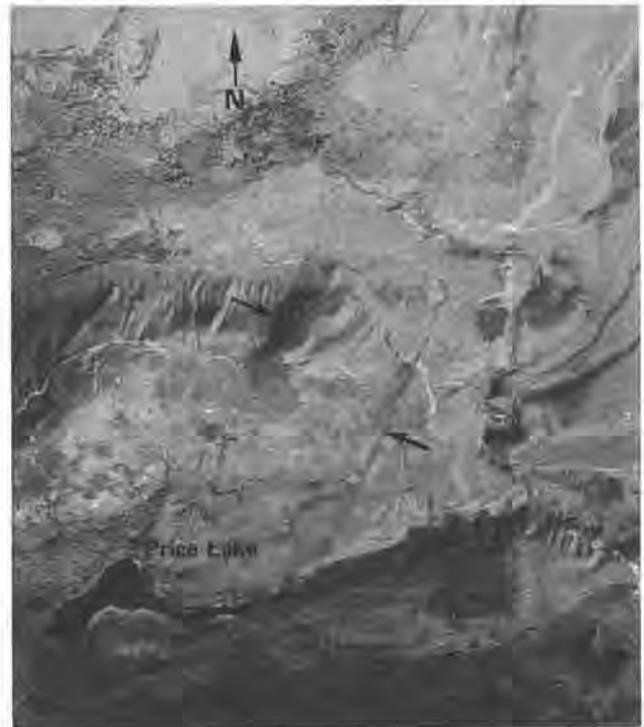
Figure 16. Aerial view of Saddle Mountain faults (arrows) near Lake Cushman, Olympic Peninsula. Note sag ponds. Price Lake was created by the damming of a stream by the upthrown east side of the east fault. (U.S. Geological Survey aerial photo GS J 6 31)

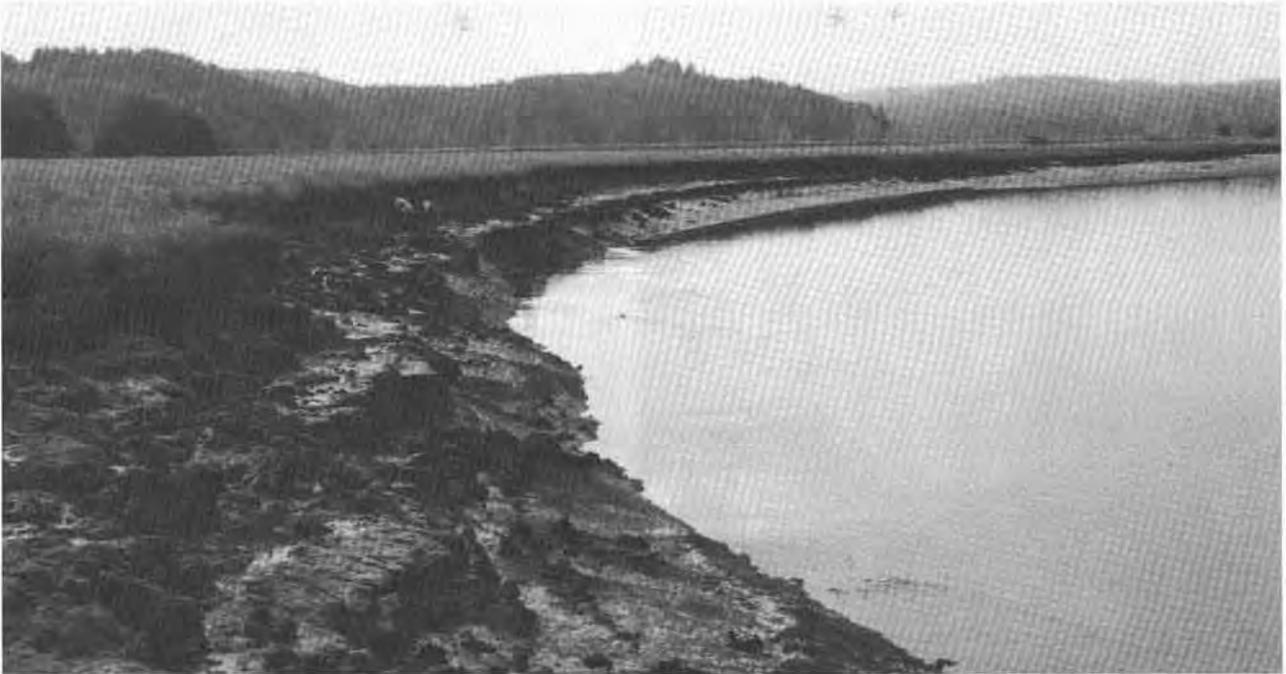
Figure 17. Evidence for subsidence of coastal southwestern Washington that was probably induced by earthquakes (Atwater, 1987, 1988). This buried, and now partially exhumed marsh is exposed at low tide along the Johns River, a tributary of Grays Harbor. The buried marsh, forming the lighter toned bench on which the people are standing, dropped 3 or more feet about 300 years ago. (Photo by B. F. Atwater)

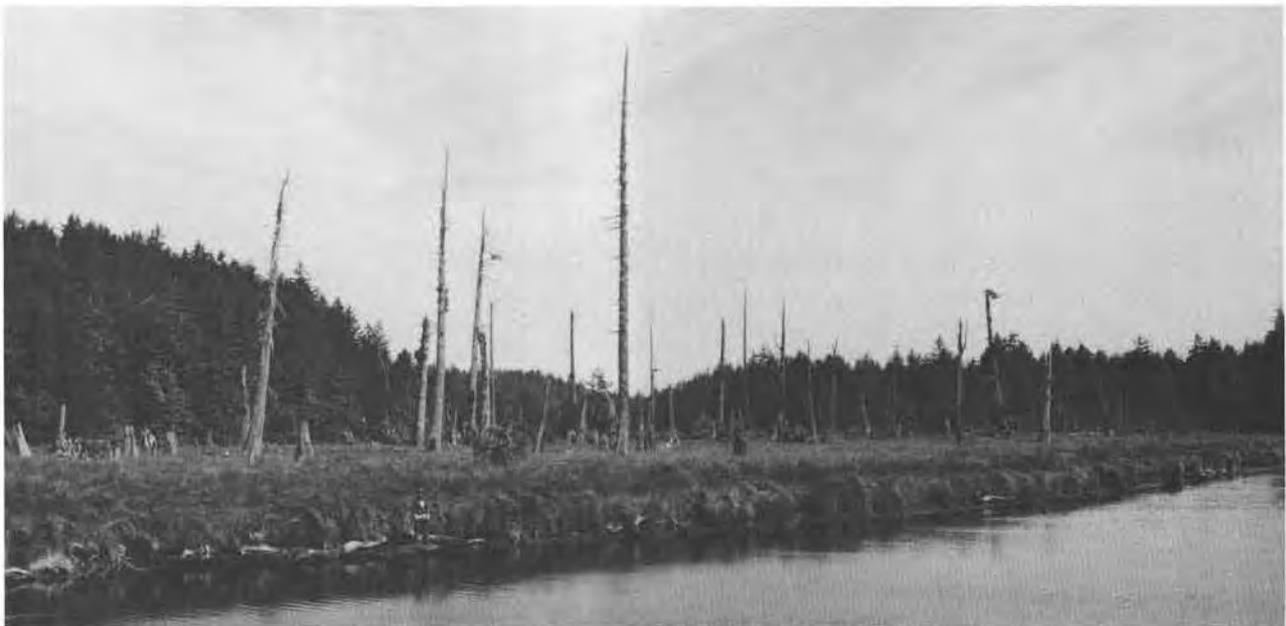
Figure 18. Evidence for subsidence of coastal southwestern Washington. A ghost forest of cedar snags protrudes through an intertidal marsh along the Copalis River. The man is standing on roots that mark the present level of the ghost forest floor. The forest was killed after being suddenly dropped into the intertidal zone about 300 years ago, perhaps at the same time as the subsidence of the marshland shown in Figure 17. (Photo by B. F. Atwater)

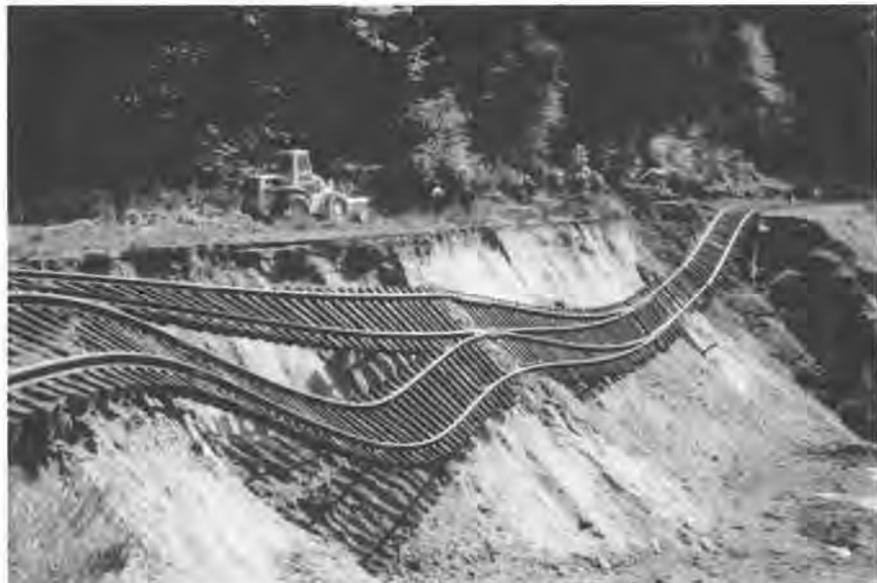
Figure 19. A hillside slid away from beneath this 400-ft section of a Union Pacific Railway branch line near Olympia during the 1965 Seattle-Tacoma earthquake. (Photo by G. W. Thorson)

Figure 19 shows damage that occurred in 1965 to a railroad line between Olympia and Tumwater.

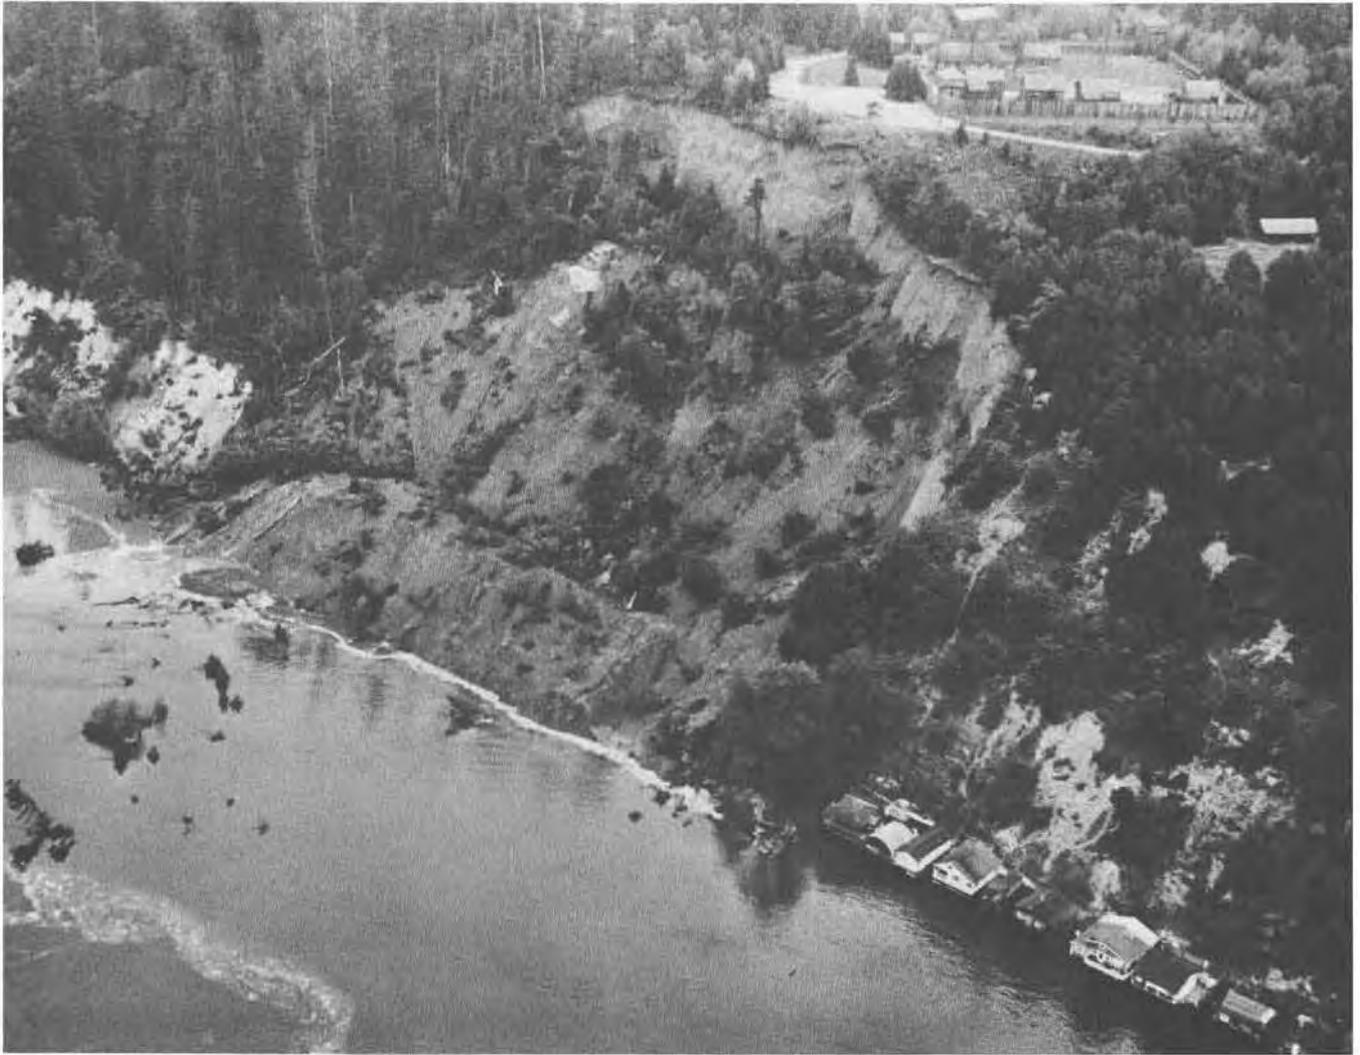
Figure 20. This ground failure was initiated by ground cracking adjacent to the banks of the Tacoma Narrows during the 1949 Olympia earthquake; the slide occurred several days after the earthquake. The landslide endangered nearby homes and induced strong waves in the Narrows. (By permission of Wide World Photos, Inc., and Associated Press)

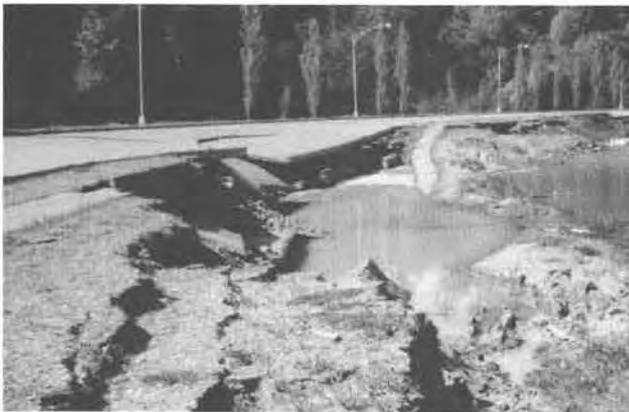
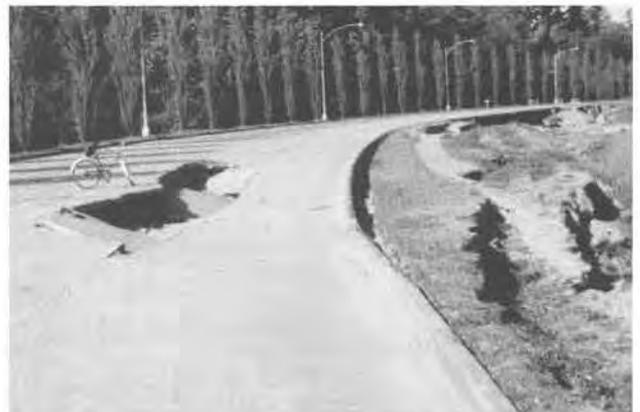
Figure 21. A road in Olympia that was damaged in 1965 by liquefaction. (Photos by G. W. Thorsen)

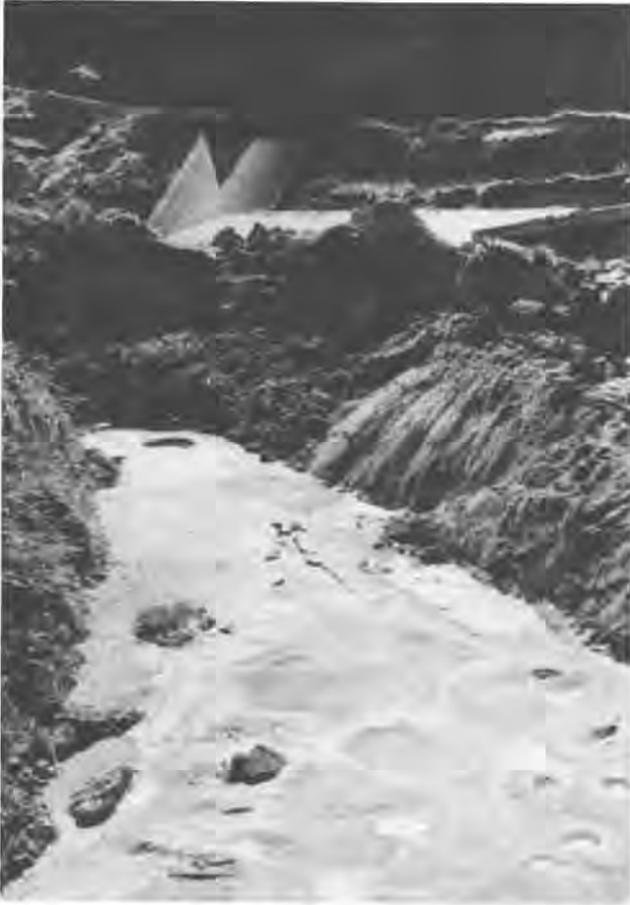
Figure 22. Sand blows at a site along Capitol Boulevard in Olympia, 1965. (Photo by G. W. Thorsen)

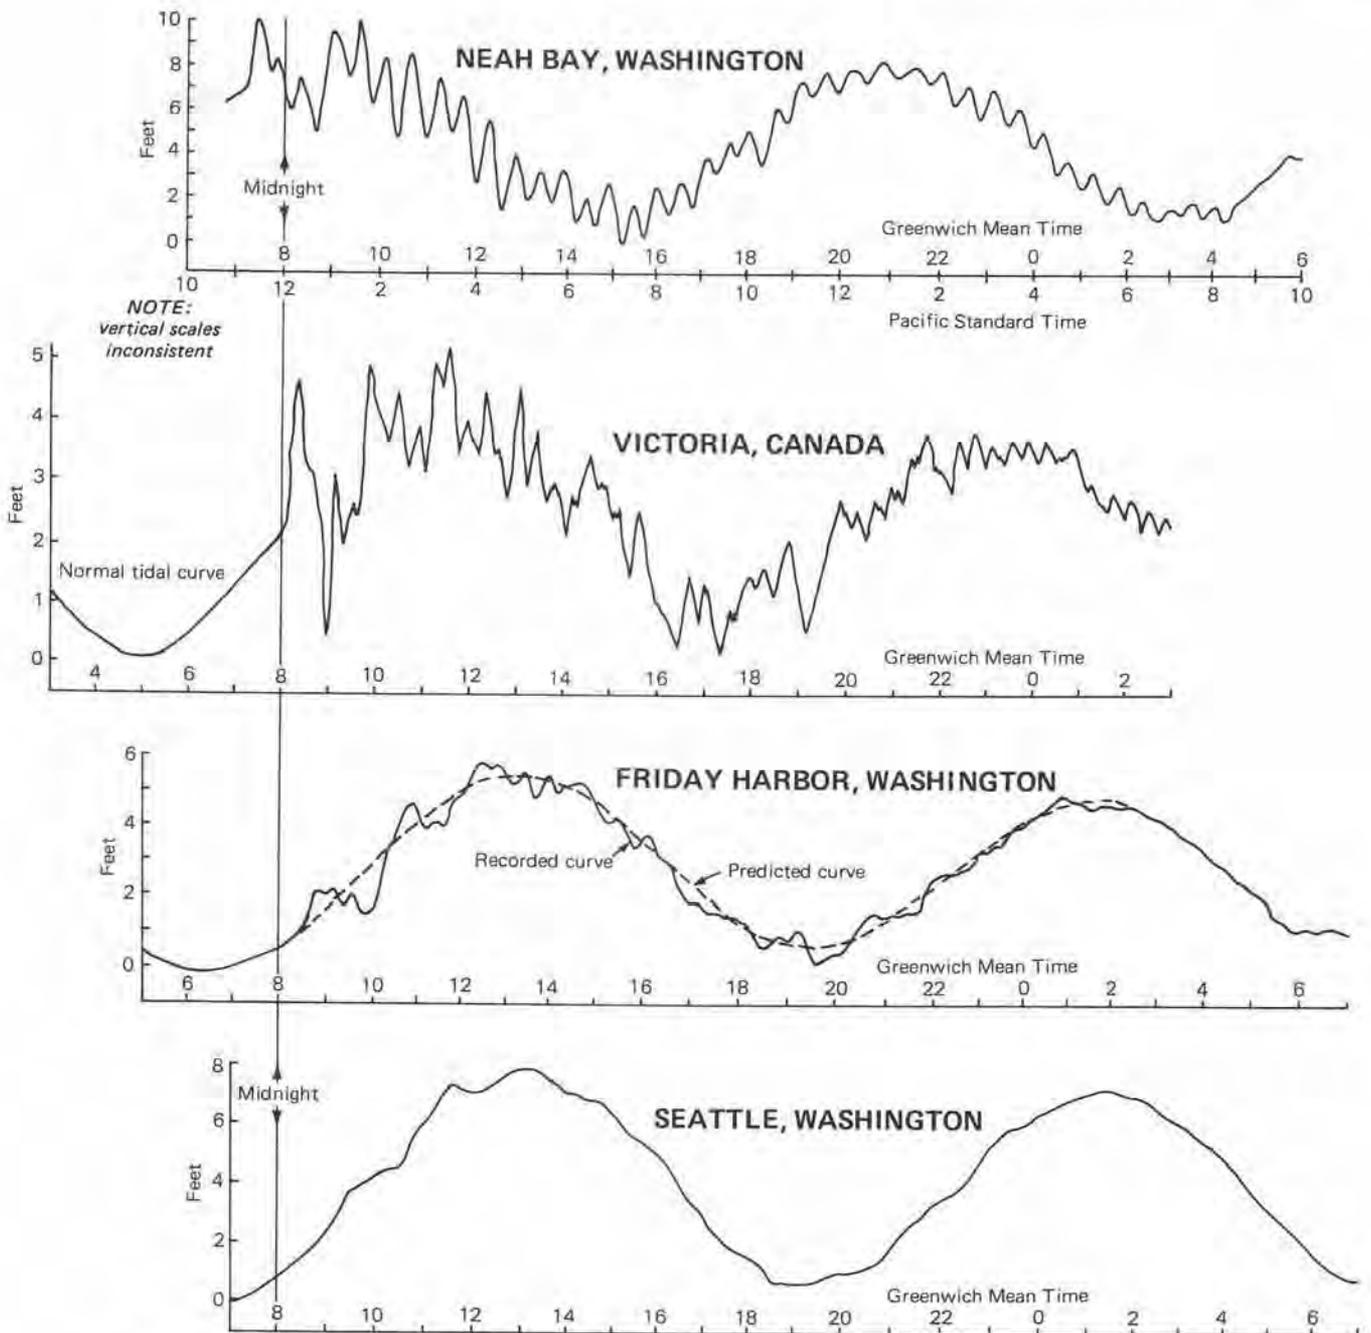
Figure 23. Tide gage records showing tsunami waves from the March 27, 1964, Alaska earthquake (magnitude 8.3) as recorded at four sites in the Pacific Northwest. Superimposed on the normal tide fluctuations having a period of about 12 hours (see predicted curve at Friday Harbor) are more rapid oscillations that have periods of about 1/2 hour that were caused by tsunami waves. Note the differences in tsunami wave amplitudes at different sites. (Modified from Spaeth and Berkman, 1972.)

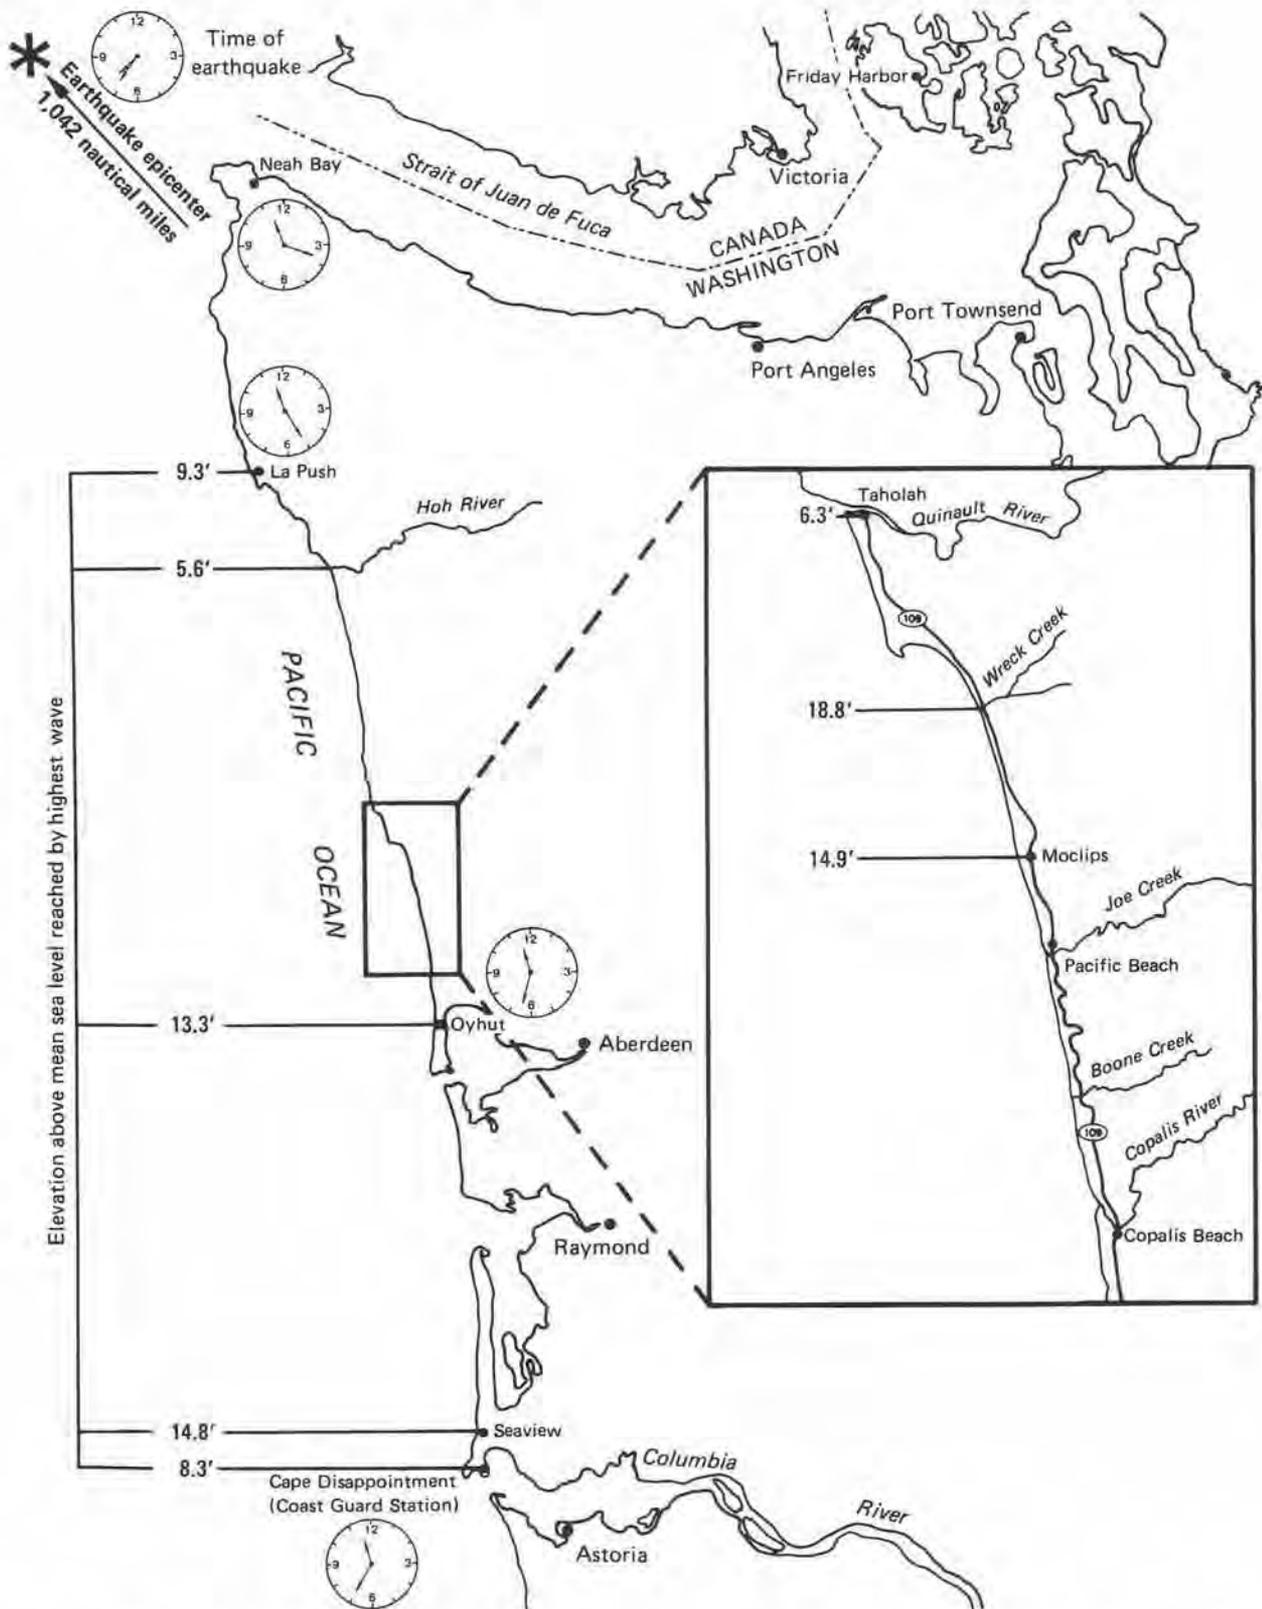
Figure 24. Tsunami damage in Washington from the 1964 Alaska earthquake. Clocks show time (Pacific Standard Time) of occurrence of 1964 Alaska earthquake and of arrival of the first tsunami waves along the Washington coast. Descriptions of damage on facing page.

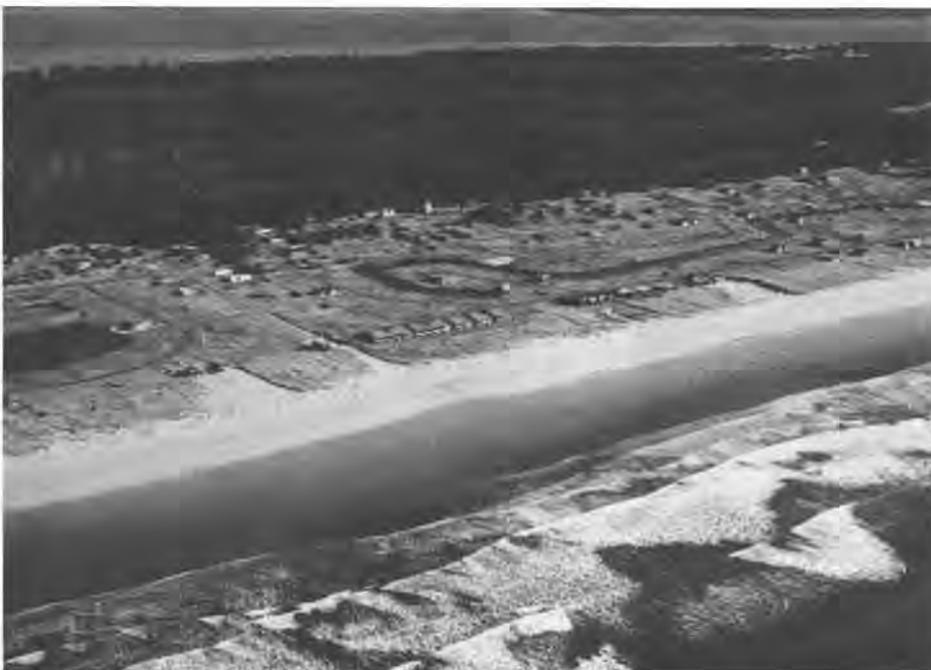
Figure 25. Dunes south of Grays Harbor have been stripped from beach property in order to enhance views. These dunes protected development on the beaches from tsunami damage in 1964 (Hogan and others, 1964). (Photo by G. W. Thorsen)

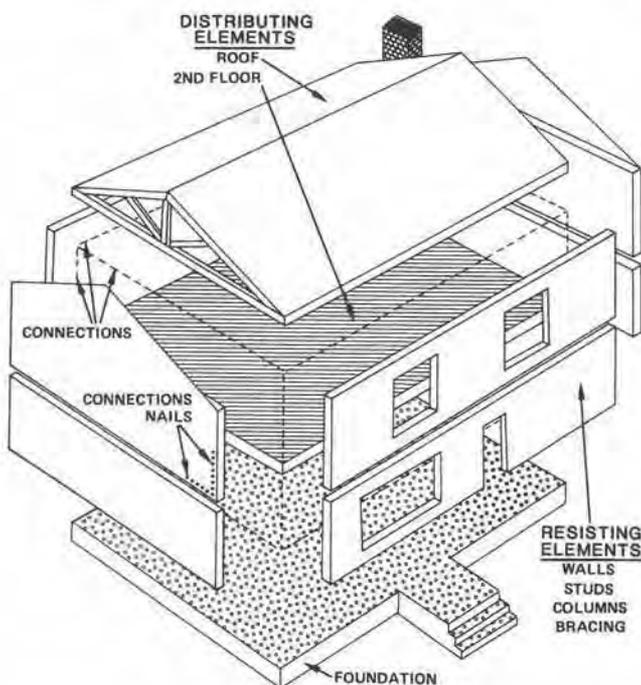
Figure 26. Structural components of a building.

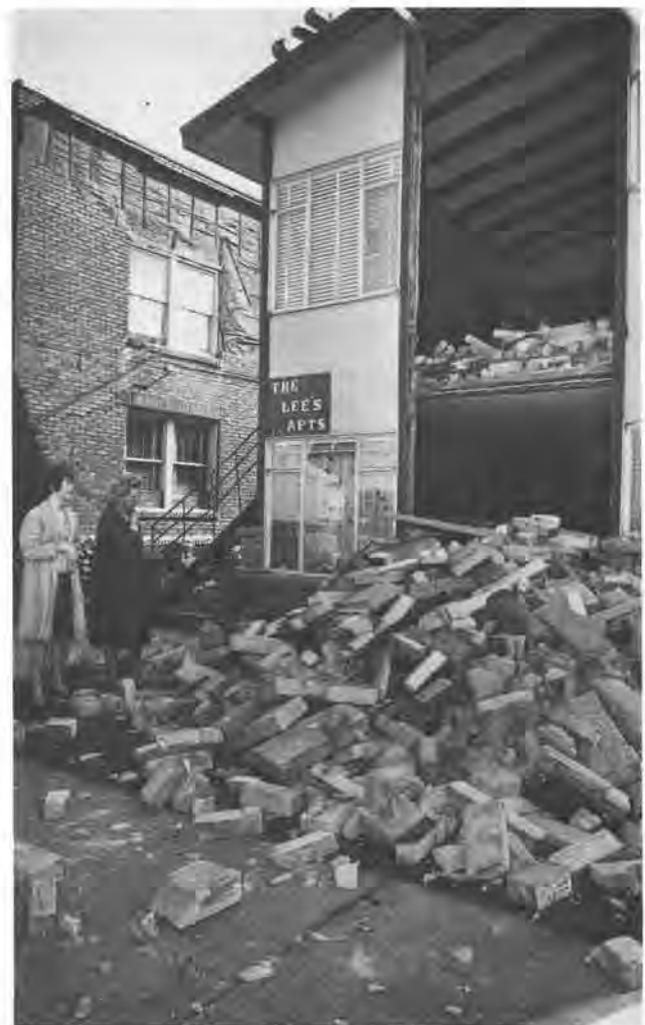
Figure 27. Failure of unreinforced masonry used in a Seattle apartment building. Damage was caused by the 1965 earthquake. Note that the wood frame part of the building was undamaged. (Photo by The Seattle Times Co.)

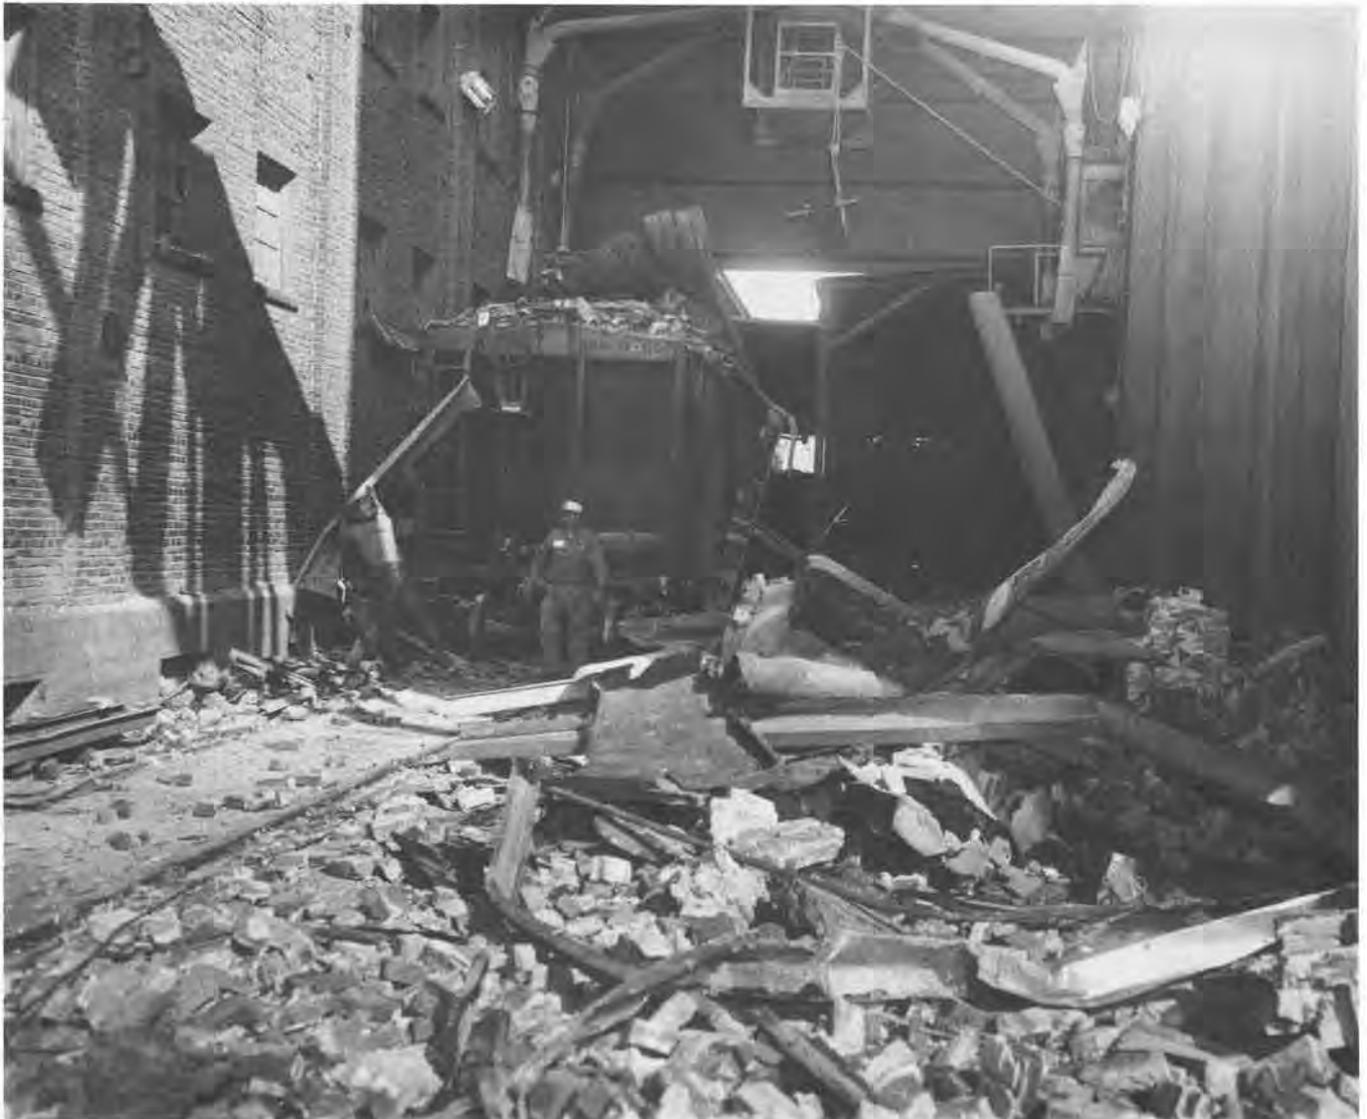
Figure 28. Portions of the unreinforced brick walls on the sixth floor of the Fisher Flouring Mills collapsed to the ground during the 1965 earthquake. (Photo by The Seattle Times Co.)

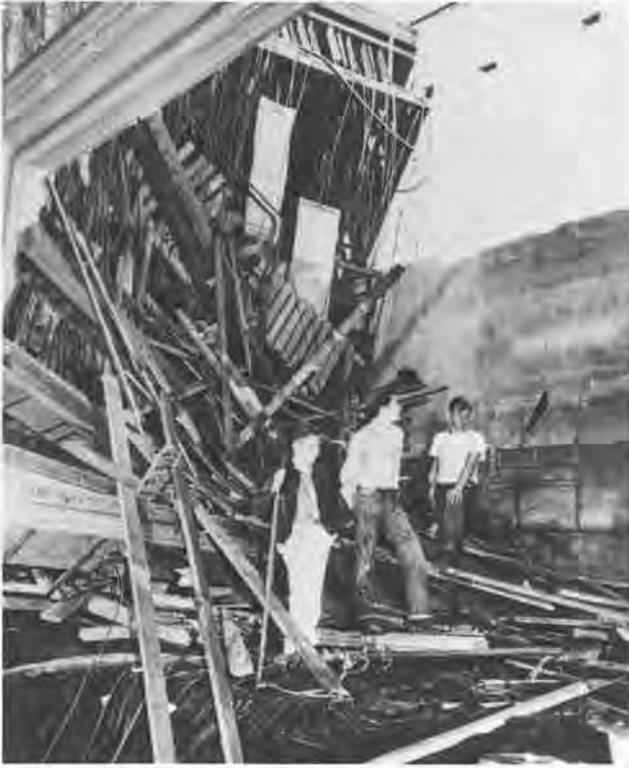
Figure 29. The unanchored roof of the Puyallup High School gymnasium collapsed onto the stage during the 1949 Olympia earthquake. (Photo by The Seattle Times Co.)

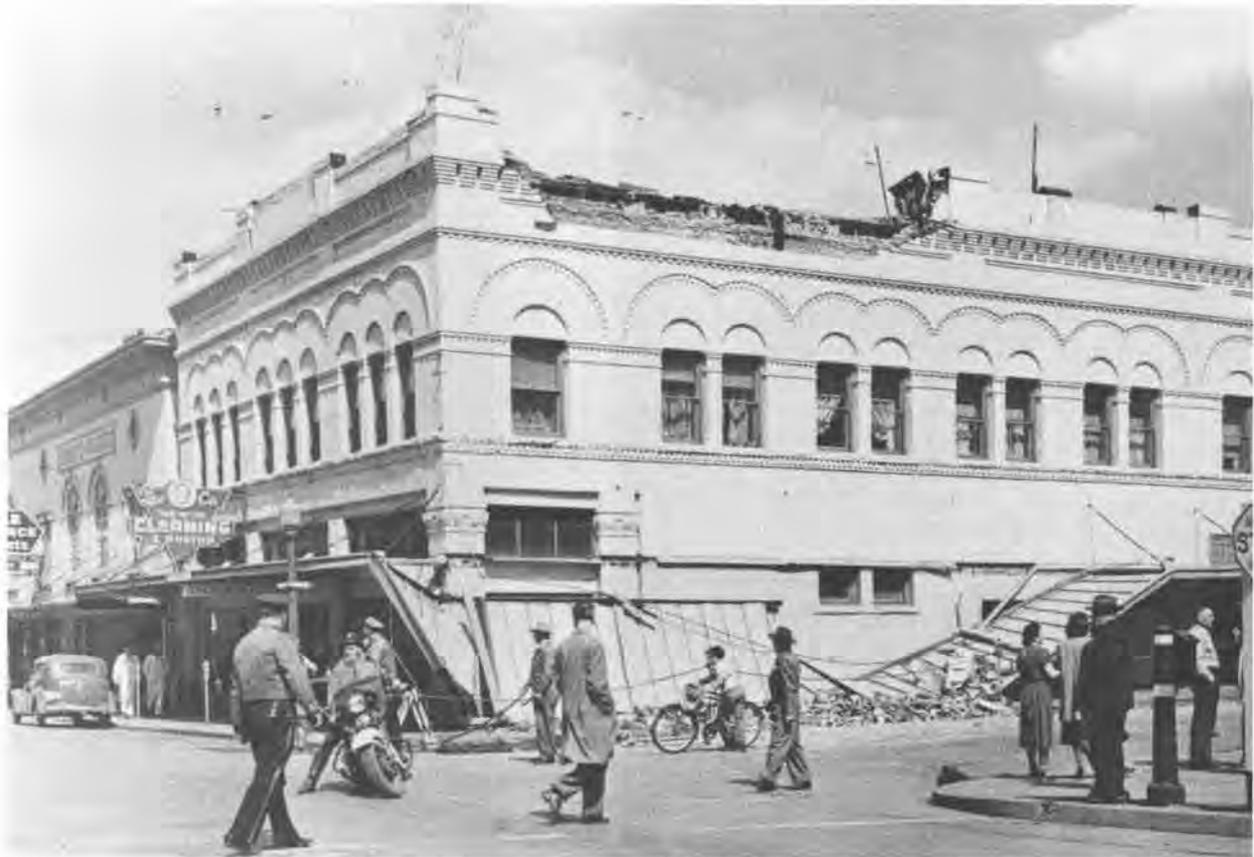
Figure 30. A collapsed parapet wall and crushed canopy in downtown Olympia, 1949 earthquake. (Photo by Roger Easton, by permission Marie Cameron)

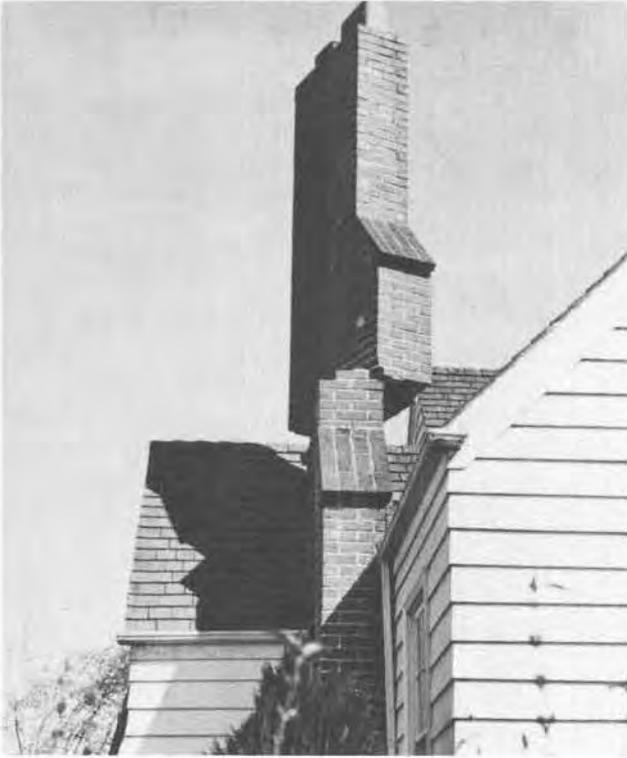
Figure 31. An unreinforced brick chimney in Kelso damaged during the 1949 Olympia earthquake. This chimney twisted on a mortar joint. (Photo from Edwards, 1951).

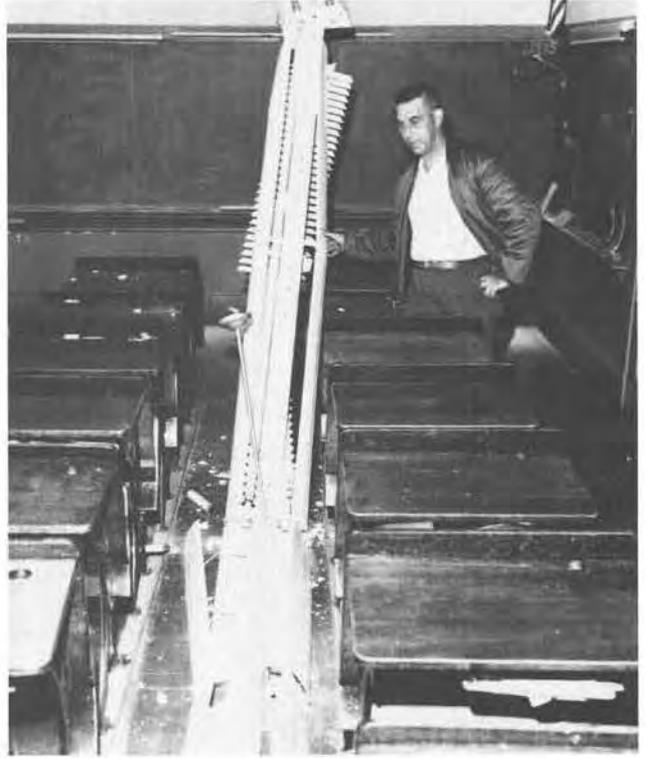
Figure 32. Fallen light fixtures in the aisle of an Olympia schoolroom; these were shaken loose during the 1965 Seattle-Tacoma earthquake. (Photo by Del Ogden, Daily Olympian)

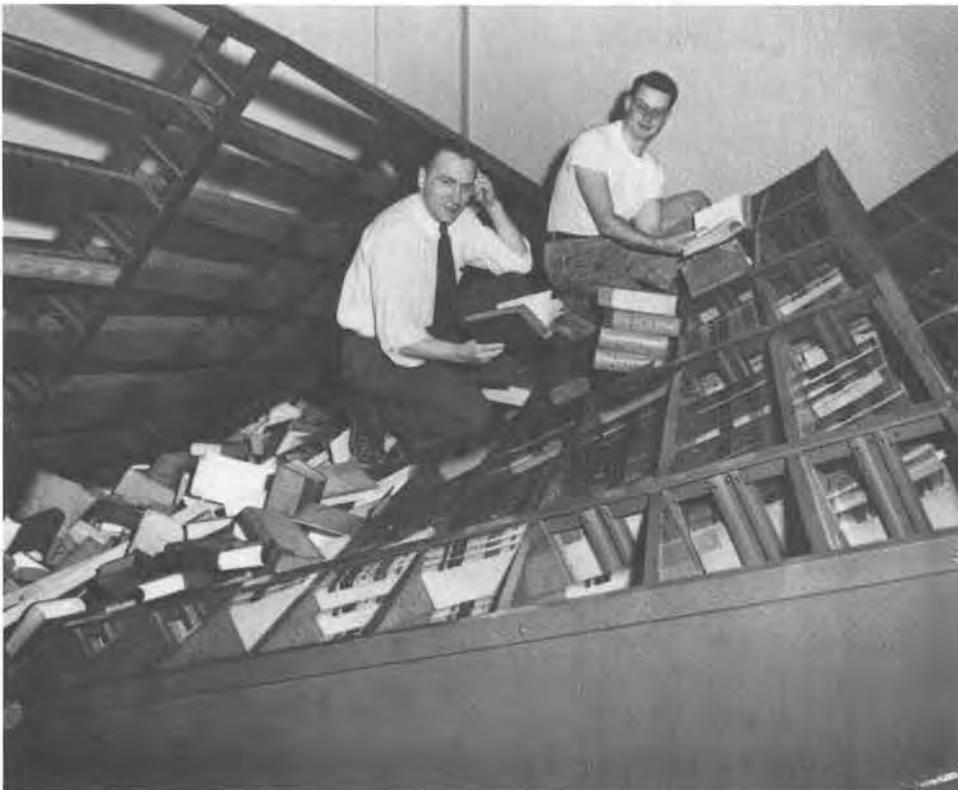
Figure 33. Library shelves overturned as a result of the 1949 Olympia earthquake. (Photo by permission of the Seattle Times Co.)

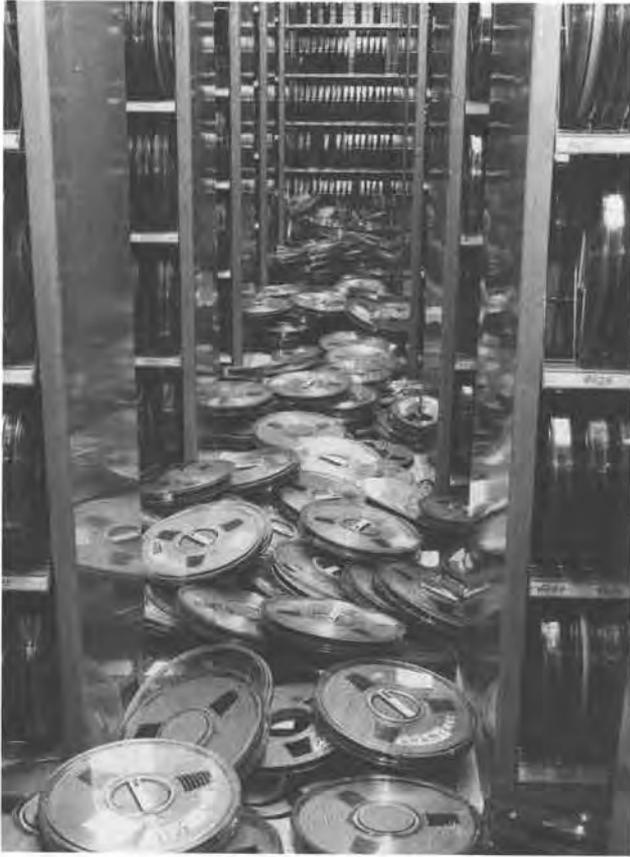
Figure 34. Computer tapes scattered on floor of Boeing Company offices by the 1965 Seattle-Tacoma earthquake. (Photo courtesy of the Boeing Company)

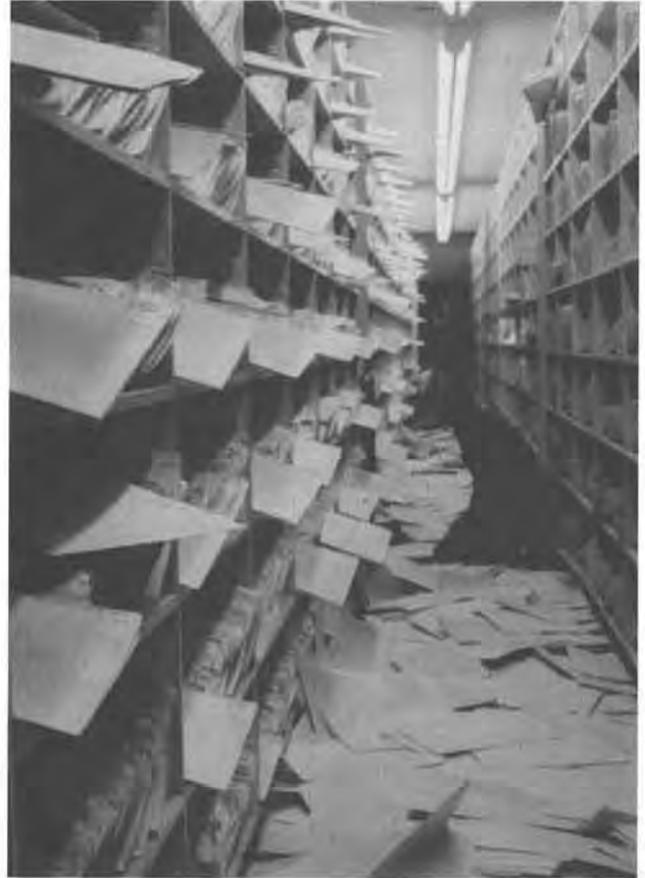
Figure 36. Files scattered on the floor of the Department of Labor and Industries records section on the third floor of the General Administration Building in Olympia after the 1965 earthquake. (Photo by Del Ogden, Daily Olympian)

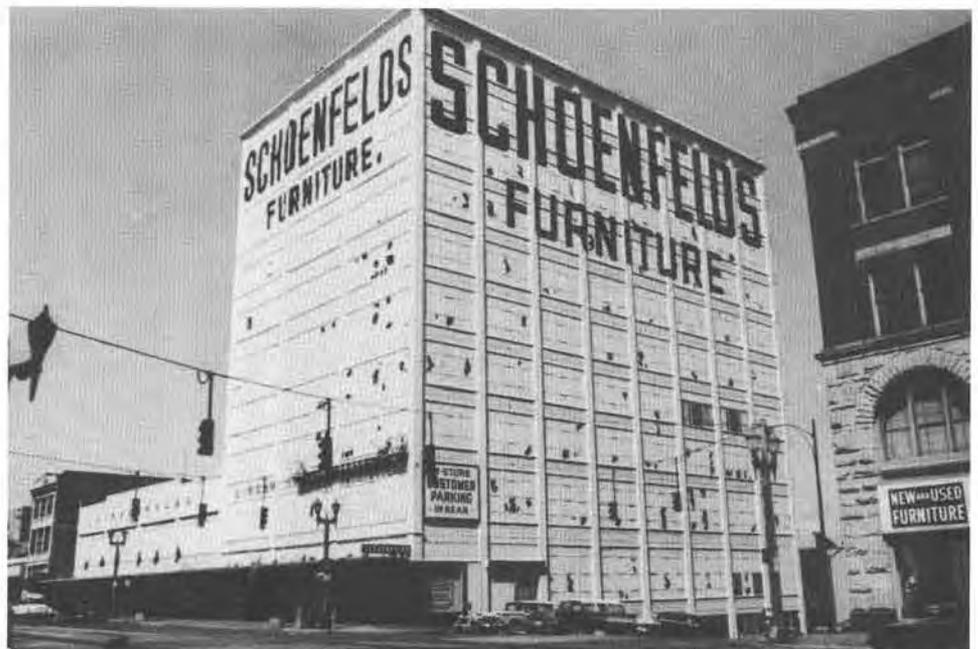
Figure 35. Glass windows broke on three sides of this ten-story building in Tacoma during the 1965 Seattle-Tacoma earthquake. (Photo by B. J. Morrill, from Steinbrugge and Cloud, 1965)

Distortion of the non-structural elements occurs when the building flexes, putting extreme stress on rigid items like windows, panels, and built-in furniture (Bay Area Regional Earthquake Preparedness Project, 1985). In 1965 many windows in the Schoenfeld furniture store in Tacoma were shattered when glass was broken by the flexing of the window frames (Fig. 35). Other examples of this type of damage are noted in Thorsen (1986).

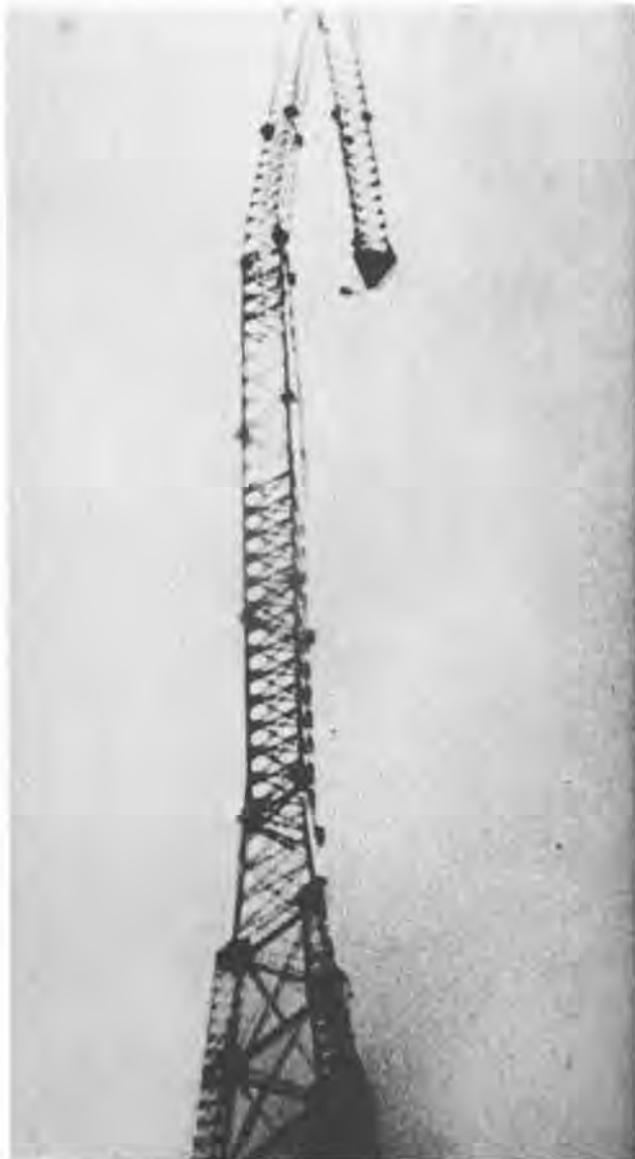
Figure 37. Damage to the tower of Seattle radio station KJR caused by the 1949 Olympia earthquake. (Photo from A. E. Miller Collection, University of Washington Archives)

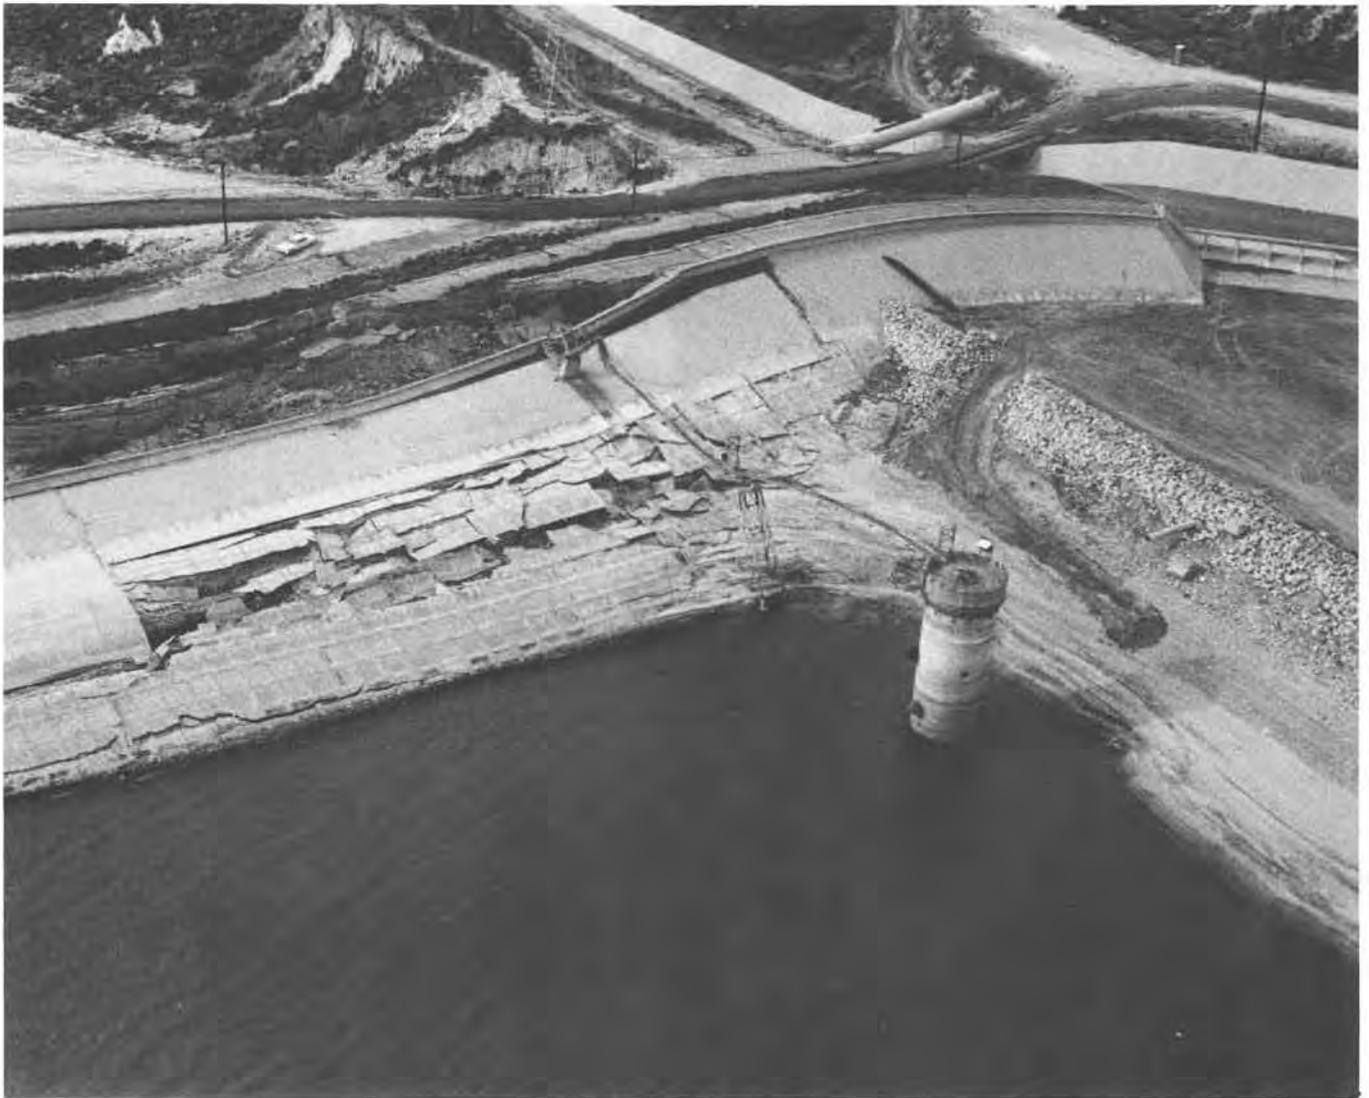
Figure 38. Damage at the Lower Van Norman Dam by the February 9, 1971, San Fernando, California, earthquake; view to the east. A massive slide into the reservoir broke off the east outlet tower and damaged the west outlet tower (foreground). No water overtopped the dam, and no leaks developed as a result of the shaking. More than 75,000 residents were evacuated from the area downstream for 3 days after the earthquake. (Photo by G. W. Thorsen)
