WASHINGTON STATE EARTHQUAKE HAZARDS

by
LINDA LAWRENCE NOSON, ANTHONY QAMAR,
AND GERALD W. THORSEN

WASHINGTON DIVISION OF GEOLOGY AND EARTH RESOURCES
INFORMATION CIRCULAR 85

1988

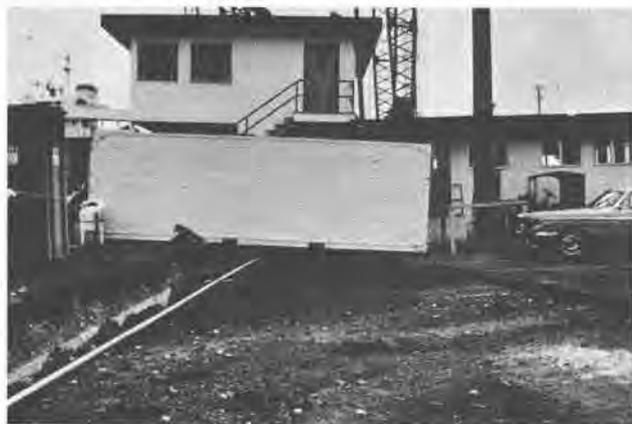
Figure 39. The ground at this Harbor Island, Seattle, site dropped when the pier at the left shifted toward the water in the 1965 earthquake. (Photo by K. V. Steinbrugge, from Steinbrugge and Cloud, 1965)

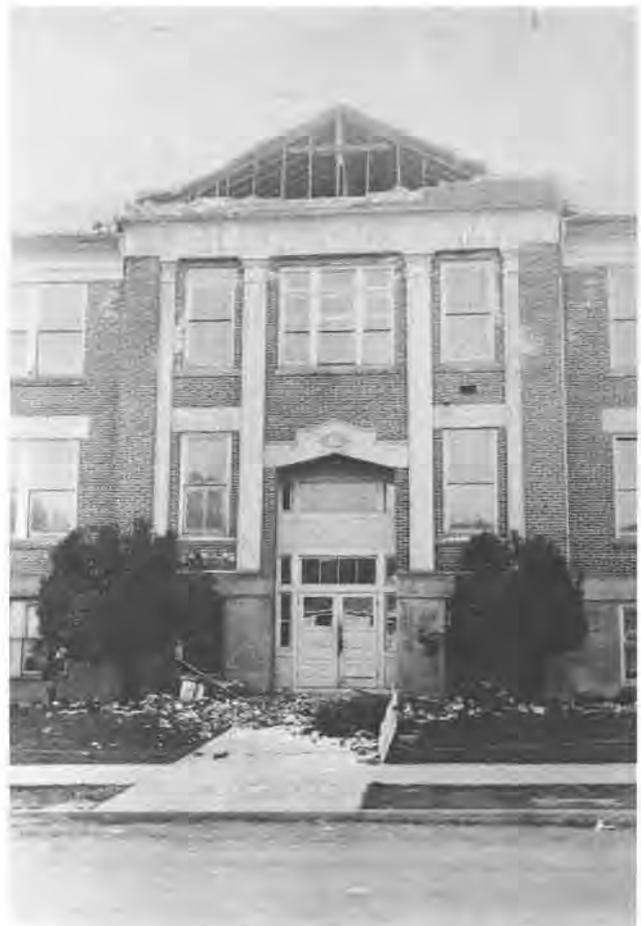
Figure 40. This unanchored gable collapsed at the Castle Rock High School in the 1949 earthquake. The building is of unreinforced masonry construction. A student was killed by falling bricks. (Photo from A. E. Miller Collection, University of Washington Archives)

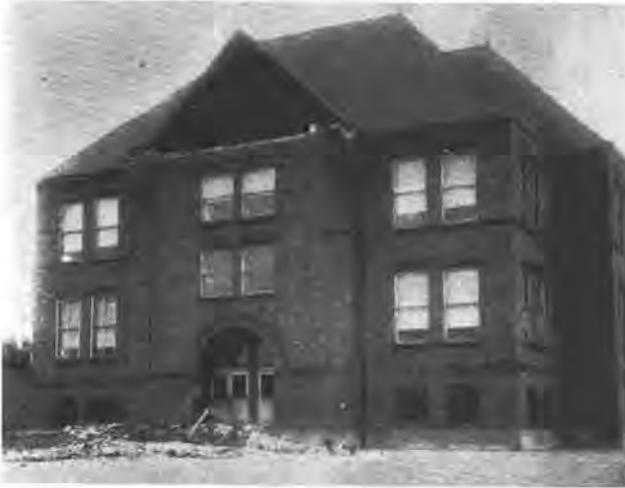
Figure 41. Lafayette School in Seattle after the 1949 earthquake. The gable fell because of lack of adequate anchorage and defective masonry. The masonry fell on the landing in front of the main entrance. (Photo from an article by C. N. Dirlam reproduced in Thorsen, 1986)

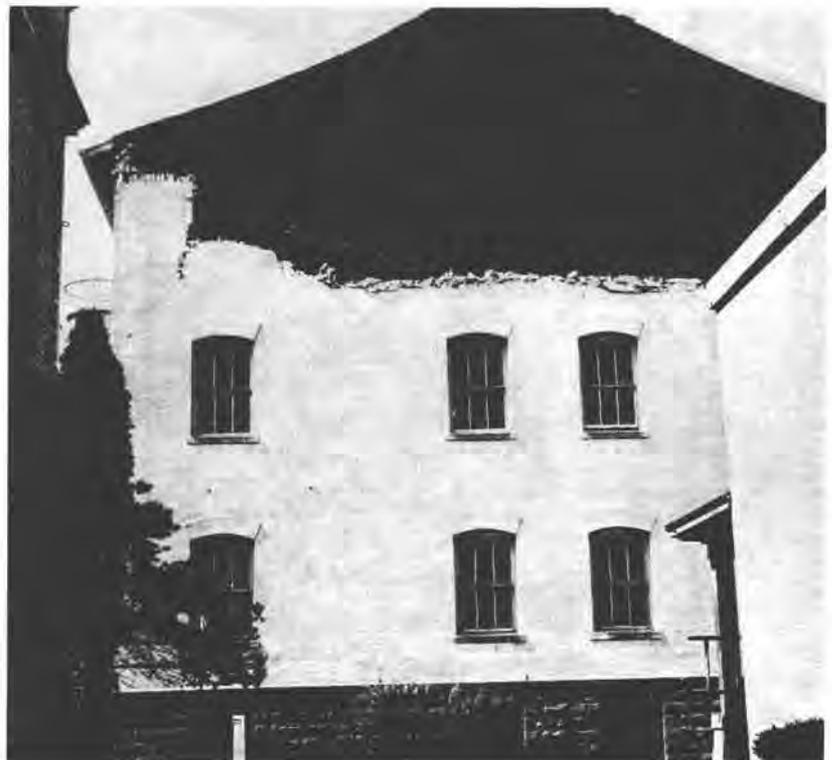
Figure 42. Damage at the Washington State Training School for Boys, in Chehalis, caused by the 1949 Olympia earthquake. Typical of pre-1900 buildings, the thin wall and unanchored gable were easily knocked out by flexing of the wood structure. Cracks show that the left wall is about to fail. Two schools in Centralia were permanently closed because of damage sustained during this earthquake. (Photo from Edwards, 1951)

Similarly, the Washington State Training School for Boys, in Chehalis, sustained severe damage when a gable collapsed during the 1949 Olympia earthquake (Fig. 42). Fatalities and injuries to school children would have been much higher had many Puget Sound schools not been vacant because of spring vacation.

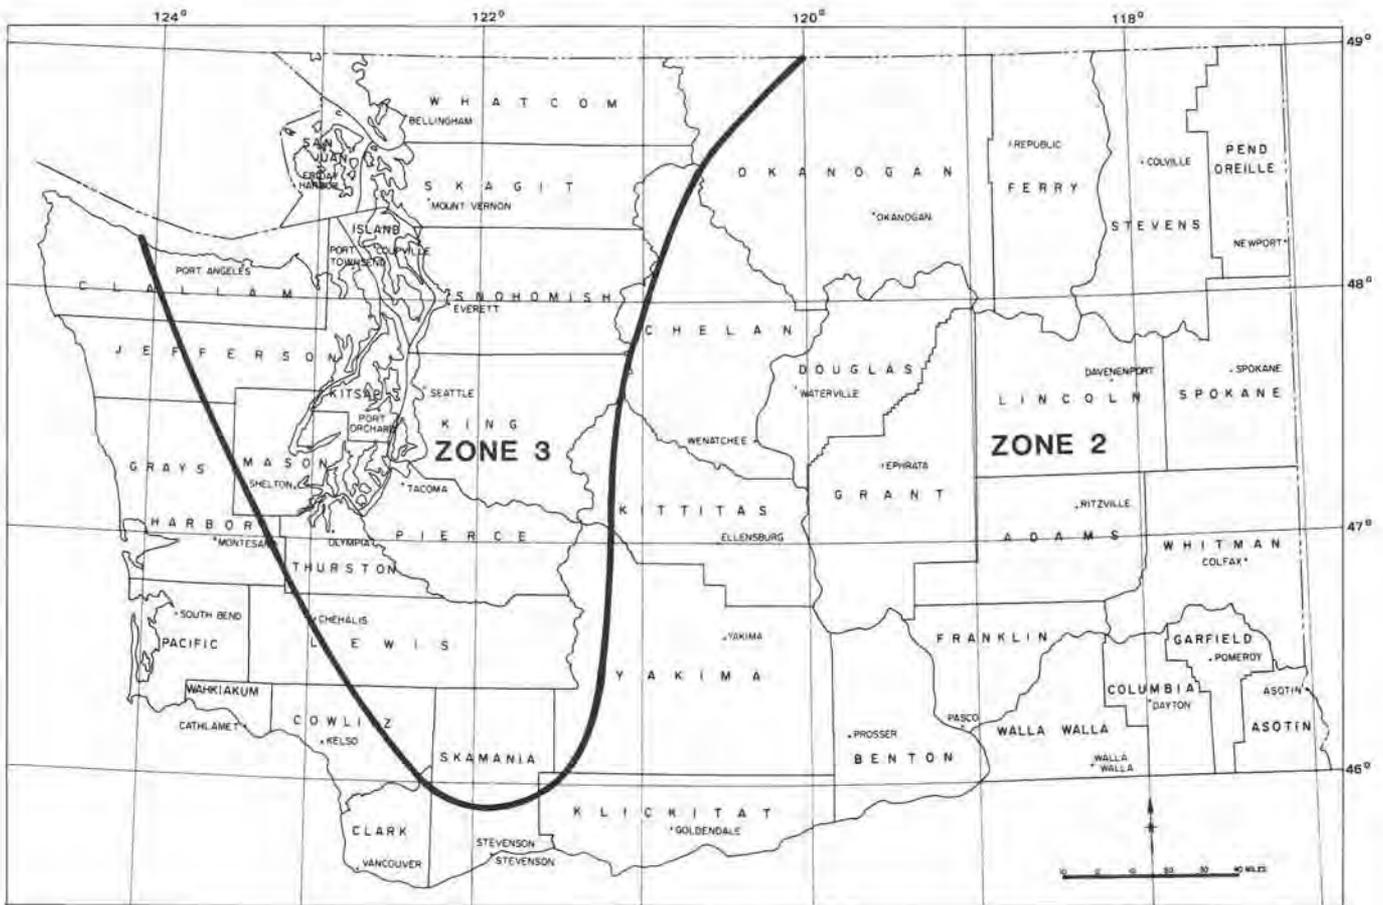
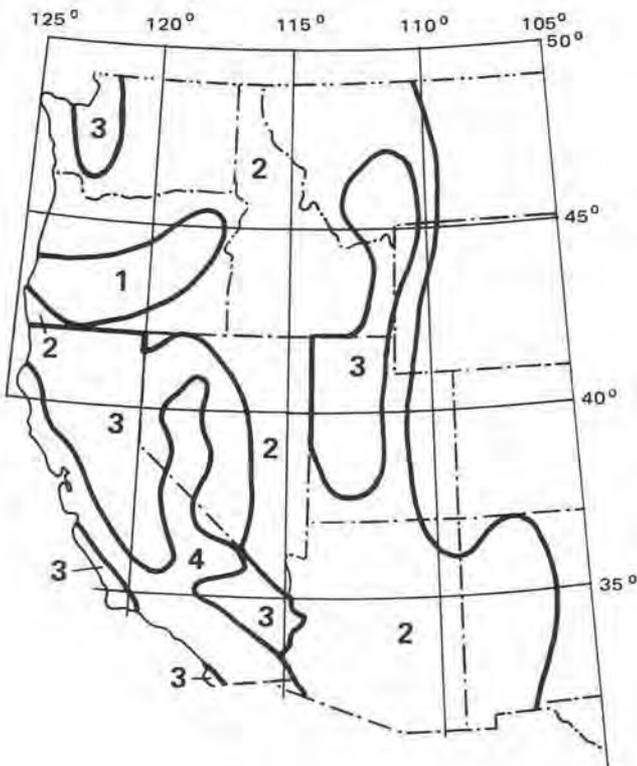
Figure 44. Uniform Building Code map of the Seismic Risk Zones of Washington (from International Conference of Building Officials, 1988). Compare this with the map to the left, which is from the 1985 edition of the code.

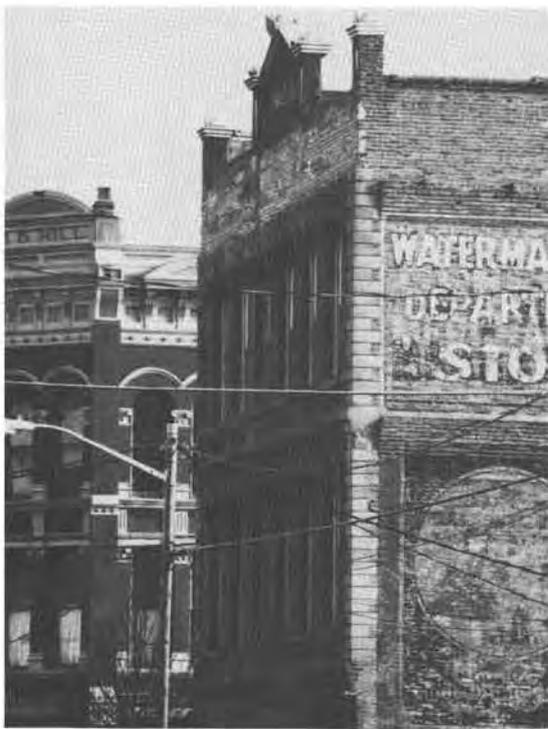
Figure 45. Examples of unreinforced masonry buildings in Port Townsend. A and B show unbraced parapet walls. C is a close-up of the parapet wall in A; note the lack of anchoring between parapet and wall below. D shows a loosely attached parapet face. E illustrates deteriorated mortar; this wall consists of brick only marginally held together. (Photos by G. W. Thorsen)

Many older masonry buildings similar to those damaged during the 1949 and 1965 earthquakes exist throughout the Puget Sound region. Some examples are shown in Figure 45. Poor maintenance further weakens such buildings, creating significant hazards to building occupants or passersby.

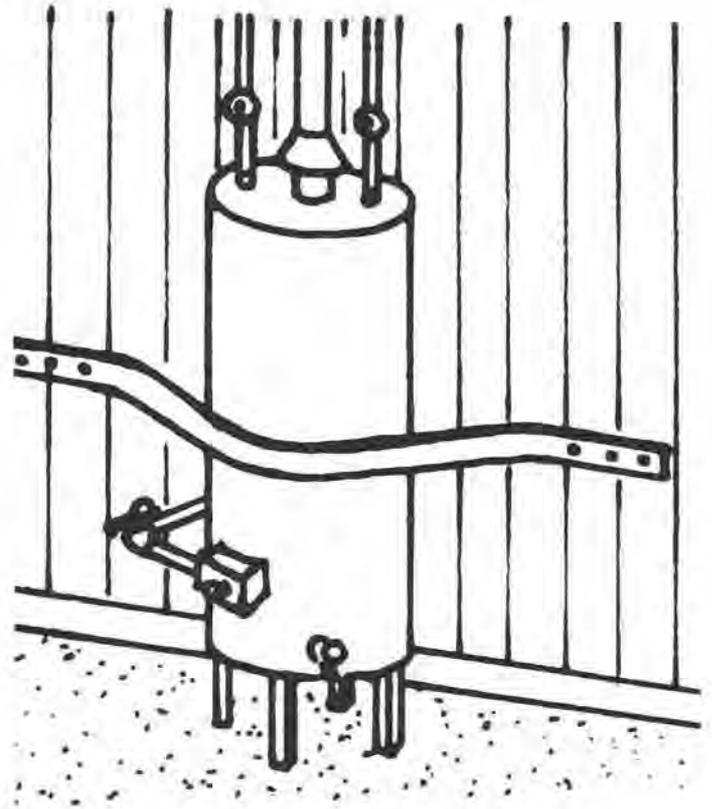
Figure 46. Water heater anchored with inexpensive plumbers' tape to prevent overturning during ground shaking. (From Federal Emergency Management Agency files)
