INACTIVE AND ABANDONED MINE LANDS— Alder Mine, Twisp Mining District, Okanogan County, Washington

WASHINGTON
DIVISION OF GEOLOGY
AND EARTH RESOURCES
Open File Report 2004-16
July 2004

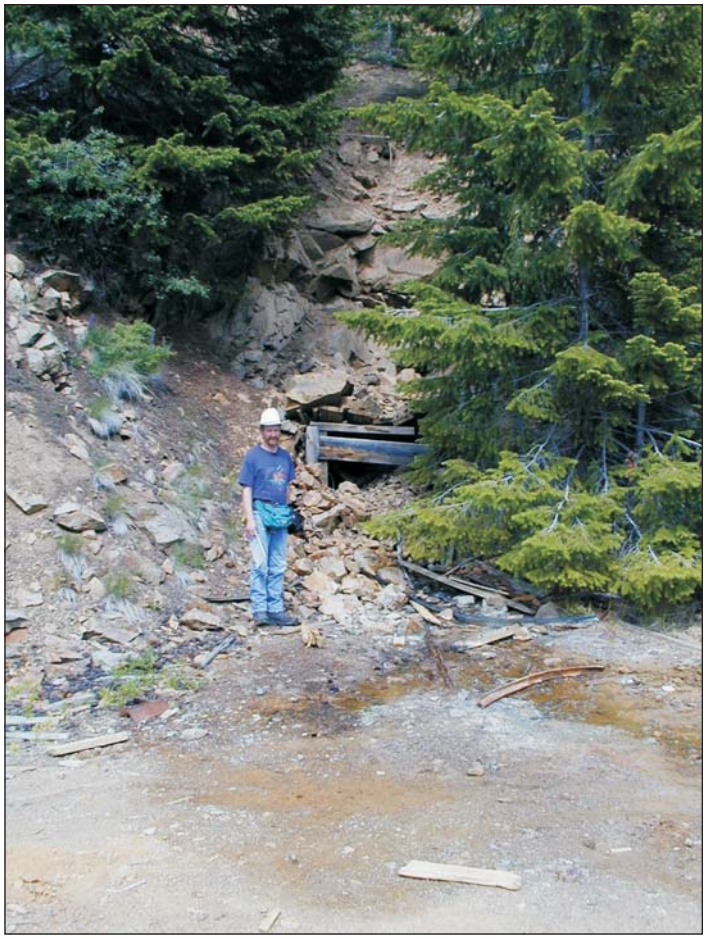
On 10 June 2002, 1 gpm of water discharged from the level 3 (Methow) portal and infiltrated the dump material within 30 feet. The discharge was clear with crusts of white precipitate on the margins. Field tests gave a pH of 4.4 and conductivity of 1400 mhos/cm.

Figure 7. Level 3 adit (Methow level). Note sheet flow discharge in front of geologist. View to the east.

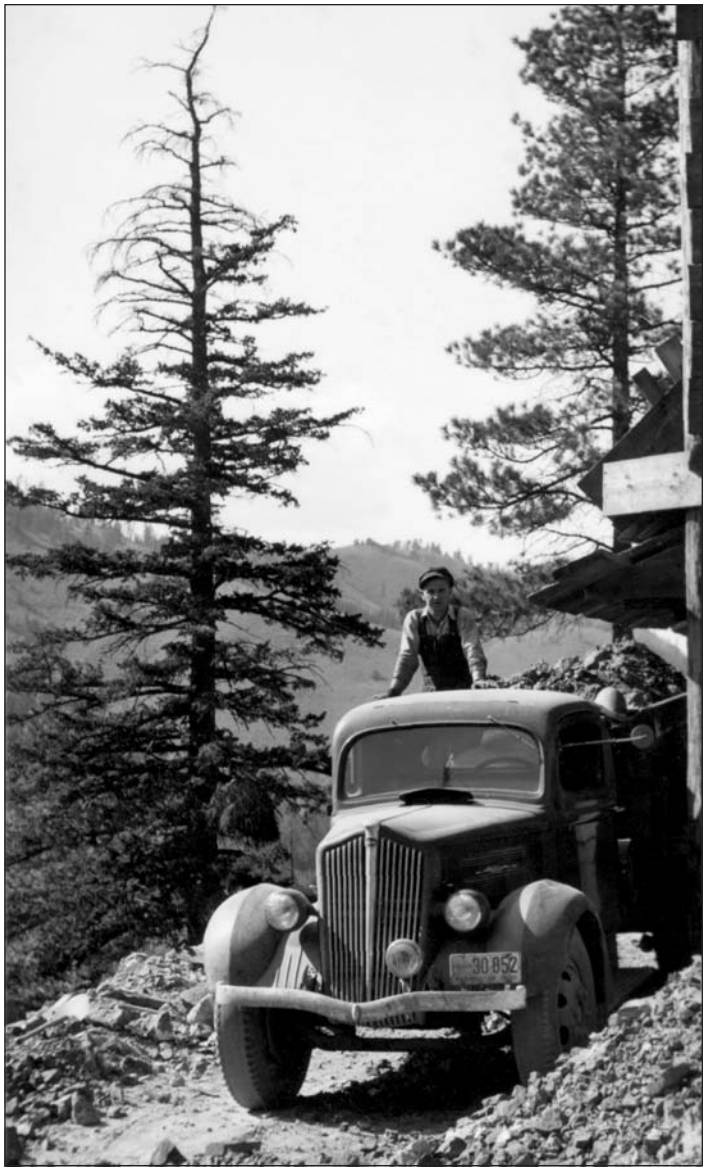
Figure 11. Loading ore at bunker circa 1940. Photo from Methow Gold Co.
