## Technical Memorandum

**Re:** Gene Coulon Park Shoreline Habitat Monitoring – Baseline Survey

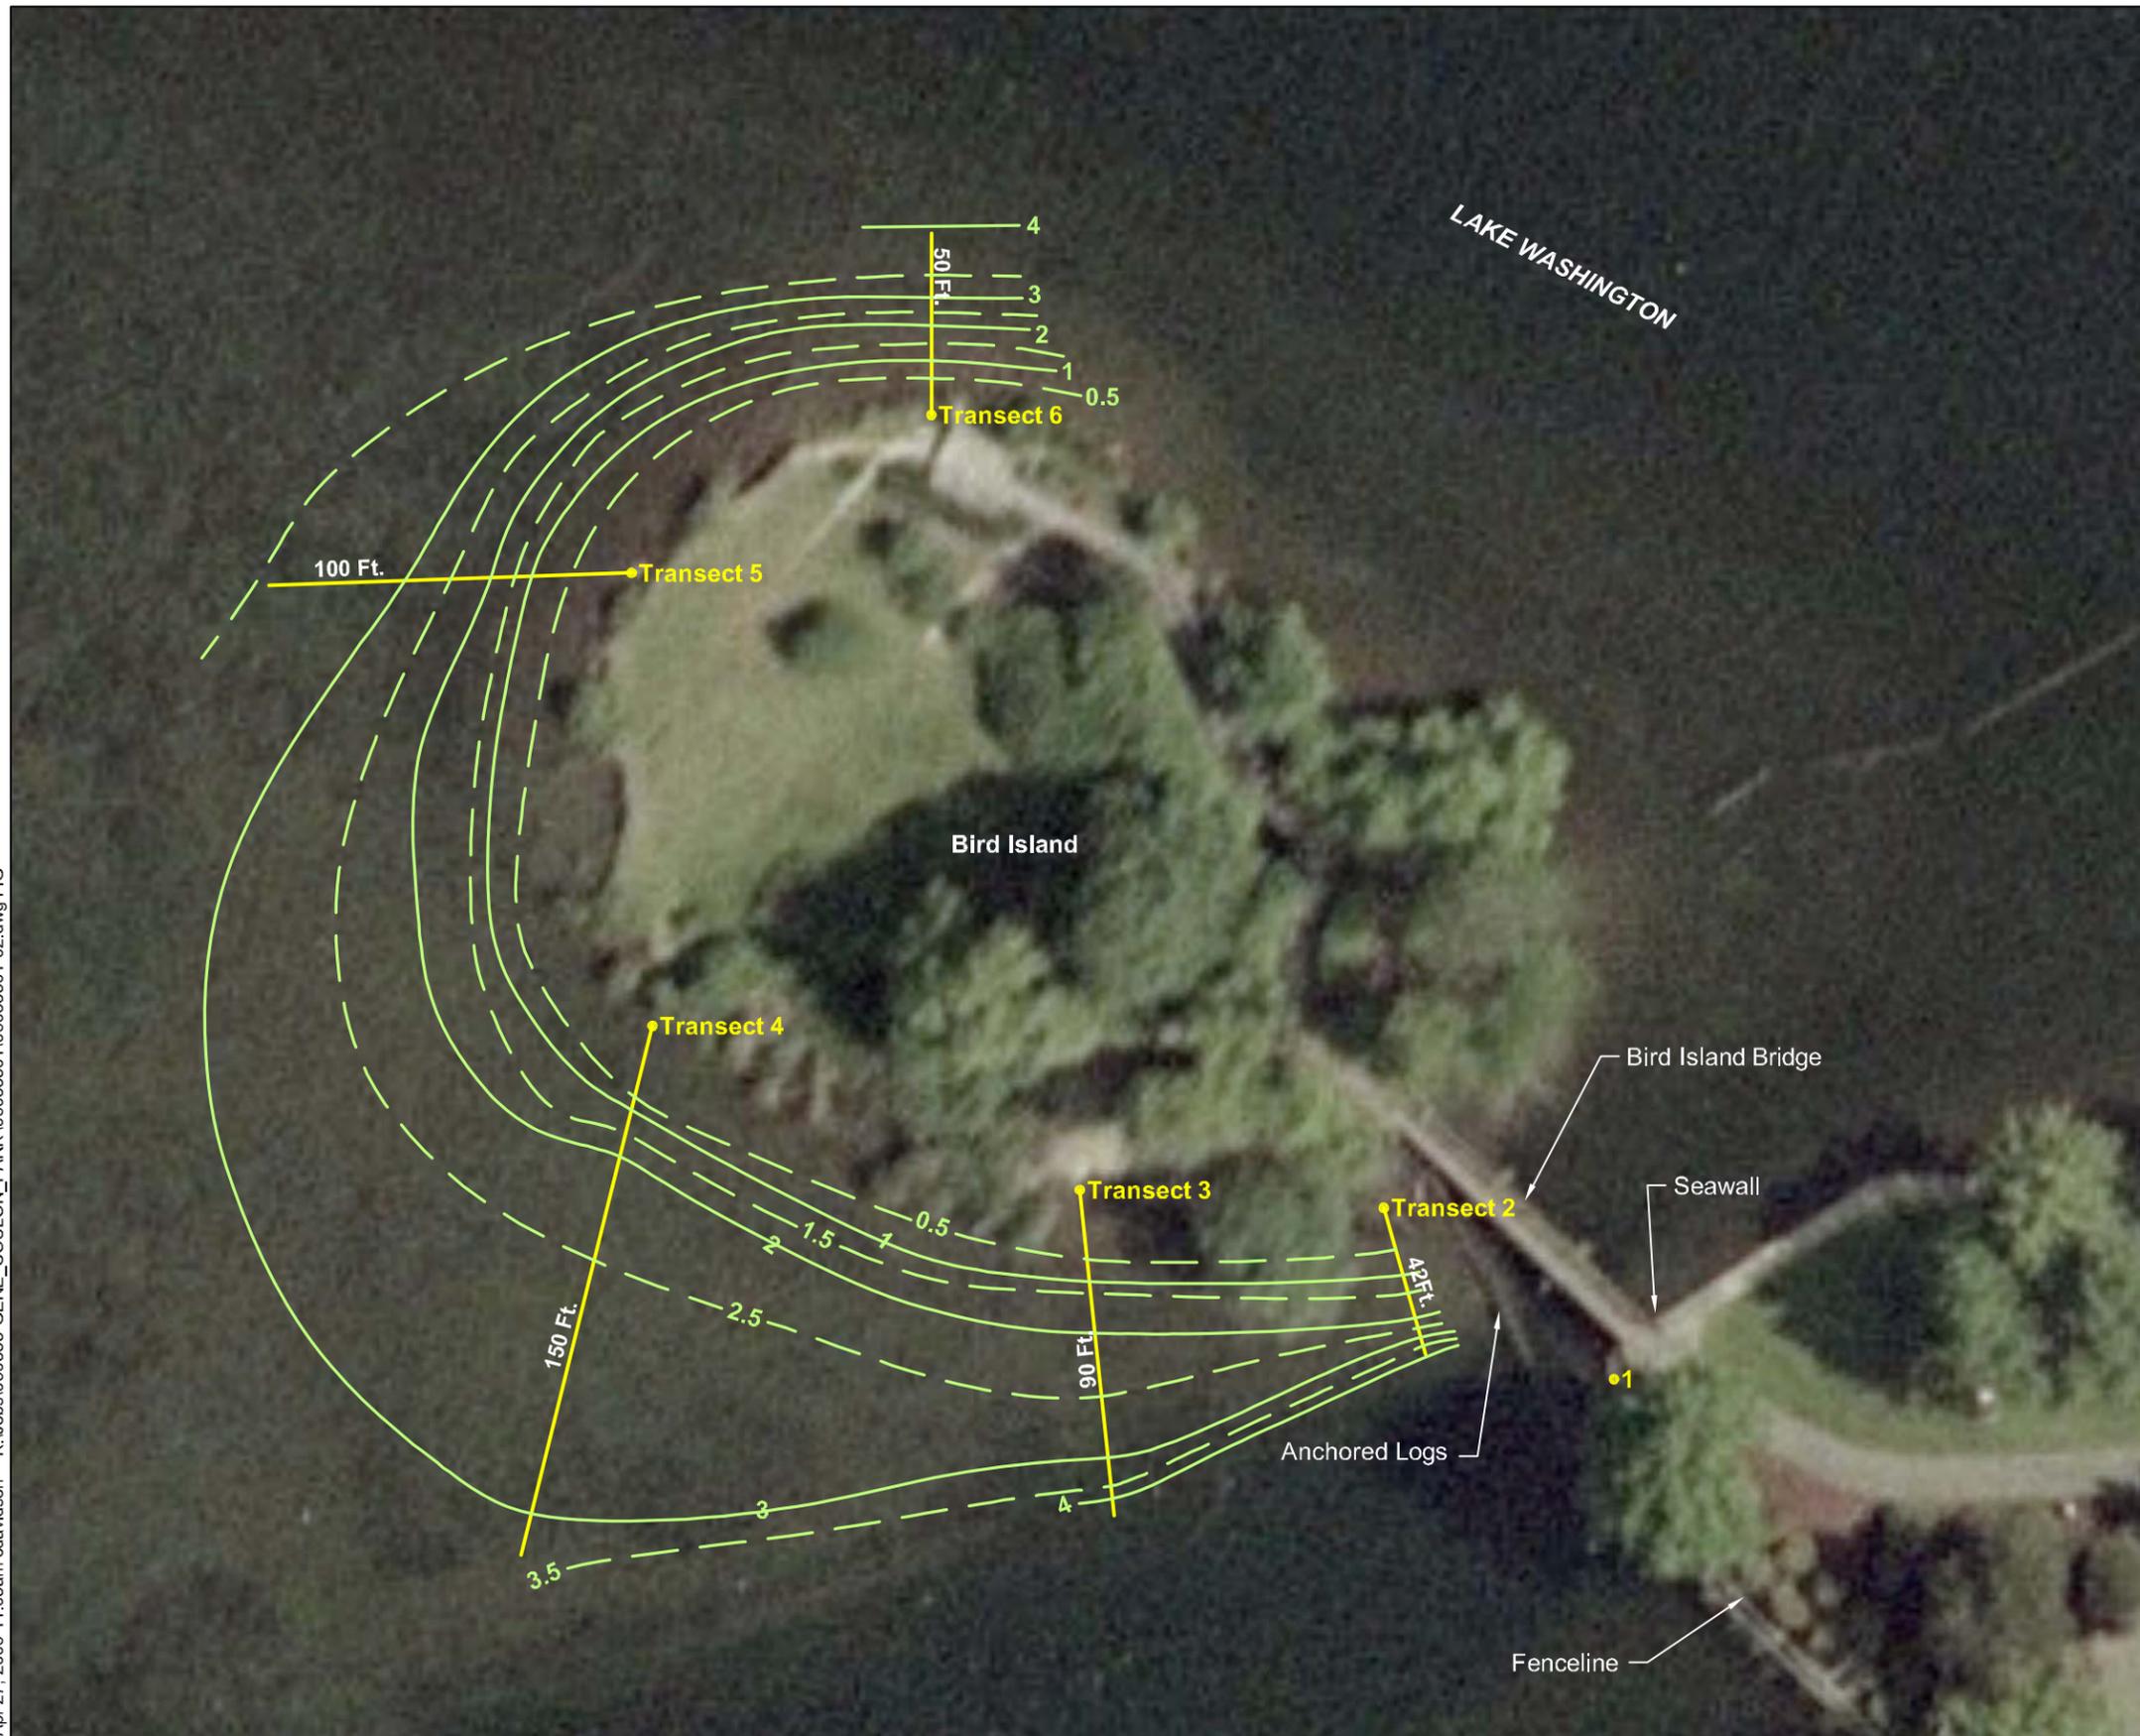
**Figure 1**  
 Gene Coulon Park Shoreline Habitat Monitoring  
 City of Renton

Notes:  
 1. Water level at time of survey was 21.9 feet (U.S. Army Corps Datum), which is 0.1 feet below highest water level (22 feet).  
 2. Aerial photo source: WAGDA Washington State Geospatial Data Archive.  
 3. Water depths as shown have been interpolated between actual transects to create an approximate depth contour for the site.

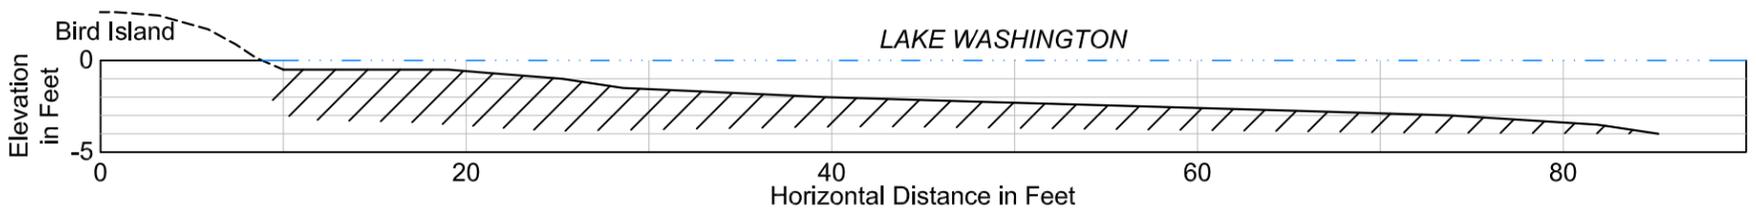
**Transect 2**

Transect 2 extended from the muddy area at the northwest Bird Island bridge footing out into the littoral zone toward the Southport development (Photo 2). This area has a small, protected cove near the bridge footing. Water depths ranged from 0 feet at the start of the transect to 4.1 feet at the end of the 42-foot-long transect. Substrate ranged from fines (sand) at the start of the transect to pebbles in the middle, transitioning to fines (muck) at the deepest end of the transect (Attachment A). Future erosion issues in this area could potentially be expressed as the disappearance of the muck and sand and/or replacement by a coarser substrate.
