Reconnaissance study of landslides related to the January 2009 storm in the Acme Watershed

January 2010

By
Jack Powell, LEG, LHG
Leslie Lingley, LEG
Garth Anderson, LEG

Washington State Department of
Natural Resources
Forest Practices Division
Olympia, Washington

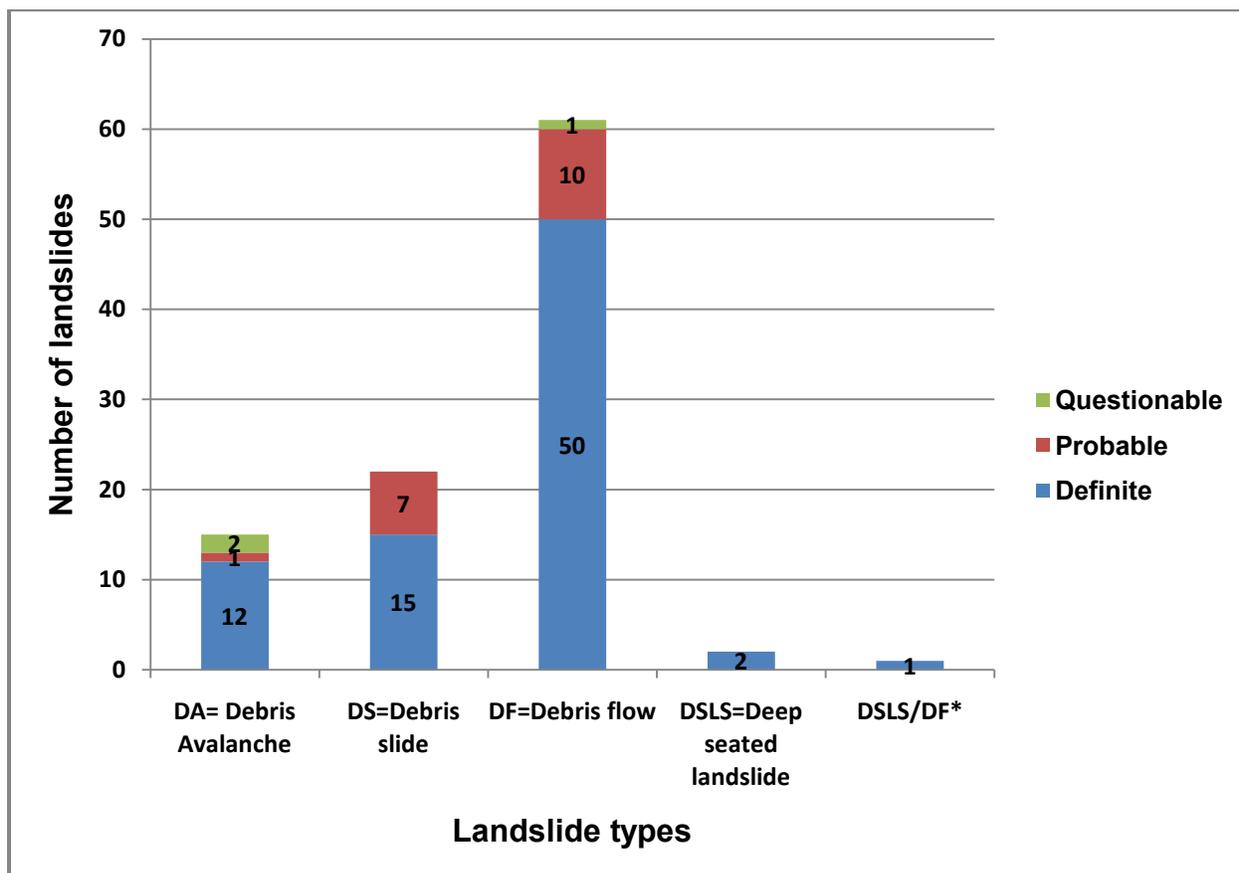
Figure 5 shows the assigned level of certainty by landslide type. Debris slides had the lowest uncertainty; almost half of those mapped were designated as ‘Probable’ due to their small size and relatively confined nature.

Figure 5. Distribution of landslide uncertainty by landslide type.

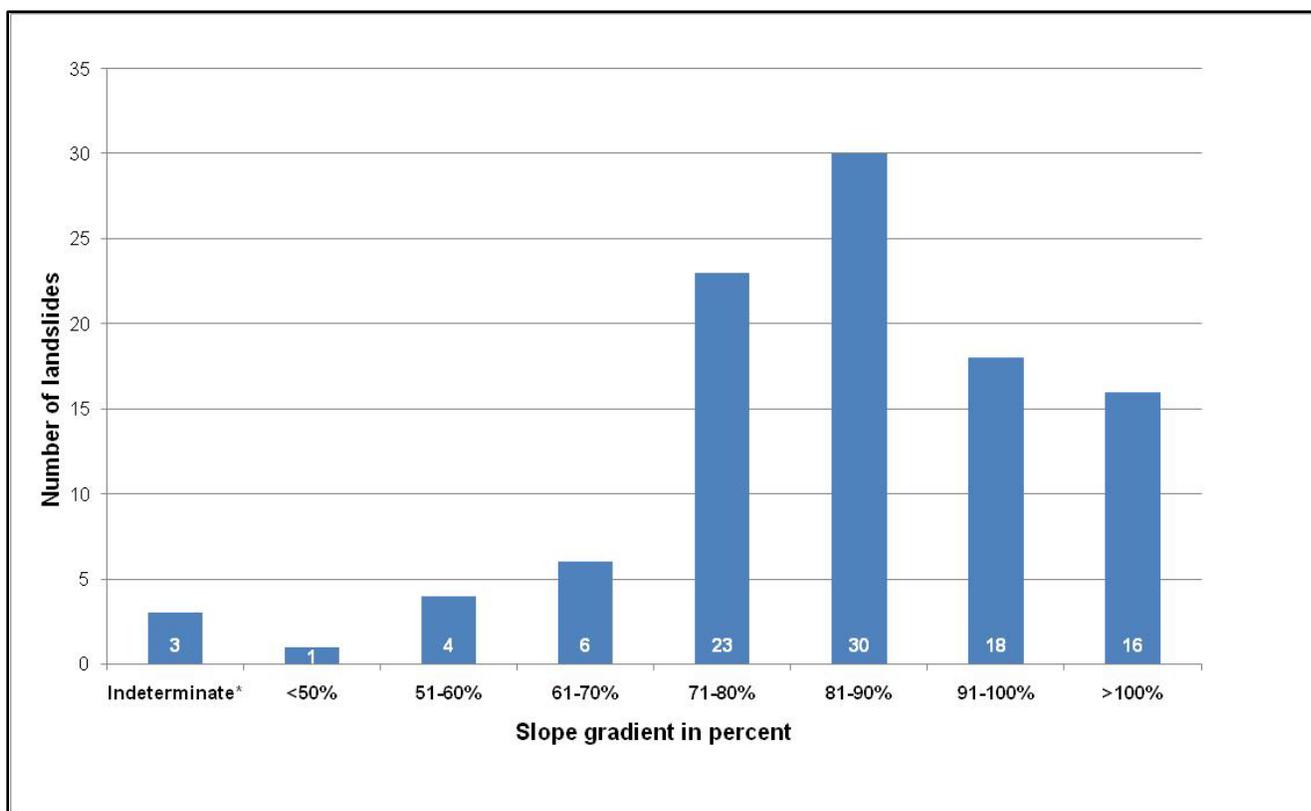
Figure 6 shows the slope gradients at the initiation areas of inventoried landslides. (Three ‘indeterminate’ designations shown on this graph are located in the Radonski Creek area where heavy canopy cover precluded identifying the initiation areas on the orthophotos.)

Eleven out of the 101 landslide had initiation area gradients <70% (i.e.; less than the threshold for rule identified inner gorges, bedrock hollows, and convergent headwalls). Some of these lower slope-gradient measurements resulted from averaging with the GIS tool utilized. Field data from Grizzel and others (2009) and more detailed GIS examination show localized zones with very steep slopes (>70%) within most of these 11 landslide initiation areas.

Figure 6. Slope gradients at landslide initiation areas for 101 landslides.

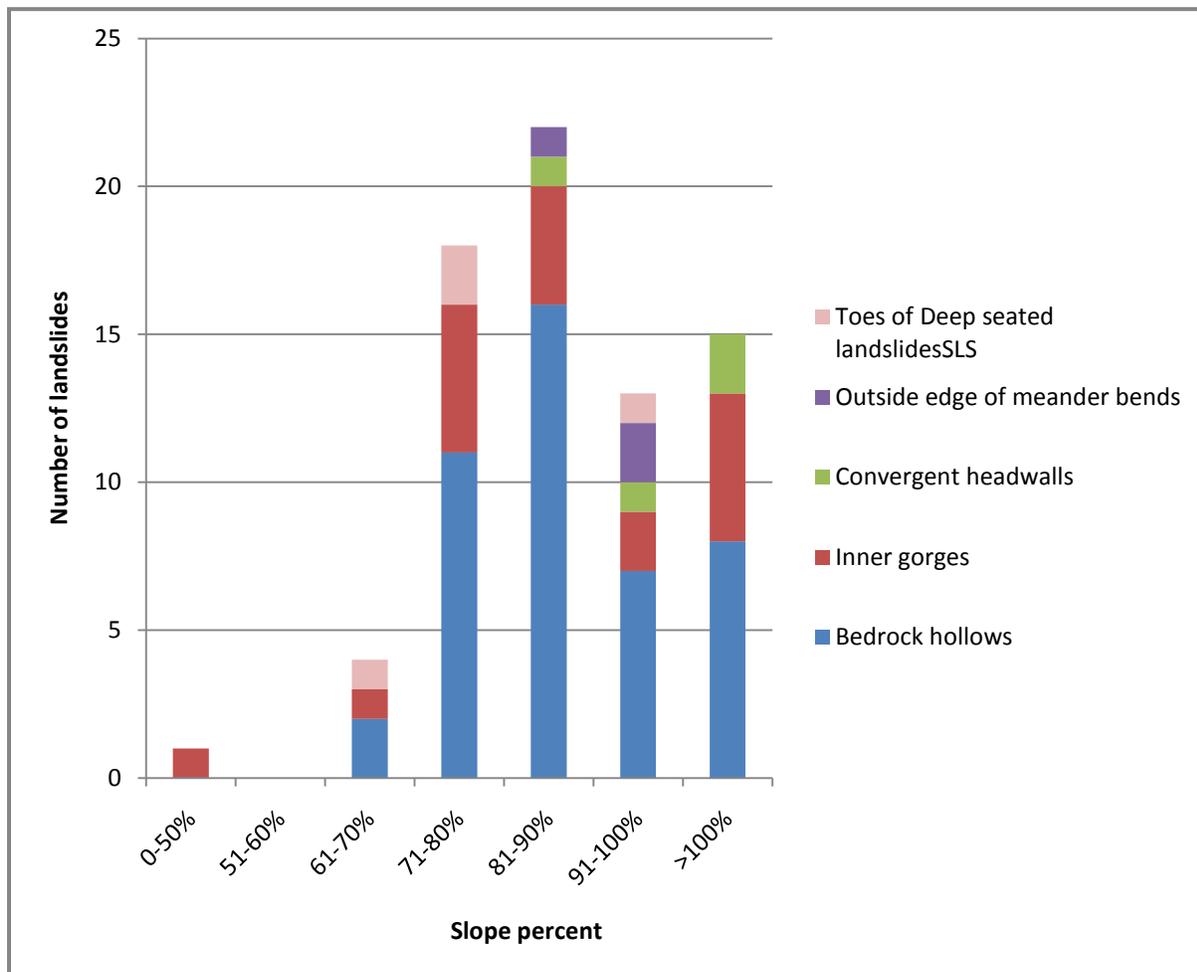
Figure 7 shows slope initiation gradients for 73 landslides associated with apparent rule identified landforms. Of these:

- A total of 68 landslides in apparent rule identified landforms are on topography steeper than 70%.
- Landslides in bedrock hollows and inner gorges occur in all gradient classes above 70%.
- Landslides in convergent headwalls were found only on slopes greater than 81%.
- A total of four deep seated landslides were reactivated from the 2009 storm.
- The one landslide that is below 50% was referenced in the State Trust Land’s report by Grizzel and others as localized evacuation area of 50 to 70%; however, to be consistent, the GIS tool estimate was used.

Figure 7. Landslide initiation slope gradients and apparent rule identified landform.

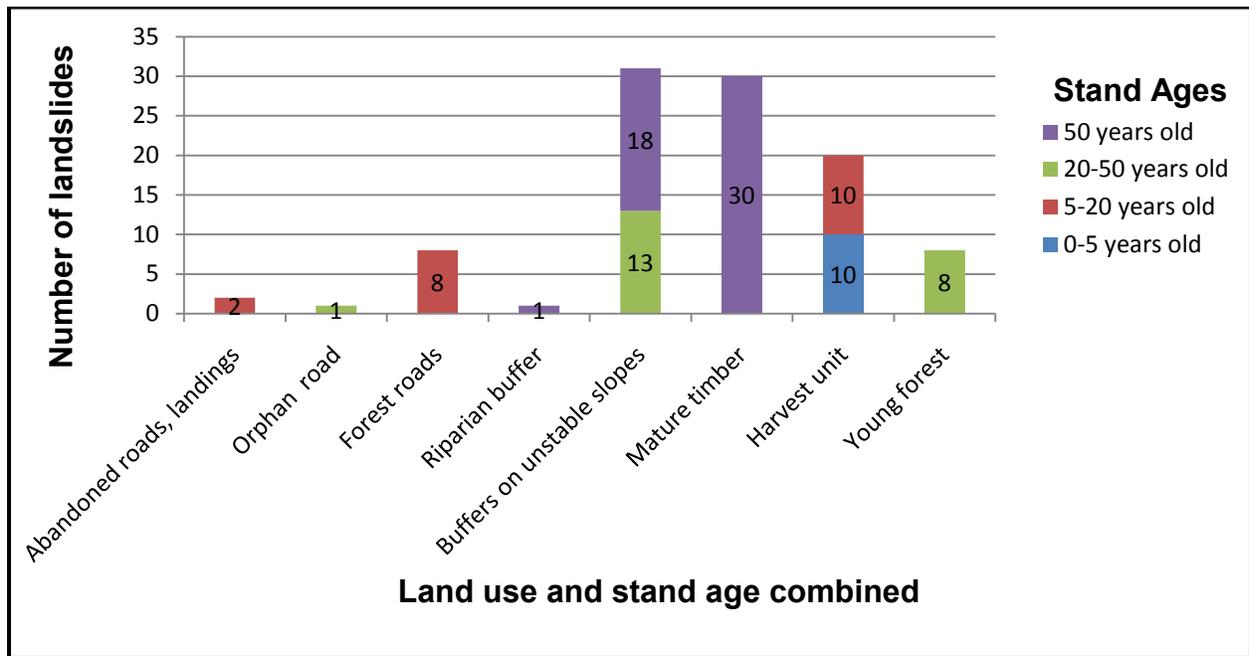
Figure 8 shows land use and stand age for the 2009 landslide initiation areas. During this investigation, about 50% of these estimates were checked against stand age data provided by Sierra Pacific Industries. Twelve landslides are associated with roads and landings. Twenty-eight landslides were associated with harvest units (0-20 year old forests) and young forests (20 to 50 years old). Seventy landslides initiated where the forest had not been harvested for at least 20 years. Of these, sixty-one slides occurred in mature forest or on buffers on unstable slopes, and 49 slides were in age class 50+ years. Ten landslides were in the age class of 0-5 years (Figure 10).

Figure 8. Land use and stand age at initiation areas for 101 mapped landslides.

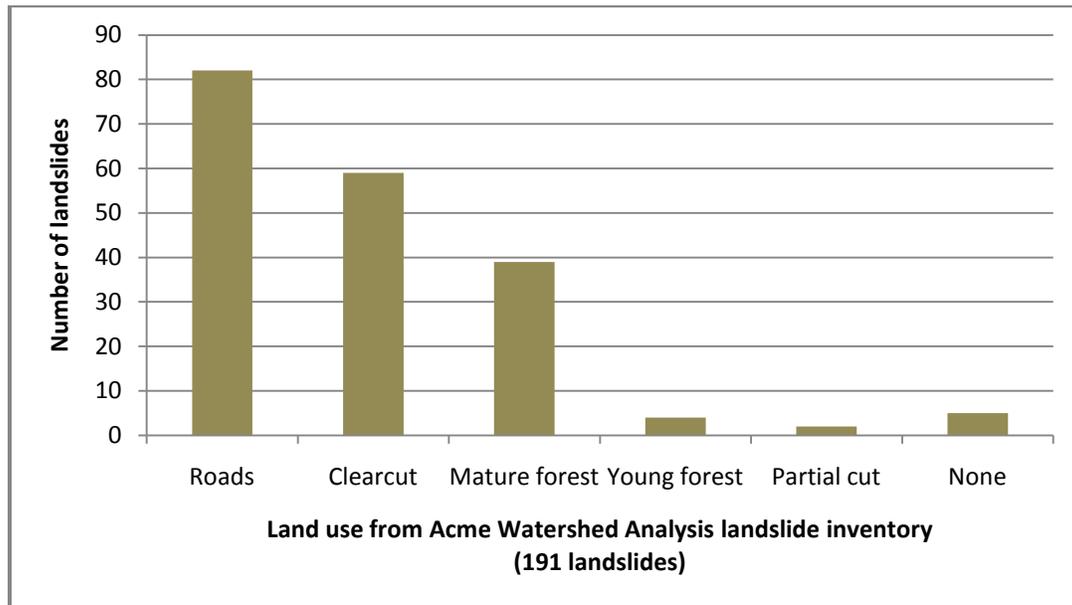
The Acme Watershed Analysis landslide inventory (191 landslides) used similar land use categories to those used for this report. However the only clear comparison is for roads; Figure 9 show that forest roads were a larger component (82 out of 191 landslides or 43%) of the inventory than are shown for this report (12 out of 101 landslides or 12%). After the Watershed Analysis process, Road Maintenance and Abandonment Plans were adopted. These contain requirements that forest roads meet higher standards before harvest activities are approved.

Figure 9. Land use data from the Acme Watershed Analysis.

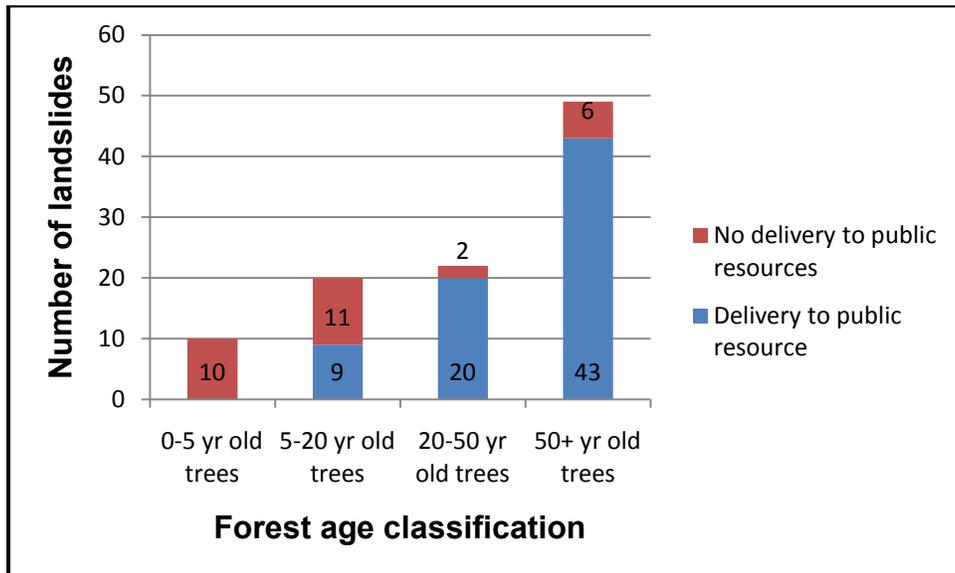
None of the landslides that initiated in harvest units with trees ranging from 0 to 5 years old delivered to a public resource or threatened public safety (see Figure 10). However, nine out of 11 landslides that initiated in harvest units having a forest age class of 5 to 20 years old delivered to a public resource. Most of the landslides that initiated in young forest (20 to 50 years) and in mature timber (50+ years) delivered to a public resource.

Figure 10. Landslides that delivered to public resources by forest age class.

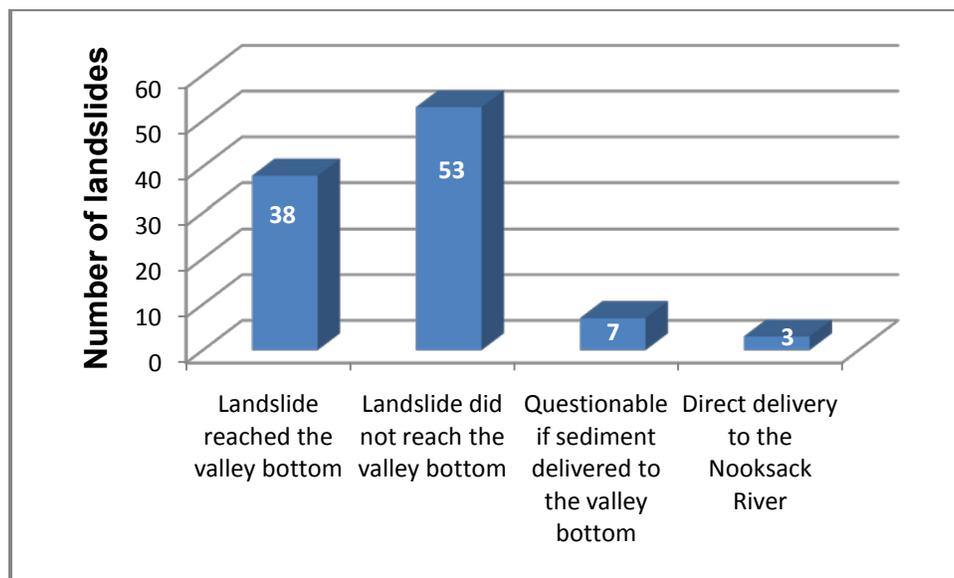
Figure 13 shows the distribution of landslides delivering to the valley. A total of 38 landslides reached the valley. The 53 that deposited debris in the upland usually ended in stream channels. These totals do not include seven questionable landslides that appear to end in higher elevation streams with no clear evidence that sediment flowed onto valley. Three landslides on fluvial terraces delivered directly to the Nooksack River.

Figure 13. Landslides that delivered to the South Fork Nooksack Valley.

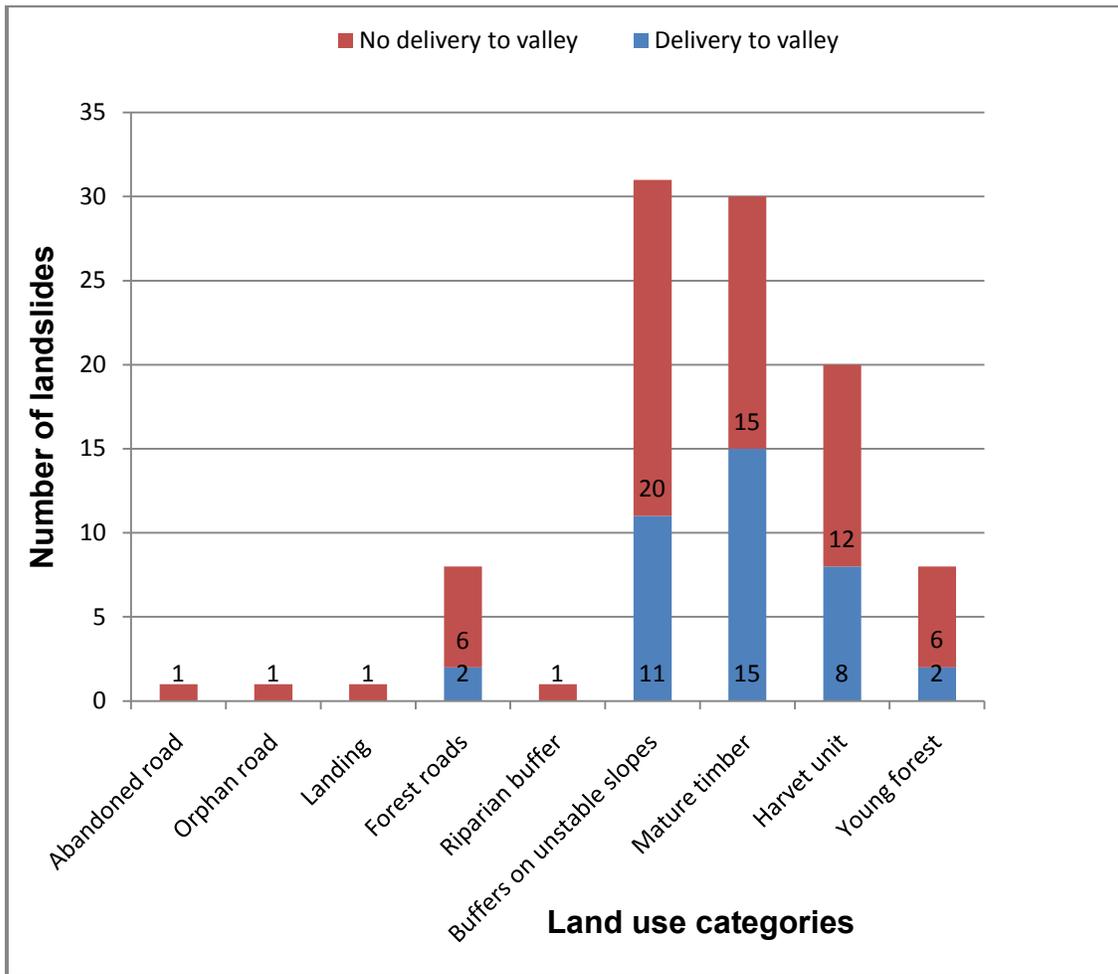
Figure 14 summarizes land use associated with landslides that deposited on the South Fork Nooksack Valley. Figure 15 shows the frequency of landslides by forest age-class at the initiation area for 38 landslides that reached the valley bottom.

Figure 14. Land use associated with landslides that delivered to the South Fork Nooksack Valley.

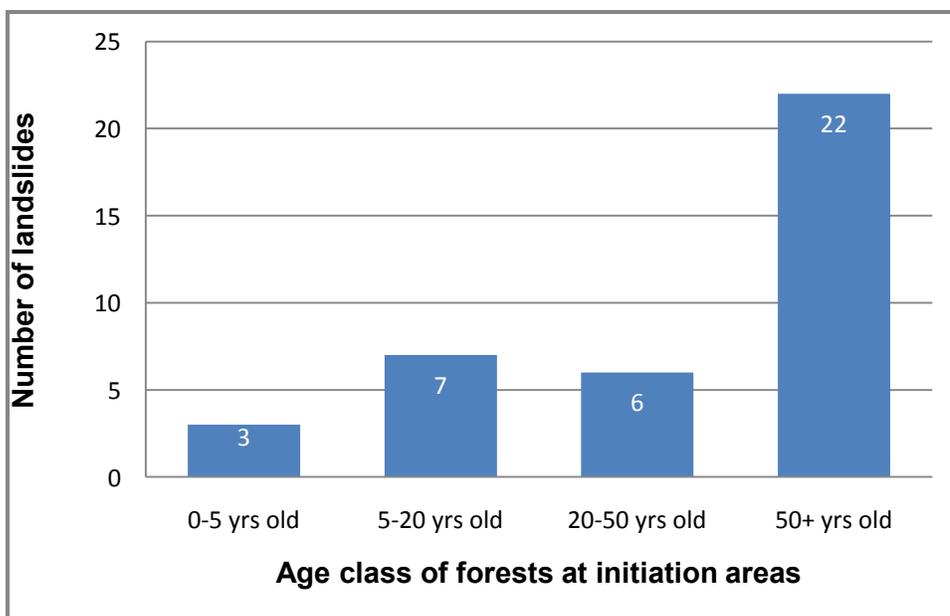
There were 22 landslides that originated in mature forests greater than 50 years old. Of these the slope gradients at initiation areas were predominantly greater than 70%. Three of these landslides were located in the steep topography near Radonski Creek and the initiation area was not evident.

Figure 15. Age class at the initiation area of landslides that reached the South Fork Nooksack Valley.

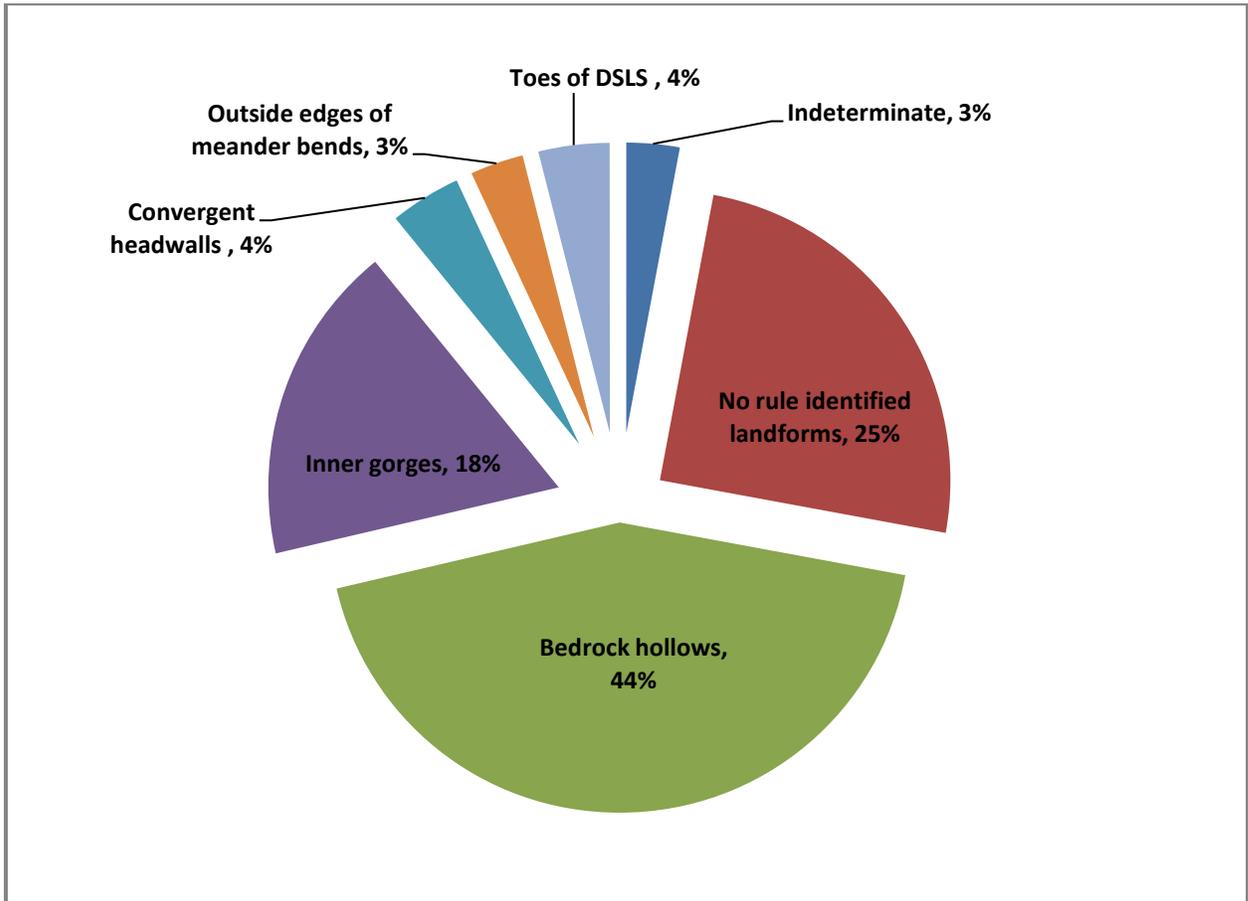
Figure 17 shows the relation of apparent rule identified landforms and inventoried landslides. The category, “No Rule Identified Landforms”, contains slopes regulated under WAC 222-16-050 (1) (d) (E), which states that *areas containing features indicating the presence of potential slope instability which cumulatively indicate the presence of unstable slopes*” are also rule-identified. We have less confidence in these determinations. Future field review may reveal contributing factors for the initiation of these landslides (e.g., seeps, springs, old roads or skid trails, or channeled water).

Twenty-five landslides are not associated with apparent rule-identified landforms. While the sample set is too small to draw meaningful conclusions, we have the following observations:

- These landslides are of particular concern because of the difficulty in predicting such instability with conventional remote sensing tools (e.g., lidar and aerial photography).
- Five landslides occurred on land that is not regulated by the DNR Forest Practices Rules.
- Road or landing failures accounted for eight landslides.
- Six landslides occur on slopes less than 70%.
- Initiation areas of three landslides in the Radonski Creek area were not determined due to steep topography and shadows even though parts of the landslide tracks were visible.

Figure 17. A total of 101 landslides and their correlation to apparent Forest Practices rule-identified landforms.
