**CAPITOL CAMPUS GREENHOUSE SOIL STABILITY INVESTIGATION
STATUS REPORT**

January 19, 1995

Stephen P. Palmer and Wendy J. Gerstel
Washington Department of Natural Resources
Geology and Earth Resources Division
P.O. Box 47007
Olympia, WA 98504-7007
(360) 902-1450

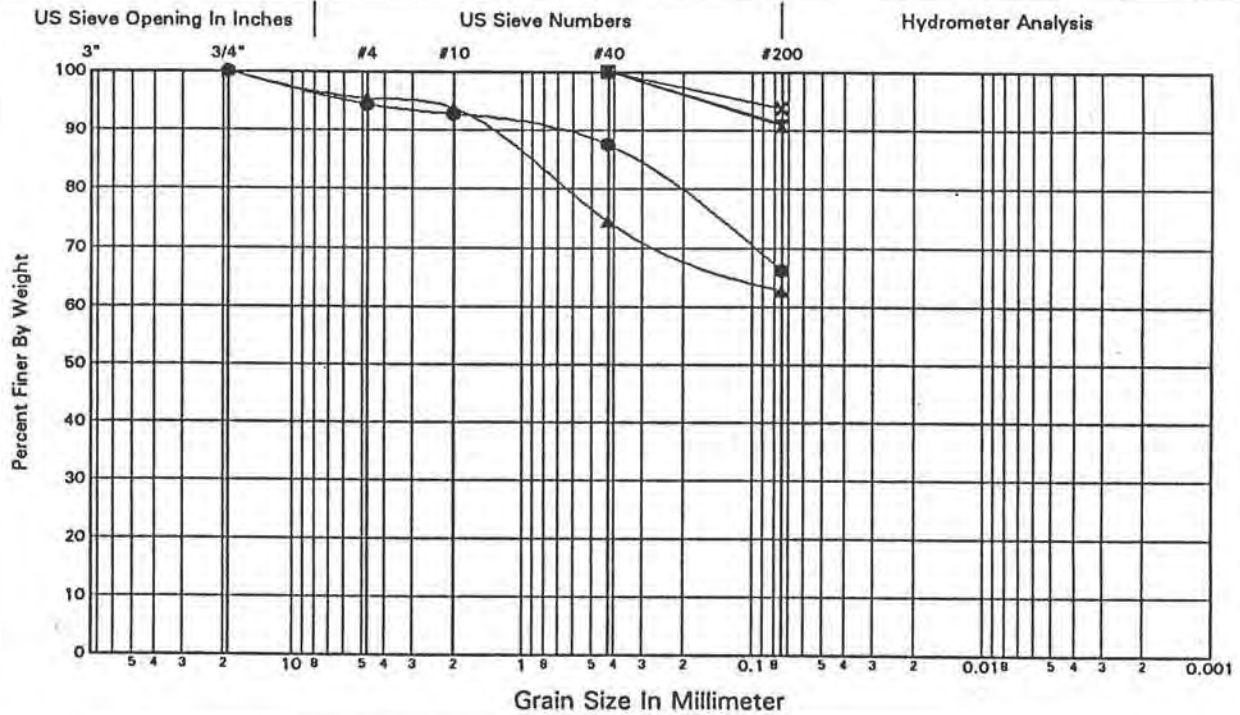
Table 1 Gradation data and Aterburg limits for six samples from boring DH-2. All samples are classified as ML soils and are either non-plastic or have low plasticity.

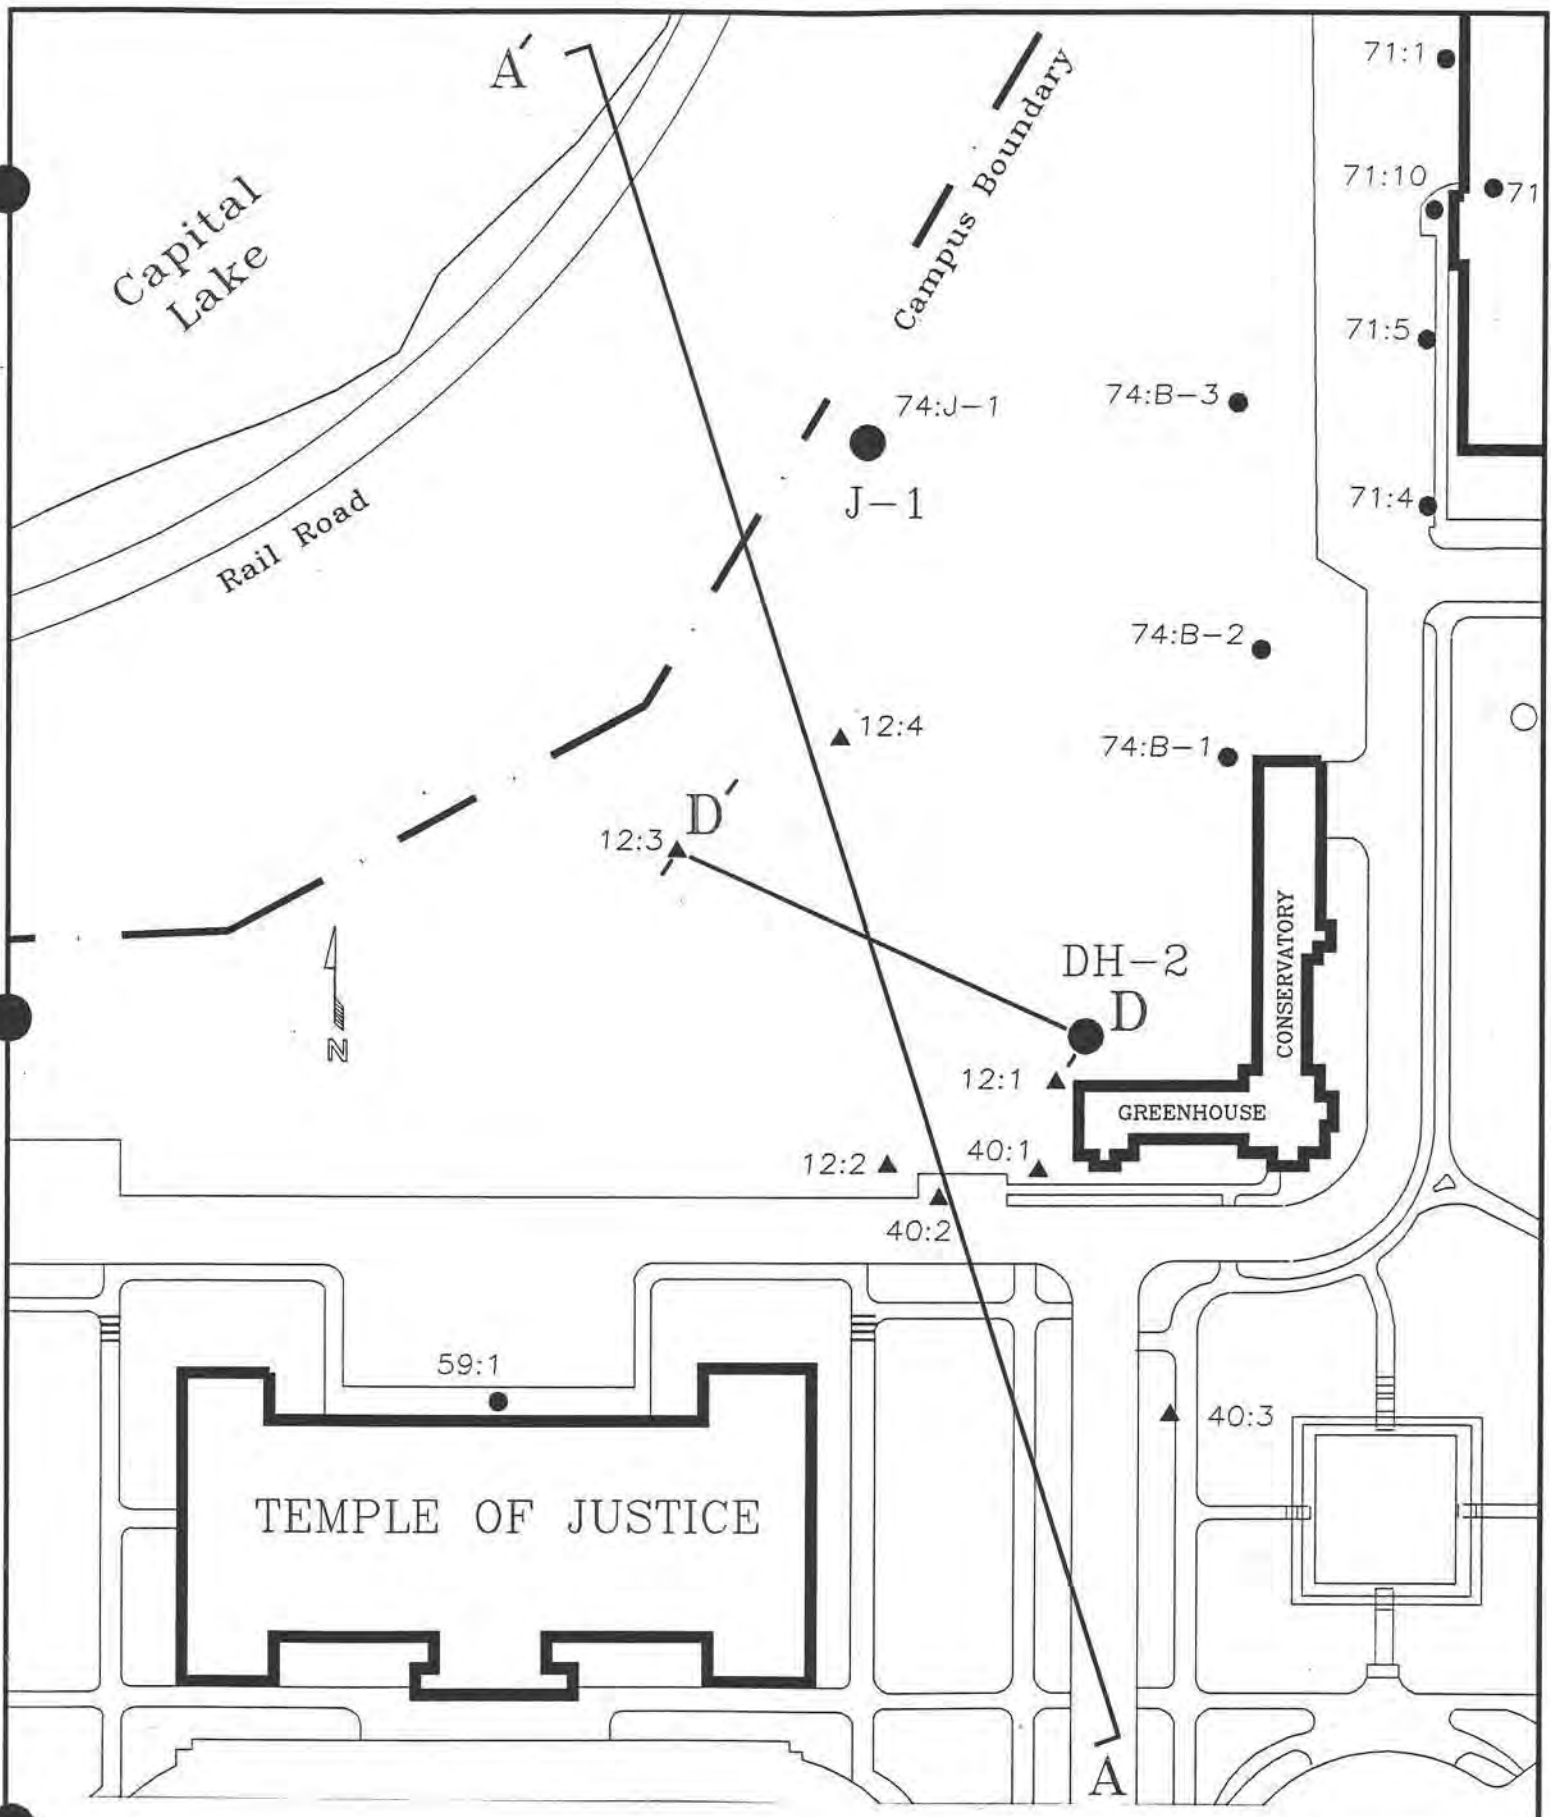
Figure 1 Location map of the Capitol Campus Greenhouse and Conservatory, including locations of borings DH-2 and J-1. Note that this map not to scale.

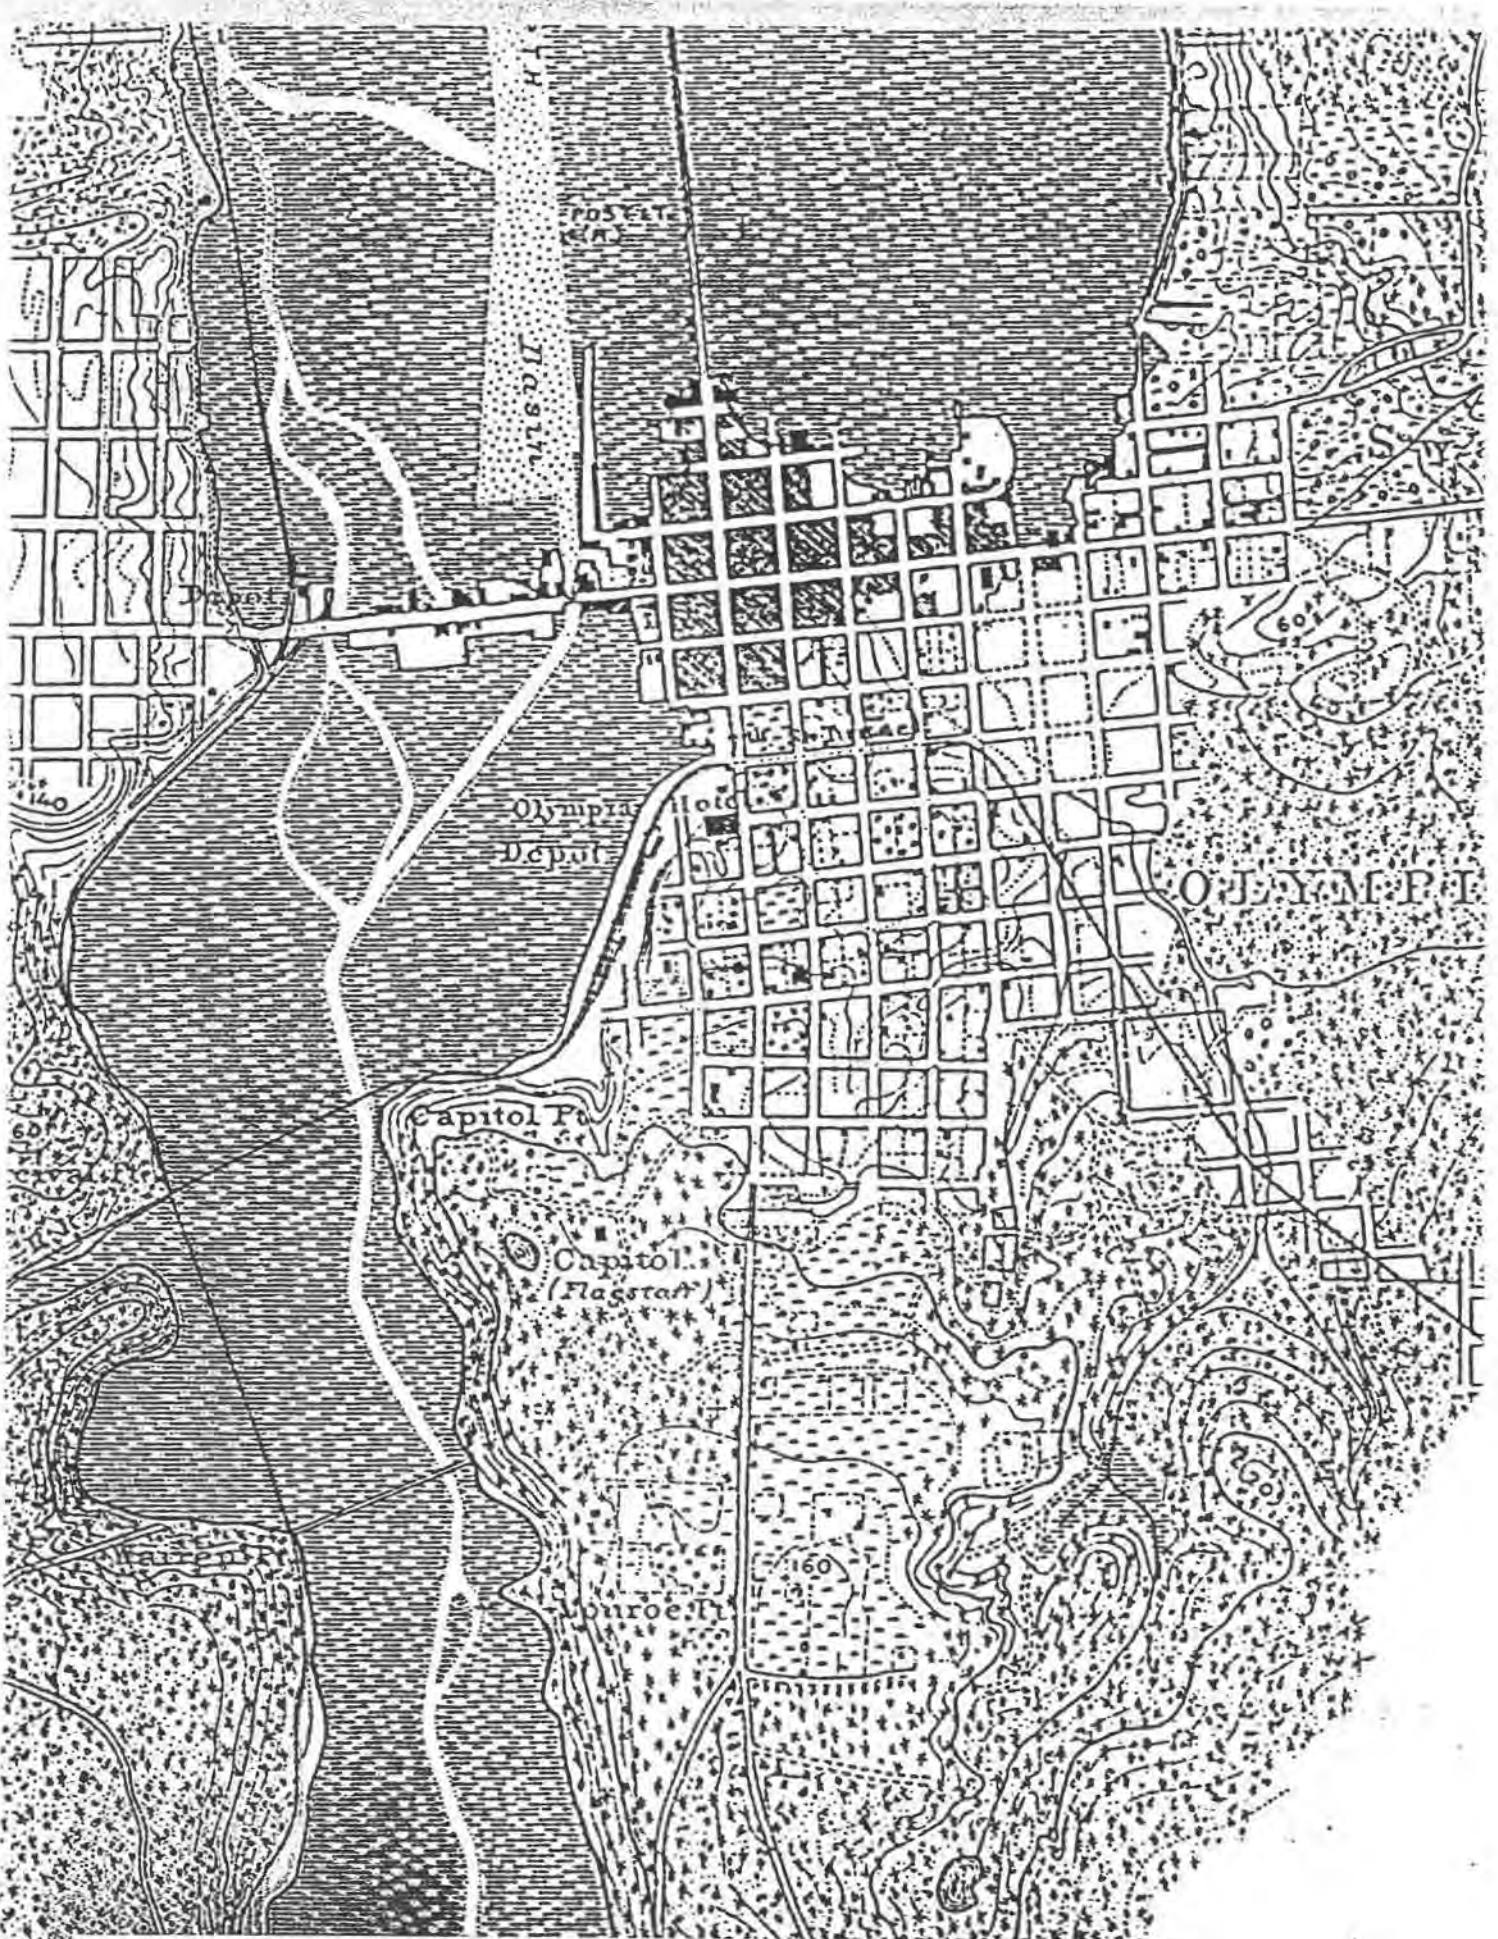
Prior to development of the Capitol Campus, a large ravine extended from the Winged Victory Monument northward past the Greenhouse and Conservatory to Capitol Lake (Figure 1). Figure 2 shows a portion of a topographic map from the Olympia area from the late 1800's, prior to development of the Capitol Campus. Figure 3 is a map of the same part of Olympia taken from a recent 1:24,000 topographic quadrangle. Comparison of these maps indicates that the original ravine (circa 1880) was much more pronounced and extensive than at present. The head of the ravine was located approximately east of the Temple of Justice building, draining almost directly north. Hand augering at the Winged Victory Monument found approximately 9 feet of blue-gray clayey silt overlying brown sandy soils, indicating that the ravine fill (and consequently the ravine) may have extended as far south as the monument. Fill depths exceeding 65 feet are found in the deepest portions of the original ravine; similar fill material was placed along the mouth of the original ravine at the level of Capitol Lake as a base for the railroad tracks. Estimates of the fill depth have been reported in previous geotechnical investigations in the vicinity of the Greenhouse/Conservatory and the Temple of Justice. All of the existing boring data, including the results of boring DH-2, are presently being incorporated in the production of a fill depth map.

Figure 2 Portion of a topographic map of the Olympia area, circa 1880, showing the future location of the Capitol Campus. Scale approximately 1:12,000

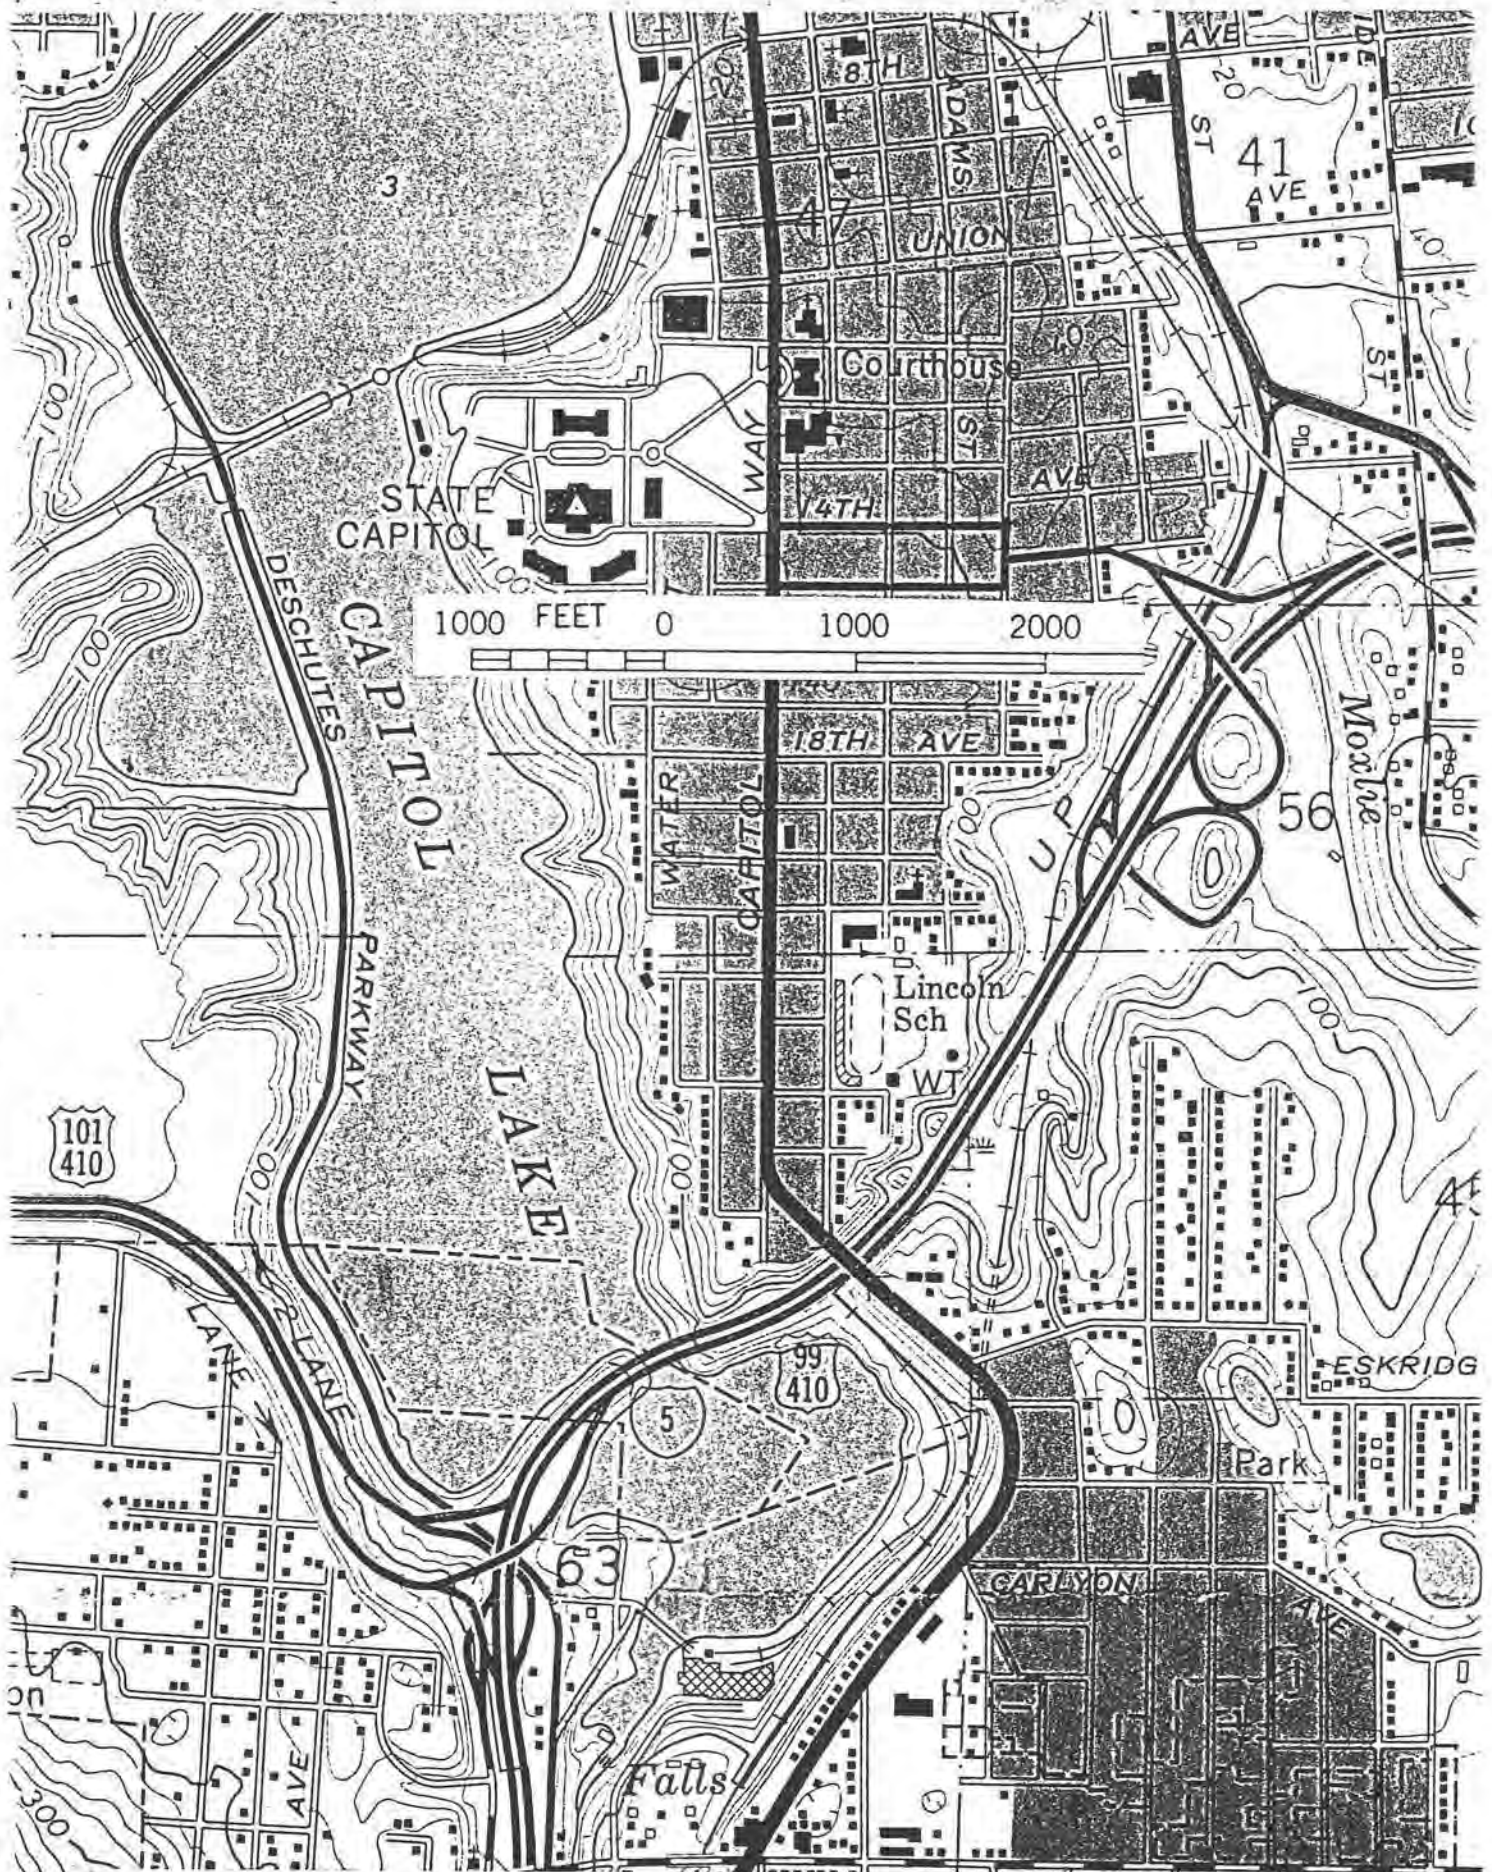
Figure 3 Recent topographic map of the Capitol Campus area taken from the Olympia 7.5' topographic quadrangle. Scale approximately 1:12,000.

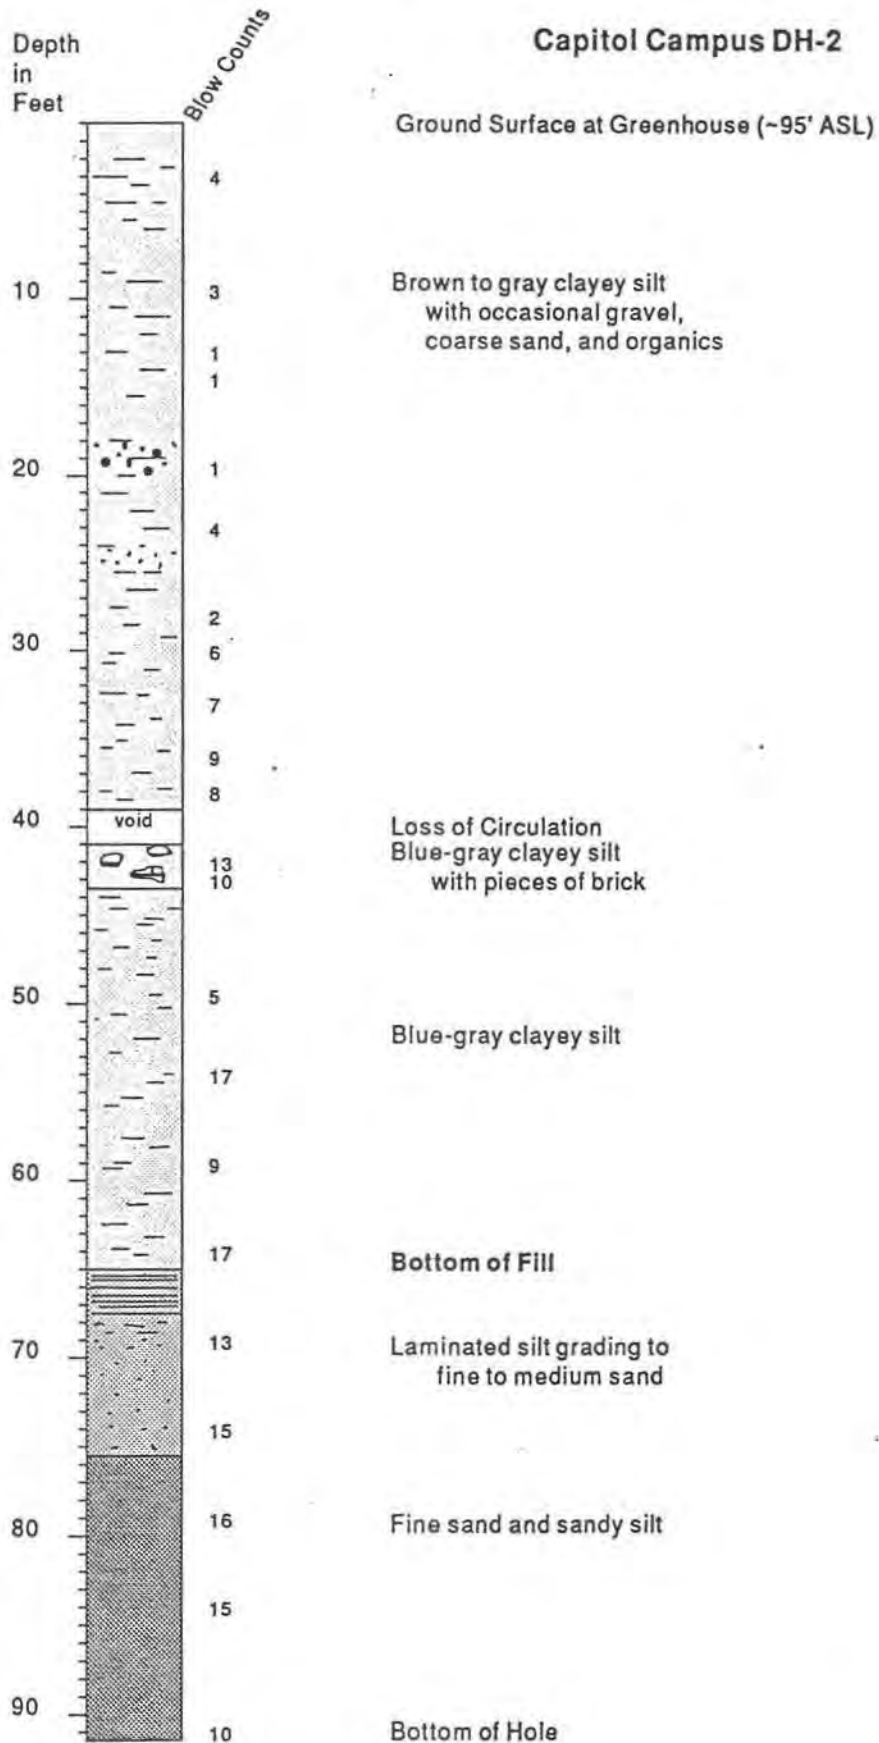
Boring DH-2 is located approximately 6 feet from the northwest corner of the Greenhouse building (see Figure 1). It was drilled in April, 1994, and reached a final depth of 91.8 feet. This site was chosen to capture the predicted maximum displacement direction of slope movement, given the limitations in drilling rig access. During drilling, disturbed samples with corresponding Standard Penetration Test blow counts were collected every 2 to 5 feet using a 2 inch OD split-spoon sampler. Undisturbed samples were collected for strength and consolidation testing. A boring log for DH-2 is presented in Figure 8. Table 1 reports gradation data and Atterburg limits for six samples selected from boring DH-2. All of these samples are ML soils, and are either non-plastic or have low plasticity.

Figure 8 Boring log for DH-2, drilled in April, 1994, near the northwest corner of the Greenhouse building.
