THUNDER CREEK BASIN
Skagit County
Report of DNR Study Team

by
Jerry Thorsen, Geologist

To
DNR-NW Regional Office
Georgia Pacific Corp.
Crown Pacific

1989

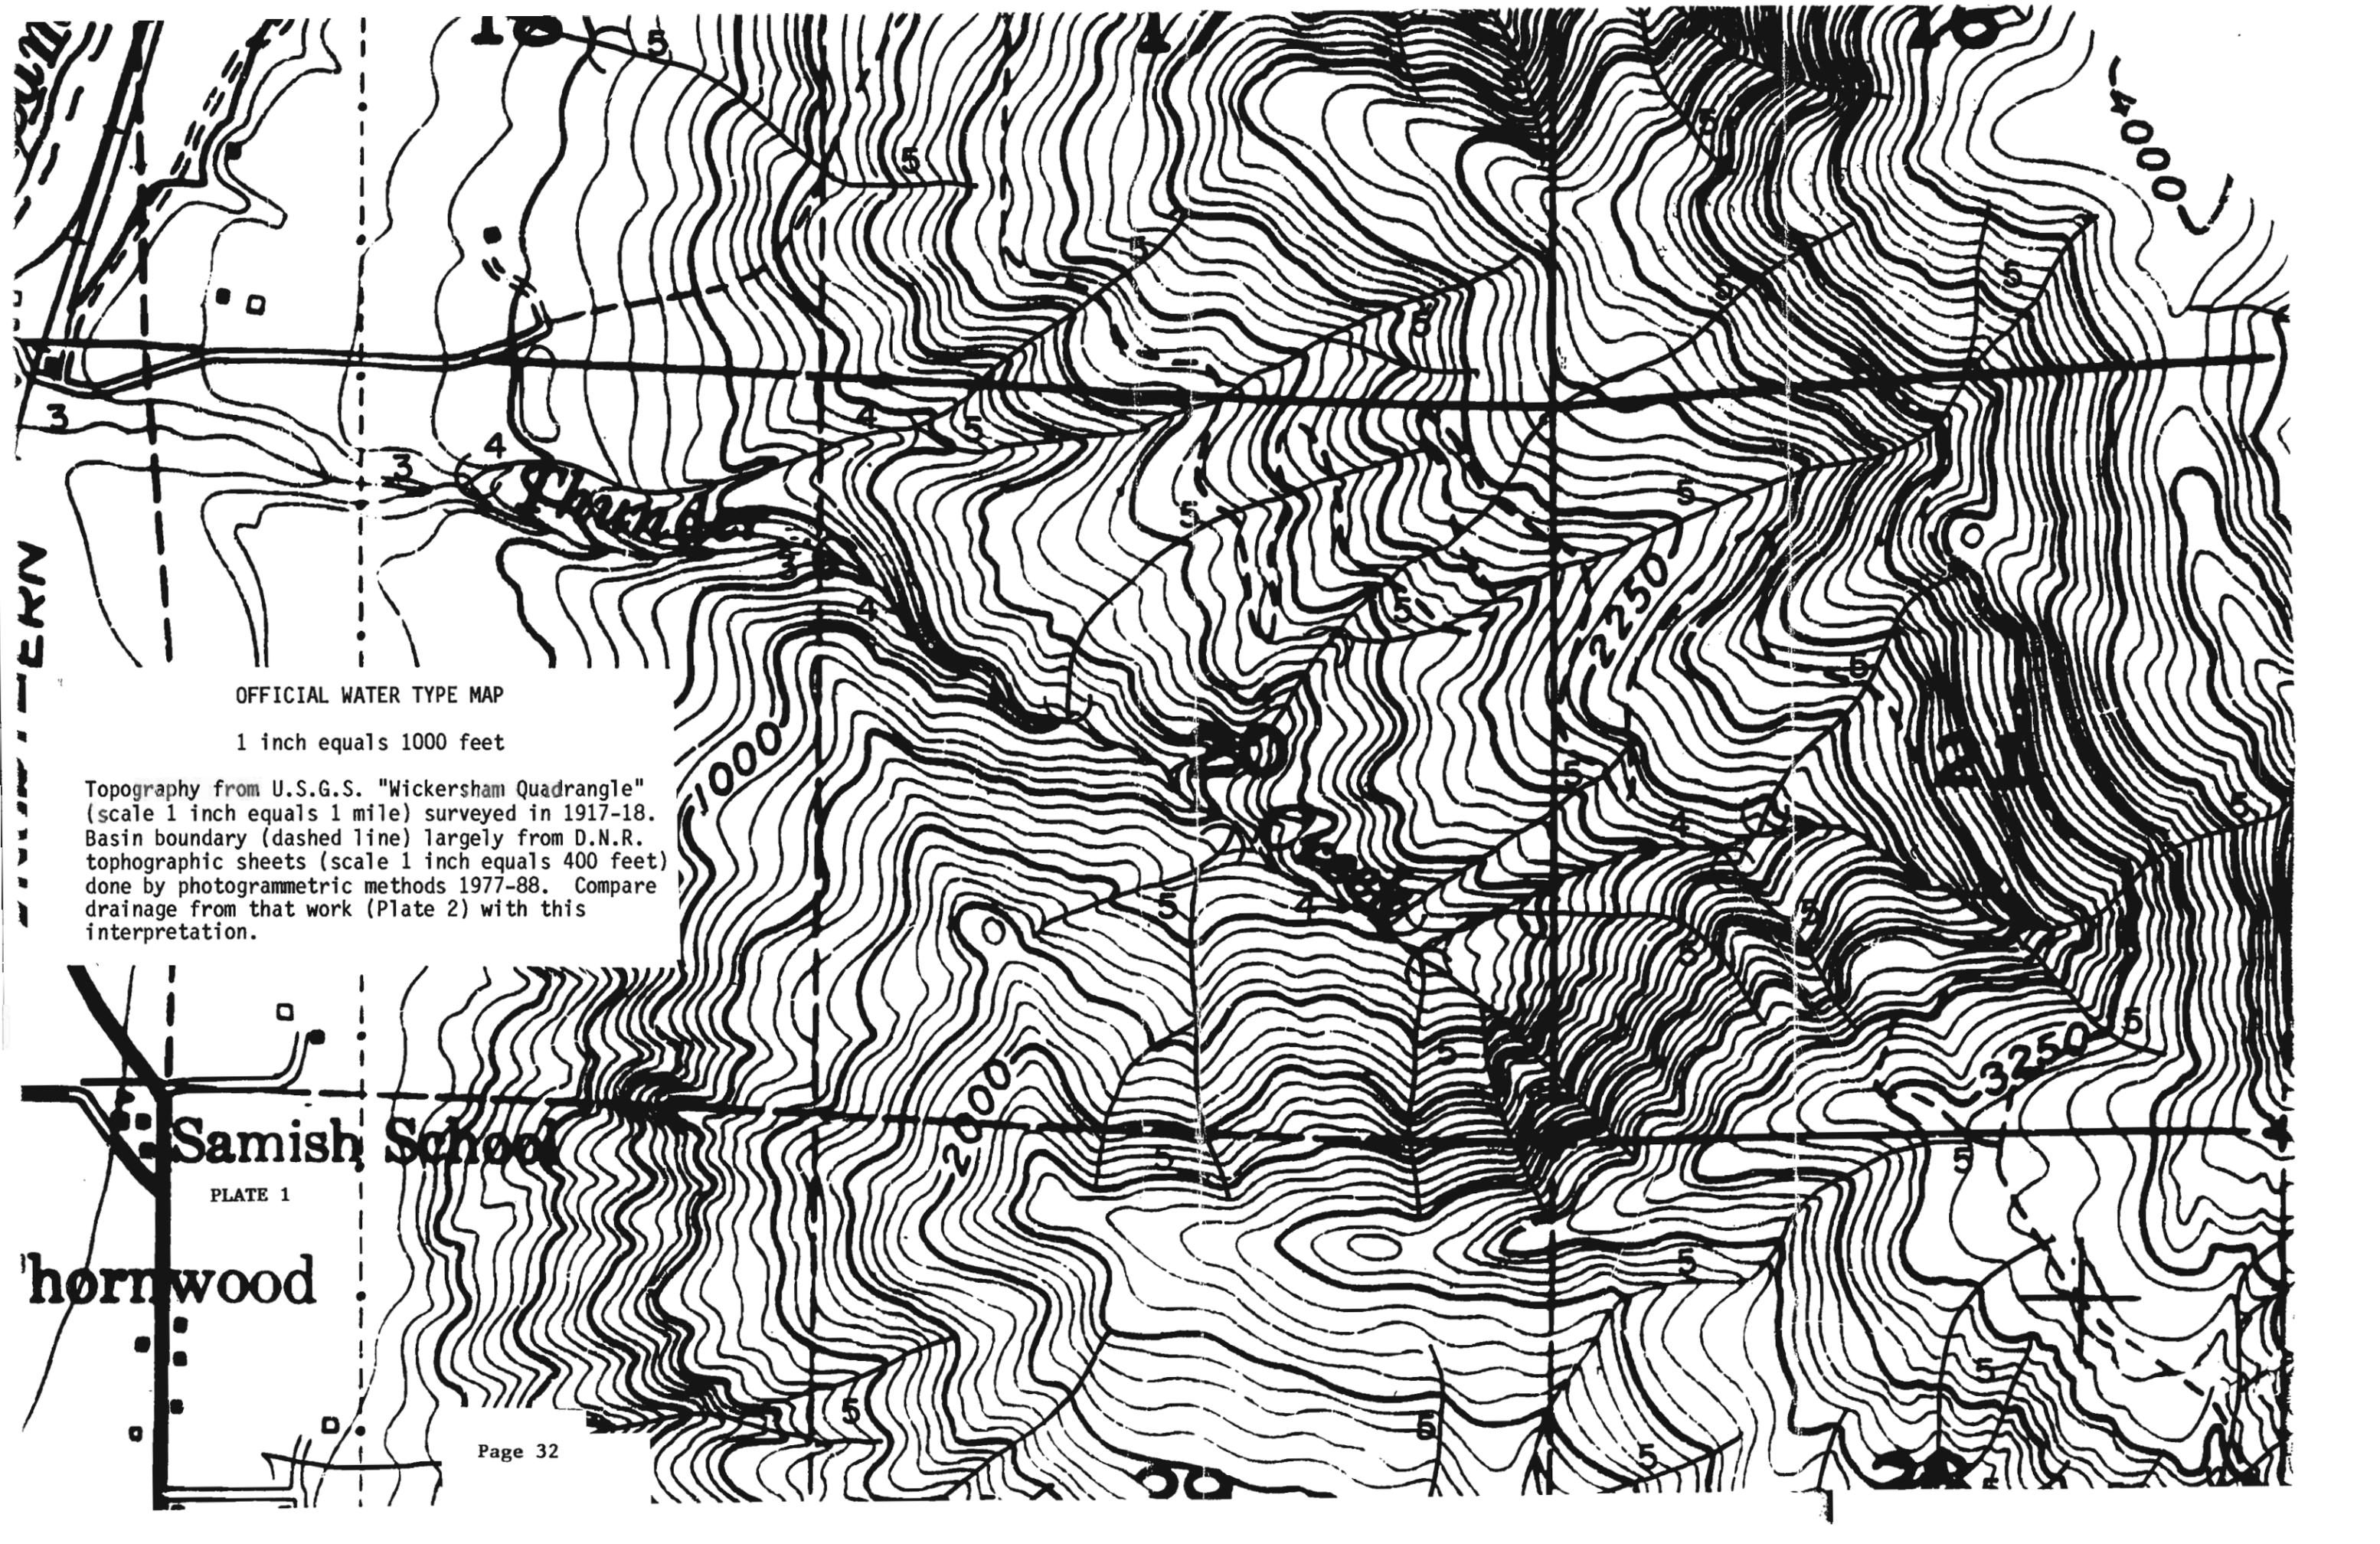
PLATE 1

The lower 8000 feet of Thunder Creek is considered to be a Type 3 stream on the water type map (Plate 1). Note that the water type map, based on an enlargement of 1917-18 planetable topography, bears little resemblance to the drainage shown on the 1981 U.S. Geological Survey base map (Fig. 4b) of larger original scale and photogrammetric origin.
