# Slope Stability Analysis of the Bluffs along the Washington State Capitol Campus, Olympia, Washington

by Wendy J. Gerstel

WASHINGTON  
DIVISION OF GEOLOGY  
AND EARTH RESOURCES

Open File Report 96-3  
April 1996

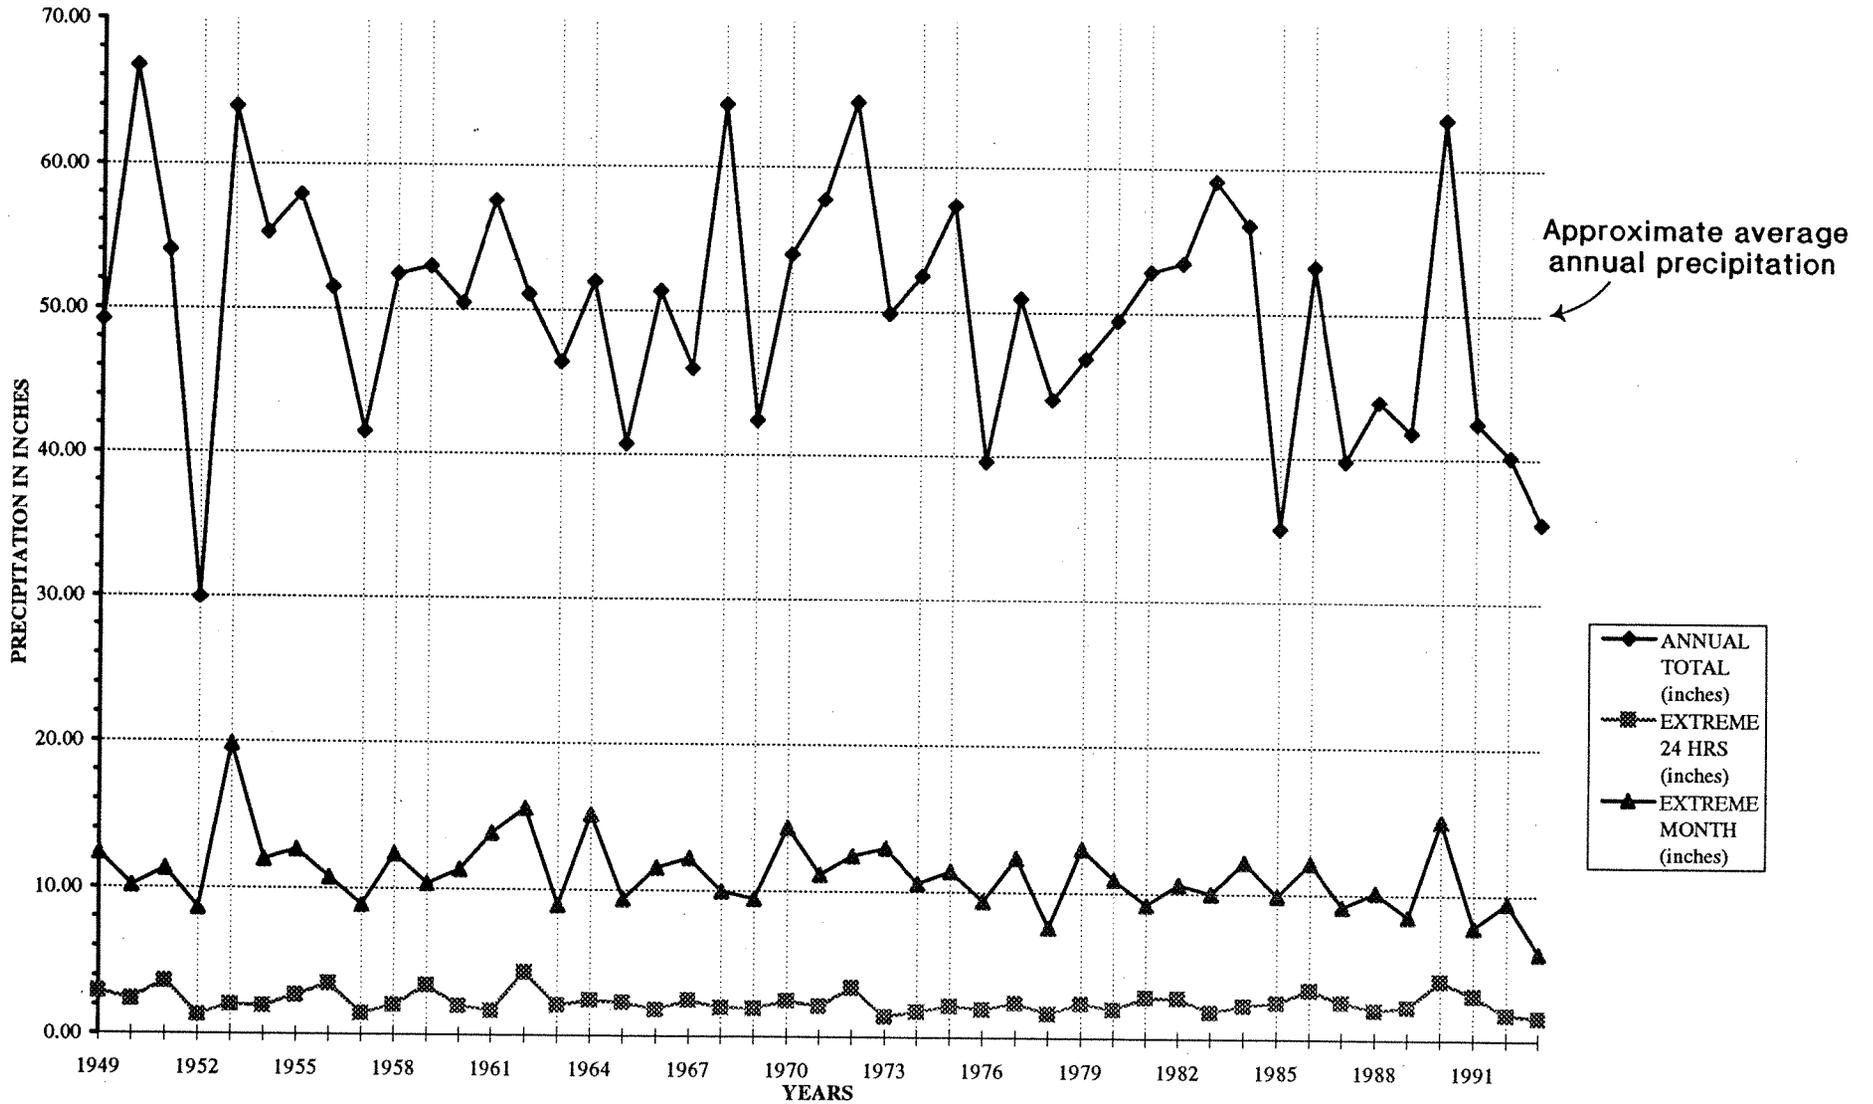
Possible correlations between precipitation and landslide activity along the Capitol bluffs were investigated. Records of precipitation from the Olympia Airport for the years 1949 to 1993 (Fig. 5) were compared to the information gathered from the 1965 through 1995 airphoto coverage. Figure 2 shows that periods of high landslide activity were concentrated in 1965 to 1972 and 1981 to 1995 (particularly 1981 to 1985). This corresponds to the generally higher precipitation from 1968 to 1972 and 1980 to 1984 shown in Figure 5. Likewise, low landslide activity seems to correspond to the lower precipitation recorded between 1972 and 1980. Correlating the slide activity of the late 1980s to the precipitation record is more difficult. In spite of a lower-than-average recorded precipitation for these years (average being approximately 50 in. per year), there is a general increase in landslide activity. This lack of correlation may be due to human influence, such as increased surface runoff caused by paving, poor drainage from the campus, plugged storm drains, or the effects of sidecast of organic and construction debris. The 1995 airphotos most likely chronicle the landslides resulting from the severe storms of 1990, recorded in the extreme monthly precipitation for that year (Fig. 5). Most of these landslides were centered around the northwest point. The largest covered the access road to the steam plant, the railroad tracks, and almost reached Capitol Lake. This slide was the subject of the investigation by Allen (1990).

Figure 5. Record of precipitation showing annual total, 24-hour extreme, and monthly extreme at the Olympia Airport for the years 1949-1993.

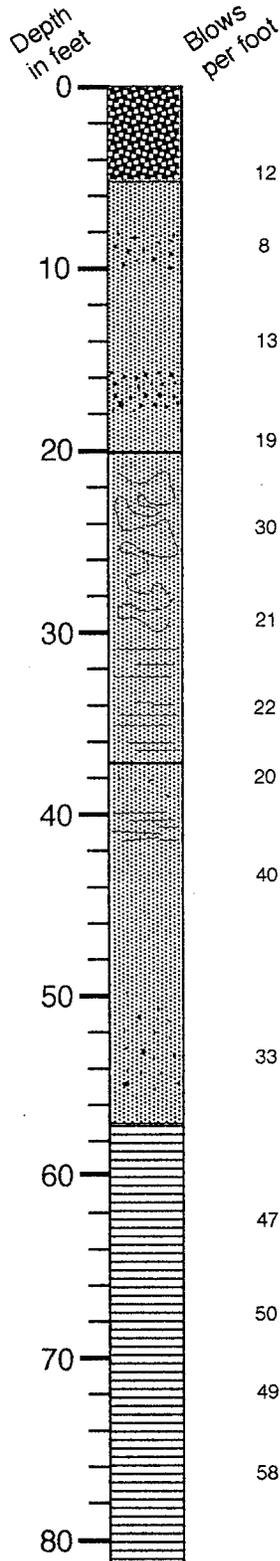
**BORING NUMBER: DH-5**  
**PROJECT: Capitol Campus Bluff Stability Investigation**  
**DATE OF DRILLING: December, 1994**

Ground Surface Elevation: approx. 105' a.s.l.

FILL: mottled gray/tan clayey silt; silty clay

Brown massive SILT with horiz. cemented iron-stained seams

Brown SILT, silty sand, and sandy silt, some iron-stained sub-horizontal partings, occasional gravel (<0.5") above lower contact

Bottom of Hole 81.0 feet

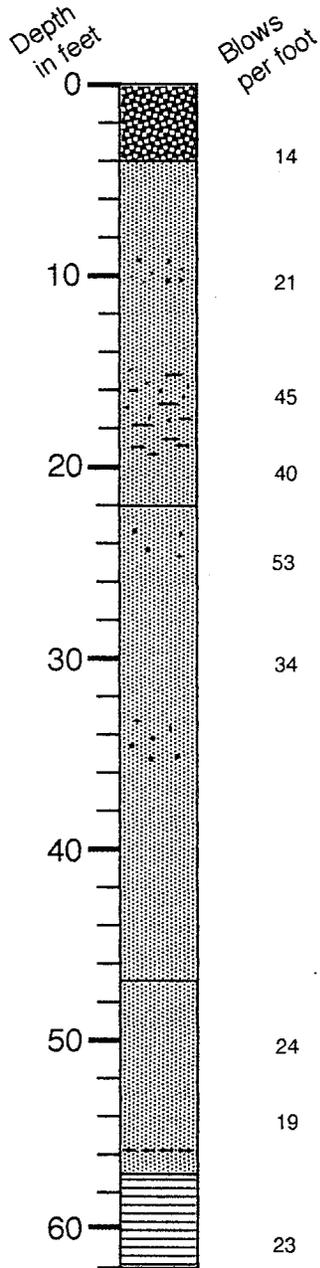
**BORING NUMBER: DH-6**  
**PROJECT: Capitol Campus Bluff Stability Investigation**  
**DATE OF DRILLING: December, 1994**

Ground Surface Elevation: approx. 110' a.s.l.

FILL: sand and gravel  
 Gray CLAY with gravel and cobbles, tan clayey SILT with occasional gravel.  
 (zone of pea gravel)

Moist brown sandySILT and silty SAND with zones of heavy iron stain and some gravel.  
 (moist-wet zone)

Tan laminated SILTS with some iron staining.

Bottom of Hole 62.0 feet

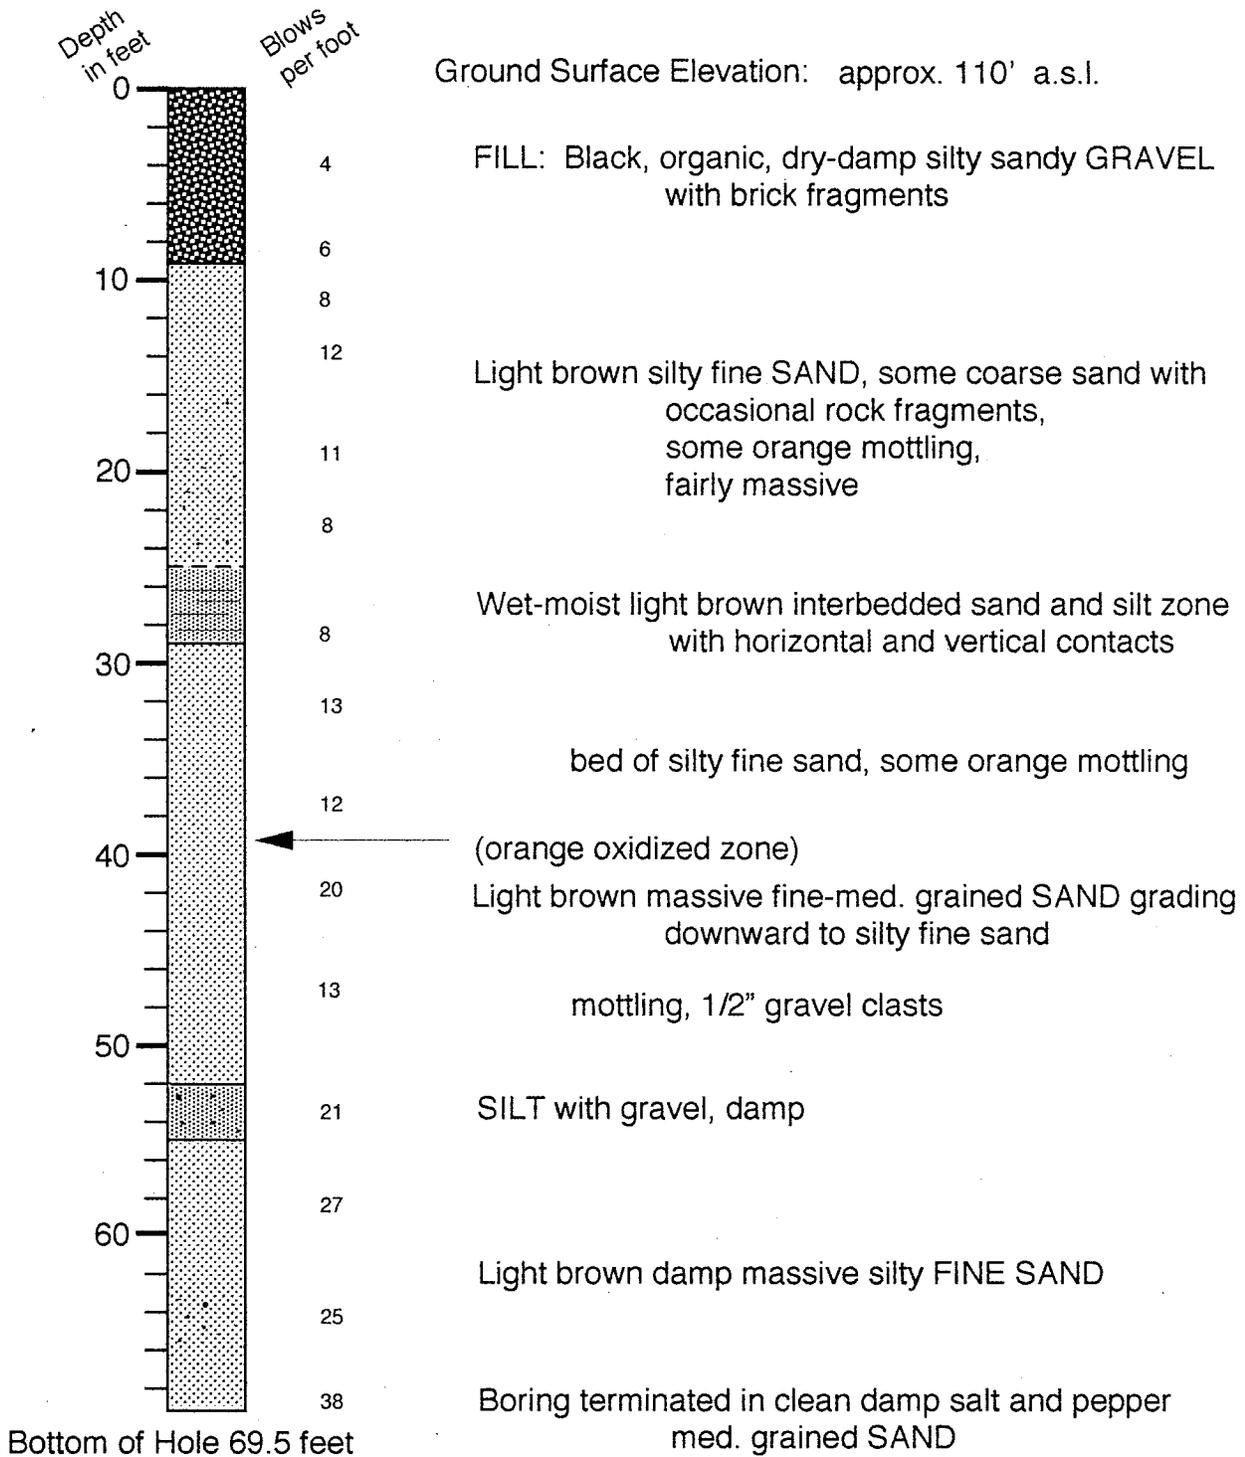
**BORING NUMBER: DH-11**  
**PROJECT: Capitol Campus Bluff Stability Investigation**  
**DATE OF DRILLING: January, 1995**

Note: 1977 photo of excavation for new oil tank at base of slope south of steam plant exposes 8-10' of light-colored fine sands/silts (?)

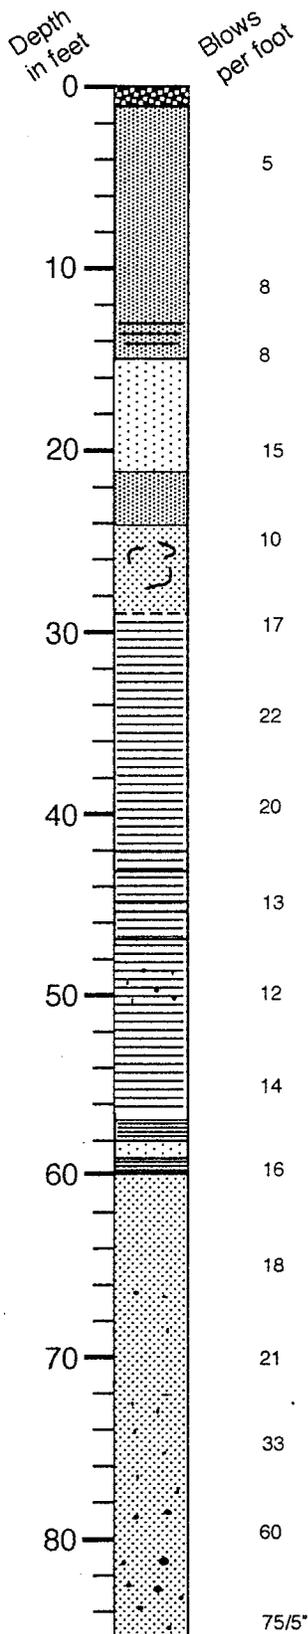
**BORING NUMBER: DH-14**  
**PROJECT: Capitol Campus Bluff Stability Investigation**  
**DATE OF DRILLING: July, 1995**

Ground Surface Elevation: approx. 125' a.s.l.

FILL(?): fine sandy silt

Dry-damp, tan fine sandy SILT, silty SAND grading downward into bedded alternating moist sand and silt.

(thin zone of Iron staining)

Moist salt and pepper med-coarse SAND

(Iron stain along laminations, and iron crusts)
