STATE OF WASHINGTON
DEPARTMENT OF NATURAL RESOURCES
DIVISION OF MINES AND GEOLOGY

HOLDEN TAILINGS

GERALD W. THORSEN

March 3, 1970

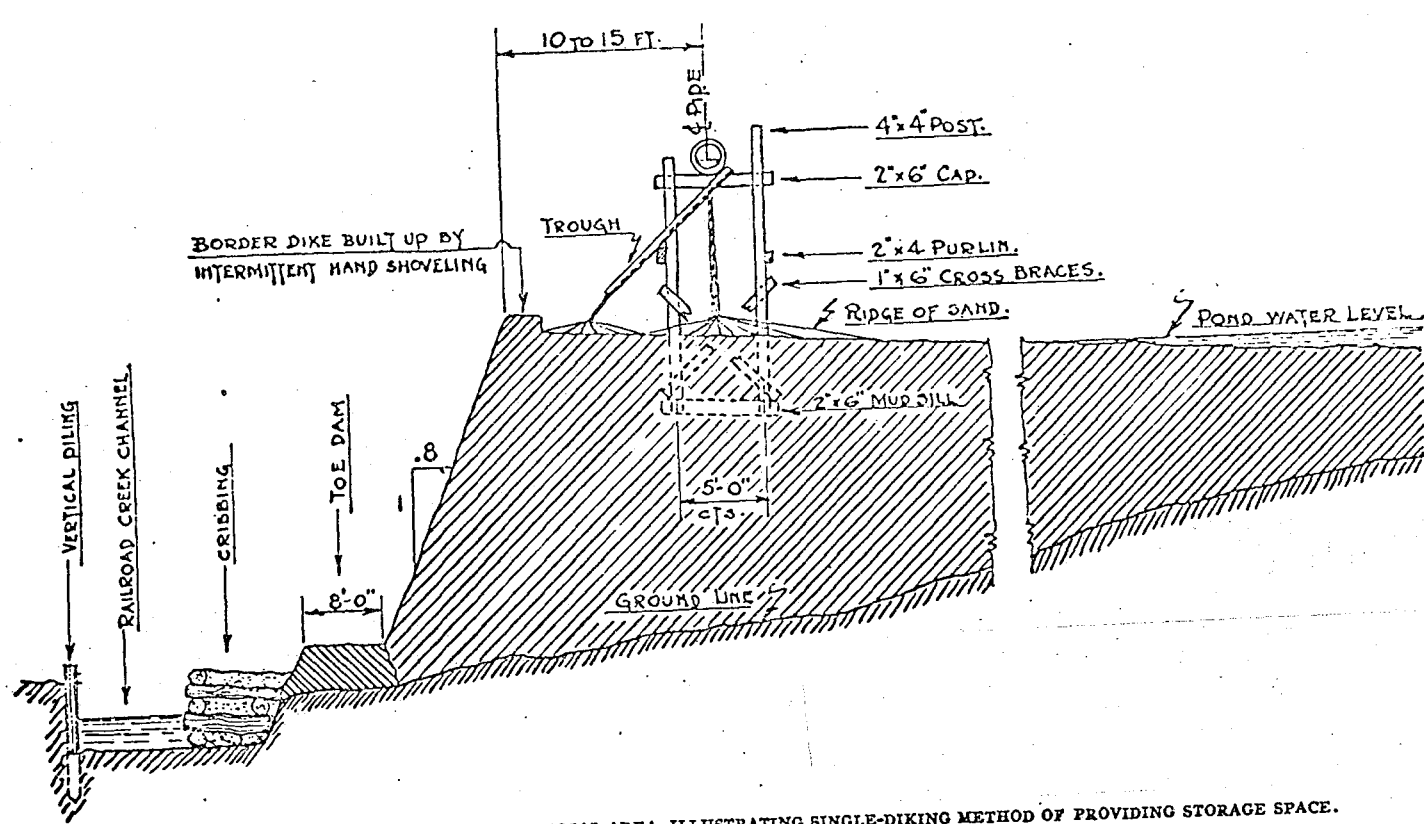
FIG. 2.—IDEALIZED SECTION OF TAILING-DISPOSAL AREA, ILLUSTRATING SINGLE-DIKING METHOD OF PROVIDING STORAGE SPACE.

The dikes that maintained the central settling pond, drained by these risers, were built as shown in Figures 2 and 3. The double dike method (Fig. 2) was used to provide extra storage capacity over the winter when it was impossible to build dikes due to the heavy snowfall. Most of the diking was done with "thickened" tailings from which the bulk of the extreme fine mud-size particles were removed (see Physical Characteristics). This enabled construction of a stable dike at slopes averaging 0.8 to 1 or about 52 degrees (Zanadvoroff, p. 690).
