Collapsing and Expansive Soils

THOMAS J. BEKEY

Rittenhouse-Zeman & Associates, Inc.,

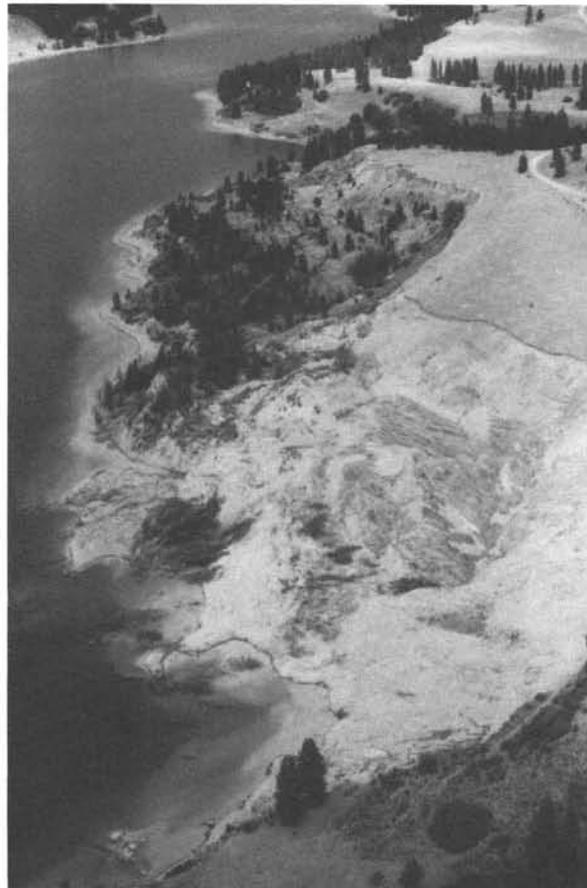
Aerial view of the Hughes landslide, Sanpoil Arm, Franklin D. Roosevelt Lake (Grand Coulee Dam reservoir). The slide is in glacial lake sediments. Photograph by R. W. Galster, July 1979.

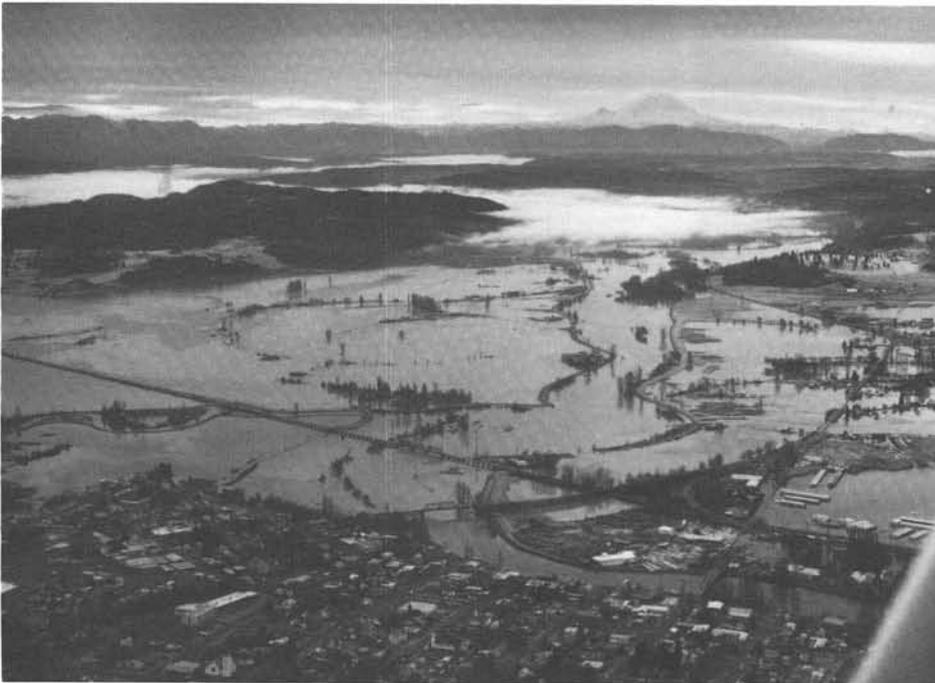
Figure 1. Aerial view southeast of the Snohomish River and valley during flood stage, December 1975. The town of Snohomish is in foreground. The river flows toward the viewer and off to the lower right; it is confined between dikes built on natural levees. The flow of the river during flood stage is constrained by highway and railroad embankments that cross the valley floor. Photo by the author.

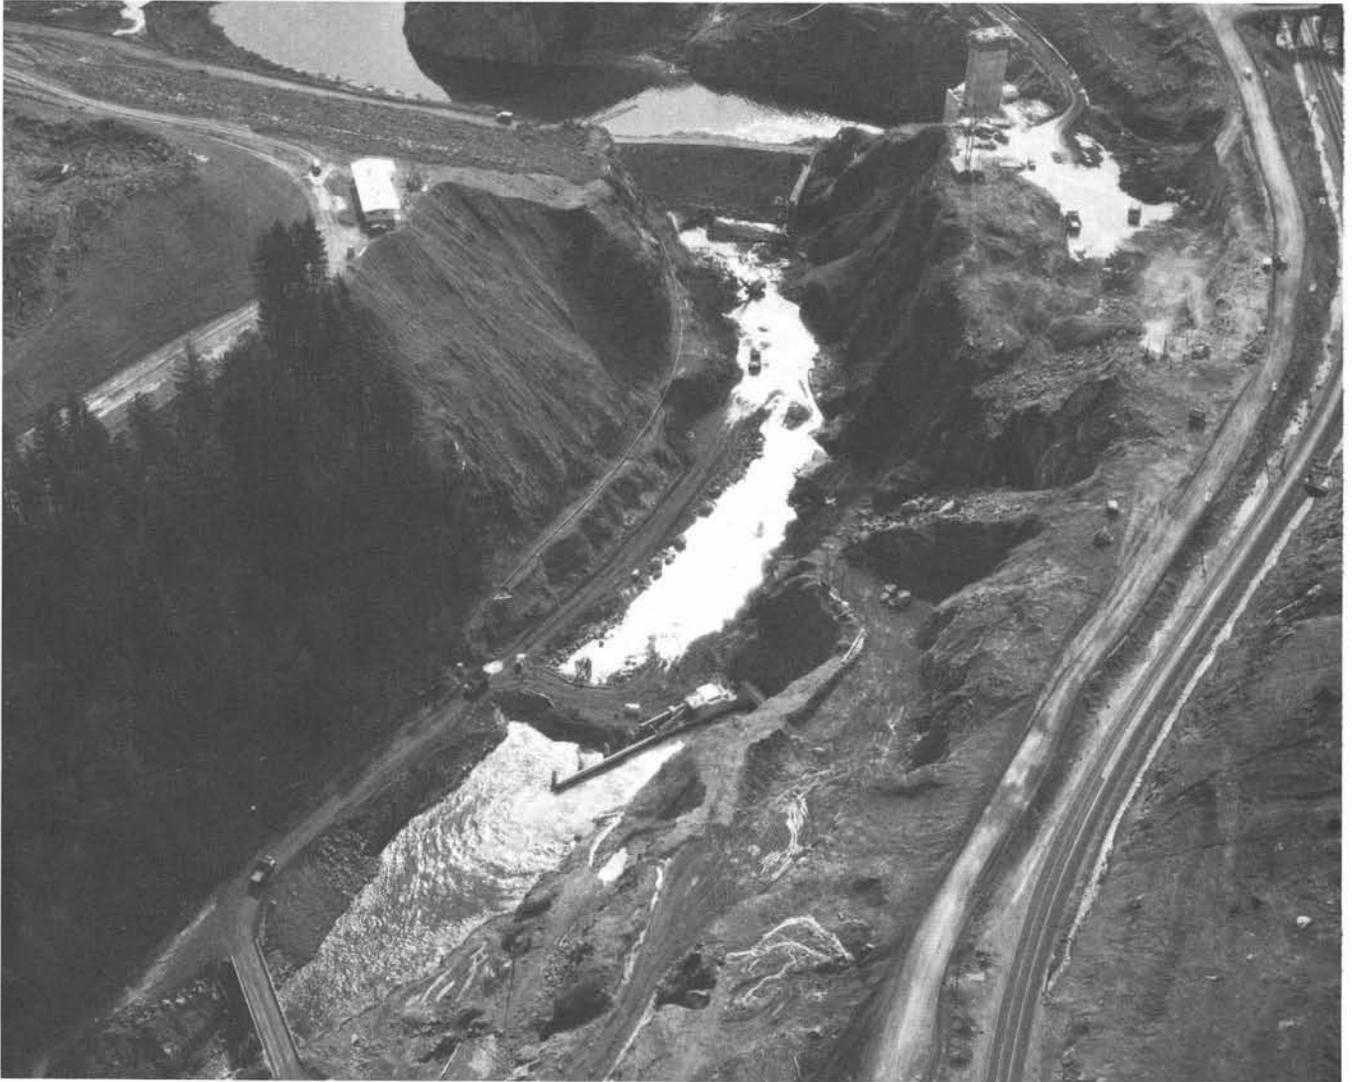
Howard Hanson Dam on the Green River; view upstream, spring 1960. The river has been diverted through a tunnel on the south (right) bank, upstream of which is a tall concrete structure. The downstream portal is in the lower center part of the photograph, just right of the downstream cofferdam. The embankment dam is to be built in the area between the two cofferdams, here being dewatered. Drilling and blasting of the spillway cut is in progress (right). Photograph by the Seattle District, U.S. Army Corps of Engineers.

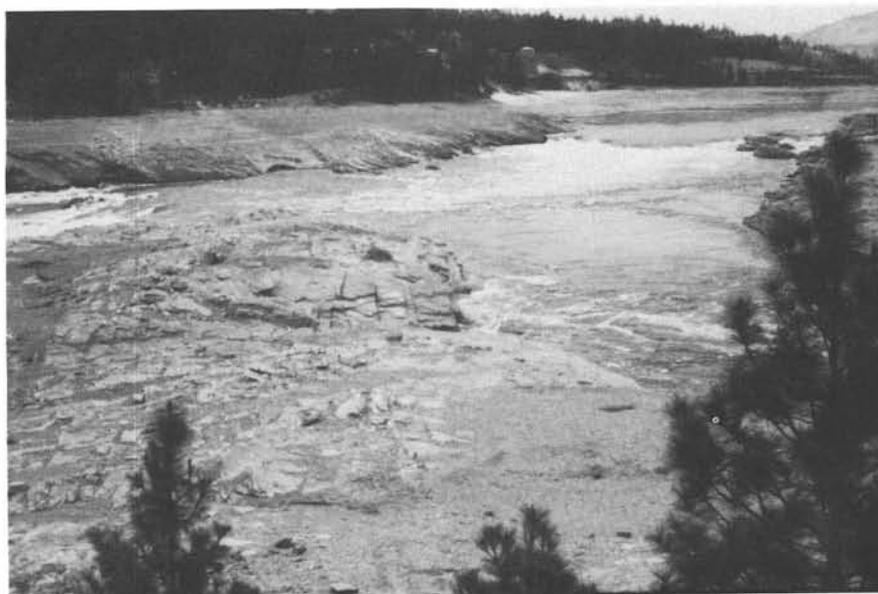
Kettle Falls, Columbia River. View to the northwest showing the condition of the former falls after 34 years of inundation by Franklin D. Roosevelt Lake. Photograph taken by R. W. Galster in May 1974 while the lake was drawn down for modification of Grand Coulee Dam.

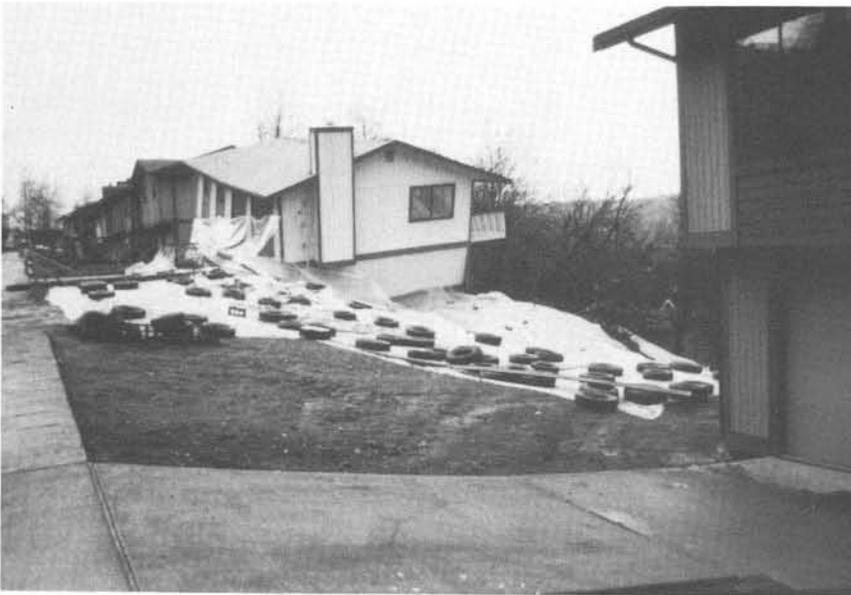
Dakota Street/Delridge Way slide, Seattle, showing the damage to houses near the headscarp. Photograph by R. W. Galster, February 20, 1986.

Dakota Street/Delridge Way slide, Seattle, showing the slide following construction of the retaining wall at the toe along the east side of Delridge Way. The slide mass is covered by plastic sheeting. The house on the right is on the slide mass and was later removed. Photograph by R. W. Galster, March 1986.

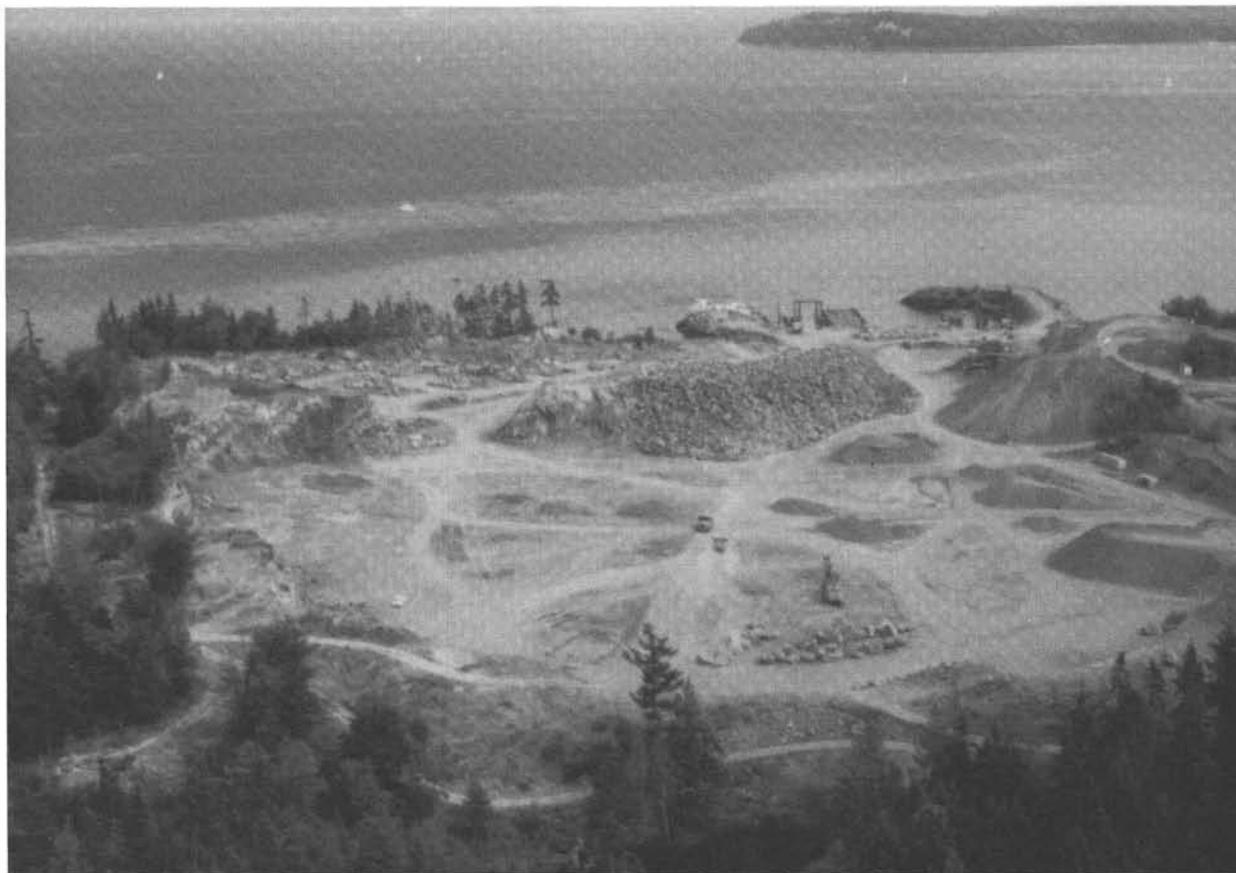
Mats Mats Quarry near Port Ludlow. This quarry has furnished rock for many breakwaters on Puget Sound. Photograph by R. W. Galster, August 1980.

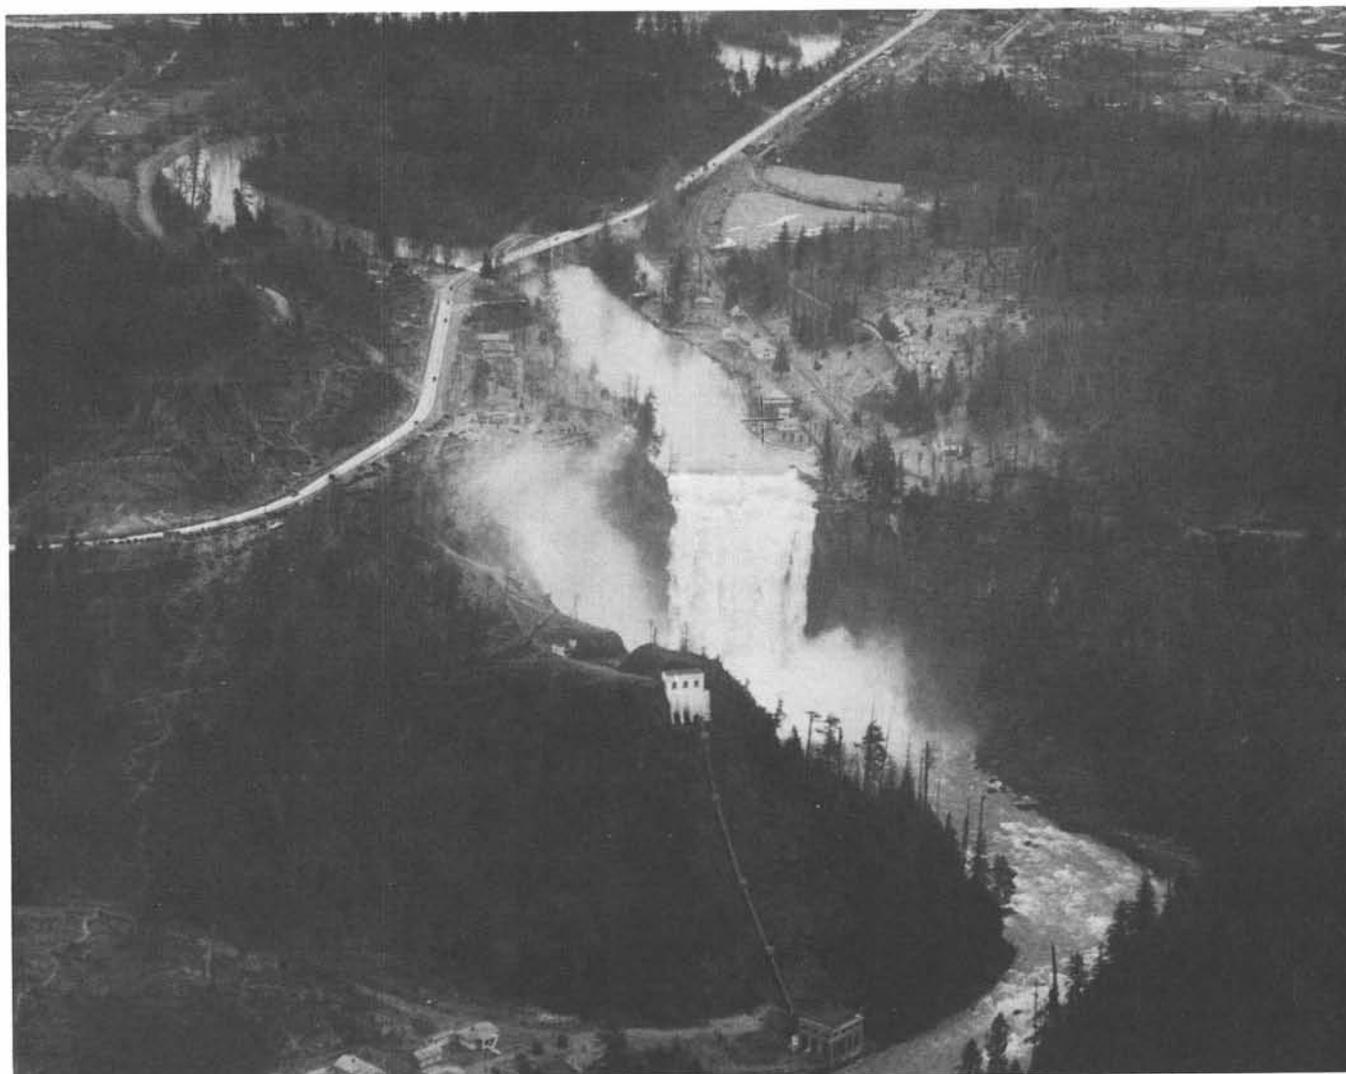
Figure 2. Aerial view of Snoqualmie Falls probably taken during the early 1930s. The tailrace tunnel for the underground powerhouse is at the edge of the spray to the right of the falls. The headworks for the underground powerhouse lies at the center of the photograph, at the cross ticks. The surface powerhouse, penstock, and gate house are at the lower center. Subsequent to this photograph, the surface facilities were expanded to include an additional penstock and powerhouse expansion. Photo courtesy of Puget Sound Power and Light Co.

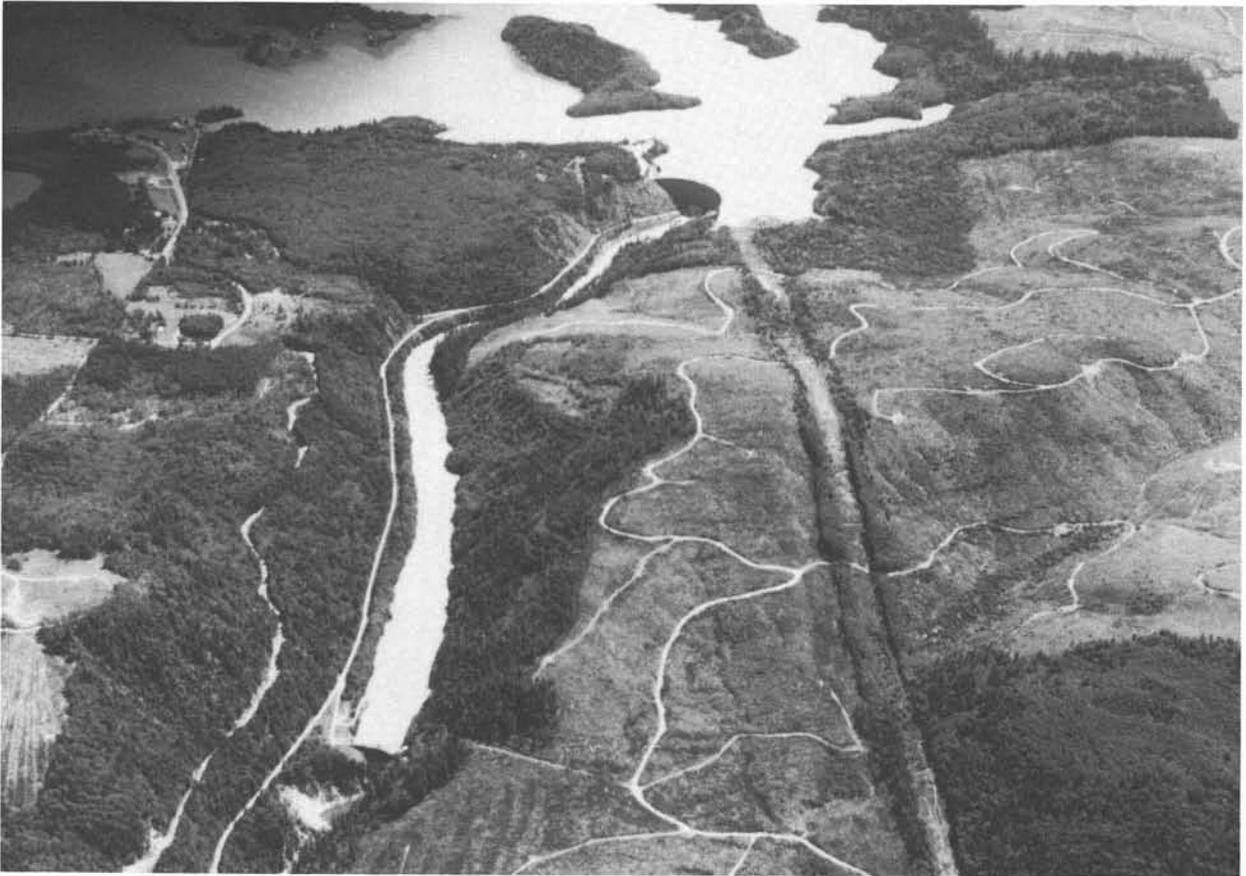
Aerial view to the southeast of the Nisqually River canyon showing the use of the canyon for damsites. La Grande Dam is at the lower left center, Alder Dam is in the upper center, with Alder Lake beyond. The original development consisted of a small diversion weir just upstream from the present Alder Dam and a tunnel that conducted water behind the south bank (right) to a powerhouse downstream of the present La Grande Dam. The present dams were constructed in the 1940s. Photograph by R. W. Galster, July 1980.

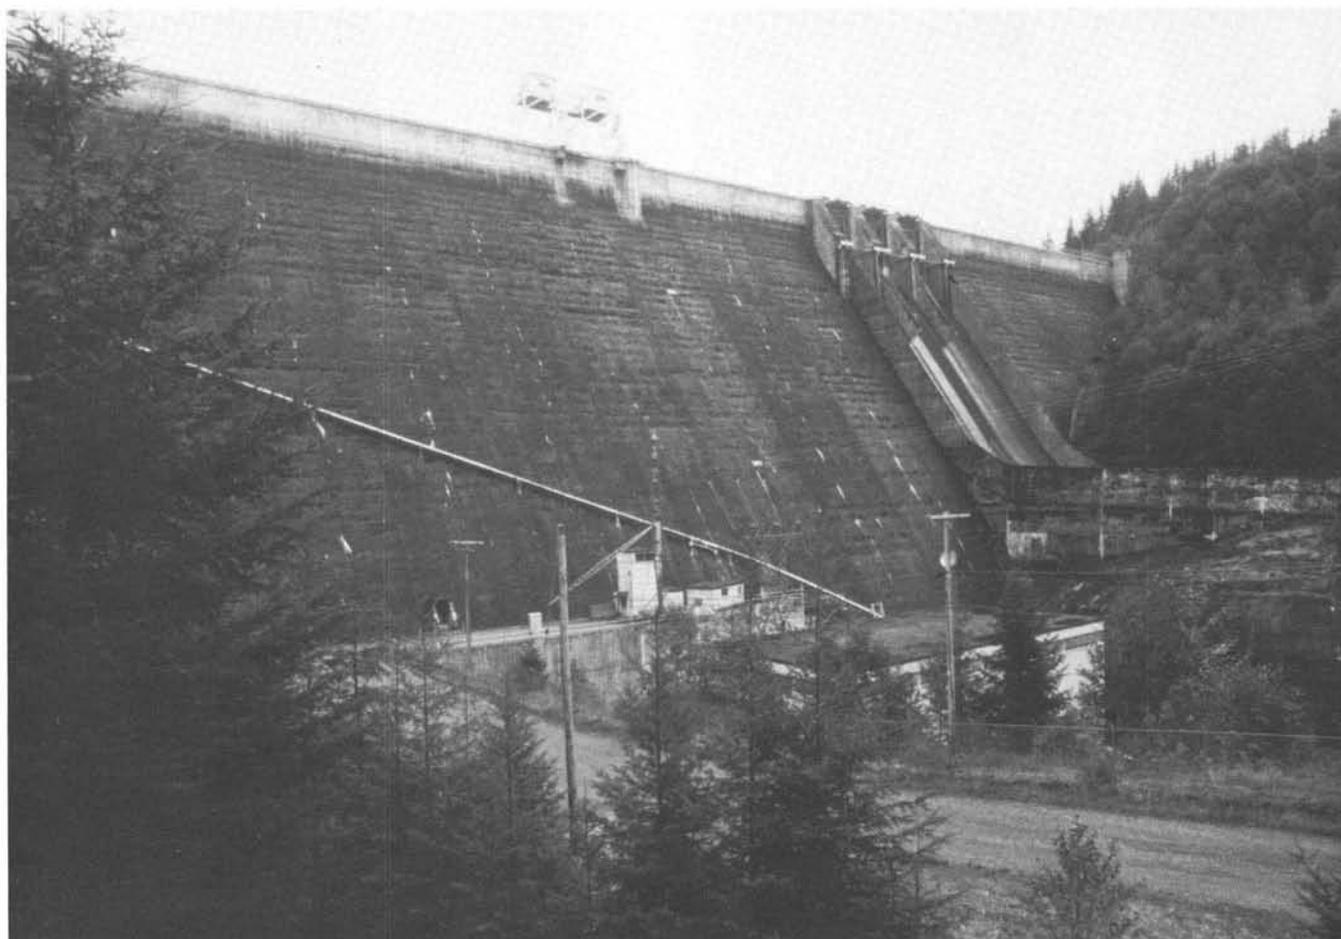
Figure 2. Upper Baker Dam and powerhouse. Photo courtesy of Puget Sound Power and Light Co.

Upper Baker Dam is a straight concrete gravity structure with a length of just over 1,200 ft and a height of approximately 300 ft (Figures 2 and 3). The reservoir behind Upper Baker Dam and the associated West Pass

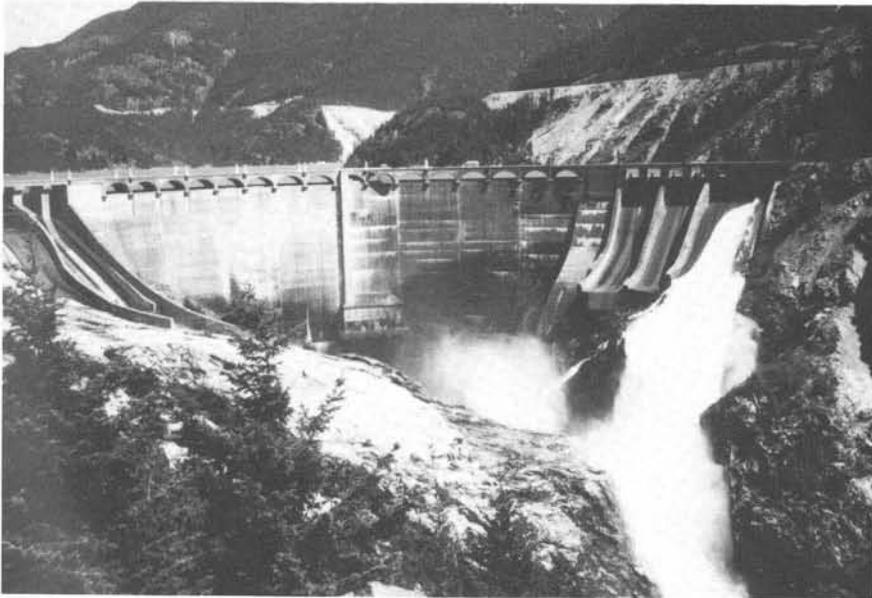
Diablo Dam, the first major dam of the City of Seattle's Skagit Hydroelectric Project.
Photograph by R. W. Galster, July 1965.

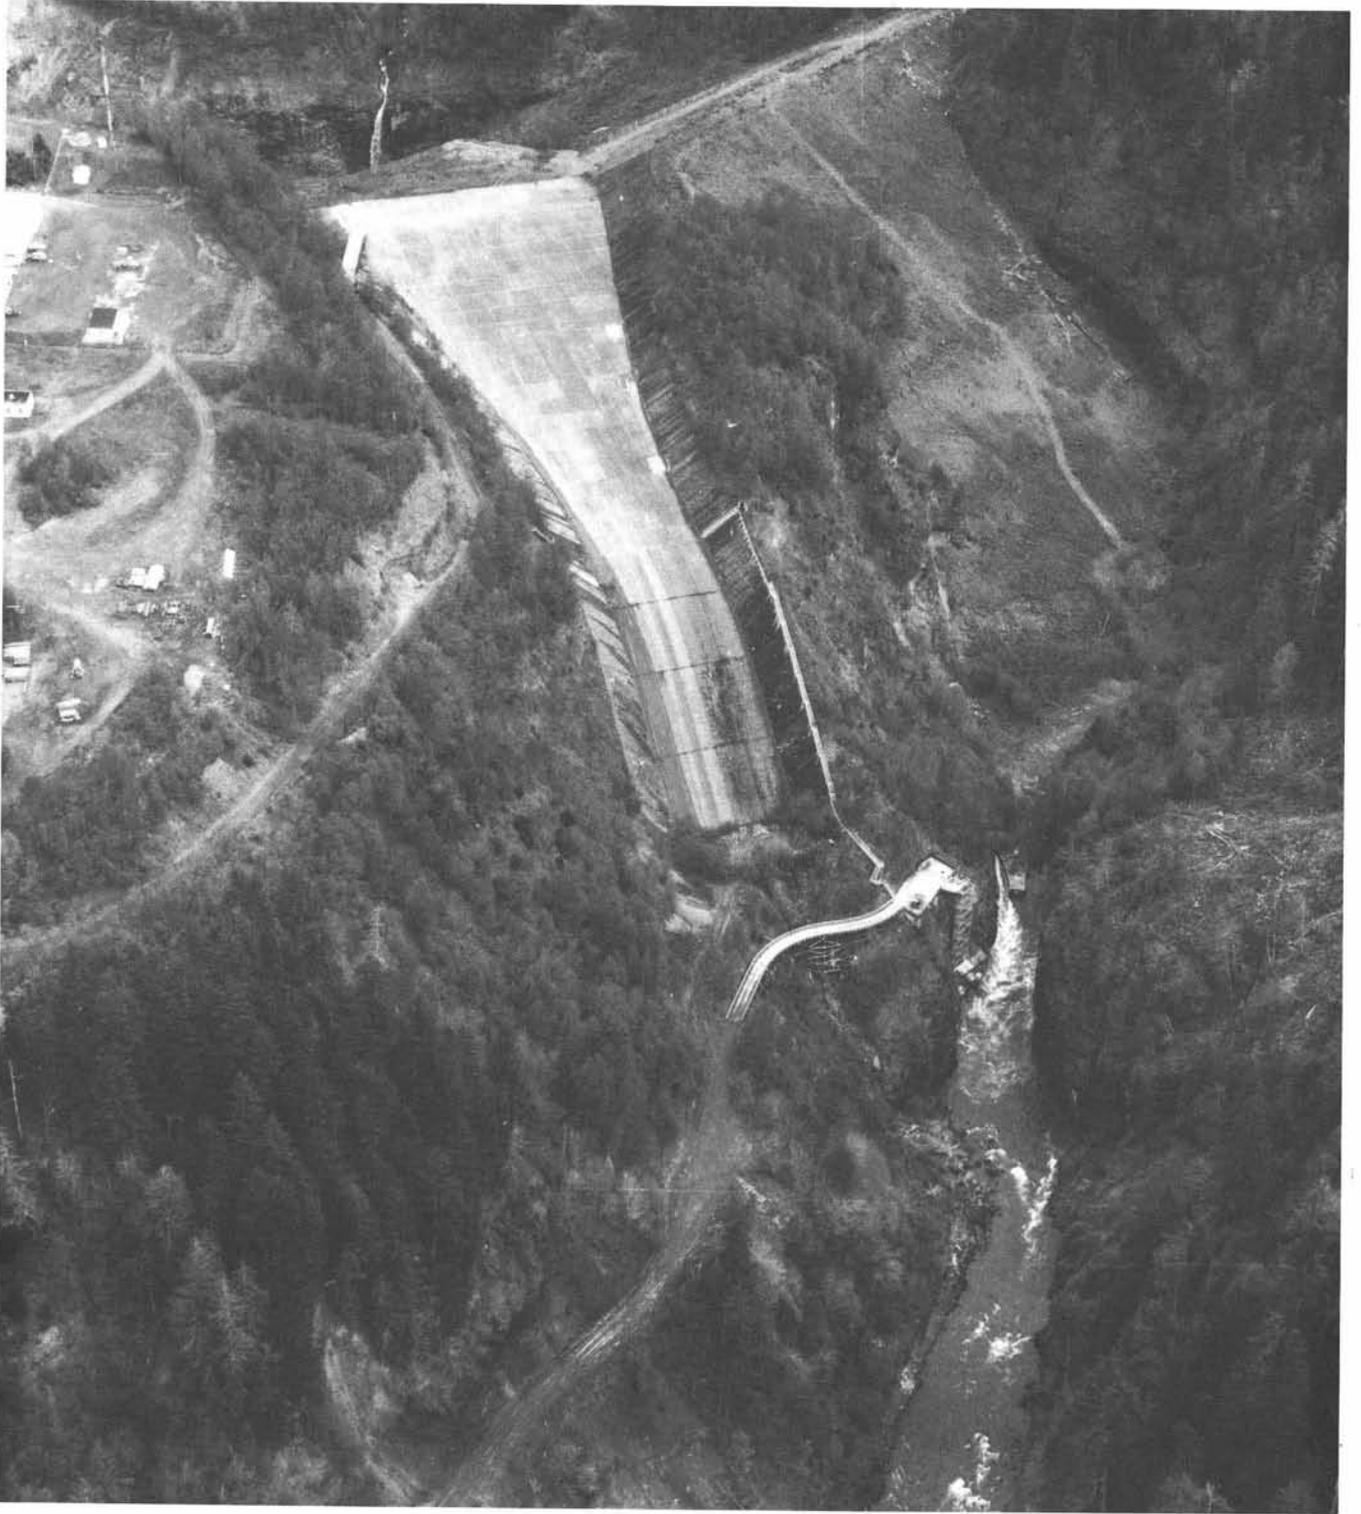
Aerial view upstream of Mud Mountain Dam on the White River, in about 1948. The only access to the valve house (center) at this time was by a 100-ft-high exterior stairway. A roadway has subsequently been constructed down the face of the embankment dam and a concrete bridge constructed through the narrow rock gorge from the toe of the dam to the valve house. The ungated concrete spillway is to the left. Photograph by Seattle District, U.S. Army Corps of Engineers.

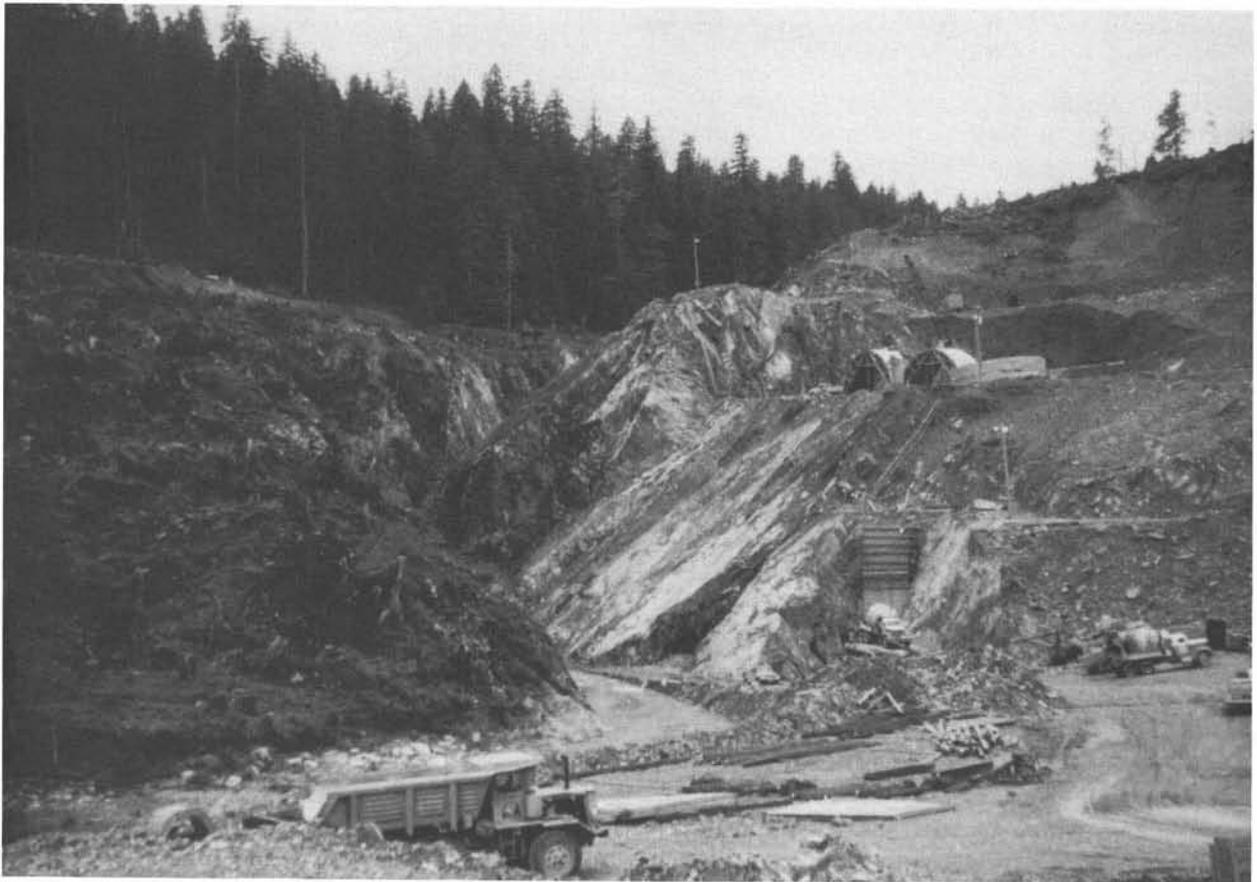
Sultan dam site; view downstream. The diversion tunnel portal is to the right center of the photograph. The Sultan River was diverted by the continental ice sheet pushing upstream and forcing the river to create a new bedrock channel, which is the present canyon. The ancestral channel is to the right of the photograph. Note the smooth fault plane dipping toward the river. Glacial clays lie unconformably above bedrock and can be seen above the form work. Photograph by H. W. Coombs, 1963.

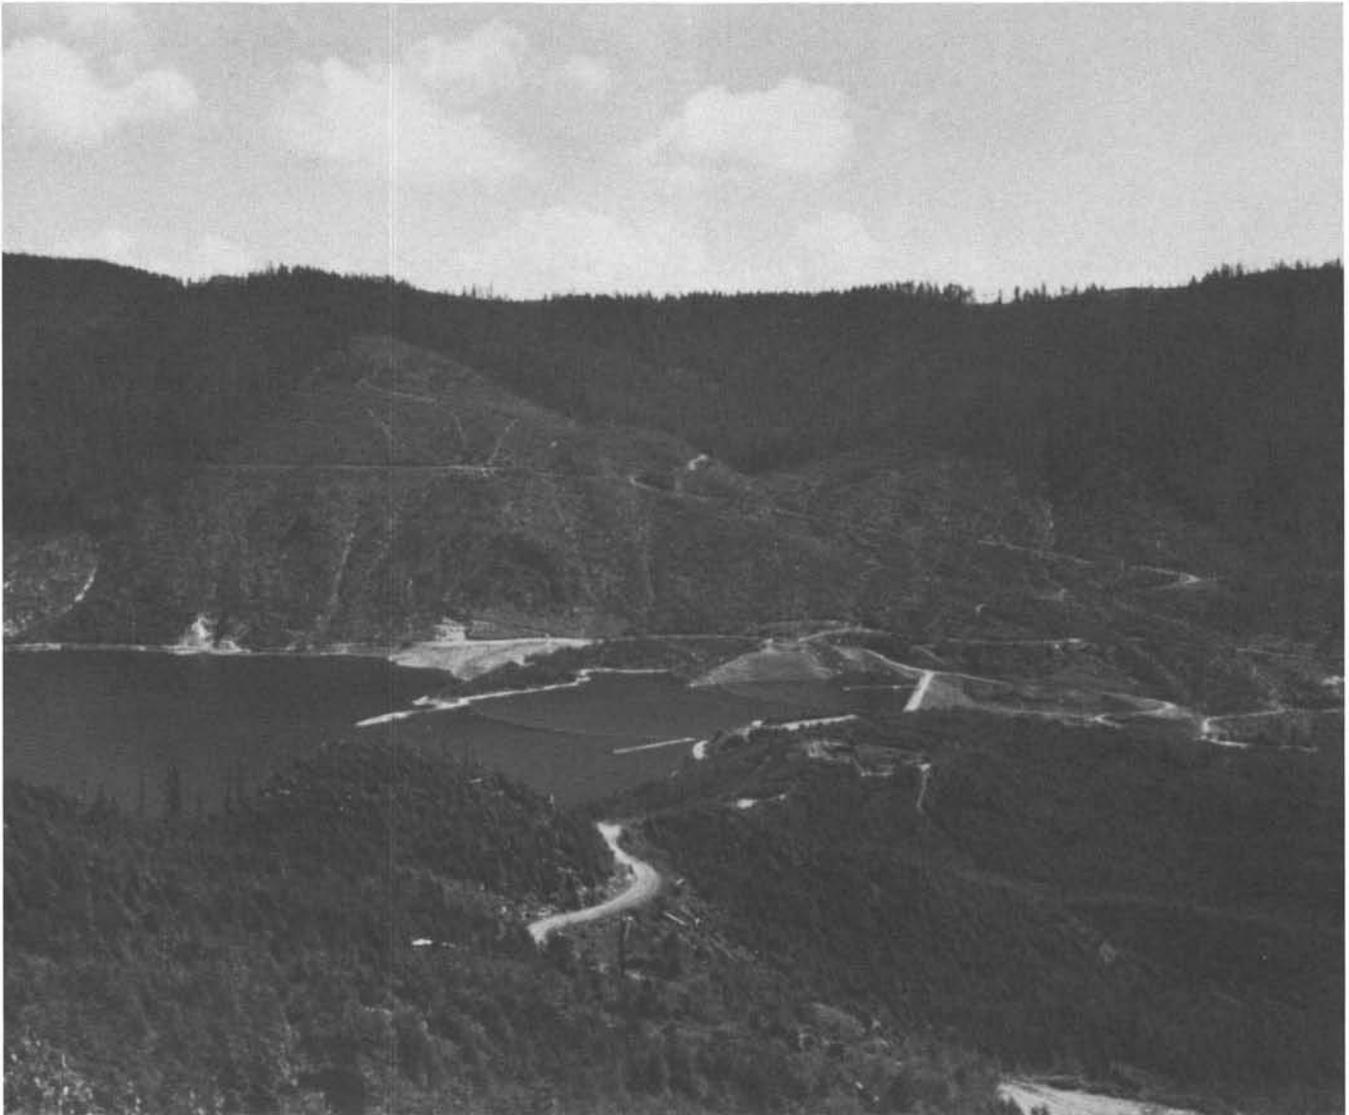
Figure 2. South Fork Tolt River Dam; view to the south. Photograph courtesy Seattle Water Department.

The South Fork Tolt River Dam is a 200-ft-high embankment structure containing approximately 1,750,000 cy of material (Figure 2). The dam has an impervious core constructed of till and other impervious fill; upstream and downstream shells are composed of select sand and gravel fill. The upstream face is protected from erosion by 18 in. of rock spalls mantled by a 10-ft thick

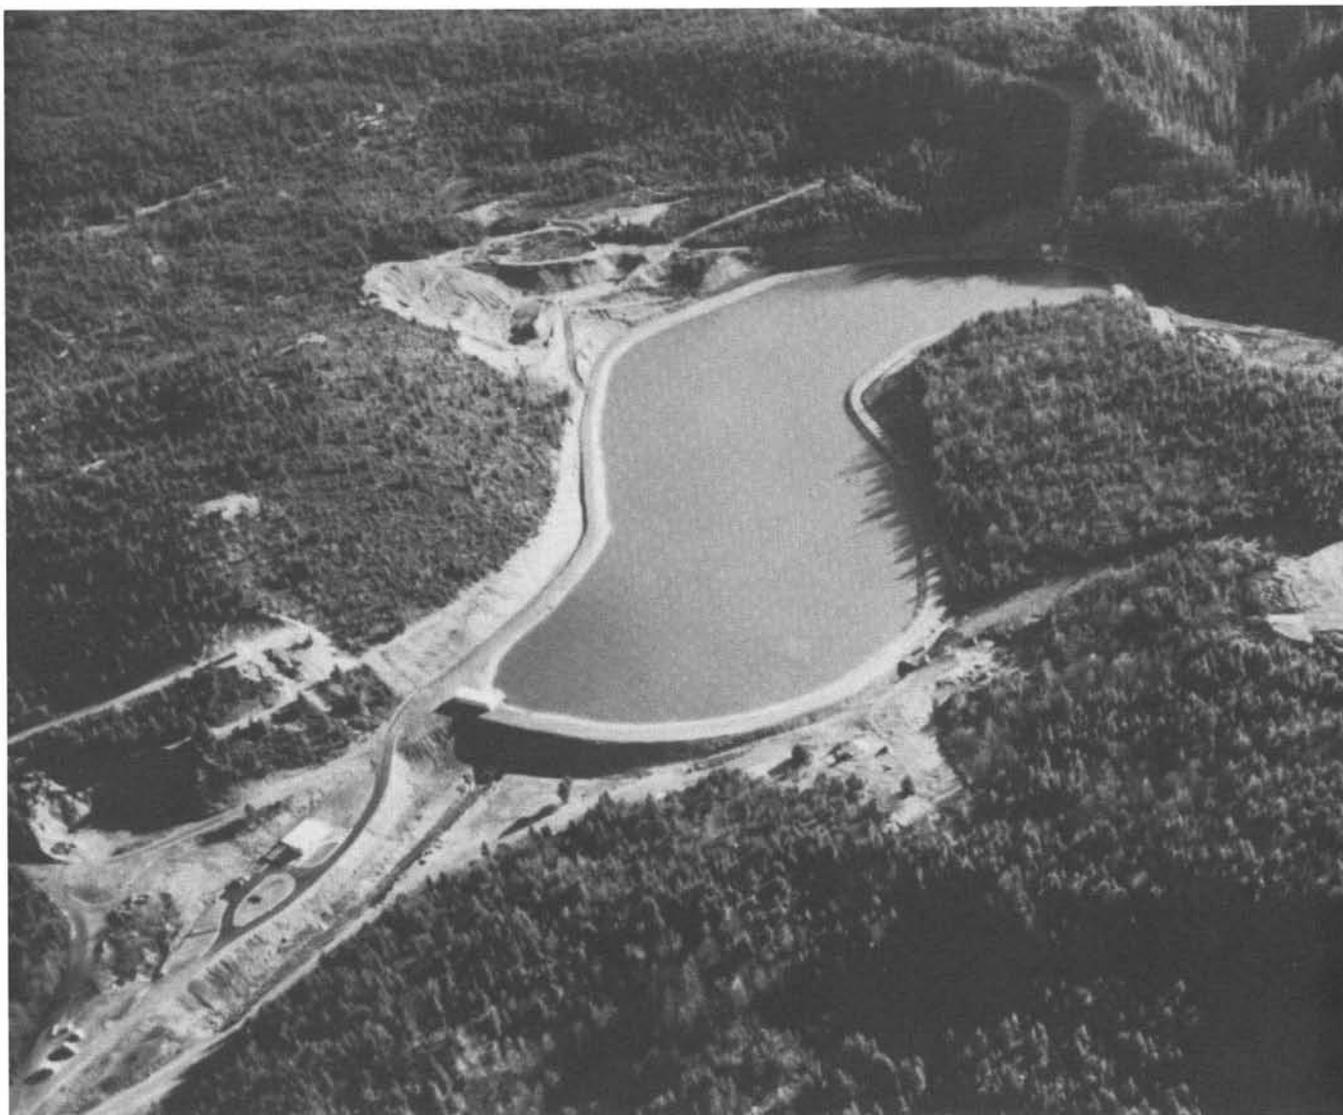
Figure 3. Regulating reservoir; view to the southwest. West Dam is in the foreground. Photograph courtesy of the Seattle Water Department.

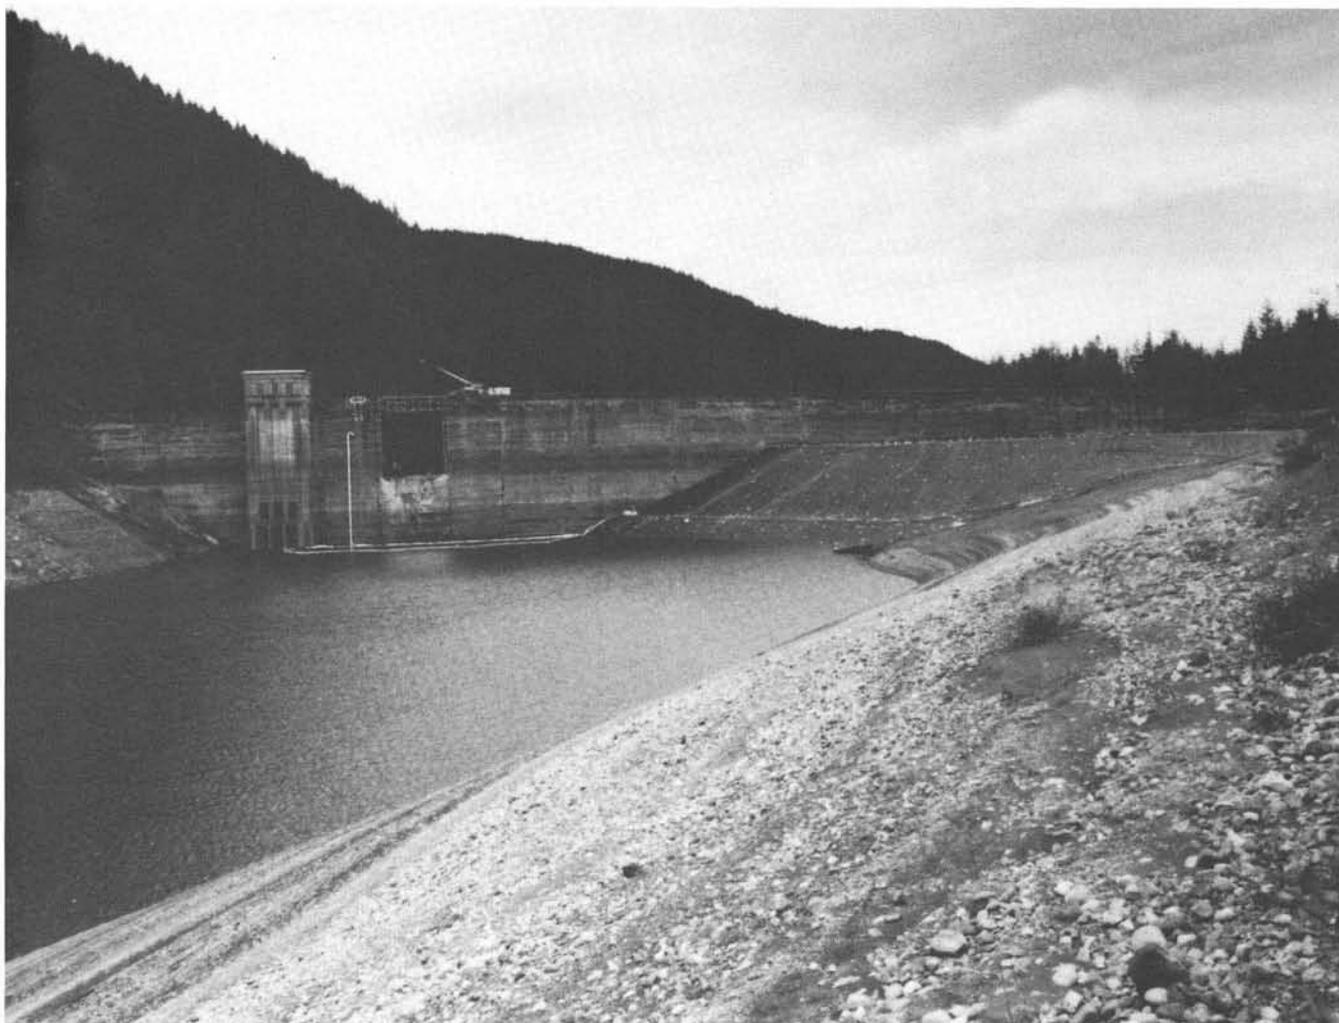
Figure 3. Masonry Dam; view downstream. The cofferdam in the right abutment area is related to construction of an emergency spillway in 1986. Photograph courtesy of R. W. Beck and Associates.

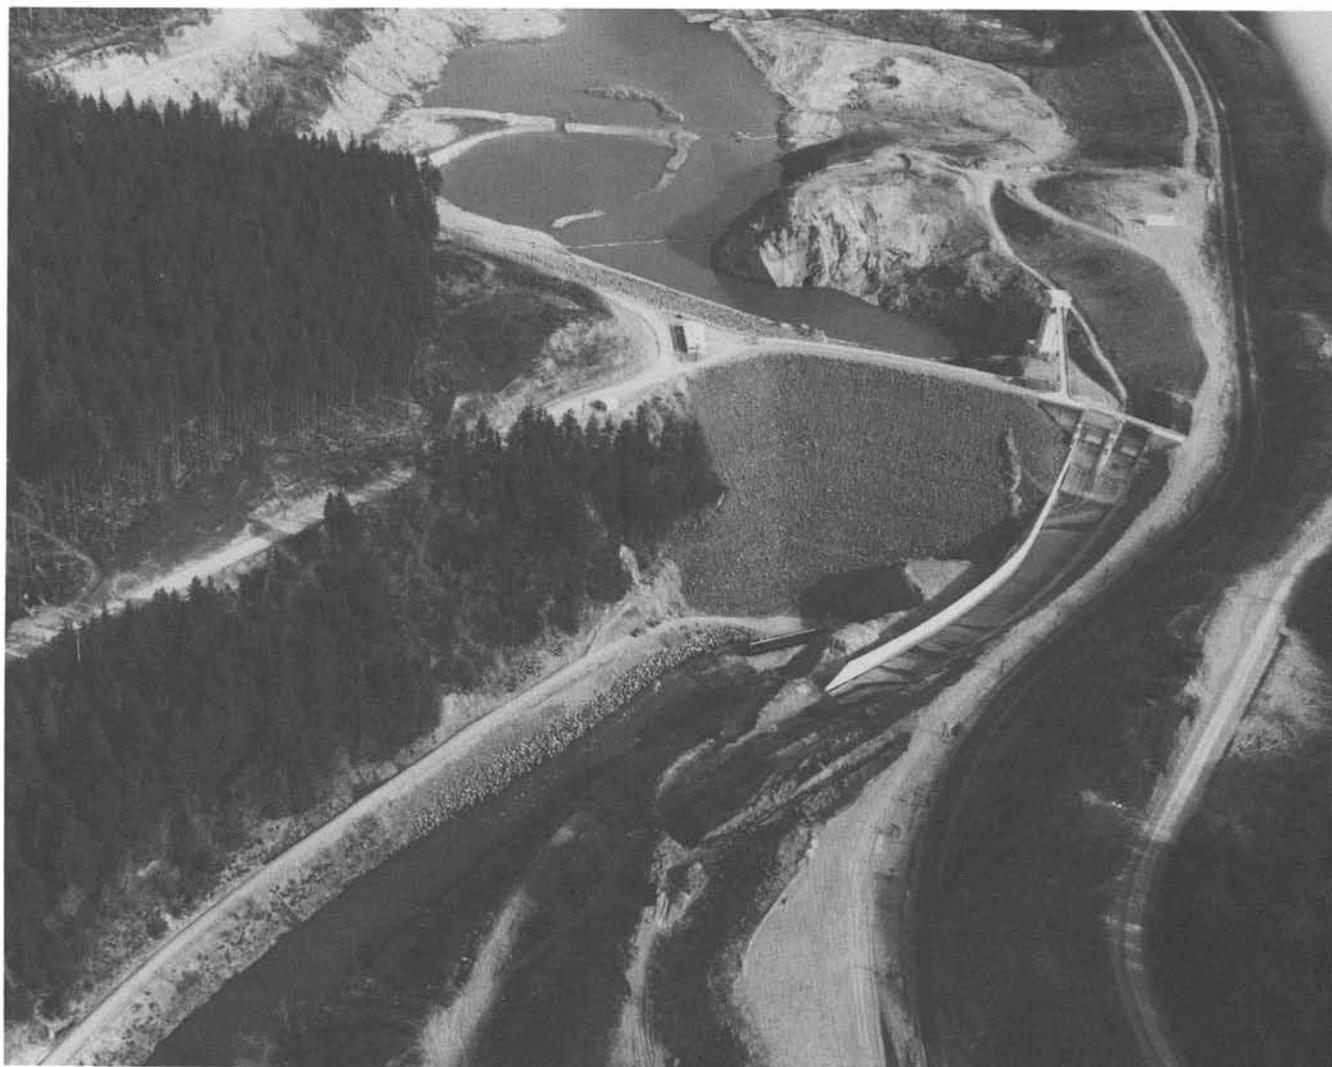
Figure 1. Aerial view upstream of Howard Hanson Dam. Intake tower and spillway are to the right. A gravel-filled crib constructed over spring area on right abutment is in the center of the photo just downstream from the embankment. Photo courtesy of Seattle District, U.S. Army Corps of Engineers.

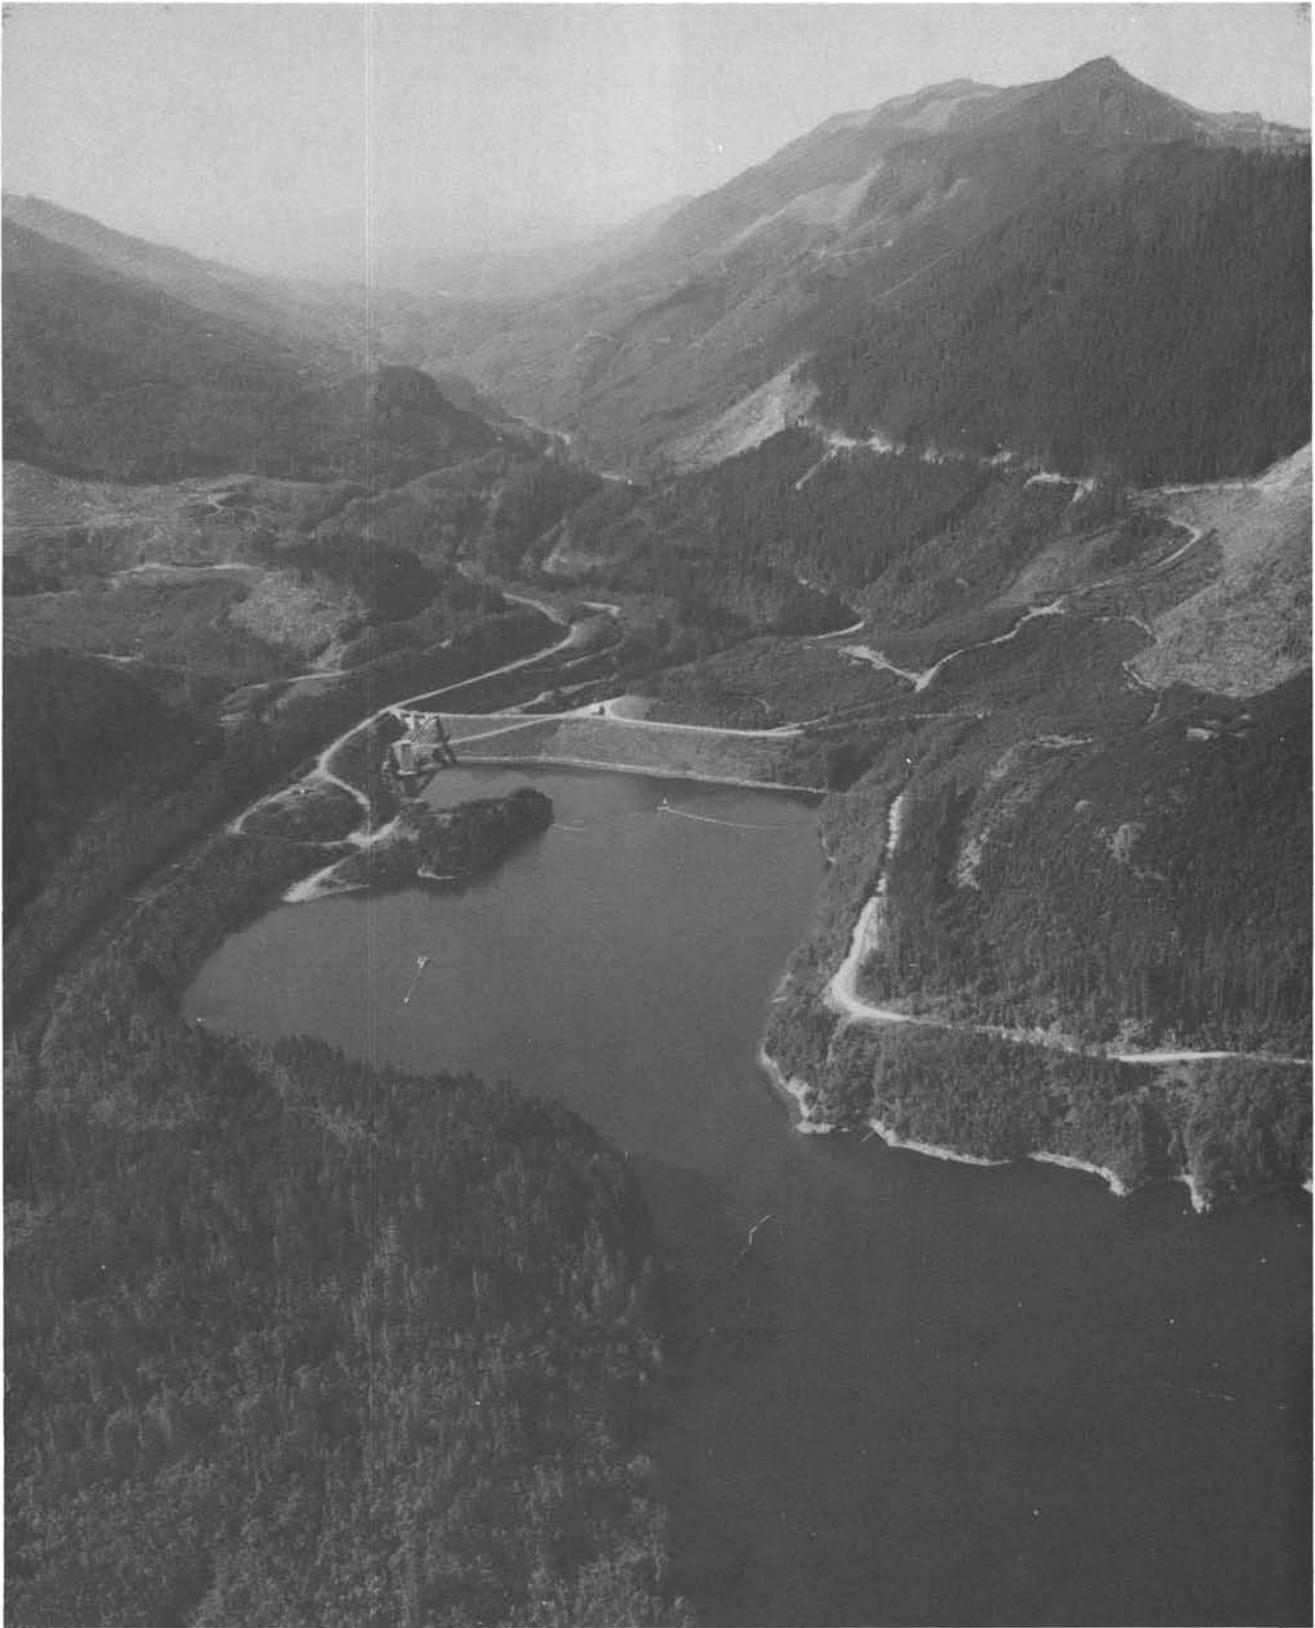
Figure 4. Aerial view downstream of Howard Hanson Dam along the post-early Pleistocene valley eroded along trace of the Green River fault. Intake tower is at left with gated spillway structure behind. The textural change near the center of the embankment reflects the transition between the embankment dam (left) and the blanket (right), the latter along the upstream side of the slide debris which forms the right abutment for the dam. Photo courtesy of the Seattle District, U.S. Army Corps of Engineers.

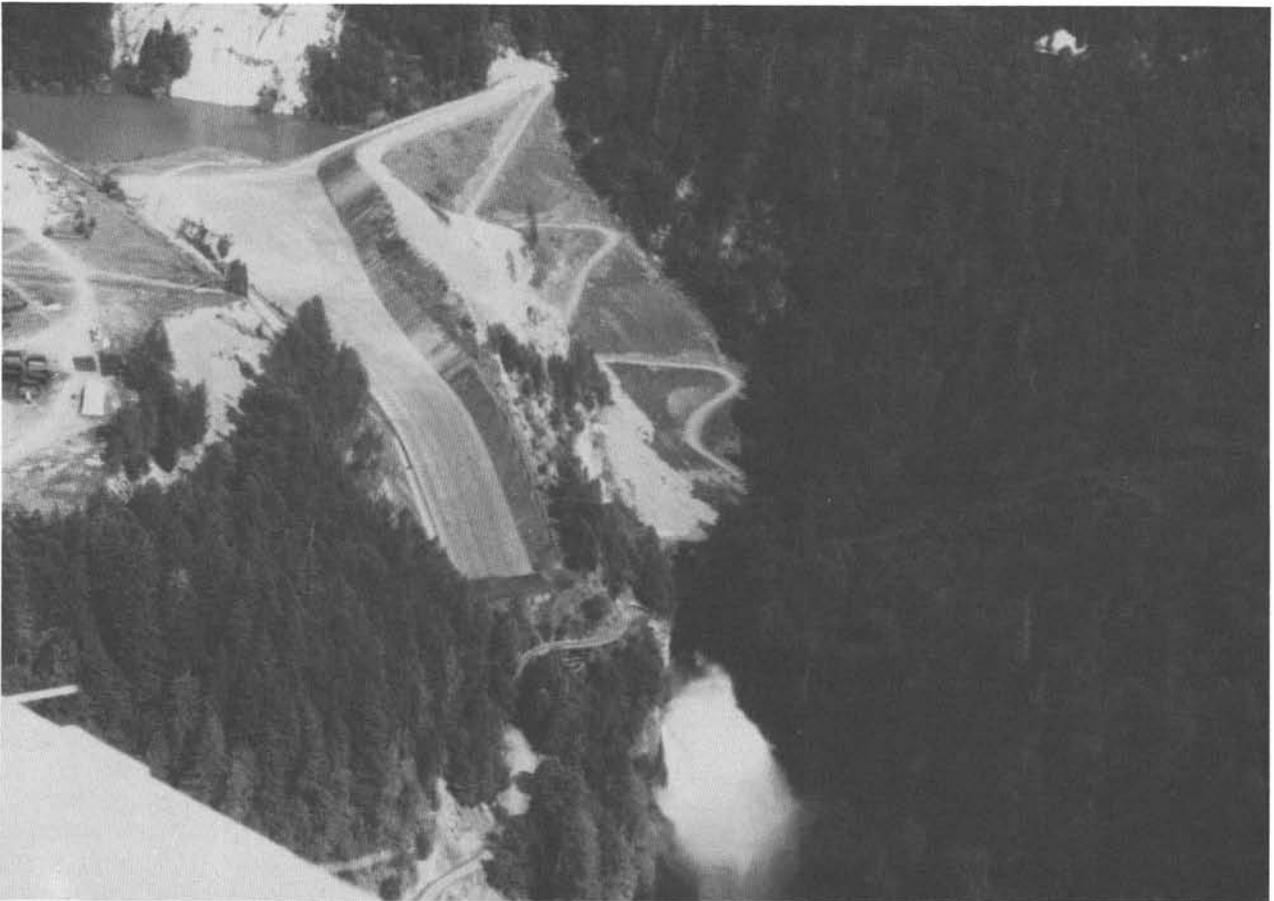
Figure 1. Mud Mountain Dam. Aerial view east on August 6, 1974, with reservoir at elevation 1,140 ft. At the lower center of the photo is the spraying discharge through three Howell-Bunger valves into the narrow, vertical-walled rock canyon downstream from the dam. The ungated spillway is right center. The lower part of the 1974 slide is at the upper left. Photo by the author.
