Collapsing and Expansive Soils

THOMAS J. BEKEY

Rittenhouse-Zeman & Associates, Inc.,

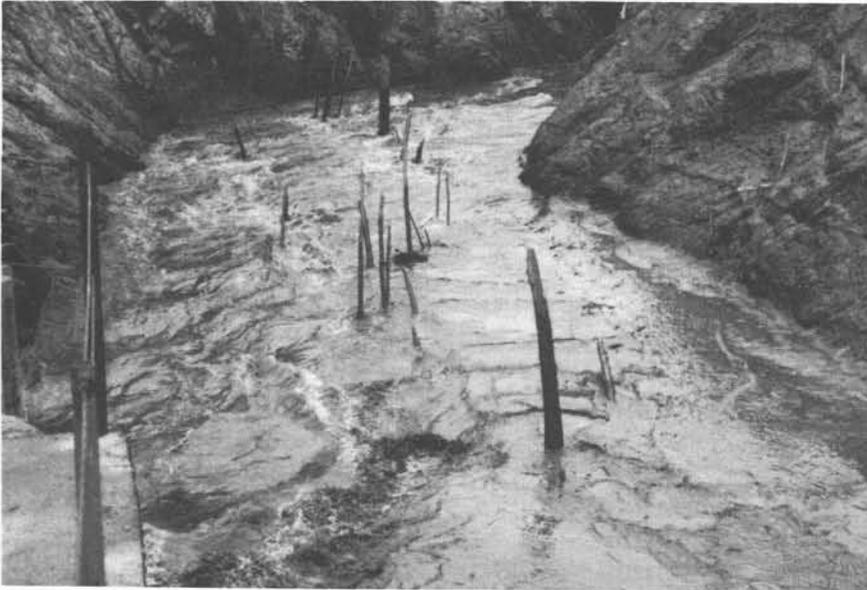
Landslide debris and upright snags (as much as 30 ft high) from the landslide of January 31, 1974, upstream from the intake at Mud Mountain Dam in March 1974. The pool level was at 938 ft, and the river was cutting into the landslide debris. Photograph by R. W. Galster.

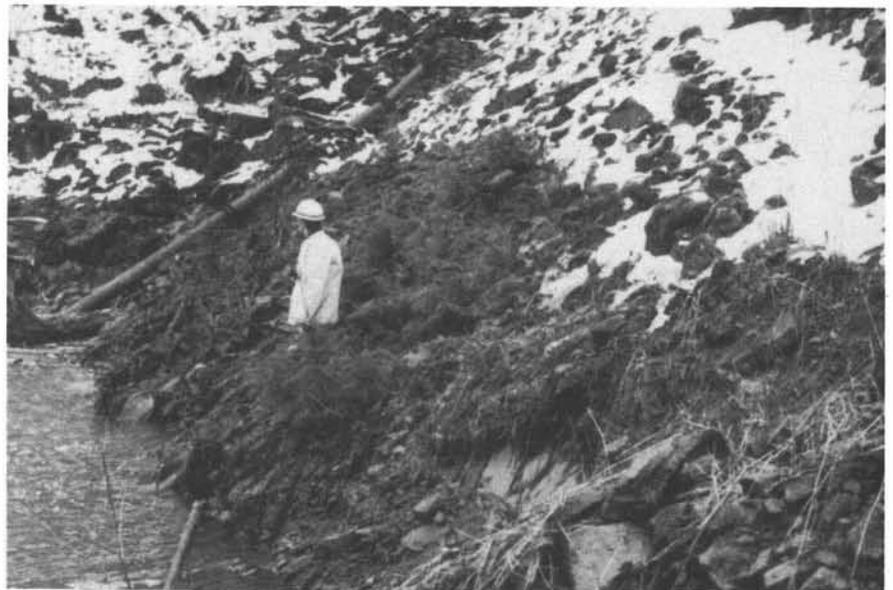
The snow line on the face of Mud Mountain Dam is evidence of the 12 feet of runup created by the landslide of January 31, 1974. Reservoir elevation is 1,150 ft. Photograph by R. W. Galster, February 11, 1974.

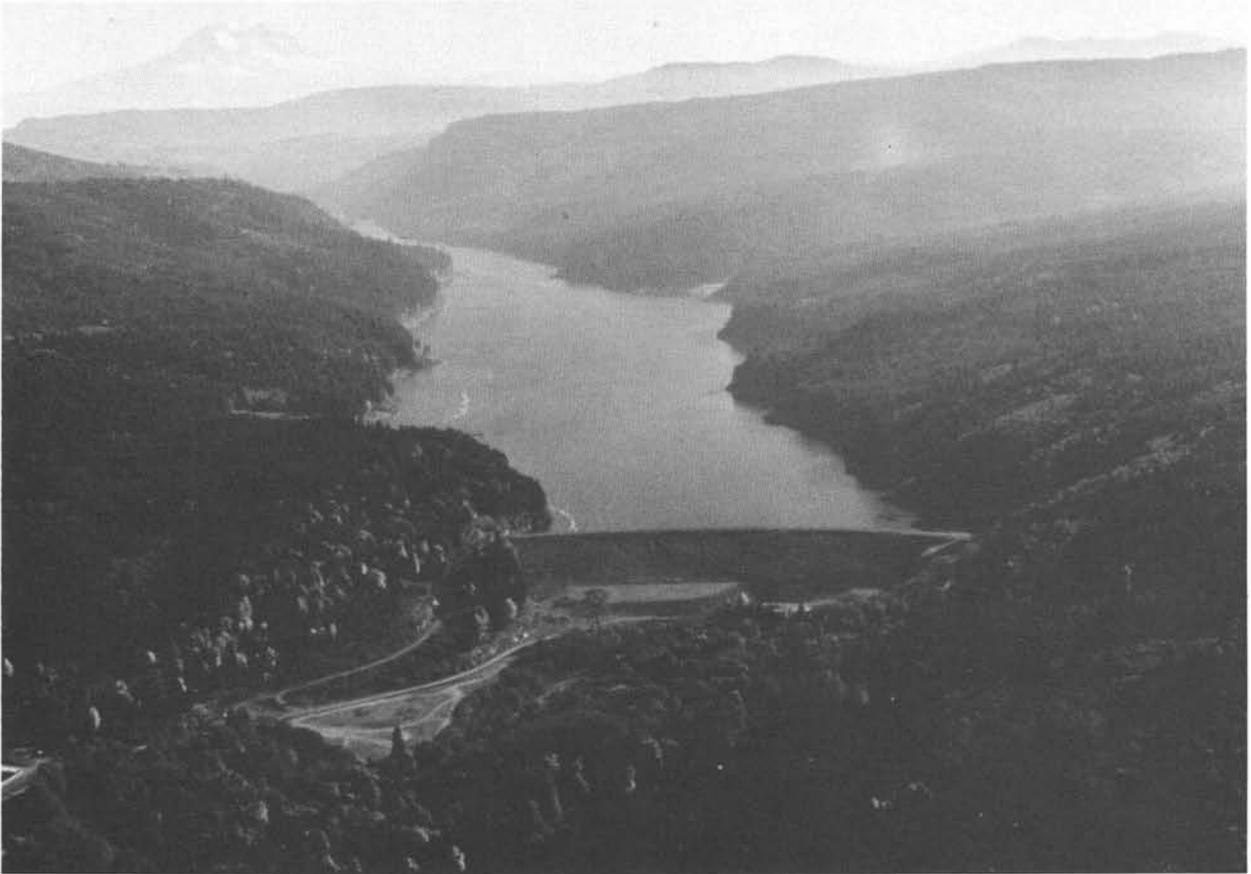
Figure 1. Skookumchuck Dam. Aerial view east. Downstream berm is shown at the toe of the dam. Spillway cut is at the right, along the edge of the trees. Photo courtesy of Pacific Power & Light Co.

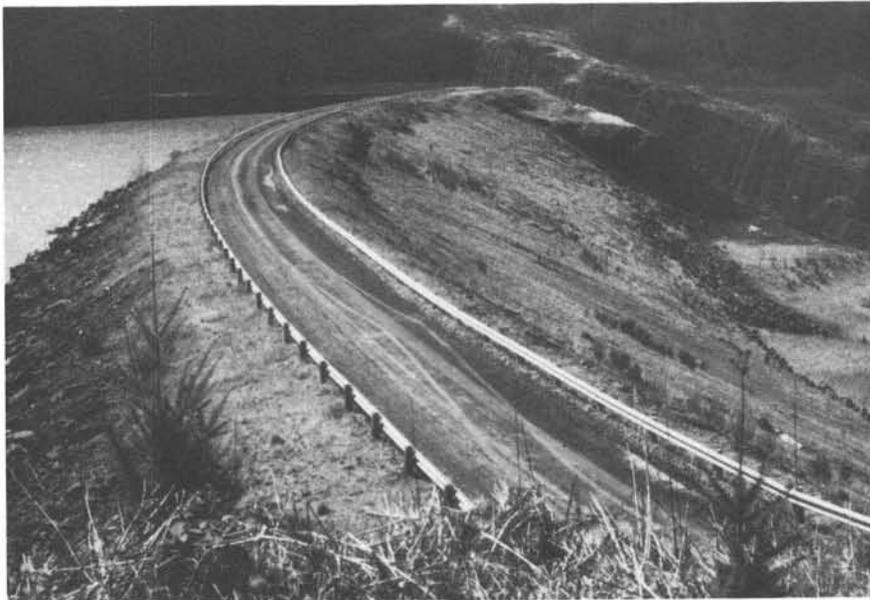
View to the south of the Skookumchuck Dam embankment from above the right abutment of the dam. The spillway structure is at the far end of the dam. Photograph by R. W. Galster, March 1981.

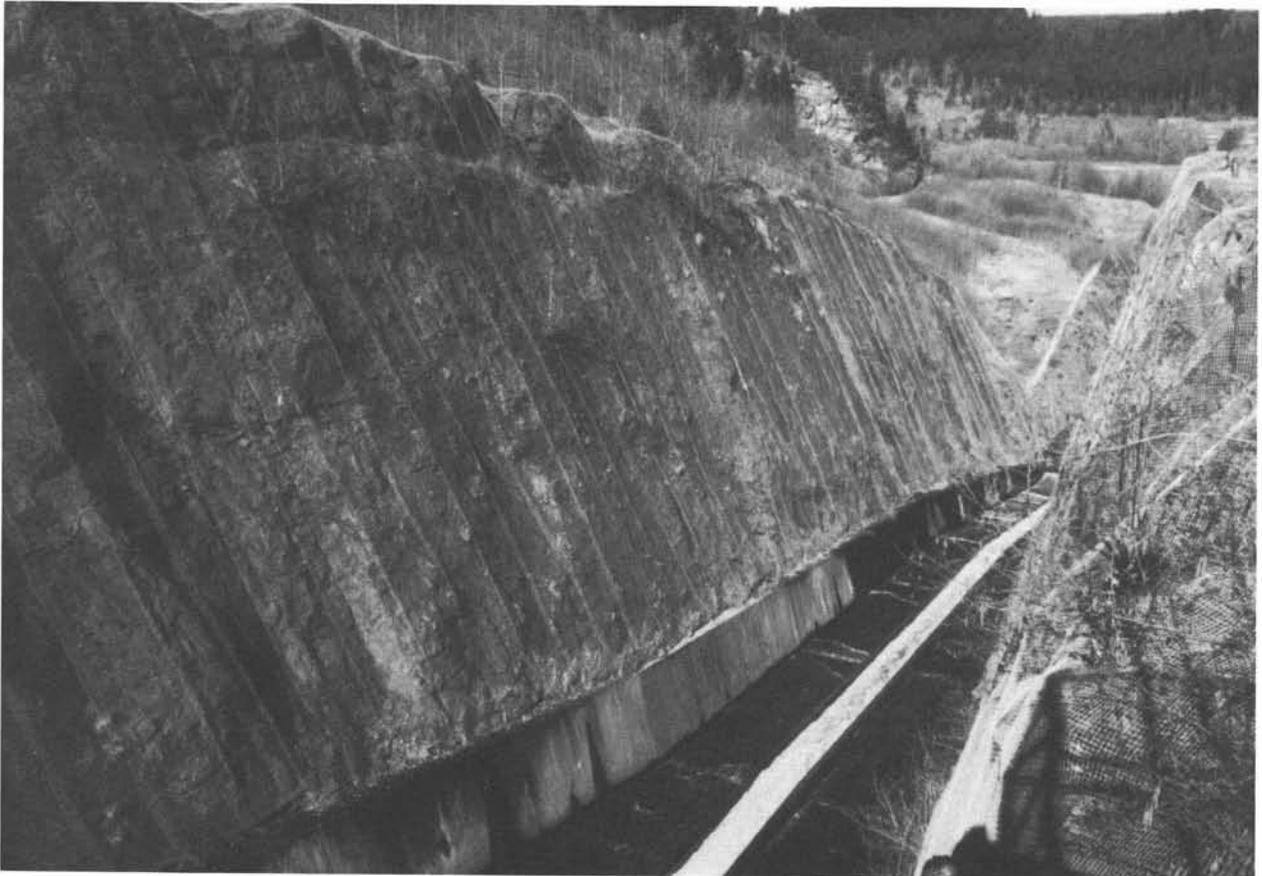
The Skookumchuck Dam spillway discharge chute on the left (south) bank. The cut is in basalt and has been draped with welded wire netting to control rock fall. The chute is designed so that low spillway flows are contained in a narrow central slot to permit ease of maintenance during low flows. Photograph by R. W. Galster, March 1981.

No major problems relating to geology have become apparent during the succeeding years of project operation. A minor amount of leakage issues from a flow contact about 300 ft downstream from the north toe of the embankment. The spillway chute has been plagued by considerable raveling of the closely jointed rock exposed in the cut above the chute. Raveling has progressed to the point where some rock bolts are ineffective (U.S. Army Corps of Engineers, unpublished data, 1981).
