The Cowlitz River Projects

The Cowlitz River Projects: Mayfield and Mossyrock Dams

HOWARD A. COOMBS
University of Washington

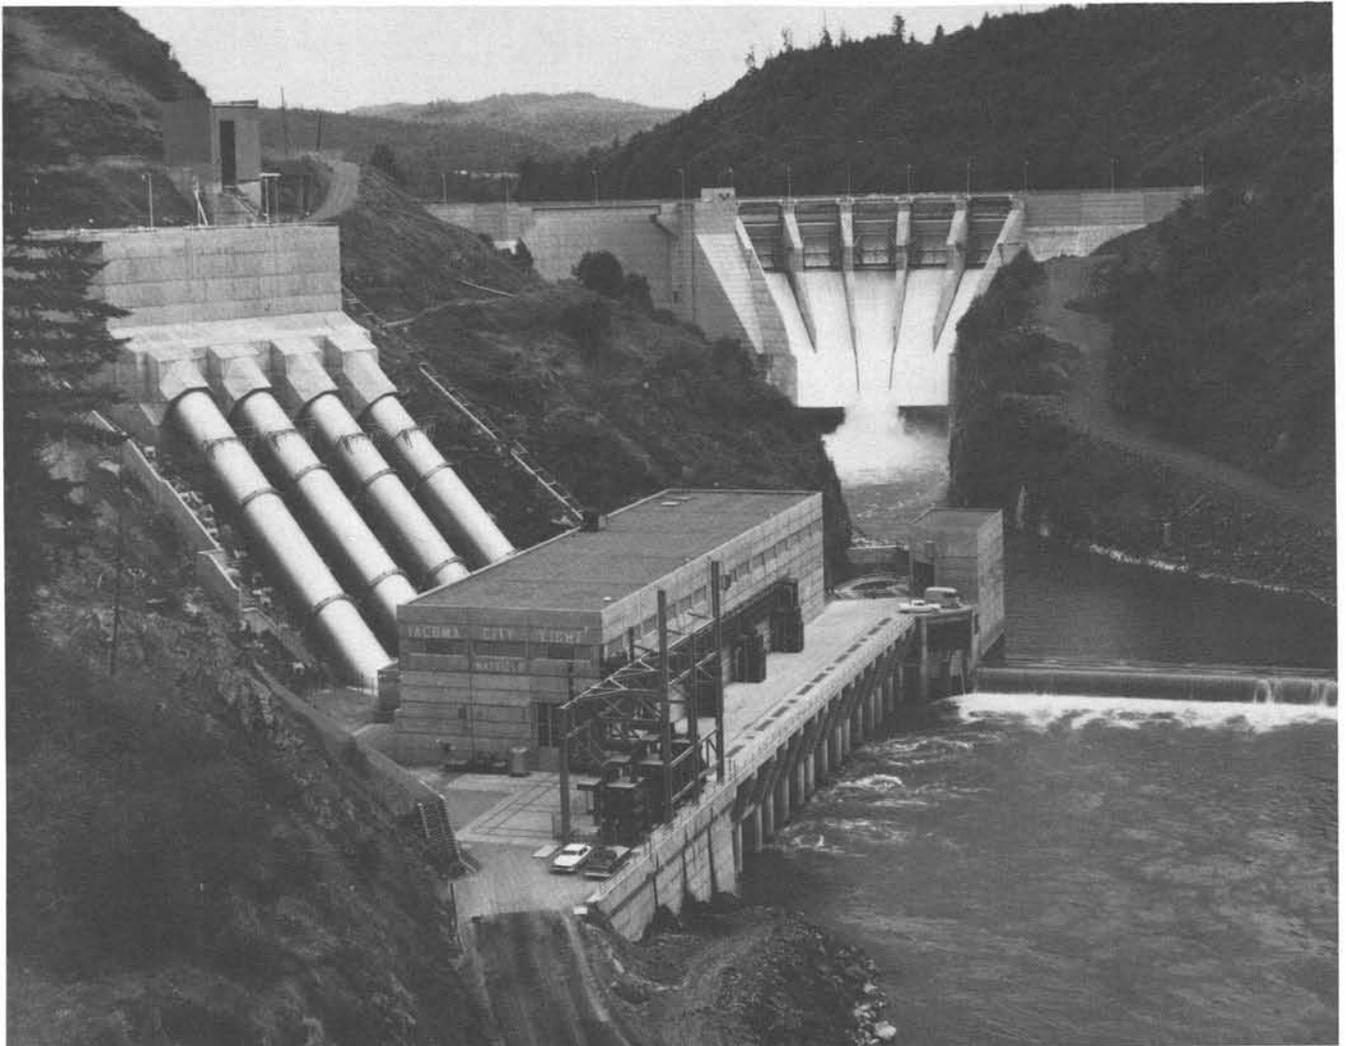
Figure 1. Mayfield Dam, spillway, forebay, penstock, and powerhouse. Photo by Tacoma City Light.

Mayfield Dam is a composite, thin wall, single curvature arch and gravity dam (Figures 1 and 2). The thin wall arch is founded on hard andesite for the lower half of the structure. The upper half rests against massive thrust blocks founded on andesite. The left, or south gravity structure contains a five-gate spillway. The powerhouse is located 1,300 ft downstream on the north bank and is connected to the dam by a horseshoe-shaped concrete-lined power tunnel leading to the forebay. The water is then led to the powerhouse through four 18-ft-diameter penstocks (Figure 1).

and powerhouse (Figure 1) on the left side of the nearest penstock.

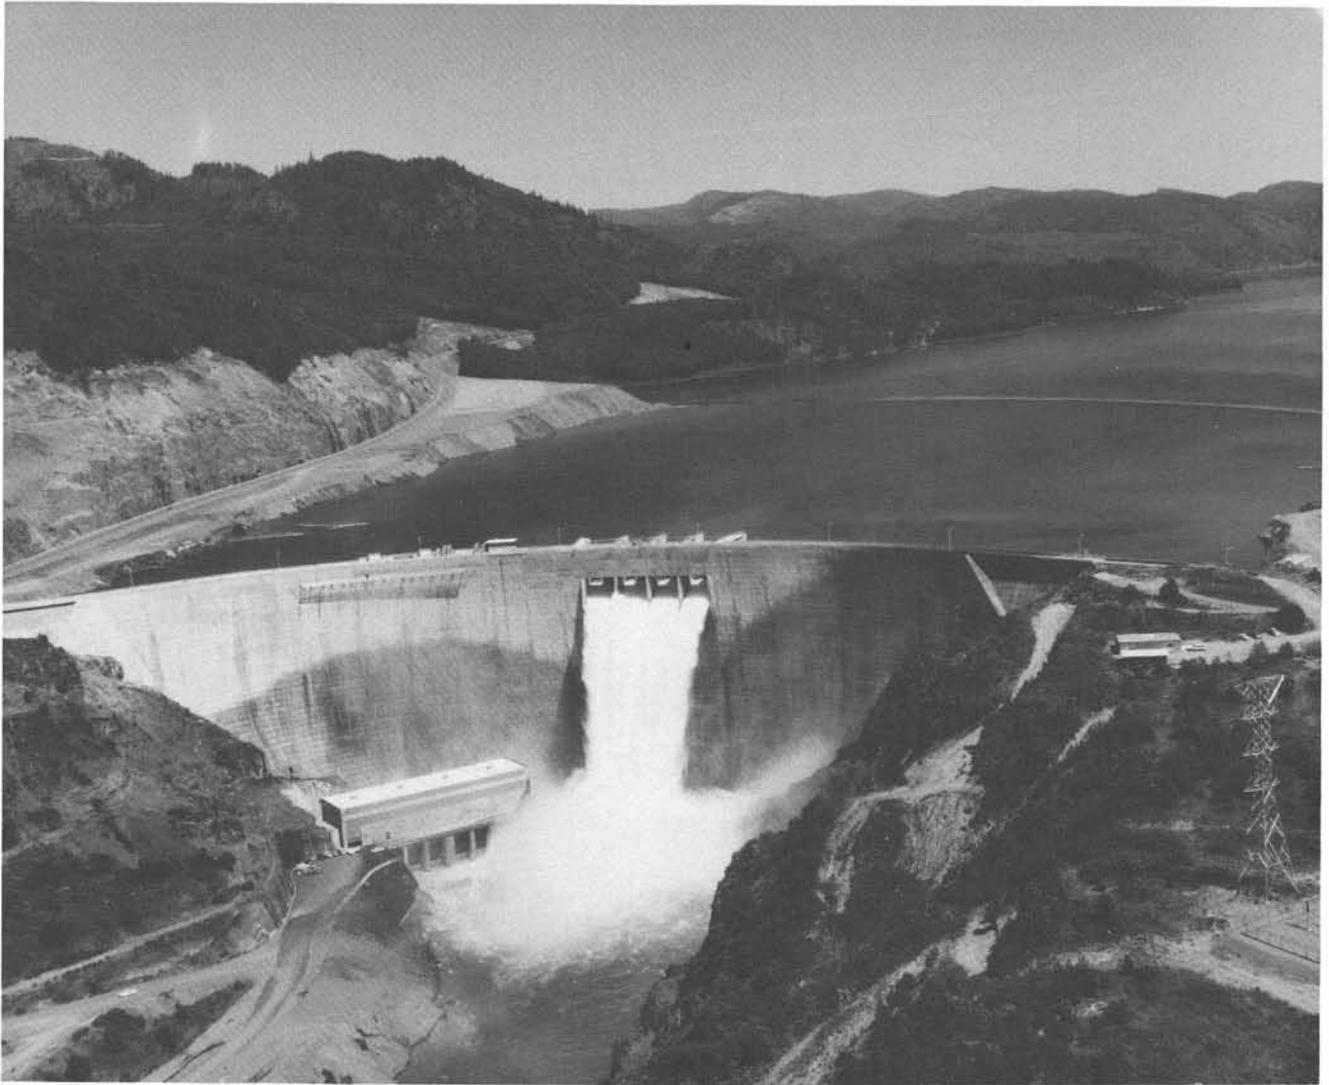
Figure 3. Mossyrock Dam and powerhouse. Note roughly horizontal layers of basalt, breccias, and sedimentary rocks along road cuts on the left side of the photo. Photo courtesy of Tacoma City Light.

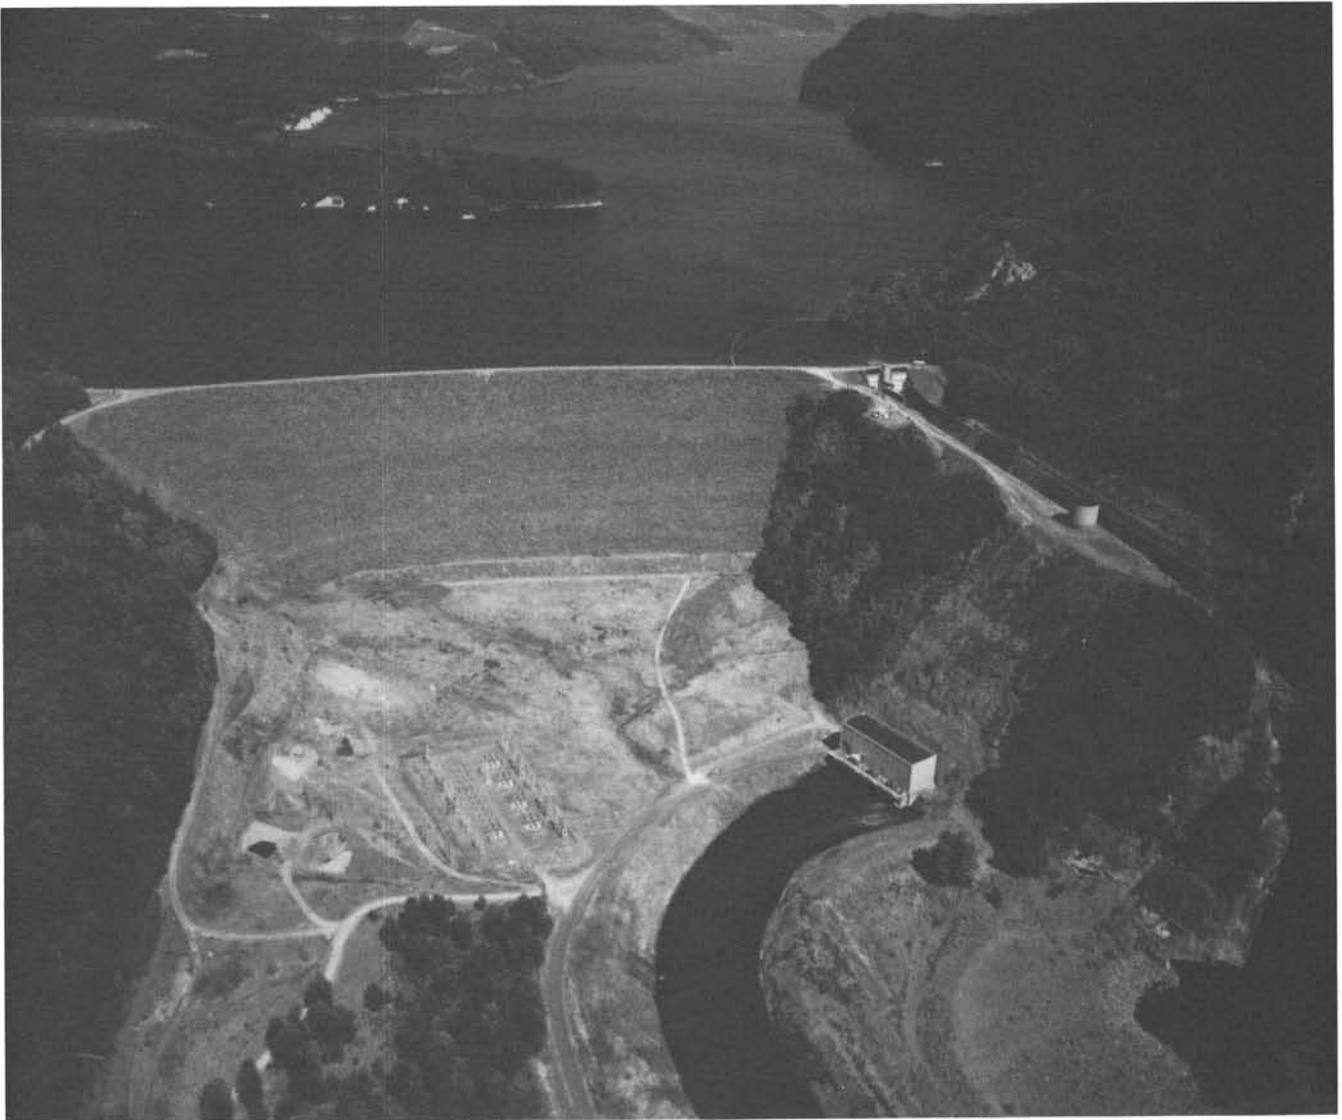
Figure 9. Swift Dam and Reservoir. Photograph courtesy of Pacific Power and Light Company.

The Swift Creek Project is located upstream of the Yale Project at river mile 33.0 (Figure 9). The dam site is located a short distance downstream from the confluence of Swift Creek and the Lewis River. The development consists of a 512-ft-high earthfill dam, diversion and power tunnels, spillway, and powerhouse (Figure 10). When it was completed in 1958, Swift Dam was the highest earthfill dam in the world.

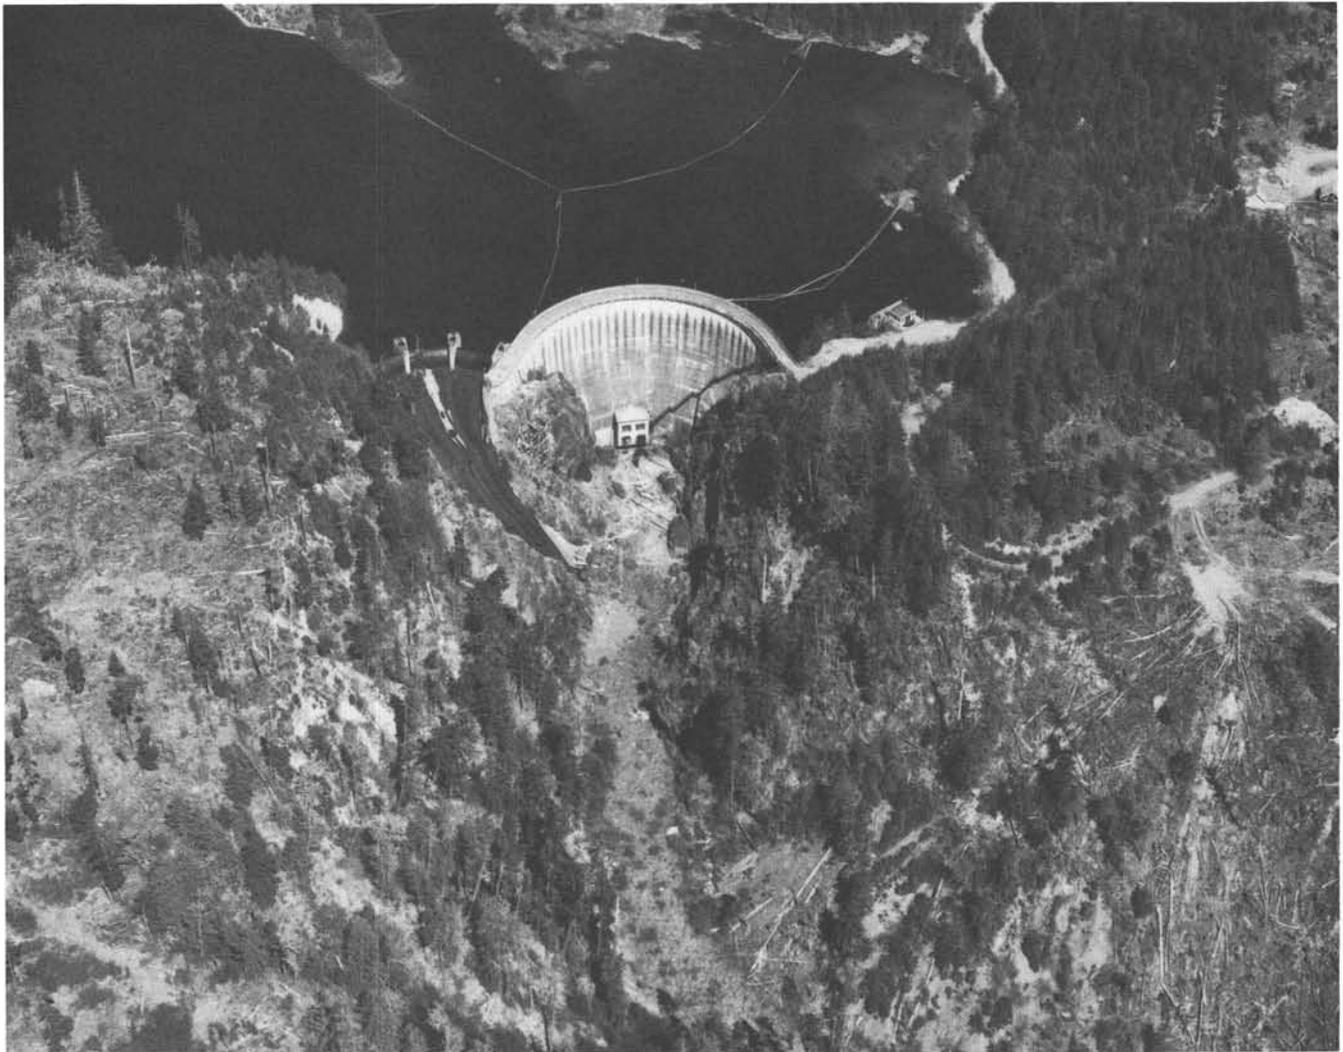
Figure 5. Cushman Dam No. 2. Note intake structure to the right of the dam and spillway on the left. Photo by Tacoma City Light.

Cushman Dam No. 2 (Figure 5), completed in 1930, is a concrete arch rising 175 ft above river level and is 400 ft in length (Figure 6). The spillway is located on the right abutment, and the power tunnel intake is lo-

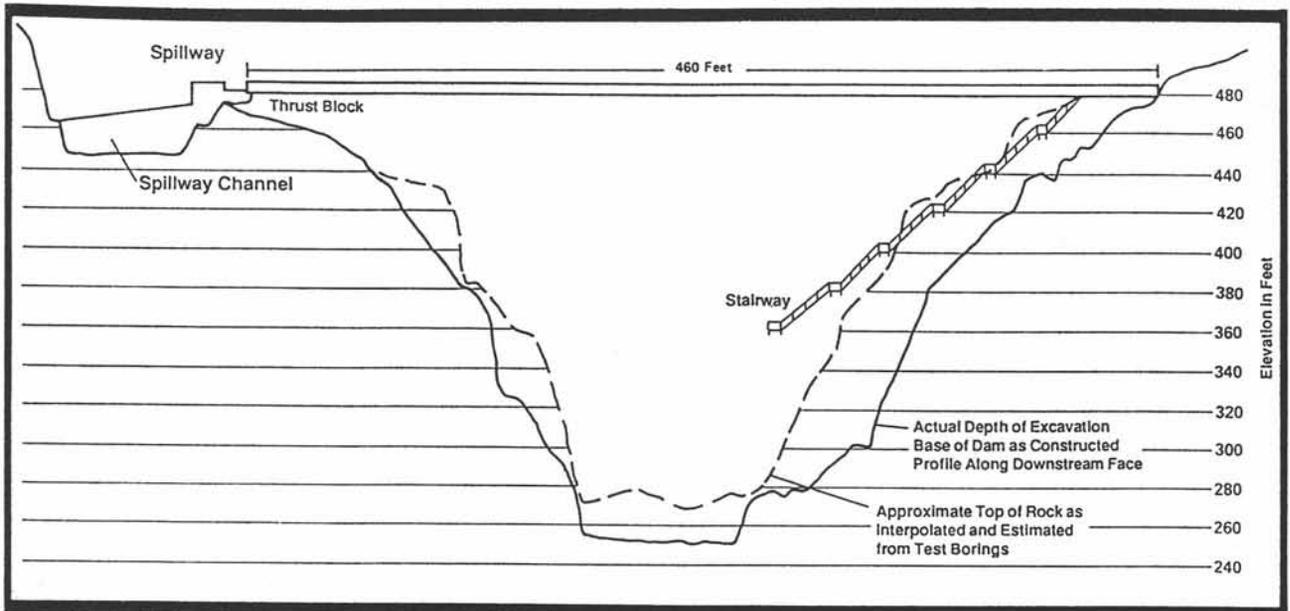
Figure 7. Section at Cushman Dam No. 2; view upstream.

Cushman Dam No. 2 is 2 mi downstream from Cushman Dam No. 1; there is little change in general rock structure and rock types. There are thin breccia zones between the massive andesites at Cushman Dam No. 2. All flows and interbeds are steeply dipping, and the rock is fractured owing to several periods of rather intensive deformation. A section along the dam axis is shown in Figure 7.

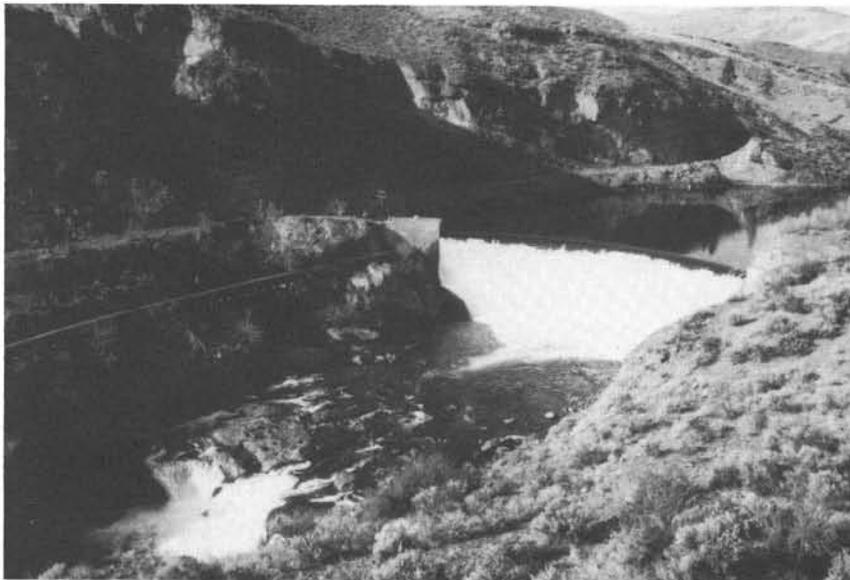
Enloe Dam on the Similkameen River, 7 mi northwest of Oroville in north-central Washington. The surface penstock can be seen on the far bank. This fed to a remote powerhouse about a quarter mile downstream. The powerhouse and gravity arch dam are no longer in use, and the reservoir is largely filled with flood detritus. Photograph by R. W. Galster, November 1982.

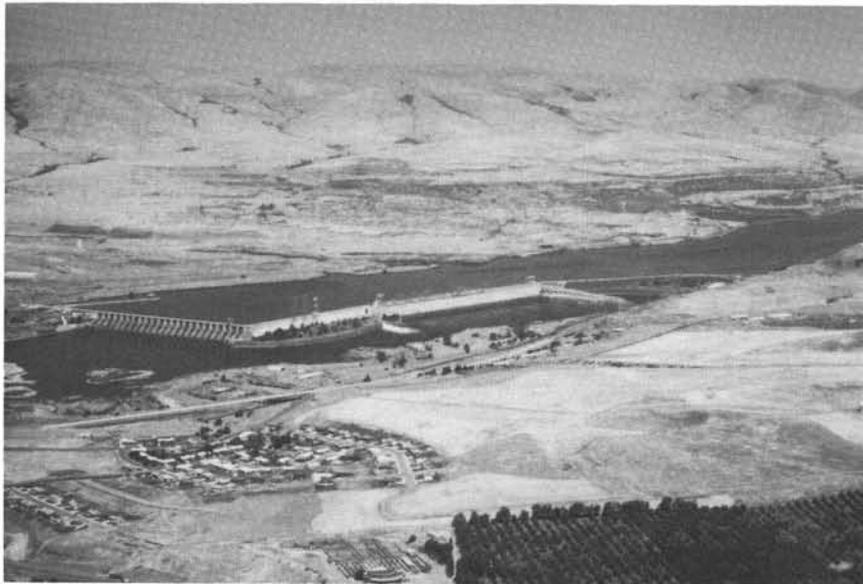
The Dalles Dam. Aerial view to the northeast toward the Columbia Hills anticline in Washington. Photograph by R. W. Galster, July 1980.

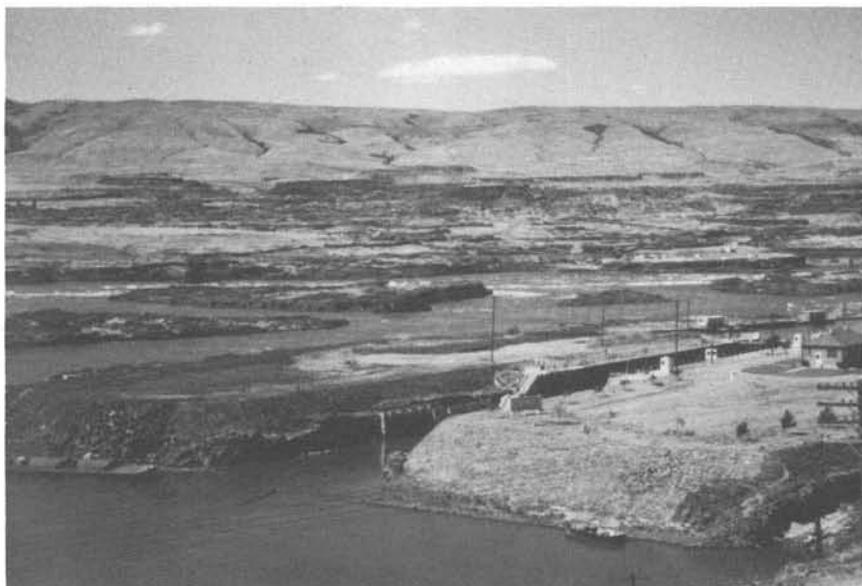
Celilo Canal at The Dalles prior to construction of The Dalles Dam. Photograph by R. W. Galster, 1949.

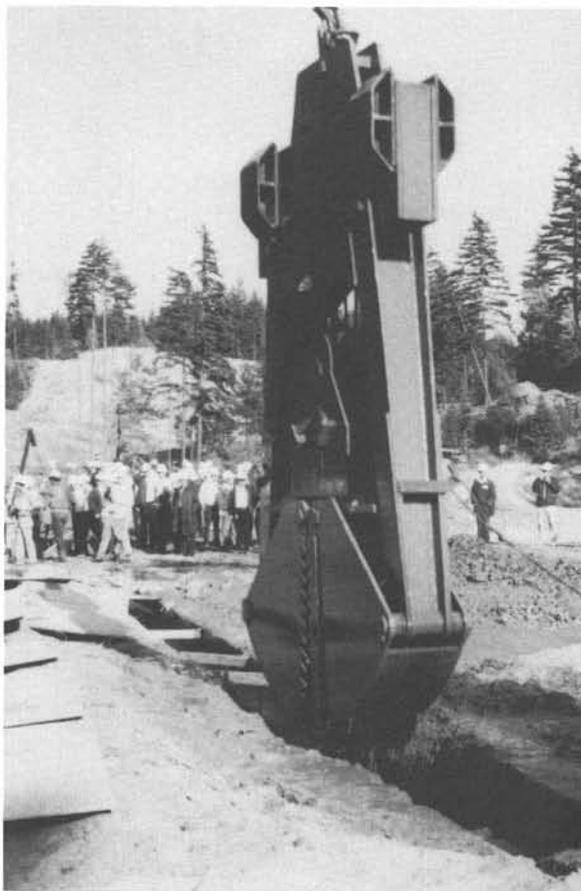
Special clam bucket use in implacement of ICOS cut-off wall prior to Bonneville Dam, north powerhouse construction. Concrete cut-off wall was required in order to dewater excavation in Cascade landslide materials. Photo by R. W. Galster, October 1976.

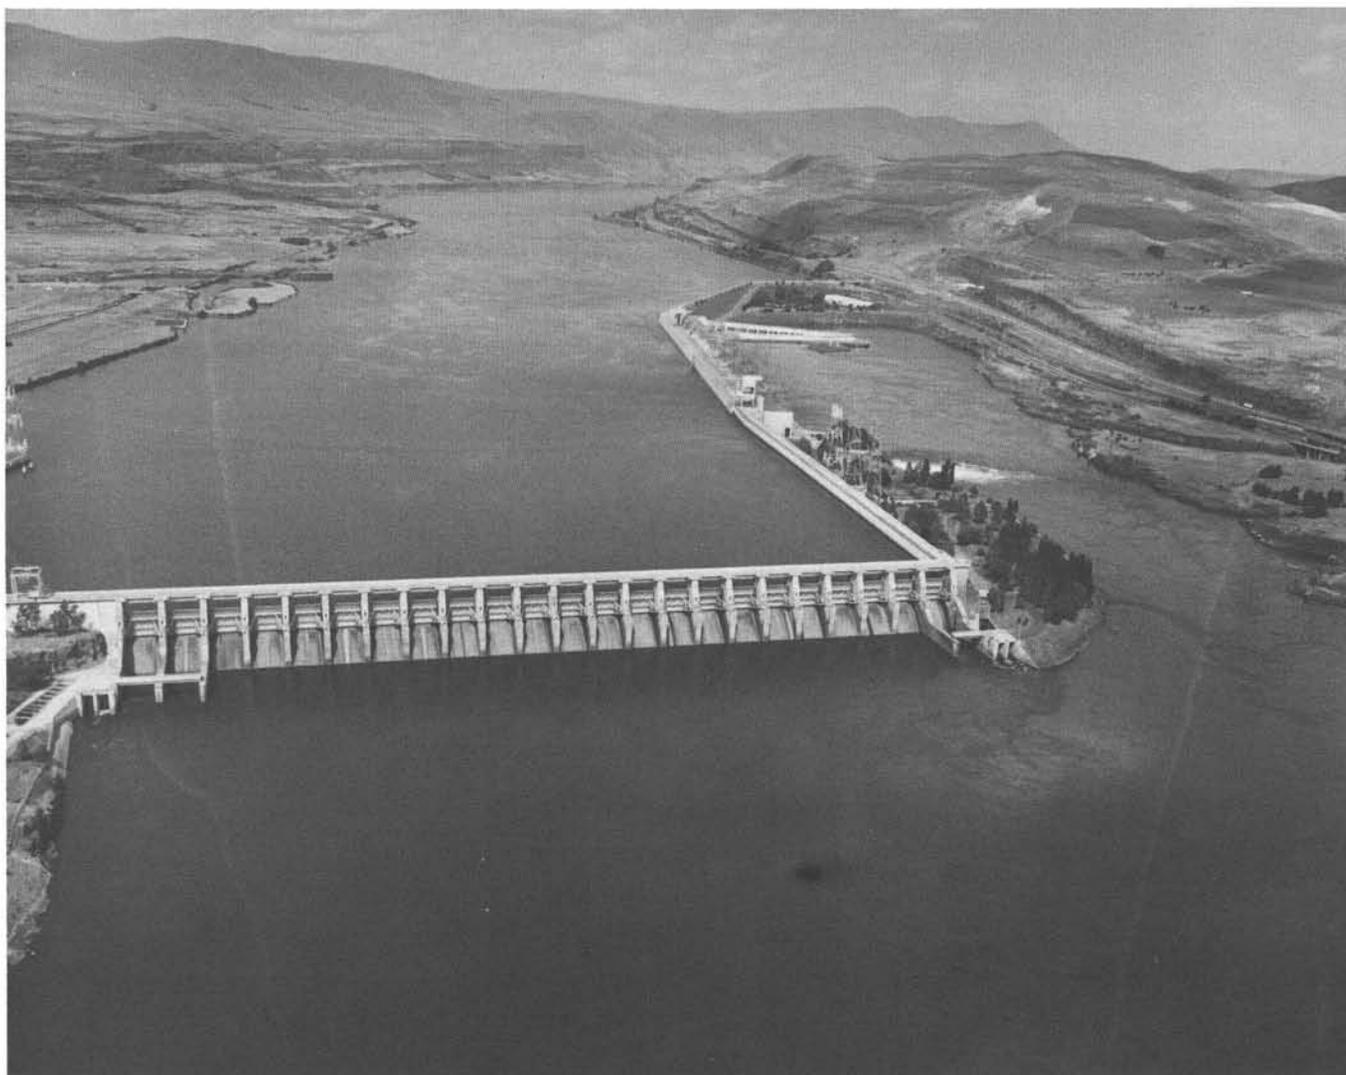
Figure 1. Aerial view northeast (upstream) of The Dalles Dam. The spillway dam dominates the view; the channel-parallel nonoverflow dam and powerhouse separate the forebay (left) from the original river channel and present tailrace. The fish ladders on the Oregon shore and embankment closure section are beyond the powerhouse. The light-colored exposures on the low hills in the upper right are Dalles Formation. A portion of the Washington shore fish ladder and the navigation lock are at the left. Photograph courtesy of the U.S. Army Corps of Engineers.

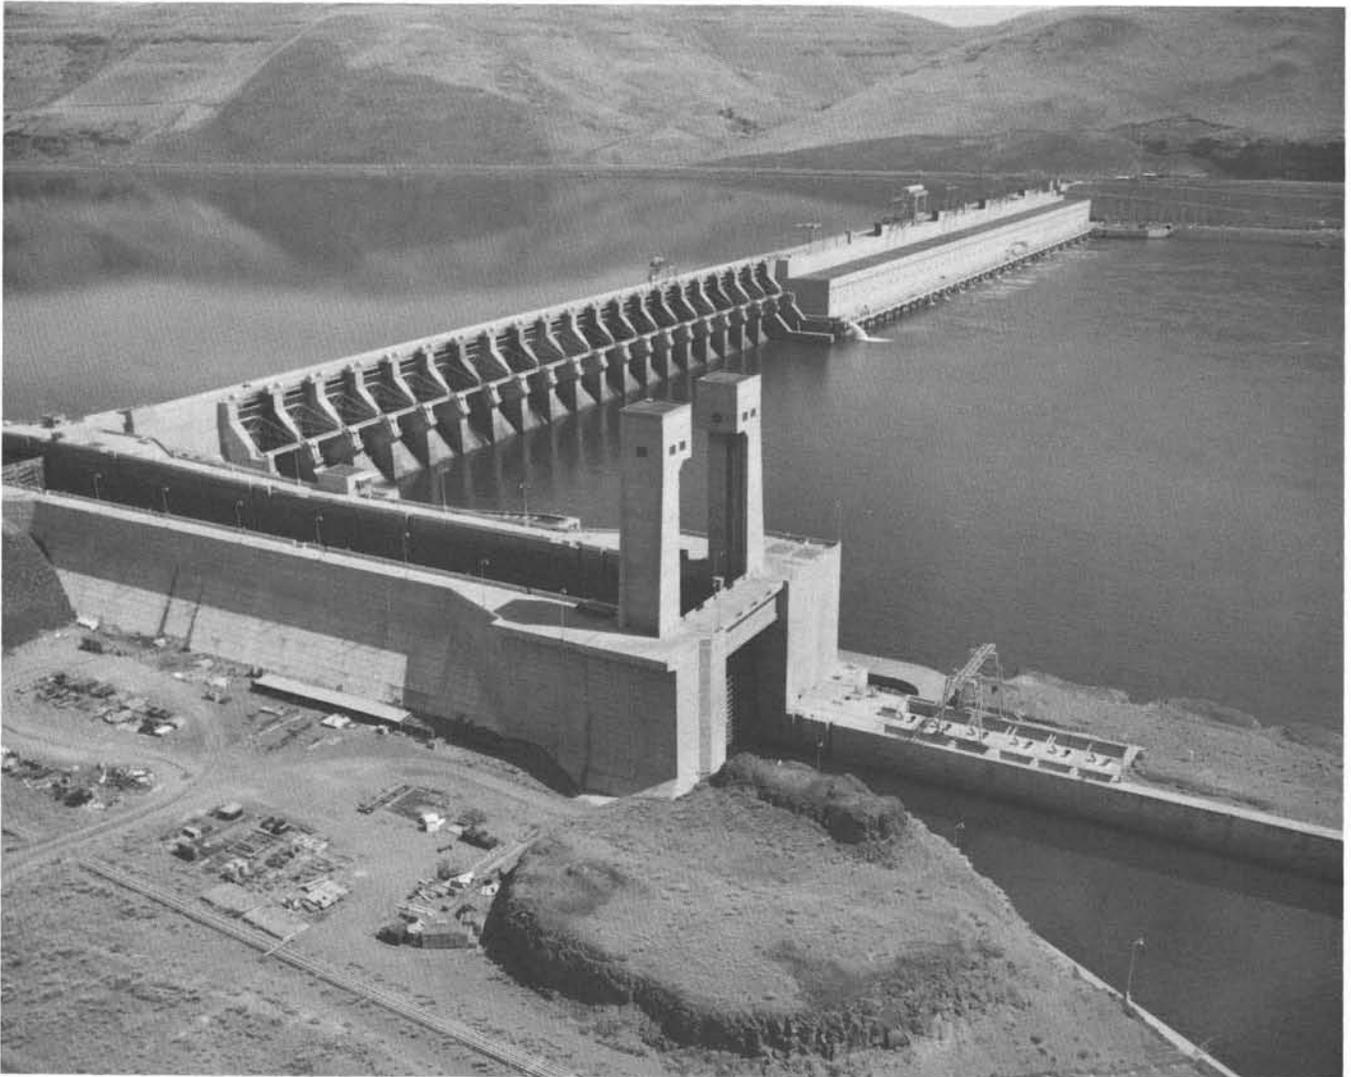
Figure 1. Aerial view of John Day Dam south (from the Washington shore) showing the navigation lock (foreground), spillway dam (center), and powerhouse/intake structure (upper right). Photograph courtesy of U.S. Army Corps of Engineers.

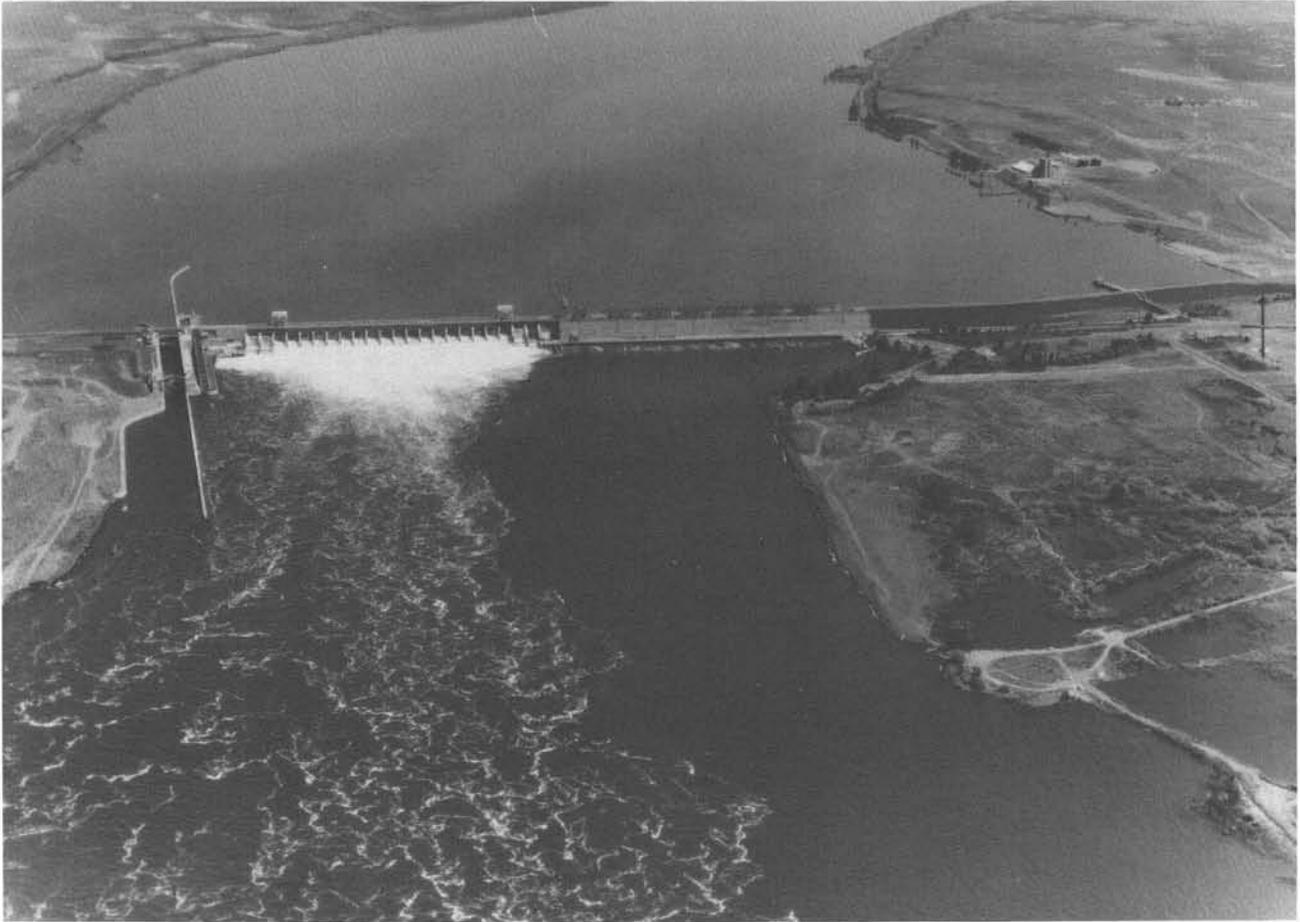
Figure 1. McNary Dam; view to the east (upstream). From left to right in the photo is a portion of the right (Washington) embankment, navigation lock, spillway dam, intake dam and powerhouse, and left (Oregon) embankment. Fish ladder facilities are located riverward of the navigation lock and along the downstream toe of the left embankment. Photograph courtesy of the U.S. Army Corps of Engineers.

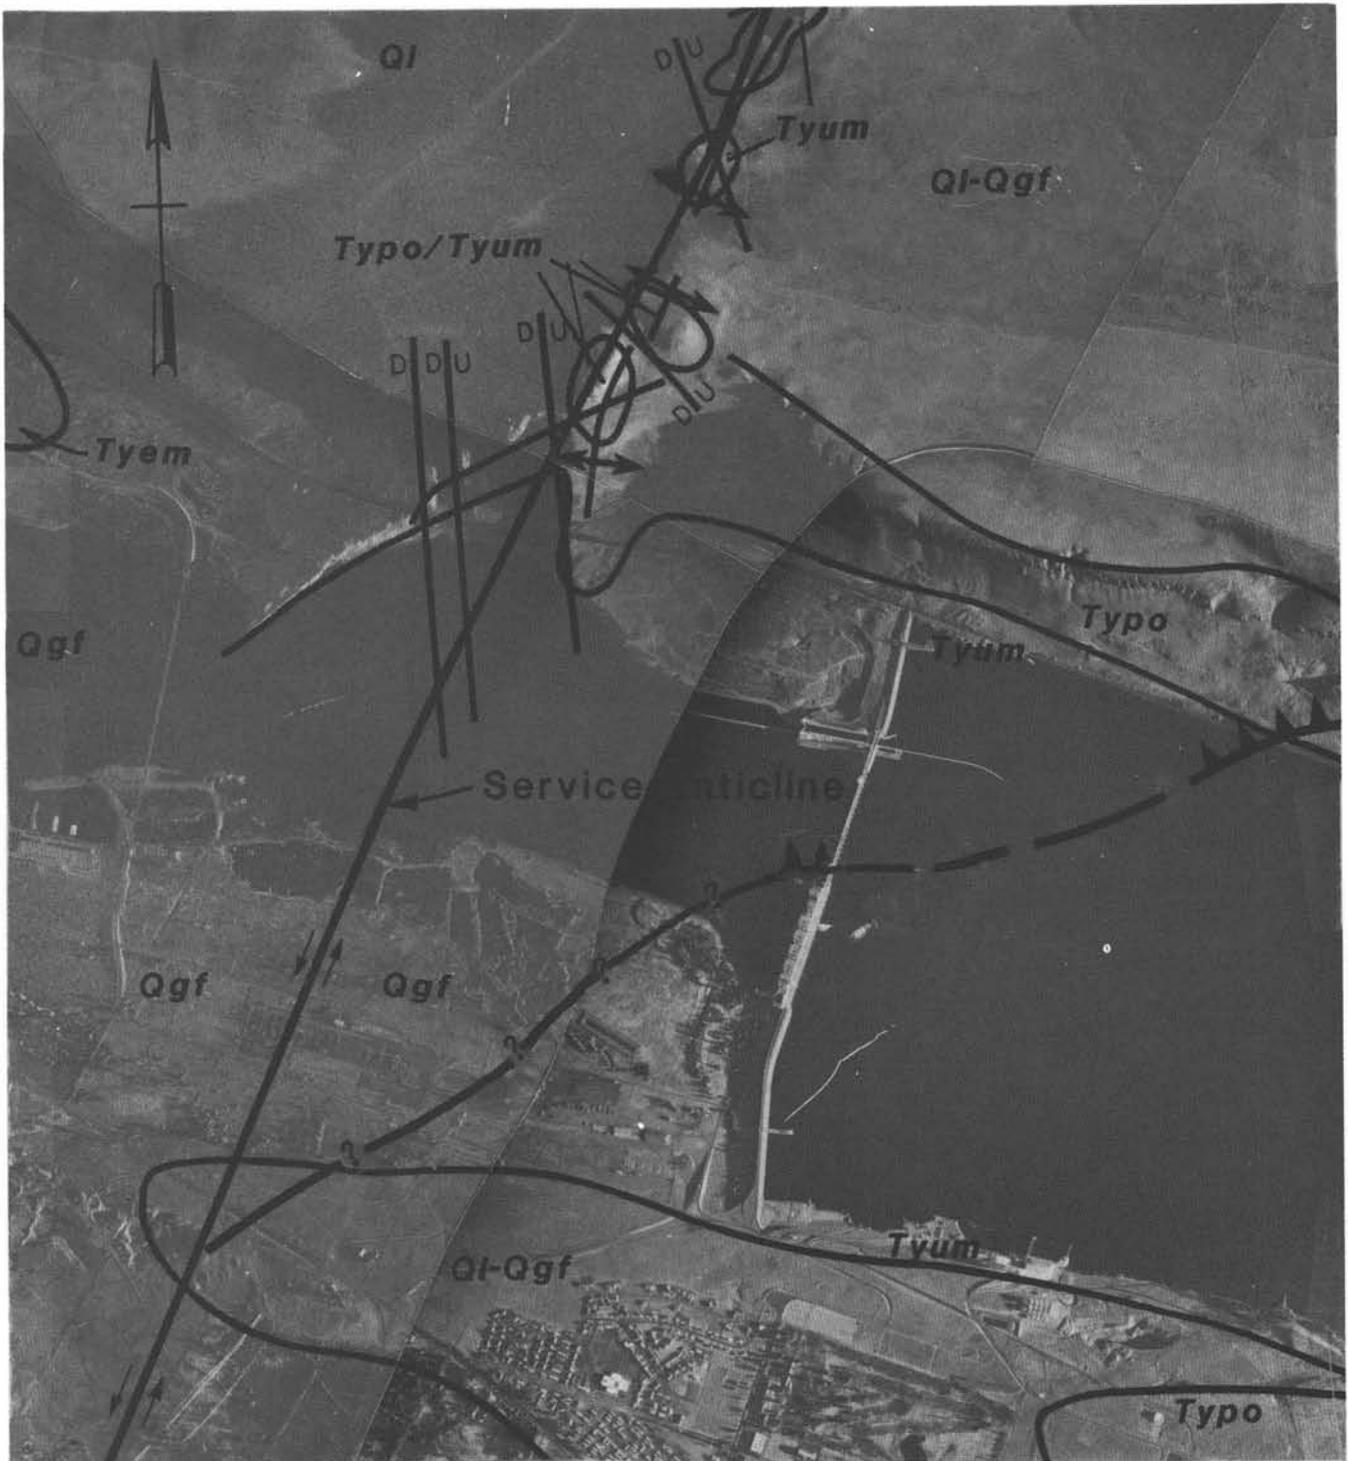
Figure 2. Photogeologic map of the McNary Dam area. Heavy solid lines indicate approximate position of contacts. *Ql*, loess; *Qgf*, glaciofluvial deposits; *Tyem*, *Typo*, and *Tyum*, Elephant Mountain, Pomona, and Umatilla members of the Saddle Mountains Basalt. Scale: 1 in. = approximately 2,000 ft. From U.S. Corps of Engineers (1982b).

The basalt bedrock provided a structurally competent foundation on which to place the concrete dam—with the exception of the two thrust faults in the spillway and powerhouse areas (Figure 3) which required remedial treatment. The fault beneath the powerhouse had a narrow gouge zone; minor overexcavation was required to remove the gouge and highly weathered rock and to replace it with several feet of dental concrete. The fault beneath the spillway was more troublesome. The fault cut the foundation at a fairly low angle at this point and contained a red clay gouge several feet thick. Excavation was carried along the footwall of the fault until a sufficient mass of sound rock was present above the hanging wall to support the concrete structures (Monahan, 1957).

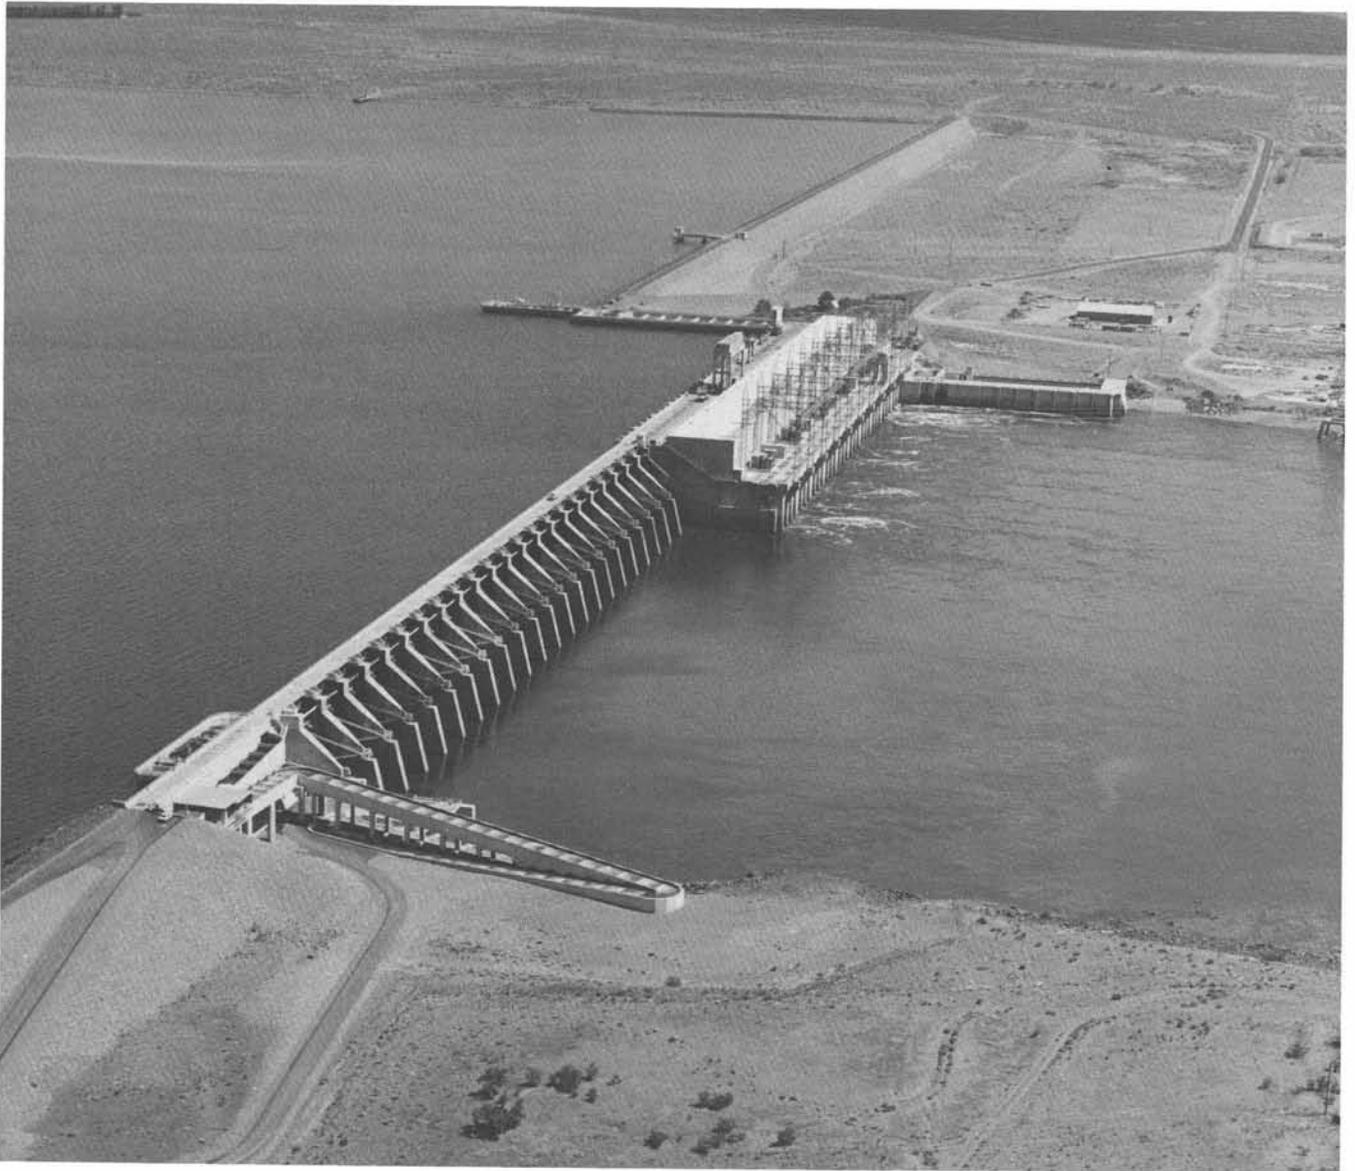
Figure 1. Priest Rapids Dam. View to the north showing part of the right embankment, concrete spillway, intake dam/powerhouse section, and offset left embankment beyond. Fish ladder facilities flank the concrete dam. Photo courtesy of Grant County.

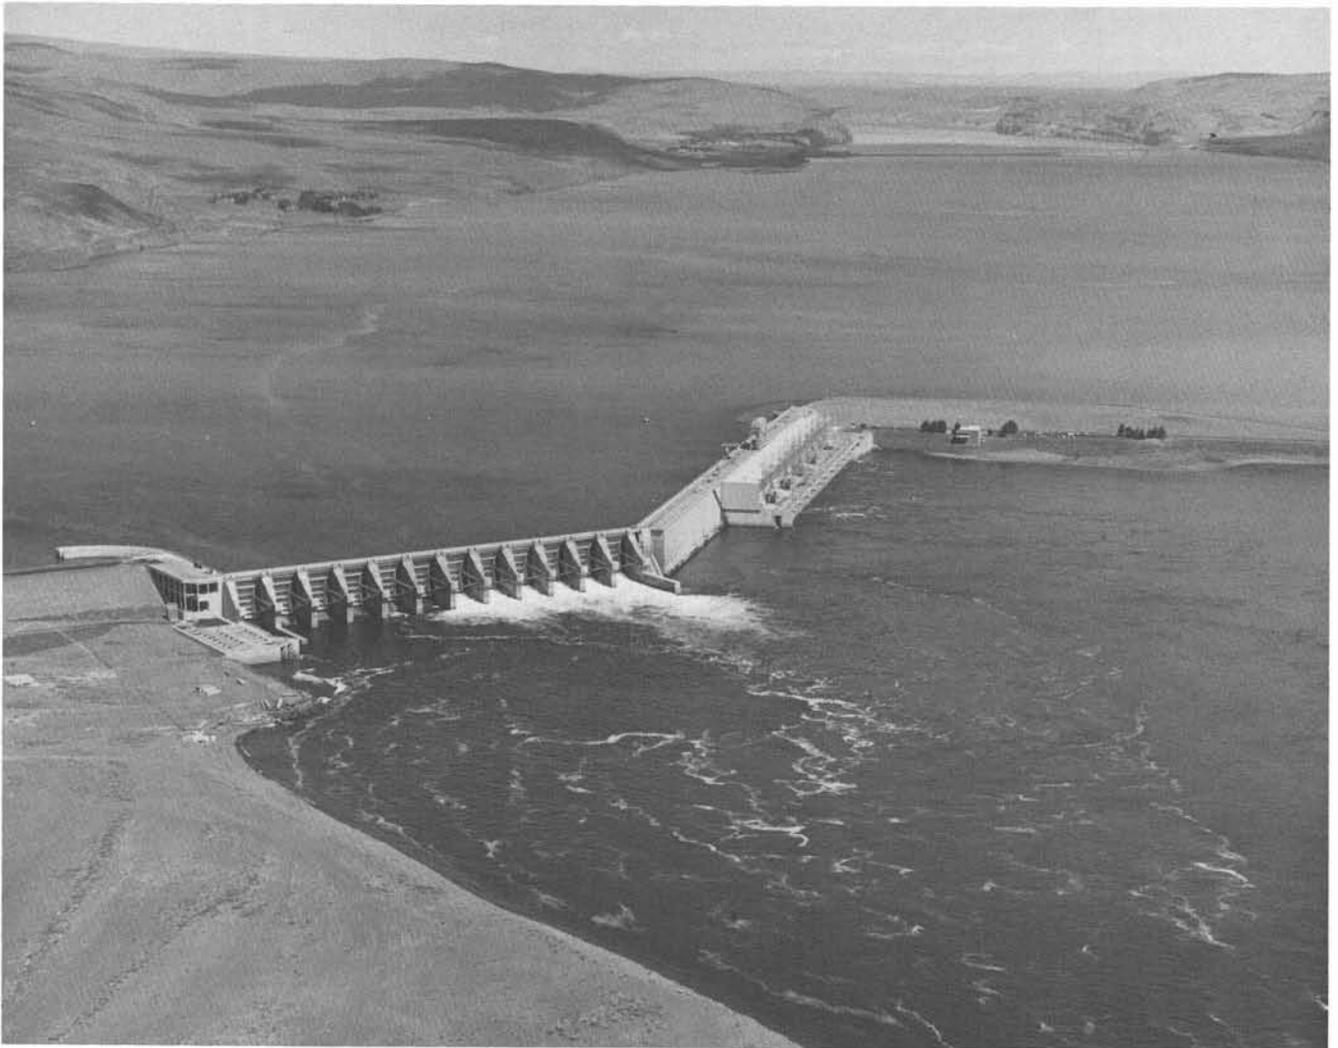
Figure 1. Wanapum Dam, View upstream (north) showing dog-leg arrangement of spillway and powerhouse and space for future units between. The left embankment is to the right. Fish passage facilities and a small part of the right embankment are to the left of the spillway. The Interstate Highway 90 bridge is in the background, at Vantage. Beyond the bridge is the canyon through the Frenchman Hills anticline. Photo courtesy of the Grant County Public Utility District

Mapping of the valley walls between the gaps revealed the presence of the Ryegrass structure and the likelihood of the resistant upper flows of the Grande Ronde Basalt being at an elevation sufficient to provide economical foundations. Location of the dam was ultimately based on an extensive seismic refraction survey which guided the early drilling program. The initial geologic interpretations proved to be true. The high, sound basalt units of the Museum and Rocky Coulee flows were available for founding the concrete structures, although the configuration of the rock surface dic-

tated the orientation of the powerhouse parallel to the channel. The bedrock configuration also required the angled spillway and longer embankment sections flanking the concrete structures than would have been necessary had a straight-line axis been economical.
