Rock Island Dam

RICHARD W. GALSTER
Consulting Engineering Geologist

PROJECT DESCRIPTION

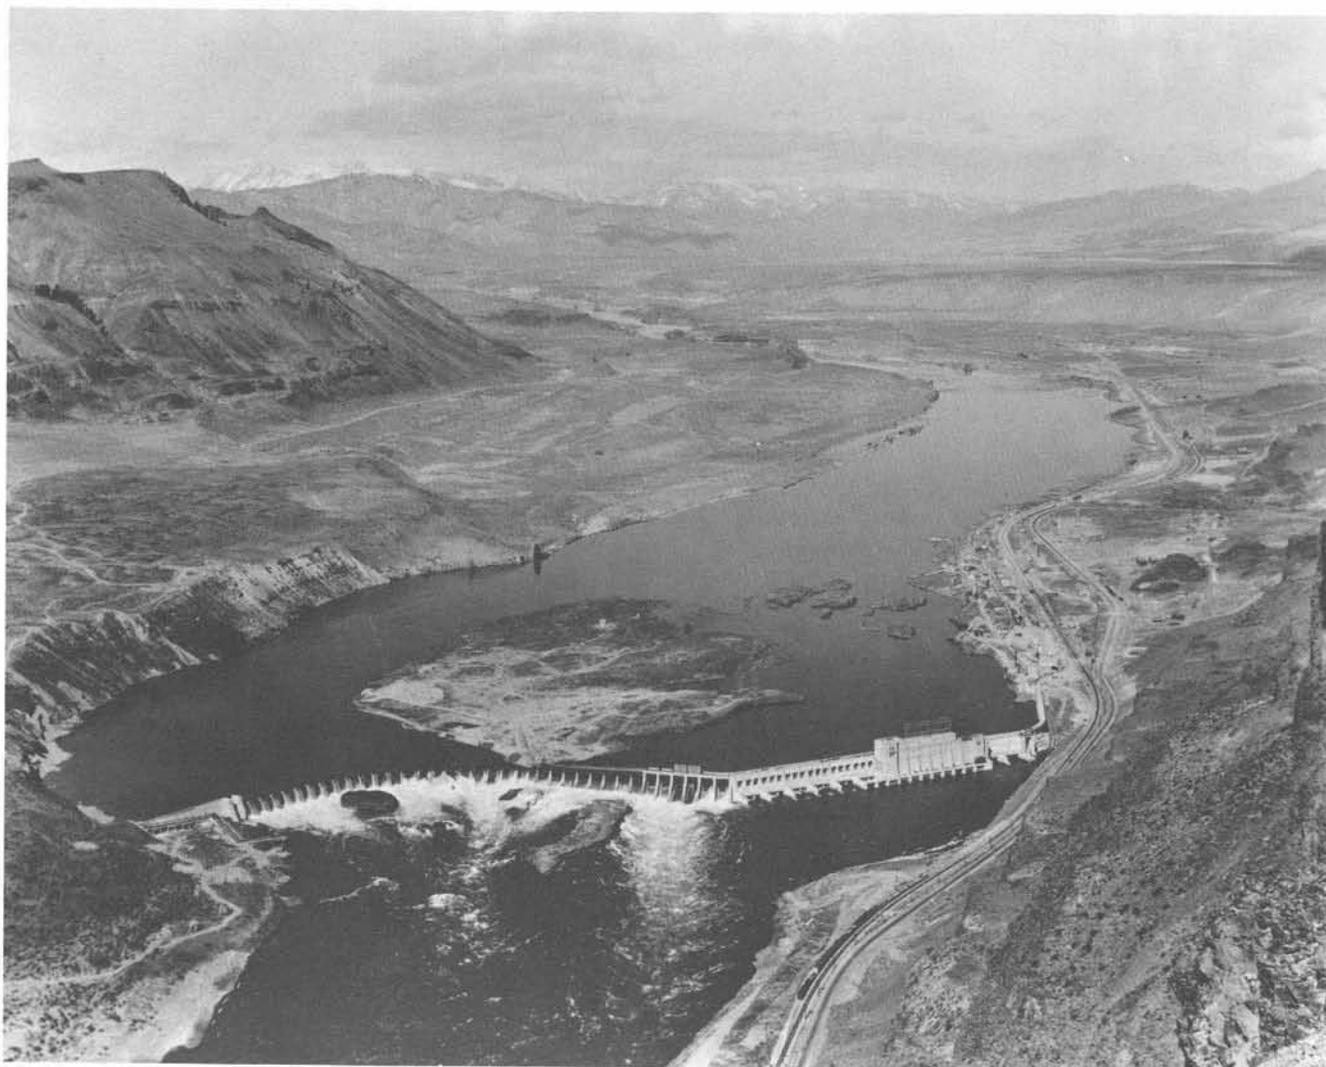
Figure 1. Rock Island Dam in about 1934 after completion of original construction. View to the northwest showing the four-unit powerhouse and blanks for future units (right) and partly undecked spillway (center and left). A glacial flood terrace is at the far left. Rock Island is at the center, upstream of the dam. High basalt cliffs are at the far right. Photo courtesy of W. L. Shannon.

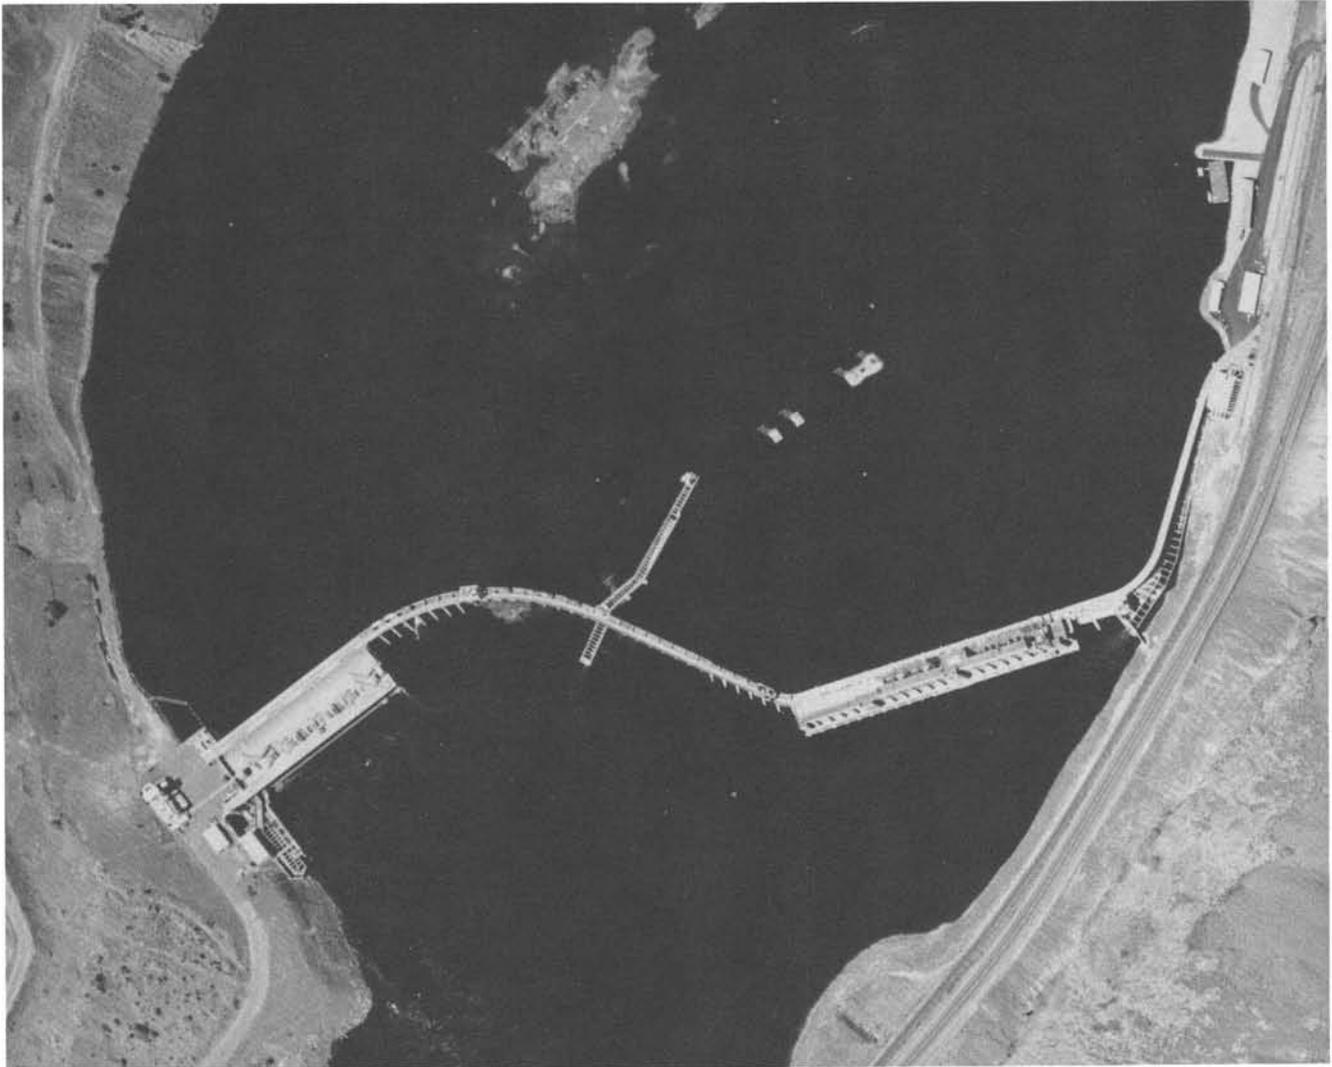
Figure 2. Vertical aerial photograph of Rock Island Dam. Powerhouse no. 1 is on the right, and powerhouse no. 2 is on the left. Large ice-rafted basalt blocks are on the surface and face of the bank terrace (at left). Three fish passage facilities are on each bank and through the center of the spillway section. Part of Rock Island remains above normal headwater upstream of the dam. The top of the photograph is to the northwest. Photograph courtesy Seattle District, U.S. Army Corps of Engineers.

During the mid-1970s, the dam was modified by construction of a second powerhouse (eight units) adjacent to the south (right) bank (Figure 2). This required removal of the original right bank concrete nonoverflow section, right embankment, fish passage facilities, and six spillway bays. The remainder of the original dam was strengthened by installation of 163 cable tendons from the top of the dam into the bedrock foundation. A new fish passage facility was also constructed on the right bank.

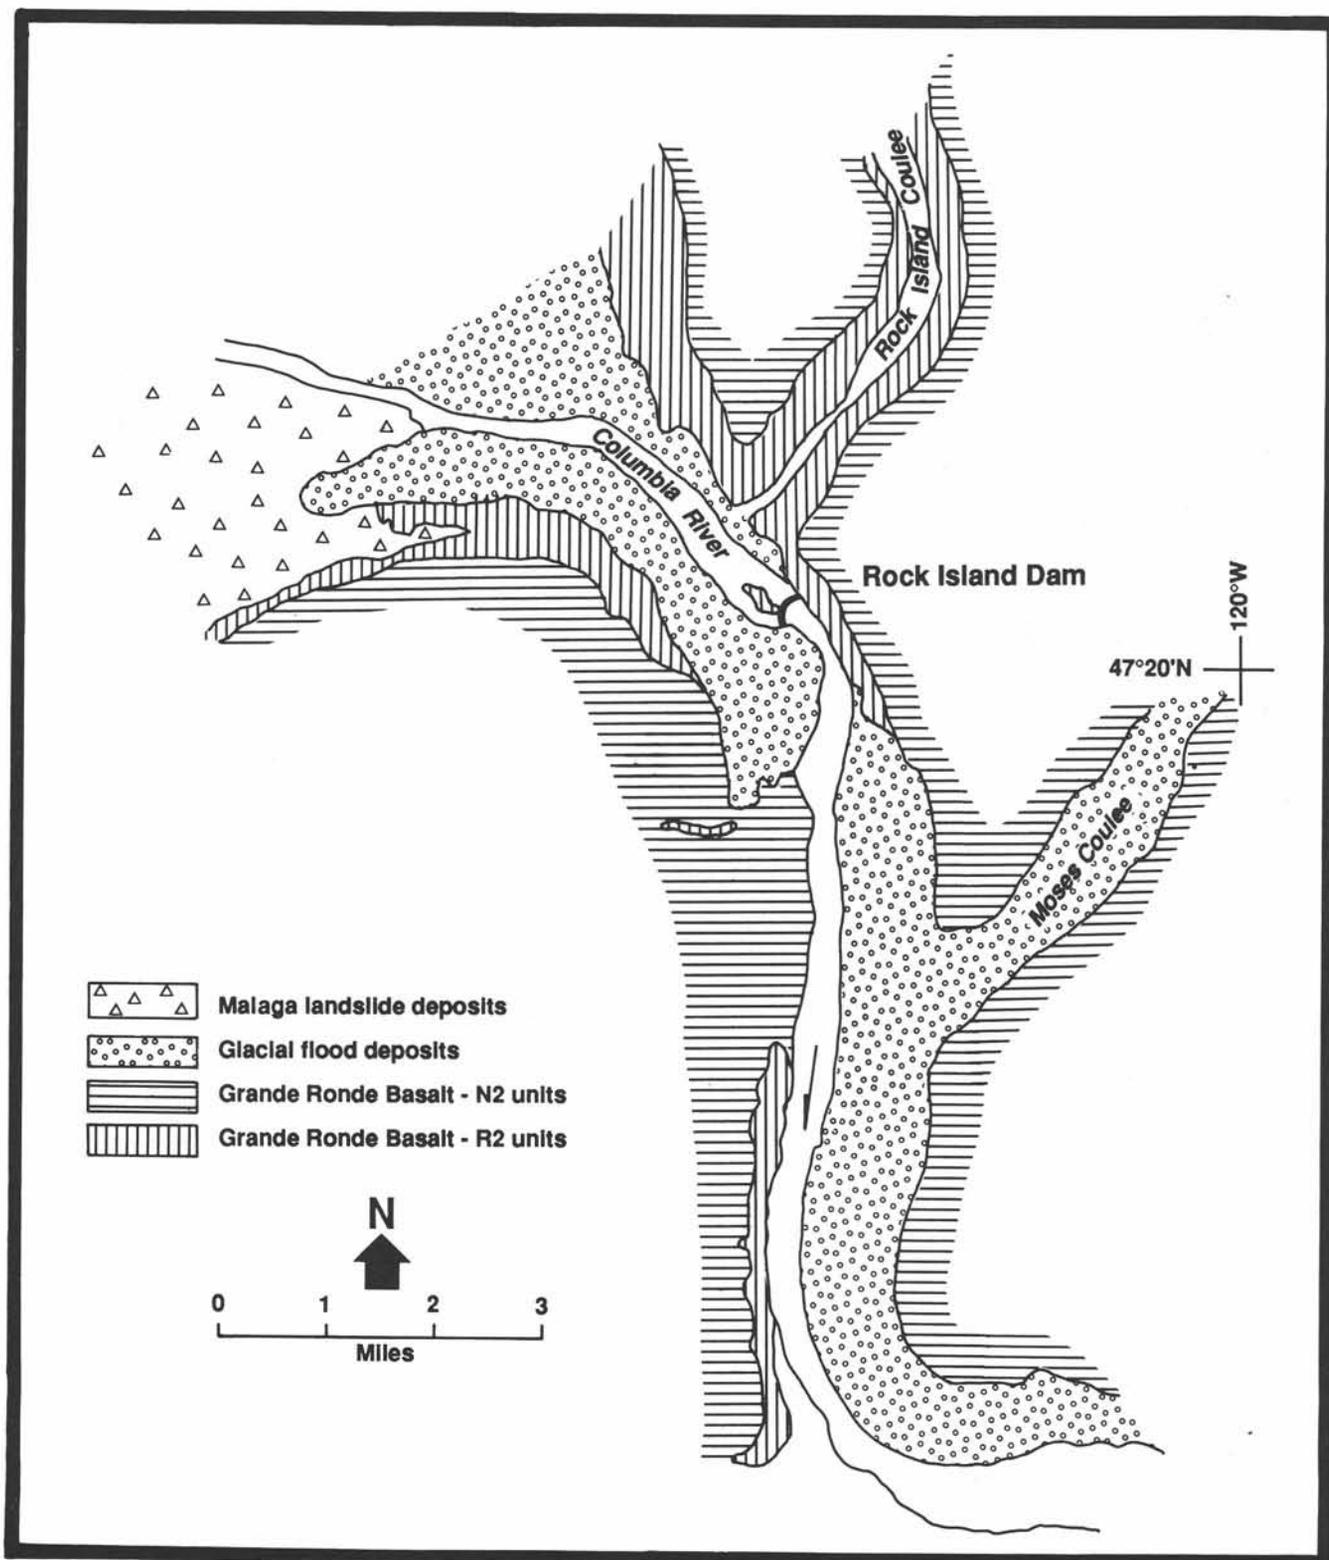
Figure 3. Generalized geologic map of the Rock Island area showing configuration of glacial-flood terrace deposits and bedrock canyon walls. Minor Holocene alluvial and landslide deposits are not shown. After Tabor et al., 1982.

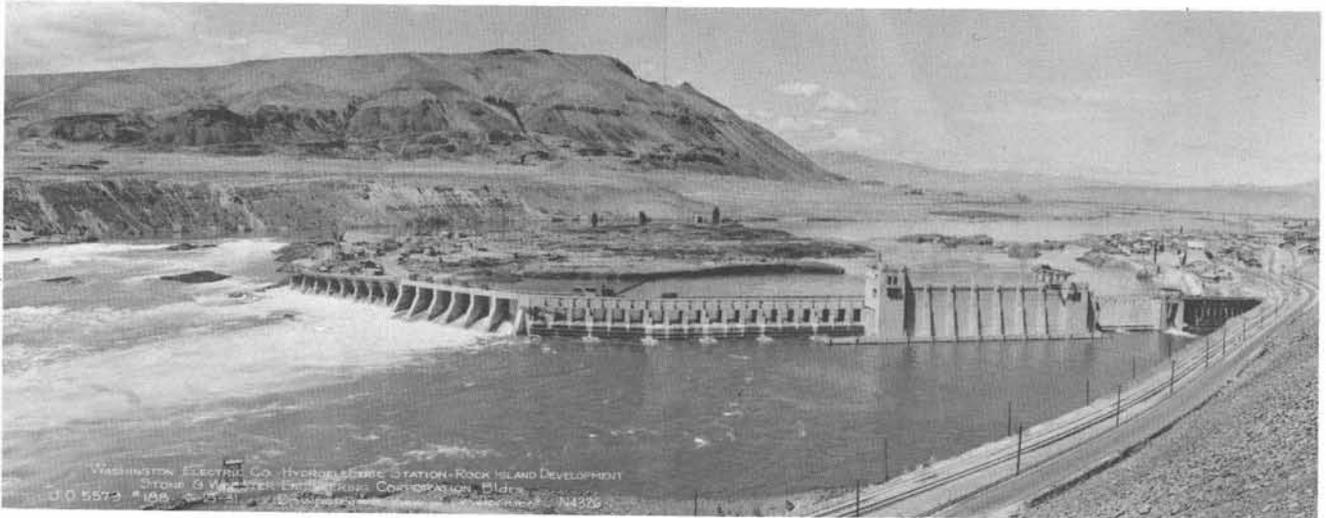
Figure 5. Rock Island Dam under construction, June 18, 1931, showing concrete work completed for the four-unit powerhouse no. 1 and the east spillway. Openings for the future addition to powerhouse no. 1 (center) are ungated, as are the spillway bays (left). Rock Island, in the center of the river, is being used as a staging area. The right bank terrace is on the far bank. (Note large ice-rafted basalt blocks.) Jumpoff Ridge rises behind the terrace. View to the west-northwest. Photograph courtesy of H. A. Coombs.

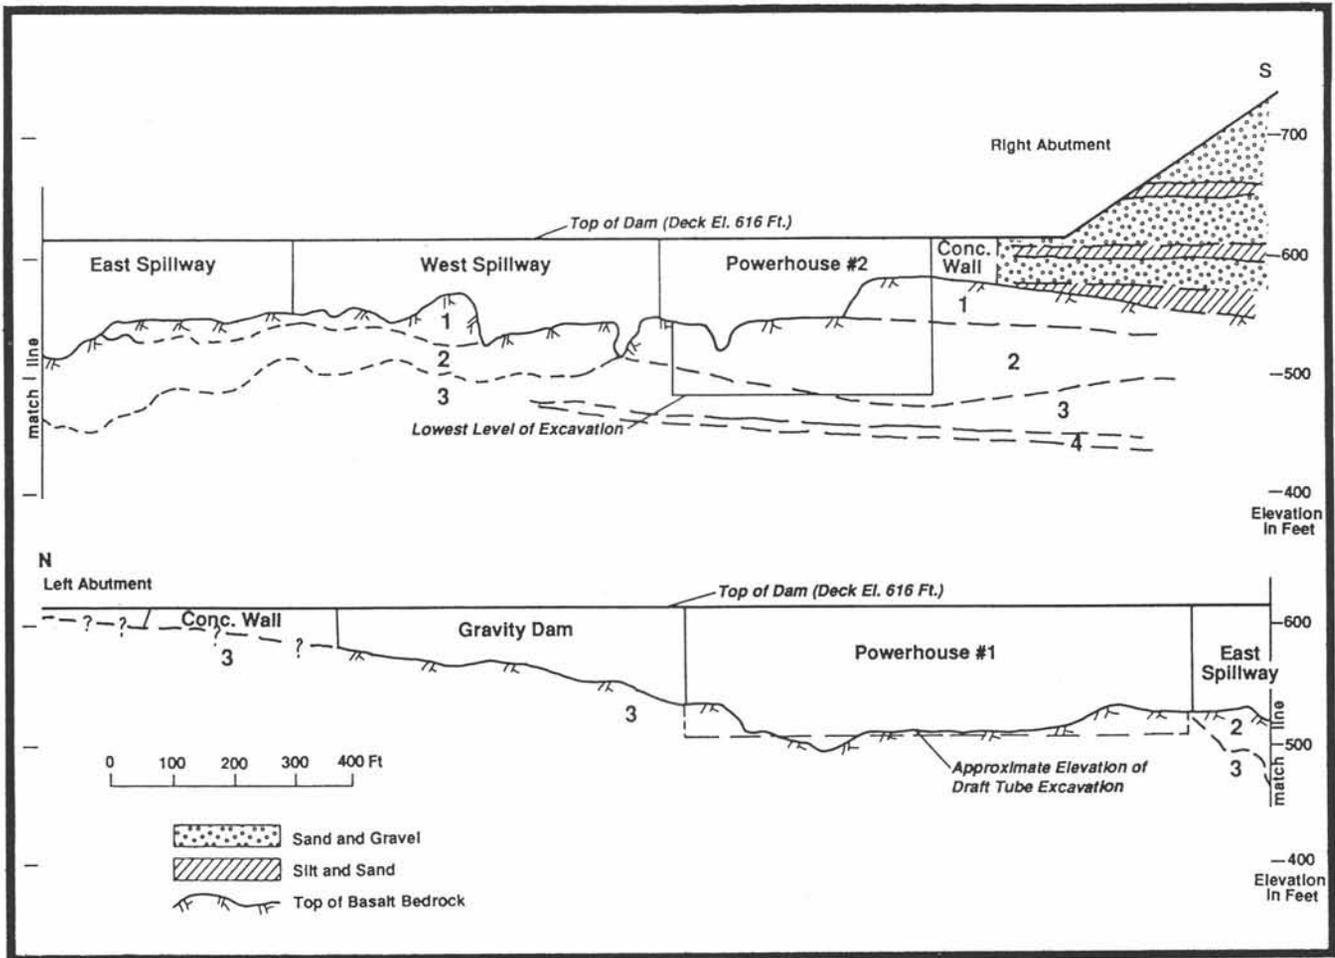
Figure 6. Geologic section at Rock Island Dam. Rock line based on tendon drilling data (R. W. Beck and Associates, unpublished data) except at powerhouse no. 2. View downstream. Numbered bedrock units are generalized as follows: 1, columnar basalt; 2, combination of invasive vesicular and scoriaceous basalt, tuffs, and breccia with highly irregular invasive characteristics; 3, generally columnar to "massive" basalt; and 4, tuff.

From data obtained during the period of tendon installation during the mid-1970s, powerhouse no. 1 and the left bank gravity and closure sections of the dam are founded on dense basalt, probably the colonnade of a single flow extending at least 60 ft beneath the powerhouse (Figure 6). Excavation for the powerhouse en-

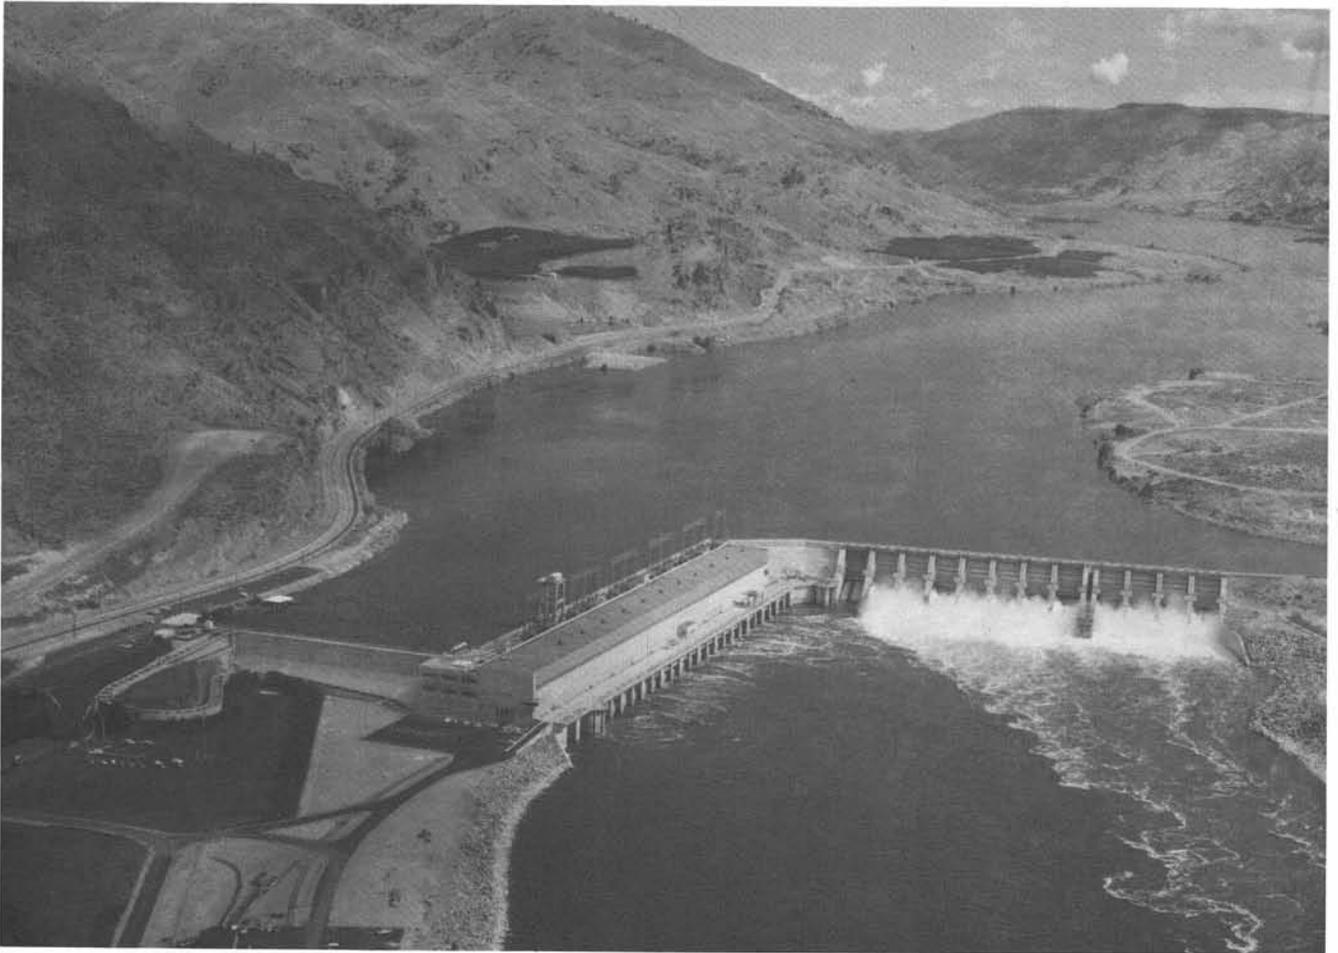
Figure 1. Rocky Reach Dam, Columbia River; view upstream. The curved structure on the left is the fish ladder. Photo by Chelan County Public Utility District.

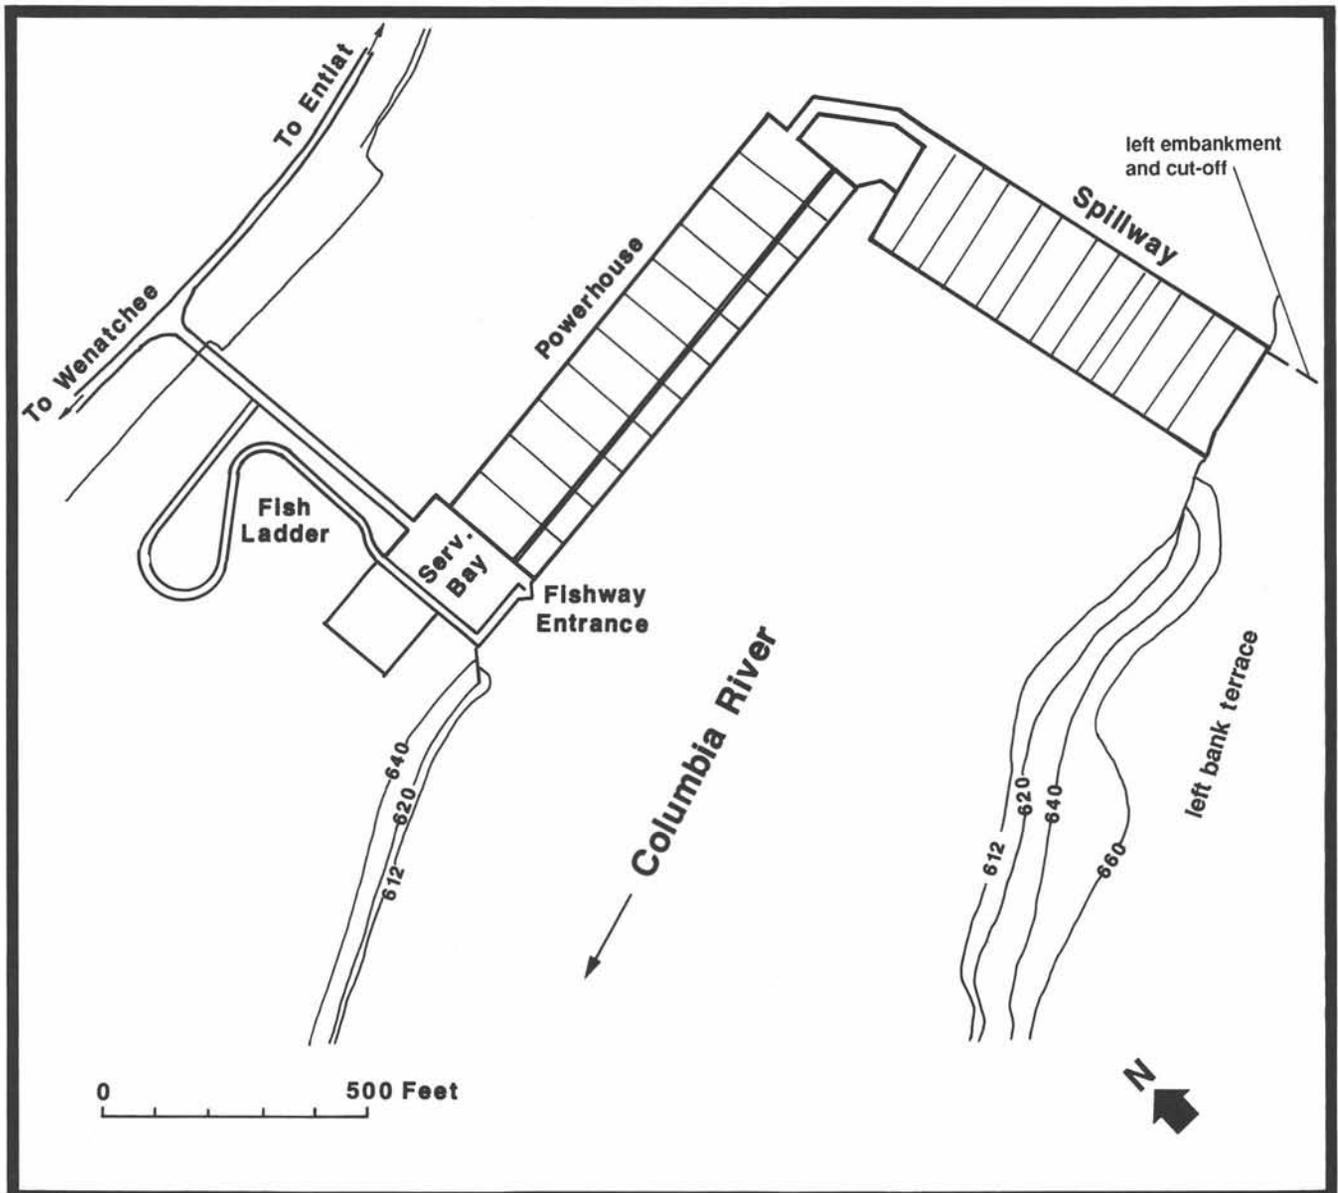
Figure 2. Plan of Rocky Reach Dam.

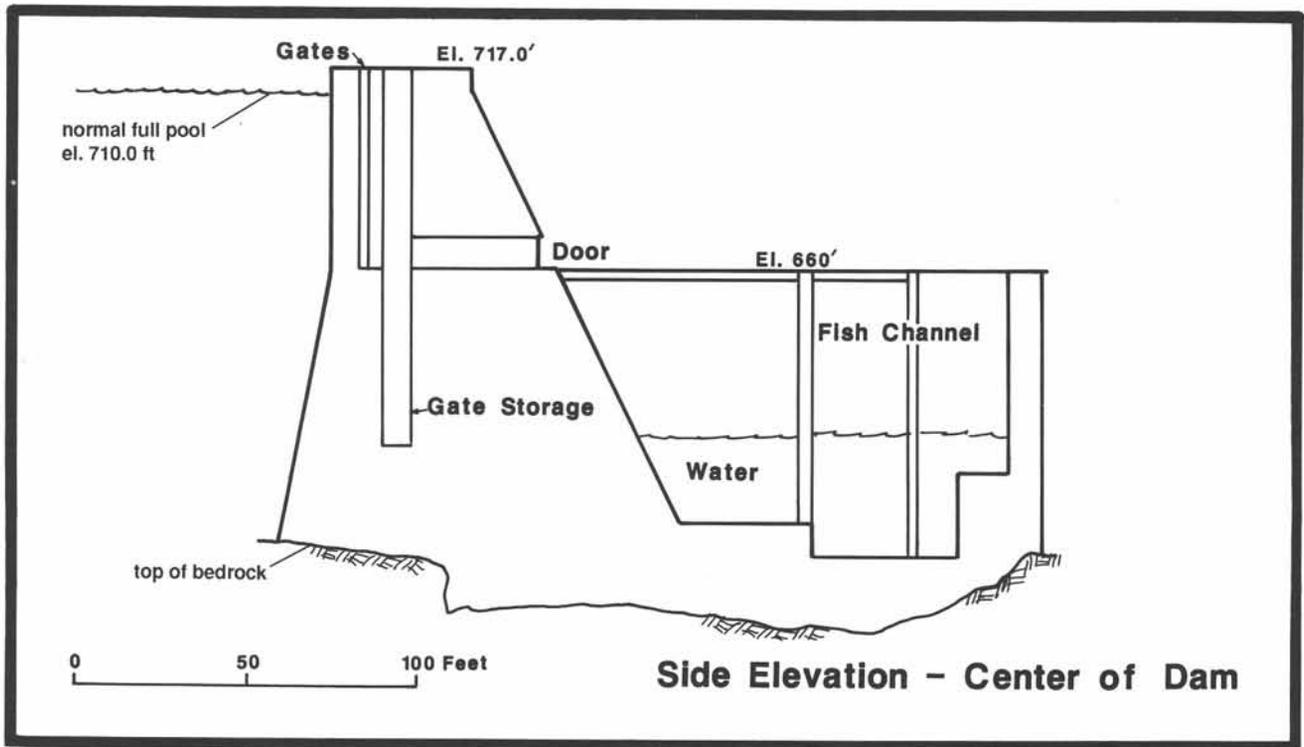
Figure 3. Side elevation of Rocky Reach Dam between the service bay and right bank in the area of the fish ladder.

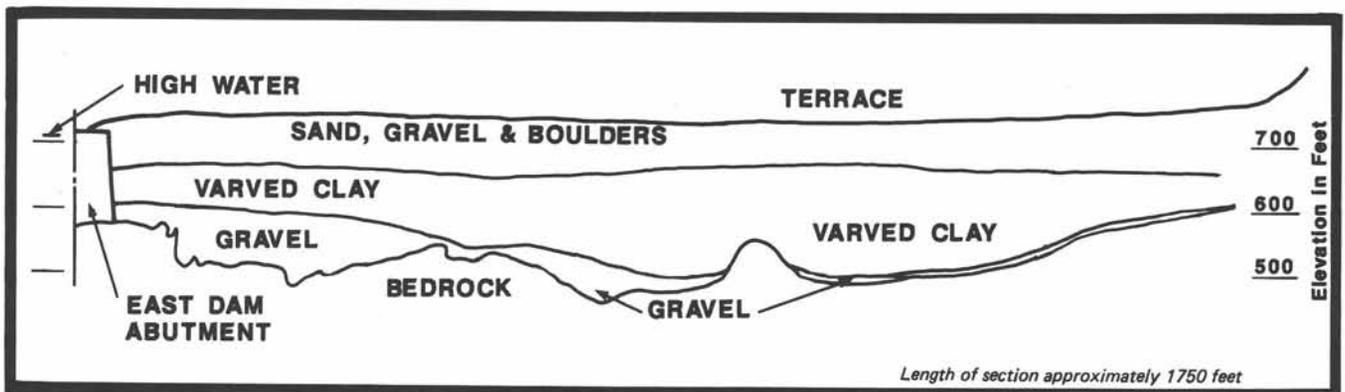
Figure 4. Profile along Rocky Reach Dam left bank cut-off; view upstream.

planned to use a relatively short upstream blanket and a downstream drainage system consisting of a series of relief wells extending into the east bank discharging through a collector pipe. Estimates based on actual observed coefficients of permeability indicated excessive seepage losses would be experienced with this design. After a study of several methods of control, it was decided to use a grouted cut-off. The plan included digging a wide trench through the upper gravels down to just above the top of the varved clays. Drills set on top of these clays would penetrate the clays and continue through the gravels to bedrock (Figures 4 and 5).

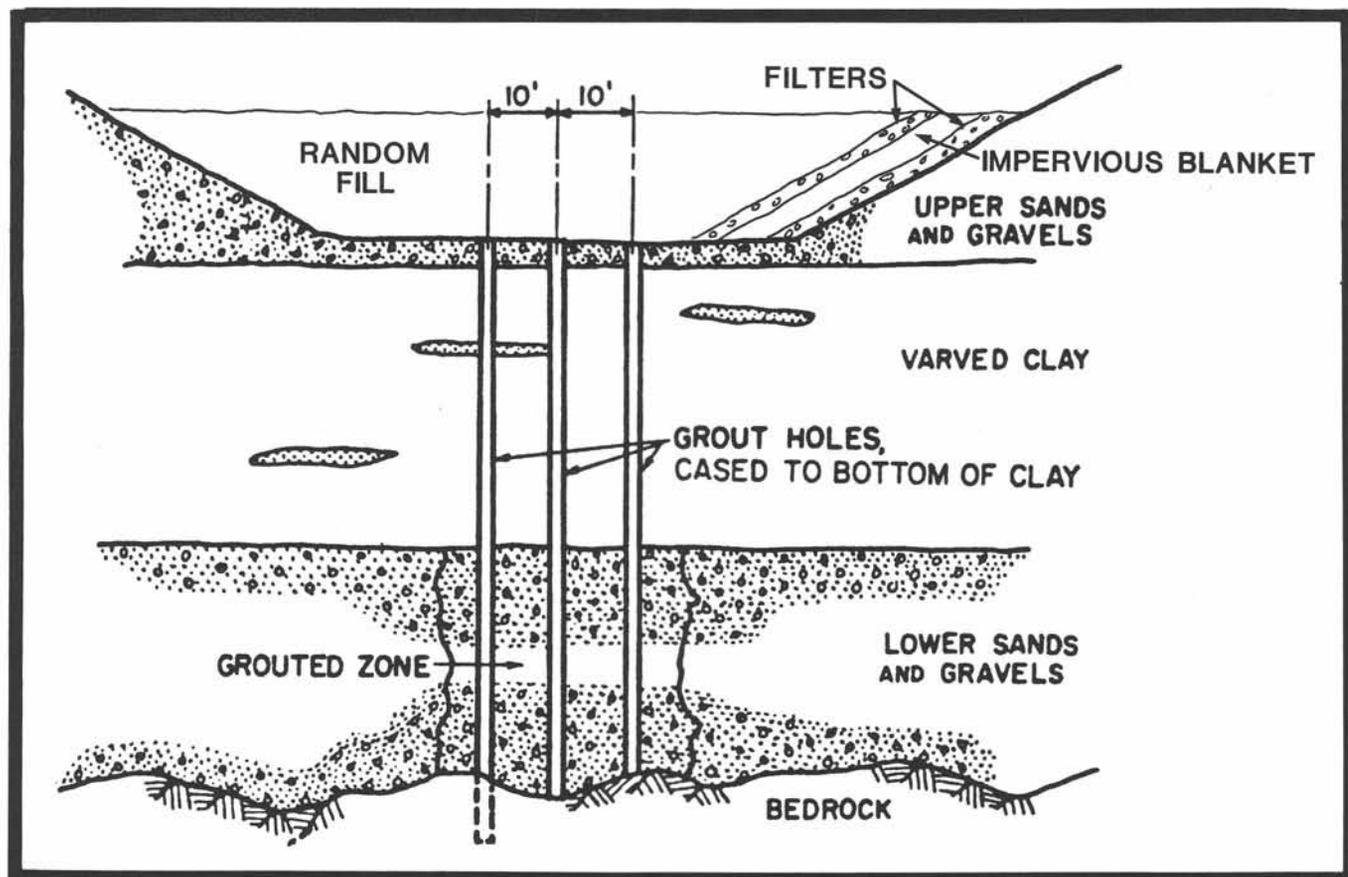
Figure 5. Section of Rocky Reach Dam cut-off. Downstream is to left.

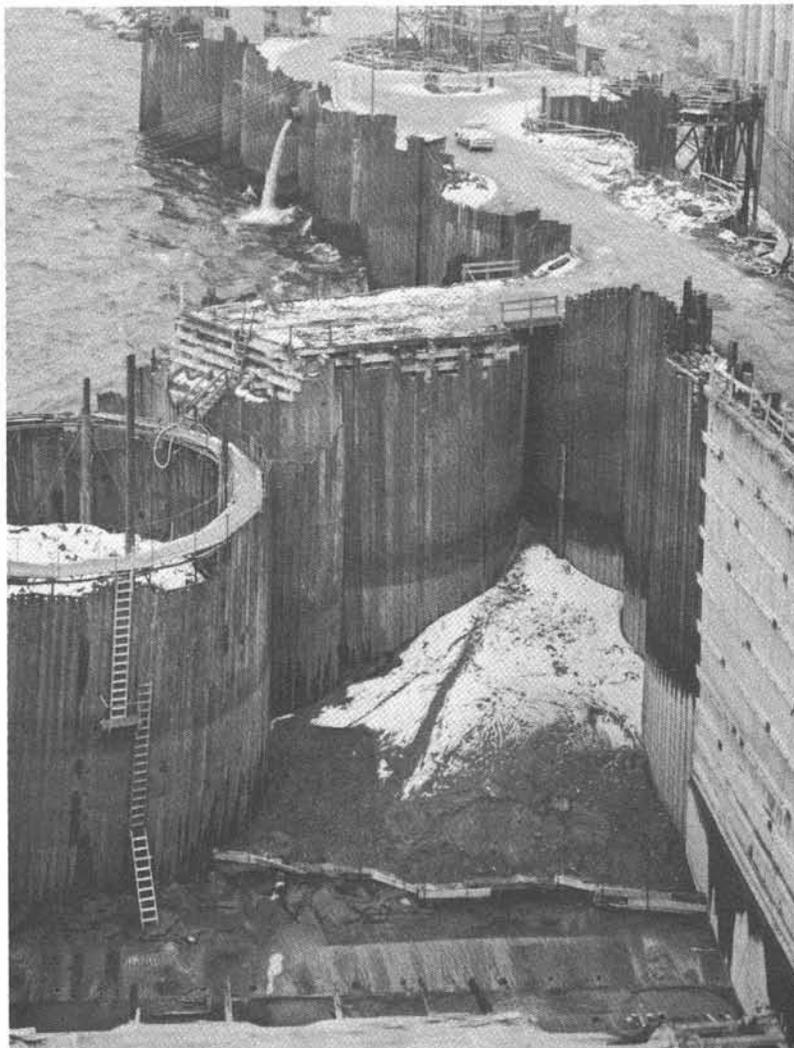
Rocky Reach project. This photograph, by the Public Utility District No. 1 of Chelan County, was taken in the summer of 1959 and shows the cofferdam needed to control the Columbia River. The downstream face of the powerhouse can be seen on the right.

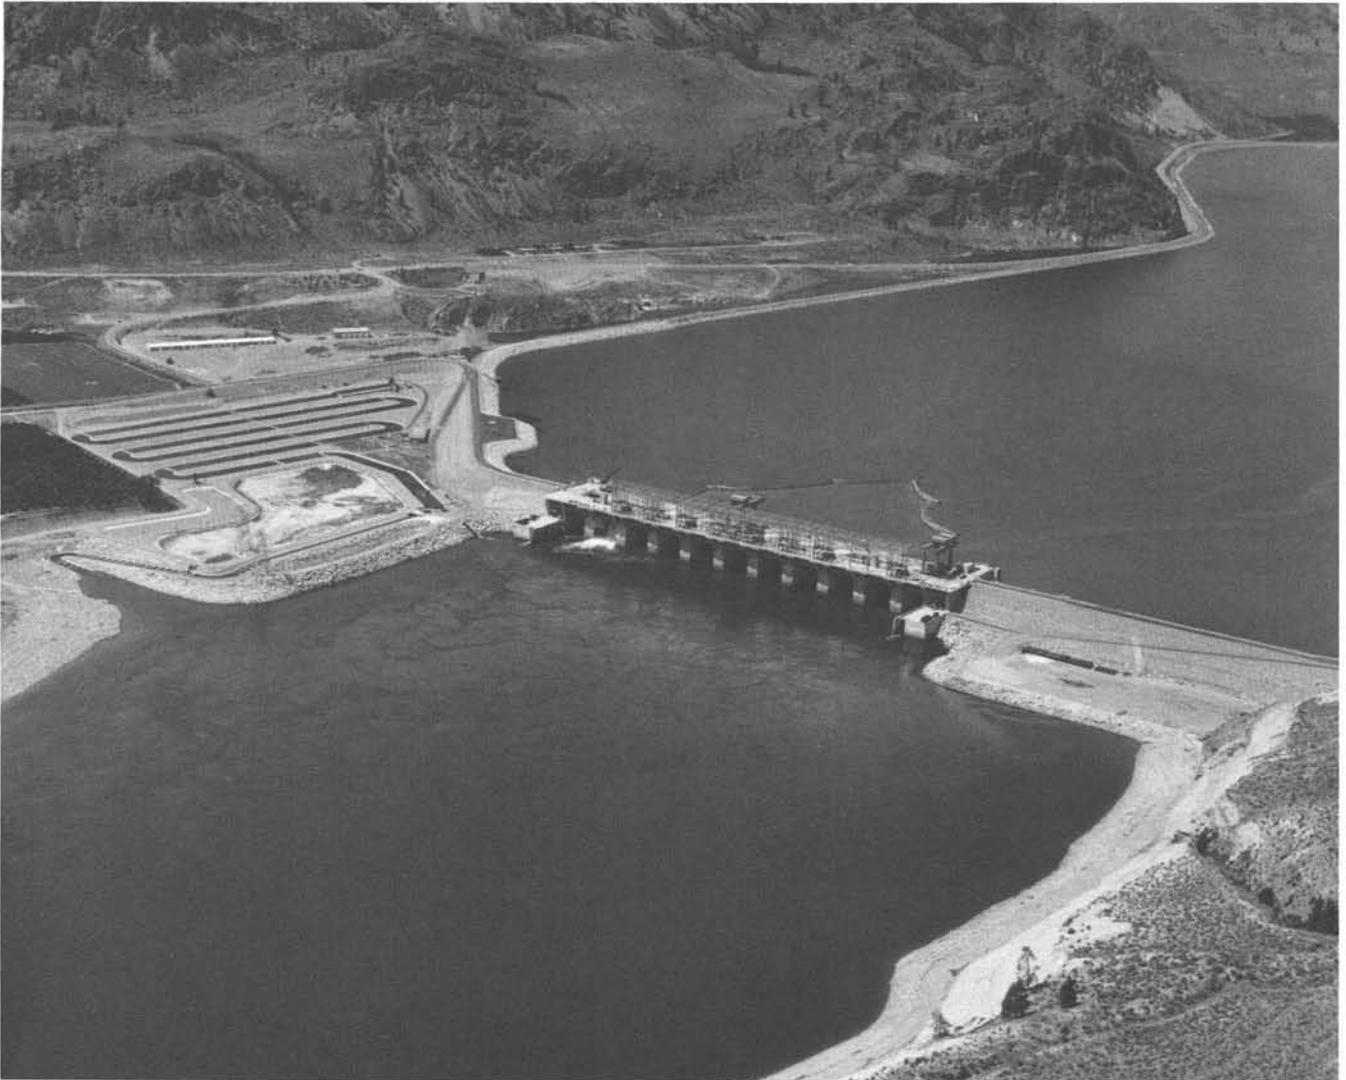
Figure 1. Aerial view to the northwest of Wells Dam showing unique hydrocombine structure (center) combining spillway and powerhouse functions. Fish-rearing facilities are located downstream from the west embankment (left). Photo courtesy of Public Utility District No. 1 of Douglas County.

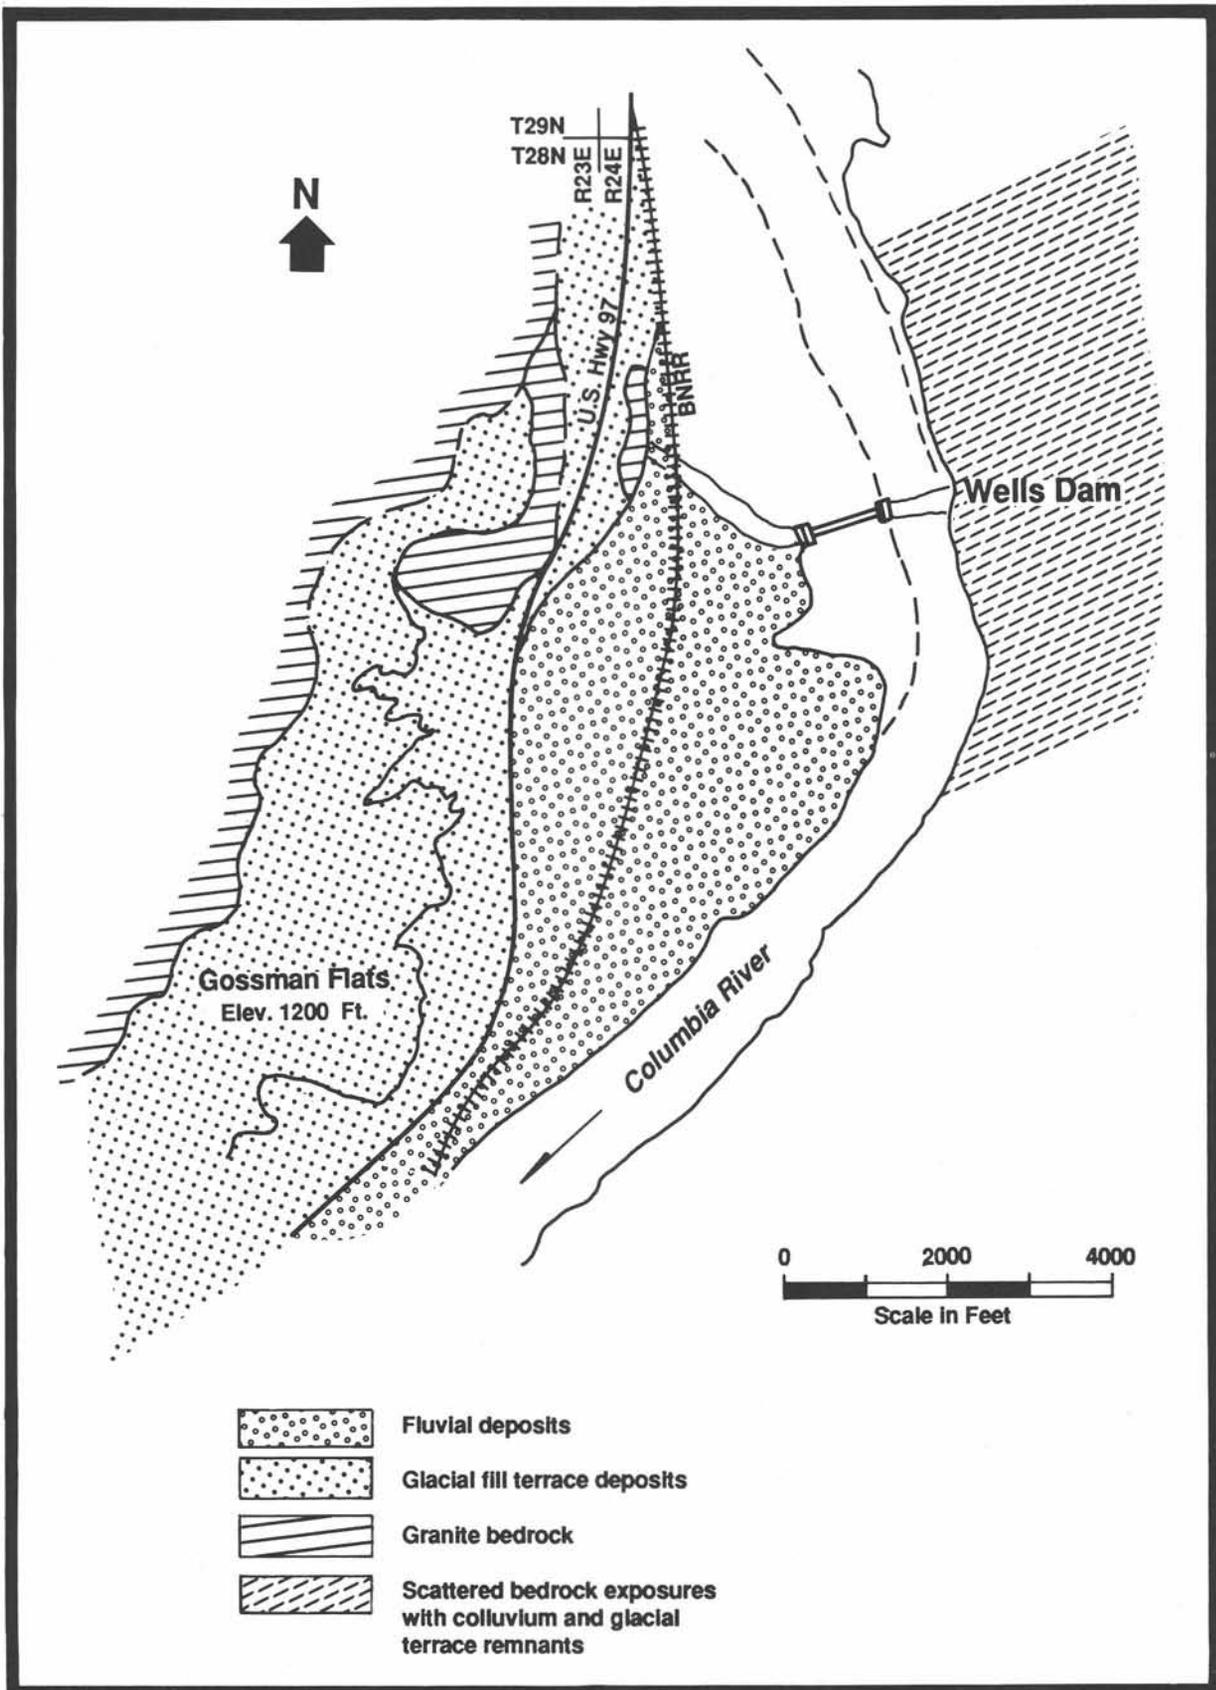
Figure 2. Generalized geologic map of the Wells Dam area. Based on U.S. Geological Survey Azwell and Wells Dam 7.5-minute topographic quadrangles. BNRR, Burlington Northern Railroad.

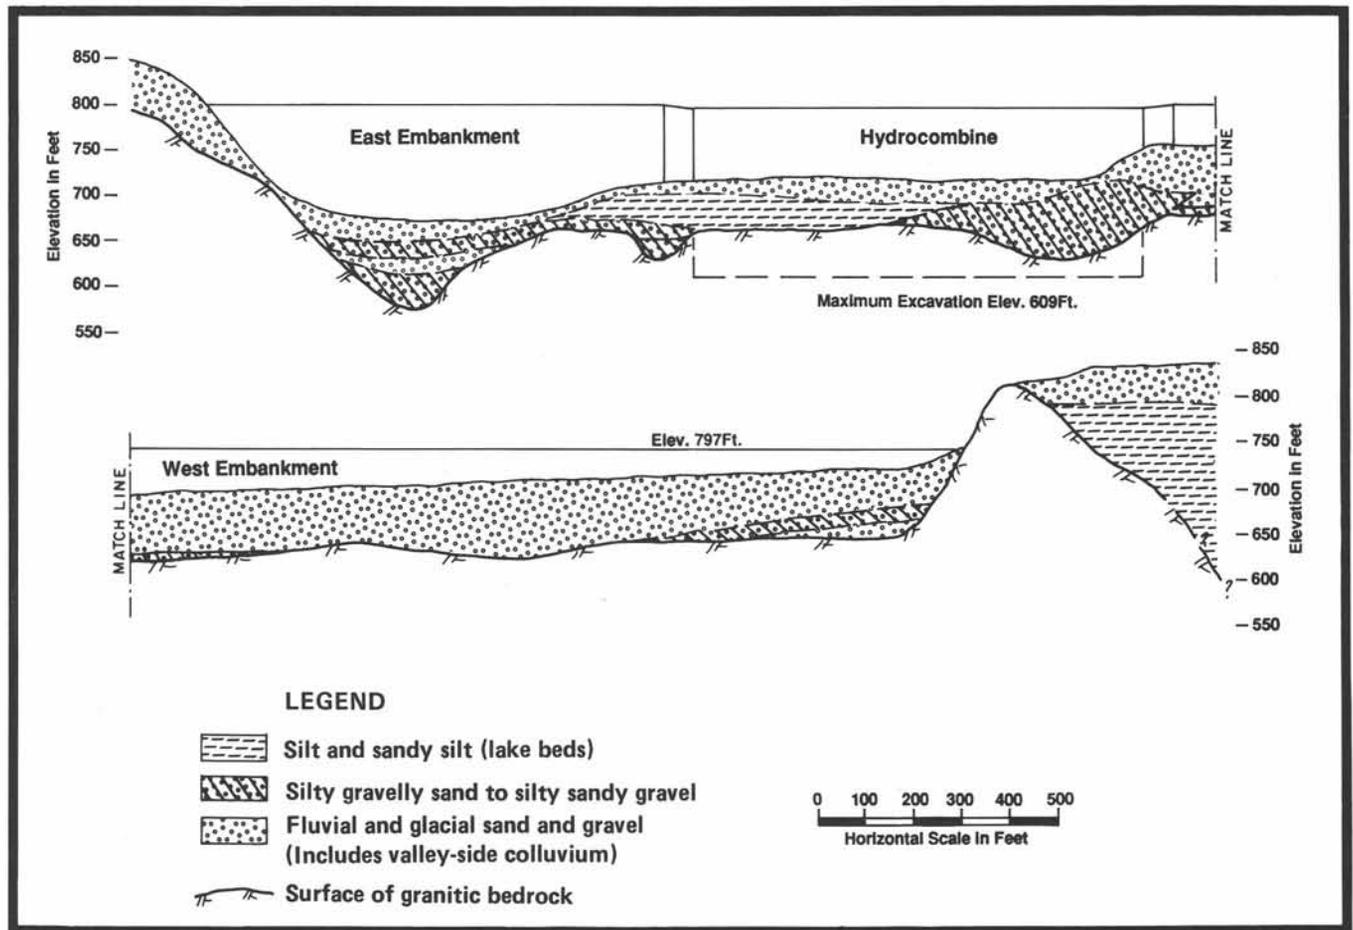
Figure 3. Generalized geologic section at Wells Dam. Surficial materials not shown. After Bechtel Corporation (1961).

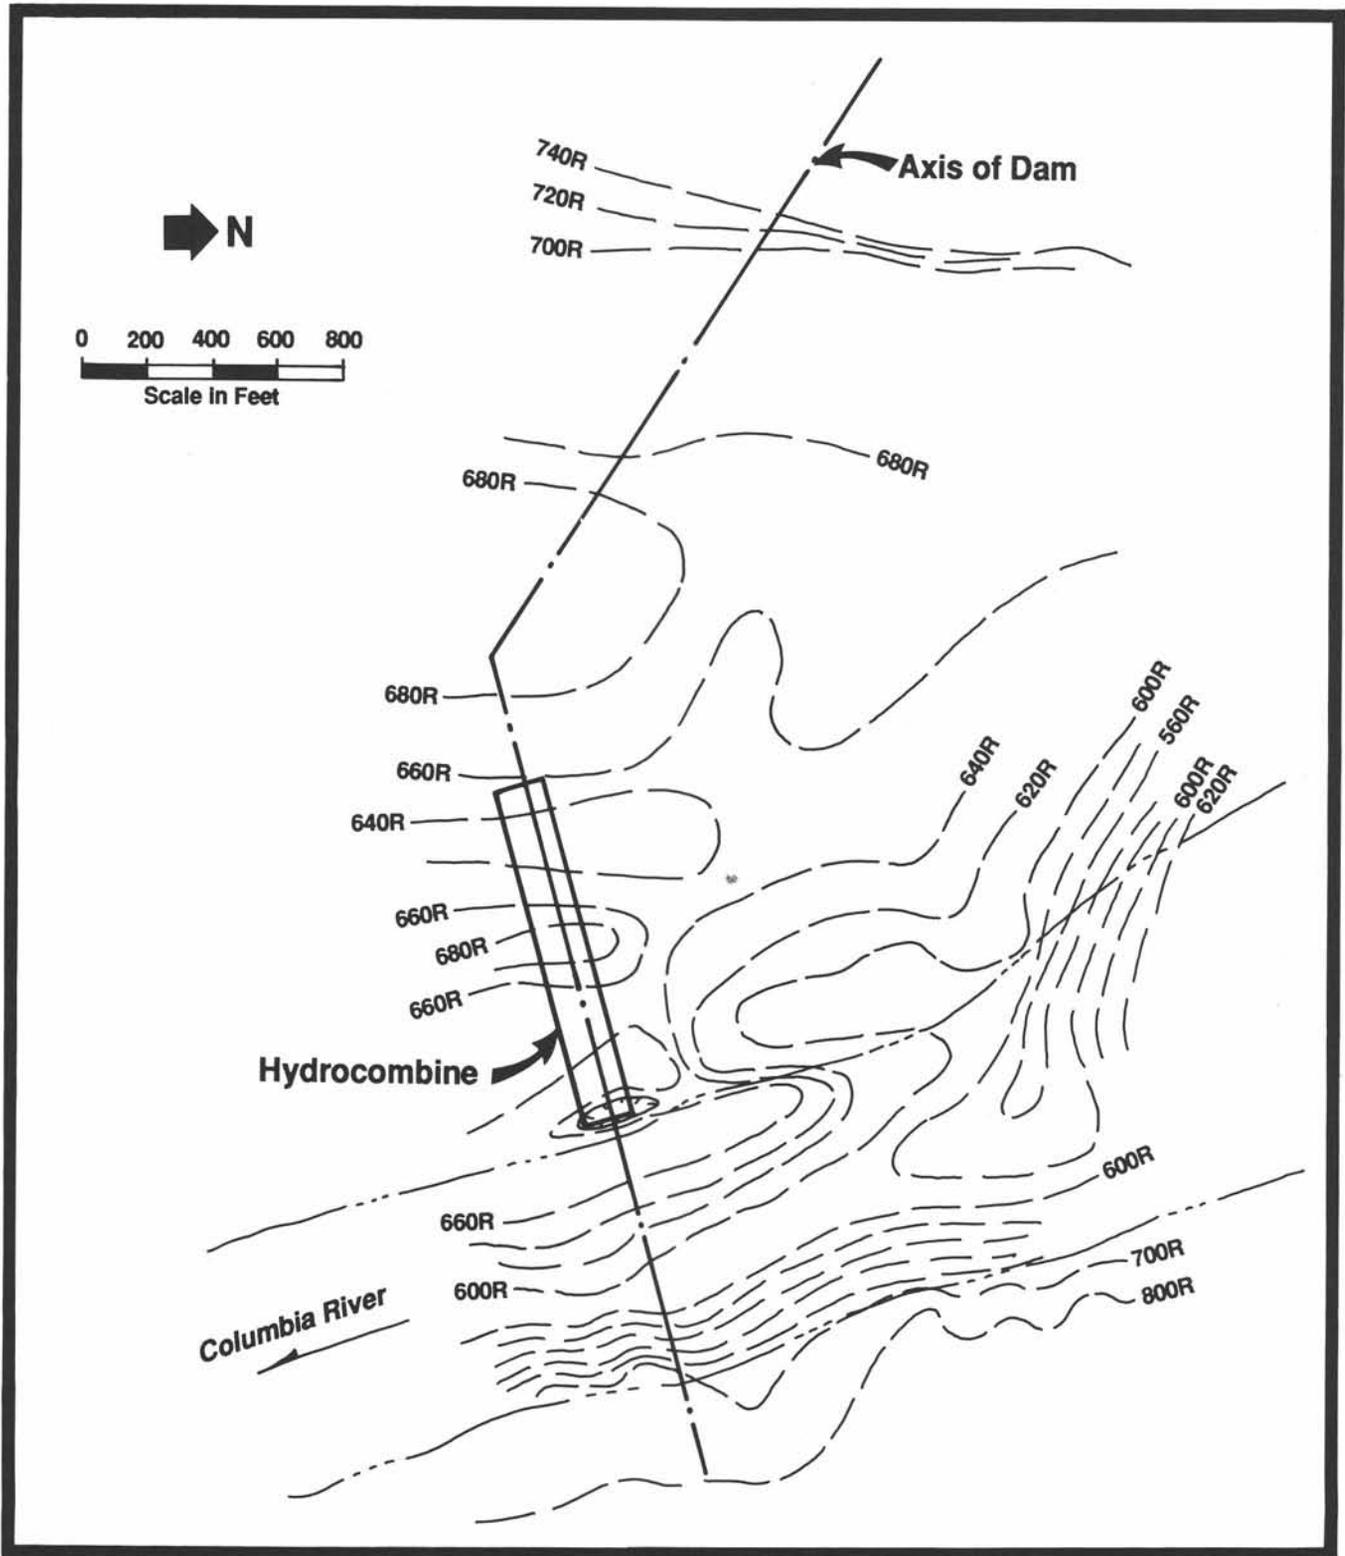
Figure 4. Bedrock configuration at Wells Dam. Rock surface contour interval 20 ft. After Bechtel Corporation (1961).

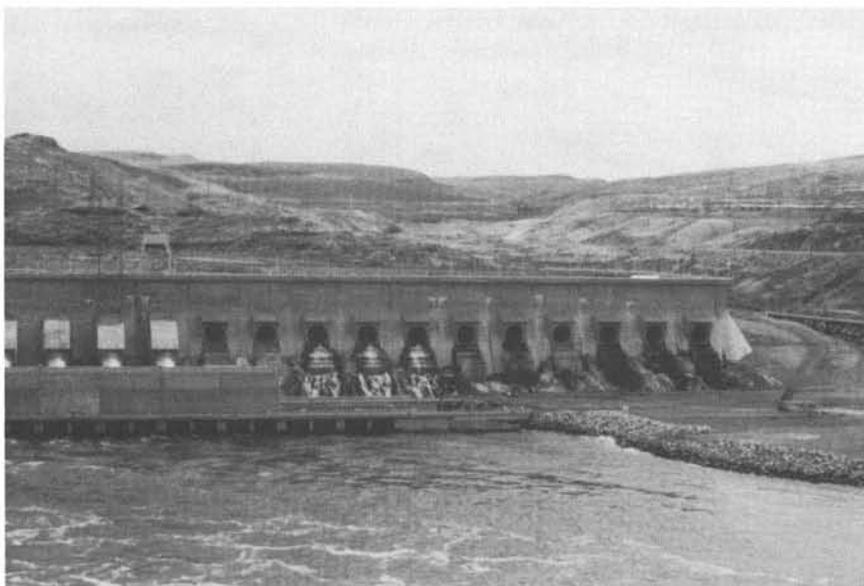
Chief Joseph Dam, showing part of the intake dam and powerhouse. Blanks for future penstocks were provided in the intake dam during the original construction, and the project had a partly finished appearance between 1956 and 1978. Photograph by R. W. Galster, July 1974.

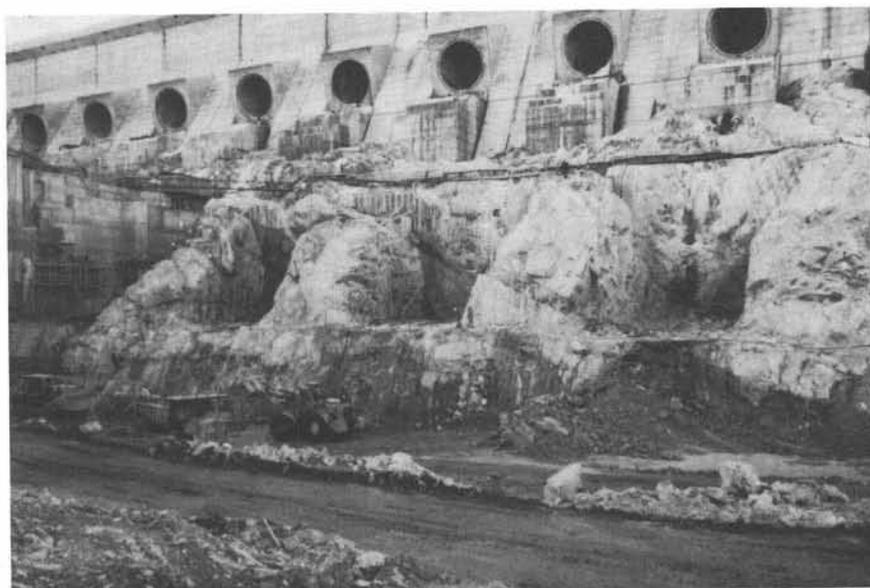
Chief Joseph Dam, showing excavation of two slots in the granite bedrock for installation of penstocks. Blanks for the future penstocks were provided during original construction. Photograph by R. W. Galster, January 1976.
